ANNUAL REPORT FOR 2013

Harris Mill Run Creek
Pitt County
TIP No. U-5018A
USACE Action ID: 200900960
DWR Project #: 20090261 v.1

Prepared By:
Roadside Environmental Unit & Natural Environment Section
North Carolina Department of Transportation
September 2013

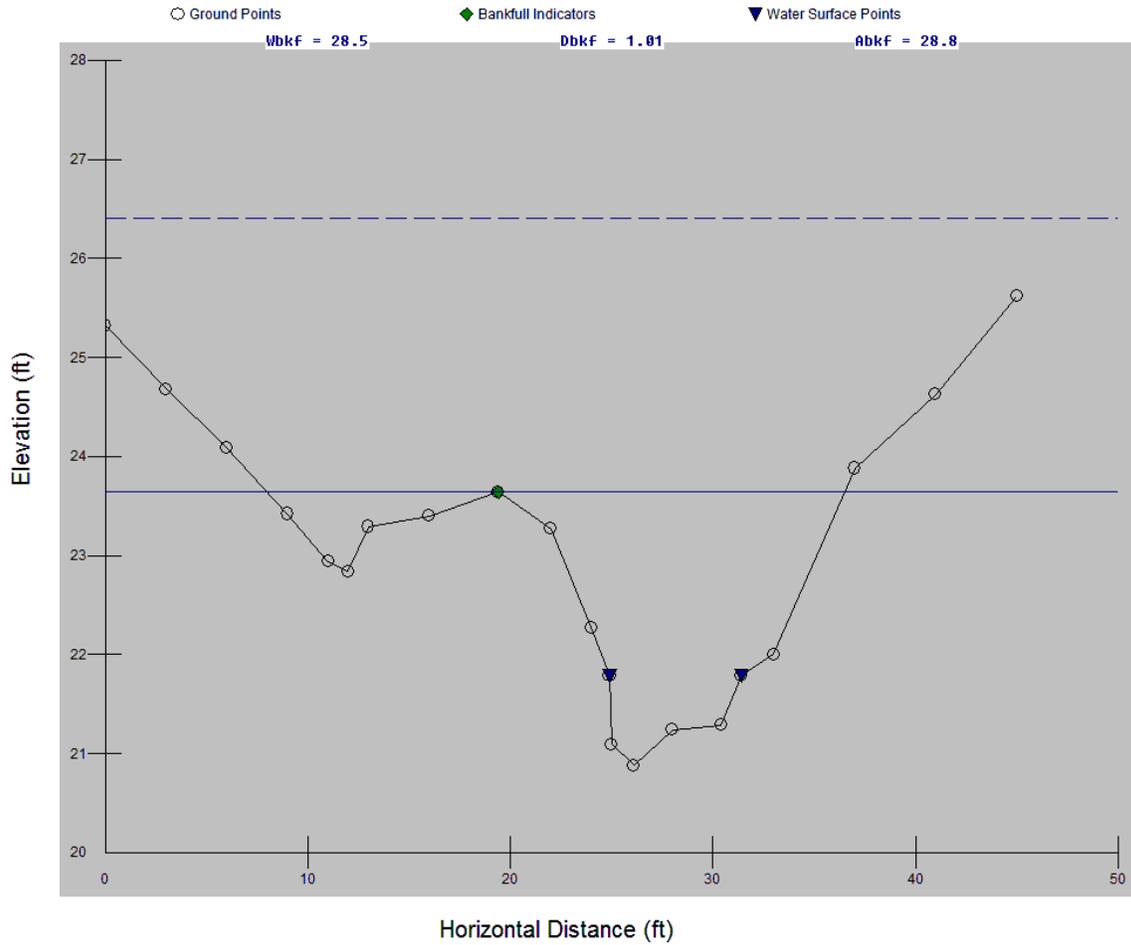
U-5018A Harris Mill Run Creek Cross Section #1

Based on the 2013 monitoring data, the one riffle cross section appears stable with little or no active bank erosion. Graph of the cross section is presented in Appendix A. Future survey data will vary depending on actual location of rod placement and alignment; however this information should remain similar in appearance. Through visual observation, the channel appears stable throughout the mitigation site at this time.

Cross-Section #1 (Riffle) Abbreviated Morphological Summary					
	2013	2014	2015	2016	2017
Bankfull Width (ft)	17.09				
Bankfull Mean Depth (ft)	1.47				
Width/Depth Ratio	11.63				
Bankfull Cross Sectional Area (ft ²)	25.17				
Maximum Bankfull Depth (ft)	2.76				
Width of the Floodprone Area (ft)	45				
Entrenchment Ratio	2.63

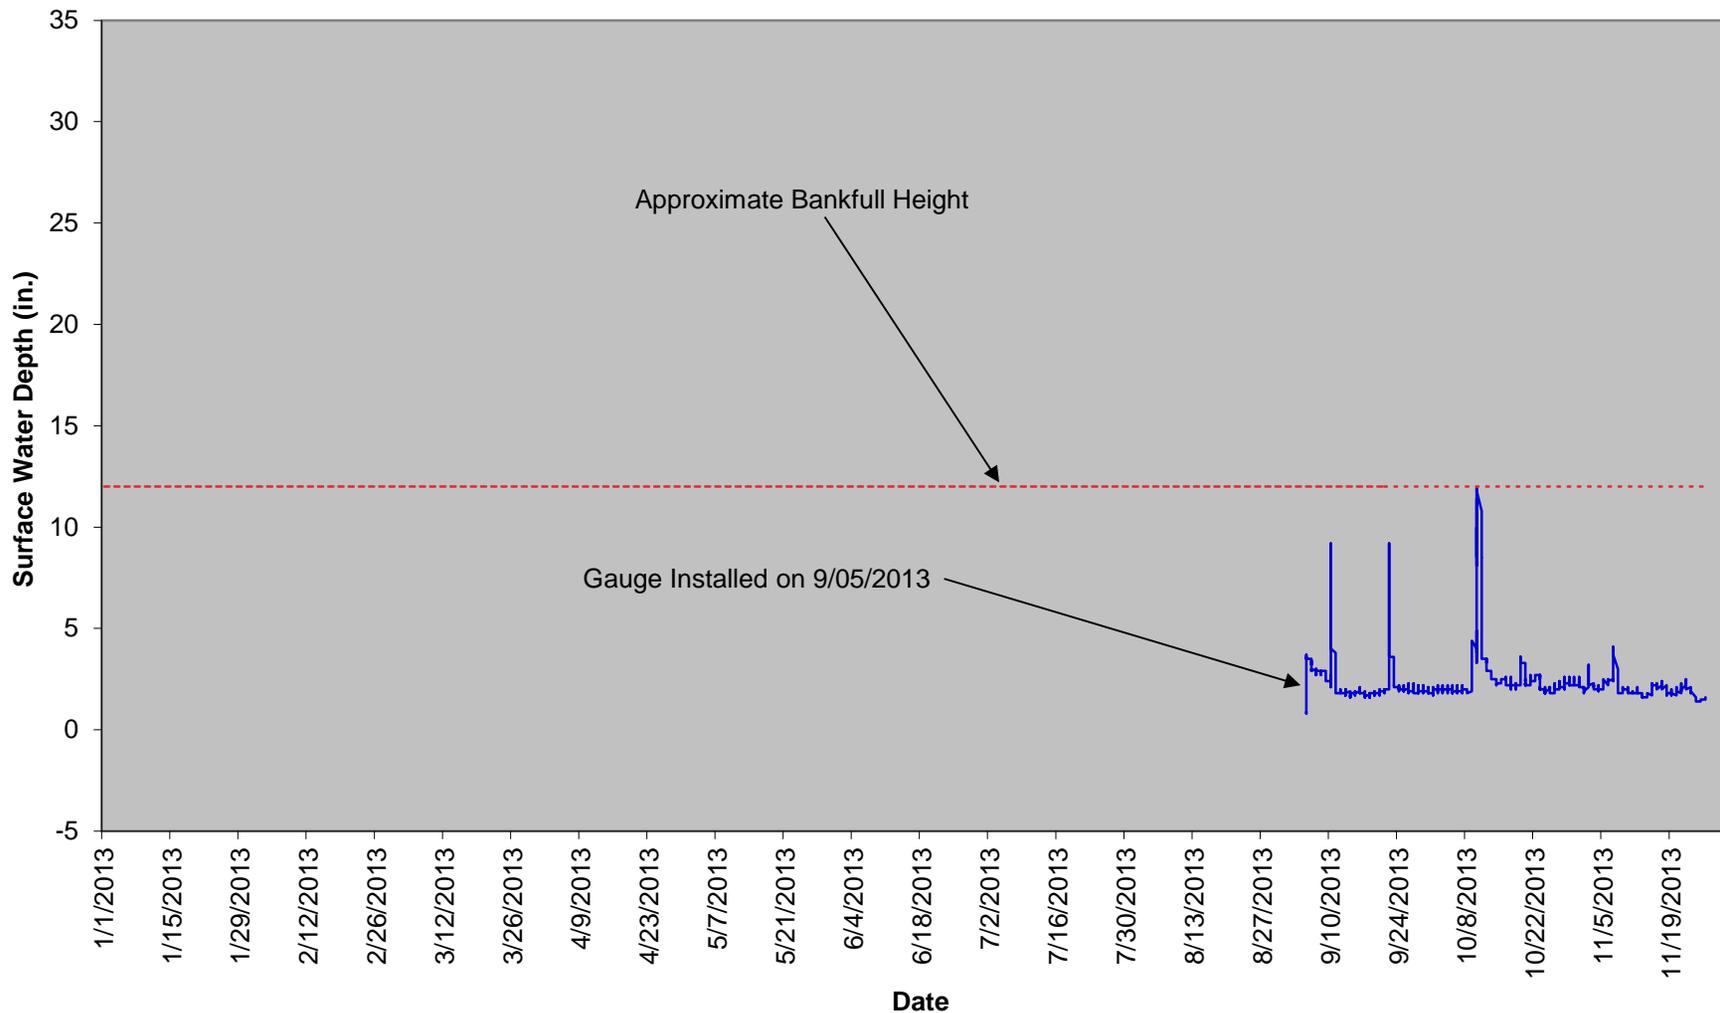
Harris Mill Run Creek
HMR-SG1
40" Surface Gauge

A surface water gauge was installed at the site September 15, 2013 in accordance with the permit conditions to assess the hydraulic conditions present at the site. A review of peak stream flows was conducted for the period between September and November 2013. According to the graph, there were zero bankfull events recorded at the site during the monitoring period. The graphical representation of the gauge data is presented in Appendix C.
