ANNUAL REPORT FOR 2014

Harris Mill Run Creek
Pitt County
TIP No. U-5018A
USACE Action ID: 200900960
DWR Project #: 20090261 v.1

Prepared By:
Roadside Environmental Unit & Natural Environment Section
North Carolina Department of Transportation
August 2014

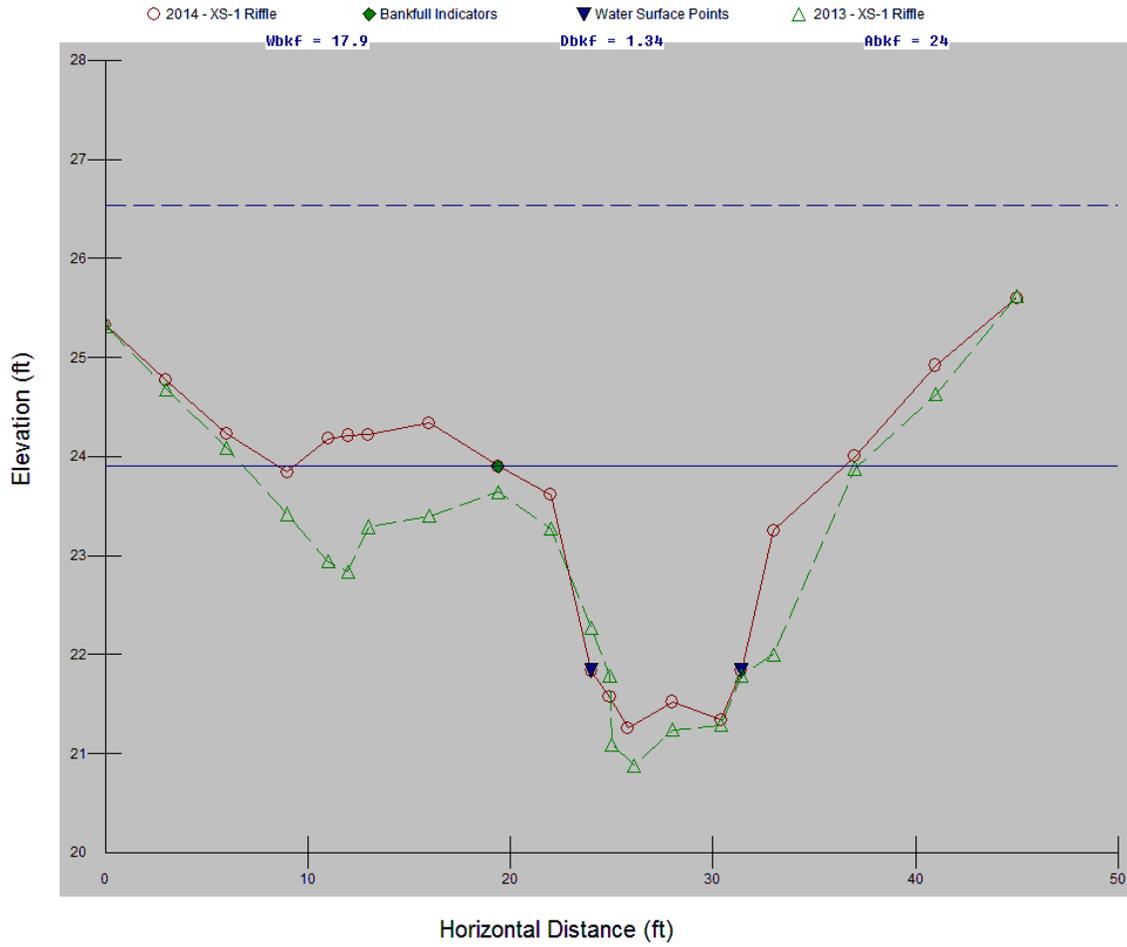
U-5018A Harris Mill Run Creek Cross Section #1

Based on the 2014 monitoring data, the one riffle cross section appears stable with little or no active bank erosion. The cross section shows a large deposit of sand along the left bank due to bankfull events (see photo in Appendix B). Graph of the cross section is presented in Appendix A. Future survey data will vary depending on actual location of rod placement and alignment; however this information should remain similar in appearance. Through visual observation, the channel appears stable throughout the mitigation site at this time, except for, some left bank scouring around the surface water gauge (see photo in Appendix B). Once the surface water gauge is removed, this area should stabilize.

Cross-Section #1 (Riffle) Abbreviated Morphological Summary					
	2013	2014	2015	2016	2017
Bankfull Width (ft)	17.09	17.88			
Bankfull Mean Depth (ft)	1.47	1.34			
Width/Depth Ratio	11.63	13.34			
Bankfull Cross Sectional Area (ft ²)	25.17	24.02			
Maximum Bankfull Depth (ft)	2.76	2.64			
Width of the Floodprone Area (ft)	45	45			
Entrenchment Ratio	2.63	2.52

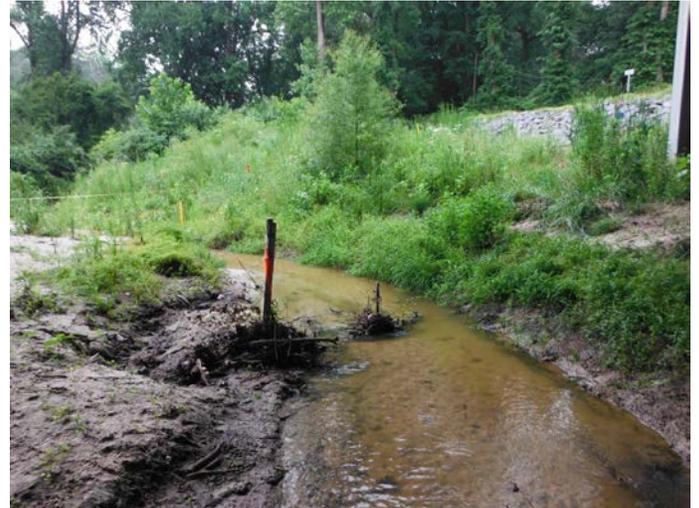
The Harris Mill Run Creek mitigation site has met the required monitoring protocols for the second formal year of monitoring. The channel remains stable at this time, except for, the left bank scouring around the surface water gauge. The streambank and buffer are meeting planted vegetation success criteria for the second year of monitoring. NCDOT will continue stream and vegetation monitoring at the Harris Mill Run Creek mitigation site for 2015.

Left bank scouring at surface water gauge

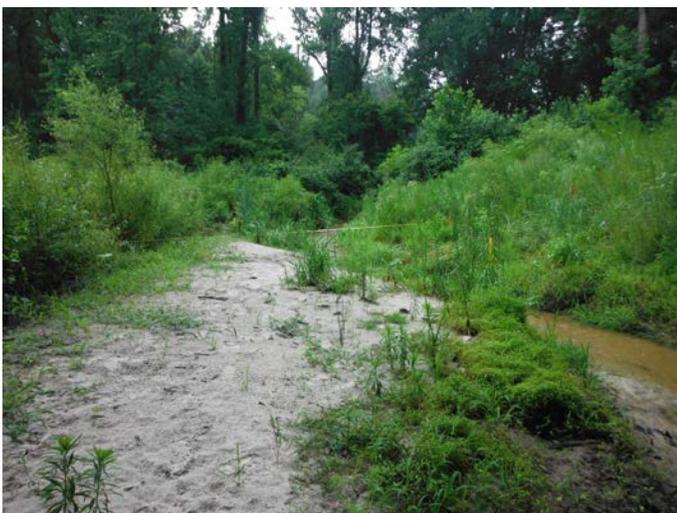
Left bank sand deposit from bankfull events
September 2013

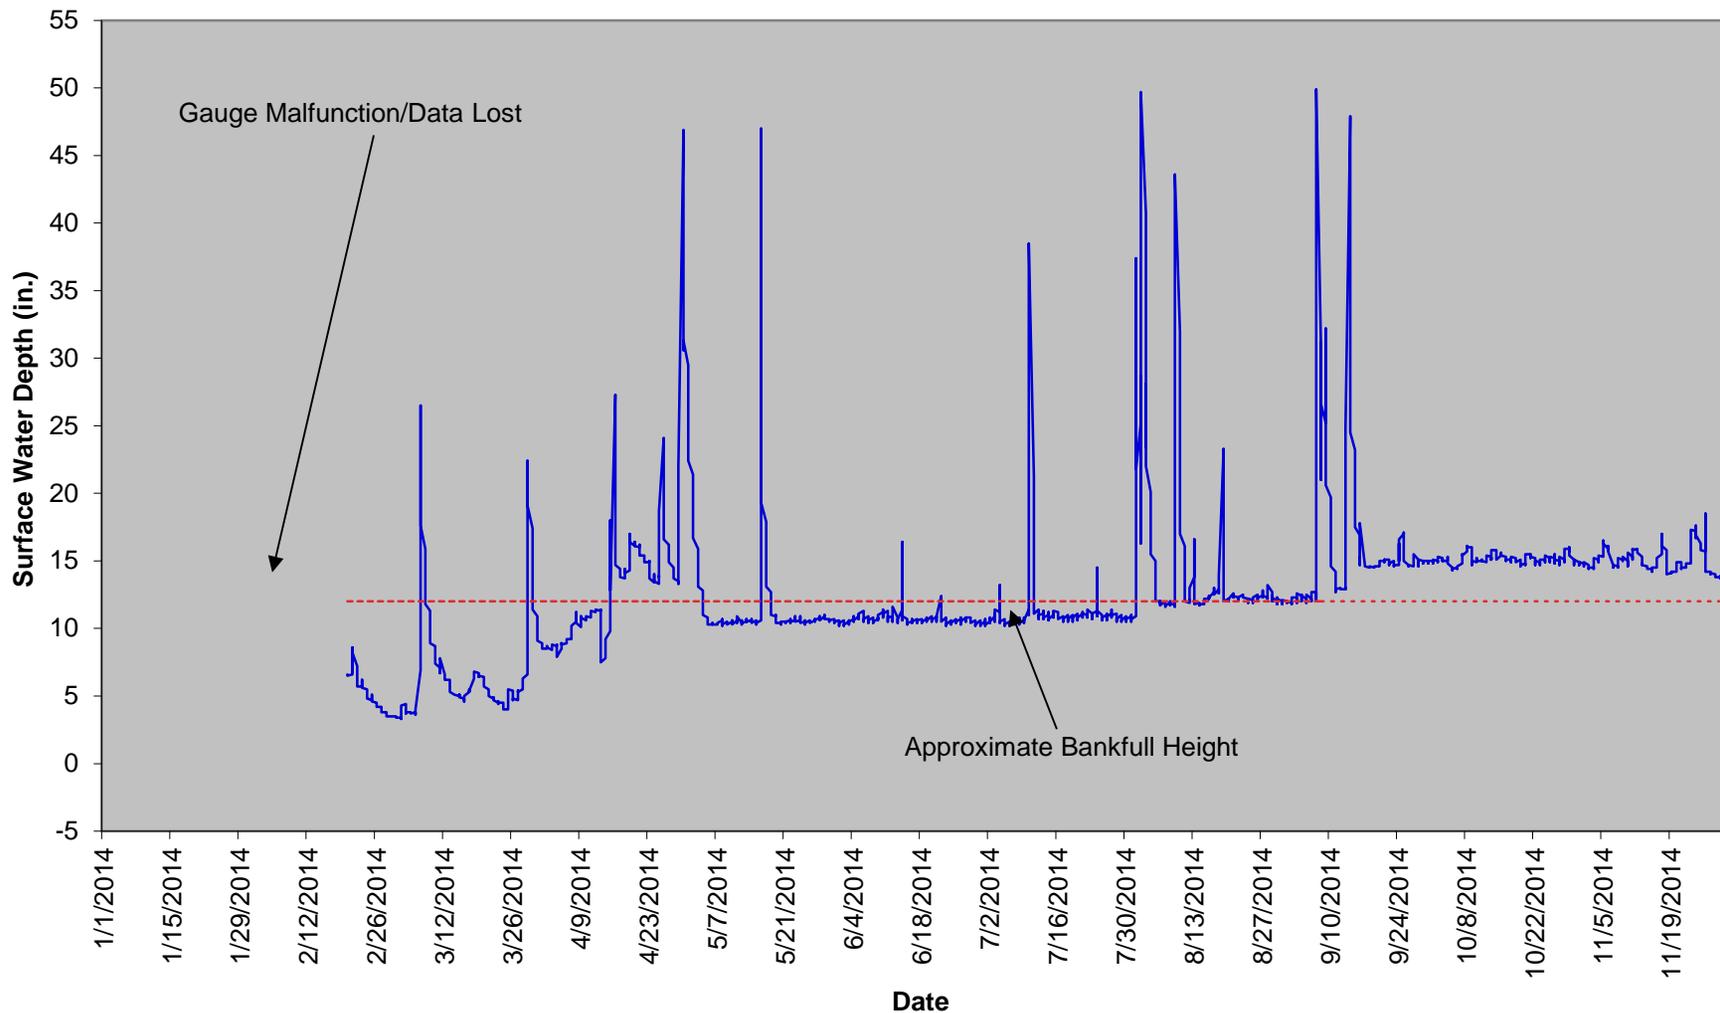
Harris Mill Run Creek
HMR-SG1
40" Surface Gauge

A surface water gauge was installed at the site September 15, 2013 in accordance with the permit conditions to assess the hydraulic conditions present at the site. A review of peak stream flows was conducted for the period between January and November 2014. According to the graph, there were numerous bankfull events recorded at the site during the monitoring period. The graphical representation of the gauge data is presented in Appendix C.
