# ANNUAL REPORT FOR 2015

**Harris Mill Run Creek**  
**Pitt County**  
**TIP No. U-5018A**  
**USACE Action ID: 200900960**  
**DWR Project #: 20090261 v.1**

Prepared By:  
Roadside Environmental Unit & Natural Environment Section  
North Carolina Department of Transportation  
August 2015

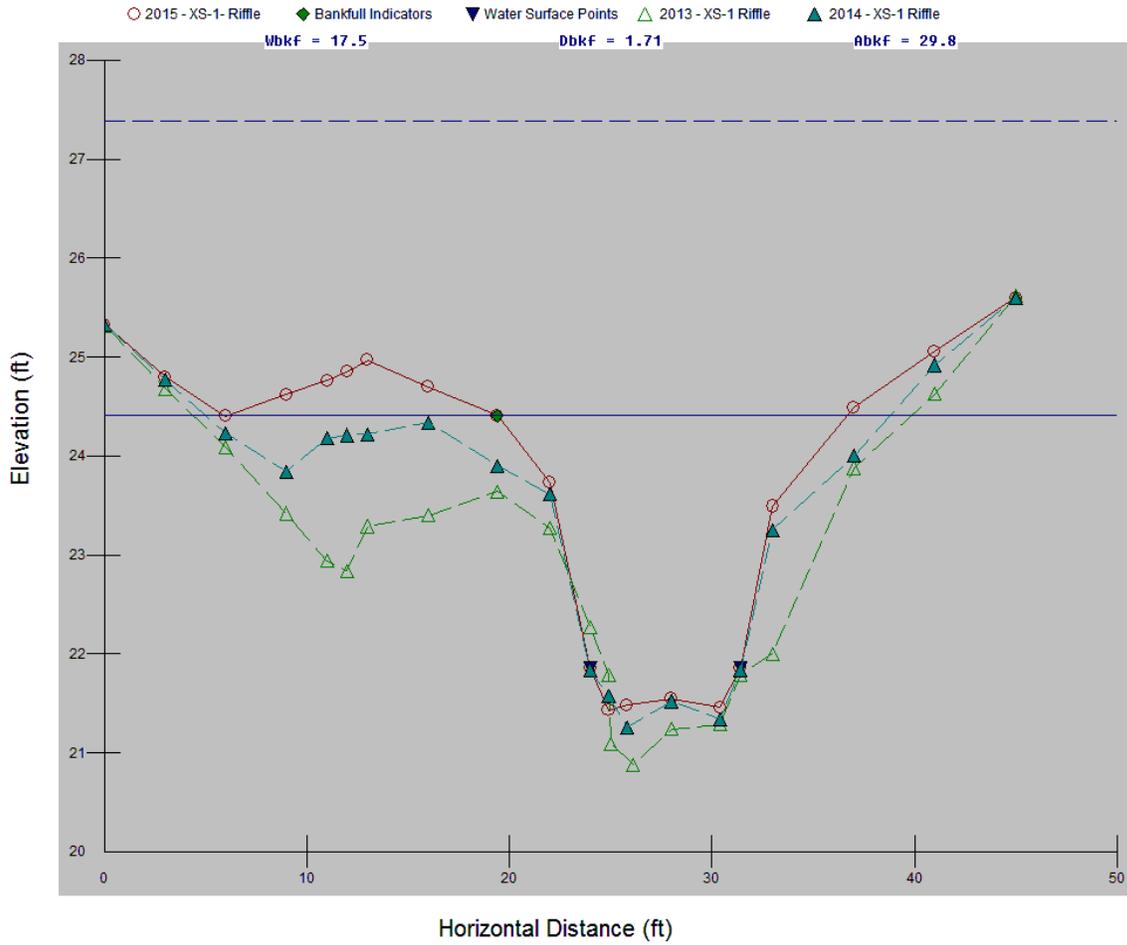
### U-5018A Harris Mill Run Creek Cross Section #1

Based on the 2015 monitoring data, the one riffle cross section appears stable with little or no active bank erosion. The cross section shows a large deposit of sand along the left bank due to numerous bankfull events (see photo in Appendix B). The graphical representation of the cross section is presented in Appendix A. Future survey data will vary depending on actual location of rod placement and alignment; however this information should remain similar in appearance. Through visual observation, the channel appears stable throughout the mitigation site at this time. The surface water gauge that was causing an area of bank scouring along the left bank was removed. This area is now stable (see photo in Appendix B).

Cross-Section #1 (Riffle) Abbreviated Morphological Summary					
	2013	2014	2015	2016	2017
Bankfull Width (ft)	17.09	17.88	17.49		
Bankfull Mean Depth (ft)	1.47	1.34	1.71		
Width/Depth Ratio	11.63	13.34	10.23		
Bankfull Cross Sectional Area (ft <sup>2</sup> )	25.17	24.02	29.82		
Maximum Bankfull Depth (ft)	2.76	2.64	2.98		
Width of the Floodprone Area (ft)	45	45	45		
Entrenchment Ratio	2.63	2.52	2.57

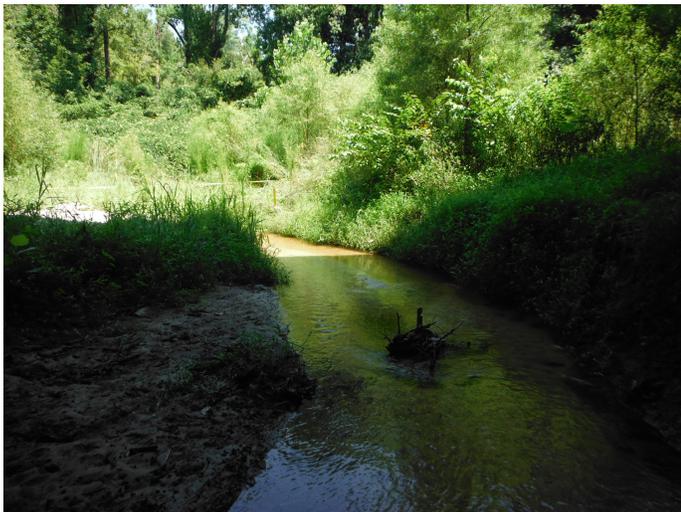
A surface water gauge was installed at the site September 15, 2013 in accordance with the permit conditions to assess the hydraulic conditions present at the site. According to the 2014 monitoring report, numerous bankfull events were recorded at the site. Due to bank stability issues caused by the surface water gauge, it was removed in March of 2015.

Left bank where surface water gauge is removed  
August 2015
