Monitoring Data Record

Project Title: Talecris access road project COE Action ID: 201000775
 Stream Name: UT Neuse River (Talecris Site) DWQ Number: 20100310
 City, County and other Location Information: Turn onto Talecris access road off of Powhatan Road in Clayton, NC.
 Date Construction Completed: February 2011 Monitoring Year: (2) of 3
 Ecoregion: _____ 8 digit HUC unit 03020201
 USGS Quad Name and Coordinates: NC-Powhatan N 35.62287, W 78.41307

UT to Neuse River

(Talecris Site)

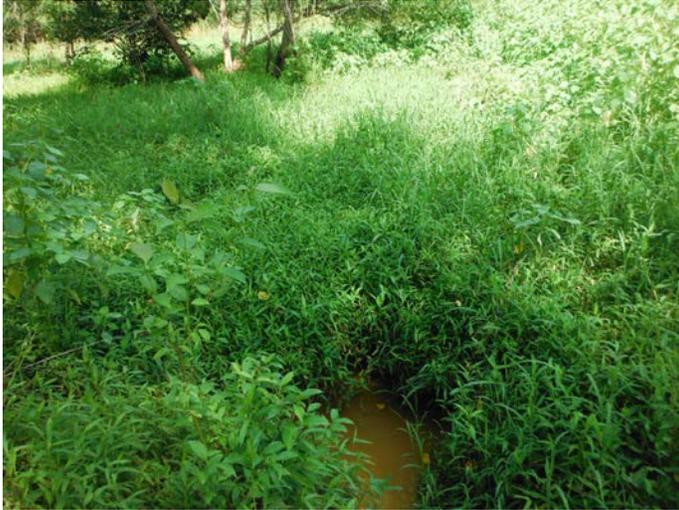
PP #4 (Upstream)

UT to Neuse River (Talecris Site) is stable for the Year 2 monitoring evaluation. A headcut that was noted previously approximately 12 feet upstream of Photo Point #4 remains stable at this time. There was no flow in the channel next to Photo Point #4, instead, the flow was in another channel north of this location. This channel remains stable and highly vegetated. A bankfull event had recently occurred. NCDOT will continue to monitor channel stability at the UT to Neuse River.

Date Inspected 6/25/13	12 feet upstream of PP #4	Station Number	Station Number	Station Number	Station Number
Structure Type					
Is water piping through or around structure?					
Head cut or down cut present?	Headcut has formed upstream of PP#4				
Bank or scour erosion present?					
Other problems noted?
