Monitoring Data Record

Project Title: Phase 1 – Middlesex Corporate Center COE Action ID: 200900640
Stream Name: UT Turkey Creek (UT-1 & UT-2) DWQ Number: 07-0228v4
City, County and other Location Information: The project is located in the southern region of Nash County where Highway 264 and Highway 231 intersect, about 2 miles east of Middlesex, NC.
Date Construction Completed: February 2011 Monitoring Year: (2) of 3
Ecoregion: _____ 8 digit HUC unit 03020203
USGS Quad Name and Coordinates: N 35 47' 50", W 78 11' 36"

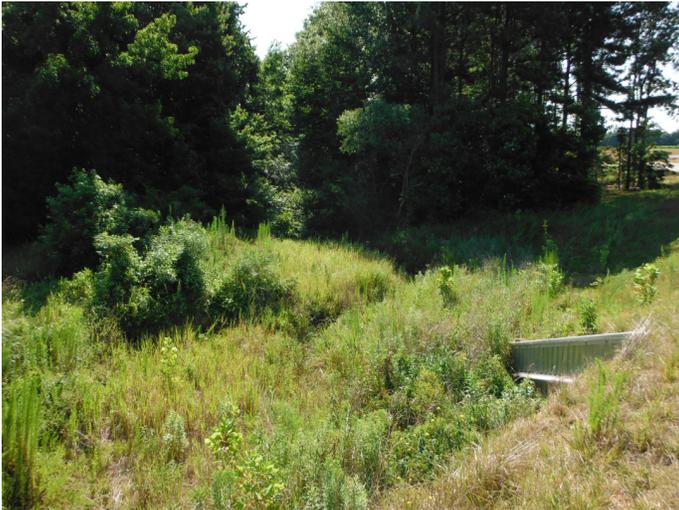
The left buffer of UT-1 has not been completely excavated due to a power pole that was left inside the buffer limits at the time of construction. The power pole has since been removed but the buffer still needs to be completely excavated. (See the overview photo for UT-1)

Overview photo looking downstream from road project

Estimated causes, and proposed/required remedial action: The Division has been contacted to complete the excavation of the buffer.

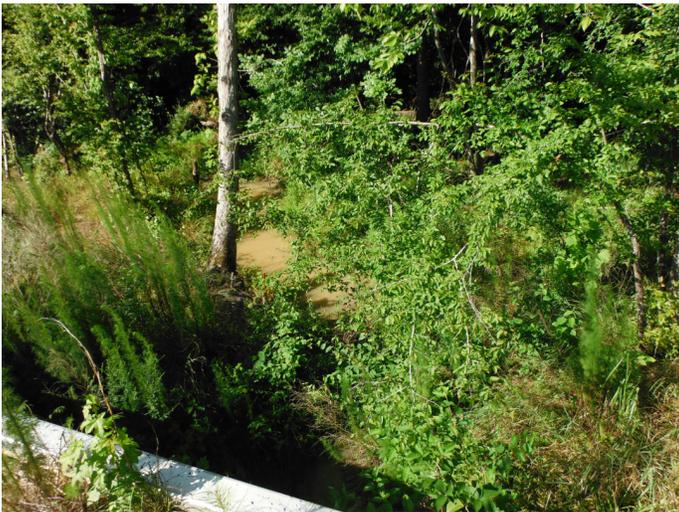
Overview photo looking upstream from road project

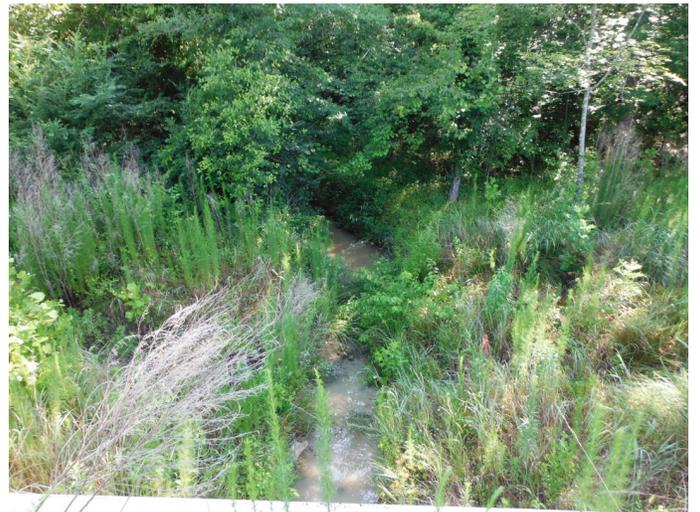
Overview photo looking downstream from road project
