Monitoring Data Record

Project Title: Phase 1 – Middlesex Corporate Center COE Action ID: 200900640
Stream Name: UT Turkey Creek (UT-1 & UT-2) DWQ Number: 07-0228v4
City, County and other Location Information: The project is located in the southern region of Nash County where Highway 264 and Highway 231 intersect, about 2 miles east of Middlesex, NC.

UT to Turkey Creek (UT-1)

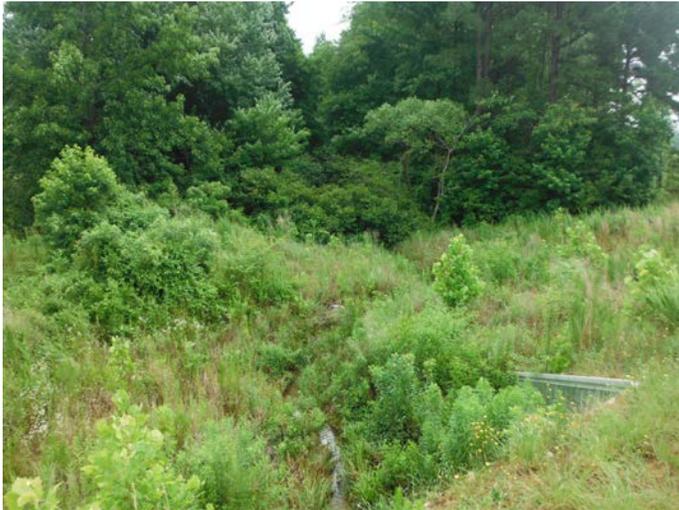
The left buffer of UT-1 has not been completely excavated due to a power pole that was left inside the buffer limits at the time of construction. The power pole has since been removed but the buffer still needs to be completely excavated (See the overview photo for UT-1).

Overview photo looking downstream from road project

Estimated causes, and proposed/required remedial action: The Division has been contacted to complete the excavation of the buffer.

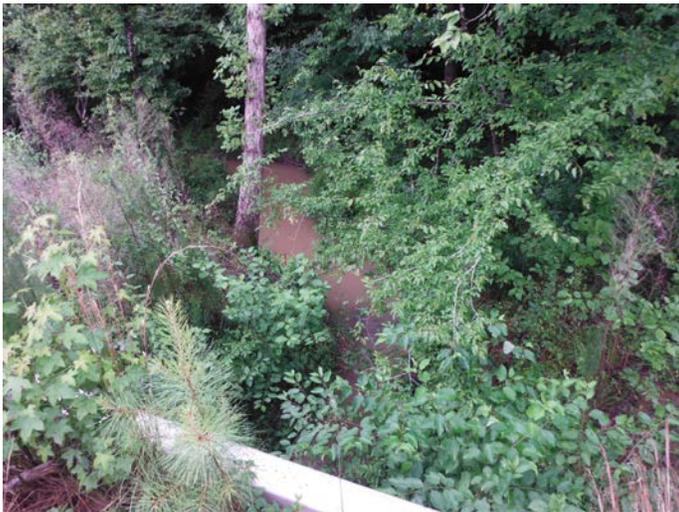
Overview photo looking upstream from road project

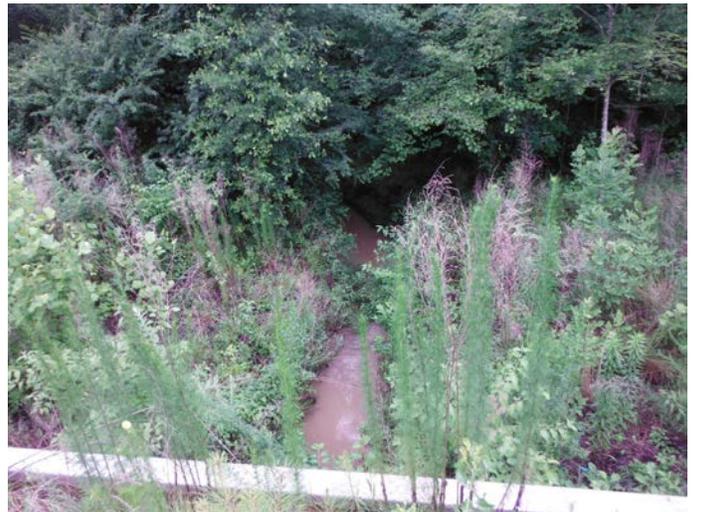
Overview photo looking downstream from road project
