# **FINAL PHASE II CLOSEOUT REPORT**

## **Croatan Wetland Mitigation Bank Craven County, North Carolina**

**The Ecosystem Enhancement Program  
EEP Project No. 103**

January 2008

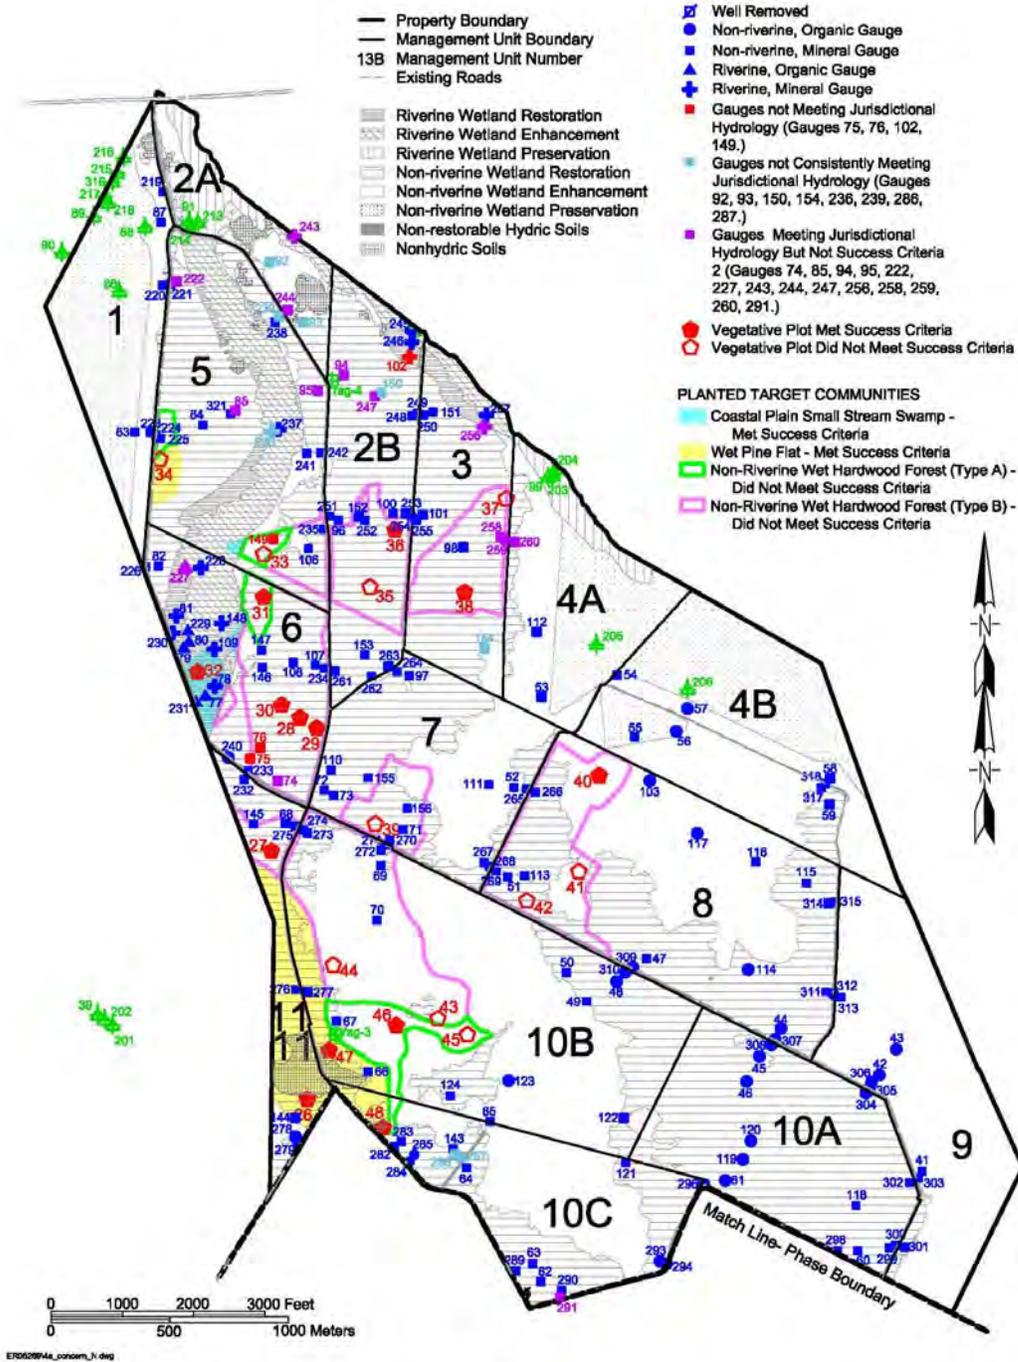
Figure 3. Summary of 5 Years Monitoring, Croatan WMB, Phase II

The majority of the monitoring gauges [158 (85.9%)] in Phase II of the CWMB met both respective hydrologic success criteria ( $\geq 12.5\%$  [mineral soils] or  $\geq 25\%$  [organic/riverine soils] of the growing season and within 20% of Reference Range) consistently ( $\geq 4$  years out of 5) throughout the five year monitoring period (**Figure 3**).

All of the gauges in Phase II should be removed and credits released based on the contingency plan developed for the areas that have not been successfully enhanced and/or restored.
