## THERMAL INTEGRITY PROFILING (TIP) Drilled Shafts in South Carolina

- **Non-Destructive Test (NDT) Methods**
  - Crosshole Sonic Logging (CSL) and TIP
- **Carolina Bays Parkway Phase III**
  - TIP; Probe, Embedded Wires, Suspended Wires
- **US-15 O-Cell Test Shaft**
  - Manufactured Anomalies
- **Project YEEO (for Your Eyes and Ears Only)**
  - Aggressive Schedule

David Schoen, EIT  
S&ME, Inc.  
Charleston, SC

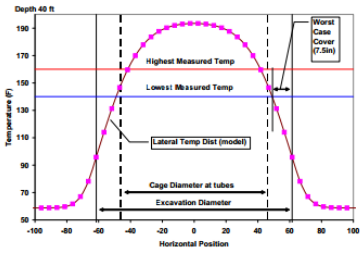
*Temperature distribution for 10 ft diameter shaft (WSDOT). Lowest temperature measured corresponded to a 7.5 in cover*

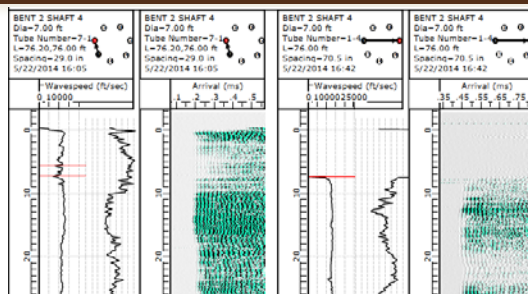
#### ■ “No Signal” in CSL data

- Long permanent casing
- Two cages in upper portion of shaft
- Common in coastal plain drilled shafts
- CSL on column cage

#### ■ “Anomalies” attributed to bleedwater

- Observed “welling” of water on top of shaft
- Coring indicated bleedwater path cavities and small air bubbles

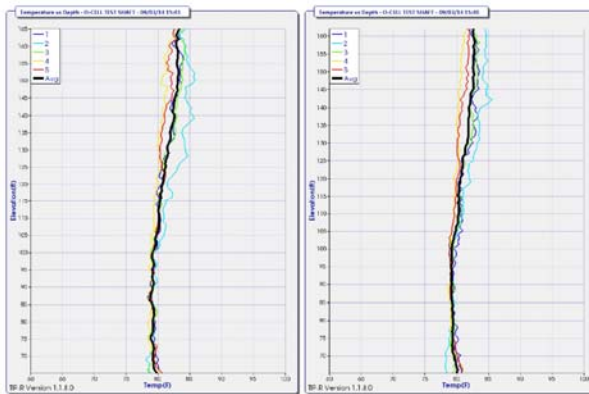
## TIP WIRES – CONCRETE PLACEMENT US-15 O-Cell Test Shaft

- Defects not apparent after concrete placement
- Concrete and slurry at similar temps?

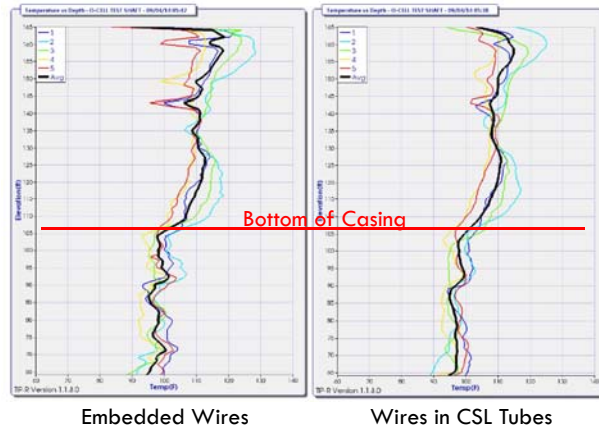
## TIP WIRES – 14 HOURS AFTER PLACEMENT US-15 O-Cell Test Shaft

- **Embedded Wires**
  - Top defect – 9 to 11% temp reduction
  - Lower defect – 10 to 13% temp reduction
- **Wires in CSL tubes**
  - Top defect – 3 to 5% temp reduction
  - Lower defect – 4 to 7% temp reduction
- **What is too big of a reduction?**
- **Tube 4 at depth of 15 ft?**

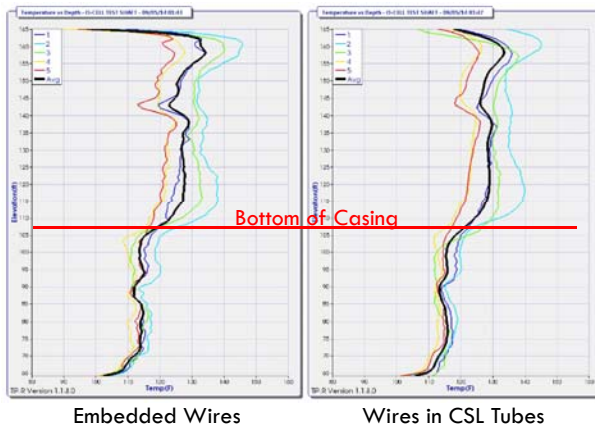
## TIP WIRES – 34 HOURS (PEAK-TEMP) US-15 O-Cell Test Shaft

- **Embedded wires**
  - Still show some indication of defects
- **Wires in CSL tubes**
  - Barely indicate defects
- **What if this was when the probe was performed?**
  - Wires allow for multiple time points to be analyzed

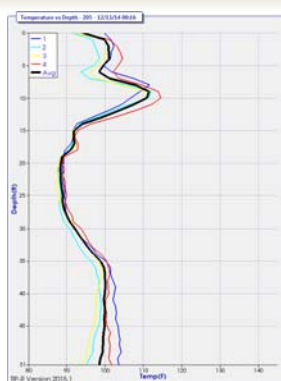
Middle truck not heating  
9 hours after concreting

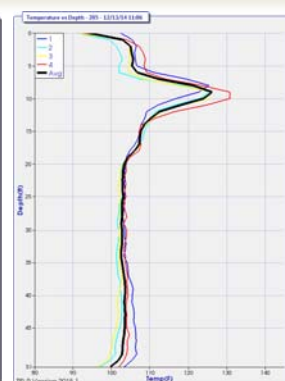
“Peak-Temp”  
21 hours after concreting

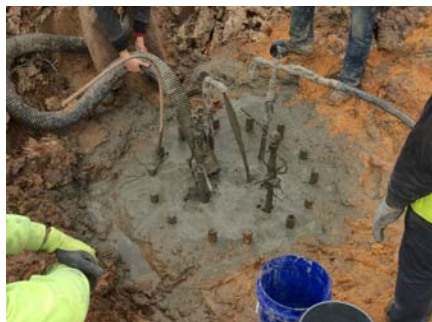
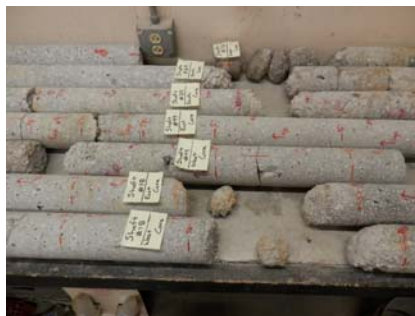
## EXPLORATORY CORING AND REMEDIATION YEEO

- Cored one 8-ft shaft and three 4-ft shafts, in two locations each

### ■ Pressure Grouting

- Packers or plugs
- Flush with water (connect holes)
- Pump with grout
