2013 Geo<sup>3</sup>T<sup>2</sup> Conference

# Crosshole Sonic Logging: A 10 Year Perspective

**Kyle Murrell, PE**

**S&ME, Inc.**

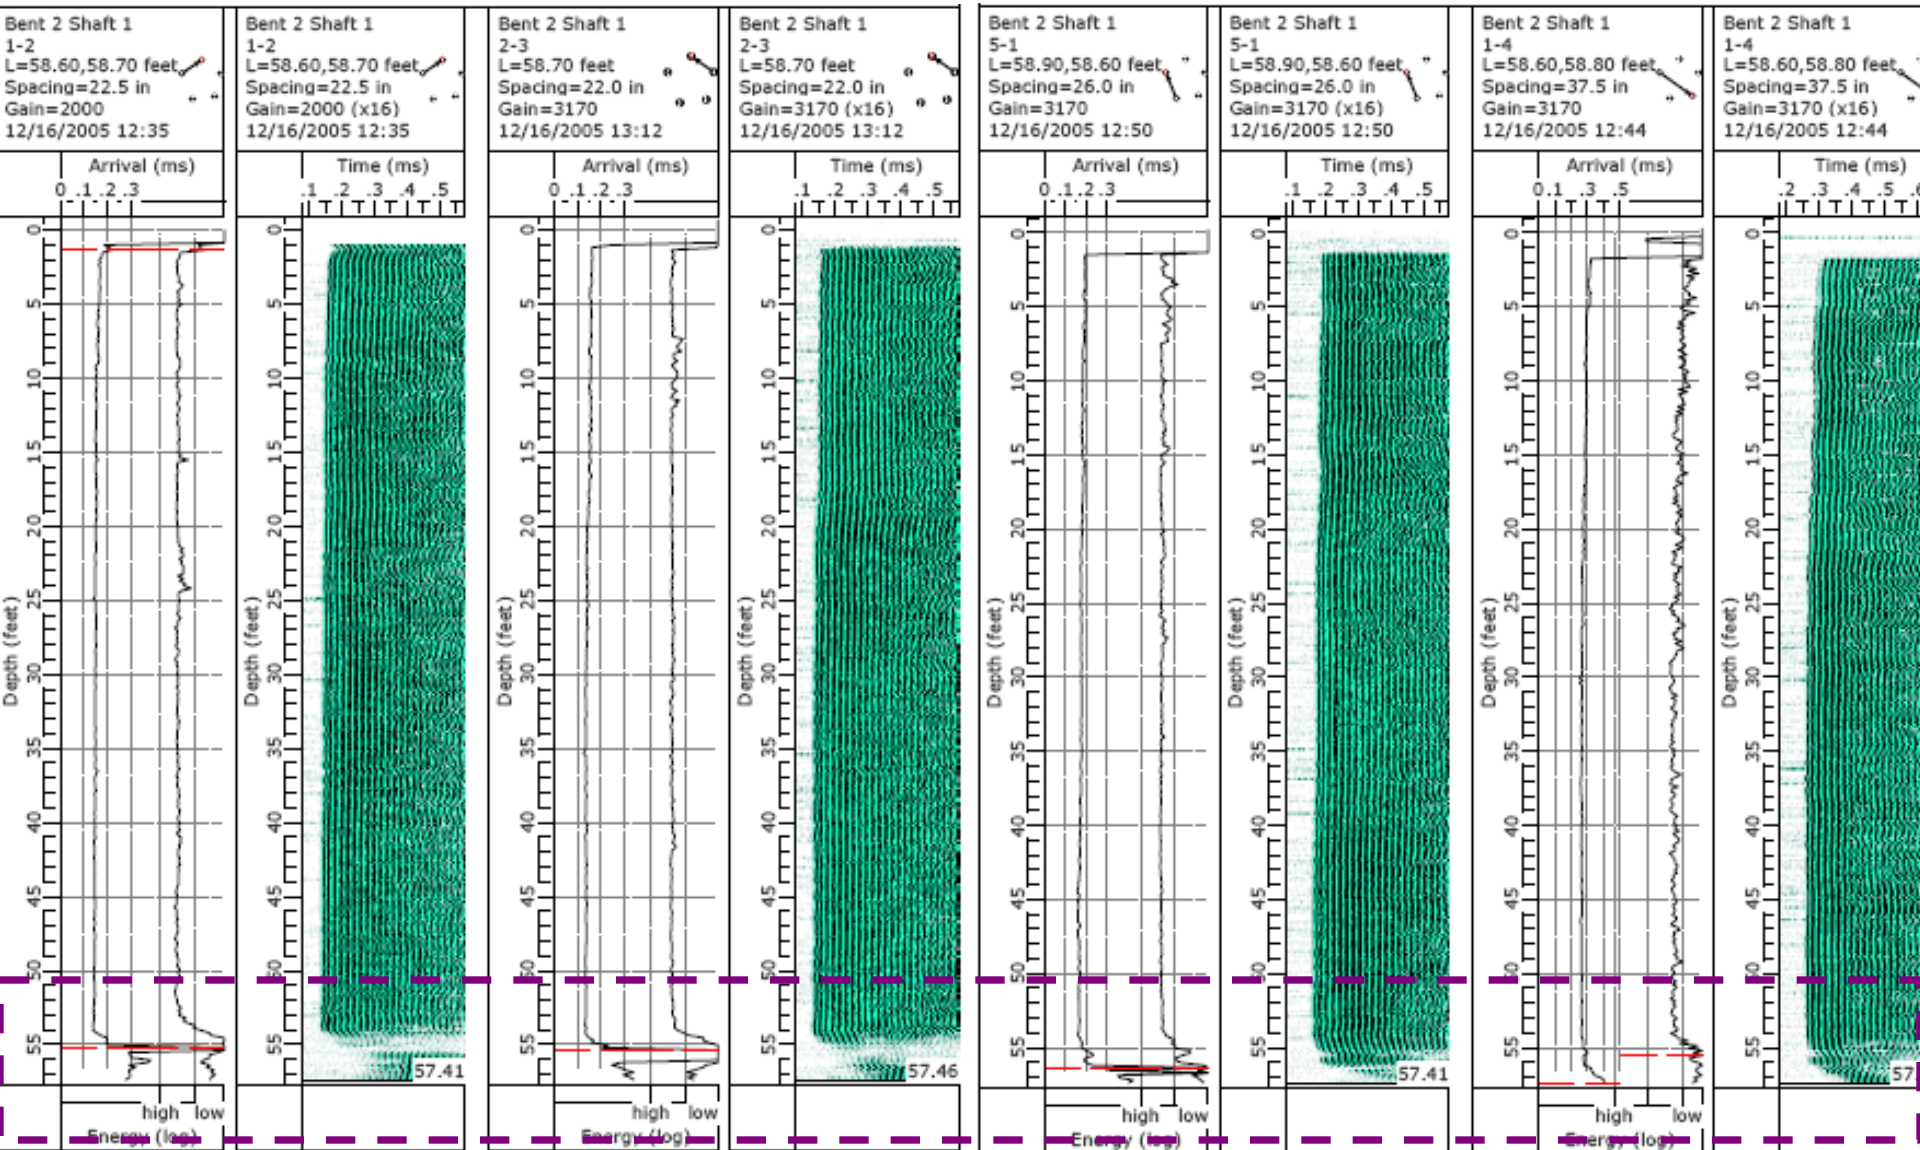
# Hellers Creek – Cont.

- Classification – “Poor/Defective”
- Recommendation - Coring

TUBE PAIR	PRESENCE OF ANOMALIES?	ANOMALY DEPTH (ft)	MAXIMUM FIRST ARRIVAL TIME DELAY (%)	INCREMENT RATING
1-2	YES	54 – 57½	>100	P/D
2-3	YES	54 – 57½	>100	P/D
3-4	YES	55 – 57½	75	P/D
4-5	YES	56 – 57½	>100	P/D
1-5	YES	54½ - 57½	>100	P/D
1-4	YES	54½ - 57½	41	P/D
1-3	YES	54 – 57½	>100	P/D
2-4	YES	54½ - 57½	>100	P/D
2-5	YES	55 -57½	>100	P/D
3-5	YES	55 – 57½	>100	P/D

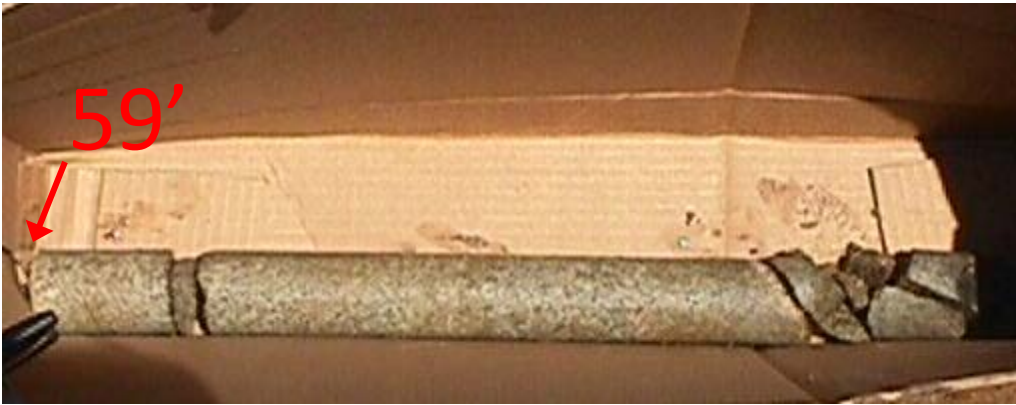
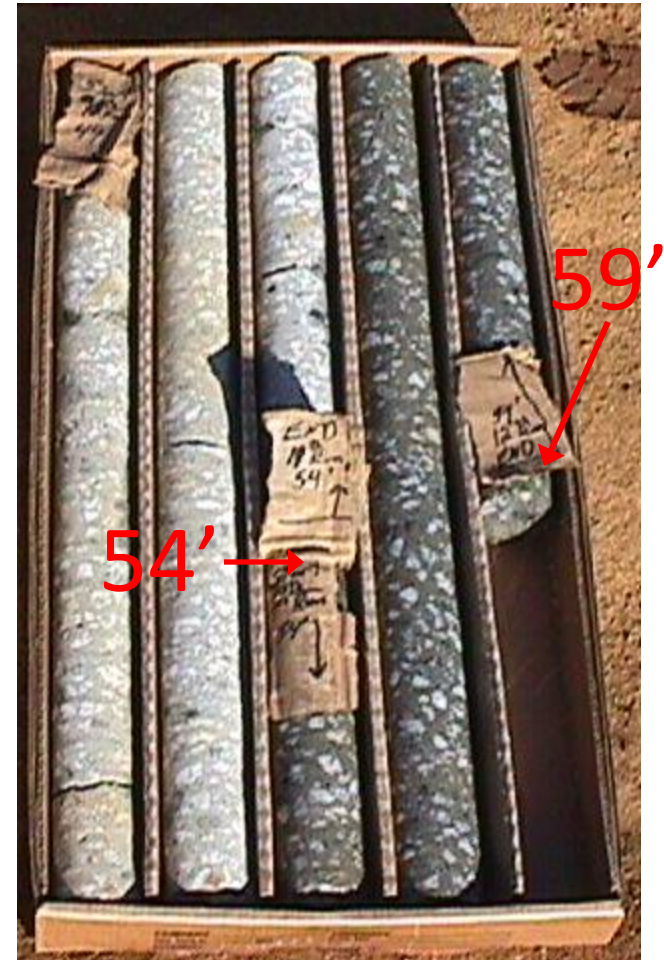
# Hellers Creek – cont.

- Cores from 54' to 60'  
(signal loss from 54' to 58'  
– no CSL below 58')
- No Irregularities Found

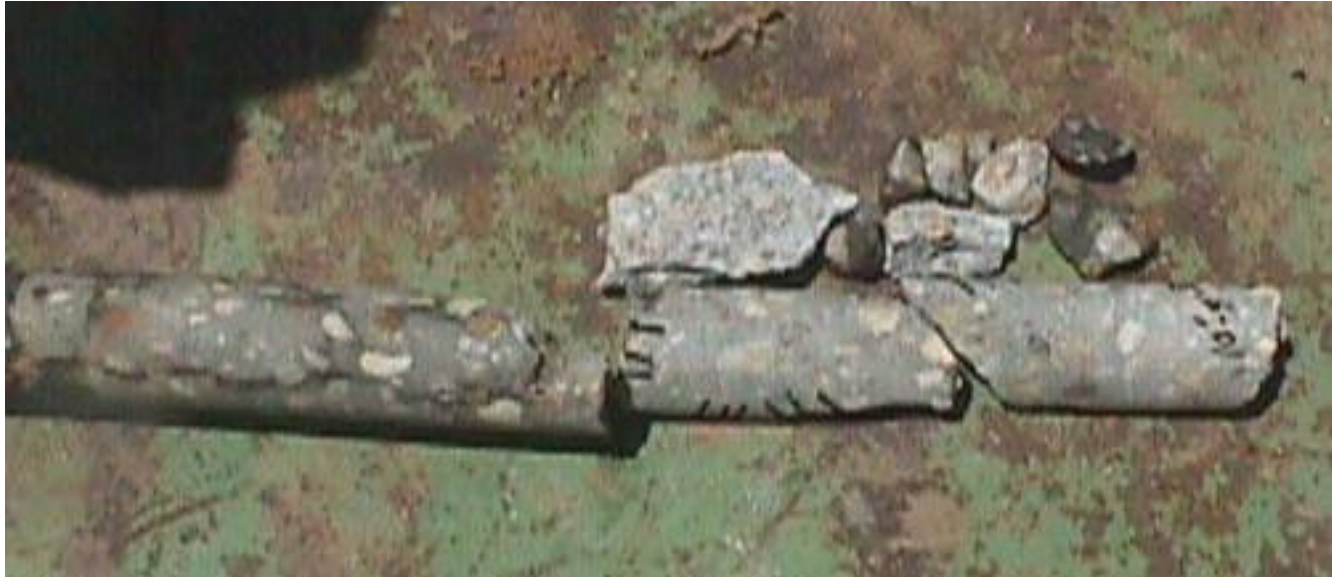
# Explanations?

- De-bonding (SCDOT access tubes are steel)
- Flowing water created large thermal gradients leading to micro-cracking during curing
- Bleed water causing flow paths through concrete
  - Supported by coring

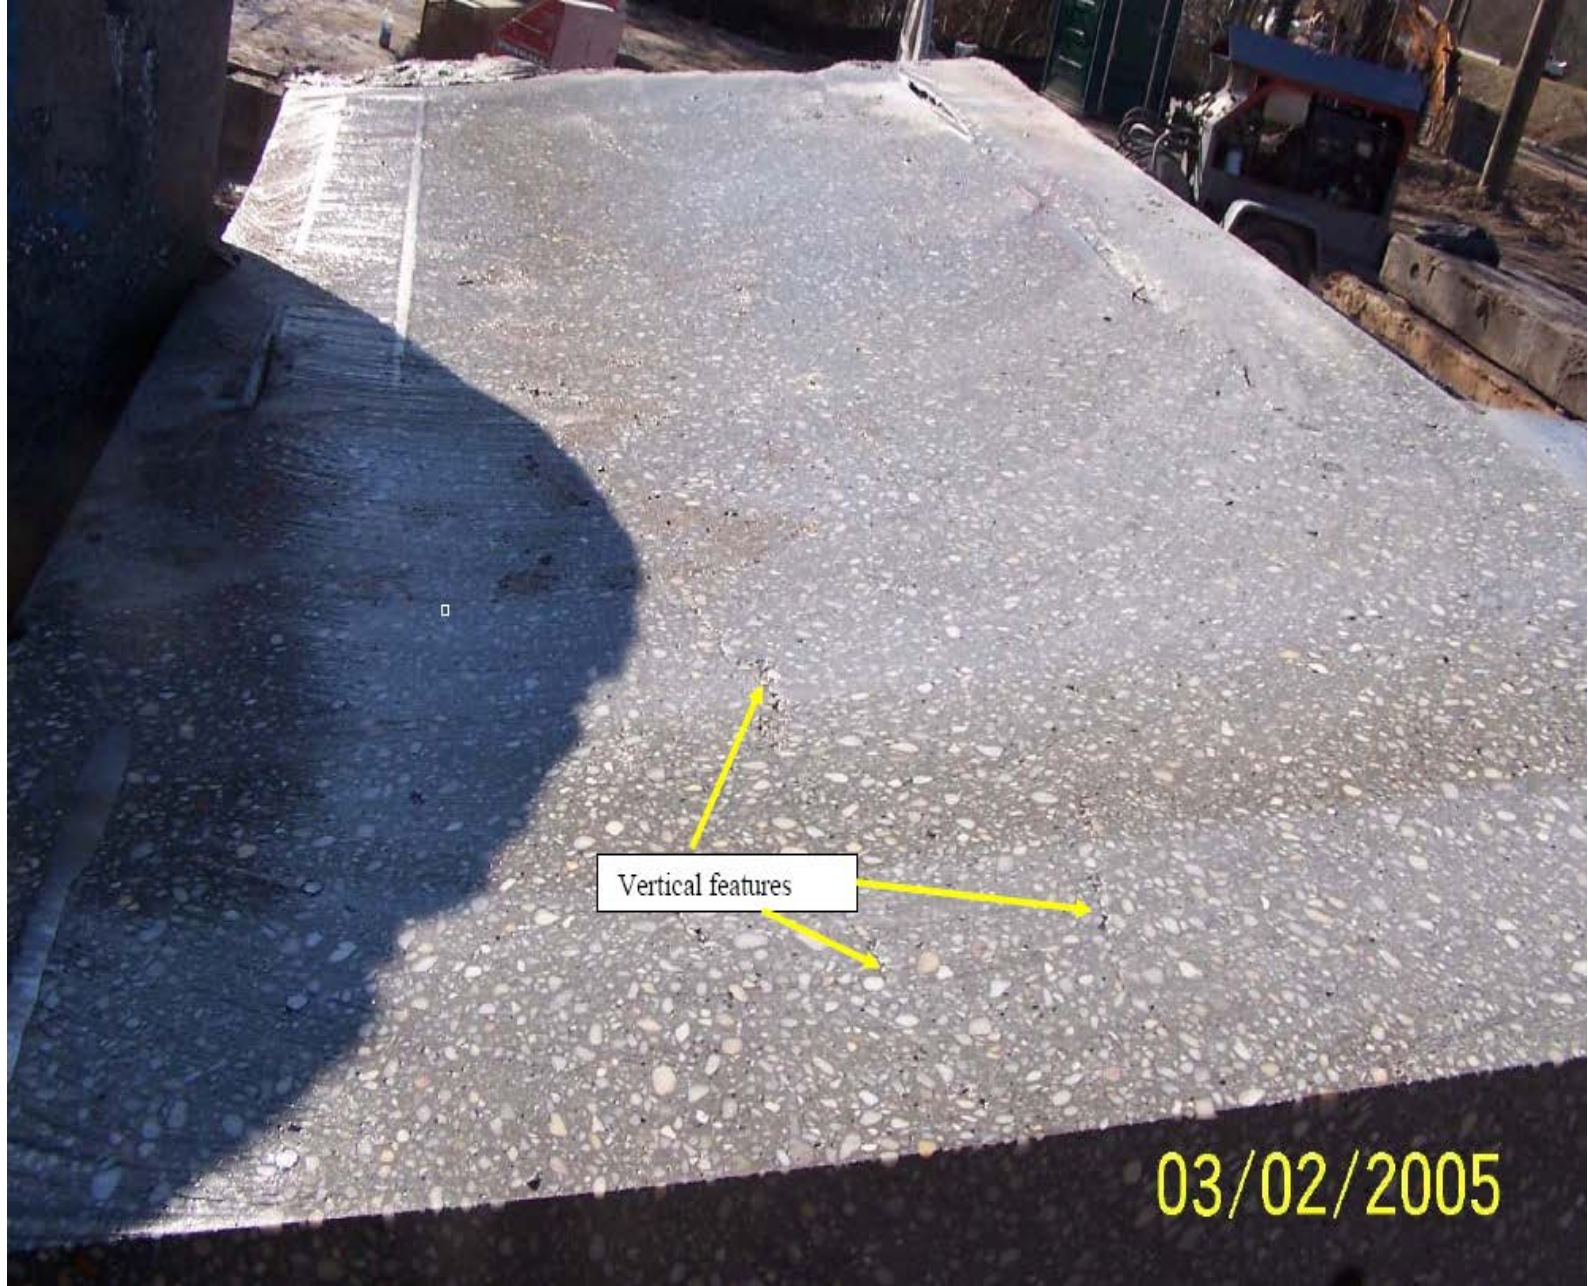
Vertical features

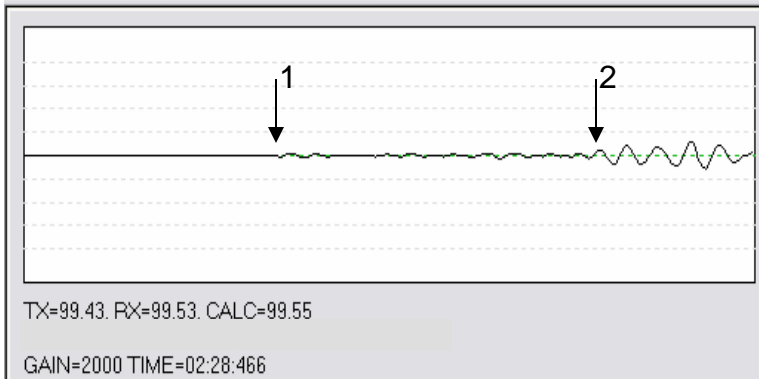
Possible interpretations at 99.55  
and 99.88 ft:

*No signal or*

1) Wavespeed of 8,564 (36%  
reduction)

2) Wavespeed of 4,647 (65%  
reduction)

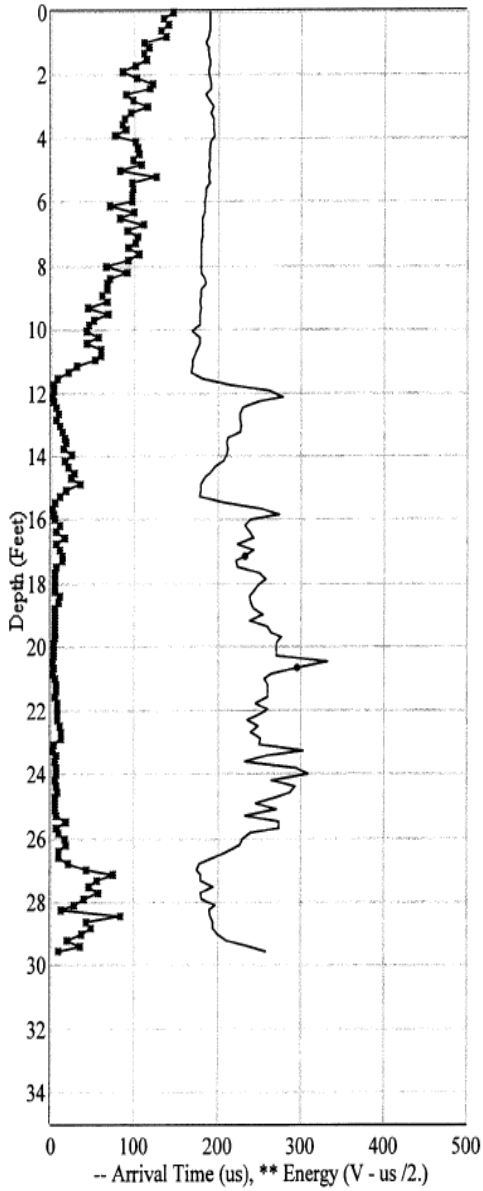
Bent 3 Shaft 2 -- Tubes 1 - 2

- From the inspector's logs
  - 4.5 ft diameter, 30 ft long shaft (approx 18 cy vol)
  - Permanent casing with rock socket below
  - No drilling fluid
  - Concrete placed via pump line
  - No problems noted

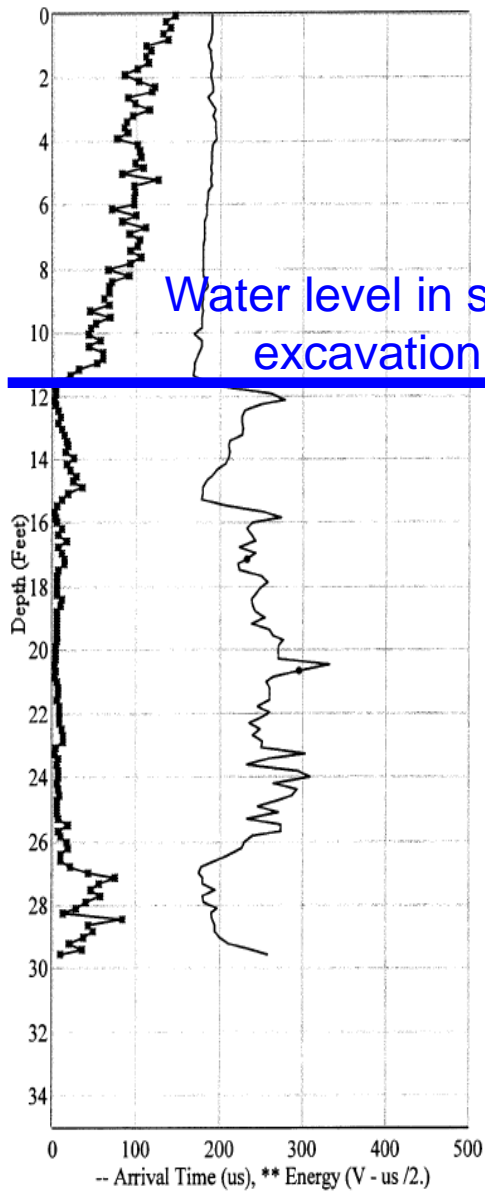
Bent 3 Shaft 2 -- Tubes 1 - 2

Water level in shaft excavation

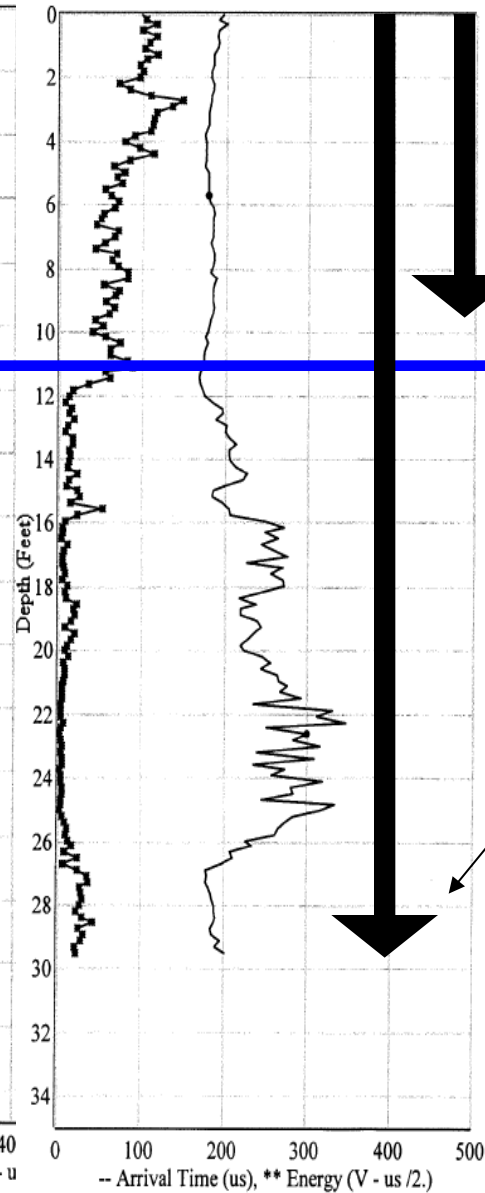
Bent 3 Shaft 2 -- Tubes 3 - 4

"Tremie" Positions
