Emergency Sinkhole Mitigation & Void Investigation of Abandoned Railroad Tunnel along US HWY 24 Tennessee Pass, CO – Case Study

Kanaan Hanna, Steve Hodges, John Nolte, ZAPATA
Joseph Elsen, Rex Goodrich, Matthew Figgs, David Thomas, CDOT
Tom Szynakiewicz, Hayward Baker
Mark Vessely, Shannon and Wilson

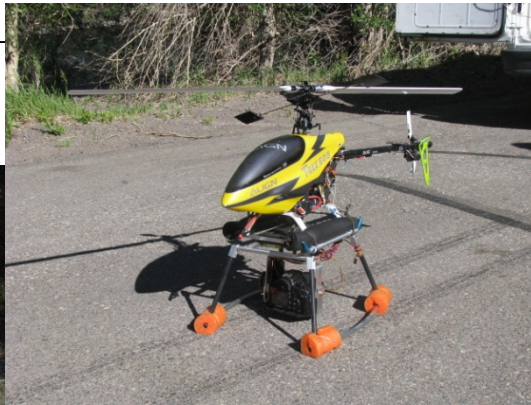
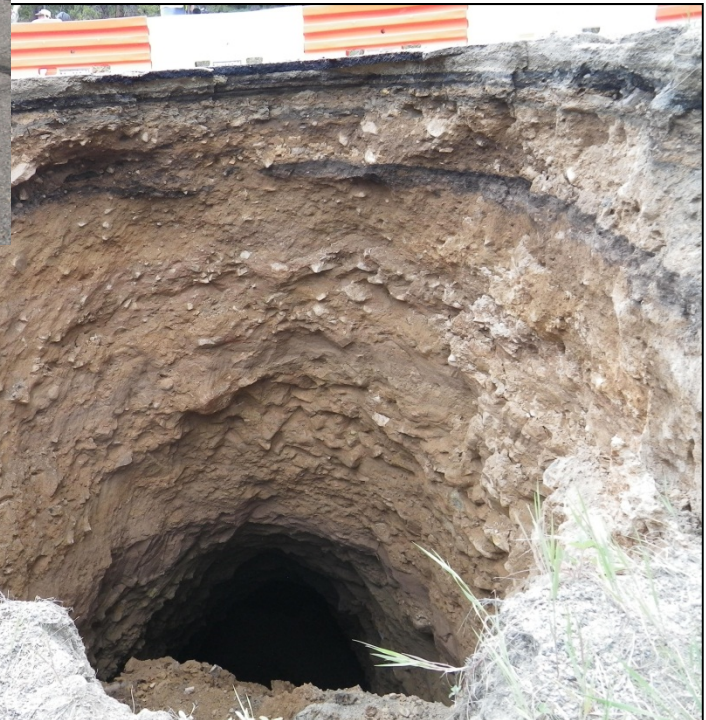
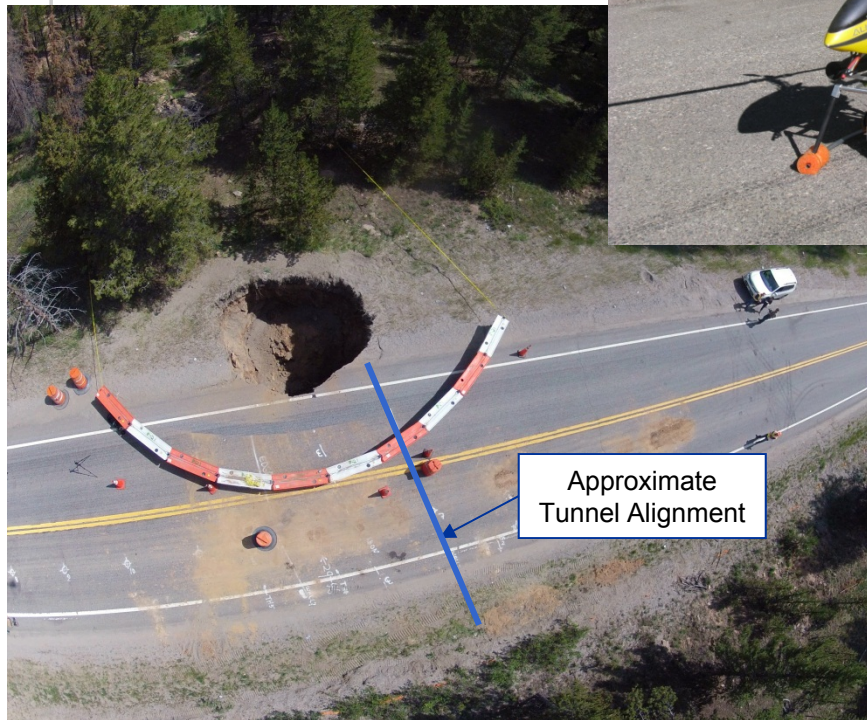
- ❑ Sinkhole above an old railroad tunnel (build in 1880)
- ❑ Sinkhole developed on July 9, 2012 on the southbound shoulder
- ❑ Approximately: 35 ft x 35 ft x 60 ft deep
- ❑ Original estimated volume was approximately 1000 CY
- ❑ Sinkhole propagated directly underneath the highway and continued to erode material
- ❑ CDOT elected to close a 4 mile stretch for safety, except for few local resident allowed to park cars on either side of closure.

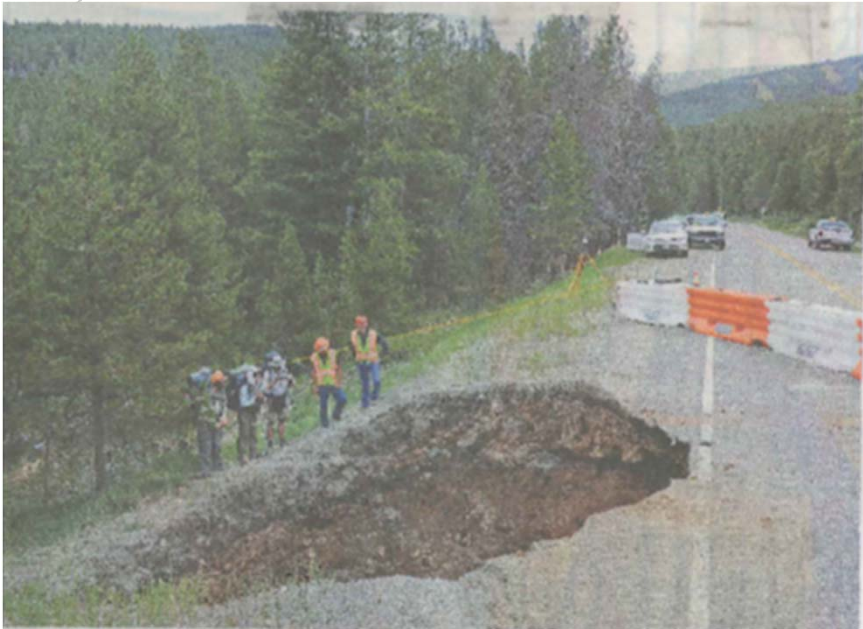
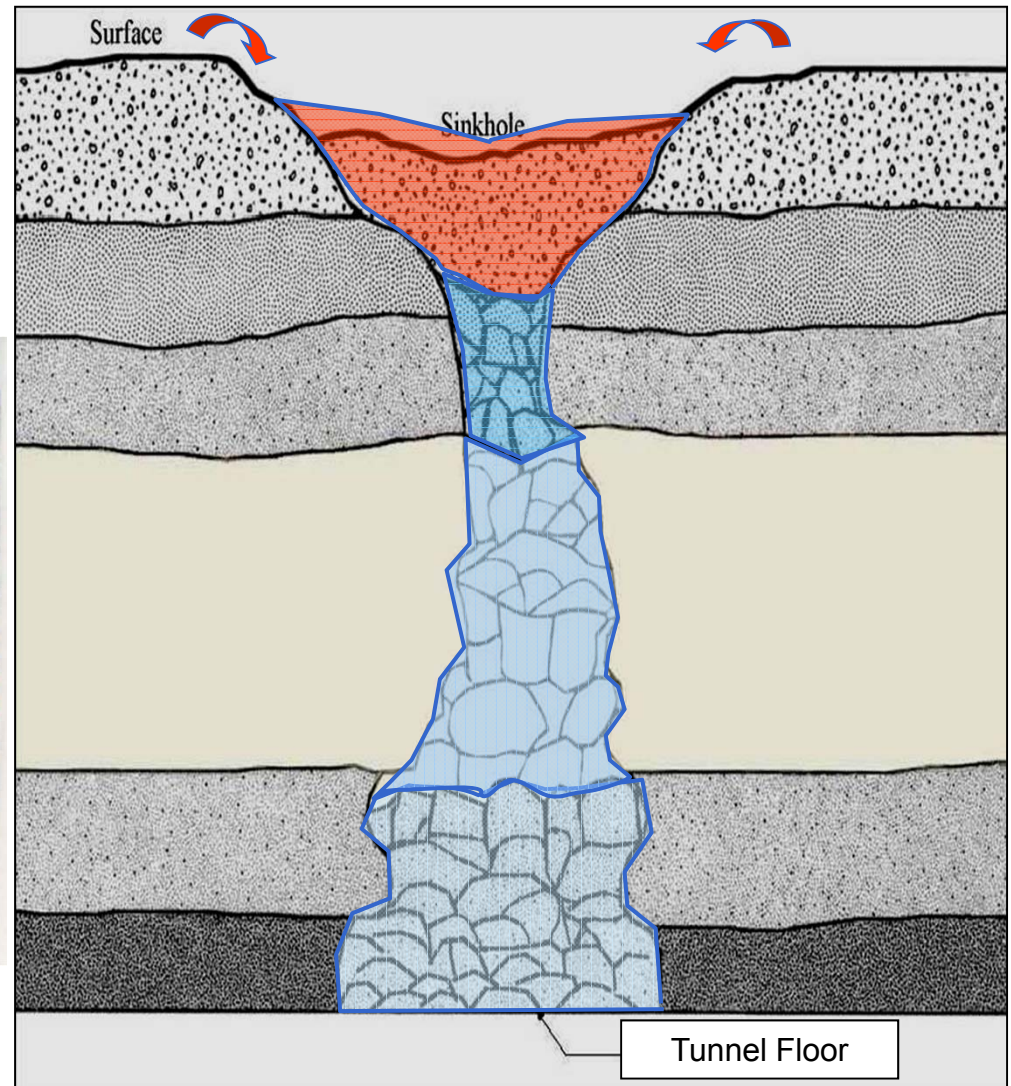
Sinkhole development
above the railroad tunnel

- ❑ Sinkhole size: ~ 35' x 35' x 60' deep
- ❑ Tunnel depth at the site ~ 158' to 175'
- ❑ Tunnel size: ~ 17' W x 20' H
- ❑ Tunnel invert: ~ 180' to 192'

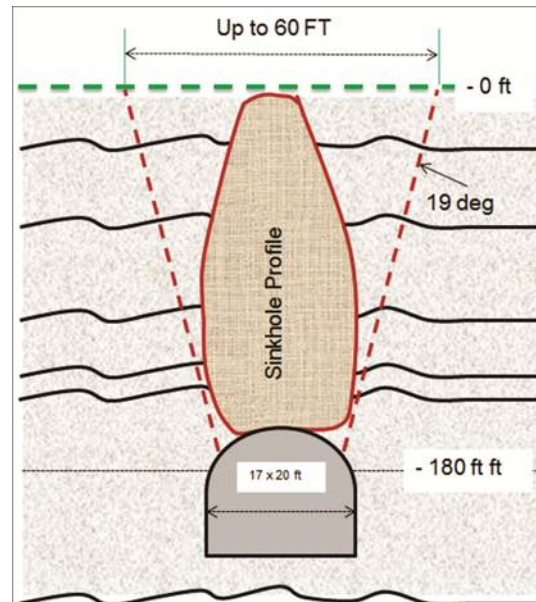
Sinkhole Limit and Sinkhole Profile Line (Not to Scale)

Sinkhole will develop if the overburden lithology consists of weak materials

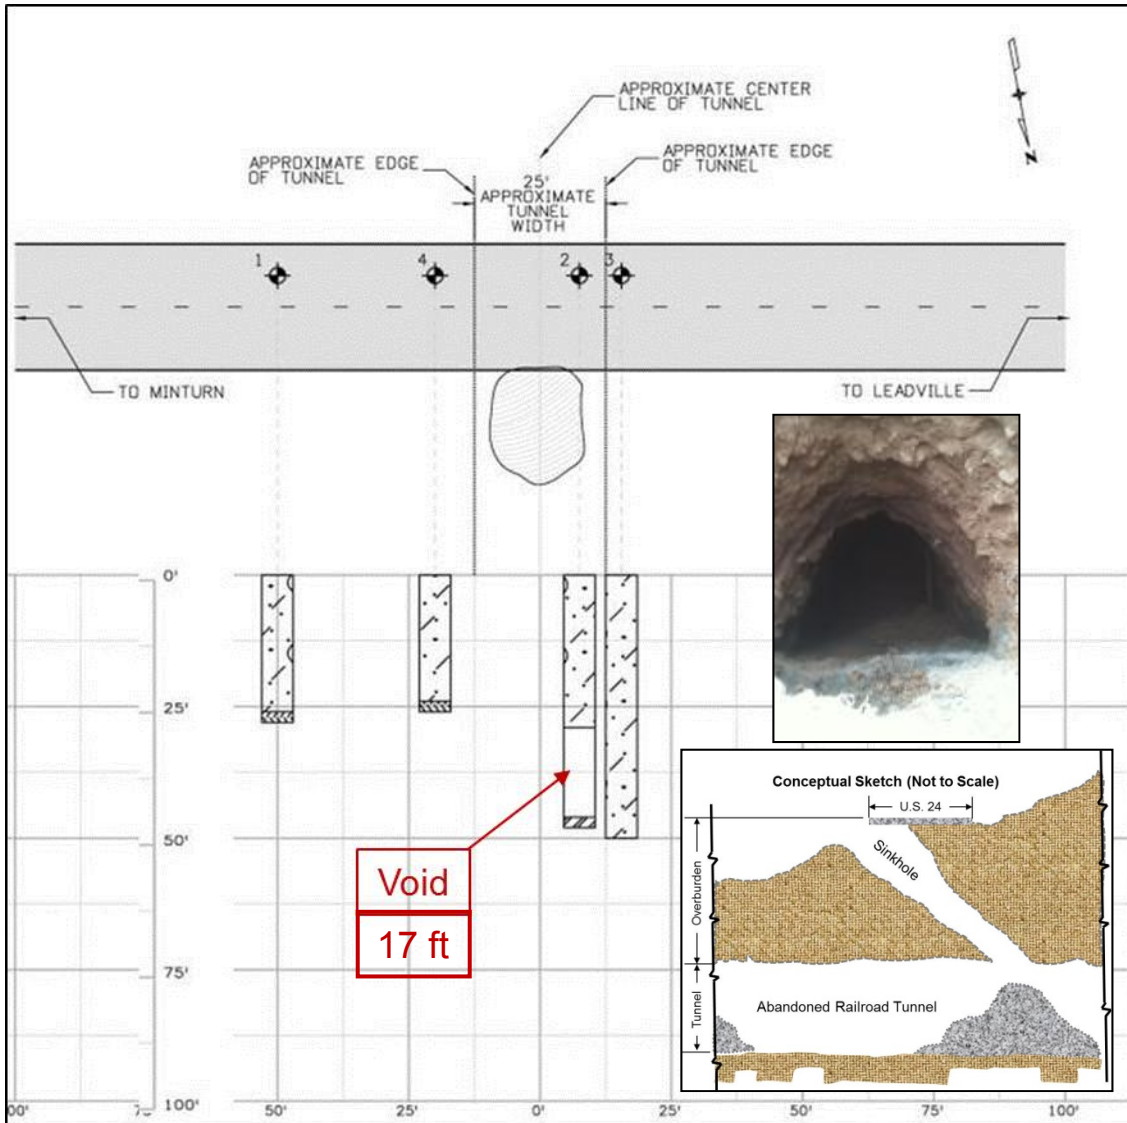
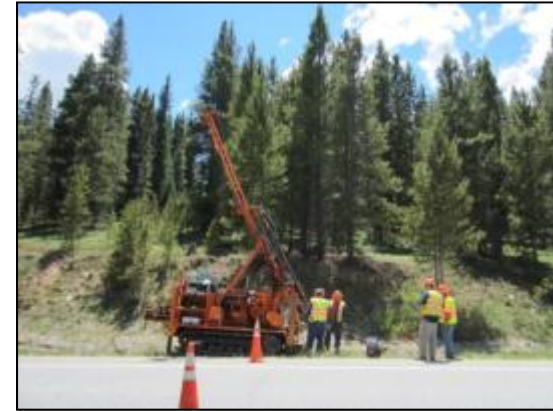
Preliminary CDOT Borings

- BORING 1:**
0'-26' ASPHALT THEN INTERBEDDED SANDY CLAY WITH CLAYEY SAND LENSES AND OCCASIONAL COBBLES.
26' LIMIT OF DRILLING. WEATHERED GRANITE.
- BORING 4:**
0'-24' ASPHALT THEN SANDY CLAY WITH SAND LENSES AND OCCASIONAL COBBLES.
24' LIMIT OF DRILLING. WEATHERED GRANITE.
- BORING 2:**
0'-29' ASPHALT THEN CLAYEY SAND AND CLAY WITH SAND LENSES AND OCCASIONAL COBBLES.
29'-46' VOID
46' LIMIT OF DRILLING. APPARENT METAL.
- BORING 3:**
0'-50' ASPHALT THEN CLAY WITH SAND LENSES AND OCCASIONAL COBBLES.

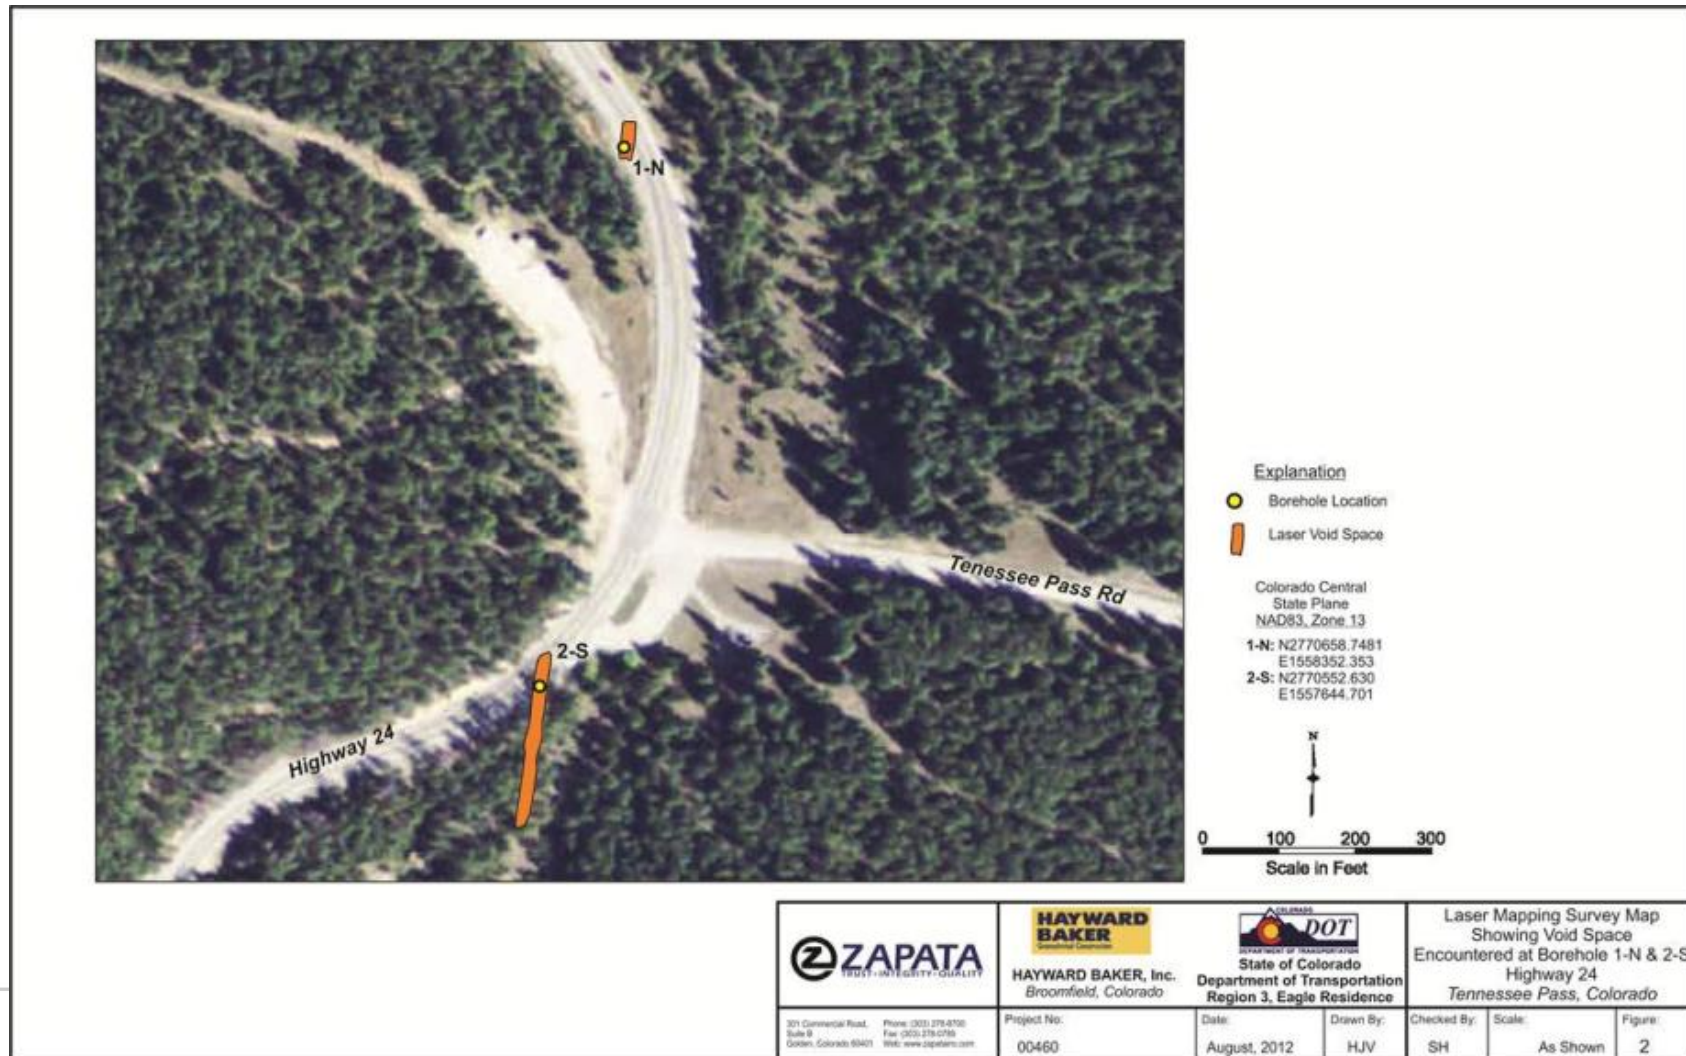
Laser Mapping Survey Map: Showing void space in Boreholes 1-N & 2-S

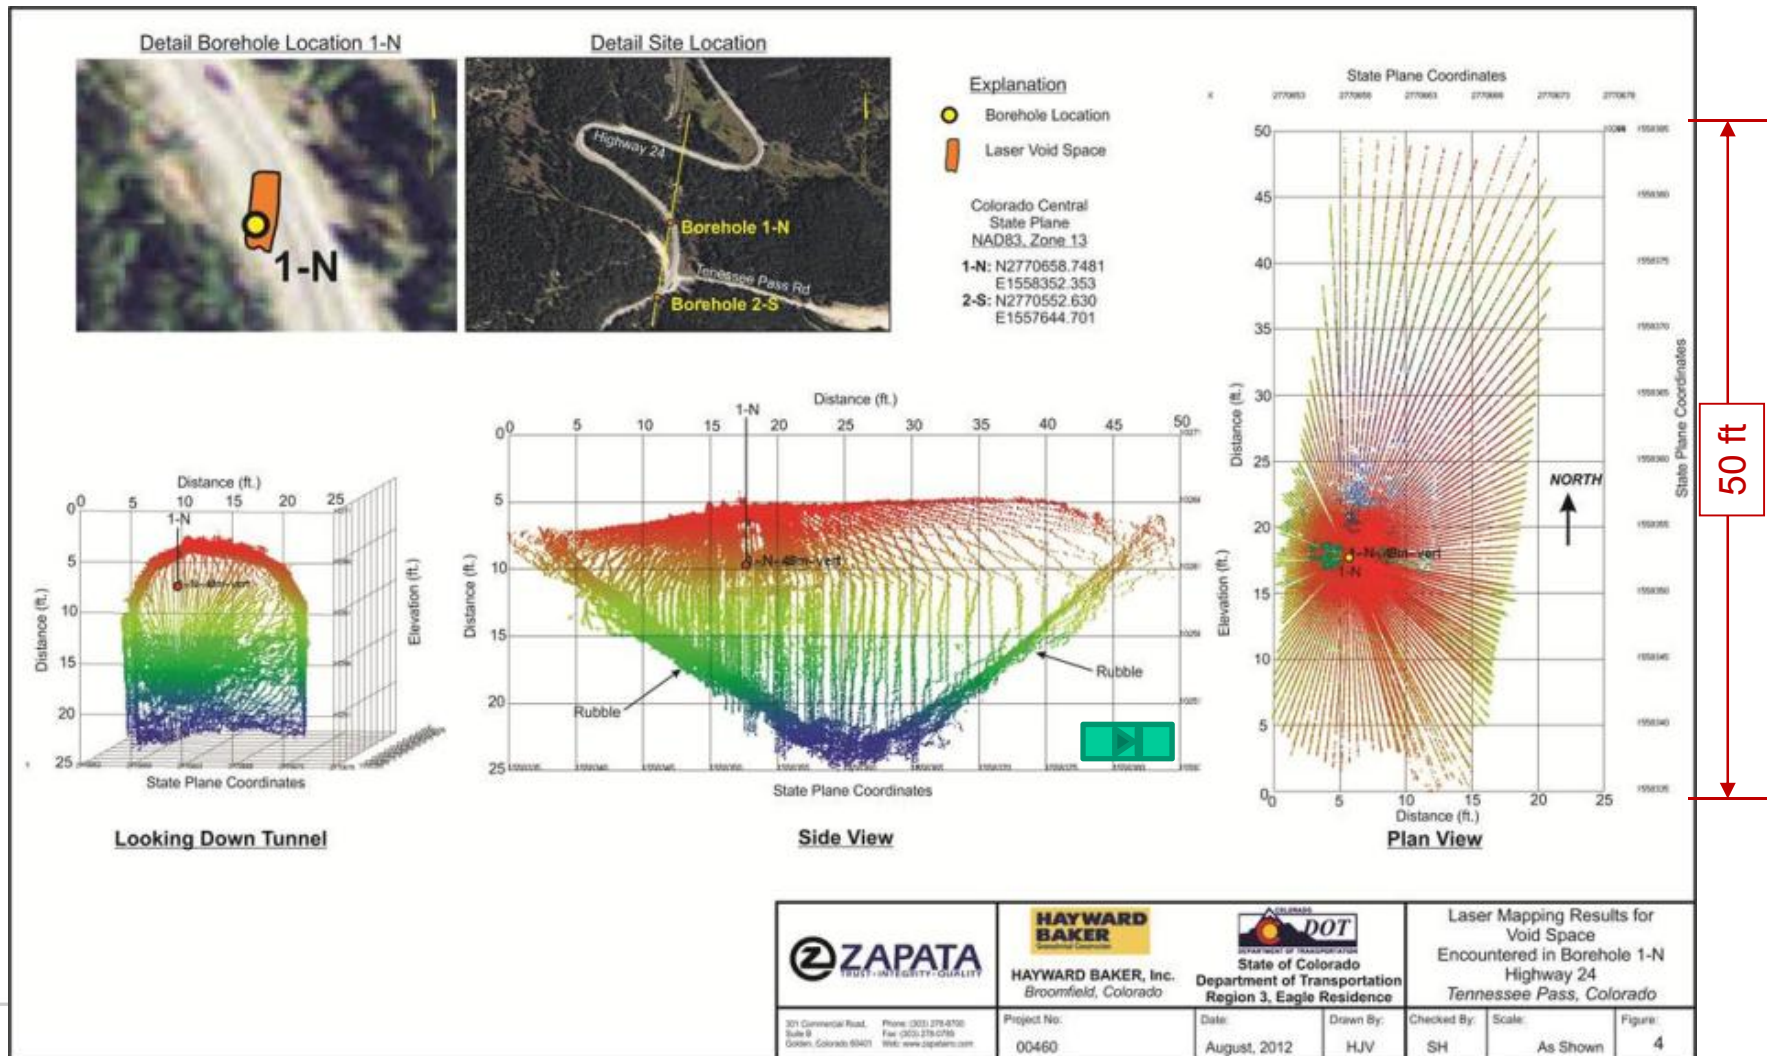
2D/3D Laser Views – Tunnel void space in Borehole 1-N

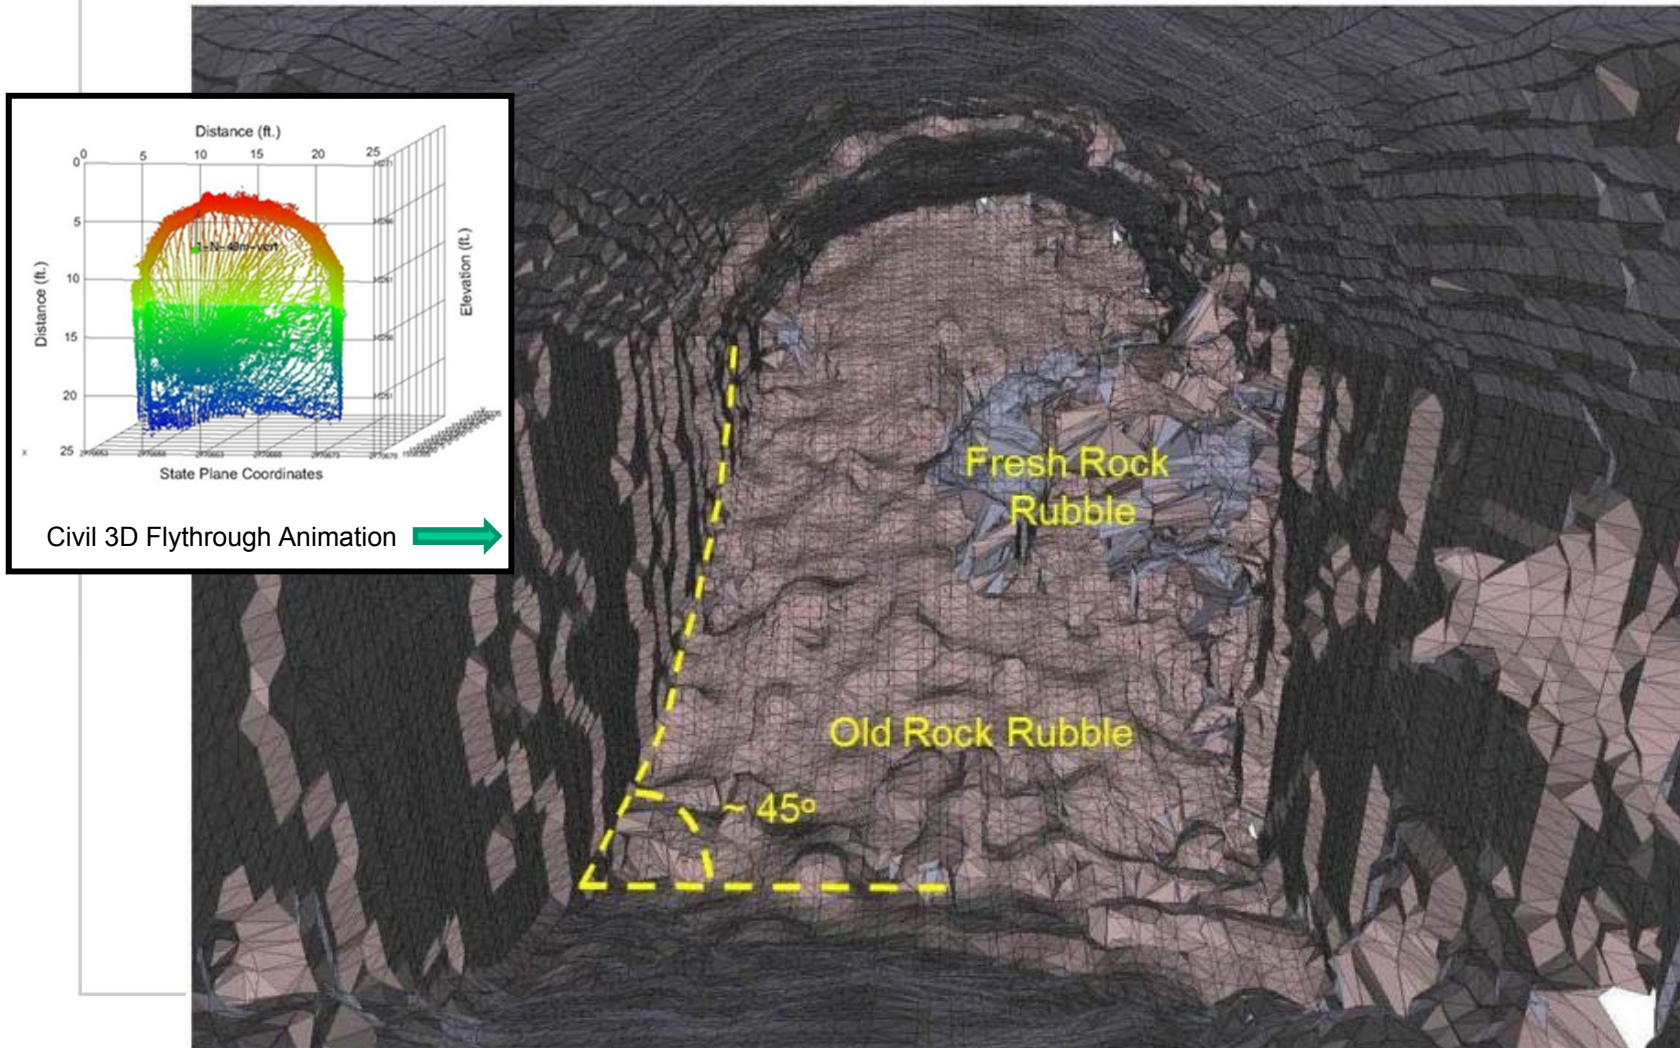
3D Laser snapshot – Looking south from inside the tunnel
“Borehole 1-N showing collapsed portion of the tunnel”

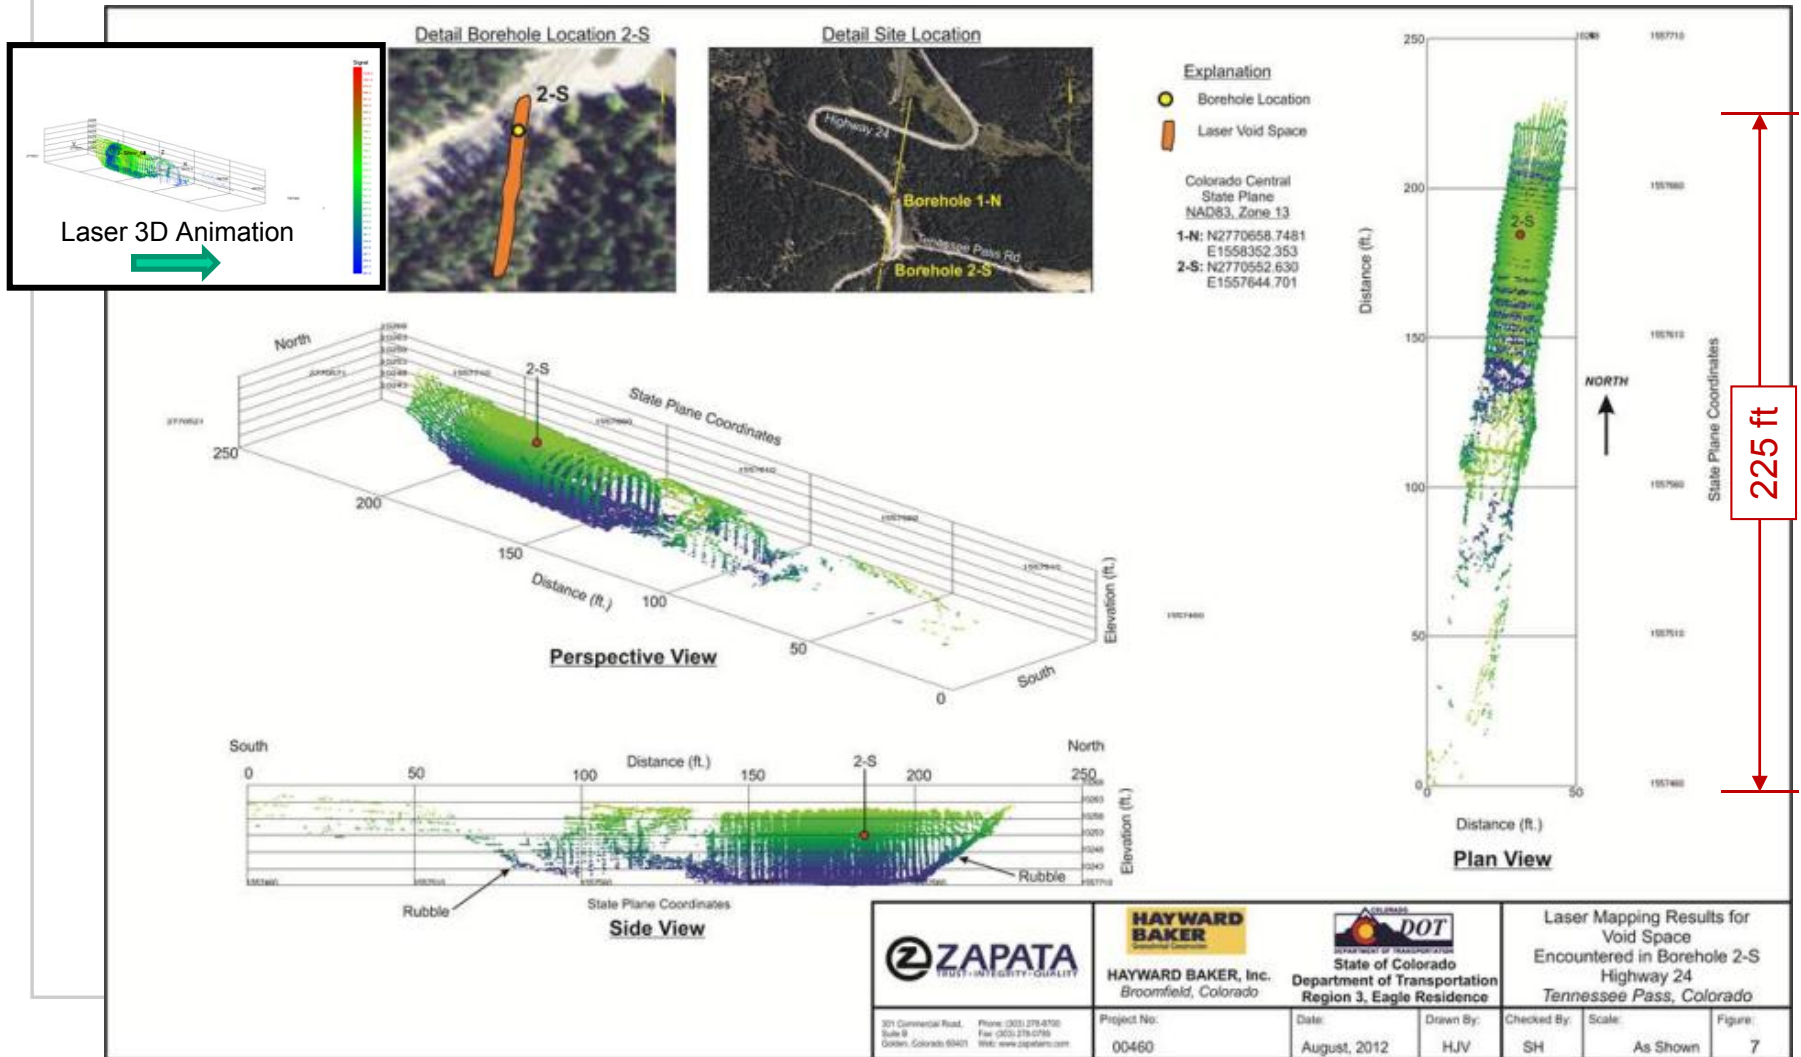
3D Laser mapping survey map: Showing void space in Borehole 2-S

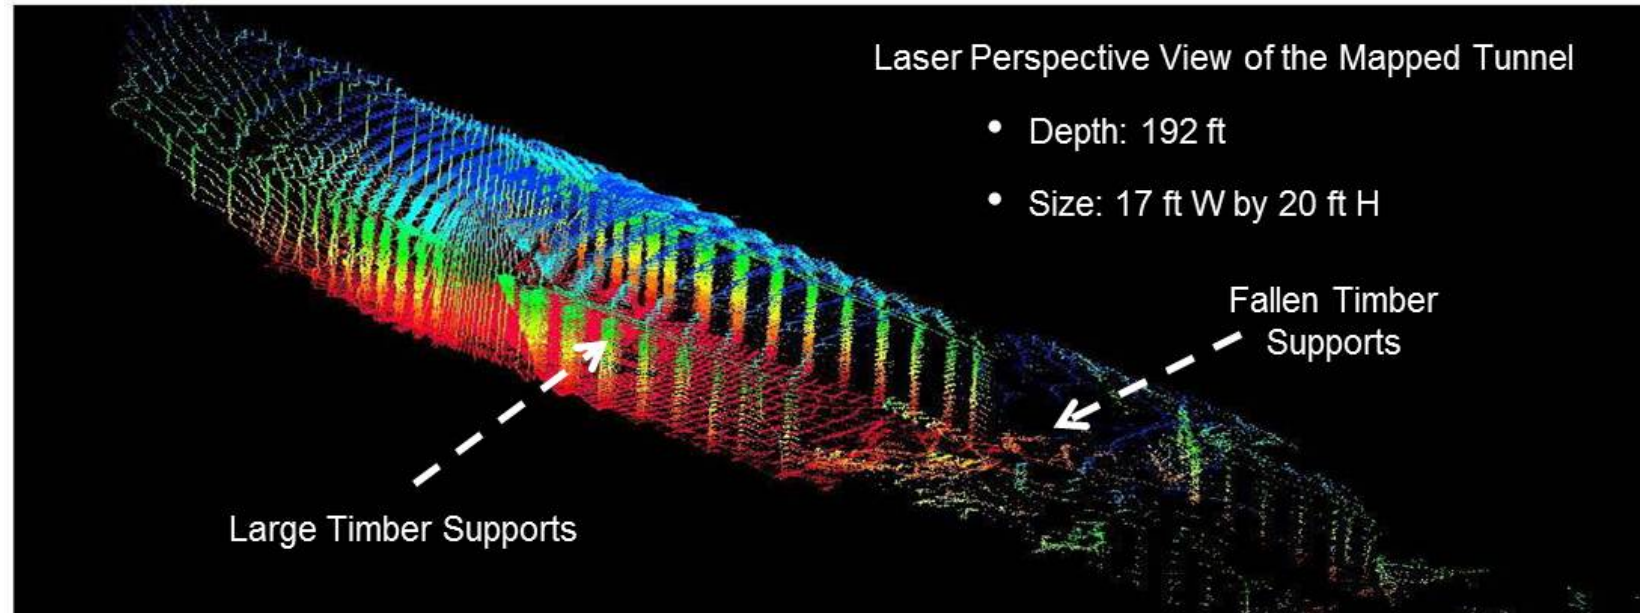
3D Laser mapping survey: Perspective view of the tunnel from **Borehole 2-S**

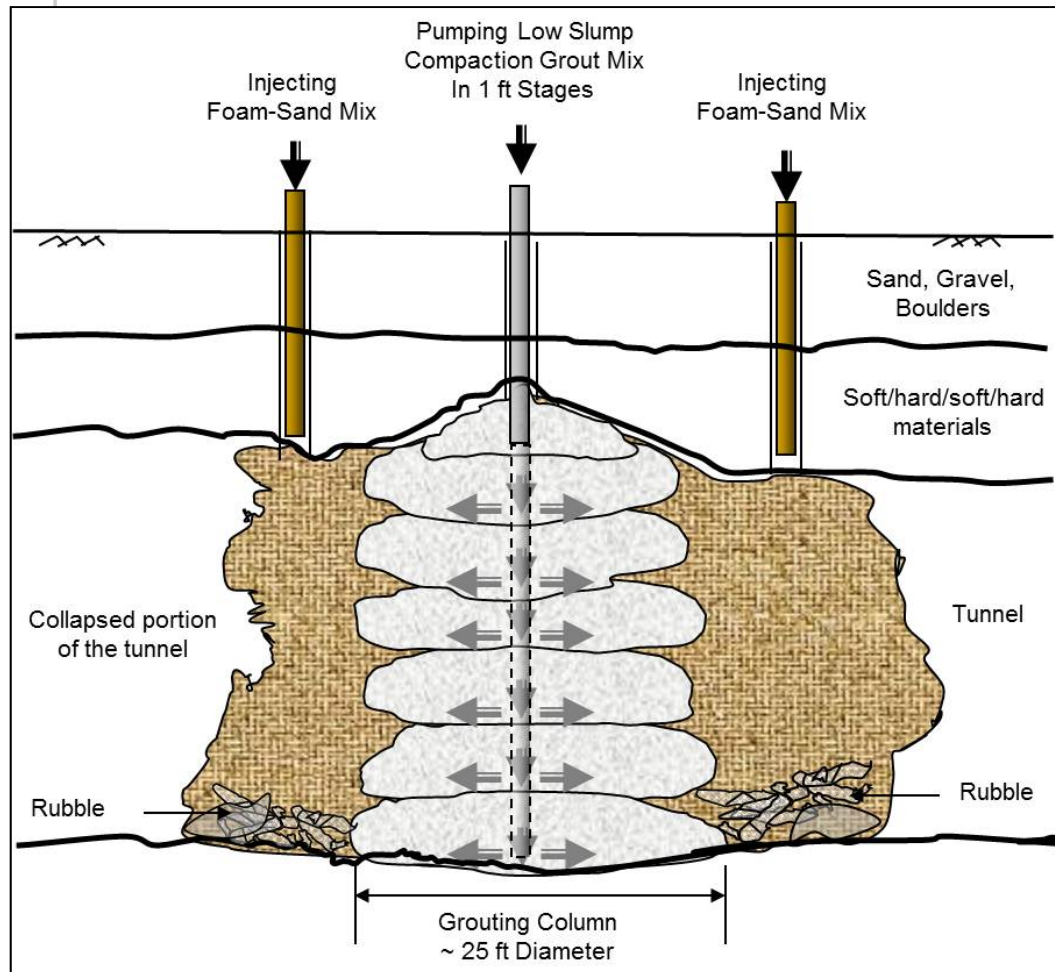
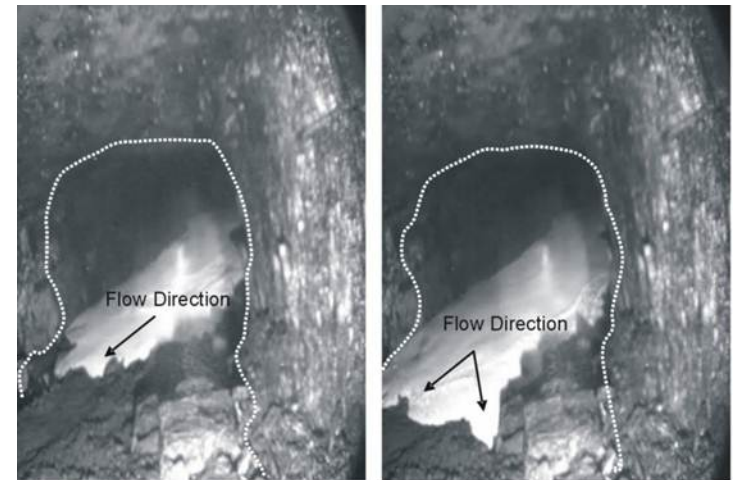
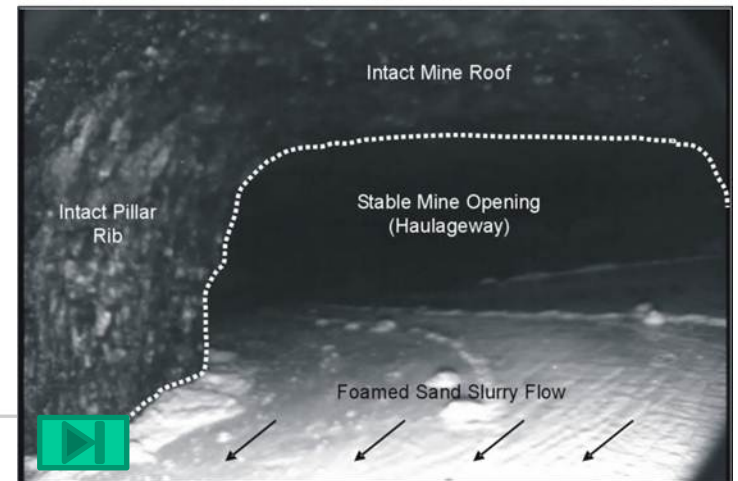
Suggested Tunnel Mitigation Strategy

“To reduce/eliminate the risk for future highway settlement/sinkhole development”

A combination of compaction grout and foamed-sand filler methods
