NC DEPARTMENT OF TRANSPORTATION
 DIVISION OF HIGHWAYS
 BRIDGE MANAGEMENT UNIT

BRIDGE INSPECTION REPORT

COUNTY GASTON BRIDGE NUMBER 350028 INSPECTION CYCLE 2 YRS
 ROUTE SR2416 ACROSS CROWDER'S CREEK M.P. 0

INSPECTION DATE 06/18/2014 PRESENT CONDITION POOR

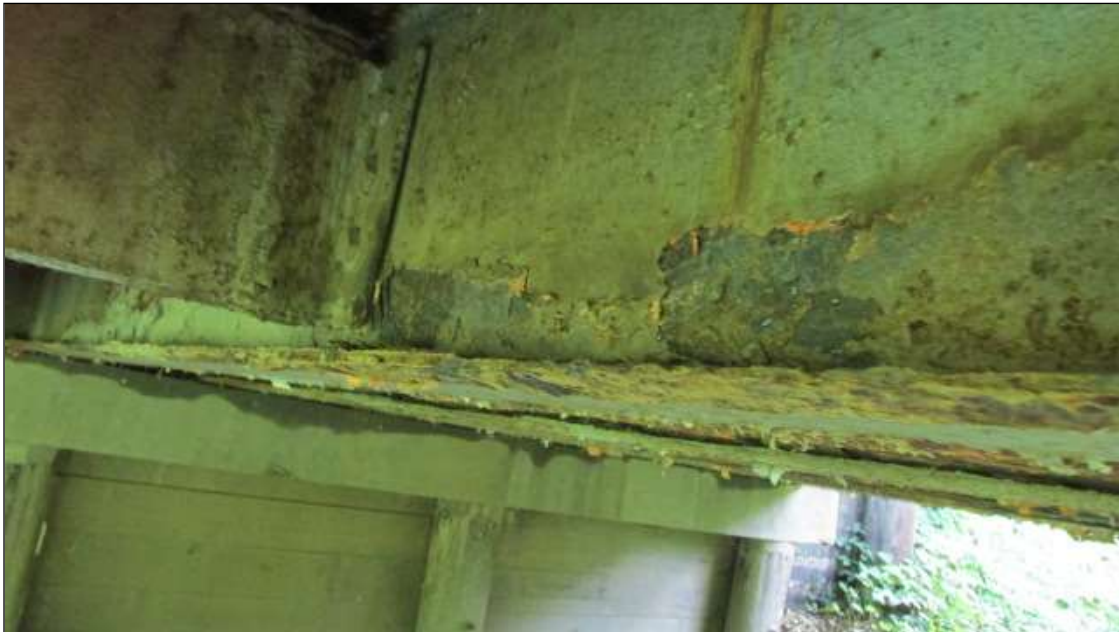
THE BMS. IN ALL THREE SPANS HAVE LAYERED RUST PRESENT ALONG THE TOP AND BOTTOM FLGS AND HAVE REDUCED DOWN TO A 1/8" FLG. THE WEB FACES HAVE SURFACE RU

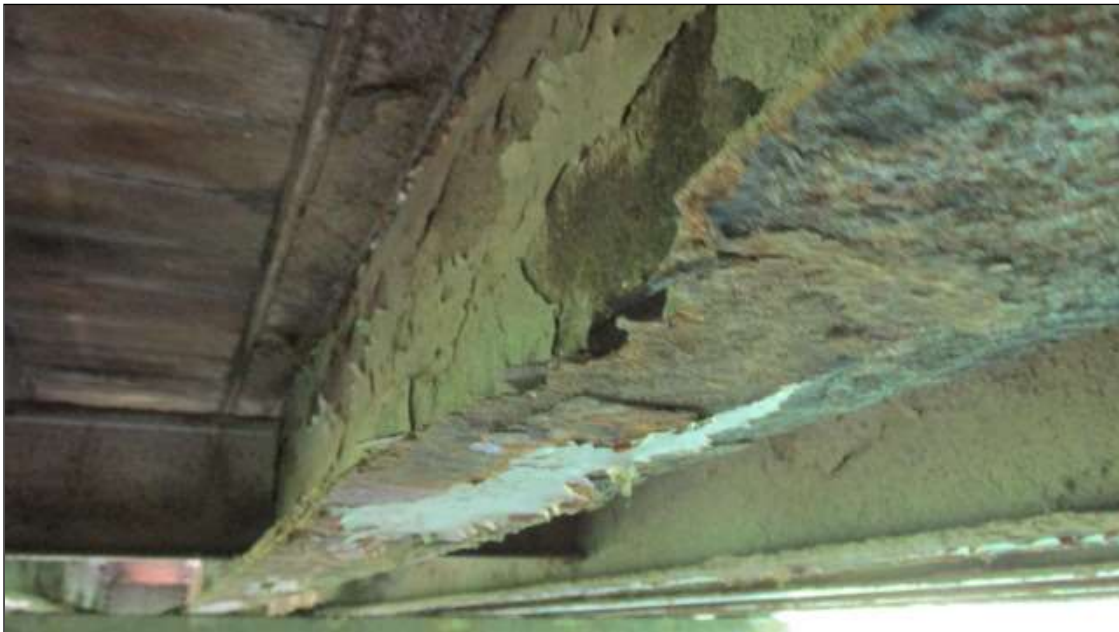
BEAM. 6 IN SPAN 3 HAS SECTION LOSS ALONG THE BOTTOM FLG. FOR 10" FROM 12' FROM THE EAST END OF THE BEAM., THE BEAM. FLGS HAS REDUCED DOWN TO A KNIFE ED

3314	Maintain Steel Superstructure Components	LF	8	BEAM. 6 IN SPAN 3 HAS SECTION LOSS ALONG THE BOTTOM FLG. FOR 10" FROM 12' FROM THE EAST END OF THE BEAM., THE BEAM. FLGS HAS REDUCED DOWN TO A KNIFE ED BEAM. 6 IN SPAN 3 HAS AREAS OF COMPLETE LOSS IN THE WEB. AT 12' FROM THE EAST END OF THE BEAM. THE LOSS IS 6" TO 8" LONG X 2" HIGH, NOTE THE WEB FACE THERE IS COMPLETE LOSS IN BEAM. 6 SPAN 3 AT 9' FROM THE EAST END OF BEAM. THE LOSS IS 3" LONG X 1/2" HIGH JUST ABOVE THE BOTTOM FLG. A PRIORITY MAINT.

MMS Code	MMS Description	Quantity
3314	Maintain Steel Superstructure Components	8 LF
Location:		
Beams and Girders Bent/Span No. 3 BM.6 IN SPAN 3		
Priority Level	Status	
Priority Maintenance	Division Bridge Maintenance Notification Received	
Submitted Date:	Submitted By:	Assisted By:
06/18/2014	DEREK RICKUS	ERIC PATTERSON
Details		
<p>BEAM. 6 IN SPAN 3 HAS SECTION LOSS ALONG THE BOTTOM FLG. FOR 10" FROM 12' FROM THE EAST END OF THE BEAM., THE BEAM. FLGS HAS REDUCED DOWN TO A KNIFE ED BEAM. 6 IN SPAN 3 HAS AREAS OF COMPLETE LOSS IN THE WEB. AT 12' FROM THE EAST END OF THE BEAM. THE LOSS IS 6" TO 8" LONG X 2" HIGH, NOTE THE WEB FACE THERE IS COMPLETE LOSS IN BEAM. 6 SPAN 3 AT 9' FROM THE EAST END OF BEAM. THE LOSS IS 3" LONG X 1/2" HIGH JUST ABOVE THE BOTTOM FLG. A PRIORITY MAINT.</p>

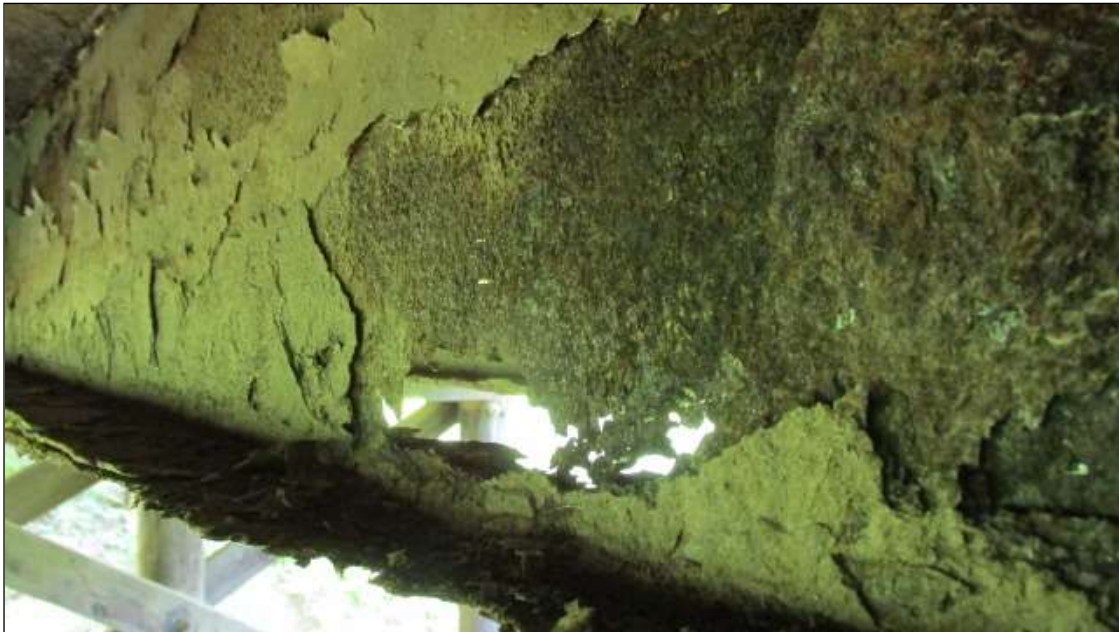
BEAM. 6 IN SPAN 3 HAS AREAS OF COMPLETE LOSS IN THE WEB. AT 12' FROM THE EAST END OF THE BEAM. THE LOSS IS 6" TO 8" LONG X 2" HIGH, NOTE THE WEB FACE

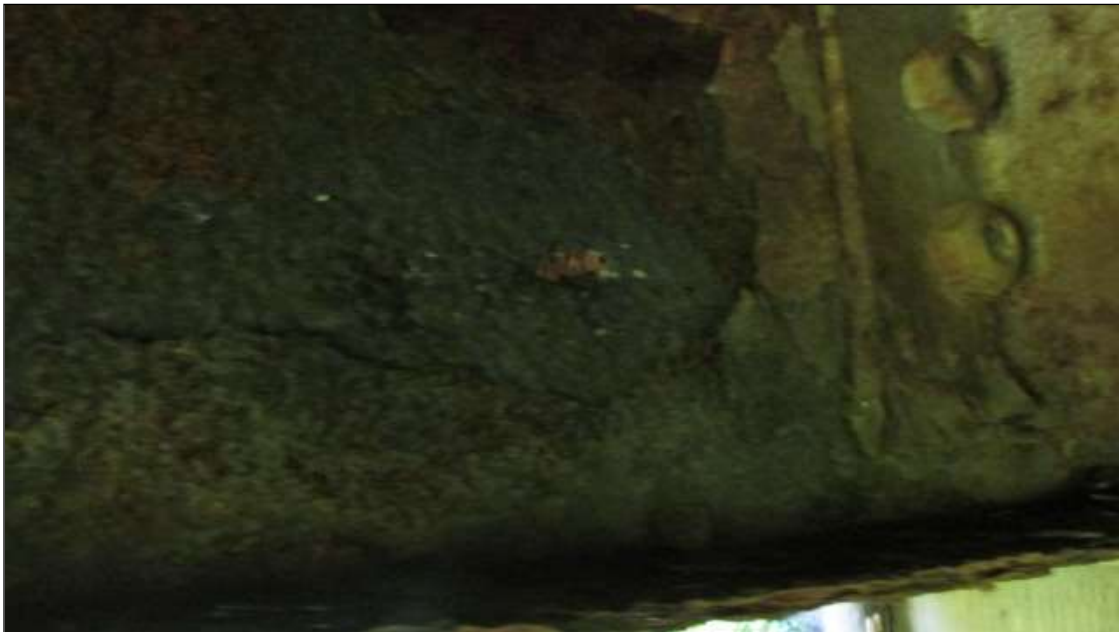
THERE IS COMPLETE LOSS IN BEAM. 6 SPAN 3 AT 9' FROM THE EAST END OF BEAM. THE LOSS IS 3" LONG X 1/2" HIGH JUST ABOVE THE BOTTOM FLG. A PRIORITY MAINT.

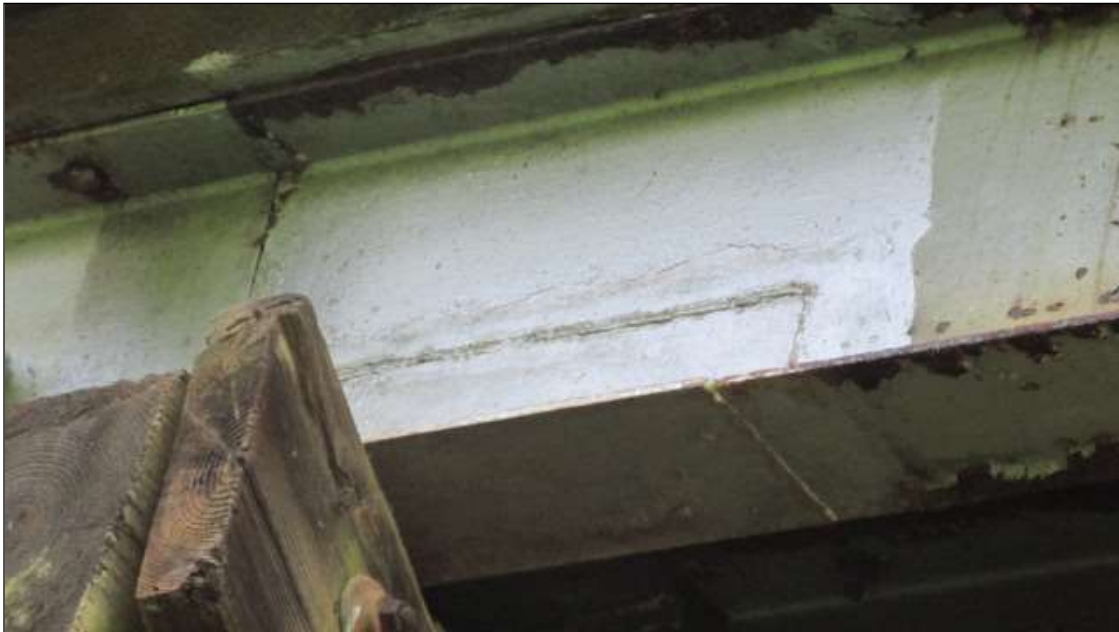
BEAM. 1 IN SPAN 2 AT BENT 2 HAS A PAST REPAIR WHERE THEY CUT AWAY DETERIORATED SECTION AND WELDED IN A SALVAGE SECTION. SALVAGE PIECE IS 6" HIGH X 18"

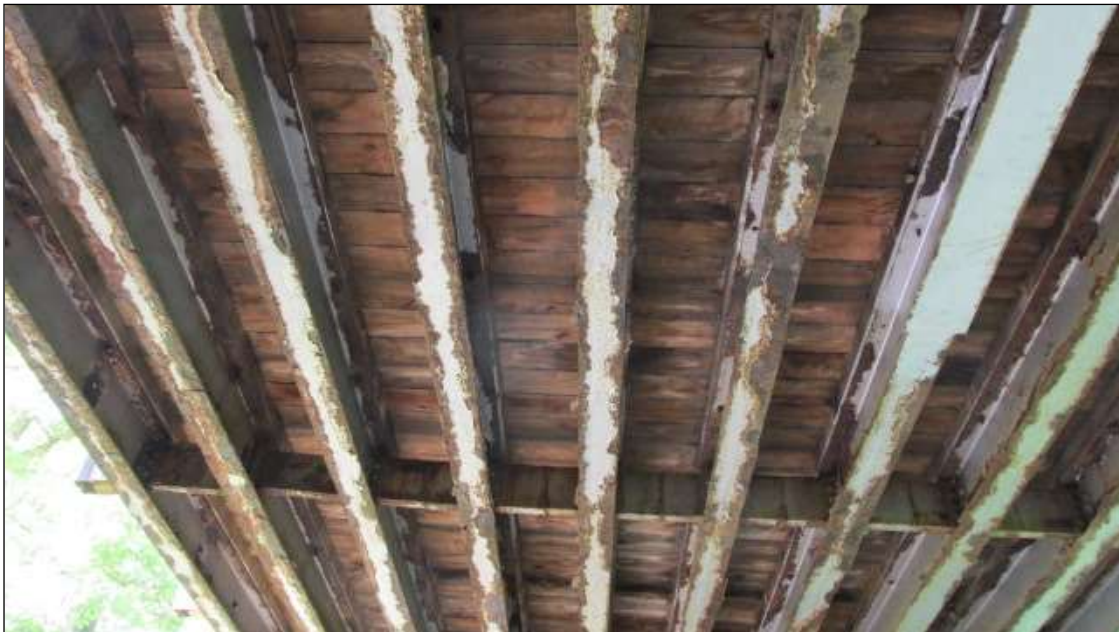
CORROSION ON BEAM FLANGES AND LOWER WEBS HAS FLANGES DOWN TO 3/16 INCH IN NUMEROUS AREAS

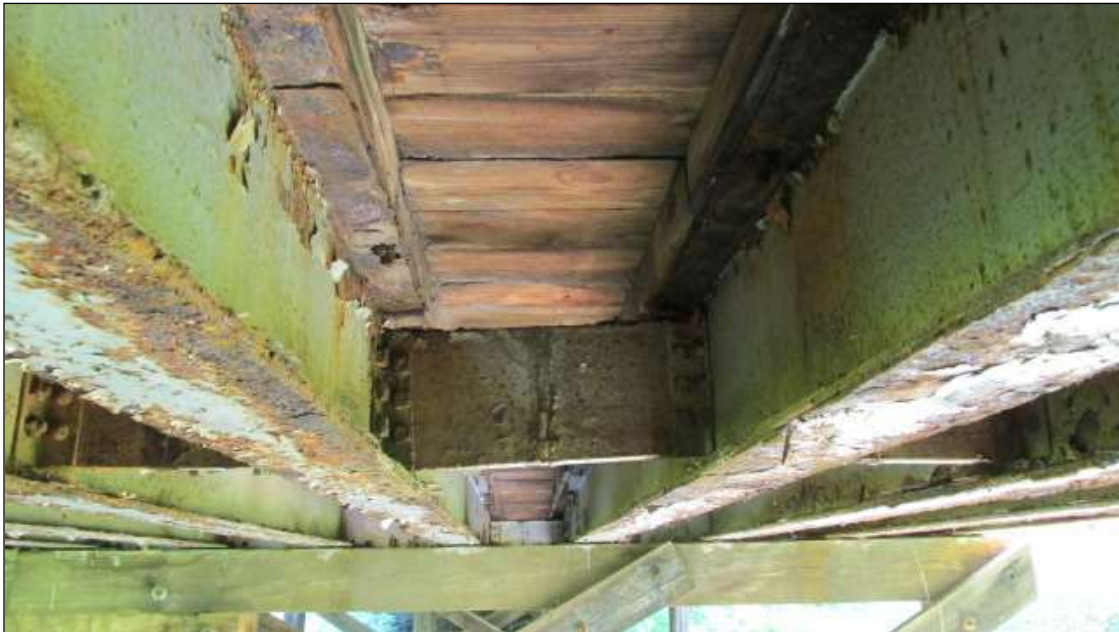
10A	NO	NO CURVED GIRDERS	
12	F	DIAPHS. HAVE SURFACE RUST AND PAINT. PEEL.	
15	F	THE BRG. PLATES ARE SHOWING SURFACE RUST PRESENT.

DIAPHS. HAVE SURFACE RUST AND PAINT. PEEL.

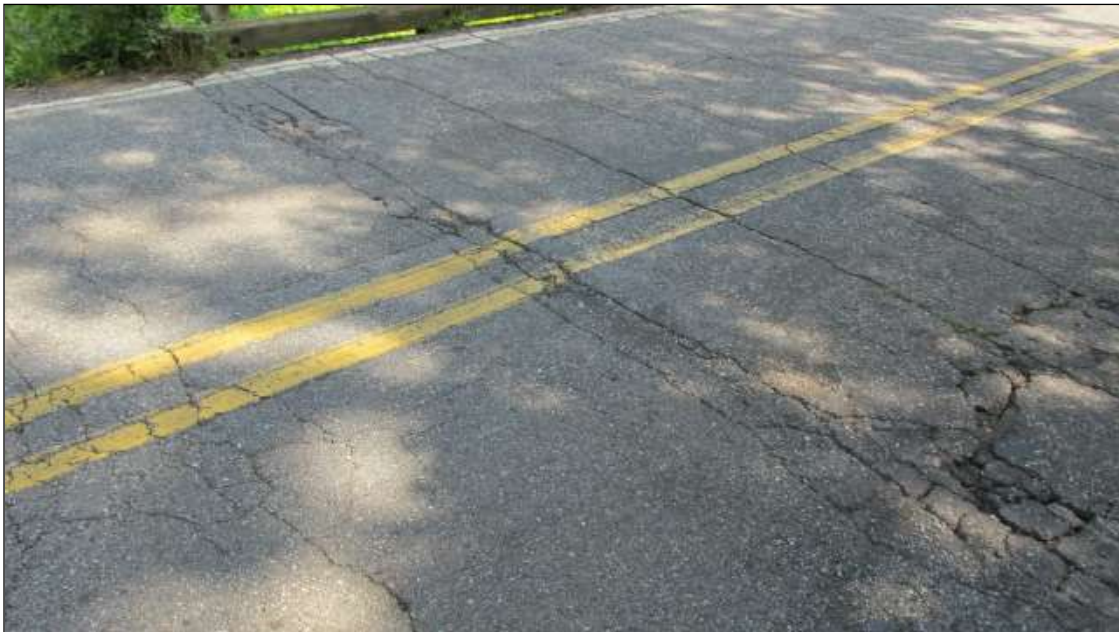
THE WEST APPROACH SETTLED ALONG THE FILLFACE.

3314	Maintain Steel Superstructure Components	LF	6	BEAM. 4 IN SPAN 3 NEAR DIAPH. HAS REDUCED DOWN TO A KNIFE EEDGE FOR 6' AT 1ST DIAPH. 10' FROM THE BEAM. END (EAST END). A PRIORITY MAINT. HAS BEEN ISSUED.	
2816	Asphalt Surface Repair or Replacement	SY	11	THE WEST APPROACH SETTLED ALONG THE FILLFACE.	
2816	Asphalt Surface Repair or Replacement	SY	202	THE ASPHALT WEARING SURFACE IS BREAKING OUT IN ALL THREE SPANS, DECK IS REBOUNDING.

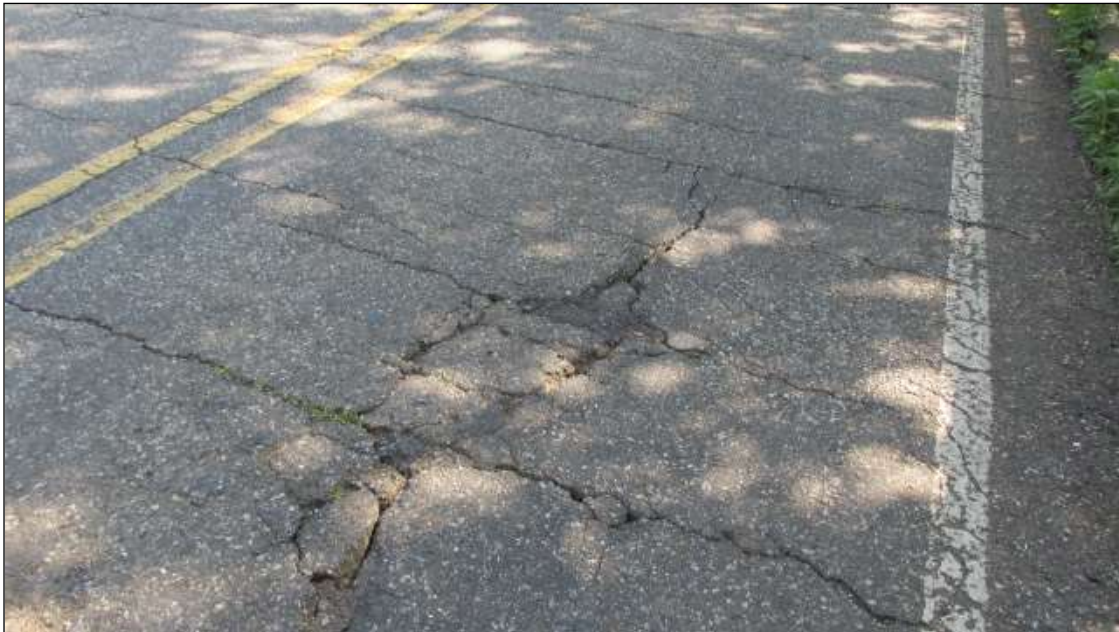
THE ASPHALT WEARING SURFACE IS BREAKING OUT IN ALL THREE SPANS, DECK IS REBOUNDING.

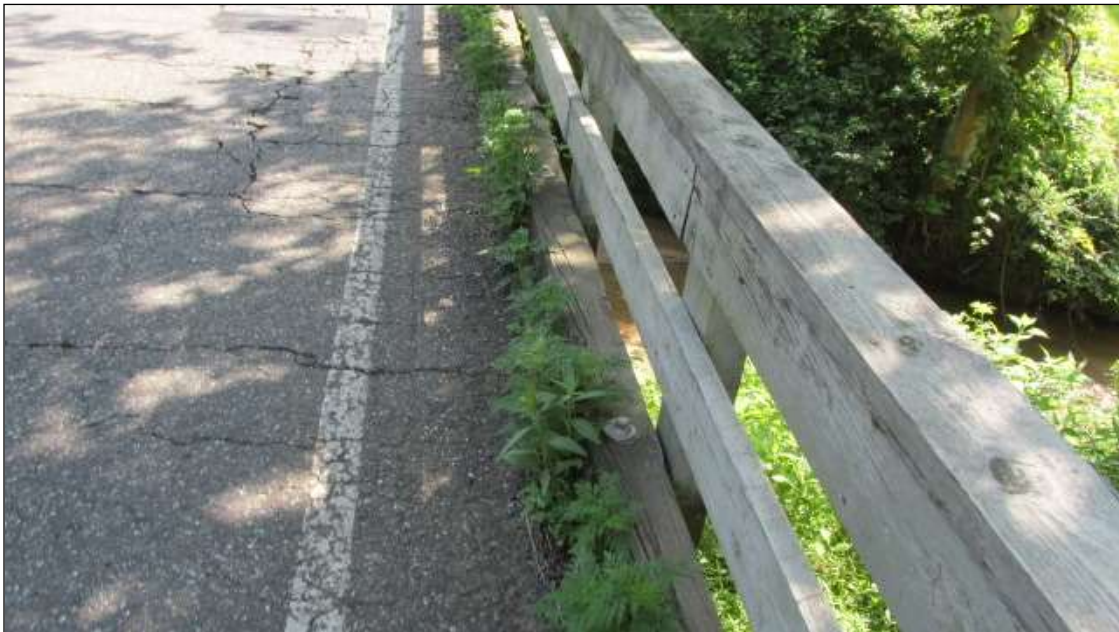
VEG. ALONG WHEELGUARDS HINDERING DRAINAGE.

3316	Maint to Timber Handrail	LF	3	THE NORTHEAST PANEL BD. MISSING.	
3376	Clean/Wash Bridge Decks	SF	182	VEG. ALONG WHEELGUARDS HINDERING DRAINAGE.

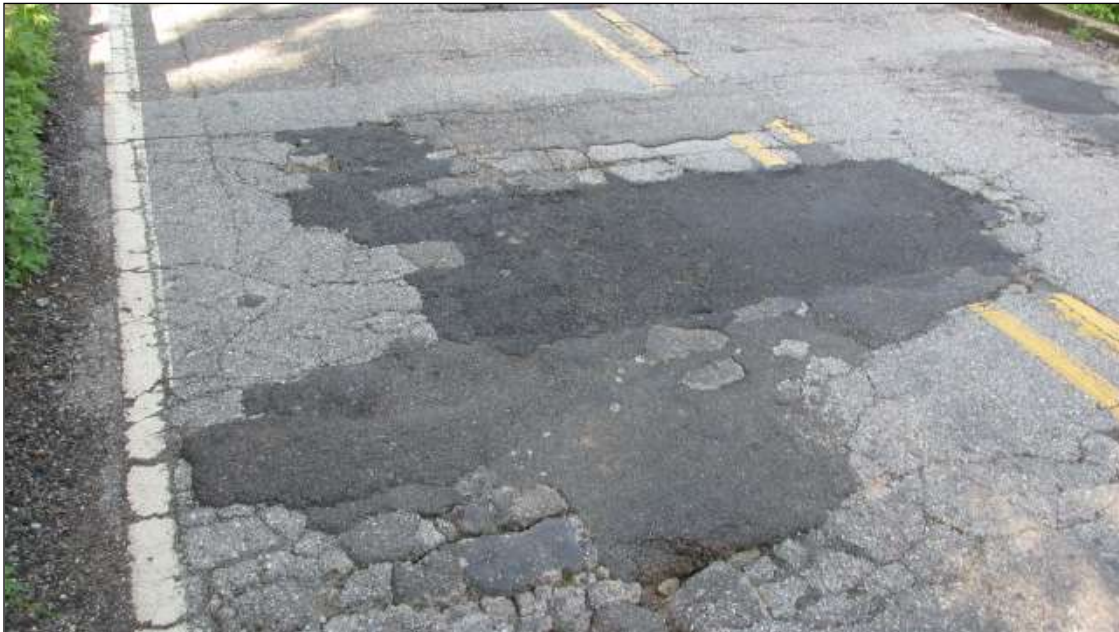
LARGE PATCHING AND ASPHALT WEARING SURFACE BREAKING OUT IN THE RT. LANE AT THE EAST END OF SPAN 3.

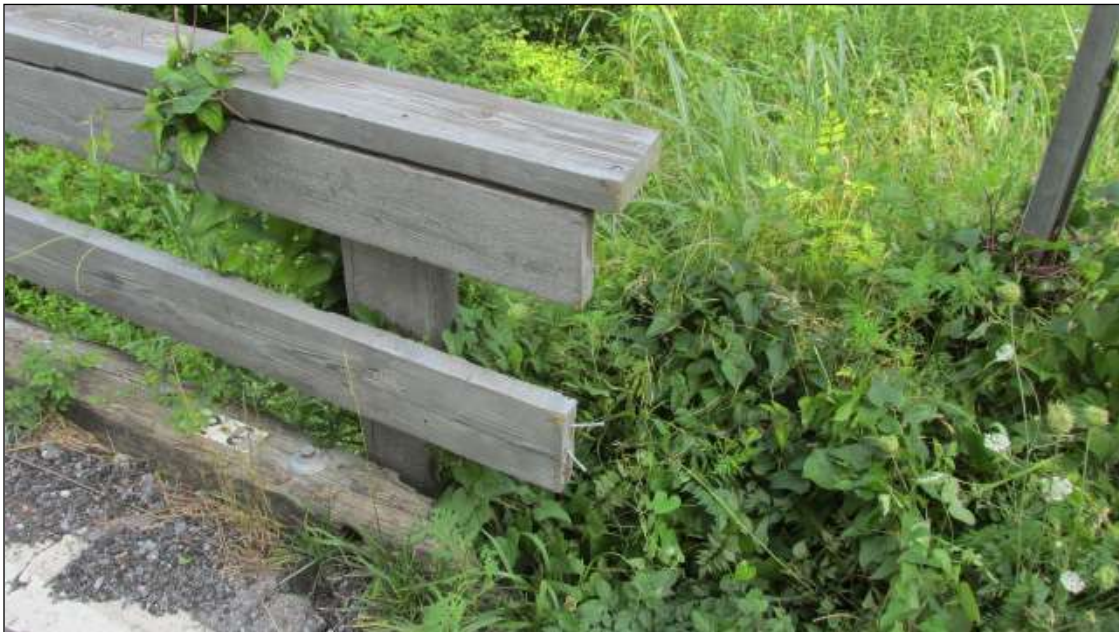
THE NORTHEAST PANEL BD. MISSING.
