NC DEPARTMENT OF TRANSPORTATION
 DIVISION OF HIGHWAYS
 STRUCTURE MANAGEMENT UNIT

Structure Safety Report

Routine Element Inspection

COUNTY: GASTON STRUCTURE NUMBER: 350118 FREQUENCY: 24 MONTHS

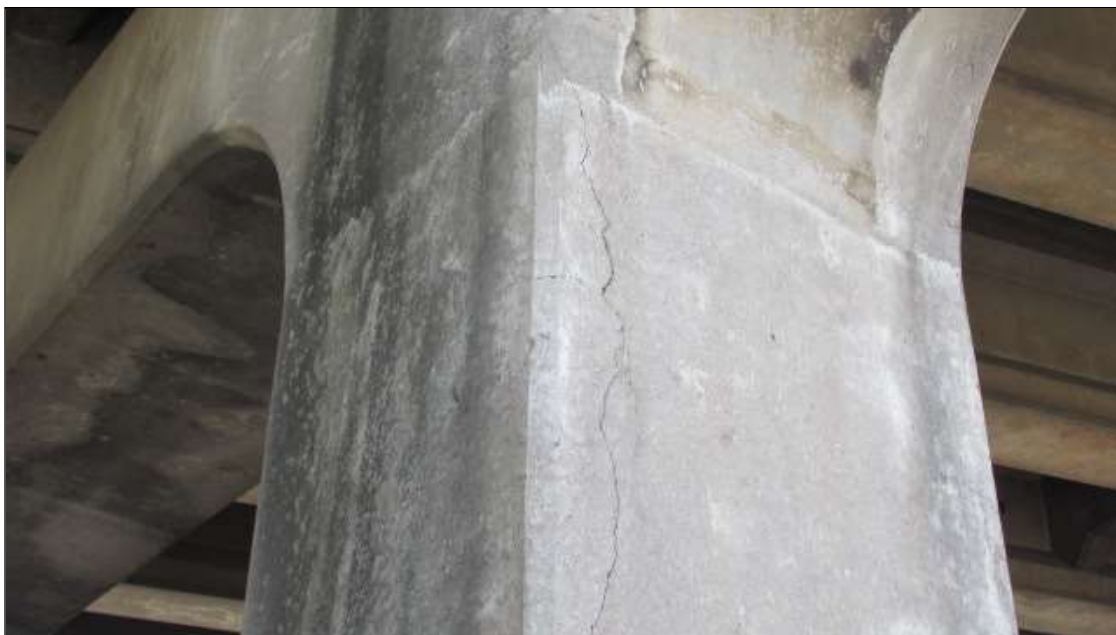
1 Each of Cracking (RC and Other): Width greater than 0.05 in. or spacing of less than 1 ft. vertical crack runs 8'

Bent 2 Pile 3: 1 Each of Cracking (RC and Other): Width greater than 0.05 in. or spacing of less than 1 ft. vertical crack runs 8'

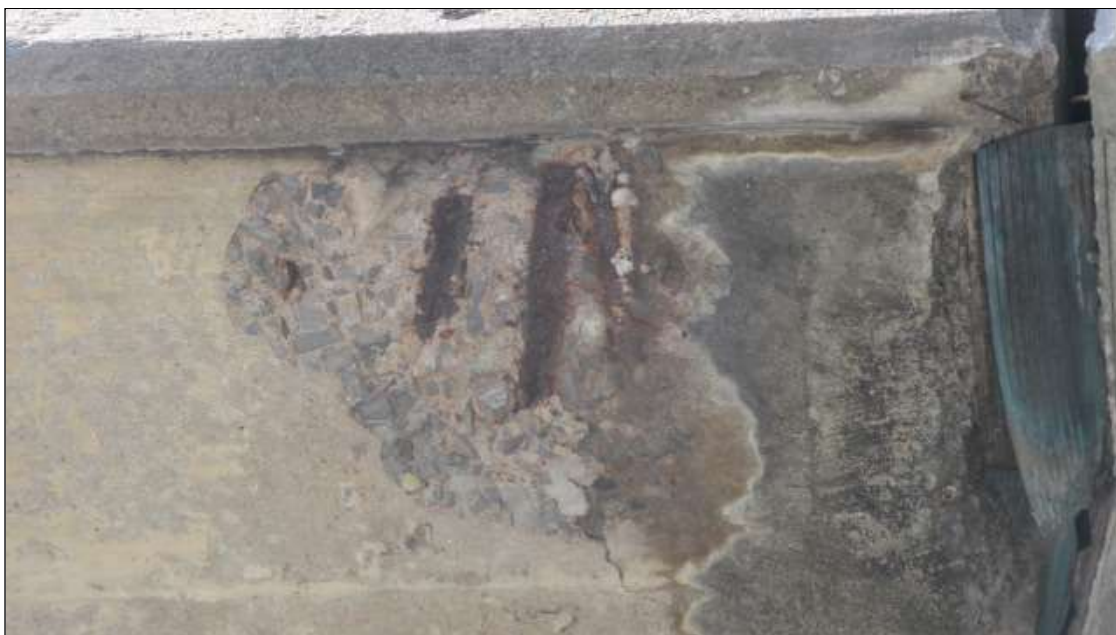
2 Square Feet of Exposed Rebar: Present without measurable section loss. 8" diam. popout under the lt. o'hang above bent 1 cap with rebar exposed.
 2000 Square Feet of Cracking (RC and Other): Width 0.012-0.05 in. or spacing of 1.0-3.0 ft.
 20 Square Feet of Delamination/Spall/Patched Area: Delaminated. Spall 1 in. or less deep or 6 in. or less in diameter. Patched area that is sound. concrete patch 2' l x 10'l in the rt. lane at the east end of span 1 at joint.

Span 1 Deck: 2 Square Feet of Exposed Rebar: Present without measurable section loss. 8" diam. popout under the lt. o'hang above bent 1 cap with rebar exposed.

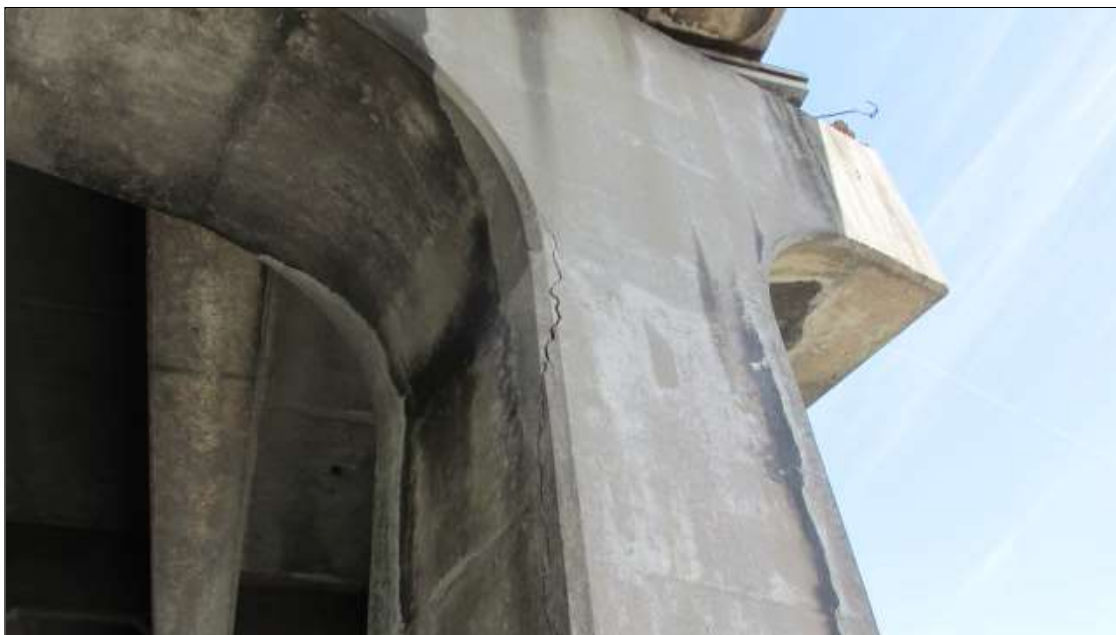
1 Each of Cracking (RC and Other): Width 0.012-0.05 in. or spacing or 1.0-3.0 ft. vertical cracking on the east face for 9'

Bent 2 Pile 1: 1 Each of Cracking (RC and Other): Width 0.012-0.05 in. or spacing or 1.0-3.0 ft. vertical cracking on the east face for 9'

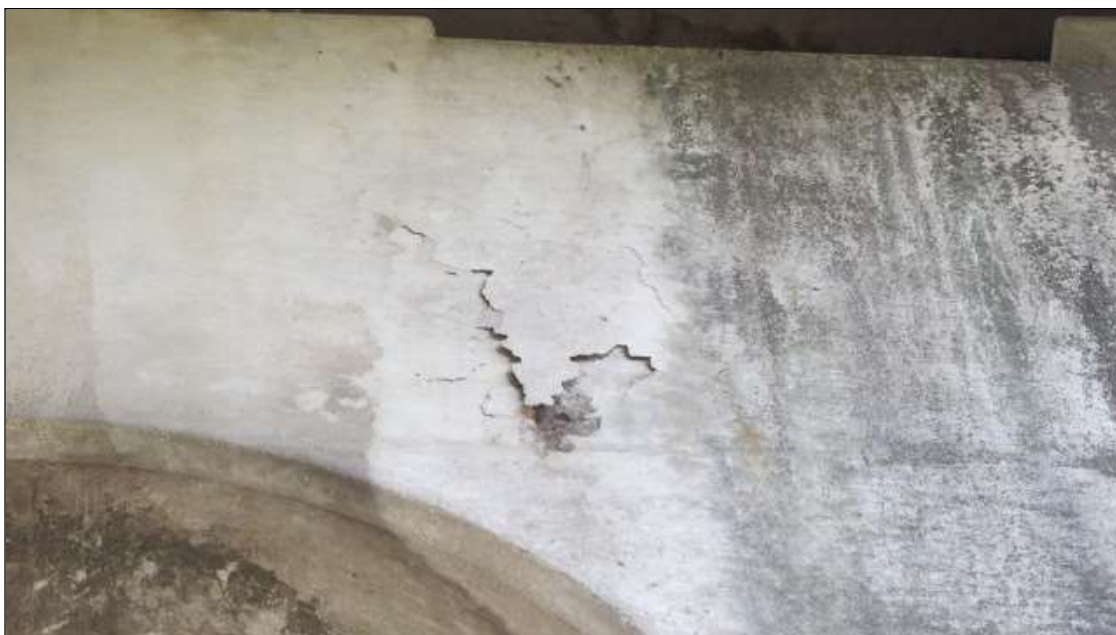
1 Feet of Cracking (RC and Other): Width 0.012-0.05 in. or spacing of 1.0-3.0 ft. 1' diam. crack/spall in progress on the east face of the cap in bay 1.

Bent 3 Cap : 1 Feet of Cracking (RC and Other): Width 0.012-0.05 in. or spacing of 1.0-3.0 ft. 1' diam. crack/spall in progress on the east face of the cap in bay 1.

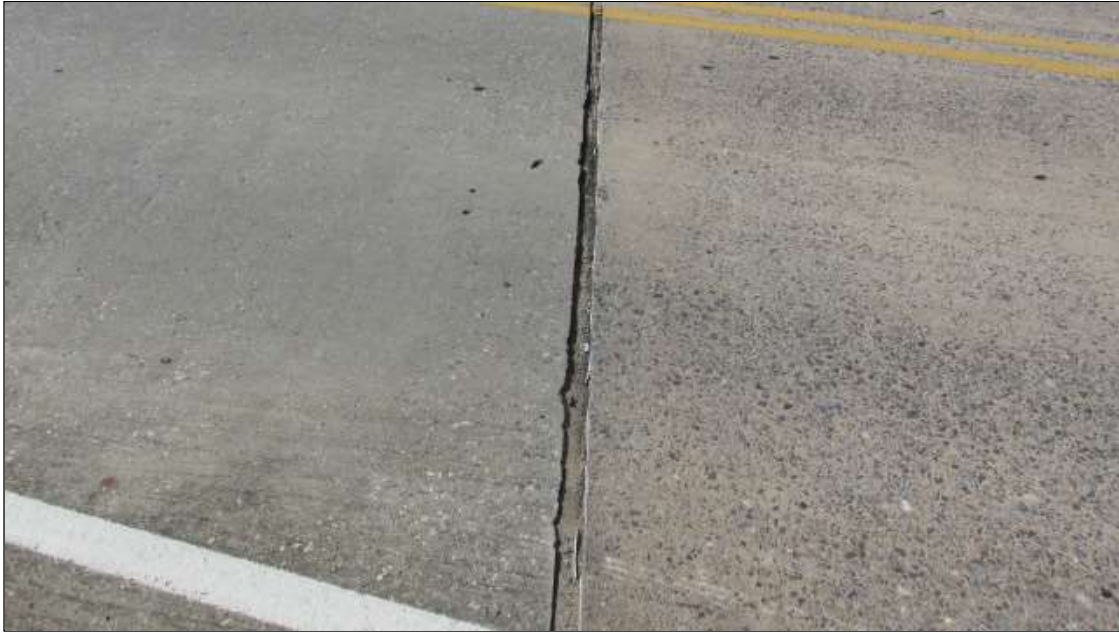
Expansion Joint 5 : 40 Feet of Debris Impaction: No debris to a shallow cover of loose debris may be evident but does not affect the performance of the joint.

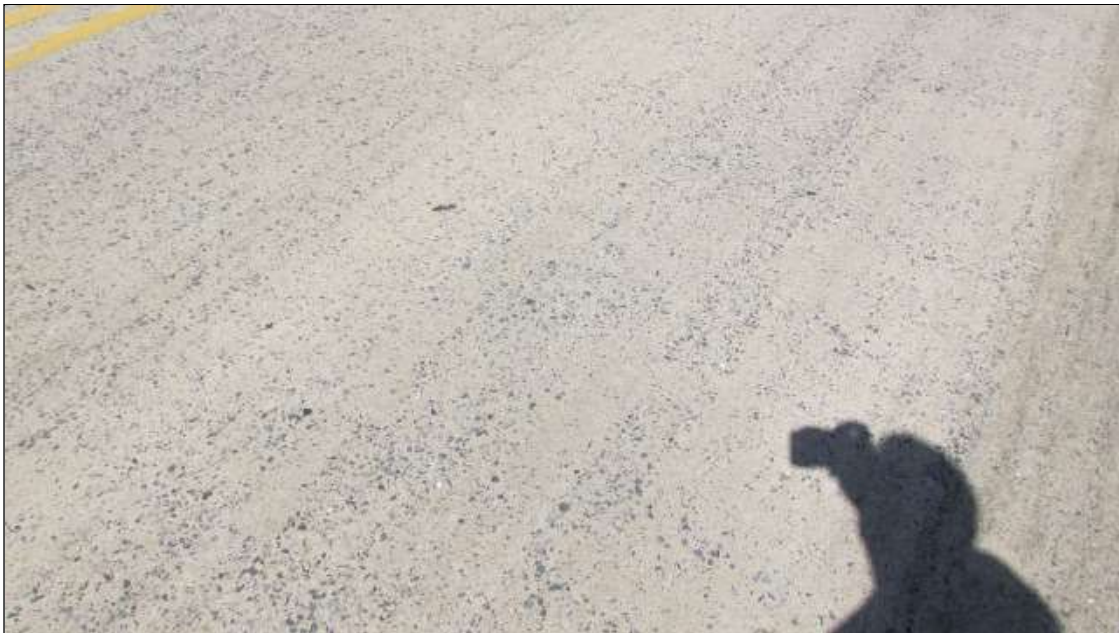
2000 Square Feet of Abrasion/Wear (PSC/RC): Abrasion or wearing has exposed coarse aggregate but the aggregate remains secure in the concrete.

Span 4 Deck: 2000 Square Feet of Abrasion/Wear (PSC/RC): Abrasion or wearing has exposed coarse aggregate but the aggregate remains secure in the concrete.

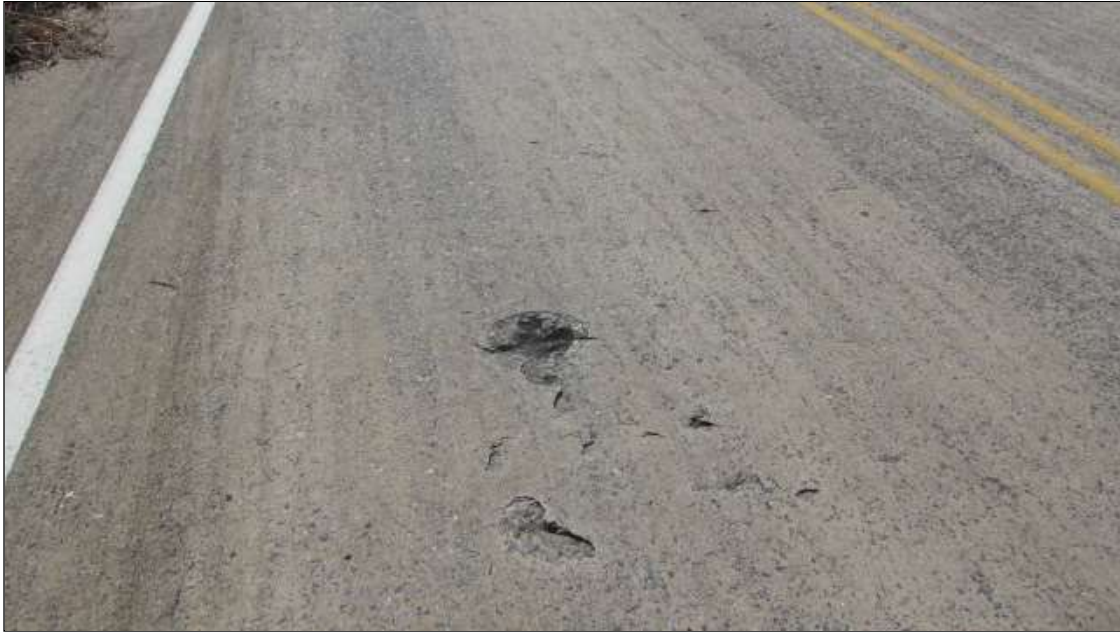
2 Square Feet of Delamination/Spall/Patched Area: Spall greater than 1 in. deep or greater than 6 in. in diameter. Patched area that is unsound or showing distress. Does not warrant structural review.

Span 3 Deck: 2 Square Feet of Delamination/Spall/Patched Area: Spall greater than 1 in. deep or greater than 6 in. in diameter. Patched area that is unsound or showing distress. Does not warrant structural review.

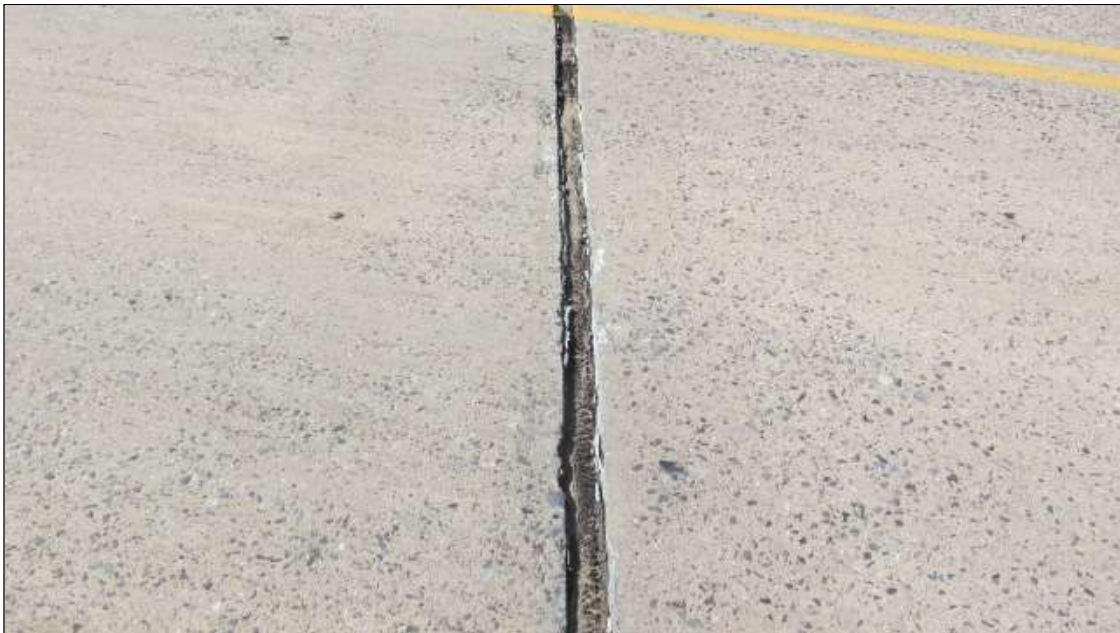
Expansion Joint 3 : 40 Feet of Debris Impaction: No debris to a shallow cover of loose debris may be evident but does not affect the performance of the joint.

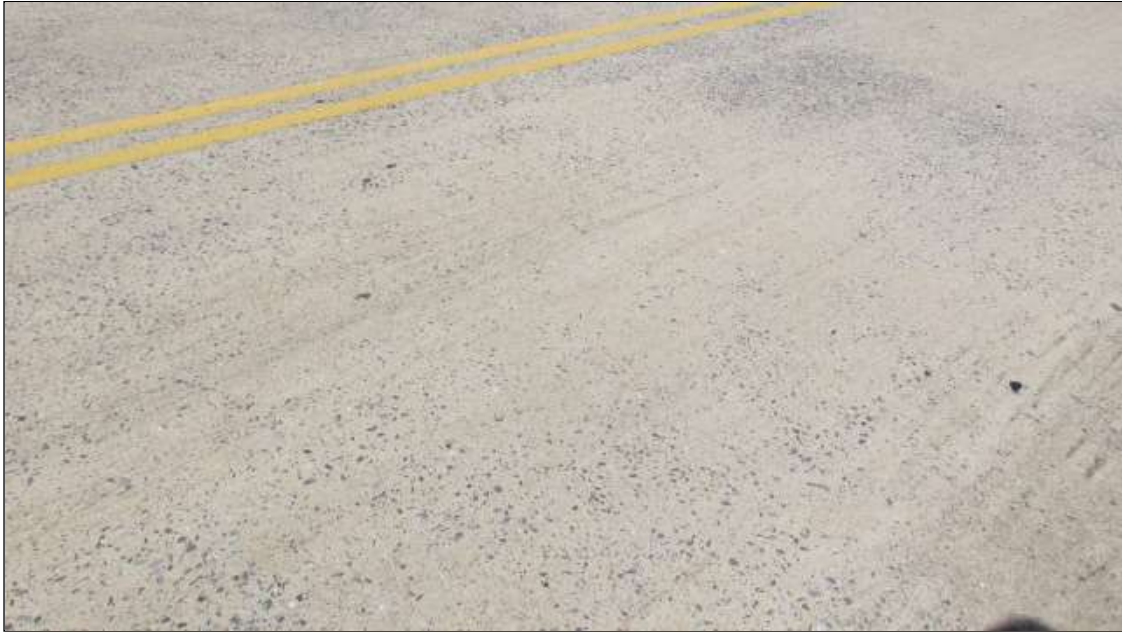
2000 Square Feet of Cracking (RC and Other): Width 0.012-0.05 in. or spacing of 1.0-3.0 ft.

Span 2 Deck: 2000 Square Feet of Cracking (RC and Other): Width 0.012-0.05 in. or spacing of 1.0-3.0 ft.

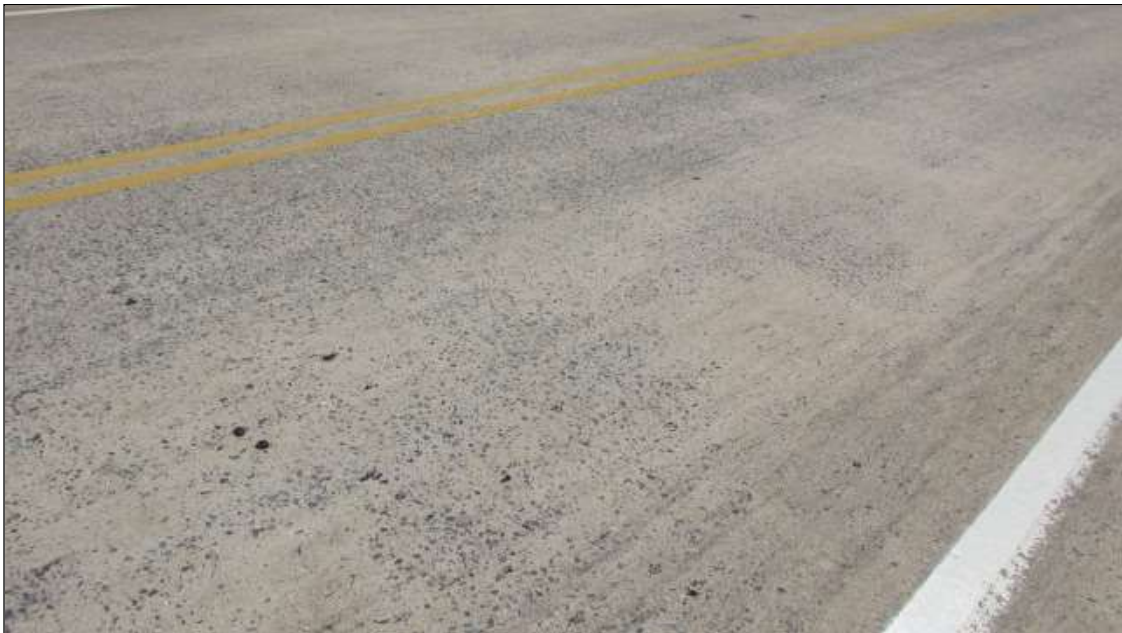
Span 1 Deck: 2000 Square Feet of Cracking (RC and Other): Width 0.012-0.05 in. or spacing of 1.0-3.0 ft.

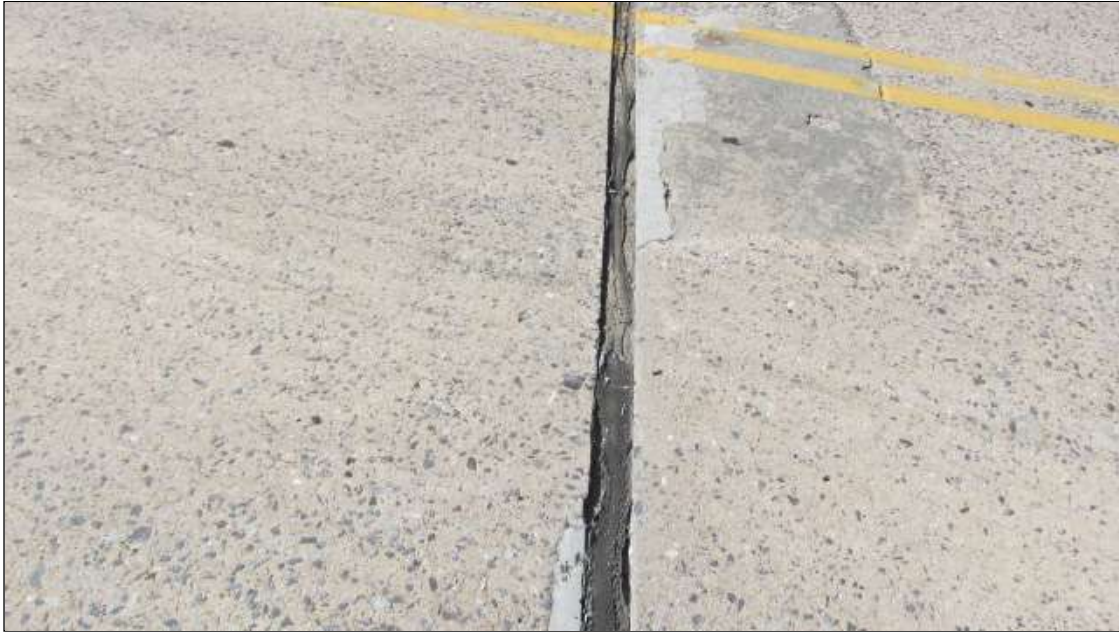
Expansion Joint 1 : 40 Feet of Debris Impaction: No debris to a shallow cover of loose debris may be evident but does not affect the performance of the joint.

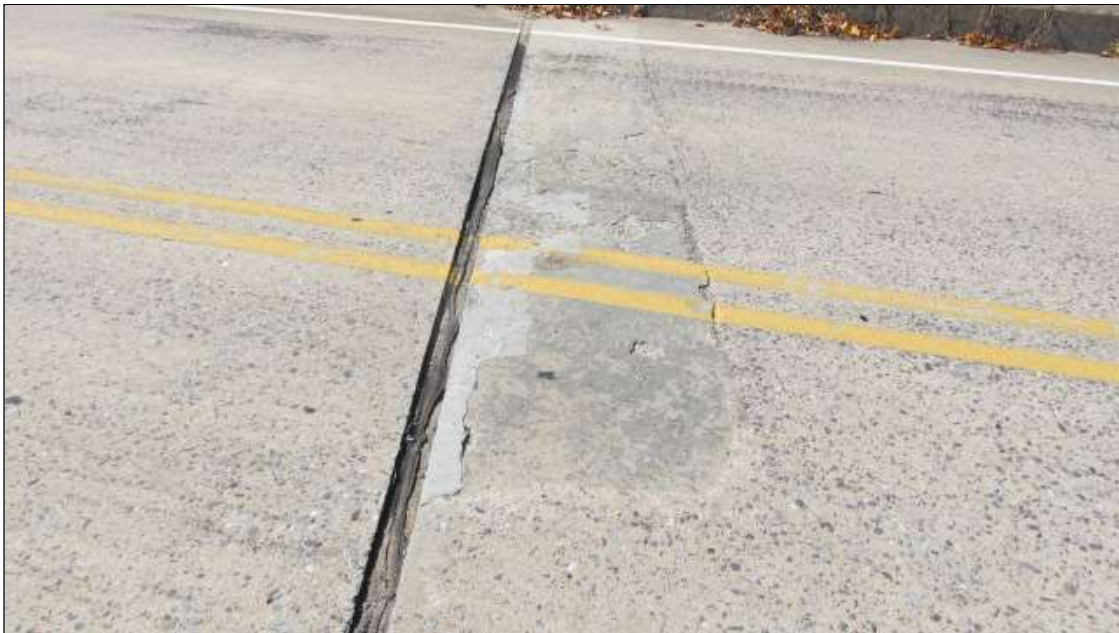
Span 1 Deck: 20 Square Feet of Delamination/Spall/Patched Area: Delaminated. Spall 1 in. or less deep or 6 in. or less in diameter. Patched area that is sound. concrete patch 2' l x 10'l in the rt. lane at the east end of span 1 at joint.

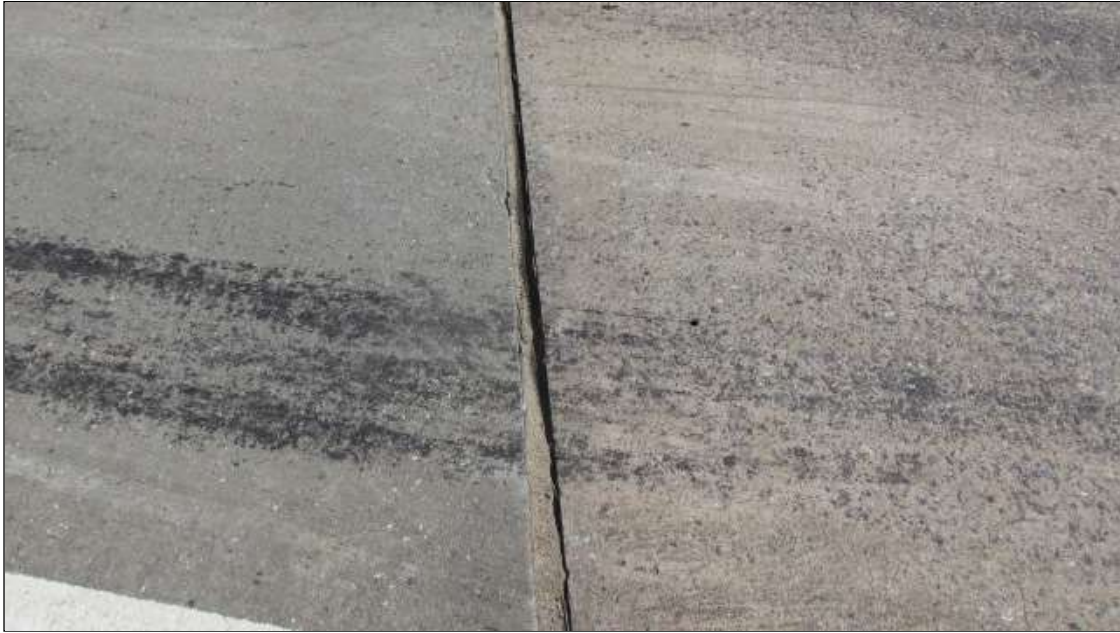
Expansion Joint 2 : 40 Feet of Debris Impaction: No debris to a shallow cover of loose debris may be evident but does not affect the performance of the joint.

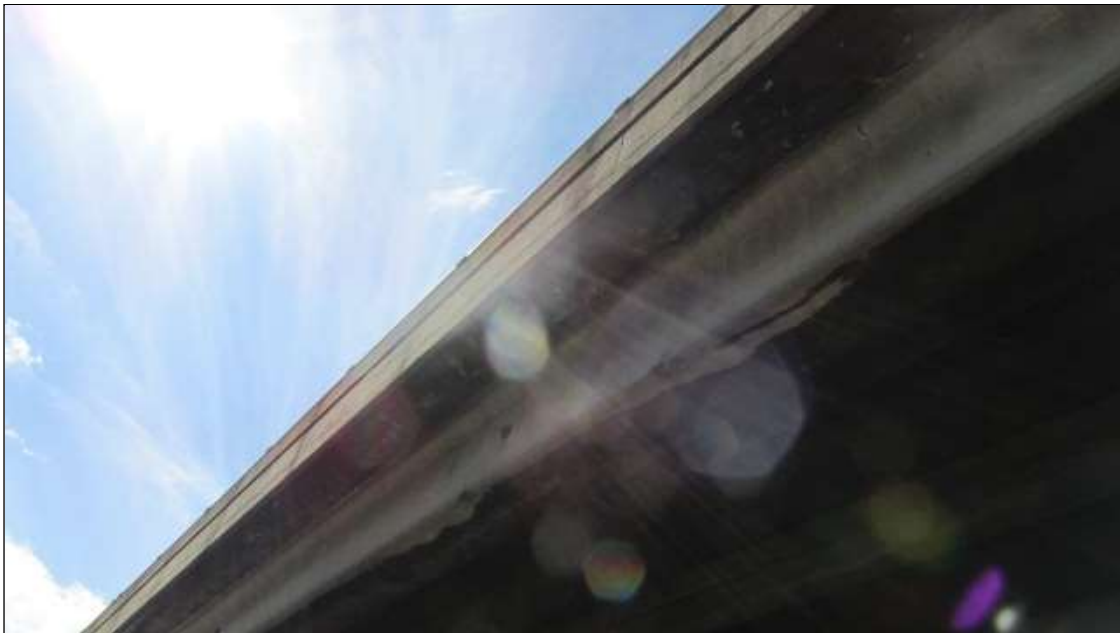
2 Feet of Delamination/Spall/Patched Area: Spall greater than 1 in. deep or greater than 6 in. diameter. Patched area that is unsound or showing distress. Does not warrant structural review. chip spall due to impact from vehicle 2' along the bottom corner over rt. lane looking south

Span 2 Beam 1: 2 Feet of Delamination/Spall/Patched Area: Spall greater than 1 in. deep or greater than 6 in. diameter. Patched area that is unsound or showing distress. Does not warrant structural review. chip spall due to impact from vehicle 2' along the bottom corner over rt. lane looking south
