# Structure Safety Report

## Routine Element Inspection

COUNTY: GASTON STRUCTURE NUMBER: 350125 FREQUENCY: 24 MONTHS

FACILITY CARRIED: SR2278 MILE POST: \_\_\_\_\_

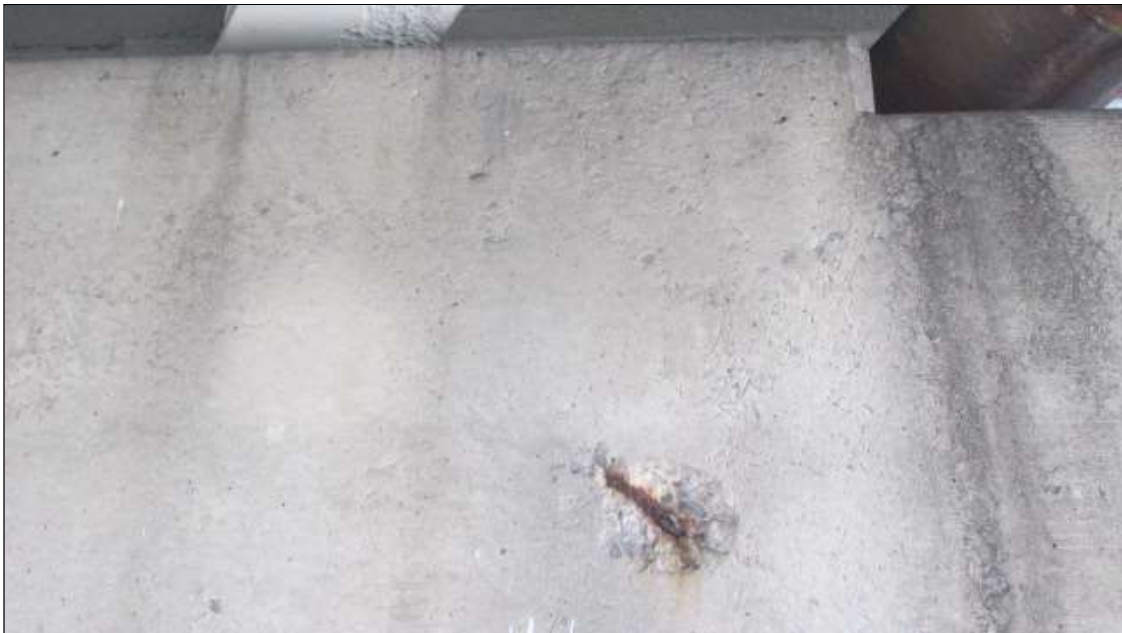
1 Feet of Exposed Rebar: Present without measurable section loss. 6" diam. spall on the east face of cap under girder 2.

Bent 3 Cap : 1 Feet of Exposed Rebar: Present without measurable section loss. 6" diam. spall on the east face of cap under girder 2.

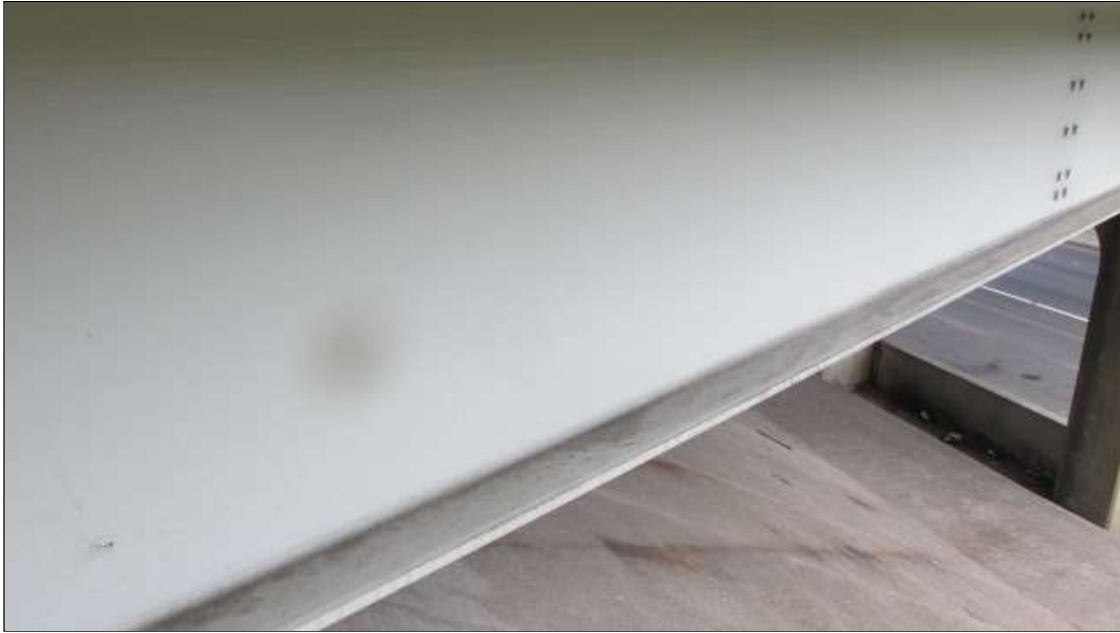
beams, bearing and diaphragms. painted recently

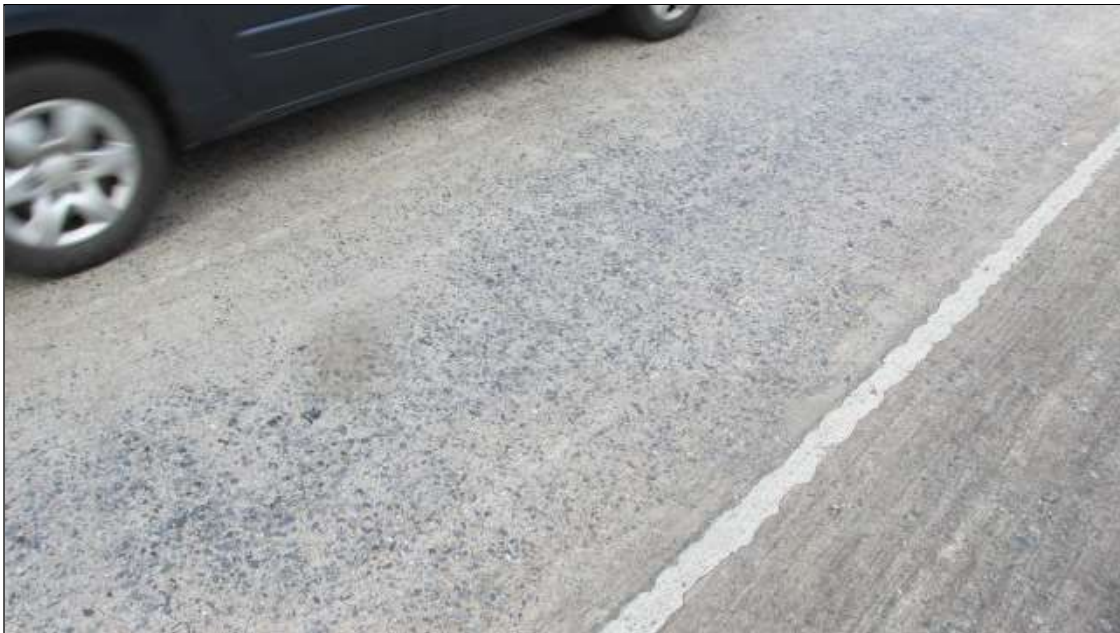
1000 Square Feet of Delamination/Spall/Patched Area: Delaminated. Spall 1 in. or less deep or 6 in. or less in diameter. Patched area that is sound.

Span 4 Deck: 1000 Square Feet of Delamination/Spall/Patched Area: Delaminated. Spall 1 in. or less deep or 6 in. or less in diameter. Patched area that is sound.

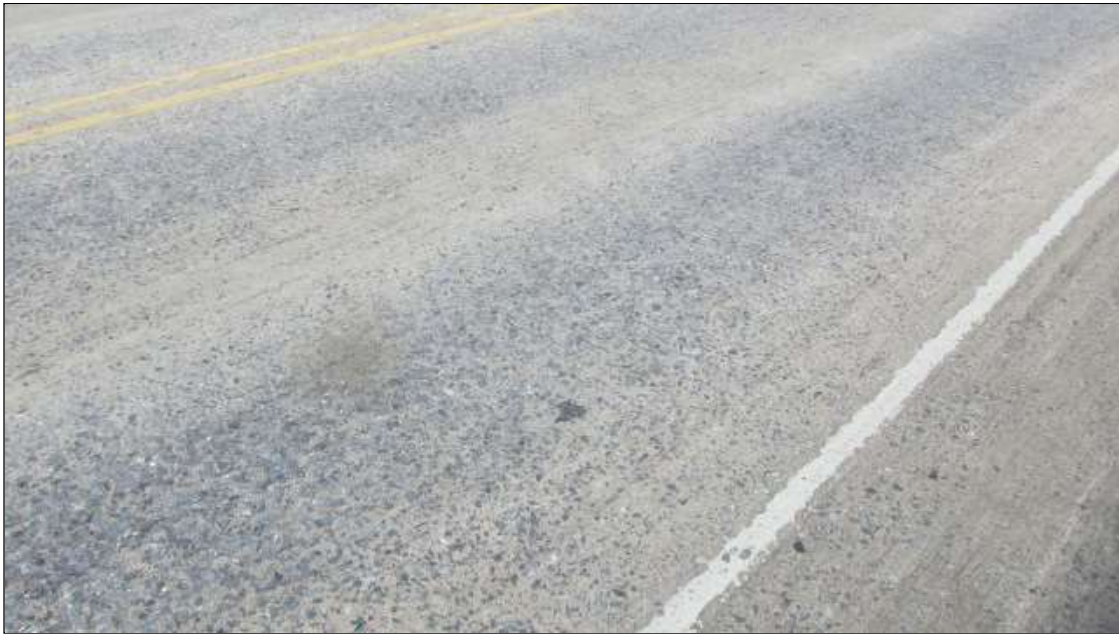
1500 Square Feet of Delamination/Spall/Patched Area: Delaminated. Spall 1 in. or less deep or 6 in. or less in diameter. Patched area that is sound.

Span 3 Deck: 1500 Square Feet of Delamination/Spall/Patched Area: Delaminated. Spall 1 in. or less deep or 6 in. or less in diameter. Patched area that is sound.

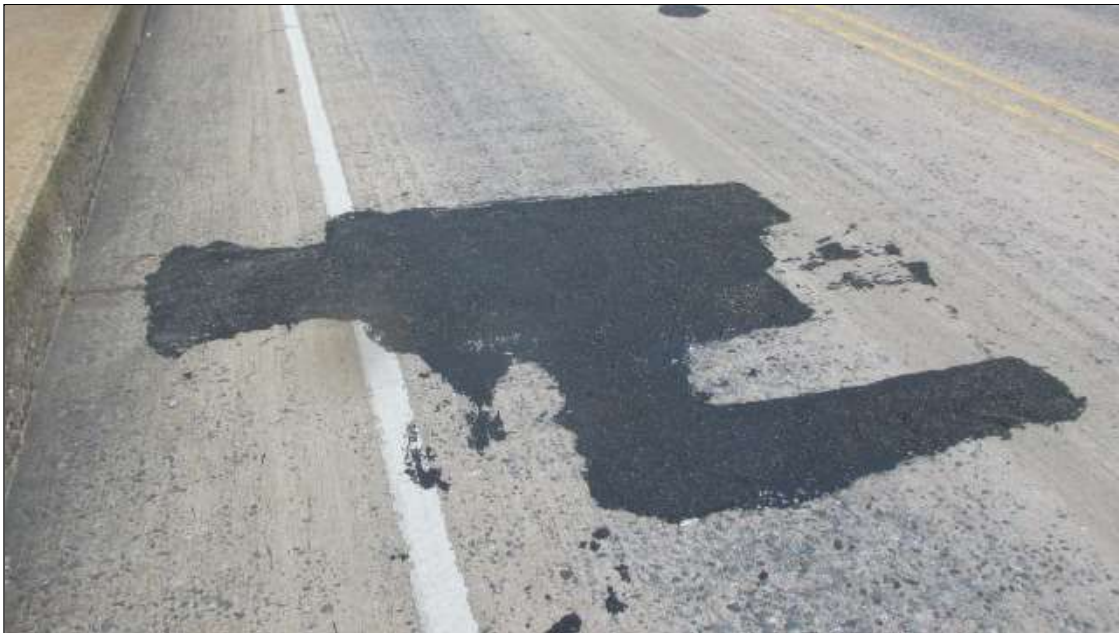
20 Square Feet of Delamination/Spall/Patched Area: Delaminated. Spall 1 in. or less deep or 6 in. or less in diameter. Patched area that is sound.. 5' l x 4' wide asphalt patch in the rt. lane

Span 2 Deck: 20 Square Feet of Delamination/Spall/Patched Area: Delaminated. Spall 1 in. or less deep or 6 in. or less in diameter. Patched area that is sound.. 5' l x 4' wide asphalt patch in the rt. lane

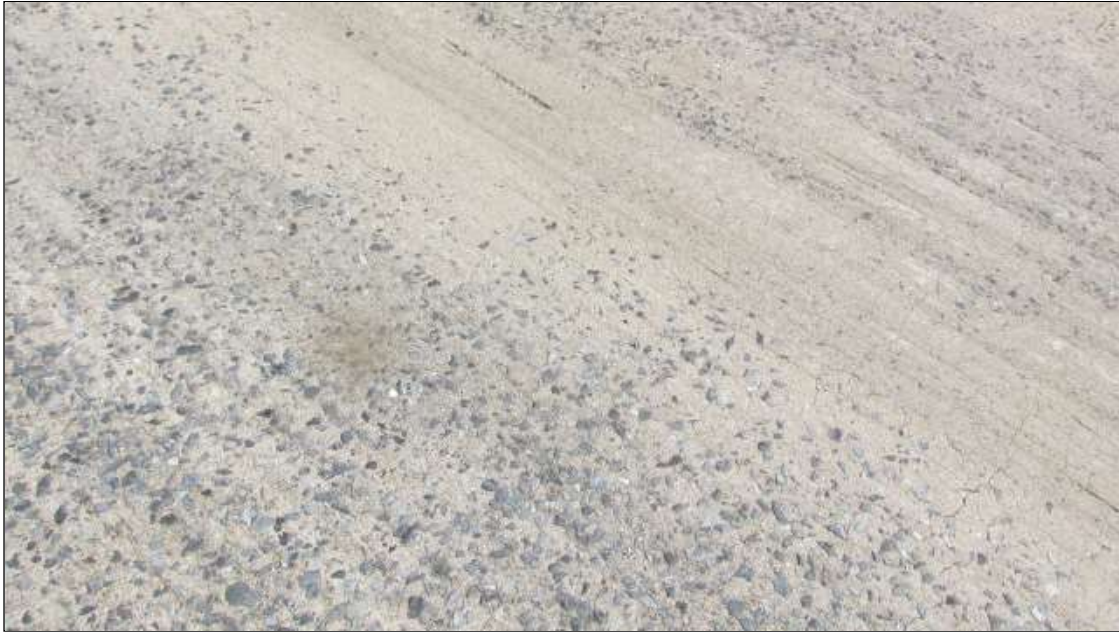
1000 Square Feet of Delamination/Spall/Patched Area: Delaminated. Spall 1 in. or less deep or 6 in. or less in diameter. Patched area that is sound.

Span 2 Deck: 1000 Square Feet of Delamination/Spall/Patched Area: Delaminated. Spall 1 in. or less deep or 6 in. or less in diameter. Patched area that is sound.

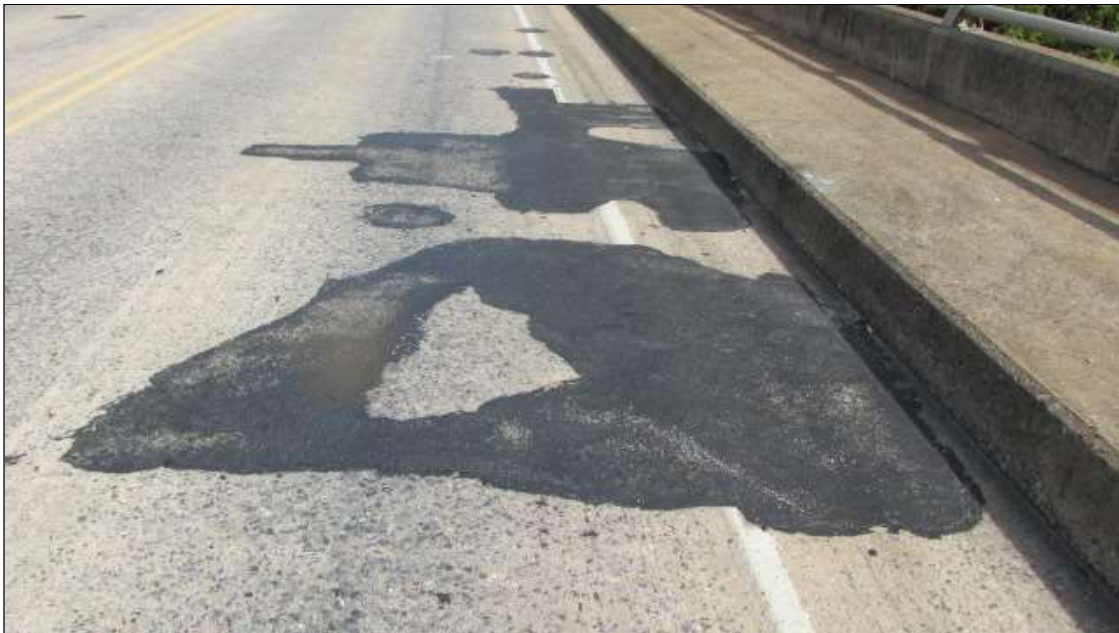
180 Square Feet of Delamination/Spall/Patched Area: Delaminated. Spall 1 in. or less deep or 6 in. or less in diameter. Patched area that is sound. a 20'l x 6' wide asphalt patch in the lt. lane of span 2.

Span 2 Deck: 180 Square Feet of Delamination/Spall/Patched Area: Delaminated. Spall 1 in. or less deep or 6 in. or less in diameter. Patched area that is sound. a 20' x 6' wide asphalt patch in the lt. lane of span 2.

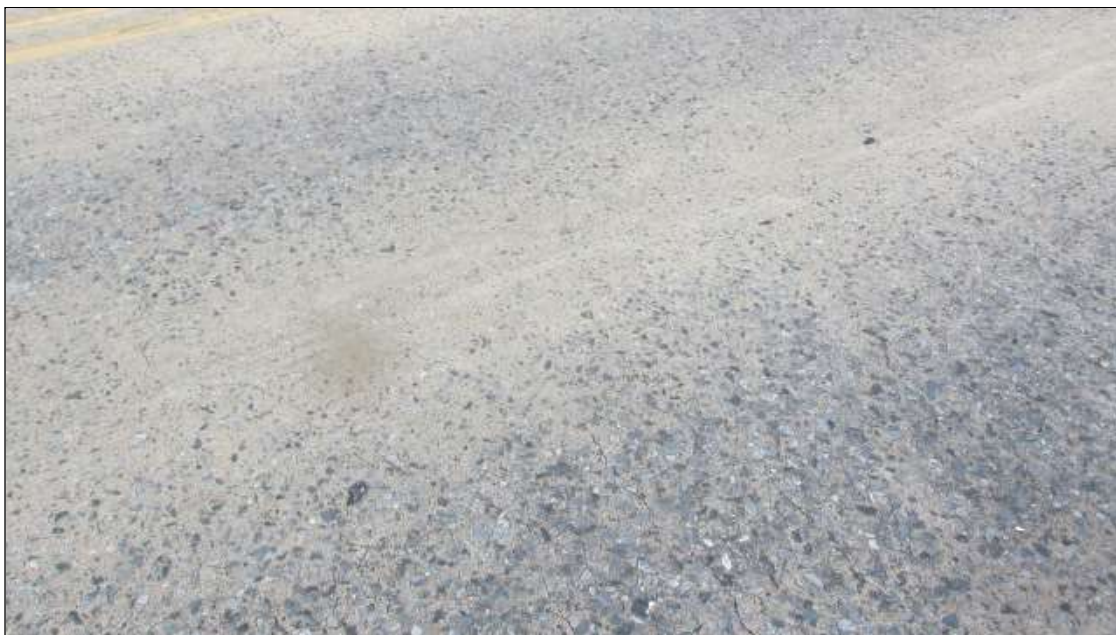
1000 Square Feet of Delamination/Spall/Patched Area: Delaminated. Spall 1 in. or less deep or 6 in. or less in diameter. Patched area that is sound.

Span 1 Deck: 1000 Square Feet of Delamination/Spall/Patched Area: Delaminated. Spall 1 in. or less deep or 6 in. or less in diameter. Patched area that is sound.

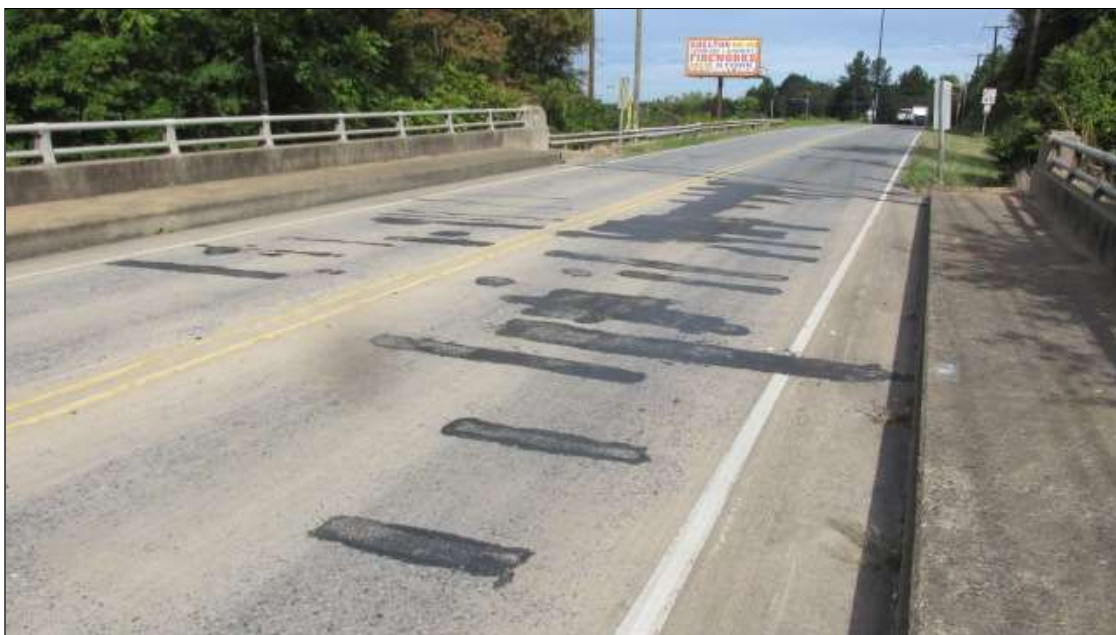
1000 Square Feet of Delamination/Spall/Patched Area: Delaminated. Spall 1 in. or less deep or 6 in. or less in diameter. Patched area that is sound. several patches in the lt. lane of span ranging from 1' x 2' to 6' x 10'.

Span 1 Deck: 1000 Square Feet of Delamination/Spall/Patched Area: Delaminated. Spall 1 in. or less deep or 6 in. or less in diameter. Patched area that is sound. several patches in the lt. lane of span ranging from 1' x 2' to 6' x 10'.

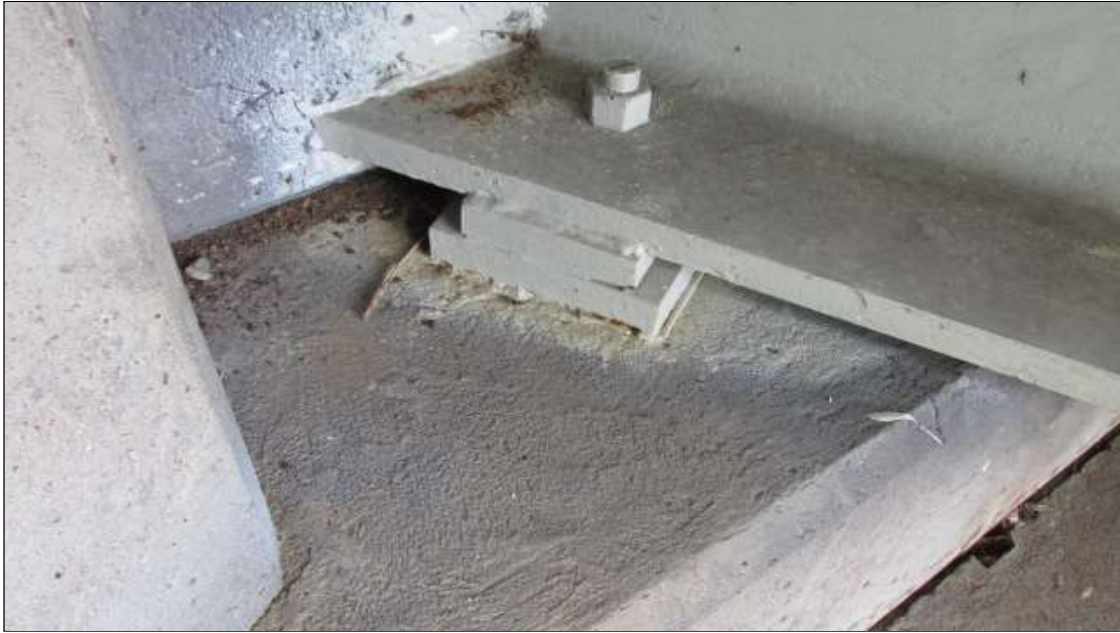
1 Each of Corrosion: None. bearing painted

Span 1 Beam 6 Near Bearing : 1 Each of Corrosion: None. bearing painted

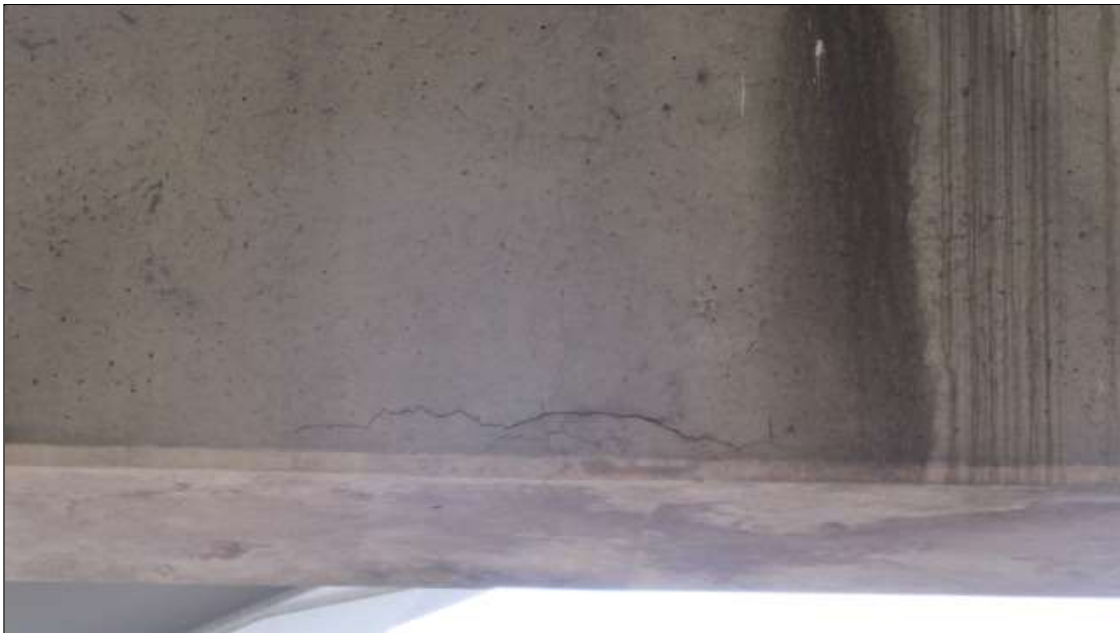
3 Feet of Cracking (RC and Other): Width greater than 0.05 in. or spacing of less than 1 ft. west face bent 1

Bent 1 Cap : 3 Feet of Cracking (RC and Other): Width greater than 0.05 in. or spacing of less than 1 ft. west face bent

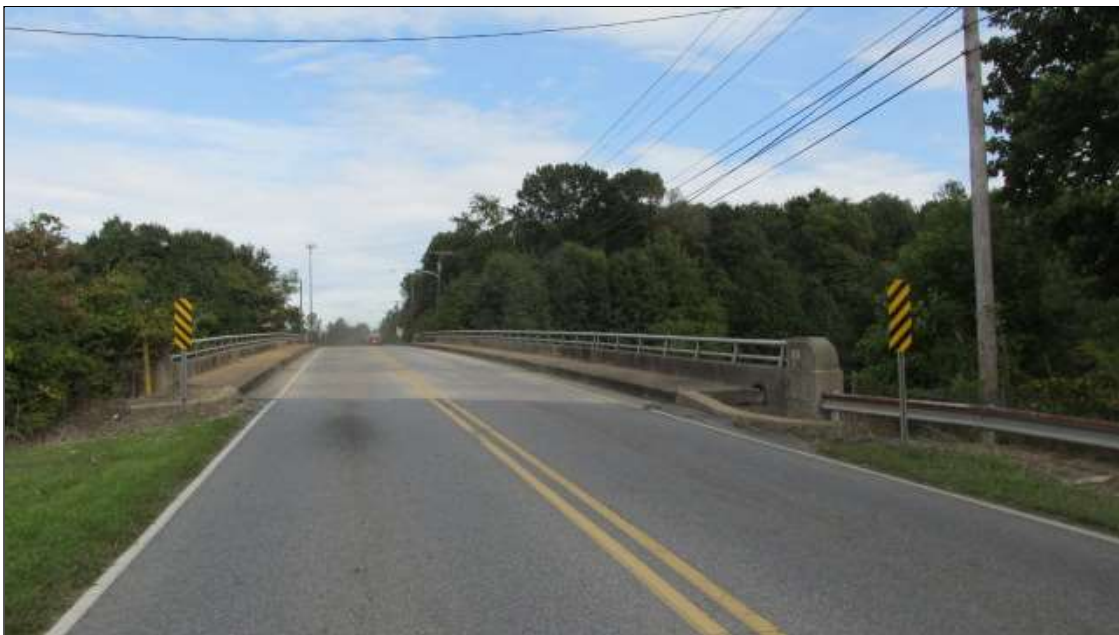
**Details** APPROACHES TAR SEALED WITH CRACKING AND SETTLEMENT.
