NC DEPARTMENT OF TRANSPORTATION  
 DIVISION OF HIGHWAYS  
 STRUCTURE MANAGEMENT UNIT

# Structure Safety Report

## Routine Element Inspection

COUNTY: GASTON STRUCTURE NUMBER: 350126 FREQUENCY: 24 MONTHS

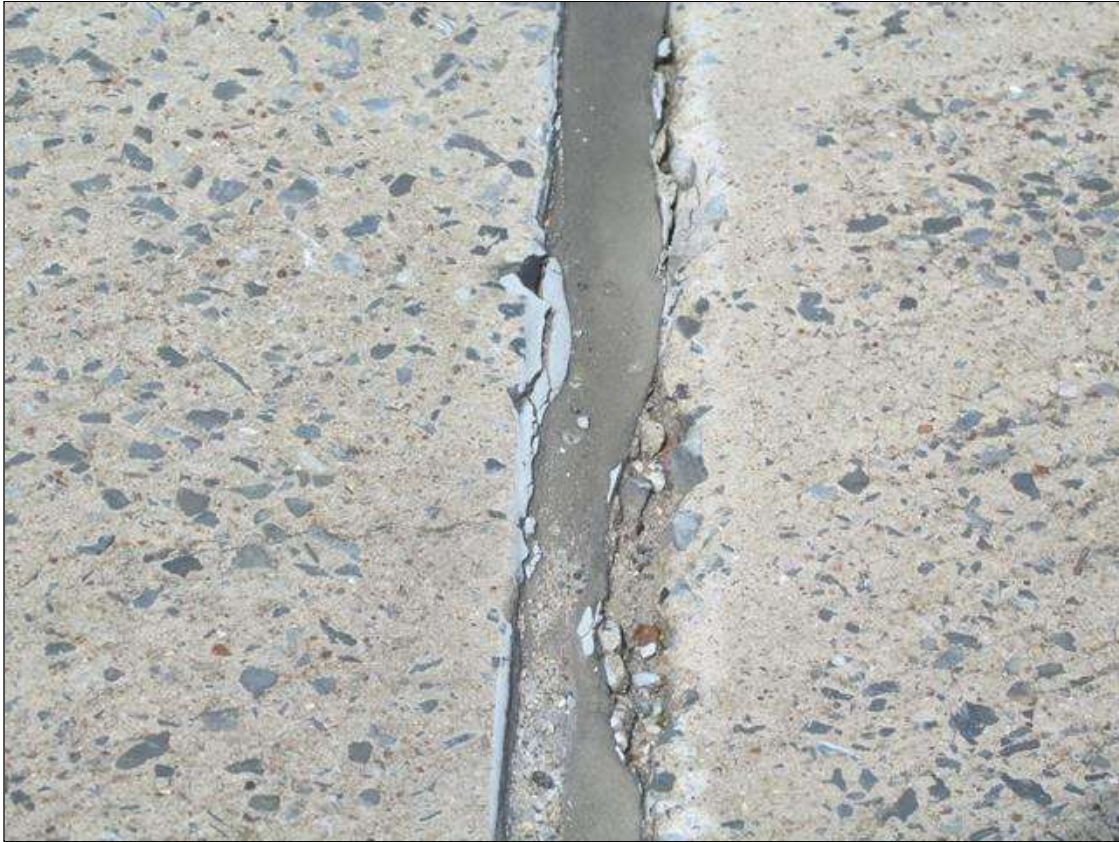
Expansion Joint 1 : 23 Feet of Seal Adhesion: Adhered for more than 50% of the joint height.

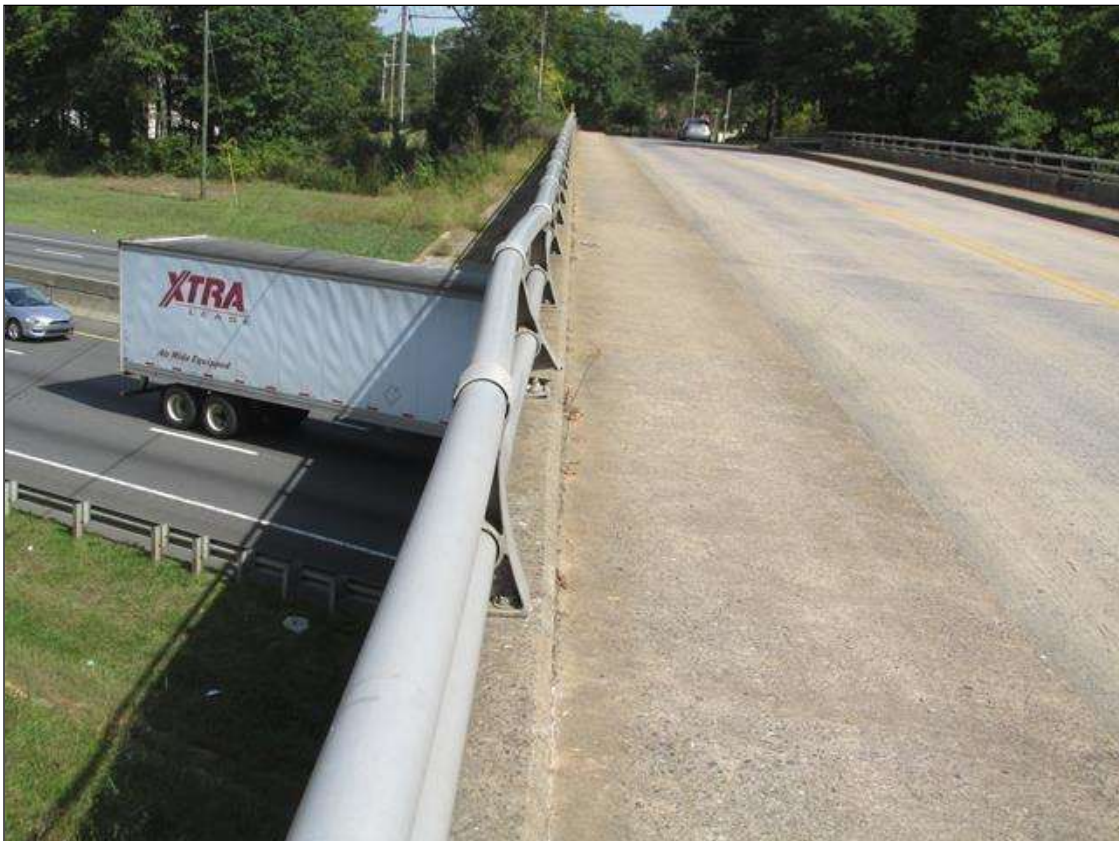
Span 4 Right Bridge Rail: 8 Feet of Distortion: Distortion not requiring mitigation of mitigated distortion.

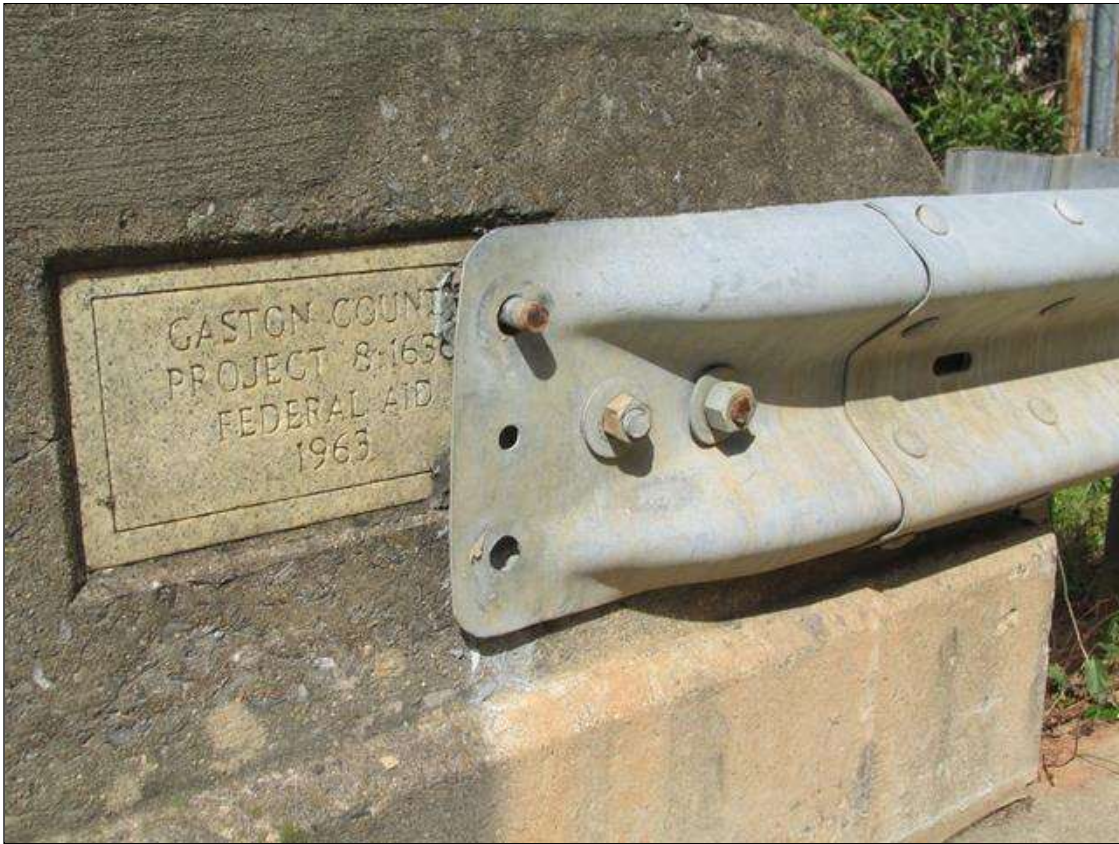
2 Feet of Connection: Missing bolts, rivets, or fasteners; broken welds; or pack rust with distortion but does not warrant a structural review. GUARDRAIL CONNECTION TO CONCRETE BRIDGE RAIL.

Span 1 Right Bridge Rail: 2 Feet of Connection: Missing bolts, rivets, or fasteners; broken welds; or pack rust with distortion but does not warrant a structural review. GUARDRAIL CONNECTION TO CONCRETE BRIDGE RAIL.

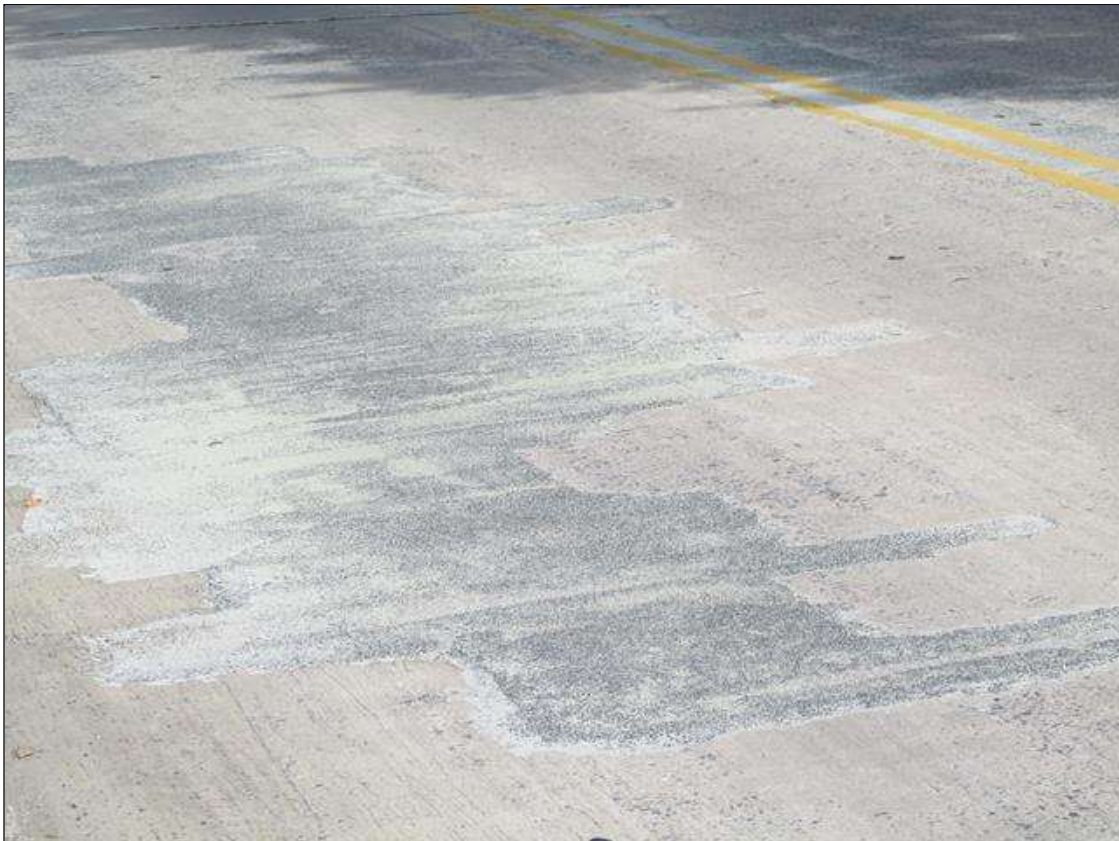
400 Square Feet of Delamination/Spall/Patched Area/Pothole (Wearing Surfaces): Delaminated. Spall less than 1 in. deep or less than 6 in. diameter. Patched area that is sound. Partial depth pothole.

Span 1 Wearing Surface: 400 Square Feet of Delamination/Spall/Patched Area/Pothole (Wearing Surfaces): Delaminated. Spall less than 1 in. deep or less than 6 in. diameter. Patched area that is sound. Partial depth pothole.

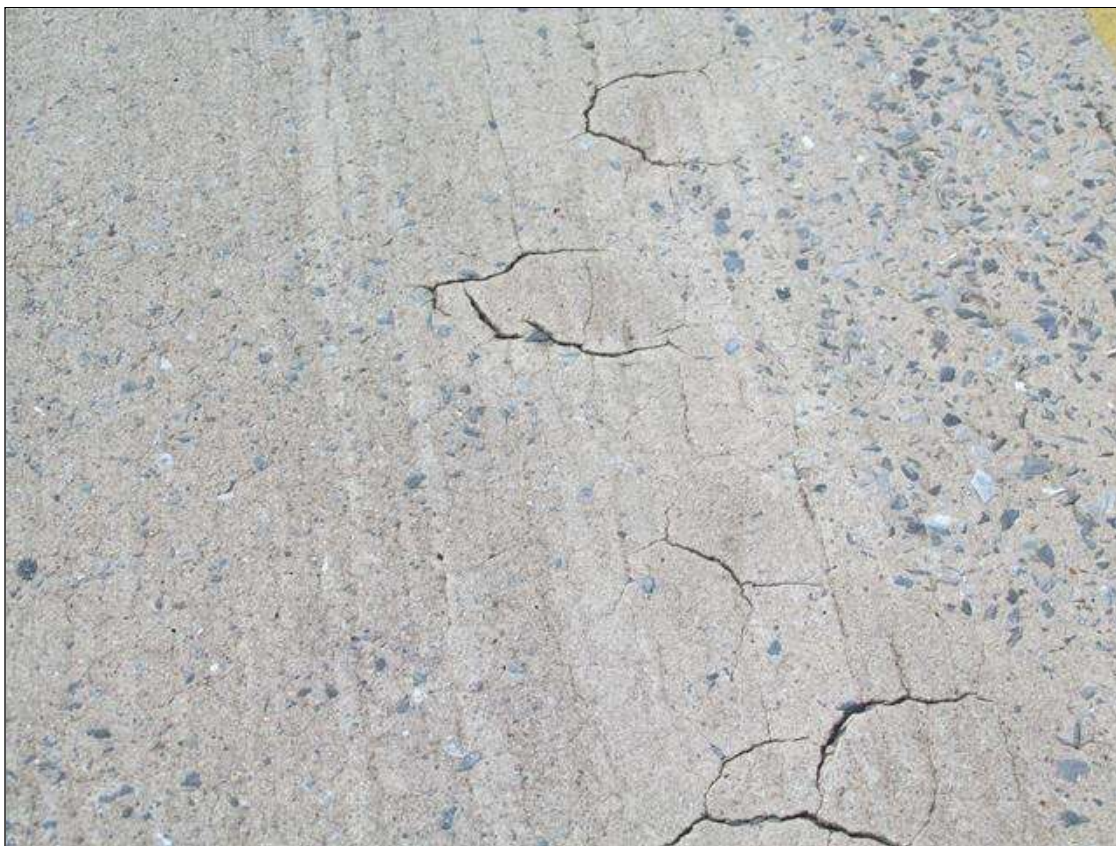
500 Square Feet of Crack (Wearing Surface): Width of more than 0.05 in. or spacing of less than 1.0 ft.

Span 2 Wearing Surface: 500 Square Feet of Crack (Wearing Surface): Width of more than 0.05 in. or spacing of less than 1.0 ft.

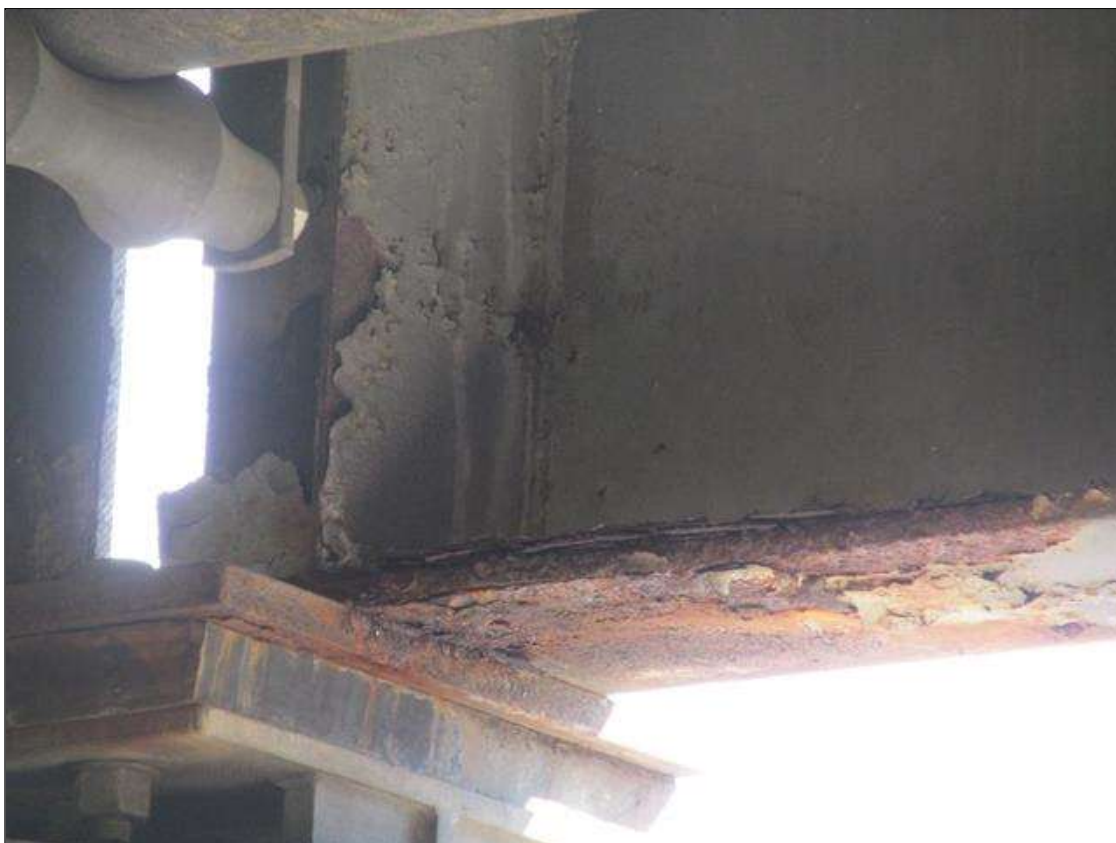
6 Feet of Corrosion: Section loss is evident or pack rust is present but does not warrant structural review.

Span 1 Beam 1: 6 Feet of Corrosion: Section loss is evident or pack rust is present but does not warrant structural review.

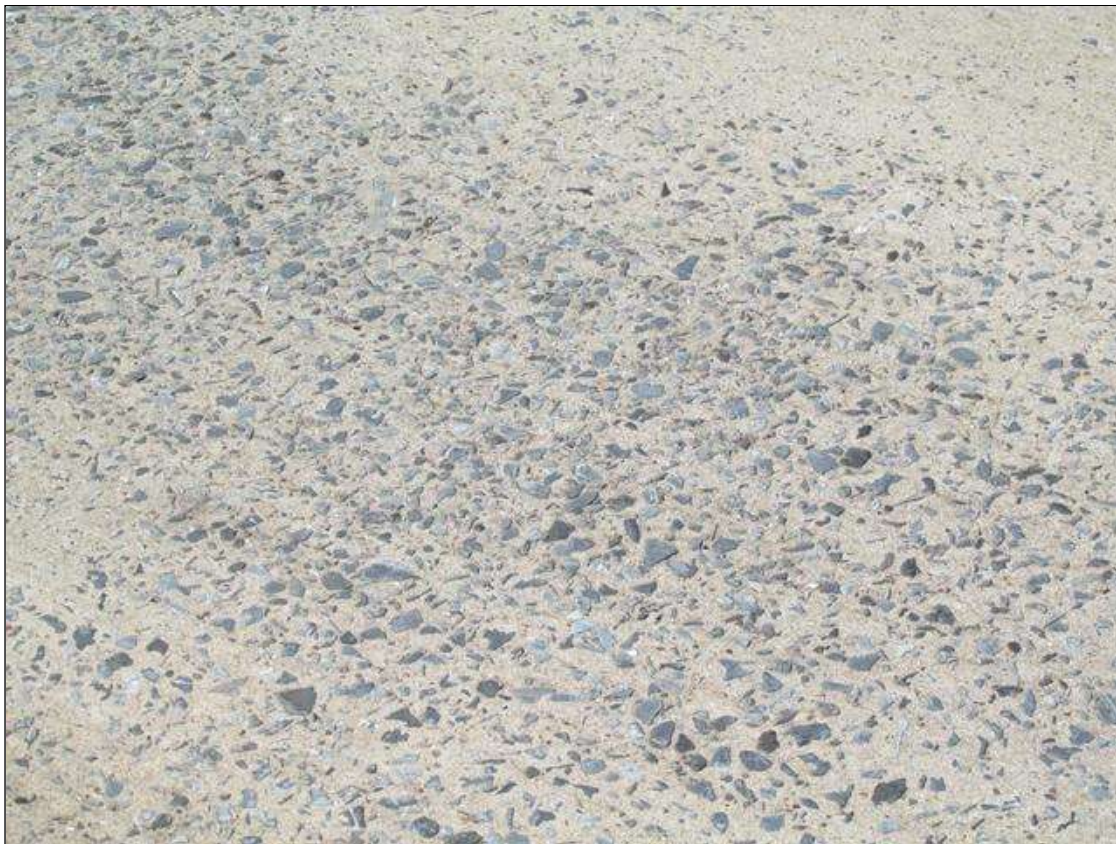
SCATTERED COARSE AGGREGATE EXPOSURE THROUGHOUT TOP OF DECK

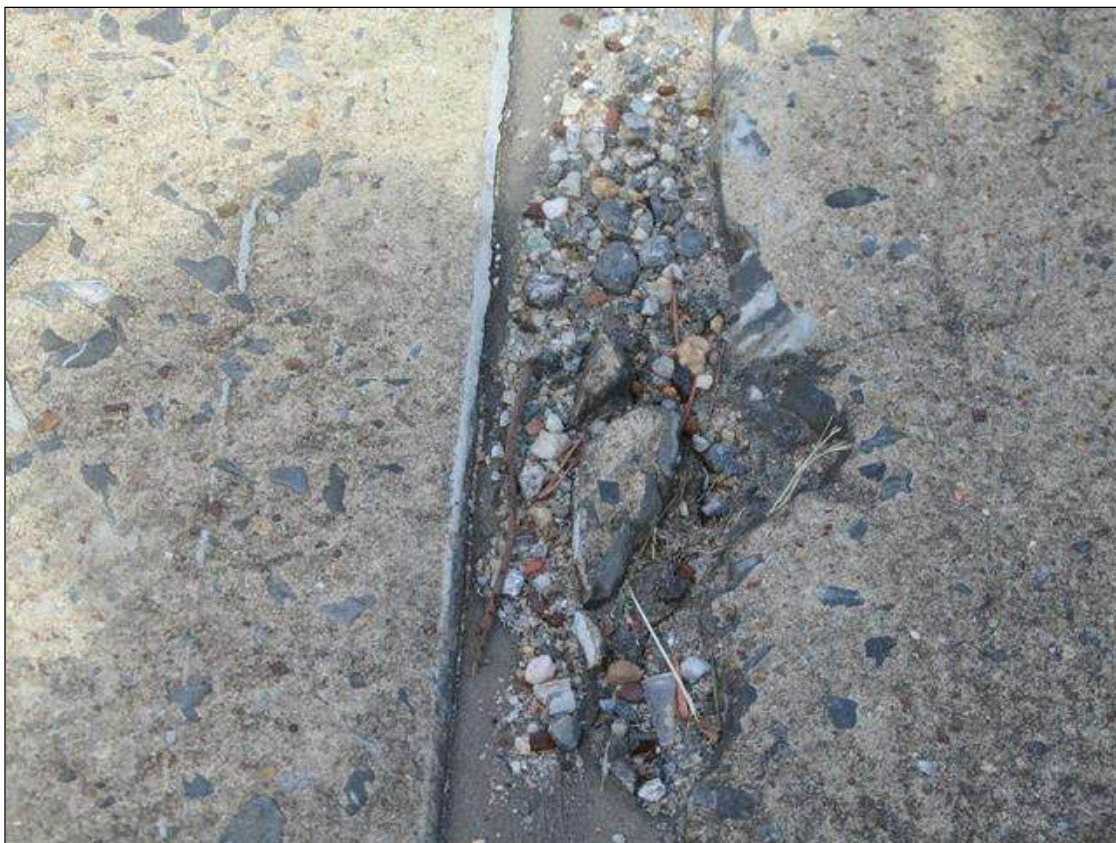
10 Square Feet of Cracking (RC and Other): Width greater than 0.05 in. or spacing of less than 1 ft. CHIPPING ALONG JOINT EDGES.

Span 1 Deck: 10 Square Feet of Cracking (RC and Other): Width greater than 0.05 in. or spacing of less than 1 ft.  
CHIPPING ALONG JOINT EDGES.

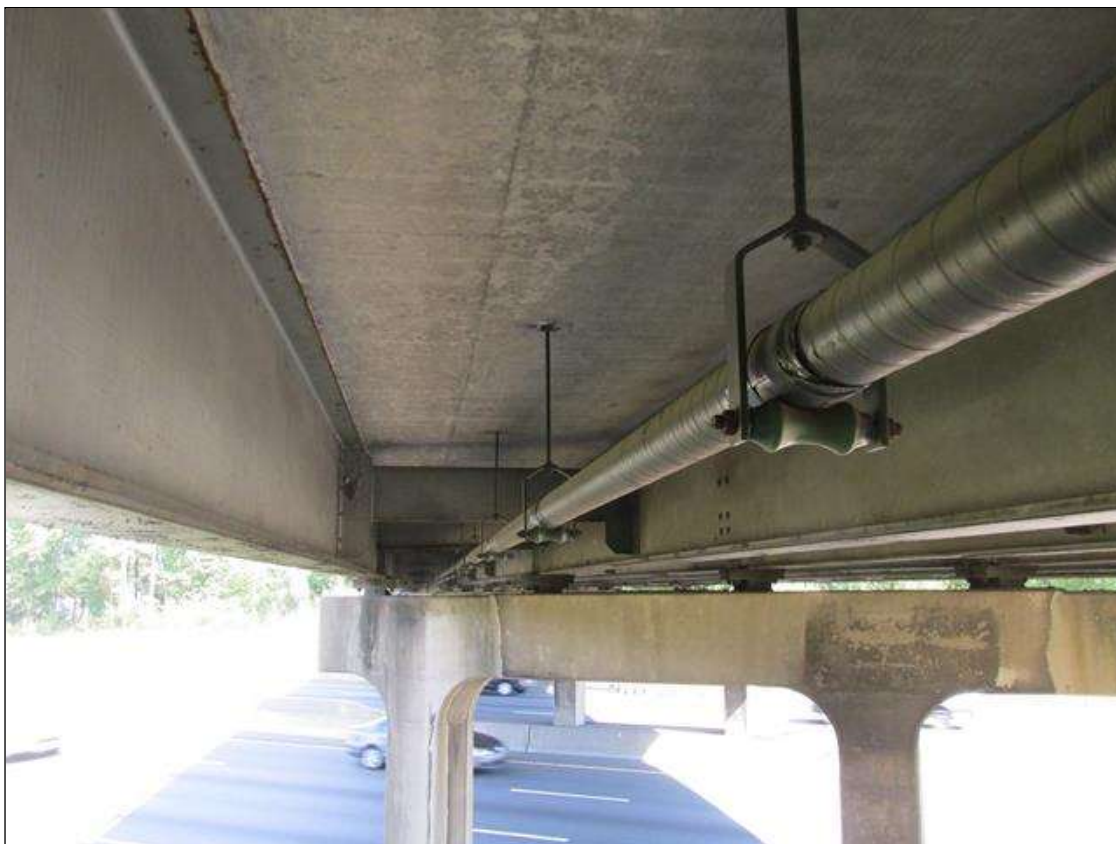
4" GAS LINE HANGING FROM STEEL SUPPORTS, BAY 5

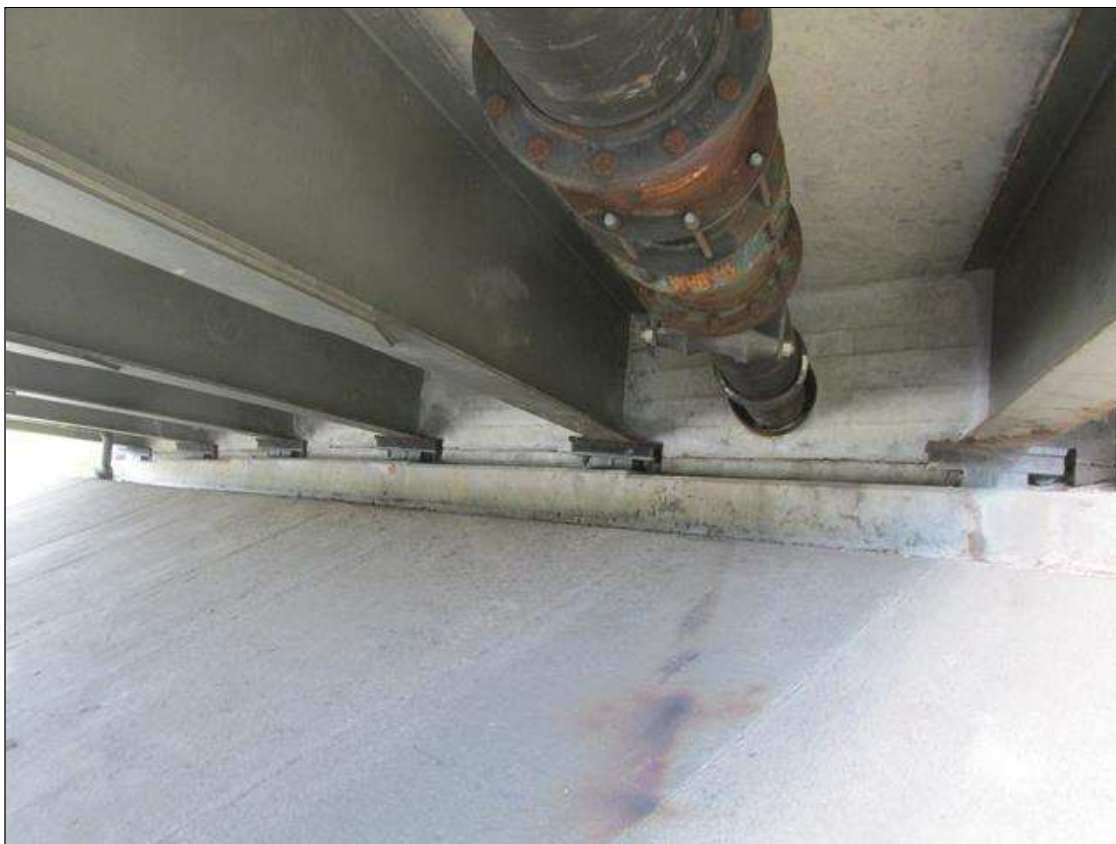
12" DIP HANGING FROM STEEL SUPPORTS, BAY 1
