NC DEPARTMENT OF TRANSPORTATION
 DIVISION OF HIGHWAYS
 BRIDGE MANAGEMENT UNIT

BRIDGE INSPECTION REPORT

INSPECTION TYPE: Routine Inspection

COUNTY GASTON BRIDGE NUMBER 350133 INSPECTION CYCLE 2 YRS
 ROUTE ABERDEEN BLVD. ACROSS I85 M.P. 0

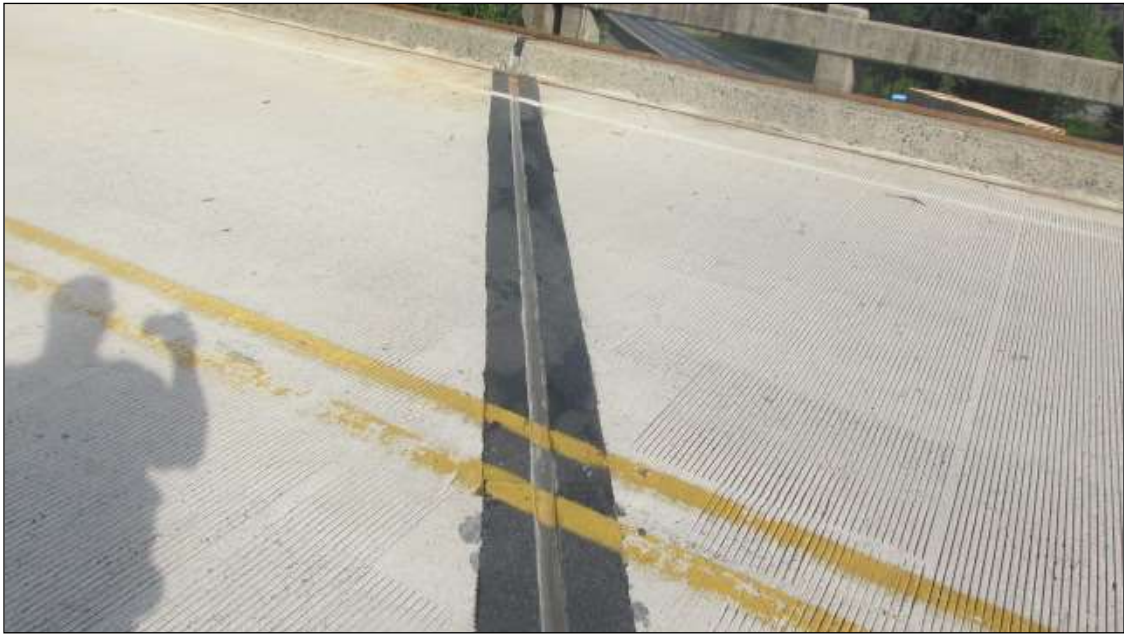
Item No.	Grade		
2a	G	DECK REHAB PHOTO SHOWING CONES ANDCABLE ALONG THE RAILS STILL IN PLACE	
6c	G	joints reworked with compression seals	
10	F	BMS., BEARING AND DIAPHS PAINTED- COATING I	
		IMPACT DAMAGE INSPECTION WAS REQUESTED FOR SPAN 3 OVER I85	
		GIRDER 4 - INITINAL POINT OF IMPACT ON GIRDER 4 IN SPAN 3 WAS 16'-4" FROM FACE OF BENT 3, A GOUGE IN THE FLANGE 2" X 8" X 1"+/- DEEP AND IS BENT UPWARD 1 1/2"+/- IN THE DAMAGED AREA. INDENTIONS IN FLANGE 1/2" X 1/16" AT 16'-3", A 1/2" X 1/16" AT 16'-1" BOTH FROM FACE OF BENT 3. A MARK ON THE OUTSIDE OF WEB FROM 19'-7" TO 45'-0" FROM FACE OF BENT 3. INDENTION IN FLANGE 25" X 1/16" AT 9'-3" FROM FACE OF BENT 3. GIRDER 4 IS 1/2" OUT OF PLUMB TO THE SOUTH AT 35'-100 FROM FACE OF BENT 2.(SEE PHOTOS).	
10A	NO	GIRDER 1 - POINT OF IMPACT ON GIRDER 1 IN SPAN 3 WAS 4'-3" FROM FACE OF BENT 3, A INDENTION IN THE FLANGE 1" X 1/16"+/- . no curved girders	
12	G	diaph from girder 3 to girder 4 repaired at connections

JOINTS REWORKED

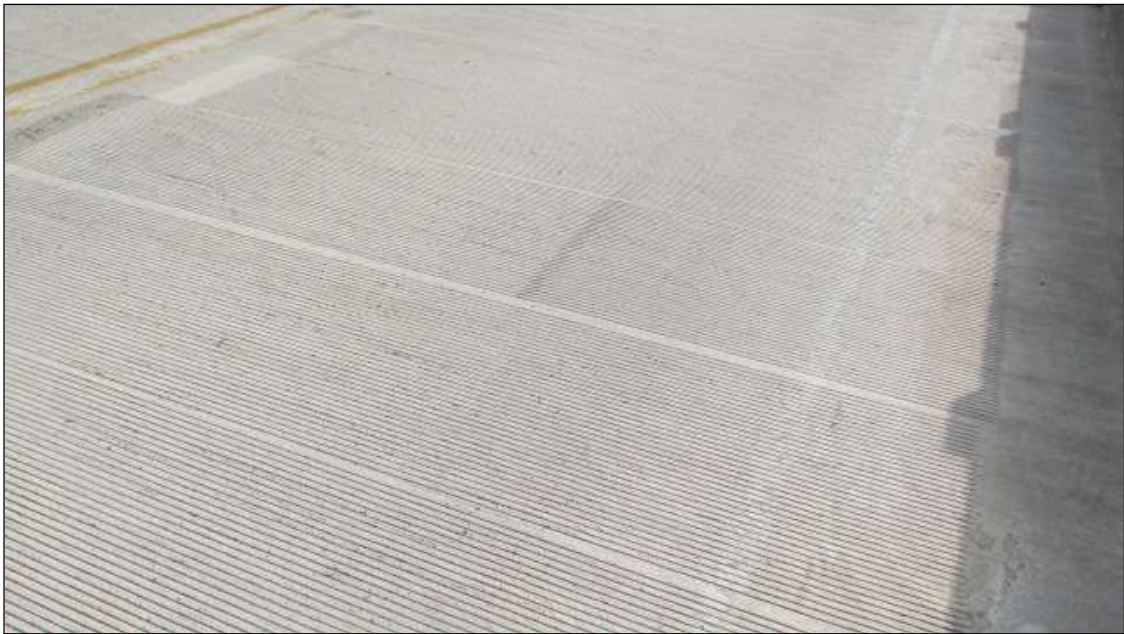
DECK REHAB

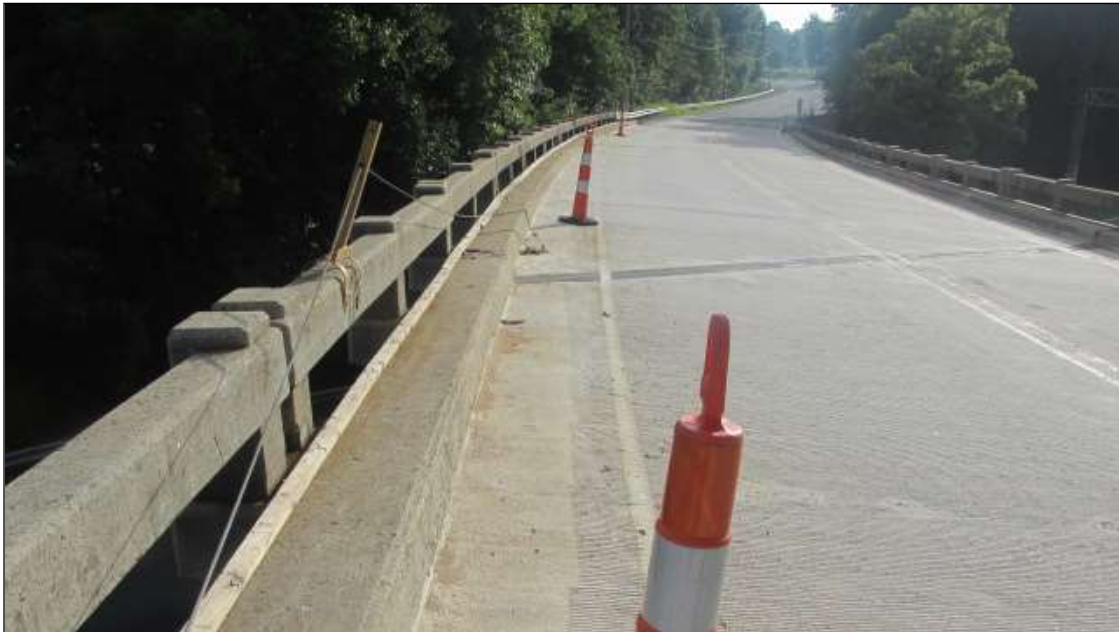
PHOTO SHOWING CONES AND CABLE ALONG THE RAILS STILL IN PLACE

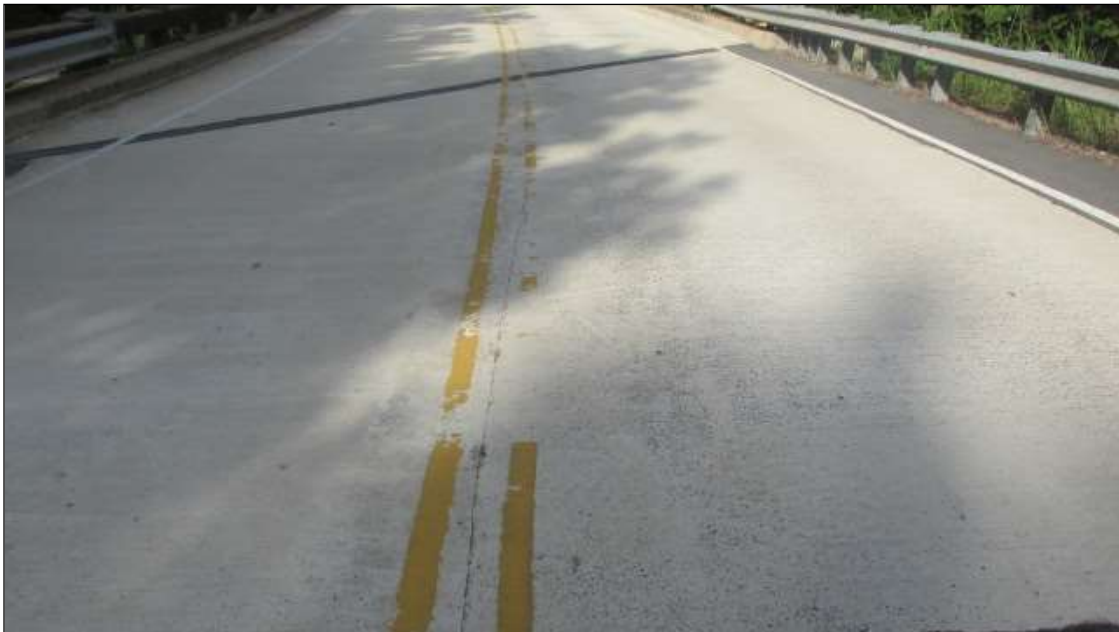
15	G	painted	
38		not visible	
39	F	BOTH CONCRETE SLOPES SHOW CRACKING UP TO 1/4 INCH WITH VEGETATION GROWING THROUGH CRACKS.	
51	G	COCNCRETE APPROACHES REWORKED.

COCONCRETE APPROACHES REWORKED.

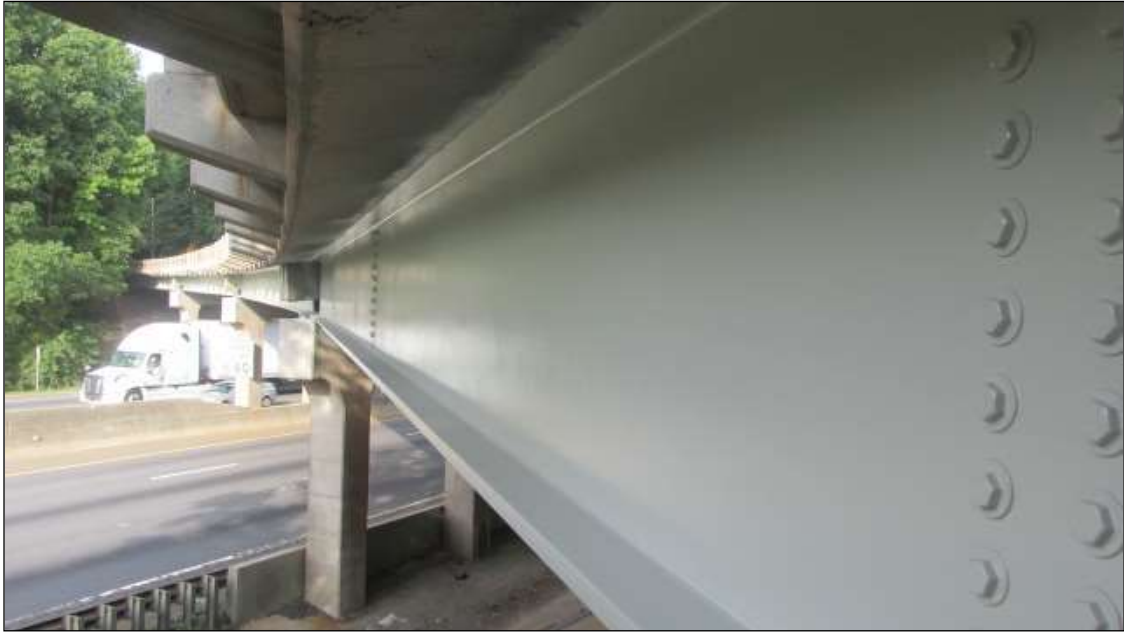
BMS., BEARING AND DIAPHS PAINTED- COATING I

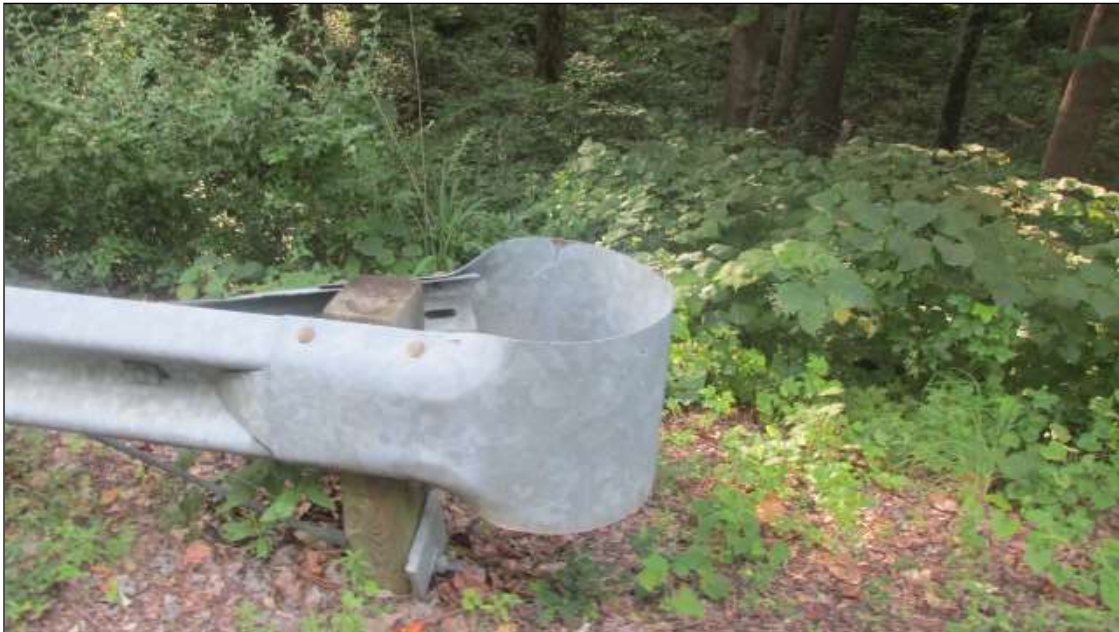
GUARDRAIL END FOR ALL FOUR CORNERS

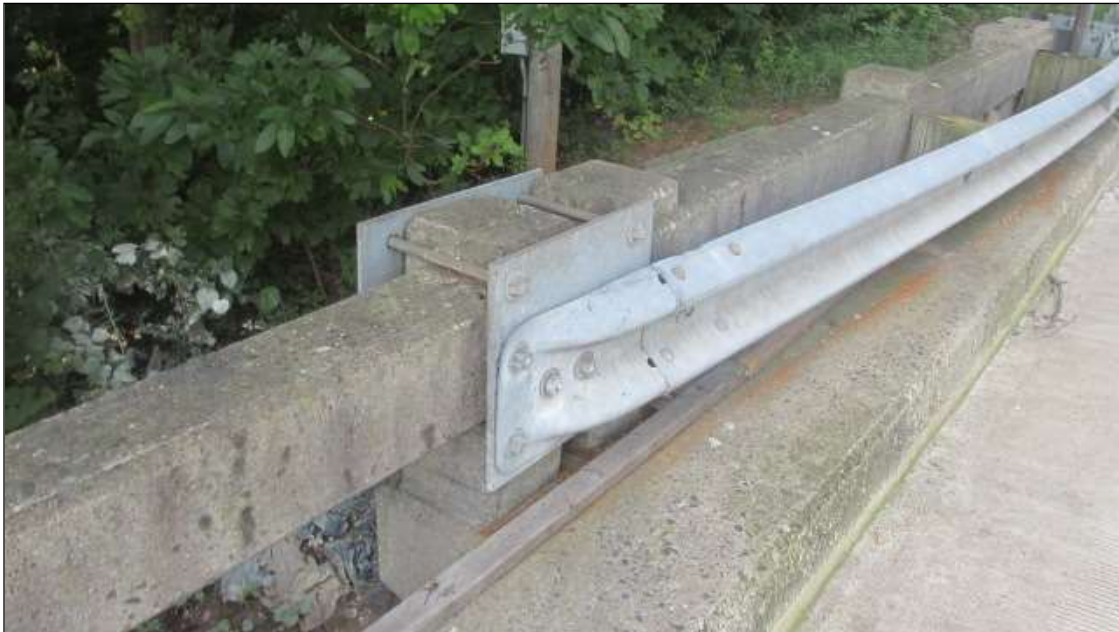
GUARDRAIL ATTACHED TO THE BRIDGE RAIL FOR ALL FOUR CORNERS
