| NC DEPARTMENT OF TRANSP DIVISION OF HIGHWAYS BRIDGE MANAGEMENT UNIT | PORTATION ATTE | ENTION VERT CLR VERIFIED | |
|---|---|---|---|
| BRIDGE | NSPEC | TION REPOR | Τ |
| COUNTY GASTON | BRIDGE NUMBER | 350136 INSPECTION CYCLE 2 | YRS |
| ROUTE SR2339 | ACROSS 185 | | M.P. 0 |
| INSPECTION DATE 08/26/2014 | PF | RESENT CONDITION GOOD | |

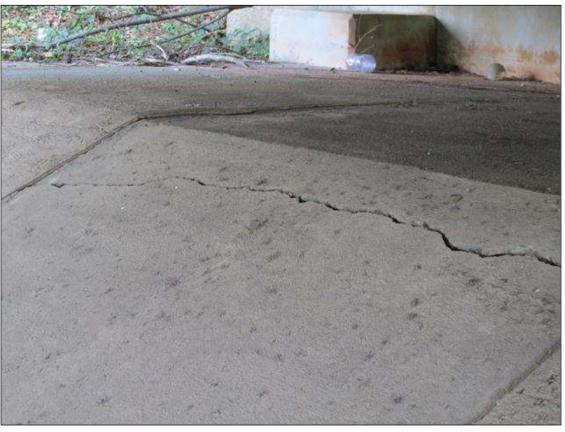
| Grade G | SCATTERED COARSE AGGREGATE EXPOSURE IN TOP OF RC DECK |
|---|---|
| F | SCATTERED CRACKING IN POURED CONCRETE SLOPE PROTECTION |

SCATTERED CRACKING IN POURED CONCRETE SLOPE PROTECTION

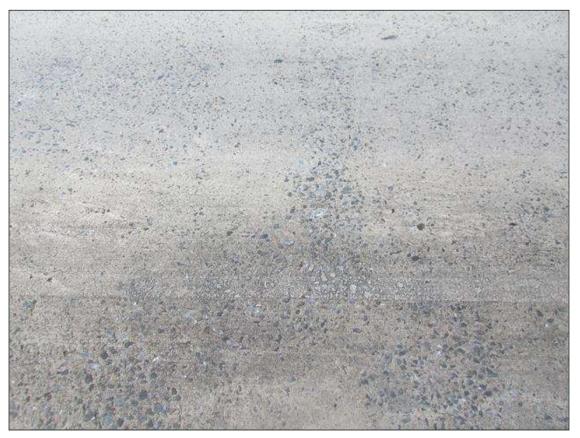
| Grade G | SCATTERED COARSE AGGREGATE EXPOSURE IN TOP OF RC DECK |

SCATTERED COARSE AGGREGATE EXPOSURE IN TOP OF RC DECK

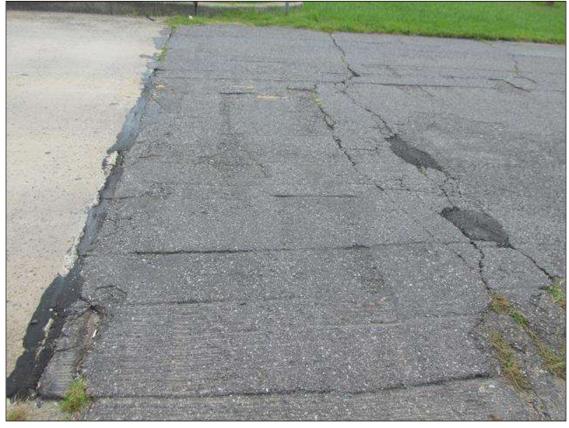
| Grade G | SCATTERED COARSE AGGREGATE EXPOSURE IN TOP OF RC DECK |
|---|---|
| F | WEST APPROACH HEAVED, CRACKED, AND POTHOLING. |

WEST APPROACH HEAVED, CRACKED, AND POTHOLING.

| MMS Code | Description of Function | Unit | Quantity | Remarks | Est. Cost |
|---|--|---|---|--|---|
| 2816 | Asphalt Surface Repair or Replacement | SY | 24 | WEST APPROACH HEAVED, CRACKED, AND POTHOLING. | |

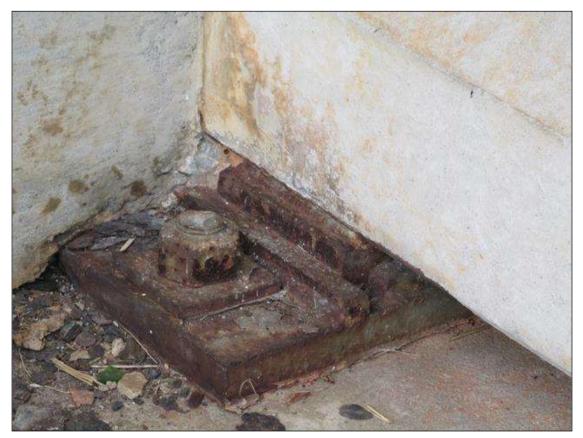
| Grade G | SCATTERED COARSE AGGREGATE EXPOSURE IN TOP OF RC DECK |
|---|---|
| G | SCATTERED SURFACE CORROSION ON BEARINGS THROUGHOUT SUPERSTRUCTURE, CONCENTRATED AT BENTS. |

SCATTERED SURFACE CORROSION ON BEARINGS THROUGHOUT SUPERSTRUCTURE, CONCENTRATED AT BENTS.

| MMS Code | Description of Function | Unit | Quantity | Remarks | Est. Cost |
|---|--|---|---|--|---|
| 3334 | Bridge Bearings | EA | 28 | SCATTERED SURFACE CORROSION ON BEARINGS THROUGHOUT SUPERSTRUCTURE, CONCENTRATED AT BENTS. | |

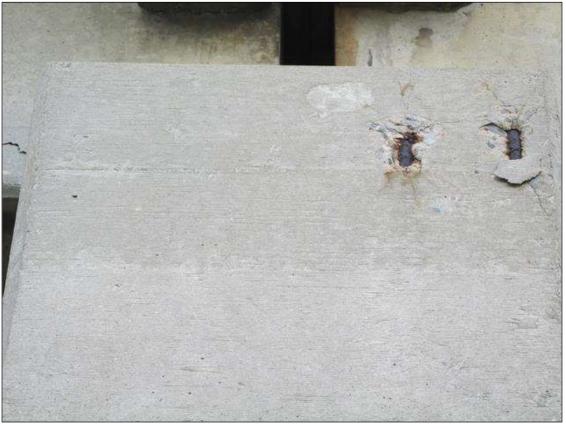
| Grade G | SCATTERED COARSE AGGREGATE EXPOSURE IN TOP OF RC DECK |
|---|---|
| G | SPALLING WITH RESTEEL EXPOSED ON SOUTH END OF BENT 2 CAP, APPROX 2SF. |

SPALLING WITH RESTEEL EXPOSED ON SOUTH END OF BENT 2 CAP, APPROX 2SF.

| MMS Code | Description of Function | Unit | Quantity | Remarks | Est. Cost |
|---|--|---|---|--|---|
| 3348 | Maintain Concrete Substructure Components | LF | 2 | SPALLING WITH RESTEEL EXPOSED ON SOUTH END OF BENT 2 CAP, APPROX 2SF. | |

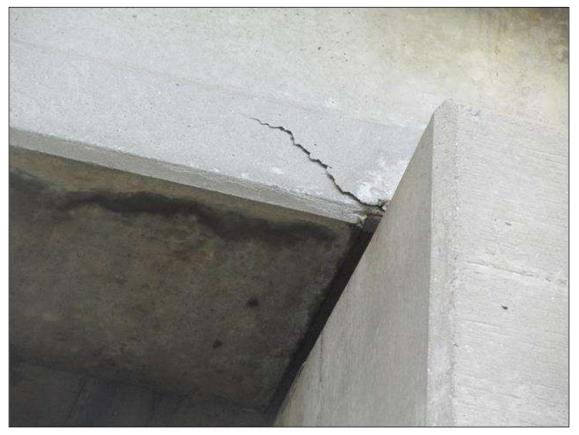
CRACKING IN BEAM 1 END OVER BENT 2, SPAN 3. APPROX 2SF

| MMS Code | Description of Function | Unit | Quantity | Remarks | Est. Cost |
|---|--|---|---|--|---|
| 3306 | Maintain Concrete Superstructure Components | SF | 2 | CRACKING IN BEAM 1 END OVER BENT 2, SPAN 3. APPROX 2SF | |

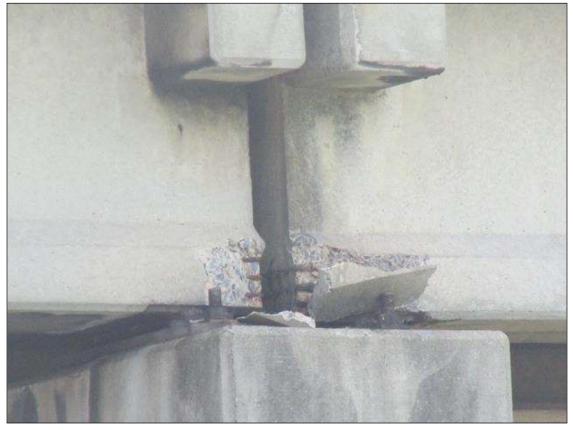
SPALLING IN BEAM ENDS WITH RESTEEL EXPOSED, OVER BENT 1, BEAM1 IN SPANS 1 AND 2.

| MMS Code | Description of Function | Unit | Quantity | Remarks | Est. Cost |
|---|--|---|---|--|---|
| 3306 | Maintain Concrete Superstructure Components | SF | 4 | SPALLING IN BEAM ENDS WITH RESTEEL EXPOSED, OVER BENT 1, BEAM1 IN SPANS 1 AND 2. | |

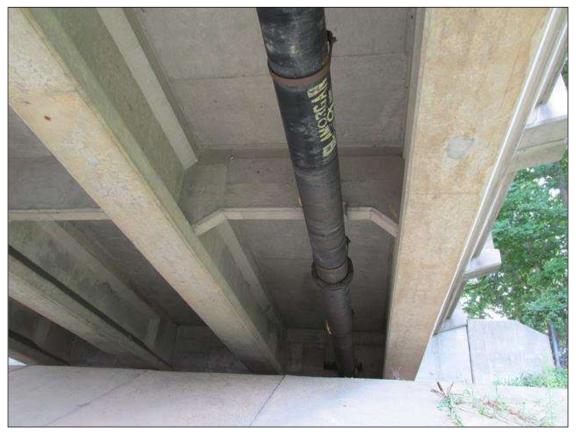
12" DIP HANGING FROM STEEL SUPPORTS IN BAY 3

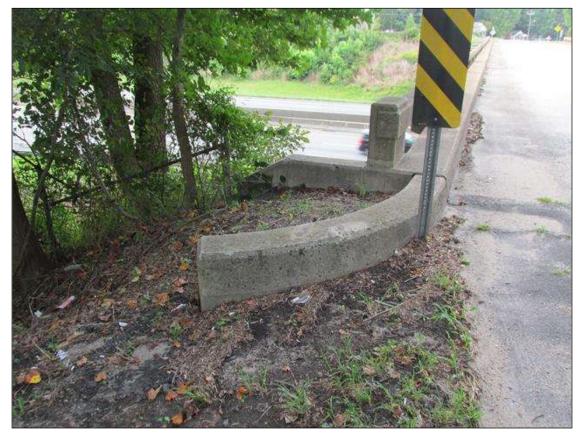
NO GR, EAST APPROACH NORTHEAST CORNER. NO GR AT WEST APPROACH.

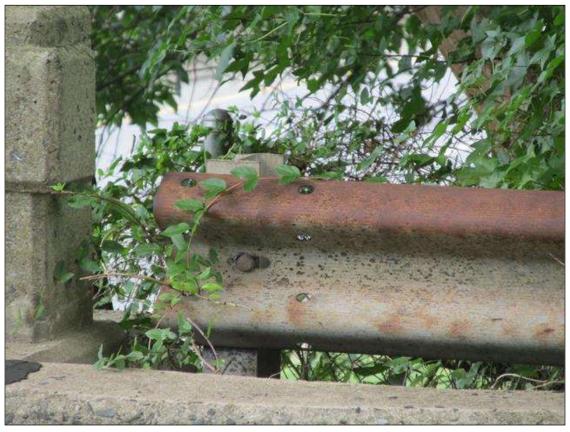
GR NOT ATTACHED, NORTHEAST CORNER
