NC DEPARTMENT OF TRANSPORTATION  
 DIVISION OF HIGHWAYS  
 BRIDGE MANAGEMENT UNIT

# BRIDGE INSPECTION REPORT

COUNTY GASTON BRIDGE NUMBER 350149 INSPECTION CYCLE 2 YRS 25.9  
 ROUTE SR2093 ACROSS I85 M.P. 0

INSPECTION DATE 08/04/2014 PRESENT CONDITION FAIR

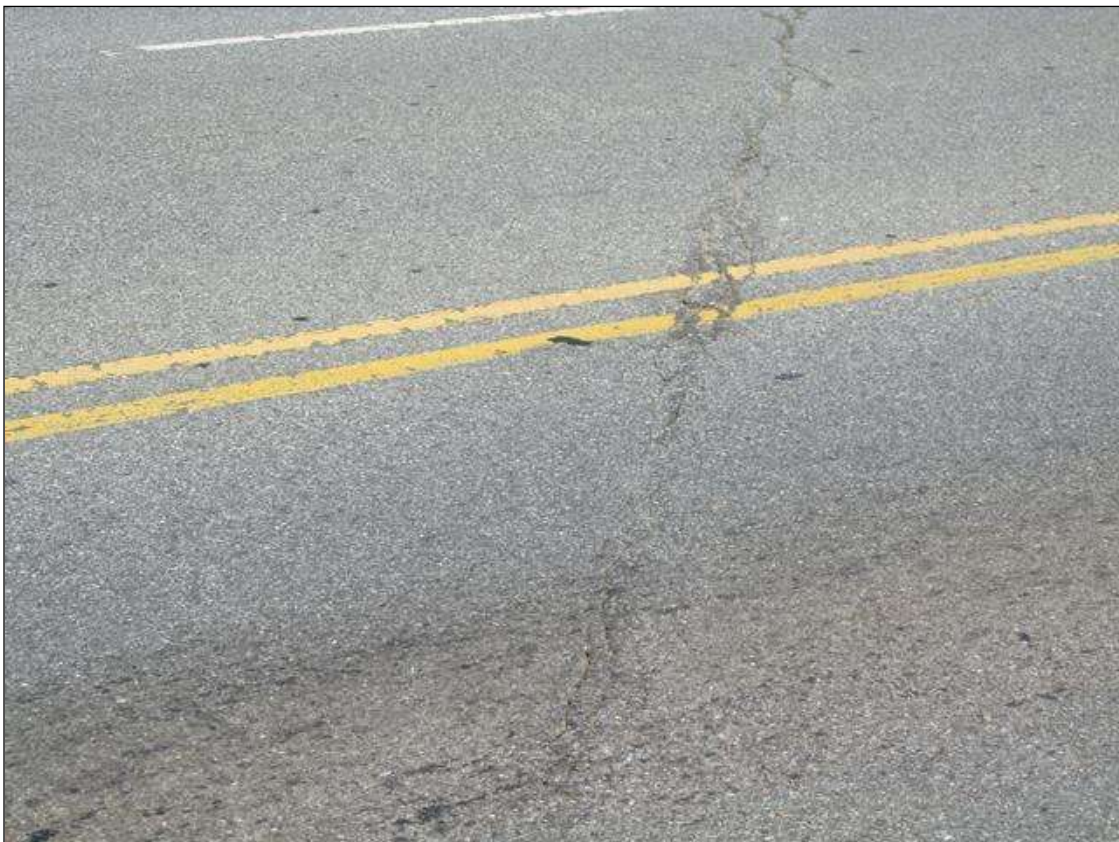
JOINT 1 CRACKED AND OPEN UP TO 1", FULL WIDTH

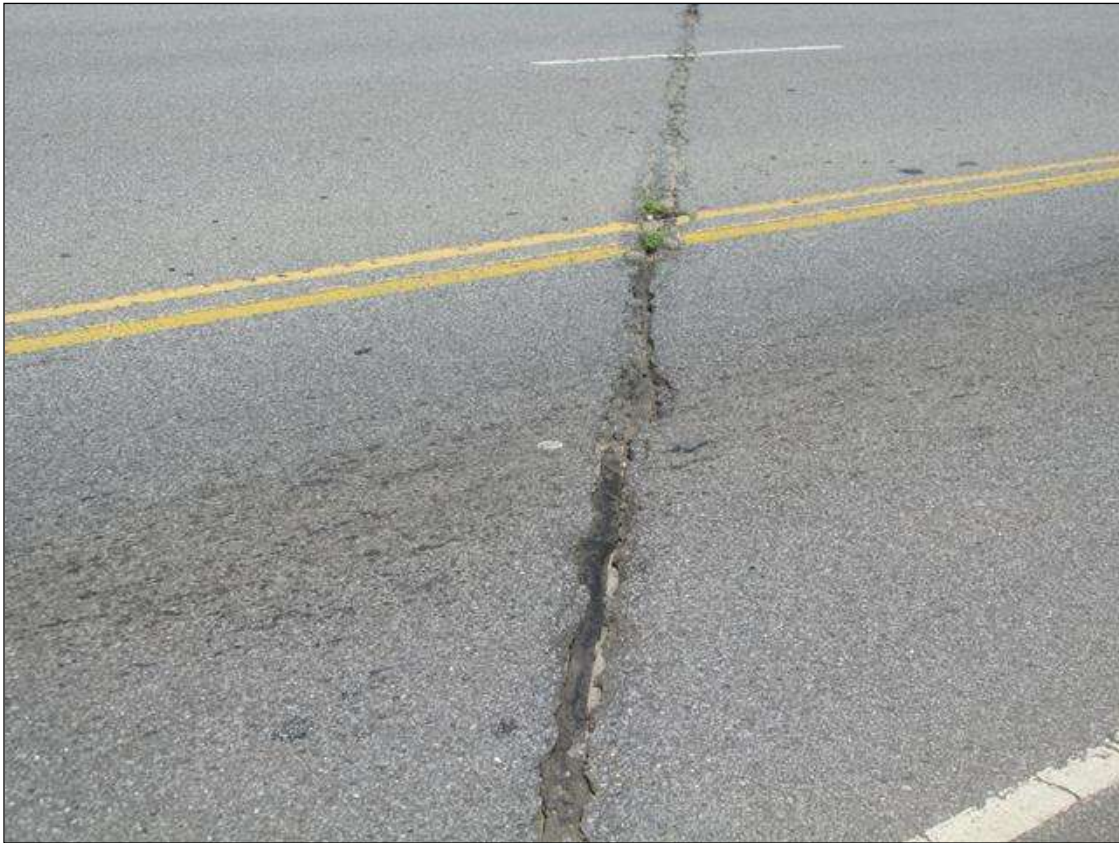
JOINT 2 CRACKED FULL WIDTH, OPEN UP TO 2.5"W X UP TO 2"D

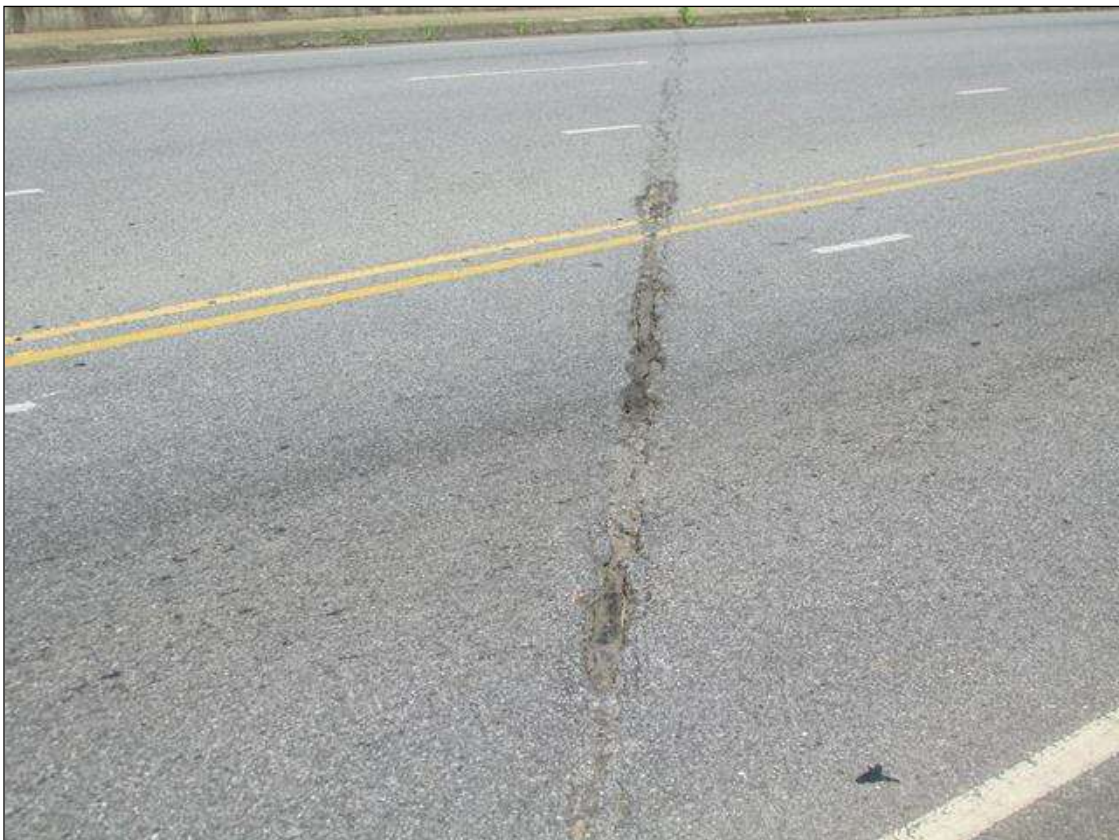
JOINT 3 CRACKED FULL WIDTH, OPEN UP TO 4"W X UP TO 2"D

MMS Code	Description of Function	Unit	Quantity	Remarks	Est. Cost
2816	Asphalt Surface Repair or Replacement	SY	240	NORTH APPROACH AWS CRACKED, POTHOLED, AND SUNKEN UP TO 1.5", FULL WIDTH.	
3310	Maintenance/Repair/Replacement of Standard Bridge Expansion Joints	LF	180	JOINT 3 CRACKED FULL WIDTH, OPEN UP TO 4"W X UP TO 2"D	
3348	Maintain Concrete Substructure Components	LF	35	SPALLING WITH RESTEEL EXPOSED, BENT 2 CAP, BETWEEN C1-2 AND BETWEEN C2-3, TOTAL AREA APPROX 35SF	
3348	Maintain Concrete Substructure Components	LF	70	SPALLING WITH RESTEEL EXPOSED, BENT 3, BOTTOM SIDE OF CAP, BTWN C3-4, APPROX 8'L X 4'W

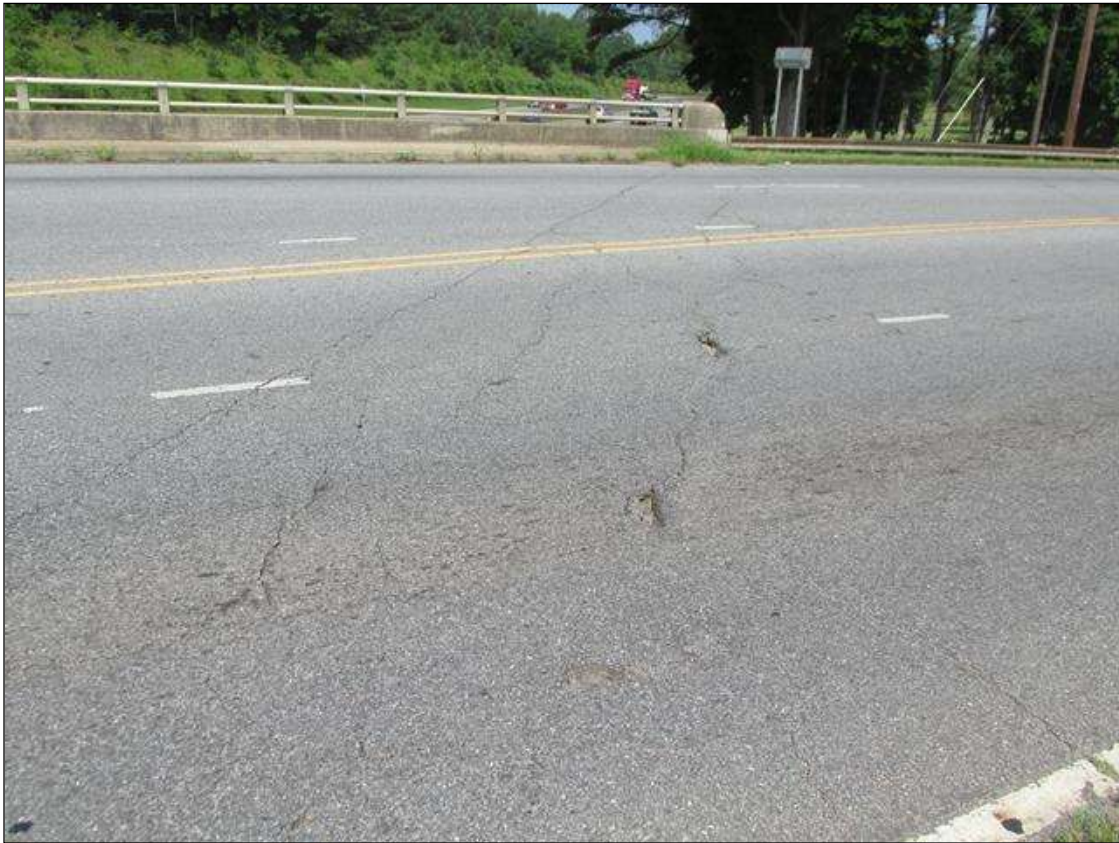
NORTH APPROACH AWS CRACKED, POTHOLED, AND SUNKEN UP TO 1.5", FULL WIDTH.

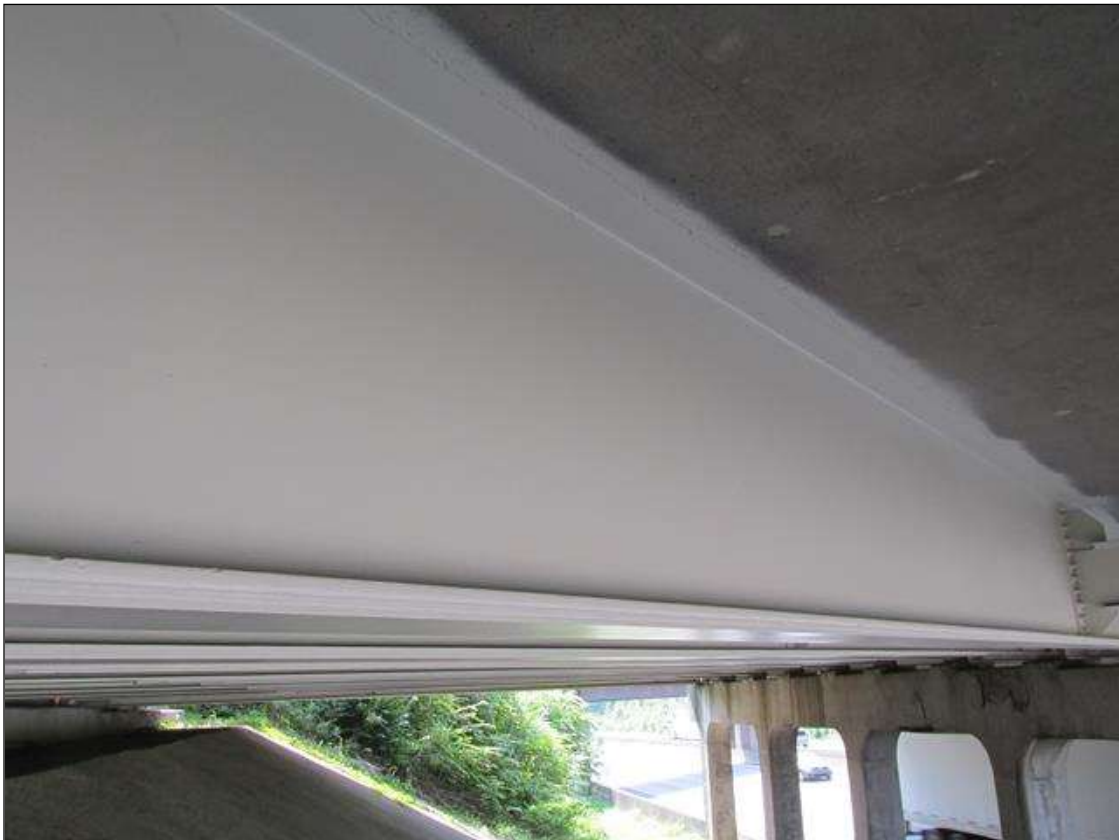
Item No.	Grade		
10	F	<p>FORM PRIOR REPORT:</p> <p>IMPACT DAMAGE INSPECTION WAS REQUESTED BY DIVISION BRIDGE MAINTENANCE FOR SPAN 2 OVER I 85 SOUTH GIRDERS HAVE BEEN PAINTED SINCE THE IMPACT.</p> <p>GIRDER #10: POINT OF IMPACT ON GIRDER #10 WAS 19'-11" FROM FACE OF BENT 1, THE FLANGE AND FLANGE COVER PLATE ARE BENT OUT OF SHAPE 1 7/8" TO THE SOUTH AT 19'-11" FROM BENT 1., A CRACK 1' -0" IN THE COVER PLATE TO FLANGE WELD, A 7" CRACK ACROSS THE COVER PLATE ONLY LEAVING 3 3/4"+/- NOT BEING CRACKED, A GOUGE IN THE COVER PLATE 8" X 1 1/4" X 1/4"+/- DEEP ALL AT 19'-11" FROM BENT 1. THE FLANGE AND COVER PLATE ARE BENT UPWARD 1/2", WITH AN INDENTION IN COVER PLATE 12"X 1/16" AT 21'-10" FROM FACE OF BENT 1. A 8" CRACK IN THE FLANGE TO COVER PLATE WELD AT 21'-2" FROM FACE OF BENT 1. INDENTIONS IN FLANGE COVER PLATE 5" X 1/16" AT 25'-9", A 2 1/2" X 1/2" AT 24'-6", A 6 1/2" X 1/4" AT 23'-11", A 3" X 1/16" AT 23'-7", 2 1/2" X 1/4" AT 23'-3", A 5 1/2" X 1/4" AT 18'-4", A 3'-4" X 1/16" AT 16'-2" ALL FROM FACE OF BENT 1. INDENTIONS IN FLANGE 2 1/2" X 1/2" AT 24'-6", A 4" X 1/4" AT 23'-11", A 1 1/2" X 1/4" AT 22'-8", A 12" X 1/4" AT 16'-2" ALL FROM FACE OF BENT 1. GIRDER IS OUT OF PLUMB 1 7/8" IN THE DIRECTION OF TRAFFIC AT 20'-2" FROM BENT 1. INDENTION IN FLANGE COVER PLATE 17" X 1/2" AND IN FLANGE 2'-0" X 5/8" AT 38'-2" FROM FACE OF BENT 1. INDENTION IN FLANGE COVER PLATE 7" X 5/8" AT 35'-7" FROM FACE OF BENT 1. GIRDER 10 IS 4 1/4" OUT OF PLUMB AT 37'-5" FROM FACE OF BENT 1. INDENTION IN FLANGE COVER PLATE 7" X 1/16" AND IN FLANGE 2'-10" X 1/4" AT 43'-1" FROM FACE OF BENT 1. (SEE PHOTOS)</p> <p>GIRDER #9: POINT OF IMPACT ON GIRDER #9 WAS 18'-0" FROM FACE OF BENT 1, INDENTION IN FLANGE COVER PLATE 1'-6" X 1/4". INDENTIONS IN FLANGE COVER PLATE 2 1/2" X 1/16" AT 19'-9", A 3" X 1/16" AT 16'-10" FROM FACE OF BENT 1. INDENTION IN FLANGE 1" X 1/16" AT 16'-10" FROM FACE OF BENT 1. A INDENTION IN FLANGE COVER PLATE 5" X 1/16" AT 36'-6" FROM FACE OF BENT 1. INDENTION IN FLANGE COVER PLATE 3" X 1/16" AT 42'-9" FROM FACE OF BENT 1. (SEE PHOTOS)</p> <p>GIRDER #8: POINT OF IMPACT ON GIRDER #8 WAS 21'-6" FROM FACE OF BENT 1, INDENTION IN FLANGE COVER PLATE 2" X 1/16" &amp; 5 1/2" X 1/16", A INDENTION IN FLANGE 1 1/2" X 1/16" ALL IN THE DAMAGED AREA. INDENTION IN FLANGE COVER PLATE 1'-7" X 1/16" AT 19'-4", 1 1/2" X 1/16 AT 18'-3" FROM FACE OF BENT 1. THE TOP WELD ON THE STIFFNER AT THE WEST END OF GIRDER #8 HAS RUSTED AWAY . (SEE PHOTOS)</p> <p>GIRDER 7: POINT OF IMPACT ON GIRDER #7 WAS 23'-11" FROM FACE OF BENT 1, INDENTION IN FLANGE COVER PLATE 3 3/4" X 1/2" AND IN FLANGE 5" X 1/4" AT DAMAGED AREA. INDENTIONS IN FLANGE COVER PLATE 6" X 1/16" AT 22'-10", A 4" X 1/16" AT 21'-9" FROM FACE OF BENT 1. (SEE PHOTOS)</p> <p>GIRDER #6: POINT OF IMPACT ON GIRDER #6 WAS 23'-6" FROM FACE OF BENT 1, INDENTION IN FLANGE COVER PLATE 2 1/2" X 1/16" AND A 4" X 1/16" IN THE DAMAGED AREA (SEE PHOTO)</p>

Item No.	Grade		
10A	NO	NO CURVED GIRDERS	
12	F	FROM PRIOR REPORT:  CONNECTION PLATE OF INTERMEDIATE DIAPHRAGMS: ON GIRDER #10 AT 19'-4" FROM FACE OF BENT 1 HAS 4 LOOSE DIAPHRAGM BOLTS AND 4 DIAPHRAGMS BOLTS WITHOUT WASHERS. SPACERS/WASHERS HAVE BEEN ADDED BEHIND THE DIAPHRAGM TO THE LOWER DIAPHRAGM BOLTS TO FILL THE SPACE BETWEEN DIAPHRAGM AND WEB. BOTTOM OF DIAPHRAGM AT 39'-11" IS 2 1/2" FROM WEB. THE DIAPHRAGM BRACE ON GIRDER 10 IS BENT TO THE WEST 1 1/4" AT 39'-11" FROM FACE OF BENT 1. WASHERS HAVE BEEN ADDED TO THE LOWER HALF OF DIAPHRAGM TO MAKE UP 2 1/2" AT 39'-11" FROM FACE OF BENT 1. ON GIRDER 10 THE 22 DIAPHRAGM BOLTS 14 ARE WITHOUT WASHERS AND 8 HAVE WASHERS AT 39'-11" FROM BENT 1. AT THE TOP OF DIAPHRAGM ON GIRDER #8 AT 13'-11" FROM BENT 1 IS PULLED AWAY FROM WEB 1/8". THE SECOND BOLT DOWN ON THE RIGHT SIDE OF DIAPHRAGM ON GIRDER #9 AT 16'-6" FROM FACE OF BENT 1 IS NOT FULLY THREADED. DIAPHRAGM BOLT ON GIRDER 9 AT 34'-7" IS NOT PULLED UP TIGHT .REPAIRS HAVE BEEN MADE TO THE DIAPHRAGM ON GIRDER #9 AT 16'-6" FROM FACE OF BENT 1. ALL GIRDERS HAVE BEEN PAINTED SINCE DAMAGE. (SEE PHOTOS)

BEAMS PAINTED SINCE LAST INSPECTION.

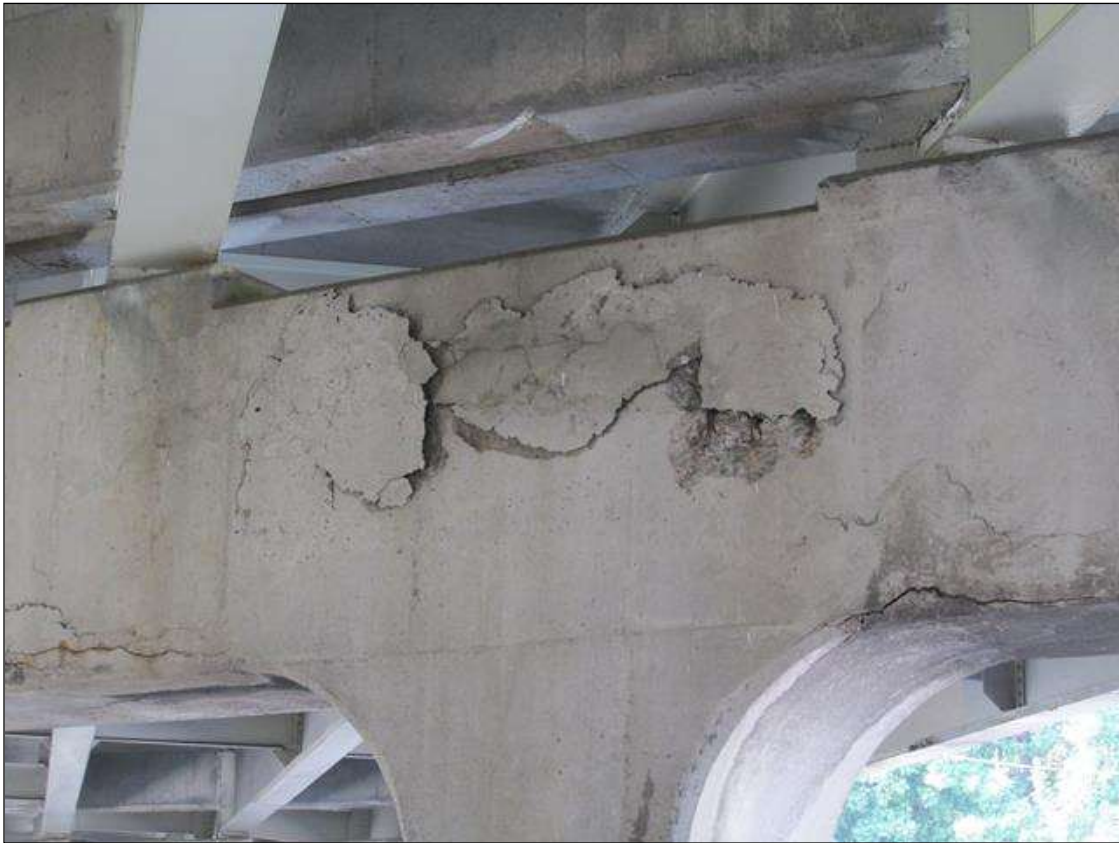
36a	F	SPALLING WITH RESTEEL EXPOSED, BENT 3, ABOVE C2, APPROX 6'L X 2'H  SPALLING WITH RESTEEL EXPOSED, BENT 3, BTWN C2-3, BOTTOM STRANDS OF RESTEEL EXPOSED AT N CORNER, APPROX 8'L X 3'H SPALLING, BENT 3, C3 RADIUS, APPROX 4'L  SPALLING WITH RESTEEL EXPOSED, BENT 3, BOTTOM SIDE OF CAP, BTWN C3-4, APPROX 8'L X 4'W  TEMP REPAIRS TO SPALLS SCATTERED ON BENT 1 CAP	
36b	F	SPALLING WITH RESTEEL EXPOSED, BENT 2 CAP, BETWEEN C1-2 BENT 2, COLUMN 2 HAS A 1 FT HIGH X 5 INCH WIDE SPALL ON THE NE CORNER JUST UNDER THE HAUNCH.	
36e		NOT VISIBLE	
39	G	POURED CONCRETE	
50	F	SOUTH APPROACH AWS CRACKED AND SUNKEN UP TO 0.5" FULL WIDTH. NORTH APPROACH AWS CRACKED, POTHOLED, AND SUNKEN UP TO 1.5", FULL WIDTH.

SPALLING WITH RESTEEL EXPOSED, BENT 3 CAP, ABOVE C2, APPROX 6'L X 2'H

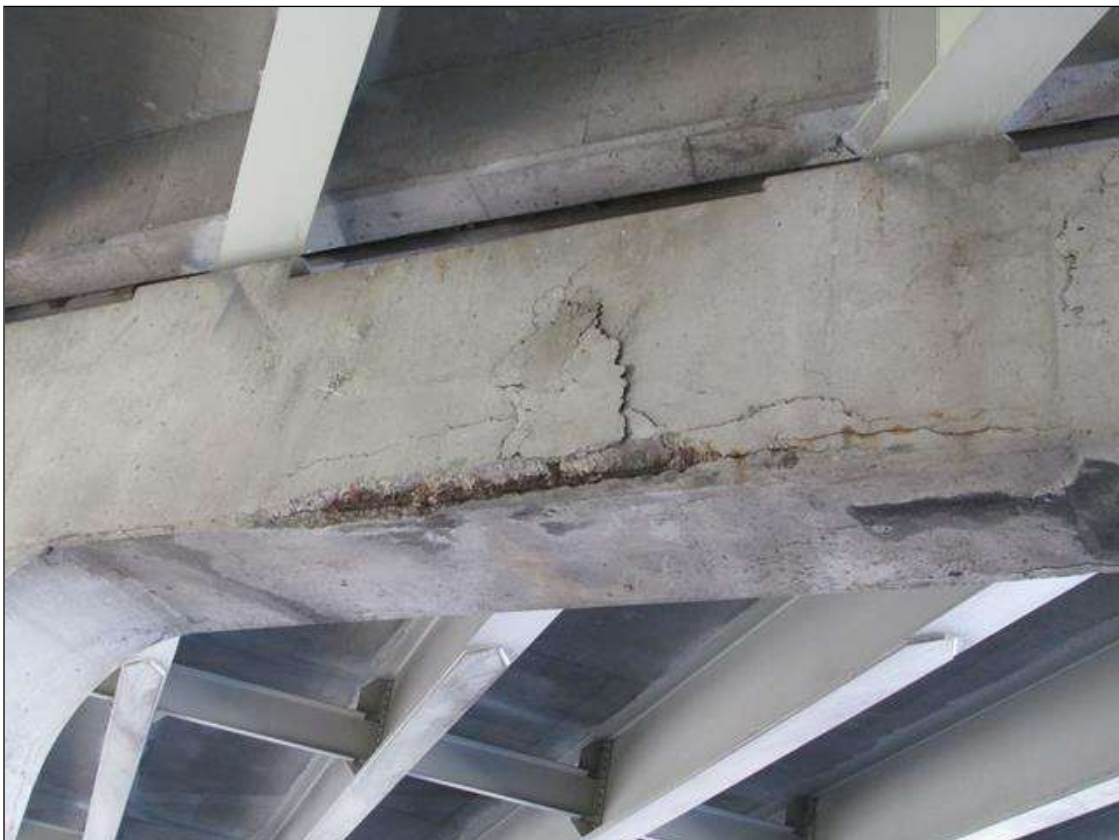
SPALLING WITH RESTEEL EXPOSED, BENT 3 CAP, BTWN C2-3, BOTTOM STRANDS OF RESTEEL EXPOSED AT N CORNER, APPROX 8'L X 3'H

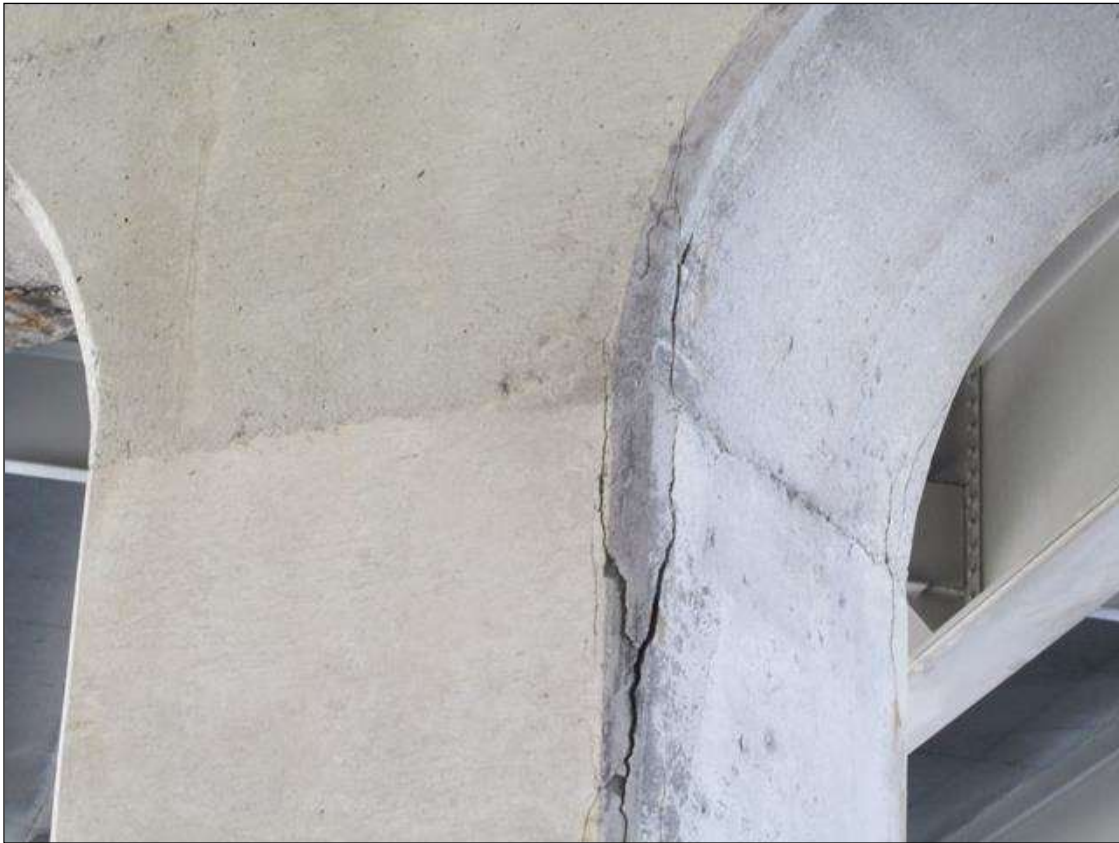
SPALLING, BENT 3, C3 RADIUS, APPROX 4'L

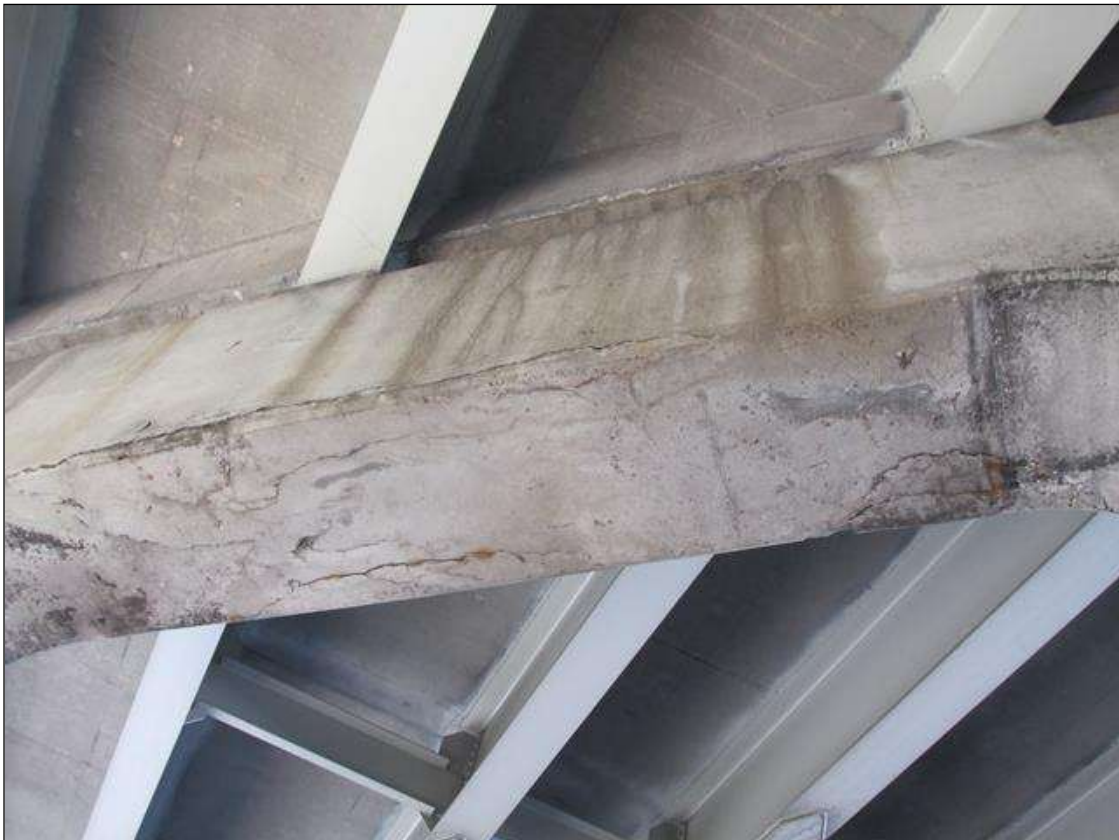
SPALLING WITH RESTEEL EXPOSED, BENT 3 CAP, BOTTOM SIDE OF CAP, BTWN C3-4, APPROX 8'L X 4'W

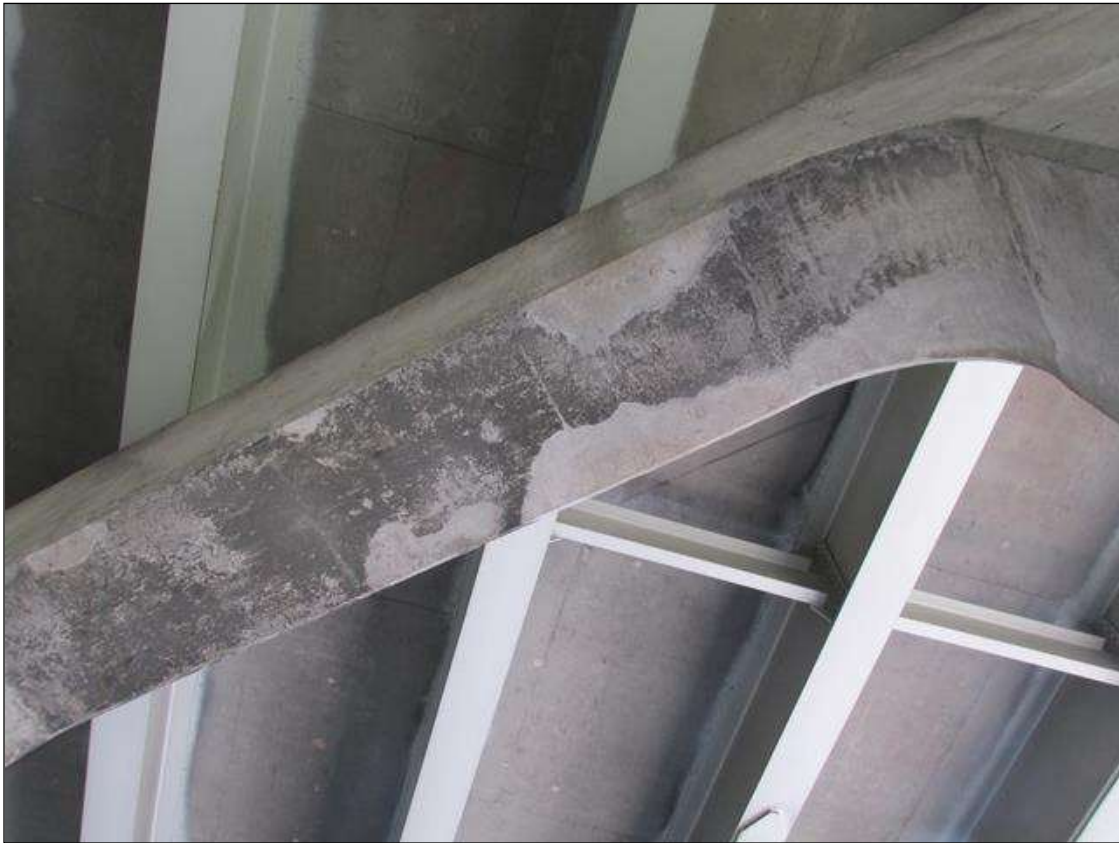
TEMP REPAIRS TO SPALLS SCATTERED ON BENT 1 CAP

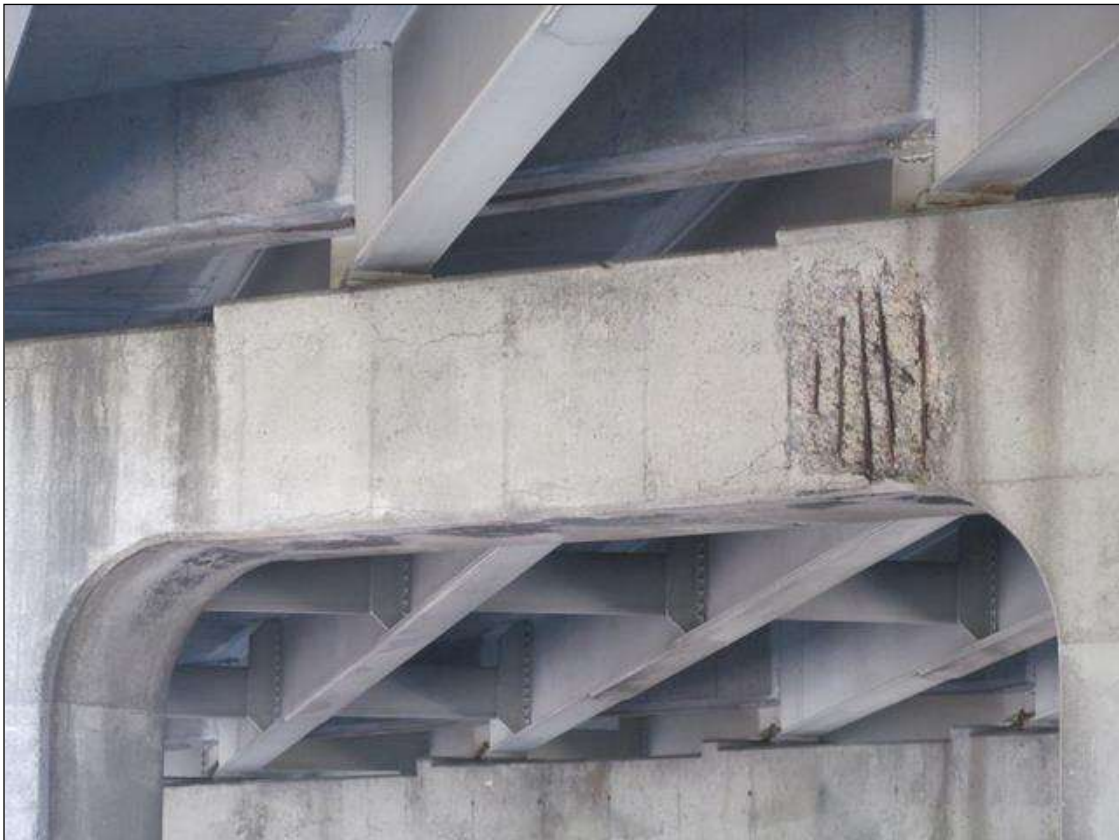
SPALLING WITH RESTEEL EXPOSED, BENT 2 CAP, BETWEEN C1-2 AND BETWEEN C2-3, TOTAL AREA APPROX 35SF

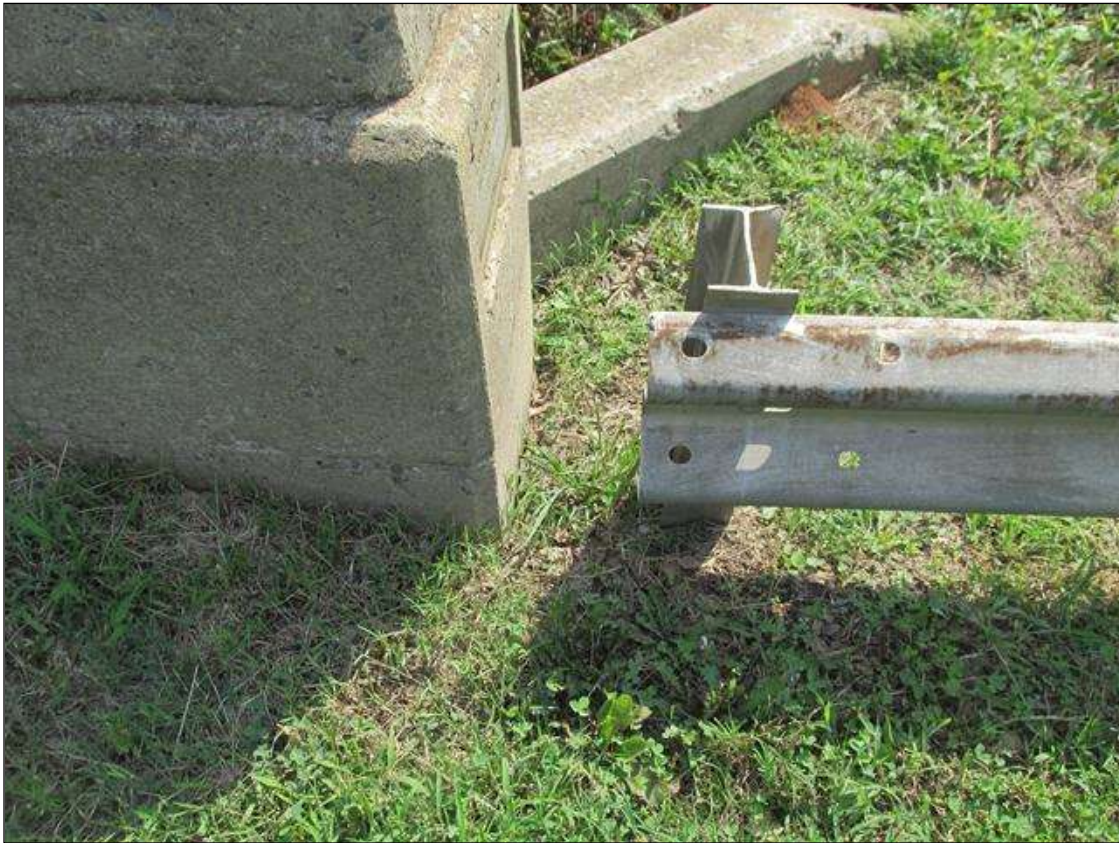
GR NOT CONNECTED, SOUTHEAST & NORTHWEST CORNERS

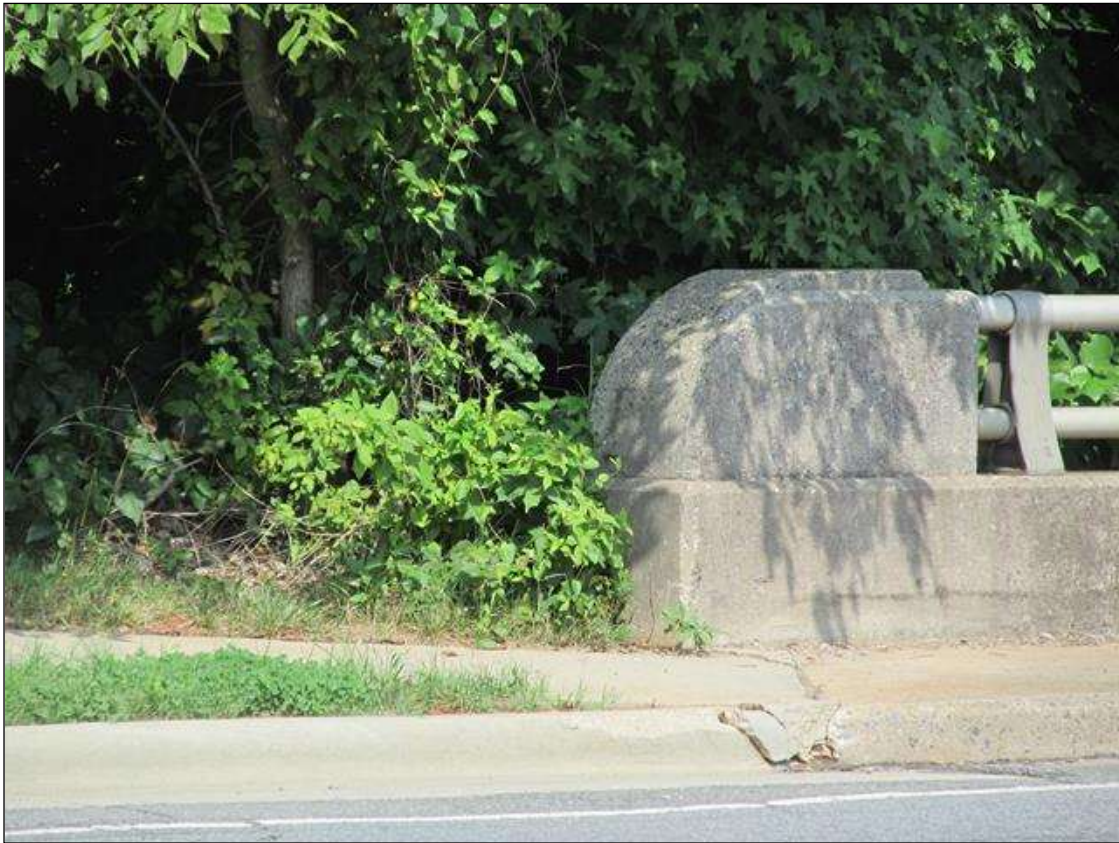
NO GR, SOUTHWEST & NORTHEAST CORNERS
