### **BRIDGE INSPECTION REPORT**

INSPECTION TYPE: Routine Inspection **COUNTY GASTON BRIDGE NUMBER** 350316 INSPECTION CYCLE 2 YRS ACROSS CREEK **ROUTE** 185 M.P. 16700 LOCATION 0.5 MI. S. JCT. US321 SUPERSTRUCTURE TRIPLE 8'X9'RC BOX CULVERT,166'9 ALONG CENTERLINE CULVERT **SUBSTRUCTURE SPANS** LONGITUDE 81° 11' 44.90" 35° 17' 86.54" LATITUDE PRESENT CONDITION FAIR **INVENTORY RATING** INSPECTION DATE 09/10/2012 **OPERATING RATING** PRESENT POSTING Not Posted **PROPOSED POSTING COMPUTER UPDATE ANALYSIS DATE**

# BRIDGE INSPECTION RECORD AND SUMMARY (R. C. BOX CULVERTS)

INSPECTION TYPE Routine Inspection BRIDGE NO. 350316

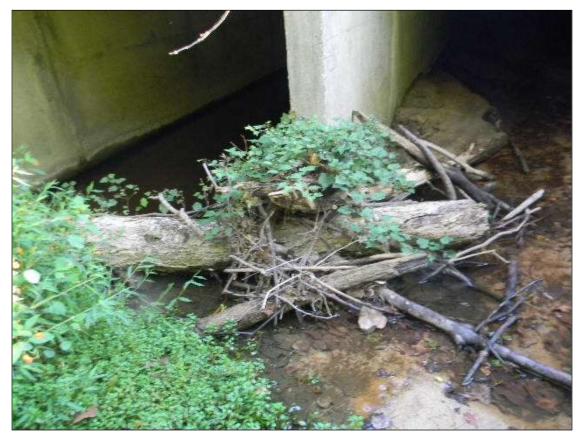
15' WIDE X 3' HIGH X 4' DEEP DRIFT ACROSS THE INLET OF BARRELS 1 & 2.

MMS Code	Description of Function	Unit	Quantity	Remarks	Est. Cost
3366	Drift and Debris Removal	HR	8	15' WIDE X 3' HIGH X 4' DEEP DRIFT ACROSS THE INLET OF BARRELS 1 & 2.	
4675	Maintenance of reinforced Concrete Box Culverts	LF	30	CONSTRUCTION JOINT AT 70' FROM THE INLET IS CRACKED AND OPEN 1/4" IN THE TOP SLAB AND WALLS.	
4675	Maintenance of reinforced Concrete Box Culverts	LF	30	CONSTRUCTION JOINT AT MIDSTRUCTURE IN CRACKED AND LEAKING.	
4675	Maintenance of reinforced Concrete Box Culverts	LF	60	SCATTERED VERTICAL H/L CRACKS IN THE WALLS.

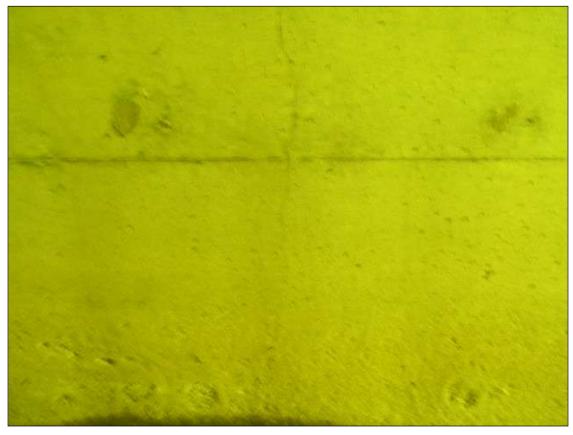
SCATTERED VERTICAL H/L CRACKS IN THE WALLS.

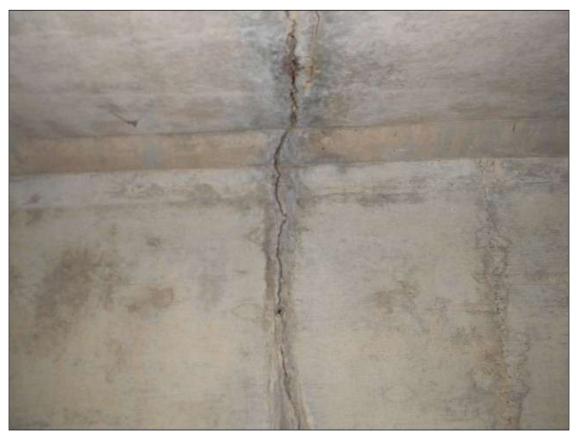
CONSTRUCTION JOINT AT 70' FROM THE INLET IS CRACKED AND OPEN 1/4" IN THE TOP SLAB AND WALLS.

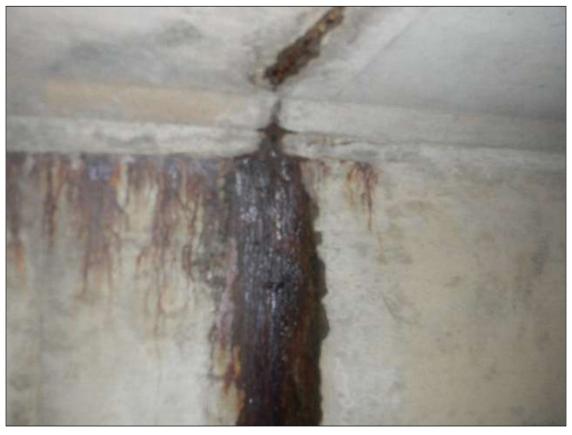
CONSTRUCTION JOINT AT MIDSTRUCTURE IN CRACKED AND LEAKING.

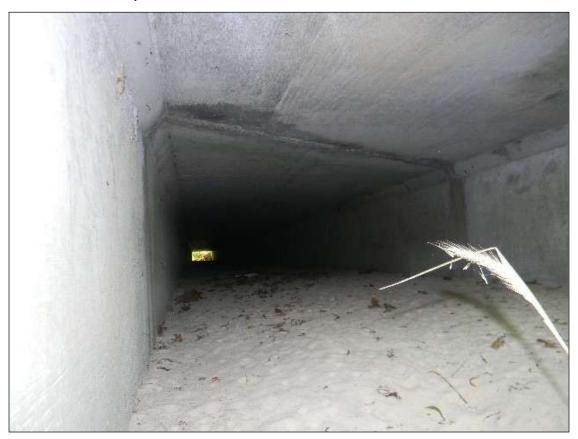
6' SEDIMENT BUILDUP IN BARREL 1. BARRELS 2 & 3 HAVE 2' SEDIMENT.

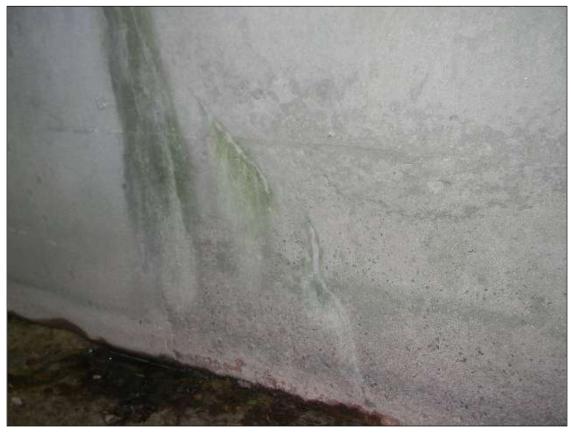
EXTERIOR WALL 2 HAS A 6' LONG DIAGONAL CRACK NEAR THE OUTLET EXTENDING FROM THE CONSTRUCTION JOINT.
