BRIDGE INSPECTION REPORT

INSPECTION TYPE: 2 Year Complete Underwater and Topside **COUNTY GASTON** BRIDGE NUMBER 350321 INSPECTION CYCLE 2 YRS 185 ACROSS DUHART'S CREEK **ROUTE** M.P. 19.70 LOCATION 0.1 MI. N. JCT. NC279 SUPERSTRUCTURE SINGLE 8'X9'RC BOX CULVERT, 822'9 ALONG CENTERLINE CULVERT SUBSTRUCTURE EXTERIOR WALLS:8, TOP & BOTTOM SLABS:9 **SPANS** LONGITUDE 81° 8' 49.41" 35° 16' 3.80" LATITUDE PRESENT CONDITION FAIR INSPECTION DATE 08/28/2014 PRESENT POSTING N **NOT POSTED** PROPOSED POSTING

BRIDGE INSPECTION RECORD AND SUMMARY (R. C. BOX CULVERTS)

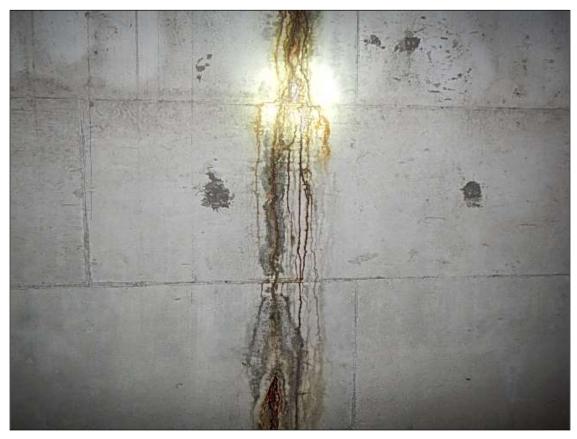
RANDOM CRACK

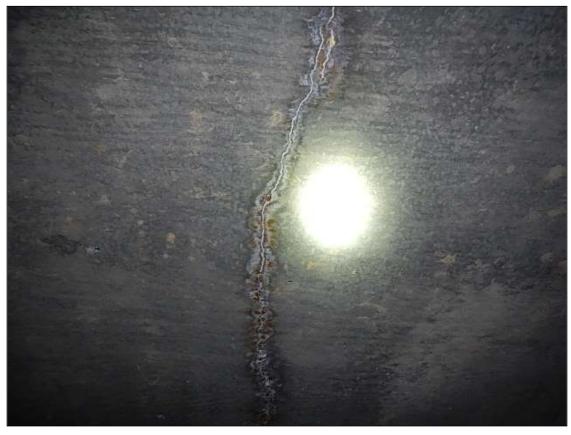
RANDOM CRACK WITH EFFLORESCENCE

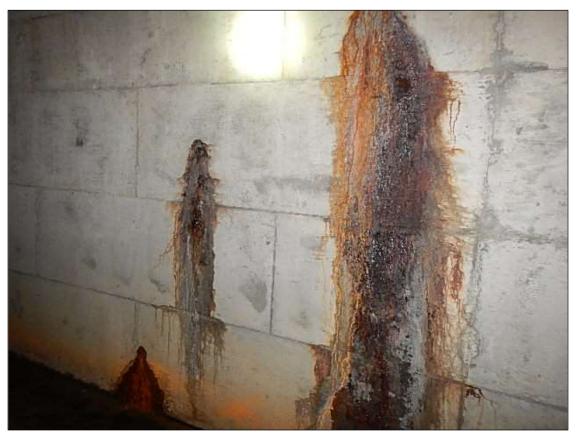
RANDOM CRACK WITH EFFLORESCENCE AND RUST
