☐ Supplemental Inspection Requested

NC DEPARTMENT OF TRANSPORTATION  
DIVISION OF HIGHWAYS  
STRUCTURE MANAGEMENT UNIT  
COUNTY: CALDWELL DIV: 11

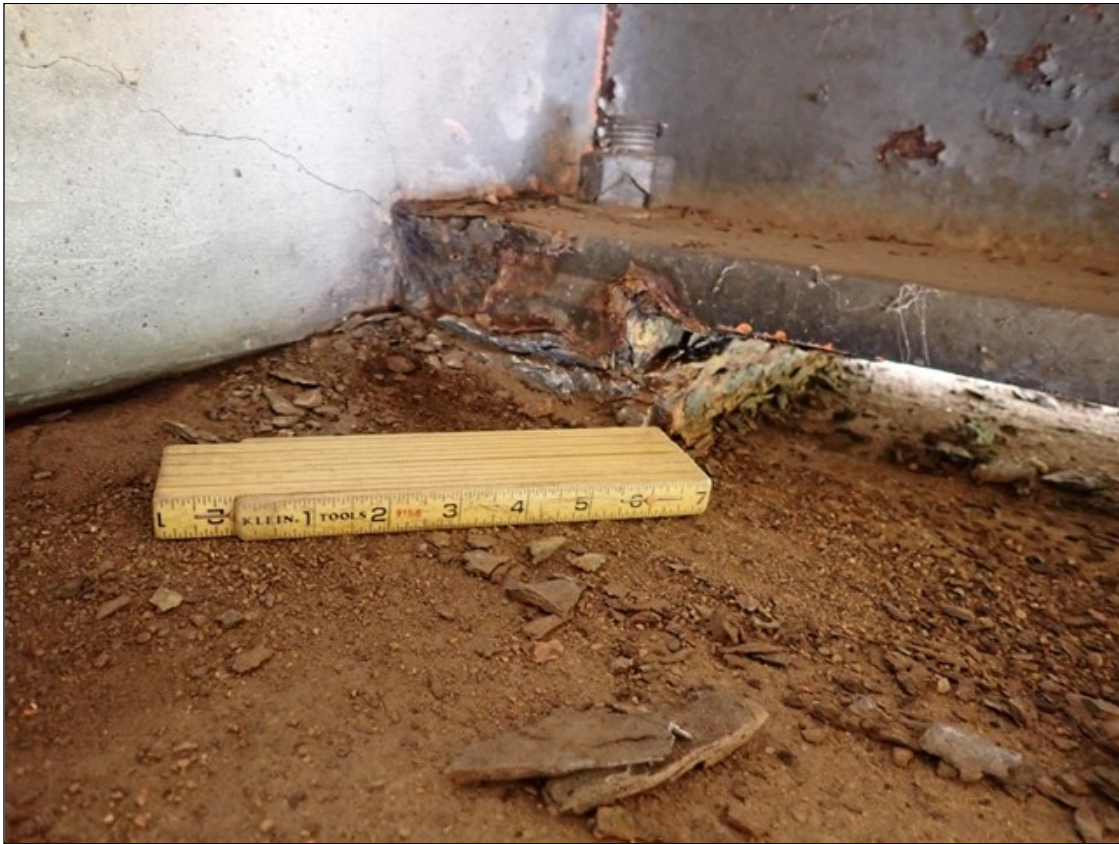
Span 10 Beam 4 - Beam 4 Far Bearing: PEELING PAINT WITH RUST

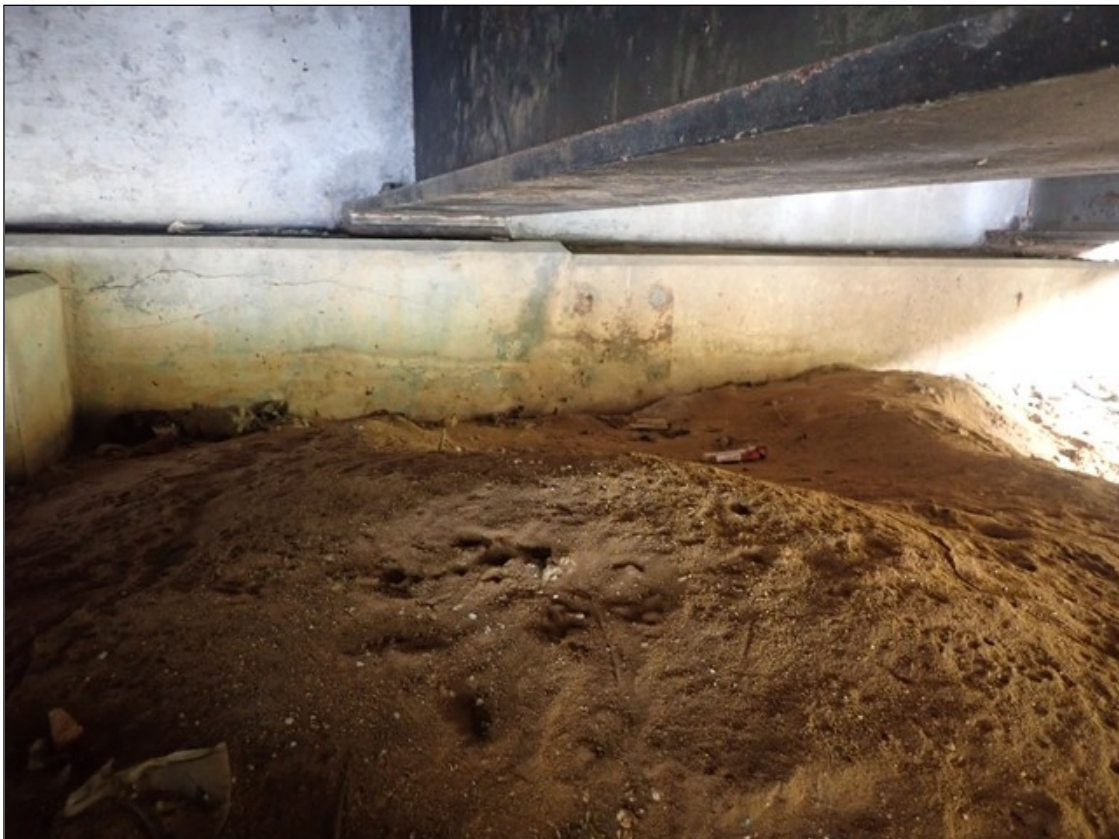
End Bent 2 Cap 1: 11 FEET LONG X UP TO 1/16 INCHES WIDE HORIZONTAL CRACKS UNDER BAYS 2 AND 3

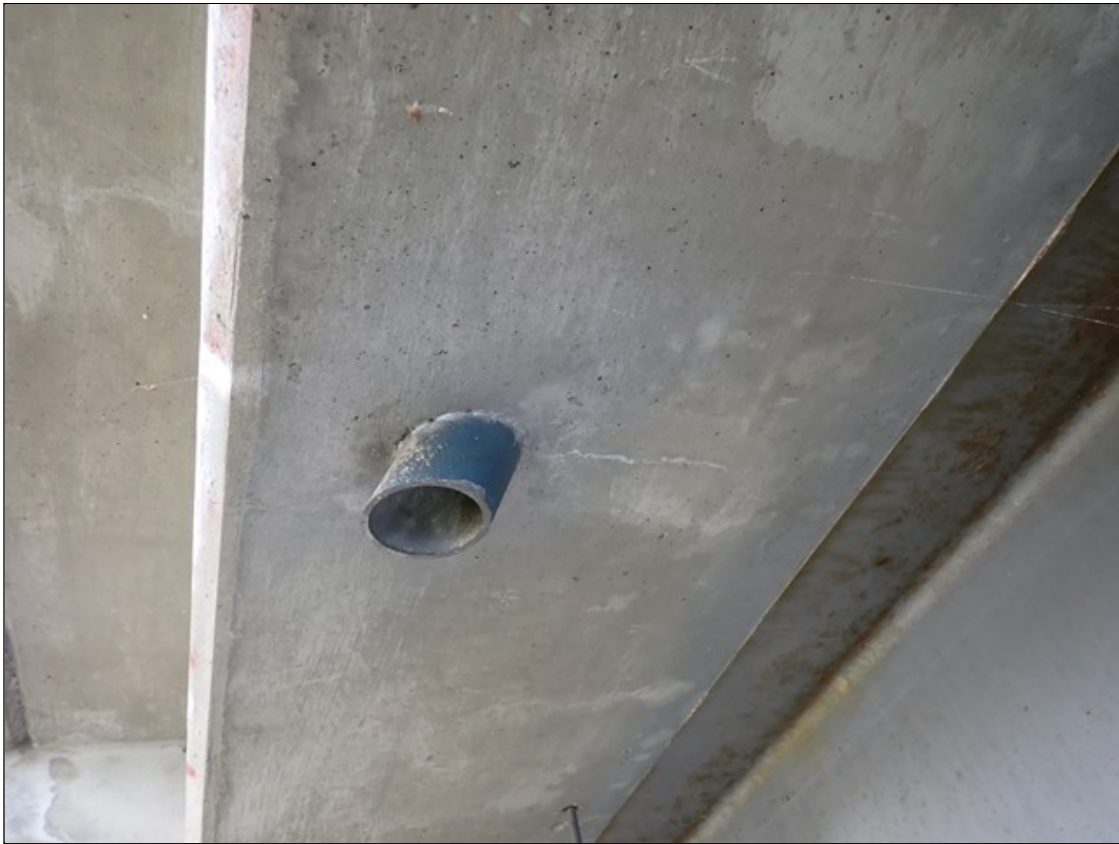
Span 10 Deck: ALONG LENGTH OF UNDERSIDE OF BOTH OVERHANGS AT DRAIN PIPES, MULTIPLE TRANSVERSE CRACKS [UP TO 3 FEET LONG X HAIRLINE]

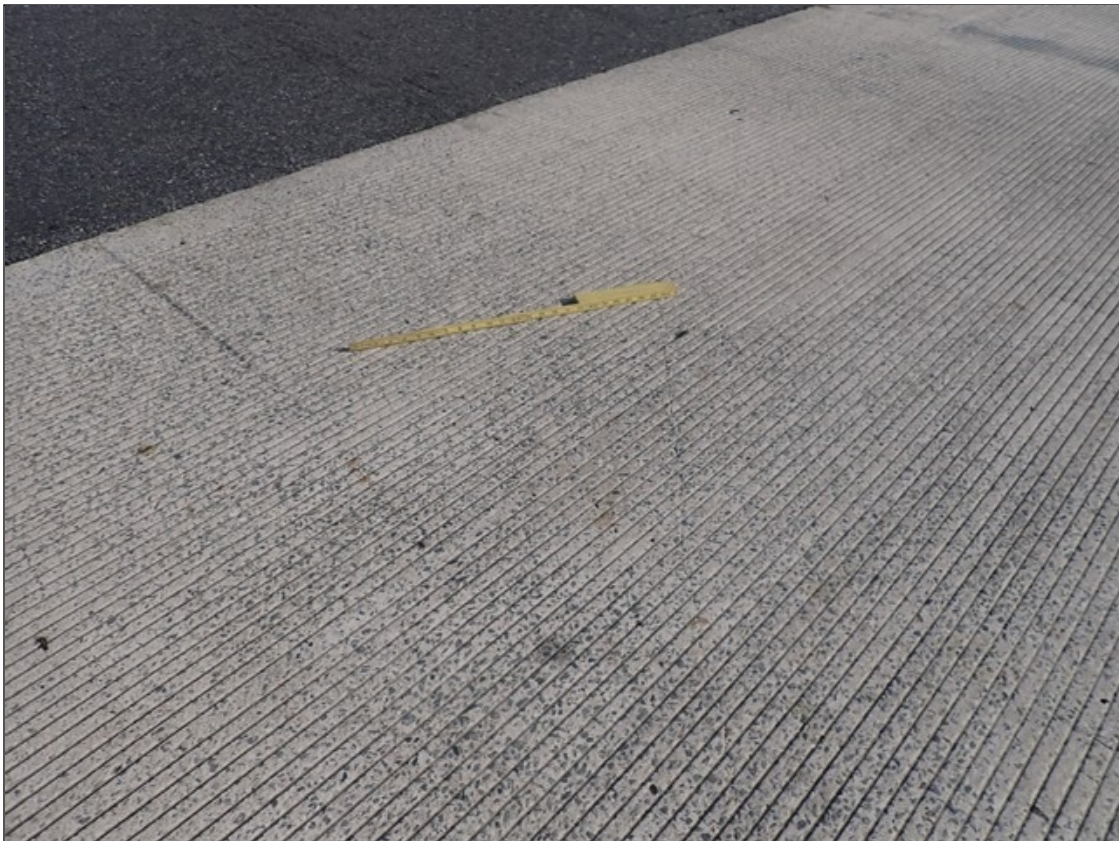
Span 10 Concrete Wearing Surface: 1/32 INCHES WIDE MAP CRACKING IN WEARING SURFACE PARTICULARLY AT JOINTS

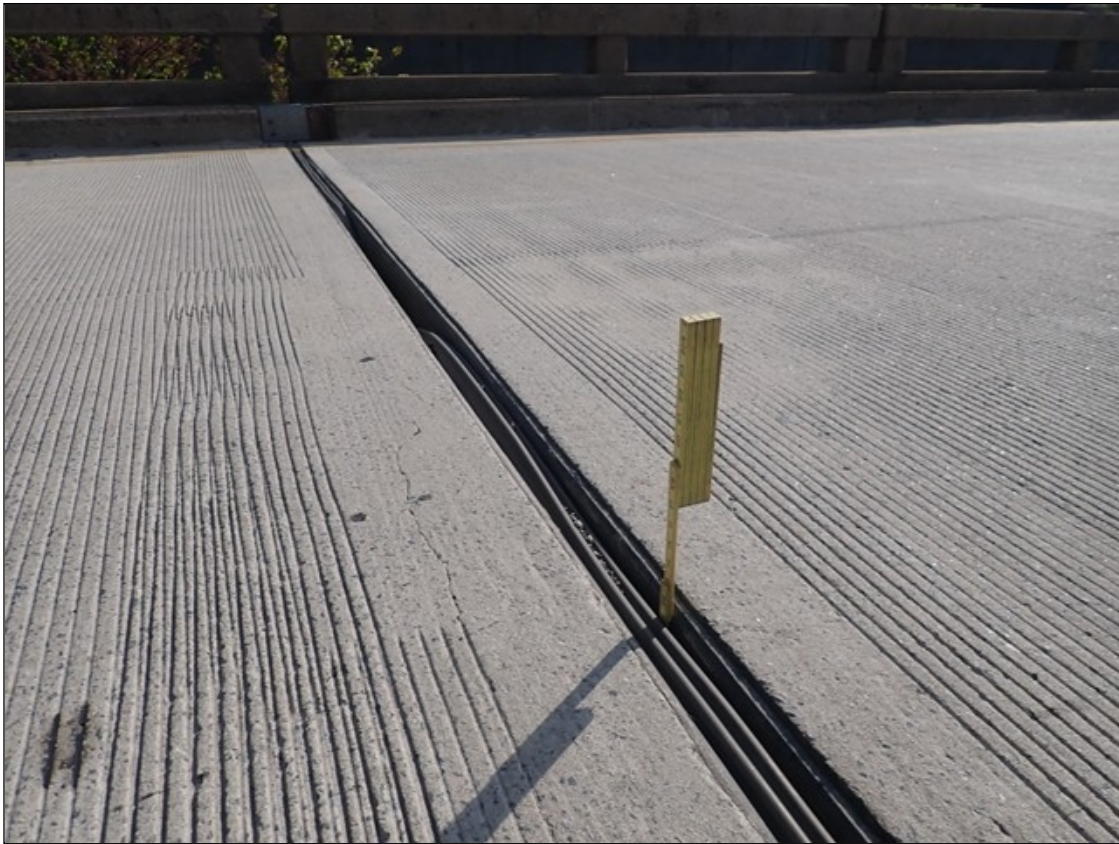
Span 10 Expansion Joint Bent 9: ALONG LENGTH OF JOINT, SEAL ADHESION FAILURE [ADHESION GREATER THAN 50%]

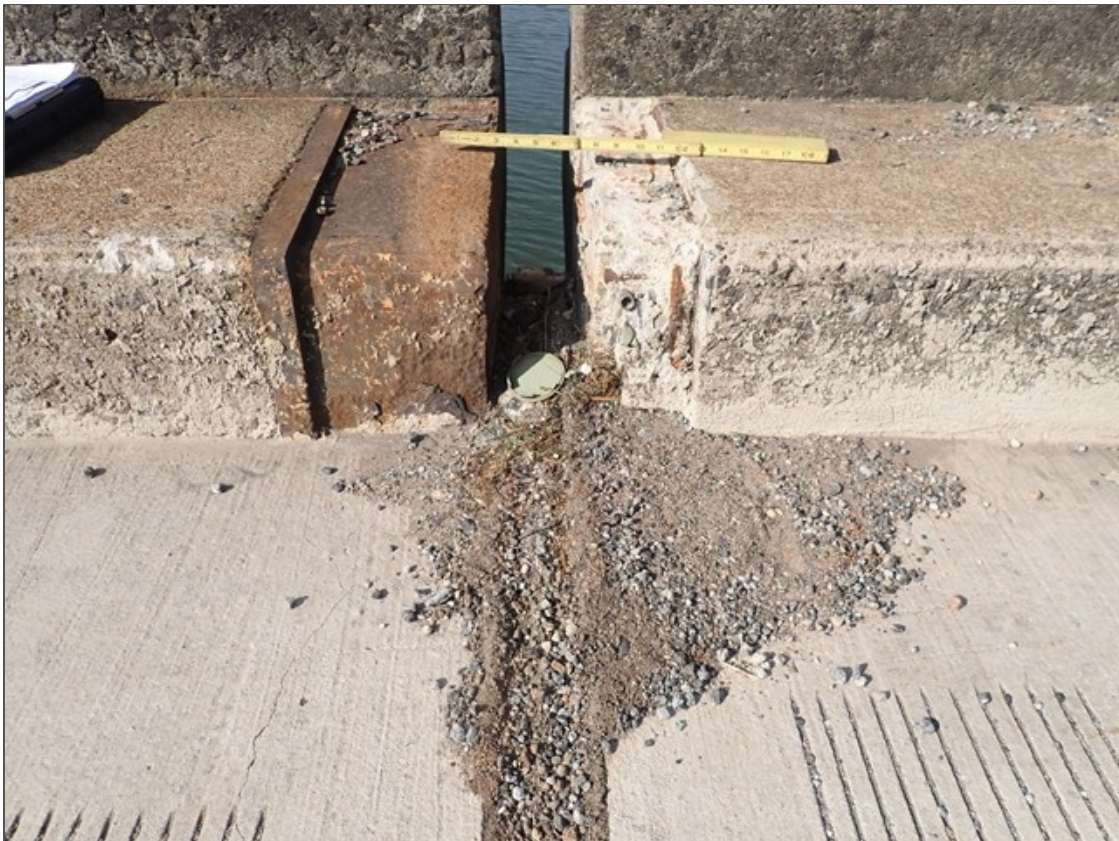
Span 10 Left Bridge Rail: STEEL COVER PLATE MISSING AT CURB

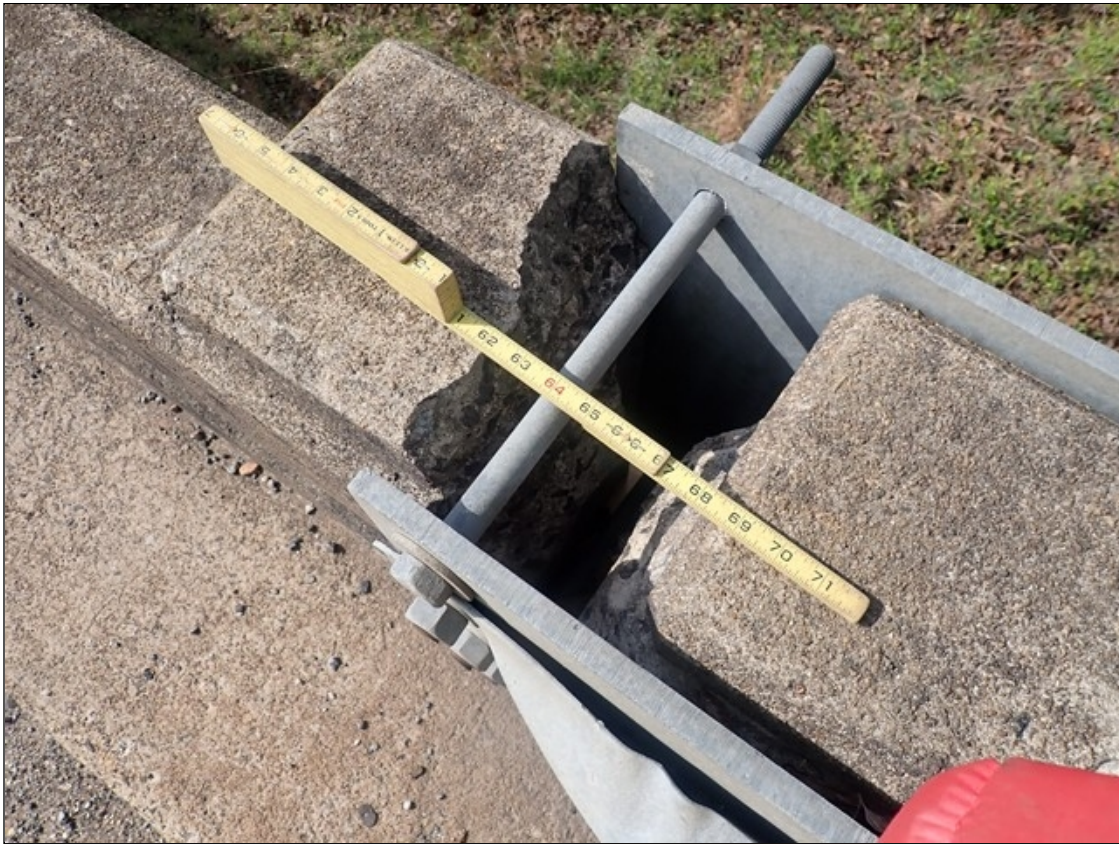
Span 10 Left Bridge Rail: (2) UP TO 10 1/2 INCHES LONG X 15 INCHES WIDE X 4 INCHES DEEP SPALL ON POST 12

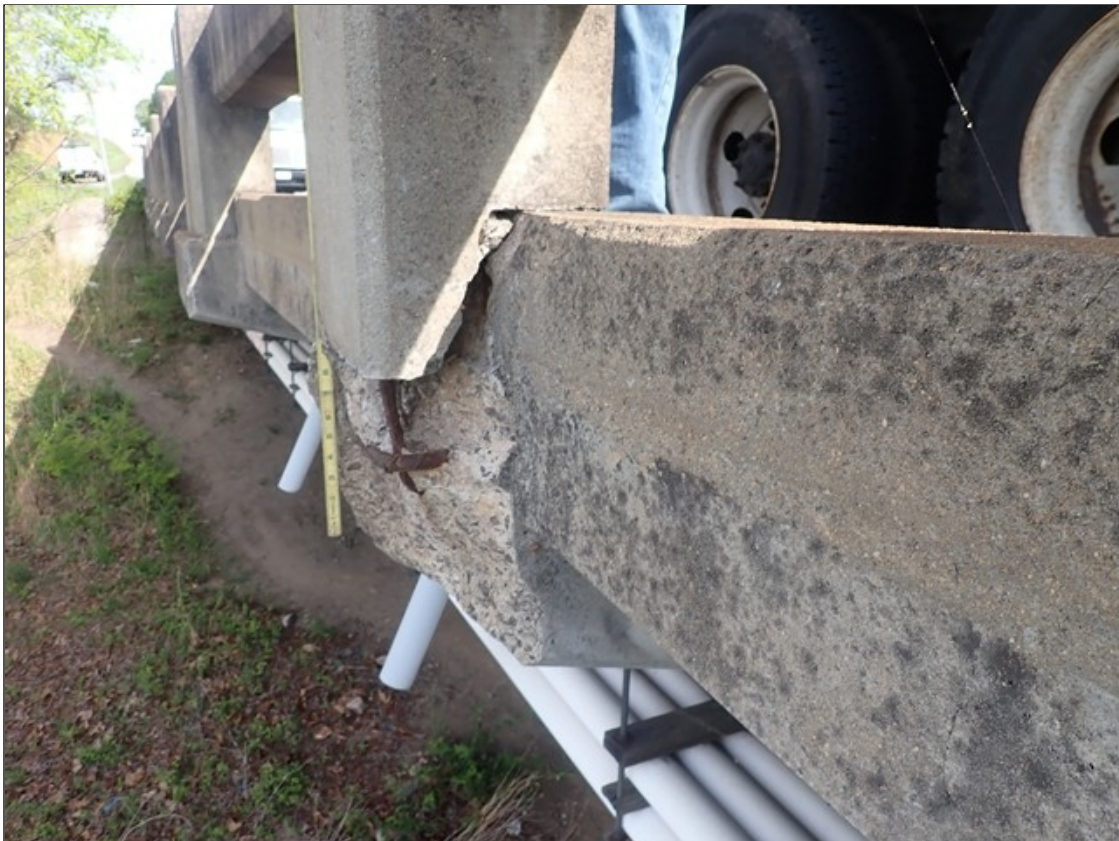
Span 10 Left Bridge Rail: 14 INCHES LONG X 17 INCHES HIGH X 9 INCHES DEEP SPALL WITH EXPOSED REBAR ON OUTSIDE FACE OF POST 5 (PAR)

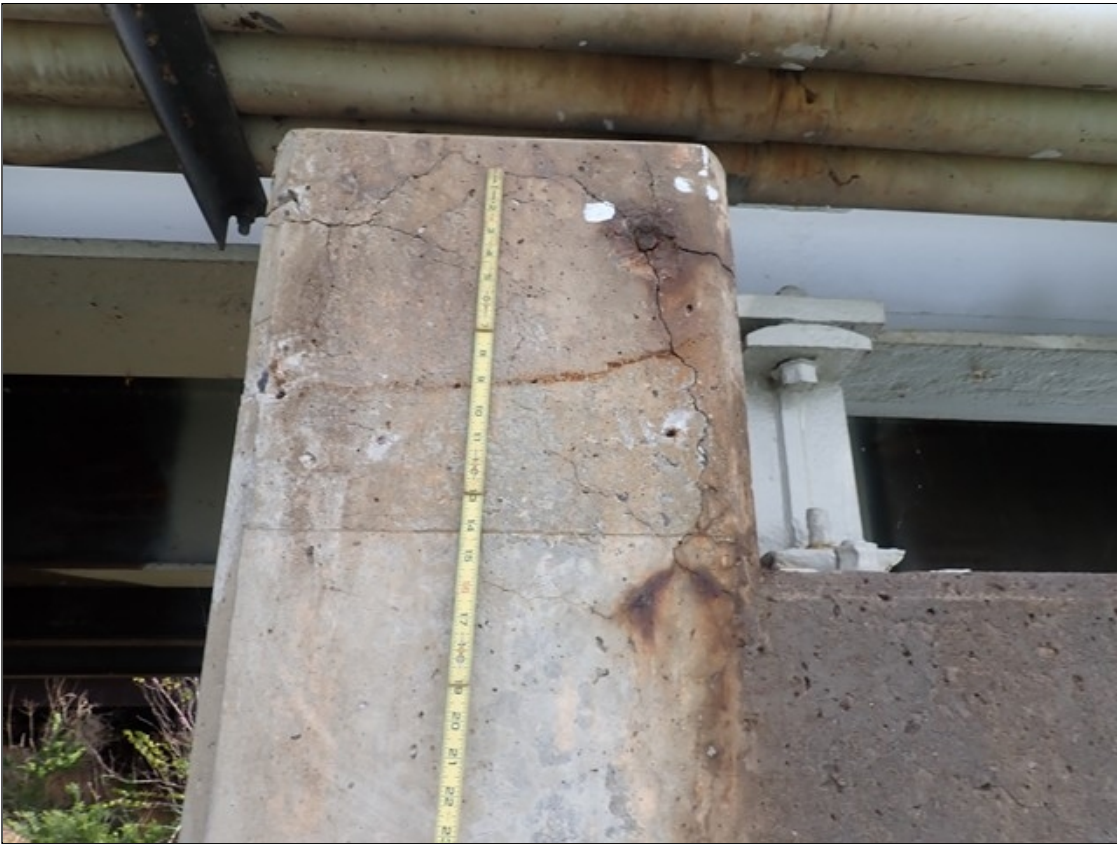
Bent 9 Cap 1: WEST FACE OF CAP, DELAMINATION/SPALL [18 INCHES LONG X 18 INCHES HIGH X UP TO 3/4 INCHES DEEP] WITH RUST STAIN

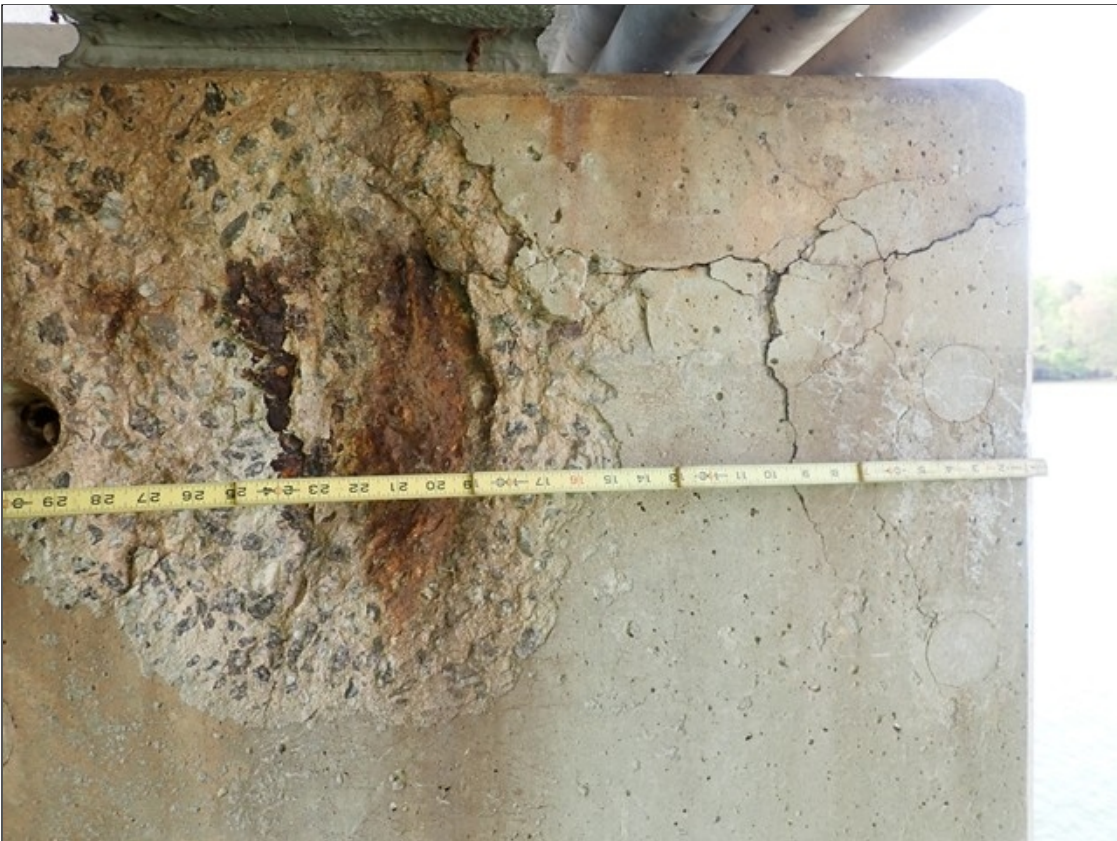
Bent 9 Cap 1: NORTH FACE AT WEST END, SPALL WITH EXPOSED REBAR AND AREA OF DELAMINATION [32 INCHES LONG X 20 INCHES HIGH X 1- 3/4 INCHES DEEP] WITH TWO [2] EXPOSED VERTICAL REBAR

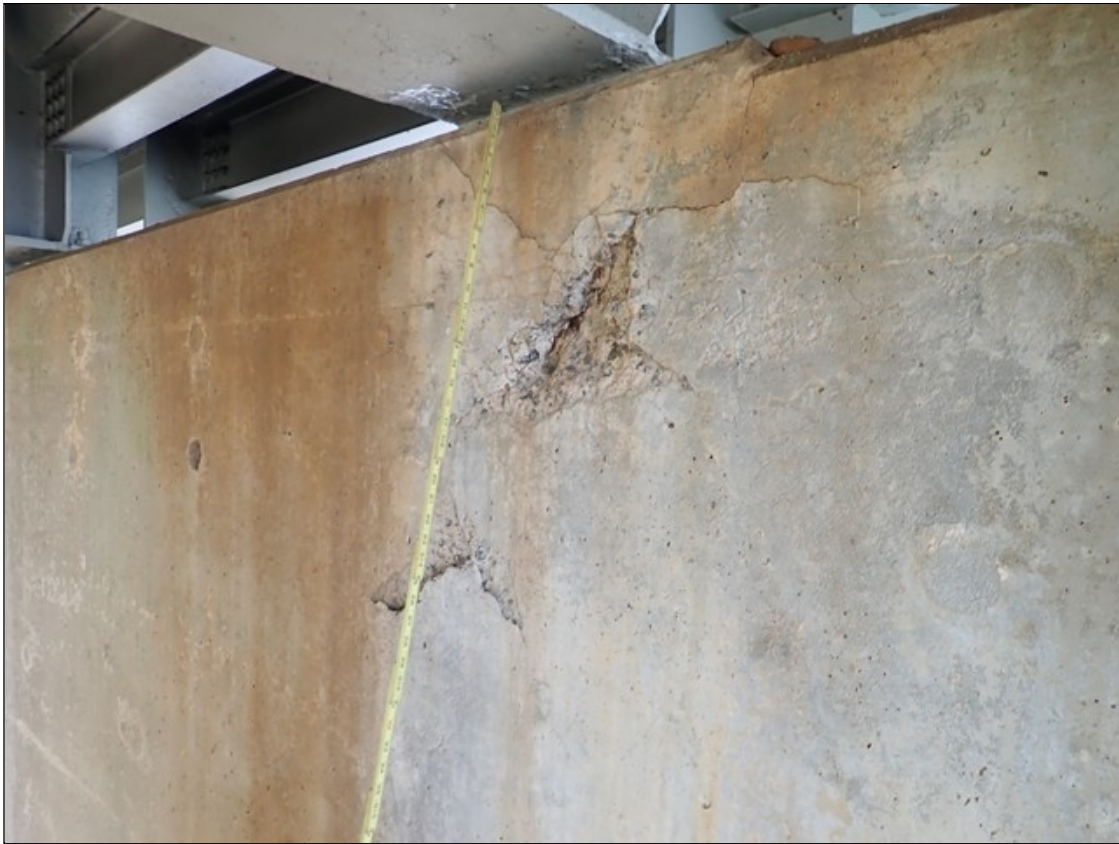
Bent 9 Cap 1: NORTH FACE UNDER BEAM 2, SPALL WITH EXPOSED REBAR AND AREA OF DELAMINATION [34 INCHES LONG X 32 INCHES HIGH X 1-1/2 INCHES DEEP]

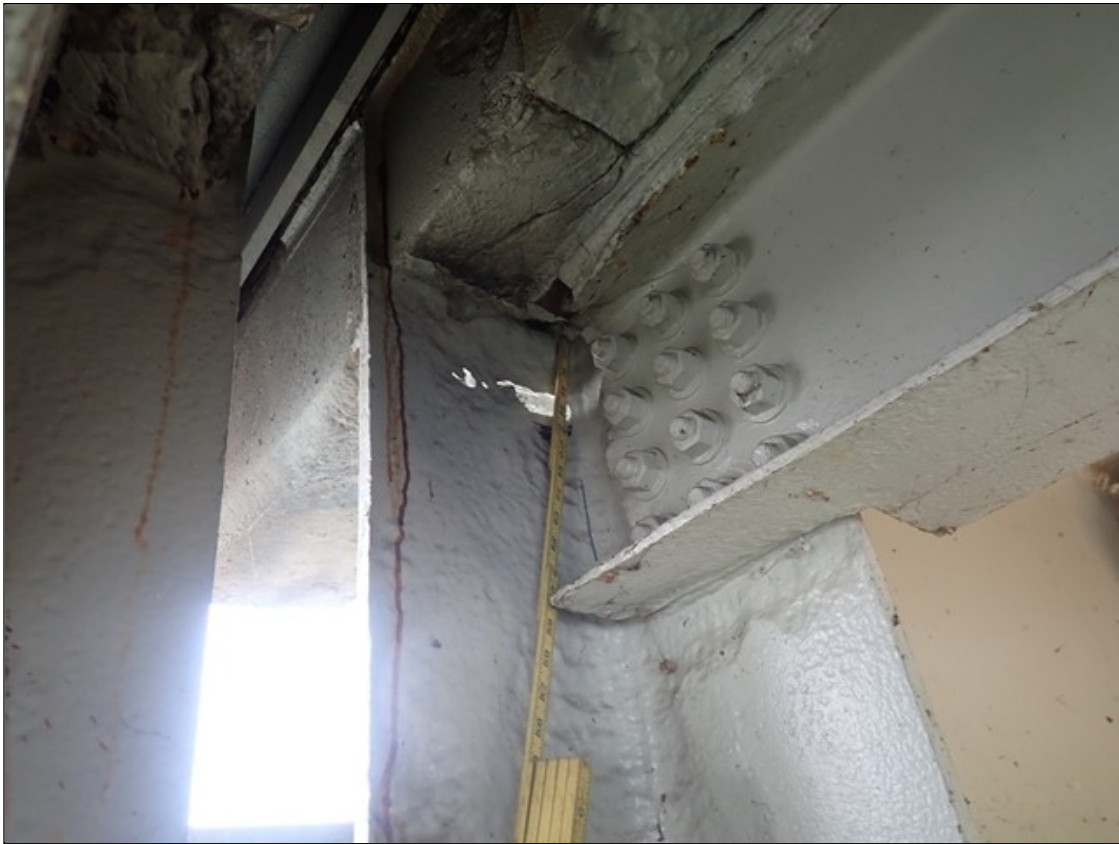
Span 10 Beam 1: AT NEAR END, CORROSION WITH SECTION LOSS, UPPER WEB AT DIAPHRAGM: CORROSION HOLE [6 INCHES LONG X 3 INCHES TALL AT 3 INCHES DOWN FROM DIAPHRAGM]; LOWER WEB: [9 INCH X 24 INCHES - AVERAGE REMAINING 7/16 INCHES]; BOTTOM FLANGE: [12 INCHES X FULL WIDTH - AVERAGE REMAINING 3/4 INCHES] (CLEANED AND PAINTED) (PAR)

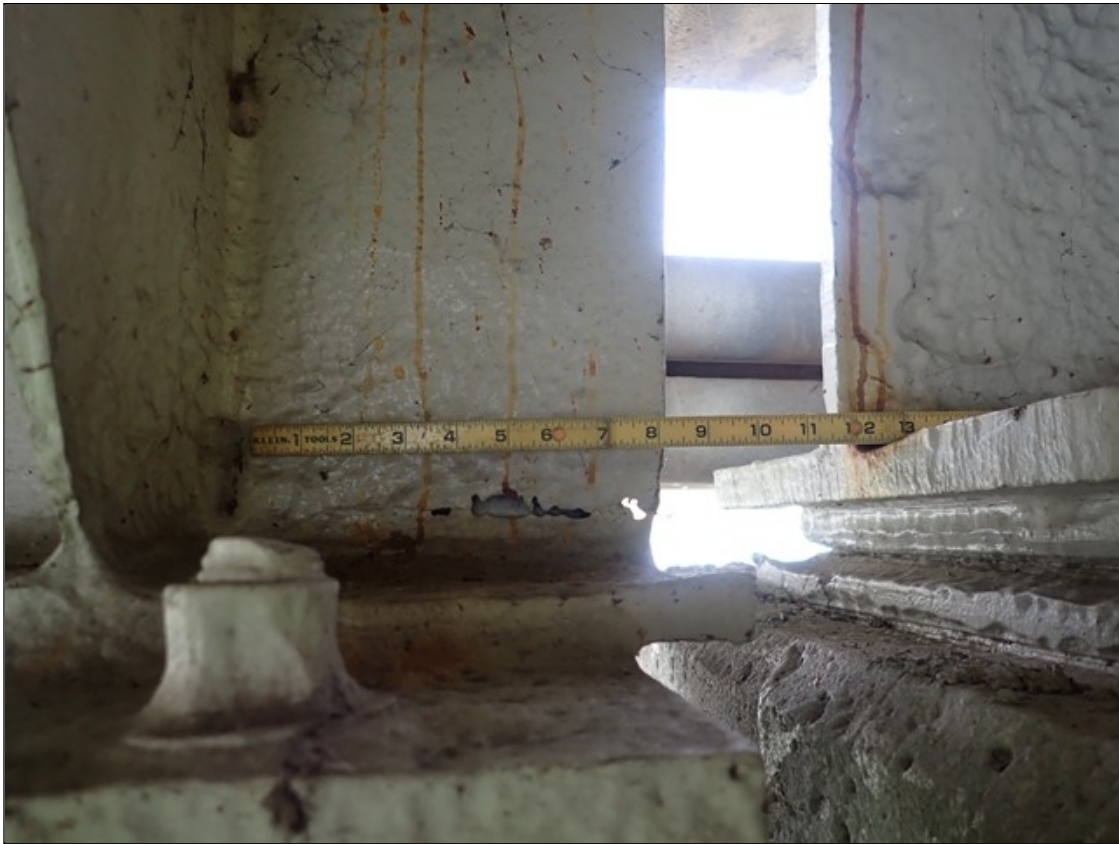
Span 6 Beam 1: 8 INCH LONG X 6 INCH HIGH AREA OF 3/16 INCH SECTION LOSS (5/16 INCH REMAINING) WITH NO RUST ON RIGHT STIFFENER IN SPAN 9 AT BENT 9 (CLEANED AND PAINTED) (PAR)

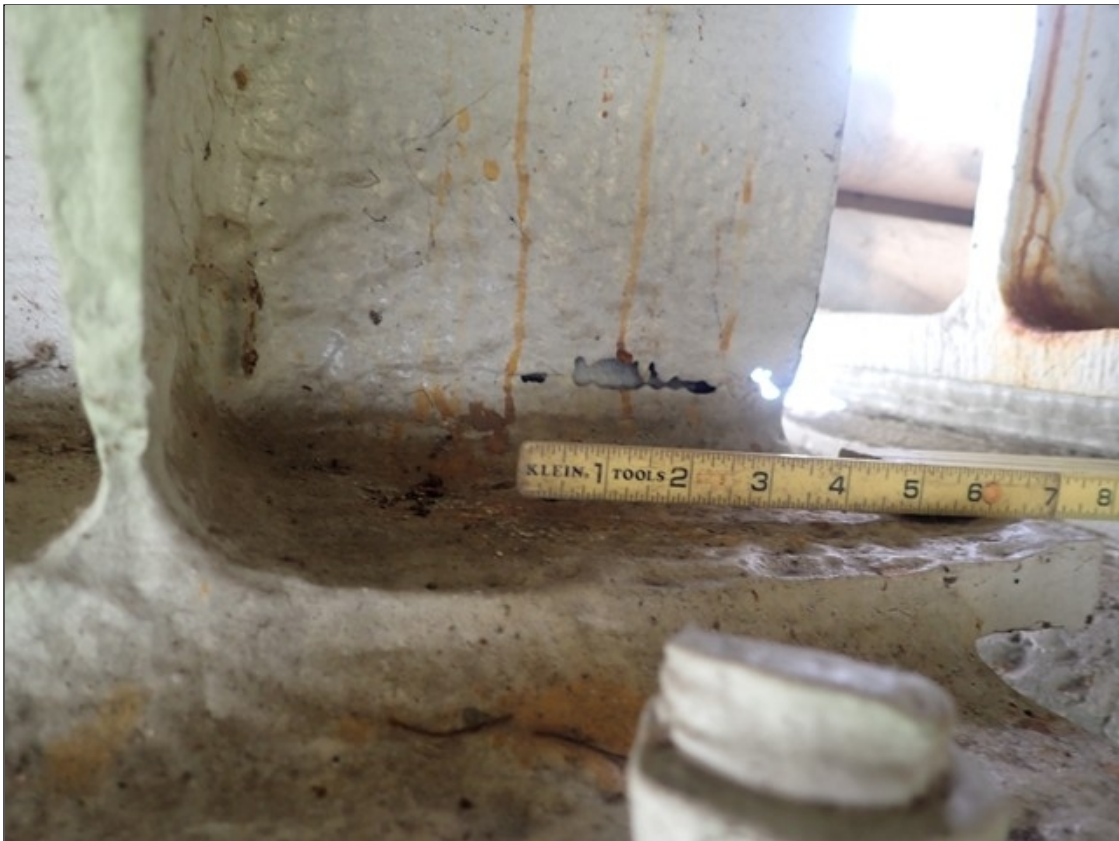
Span 6 Beam 1: IN SPAN 9 AT FAR END, CORROSION WITH SECTION LOSS, BOTTOM FLANGE: [15 INCHES LONG X FULL WIDTH - AVERAGE REMAINING 3/4 INCHES] (CLEANED AND PAINTED) (PAR)

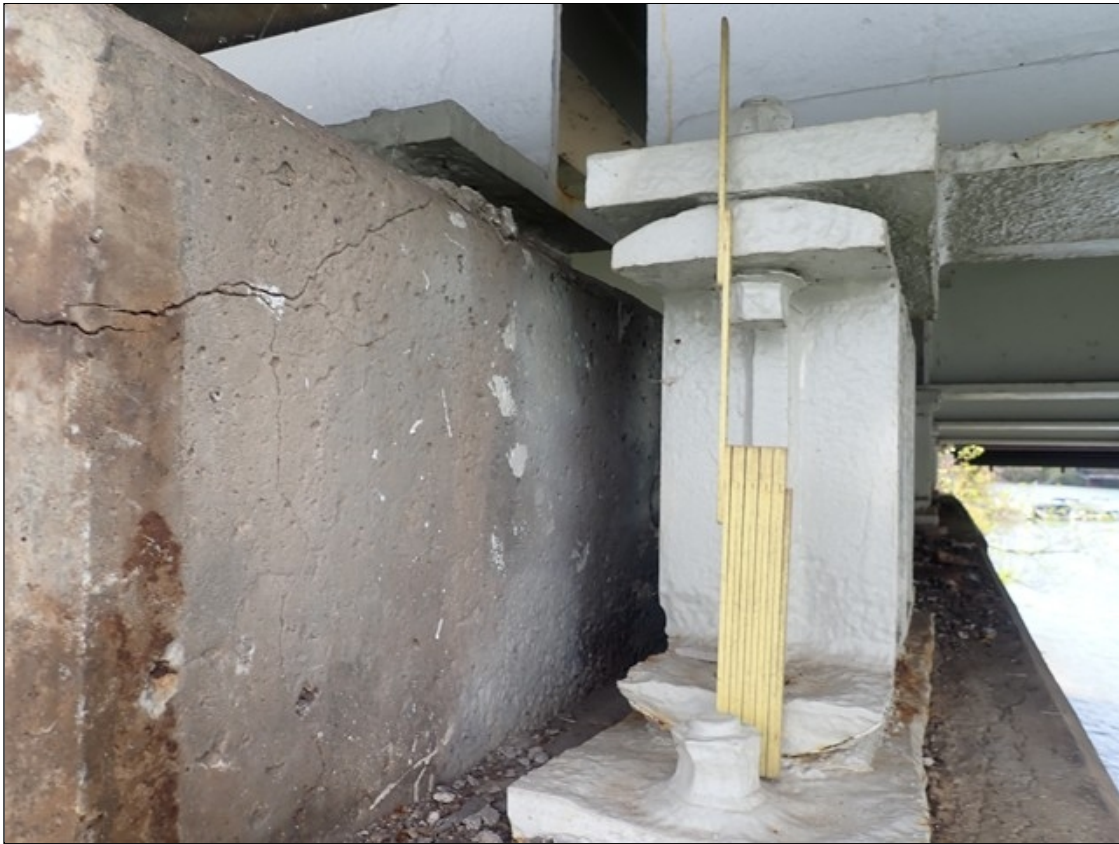
Span 6 Beam 1 Far Bearing - Protective System: SUBSTANTIALLY EFFECTIVE

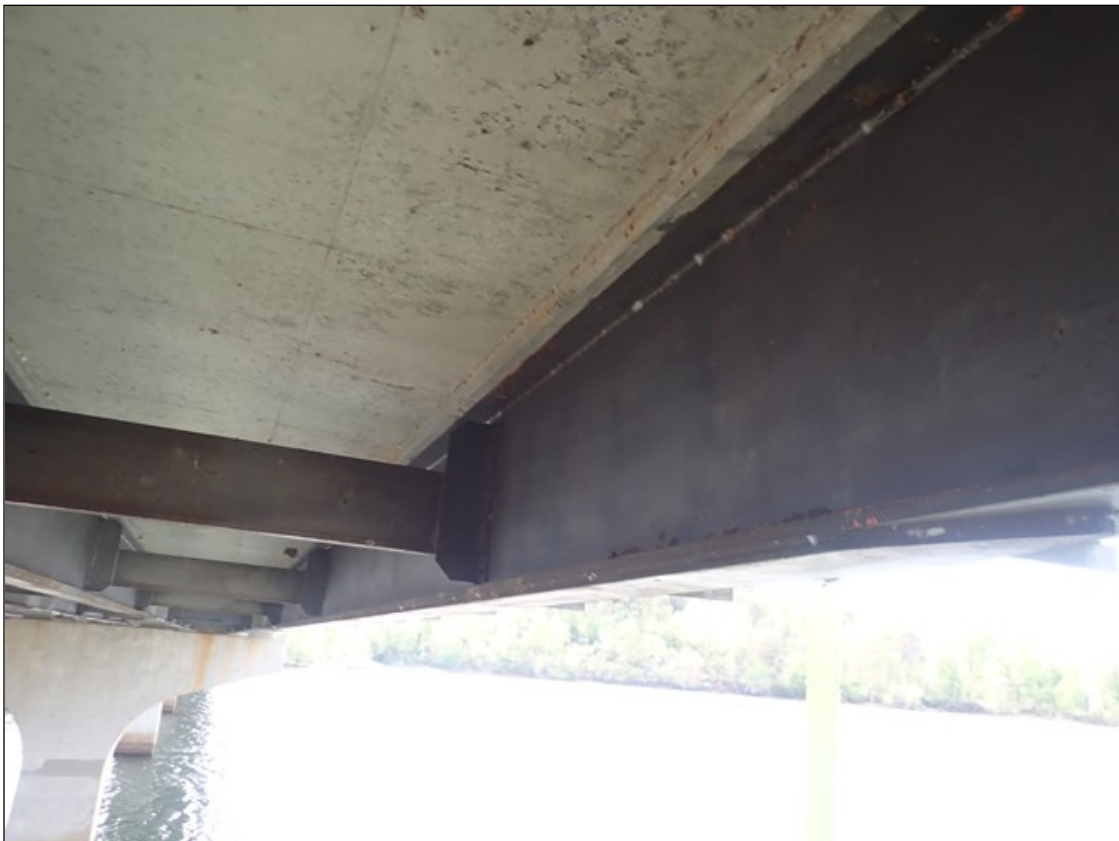
Span 6 Beam 1: PEELING PAINT WITH RUST AND SURFACE RUST ON BOTH FLANGES AND WEB AT RANDOM THROUGHOUT IN SPANS 6-9

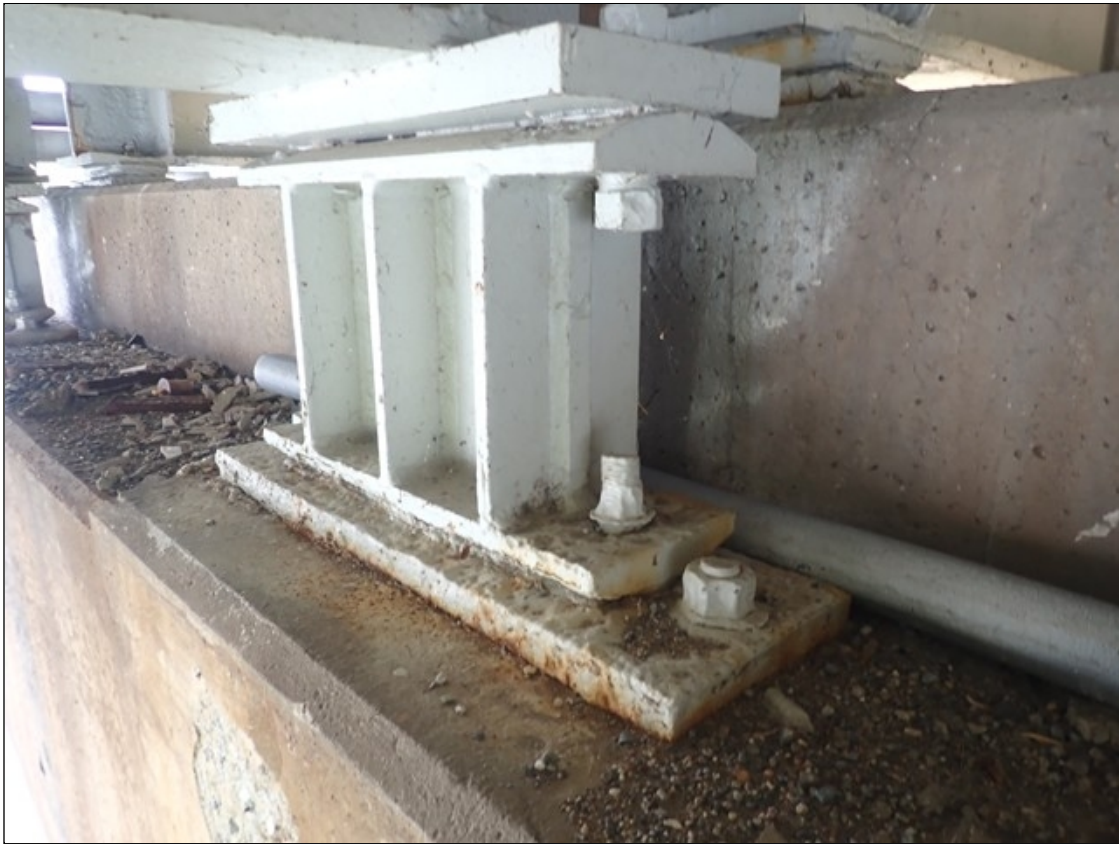
Span 6 Beam 2 Far Bearing - Protective System: SUBSTANTIALLY EFFECTIVE (CLEANED AND PAINTED)

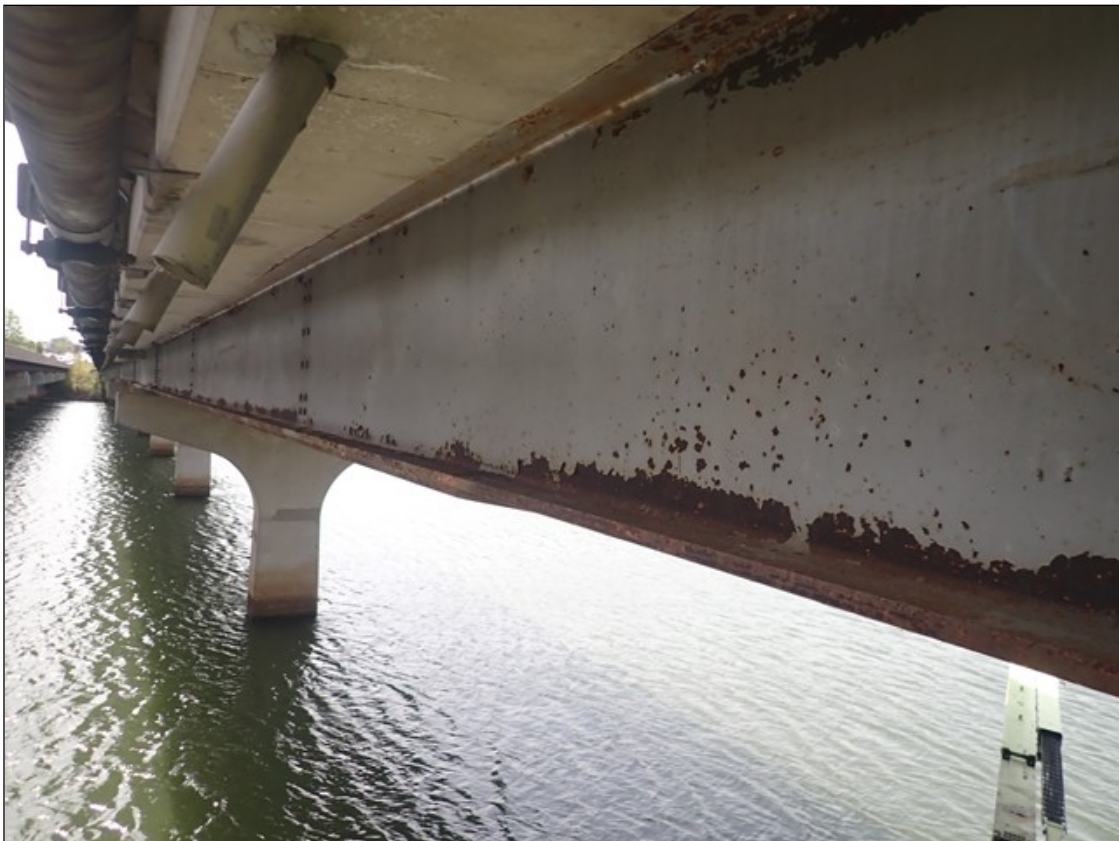
Span 6 Beam 4: PEELING PAINT WITH RUST AND SURFACE RUST ON BOTH FLANGES AND WEB AT RANDOM THROUGHOUT IN SPANS 6-9

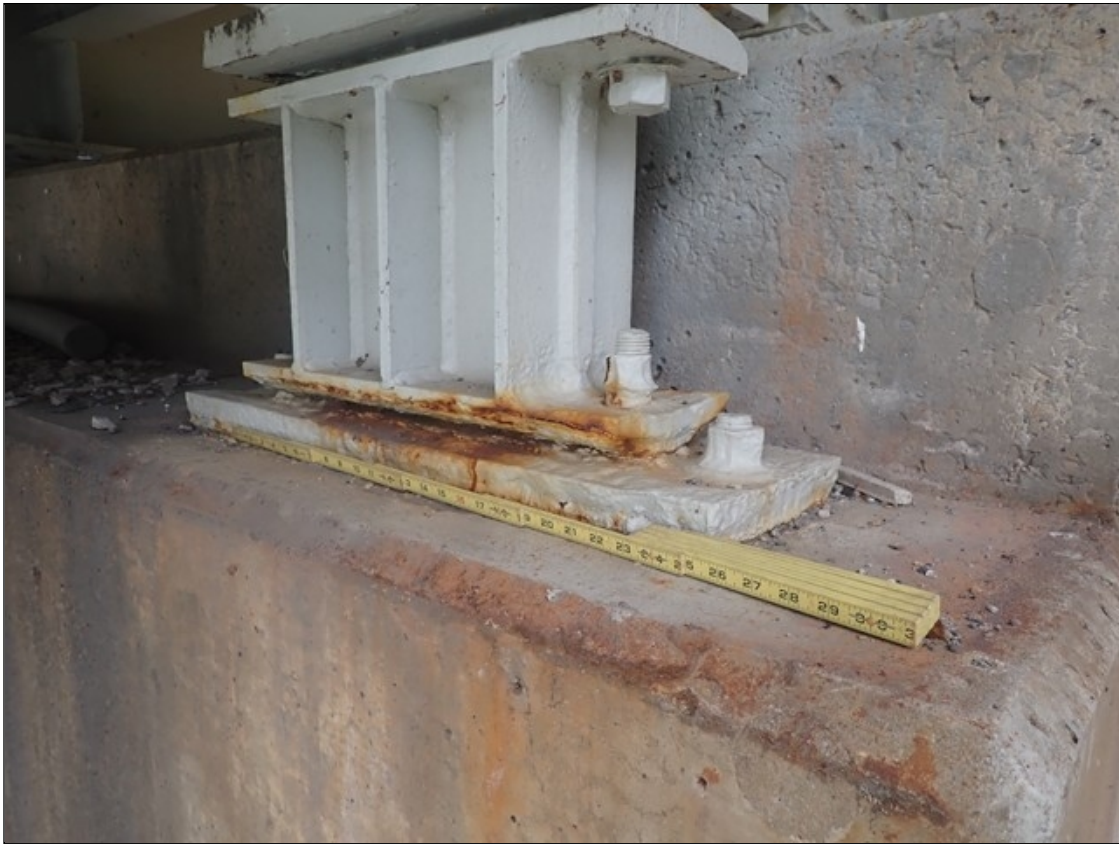
Span 6 Beam 4 Far Bearing: SURFACE RUST WITH PITTING

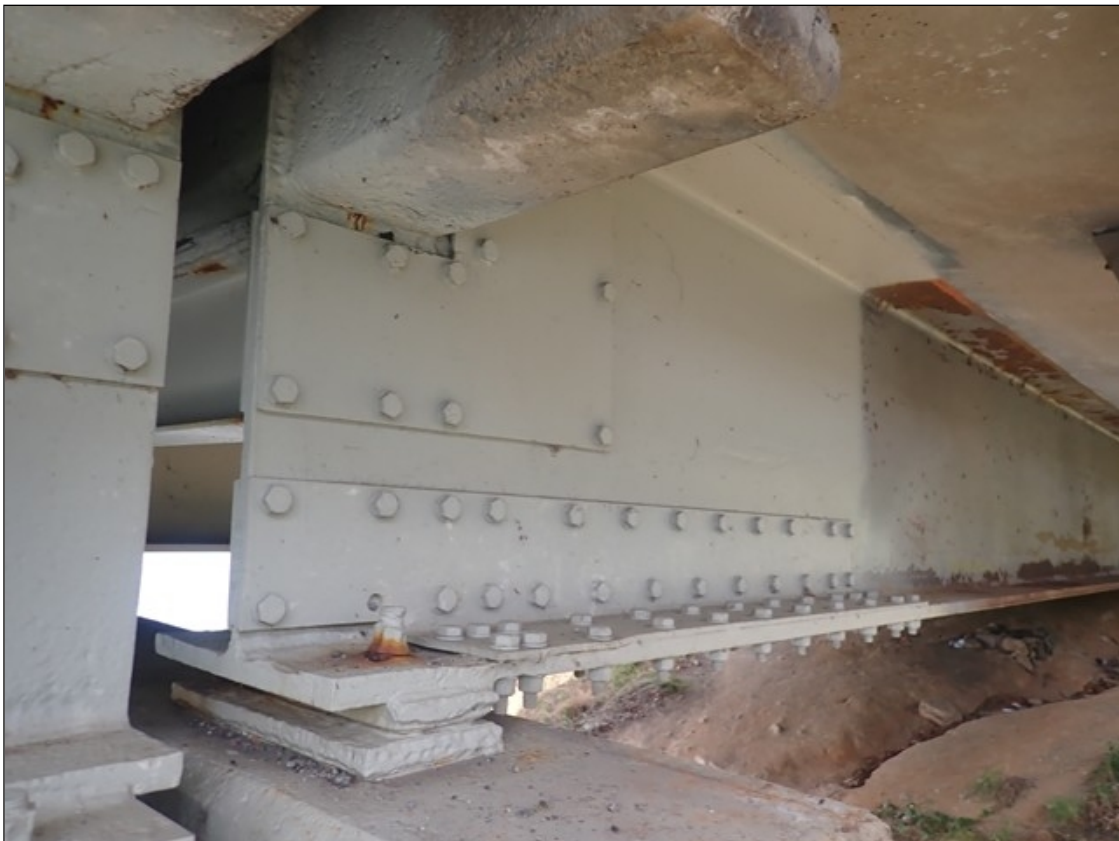
Span 10 Beam 4: MISSING BOLT ON WEB REPAIR PLATE AT BENT 9 (PAR)

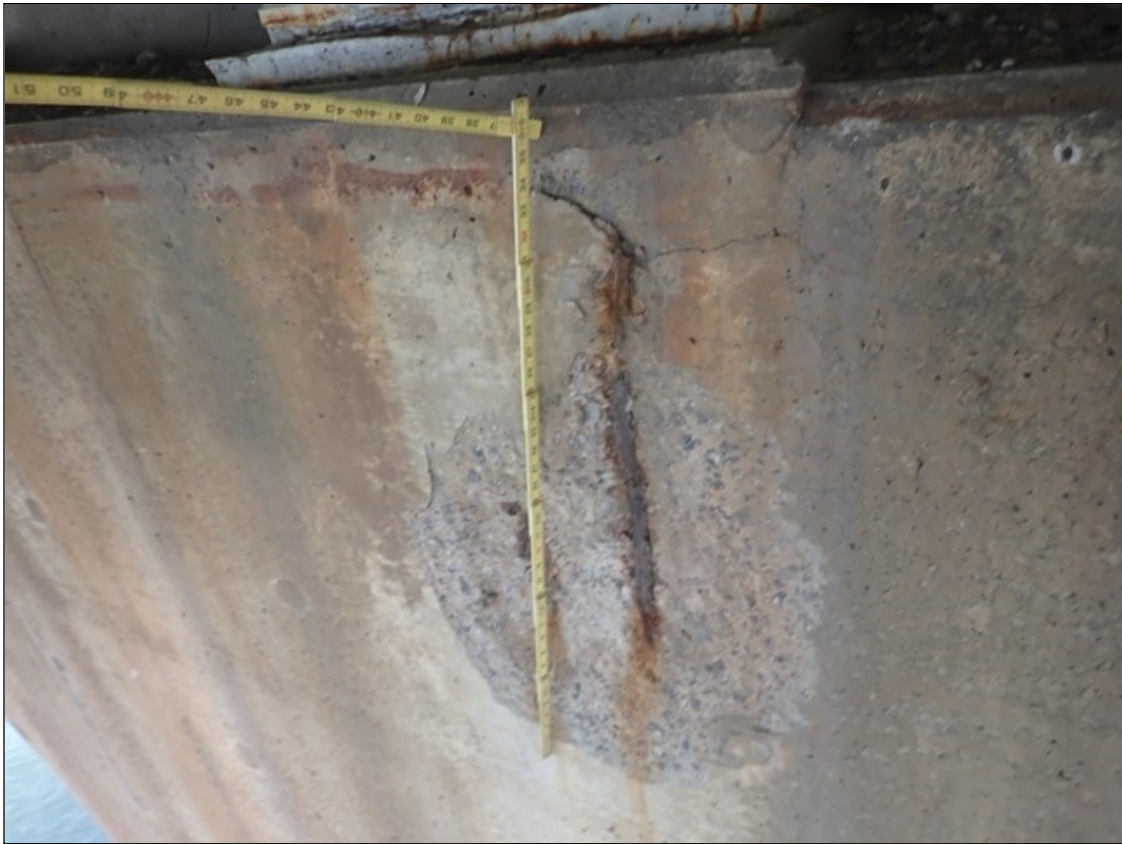
Bent 9 Cap 1: SOUTH FACE AT BEAM 3, SPALL WITH EXPOSED REBAR [22 INCHES WIDE X 34 INCHES TALL X UP TO 2 INCHES DEEP] WITH TWO [2] EXPOSED VERTICAL REBAR WITH SECTION LOSS (PAR)

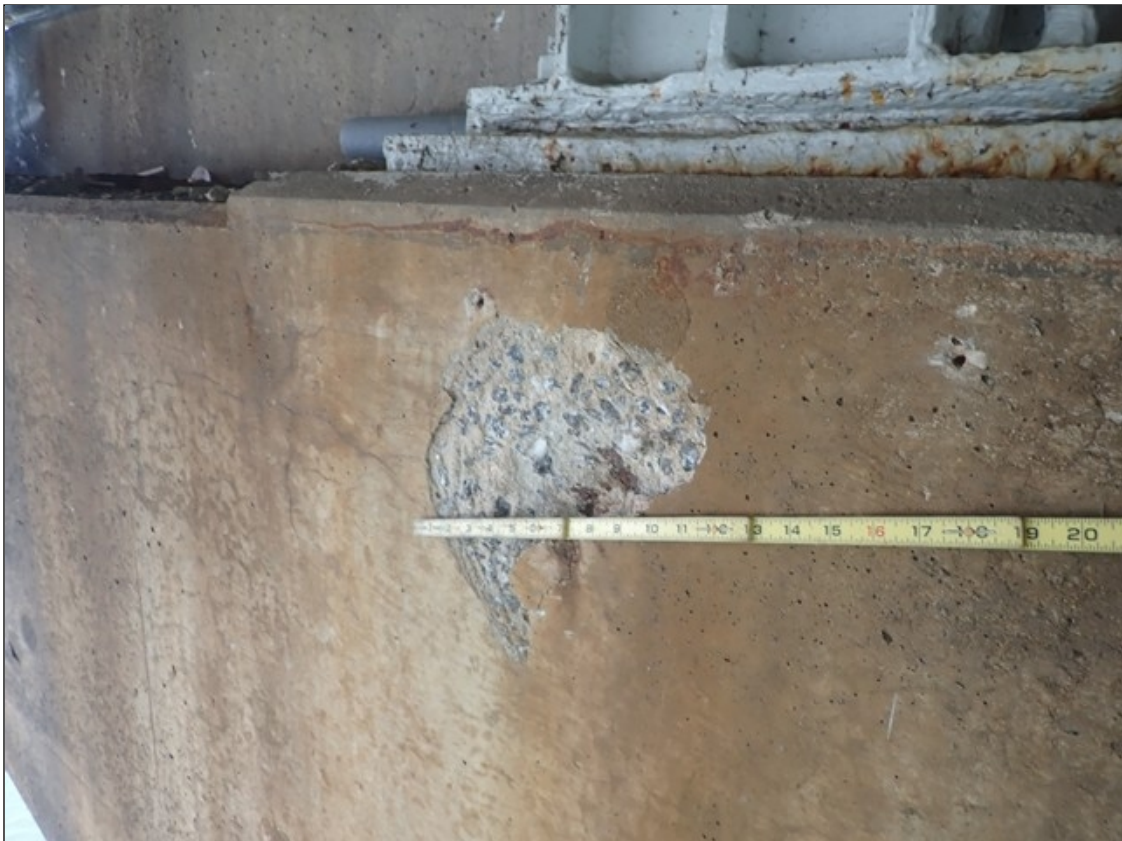
Bent 9 Cap 1: 12 INCH LONG X 12 INCH WIDE X 1/2 INCH DEEP SPALL AND AREA OF DELAMINATION ON SPAN 9 FACE UNDER BEAM 2

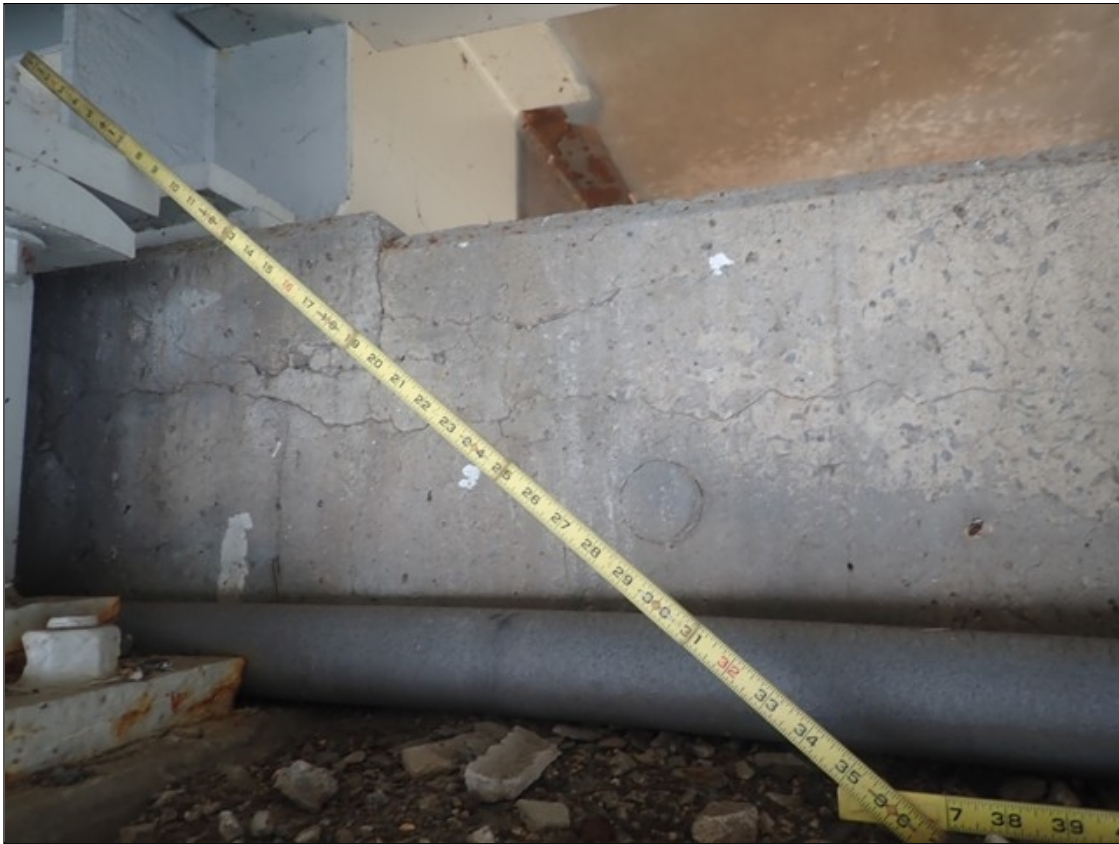
Bent 9 Cap 1: 18 INCHES LONG X 4 INCHES WIDE AREA OF DELAMINATION WITH 3 FEET LONG UP TO 1/16 INCH HORIZONTAL CRACKS ON SPAN 9 FACE OF BEAM STEP-UP UNDER BAY 3
