☐ Supplemental Inspection Requested

NC DEPARTMENT OF TRANSPORTATION  
DIVISION OF HIGHWAYS  
STRUCTURE MANAGEMENT UNIT  
COUNTY: CALDWELL DIV: 11

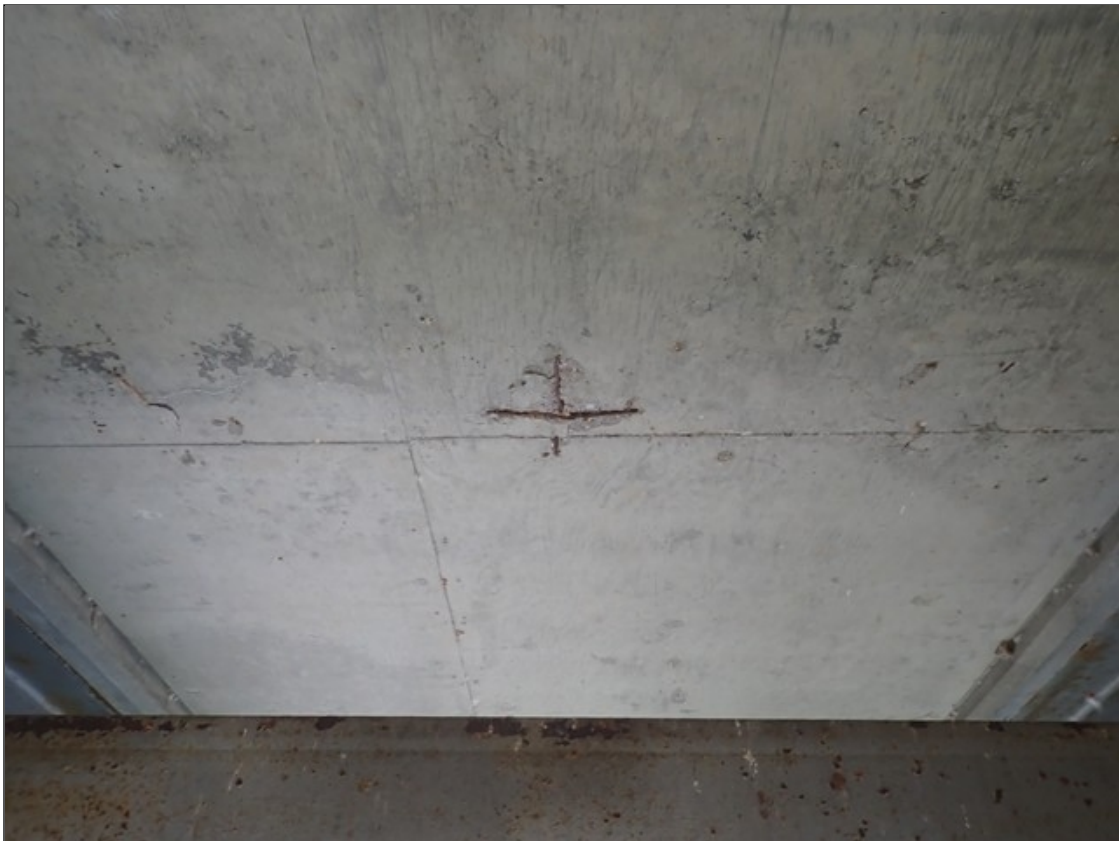
Span 9 Deck: 10 INCH LONG X 10 INCH WIDE X 1/2 INCH DEEP SPALL WITH EXPOSED REBAR CHAIRS ON BOTTOM OF DECK IN BAY 3 NEAR MIDSPAN

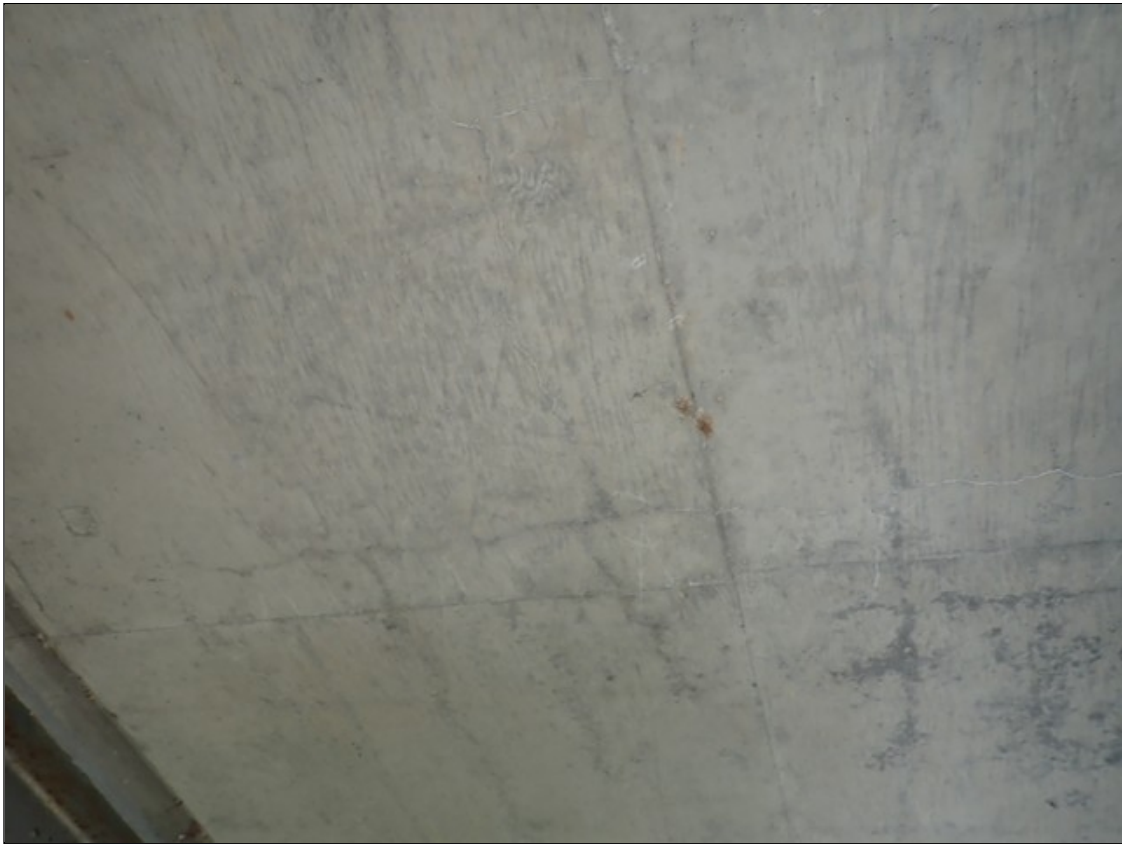
Span 9 Deck: HAIRLINE TRANSVERSE CRACKS ON BOTTOM OF DECK AT RANDOM THROUGHOUT IN BAYS 1 AND 3

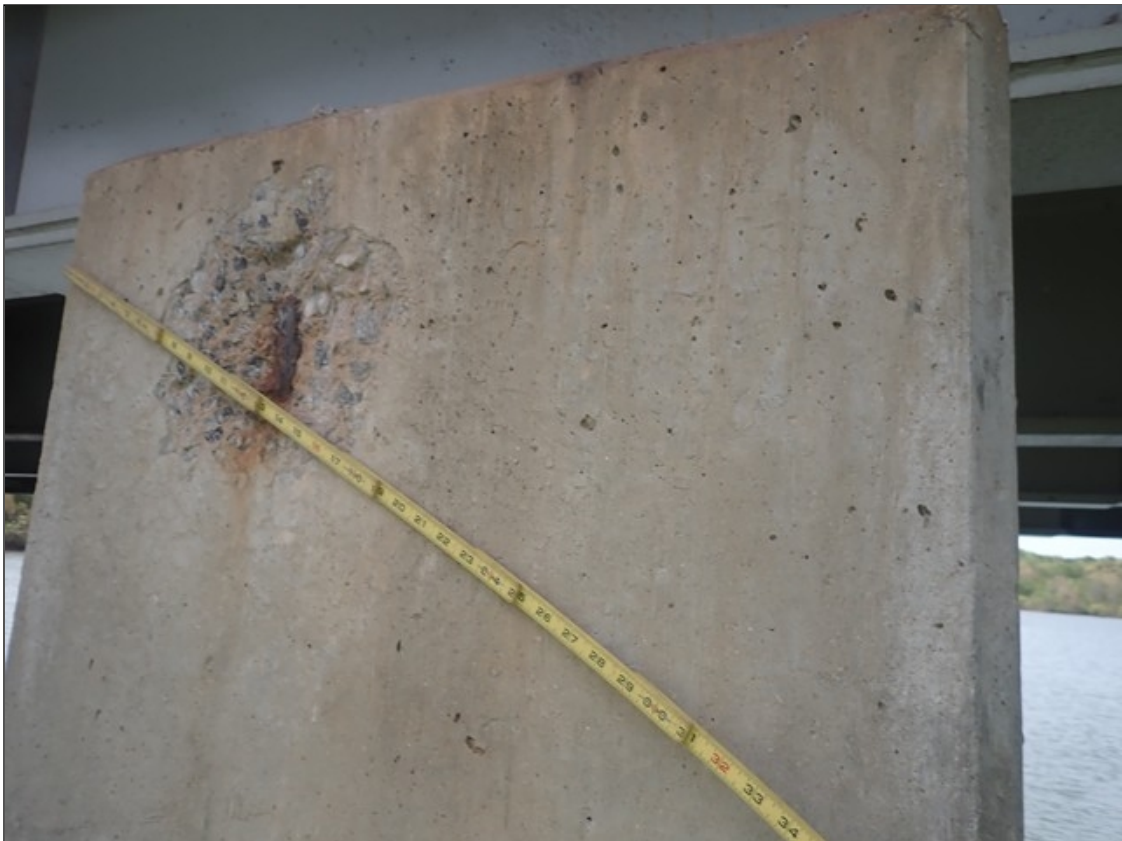
Bent 8 Cap 1: 12 INCHES LONG X 11 INCHES WIDE X 1 INCHES DEEP SPALL WITH EXPOSED REBAR ON EAST FACE (PAR)

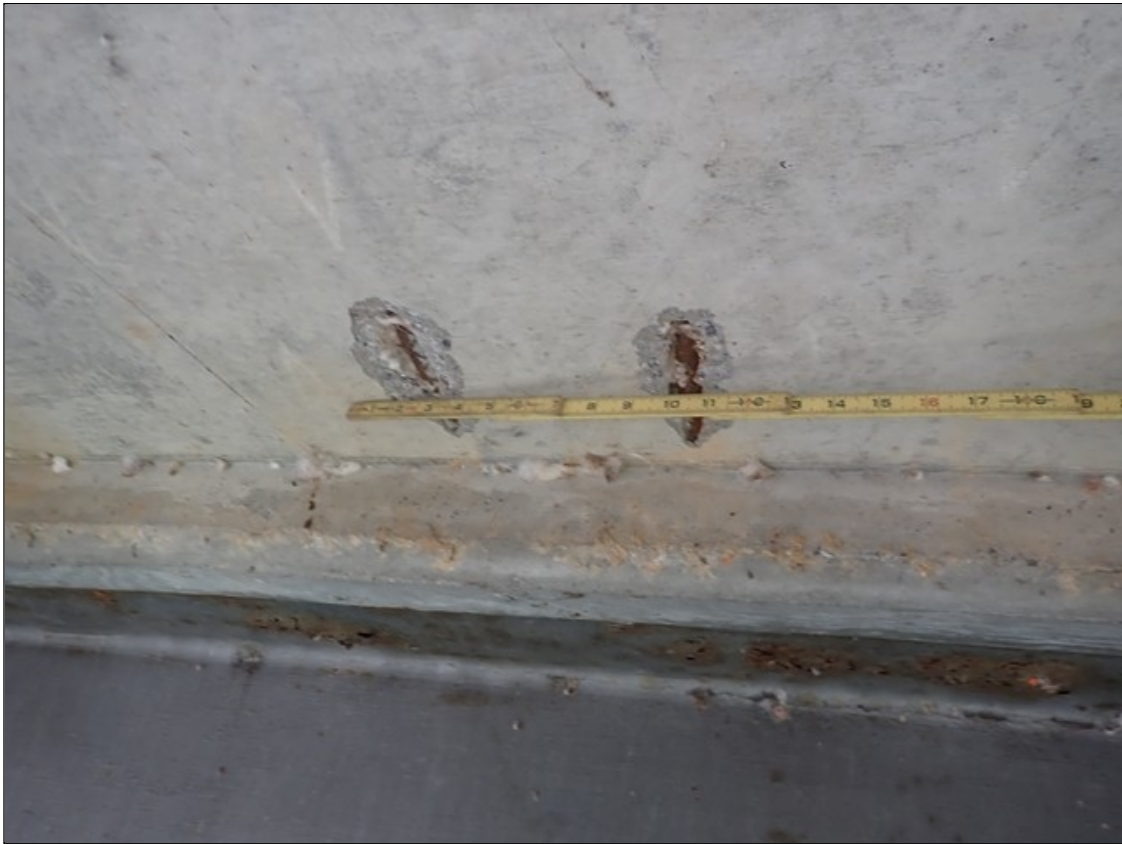
Span 9 Deck: (5) UP TO 7 INCHES LONG X 3 INCHES WIDE X 1/2 INCHES DEEP SPALLS WITH EXPOSED REBAR ON BOTTOM OF DECK IN BAY 1

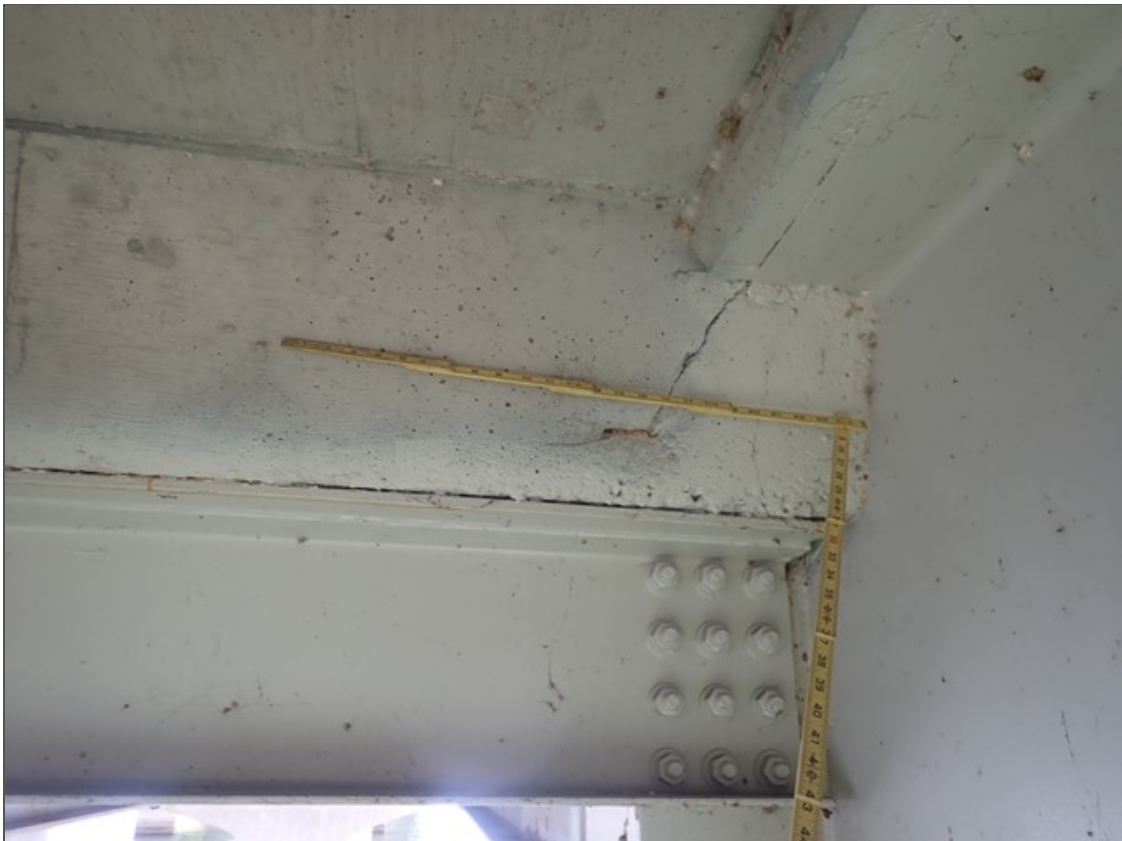
Span 9 Deck: DECK HAUNCH AT BEAM 1 OVER BENT 8, DELAMINATION/SPALL [18 INCHES LONG X 12 HIGH WIDE X 1-1/4 INCHES DEEP] WEST ONE [1] EXPOSED RUSTED REINFORCING [NO SECTION LOSS NOTED]

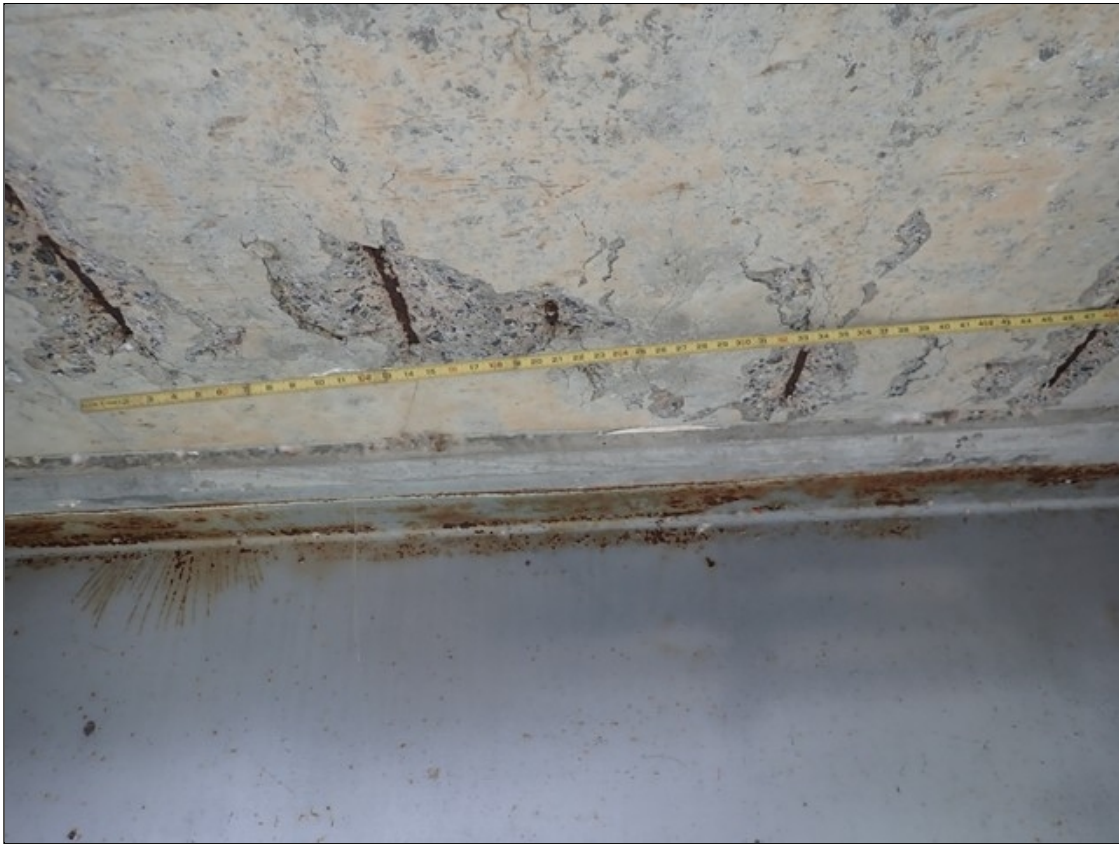
Span 8 Deck: 70 INCHES LONG X 24 INCHES WIDE X 1 INCH DEEP SPALLING WITH EXPOSED REBAR WITH NO SECTION LOSS AND DELAMINATION IN BAY 2 STARTING 10 FEET FROM BENT 8

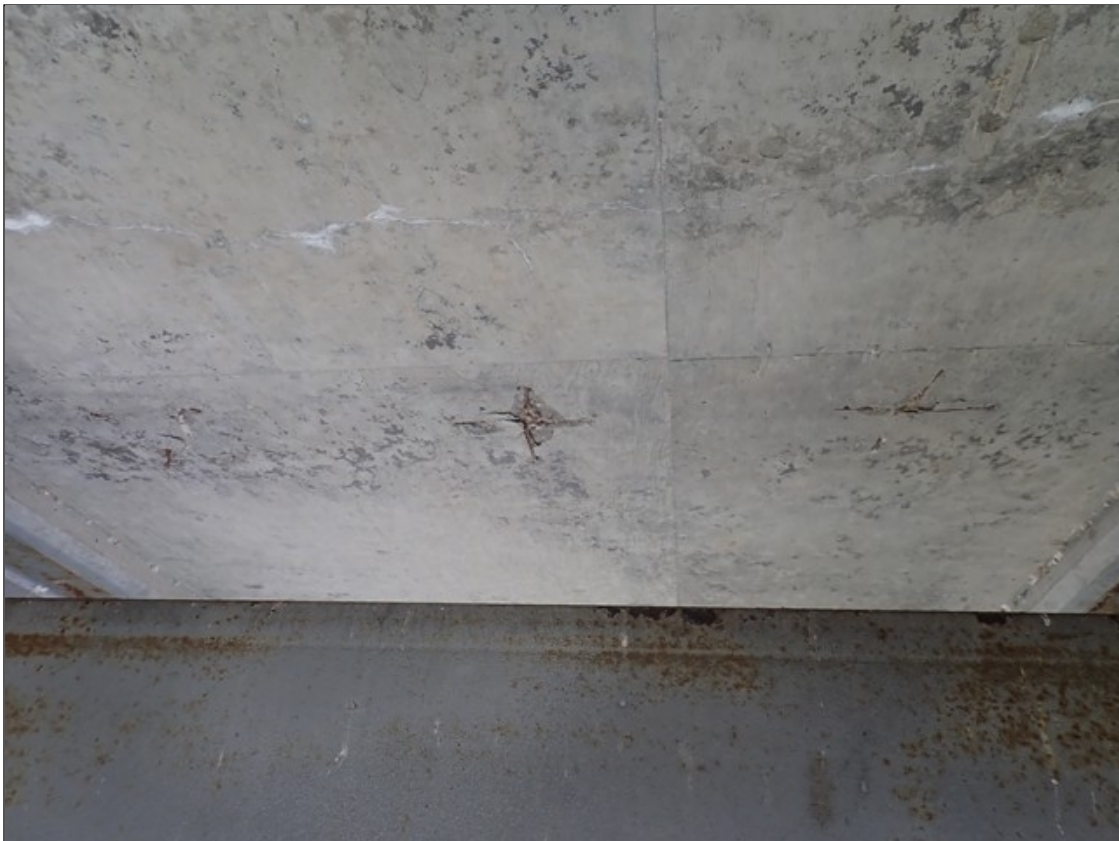
Span 8 Deck: (3) UP TO 9 INCH LONG X 9 INCH WIDE X 1/2 INCH DEEP SPALLS WITH EXPOSED REBAR ON BOTTOM OF DECK NEAR MIDSPAN (EACH BAY SIMILAR)

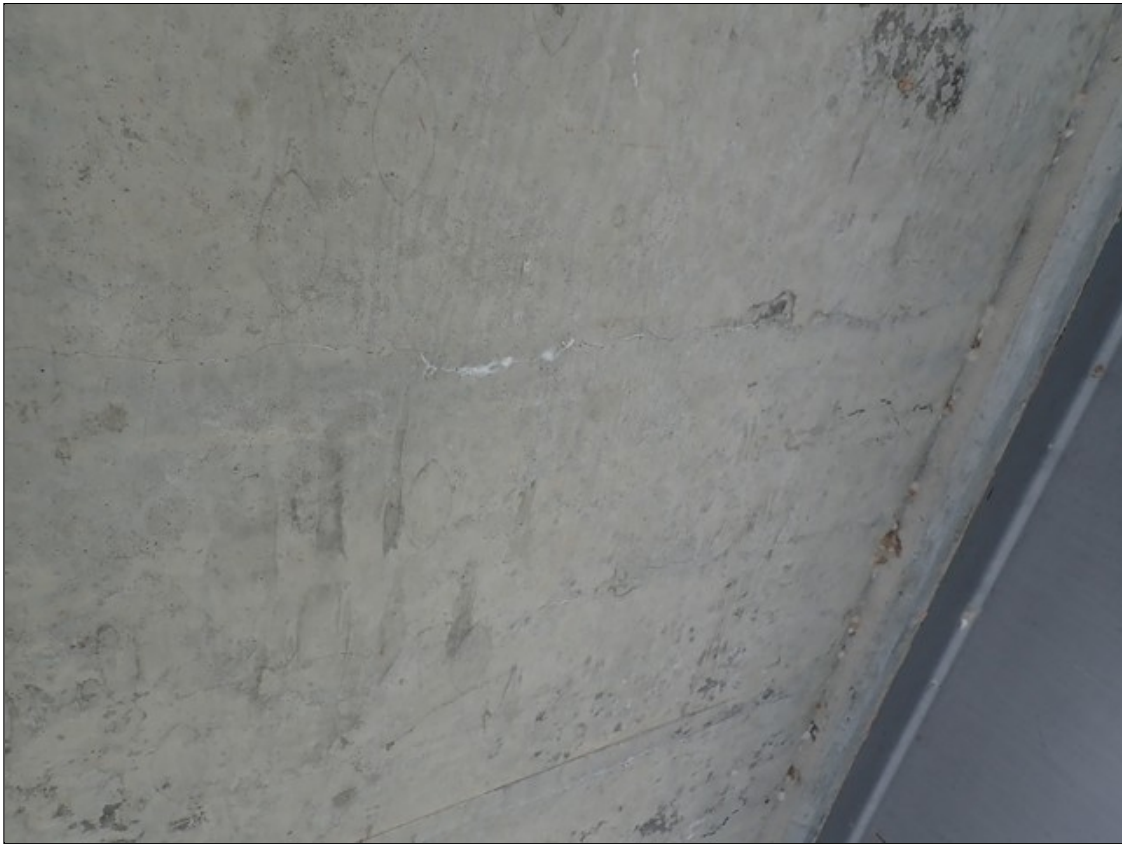
Span 8 Deck: HAIRLINE LONGITUDINAL AND TRANSVERSE CRACKS WITH EFFLORESCENCE ON BOTTOM OF DECK AT RANDOM THROUGHOUT EACH BAY

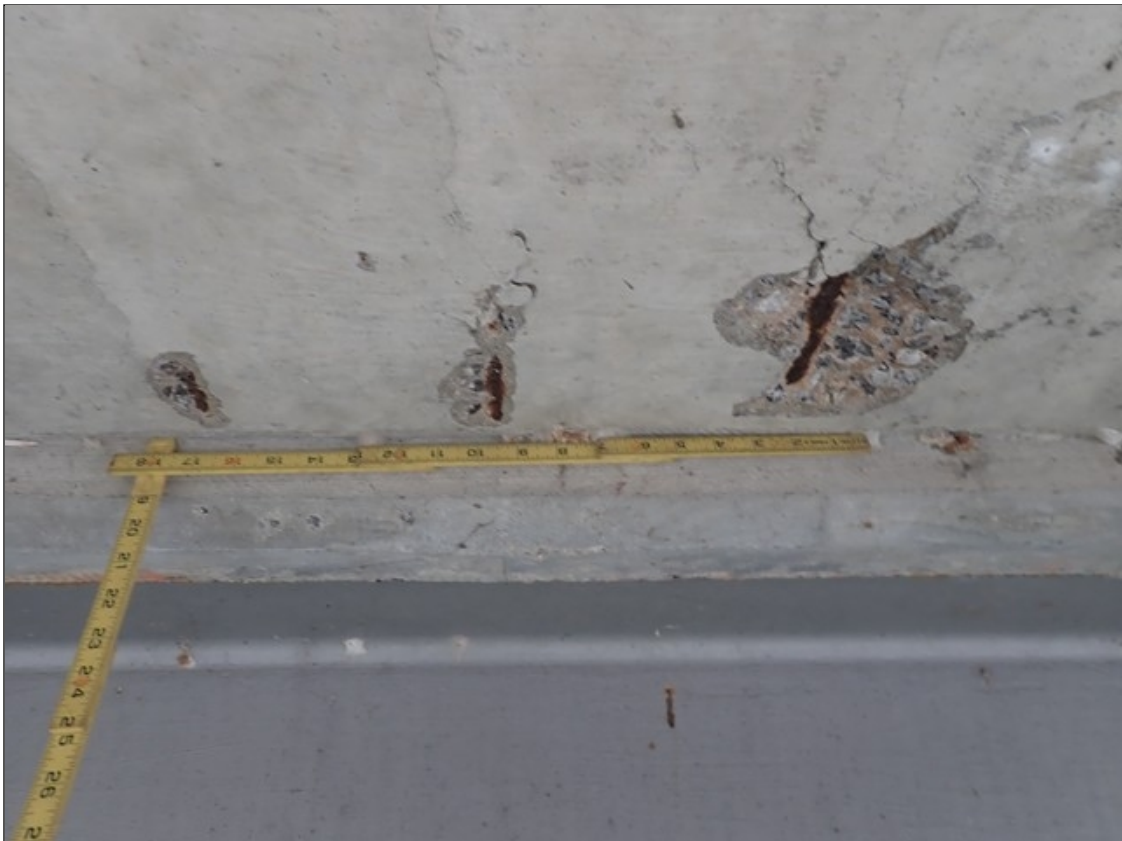
Span 8 Deck: (2) UP TO 6 INCH LONG X 2 INCH WIDE X 1/2 INCH DEEP SPALLS WITH EXPOSED REBAR ON BOTTOM OF DECK IN BAY 3, 30 FEET FROM BENT 8

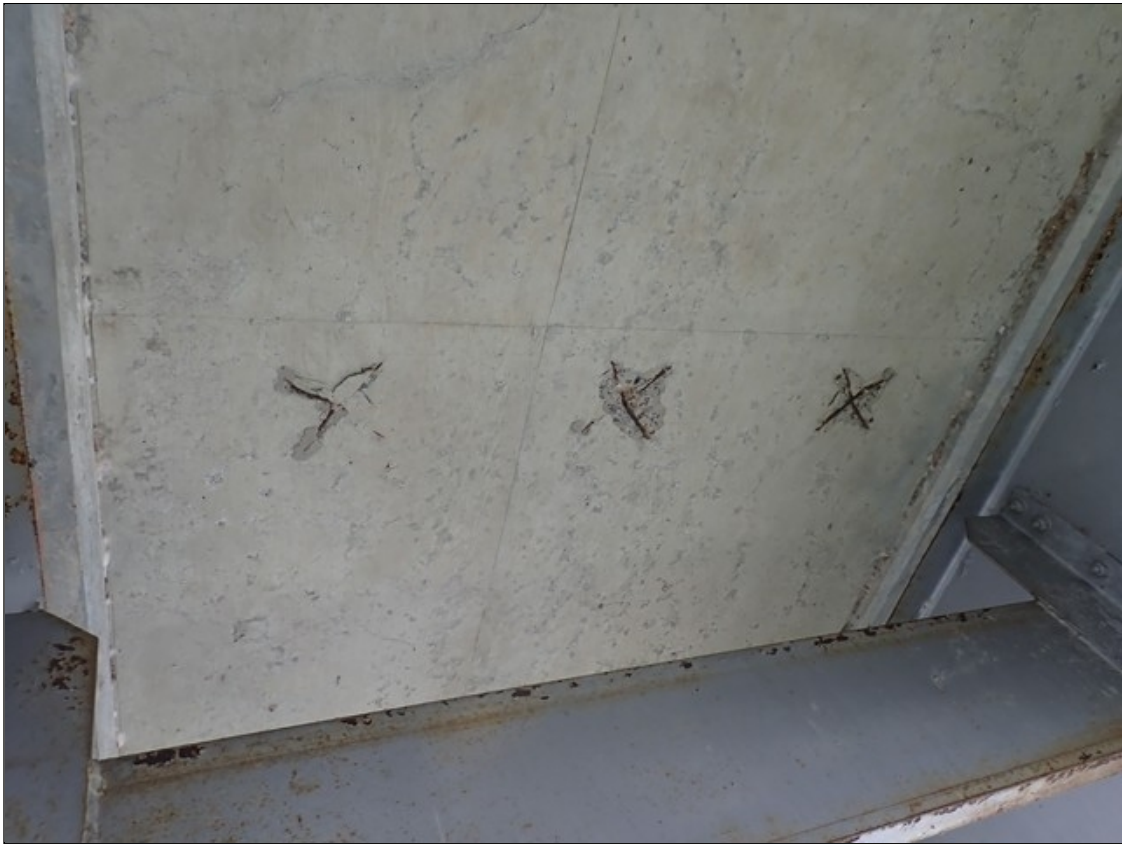
Span 7 Deck: (3) UP TO 9 INCH LONG X 9 INCH WIDE X 1/2 INCH DEEP SPALLS WITH EXPOSED REBAR ON BOTTOM OF DECK NEAR MIDSPAN AT RANDOM THROUGHOUT EACH BAY

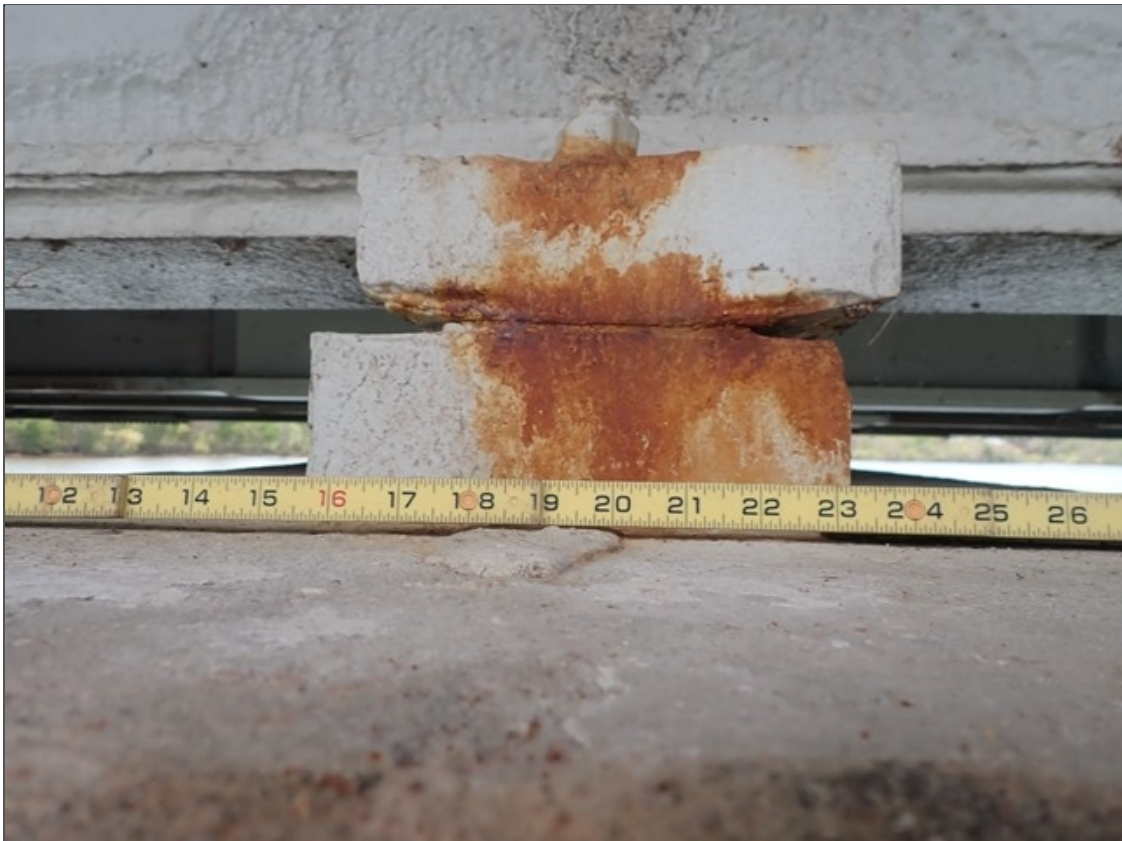
Span 6 Beam 4 Intermediate Bearing Bent 6: BEARING OVER BENT 6 EXHIBITS PACK RUST [1/8 INCHES] (CLEANED AND PAINTED)

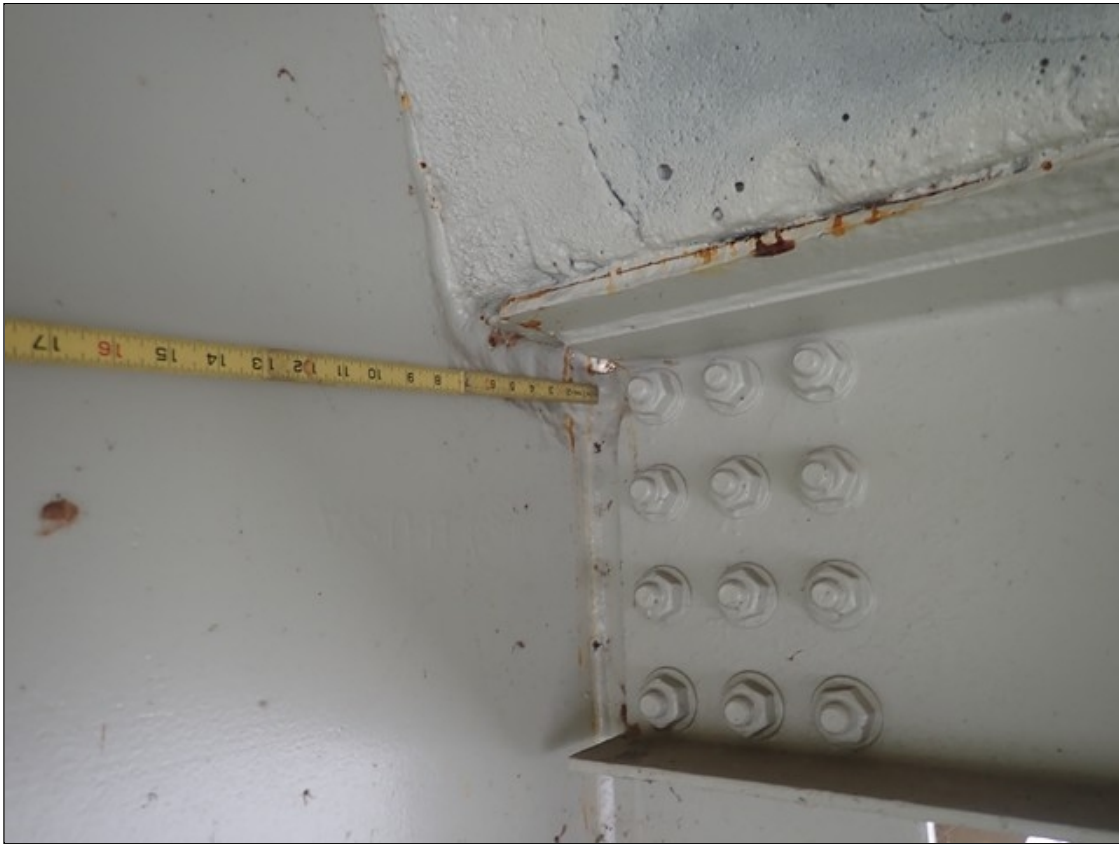
UPPER WEB AT BOTH FACES OF BENT 6 DECK HAUNCH, CORROSION WITH SECTION LOSS [18 INCHES LONG X UP TO 10 INCHES HIGH - AVERAGE REMAINING 1/4 INCHES]; LOWER WEB [20 INCHES LONG X 2 INCHES HIGH - SECTION LESS LESS THAN 1/16 INCHES] (CLEANED AND PAINTED) (PAR)

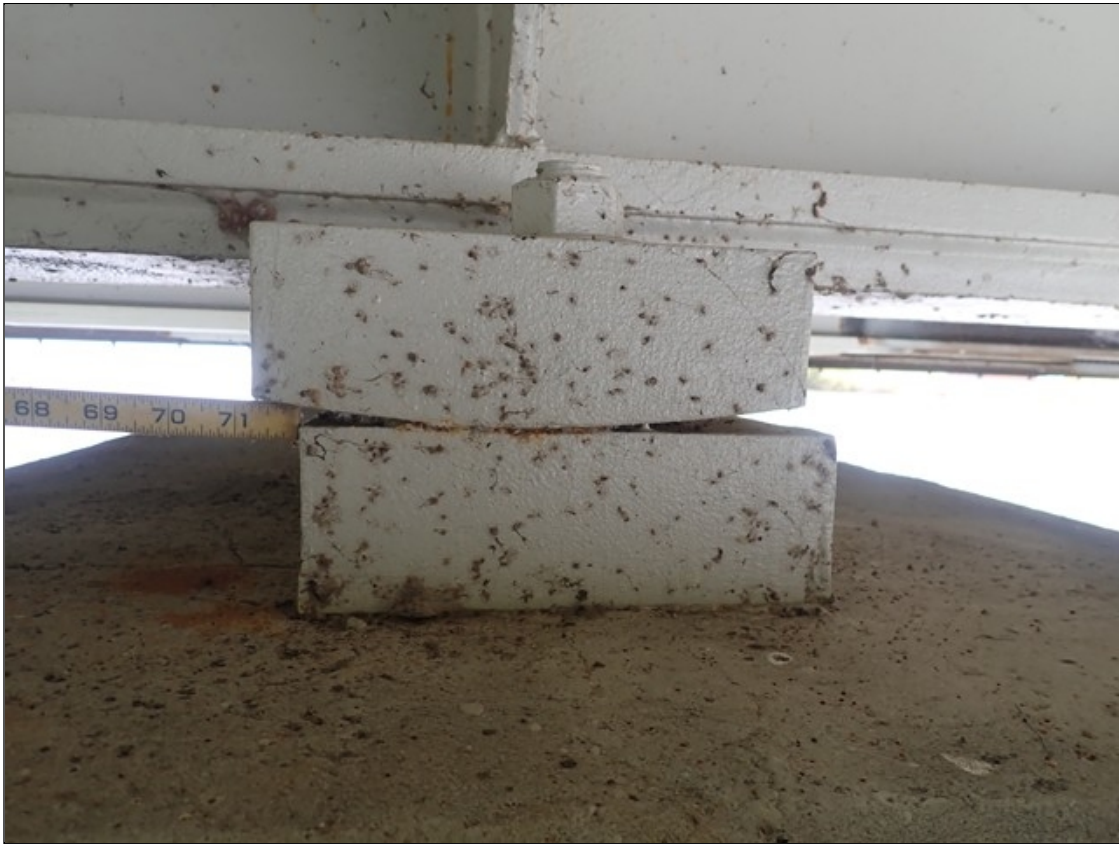
Span 6 Beam 2 Intermediate Bearing Bent 6: BEARING IS IN CONTRACTION [3/4 INCHES]

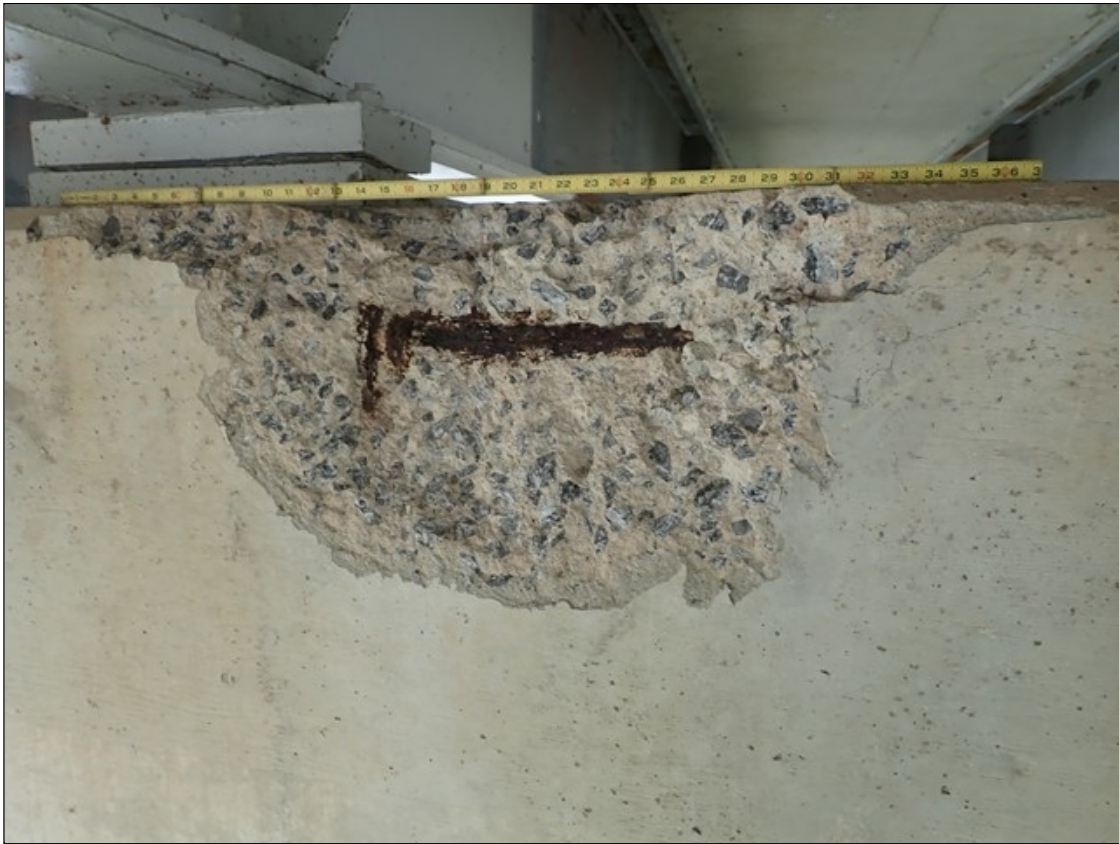
Bent 6 Cap 1: 36 INCHES LONG X 15 INCHES TALL X 6 INCHES WIDE SPALLING WITH EXPOSED REBAR WITH SECTION LOSS ON SOUTH FACE AND TOP OF CAP UNDER GIRDER 2 (PAR)

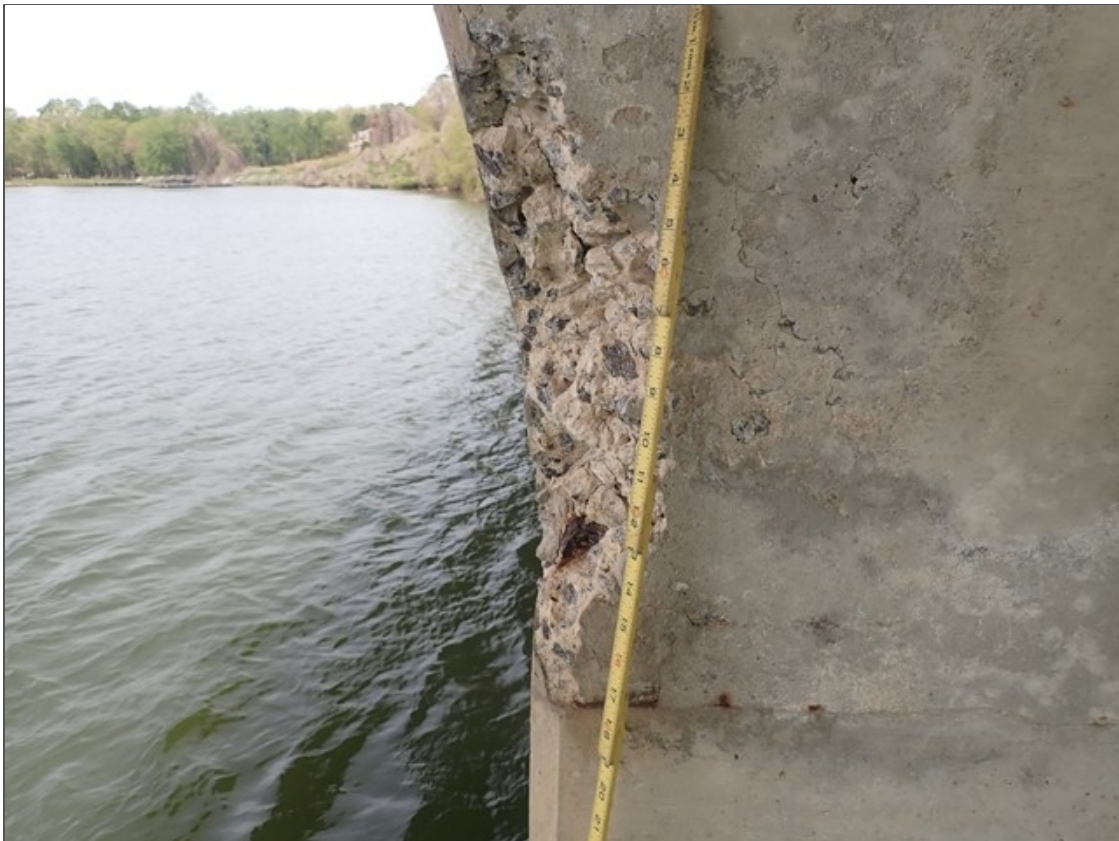
Bent 6 Pile 1: 5 INCHES WIDE X 4 INCHES LONG X 18 INCHES TALL SPALL WITH EXPOSED STEEL ON SOUTHWEST CORNER

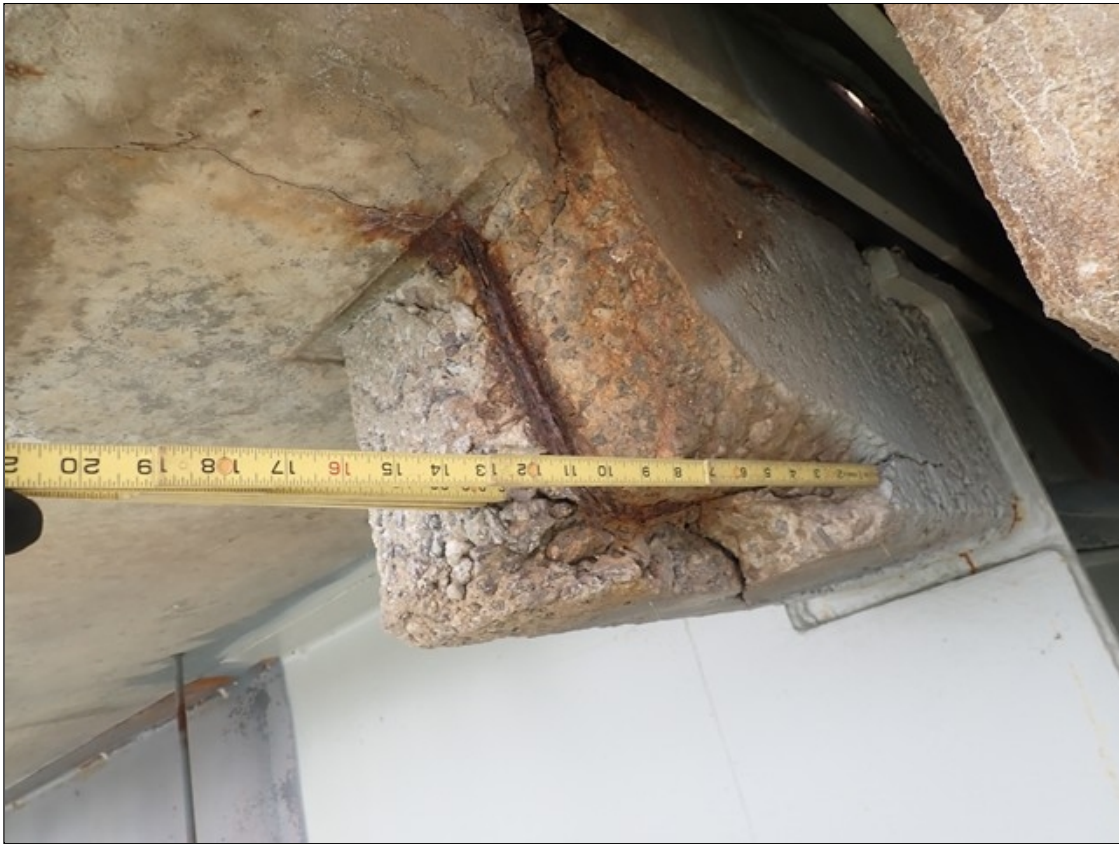
Span 6 Deck: 2 FEET WIDE X 8 INCH LONG X 12 INCH TALL SPALL WITH EXPOSED REBAR IN LEFT END DIAPHRAGM OVER BENT 5

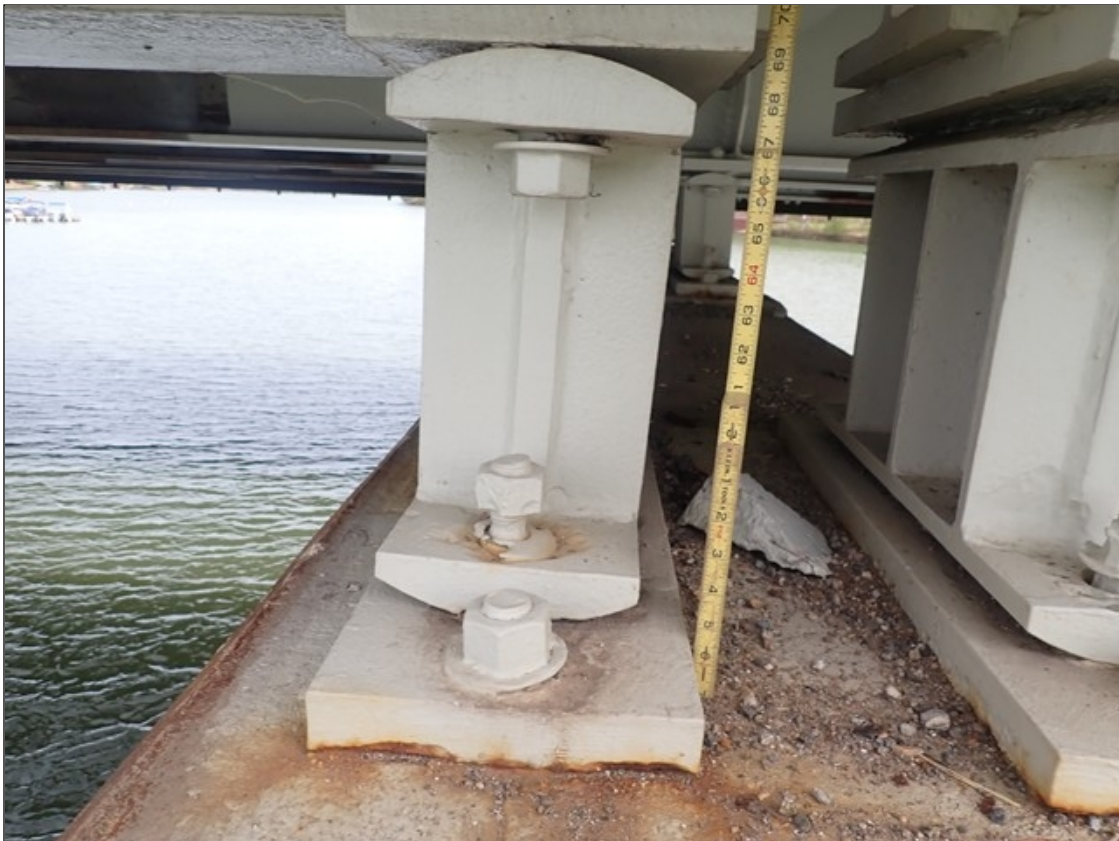
Span 6 Beam 1 Near Bearing: 3/8 INCHES ROTATION TO THE SOUTH

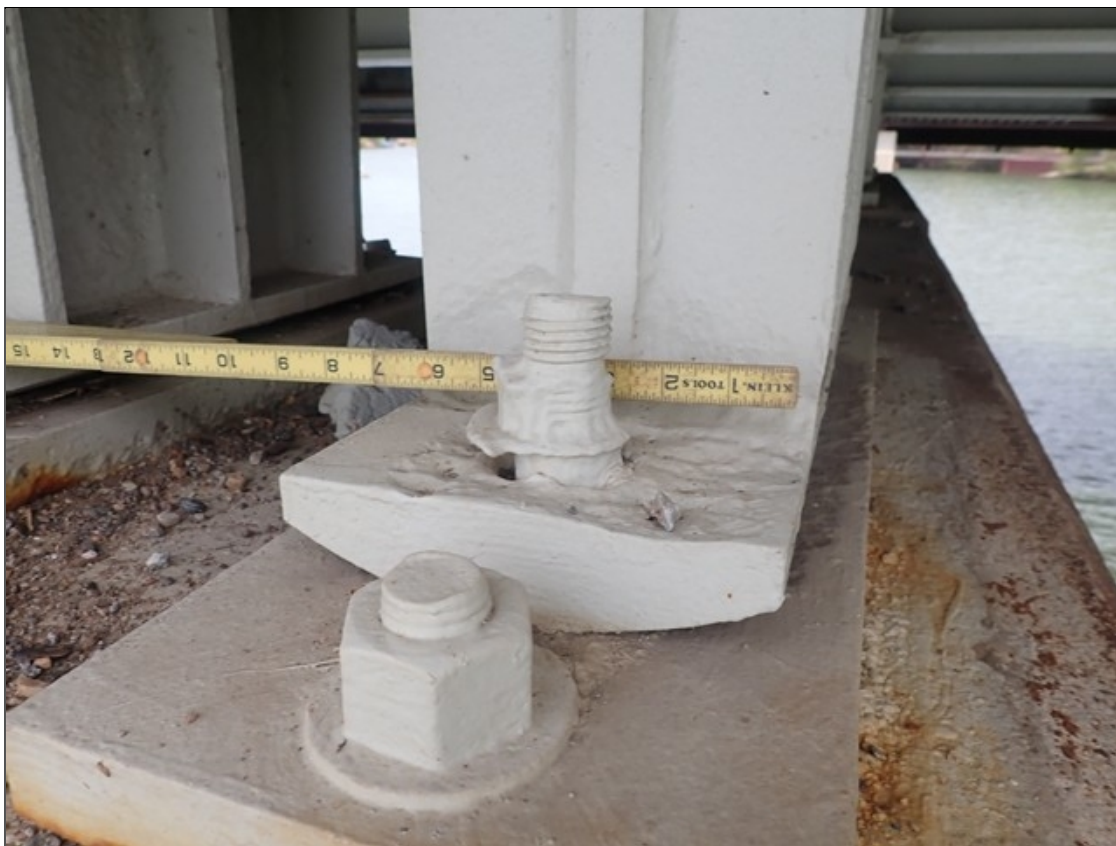
Span 6 Beam 2 Near Bearing - Protective System: PAINT FAILURE WITH ACTIVE CORROSION AND SECTION LOSS (CLEANED AND PAINTED)

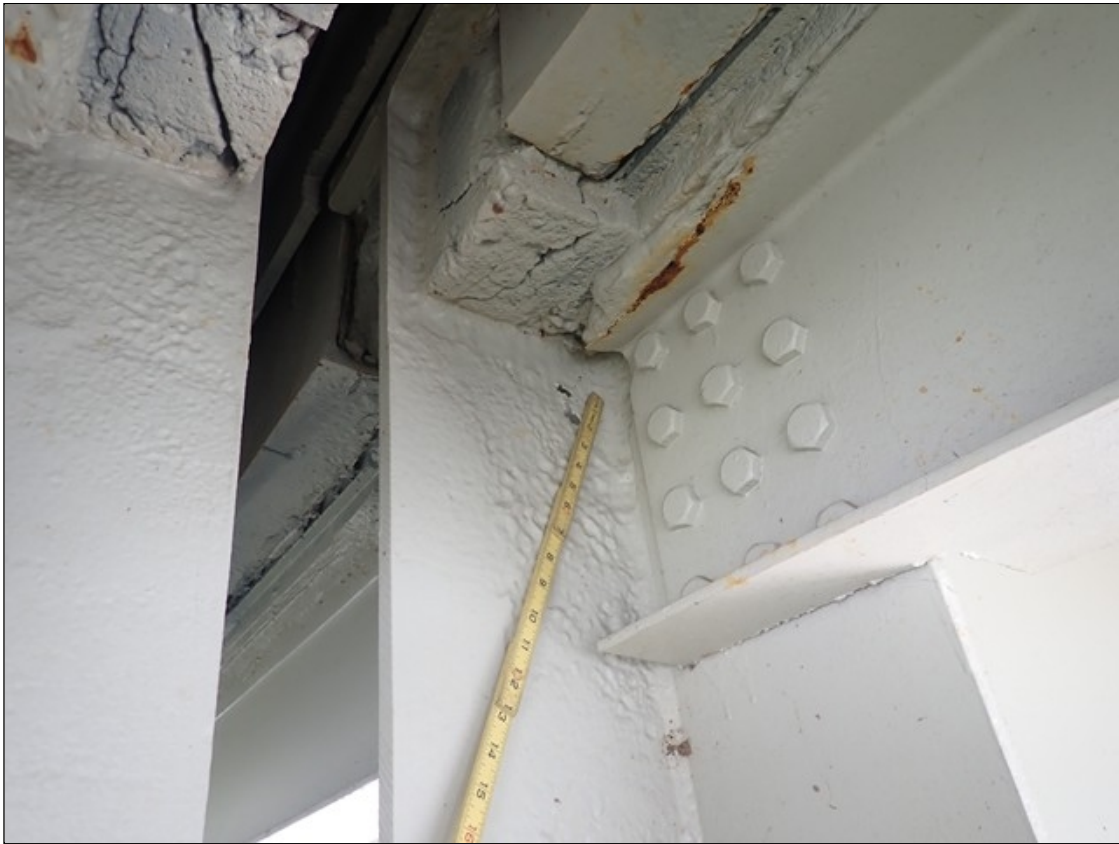
Span 2 Beam 2: 9 INCHES LONG X 24 INCHES HIGH AREA OF 3/16 INCHES SECTION LOSS (9/16 INCHES REMAINING) WITH 1 INCH LONG X 2 INCH HIGH AREA OF 100% SECTION LOSS ON WEB IN SPAN 5 AT BENT 5 (CLEANED AND PAINTED) (PAR)

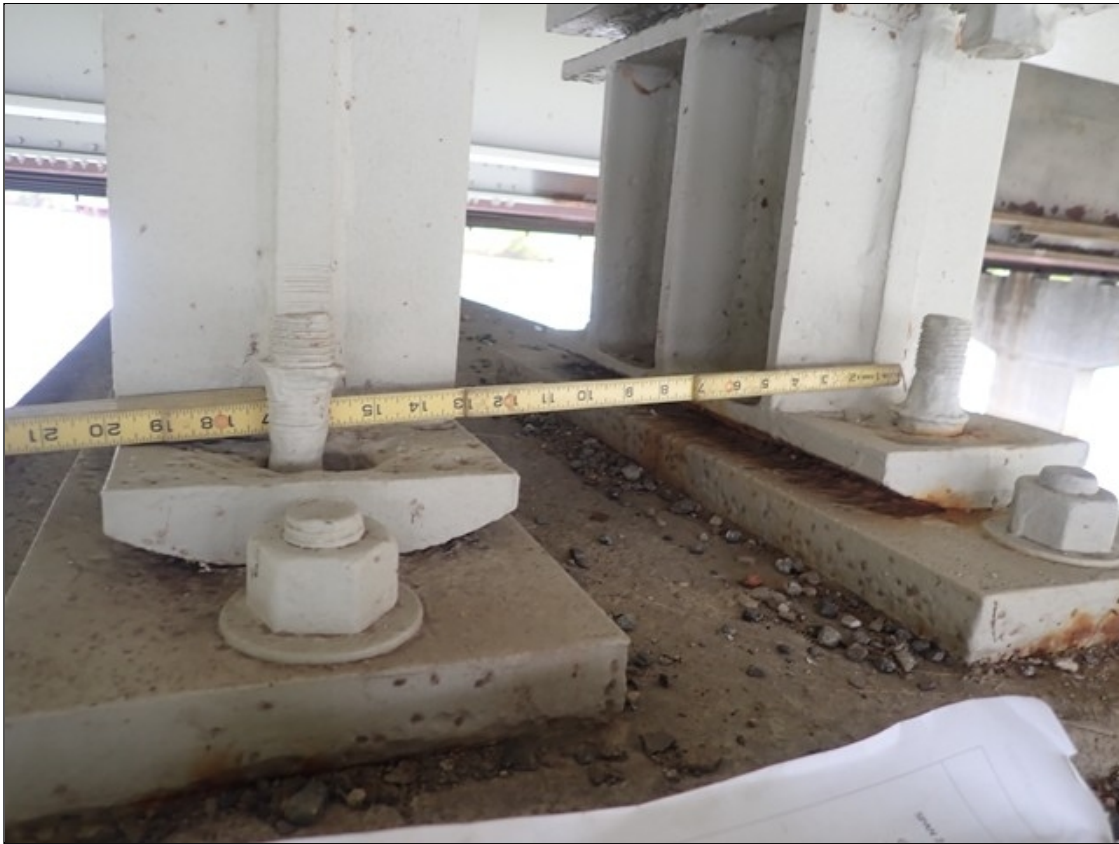
Span 2 Beam 2 Far Bearing: BEARING EXHIBITS PACK RUST [3/16 INCHES] AND CORROSION WITH SECTION LOSS [SECTION LOSS UP TO 1/16 INCHES] (CLEANED AND PAINTED)

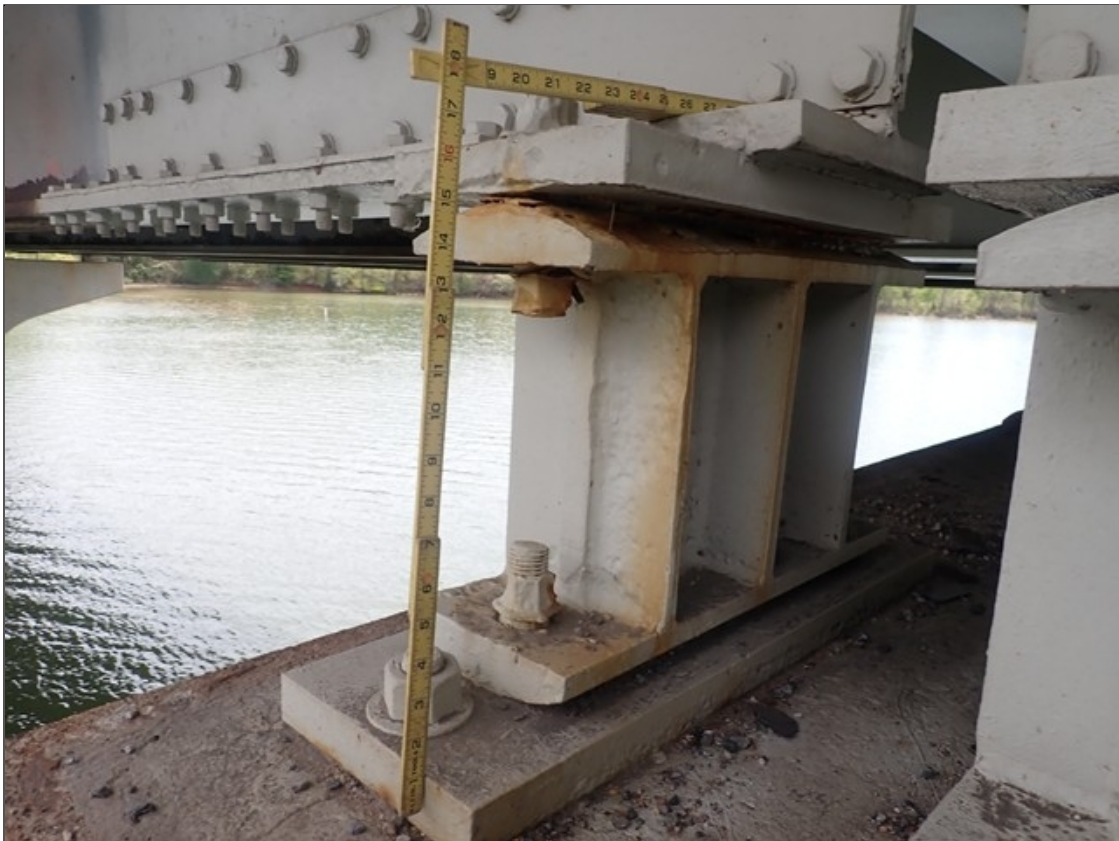
Span 2 Beam 4 Far Bearing - Protective System: PAINT FAILURE WITH ACTIVE CORROSION AND SECTION LOSS (CLEANED AND PAINTED)

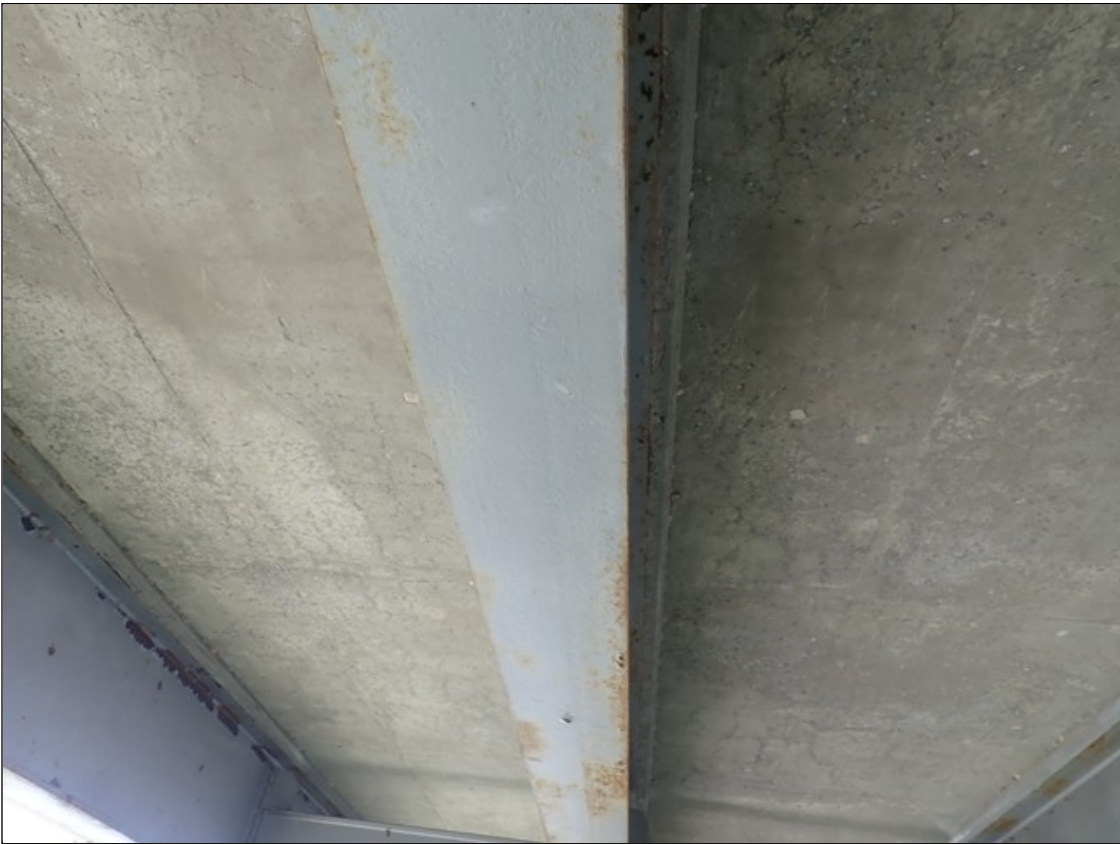
Span 4 Deck: WEATHERED CONCRETE WITH EXPOSED AGGREGATE WITH HAIRLINE MAP CRACKING ON BOTTOM OF DECK AT RANDOM THROUGHOUT

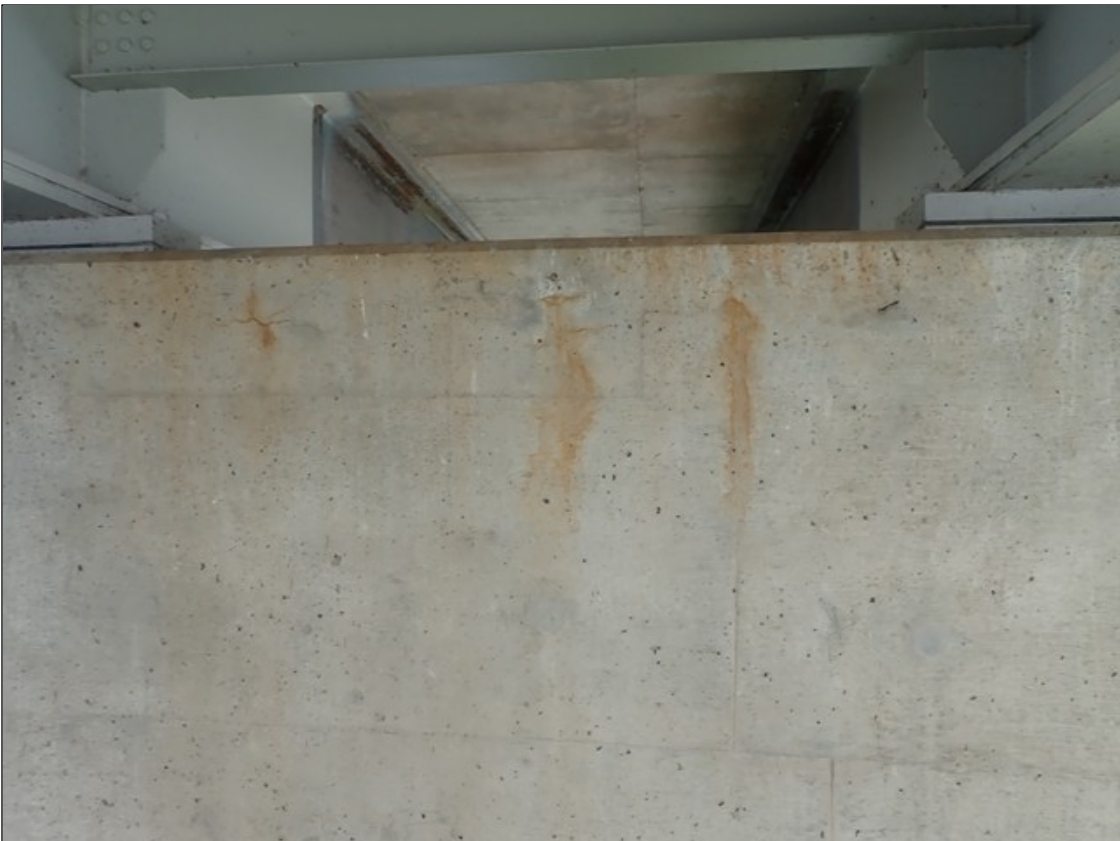
Bent 2 Cap 1: (3) UP TO 1 FEET LONG X 1 FEET WIDE AREA OF HAIRLINE HORIZONTAL AND VERTICAL CRACKS WITH EFFLORESCENCE AND RUST STAINS ON SPAN 3 FACE UNDER BAY 2
