☐ Supplemental Inspection Requested

NC DEPARTMENT OF TRANSPORTATION  
DIVISION OF HIGHWAYS  
STRUCTURE MANAGEMENT UNIT  
COUNTY: CALDWELL DIV: 11

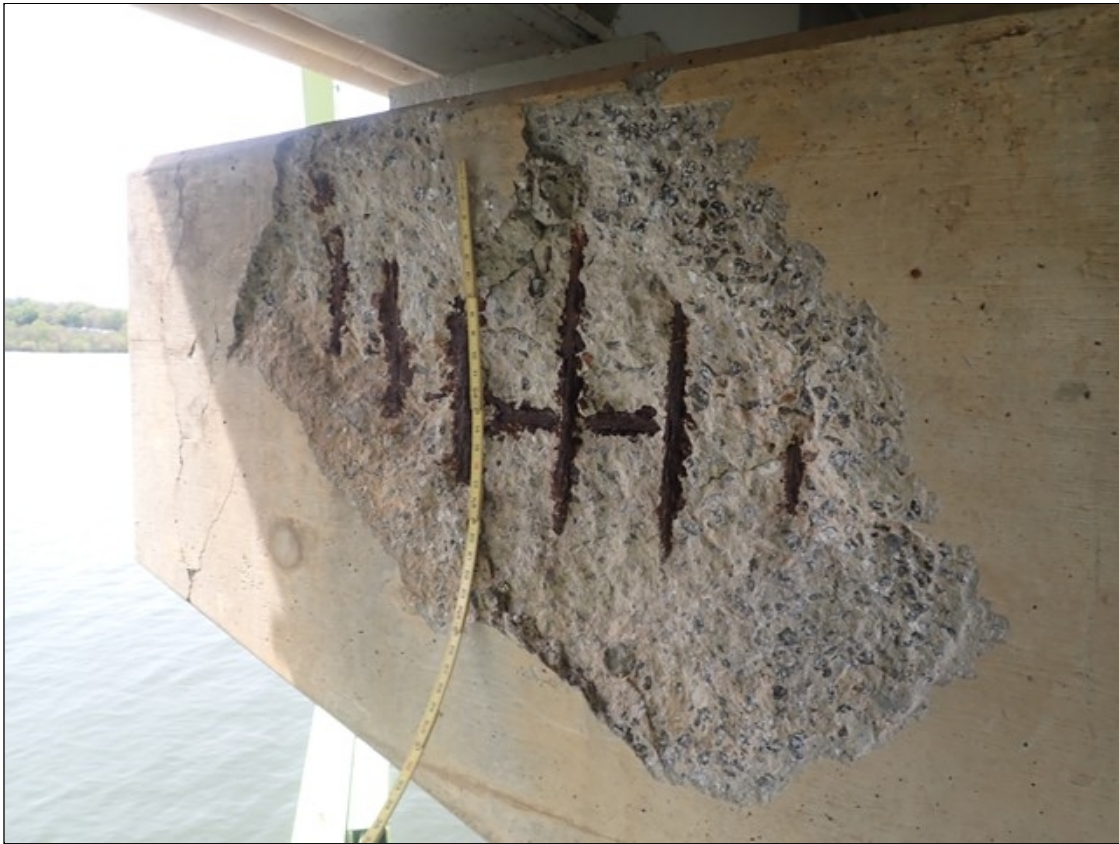
Bent 2 Cap 1: 42 INCHES WIDE X 33 INCHES TALL X 2 INCHES DEEP SPALLING WITH EXPOSED REBAR WITH SECTION LOSS WITH 14 INCH X 30 INCH AREA OF DELAMINATION ON SOUTH FACE UNDER GIRDER (PAR)

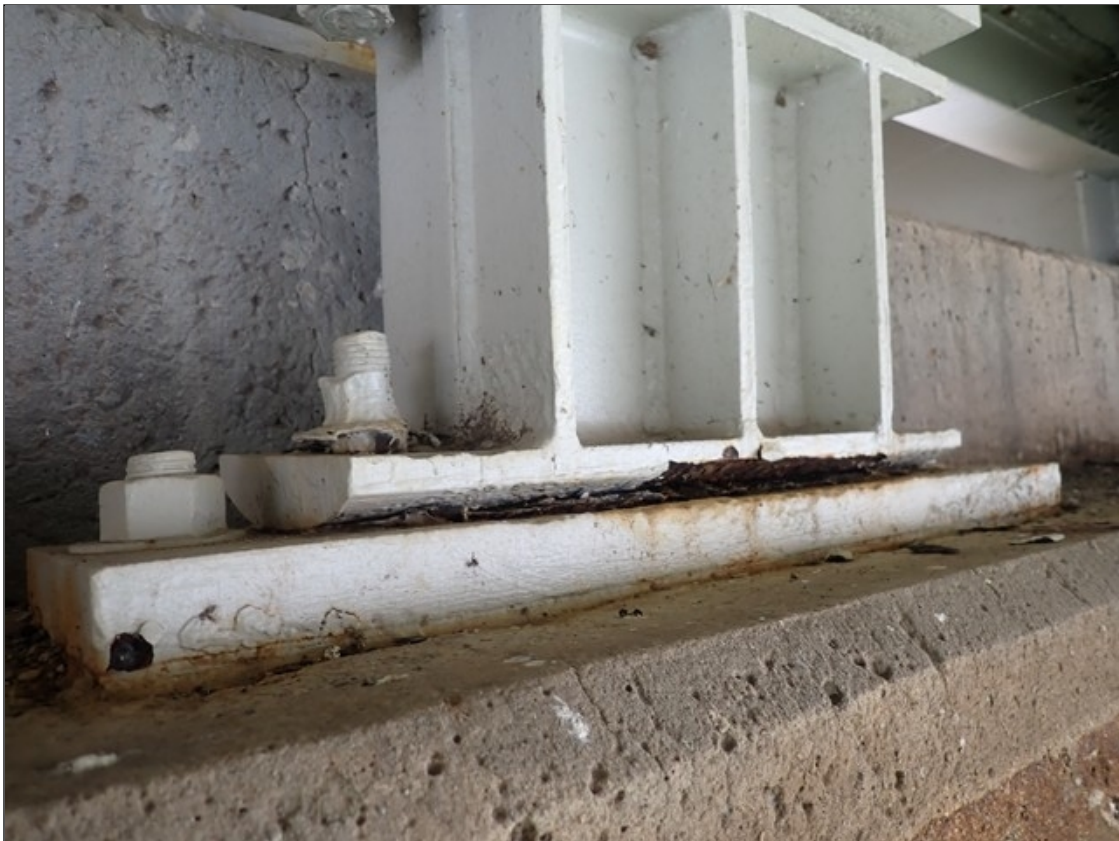
Span 2 Beam 3 Near Bearing: BEARING EXHIBITS PACK RUST [1/8 INCHES] WITH ACTIVE SURFACE CORROSION [NO SECTION LOSS NOTED] (CLEANED AND PAINTED) COATING UNDER ROCKER IS FAILING

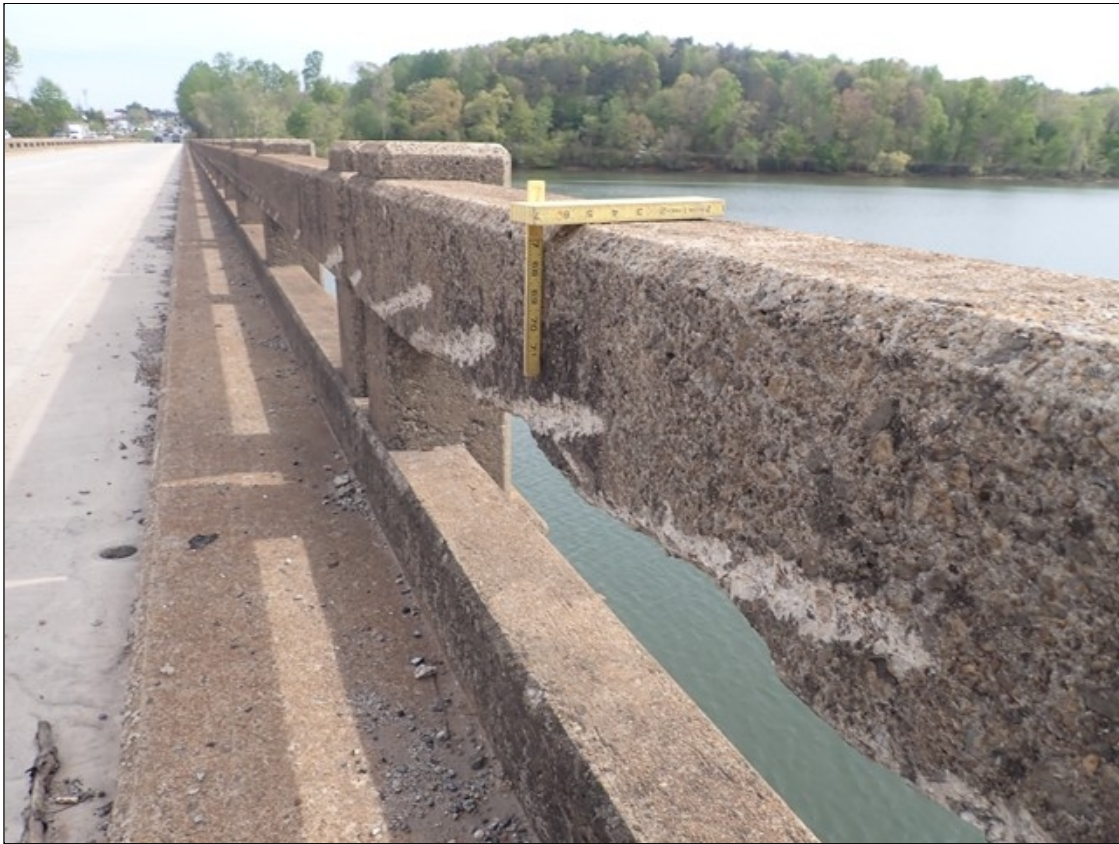
Span 9 Left Bridge Rail: 55 FEET AREA OF UP TO 15 INCH LONG X 3 INCH HIGH X 1 1/2 INCH DEEP SPALLS ON FAIL NEAR BENT 9

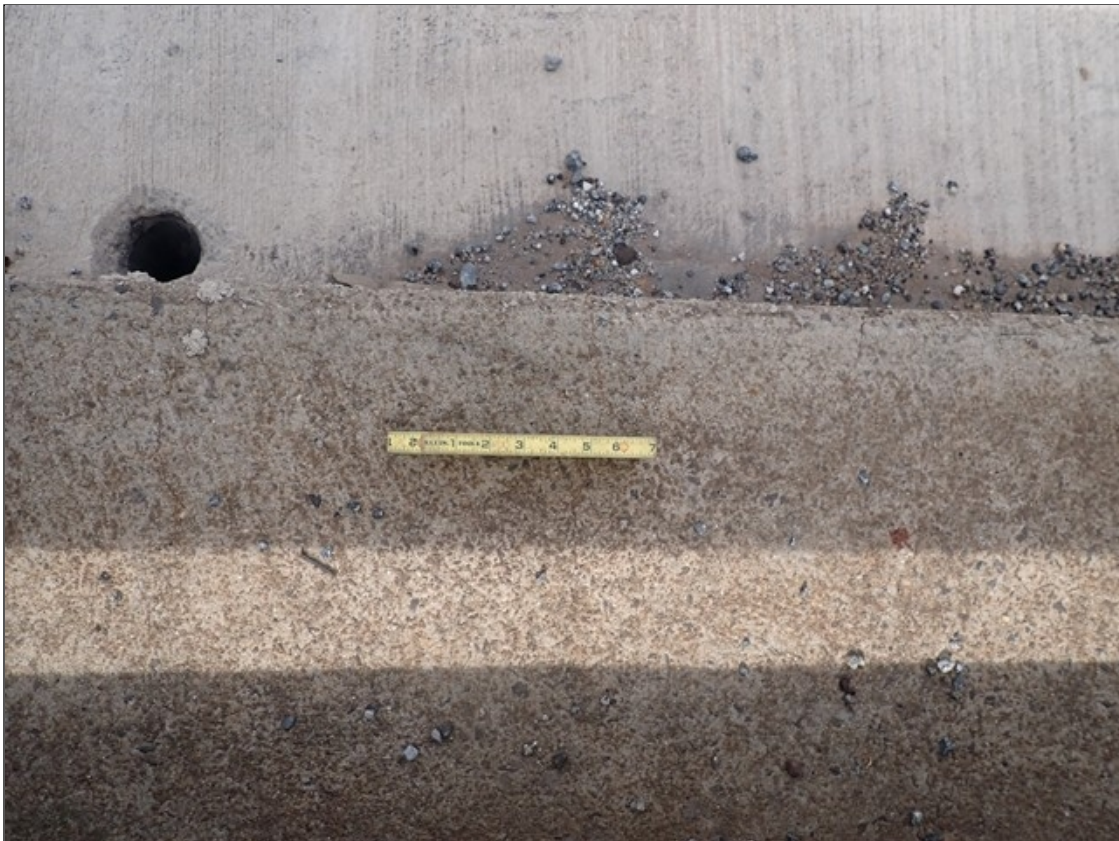
Span 9 Left Bridge Rail: HAIRLINE TRANSVERSE CRACKS ON RAIL AND CURB AT RANDOM THROUGHOUT

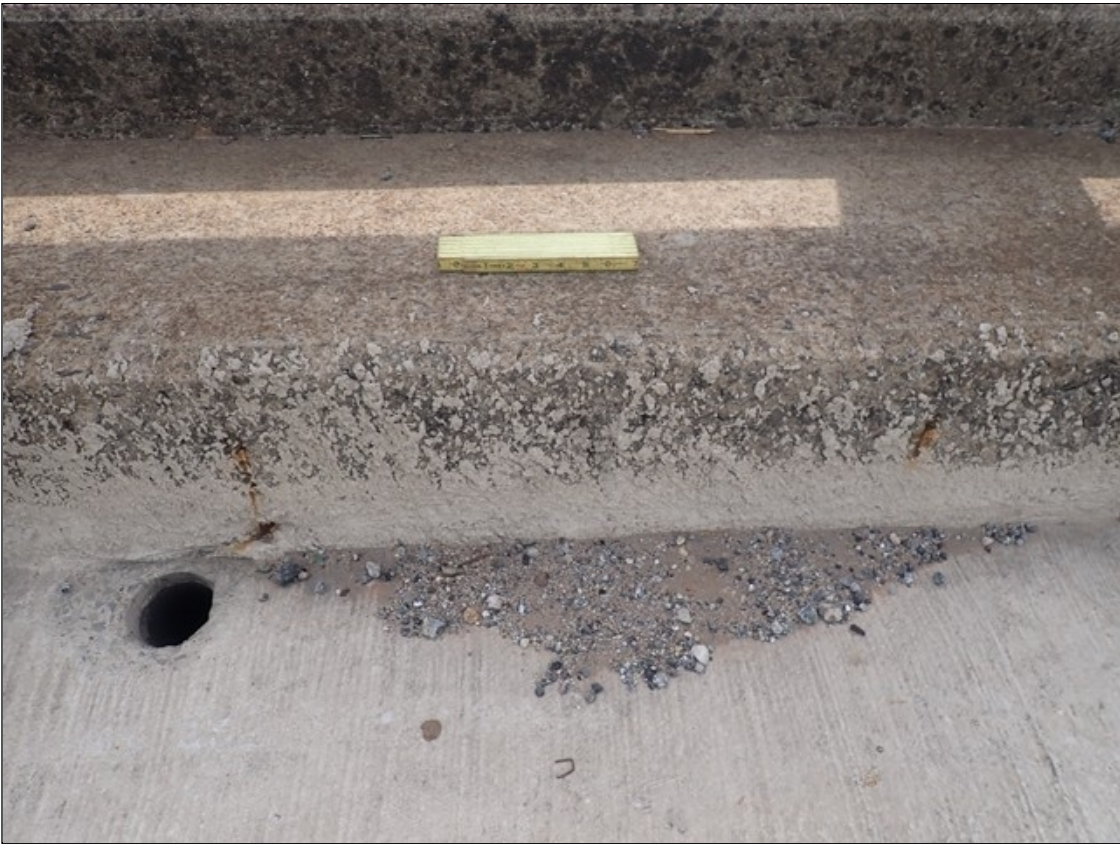
Span 8 Left Bridge Rail: ALONG LENGTH OF RAIL AND CURB, FIVE [5] SPALLS [UP TO 6 INCHES X 2 INCHES X 1/2 INCHES DEEP] EXPOSING FIVE [5] EXPOSED RUSTED REINFORCING [NO SECTION LOSS NOTED]

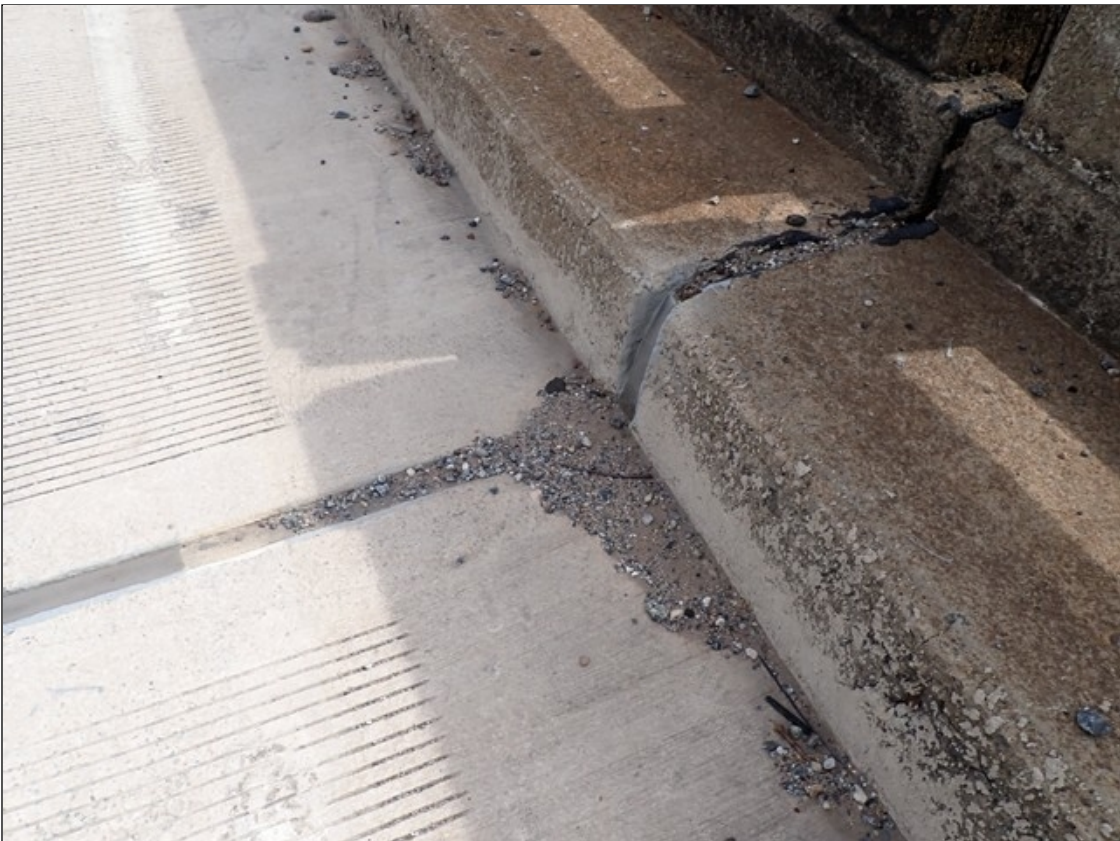
Span 8 Joint Bent 7: 2 FEET DIRT AND DEBRIS

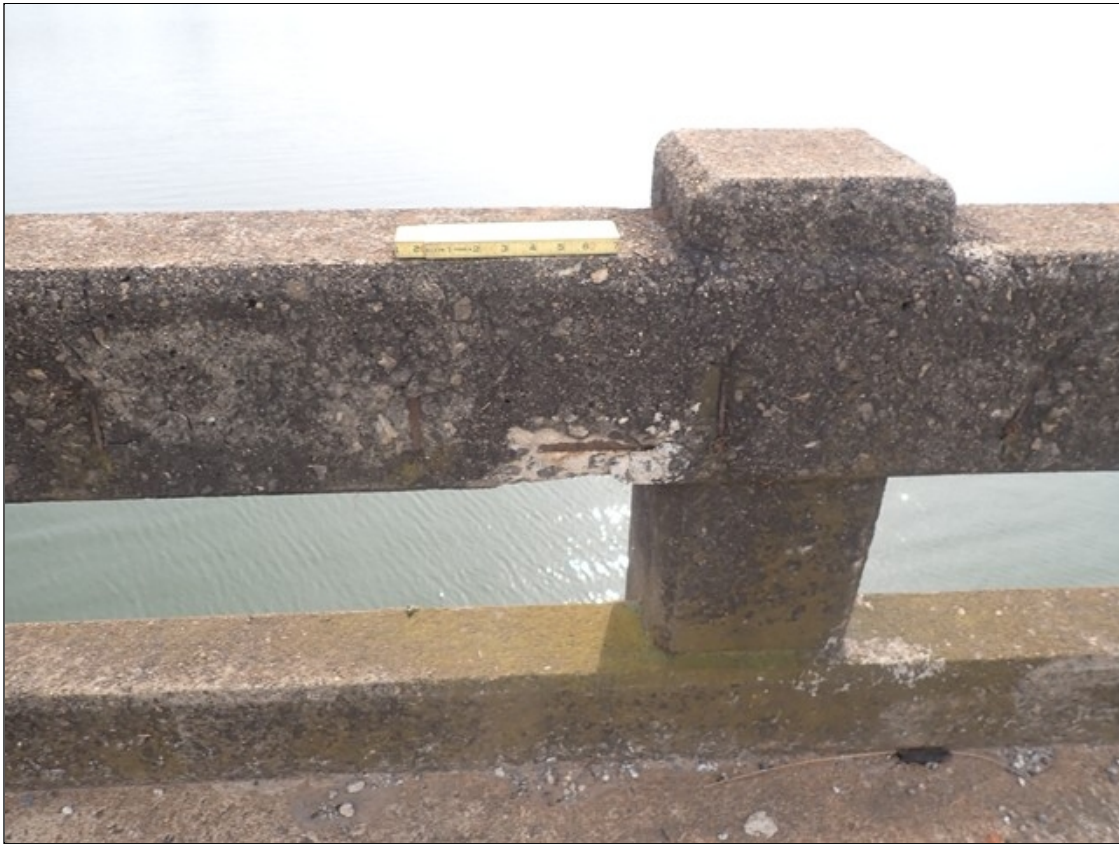
Span 7 Left Bridge Rail: (10) UP TO 8 INCHES LONG X 3 INCHES HIGH X 1 INCH DEEP SPALLS WITH EXPOSED REBAR ON RAIL BETWEEN POSTS 3 AND 6

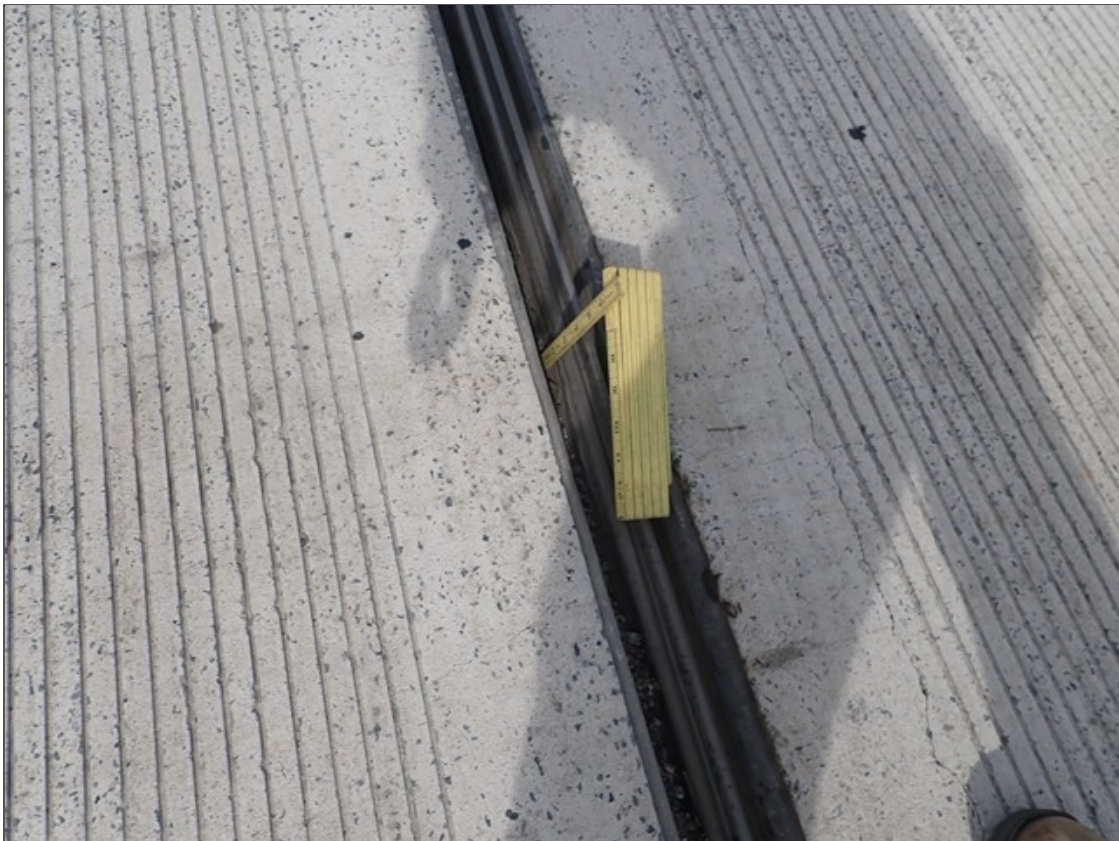
Span 6 Expansion Joint Bent 5: LOSS OF ADHESION OVER 80 PERCENT OF THE FULL LENGTH

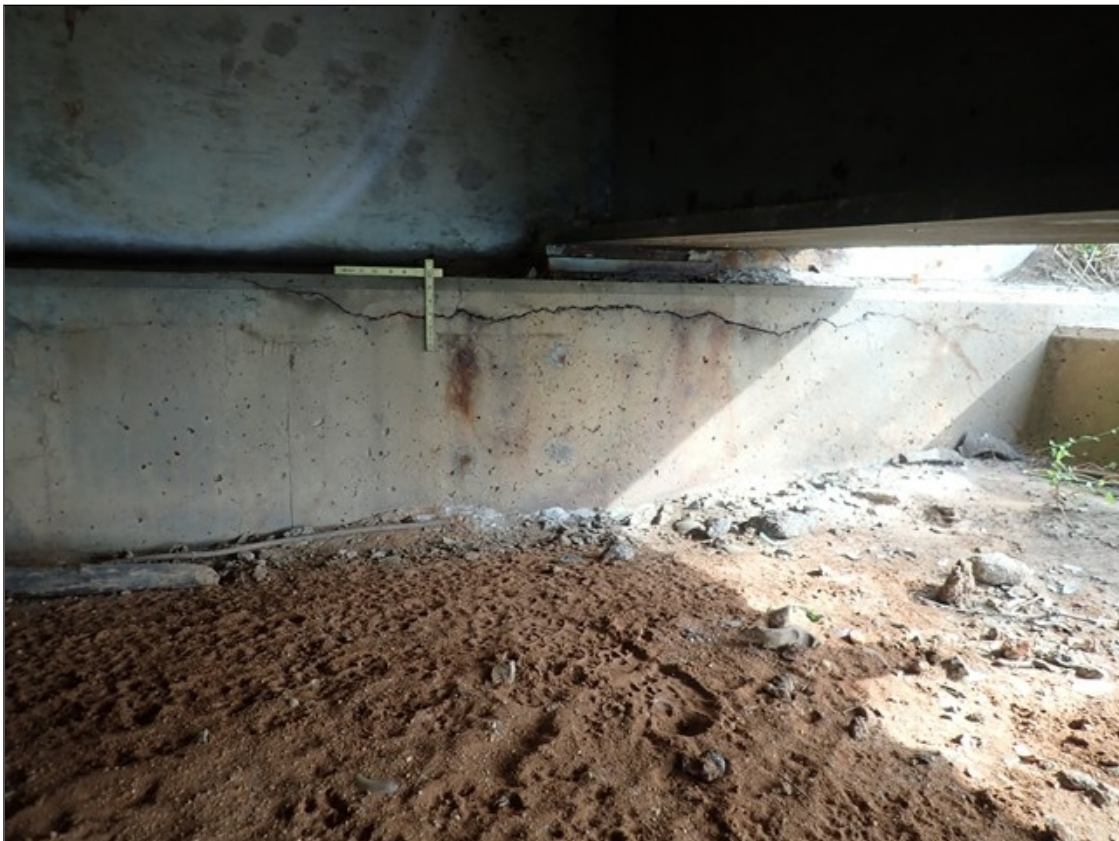
End Bent 1 Cap 1: ALONG LENGTH OF CAP BELOW BAY 1, HORIZONTAL CRACK [UP TO 10 FEET LONG X UP TO 1/8 INCHES] WITH 48 INCHES LONG X 8 INCHES HIGH AREA OF DELAMINATION

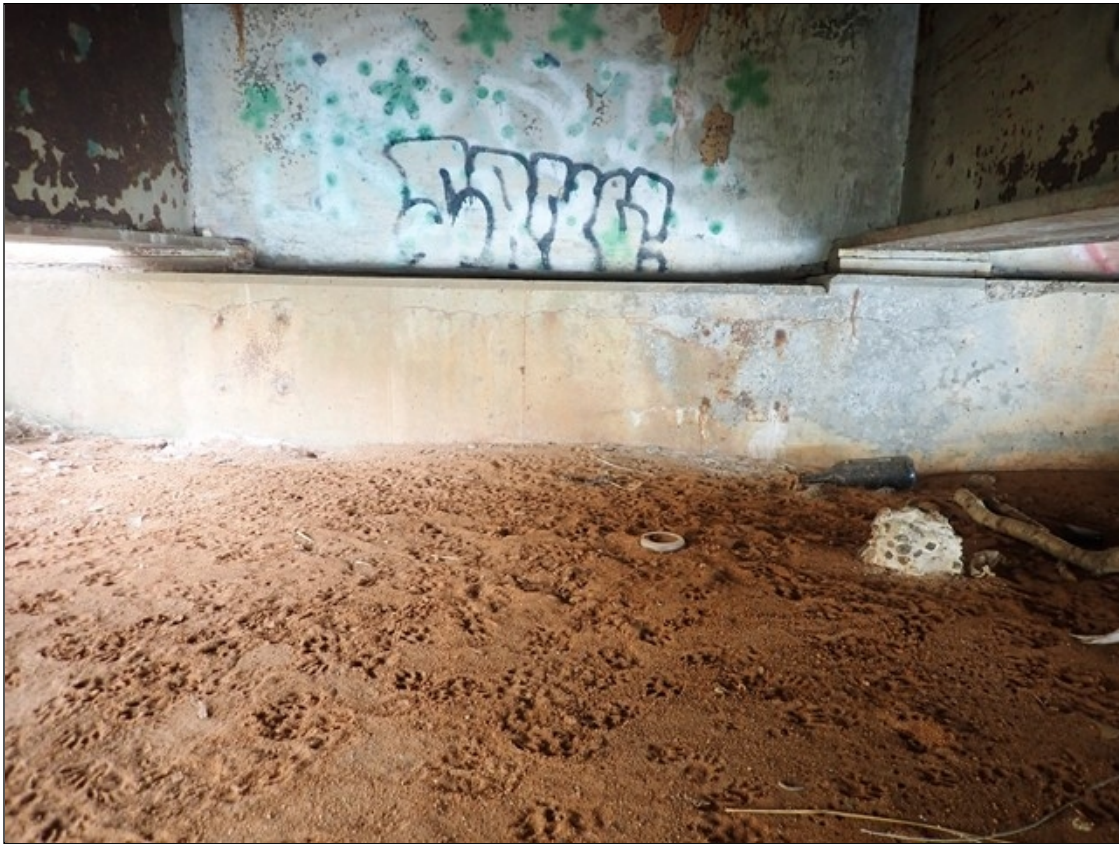
End Bent 1 Cap 1: 60 INCHES LONG X 9 INCHES HIGH X 1 INCHES DEEP SPALL AND AREA OF DELAMINATION WITH 7 FEET LONG UP TO 1/8 INCHES HORIZONTAL CRACK UNDER BAY 3

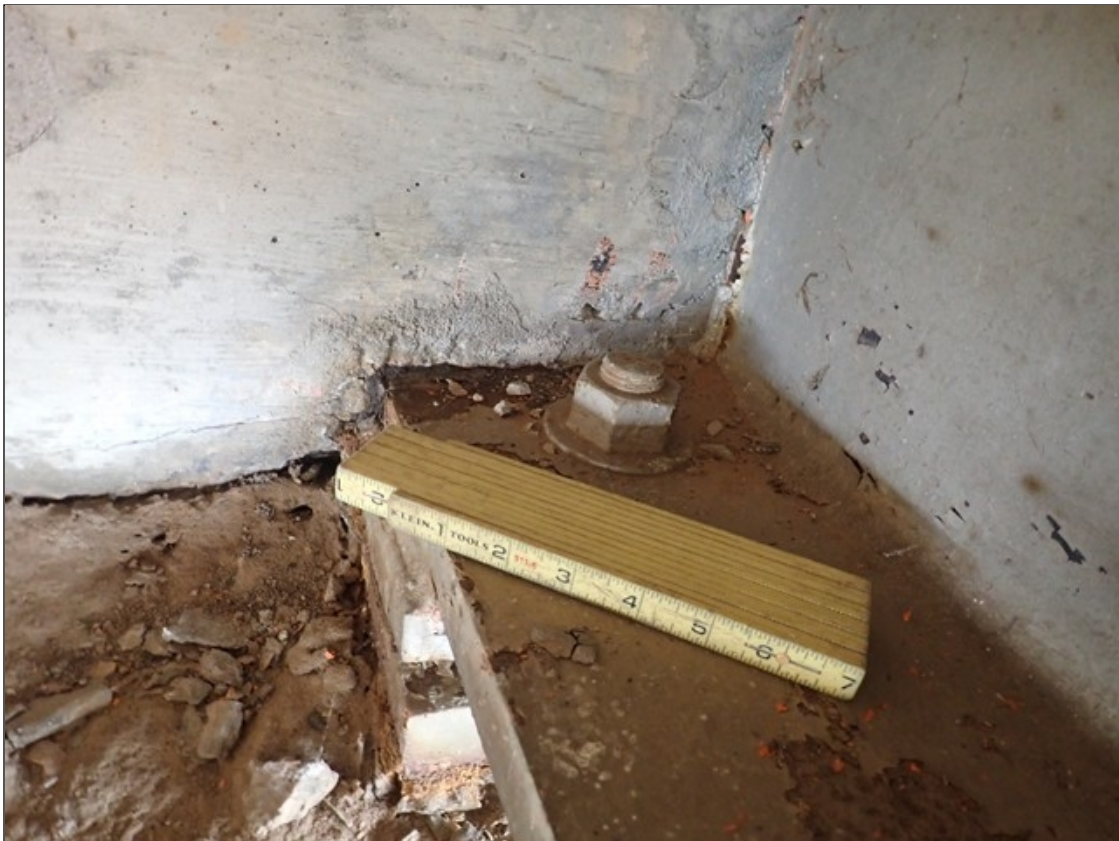
Span 1 Beam 1: 1 1/2 INCH LONG X 5 INCH HIGH AREA OF 1/8 INCH SECTION LOSS (1 1/8 INCH REMAINING) WITH NO RUST ON RIGHT SIDE OF BOTTOM FLANGE AT END BENT 1

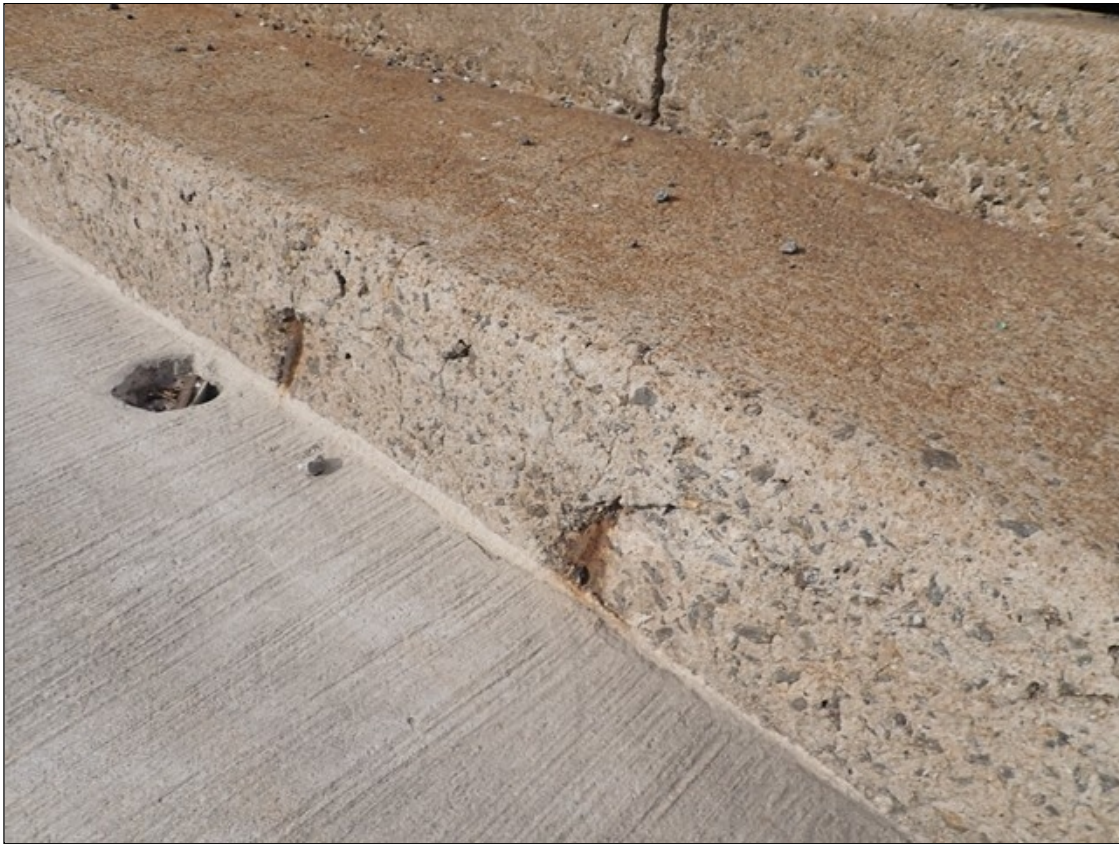
Span 3 Right Bridge Rail: 16 FEET FROM BENT 2, TWO [2] SPALLS [UP TO 6 INCHES LONG X 2 INCHES HIGH X 1/4 INCHES DEEP] WITH TWO [2] EXPOSED RUSTED REINFORCING [NO LOSS NOTED]

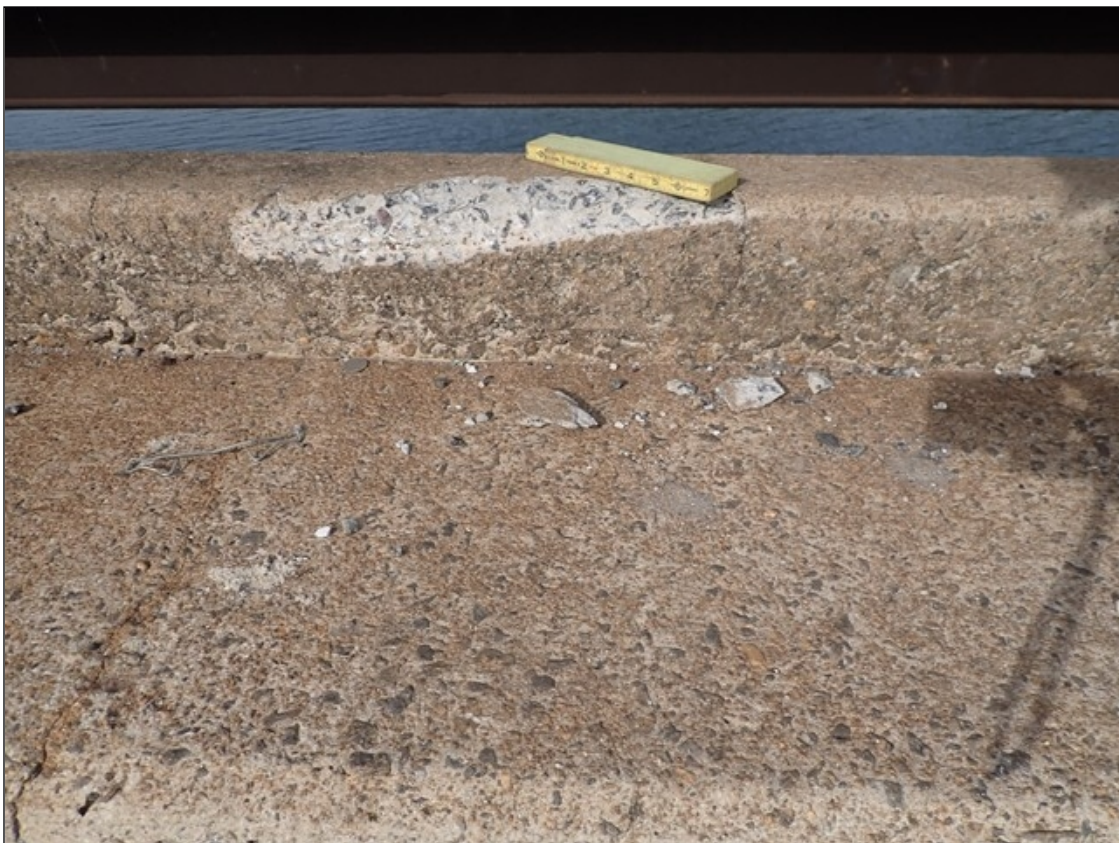
Span 3 Right Bridge Rail: 18 INCH LONG X 1 INCH HIGH X 2 INCH WIDE SPALL

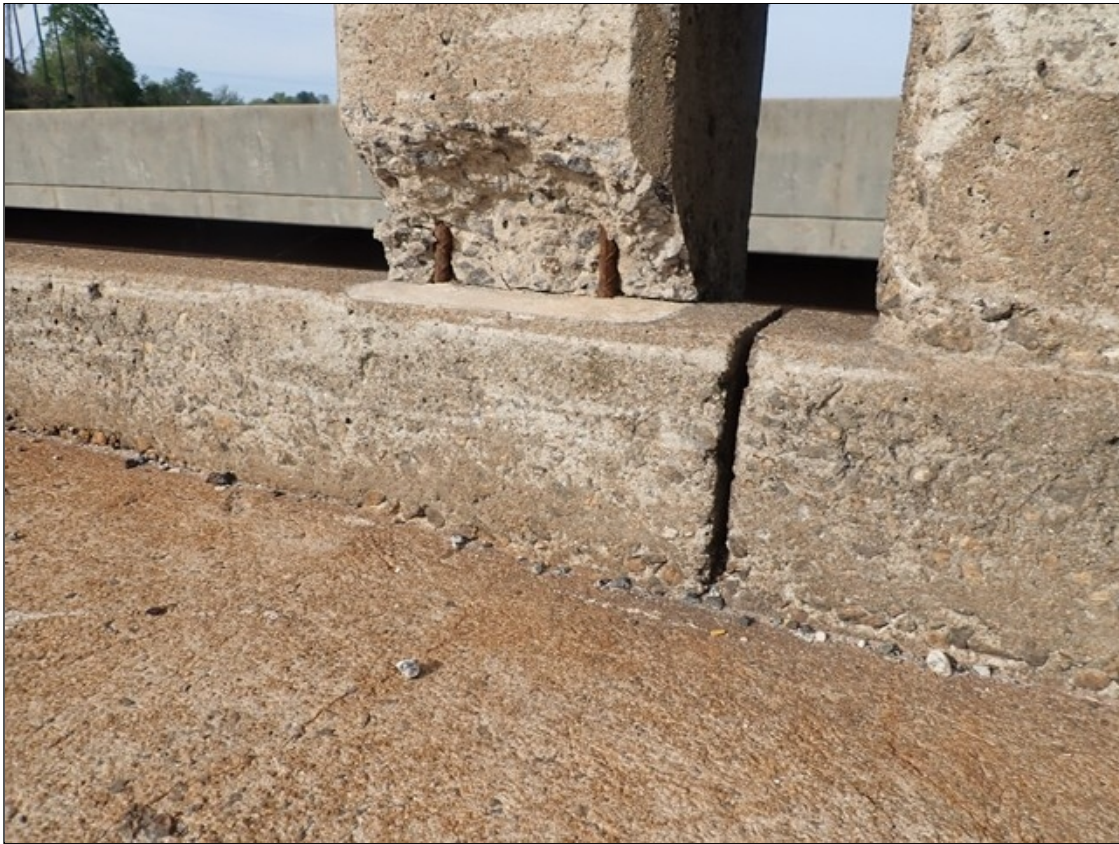
Span 7 Right Bridge Rail: 10 INCH X 4 INCH X 3 INCH DEEP SPALL WITH EXPOSED REBAR ON POST 4

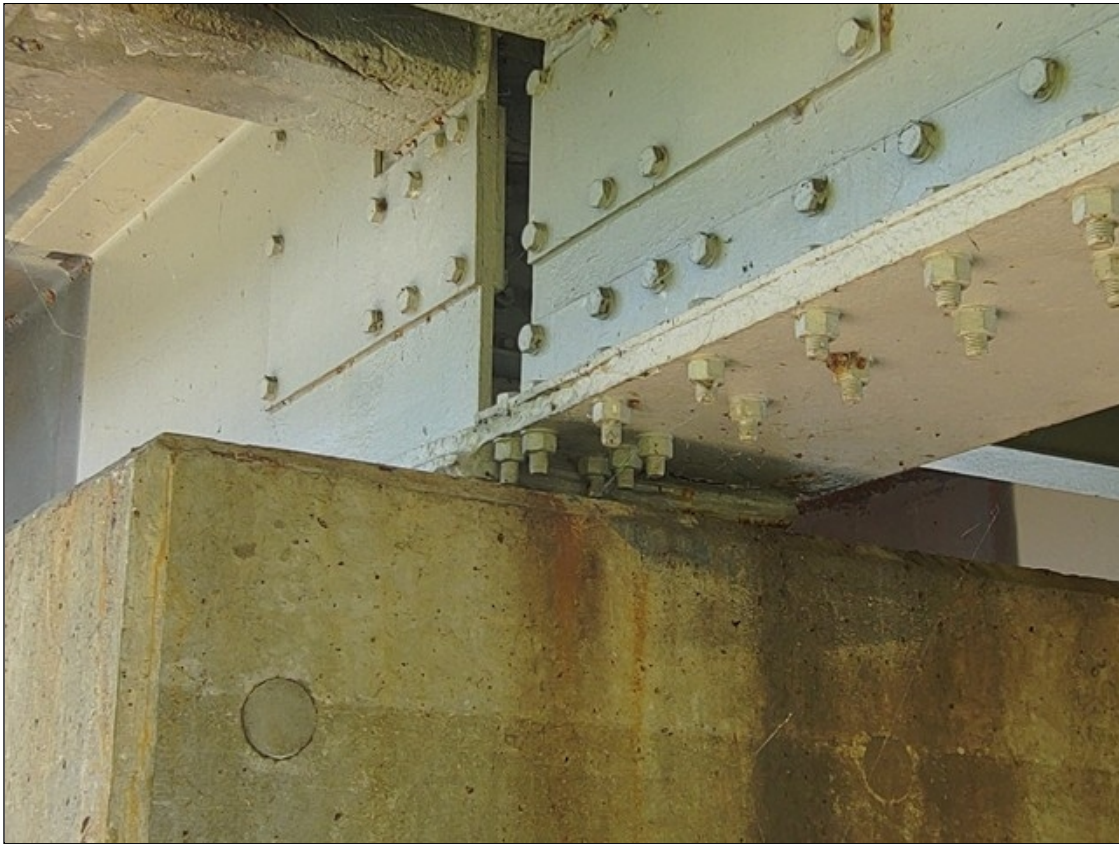
Span 10 Beam 4: AT NEAR END, CORROSION WITH SECTION LOSS, UPPER WEB AT DIAPHRAGM: [12 INCHES LONG X 1 INCHES WIDE - AVERAGE REMAINING 1/4 INCHES] ; LOWER WEB: [19 INCHES LONG X 3 INCHES HIGH - AVERAGE REMAINING 7/16 INCHES]; BOTTOM FLANGE: [20 INCHES LONG X 5 INCHES WIDE - AVERAGE REMAINING 7/8 INCHES] (REPAIRED IN 2022) (PAR)

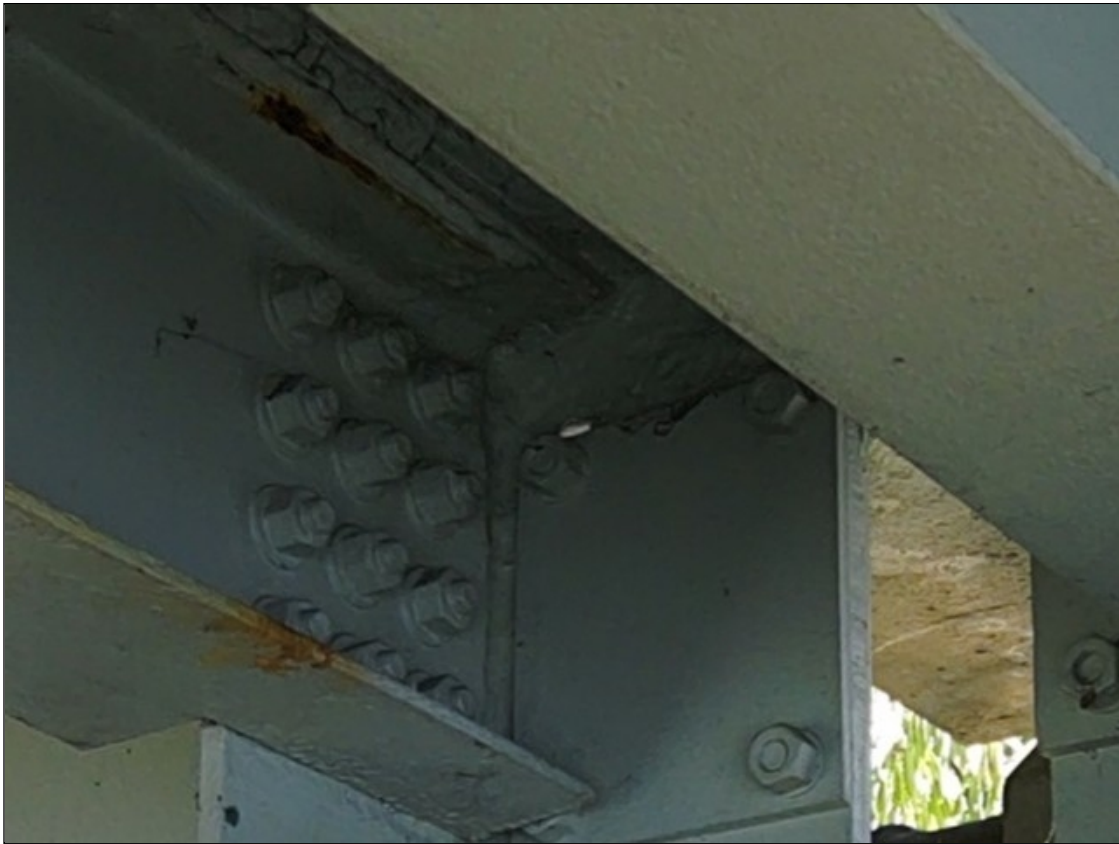
Span 10 Beam 4: PAR: 1 INCH DIAMETER AREA OF COMPLETE SECTION LOSS IN TOP OF WEB STARTING 6 INCHES FROM BEAM END AND 2 INCHES DOWN FROM DIAPHRAGM AT BENT 9 (CLEANED AND PAINTED)

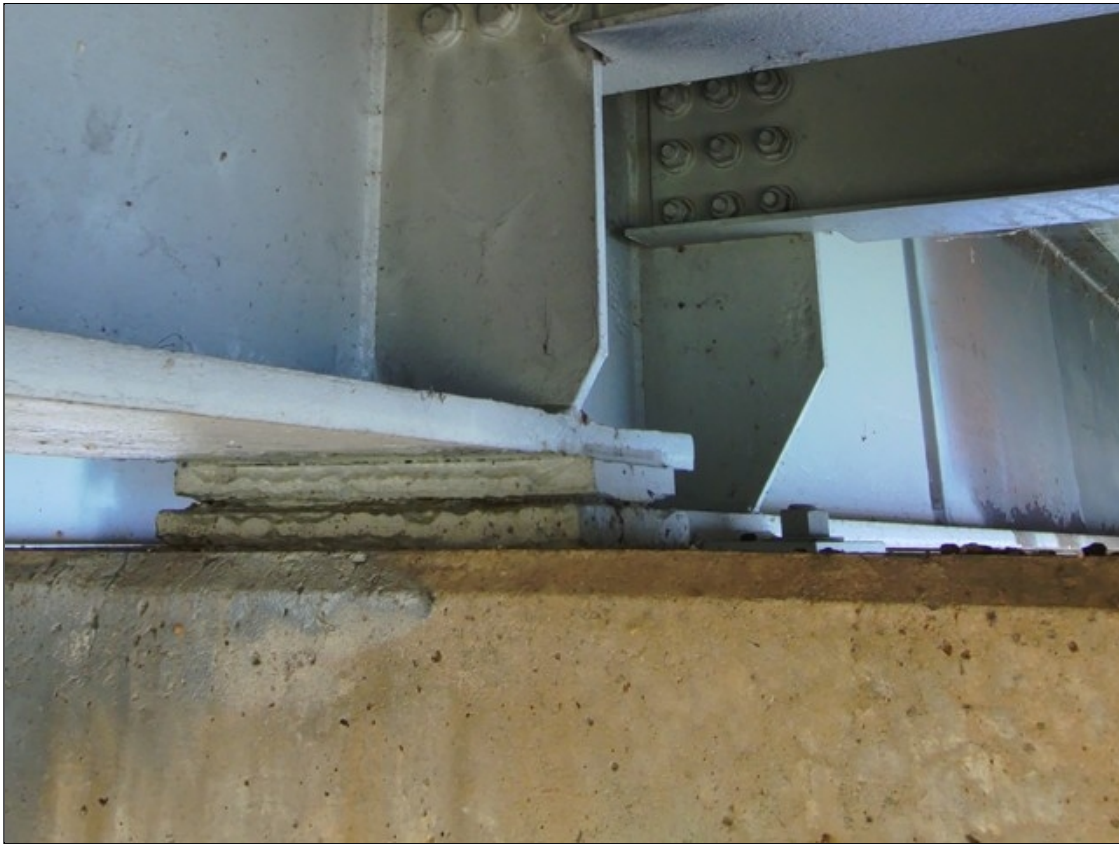
Span 10 Beam 3: [PAR] AT NEAR END, CORROSION WITH SECTION LOSS, WEB OVER BEARING: [23 INCHES LONG X UP TO FULL HEIGHT - AVERAGE REMAINING 1/2 INCHES]; BOTTOM FLANGE: [14 INCHES LONG X FULL WIDTH - AVERAGE REMAINING 1-1/8 INCHES] (CLEANED AND PAINTED)

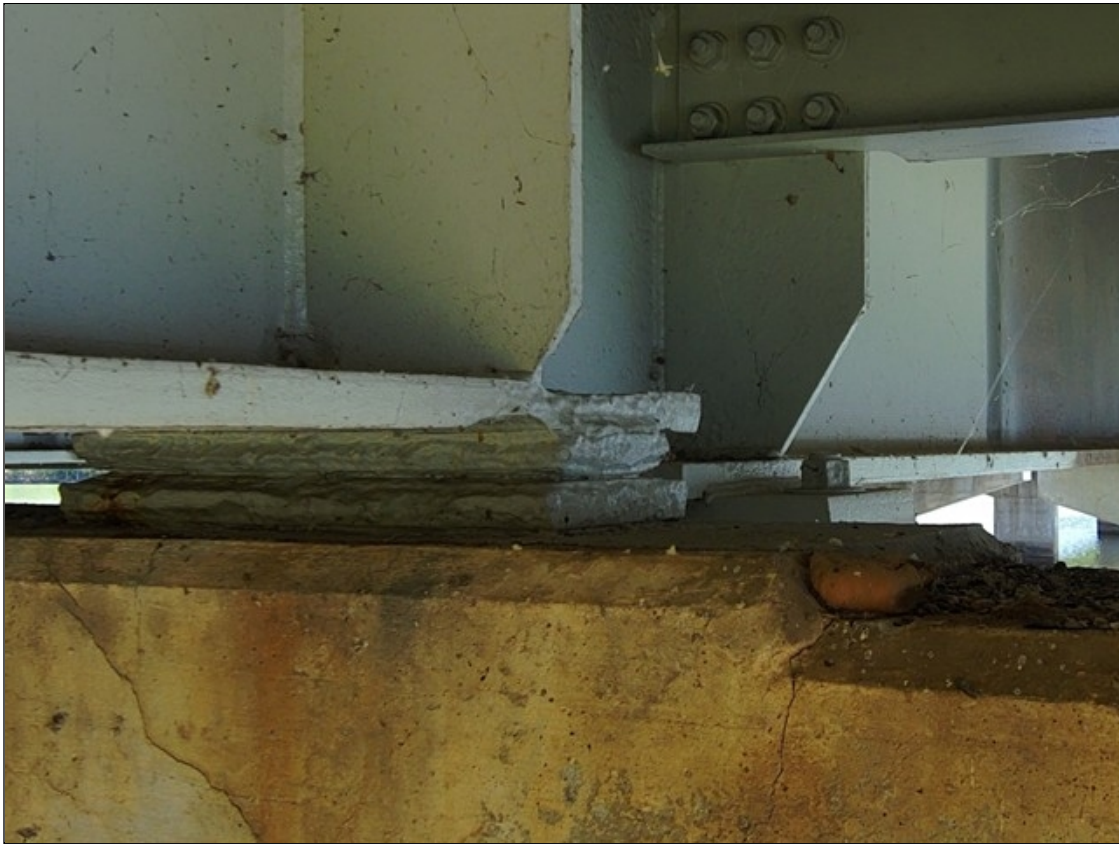
Span 10 Beam 2: 10 INCH LONG X 3 INCH HIGH AREA OF 1/8 INCH SECTION LOSS (3/8 INCH REMAINING) WITH NO RUST ON BOTH STIFFENERS AT BENT 9 (PAR) (CLEANED AND PAINTED)

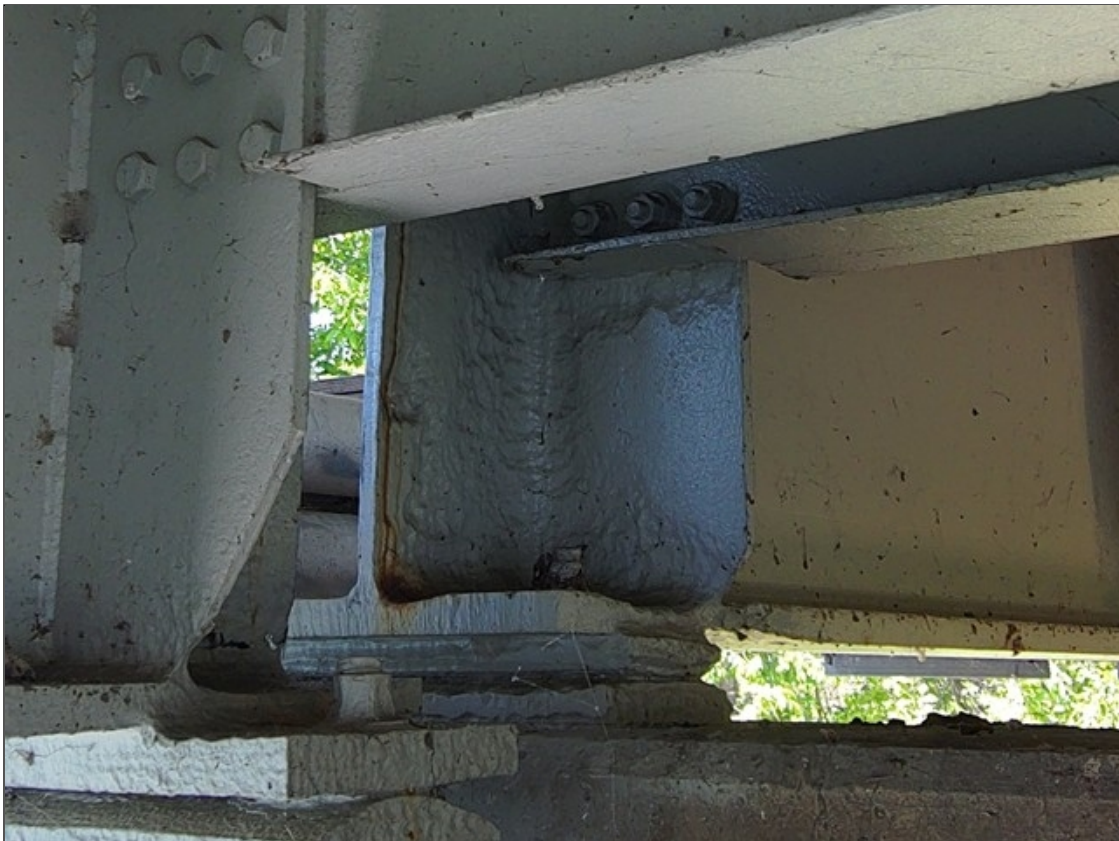
Span 10 Beam 1: 10 INCH LONG X 12 INCH HIGH AREA OF 1/8 INCH SECTION LOSS (3/8 INCH REMAINING) WITH NO RUST ON RIGHT STIFFENER AT BENT 9 (PAR)

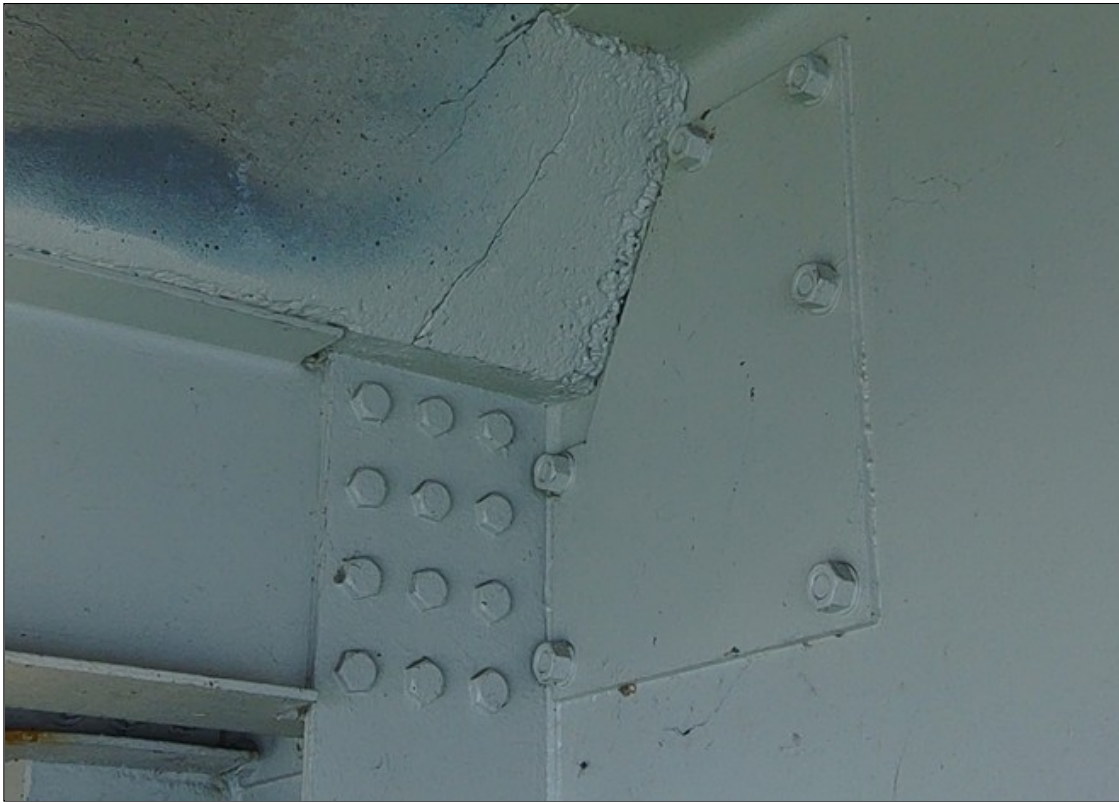
Span 6 Beam 4: IN SPAN 9 AT FAR END, ACTIVE CORROSION ABOVE PLATE, LEFT SIDE WEB AT DIAPHRAGM [12 INCHES LONG X 5 INCHES HIGH - AVERAGE REMAINING 1/2 INCHES] (CLEANED AND PAINTED) (PAR)

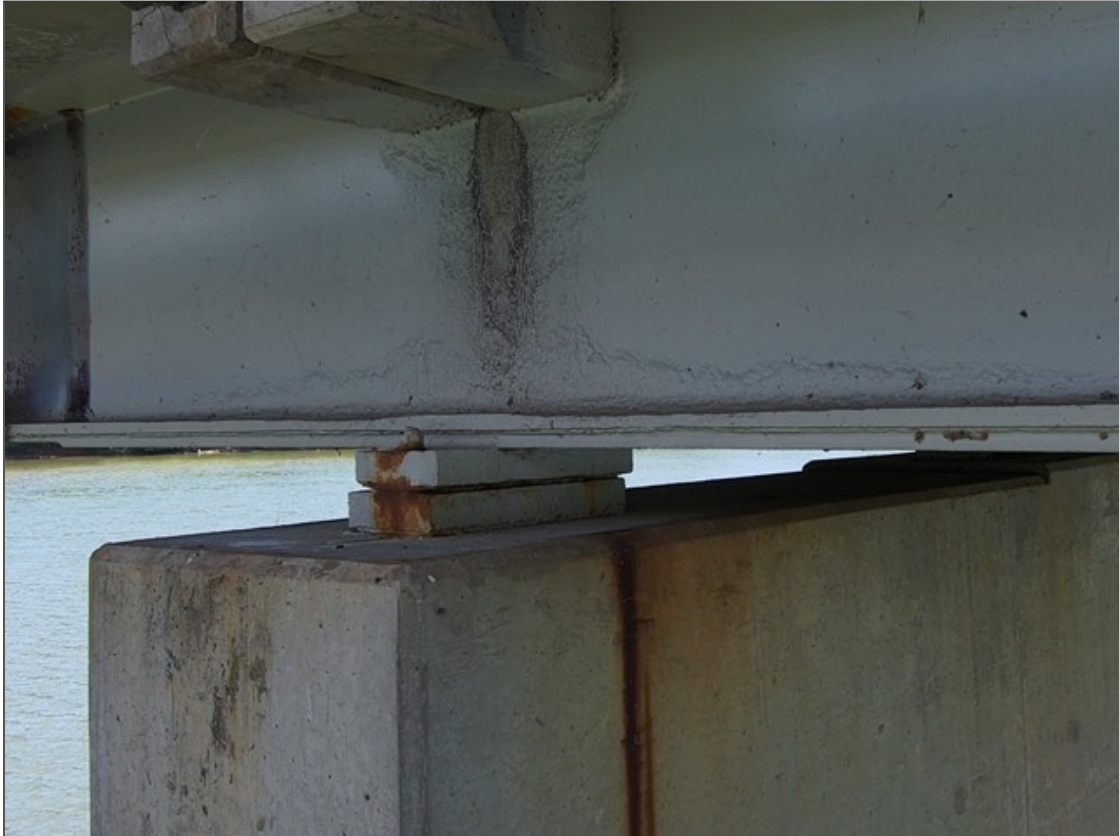
Span 6 Beam 4: 10 FEET LONG X 5 INCHES HIGH AREA OF UP TO 5/8 INCHES SECTION LOSS (7/8 INCHES REMAINING) ON RIGHT SIDE OF BOTTOM FLANGE IN SPAN 7 AT BENT 6 (CLEANED AND PAINTED) (PAR)

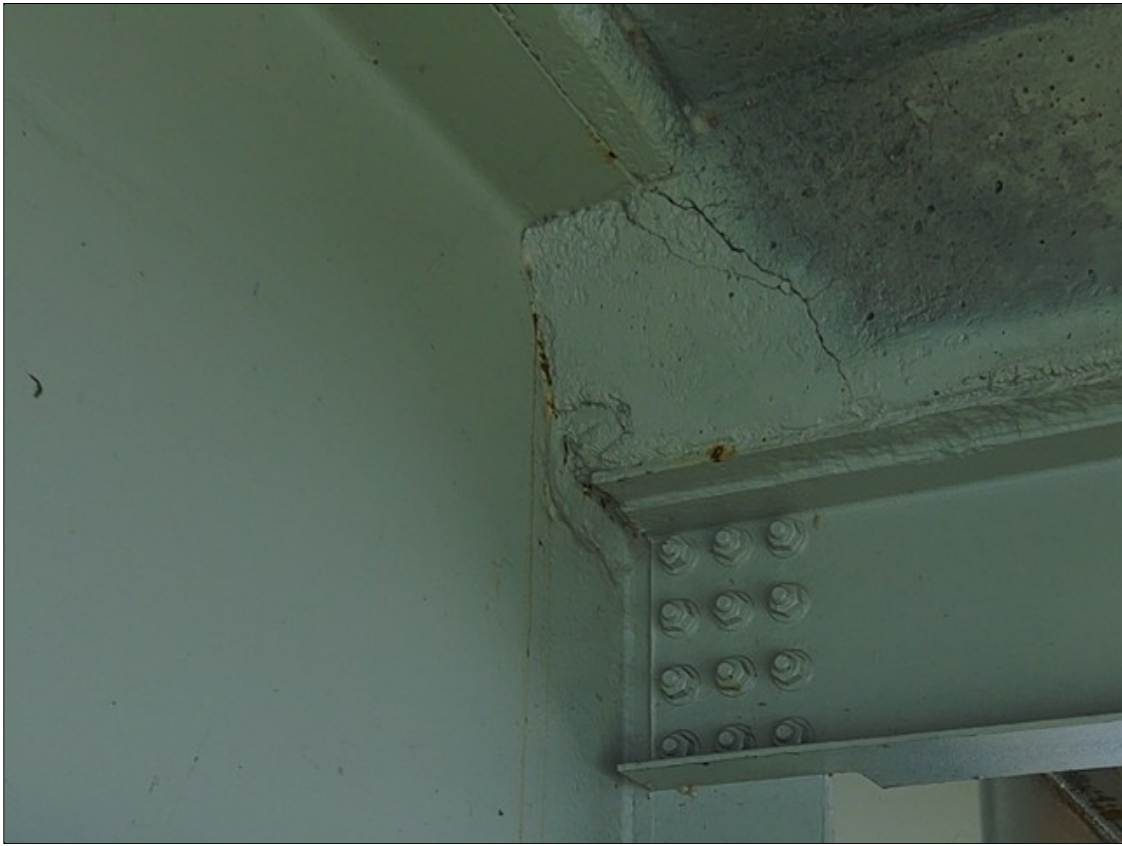
Span 6 Beam 4: UPPER WEB AT DIAPHRAGM AT BENT 6, CORROSION WITH SECTION LOSS [30 INCHES LONG X UP TO 12 INCHES HIGH - AVERAGE REMAINING 1/4 INCHES]; LOWER WEB [10 FEET LONG X UP TO 7 INCHES HIGH - AVERAGE REMAINING 3/8 INCHES] (CLEANED AND PAINTED) (PAR)

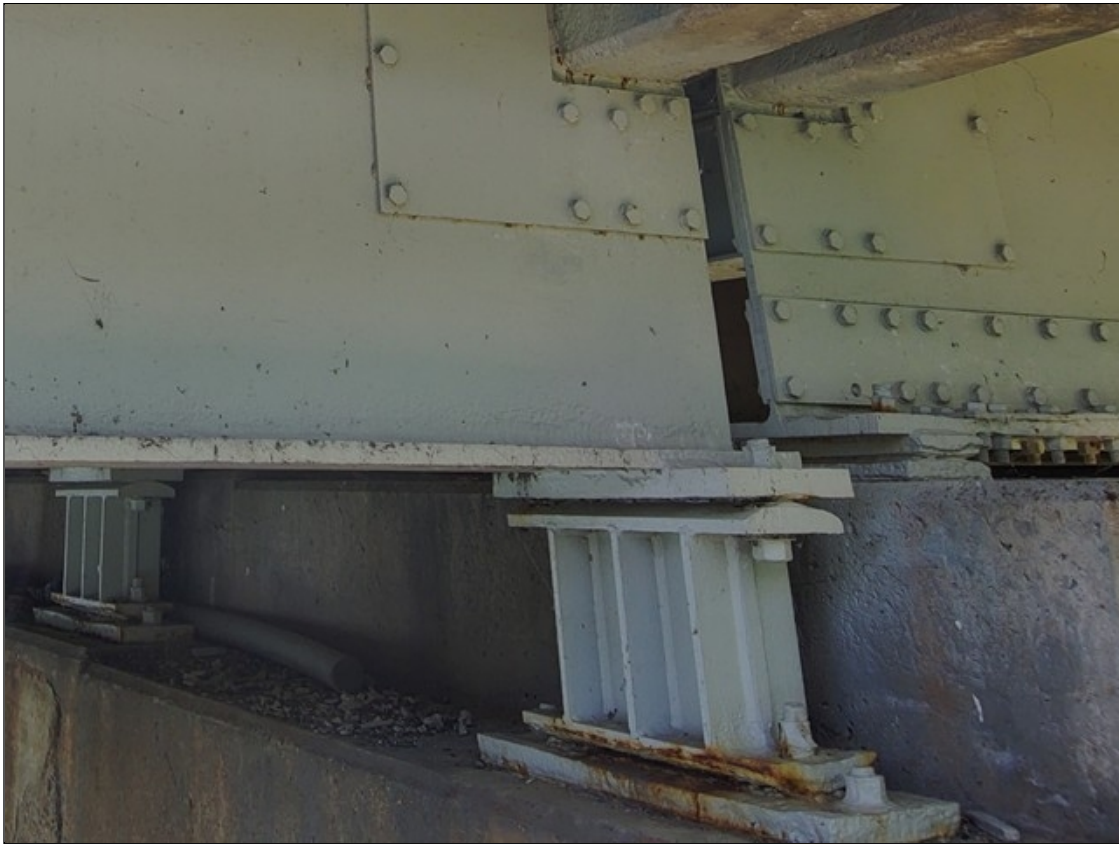
Span 6 Beam 4: IN SPAN 9 AT FAR END, CORROSION, LOWER WEB [34 INCHES LONG X 2 INCHES HIGH - AVERAGE REMAINING 11/16 INCHES]; BOTTOM FLANGE [32 INCHES LONG X UP TO 6 INCHES WIDE- AVERAGE REMAINING 7/8 INCHES] (PAINTED WITH NO RUST) (PAR)
