☐ Supplemental Inspection Requested

NC DEPARTMENT OF TRANSPORTATION  
DIVISION OF HIGHWAYS  
STRUCTURE MANAGEMENT UNIT  
COUNTY: CALDWELL DIV: 11

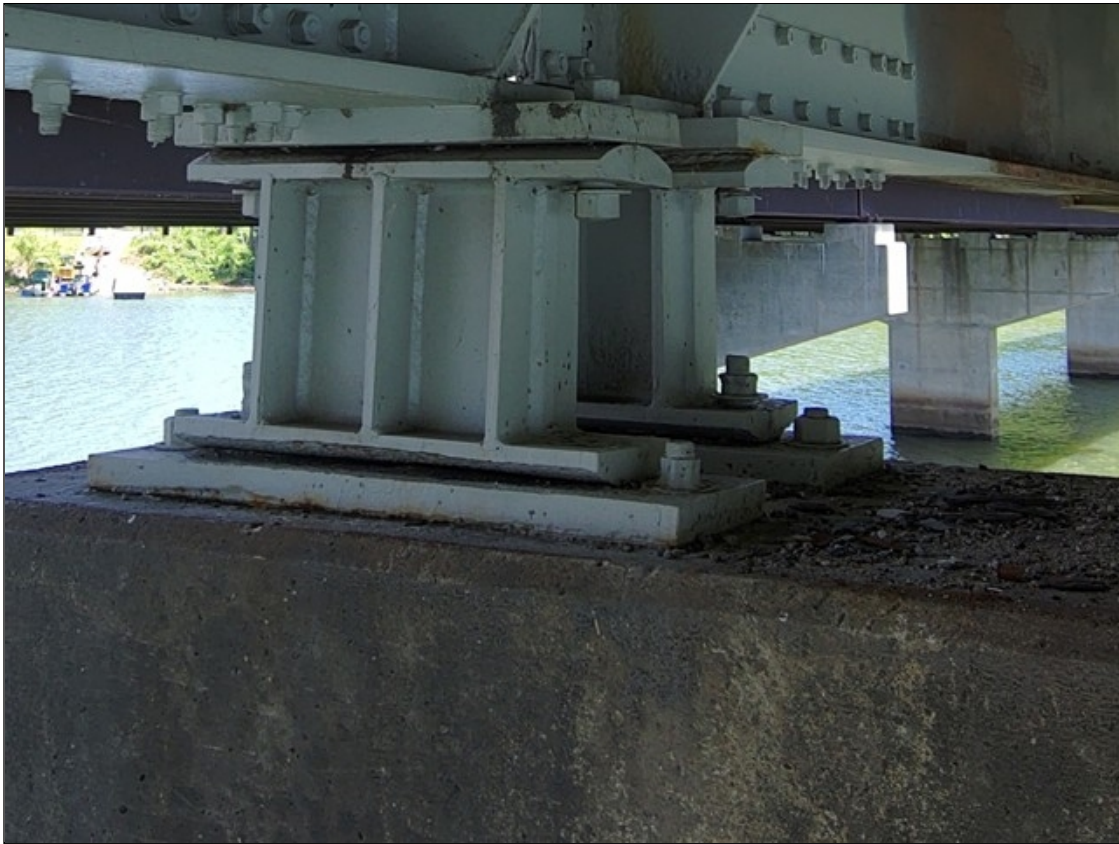
Span 6 Beam 4 - Beam 4 Near Bearing: WEST ROCKER BOLT IS MISSING (PAR)

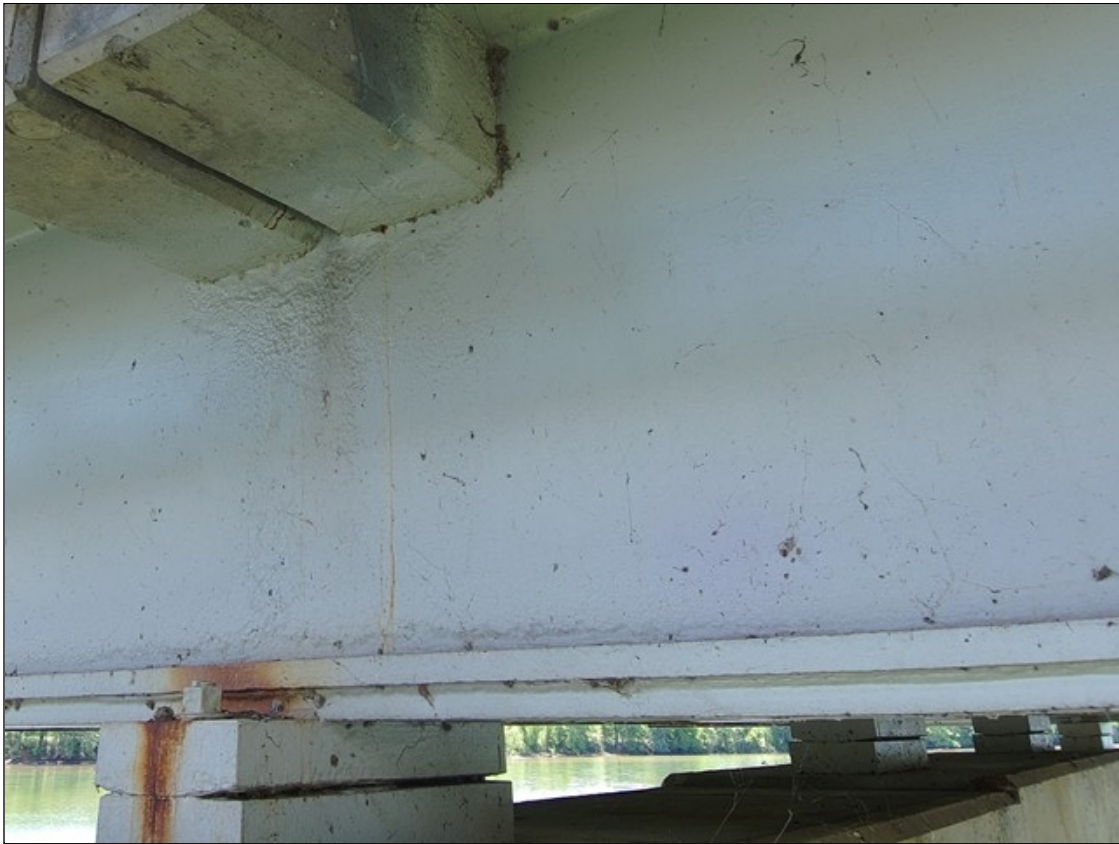
Span 6 Beam 4: OVER BENT 8 UPPER WEB AT DIAPHRAGM, CORROSION [24 INCHES LONG X UP TO 3 INCHES HIGH - AVERAGE REMAINING 5/8 INCHES]; LOWER WEB [4 FEET LONG X 2 INCHES WIDE - AVERAGE REMAINING 5/8 INCHES] (PAINTED WITH NO RUST) (PAR)

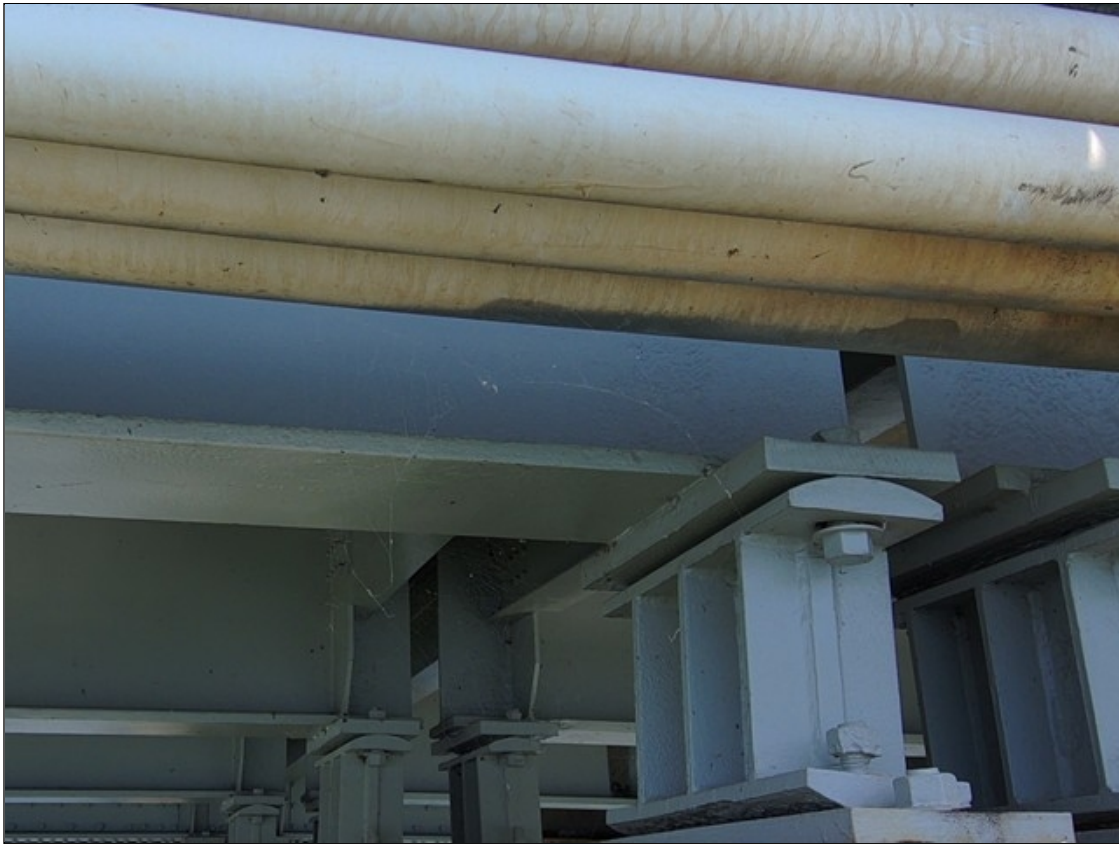
Span 6 Beam 1: NEAR END AT BENT 5, CORROSION WITH SECTION LOSS, LOWER WEB: [3 FEET LONG X 4 INCHES HIGH - AVERAGE REMAINING 3/8 INCHES] ; BOTTOM FLANGE: [18 INCHES LONG X FULL WIDTH - SECTION LOSS LESS THAN 1/16 INCHES] (UPPER WEB REPAIRED IN 2022) (PAR)

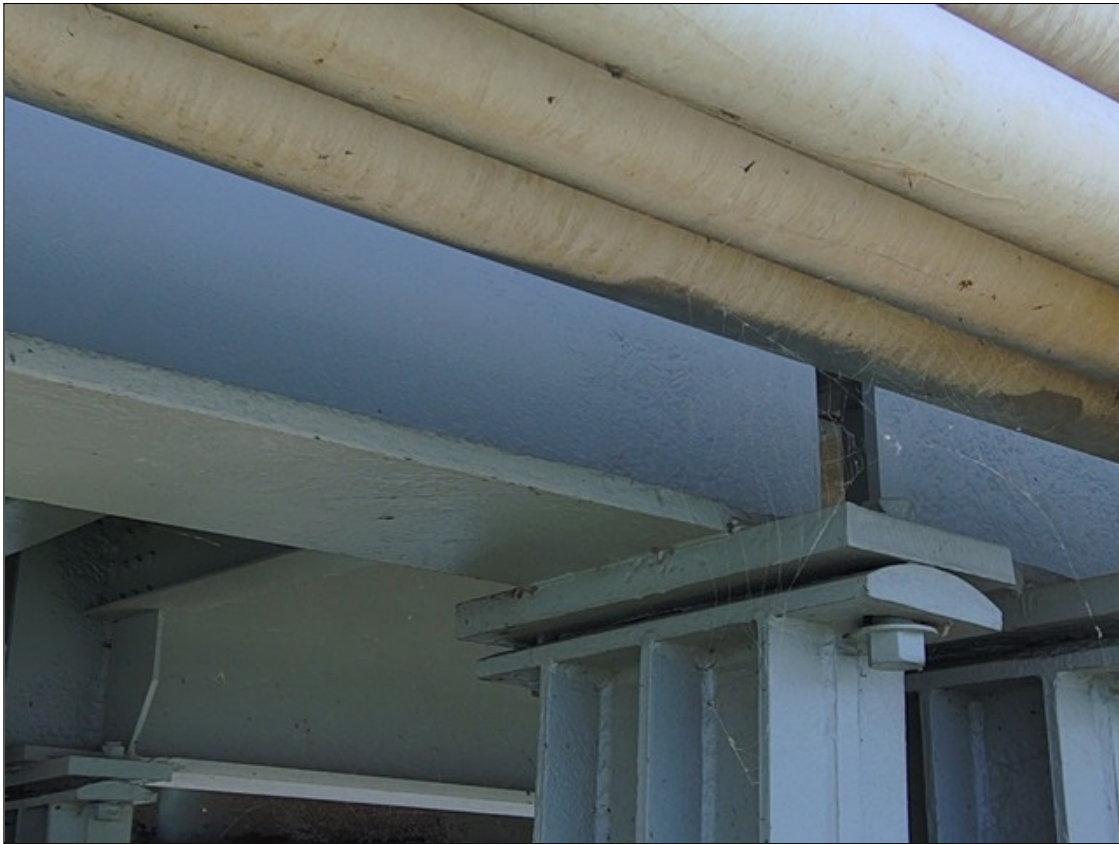
Span 6 Beam 1: 15 INCHES LONG X 10 INCHES HIGH AREA OF 1 INCHES SECTION LOSS (1/4 INCHES REMAINING) ON LEFT SIDE OF WEB IN SPAN 6 AT BENT 5 (CLEANED AND PAINTED) (PAR)

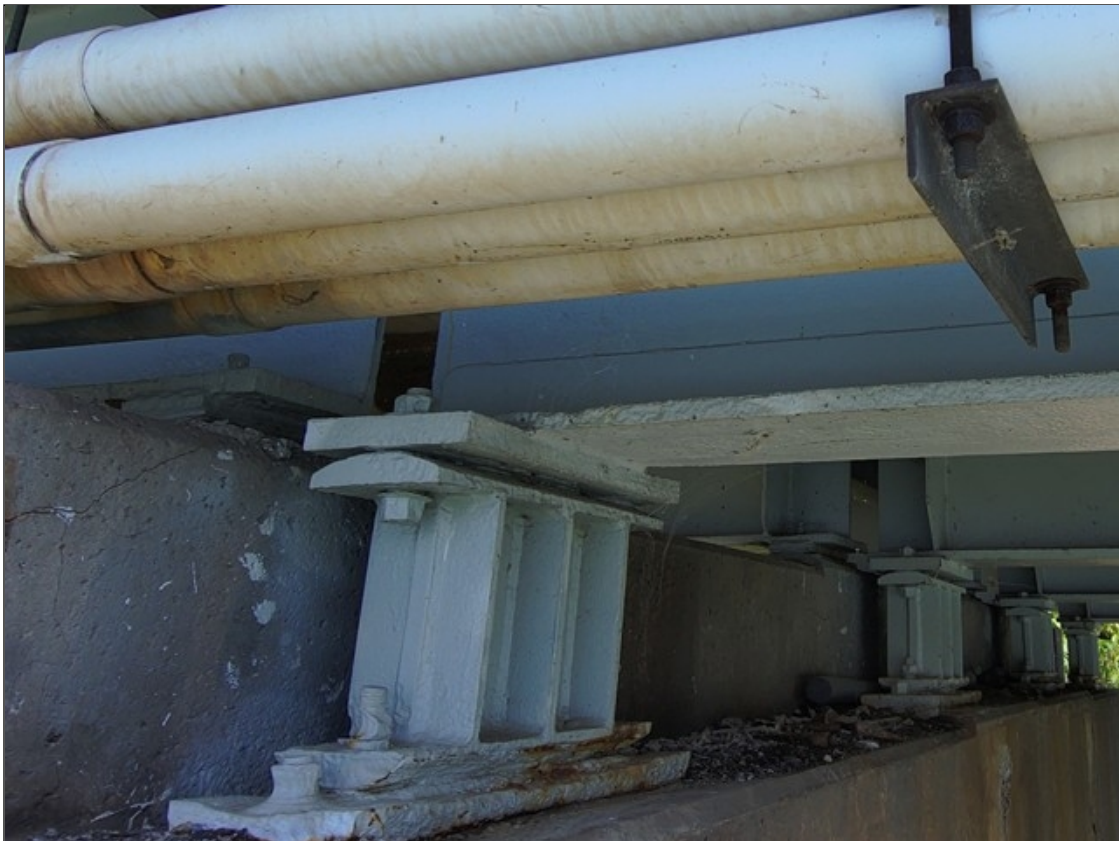
Span 6 Beam 1: [PAR] IN SPAN 9 AT FAR END, CORROSION WITH SECTION LOSS, BOTTOM FLANGE: [15 INCHES LONG X FULL WIDTH - AVERAGE REMAINING 3/4 INCHES] (CLEANED AND PAINTED)

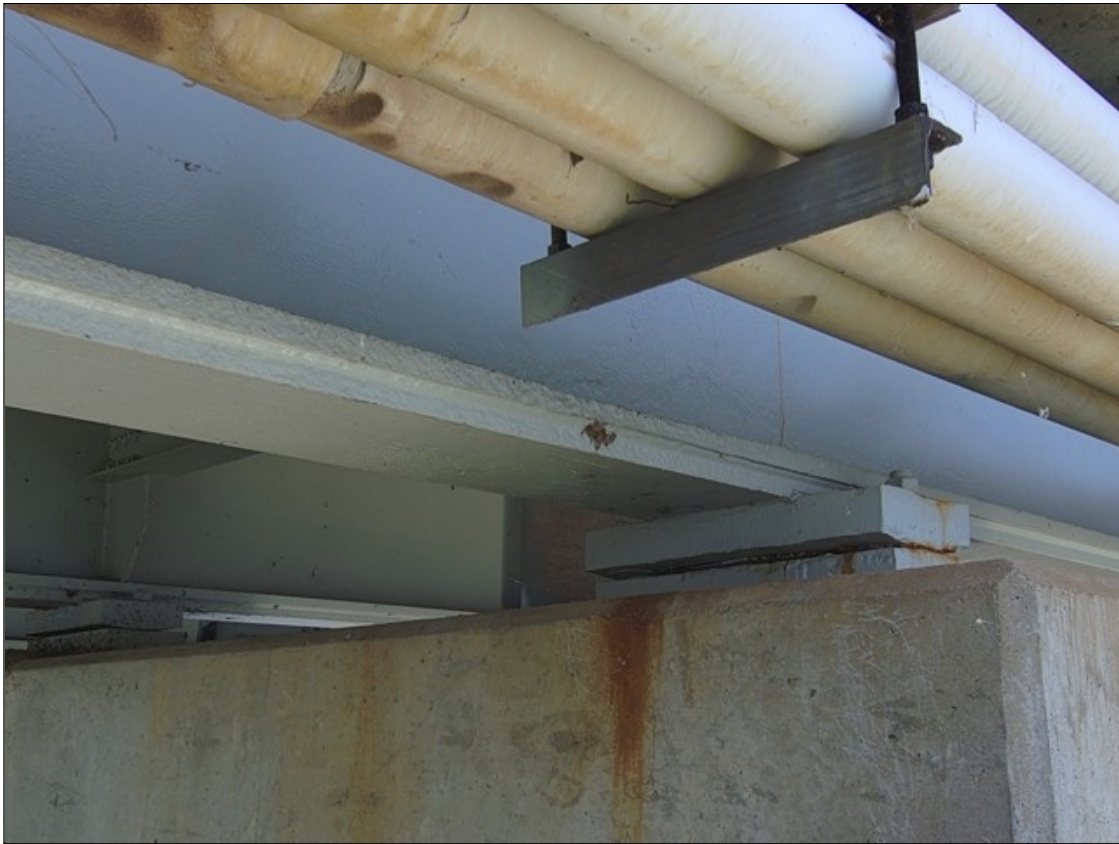
Span 6 Beam 1: AT BENT 6, CORROSION WITH SECTION LOSS, UPPER WEB AT DIAPHRAGM [18 INCHES LONG X 10 INCHES HIGH - AVERAGE REMAINING 1/4 INCHES]; LOWER WEB [6 FEET LONG X 4 INCHES WIDE - AVEERAGE REMAINING 5/16 INCHES]; BOTTOM FLANGE [2 FEET LONG X FULL WIDTH - 1 INCHES REMAINING] (CLEANED AND PAINTED WITH NO RUST) (PAR)

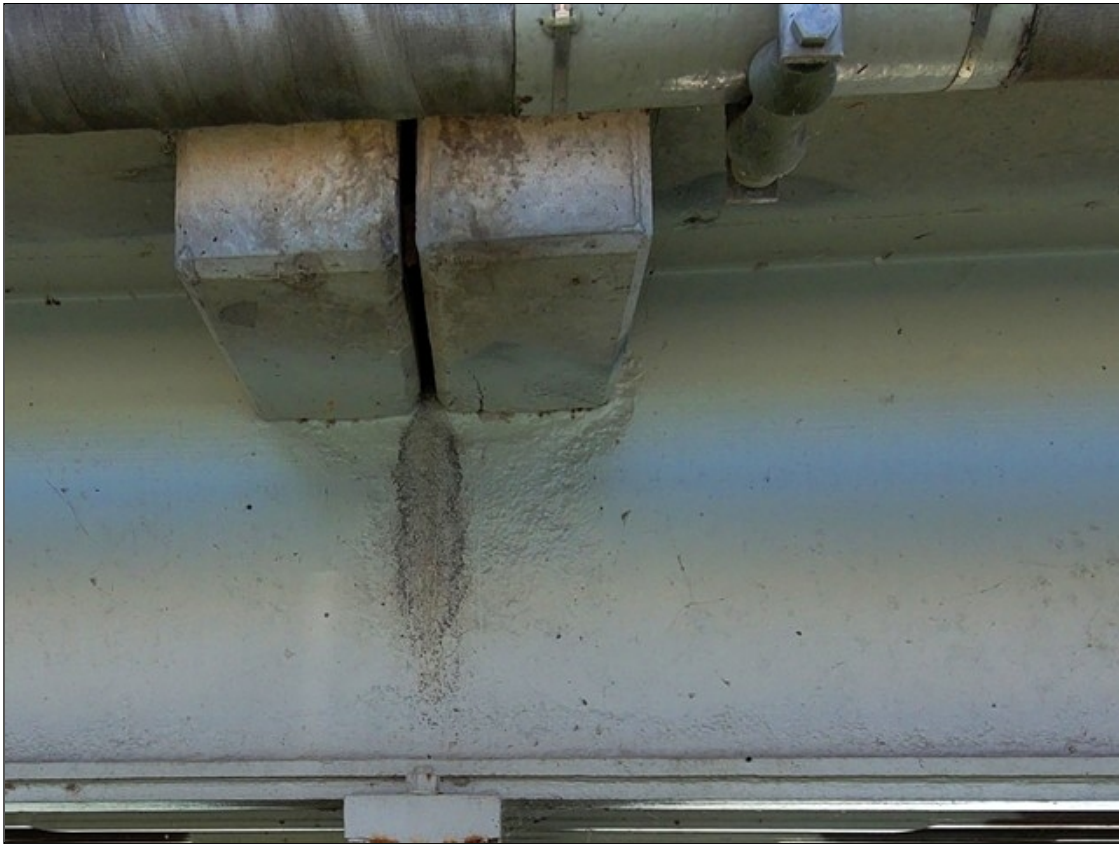
Span 2 Beam 4: OVER BENT 2, CORROSION WITH SECTION LOSS WEB OVER BEARING: [24 INCHES LONG X 17 INCHES HIGH - 5/8 INCHES AVERAGE REMAINING]; LOWER WEB: [7 FEET LONG X UP TO 5 INCHES WIDE - 5/8 INCHES AVERAGE REMAINING]; BOTTOM FLANGE: [11 FEET LONG X FULL WIDTH - 1 INCHES REMAINING] (CLEANED AND PAINTED) (PAR)

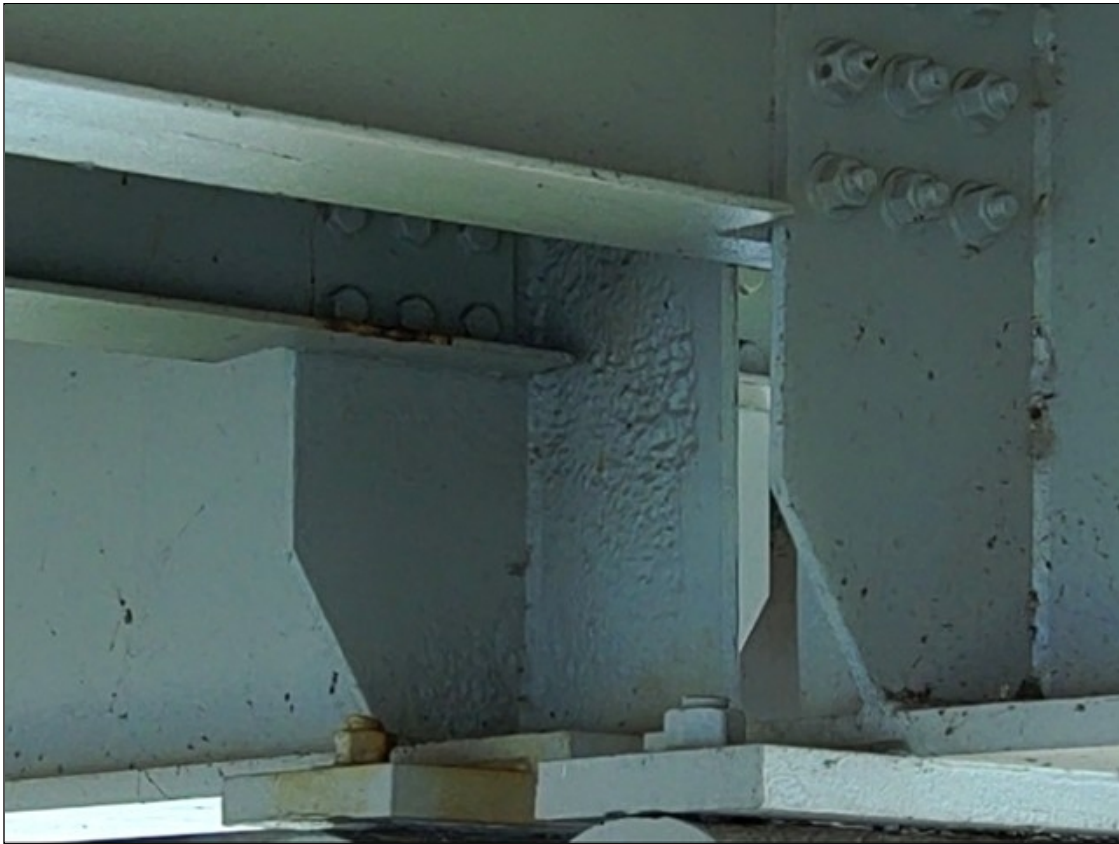
Span 2 Beam 3: 9 INCHES LONG X 24 INCHES HIGH AREA OF 1/4 INCHES SECTION LOSS (1/2 INCHES REMAINING) ON WEB IN SPAN 5 AT BENT 5 (CLEANED AND PAINTED) (PAR)

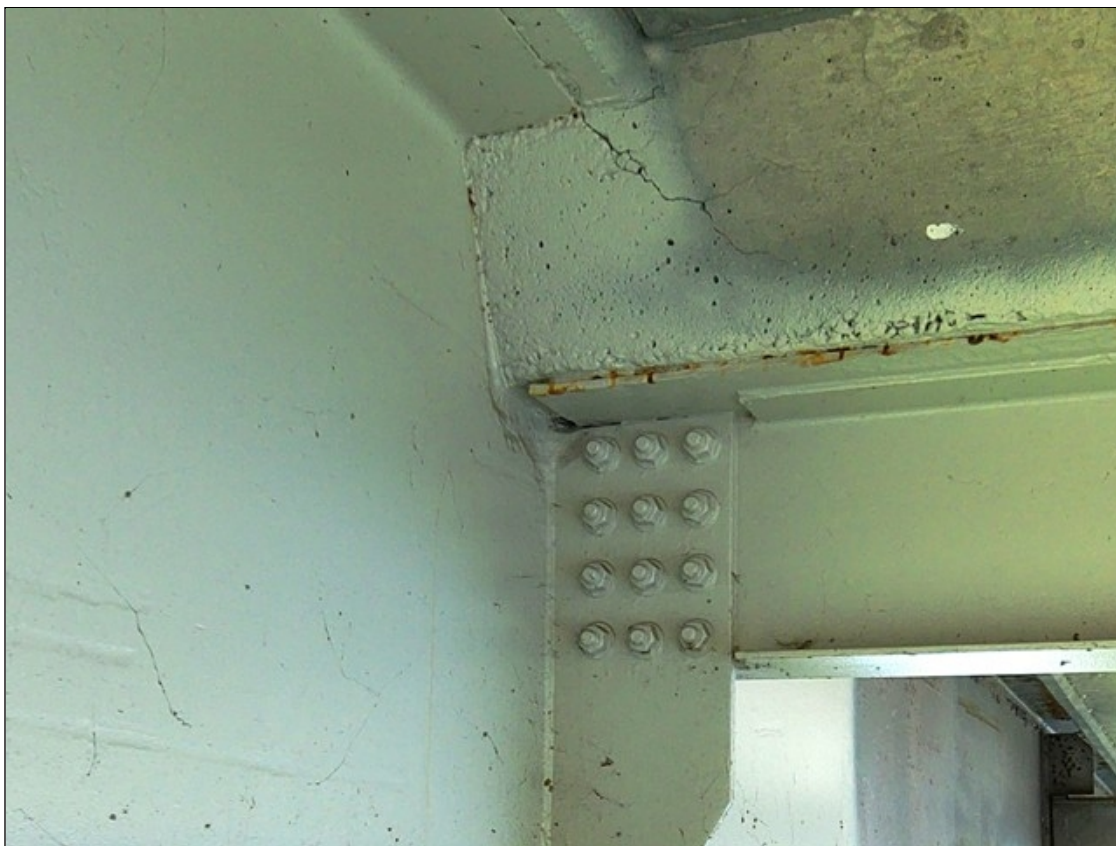
Span 2 Beam 3: OVER BENT 2, CORROSION WITH SECTION LOSS UPPER WEB ADJACENT TO DECK HAUNCH: [22 INCHES LONG X UP TO 10 INCHES WIDE - AVERAGE REMAINING 5/16 INCHES] (CLEANED AND PAINTED) (PAR)

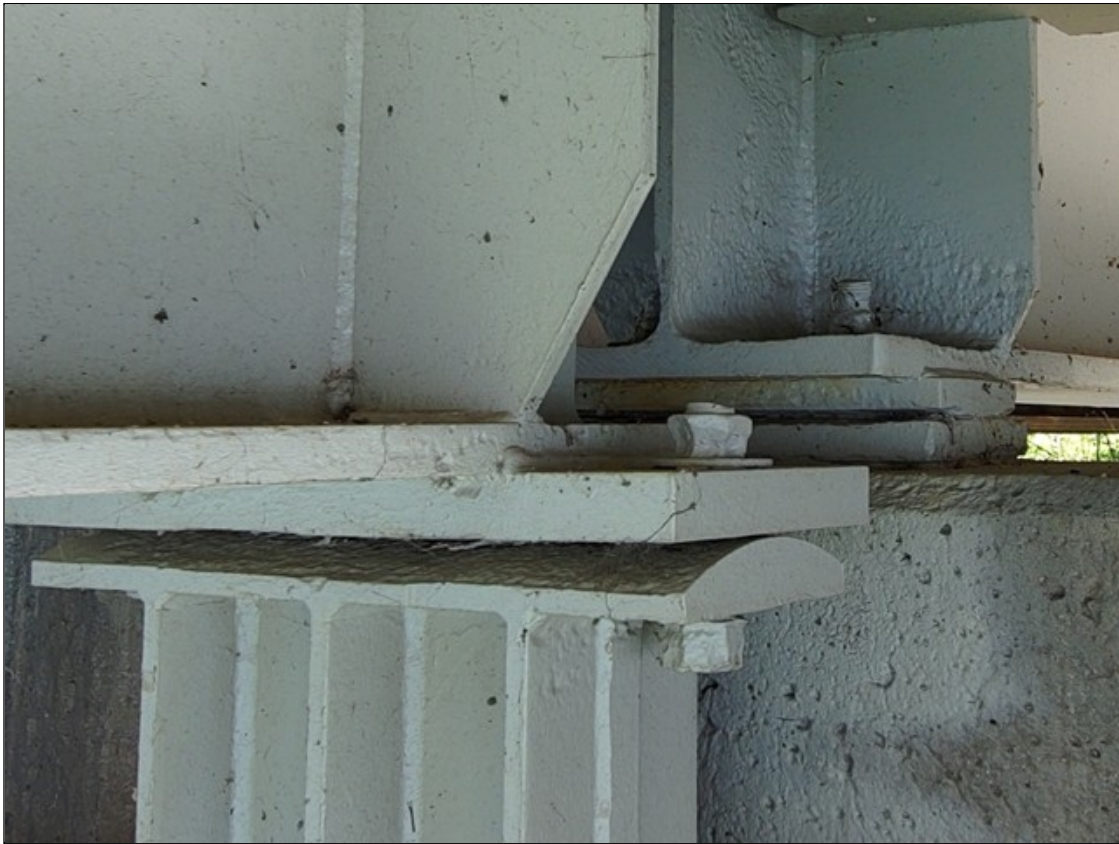
Span 2 Beam 2: SPAN 2 OVER BENT 1, CORROSION WITH SECTION LOSS: BOTH SIDES WEB OVER BEARING [8 INCHES LONG X 12 INCHES HIGH - AVERAGE REMAINING 5/8 INCHES]; LOWER WEB [2 FEET LONG X 1 FOOT HIGH- NO LOSS NOTED]; BOTTOM FLANGE [16 INCHES LONG X FULL WIDTH - NO LOSS NOTED] (CLEANED AND PAINTED) (PAR)

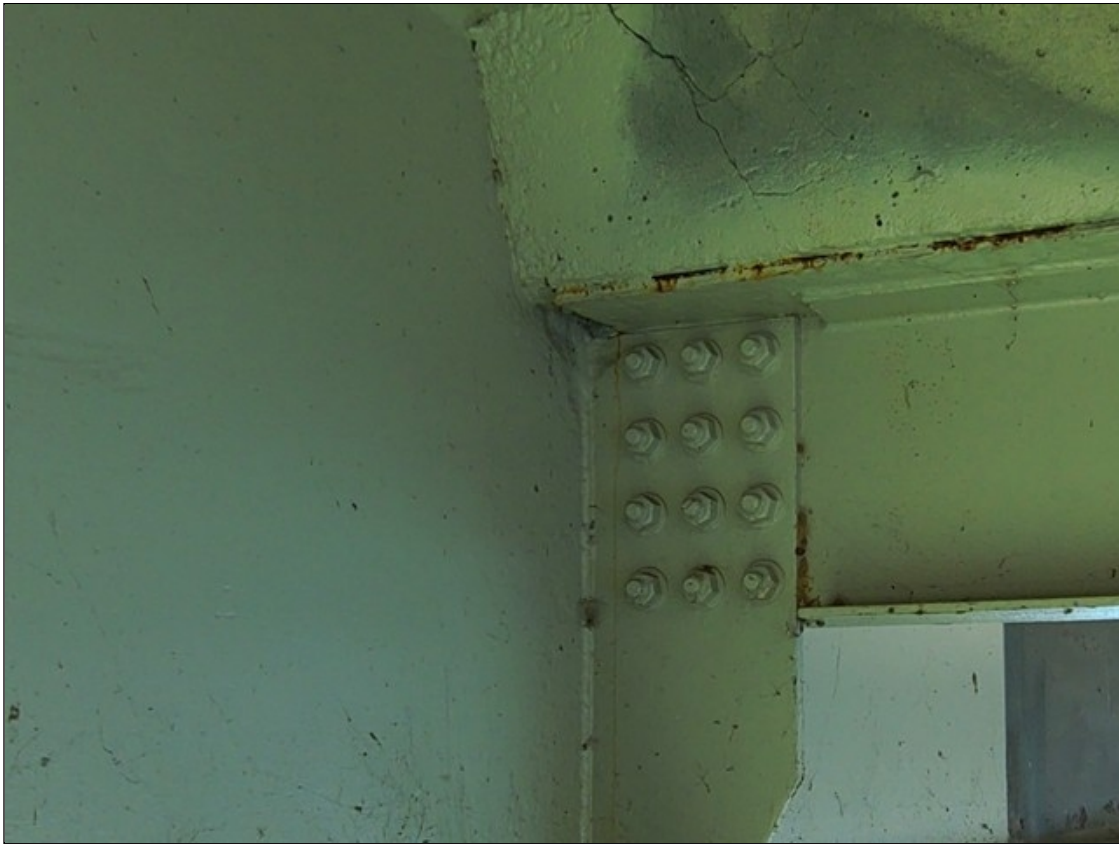
Span 2 Beam 1: AT BENT 2, CORROSION WITH SECTION LOSS UPPER WEB AT DIAPHRAGM: [18 INCHES LONG X 13 INCHES WEB - 3/8 INCHES AVERAGE REMAINING]; LOWER WEB: [3 FEET LONG X 4 INCHES WIDE - LOSS LESS THAN 1/16 INCHES]; BOTTOM FLANGE: [2 FEET LONG X FULL WIDTH - SECTION LOSS LESS THAN 1/16 INCHES] (PAR)

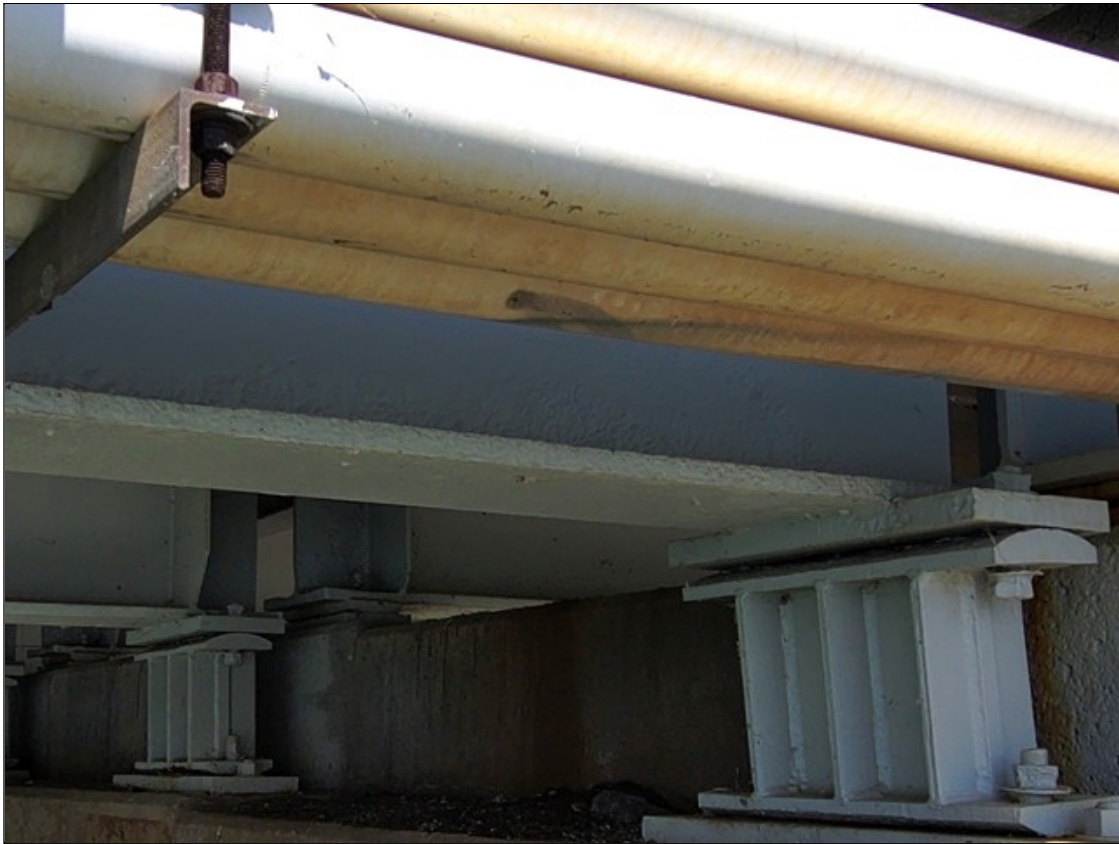
Span 2 Beam 1: SPAN 2 AT NEAR END, CORROSION WITH SECTION LOSS: LOWER WEB: [4 FEET LONG X 5 INCHES HIGH - 5/8 INCHES AVERAGE REMAINING]; BOTTOM FLANGE: [4 FEET LONG X FULL WIDTH - 1 INCHES AVERAGE REMAINING] (UPPER WEB REPAIRED IN 2022) (PAR)

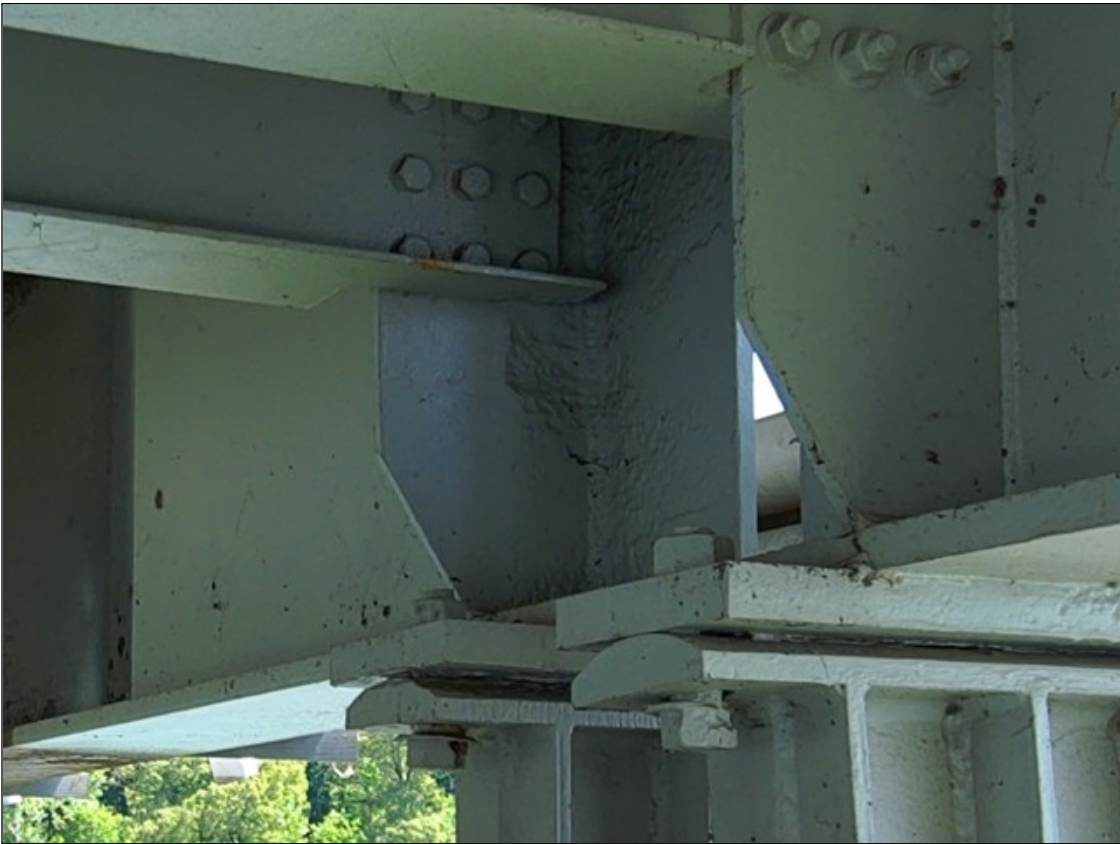
Span 2 Beam 1: 5 INCH LONG X 21 INCH HIGH AREA OF 1/8 INCH SECTION LOSS (3/8 INCH REMAINING) WITH NO RUST ON RIGHT STIFFENER AT BENT 5 (CLEANED AND PAINTED) (PAR)

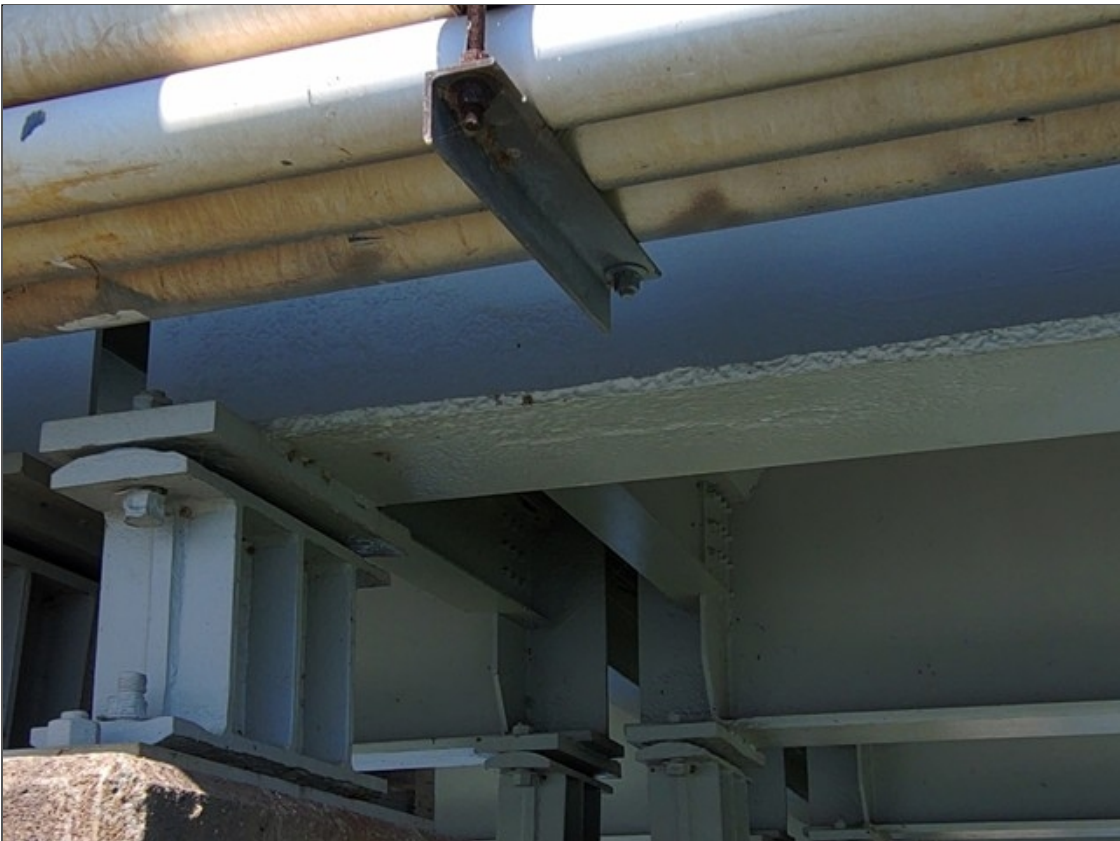
Span 2 Beam 1: SPAN 5 AT FAR END, CORROSION WITH SECTION LOSS; BOTTOM FLANGE: [6 FEET LONG X FULL WIDTH - 3/4 INCHES AVERAGE REMAINING] (CLEANED AND PAINTED) (PAR)

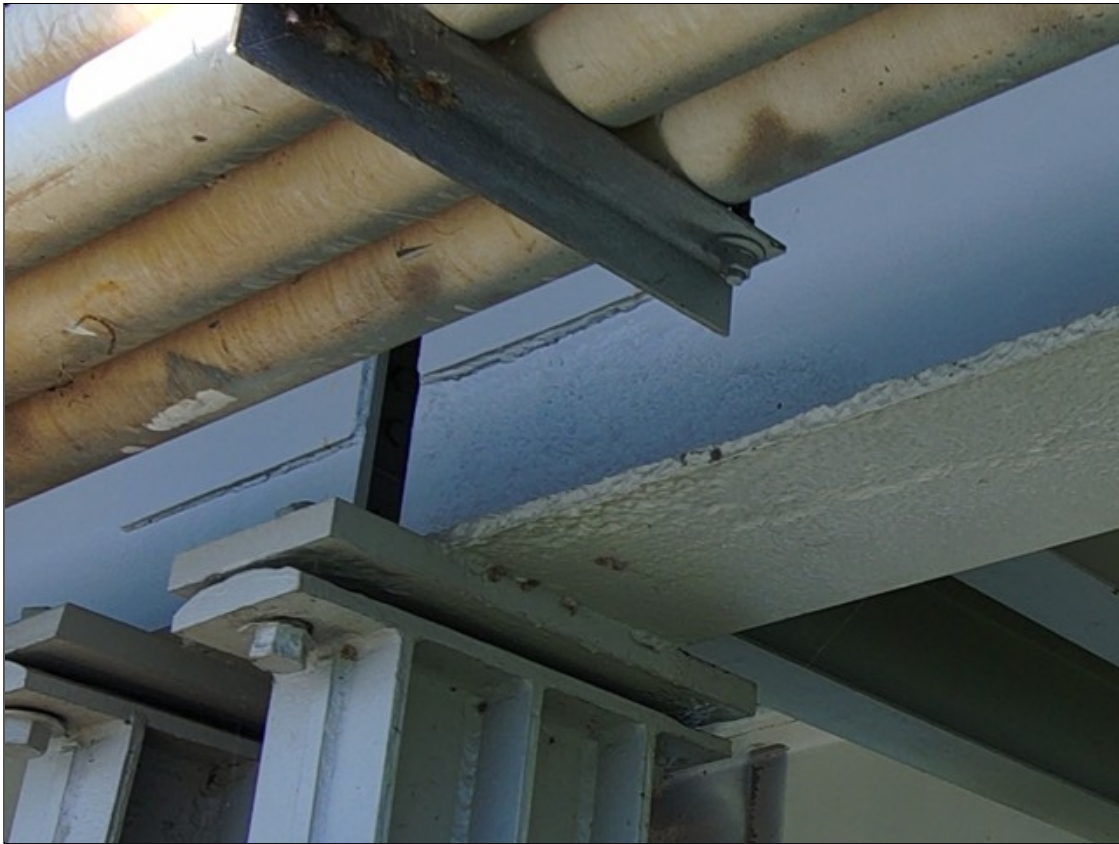
Span 2 Beam 1: 5 INCHES LONG X 11 INCHES HIGH AREA OF 1/8 INCH SECTION LOSS (3/8 INCH REMAINING) WITH NO RUST ON BOTH SIDES OF WEB AT BENT 5 (PAR) (CLEANED AND PAINTED)

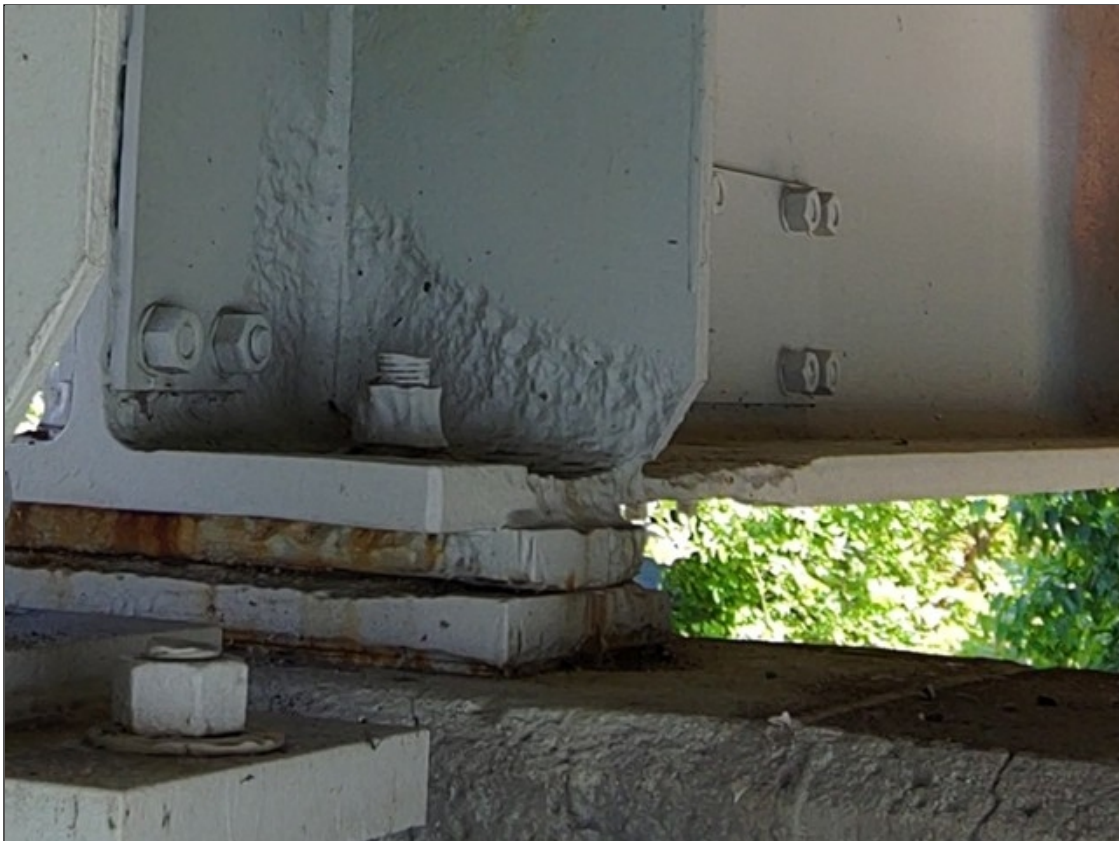
Span 1 Beam 4: 7/16 INCHES REMAINING X 8 INCHES WIDE ON BOTTOM LEFT FLANGE FOR 18 INCHES LONG AT BENT 1 (CLEANED AND PAINTED) (PAR)

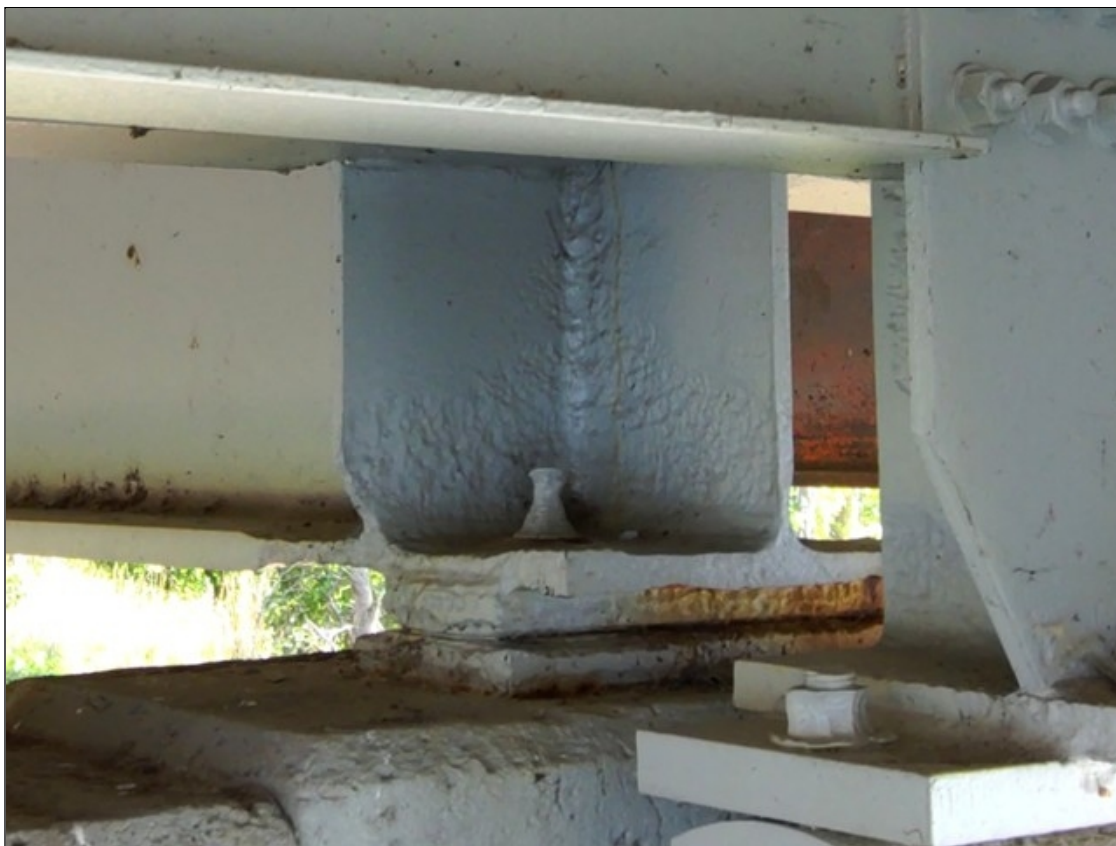
Span 1 Beam 3: 9 INCH LONG X 9 INCH HIGH AREA OF 1/8 INCH SECTION LOSS (3/8 INCH REMAINING) WITH NO RUST ON BOTH SIDES OF STIFFENER AT BENT 1 (CLEANED AND PAINTED) (PAR)

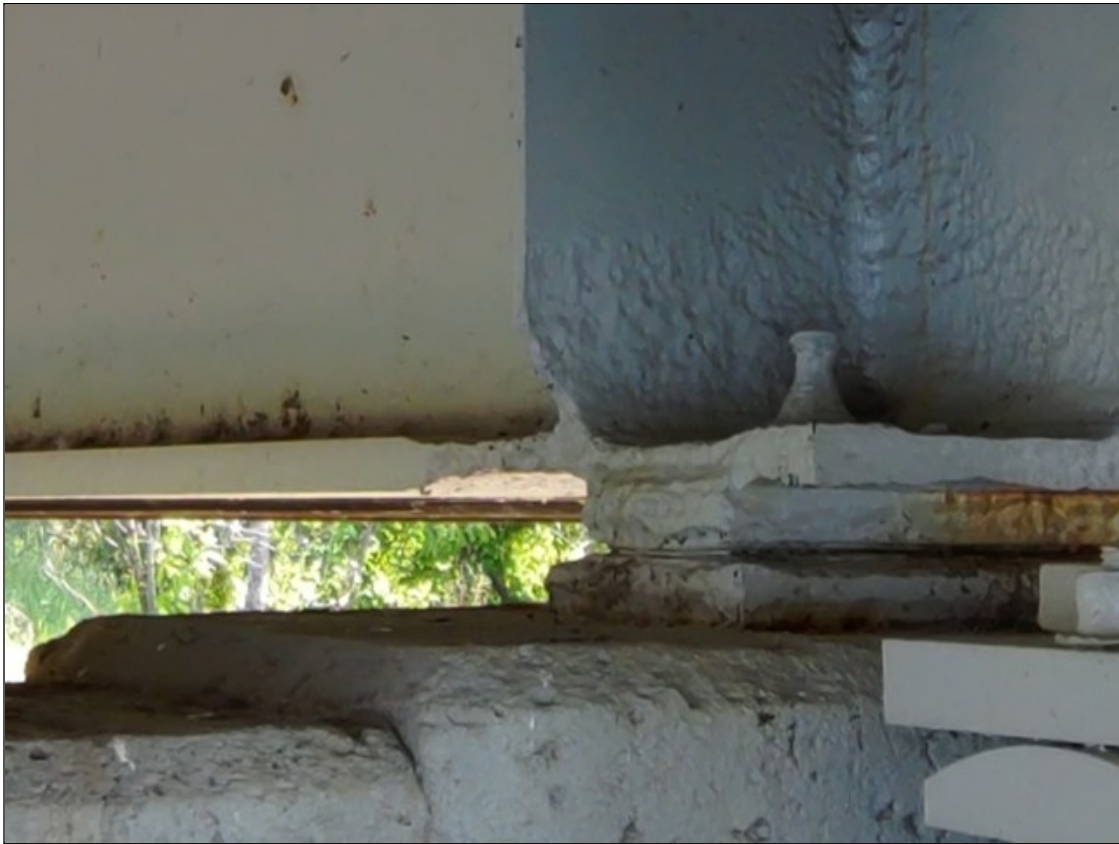
Span 1 Beam 3: FAR END, CORROSION WITH SECTION LOSS: BOTTOM FLANGE [15 INCHES LONG X FULL WIDTH - AVERAGE REMAINING 5/8 INCHES]; WEB OVER BEARING [9 INCHES LONG X FULL HEIGHT - AVERAGE REMAINING 1/2 INCHES] (CLEANED AND PAINTED) (PAR)

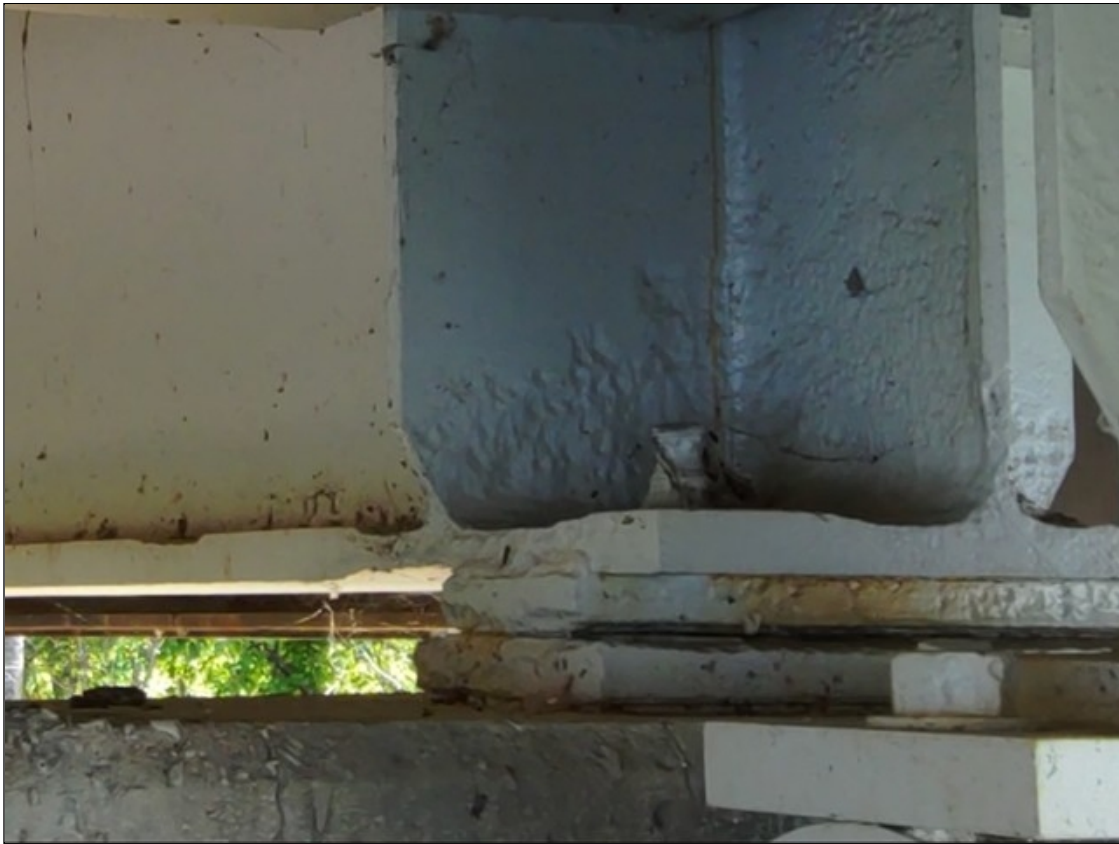
Span 1 Beam 2: 9 INCH LONG X 5 INCH HIGH AREA OF 1/8 INCH SECTION LOSS (3/8 INCH REMAINING) WITH NO RUST ON BOTH SIDES OF STIFFENER AT BENT 1 (PAR) (CLEANED AND PAINTED)

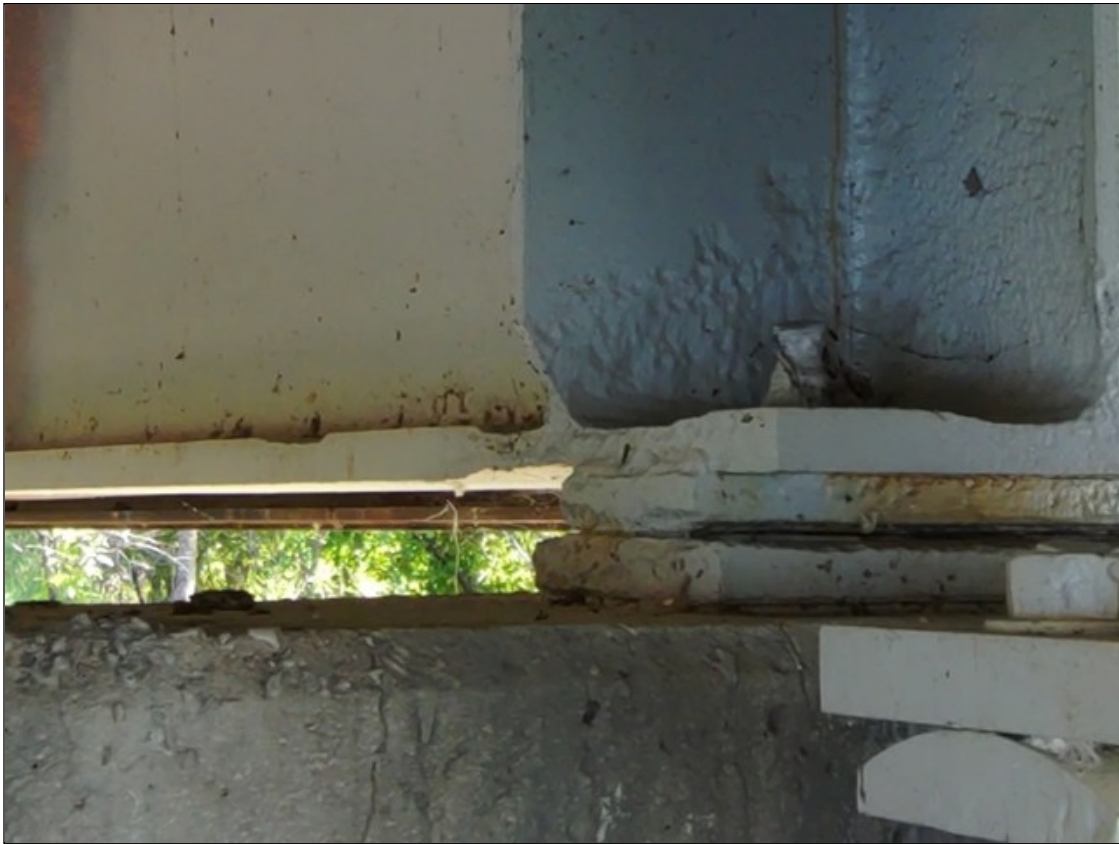
Span 1 Beam 2: AT FAR END, CORROSION WITH SECTION LOSS: BOTTOM RIGHT FLANGE [(2) UP TO 8 INCHES LONG X FULL WIDTH - AVERAGE REMAINING 3/4 INCHES], WEB OVER BEARING [9 INCHES LONG X FULL HEIGHT - AVERAGE REMAINING 1/2 INCHES] (CLEANED AND PAINTED) (PAR)

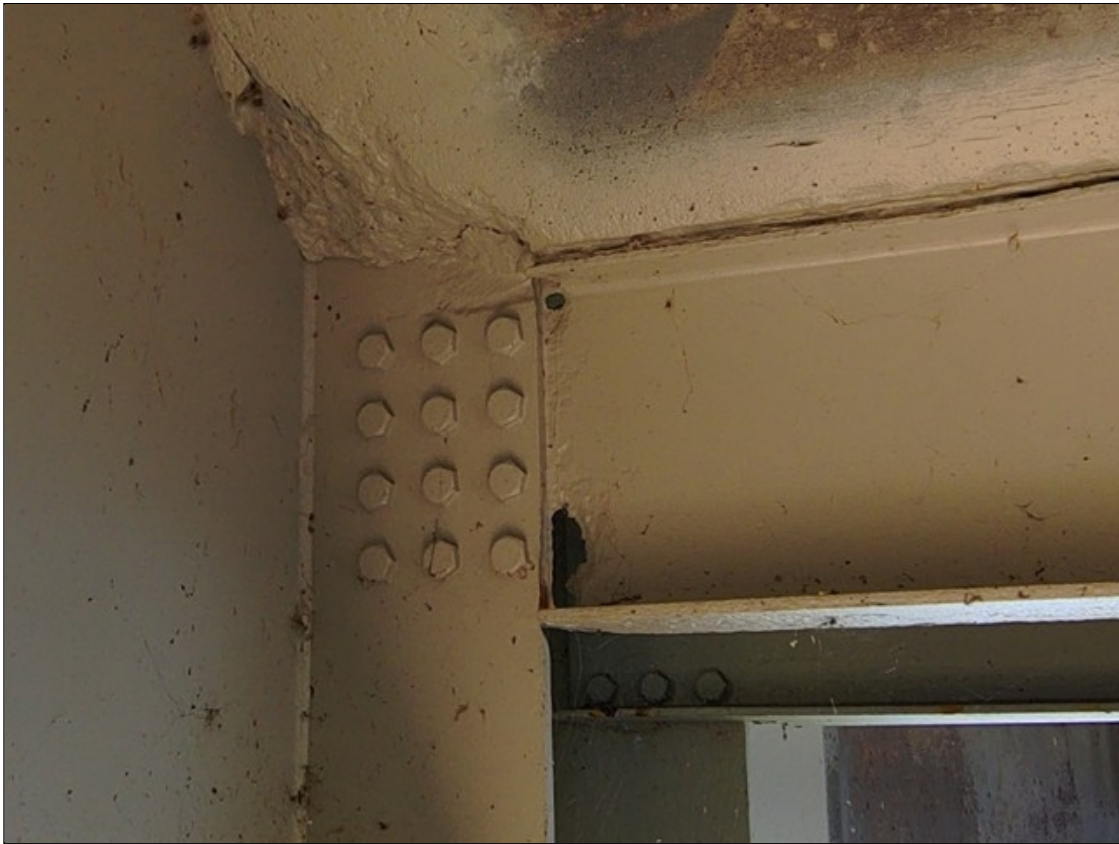
AT END DIAPHRAGM IN BAY 1 ADJACENT TO BEAM 1, ACTIVE CORROSION WITH SECTION LOSS [AVERAGE LOSS OF 1/8 INCH WITH 3 INCH LONG X 1 INCH HIGH CORROSION HOLE] (CLEANED AND PAINTED);  
TEMPORARY REPAIR: 5 FEET LONG X 21 INCHES HIGH WELDED REPAIR TO WEB AT BENT 1 (PAR)

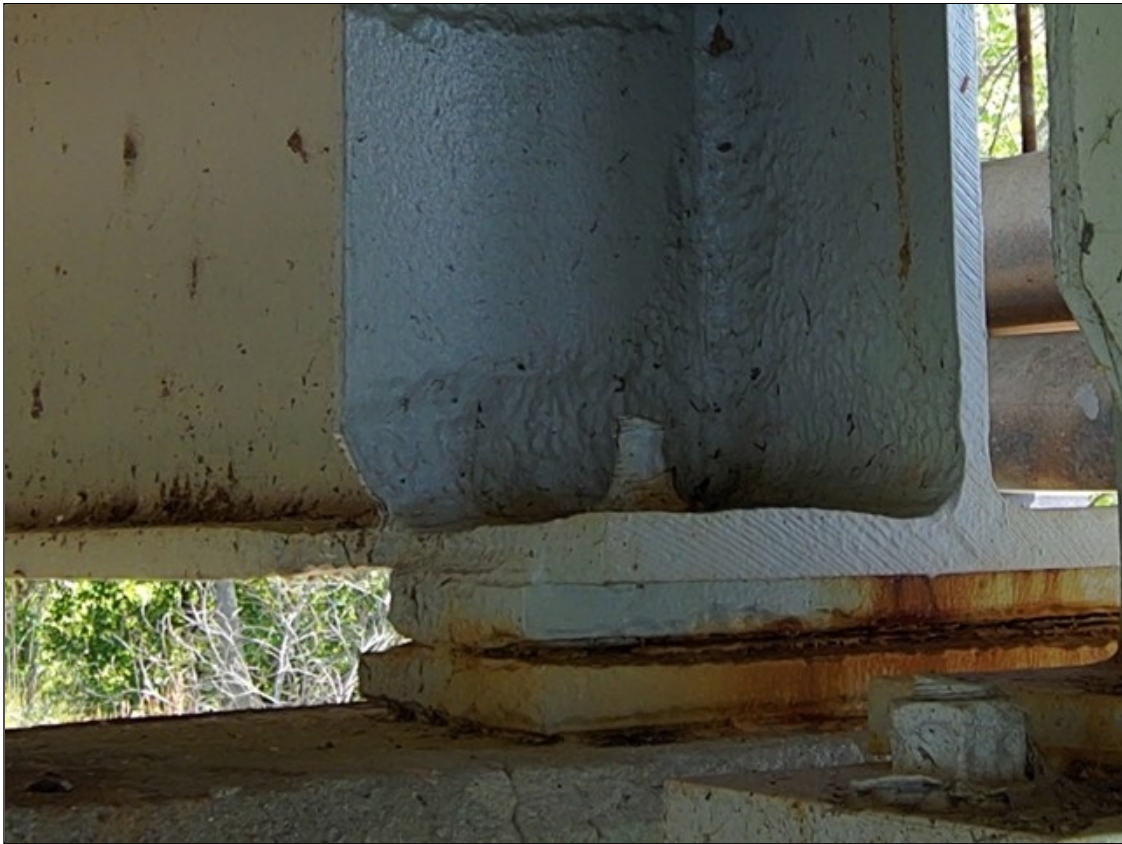
Span 1 Beam 1: 9 INCH LONG X 13 INCH HIGH AREA OF 1/8 INCH SECTION LOSS (3/8 INCH REMAINING) ON RIGHT SIDE OF STIFFENER AT BENT 1 (CLEANED AND PAINTED) (PAR)

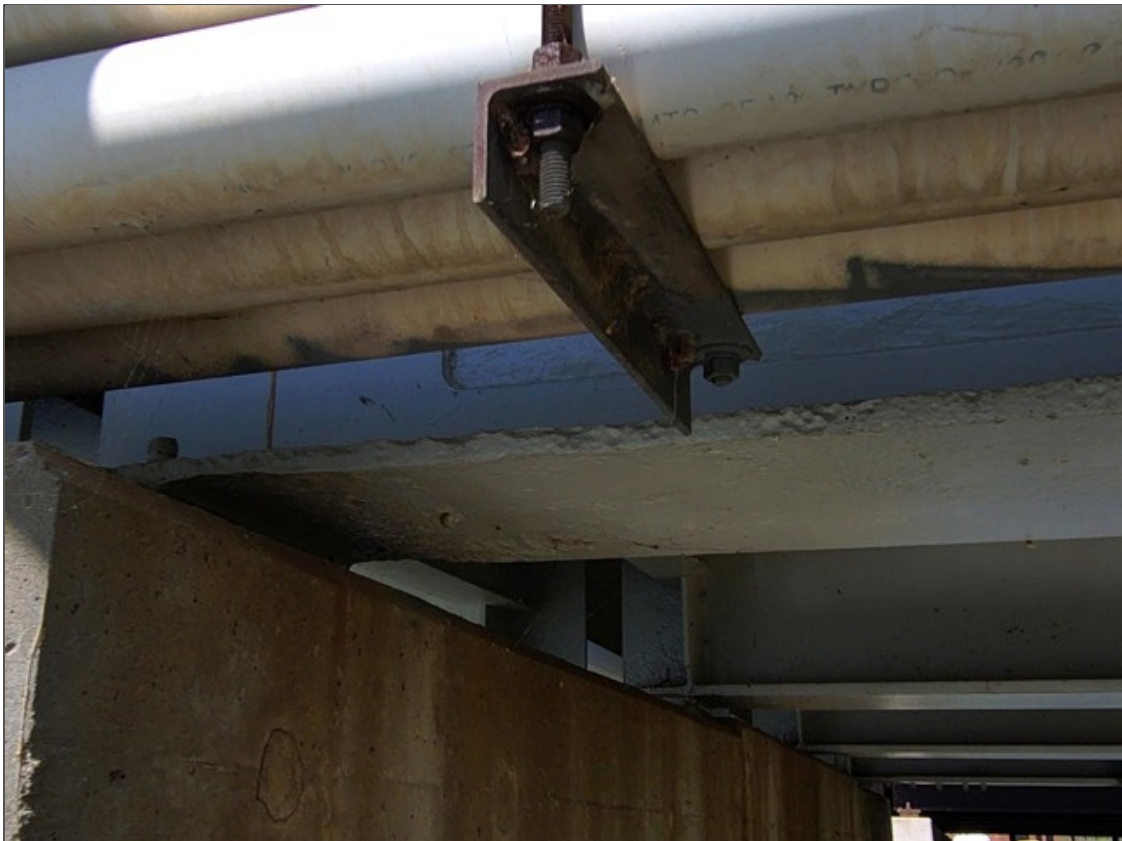
Span 1 Beam 1: AT FAR END, CORROSION WITH SECTION LOSS: BOTTOM FLANGE [18 INCHES LONG X FULL WIDTH - AVERAGE REMAINING 7/8 INCHES] (CLEANED AND PAINTED) (PAR)
