☐ Supplemental Inspection Requested

NC DEPARTMENT OF TRANSPORTATION  
DIVISION OF HIGHWAYS  
STRUCTURE MANAGEMENT UNIT  
COUNTY: CALDWELL DIV: 11

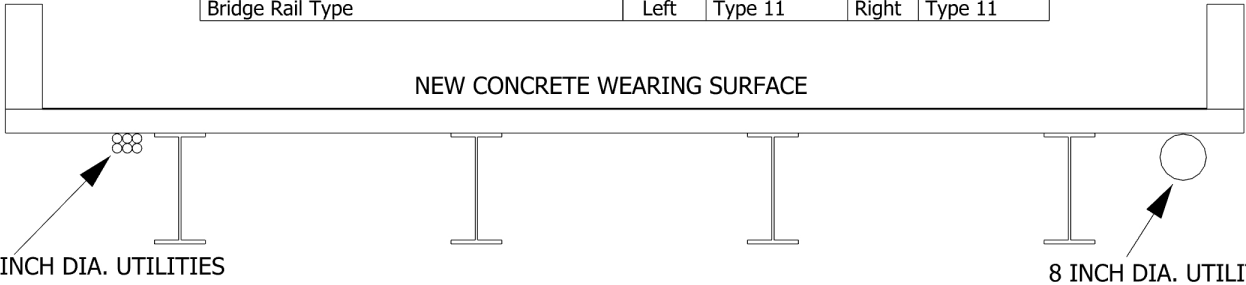
| Measurements for Span # | 1 | | |

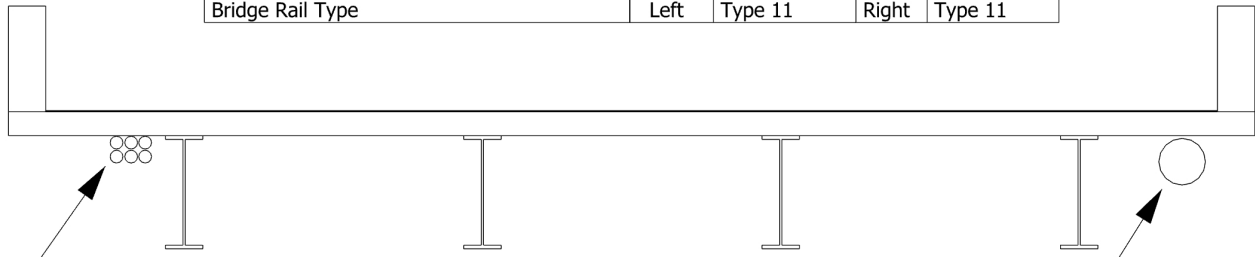
6 - 4 INCH DIA. UTILITIES

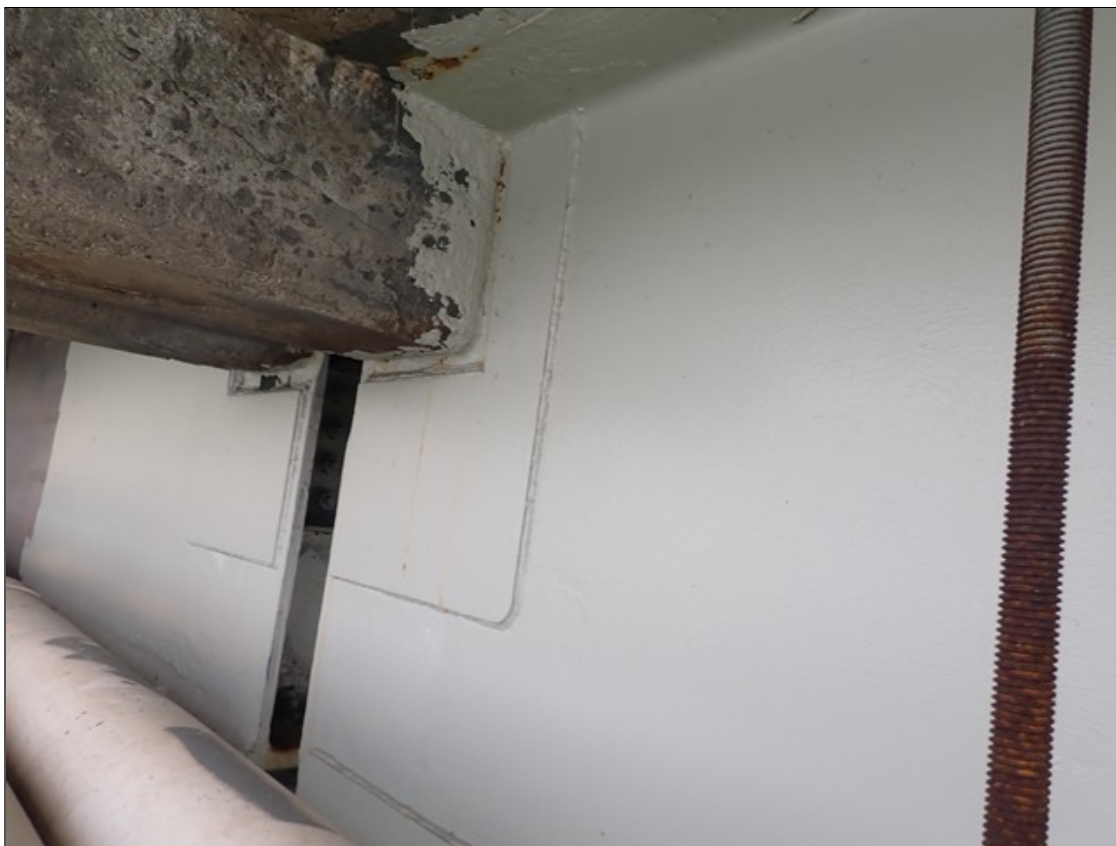
EXTERIOR BEAM 1 REPAIR PLATE AT BENT 9

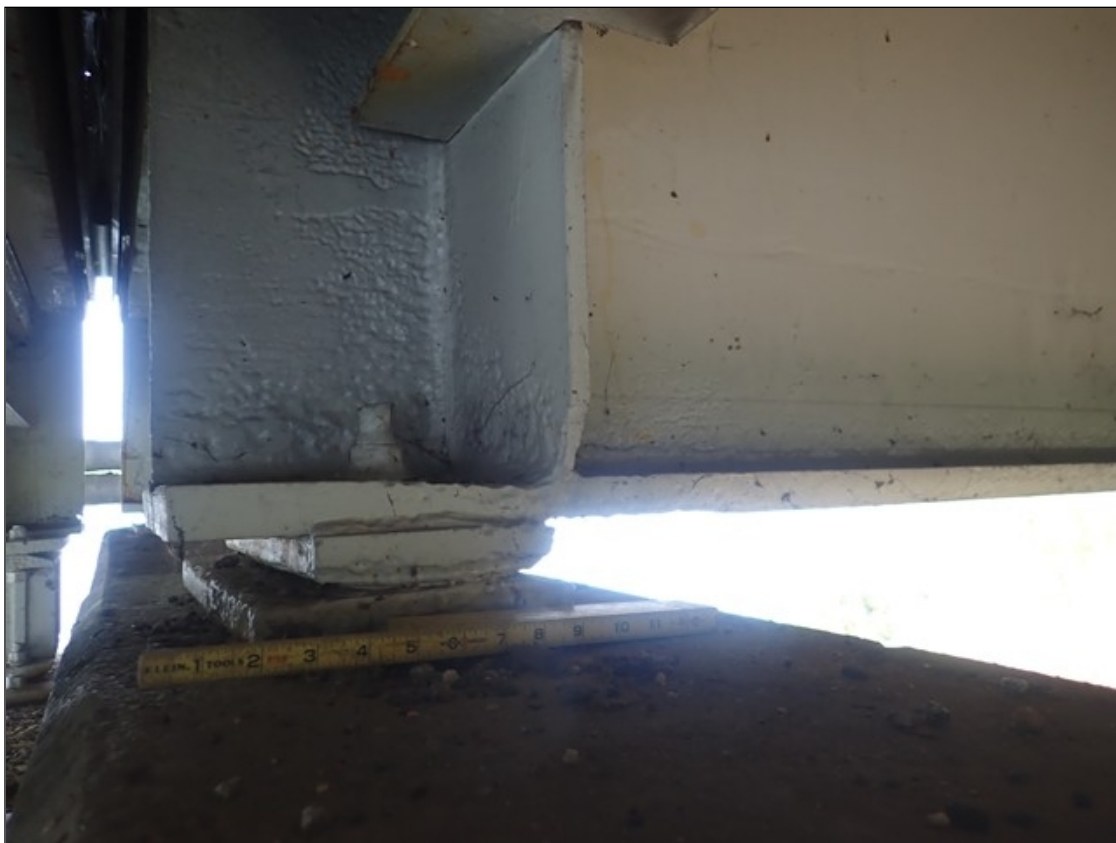
BENT 9 STEEL EXPANSION BEARING

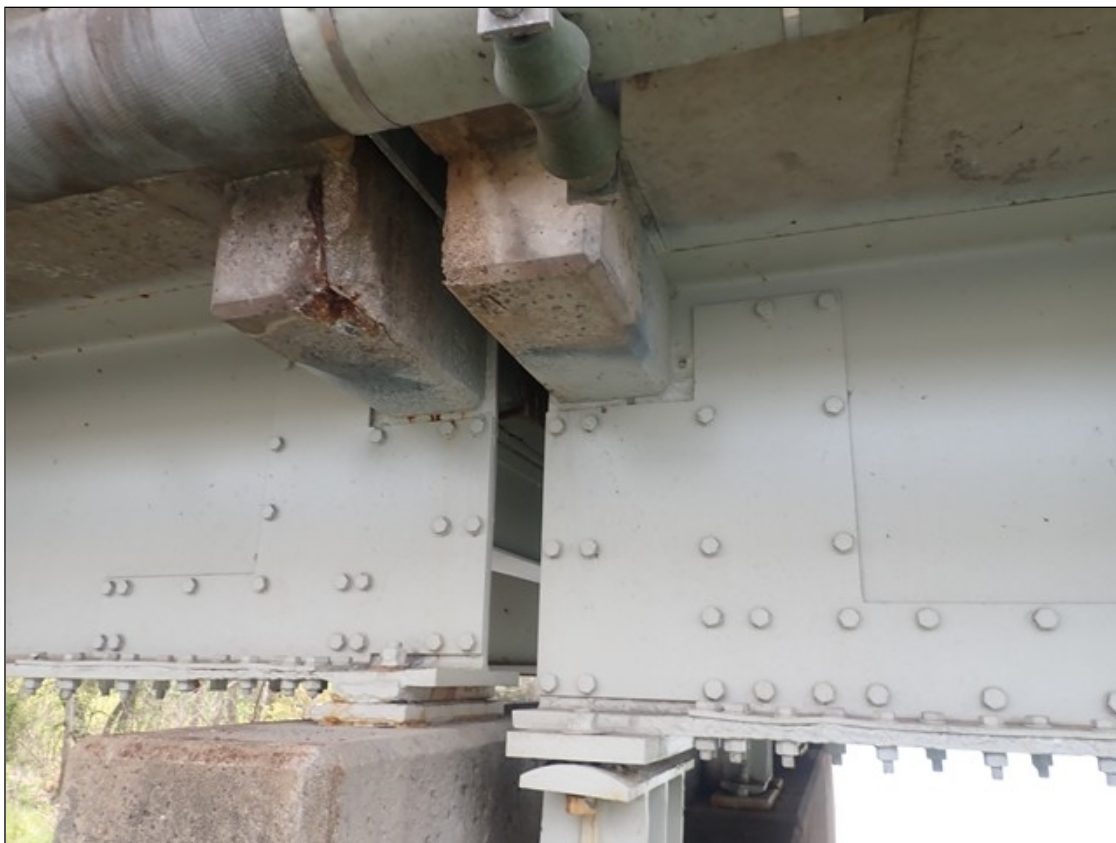
BEAM REPAIRS TO BEAM 4

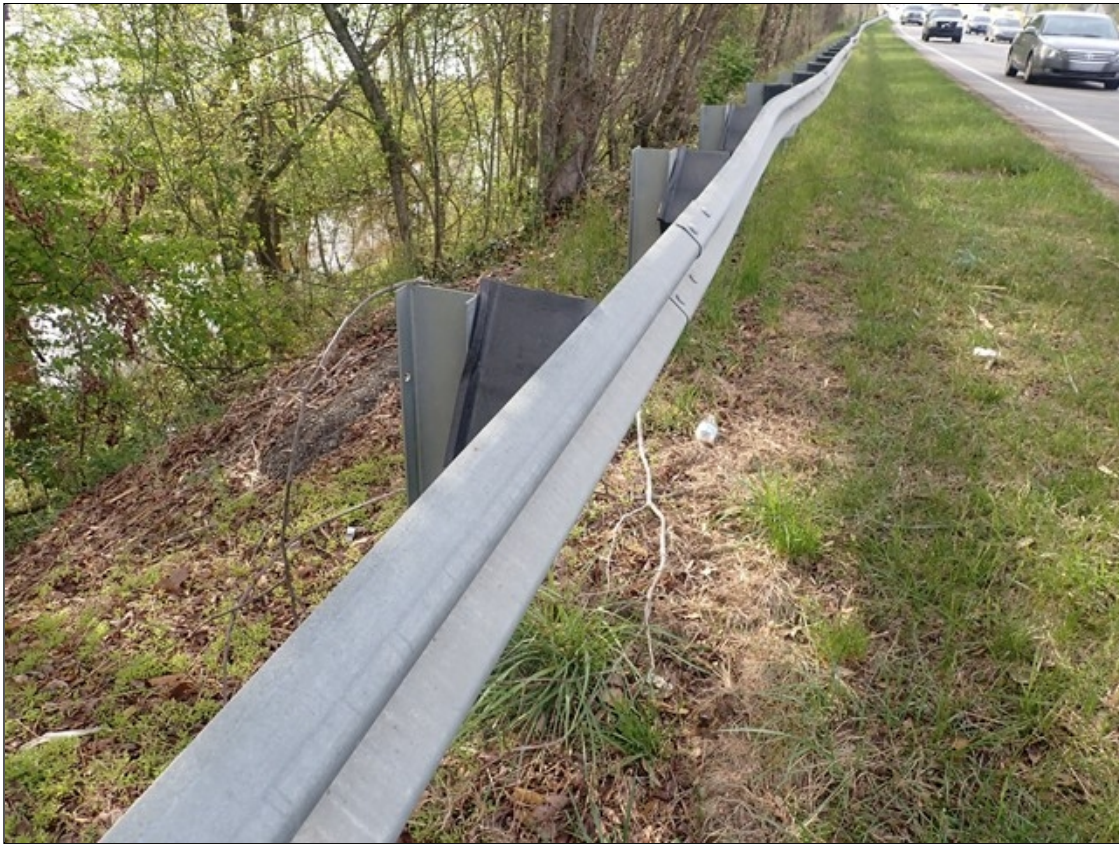
(2) AREAS OF 25 FEET OF IMPACT DAMAGE ON SOUTHWEST GUARDRAIL ACROSS FROM SOUTHEAST GUARDRAIL TERMINAL (PAR)
