NC DEPARTMENT OF TRANSPORTATION  
 DIVISION OF HIGHWAYS  
 STRUCTURE MANAGEMENT UNIT

ATTENTION: **PRIORITY ACTION REQUEST ISSUED; NEW ASPHALT WEARING SURFACE**

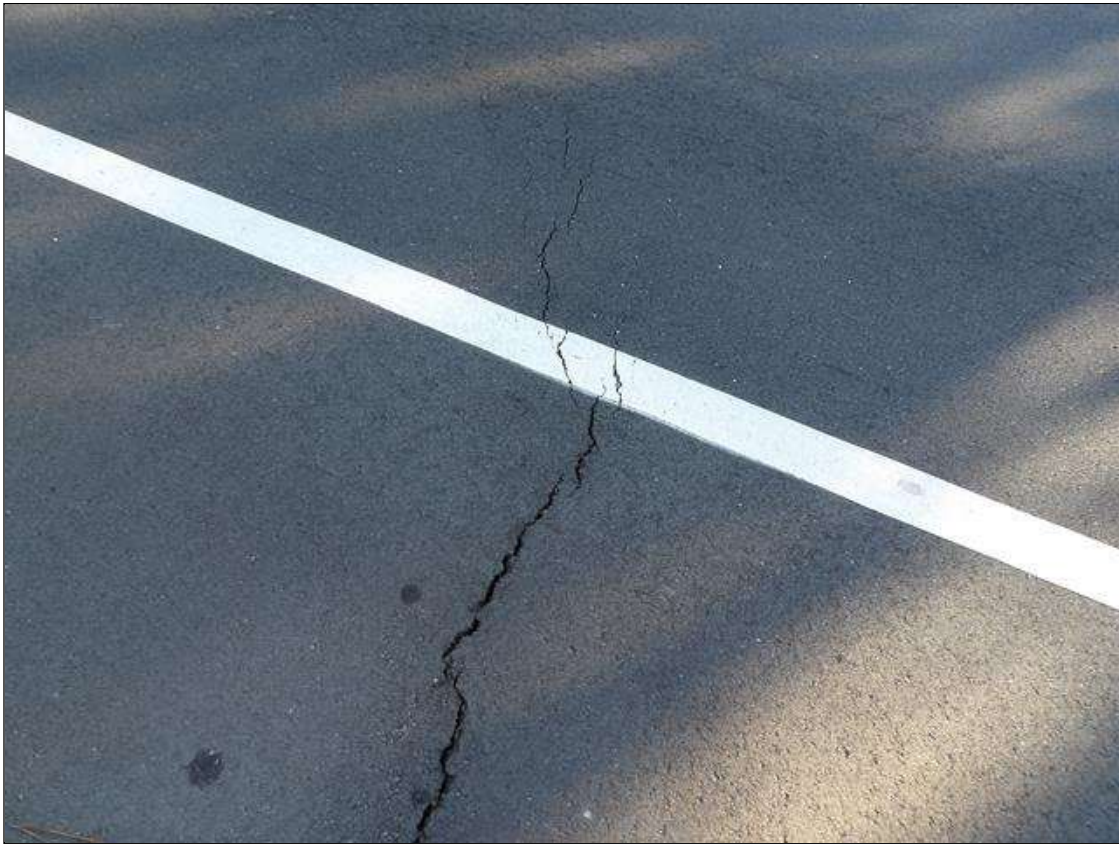
Span 4 Wearing Surface: FULL WIDTH TRANSVERSE/MP CRACKING UP TO 1/4 INCHES WIDE OVER BENT 4,

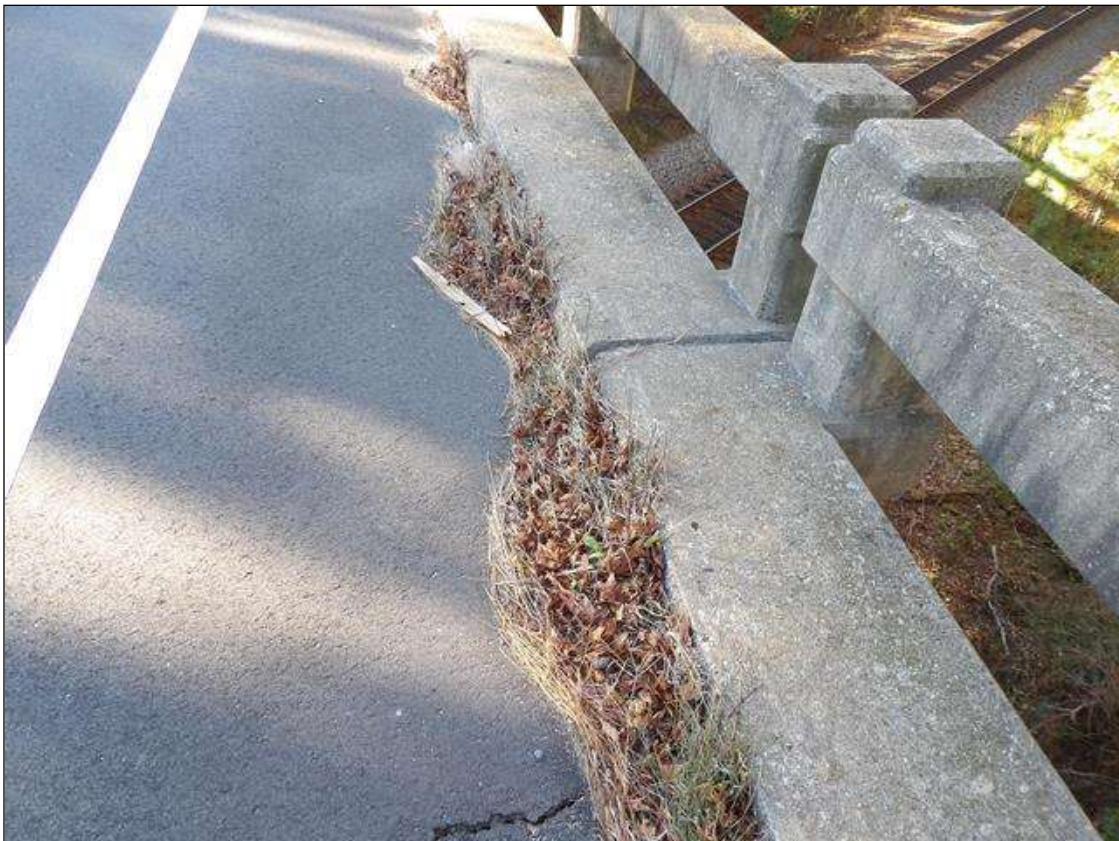
MINOR DEBRIS ACCUMULATION ALONG LEFT RAIL

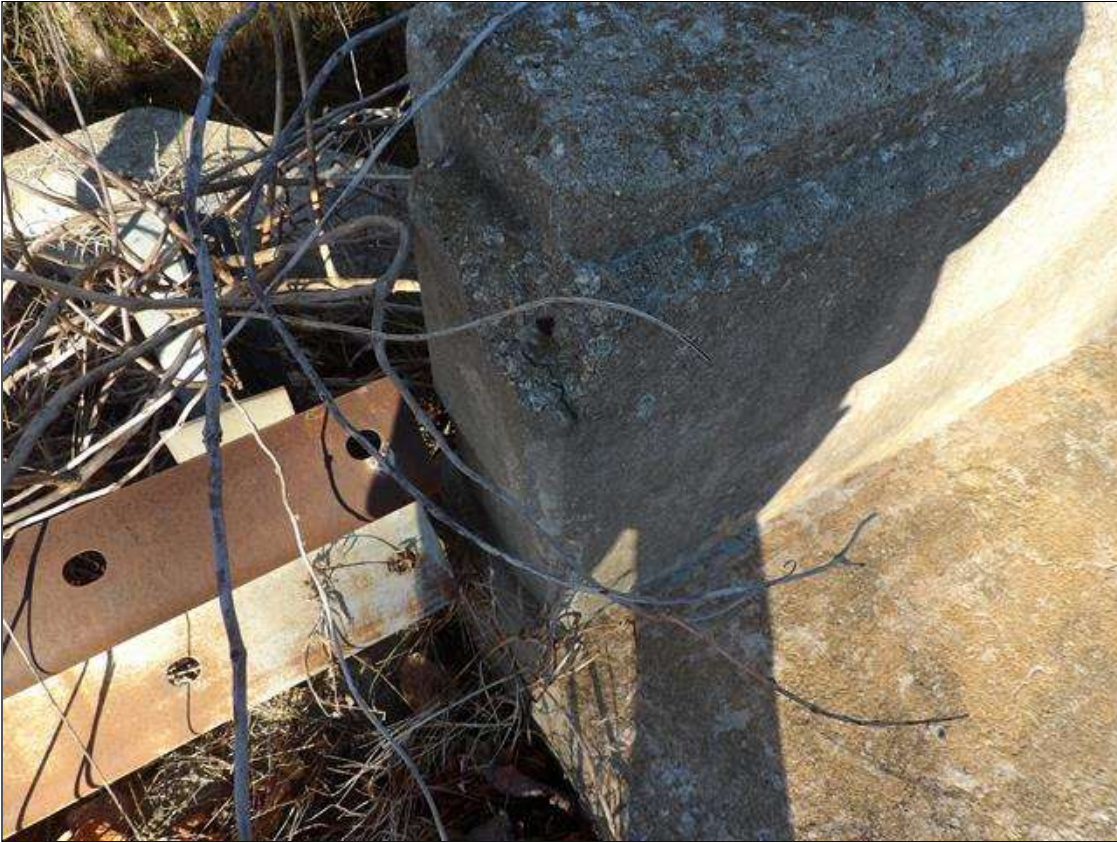
Span 1 Left Bridge Rail: 4 INCHES DIAMETER X 1 INCHES DEEP SPALL WITH EXPOSED REBAR NO LOSS AT END POST AT SOUTHWEST CORNER

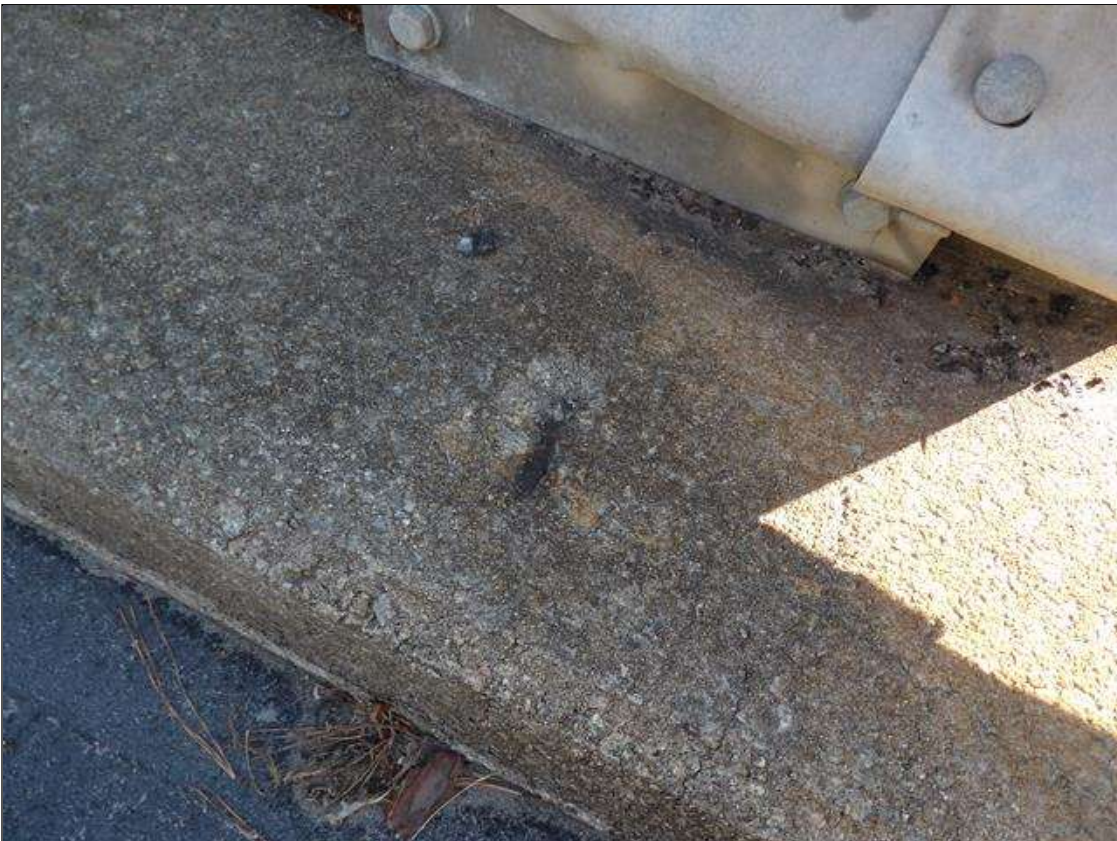
Span 1 Right Bridge Rail: 3 INCHES X 1 INCHES X 1/2 INCHES DEEP SPALL WITH EXPOSED REBAR NO LOSS IN TOP OF CURB AT GUARDRAIL ATTACHMENT

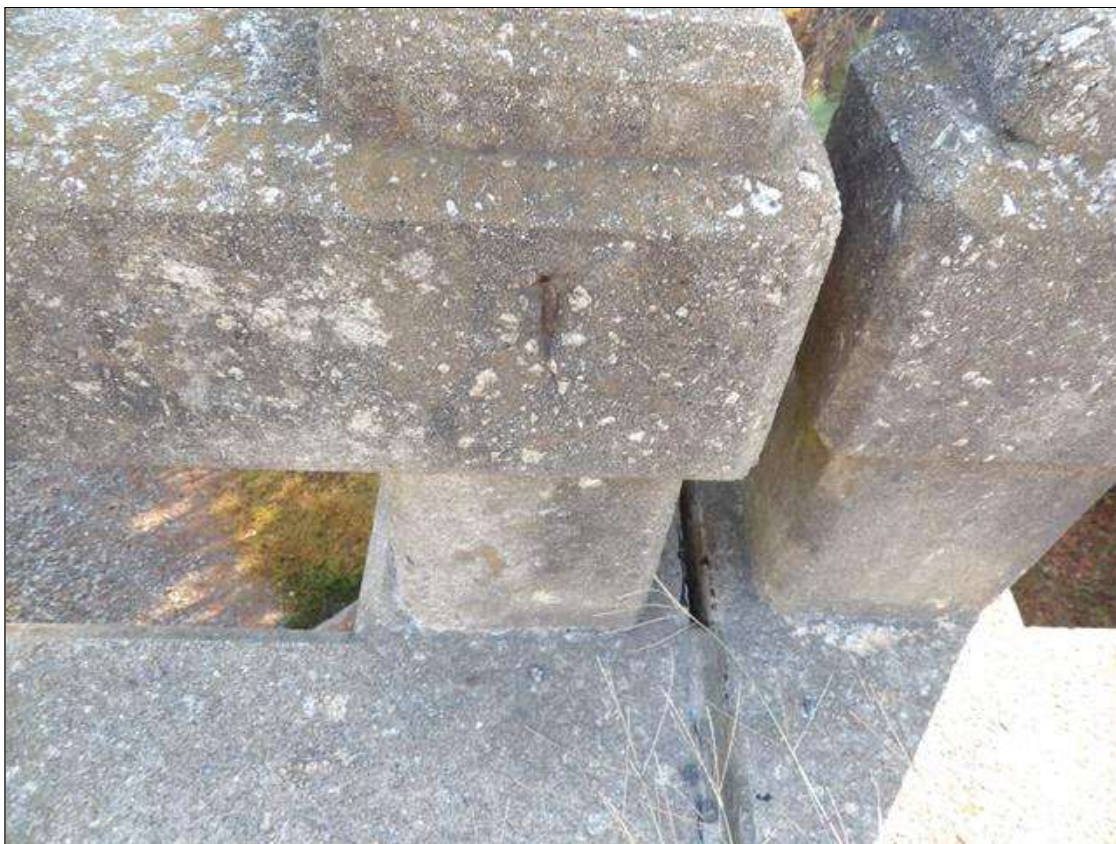
Span 3 Right Bridge Rail: 3 INCHES X 1 INCHES X 1/2 INCHES DEEP SPALL WITH EXPOSED REBAR NO LOSS IN FACE OF RAIL POST AT BENT 2

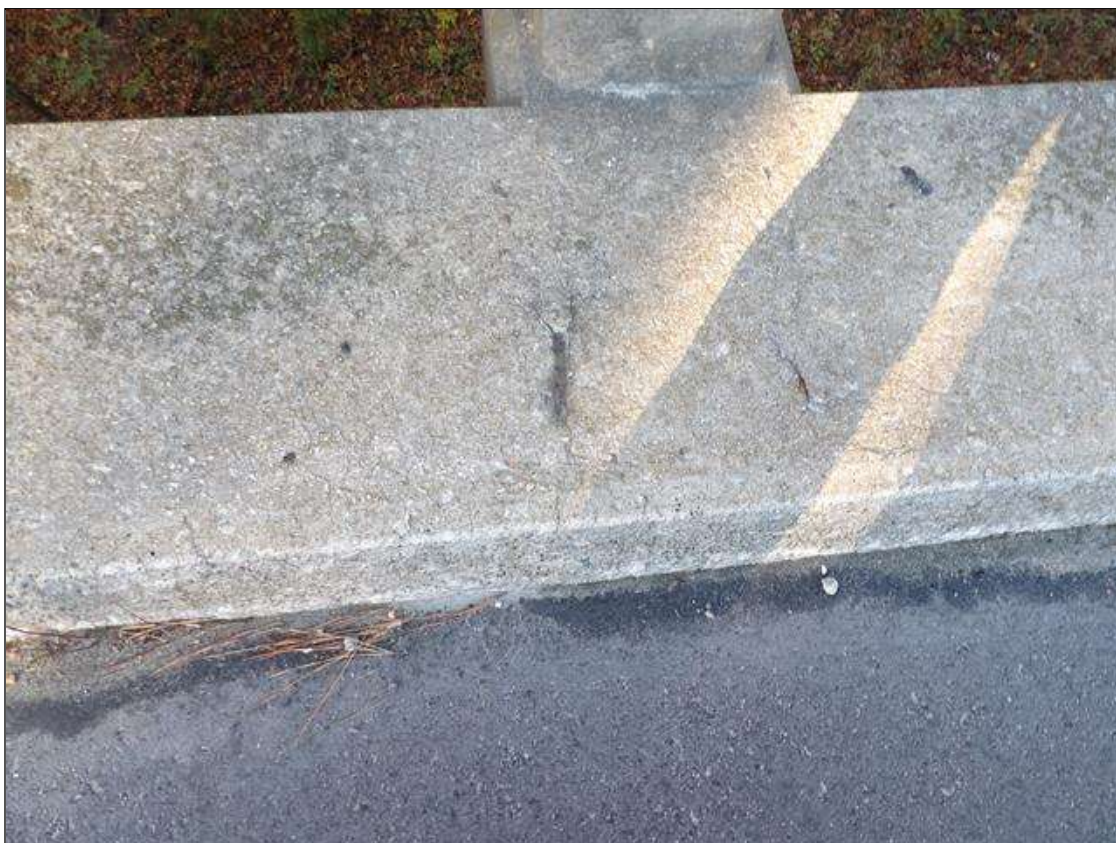
Span 4 Left Bridge Rail: 3 INCHES X 1 INCHES X 1/2 INCHES DEEP SPALL WITH EXPOSED REBAR NO LOSS IN TOP OF CURB AT 10 FEET FROM BENT 4

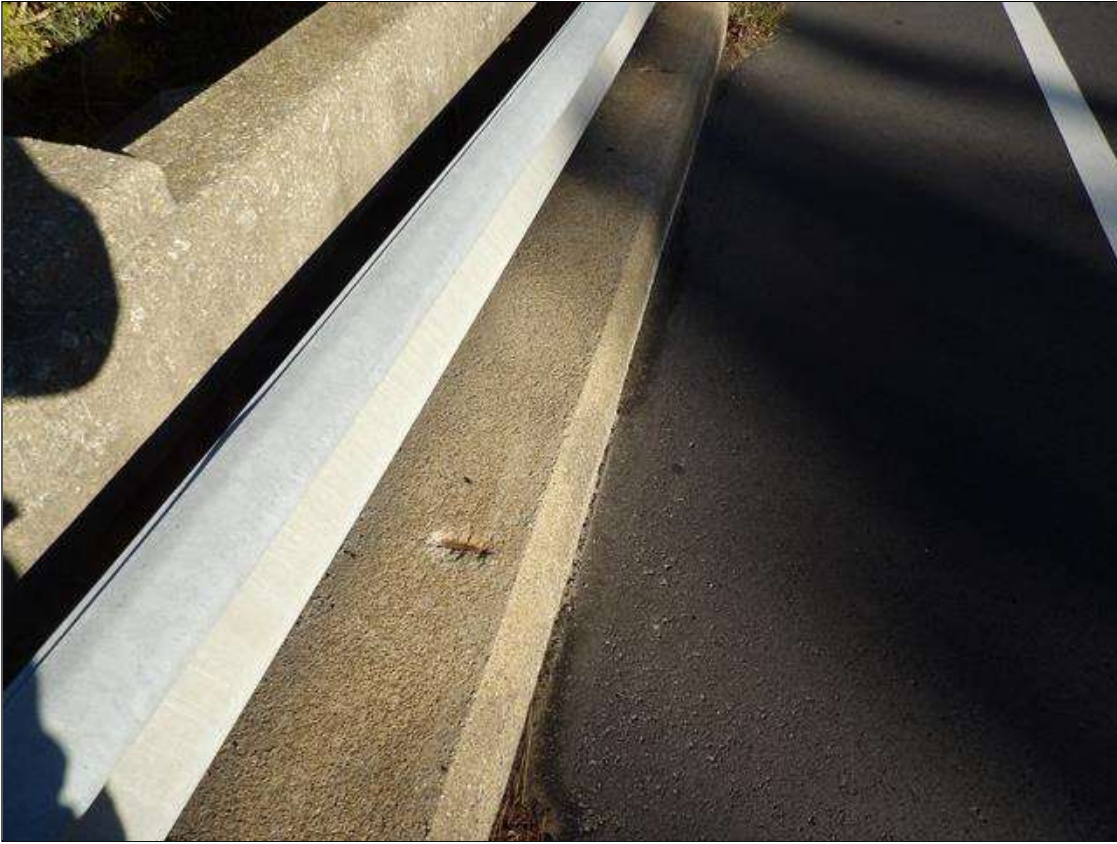
Span 5 Left Bridge Rail: TWO SPALLS WITH EXPOSED REBAR NO LOSS 3 INCHES X 1 INCHES X 1/2 INCHES DEEP IN TOP OF CURB AT 12 FEET AND 6 FEET FROM END BENT 2

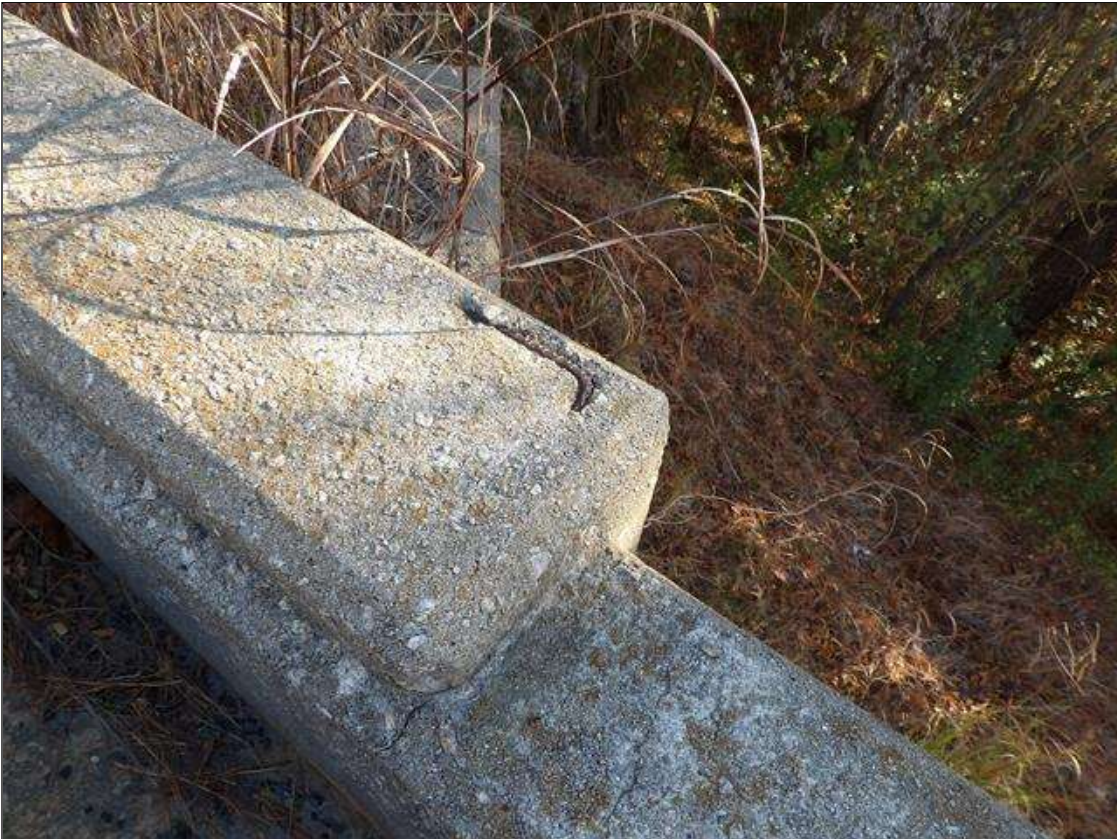
Span 5 Right Bridge Rail: FAR END ON THE TOP OF THE REINFORCED CONCRETE RAIL, EXPOSED REBAR [APPROXIMATELY 5 INCHES LONG X 1/2 INCHES WIDE] WITH NO MEASURABLE SECTION LOSS

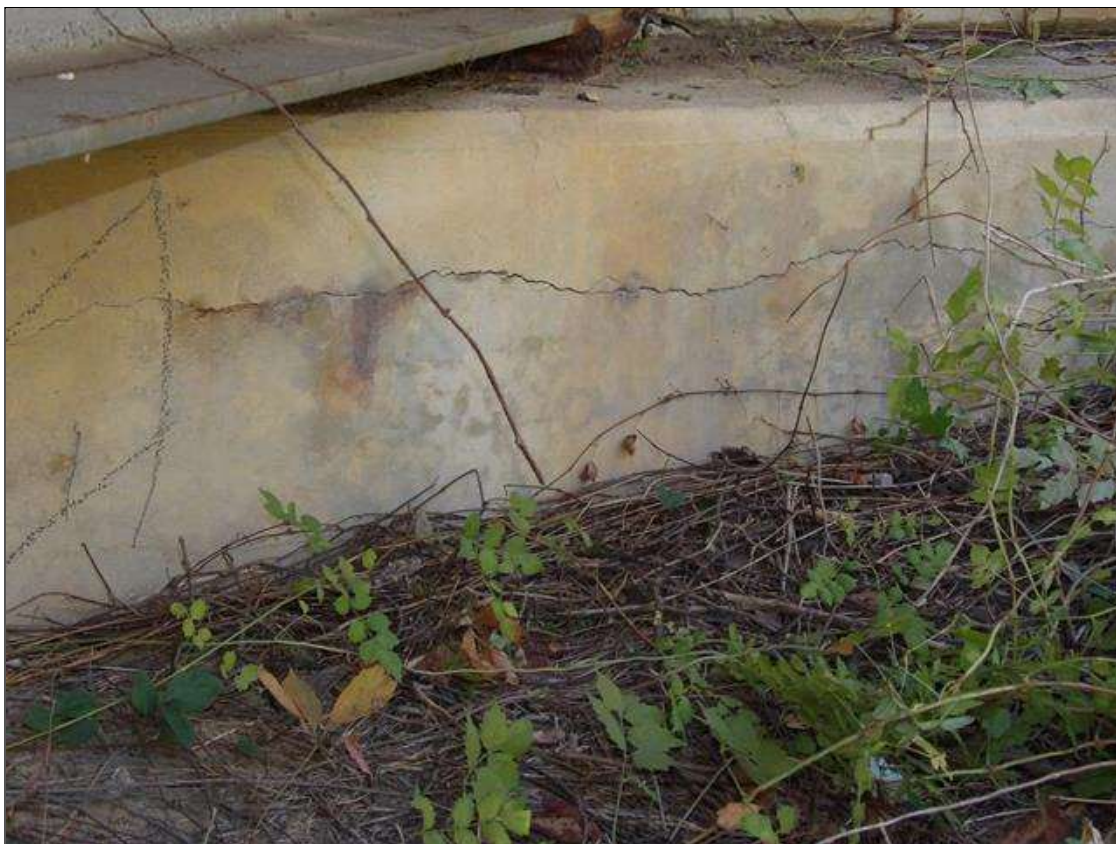
End Bent 1 Cap 1: 6 FEET HORIZONTAL CRACK UP TO 1/8 INCHES WIDE UNDER BEAM 1

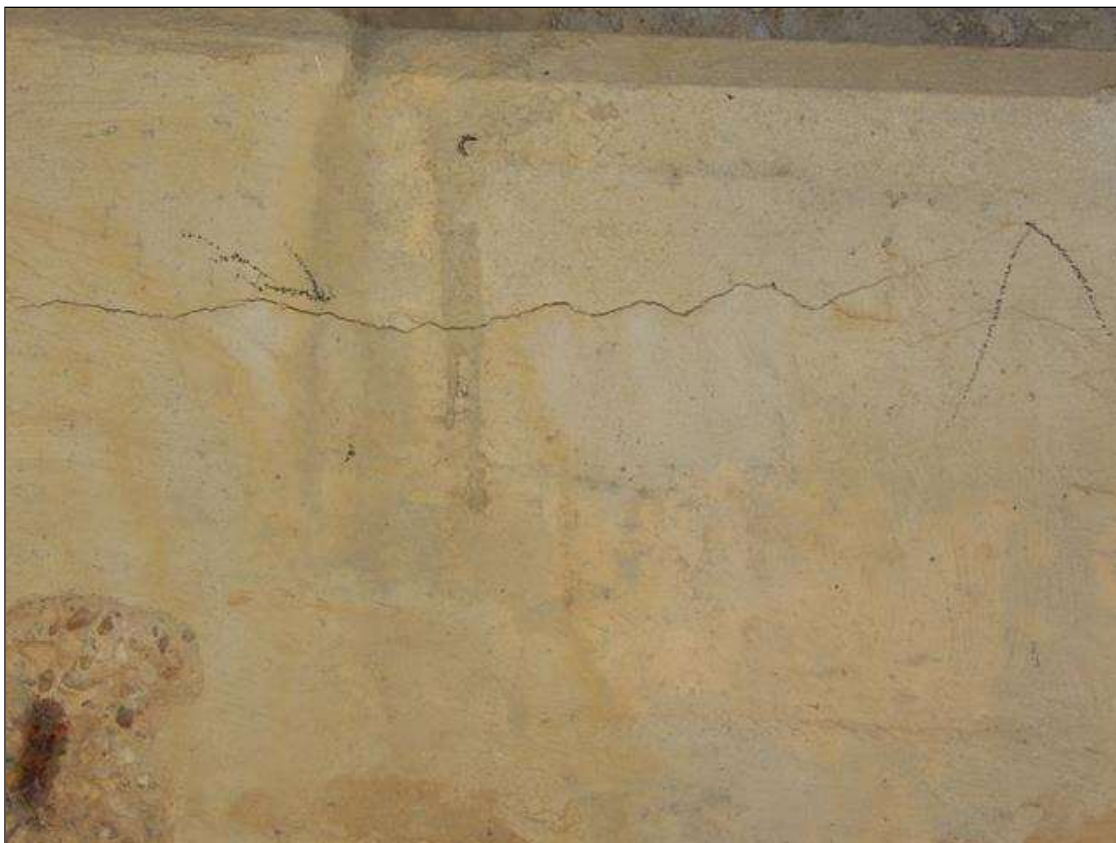
End Bent 1 Cap 1: 3 FEET HORIZONTAL CRACK UP TO 1/16 INCHES WIDE UNDER BAY 4

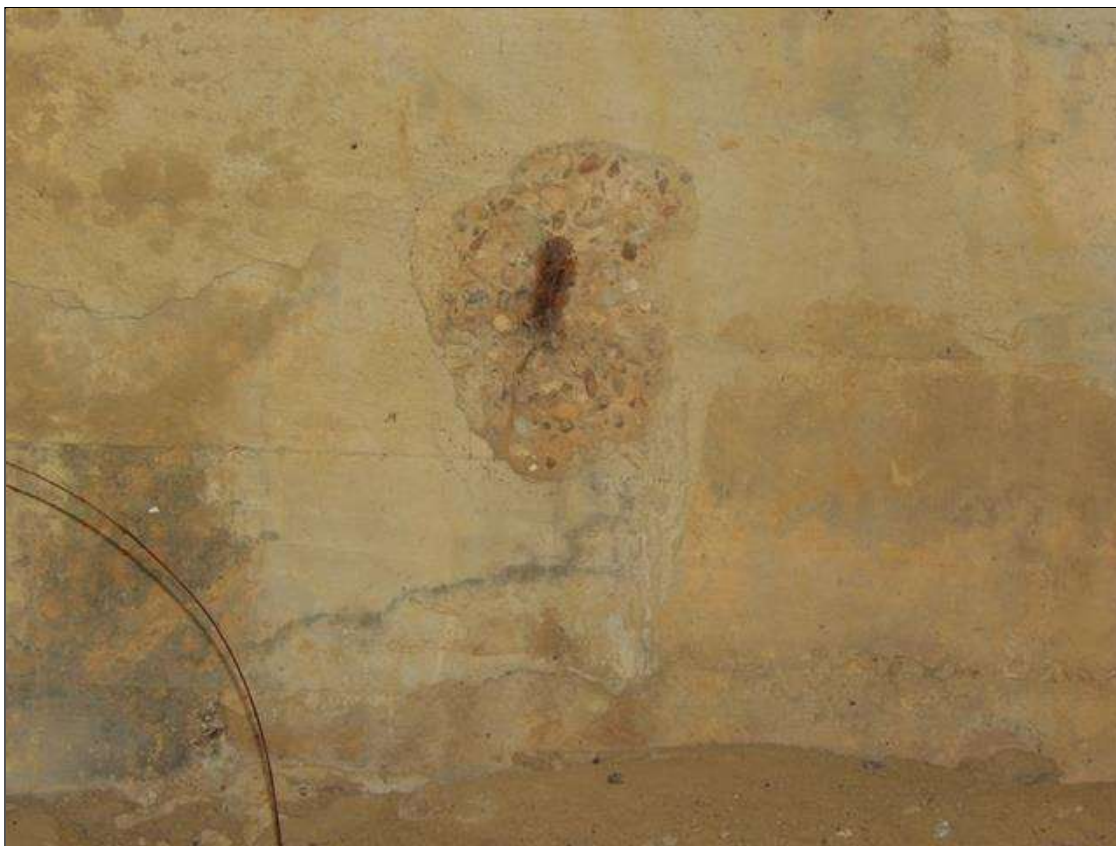
End Bent 1 Cap 1: 8 INCHES DIAMETER X 1 INCHES DEEP SPALL WITH EXPOSED REBAR NO LOSS UNDER BAY 4

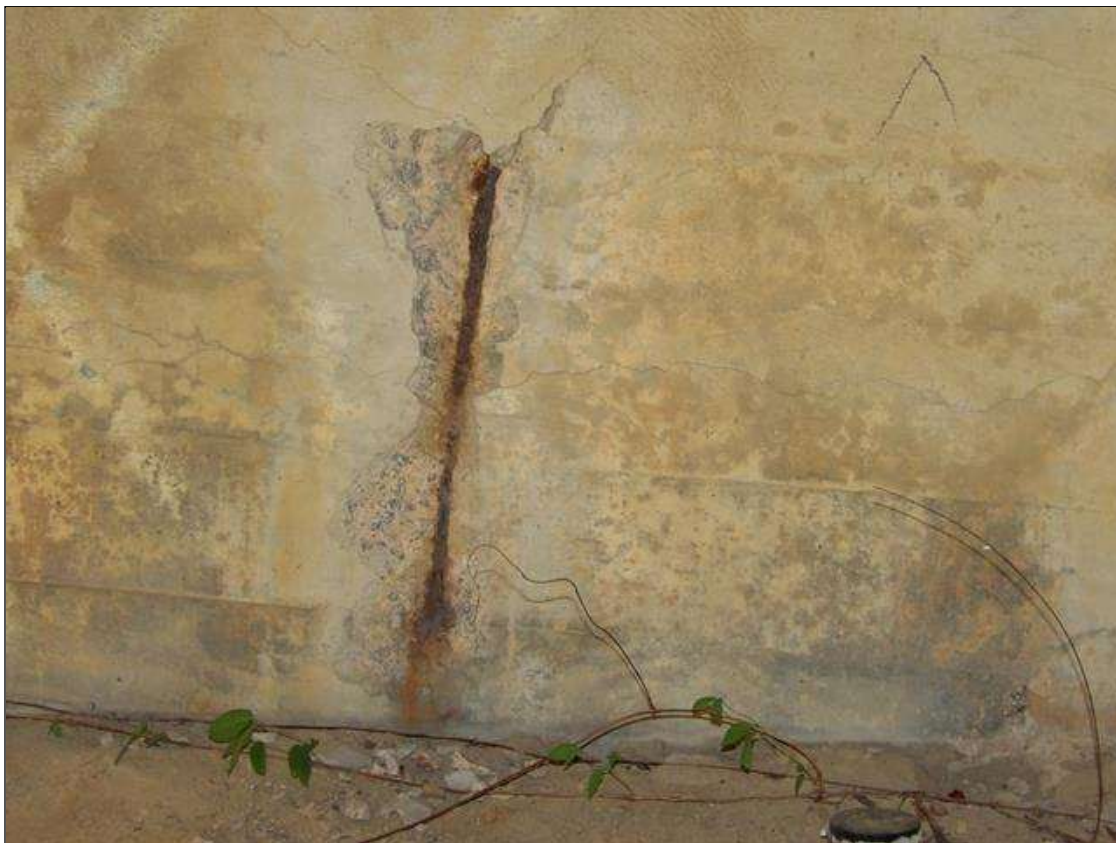
End Bent 1 Cap 1: 8 INCHES X 2 FEET X 3/4 INCHES DEEP SPALL WITH EXPOSED REBAR NO LOSS UNDER BAY 4

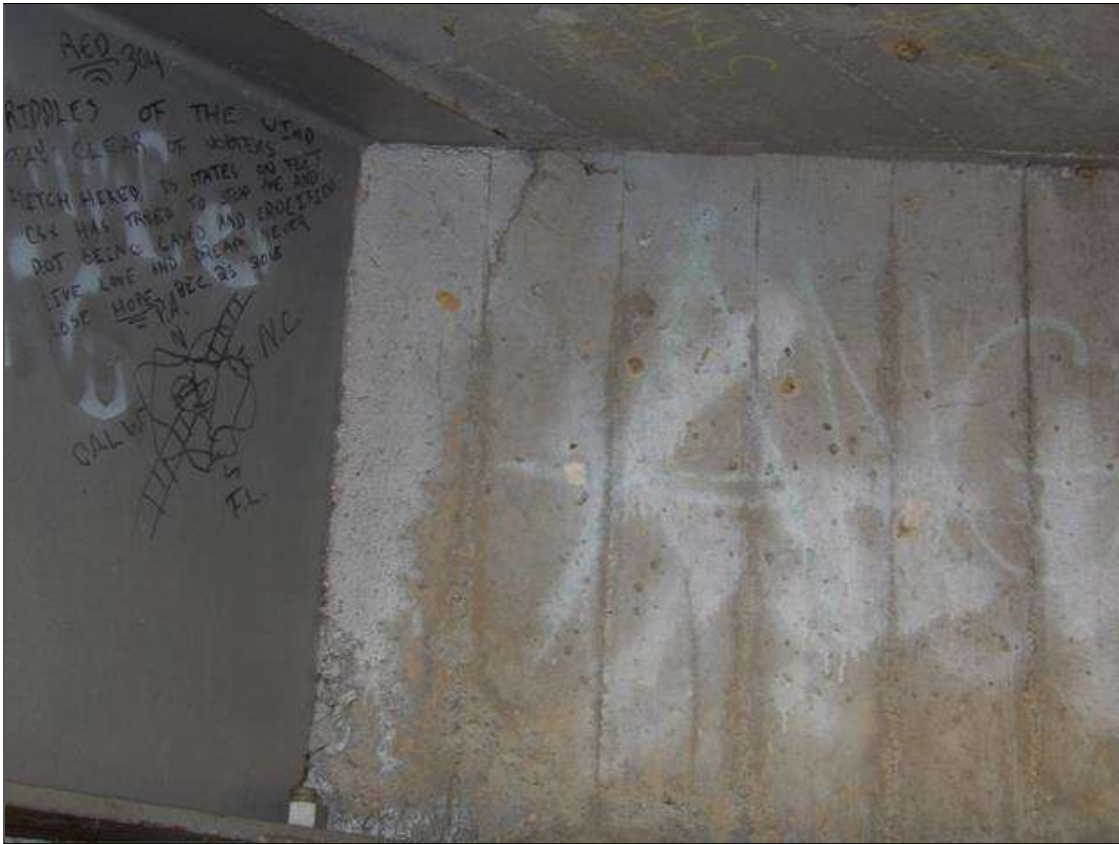
End Bent 1 Abutment: 1 FEET LONG VERTICAL HAIRLINE TO 1/32 INCHES CRACK BAY 3

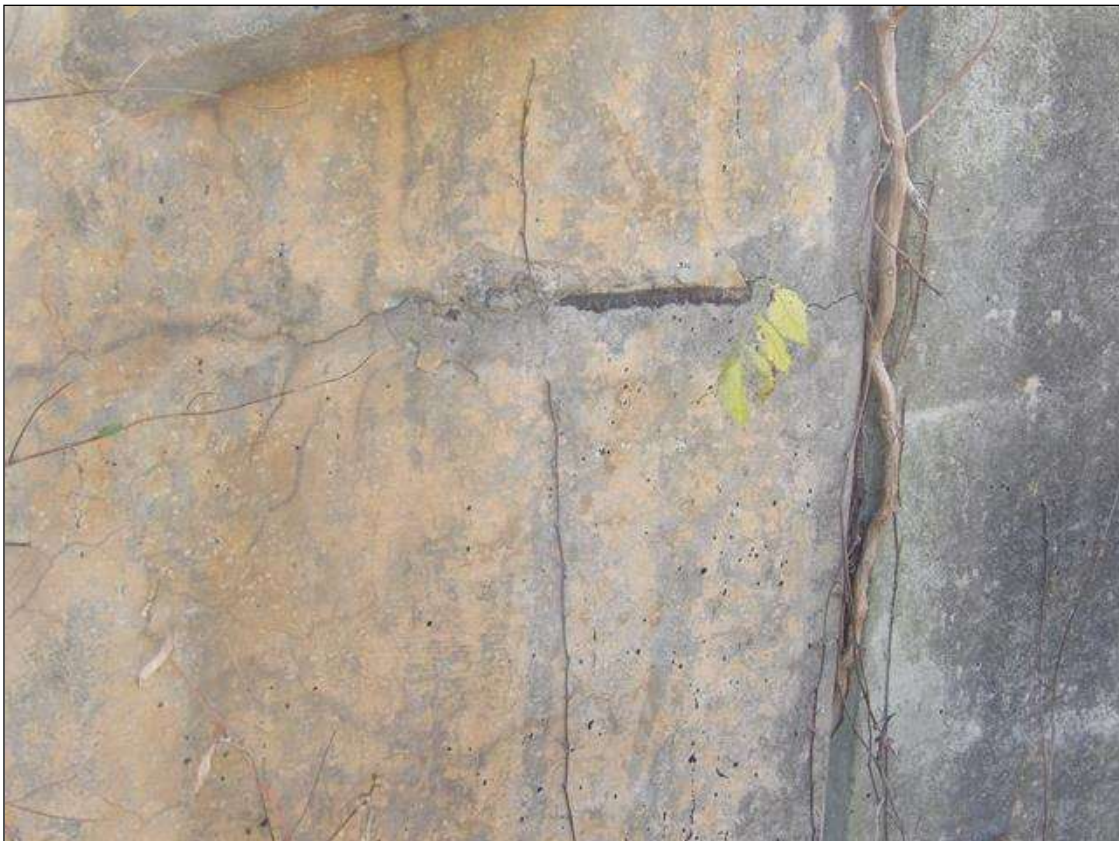
End Bent 1 Abutment: SPALL WITH EXPOSED REBAR NO LOSS 12 INCHES X 2 INCHES X 1/2 INCHES DEEP WITH CRACK WITH EFFLORESCENCE 12 INCHES LONG X UP TO 1/32 INCHES WIDE AT WEST END

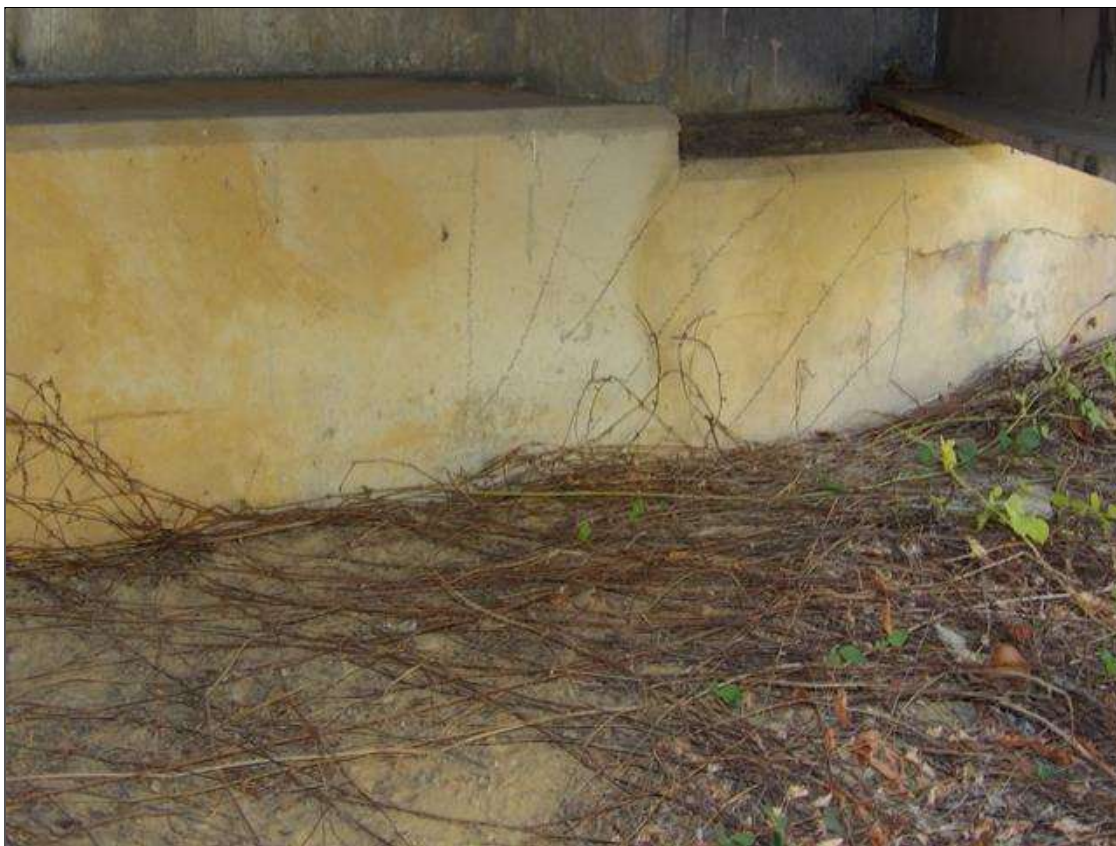
End Bent 1 Cap 1: DELAMINATION 3 FEET LONG X 2 FEET HIGH UNDER BEAM 1 NORTH FACE

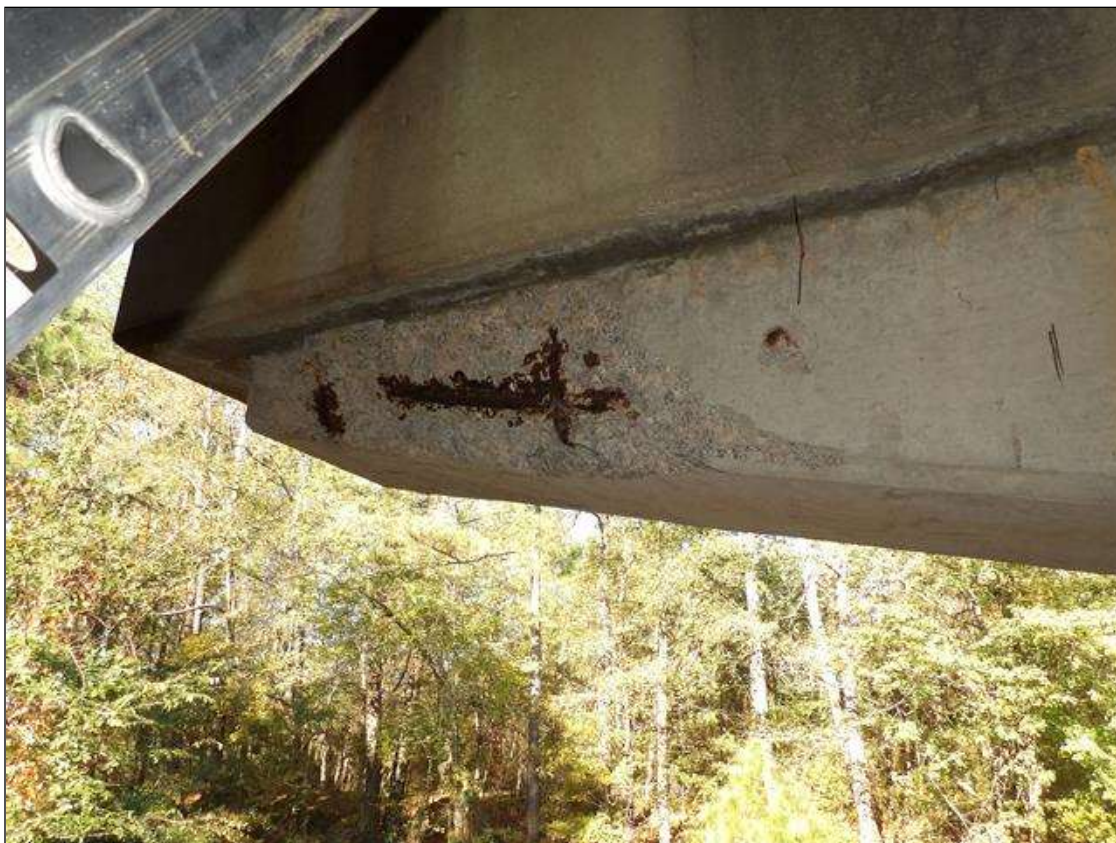
Bent 1 Cap 1: SOUTH FACE AT THE LEFT END, LOWER 10 INCHES, SPALLING WITH EXPOSED REBAR NO MEASURABLE SECTION LOSS [APPROXIMATLY 40 INCHES LONG X UP TO 2.5 INCHES DEEP]

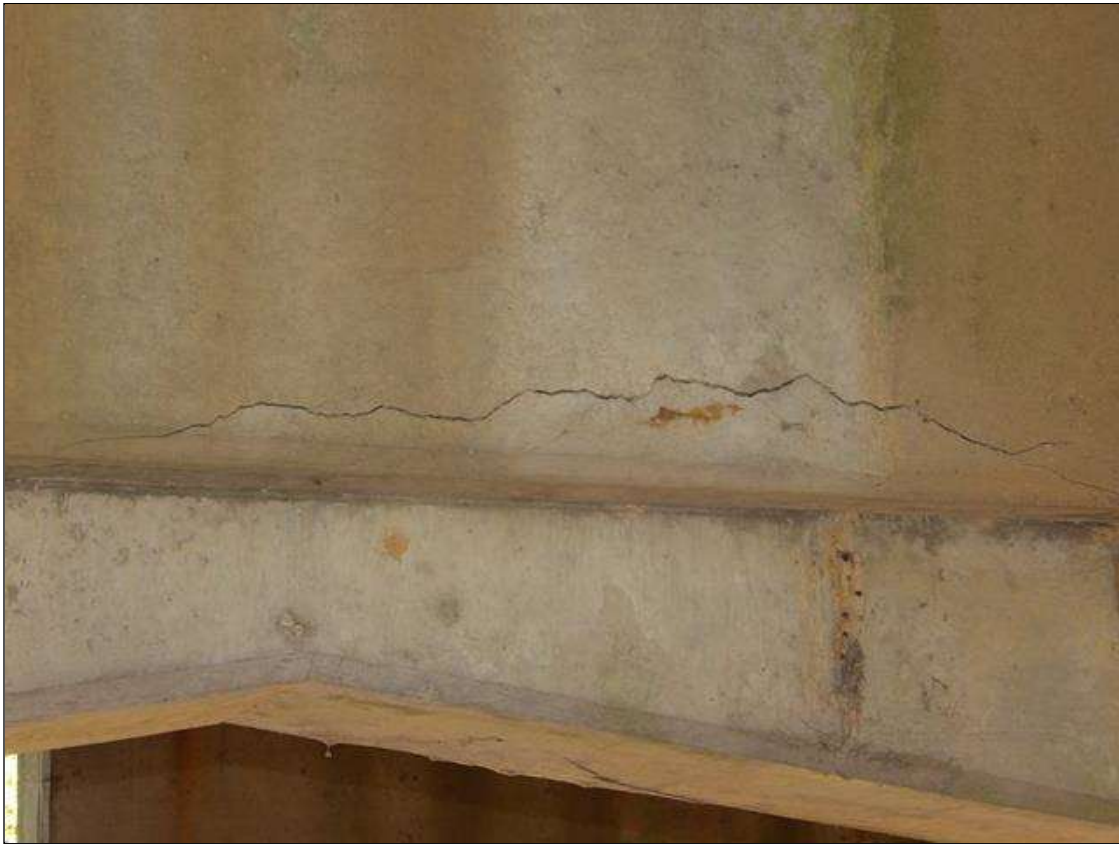
Bent 1 Cap 1: HORIZONTAL CRACK 3 FEET LONG UP TO 3/16 INCHES WIDE IN SOUTH FACE MID WAY BETWEEN COLUMNS 1 AND 2

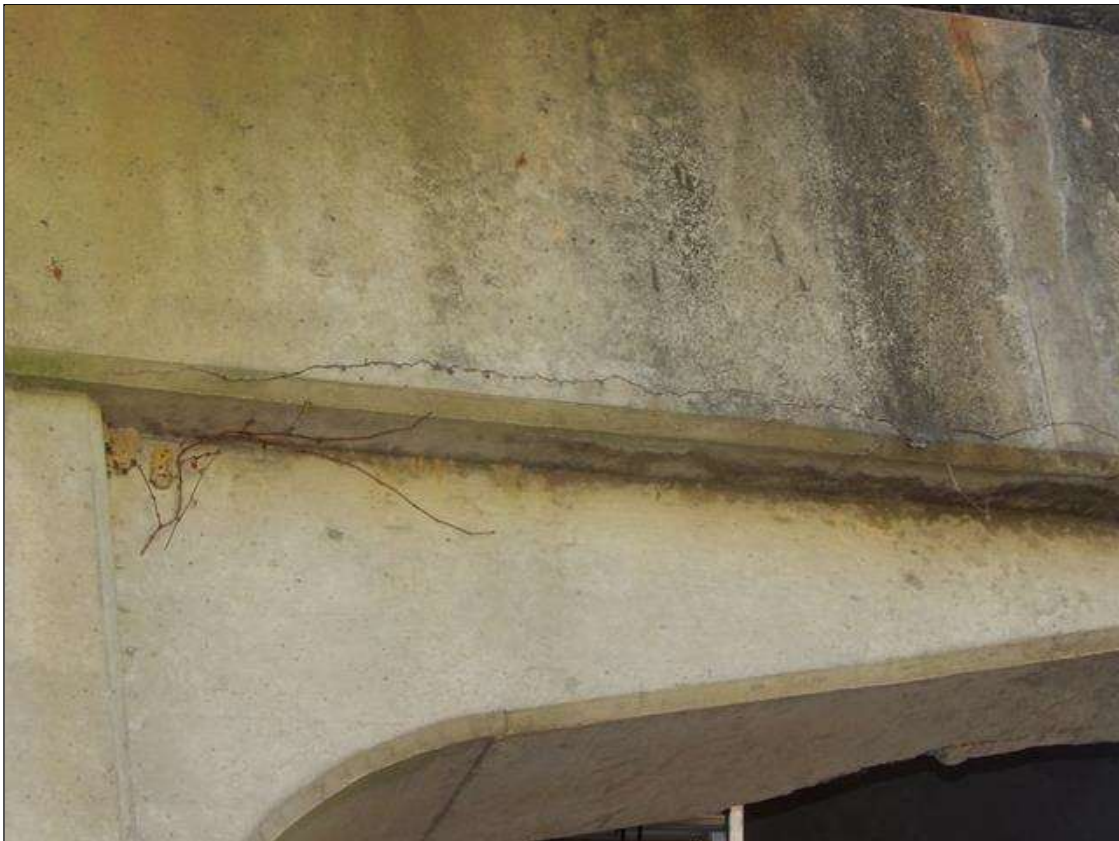
Bent 1 Cap 1: 6 FEET LONG X 1/8 INCHES WIDE HORIZONTAL CRACK NORTH FACE UNDER BAY 1 AND A 1/16 INCH WIDE HORIZONTAL CRACK 1.5 FOOT LONG UNDER BEAM 4

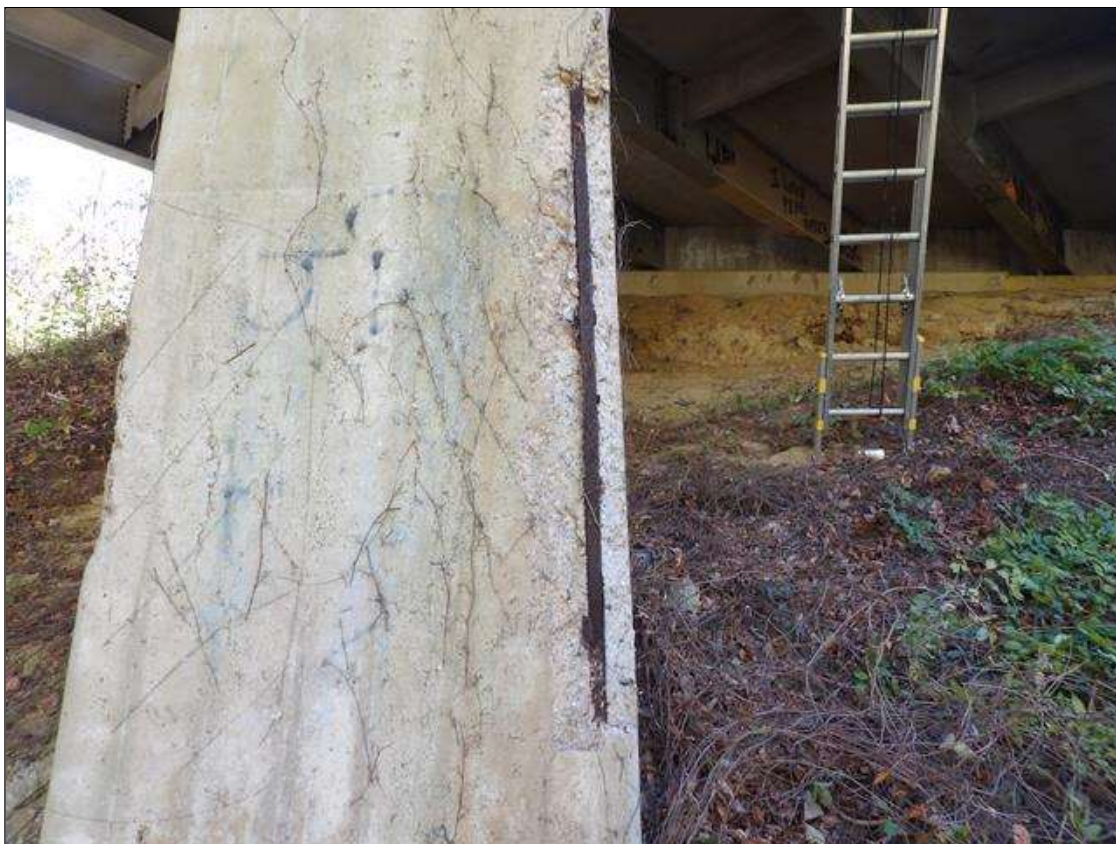
Bent 1 Pile 1: 6 FOOT X 9 INCHES X 2 INCHES DEEP SPALL WITH EXPOSED RUSTED REBAR NO SECTION LOSS AT NORTHWEST CORNER

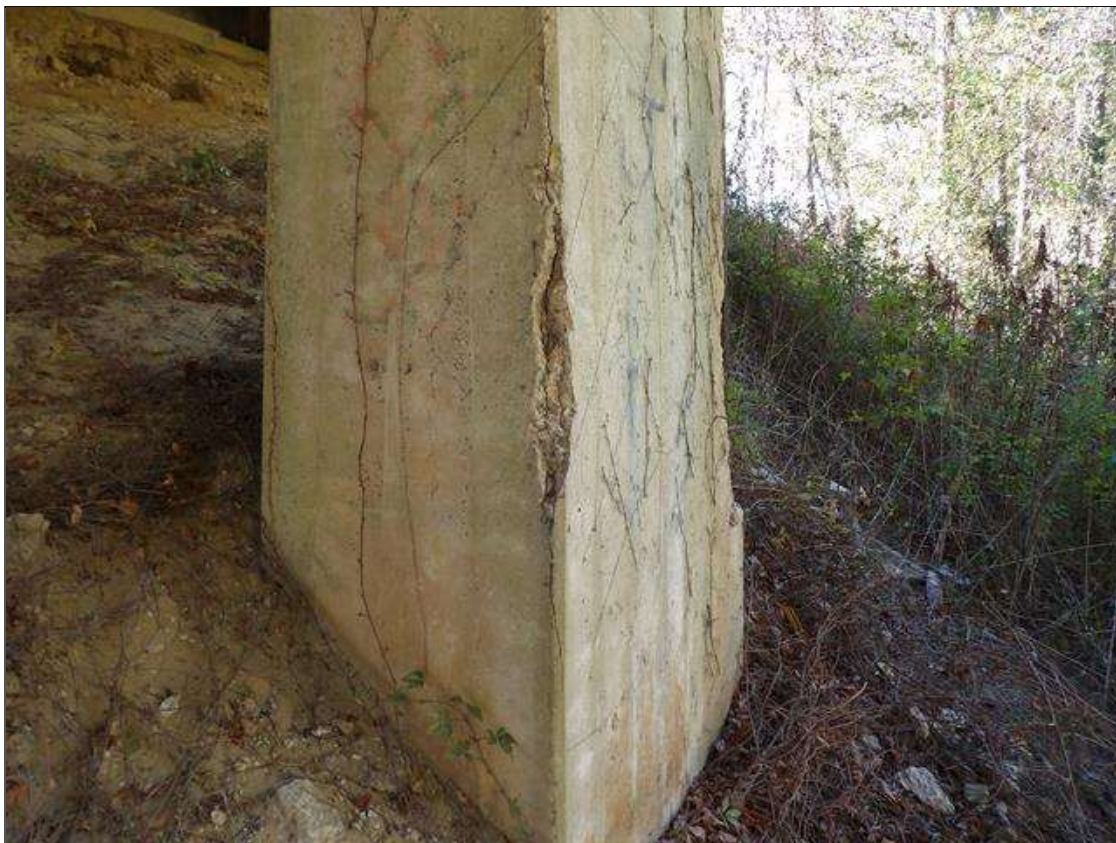
Bent 1 Pile 1: 24 FEET X 9 INCHES X 2 INCHES DEEP SPALL AND 5 FOOT X 3 FOOT DELAMINATION AT NORTHEAST CORNER

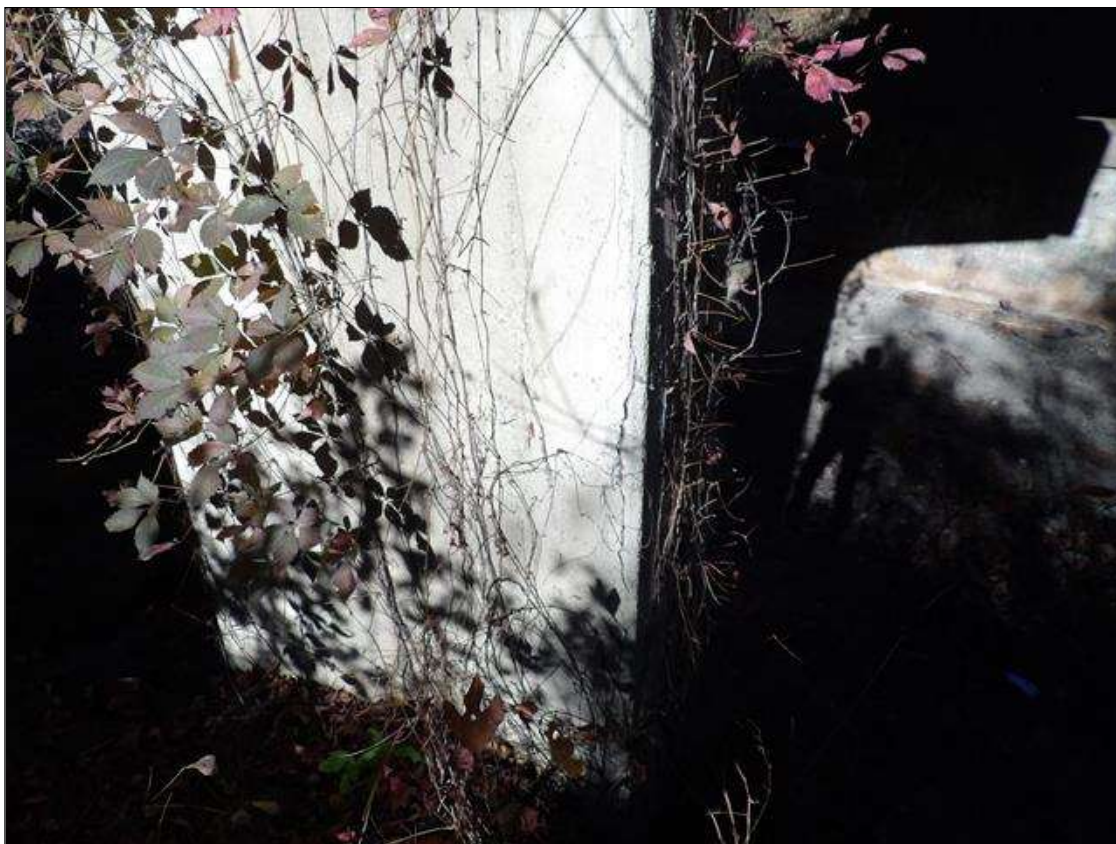
Bent 1 Pile 2: 6 FOOT X 1.5 FOOT AREA OF DELAMINATION ON SOUTHEAST CORNER

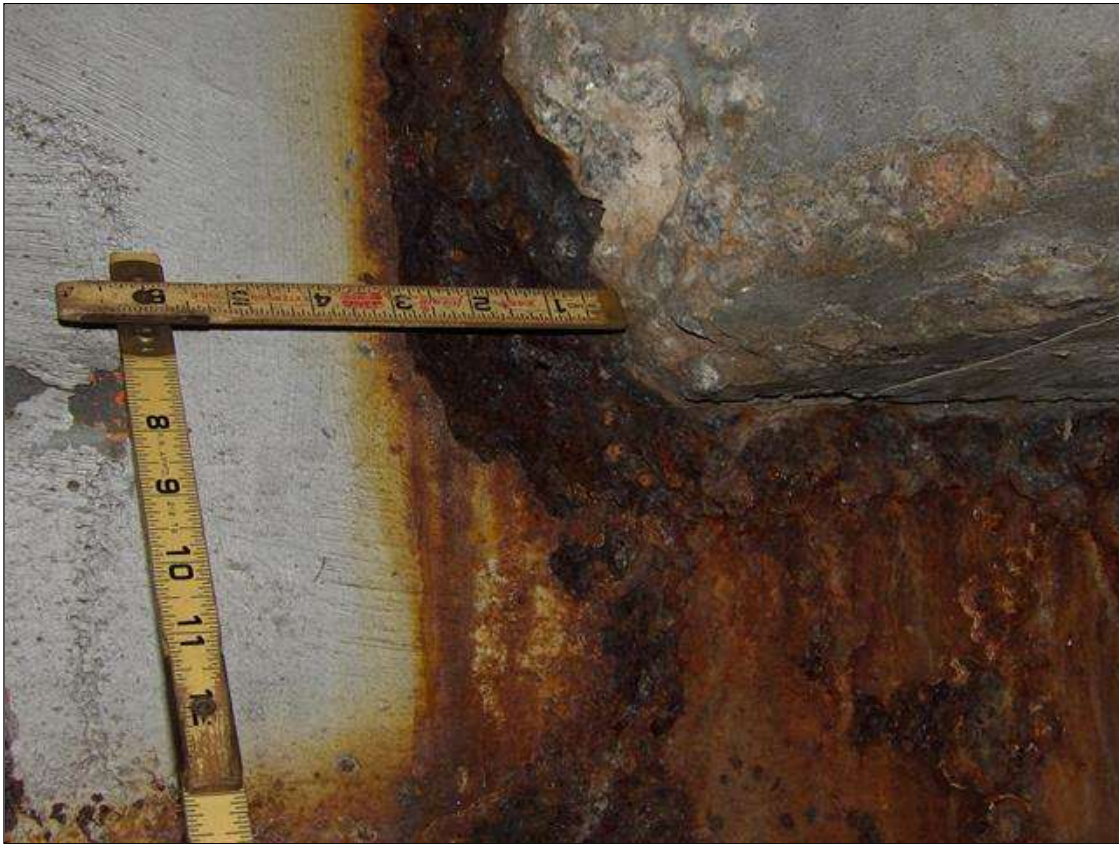
Span 1 Beam 1: PAR--BEAM END AT BENT 1 AT THE INTERFACE WITH THE REINFORCED CONCRETE DIAPHRAGM, THERE IS A BAND OF CORROSION UP TO 3 INCHES WIDE WITH SECTION LOSS [AVERAGE 1/4 INCHES AVERAGE REMAINING] FOR APPROXIMATELY 1 FEET LONG X UP TO THE FULL HEIGHT OF THE DIAPHRAGM. AT THE LOWER CORNER OF THE INTERFACE THERE IS A HOLE [APPROXIMATELY 1/2 INCHES DIAMETER]. AT THE SAME END IN THE LOWER FLANGE, CORROSION WITH SECTION LOSS [AVERAGE 7/16 INCHES REMAINS] FOR APPROXIMATELY 6 FEET LONG. AT THE SAME END IN THE LOWER 3 INCHES OF THE WEB, CORROSION WITH SECTION LOSS [AVERAGE 3/8 INCHES REMAINS] FOR APPROXIMATELY 6 FEET LONG.

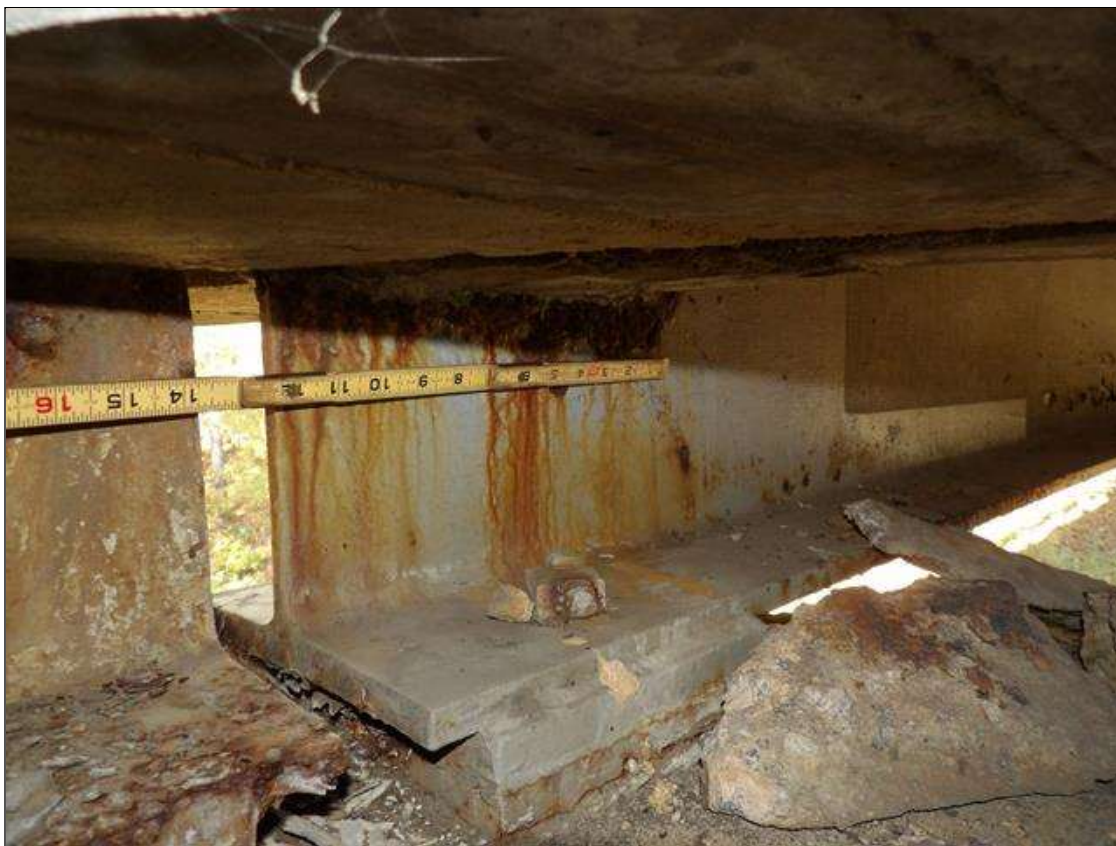
Span 2 Beam 1: PAR--BEAM END AT BENT 1 AT THE INTERFACE WITH THE REINFORCED CONCRETE DIAPHRAGM, THERE IS A BAND OF CORROSION UP TO 2 INCHES WIDE WITH SECTION LOSS [AVERAGE 3/8 INCHES REMAINS] FOR APPROXIMATELY 1 FEET LONG X UP TO THE FULL HEIGHT OF THE DIAPHRAGM.
