NC DEPARTMENT OF TRANSPORTATION  
 DIVISION OF HIGHWAYS  
 STRUCTURE MANAGEMENT UNIT

ATTENTION: **PRIORITY ACTION REQUEST ISSUED; NEW ASPHALT WEARING SURFACE**

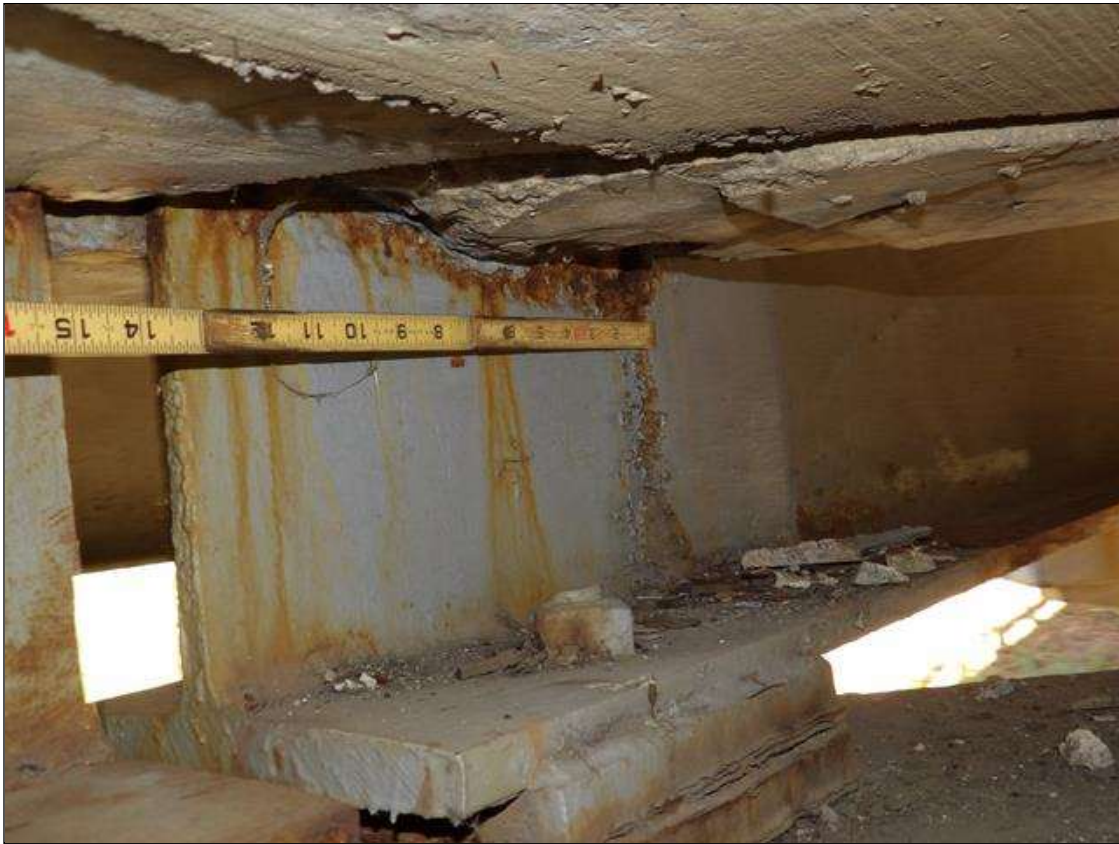
Span 2 Beam 2: PAR--BEAM END AT BENT 1 AT THE INTERFACE WITH THE REINFORCED CONCRETE DIAPHRAGM, THERE IS A BAND OF CORROSION UP TO 3 INCHES WIDE WITH SECTION LOSS [AVERAGE 3/8 INCHES REMAINS] FOR APPROXIMATELY 1 FOOT LONG X UP TO THE FULL HEIGHT OF THE DIAPHRAGM.

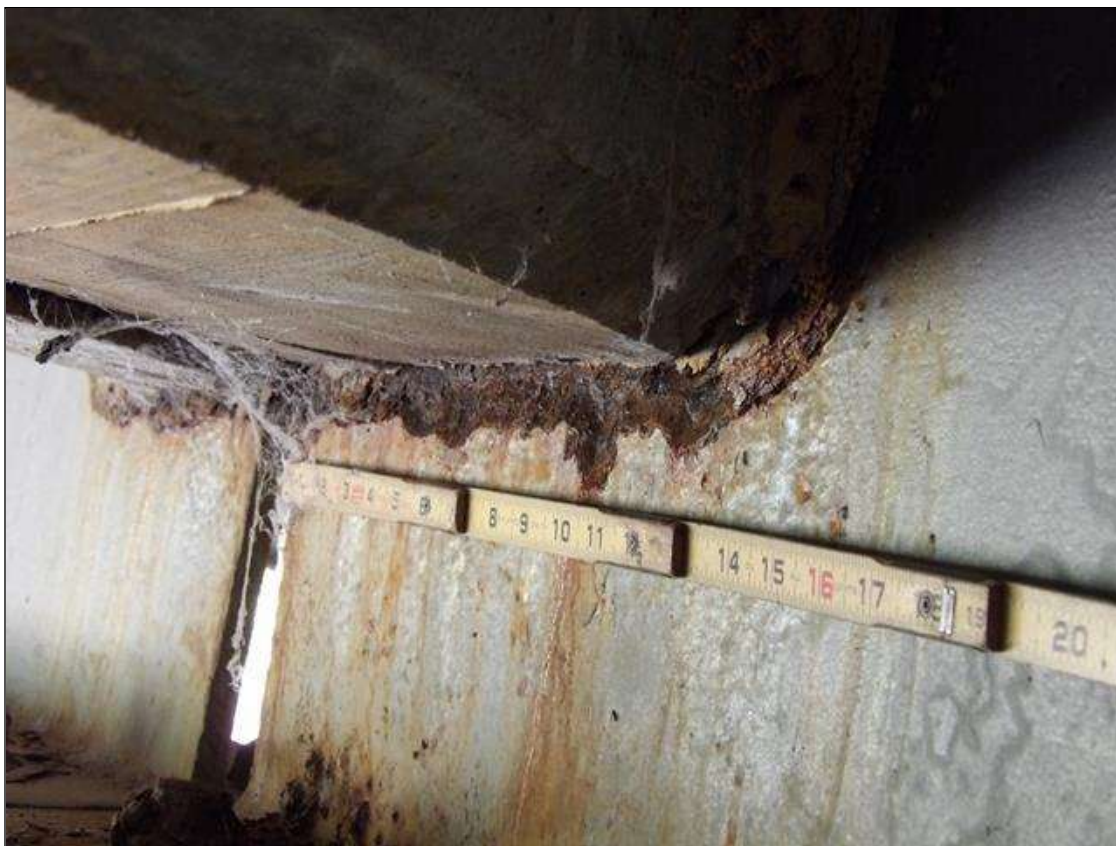
TYPICAL CORROSION UP TO 1/8 INCH LOSS X UP TO 2 FEET HIGH AT BEAM ENDS ADJACENT TO DIAPHRAGMS OVER PIERS WITH 7/16 INCH AVERAGE REMAINING. BEAM 3 SPAN 1 AT PIER 1 SHOWN

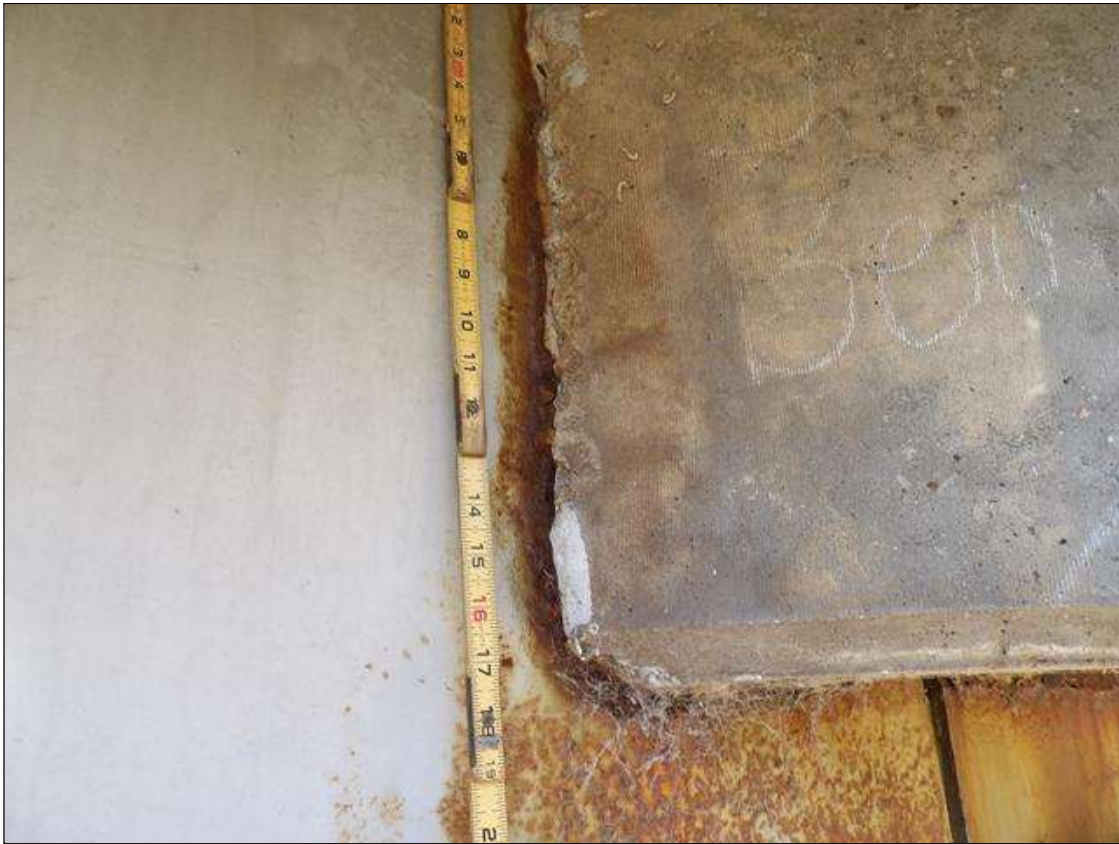
Span 1 Beam 5: PAR--BEAM END AT BENT 1 AT THE INTERFACE WITH THE REINFORCED CONCRETE DIAPHRAGM, THERE IS A BAND OF CORROSION UP TO 2 INCHES WIDE WITH SECTION LOSS [AVERAGE 3/16 INCHES REMAINS] FOR APPROXIMATELY 1 FEET LONG X UP TO THE FULL HEIGHT OF THE DIAPHRAGM.

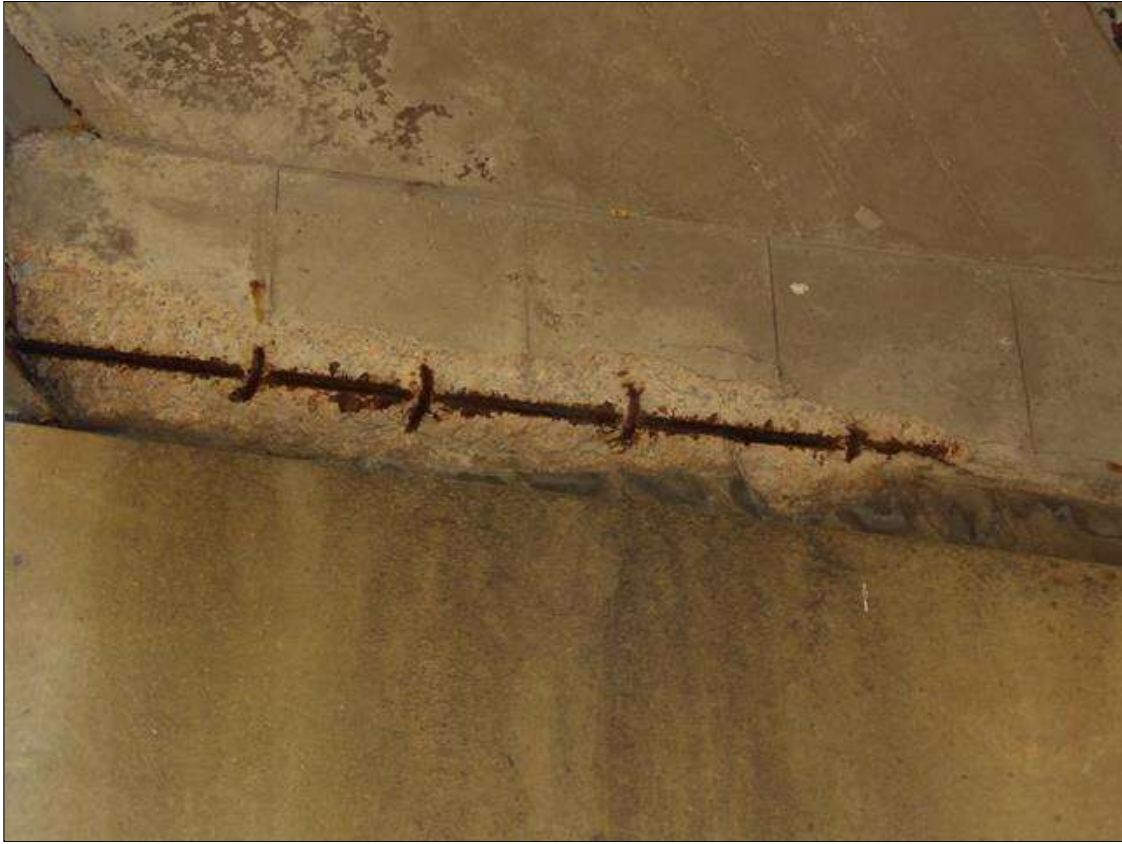
TYPICAL DIAPHRAGM SPALL UP TO 4 FOOT LONG X 1 FOOT HIGH X 4 INCHES DEEP WITH EXPOSED REBAR  
NO LOSS OVER PIERS, SPAN 2 BAY 4 OVER PIER 1 SHOWN

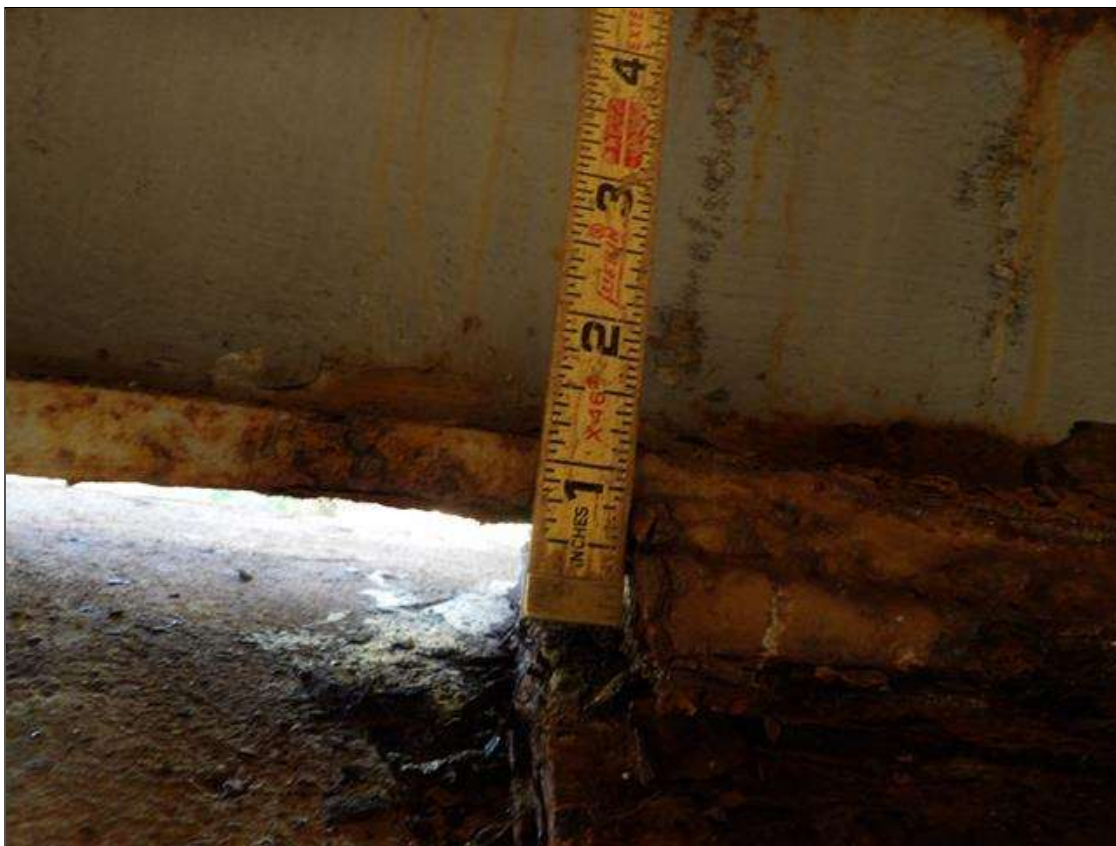
Span 2 Beam 1: 1 FEET OF CORROSION WITH 1/2 INCHES REMAINING SECTION IN BOTTOM FLANGE AND 7/16 INCHES REMAINING SECTION IN WEB AROUND END DIAPHRAGM AT BENT 2 HAS BEEN PREVIOUSLY PAINTED OVER WITH ACTIVE CORROSION.

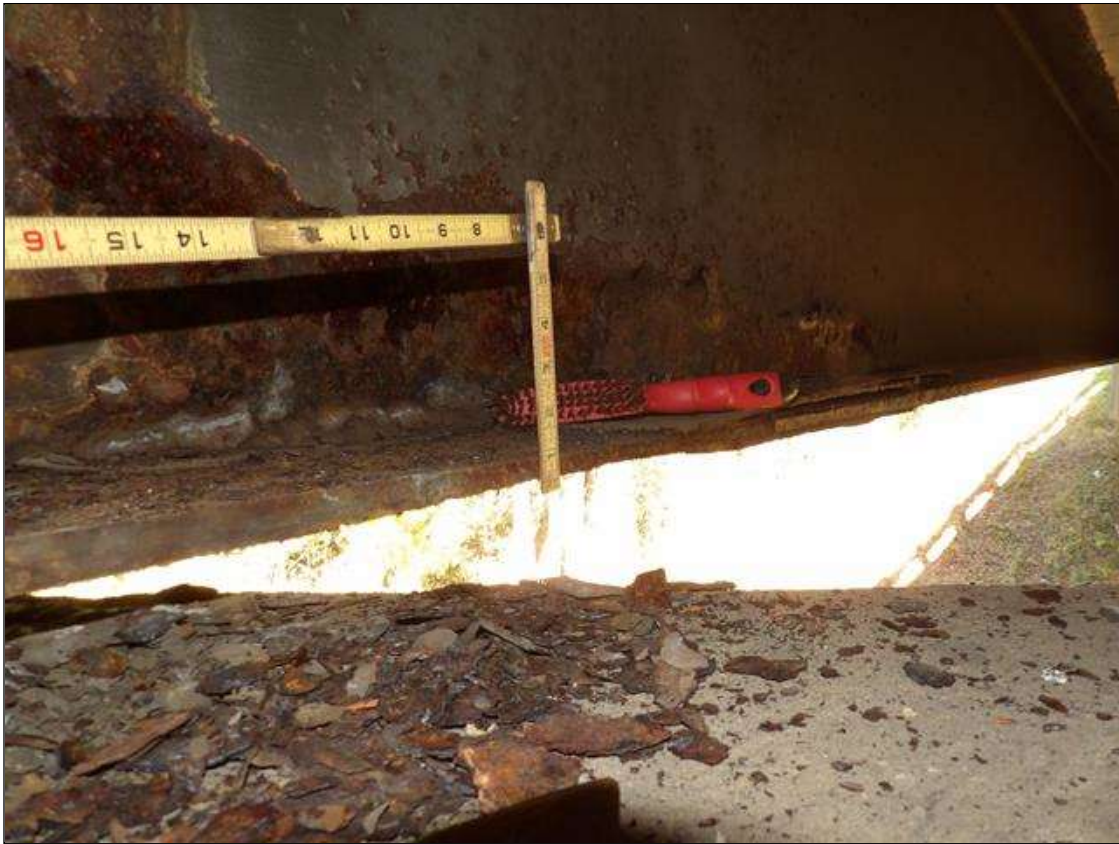
Span 3 Beam 1: PAR--CORROSION AROUND DIAPHRAGM OVER PIER 2- 2 INCHES WIDE WITH 3/8 INCHES AVERAGE REMAINING THICKNESS AND 6 INCHES HIGH IN BOTTOM OF WEB 4 FEET LONG. CORROSION IN BOTTOM FLANGE 4 FOOT LONG WITH 7/16 INCH SECTION LOSS WITH 1/2 INCH AVERAGE REMAINING STARTING AT PIER 2

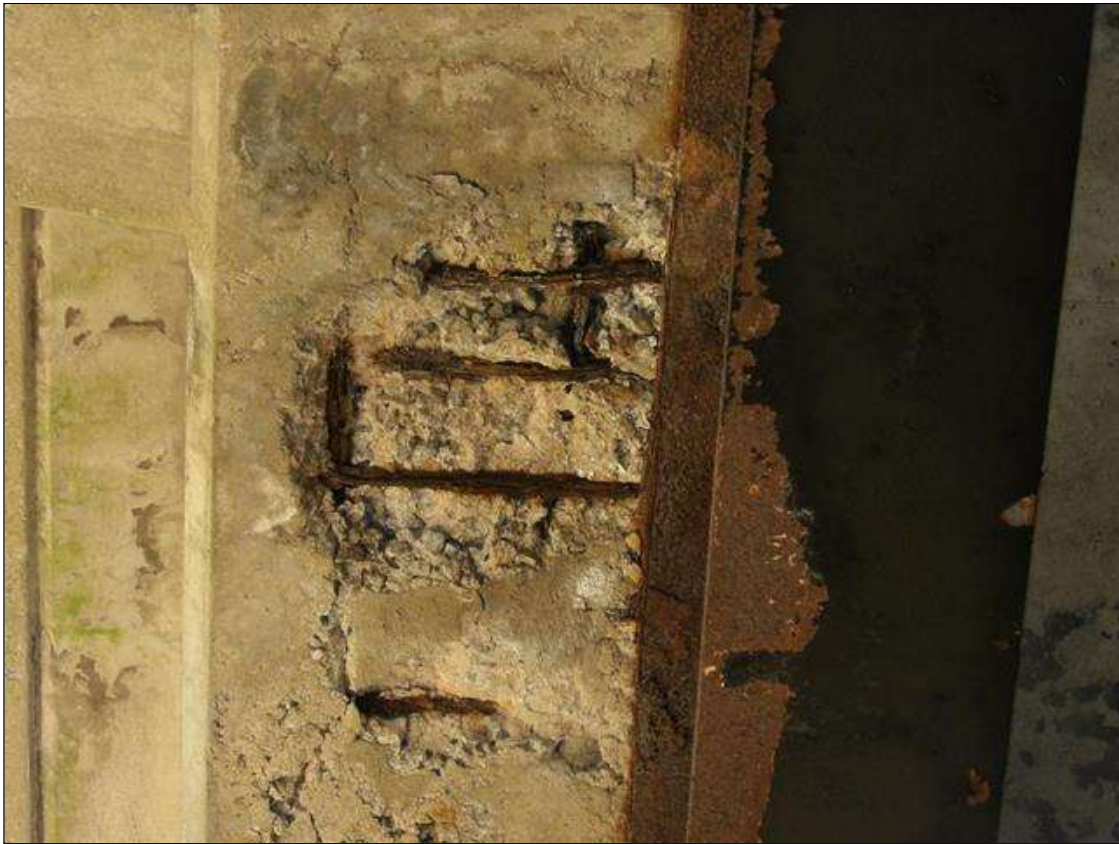
Span 3 Deck: PAR--3 FOOT LONG X 15 INCHES WIDE X 2 INCHES DEEP SPALL WITH EXPOSED REBAR IN UNDERSIDE OF LEFT OVERHANG NEAR MID SPAN. MULTIPLE EXPOSED BARS TRANSVERSE AND LONGITUDINAL HAVE SECTION LOSS WITH 50 PERCENT AREA REMAINING

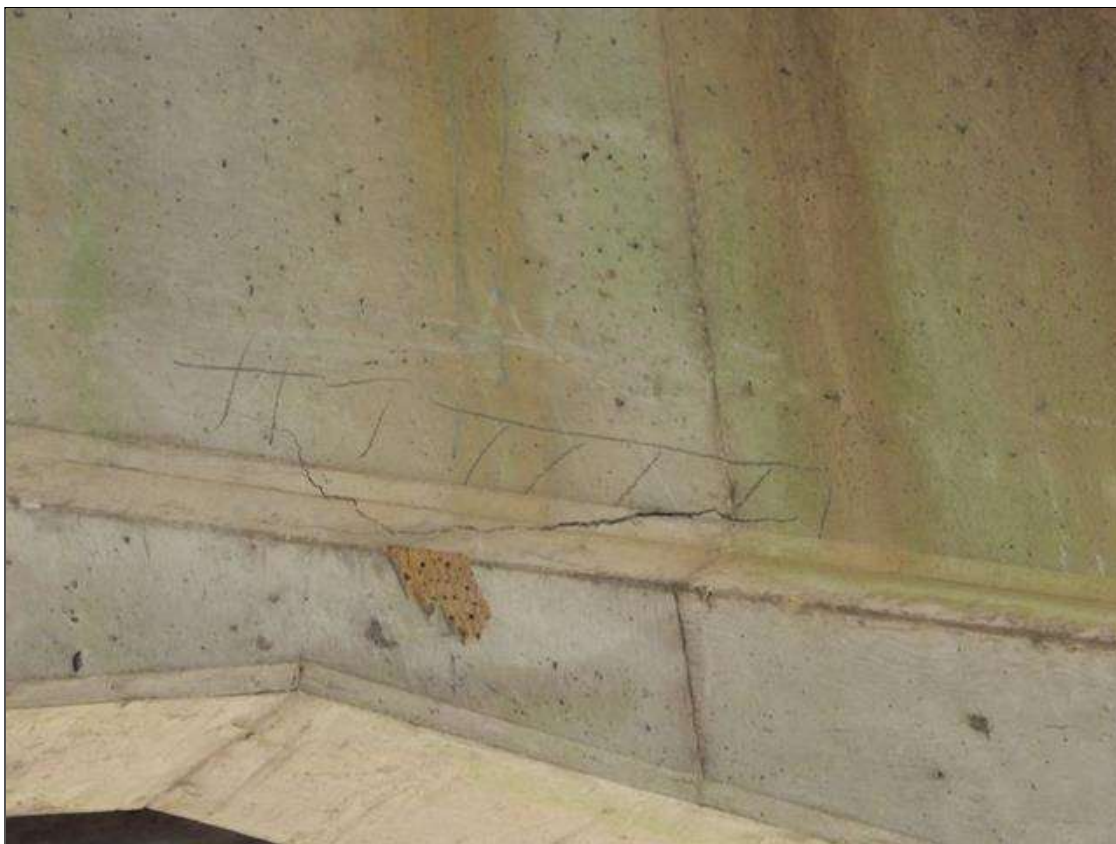
Bent 2 Cap 1: 3 FEET X 1.5 FEET HIGH DELAMINATION IN SOUTH FACE UNDER BEAM 3

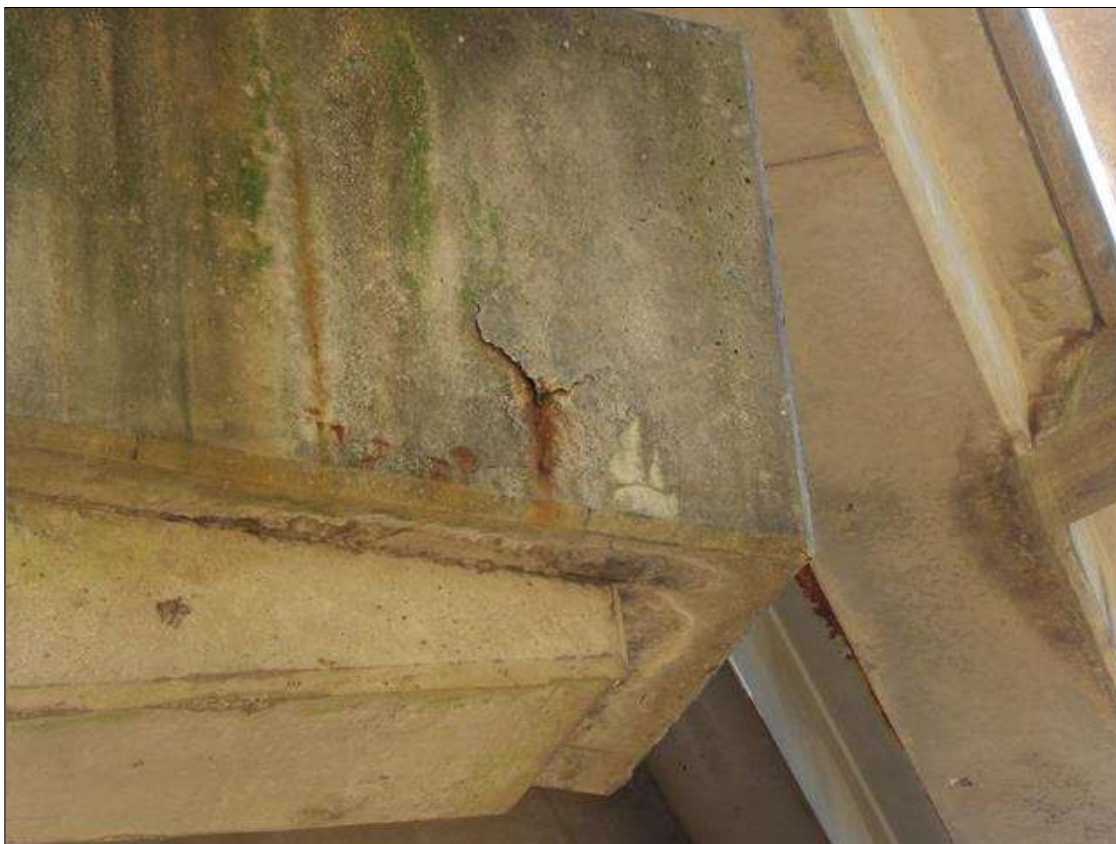
Bent 2 Cap 1: 8 INCHES DIAMETER DELAMINATION AND 6 INCHES DIAMETER X 1/2 INCHES DEEP SPALL WITH EXPOSED REBAR NO LOSS IN NORTH FACE UNDER BEAM 1

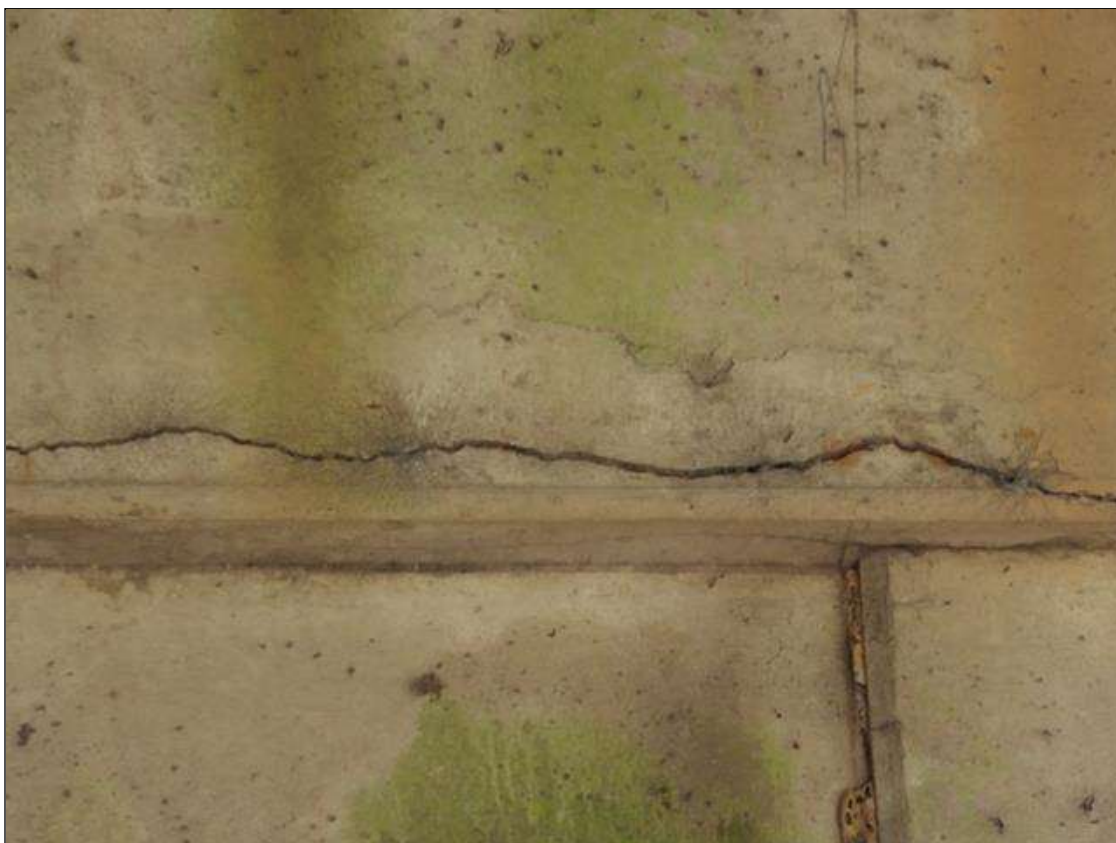
Bent 2 Cap 1: 6 FEET LONG HORIZONTAL CRACK UP TO 1/4 INCHES WIDE UNDER BAYS 1 AND 2 NORTH FACE

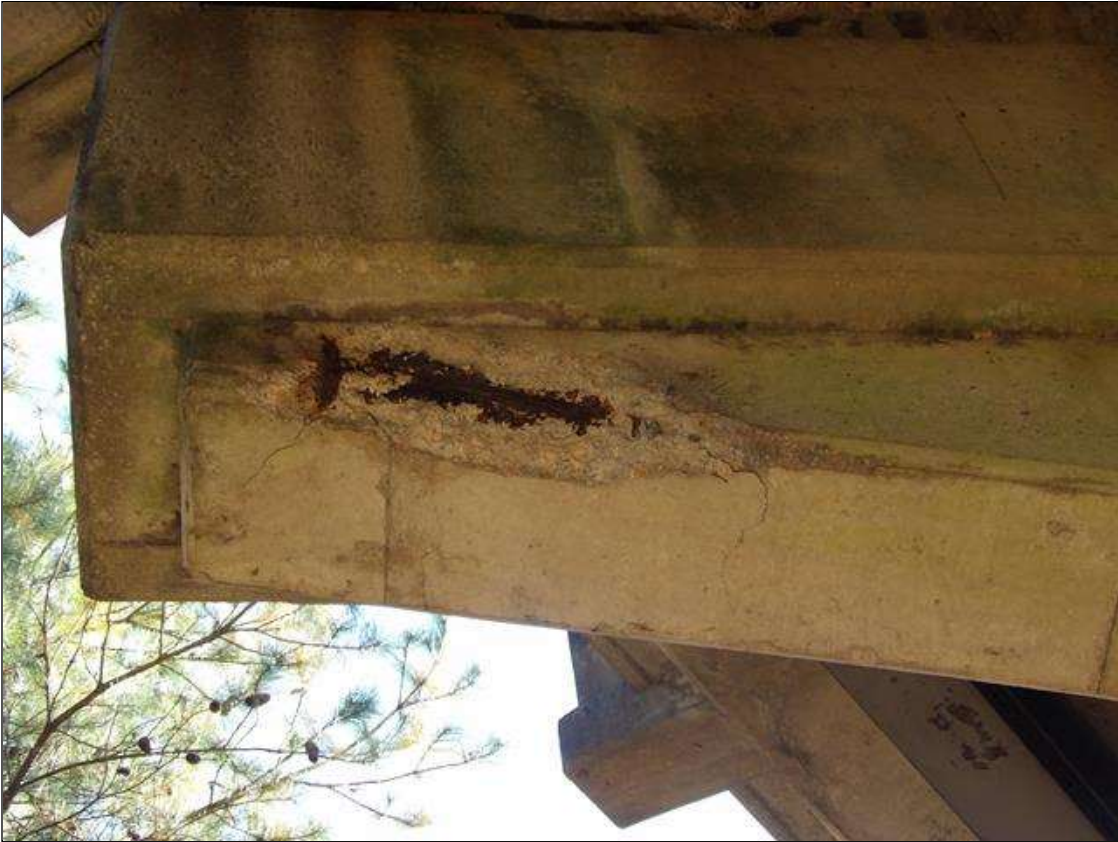
Bent 2 Cap 1: 3 FEET X 1 FEET X 6 INCHES DELAMINATION WITH A SPALL 2 FOOT X 9 INCH X 3 INCH DEEP WITH EXPOSED REBAR NO LOSS IN UNDERSIDE UNDER BEAM 5 IN FLUTED PORTION

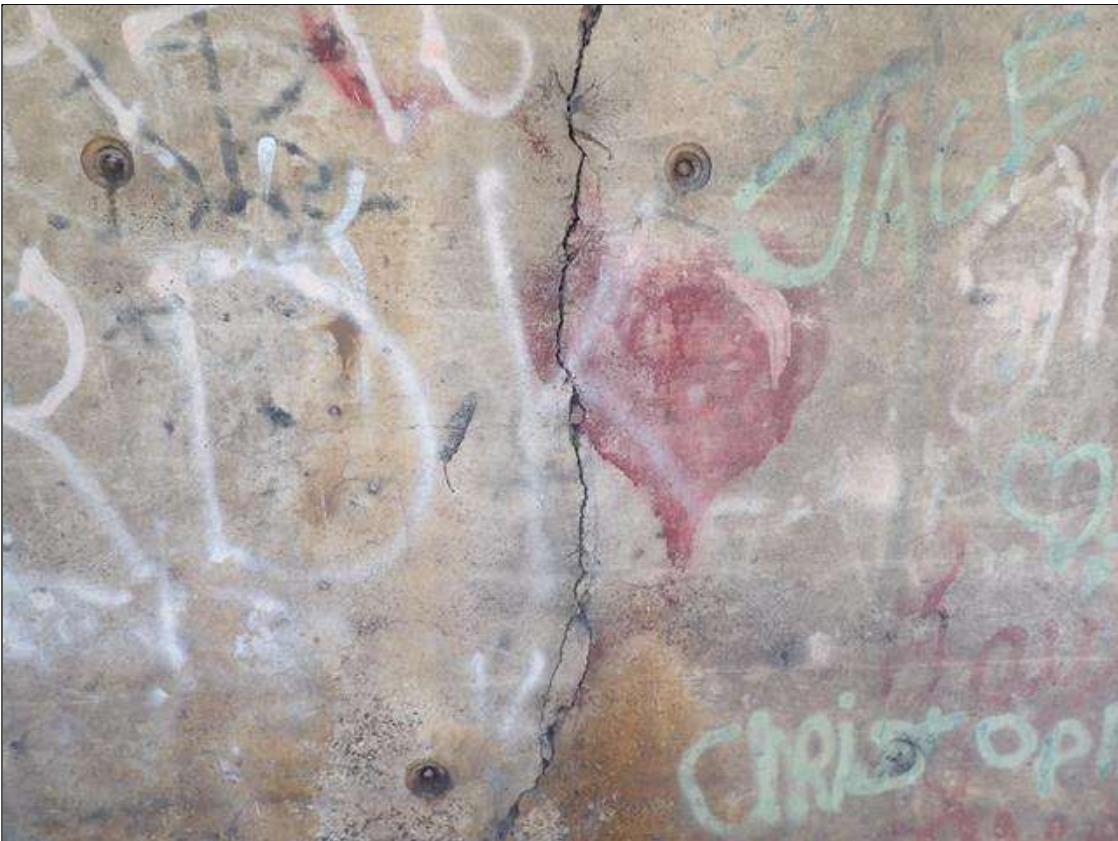
Bent 2 Pile 1: VERTICAL THRU CRACK 7 FOOT LONG UP TO 1/4 INCH WIDE WITH EDGE SPALLING IN MIDDLE OF CRASH WALL BOTH FACES

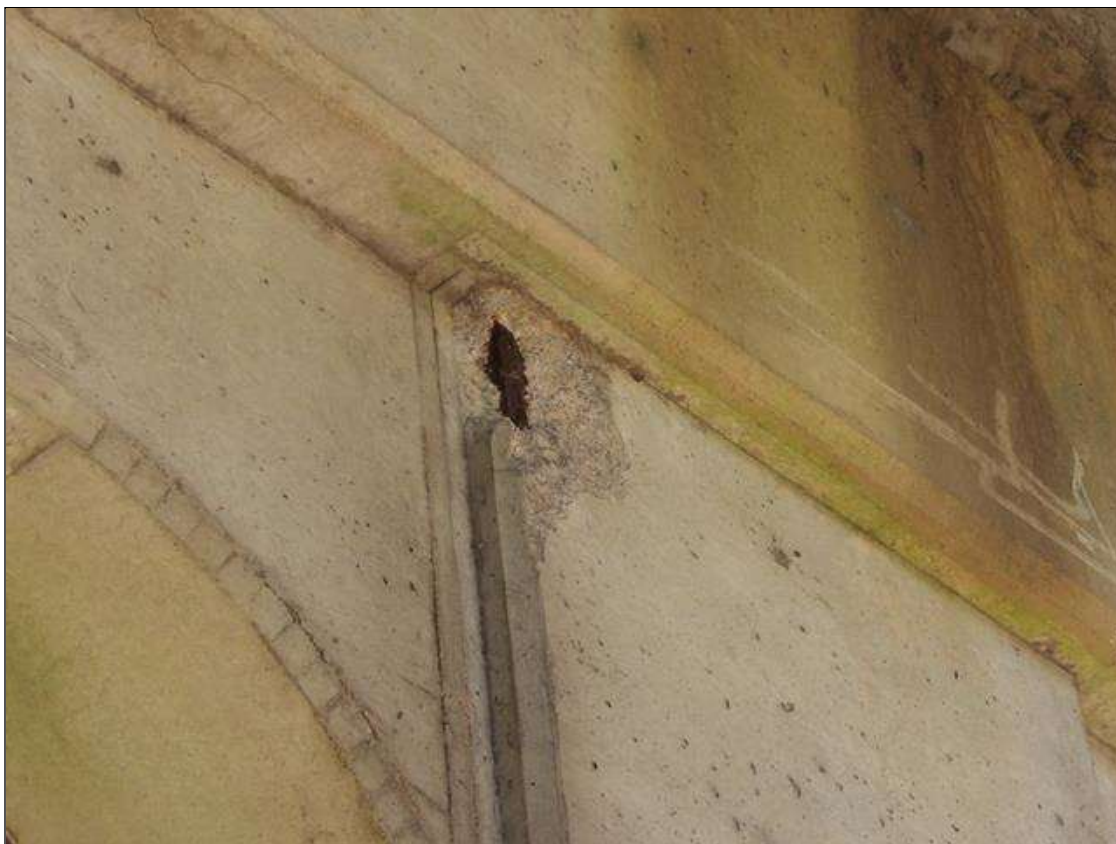
Bent 2 Pile 2: SPALL 10 INCH X 9 INCH X 2 INCH DEEP WITH EXPOSED REBAR NO LOSS AT TOP SOUTHWEST CORNER

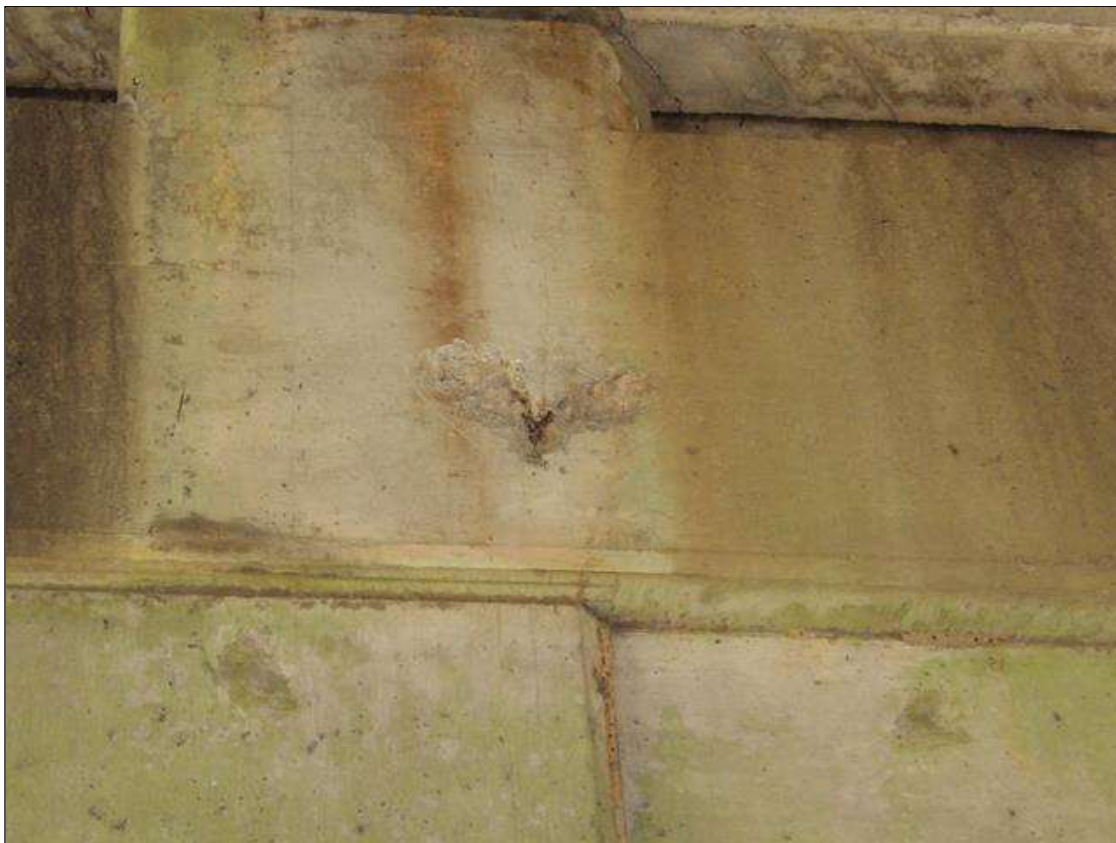
Bent 3 Cap 1: SPALL WITH EXPOSED REBAR NO LOSS 1 FEET X 9 INCHES X 1 INCHES DEEP IN NORTH FACE UNDER BEAM 4

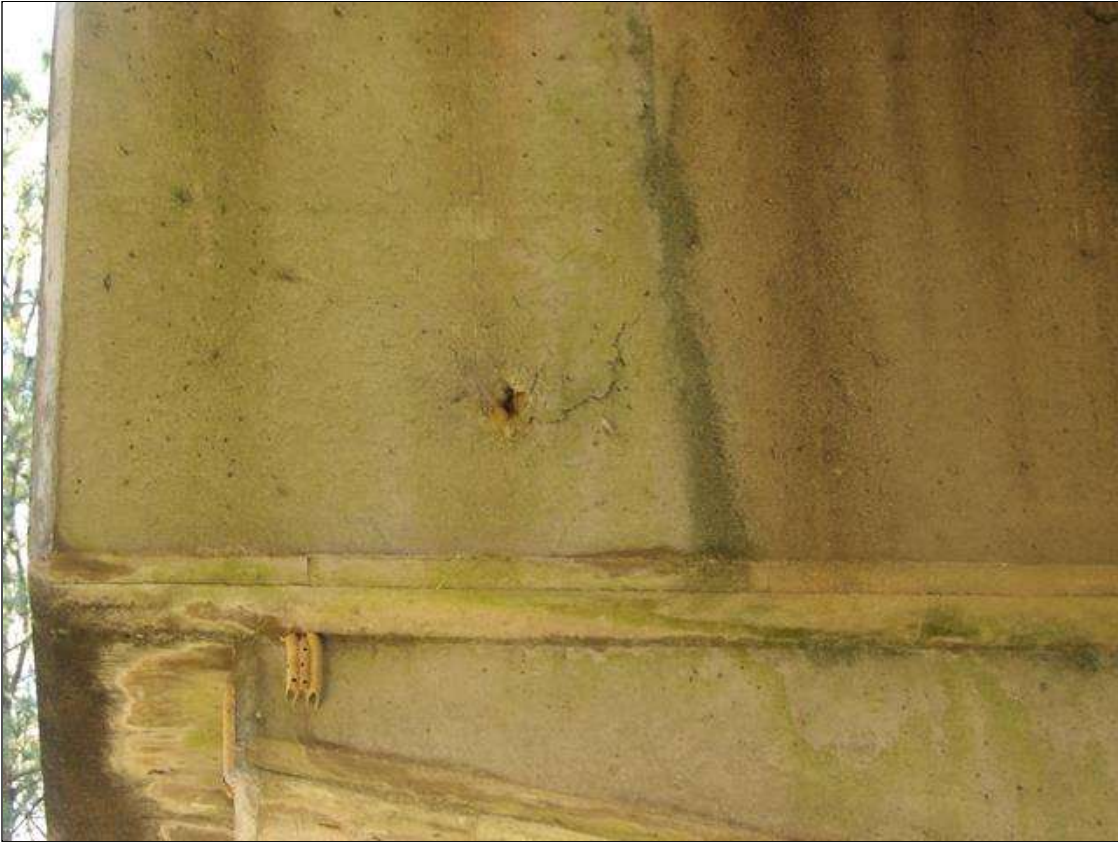
Bent 3 Cap 1: 9 INCHES DIAMETER DELAMINATION WITH SPALL 3 INCH X 2 INCH X 1 INCH DEEP WITH EXPOSED REBAR NO LOSS NORTH FACE UNDER BEAM 5

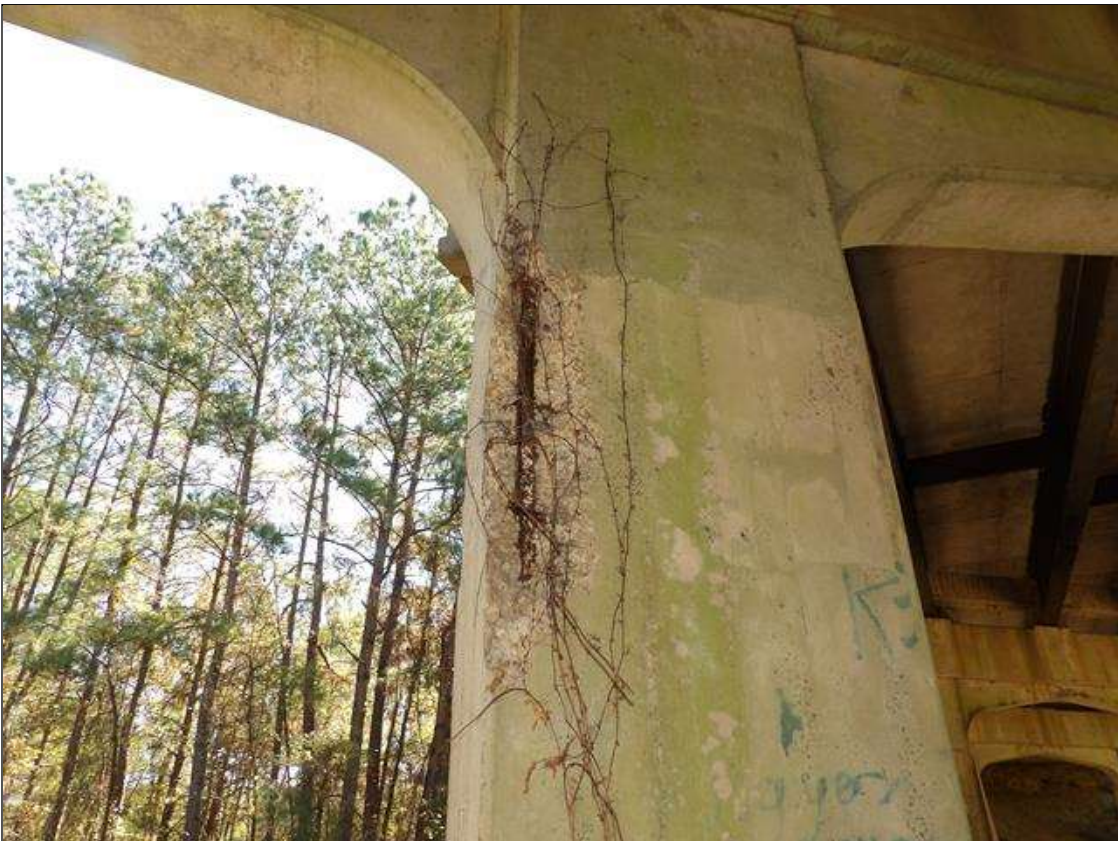
Bent 3 Pile 2: PAR--SPALL WITH EXPOSED REBAR AND BROKEN HORIZONTAL TIE 3 FOOT X 1 FOOT X 4 INCHES DEEP IN NORTHEAST CORNER MID HEIGHT WITH SECTION LOSS

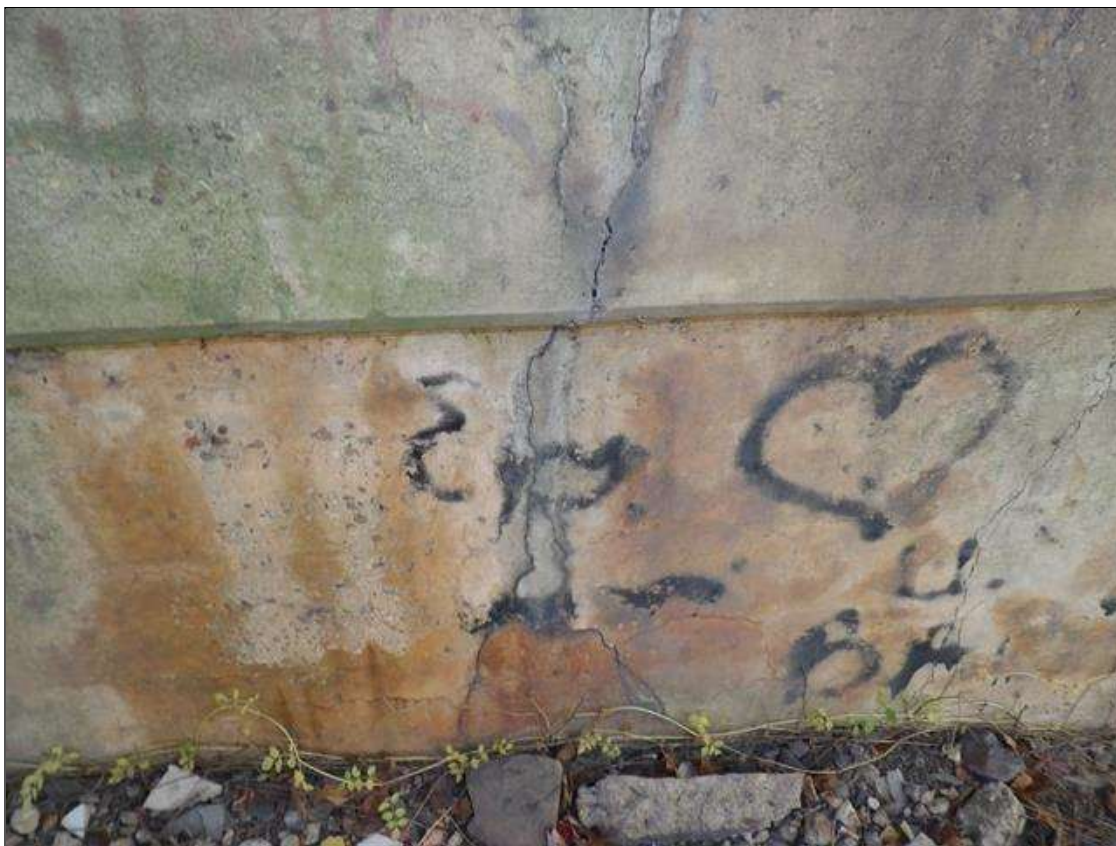
Bent 3 Pile 1: VERTICAL THROUGH CRACK 7 FOOT LONG X 1/8 INCHES WIDE IN MIDDLE OF CRASHWALL BOTH FACES

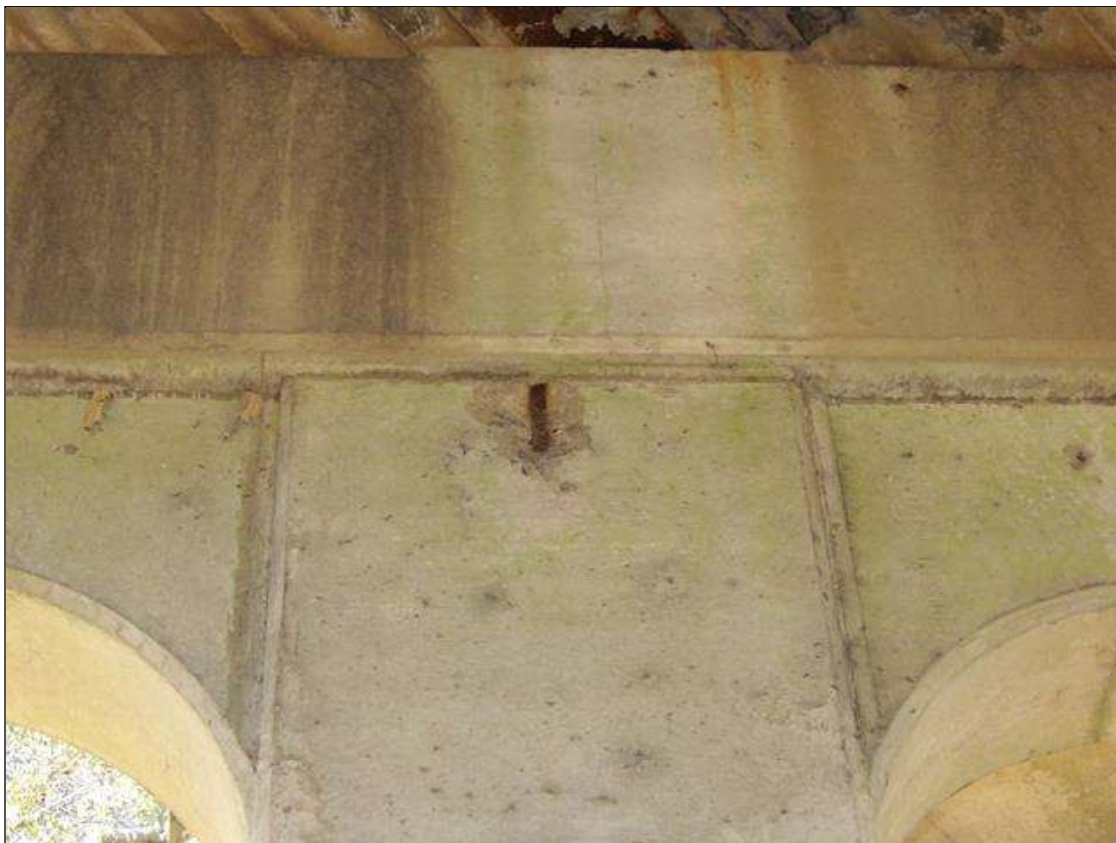
Bent 3 Pile 1: 9 INCHES X 6 INCHES X 1/2 INCHES DEEP SPALL WITH EXPOSED REBAR NO LOSS IN SOUTH FACE BELOW CAP

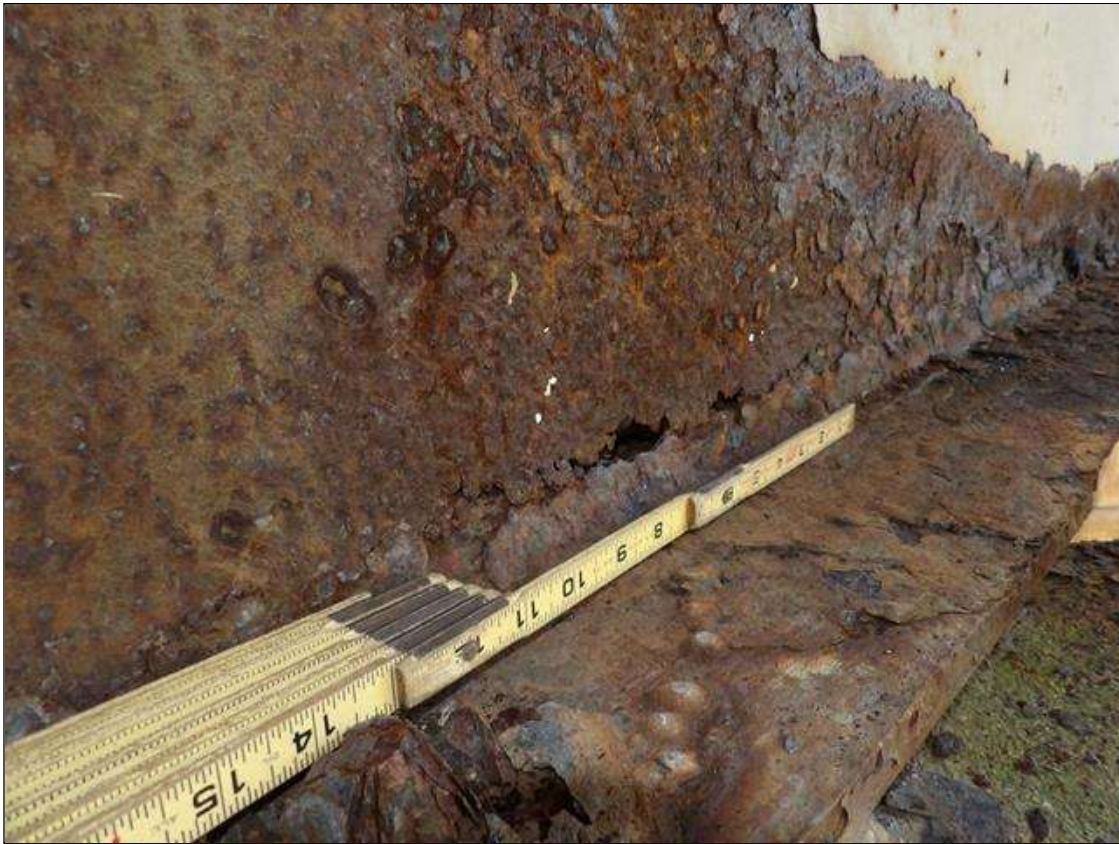
Span 3 Beam 1: PAR-- BEAM END AT BENT 3 IN THE LEFT LOWER FLANGE, CORROSION WITH SECTION LOSS DOWN TO KNIFE EDGE [AVERAGE 3/8 INCHES REMAINS FULL WIDTH OF FLANGE ] FOR APPROXIMATELY 4 FEET LONG WITH EDGE HOLES UP TO 3/4 INCHES DIAMETER. AT THE SAME END IN THE LOWER 6 INCHES OF THE WEB, CORROSION WITH SECTION LOSS [AVERAGE 1/16 INCHES REMAINS] FOR APPROXIMATELY 4 FEET LONG WITH PERFORATIONS THROUGHOUT.

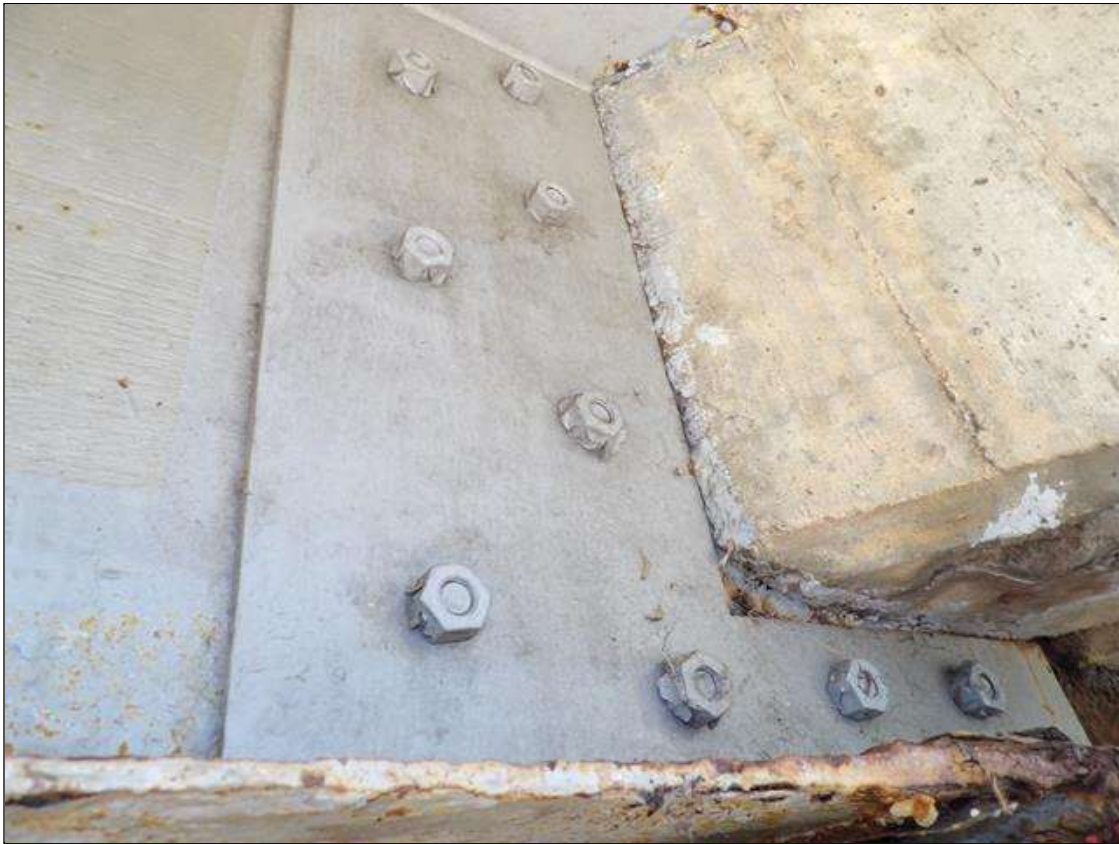
SPAN 4 BEAM 1 BOLTED PLATE REPAIR FULL HEIGHT X 1 FOOT LONG TO WEB AT BENT 3, BEAMS 3 AND 5 SIMILAR

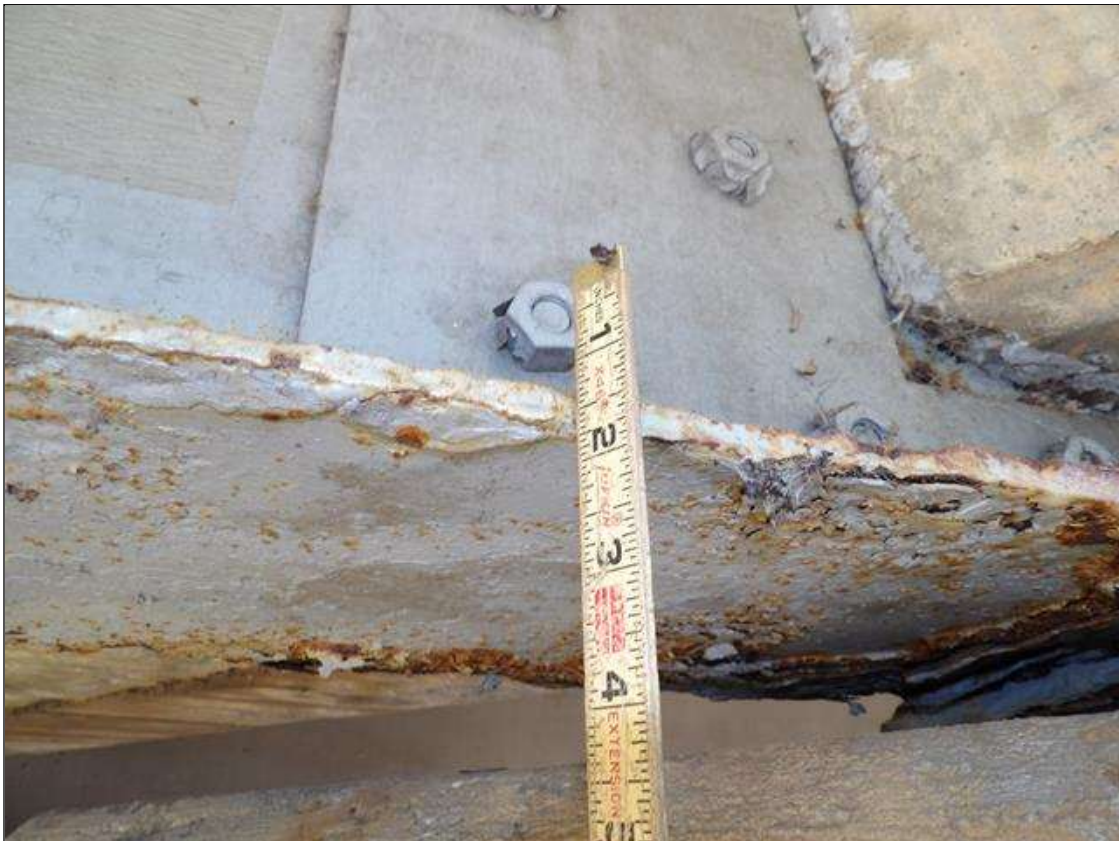
Span 4 Beam 1: PAR--BEAM END AT BENT 3 IN THE LOWER FLANGE, CORROSION WITH SECTION LOSS [AVERAGE 3/8 INCHES REMAINS FULL WIDTH OF FLANGE] FOR APPROXIMATELY 3 FEET LONG.

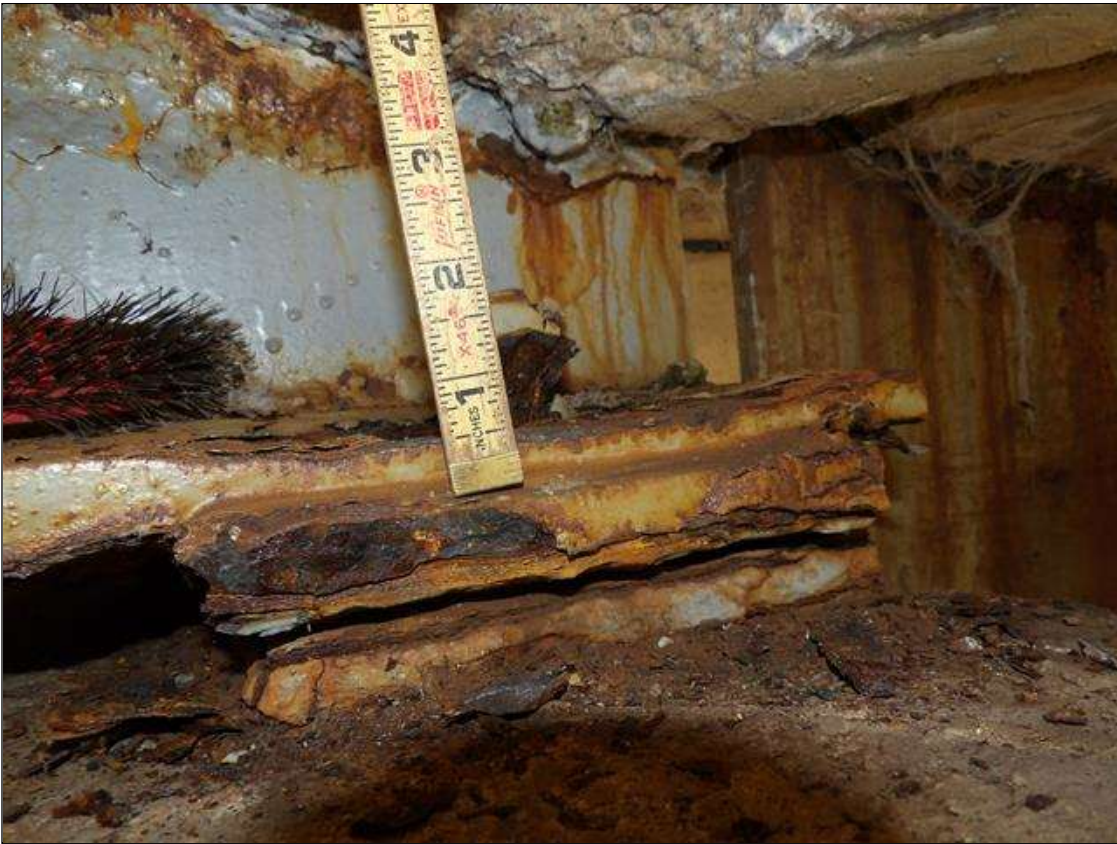
Span 4 Beam 2: PAR--SECTION LOSS IN BOTTOM FLANGE UP TO 1/4 INCHES WITH 1/2 INCHES AVERAGE REMAINING FULL WIDTH 9 INCHES LONG AT BEAM END OVER PIER 3.

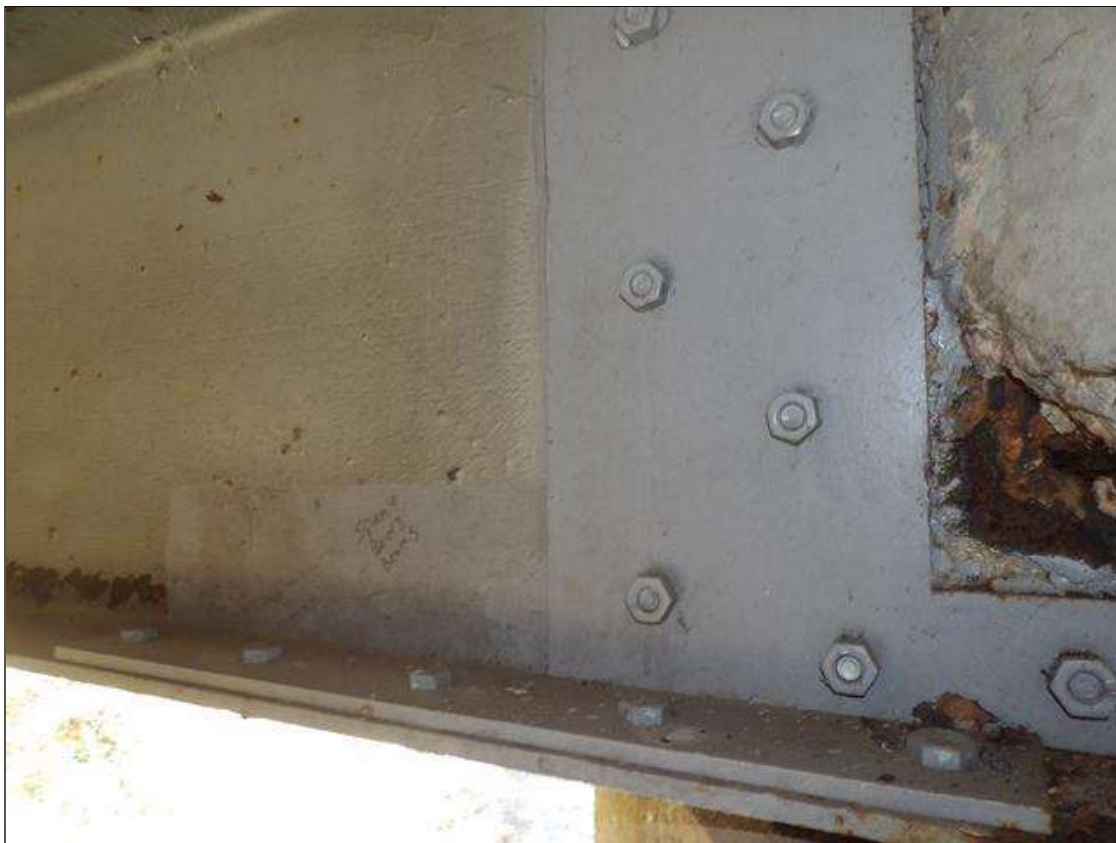
BOLTED PLATE REPAIR 24 INCH X 24 INCH TO WEB BOTH SIDES AND 24 INCH BOTTOM FLANGE WEST SIDE BEAM 5 SPAN 4 AT BENT 3
