NC DEPARTMENT OF TRANSPORTATION  
 DIVISION OF HIGHWAYS  
 STRUCTURE MANAGEMENT UNIT

ATTENTION: **PRIORITY ACTION REQUEST ISSUED; NEW ASPHALT WEARING SURFACE**

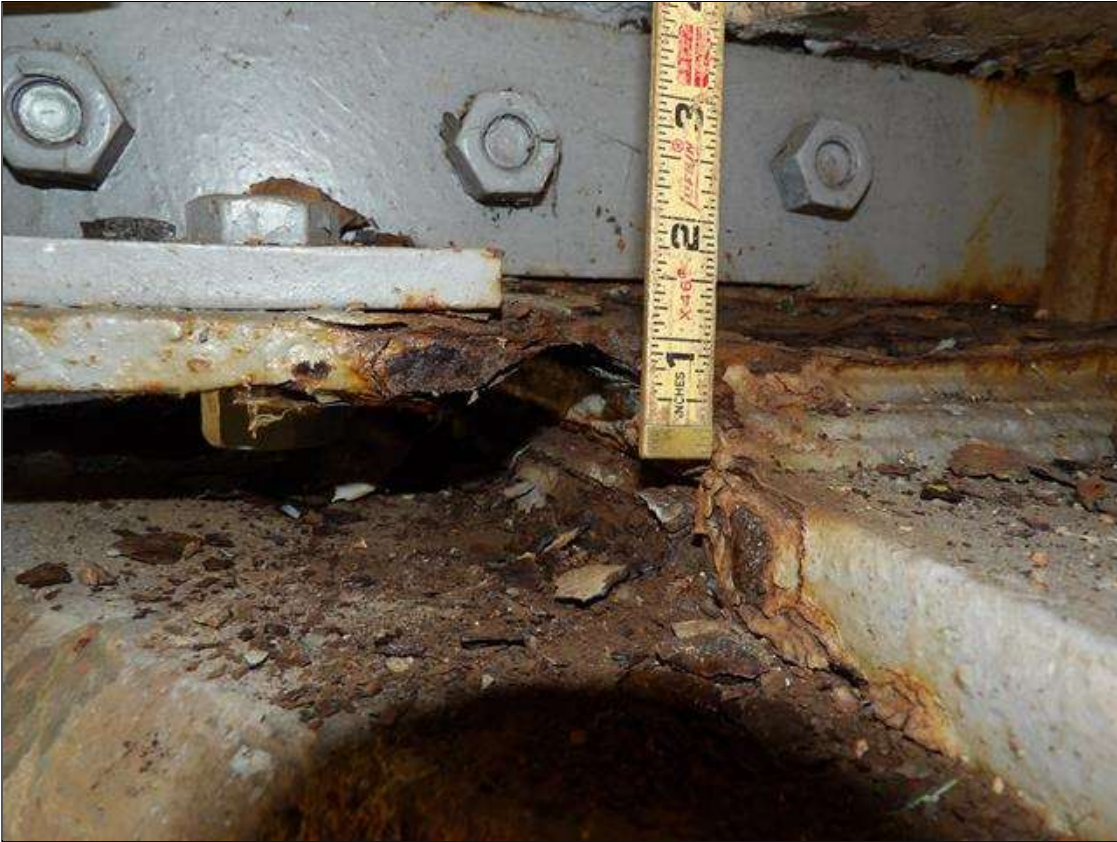
Span 4 Beam 5: PAR--SECTION LOSS UP TO 3/8 INCHES WITH 3/8 INCHES AVERAGE REMAINING FULL WIDTH OF BOTTOM FLANGE 1 FEET LONG ON BEAM END OVER PIER 3. BEAM END HAS BEEN CLEANED AND PAINTED WITH ACTIVE SURFACE CORROSION. PLATE REPAIR ADDED BUT DOES NOT EXTEND OUT TO DEFECT.

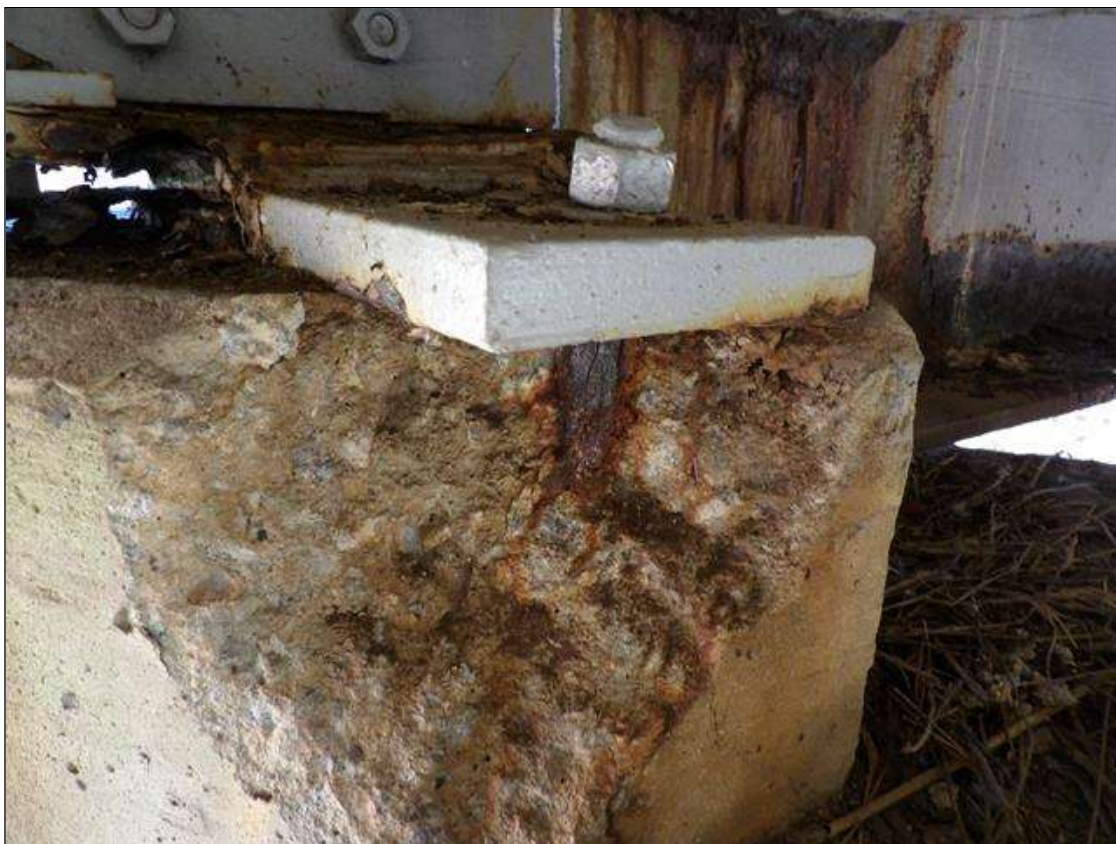
Span 4 Near Bearing 5: PAR--BEARING LATERAL RETROFIT PLATE ON LEFT SIDE OF BEARING WITH EXPOSED BENT ANCHOR BOLT DUE TO SPALL IN CAP

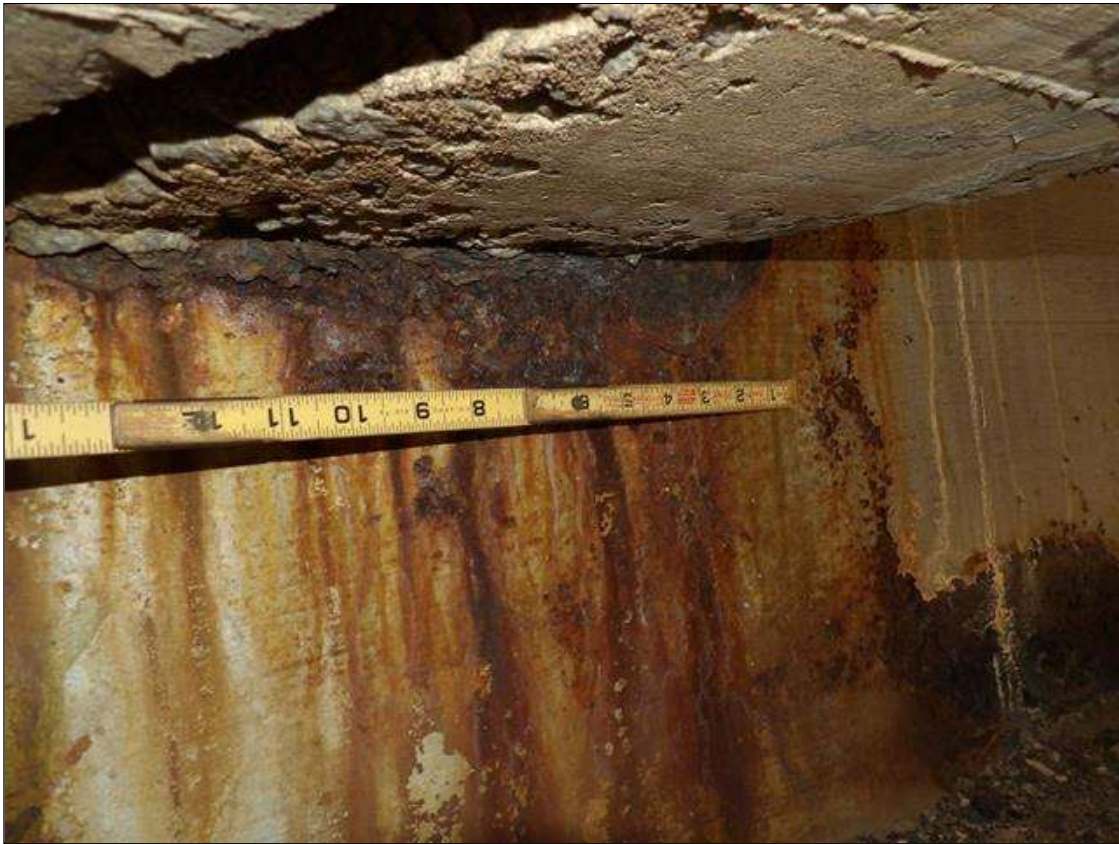
Span 3 Beam 5: PAR-- BEAM END AT BENT 3 AT THE INTERFACE WITH THE REINFORCED CONCRETE DIAPHRAGM, THERE IS A BAND OF CORROSION UP TO 2 INCHES WIDE WITH SECTION LOSS [AVERAGE 5/16 INCHES REMAINS] FOR APPROXIMATELY 1 FEET LONG X UP TO THE FULL HEIGHT OF THE DIAPHRAGM. AT THE SAME END IN THE LOWER LEFT FLANGE, CORROSION WITH SECTION LOSS [AVERAGE 3/4 INCHES AVERAGE REMAINS FULL WIDTH] FOR APPROXIMATELY 5 FEET LONG. AT 1.5 FEET OUT FROM THE SAME END IN THE LOWER 5 INCHES OF THE WEB, CORROSION WITH SECTION LOSS [AVERAGE 1/8 INCHES REMAINS] FOR APPROXIMATELY 3 FEET LONG.

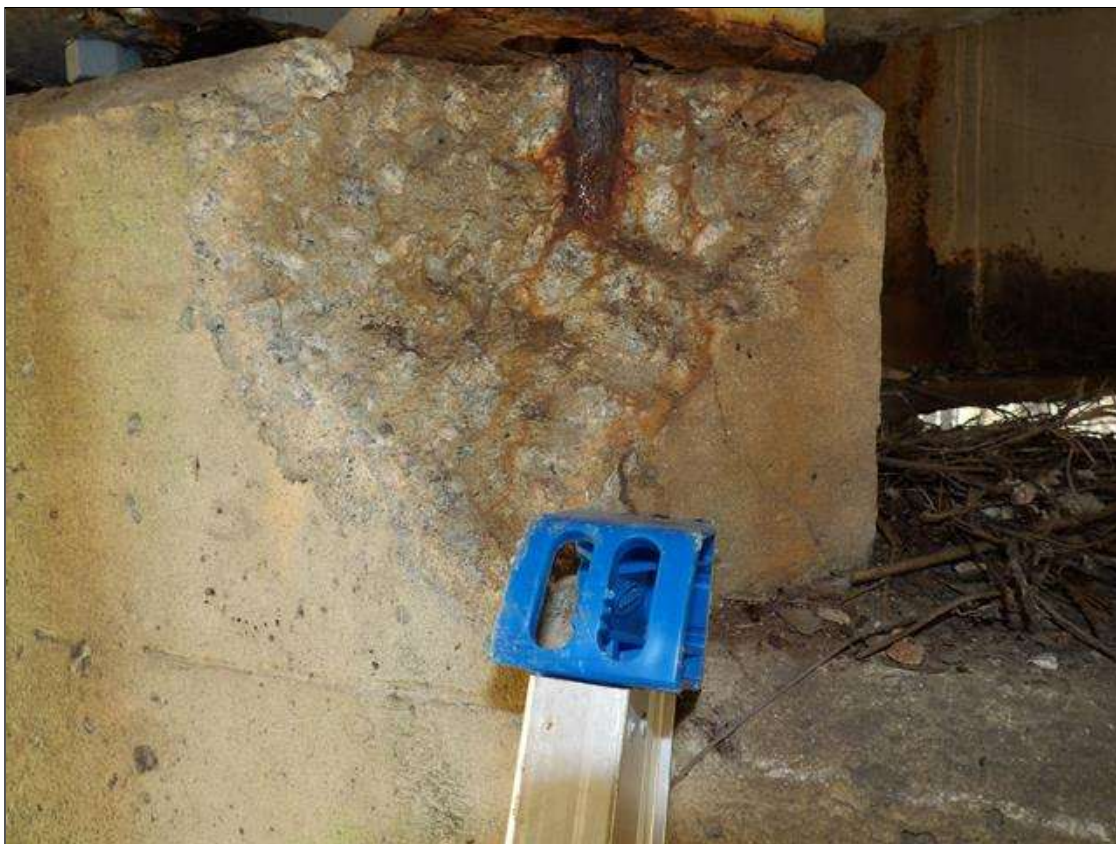
Bent 3 Cap 1: SPALL 9 INCH X 9 INCH X 3 INCHES DEEP WITH EXPOSED REBAR NO LOSS IN PEDESTAL AT BEAM 5 NORTH FACE. PAR SENT UNDER BEARING

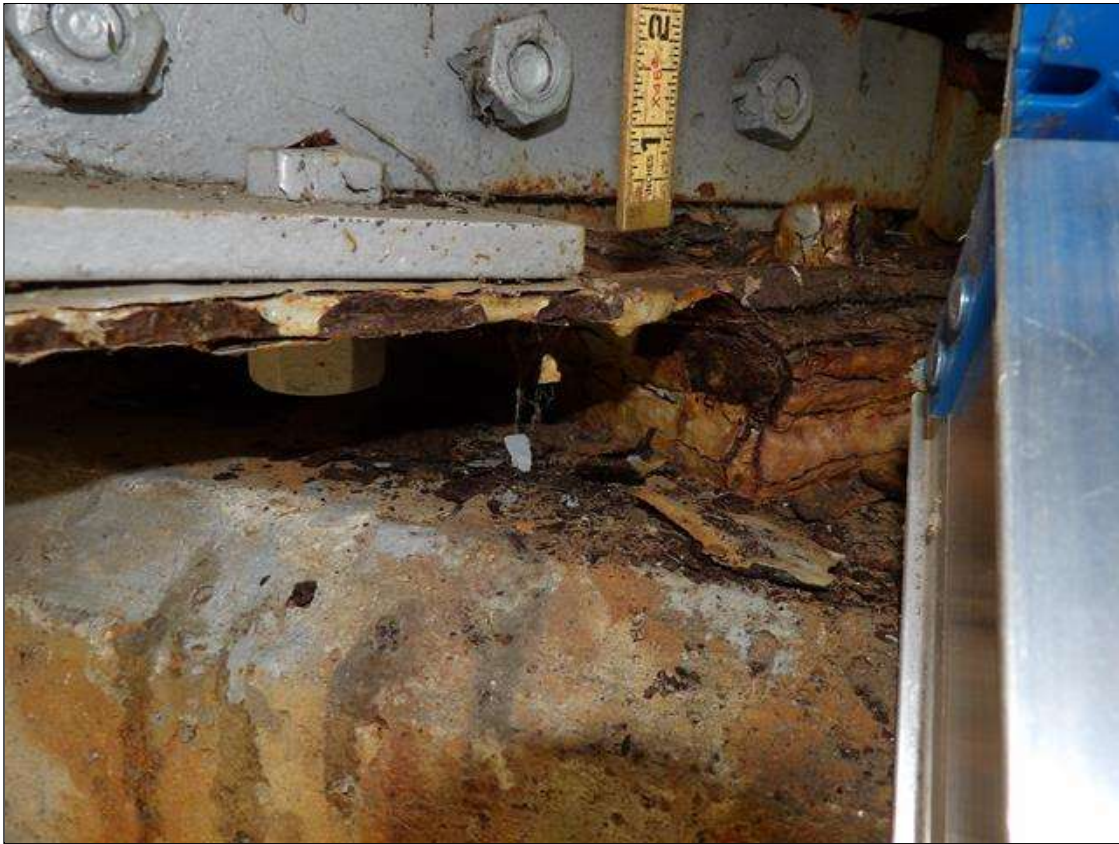
Span 5 Beam 1: PAR--1/4 INCH SECTION LOSS WITH 3/8 INCHES AVERAGE REMAINING FULL WIDTH OF BOTTOM FLANGE. BEAM END HAS BEEN PAINTED WITH ACTIVE SURFACE CORROSION PRESENT. BOLTED REPAIR REPAIR PLATE ADDED AND DOES NOT EXTEND UNDER DEFECT AT PIER 4.

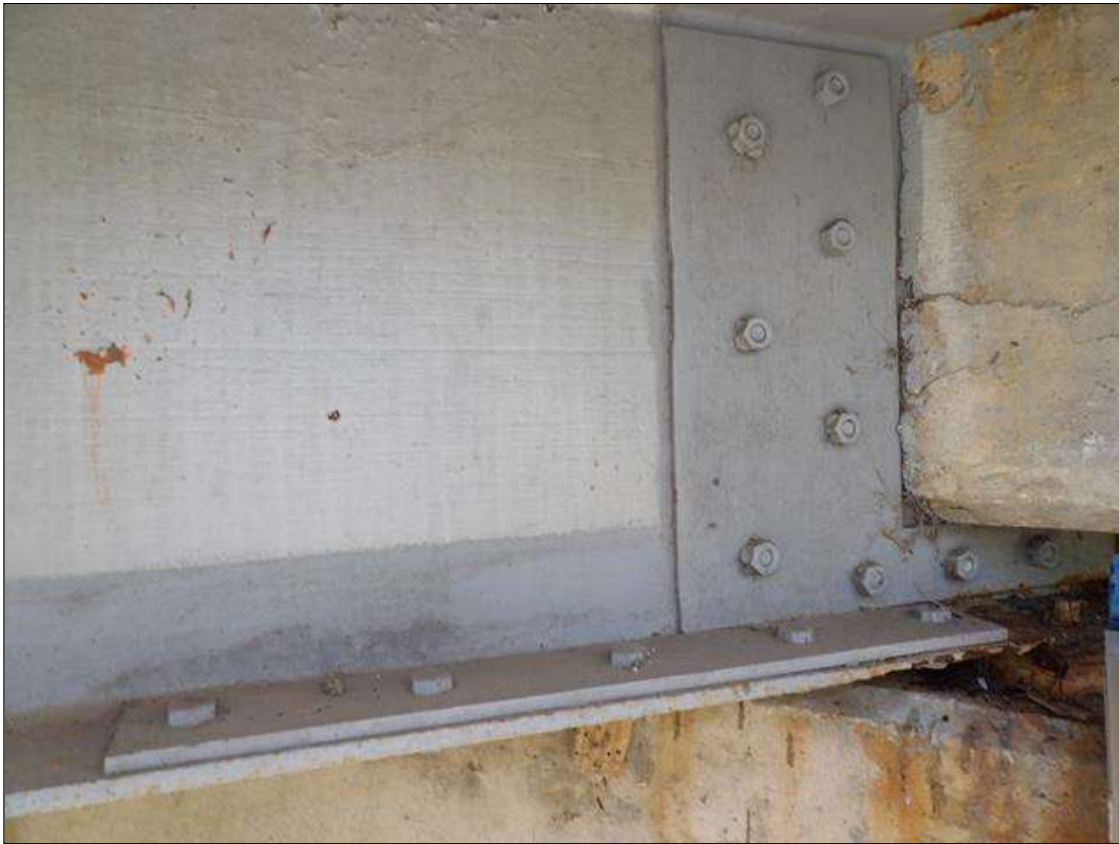
BOLTED PLATE REPAIR TO BOTTOM FLANGE WEST AND BOTH FACES OF WEB AT BENT 4 SPAN 5 BEAM 1

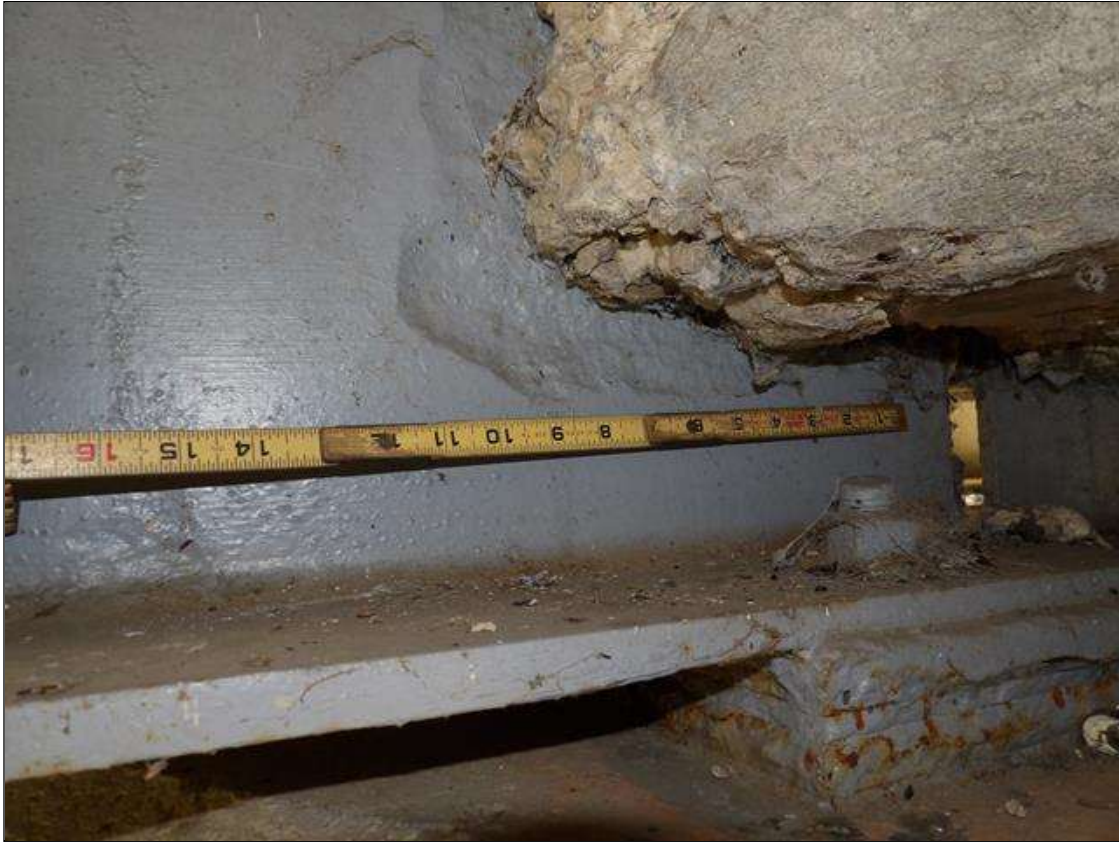
Span 5 Beam 2: PAR--1 FEET LONG X 2 INCHES WIDE AREA OF PREVIOUS CORROSION WITH 1/4 INCHES REMAINING SECTION IN WEB AROUND END DIAPHRAGM AT BENT 4 AREA HAS BEEN PAINTED OVER AND ARRESTED.

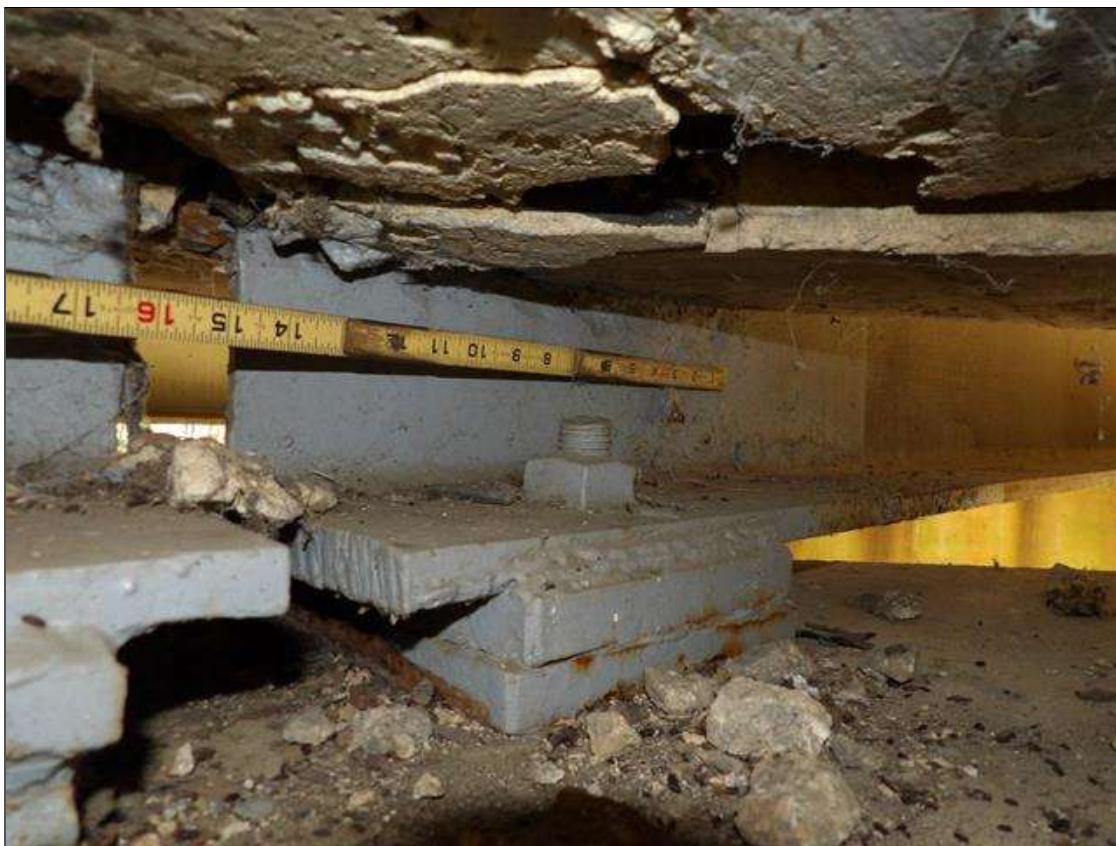
Span 4 Beam 2: PAR--BEAM END AT BENT 4 AT THE INTERFACE WITH THE REINFORCED CONCRETE DIAPHRAGM, THERE IS A BAND OF CORROSION UP TO 1 INCHES WIDE WITH SECTION LOSS [AVERAGE 3/8 INCHES REMAINS] FOR APPROXIMATELY 1 FEET LONG X UP TO THE FULL HEIGHT OF THE DIAPHRAGM.

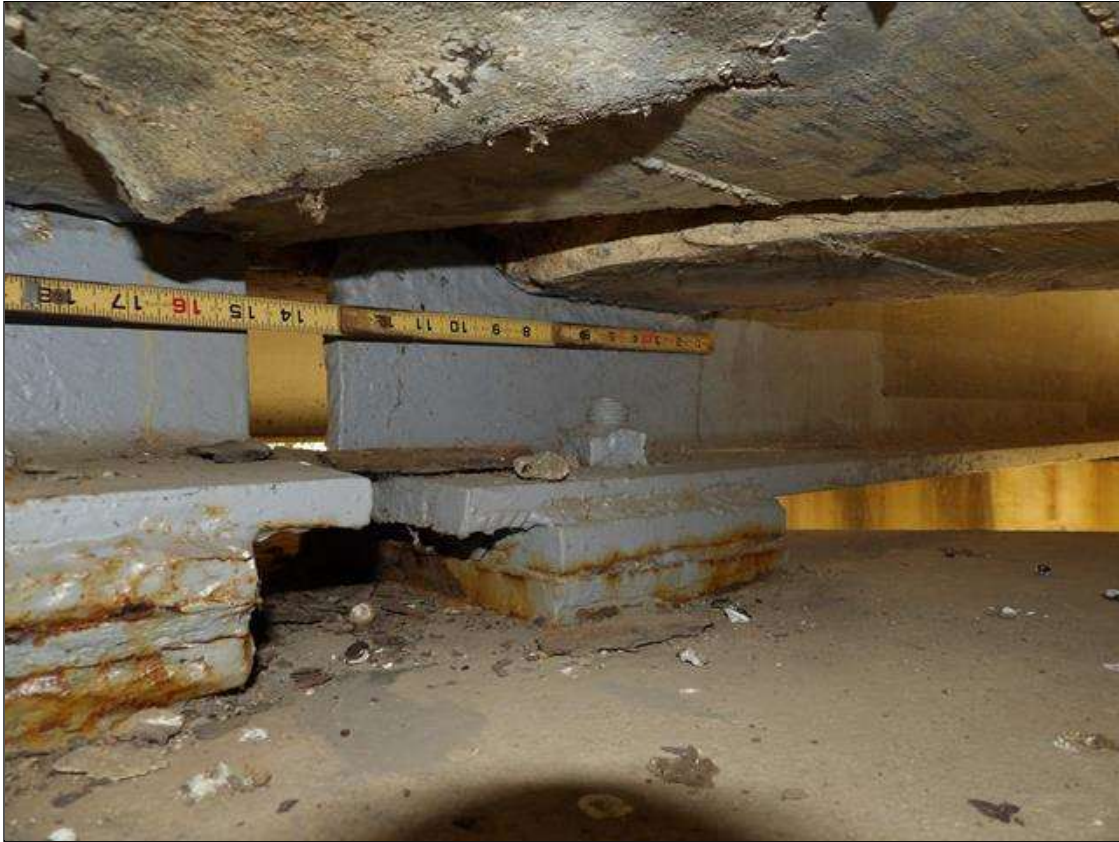
Span 4 Beam 3: PAR--BEAM END AT BENT 4 AT THE INTERFACE WITH THE REINFORCED CONCRETE DIAPHRAGM, THERE IS A BAND OF CORROSION UP TO 1 INCHES WIDE WITH SECTION LOSS [AVERAGE 5/16 INCHES REMAINS] FOR APPROXIMATELY 1 FEET LONG X UP TO THE FULL HEIGHT OF THE DIAPHRAGM. BEAM END HAS BEEN PAINTED WITH NO ACTIVE CORROSION

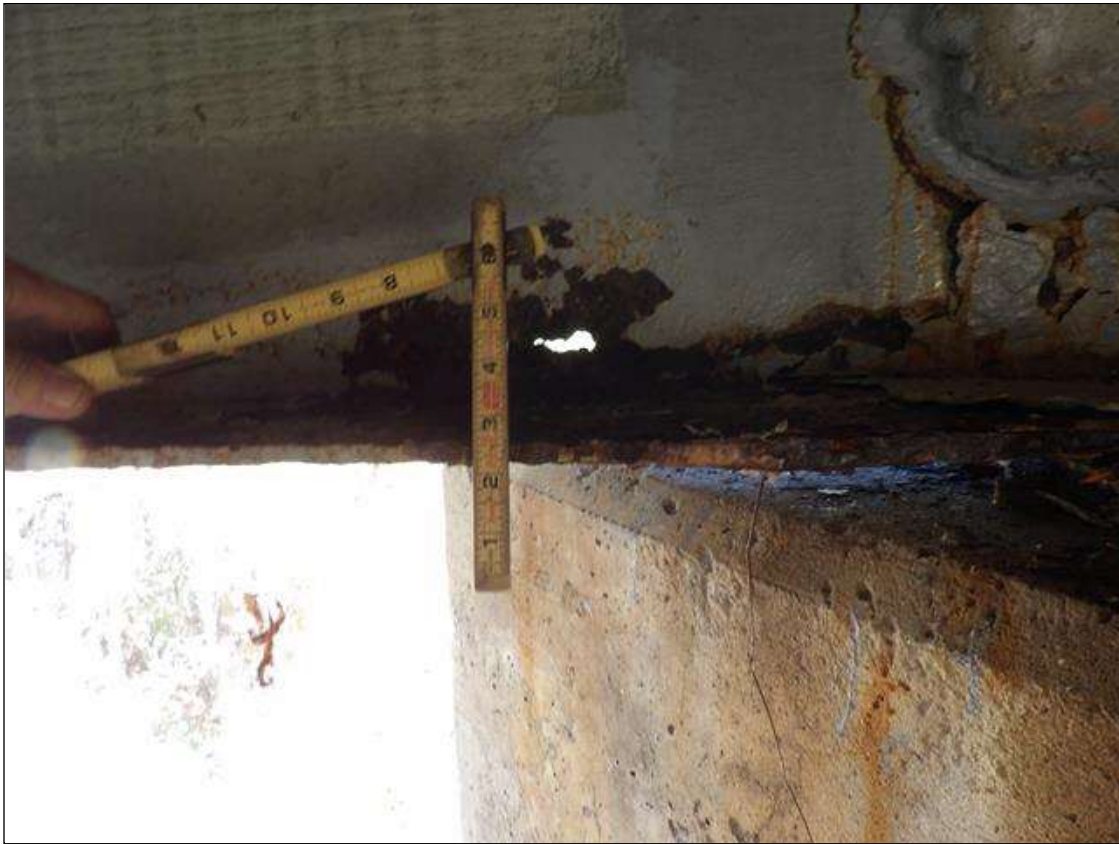
Span 5 Beam 5: PAR--BEAM END AT BENT 4 IN THE LOWER FLANGE, CORROSION WITH SECTION LOSS [AVERAGE 1/4 INCHES AVERAGE REMAINS FULL WIDTH] FOR APPROXIMATELY 4 FEET LONG. AT THE SAME END IN THE LOWER 4 INCHES OF THE WEB, CORROSION WITH 100 PERCENT SECTION LOSS WITH 1 INCH X 1/2 INCH HOLE 2 FEET FROM BEAM END [AVERAGE 5/16 INCHES REMAINS] FOR APPROXIMATELY 4 FEET LONG.

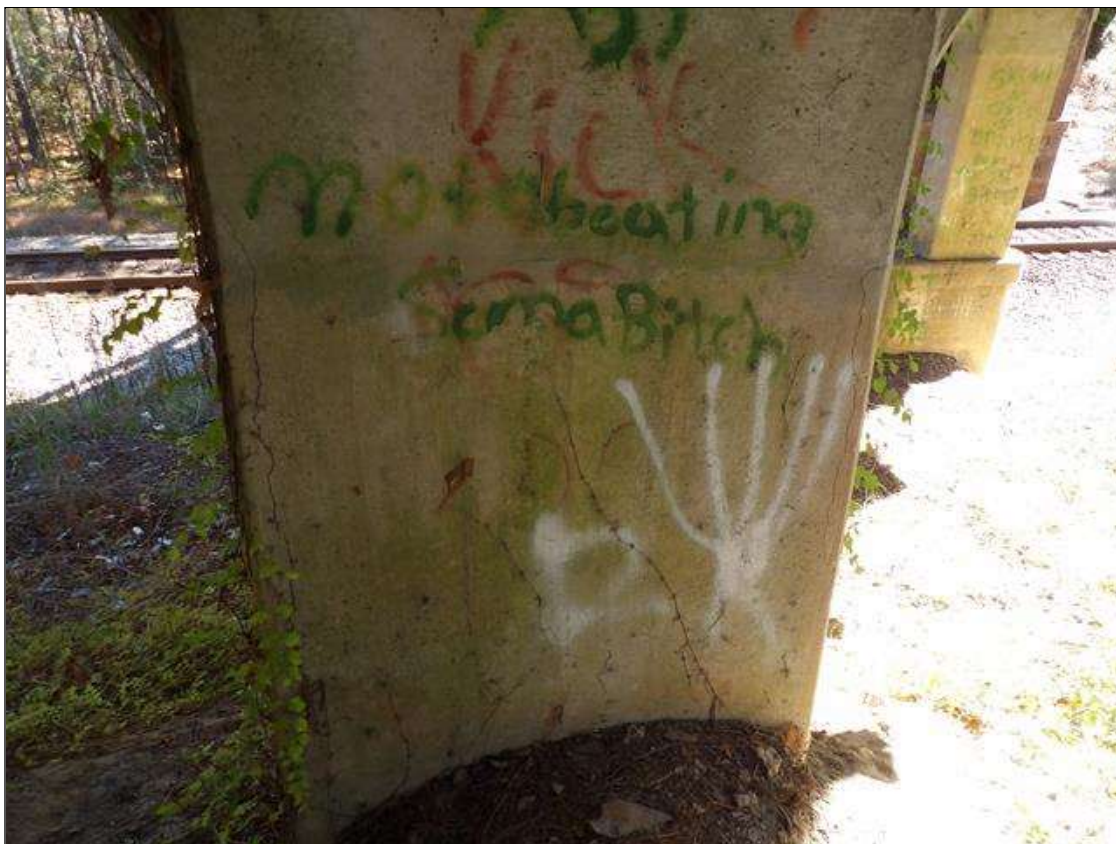
Bent 4 Pile 1: VERTICAL CRACK 5 FEET LONG UP TO 1/8 INCHES WIDE AT NORTHEAST AND NORTHWEST CORNERS

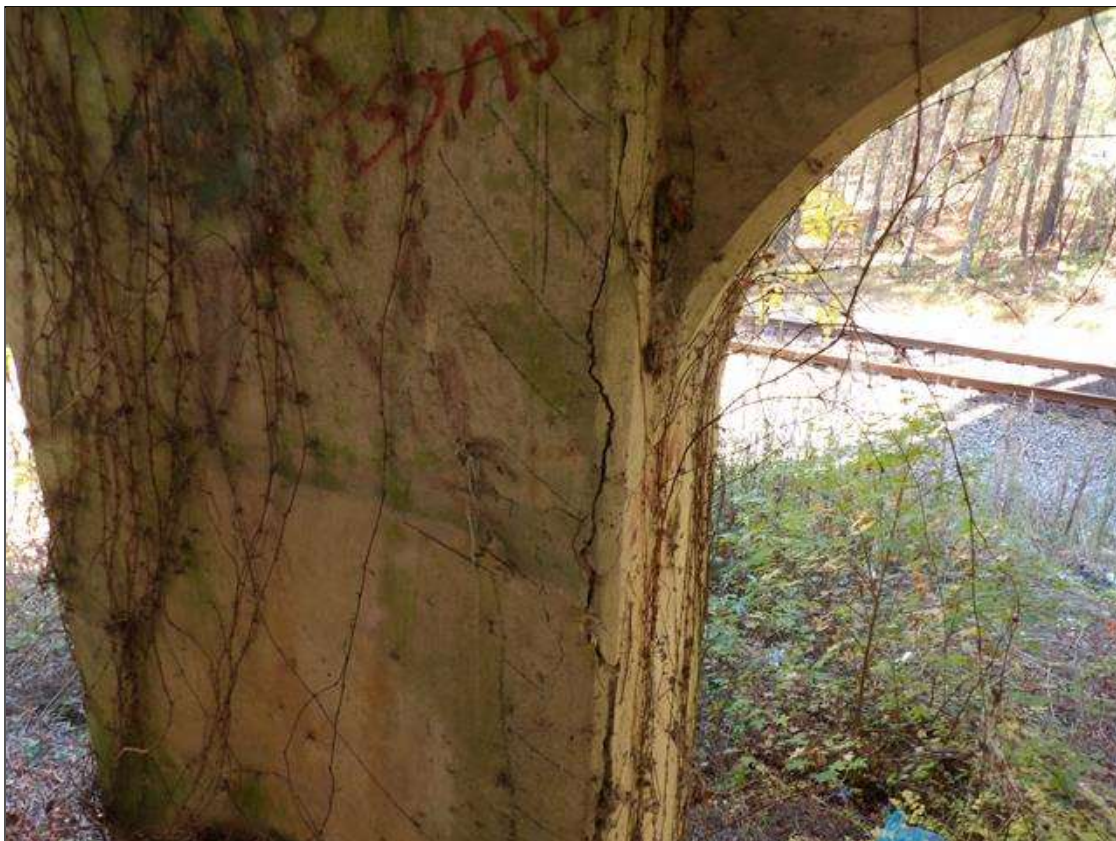
Bent 4 Pile 2: 6 FOOT X 9 INCH AREA OF DELAMINATION AT NORTHWEST CORNER

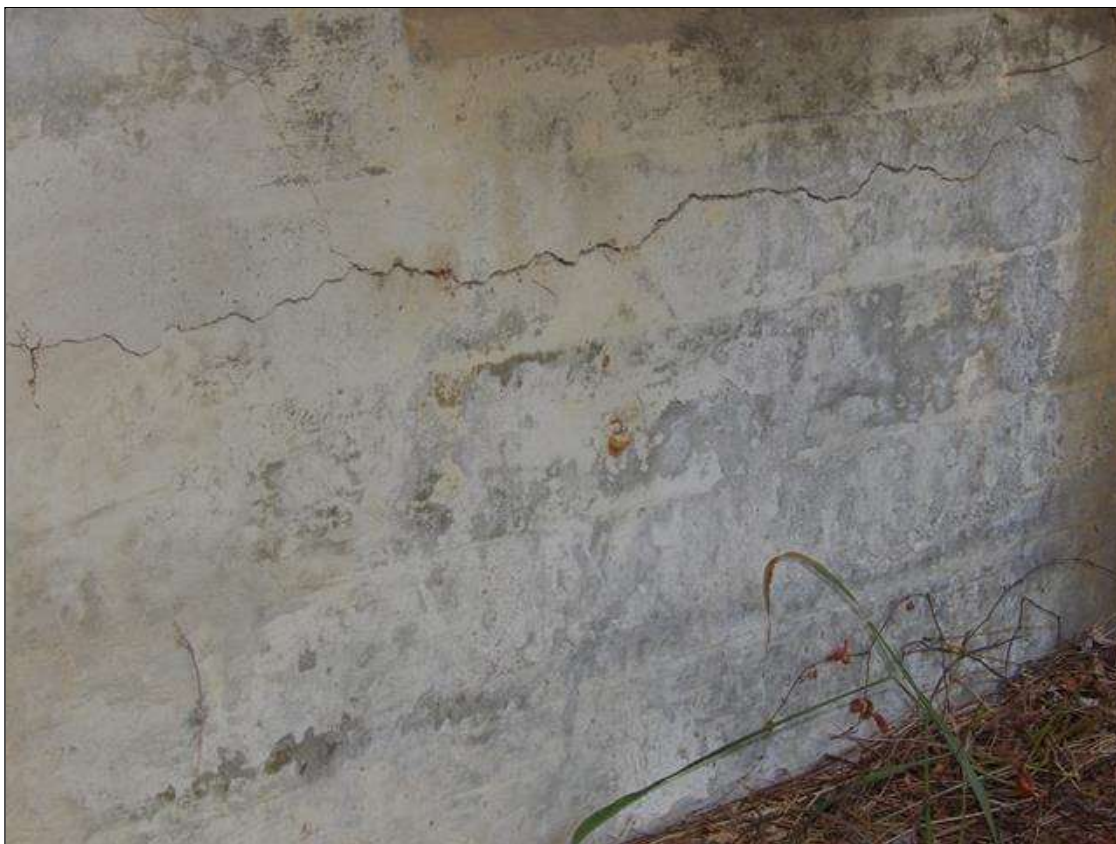
End Bent 2 Cap 1: HORIZONTAL CRACK 4 FEET LONG UP TO 1/8 INCH WIDE IN FACE OF CAP UNDER BEAM 5

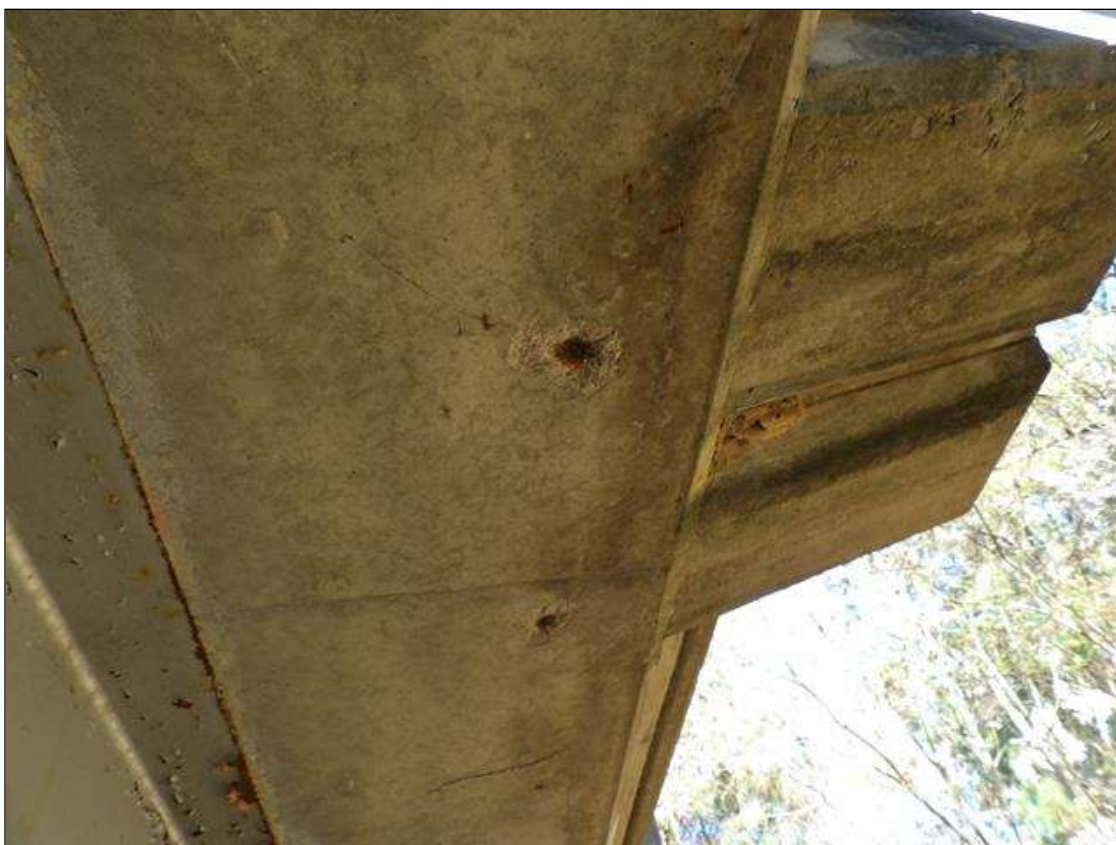
TYPICAL--SPALL WITH EXPOSED REBAR NO LOSS IN EAST/WEST EDGES OF DECK 4 INCHES DIAMETER X 1 INCHES DEEP IN SPAN 5 DECK

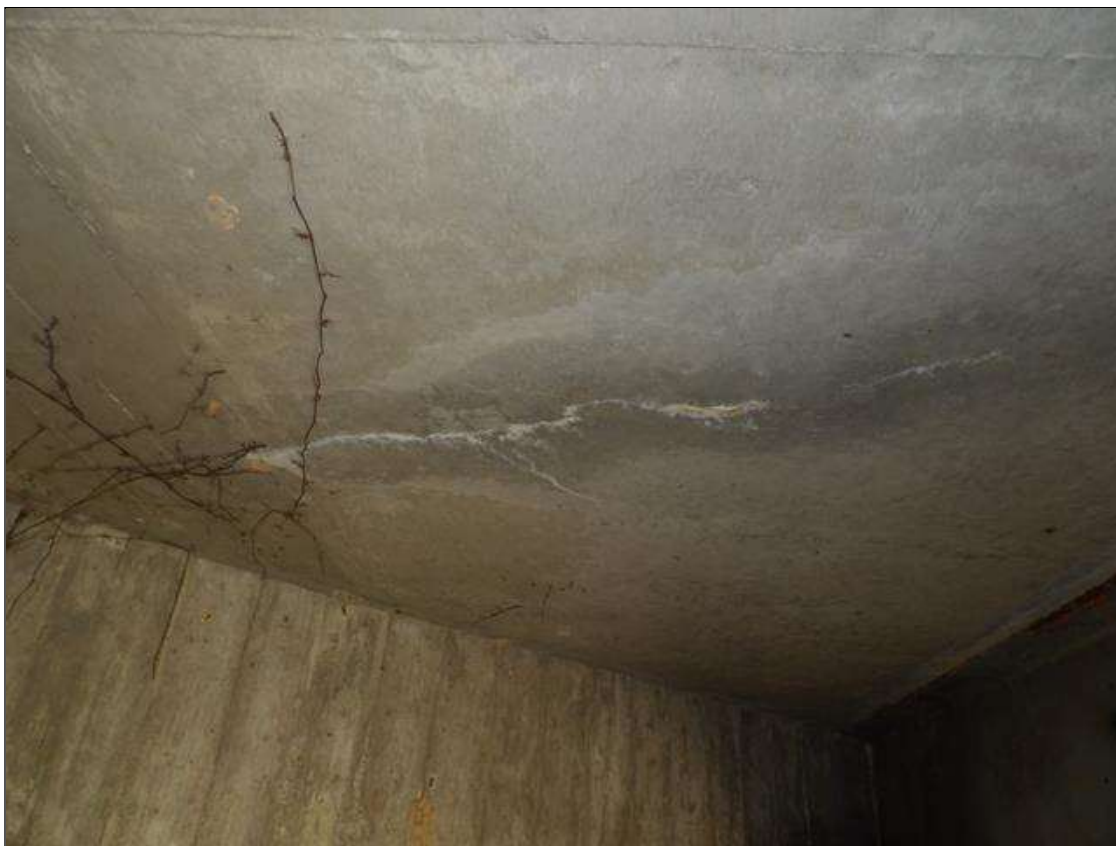
Span 5 Deck: 7 FEET LONG HAIRLINE DIAGONAL CRACK WITH MINOR EFFLORESCENCE IN UNDERSIDE OF DECK BAY 4 AT ABUTMENT 2

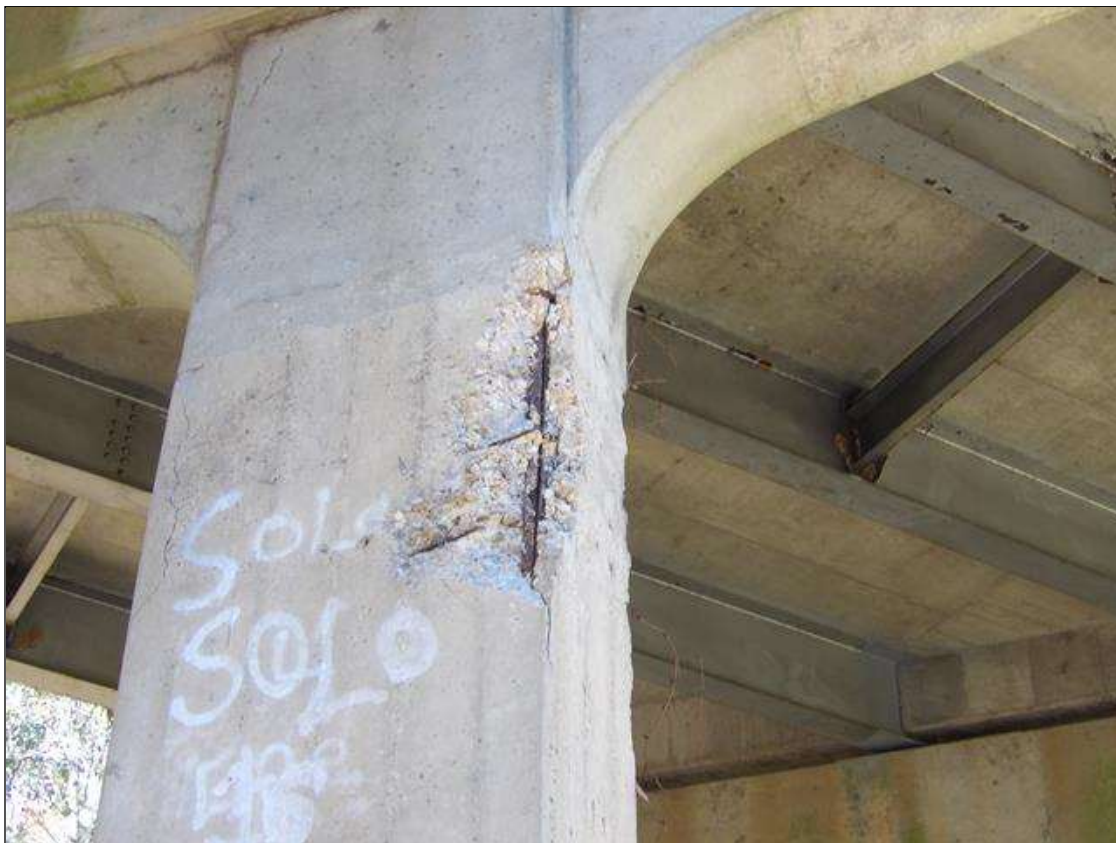
Bent 3 Pile 2: PAR--SOUTHEAST CORNER, SPALLING WITH EXPOSED REBAR [APPROXIMATELY 4 FEET HIGH X UP TO 1.25 FEET WIDE X UP TO 3 INCHES DEEP]

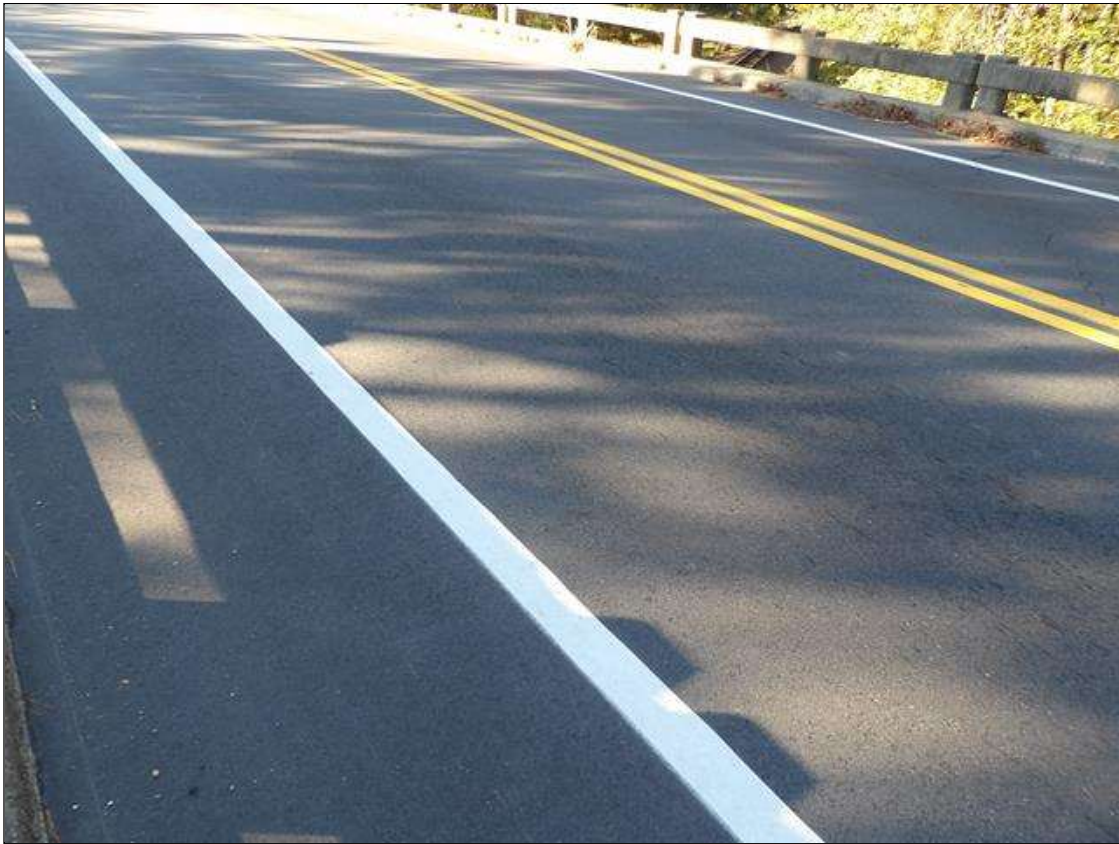
NEW ASPHALT WEARING SURFACE

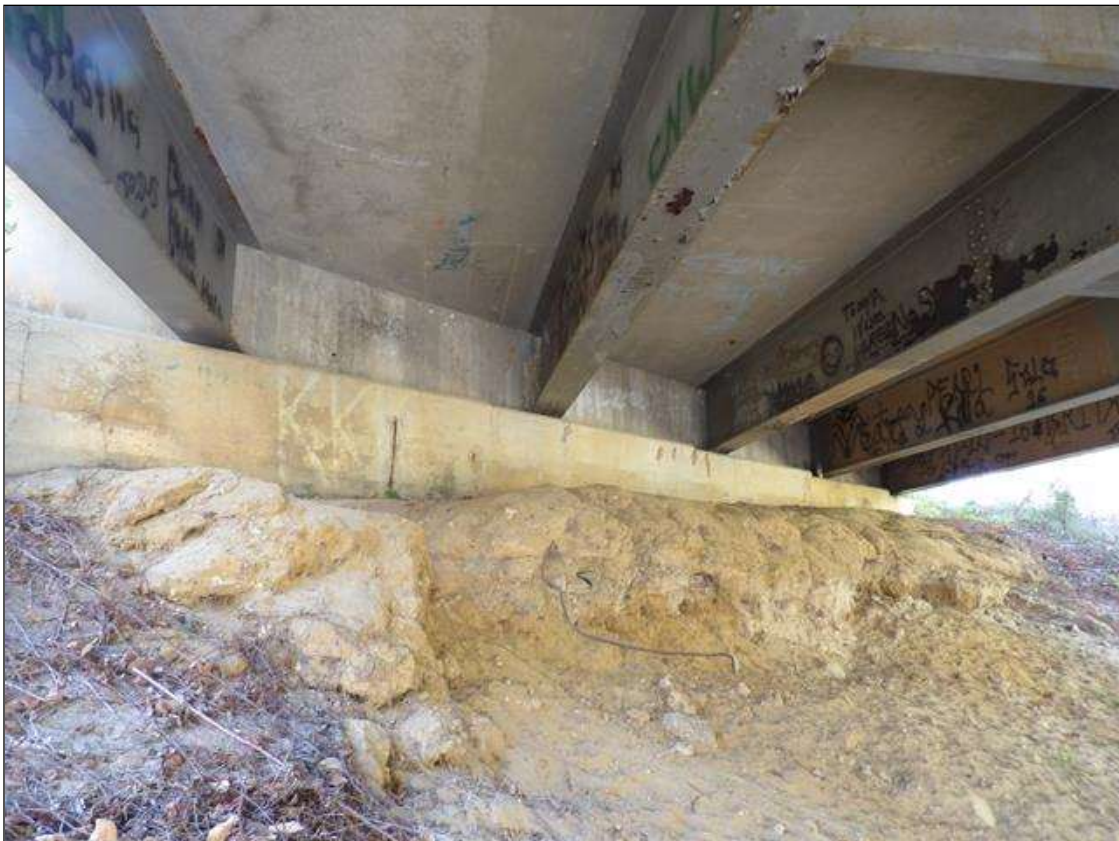
ABUTMENT 1, ABUTMENT 2 SIMILAR
