NC DEPARTMENT OF TRANSPORTATION
 DIVISION OF HIGHWAYS
 STRUCTURE MANAGEMENT UNIT

ATTENTION: **PRIORITY ACTION REQUEST ISSUED**

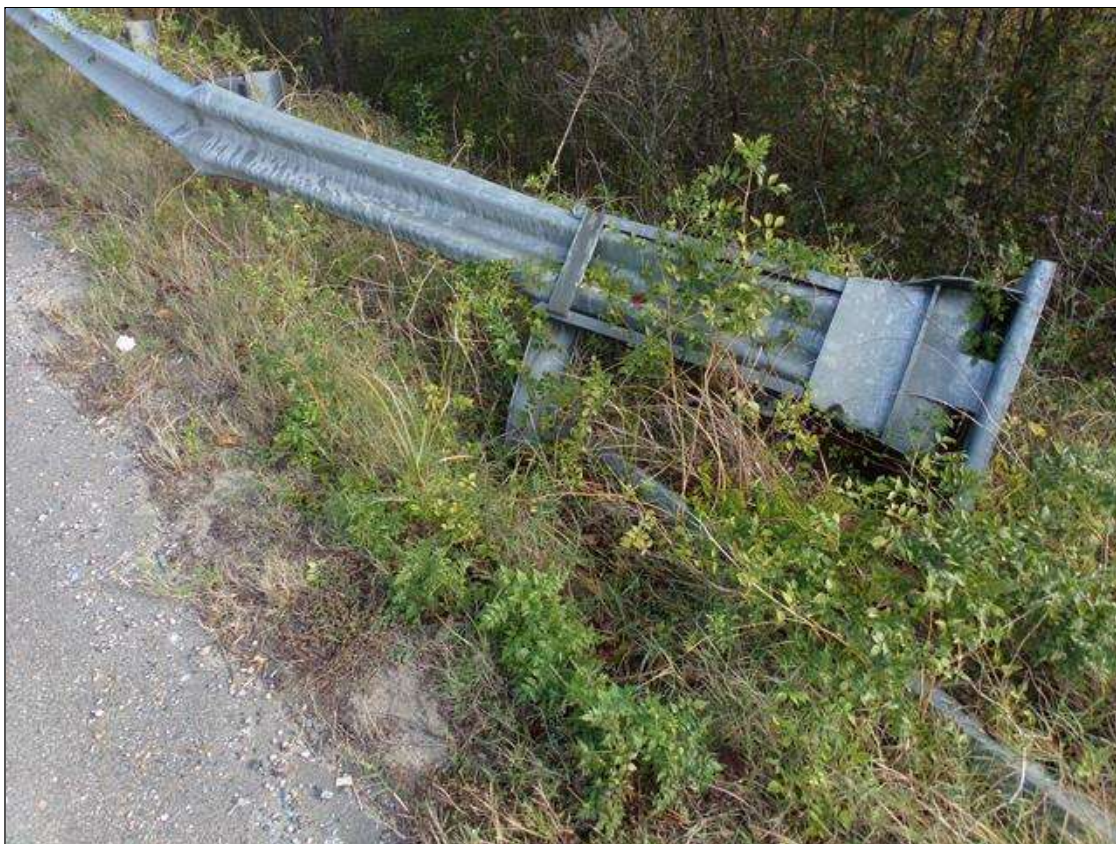
Guardrail impact damage to southeast terminal end

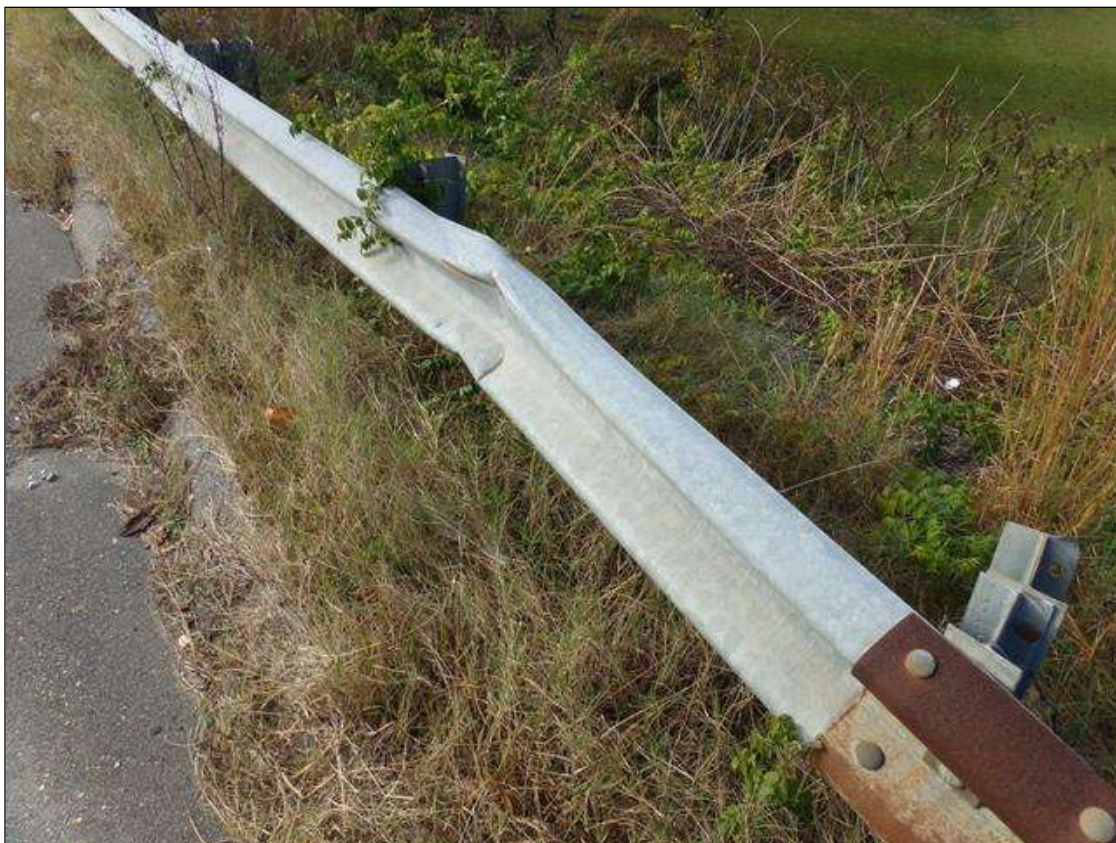
Guardrail impact damage to southwest rail midway 10' long

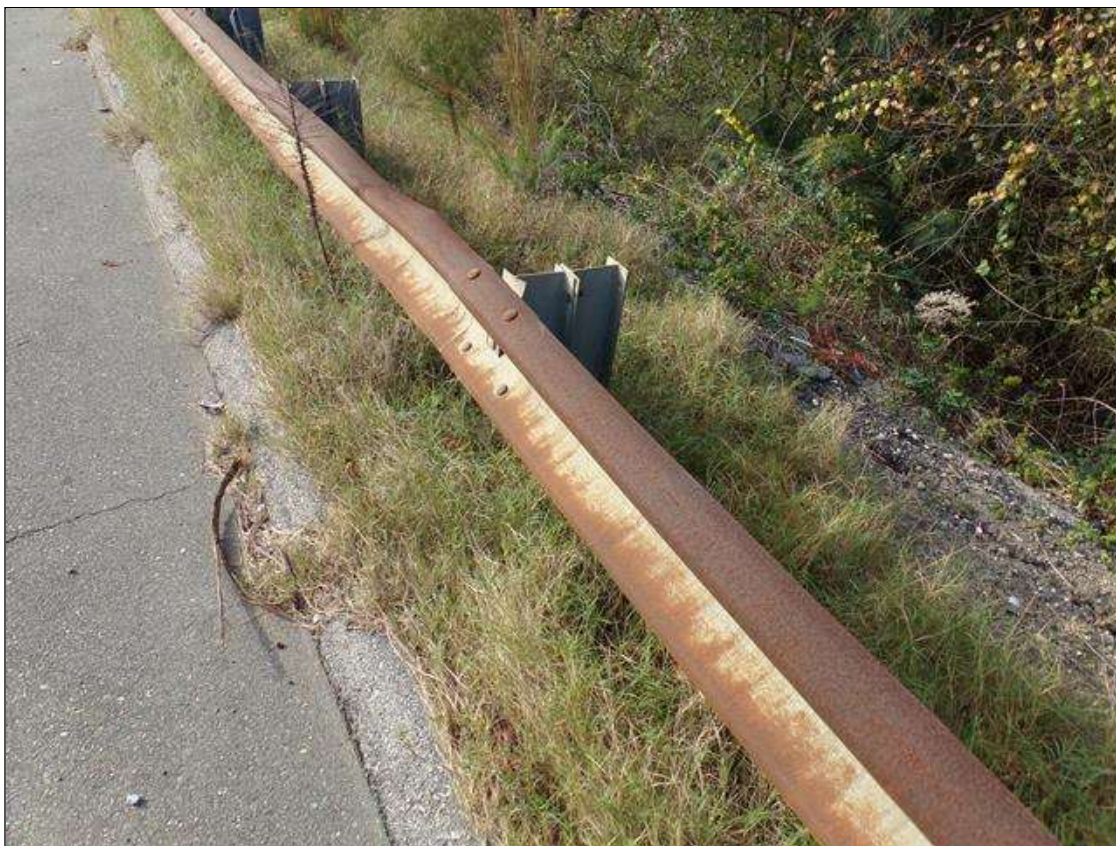
Guardrail impact damage to southwest rail 40' from bridge 10' long

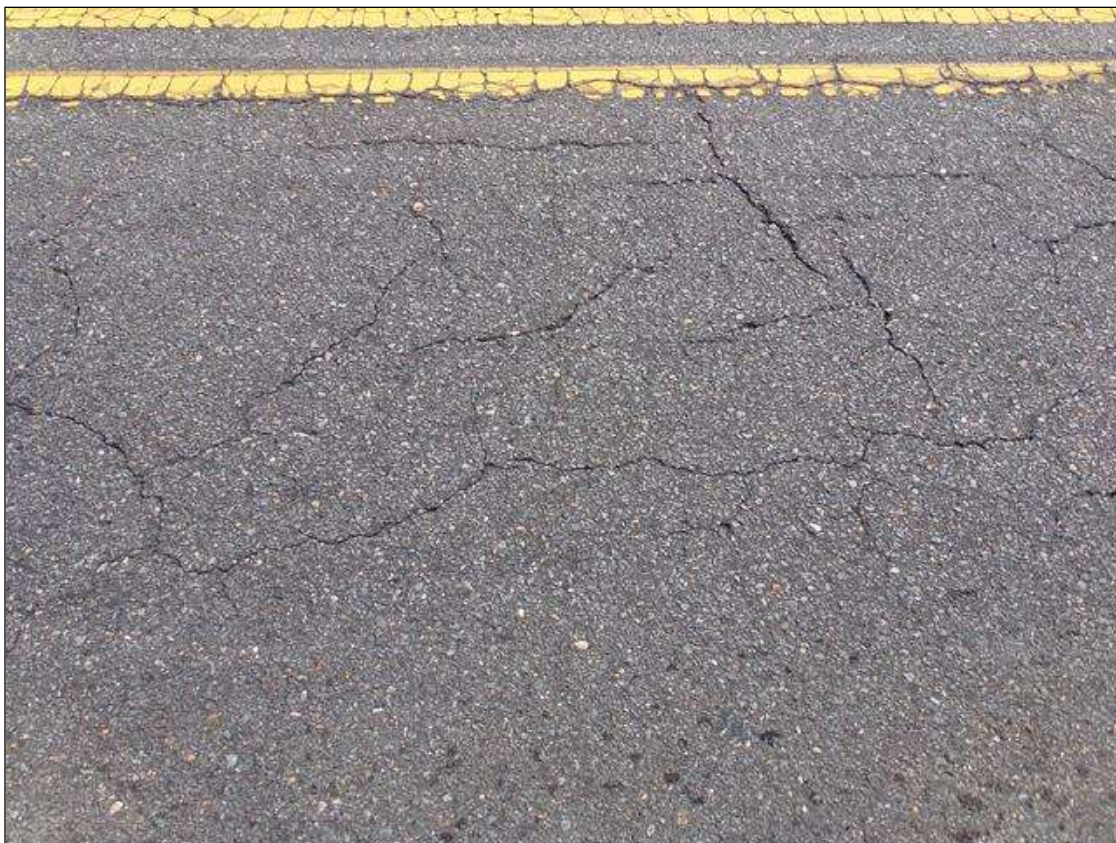
Span 1 Wearing Surface: Full length longitudinal/map cracking up to 1/4" wide in travel lanes

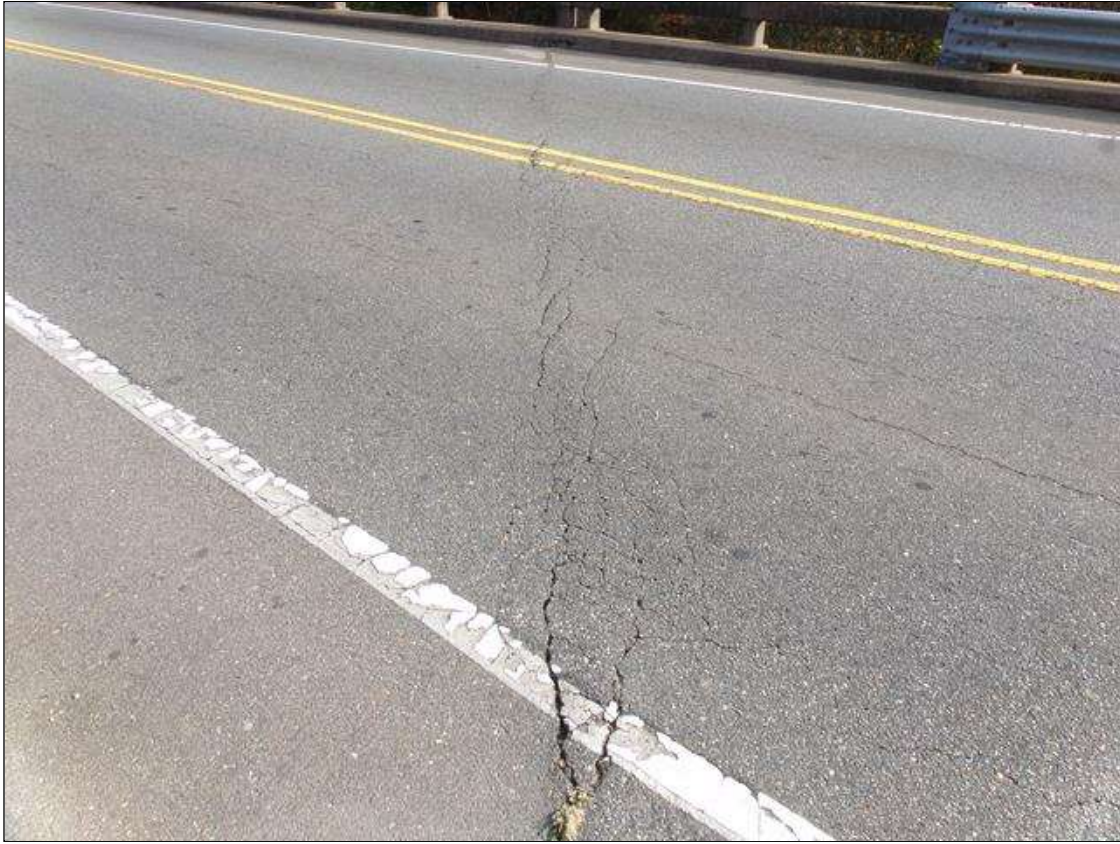
Span 1 Wearing Surface: FULL WIDTH TRANSVERSE/MAP CRACKING UP TO 1/2" WIDE OVER END BENT 1 AND BENT 1, BENT 1 SHOWN

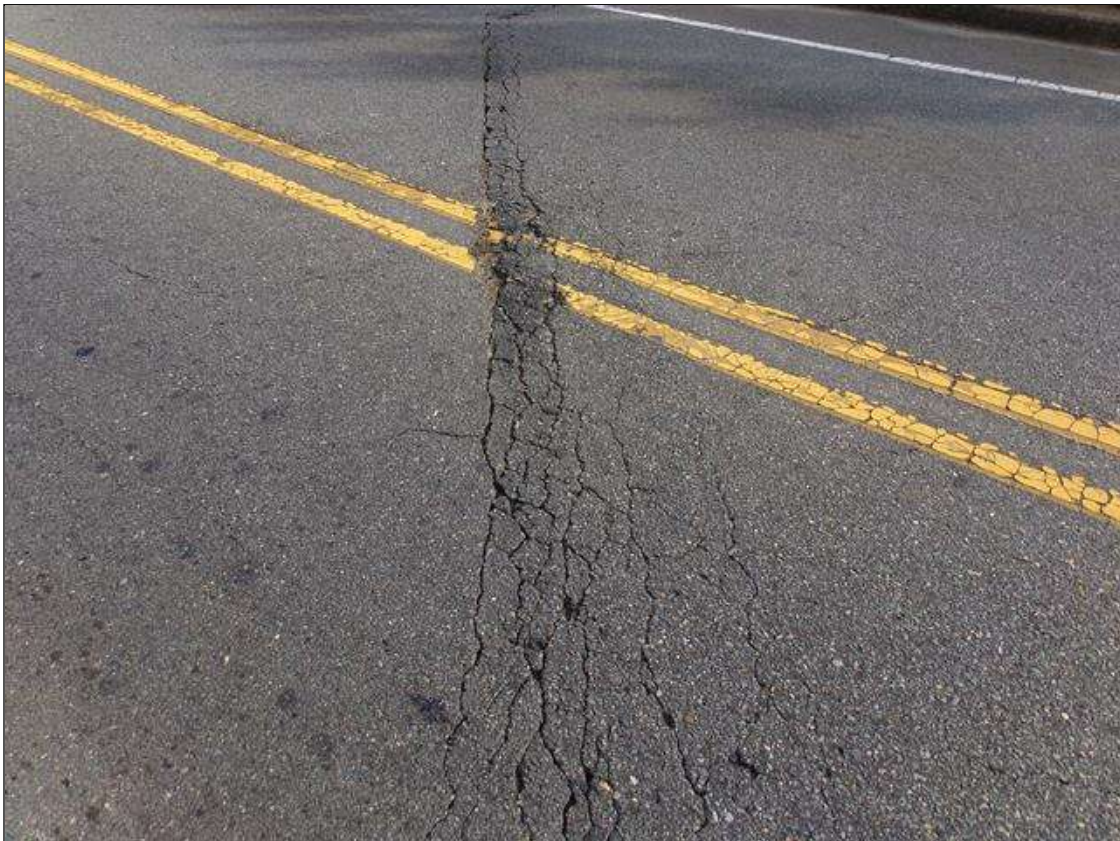
Span 3 Wearing Surface: FULL WIDTH TRANSVERSE/MAP CRACK UP TO 2" WIDE WITH ASPHALT DETERIORATION WITH UP TO 3/4" DEEP POT HOLES UP TO 1' LONG X 2" WIDE OVER BENT 3

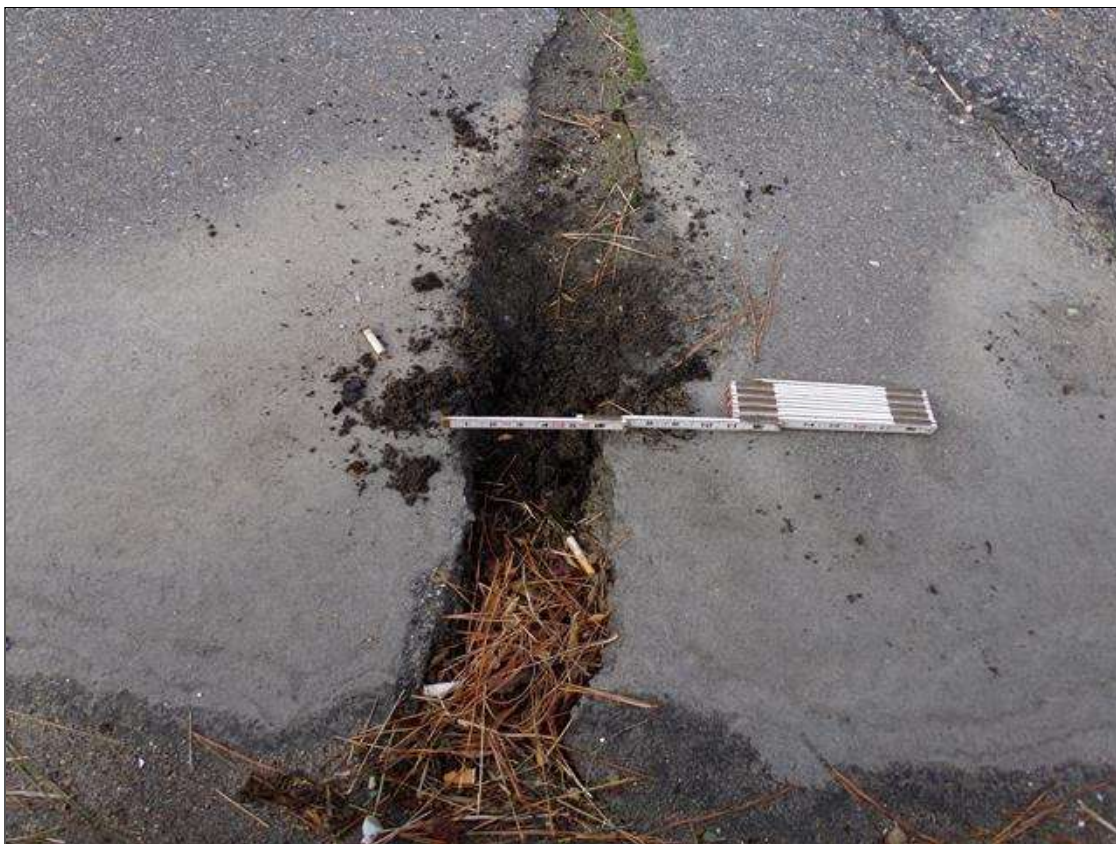
Span 3 Wearing Surface: 3' Long x 6" wide x 2 1/2" deep pothole at right shoulder at pier 3

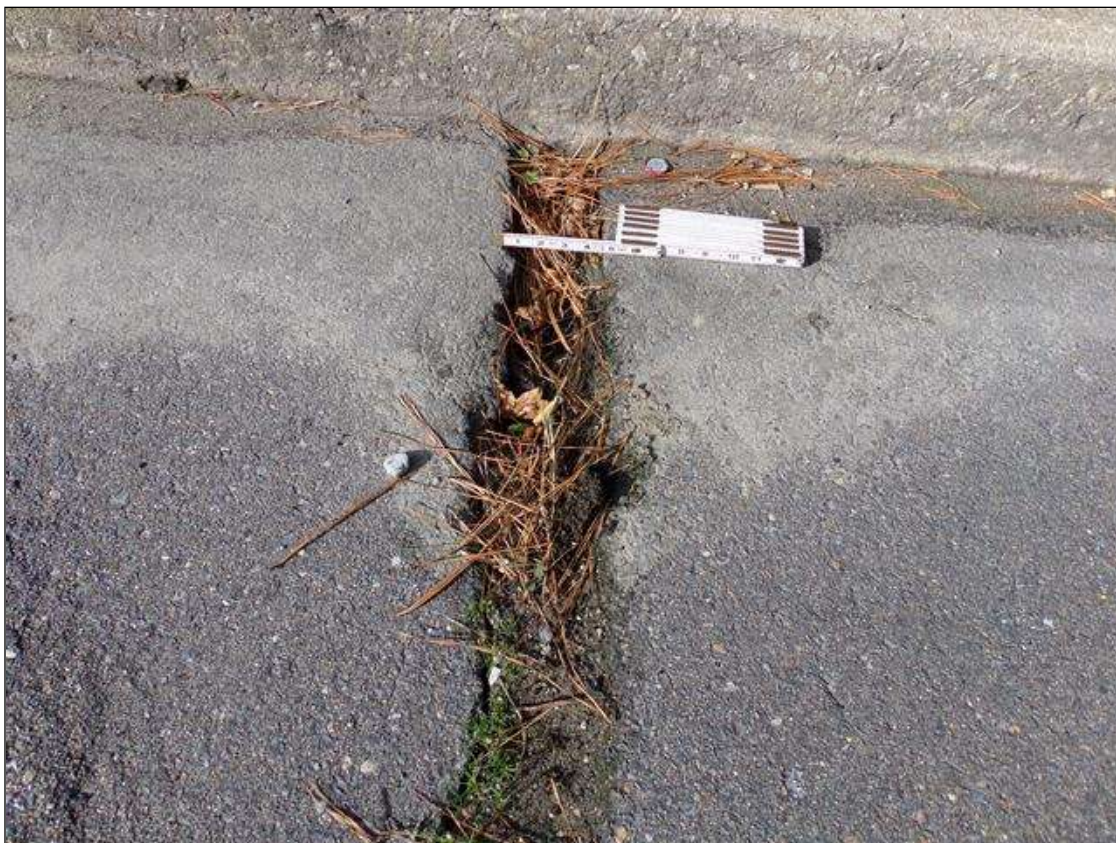
Span 4 Wearing Surface: 3' Long x 6" wide x 2 1/2" deep pothole at left shoulder at pier 3

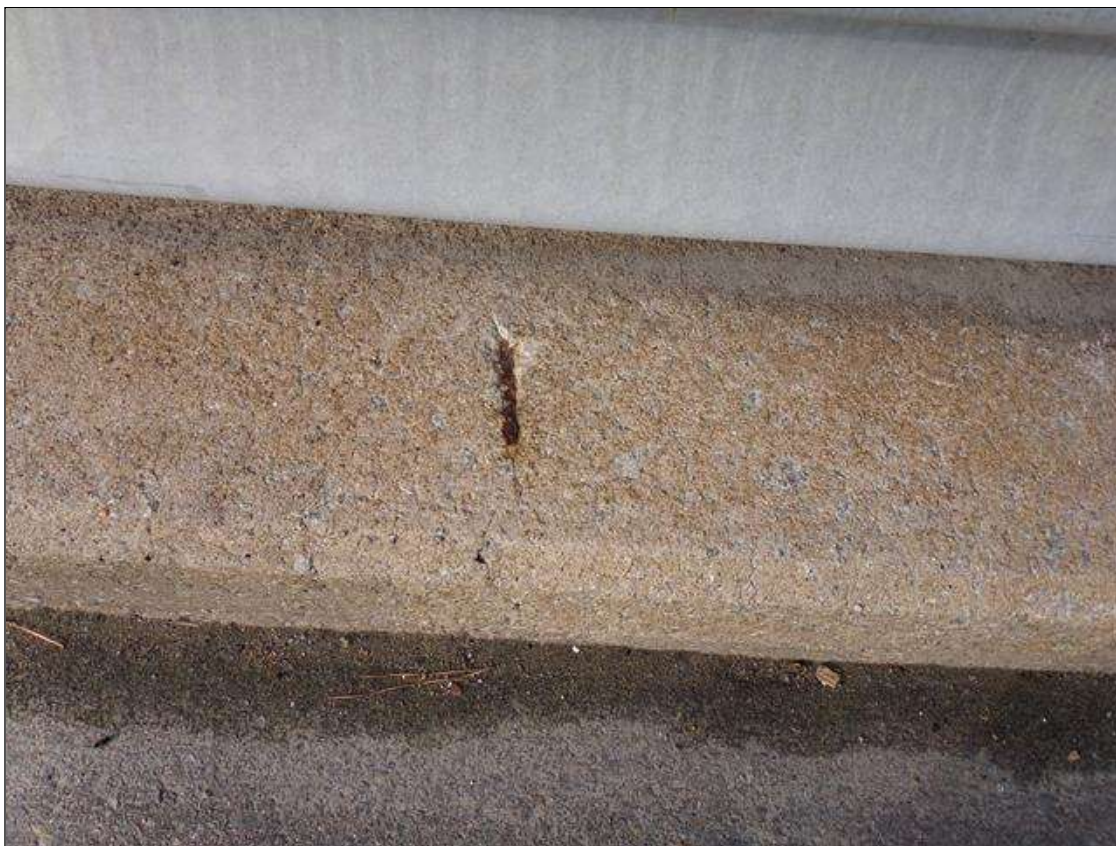
Typical small surface spall with exposed rebar in top of curb, span 5 left rail shown

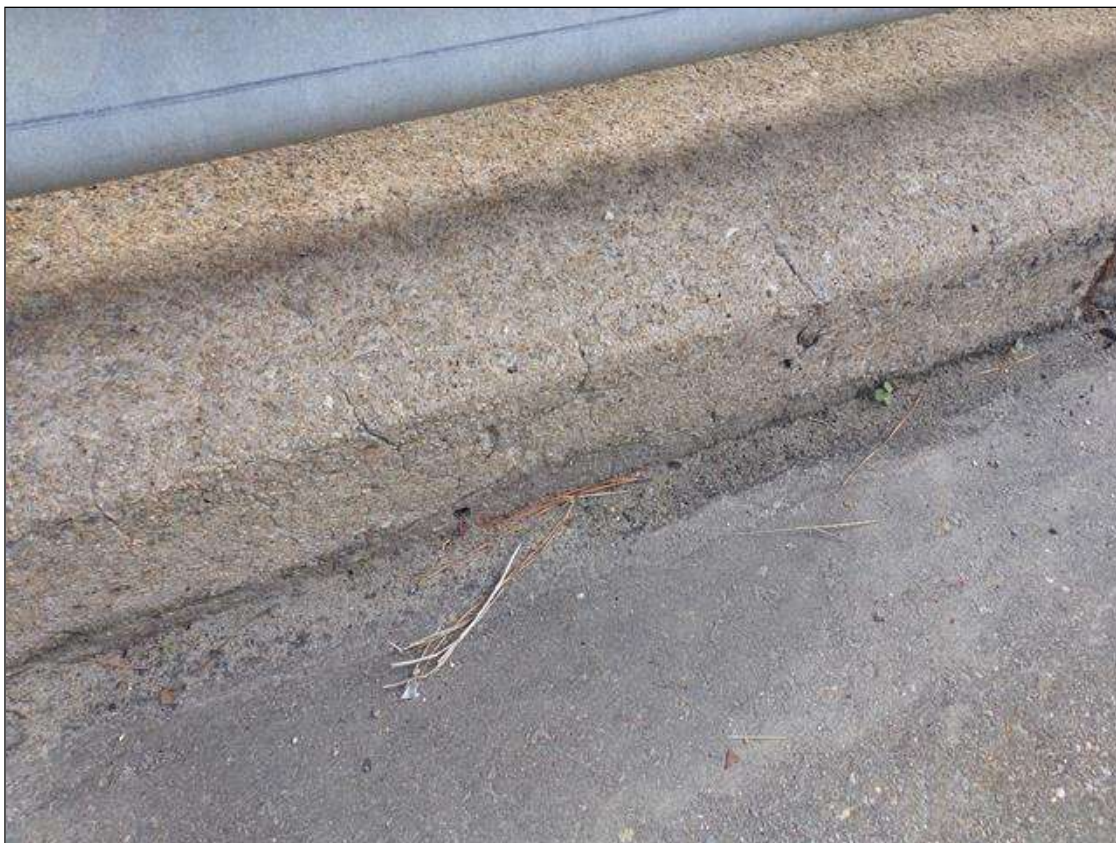
Typical hairline to 1/16" wide transverse/map cracking in curb portion of rail, right rail span 5 shown

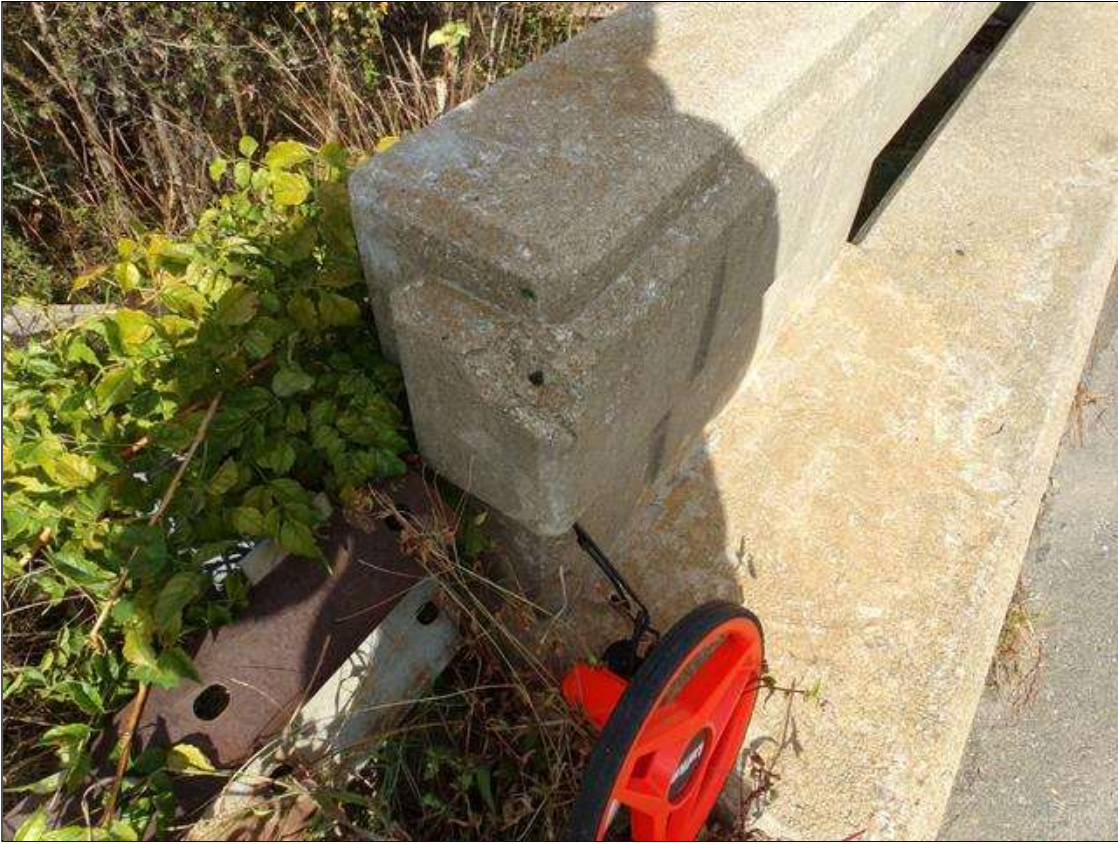
Span 1 Left Bridge Rail: 4" DIAMETER X 1" DEEP SPALL WITH EXPOSED REBAR AT END POST AT SOUTHWEST CORNER

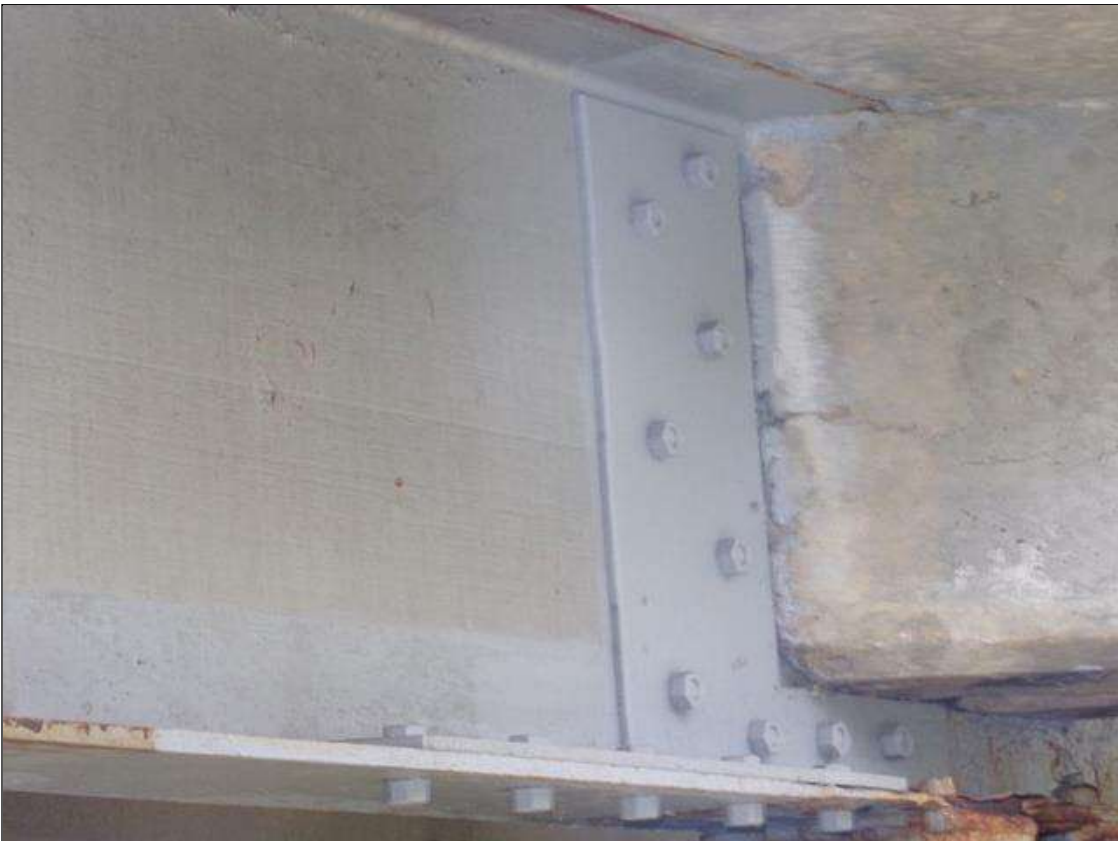
BEAM 1 BOLTED PLATE REPAIR TO BOTTOM FLANGE WEST SIDE AND BOTH FACES OF WEB AT BENT 4 SPAN

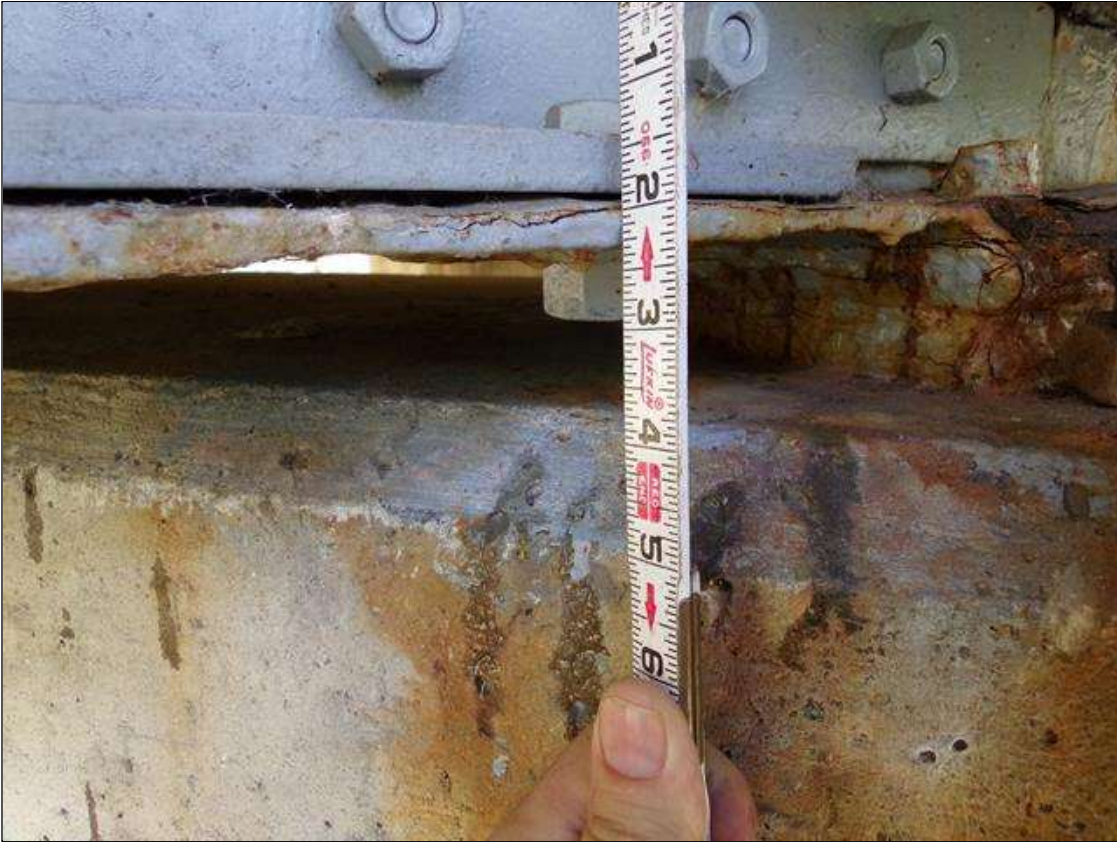
Span 5 Beam 1: 1/4" section loss with 3/8" average remaining full width of bottom flange. Beam end has been painted with active surface corrosion present. No PAR issued due to repair plate added at pier 4.

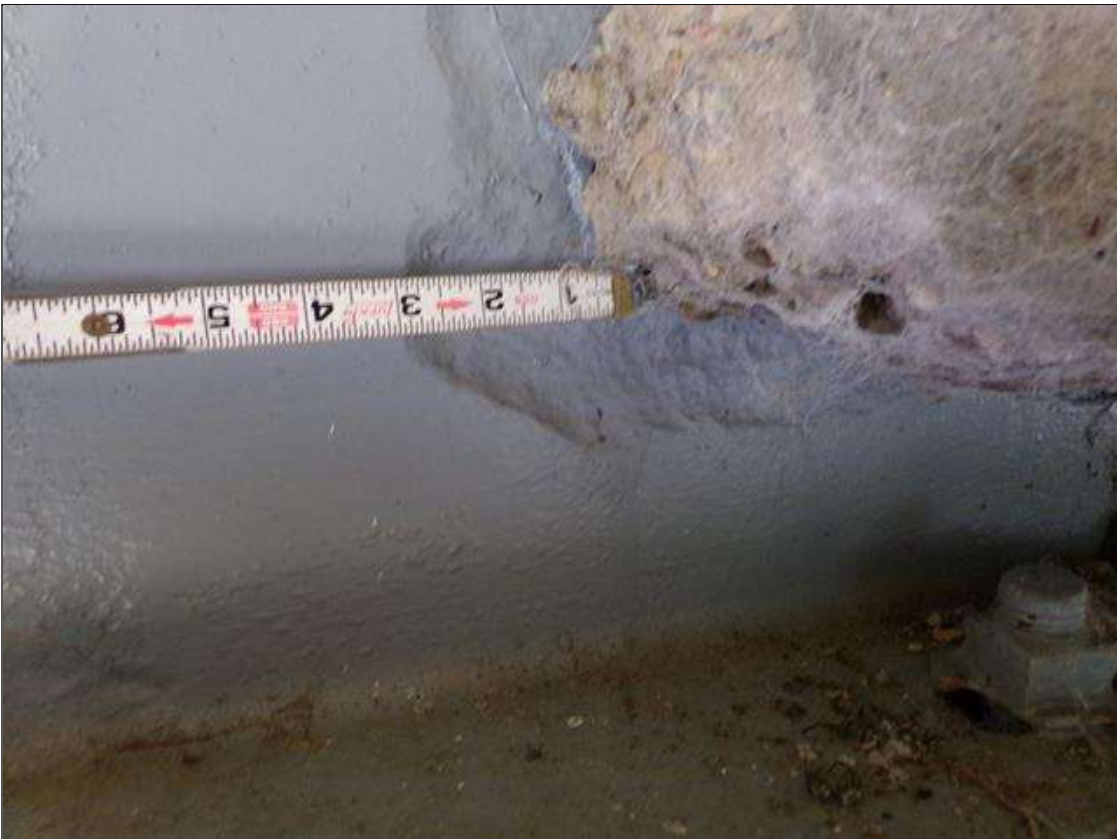
Span 5 Beam 2: PAR--1 FT LONG X 2" WIDE AREA OF PREVIOUS CORROSION WITH 1/4" REMAINING SECTION IN WEB AROUND END DIAPHRAGM AT BENT 4 AREA HAS BEEN PAINTED OVER AND ARRESTED.

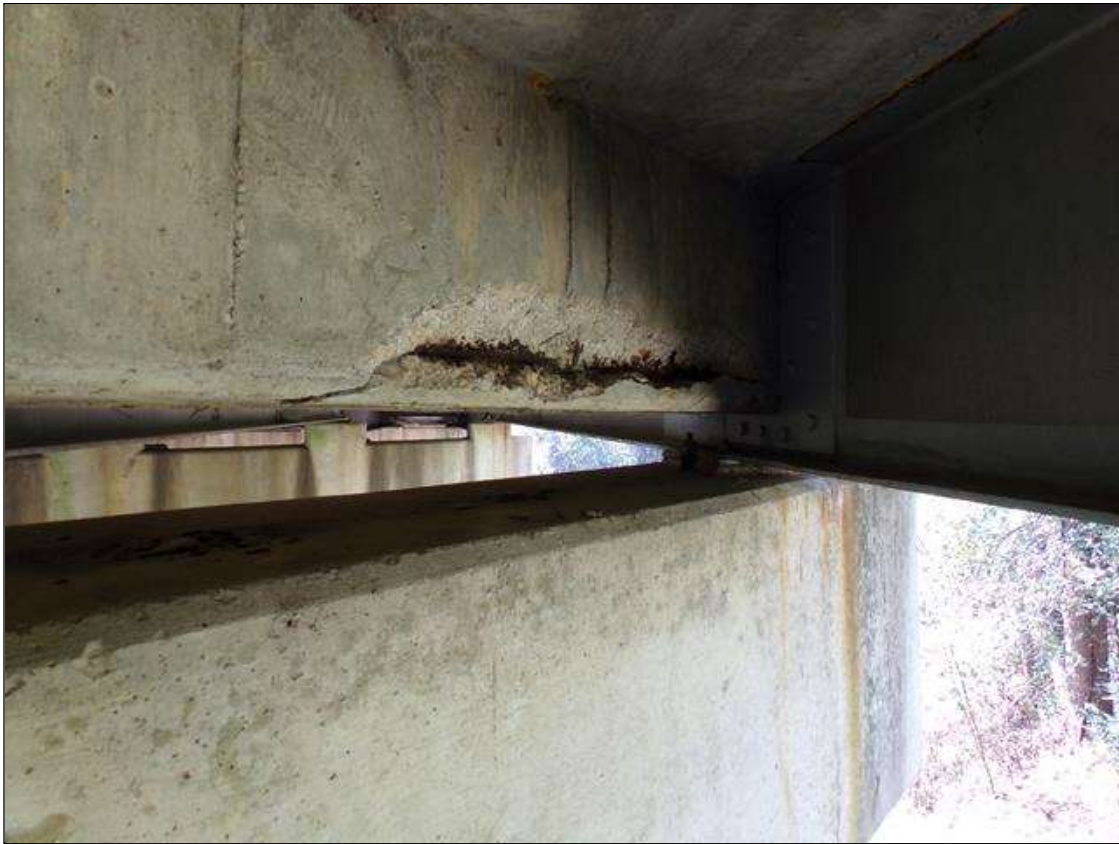
36" X 8" X 3" DEEP SPALL WITH EXPOSED REBAR IN BENT 4 END DIAPHRAGM IN BAY 1 SPAN 5 AND A 9" WIDE X 1' HIGH X 2" DEEP SPALL AT BEAM 2 IN BAY 1 SPAN 5

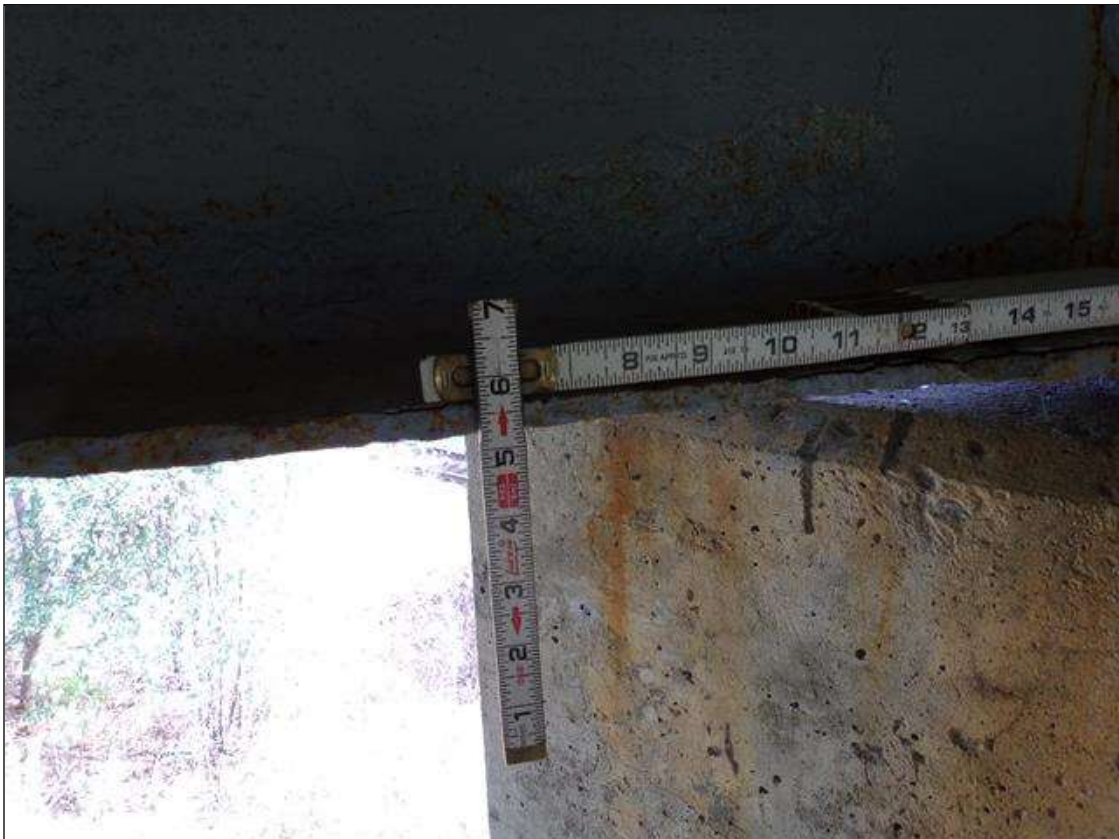
Span 5 Beam 5: PAR--1/4" section loss with 3/8" average remaining full width of bottom flange 4' long. Beam end has been painted with rust staining present at pier 4.

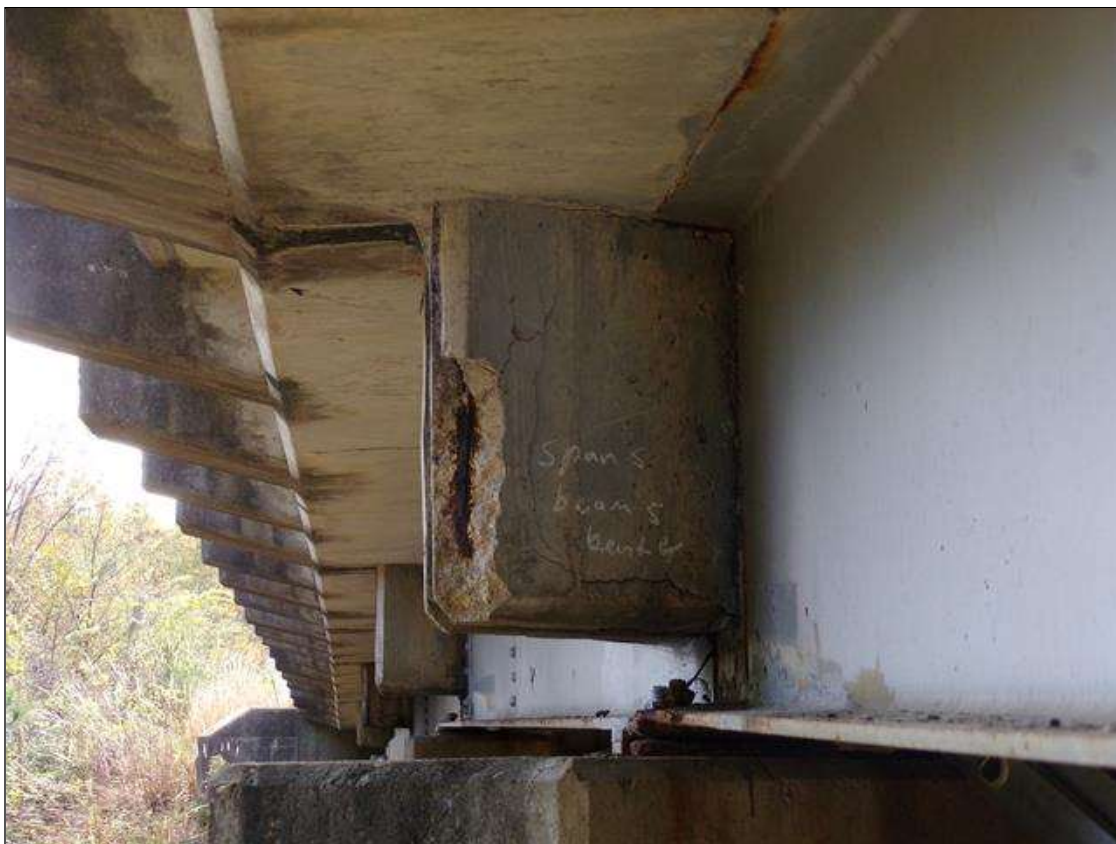
12" X 4" X 2" DEEP SPALL WITH EXPOSED REBAR IN BENT 4 END DIAPHRAGM AT EAST END

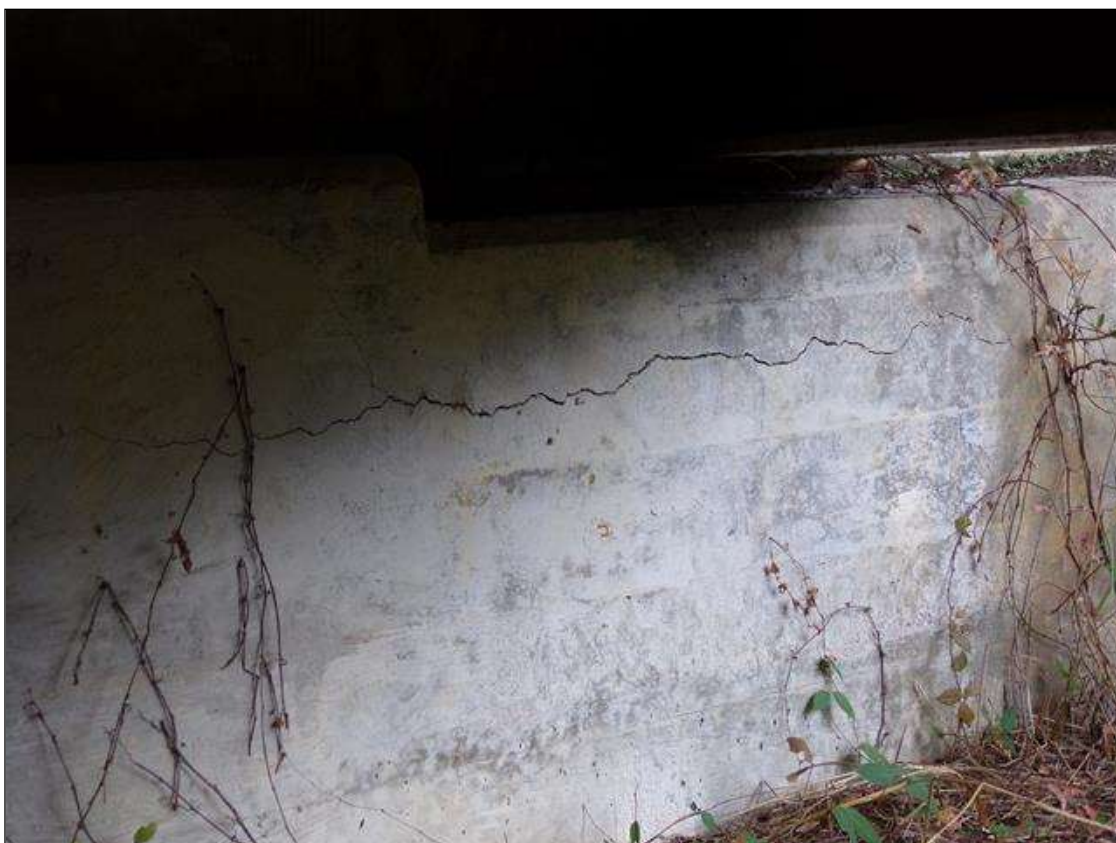
End Bent 2 Cap 1: HORIZONTAL CRACK 4 FT LONG UP TO 1/8" WIDE IN FACE OF CAP UNDER BEAM 5

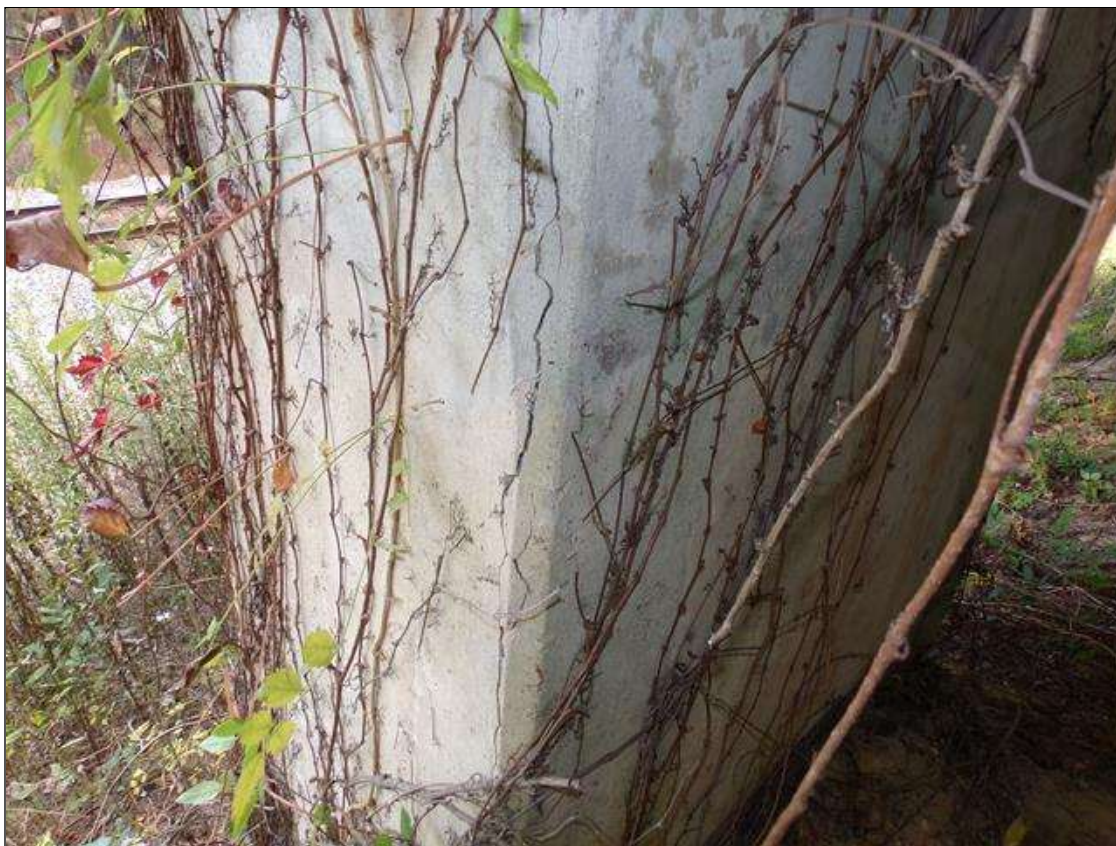
Bent 4 Pile 2: 6 FT X 9" AREA OF DELAMINATION WITH CRACKING UP TO 1/8" WIDE AT NORTHEAST CORNER

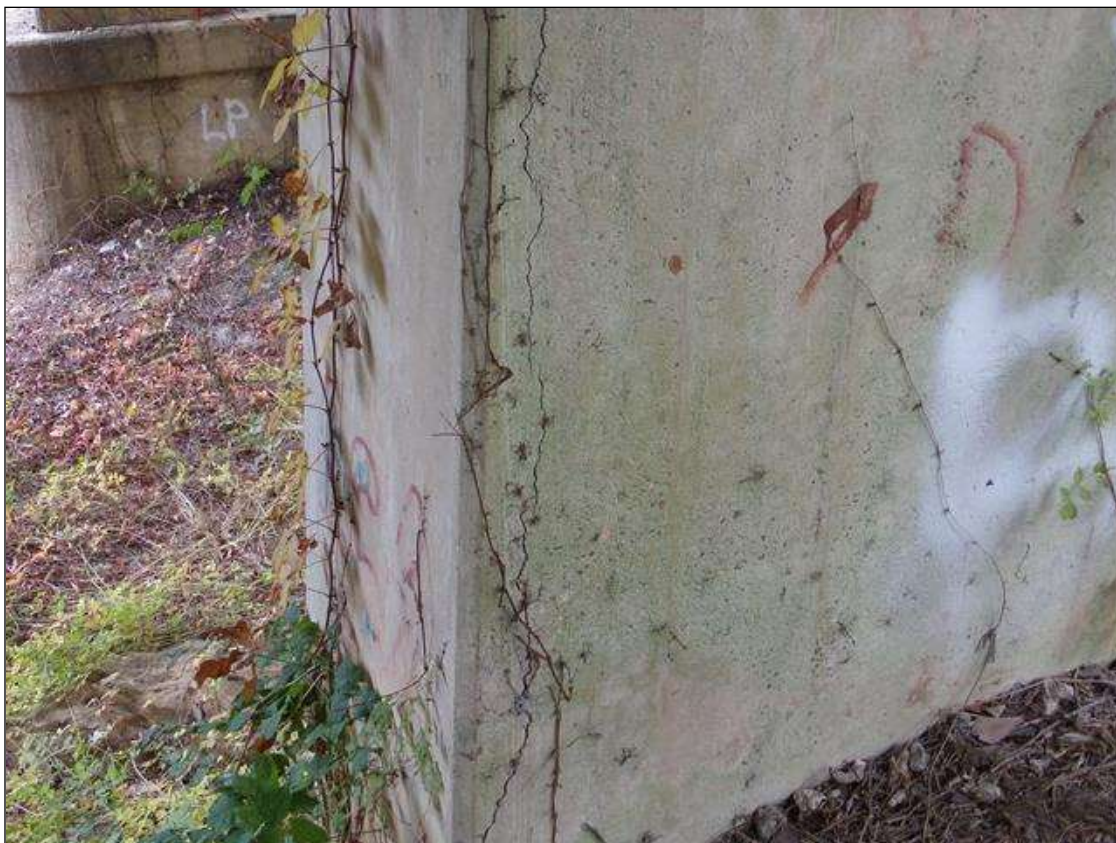
Bent 4 Pile 1: VERTICAL CRACK 5 FT LONG UP TO 1/8" WIDE AT NORTHEAST CORNER

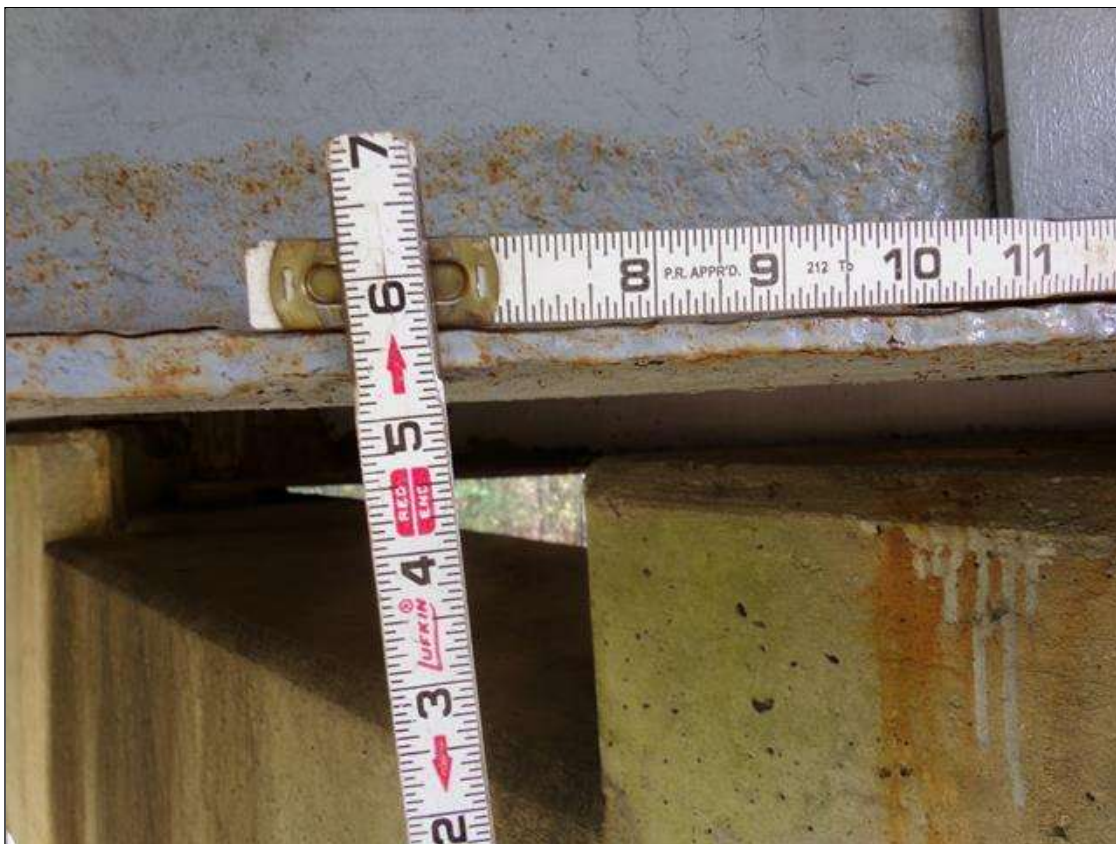
Span 4 Beam 1: PAR--1/4" section loss with 3/8" average remaining full width of bottom flange 3' long. Beam end has been painted with rust staining present at pier 3.

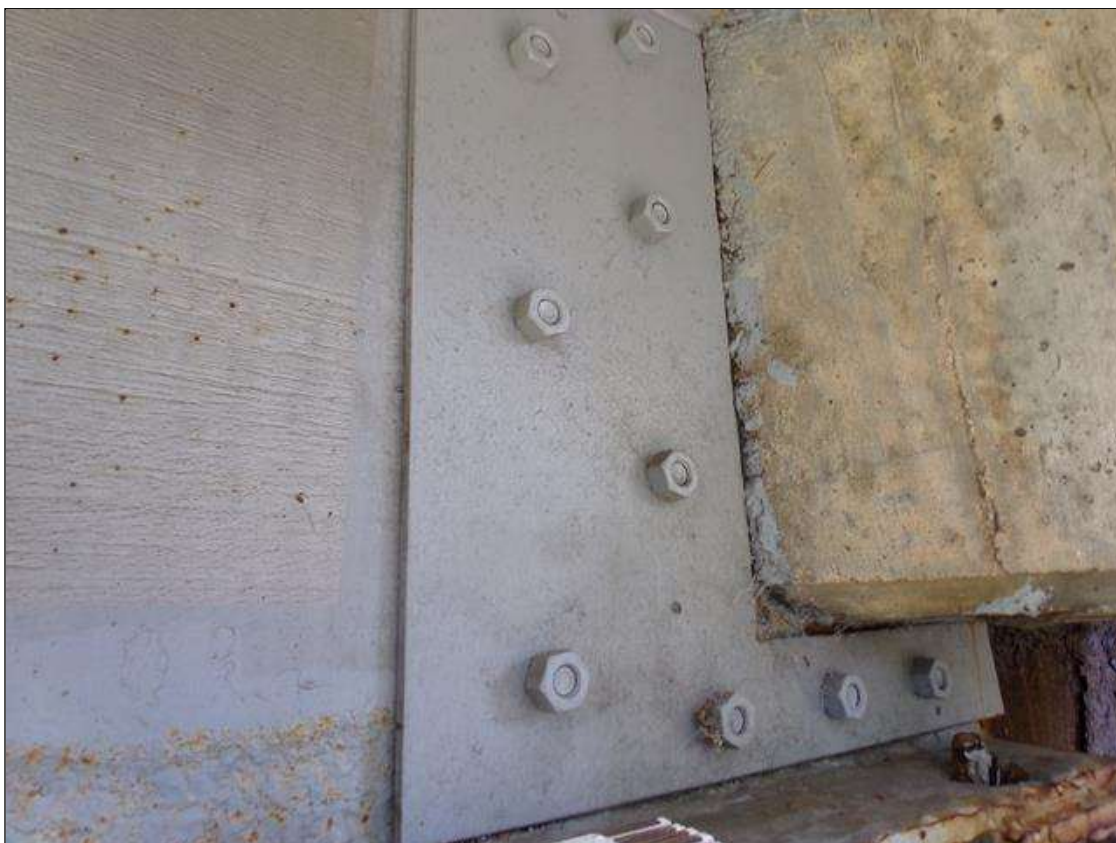
BOLTED PLATE REPAIR FULL HEIGHT X 1' LONG TO WEB AT BENT 3 BEAM 1 SPAN 4

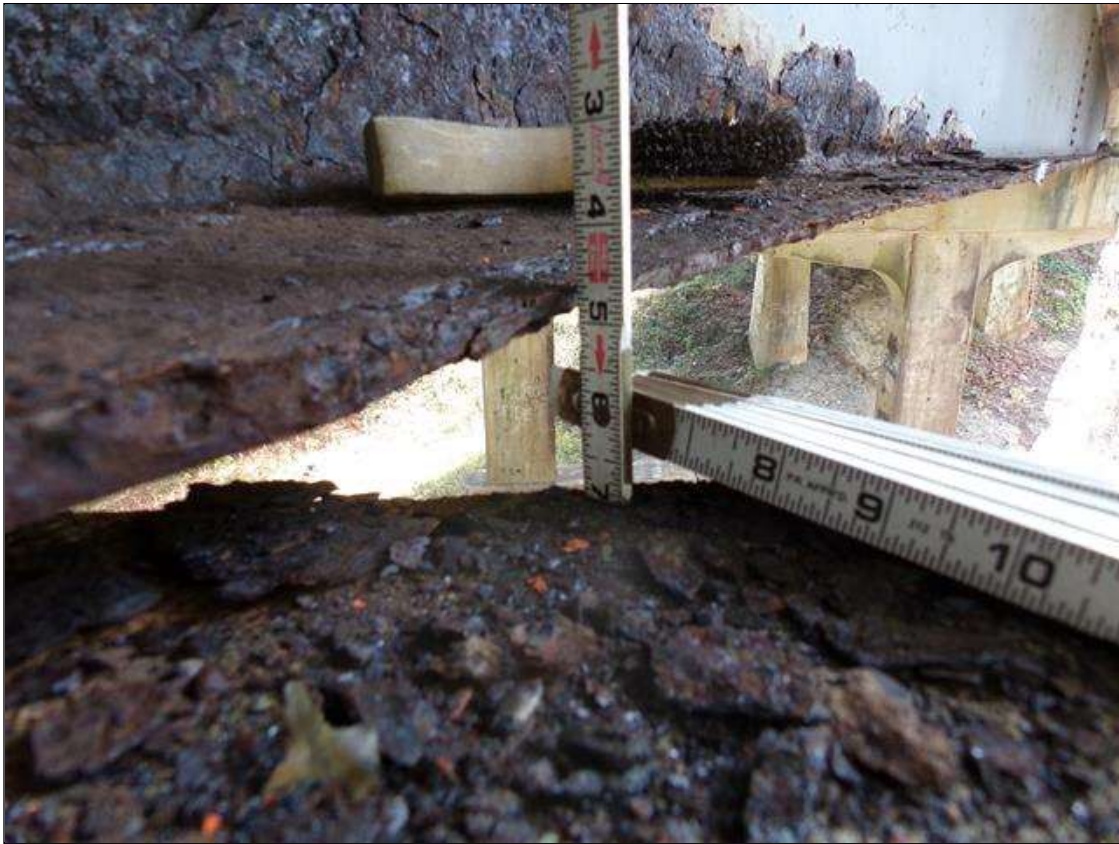
Span 3 Beam 1: PAR--CORROSION 5FT LONG WITH UP TO 5/8" LOSS AT OUTER EDGES OF BOTTOM FLANGE WITH 1/2" AVERAGE REMAINING FULL WIDTH AND 1/2" THICKNESS REMAINING IN WEB 5FT LONG AT BENT 3

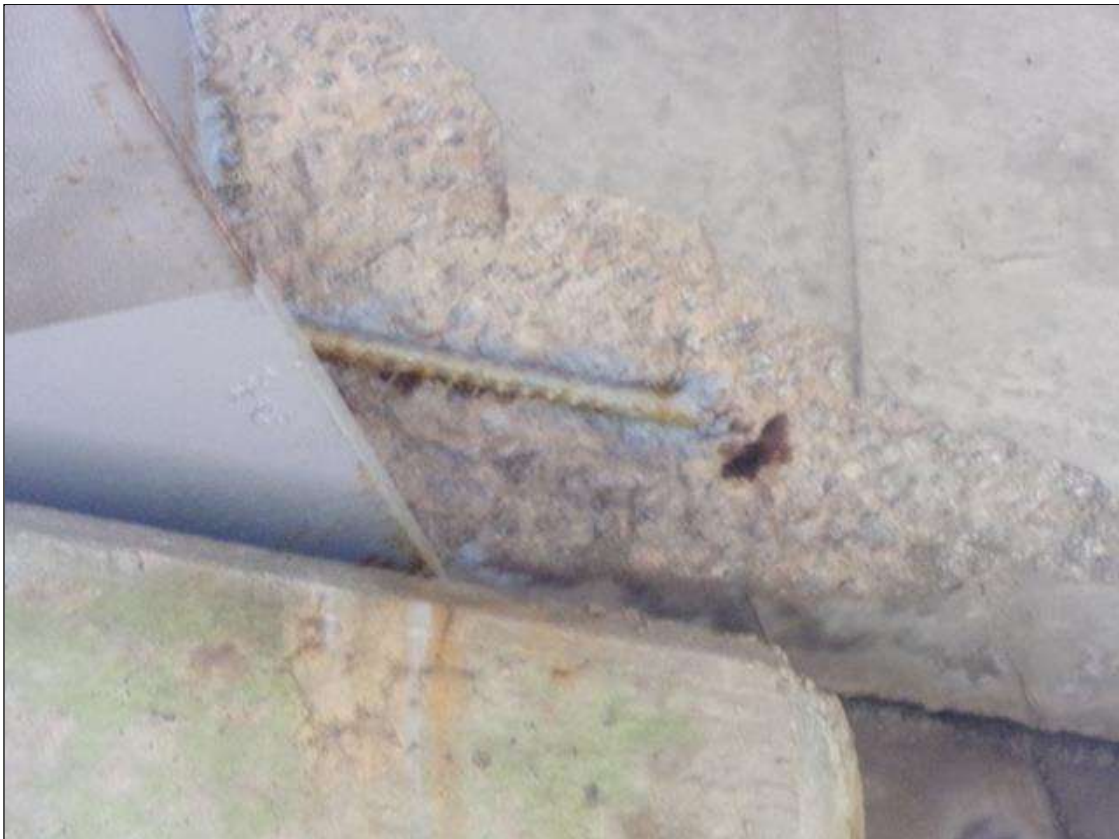
18" X 12" X 3" DEEP SPALL WITH EXPOSED REBAR AND A 1' LONG X 9" WIDE X 2" DEEP SPALL NO EXPOSED REBAR AT BEAM 2 IN BENT 3 DIAPHRAGM OVER PIER 3 IN BAY 1, BAY 2 SIMILAR
