NC DEPARTMENT OF TRANSPORTATION
 DIVISION OF HIGHWAYS
 STRUCTURE MANAGEMENT UNIT

ATTENTION: **PRIORITY ACTION REQUEST ISSUED**

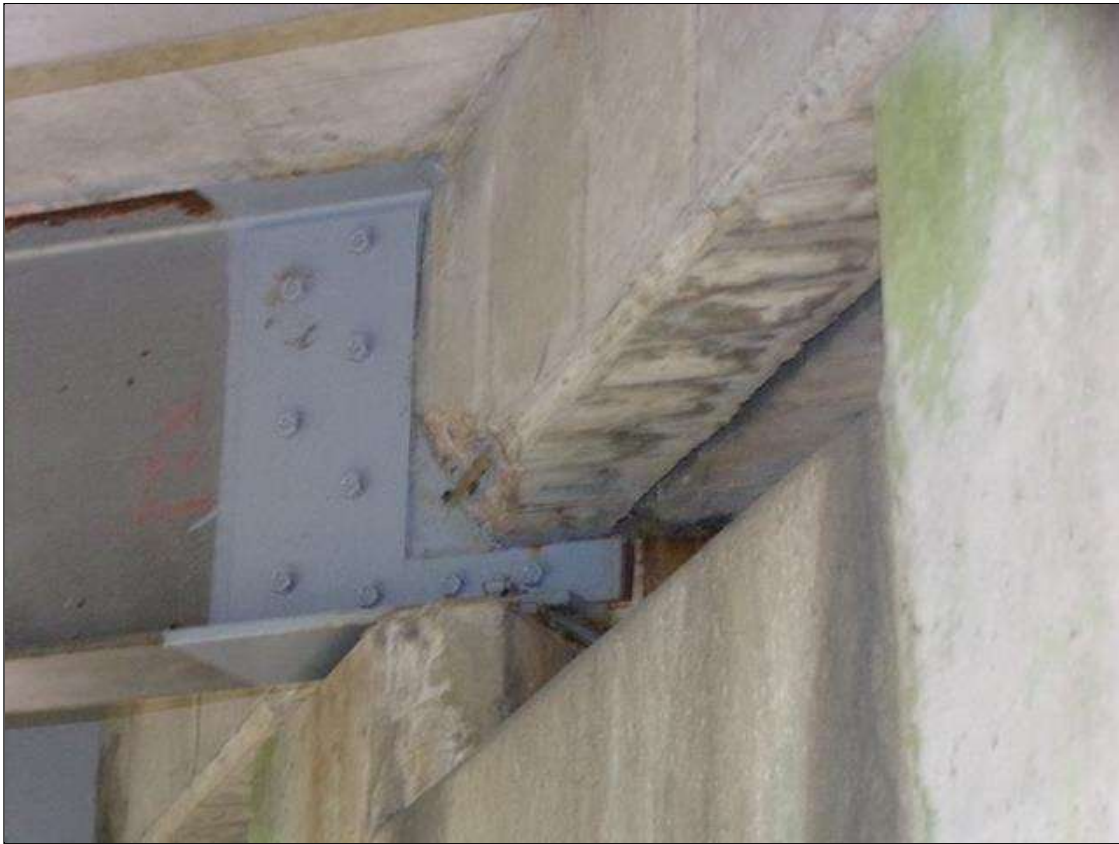
BOLTED PLATE REPAIR TO WEB ON BEAM 3 SPAN 4 24" X 24" AT BENT 3 END BOTH FACES

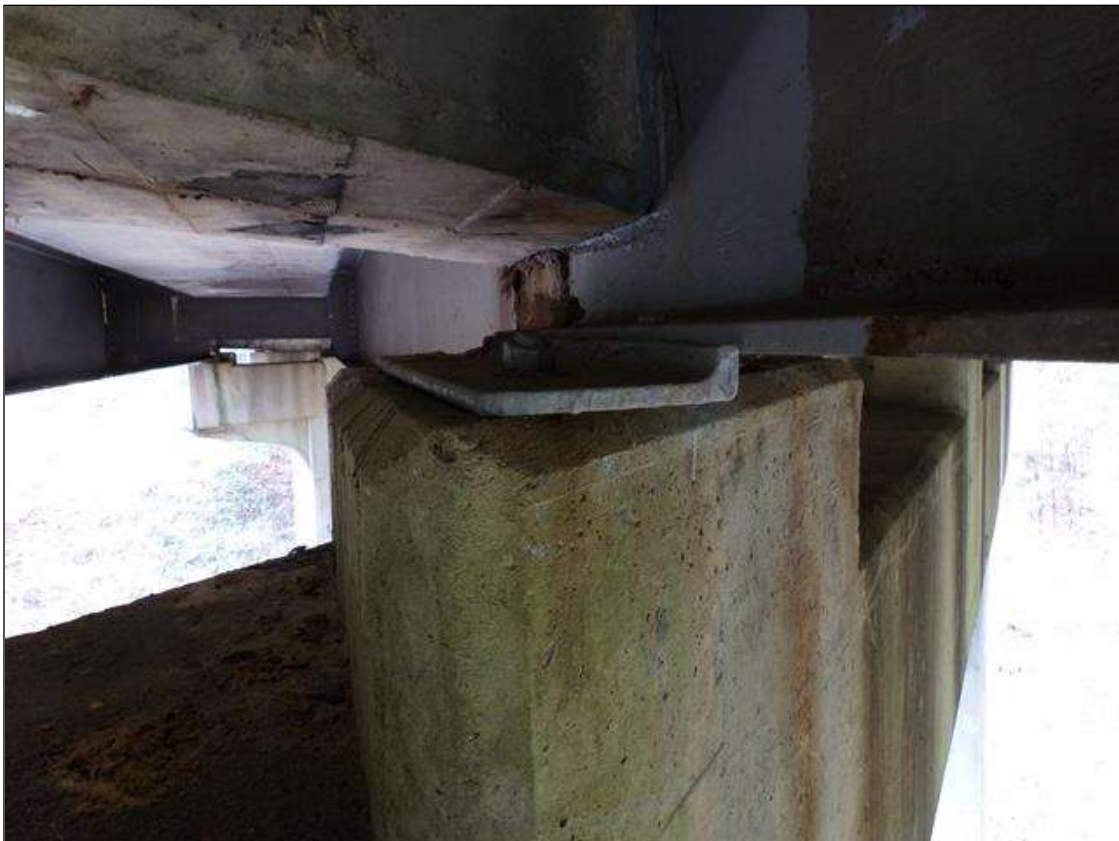
BEARING REPAIR AT BEAM 4 PIER 3 SPAN 4 EAST SIDE.

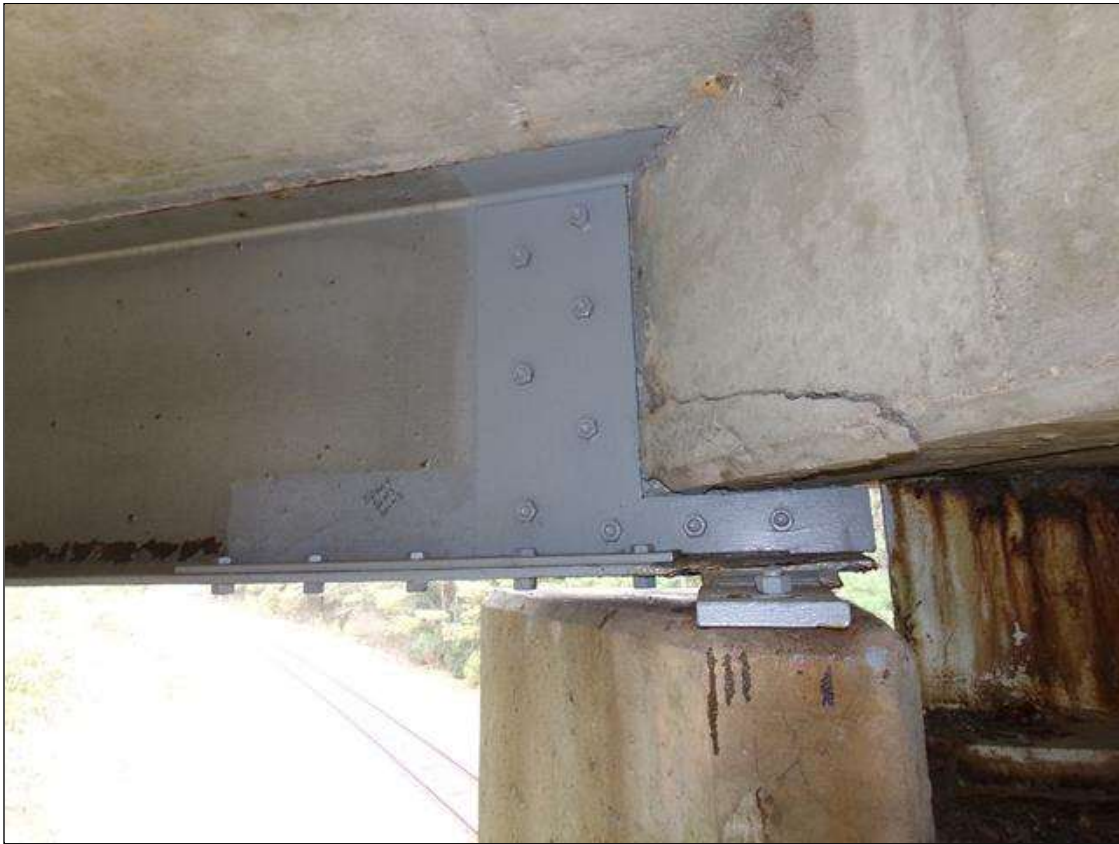
BOLTED PLATE REPAIR 24" X 24" TO WEB BOTH SIDES AND 24" BOTTOM FLANGE WEST SIDE BEAM 5 SPAN 4 AT BENT 3

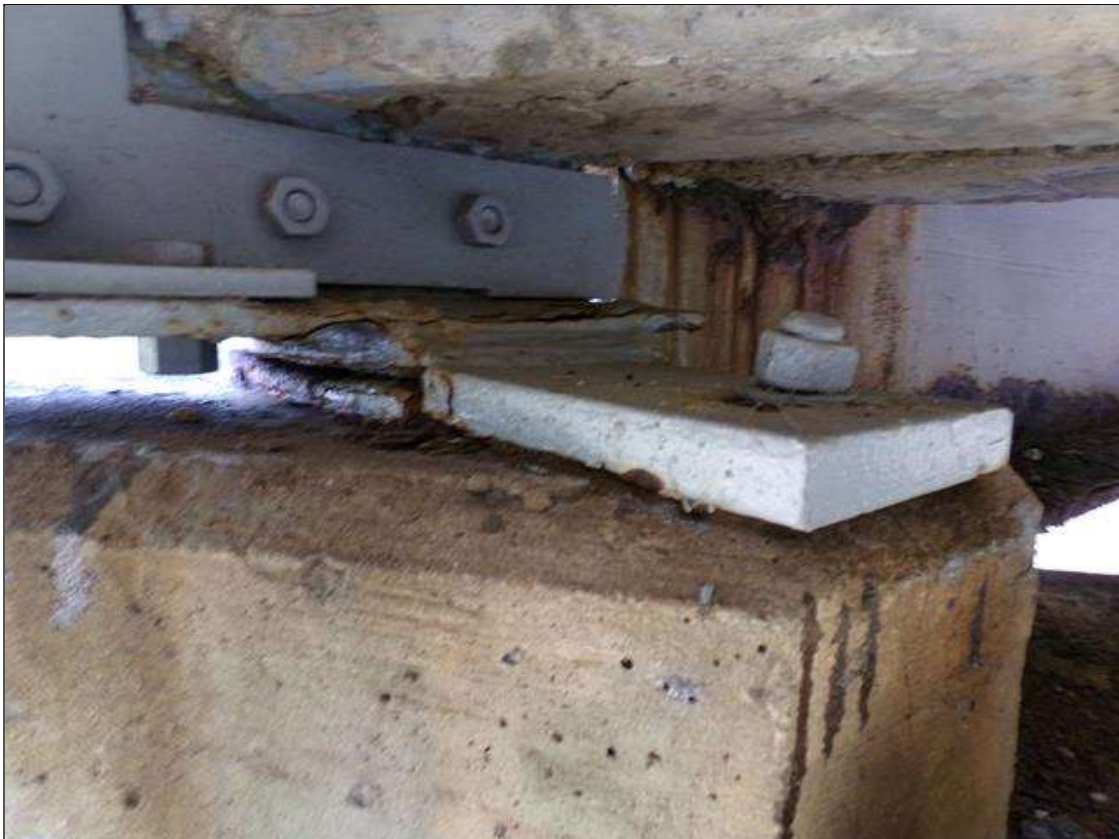
BEARING REPAIR AT BEAM 5 PIER 3 SPAN 4 WEST SIDE.

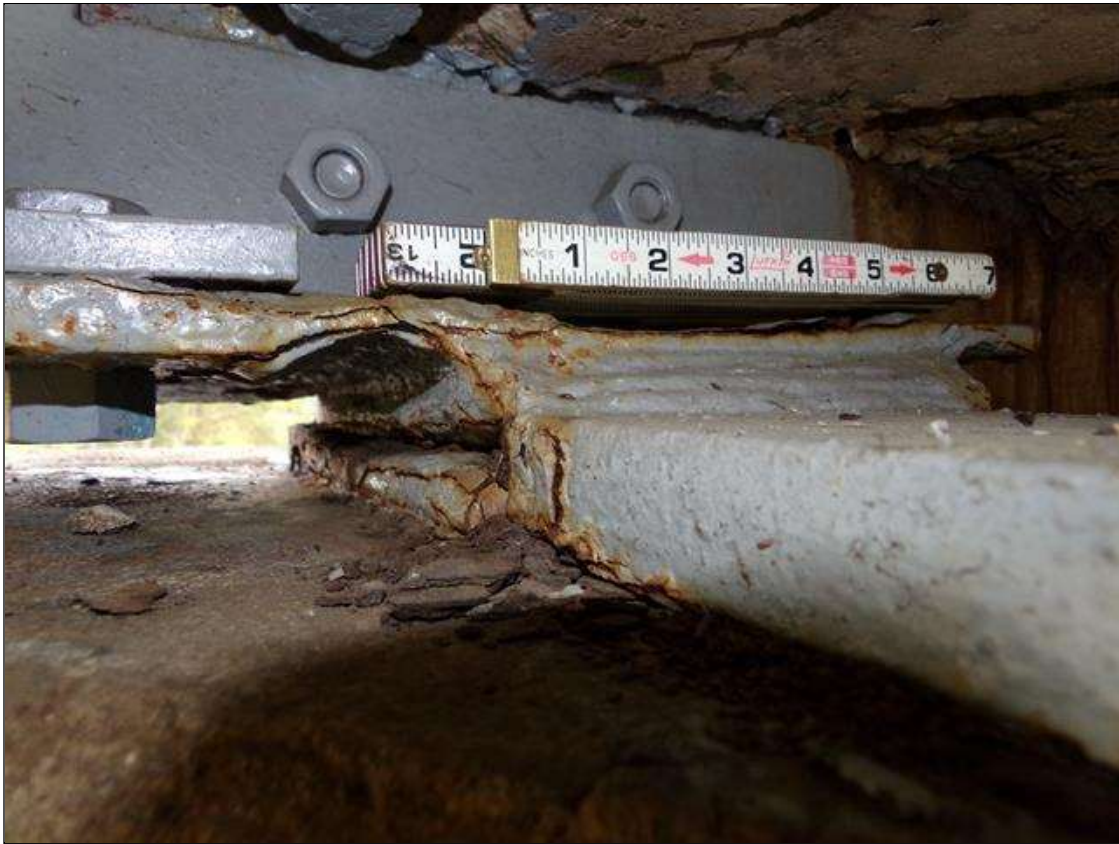
Span 4 Beam 5: PAR--SECTION LOSS UP TO 3/8" WITH 3/8" AVERAGE REMAINING FULL WIDTH OF BOTTOM FLANGE 1FT LONG ON BEAM END OVER PIER 3. BEAM END HAS BEEN CLEANED AND PAINTED WITH ACTIVE SURFACE CORROSION. PLATE REPAIR ADDED BUT DOES NOT EXTEND OUT TO DEFECT.

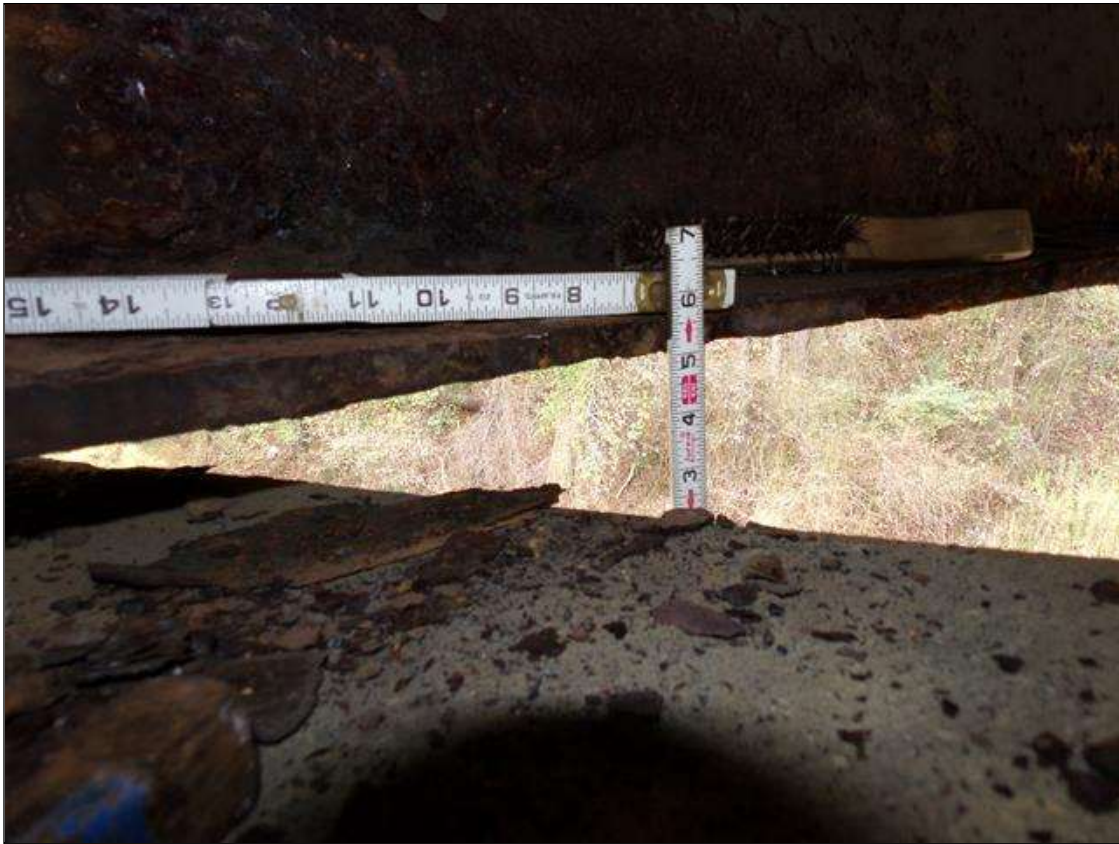
Span 3 Beam 1: PAR--SECTION LOSS WITH 7/16" REMAINING SECTION IN WEB AROUND END DIAPHRAGM 1 FT LONG AND 1/2" REMAINING IN BOTTOM 6" OF WEB WITH 5/8" X FULL WIDTH REMAINING 3 FT LONG ON BOTTOM FLANGE AT BENT 2

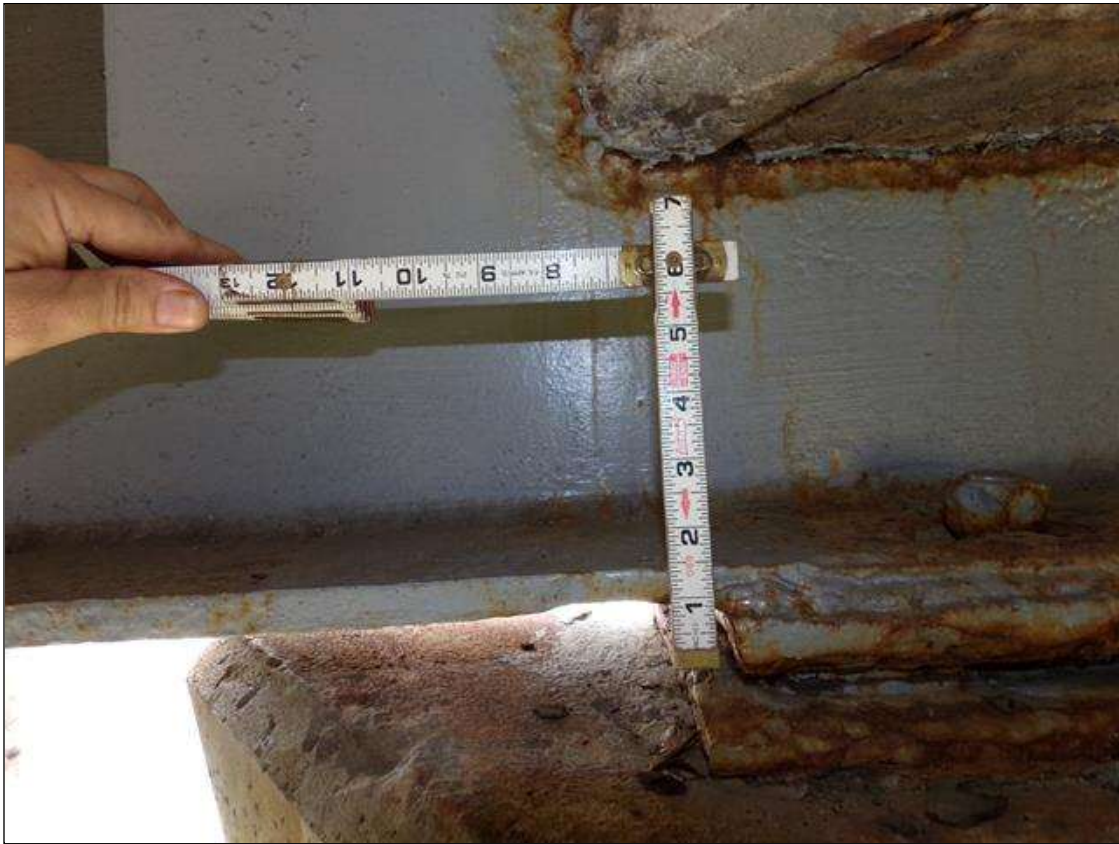
Span 2 Beam 1: 1 FT. OF PREVIOUS CORROSION WITH 1/2" REMAINING SECTION IN BOTTOM FLANGE AND 7/16" REMAINING SECTION IN WEB AROUND END DIAPHRAGM AT BENT 2 HAS BEEN PAINTED OVER AND ARRESTED.

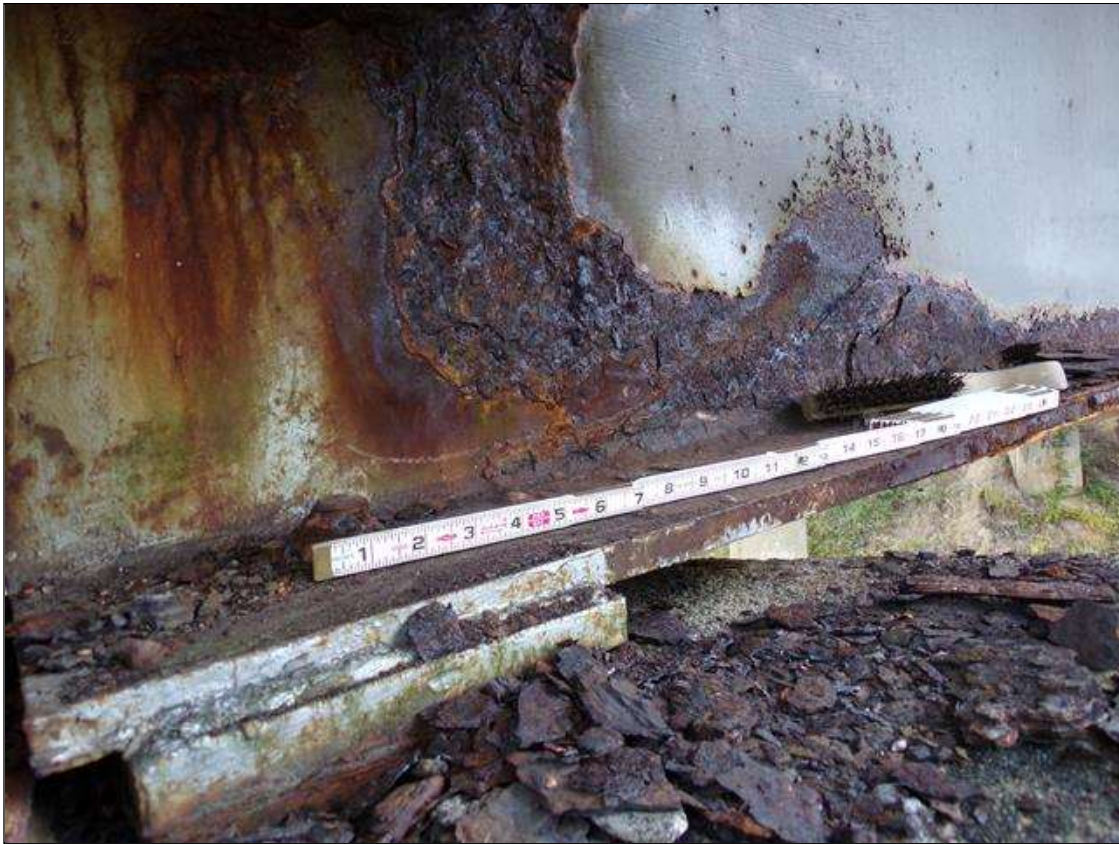
Span 3 Beam 5: 4 FT. OF ACTIVE CORROSION WITH 1/2" REMAINING SECTION IN WEB AROUND DIAPHRAM AND BOTTOM 6" OF WEB AND 3/4" THICKNESS REMAINING FULL WIDTH BOTTOM FLANGE AT BENT 2 BEAM ENDS HAVE BEEN PAINTED WITH ACTIVE SURFACE CORROSION

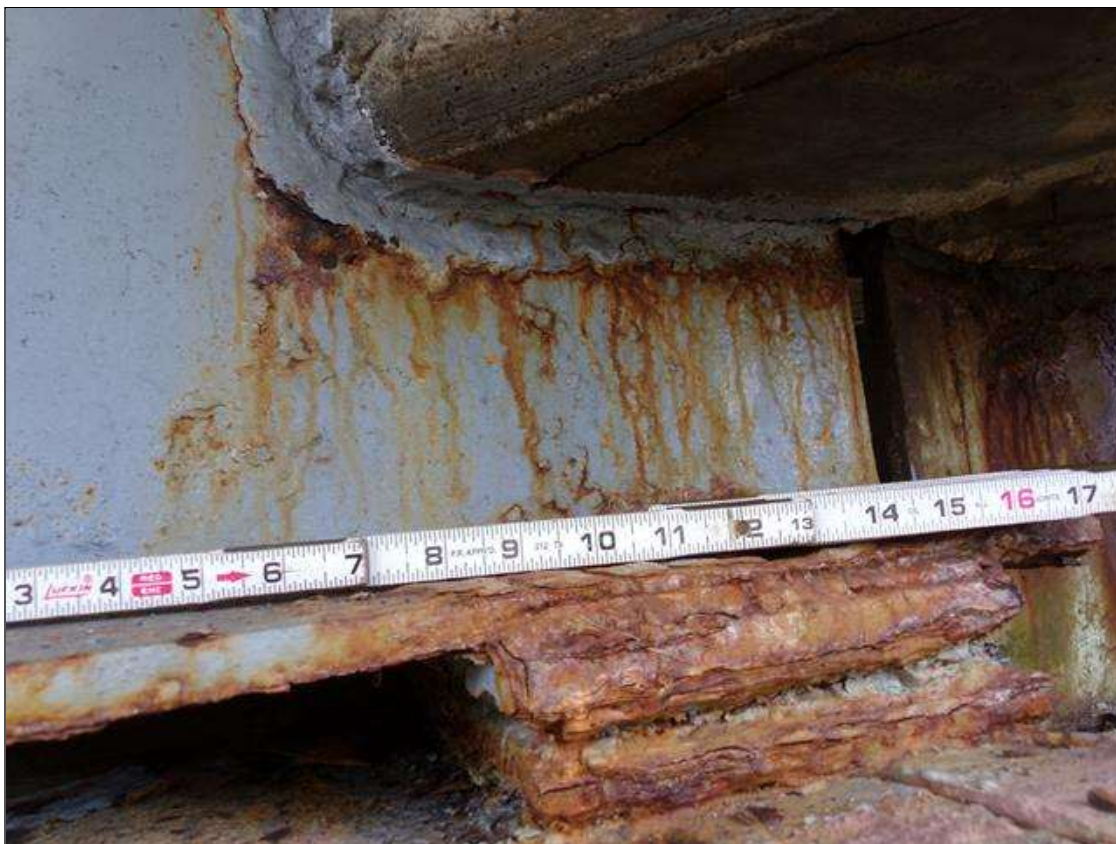
Span 2 Beam 5: 1 FT. OF PREVIOUS CORROSION WITH 1/2" X FULL WIDTH REMAINING SECTION IN BOTTOM FLANGE AND 7/16" REMAINING SECTION IN WEB AROUND END DIAPHRAGM AT BENT 2 HAS BEEN PAINTED WITH ACTIVE SURFACE CORROSION

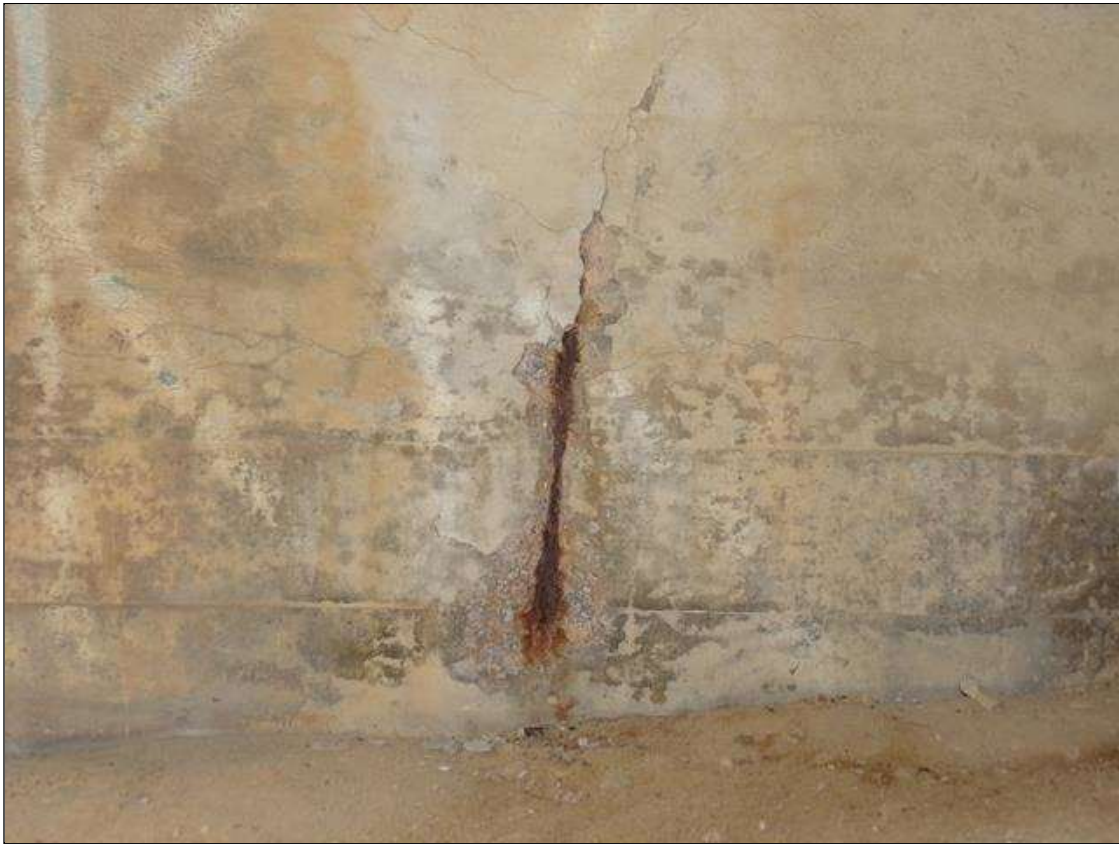
End Bent 1 Cap 1: 8" X 2 FT X 1/2" DEEP SPALL WITH EXPOSED REBAR UNDER BAY 4

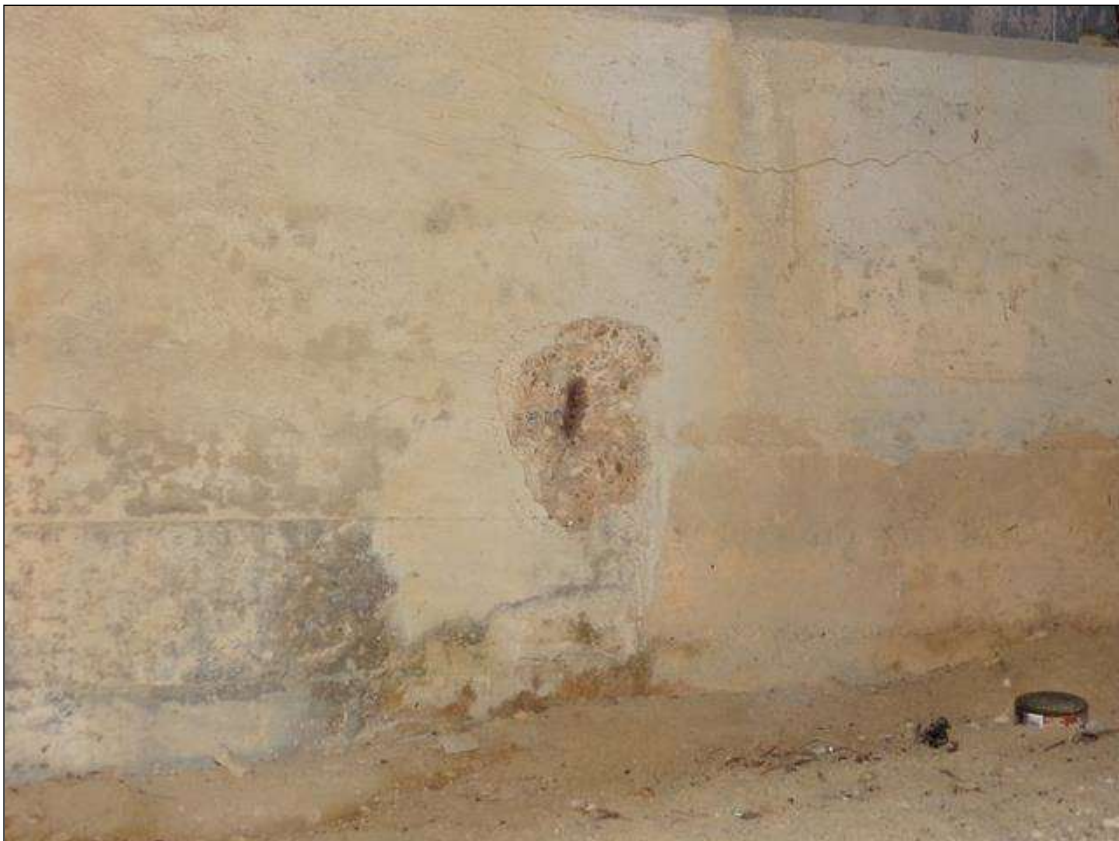
End Bent 1 Cap 1: 8" DIAMETER X 1" DEEP SPALL WITH EXPOSED REBAR UNDER BAY 4

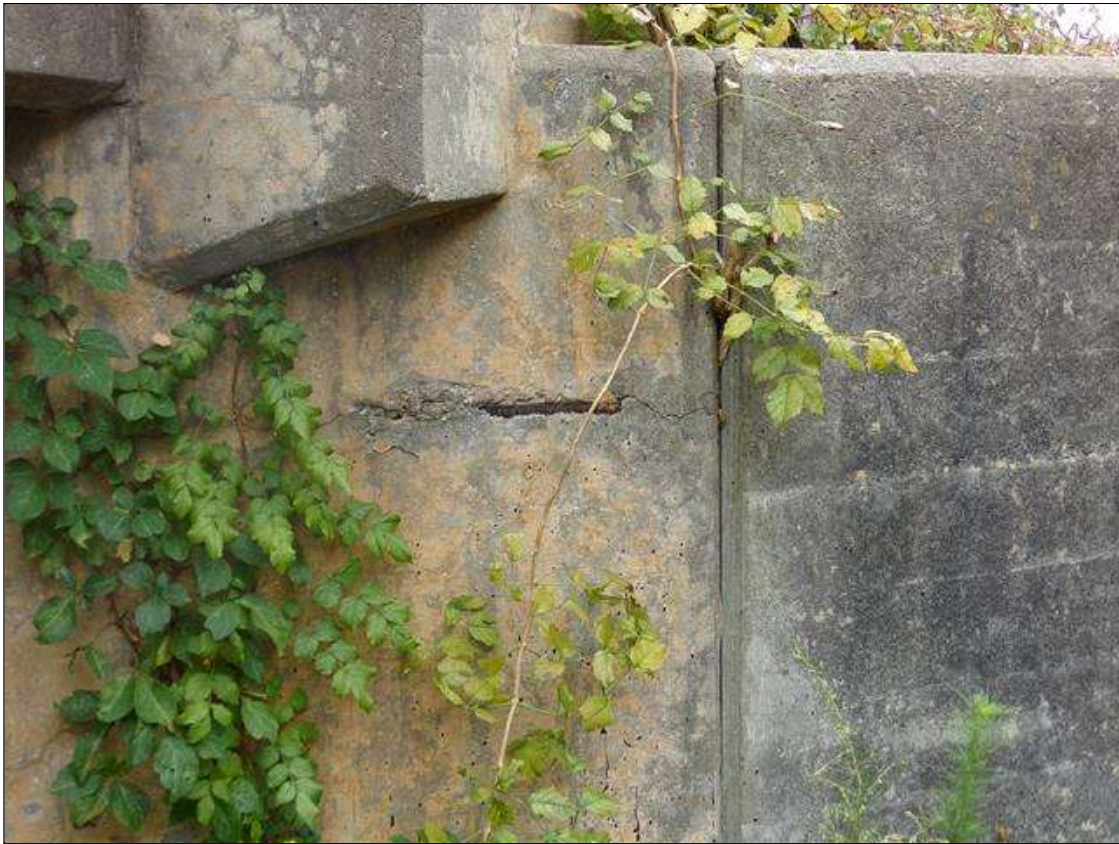
End Bent 1 Abutment/Backwall : SPALL WITH EXPOSED REBAR 12" X 2" X 1/2" DEEP WITH CRACK WITH EFFLORESCENCE 12" LONG X UP TO 1/32" WIDE IN CURTAIN WALL AT WEST END

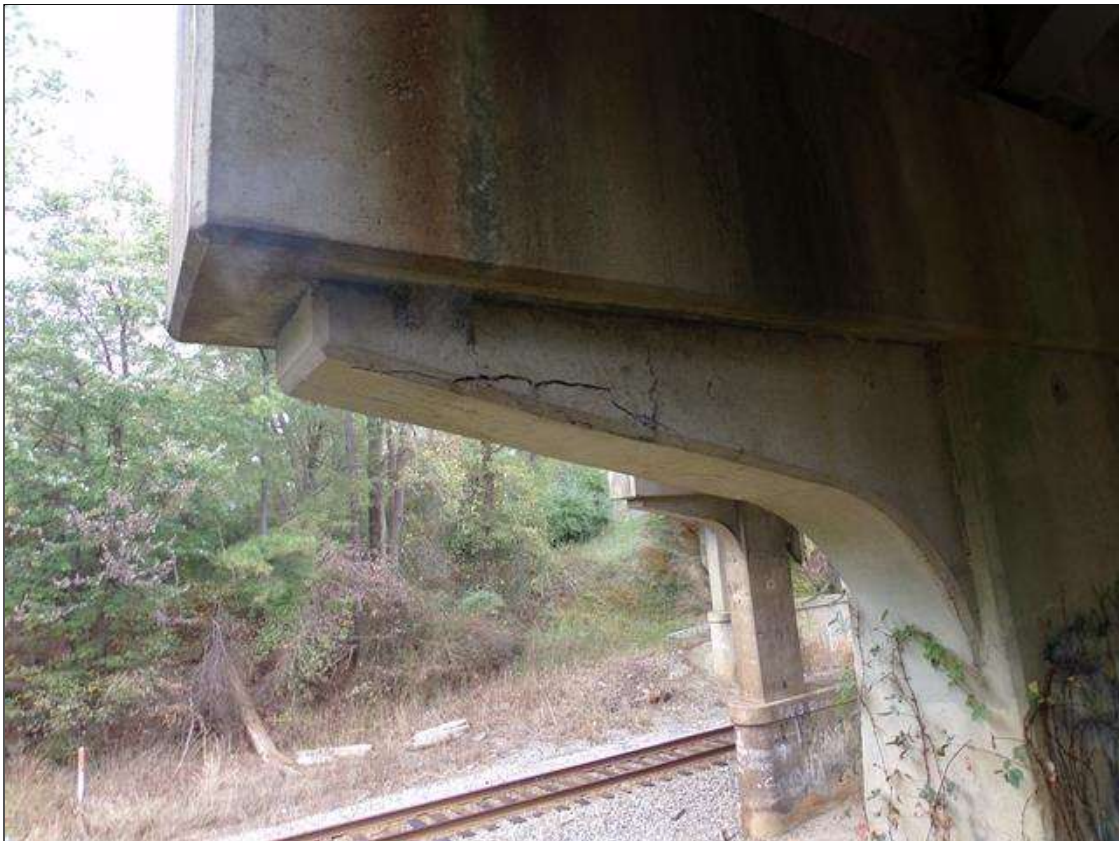
Bent 1 Cap 1: 24" X 8" DELAMINATION WITH CRACKS UP TO 1/4" WIDE IN SOUTH FACE UNDER WEST OVERHANG IN FLUTED PORTION

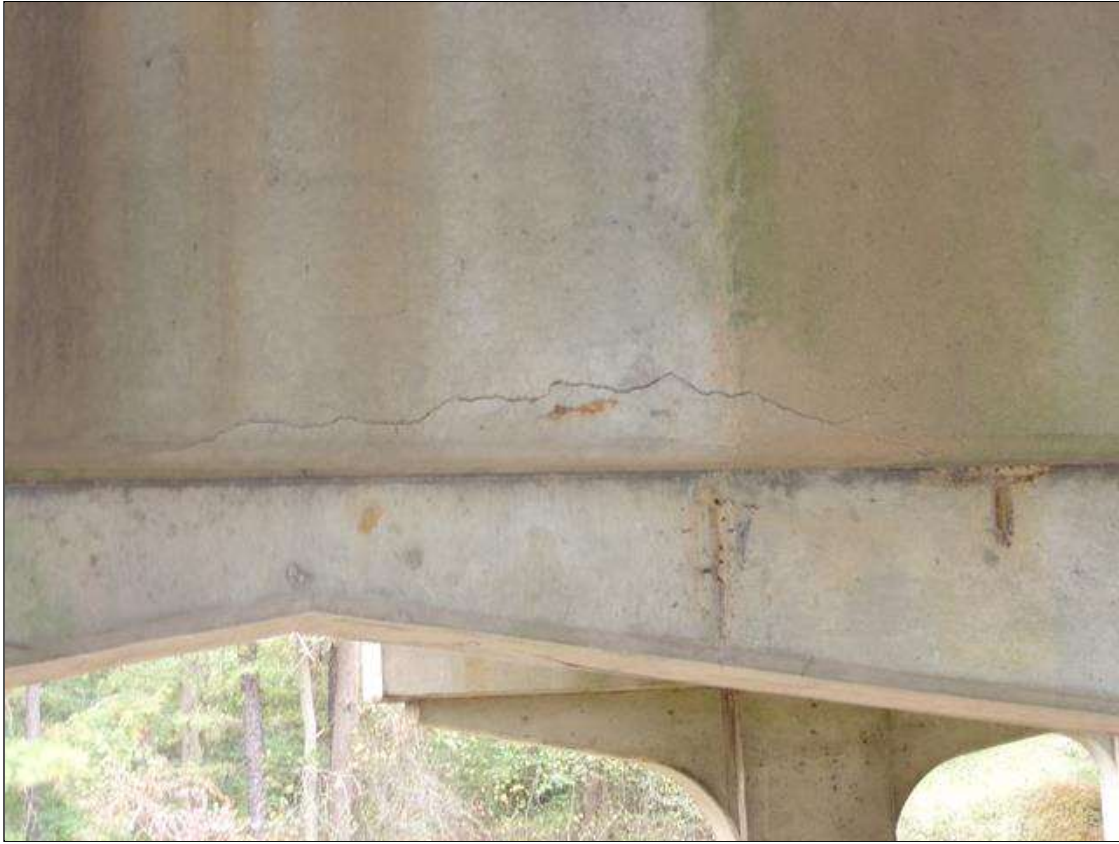
Bent 1 Cap 1: HORIZONTAL CRACK 3 FT LONG UP TO 1/8" WIDE IN SOUTH FACE MID WAY BETWEEN COLUMNS 1 AND 2

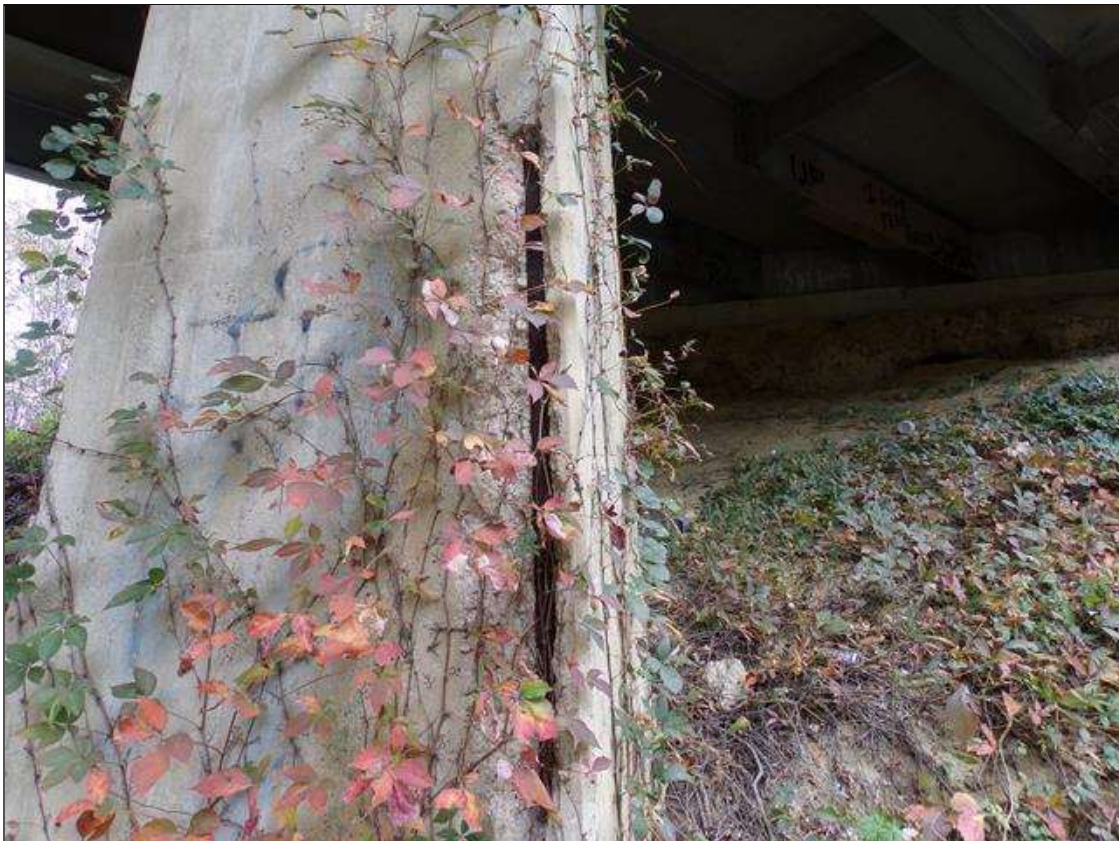
Bent 1 Pile 1: 6 FT X 9" FT X 2" DEEP SPALL WITH EXPOSED RUSTED REBAR NO SECTION LOSS AT NORTHWEST CORNER

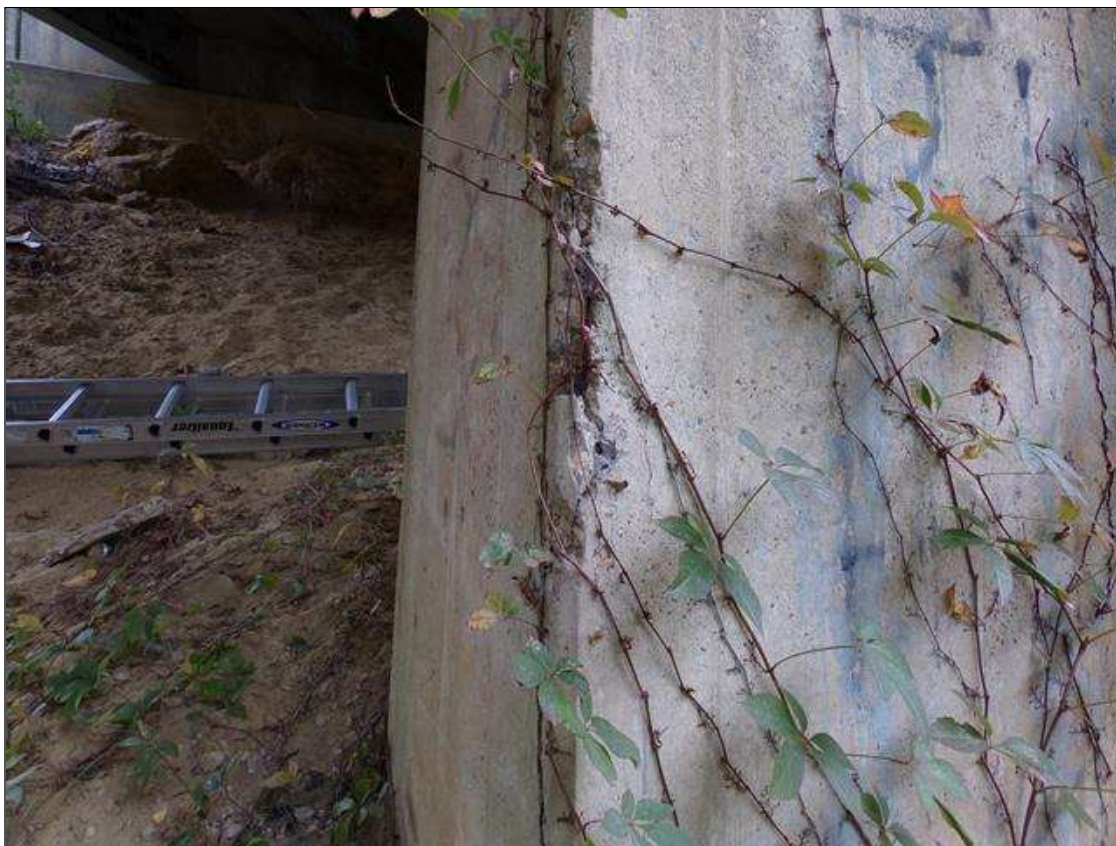
Bent 1 Pile 1: 3 FT X 9" X 1" DEEP SPALL AND DELAMINATION AT NORTHEAST CORNER

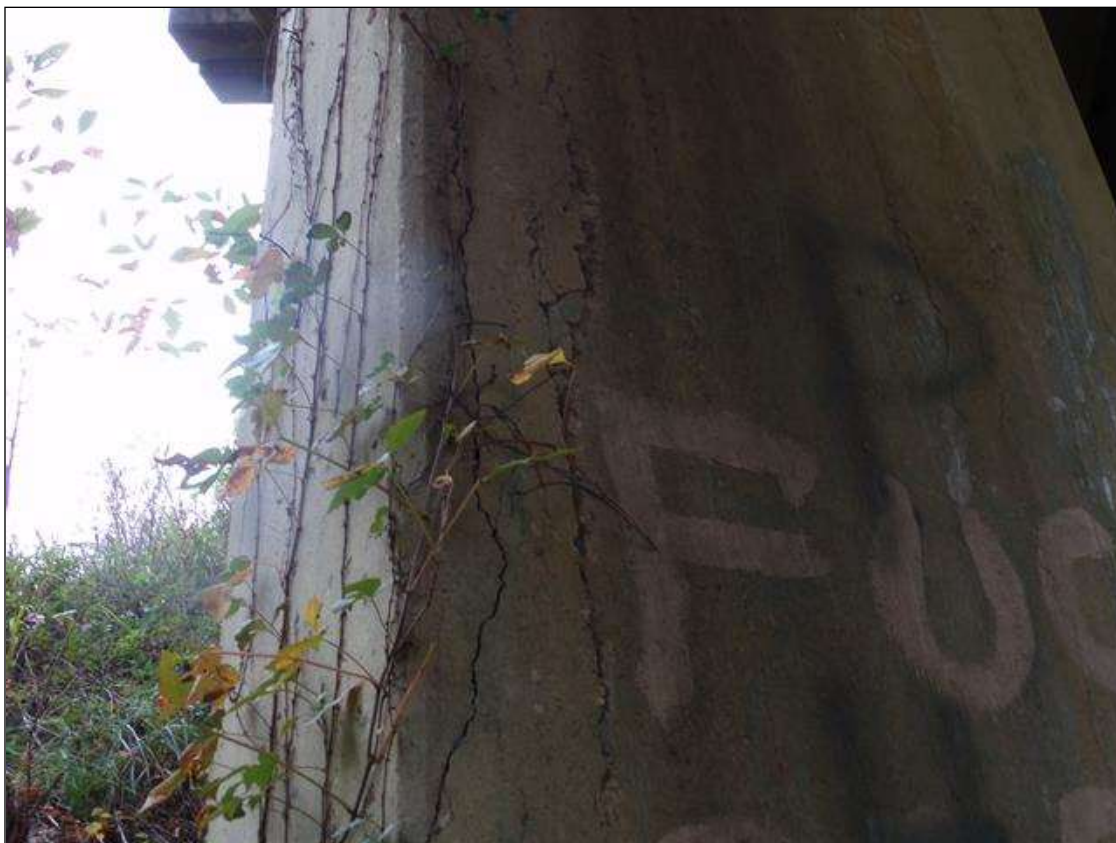
Bent 1 Pile 2: 4 FT X 1 FT X 1/2" DEEP SPALL AND DELAMINATION WITH CRACKS UP TO 1/8" WIDE IN NORTH FACE

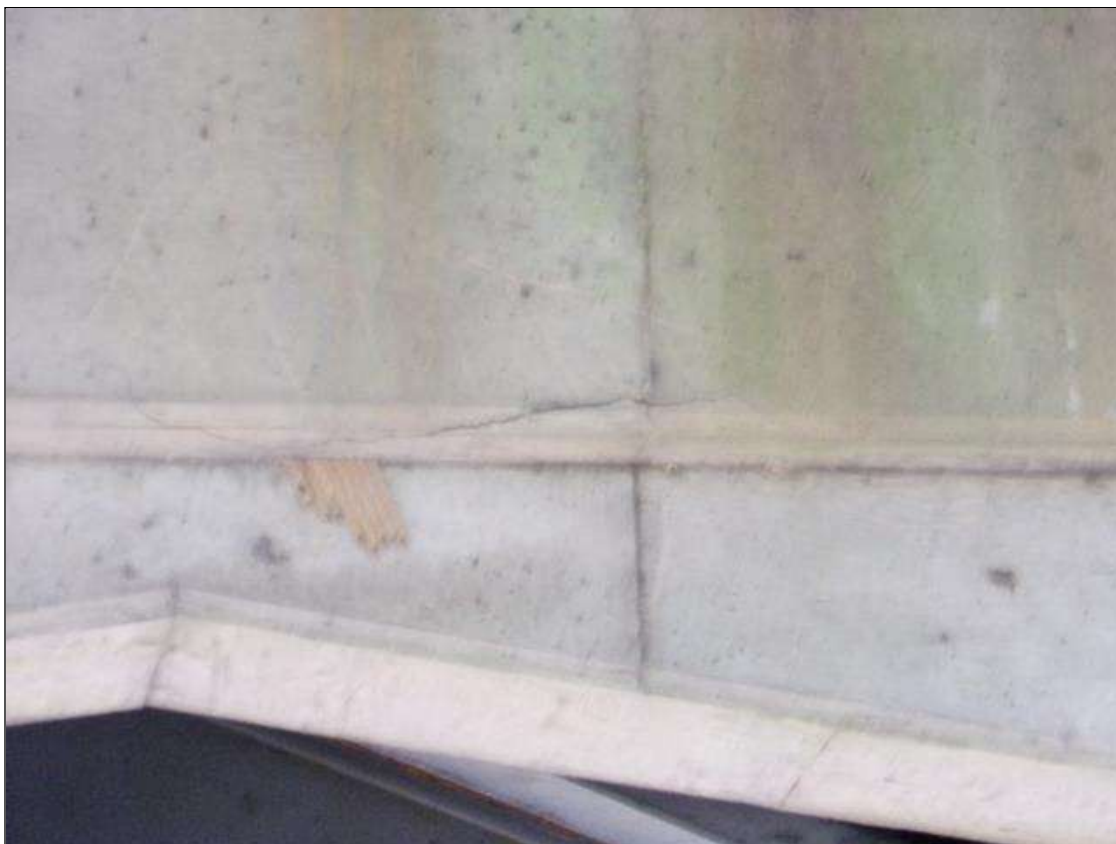
Bent 2 Cap 1: 3 FT X 1.5 FT HIGH DELAMINATION WITH CRACK UP TO 1/4" WIDE IN SOUTH FACE UNDER BEAM

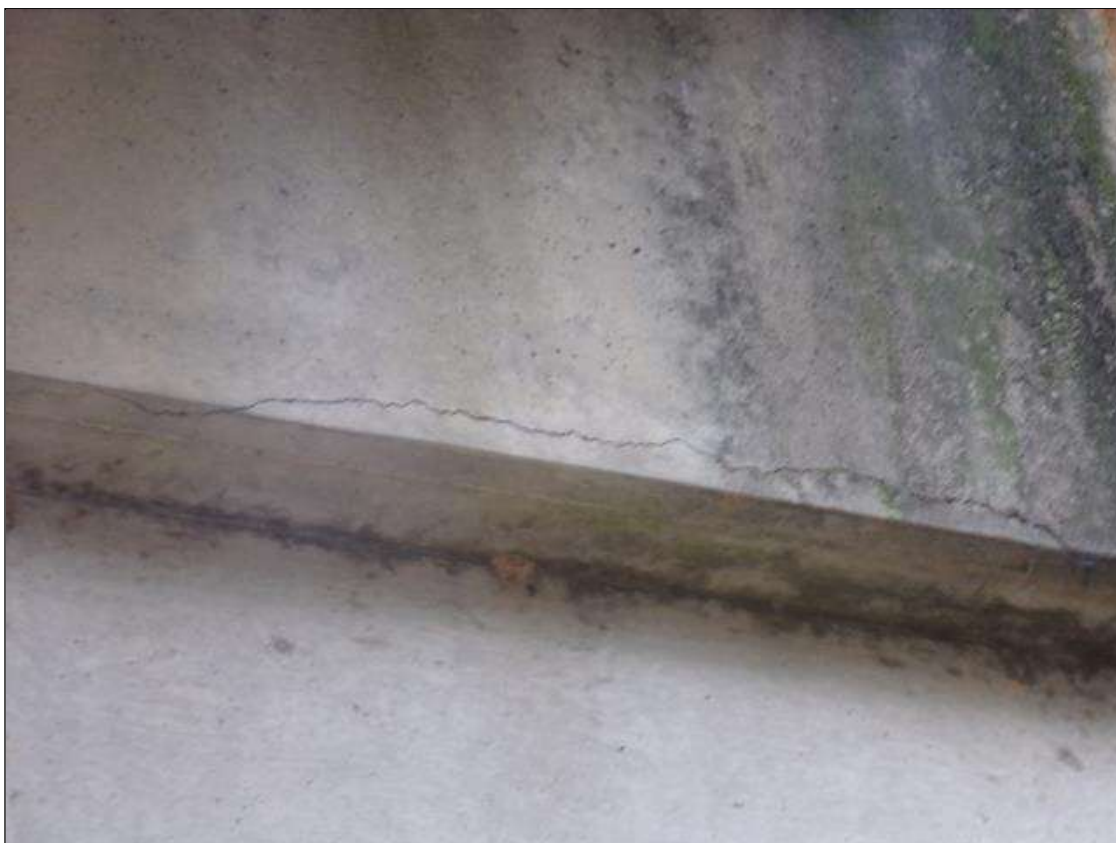
Bent 1 Cap 1: 6' LONG X 1/8" WIDE HORIZONTAL CRACK NORTH FACE UNDER BAY 1

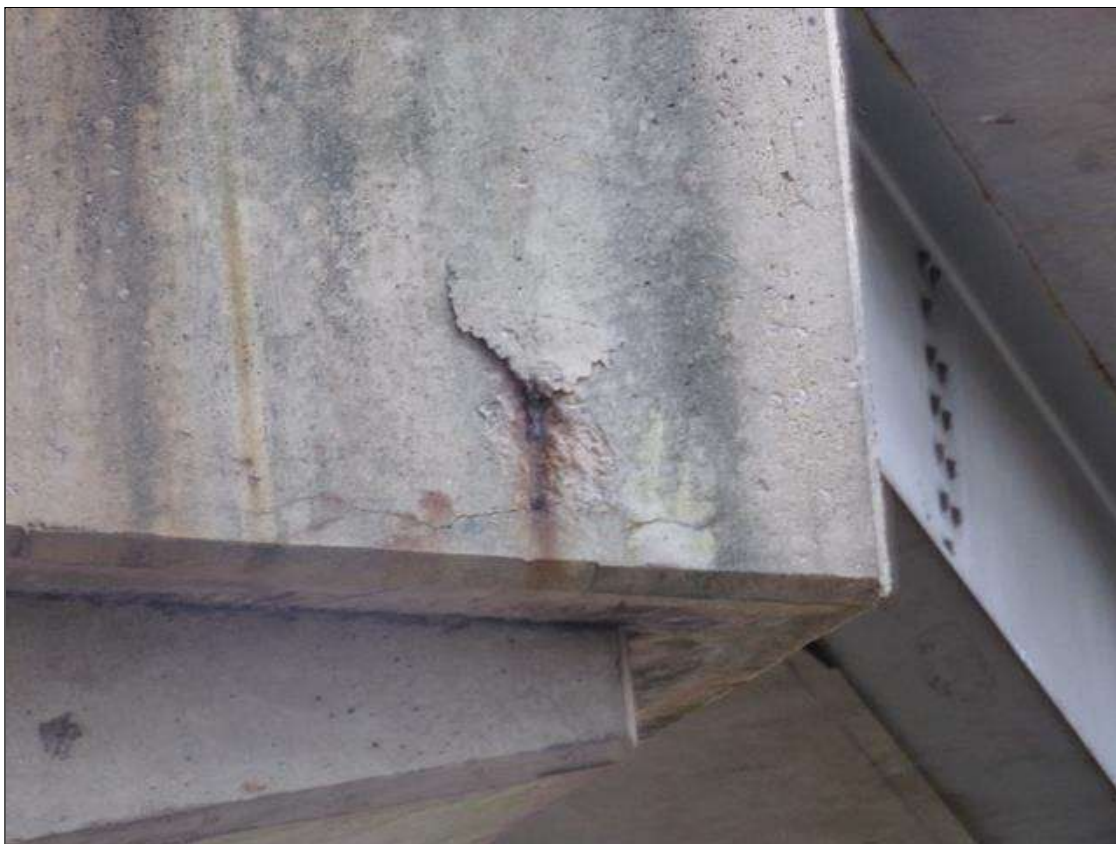
Bent 2 Cap 1: 8" DIAMETER DELAMINATION AND 6" DIAMETER X 1/2" DEEP SPALL WITH EXPOSED REBAR NO LOSS IN NORTH FACE UNDER BEAM 1

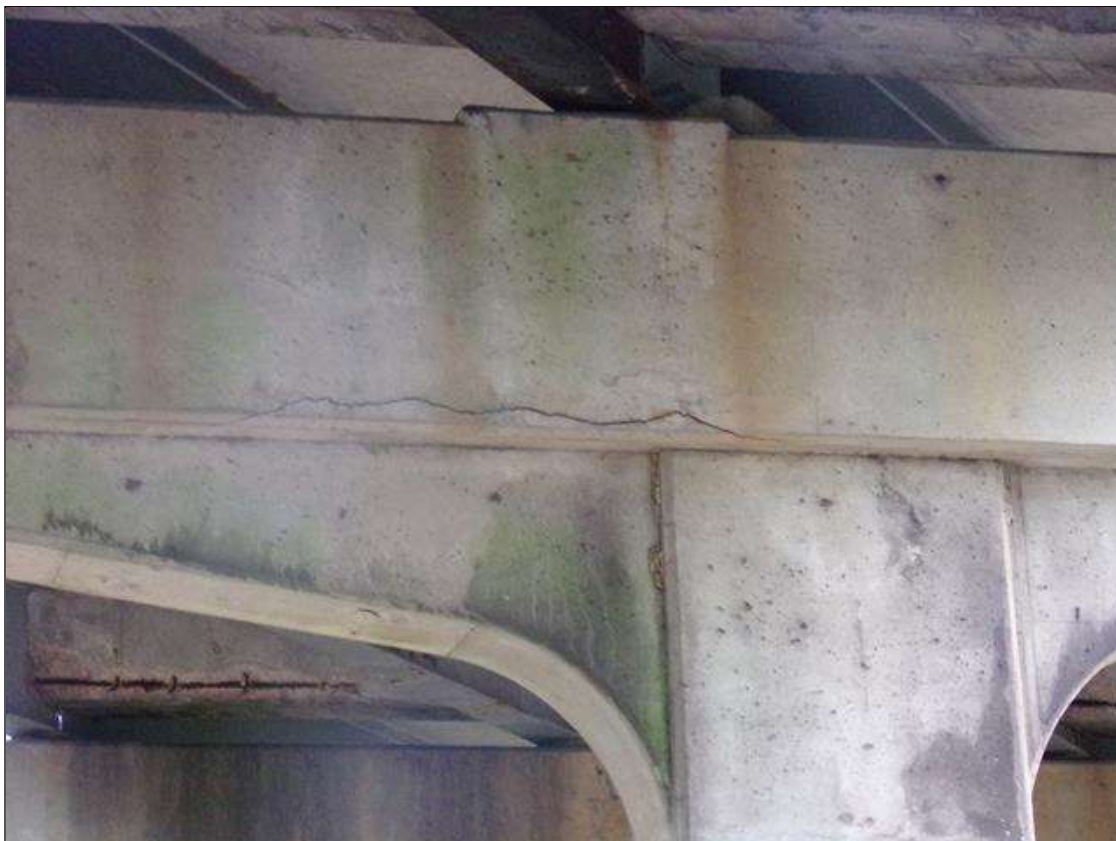
Bent 2 Cap 1: 6FT LONG HORIZONTAL CRACK UP TO 1/4" WIDE UNDER BAYS 1 AND 2 NORTH FACE

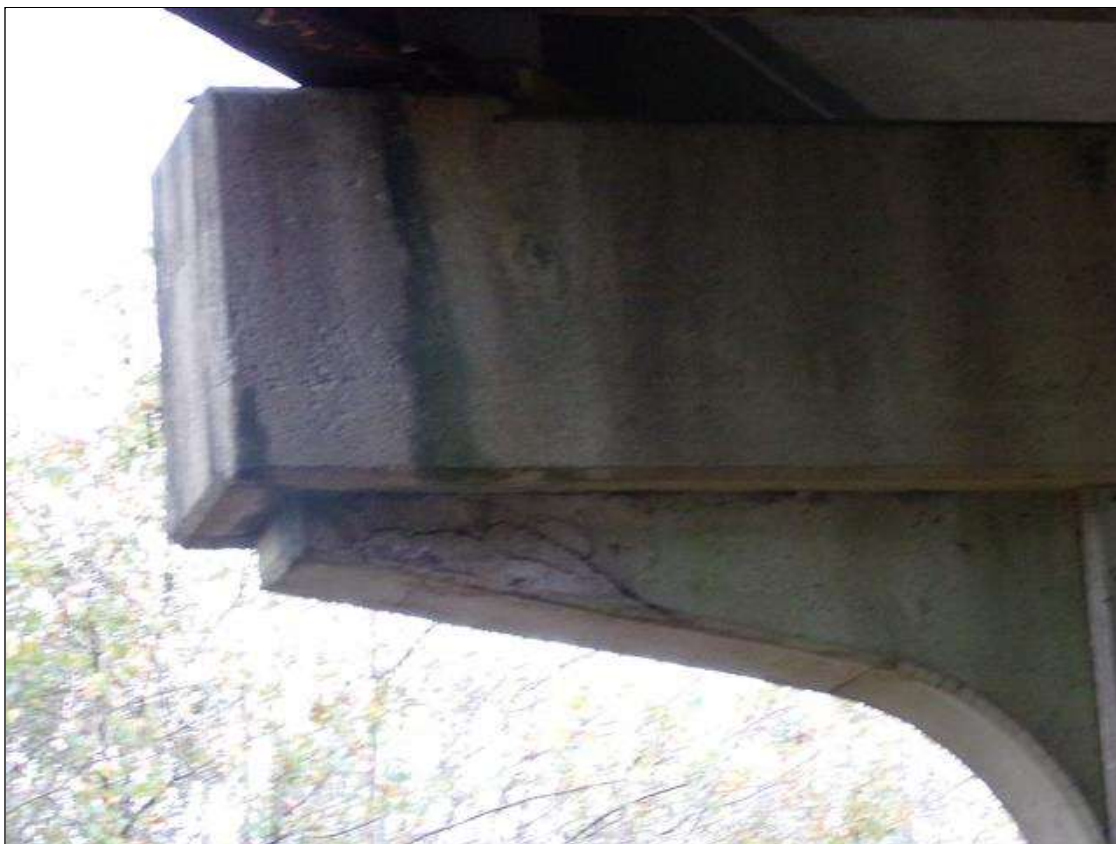
Bent 2 Cap 1: 3 FT X 1 FT X 6" DELAMINATION IN UNDERSIDE UNDER BEAM 5 IN FLUTED PORTION

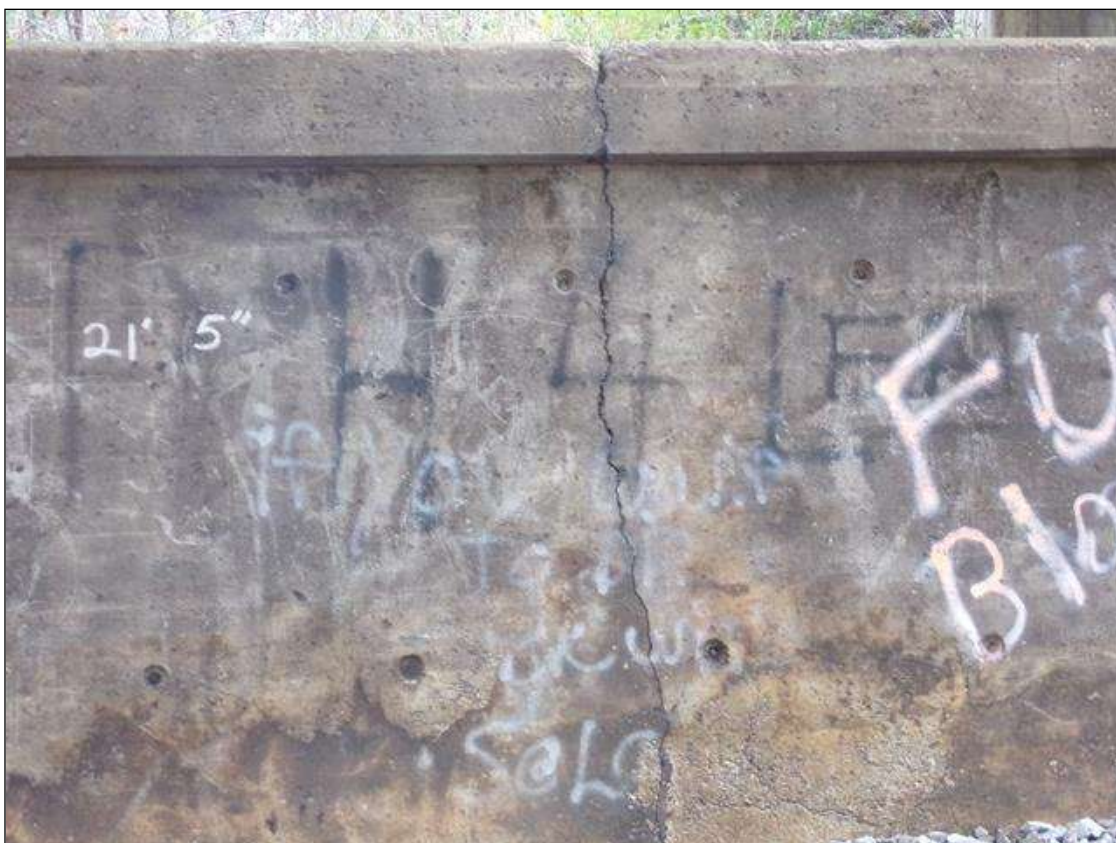
Bent 2 Pile 1: VERTICAL THRU CRACK 7 FT LONG UP TO 1/2" WIDE IN MIDDLE OF CRASH WALL BOTH FACES
