NC DEPARTMENT OF TRANSPORTATION
 DIVISION OF HIGHWAYS
 STRUCTURE MANAGEMENT UNIT

ATTENTION: **PRIORITY ACTION REQUEST ISSUED**

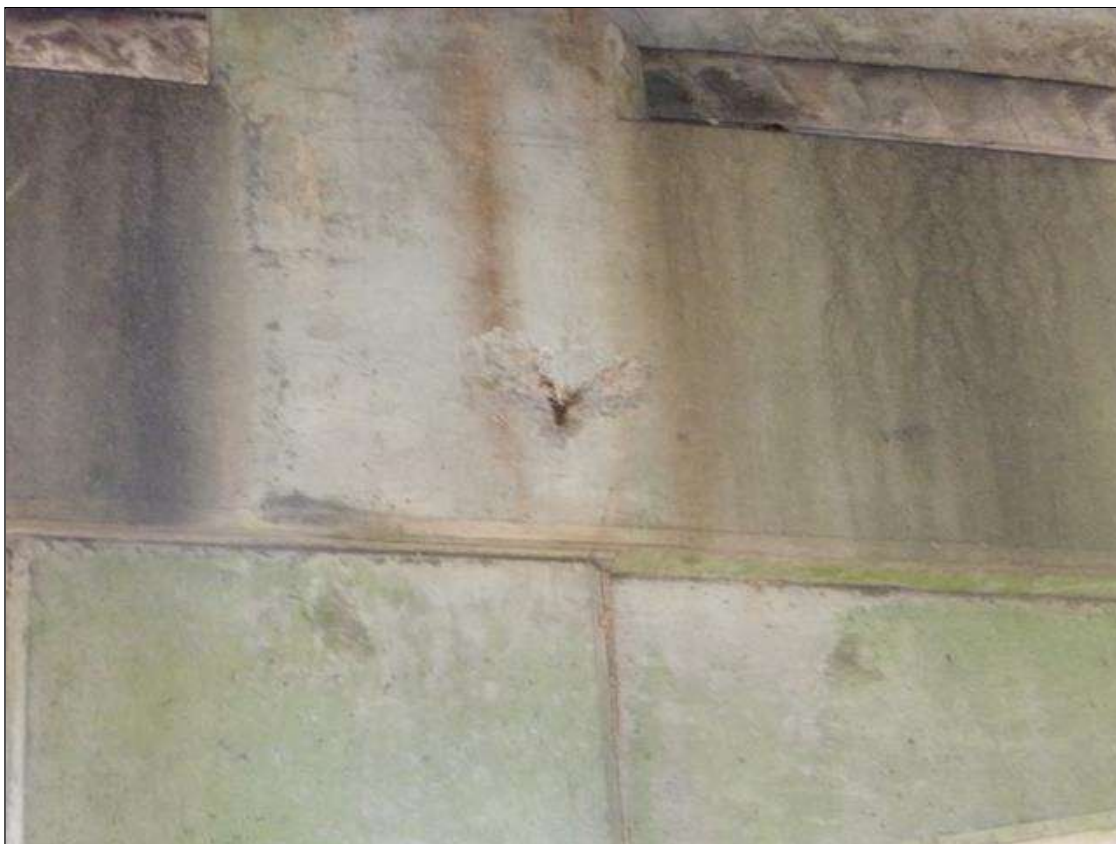
Bent 3 Cap 1: SPALL WITH EXPOSED REBAR 1 FT X 9" X 1" DEEP IN NORTH FACE UNDER BEAM 4

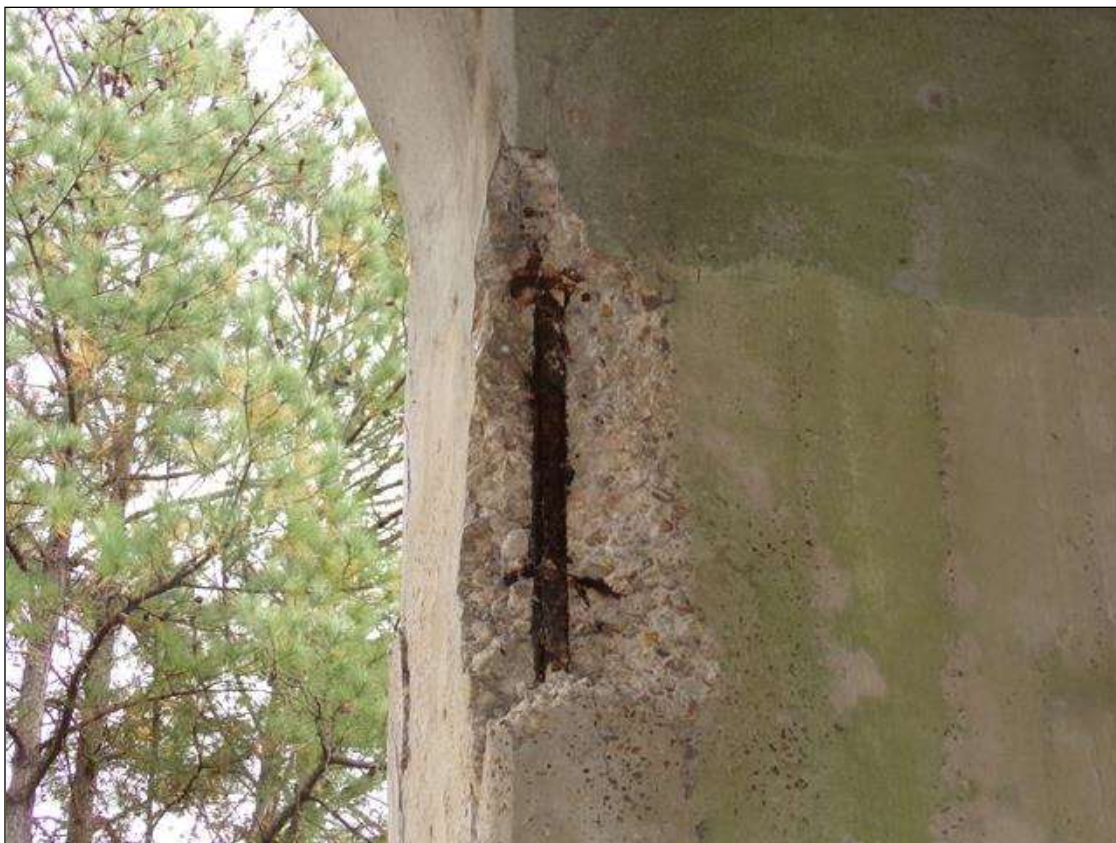
Bent 3 Pile 2: PAR--SPALL WITH EXPOSED REBAR AND BROKEN HORIZONTAL TIE 3 FT X 1 FT X 4" DEEP IN NORTHEAST CORNER MID HEIGHT WITH SECTION LOSS

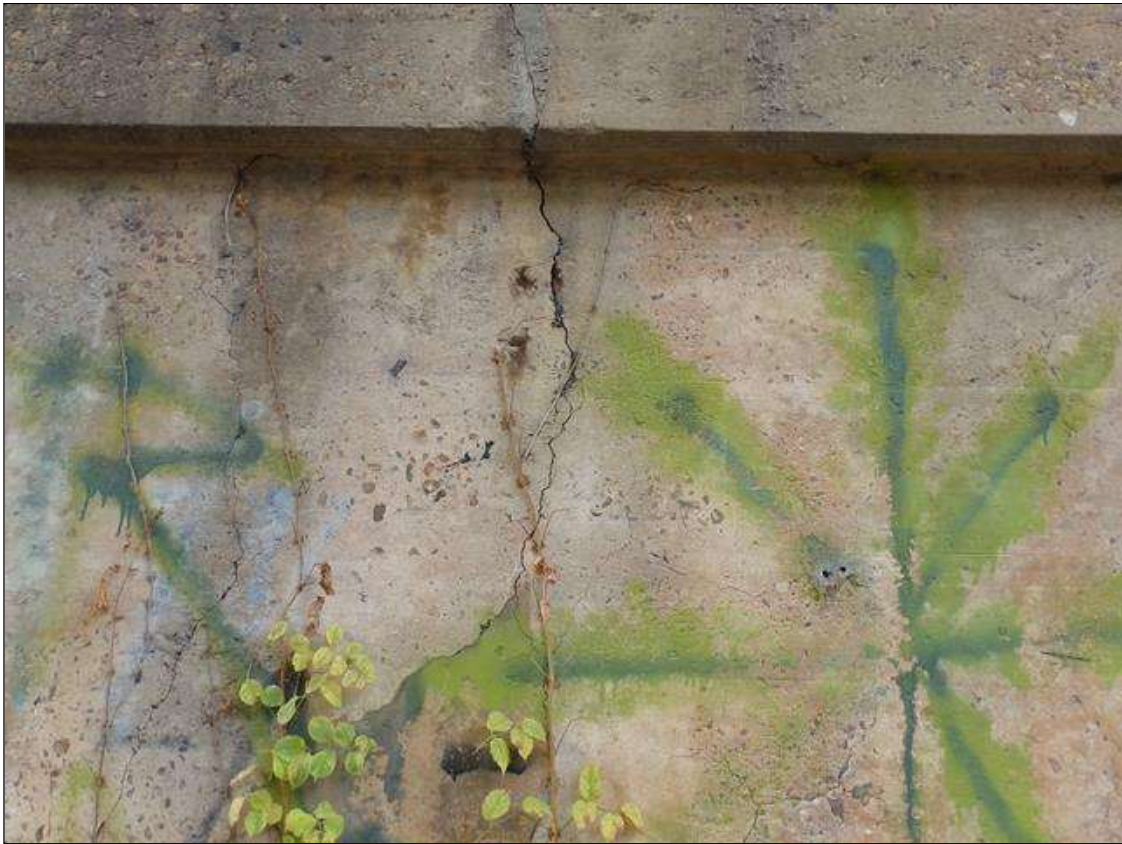
Bent 3 Pile 1: VERTICAL THRU CRACK 7 FT LONG X 1/4" WIDE IN MIDDLE OF CRASHWALL BOTH FACES

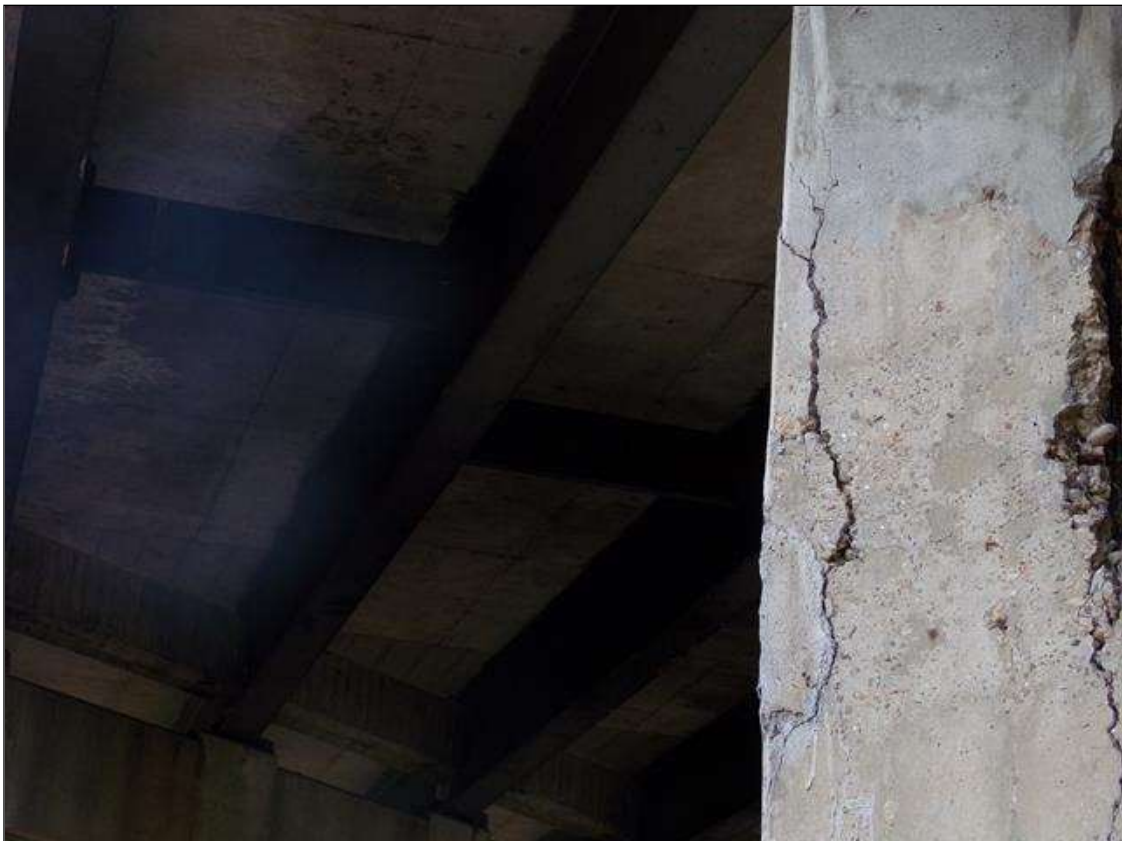
Bent 3 Pile 2: 4 FT X 2 FT AREA OF DELAMINATION WITH CRACKING UP TO 1/2" WIDE AT SOUTHEAST CORNER

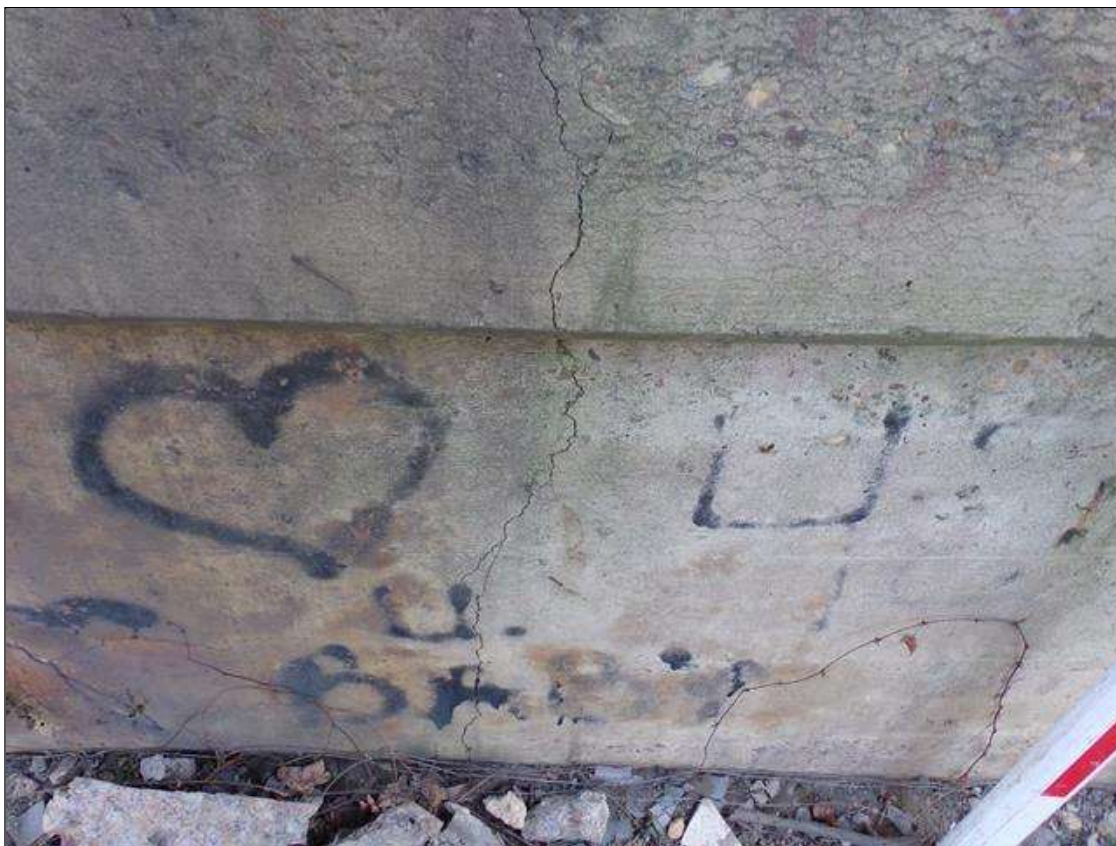
Bent 3 Pile 1: VERTICAL THRU CRACK 7 FT LONG X 1/8" WIDE IN MIDDLE OF CRASHWALL BOTH FACES

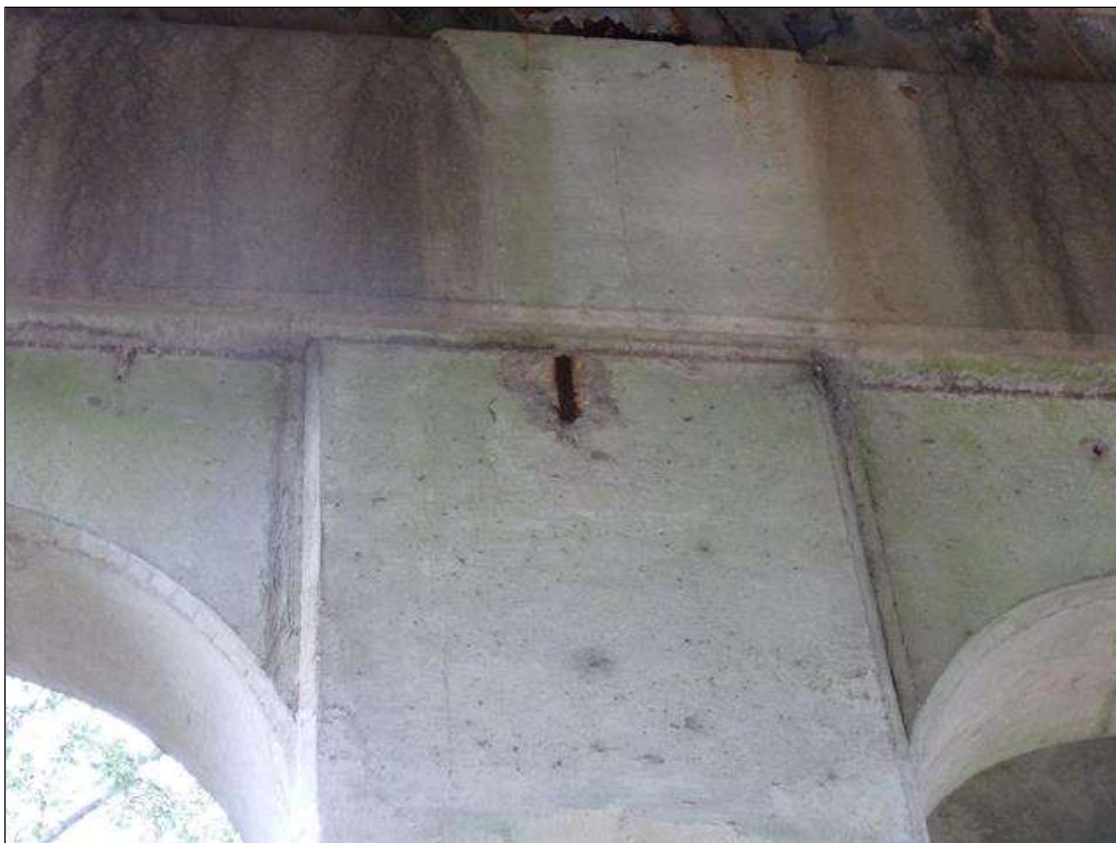
Bent 3 Pile 1: 9" X 6" X 1/2" DEEP SPALL WITH EXPOSED REBAR NO LOSS IN SOUTH FACE BELOW CAP

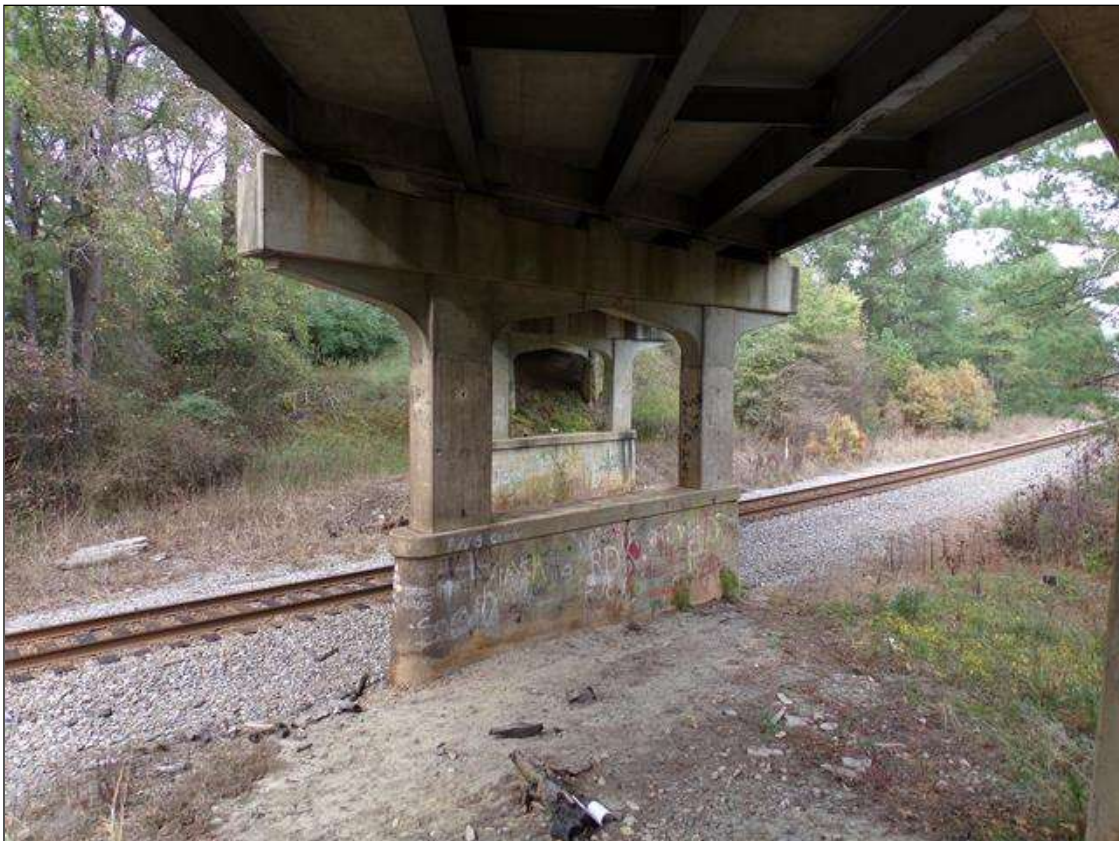
Pier 2, pier 3 similar

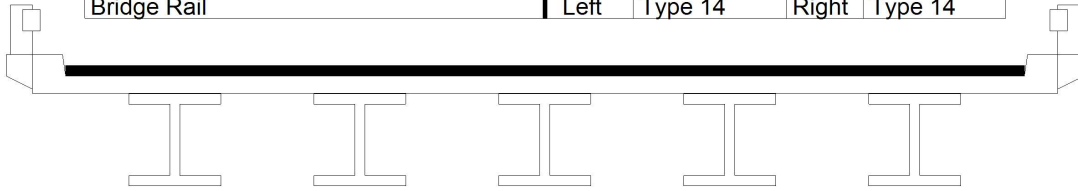
Measurements for Span #	1		
Deck Thickness	0.542	Left Overhang	4.041
Top of Rail to Bottom of Beam (A&B)	5.25	Right Overhang	4.041
