NC DEPARTMENT OF TRANSPORTATION  
 DIVISION OF HIGHWAYS  
 STRUCTURE MANAGEMENT UNIT

ATTENTION: **PROMPT ACTION REQUEST**

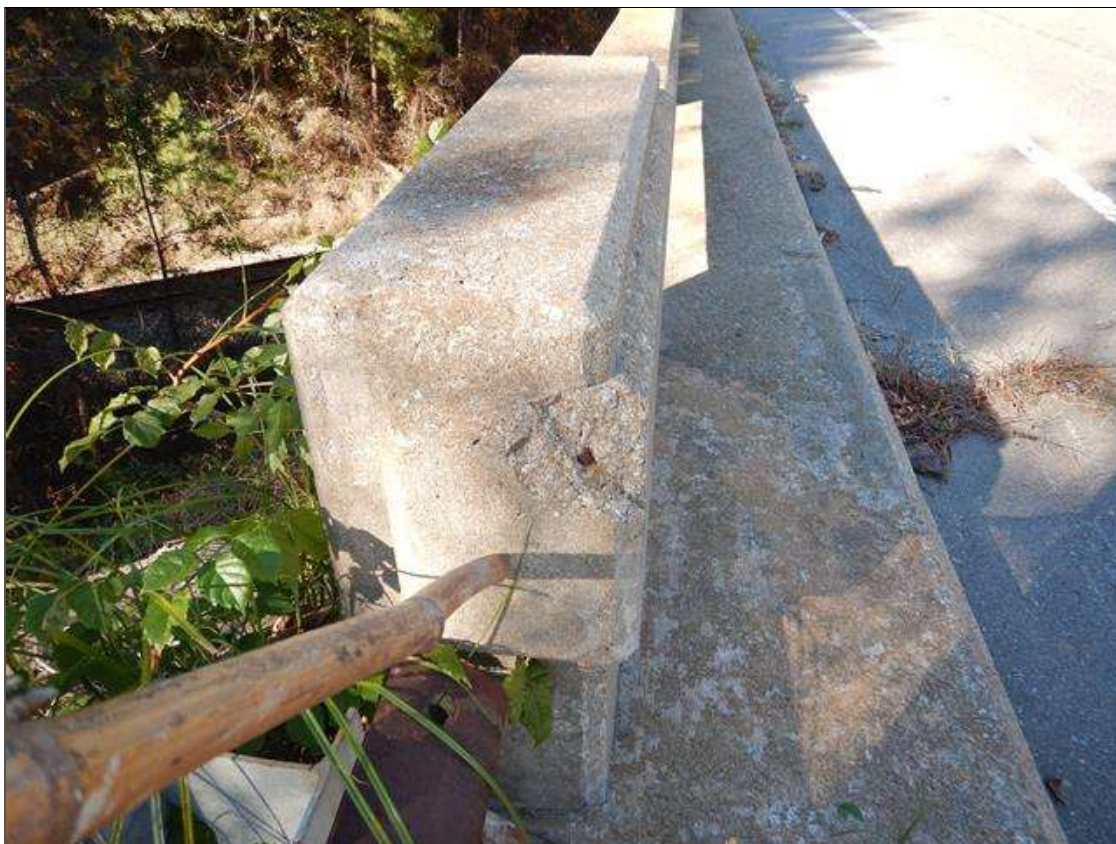
Span 1 Left Bridge Rail: 4" DIAMETER X 1" DEEP SPALL WITH EXPOSED REBAR AT END POST AT SOUTHWEST CORNER

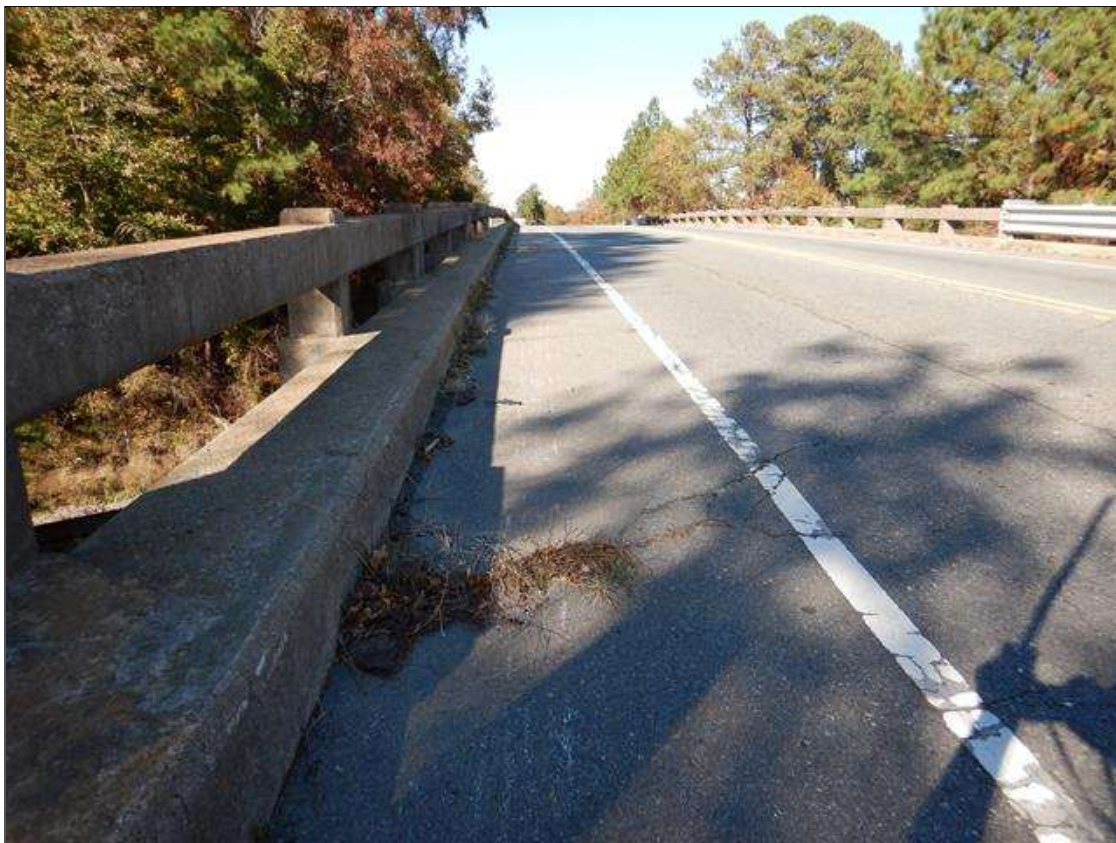
RIGHT AND LEFT GUTTERLINES, DEBRIS ACCUMULATION ALONG THE LENGTHS

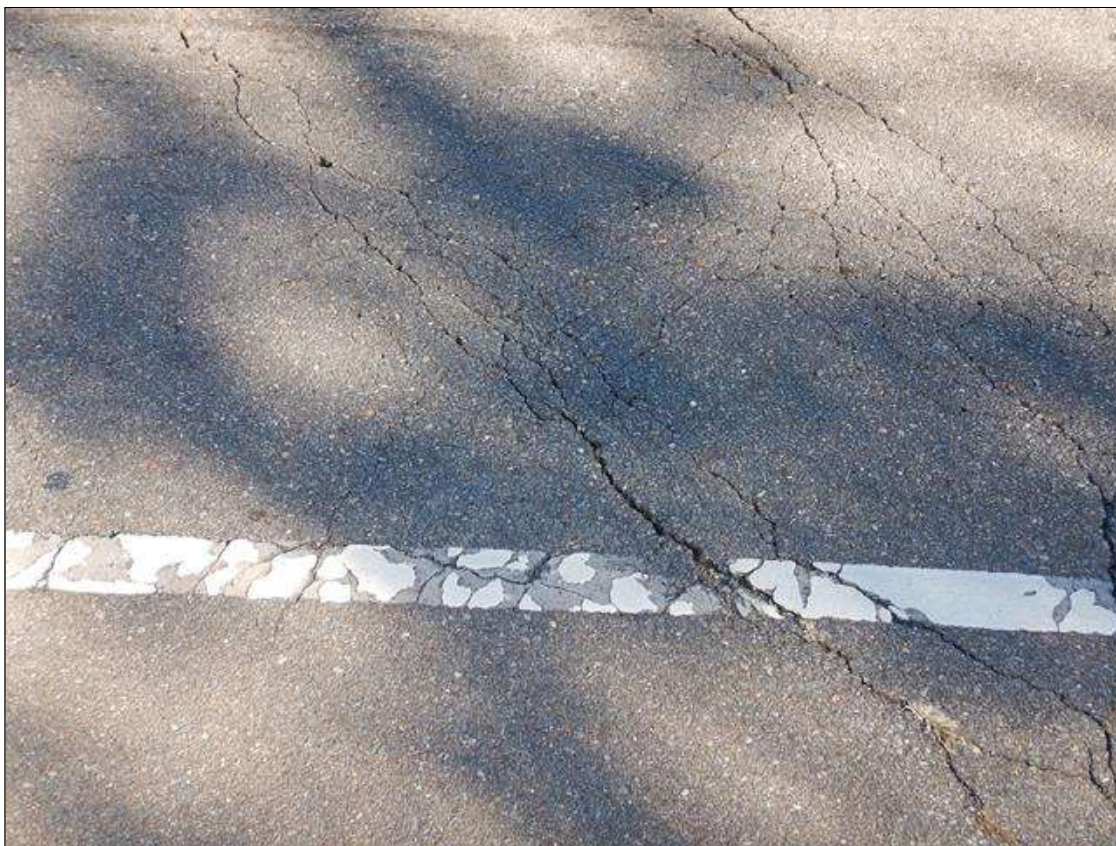
Span 1 Wearing Surface: FULL WIDTH TRANSVERSE/MAP CRACKING UP TO 1/2" WIDE OVER END BENT 1 AND BENT 1, BENT 1 SHOWN

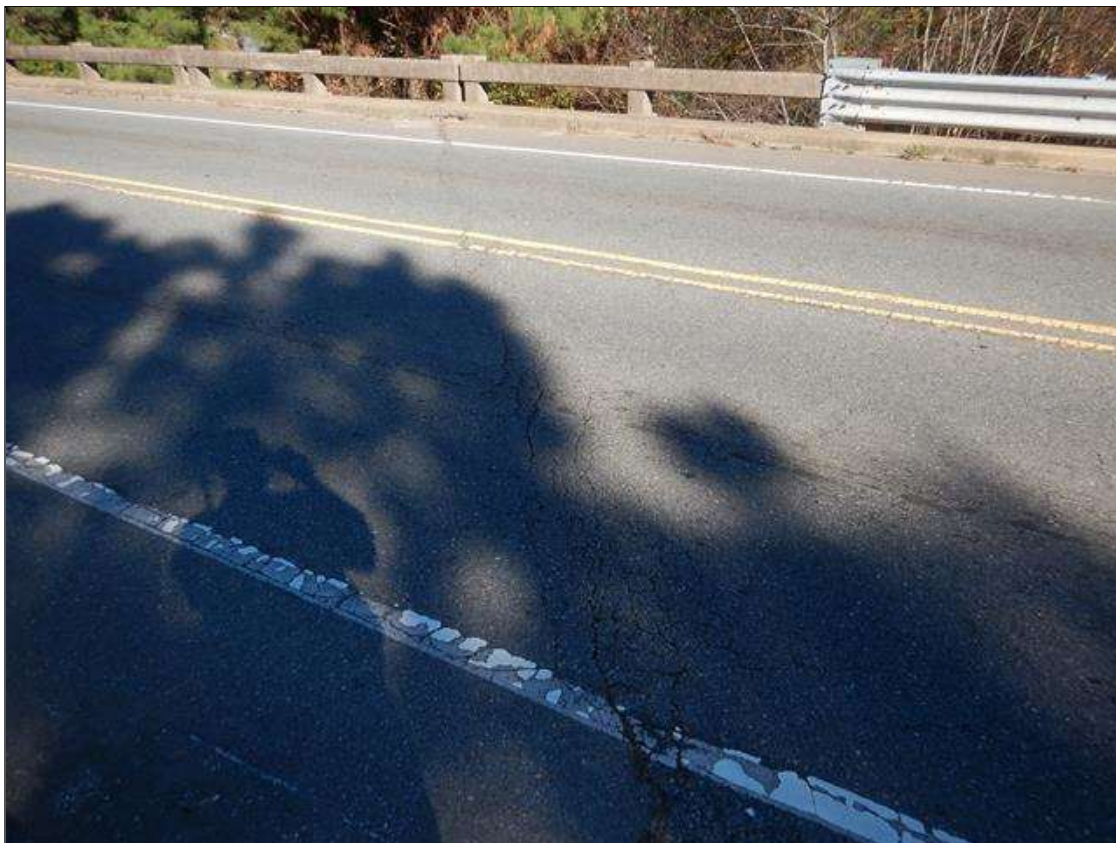
Span 1 Wearing Surface: FULL WIDTH TRANSVERSE/MAP CRACKING UP TO 1/2" WIDE OVER END BENT 1 AND BENT 1, BENT 1 SHOWN

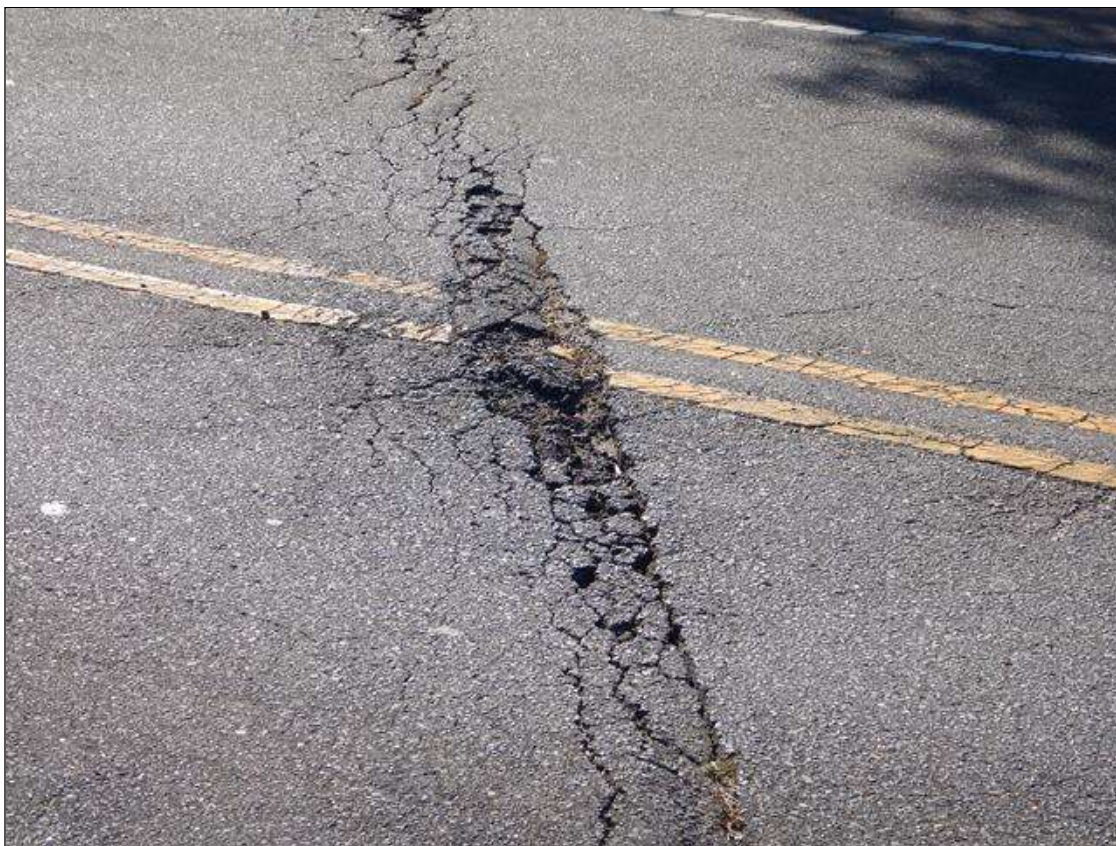
Span 3 Wearing Surface: FULL WIDTH TRANSVERSE/MAP CRACK UP TO 2" WIDE WITH ASPHALT DETERIORATION WITH UP TO 3/4" DEEP POT HOLES UP TO 1' LONG X 2" WIDE OVER BENT 3

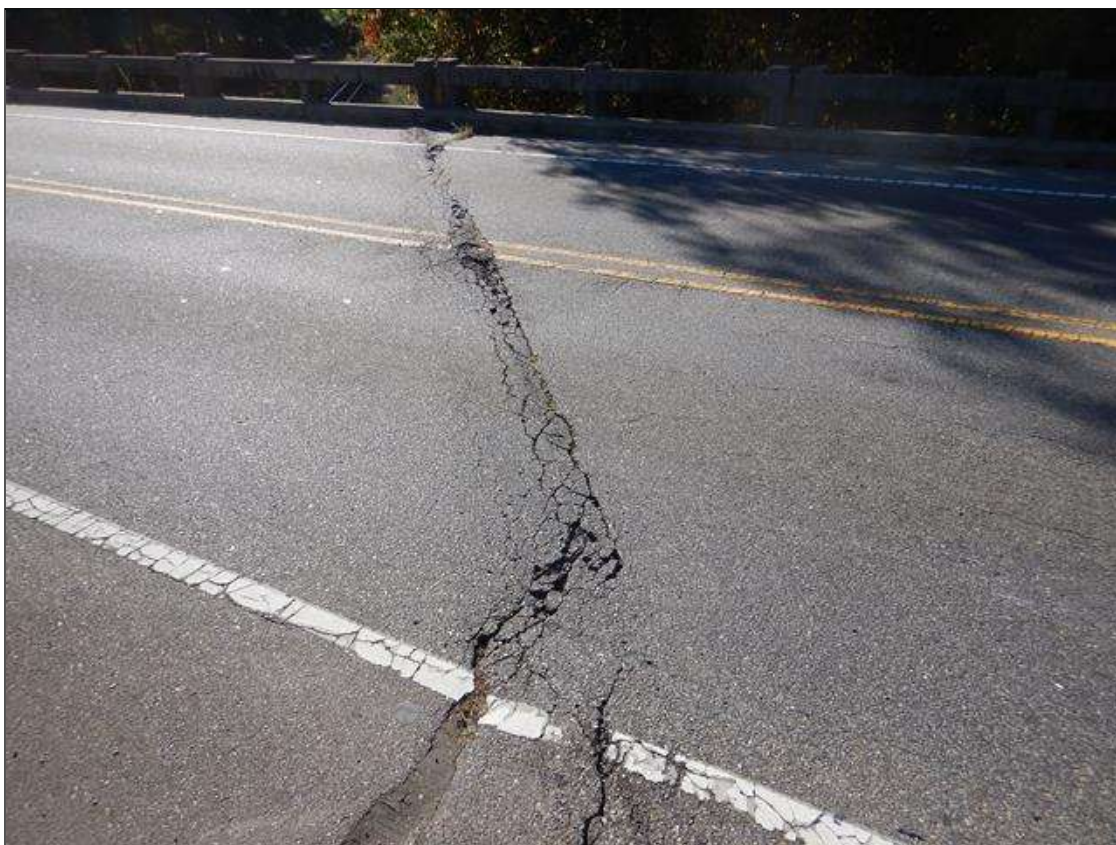
Span 3 Wearing Surface: FULL WIDTH TRANSVERSE/MAP CRACK UP TO 2" WIDE WITH ASPHALT DETERIORATION WITH UP TO 3/4" DEEP POT HOLES UP TO 1' LONG X 2" WIDE OVER BENT 3

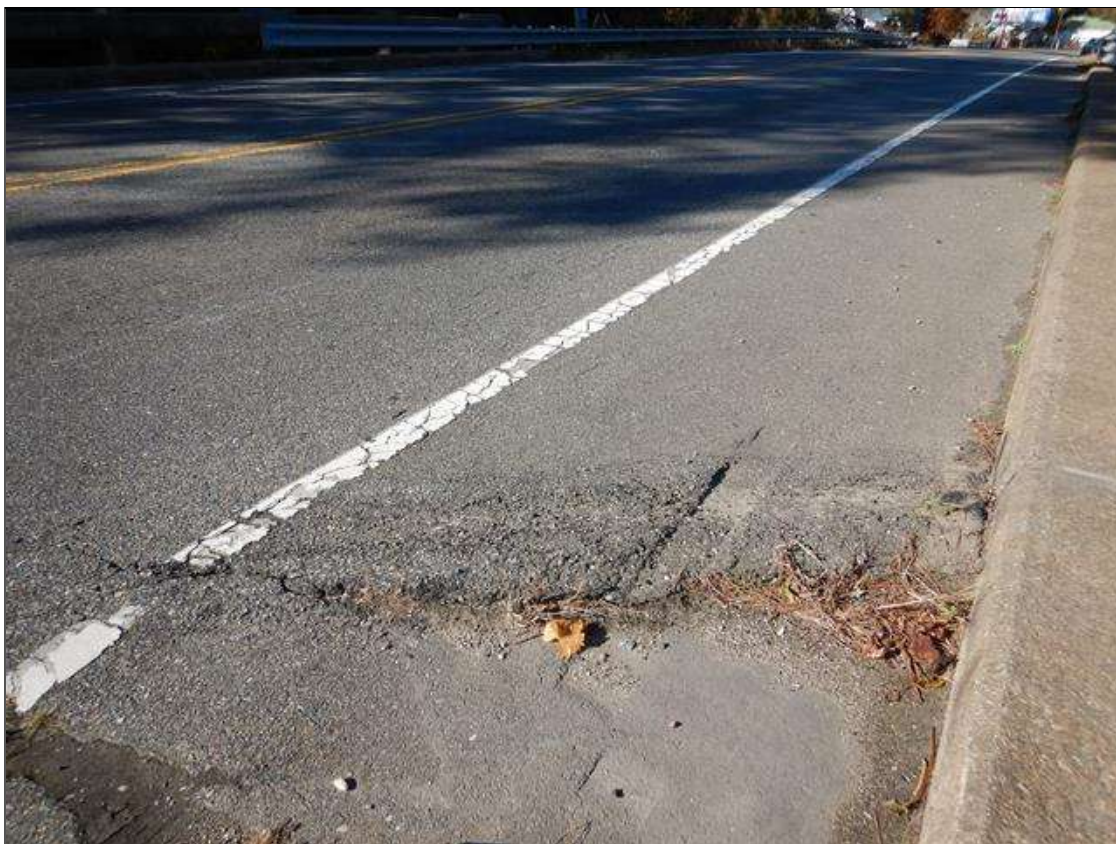
Span 3 Wearing Surface: 3' Long x 6" wide x 2 1/2" deep pothole at right shoulder at pier 3

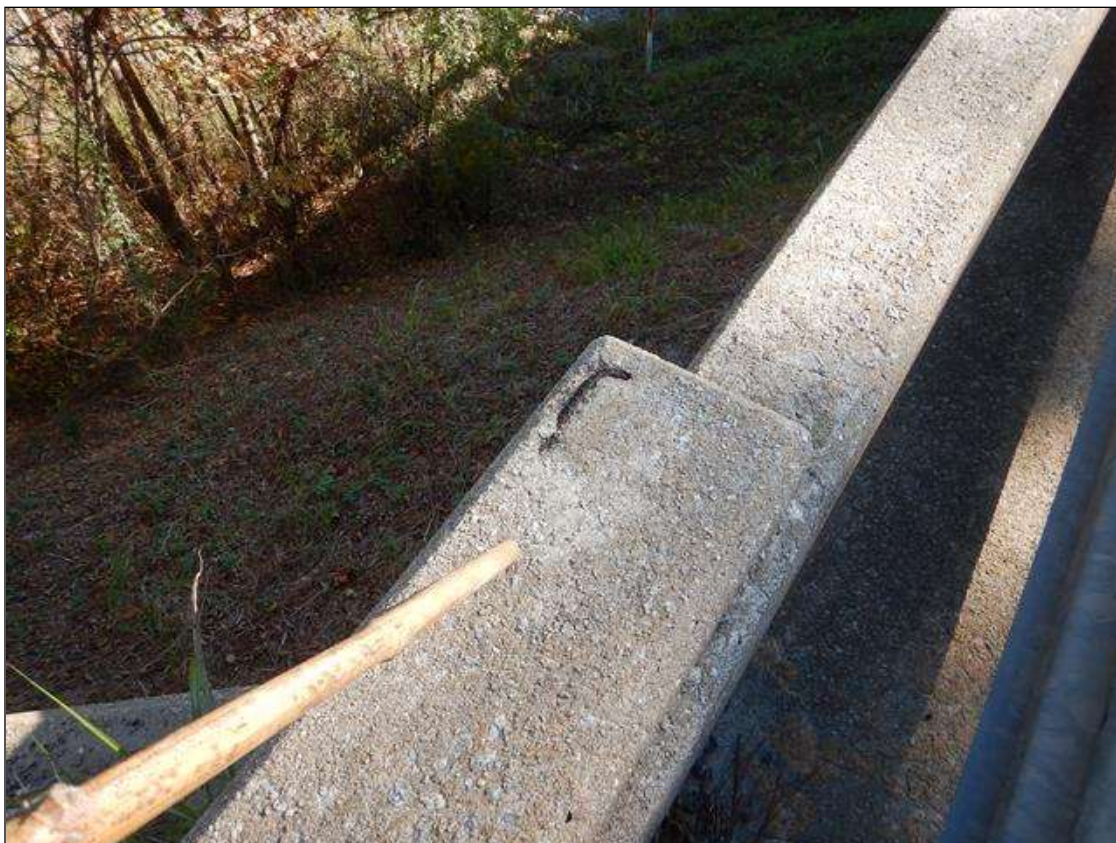
Span 5 Right Bridge Rail: FAR END ON THE TOP OF THE REINFORCED CONCRETE RAIL, EXPOSED REBAR [APPROXIMATELY 5" LONG X 1/2" WIDE] WITH NO MEASURABLE SECTION LOSS

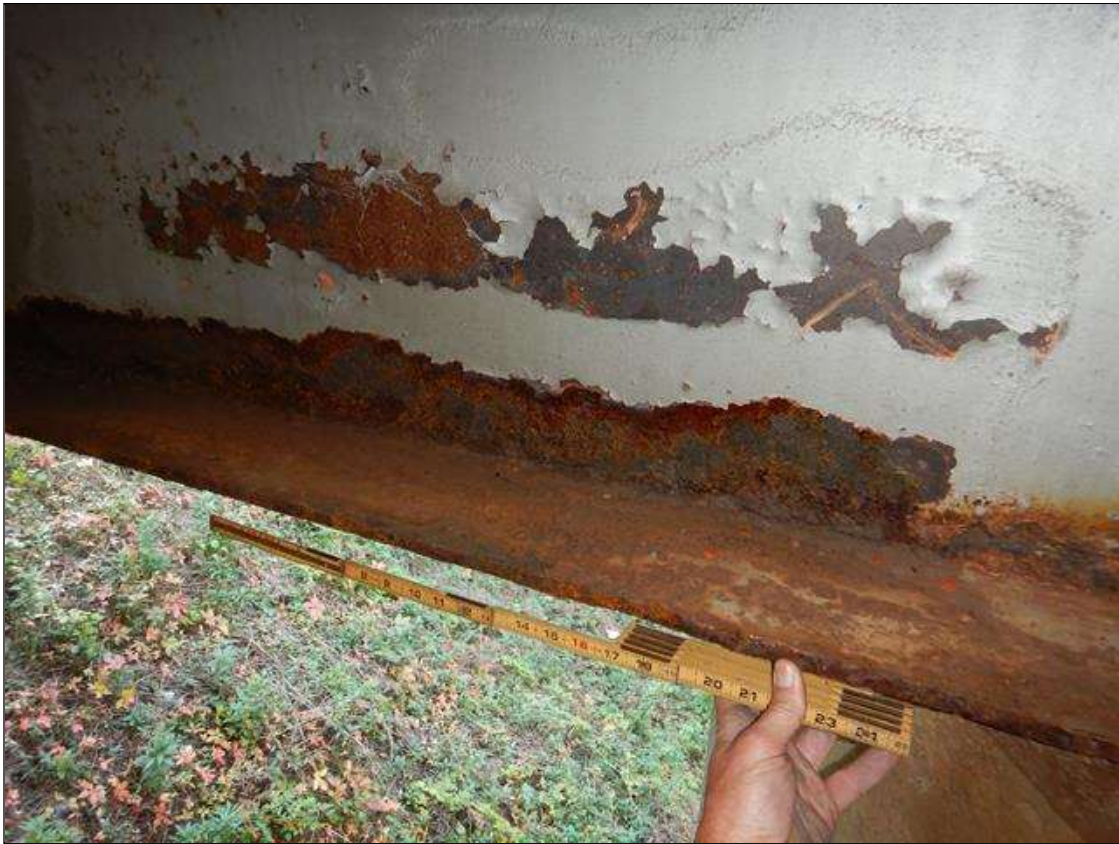
Span 1 Beam 1: [PROMPT ACTION REQUEST] BEAM END AT BENT 1 AT THE INTERFACE WITH THE REINFORCED CONCRETE DIAPHRAGM, THERE IS A BAND OF CORROSION UP TO 2" WIDE WITH SECTION LOSS [AVERAGE 1/8" REMAINS] FOR APPROXIMATELY 1' LONG X UP TO THE FULL HEIGHT OF THE DIAPHRAGM. AT THE LOWER CORNER OF THE INTERFACE THERE IS A HOLE [APPROXIMATELY 1/2" DIAMETER]. AT THE SAME END IN THE LOWER FLANGE, CORROSION WITH SECTION LOSS [AVERAGE 7/16" REMAINS] FOR APPROXIMATELY 6' LONG. AT THE SAME END IN THE LOWER 3" OF THE WEB, CORROSION WITH SECTION LOSS [AVERAGE 3/8" REMAINS] FOR APPROXIMATELY 6' LONG.

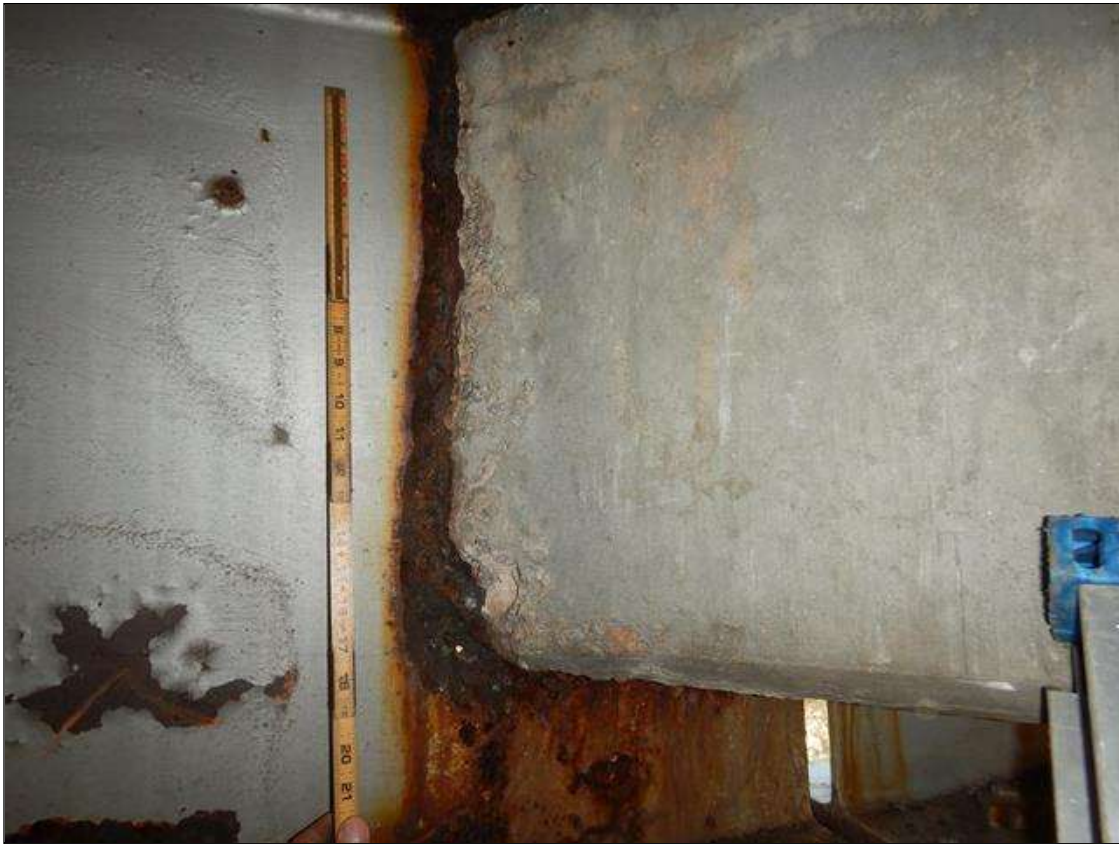
Span 1 Beam 1: [PROMPT ACTION REQUEST] BEAM END AT BENT 1 AT THE INTERFACE WITH THE REINFORCED CONCRETE DIAPHRAGM, THERE IS A BAND OF CORROSION UP TO 2" WIDE WITH SECTION LOSS [AVERAGE 1/8" REMAINS] FOR APPROXIMATELY 1' LONG X UP TO THE FULL HEIGHT OF THE DIAPHRAGM. AT THE LOWER CORNER OF THE INTERFACE THERE IS A HOLE [APPROXIMATELY 1/2" DIAMETER]. AT THE SAME END IN THE LOWER FLANGE, CORROSION WITH SECTION LOSS [AVERAGE 7/16" REMAINS] FOR APPROXIMATELY 6' LONG. AT THE SAME END IN THE LOWER 3" OF THE WEB, CORROSION WITH SECTION LOSS [AVERAGE 3/8" REMAINS] FOR APPROXIMATELY 6' LONG.

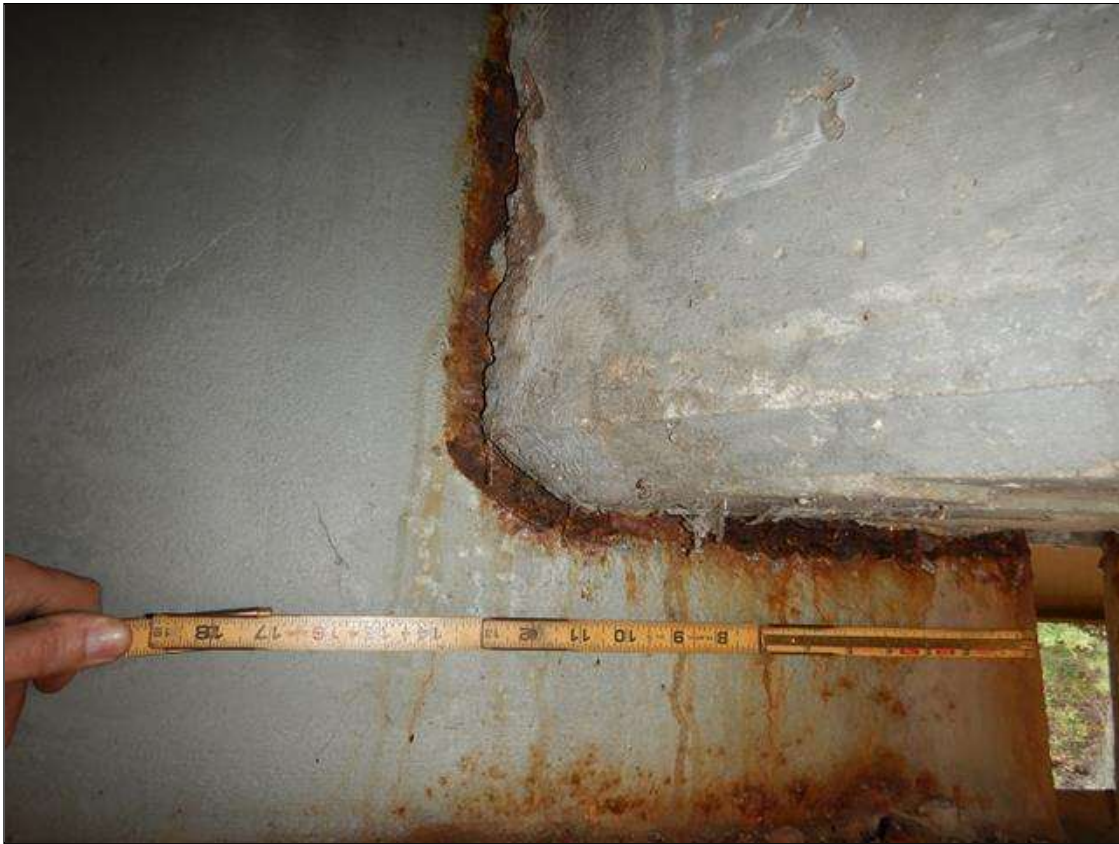
Span 1 Beam 3: [PROMPT ACTION REQUEST] BEAM END AT BENT 1 AT THE INTERFACE WITH THE REINFORCED CONCRETE DIAPHRAGM, THERE IS A BAND OF CORROSION UP TO 1" WIDE WITH SECTION LOSS [AVERAGE 3/8" REMAINS] FOR APPROXIMATELY 1' LONG X UP TO THE FULL HEIGHT OF THE DIAPHRAGM.

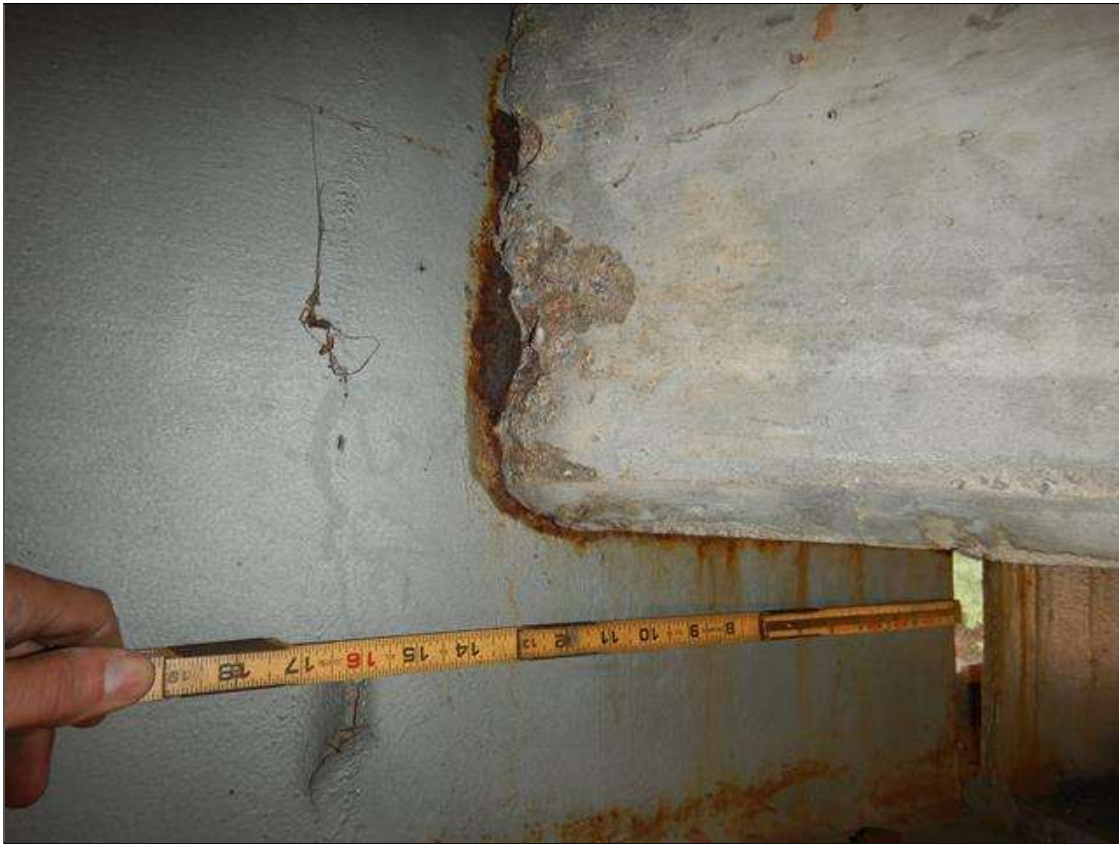
Span 1 Beam 2: [PROMPT ACTION REQUEST] BEAM END AT BENT 1 AT THE INTERFACE WITH THE REINFORCED CONCRETE DIAPHRAGM, THERE IS A BAND OF CORROSION UP TO 1" WIDE WITH SECTION LOSS [AVERAGE 3/8" REMAINS] FOR APPROXIMATELY 1' LONG X UP TO THE FULL HEIGHT OF THE DIAPHRAGM.

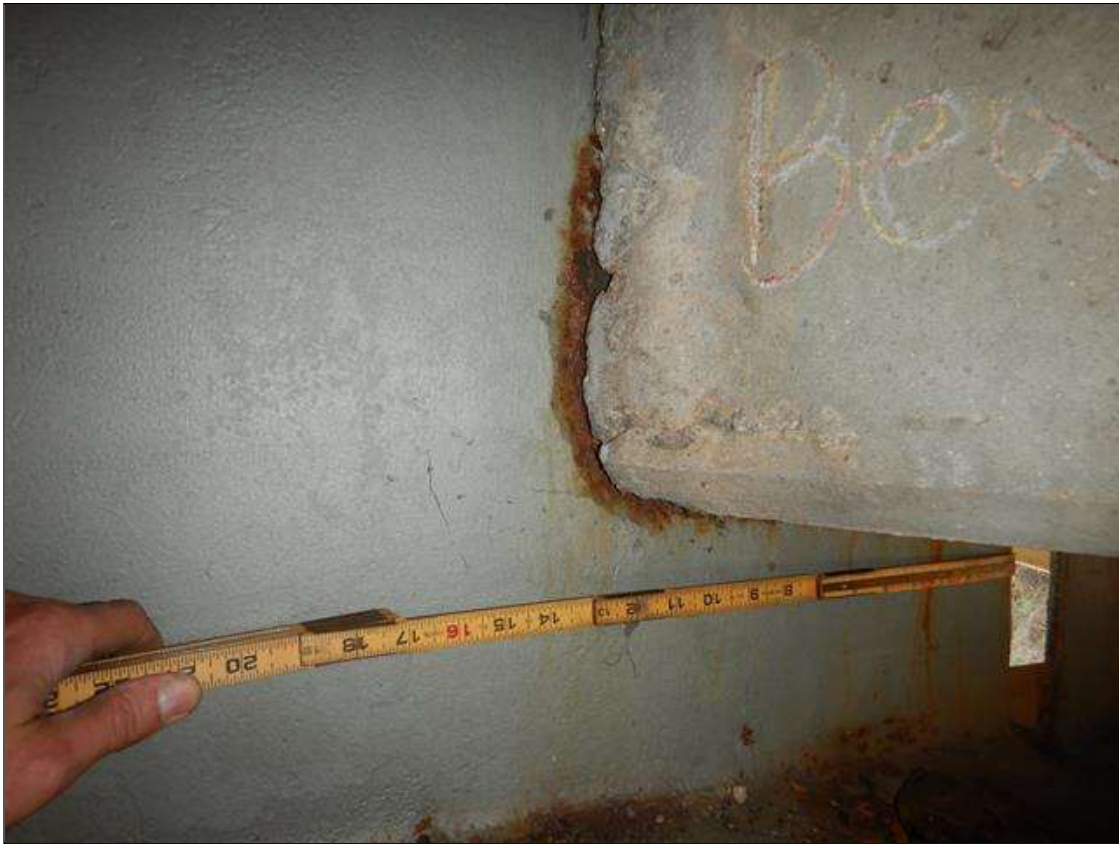
Span 1 Beam 4: [PROMPT ACTION REQUEST] BEAM END AT BENT 1 AT THE INTERFACE WITH THE REINFORCED CONCRETE DIAPHRAGM, THERE IS A BAND OF CORROSION UP TO 1" WIDE WITH SECTION LOSS [AVERAGE 3/8" REMAINS] FOR APPROXIMATELY 1' LONG X UP TO THE FULL HEIGHT OF THE DIAPHRAGM.

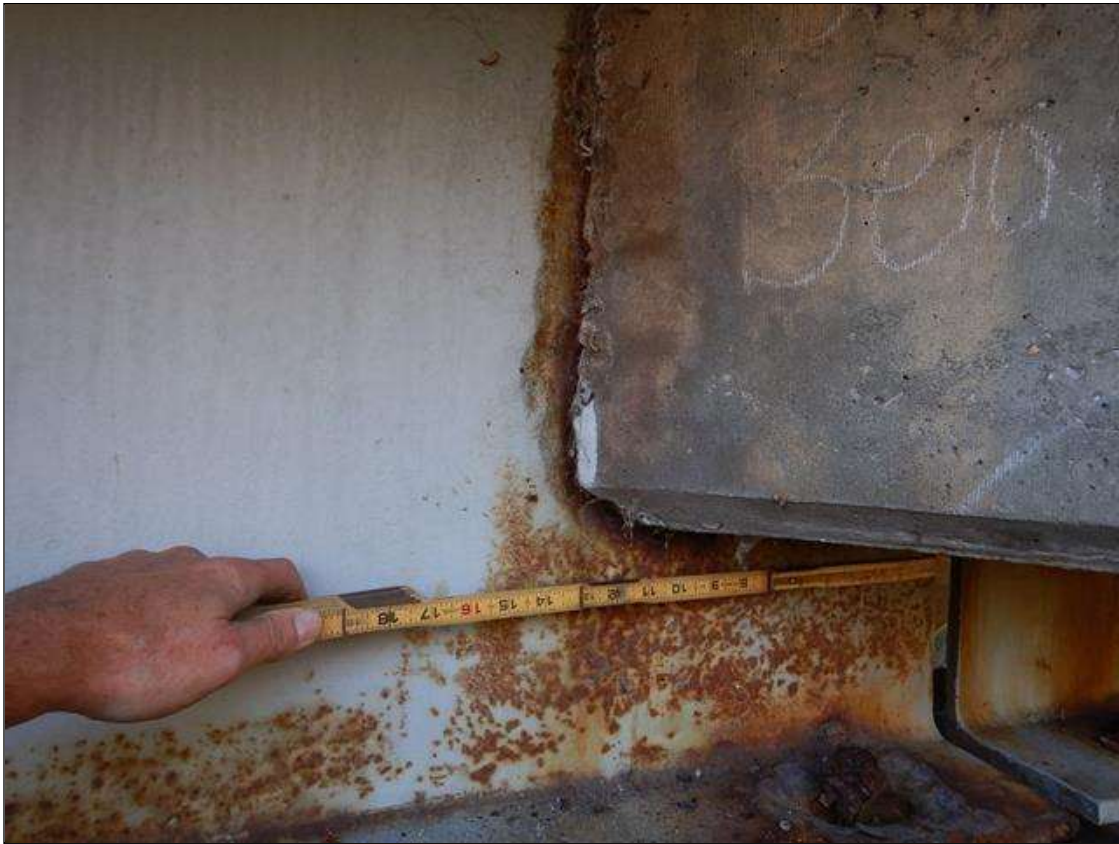
Span 1 Beam 5: [PROMPT ACTION REQUEST] BEAM END AT BENT 1 AT THE INTERFACE WITH THE REINFORCED CONCRETE DIAPHRAGM, THERE IS A BAND OF CORROSION UP TO 2" WIDE WITH SECTION LOSS [AVERAGE 3/16" REMAINS] FOR APPROXIMATELY 1' LONG X UP TO THE FULL HEIGHT OF THE DIAPHRAGM.

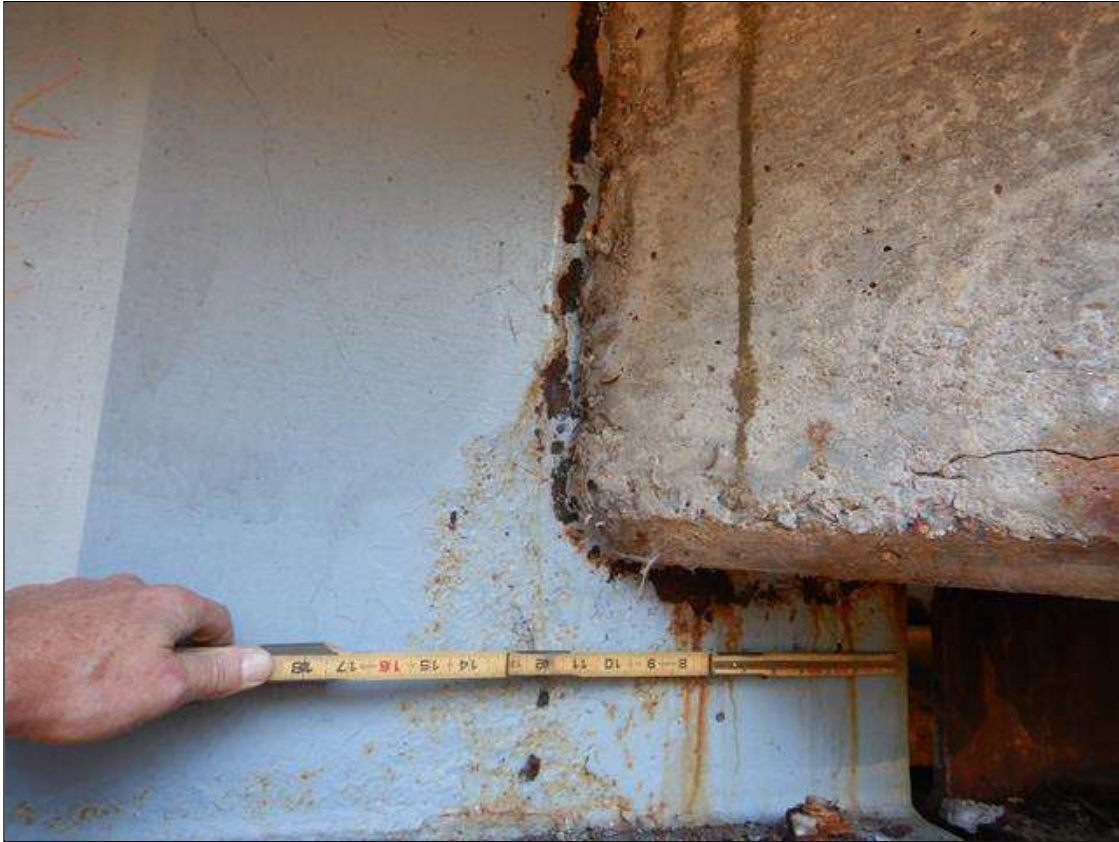
Span 2 Beam 1: [PROMPT ACTION REQUEST] BEAM END AT BENT 1 AT THE INTERFACE WITH THE REINFORCED CONCRETE DIAPHRAGM, THERE IS A BAND OF CORROSION UP TO 2" WIDE WITH SECTION LOSS [AVERAGE 3/8" REMAINS] FOR APPROXIMATELY 1' LONG X UP TO THE FULL HEIGHT OF THE DIAPHRAGM.

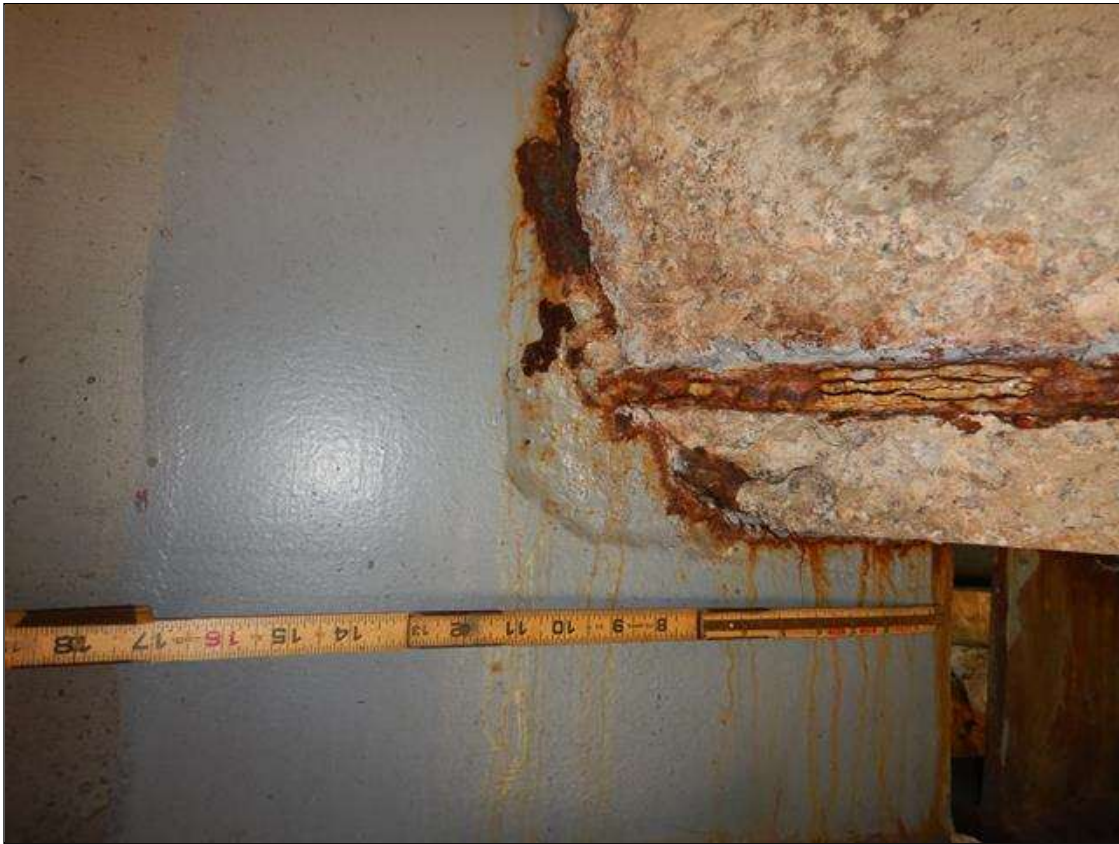
Span 2 Beam 2: [PROMPT ACTION REQUEST] BEAM END AT BENT 1 AT THE INTERFACE WITH THE REINFORCED CONCRETE DIAPHRAGM, THERE IS A BAND OF CORROSION UP TO 3" WIDE WITH SECTION LOSS [AVERAGE 3/8" REMAINS] FOR APPROXIMATELY 1' LONG X UP TO THE FULL HEIGHT OF THE DIAPHRAGM.

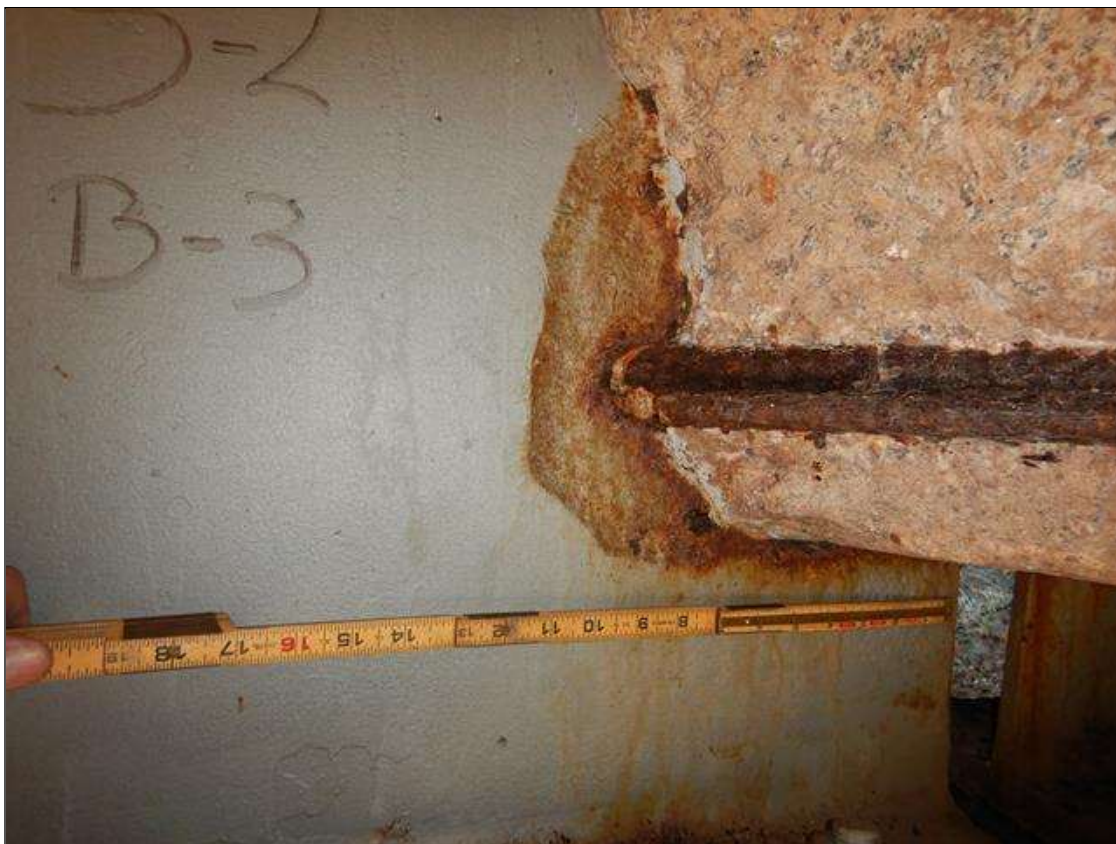
Span 2 Beam 3: [PROMPT ACTION REQUEST] BEAM END AT BENT 1 AT THE INTERFACE WITH THE REINFORCED CONCRETE DIAPHRAGM, THERE IS A BAND OF CORROSION UP TO 3" WIDE WITH SECTION LOSS [AVERAGE 3/8" REMAINS] FOR APPROXIMATELY 1' LONG X UP TO THE FULL HEIGHT OF THE DIAPHRAGM.

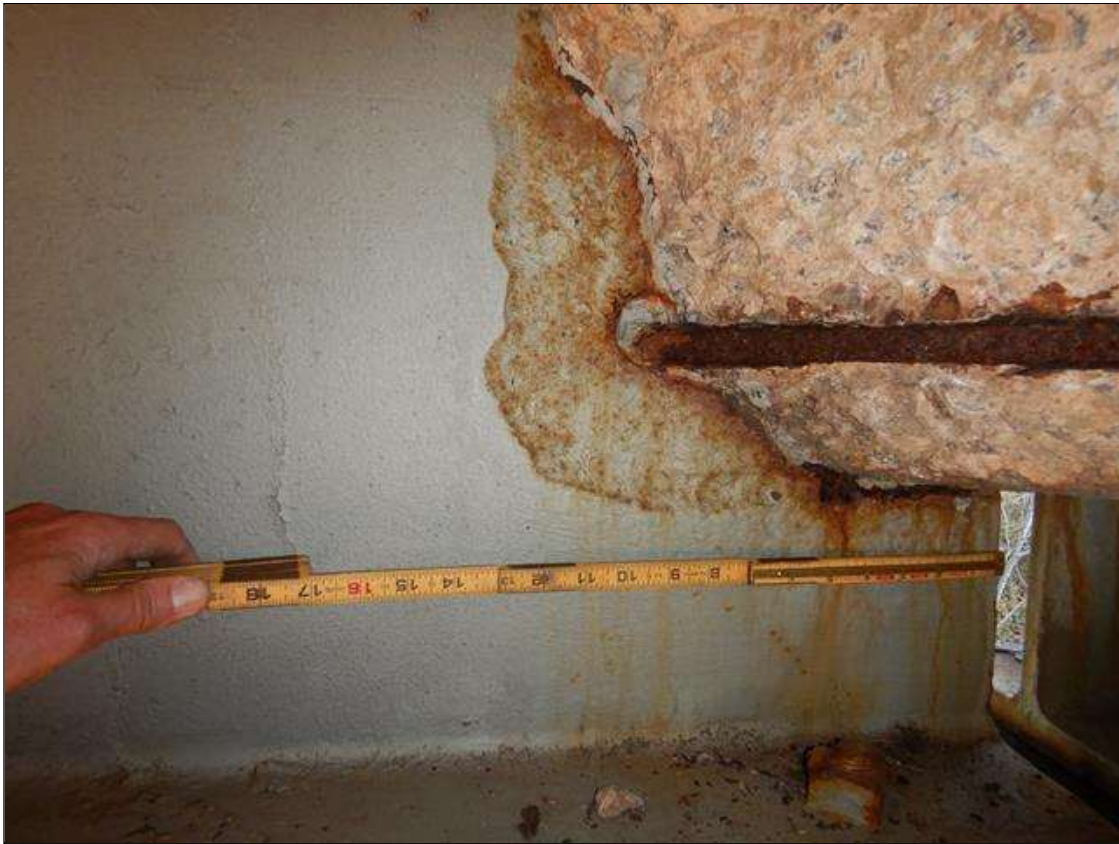
Span 2 Beam 5: [PROMPT ACTION REQUEST] BEAM END AT BENT 1 AT THE INTERFACE WITH THE REINFORCED CONCRETE DIAPHRAGM, THERE IS A BAND OF CORROSION UP TO 3" WIDE WITH SECTION LOSS [AVERAGE 3/8" REMAINS] FOR APPROXIMATELY 1' LONG X UP TO THE FULL HEIGHT OF THE DIAPHRAGM.

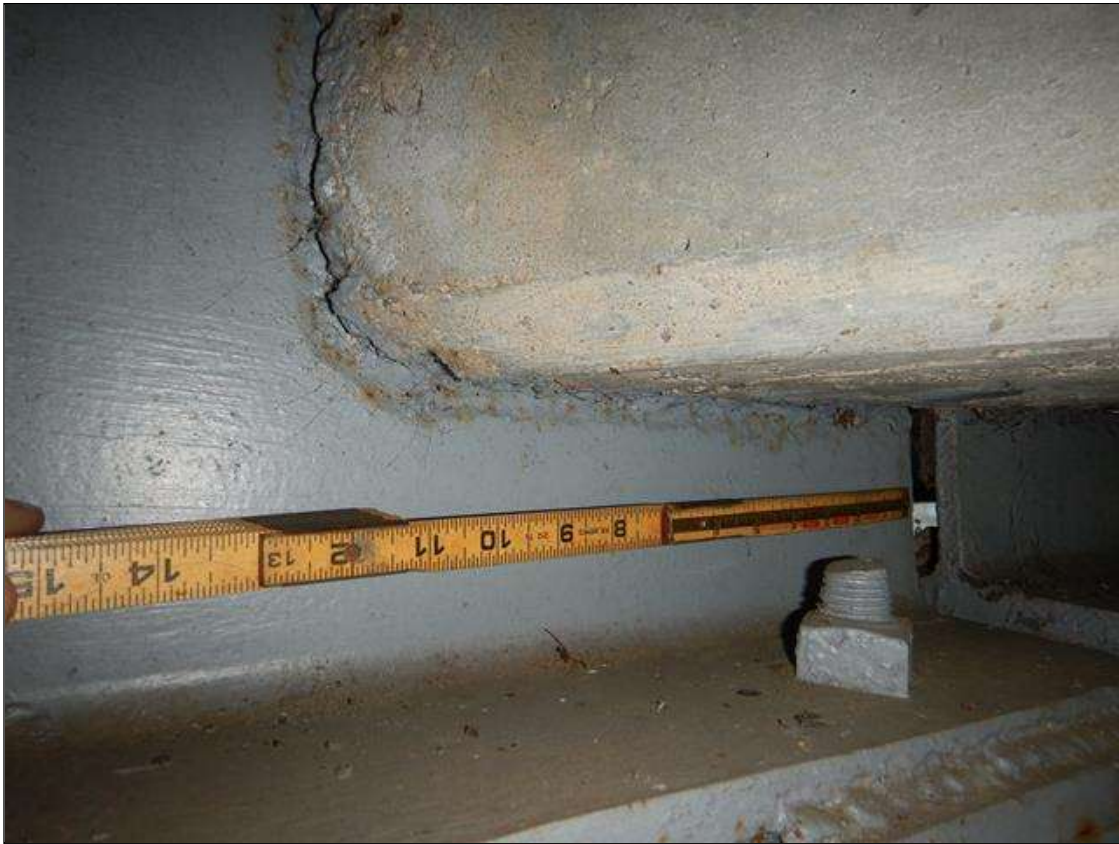
Span 4 Beam 2: [PROMPT ACTION REQUEST] BEAM END AT BENT 4 AT THE INTERFACE WITH THE REINFORCED CONCRETE DIAPHRAGM, THERE IS A BAND OF CORROSION UP TO 1" WIDE WITH SECTION LOSS [AVERAGE 3/8" REMAINS] FOR APPROXIMATELY 1' LONG X UP TO THE FULL HEIGHT OF THE DIAPHRAGM.

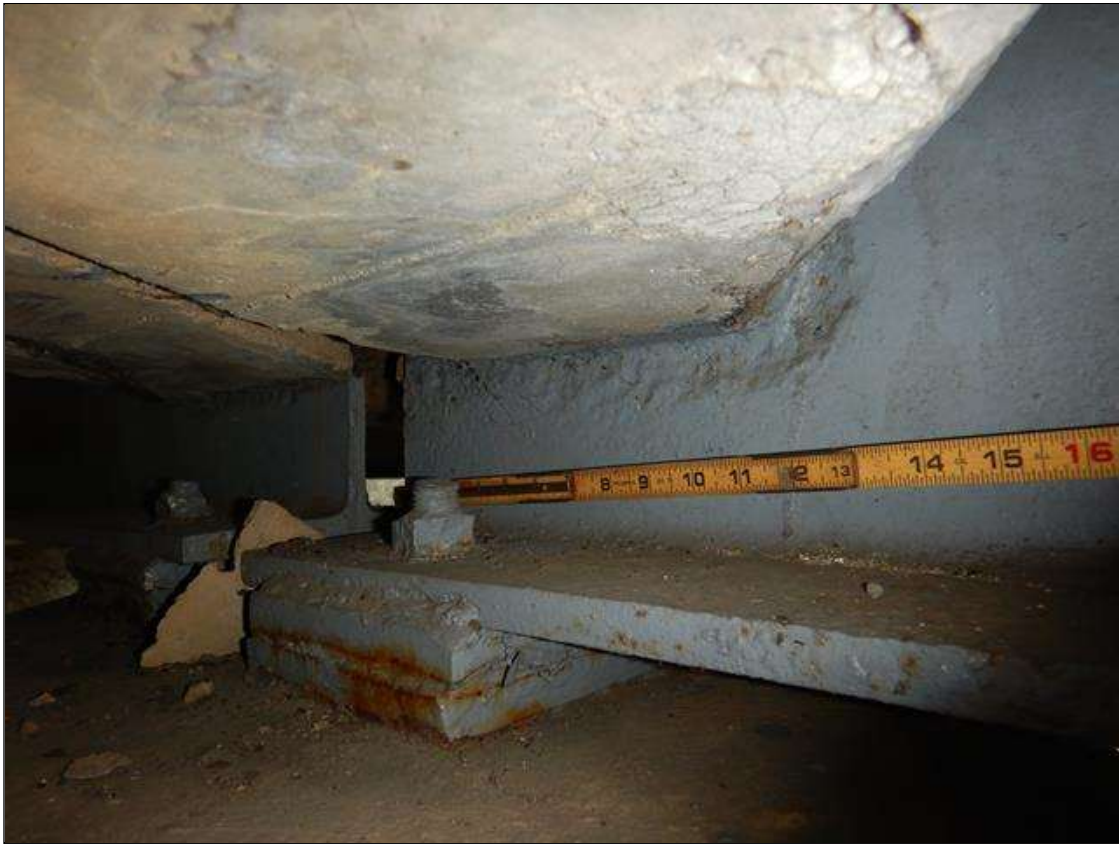
Span 4 Beam 3: [PROMPT ACTION REQUEST] BEAM END AT BENT 4 AT THE INTERFACE WITH THE REINFORCED CONCRETE DIAPHRAGM, THERE IS A BAND OF CORROSION UP TO 1" WIDE WITH SECTION LOSS [AVERAGE 5/16" REMAINS] FOR APPROXIMATELY 1' LONG X UP TO THE FULL HEIGHT OF THE DIAPHRAGM.

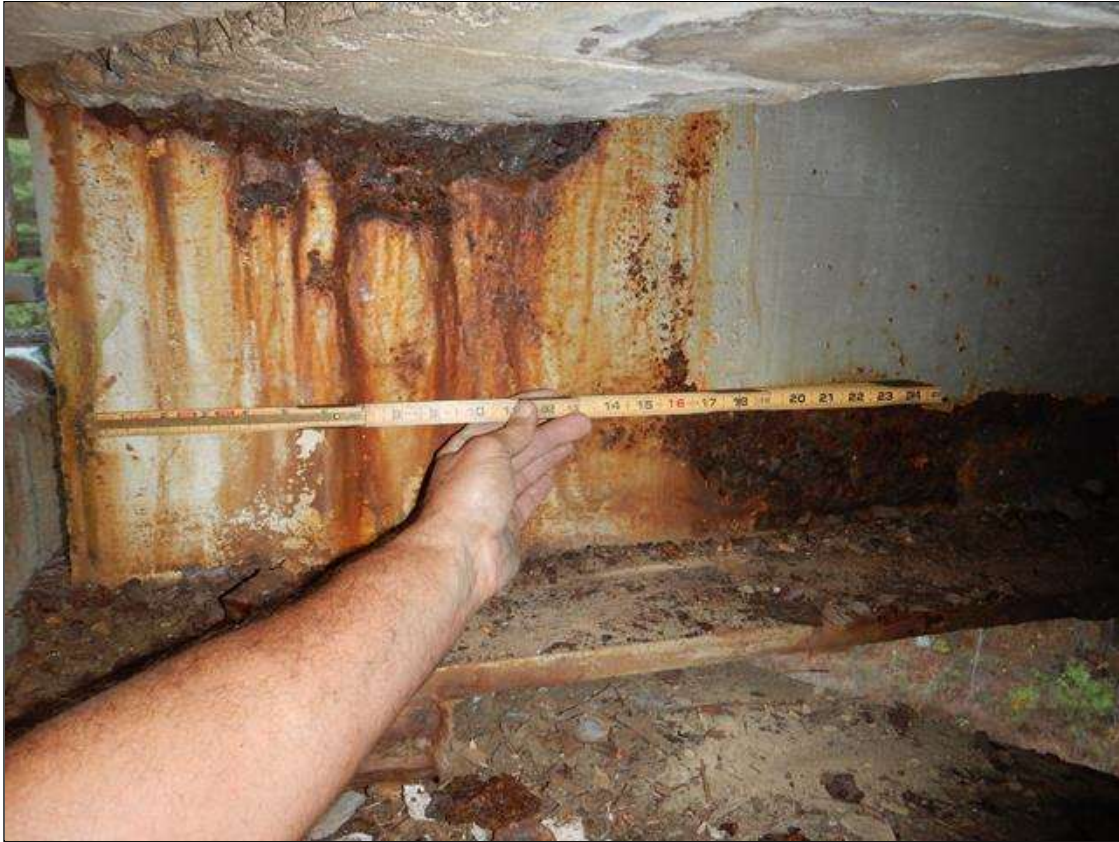
Span 3 Beam 5: [PROMPT ACTION REQUEST] BEAM END AT BENT 3 AT THE INTERFACE WITH THE REINFORCED CONCRETE DIAPHRAGM, THERE IS A BAND OF CORROSION UP TO 2" WIDE WITH SECTION LOSS [AVERAGE 5/16" REMAINS] FOR APPROXIMATELY 1' LONG X UP TO THE FULL HEIGHT OF THE DIAPHRAGM. AT THE SAME END IN THE LOWER LEFT FLANGE, CORROSION WITH SECTION LOSS [AVERAGE 1/8" REMAINS] FOR APPROXIMATELY 5' LONG. AT 1.5' OUT FROM THE SAME END IN THE LOWER 5" OF THE WEB, CORROSION WITH SECTION LOSS [AVERAGE 1/8" REMAINS] FOR APPROXIMATELY 3' LONG.

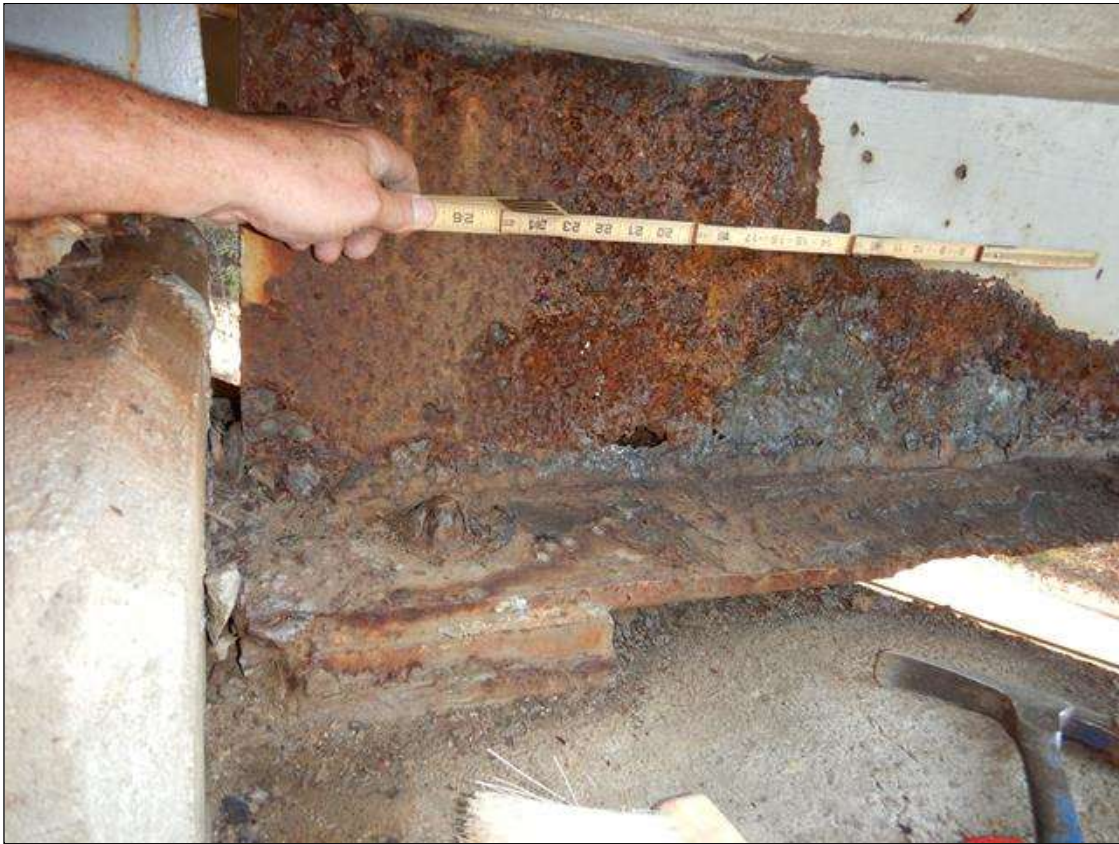
Span 3 Beam 1: [PROMPT ACTION REQUEST] BEAM END AT BENT 3 IN THE LEFT LOWER FLANGE, CORROSION WITH SECTION LOSS [AVERAGE 1/16" REMAINS] FOR APPROXIMATELY 4' LONG WITH EDGE HOLES UP TO 3/4" DIAMETER. AT THE SAME END IN THE LOWER 6" OF THE WEB, CORROSION WITH SECTION LOSS [AVERAGE 1/16" REMAINS] FOR APPROXIMATELY 4' LONG WITH PERFORATIONS THROUGHOUT.
