NC DEPARTMENT OF TRANSPORTATION  
 DIVISION OF HIGHWAYS  
 STRUCTURE MANAGEMENT UNIT

ATTENTION: **PROMPT ACTION REQUEST**

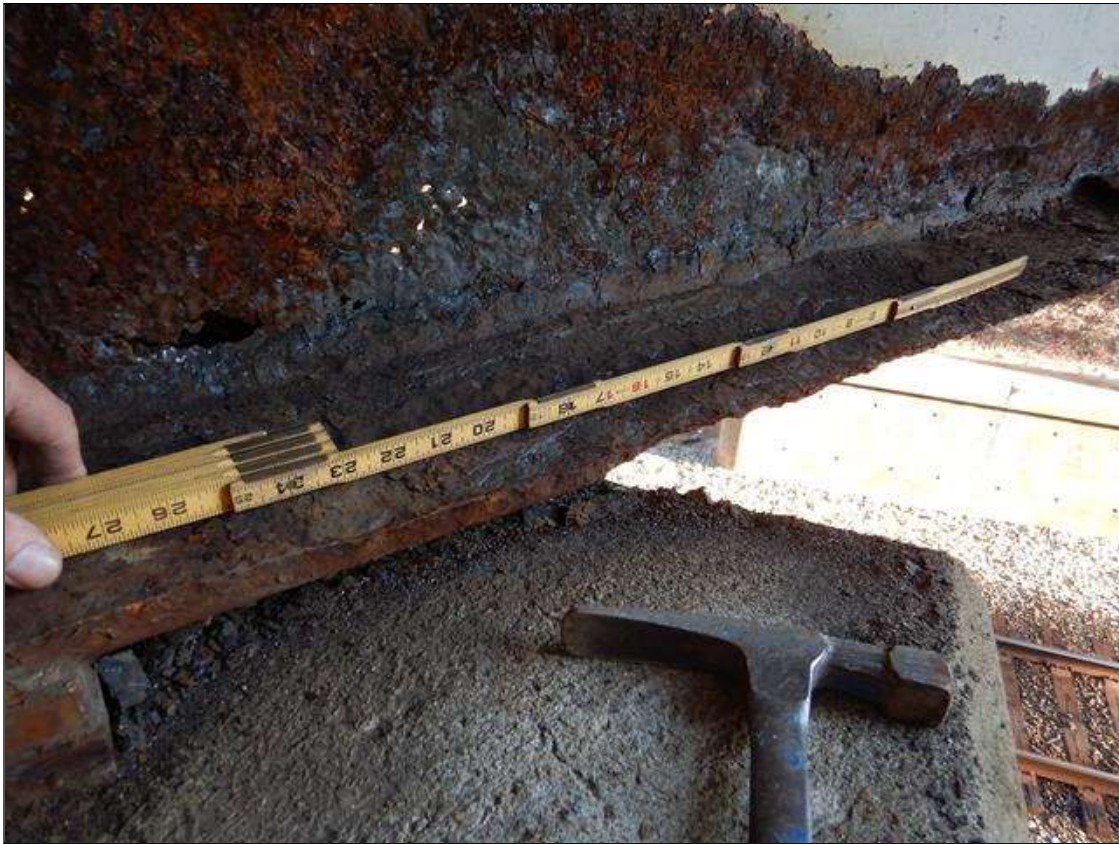
Span 3 Beam 1: [PROMPT ACTION REQUEST] BEAM END AT BENT 3 IN THE LEFT LOWER FLANGE, CORROSION WITH SECTION LOSS [AVERAGE 1/16" REMAINS] FOR APPROXIMATELY 4' LONG WITH EDGE HOLES UP TO 3/4" DIAMETER. AT THE SAME END IN THE LOWER 6" OF THE WEB, CORROSION WITH SECTION LOSS [AVERAGE 1/16" REMAINS] FOR APPROXIMATELY 4' LONG WITH PERFORATIONS THROUGHOUT.

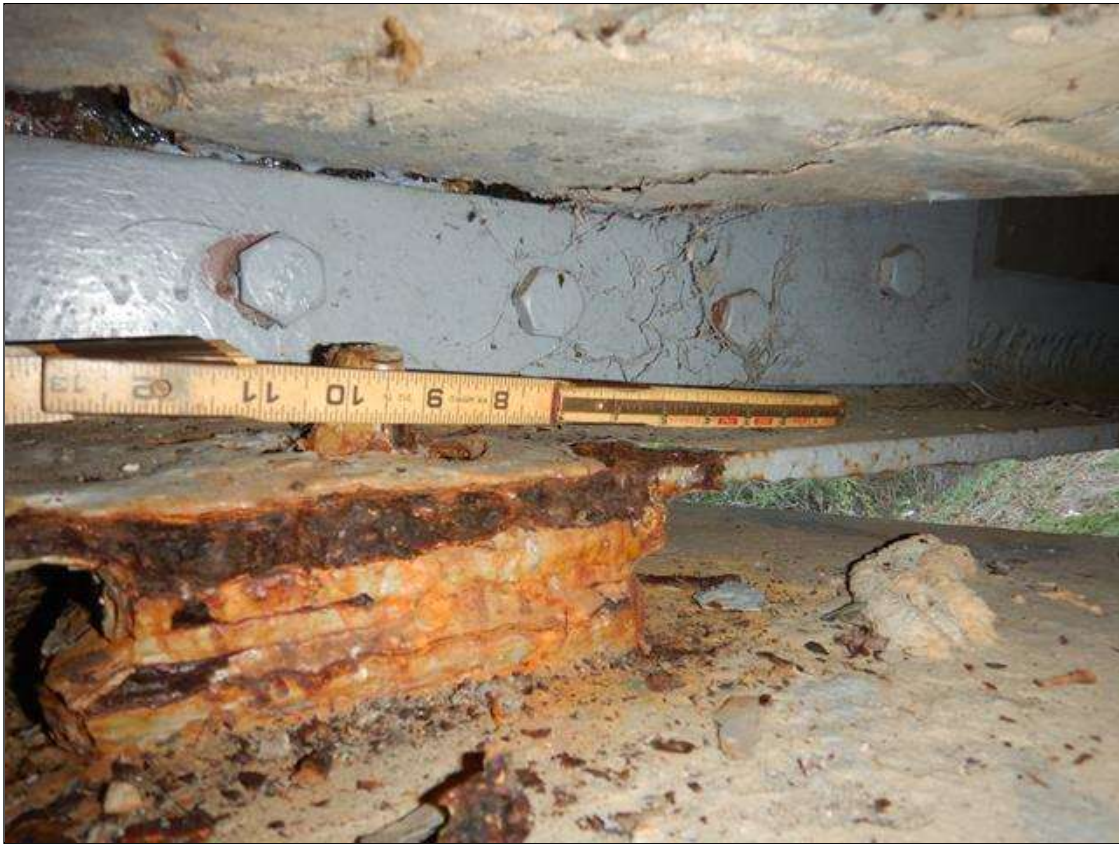
Span 4 Beam 1: [PROMPT ACTION REQUEST] BEAM END AT BENT 3 AT THE INTERFACE WITH THE REINFORCED CONCRETE DIAPHRAGM, THERE IS A BAND OF CORROSION UP TO 1" WIDE WITH SECTION LOSS [AVERAGE 3/8" REMAINS] FOR APPROXIMATELY 1' LONG X UP TO THE FULL HEIGHT OF THE DIAPHRAGM. AT THE SAME END IN THE LOWER FLANGE, CORROSION WITH SECTION LOSS [AVERAGE 3/8" REMAINS] FOR APPROXIMATELY 3' LONG.

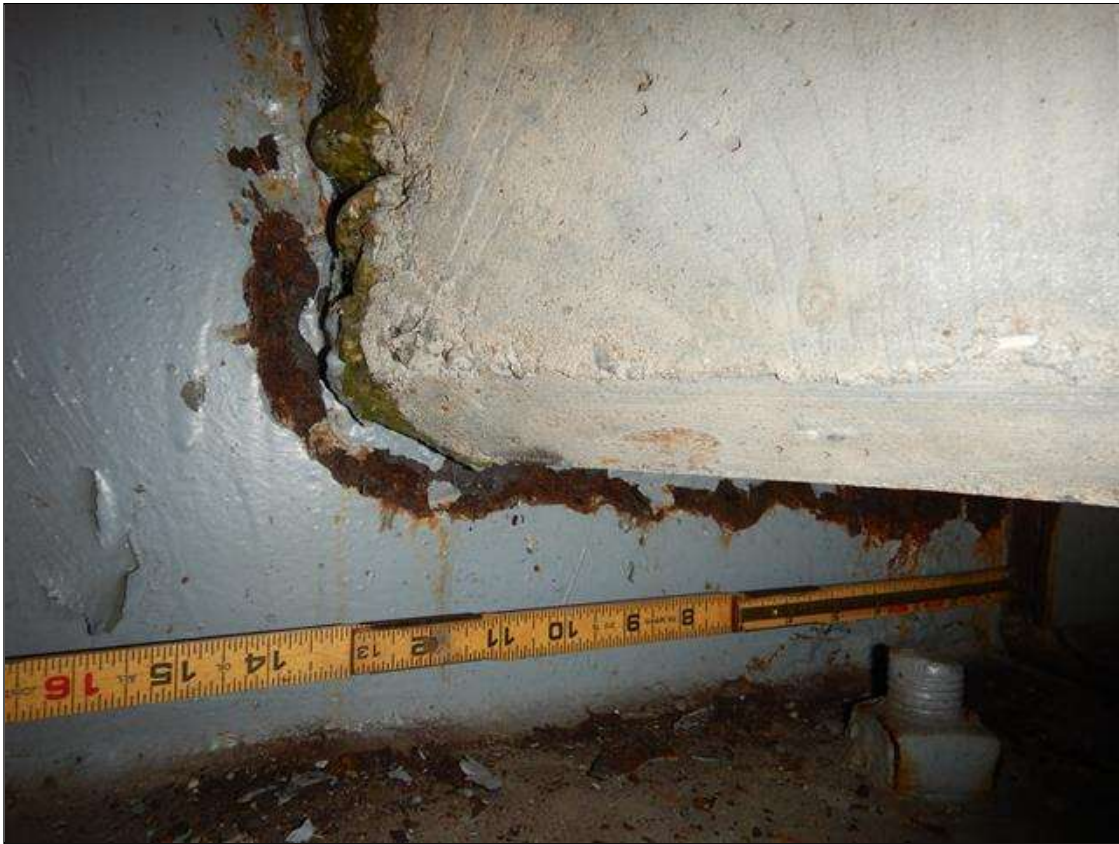
Span 4 Beam 1: [PROMPT ACTION REQUEST] BEAM END AT BENT 3 AT THE INTERFACE WITH THE REINFORCED CONCRETE DIAPHRAGM, THERE IS A BAND OF CORROSION UP TO 1" WIDE WITH SECTION LOSS [AVERAGE 3/8" REMAINS] FOR APPROXIMATELY 1' LONG X UP TO THE FULL HEIGHT OF THE DIAPHRAGM. AT THE SAME END IN THE LOWER FLANGE, CORROSION WITH SECTION LOSS [AVERAGE 3/8" REMAINS] FOR APPROXIMATELY 3' LONG.

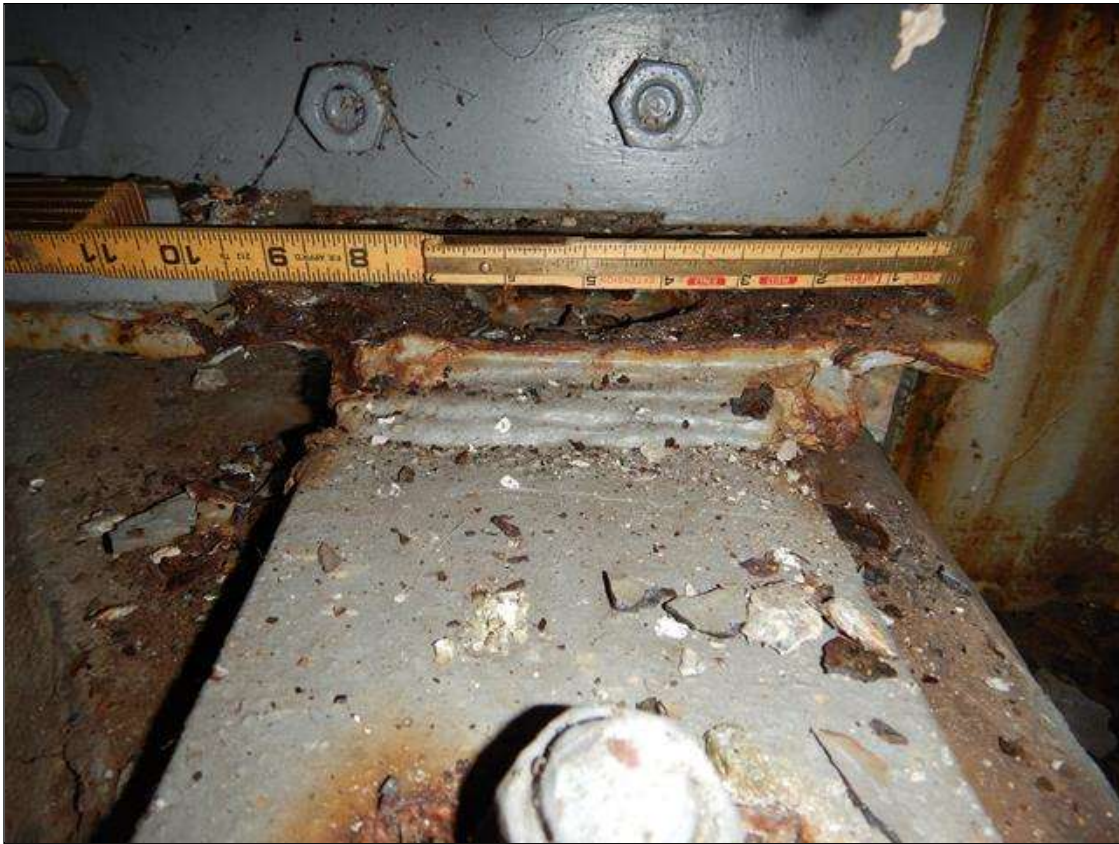
Span 4 Beam 5: PAR--SECTION LOSS UP TO 3/8" WITH 3/8" AVERAGE REMAINING FULL WIDTH OF BOTTOM FLANGE 1FT LONG ON BEAM END OVER PIER 3. BEAM END HAS BEEN CLEANED AND PAINTED WITH ACTIVE SURFACE CORROSION. PLATE REPAIR ADDED BUT DOES NOT EXTEND OUT TO DEFECT.

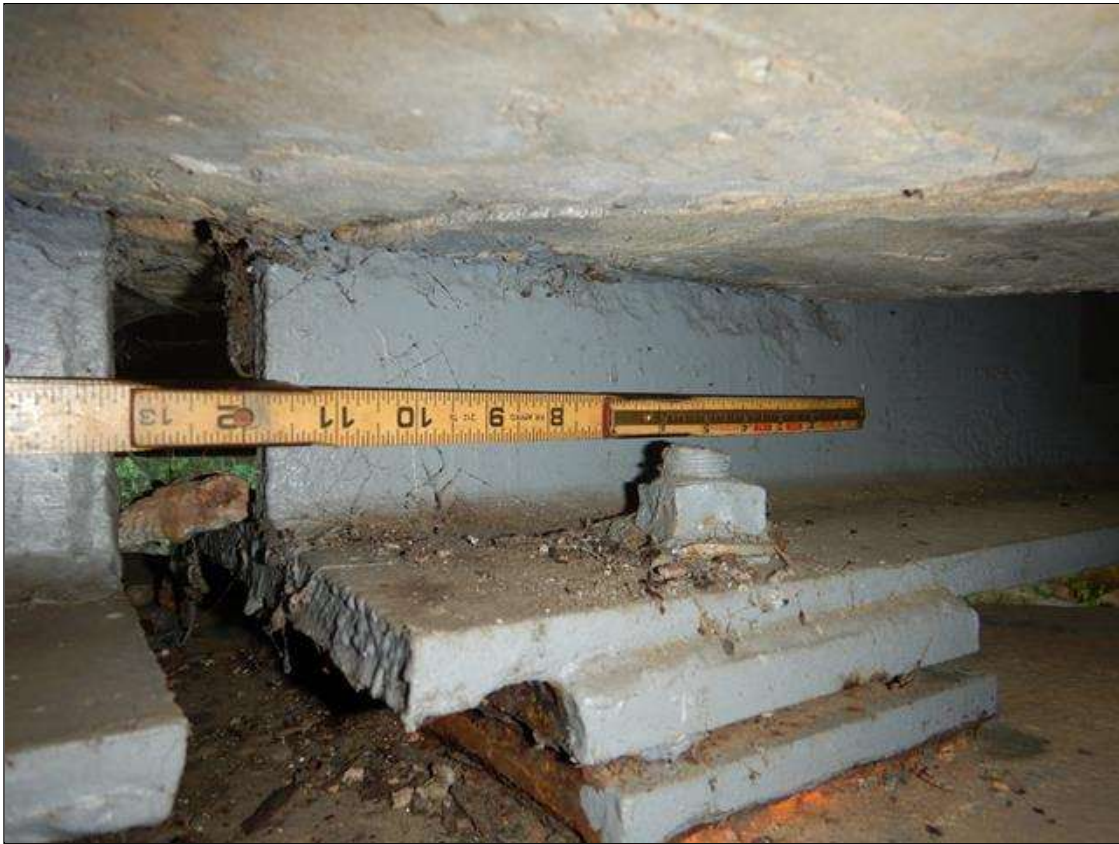
Span 5 Beam 2: PAR--1 FOOT LONG X 2" WIDE AREA OF PREVIOUS CORROSION WITH 1/4" REMAINING SECTION IN WEB AROUND END DIAPHRAGM AT BENT 4 AREA HAS BEEN PAINTED OVER AND ARRESTED.

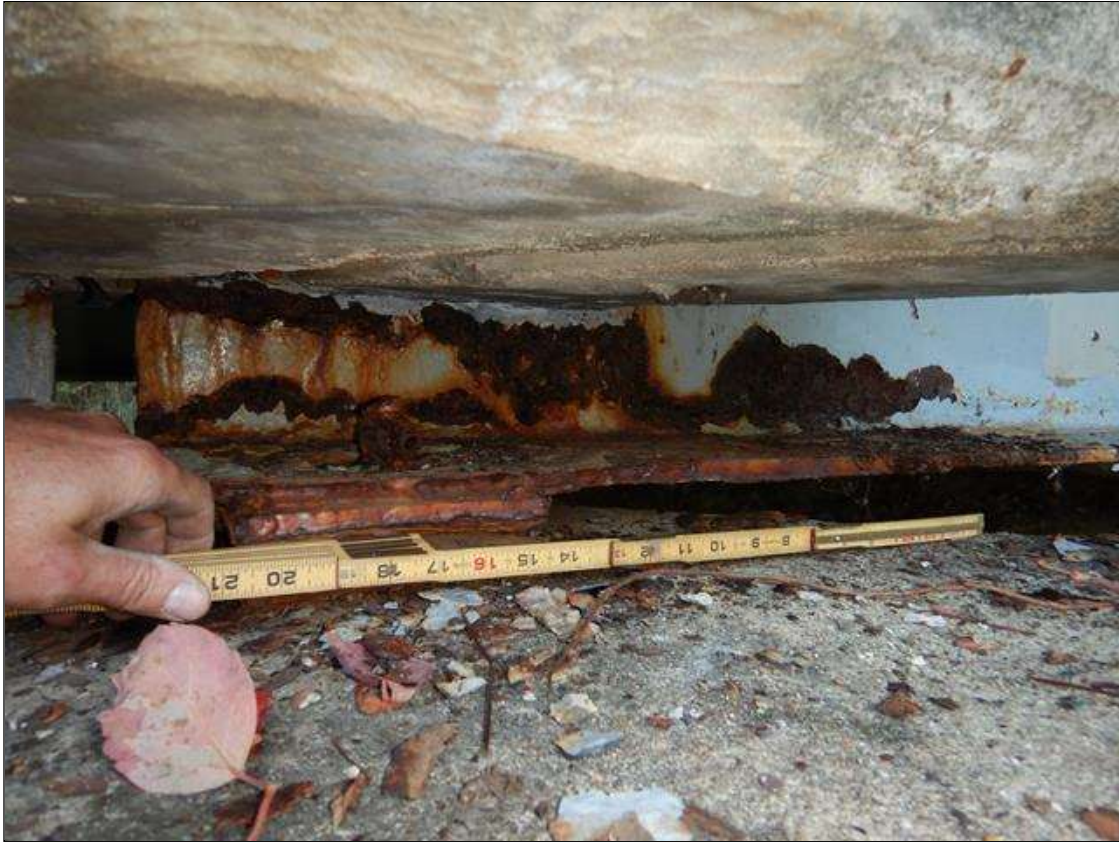
Span 5 Beam 5: [PROMPT ACTION REQUEST] BEAM END AT BENT 4 IN THE LOWER FLANGE, CORROSION WITH SECTION LOSS [AVERAGE 1/4" REMAINS] FOR APPROXIMATELY 4' LONG. AT THE SAME END IN THE LOWER 4" OF THE WEB, CORROSION WITH SECTION LOSS [AVERAGE 5/16" REMAINS] FOR APPROXIMATELY 4' LONG.

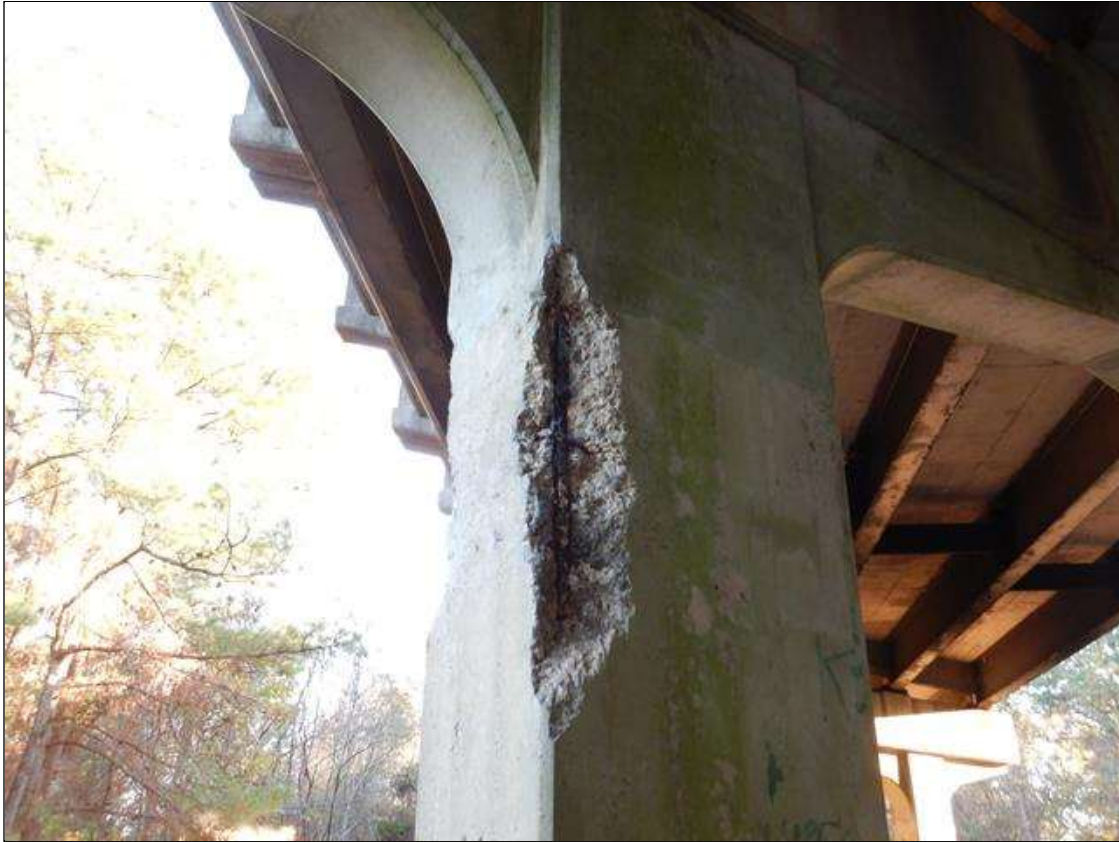
Bent 3 Pile 2: PAR--SPALL WITH EXPOSED REBAR AND BROKEN HORIZONTAL TIE 3 FOOT X 1 FOOT X 4" DEEF IN NORTHEAST CORNER MID HEIGHT WITH SECTION LOSS

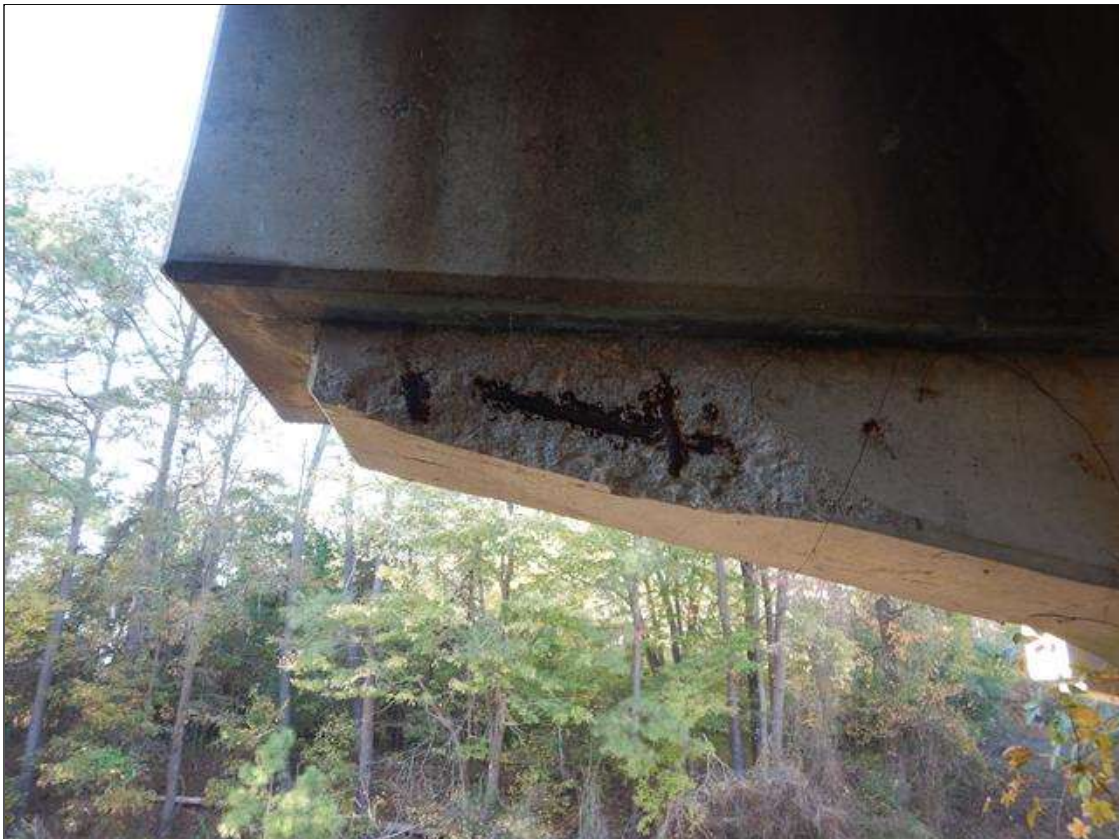
Bent 1 Cap 1: [PROMPT ACTION REQUEST] SOUTH FACE AT THE LEFT END, LOWER 10", SPALLING WITH EXPOSED REBAR [APPROXIMATELY 40" LONG X UP TO 2.5" DEEP]

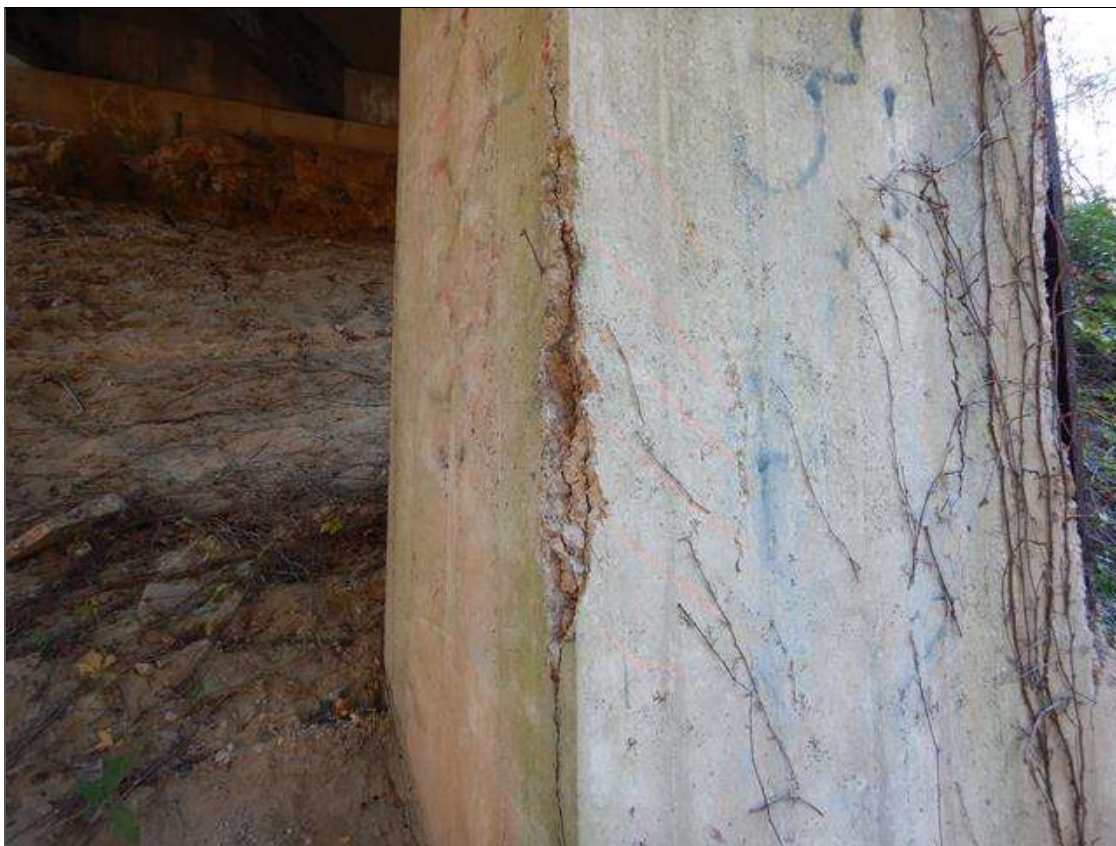
Bent 1 Pile 1: 3 FOOT X 9" X 1" DEEP SPALL AND DELAMINATION AT NORTHEAST CORNER

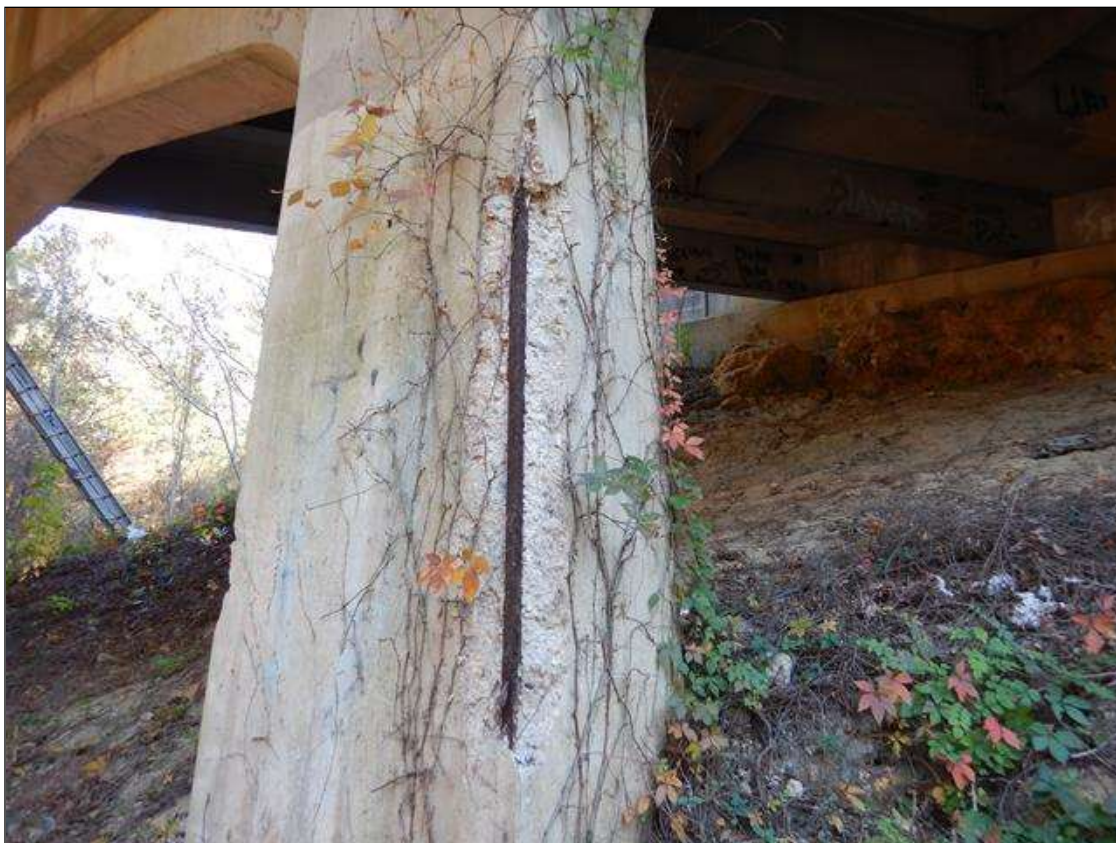
Bent 1 Pile 1: [PROMPT ACTION REQUEST] 6 FOOT X 9" X 2" DEEP SPALL WITH EXPOSED RUSTED REBAR NO SECTION LOSS AT NORTHWEST CORNER

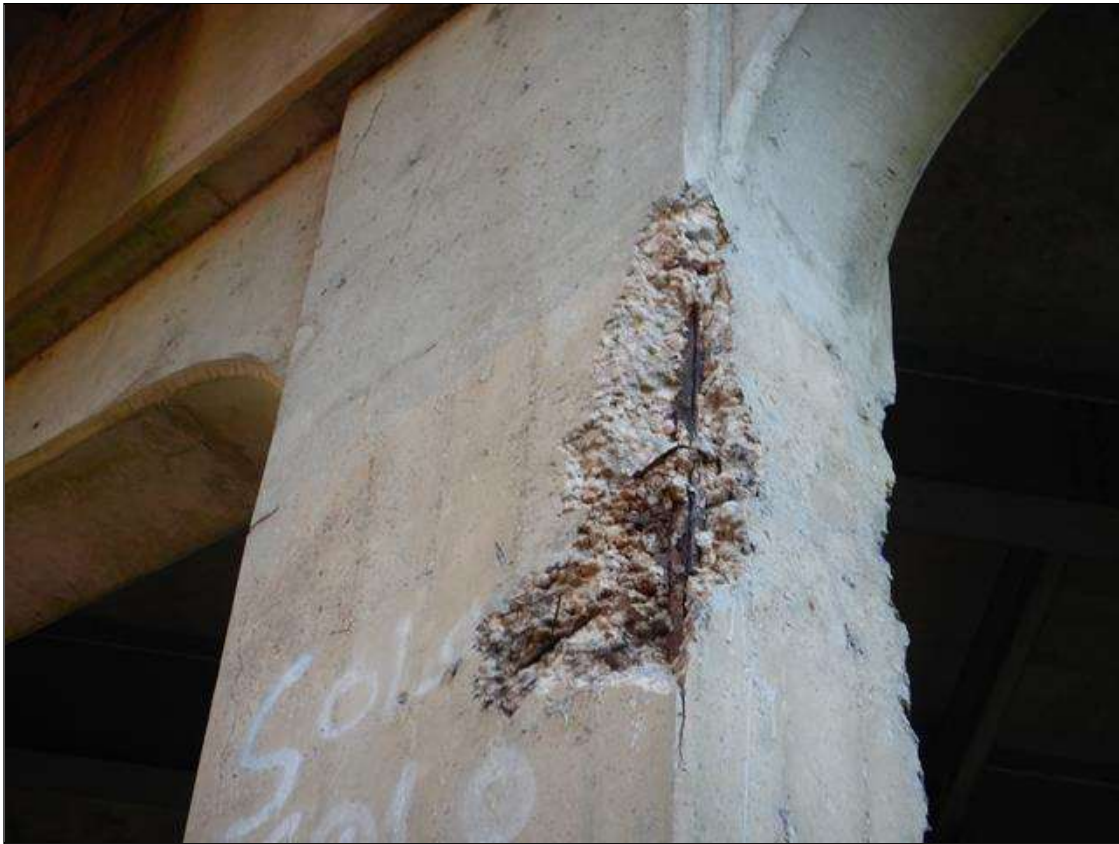
Bent 3 Pile 2: [PROMPT ACTION REQUEST] NORTHEAST CORNER, SPALLING WITH EXPOSED REBAR  
[APPROXIMATELY 4' HIGH X UP TO 1.25' WIDE X UP TO 3" DEEP]

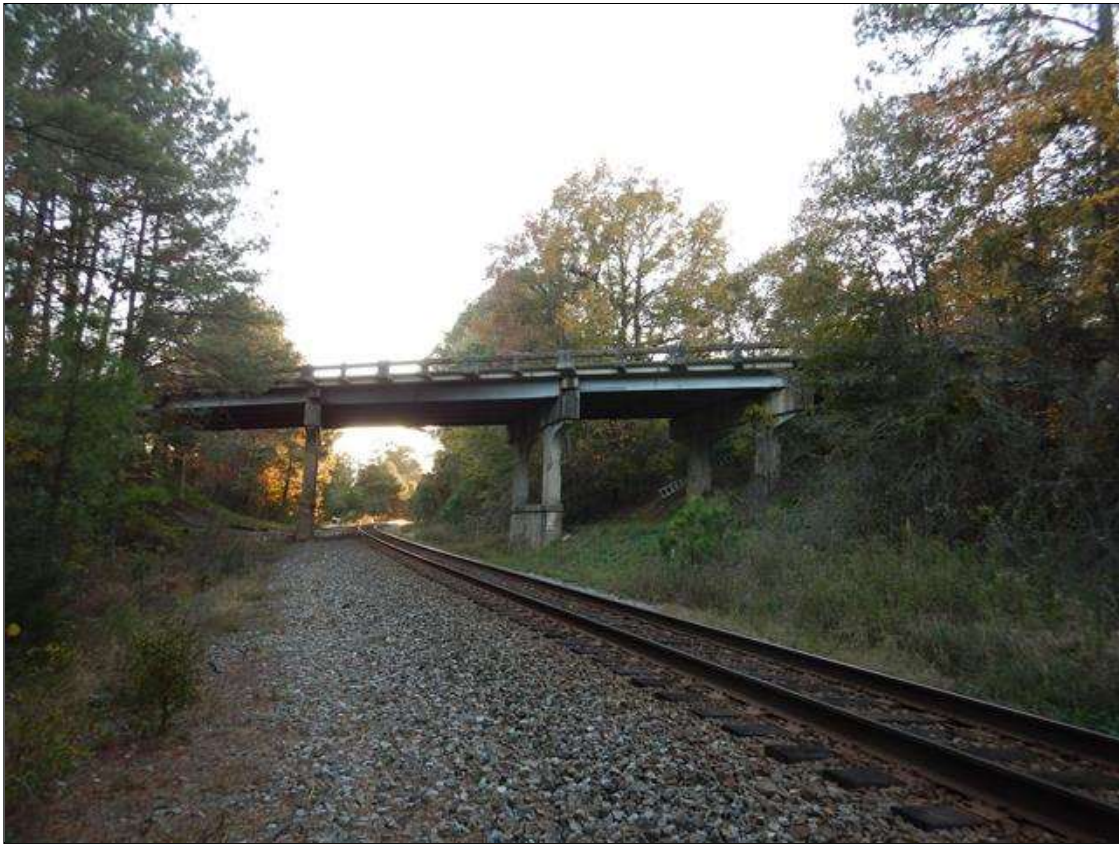
EAST PROFILE, LOOKING WEST

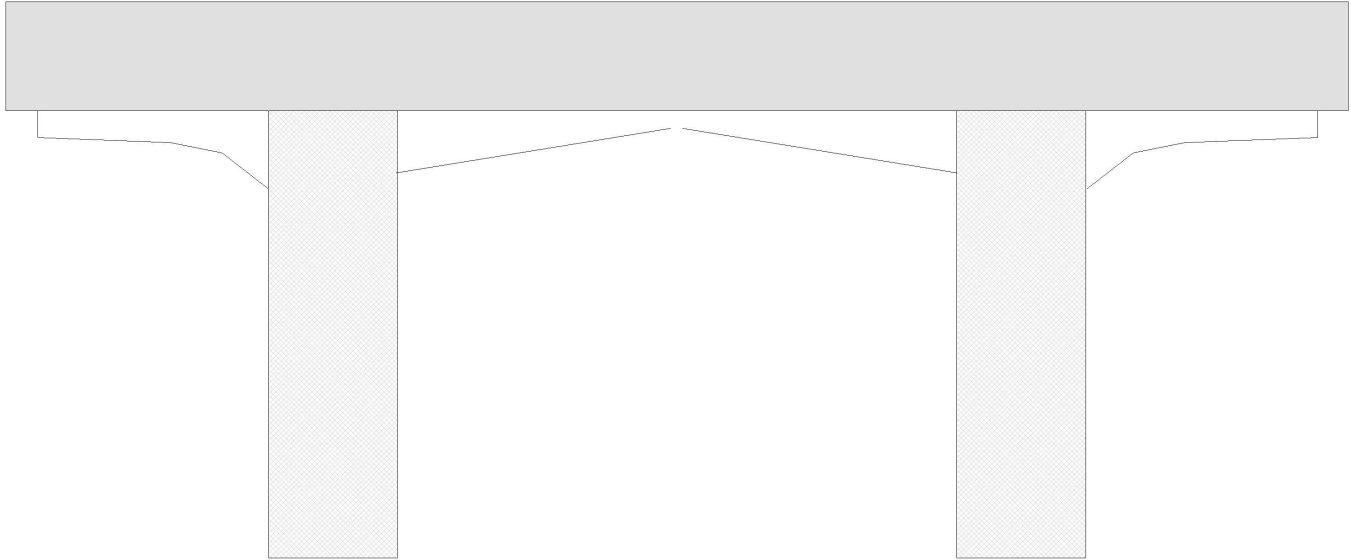
<b>Cap Information</b>			<b>Material</b> Cast-in-Place Concrete							
Length	Width	Height	Left Overhang	Right Overhang	Left Beam to End of Cap.	Right Beam to End of Cap.				
39.000 ft.	2.500 ft.	3.167 ft.	9.500 ft.	9.500 ft.	2.000 ft.	2.000 ft.				
<b>Subcap Information</b>			<b>Material</b>							
Length	Width	Height	Left Overhang	Right Overhang	Left Pile to Splice.					
<b>Sill Information</b>			<b>Material</b>							
Length	Width	Height								
<b>Pile #</b>	<b>Material</b>	<b>Spacing</b>	<b>Width/Dia.</b>	<b>Height</b>	<b>Length</b>	<b>Orientation</b>	<b>Driven?</b>	<b>Replacement?</b>	<b>Removed?</b>	<b>Collar?</b>
1	Concrete	20 ft.	3.75 ft.	2 ft.		Vertical	No	No	No	No
2	Concrete		3.75 ft.	2 ft.		Vertical	No	No	No	No
<b>Bent/Abutment #:</b> 1			<b>Similar Bents:</b> 2-4

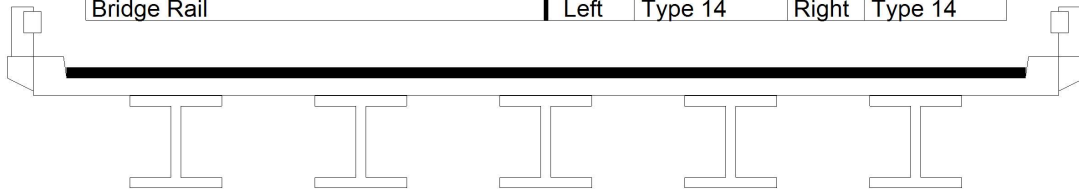
Measurements for Span #	1	ALL SPANS SIMILAR	
Deck Thickness	0.542	Left Overhang	4.041
Top of Rail to Bottom of Beam (A&B)	5.25	Right Overhang	4.041
