NC DEPARTMENT OF TRANSPORTATION  
 DIVISION OF HIGHWAYS  
 STRUCTURE MANAGEMENT UNIT

ATTENTION: **PAR ISSUED.**

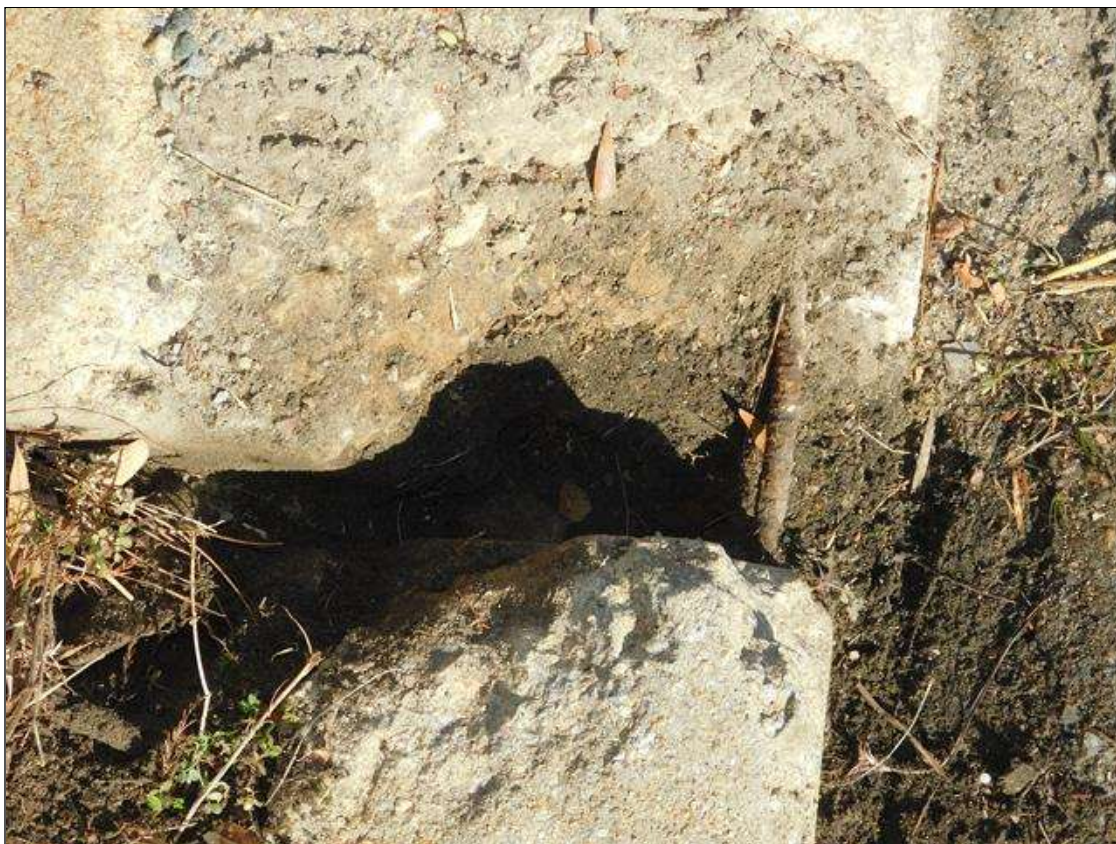
Span 1 Deck: 1 SQUARE FOOT SPALL 8 IN. DEEP WITH EXPOSED REBAR IN LEFT CURB AT END BENT 1.

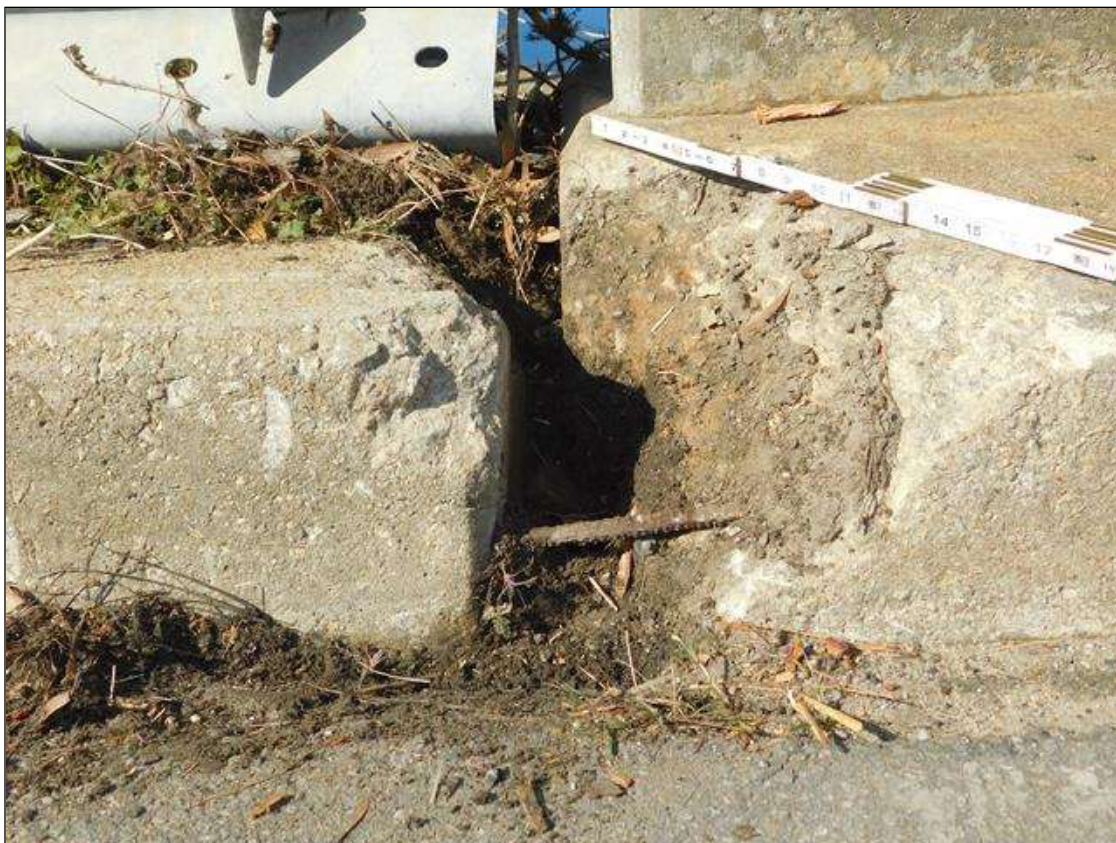
Span 1 Deck: 1 SQUARE FOOT SPALL 8 IN. DEEP WITH EXPOSED REBAR IN LEFT CURB AT END BENT 1.

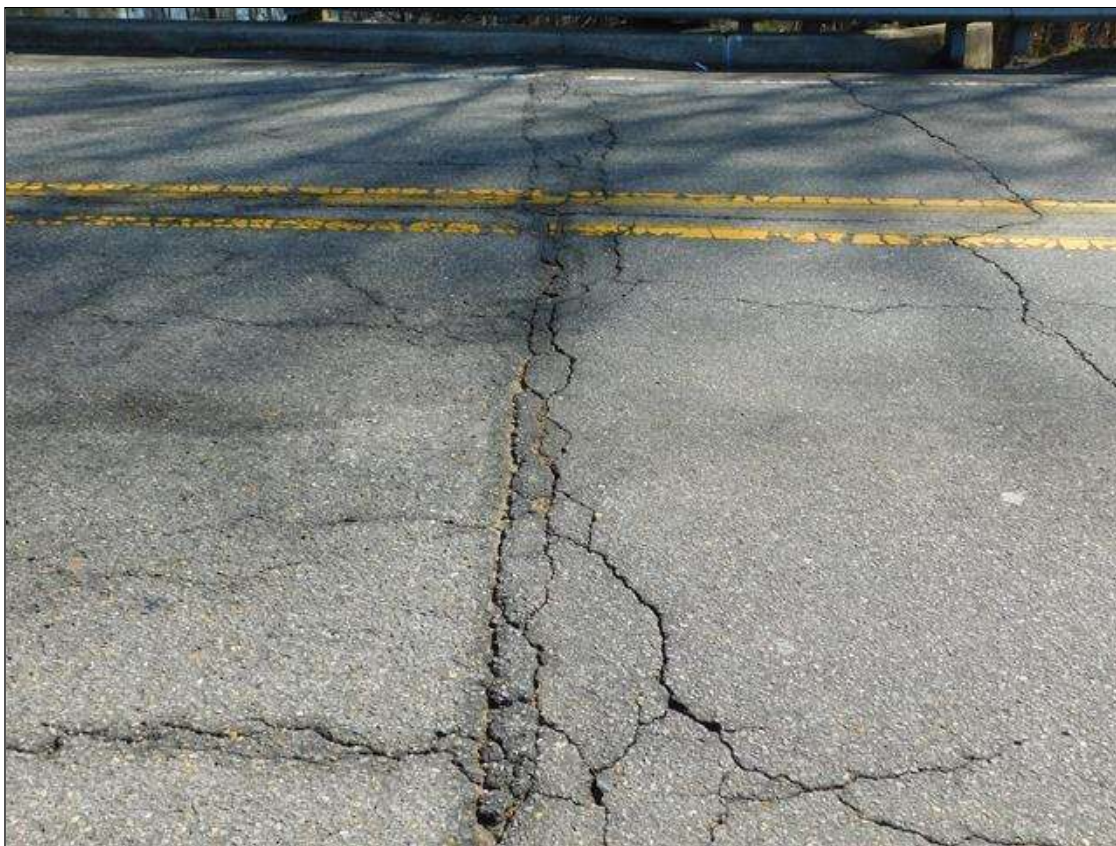
Span 1 Wearing Surface: 28 SQUARE FEET OF CRACKING NEAR END BENT 1.

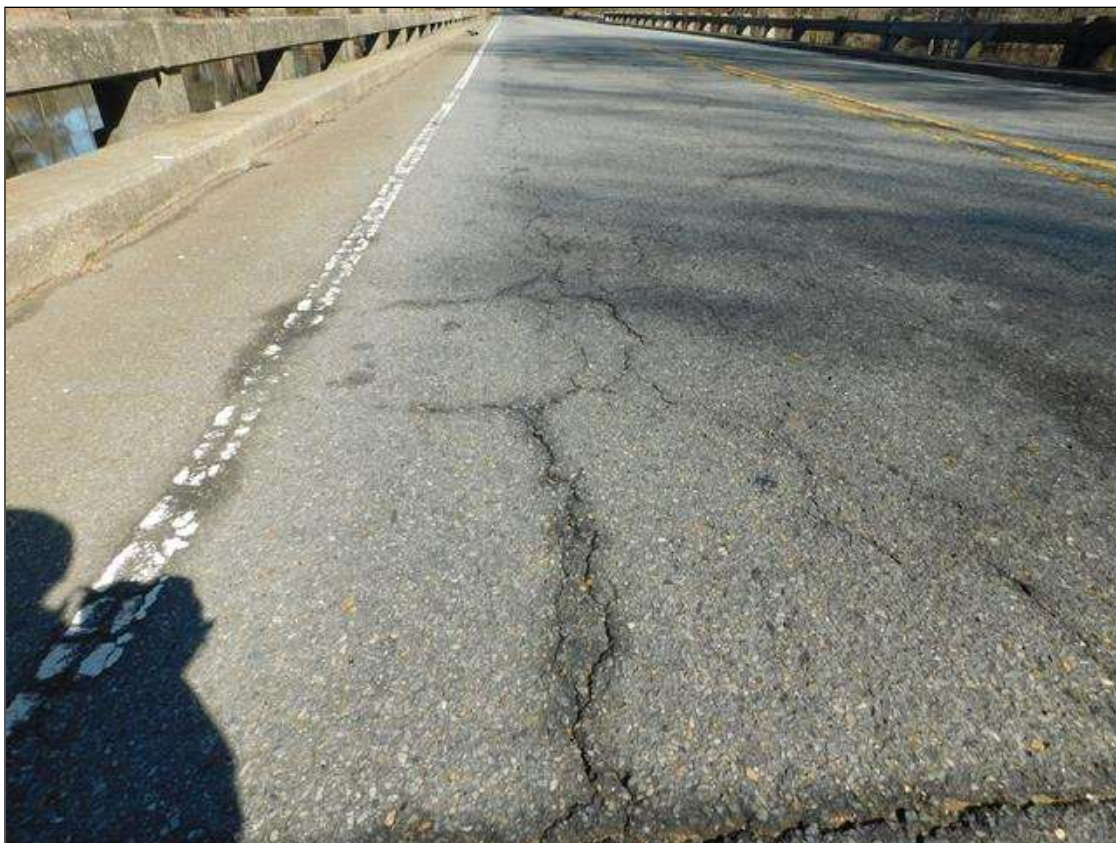
Span 1 Wearing Surface: CRACKING ALONG TRAVEL LANES.

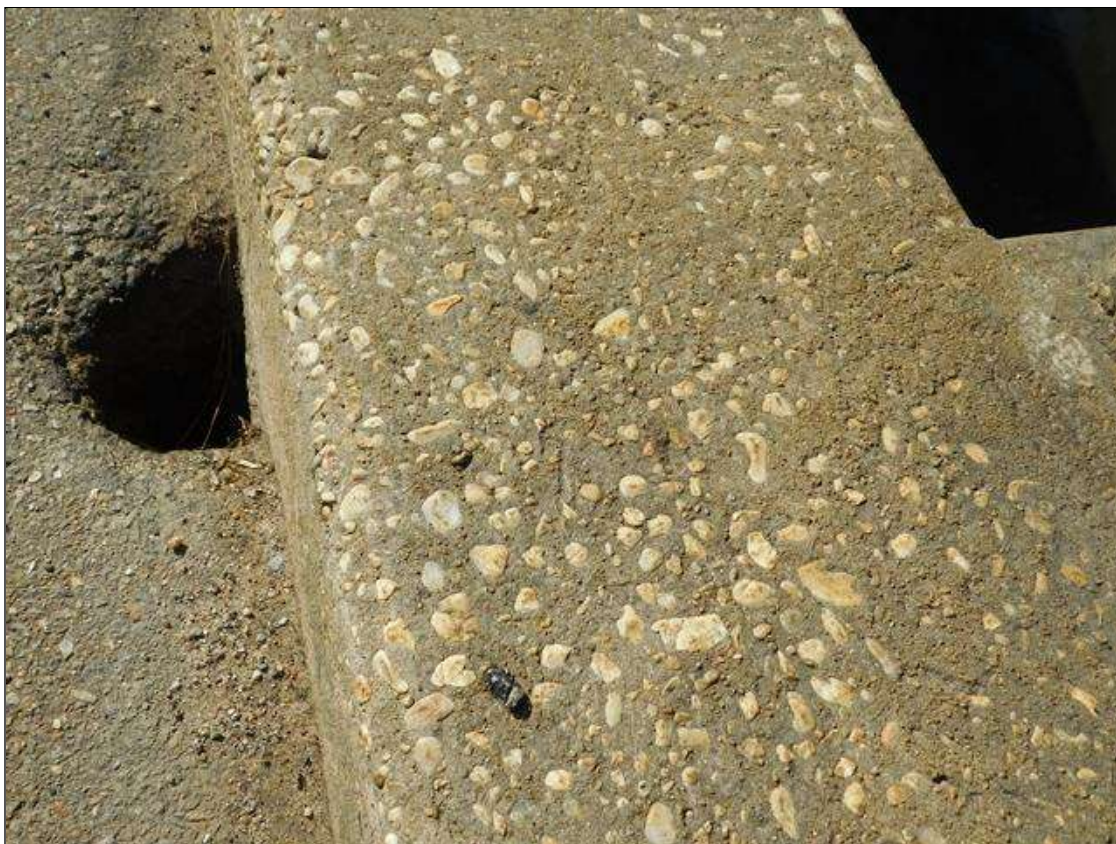
Span 1 Deck: ABRASION ALONG CURBS.

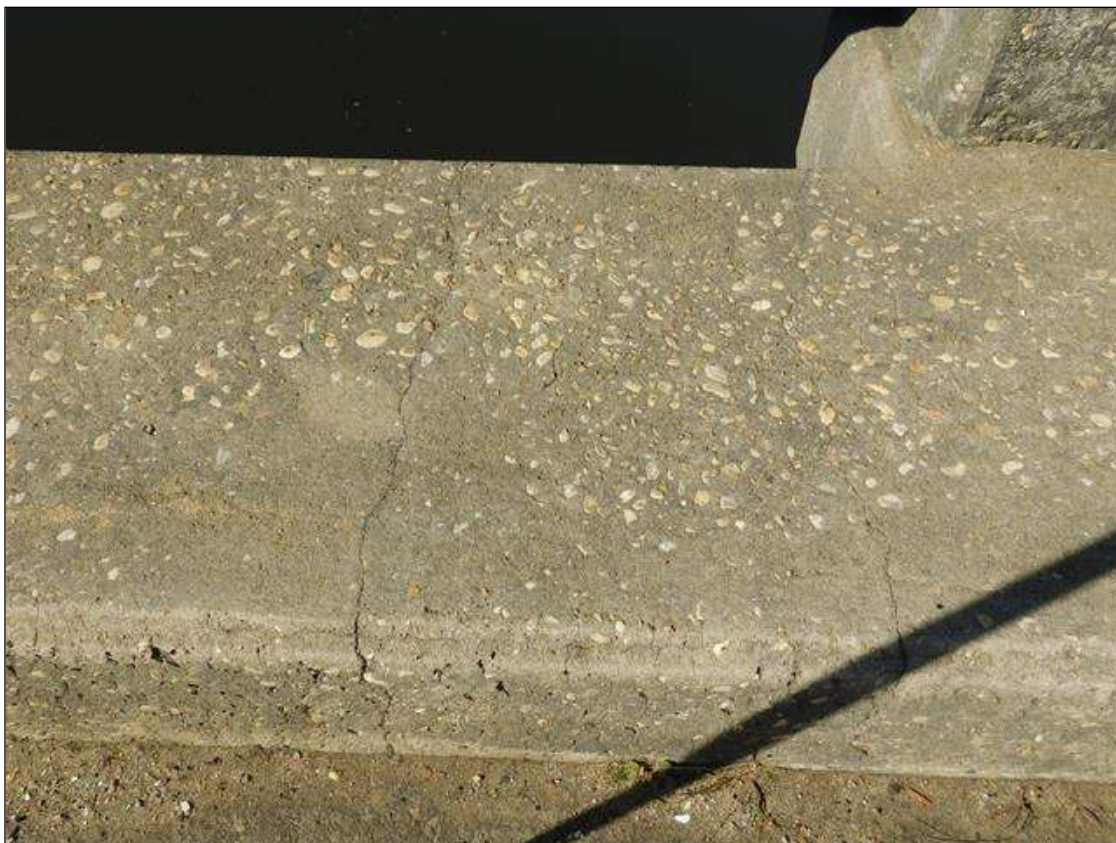
Span 1 Deck: CRACKING IN CURBS.

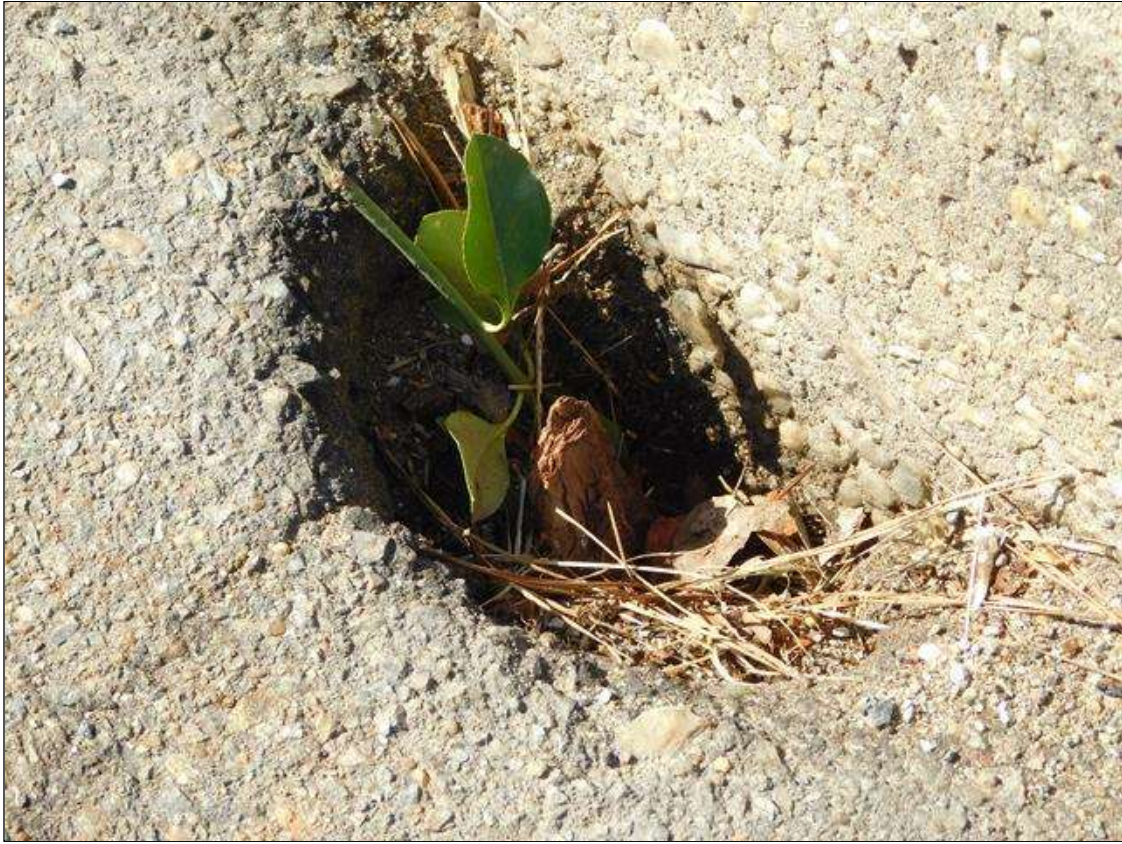
DECK DRAINS BLOCKED BY DECK DEBRIS (SEE DECK DEBRIS)

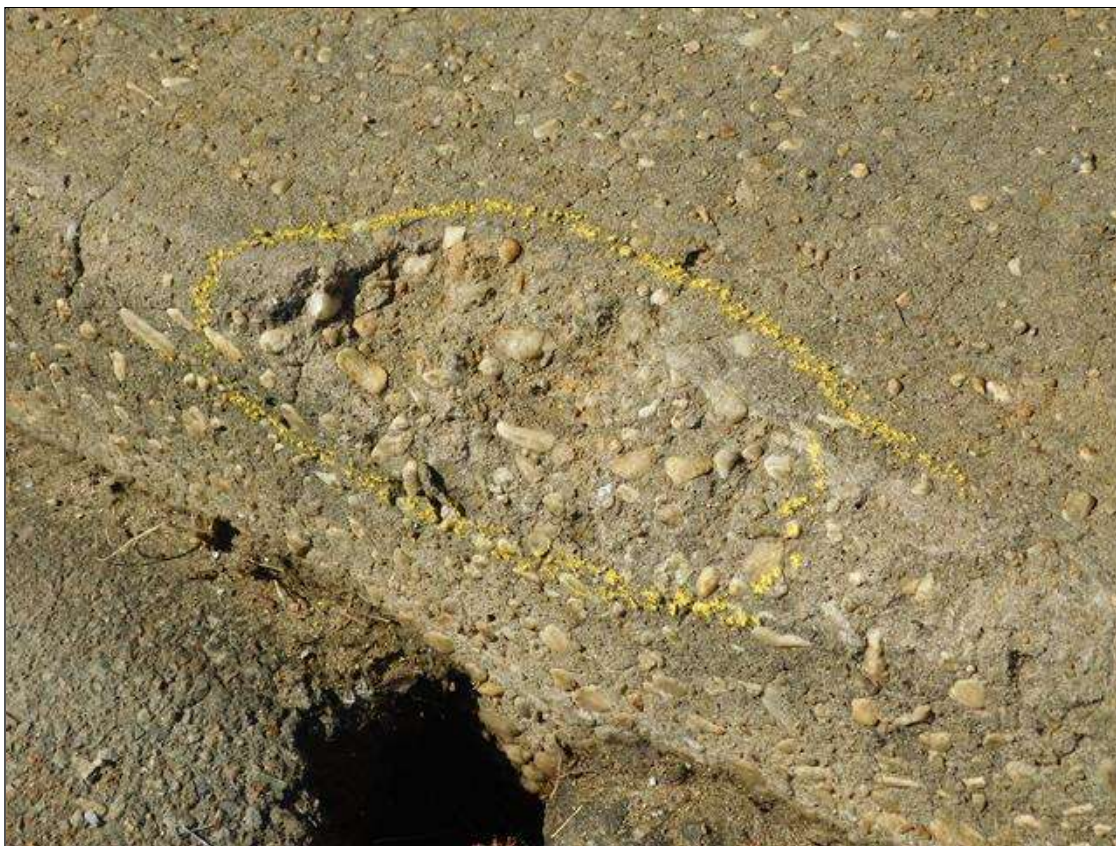
Span 1 Deck: SPALL IN THE LEFT CURB AT BENT 1.

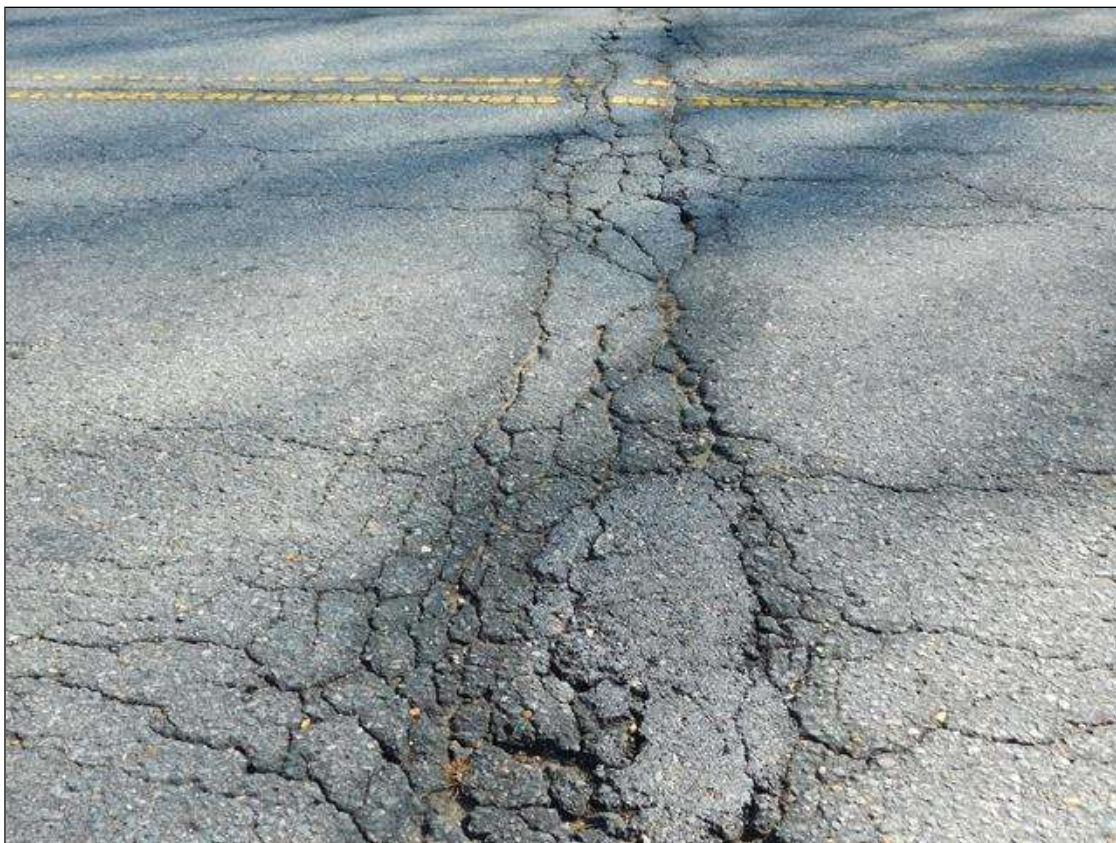
Span 2 Wearing Surface: CRACKING OVER BENT 1.

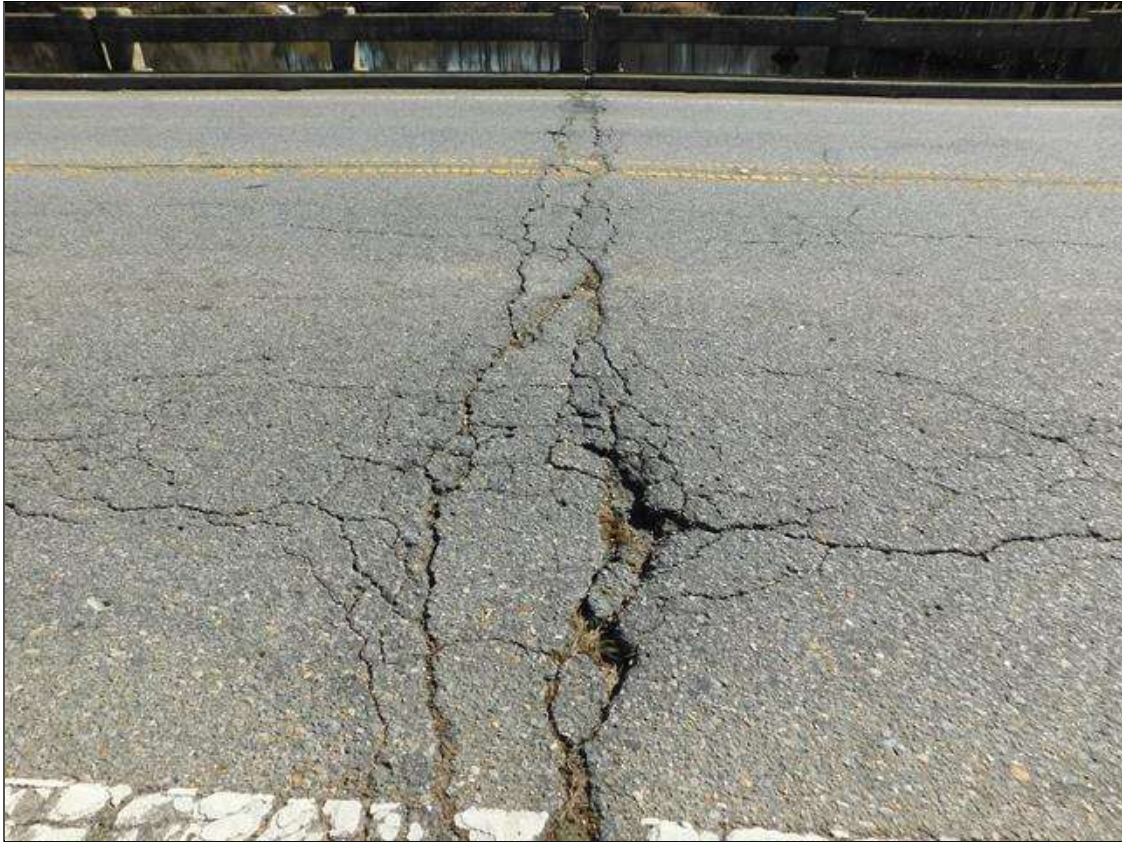
Span 3 Wearing Surface: CRACKING OVER BENT 2.

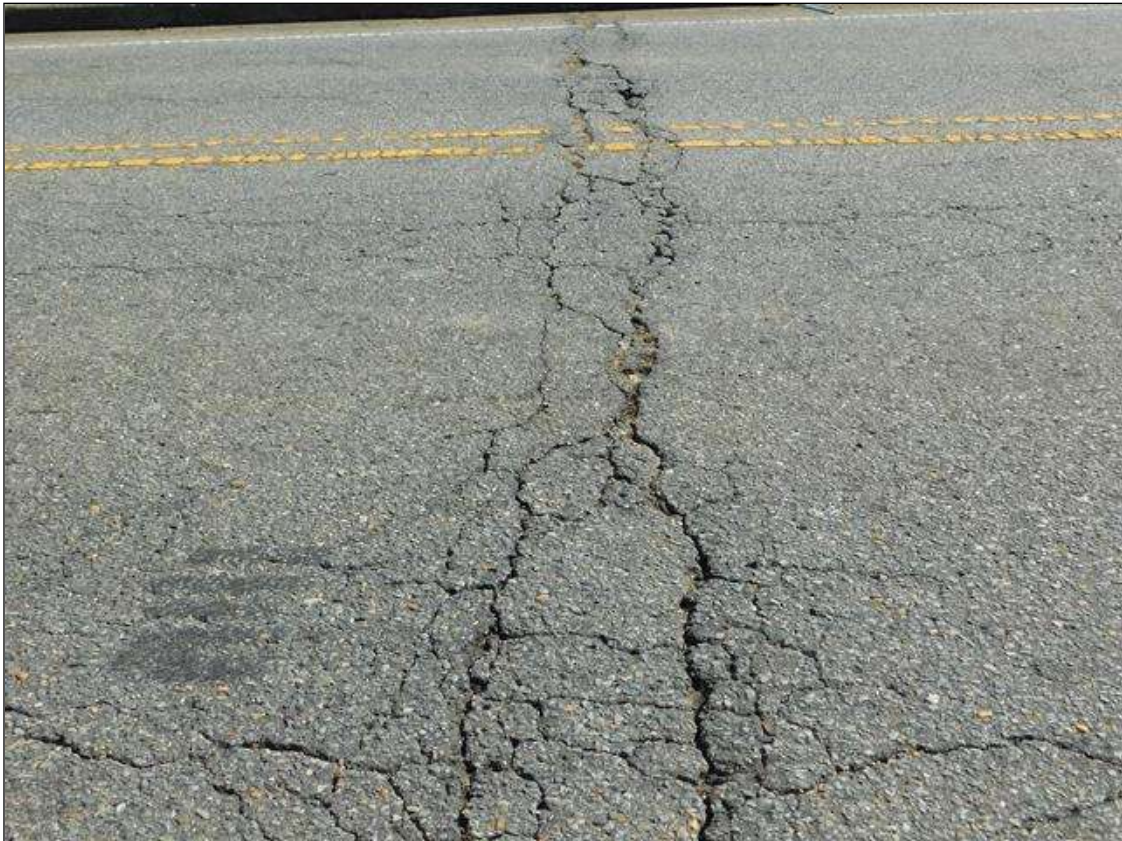
Span 4 Wearing Surface: CRACKING OVER BENT 3 AND END BENT 2 AND ALONG TRAVEL LANES.

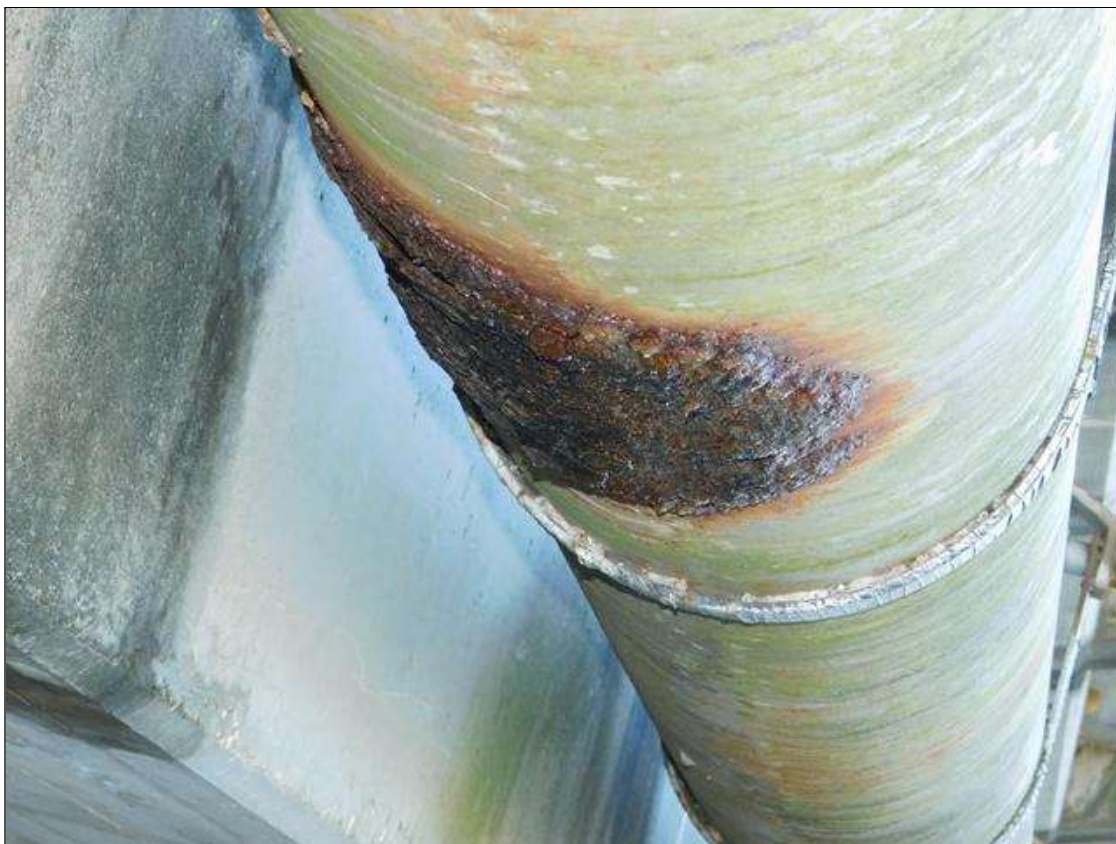
AREAS OF CORROSION ALONG BOTTOM OF 12" UTILITIES PIPES ALONG THE LEFT SIDE OVERHANG.

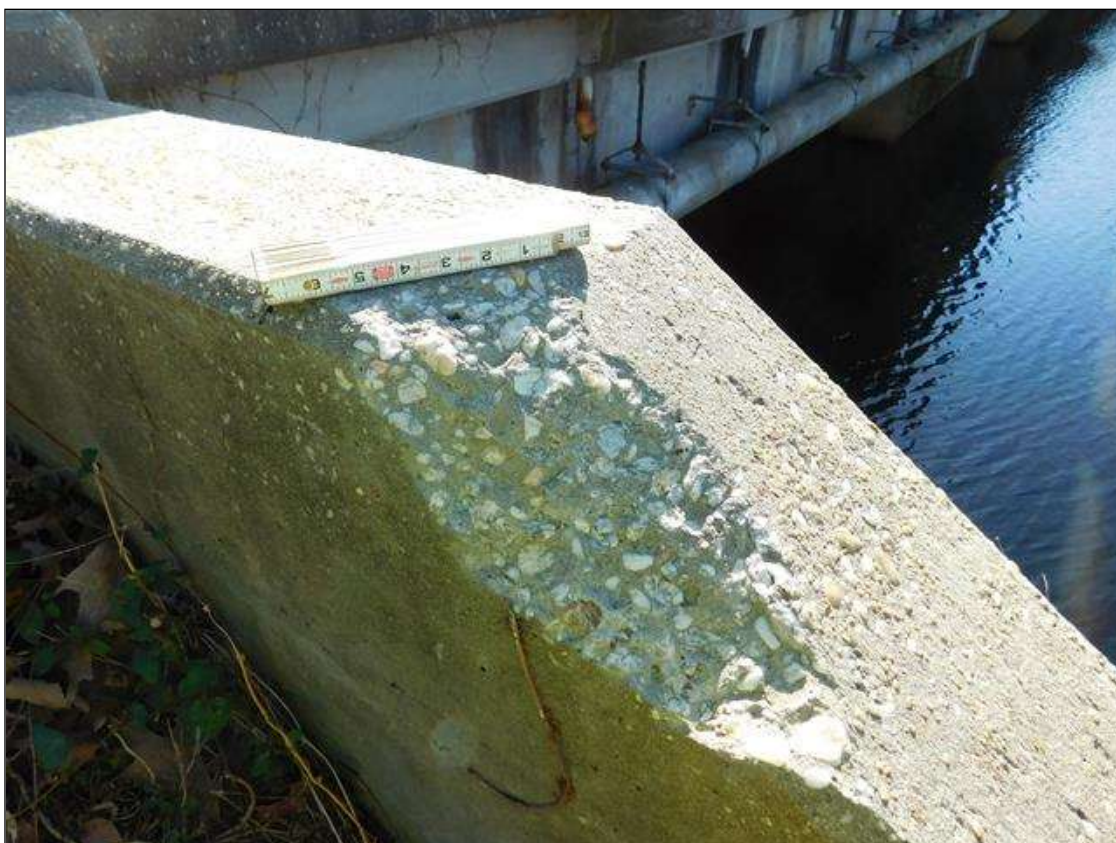
12 IN. LONG X 4 IN. WIDE X 1.25 IN. DEEP SPALL IN LEFT WINGWALL AT END BENT 2.

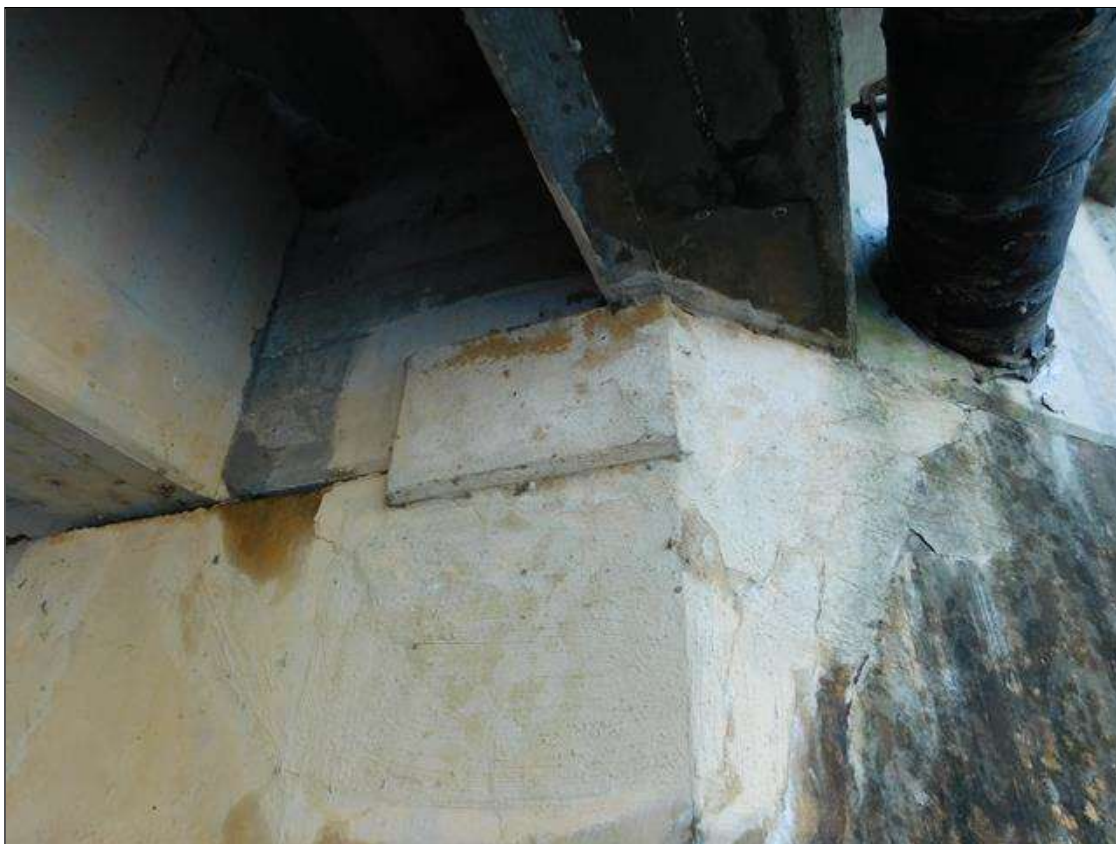
End Bent 1 Abutment: SOUND PATCHING IN CAP UNDER GIRDERS 1, 2 & 3.

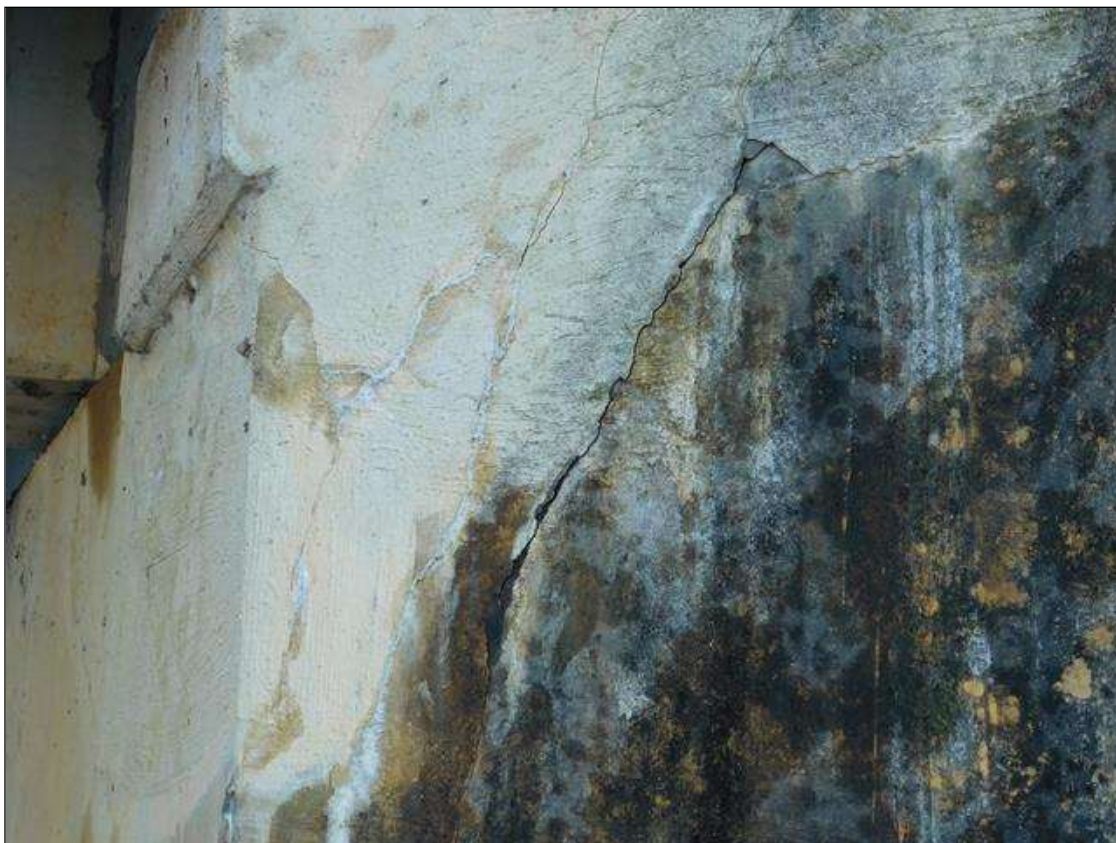
End Bent 1 Abutment: DIAGONAL CRACKING WITH DELAMINATION AND EFFLORESCENCE IN LEFT WINGWALL UNDER GIRDER 1.

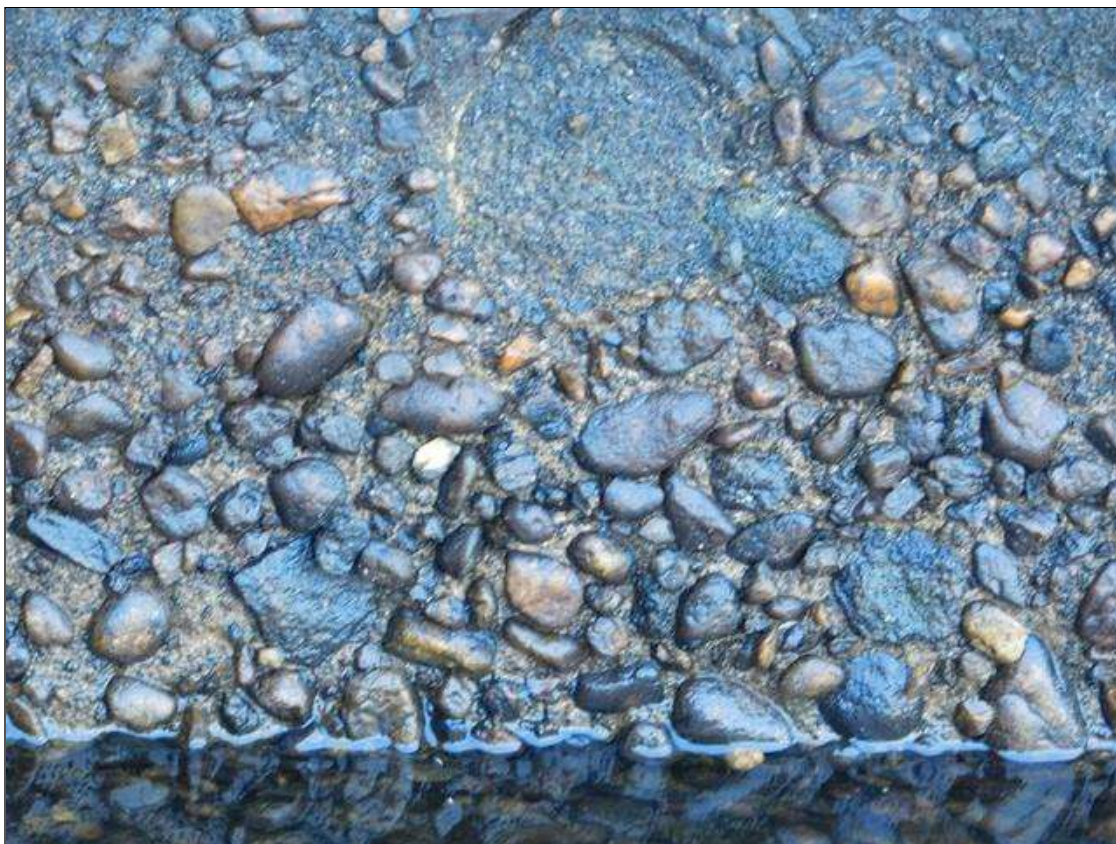
End Bent 1 Abutment: 57 FEET OF ABRASION WITH COARSE AGGREGATE EXPOSED FROM WATERLINE UP 3 FT.

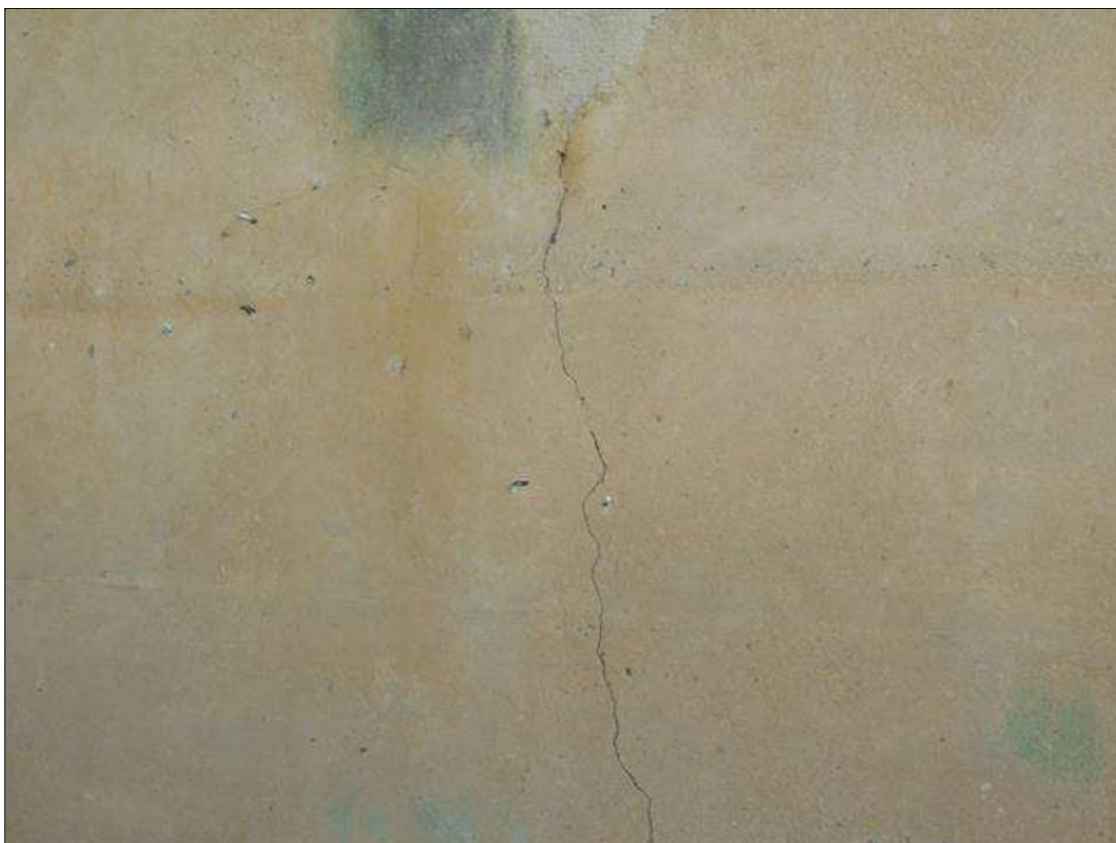
End Bent 1 Abutment: VERTICAL CRACKING 1/16" WIDE IN FACE OF CAP AT GIRDERS 2 & 4 EXTENDING DOWN BREAST WALL.

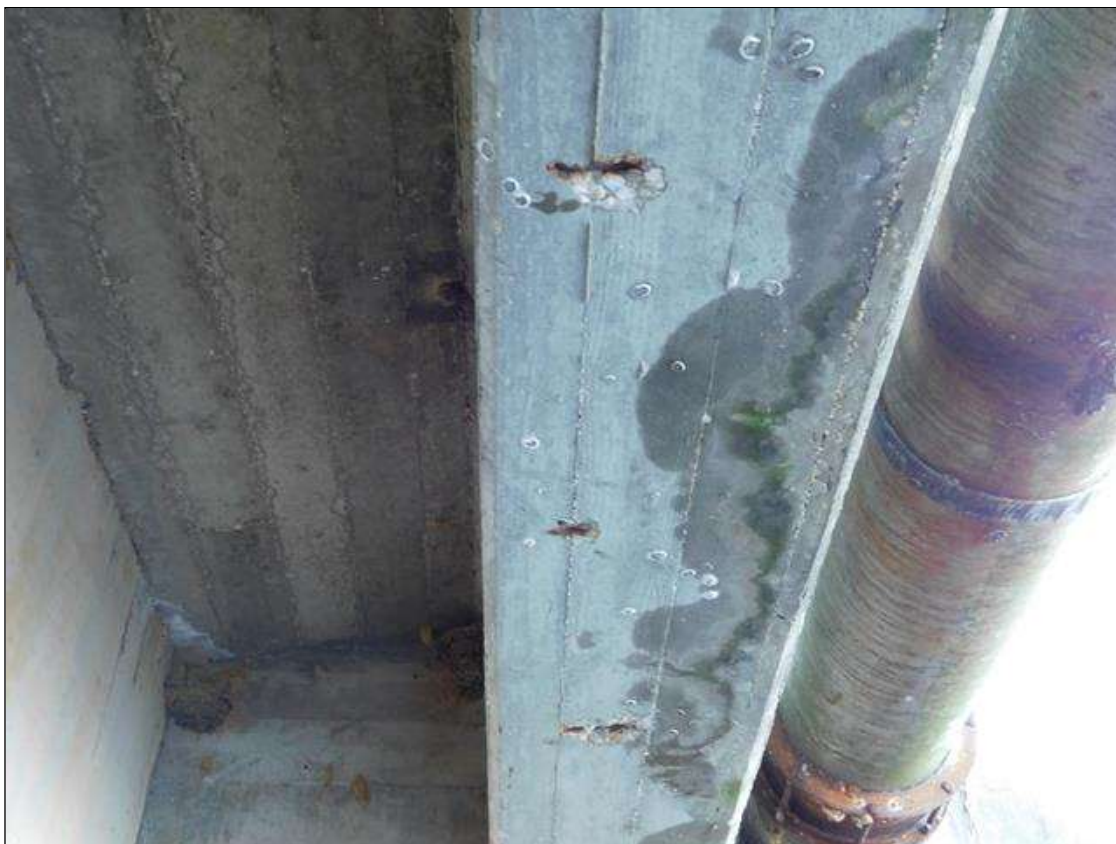
Span 1 Beam 1: SHALLOW SPALLS WITH EXPOSED REBAR IN BOTTOM OF GIRDER UP TO 6 FT. OUT FROM END BENT 1.

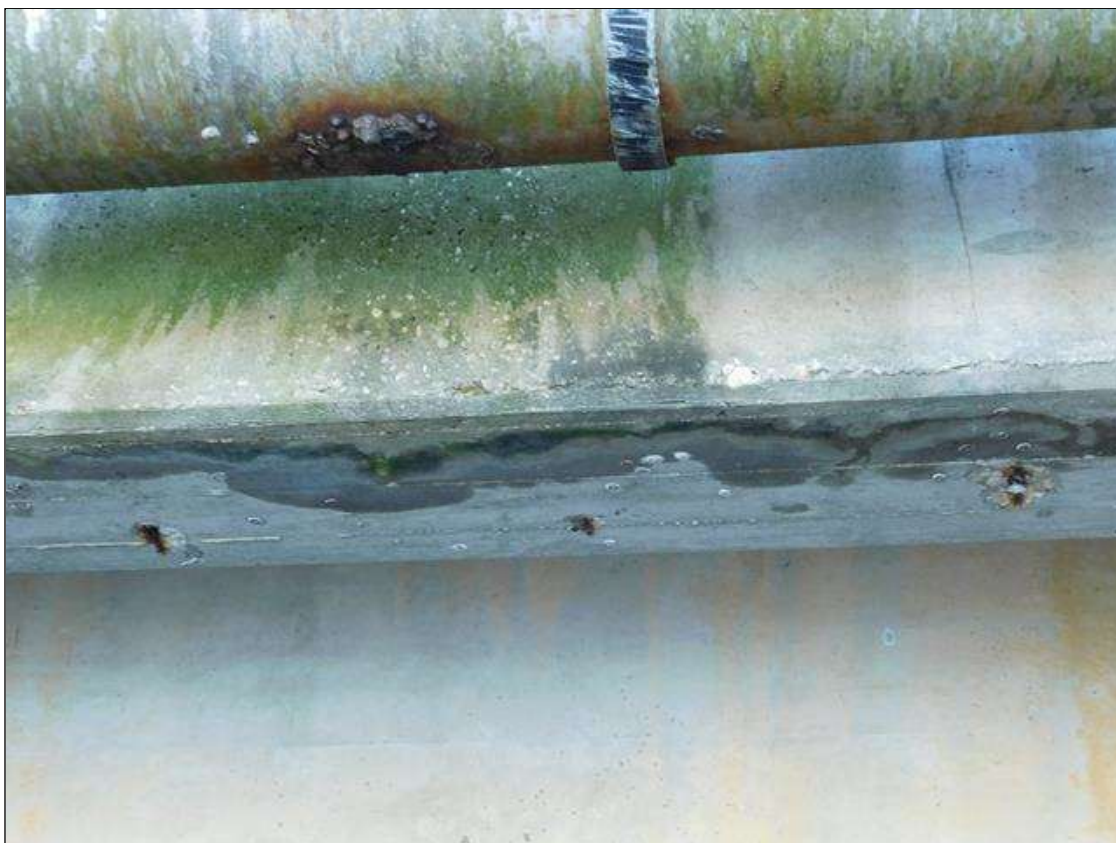
Span 1 Beam 1: SHALLOW SPALLS WITH EXPOSED REBAR IN BOTTOM OF GIRDER UP TO 6 FT. OUT FROM END BENT 1.

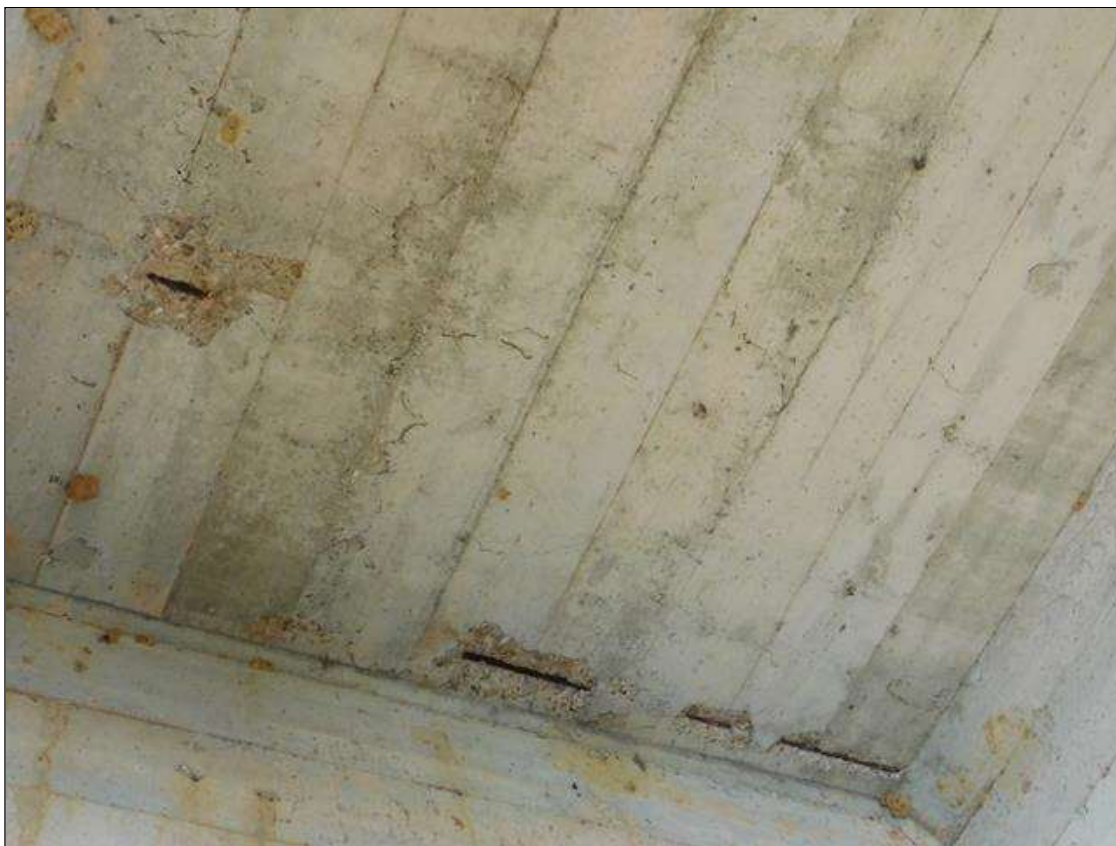
Span 1 Deck: 3 SQUARE FOOT OF SHALLOW SPALLING WITH EXPOSED REBAR IN BOTTOM OF DECK BAY 3 AT END BENT 1.

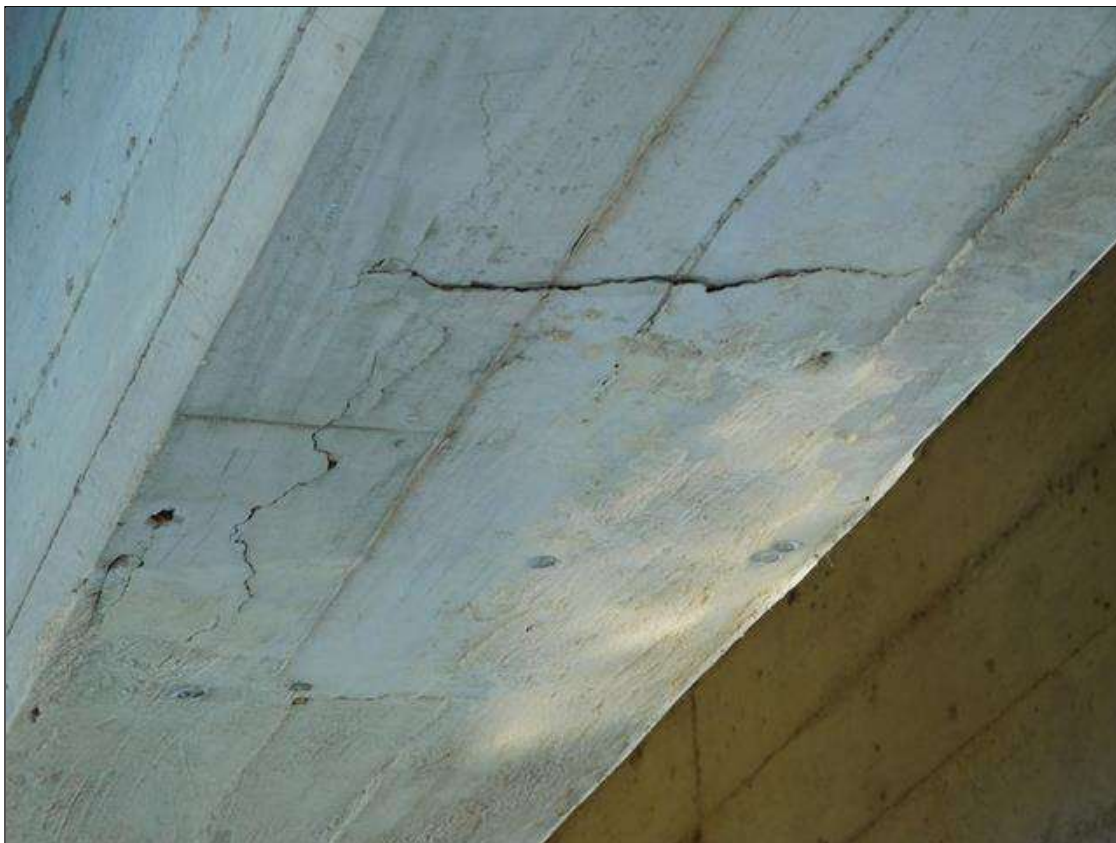
Span 1 Beam 4: 12" DIAMETER DELAMINATION IN BOTTOM OF BEAM AT MID-SPAN.

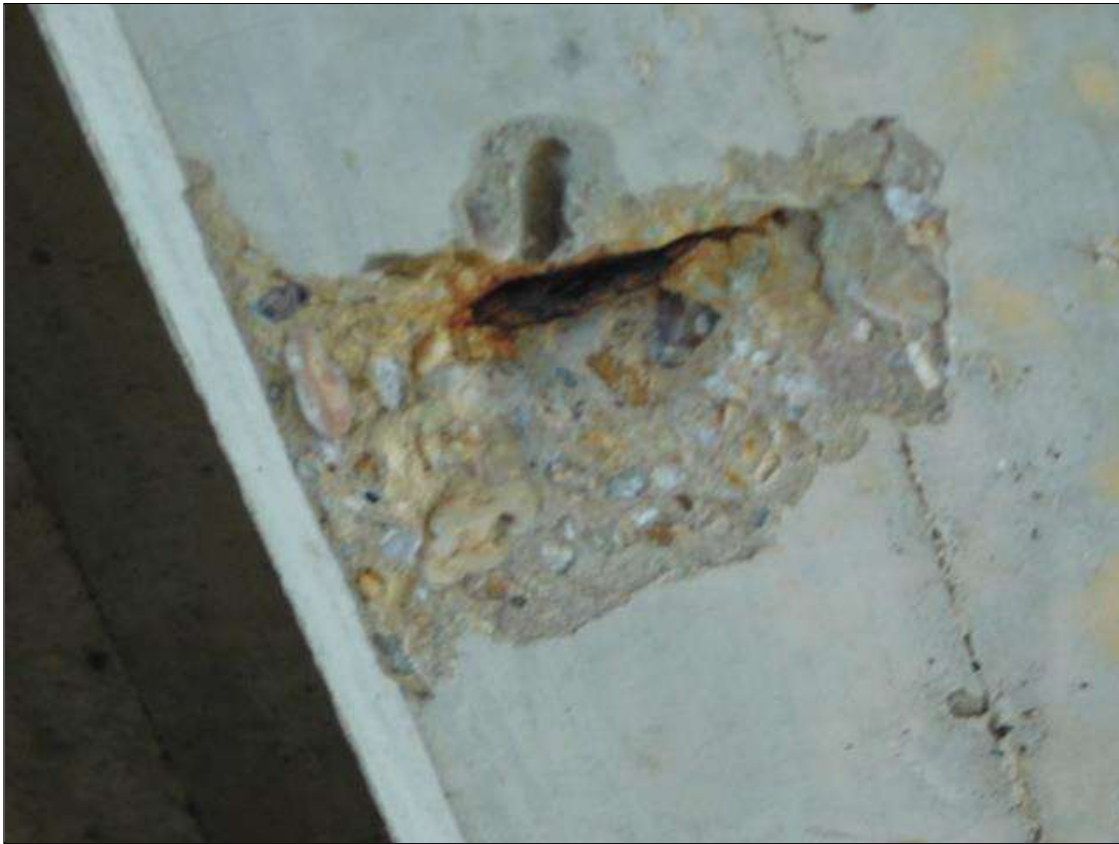
Span 1 Beam 4: 6" DIAMETER SPALL 3/4" DEEP WITH EXPOSED STEEL.

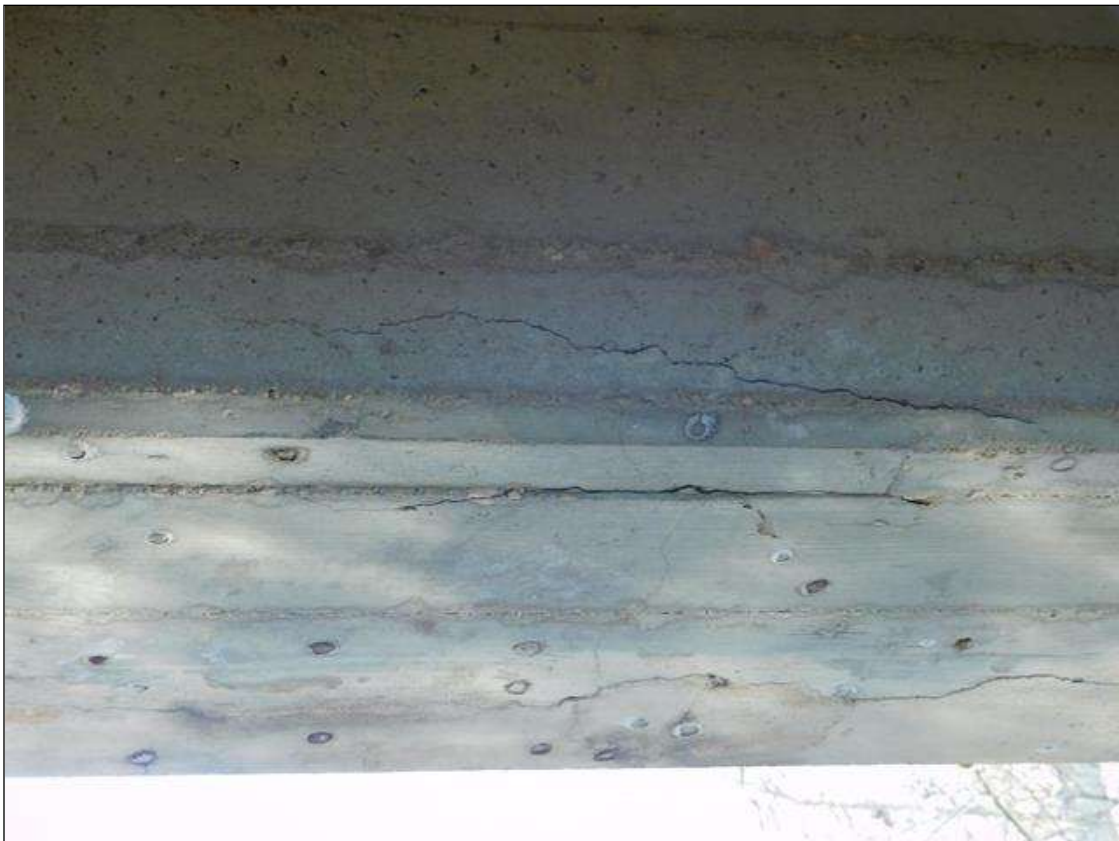
Span 1 Beam 5: LONGITUDINAL CRACKING IN BOTTOM AND LEFT SIDE.

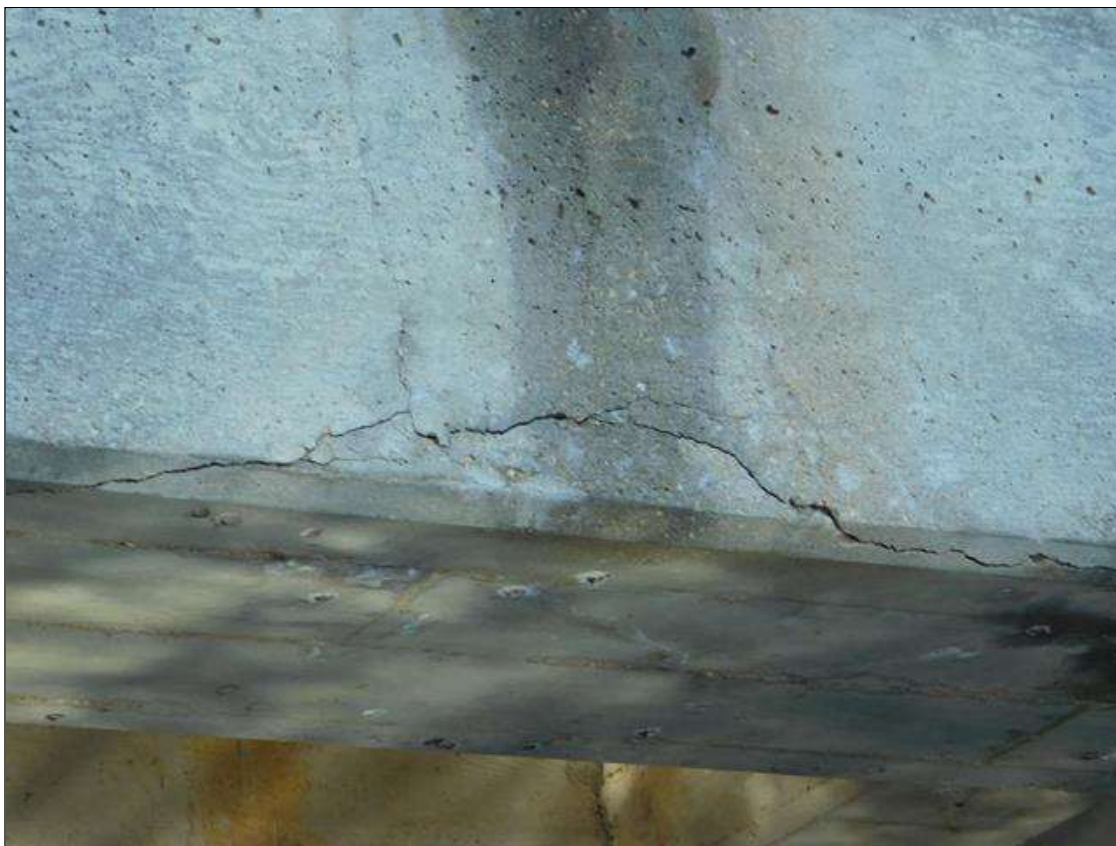
Span 1 Beam 5: CRACKING AND DELAMINATION IN RIGHT SIDE BOTTOM CORNER NEAR MID-SPAN.
