NC DEPARTMENT OF TRANSPORTATION  
 DIVISION OF HIGHWAYS  
 STRUCTURE MANAGEMENT UNIT

ATTENTION: **PAR ISSUED.**

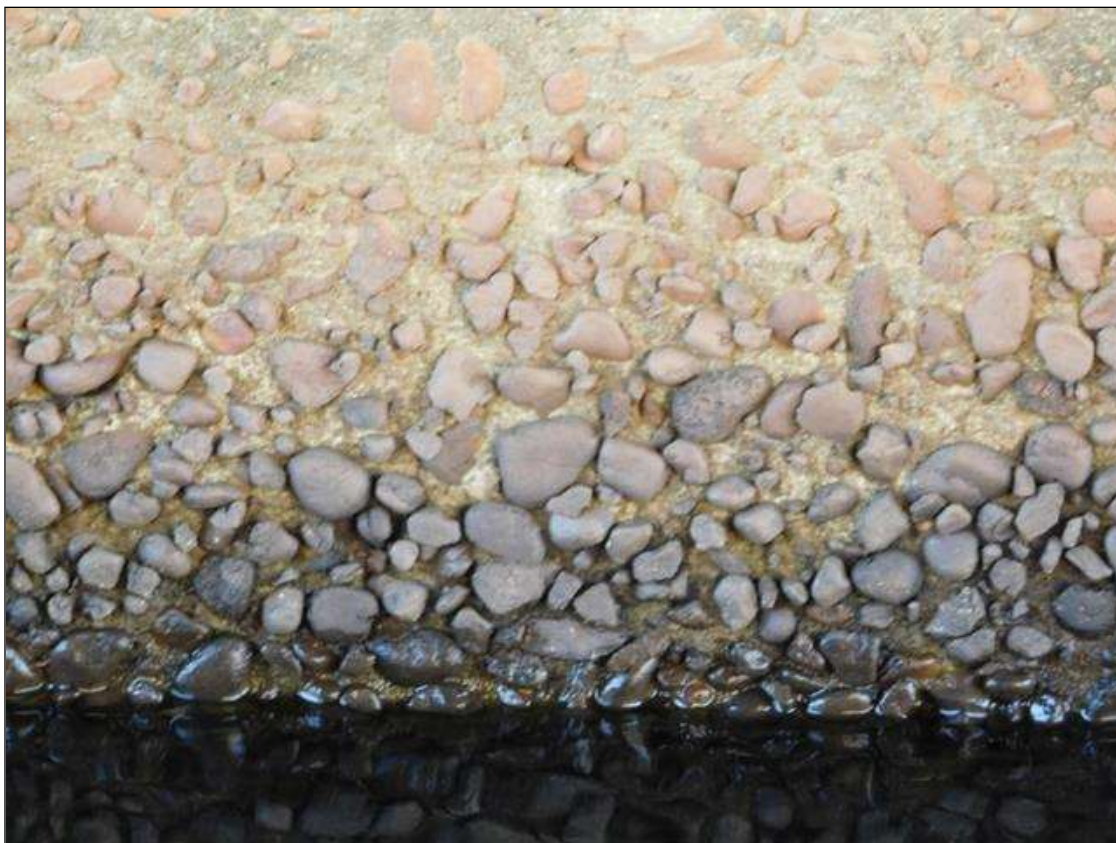
Bent 1 Pile 1: ABRASION WITH COARSE AGGREGATE EXPOSED FROM WATERLINE UP 3 FEET.

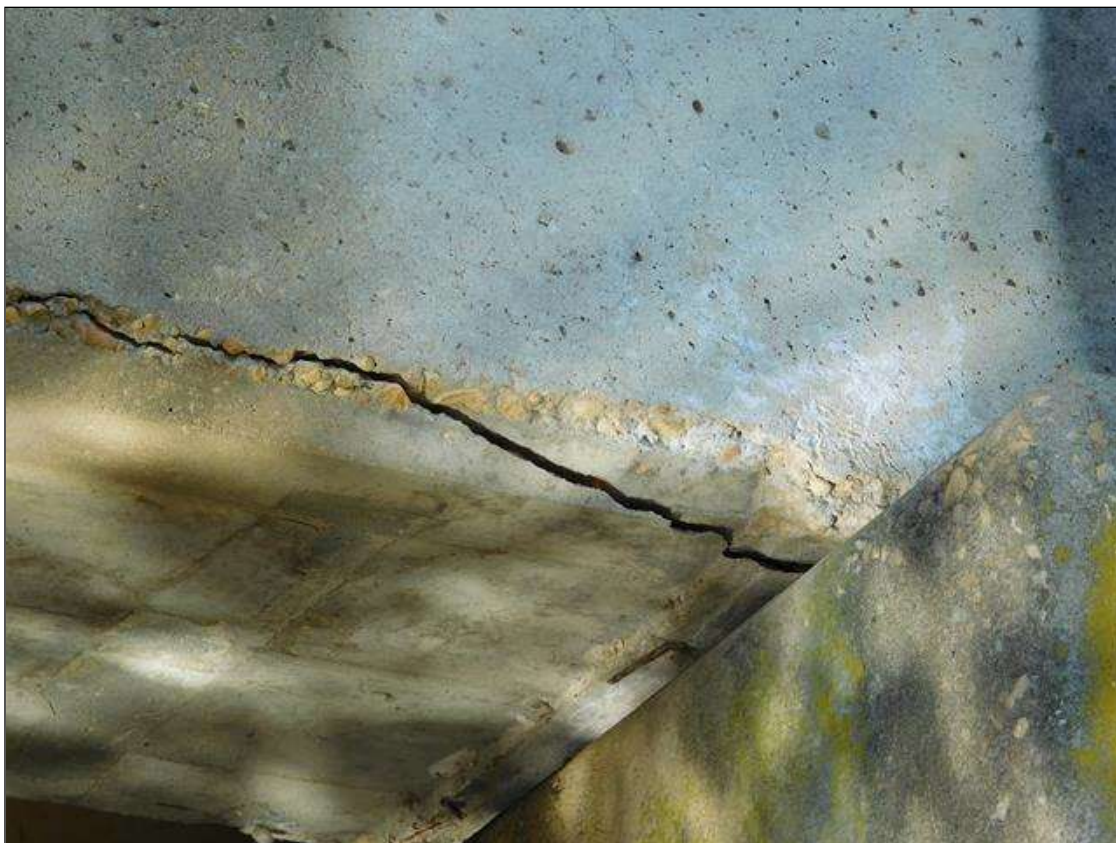
Span 3 Beam 5: 3/16" WIDE LONGITUDINAL CRACK 2' LONG IN BOTTOM RIGHT CORNER AT BENT 3.

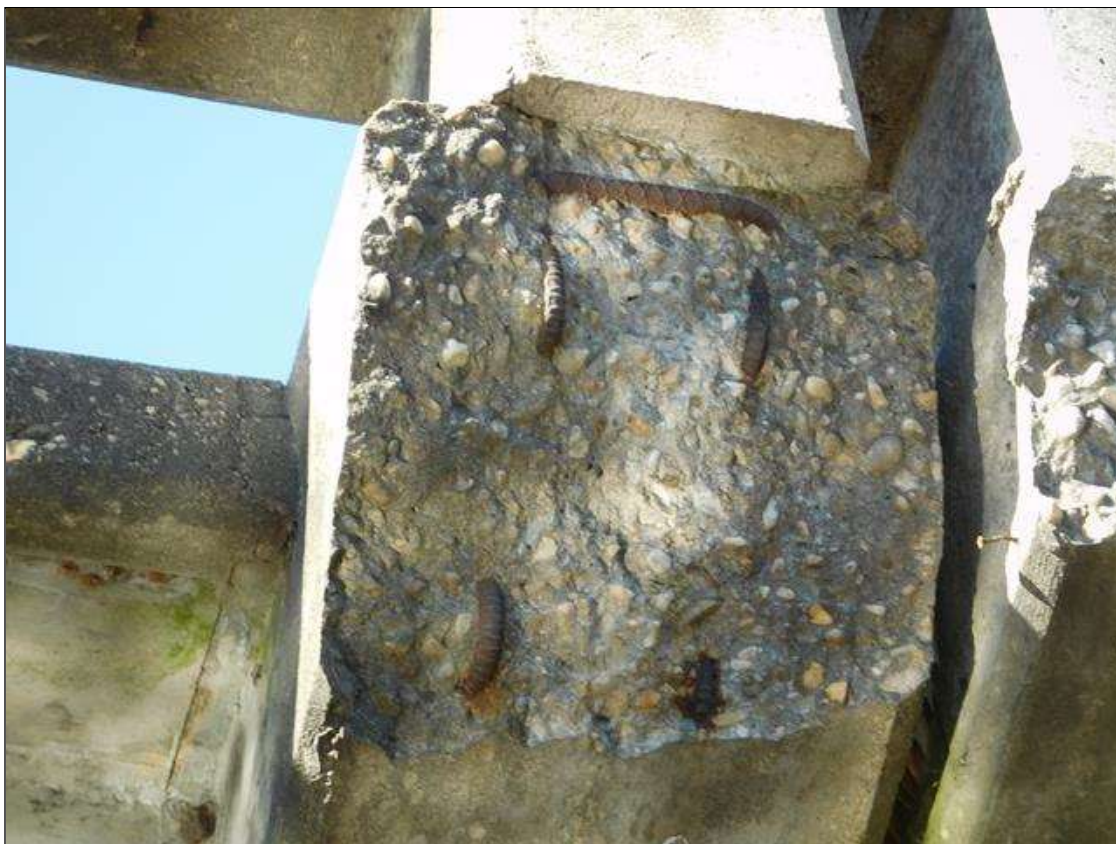
Span 3 Right Bridge Rail: 1 FOOT OF SPALLING 3" DEEP WITH EXPOSED REBAR IN THE GUARDRAIL POST BASE AT BENT 3. PAR ISSUED.

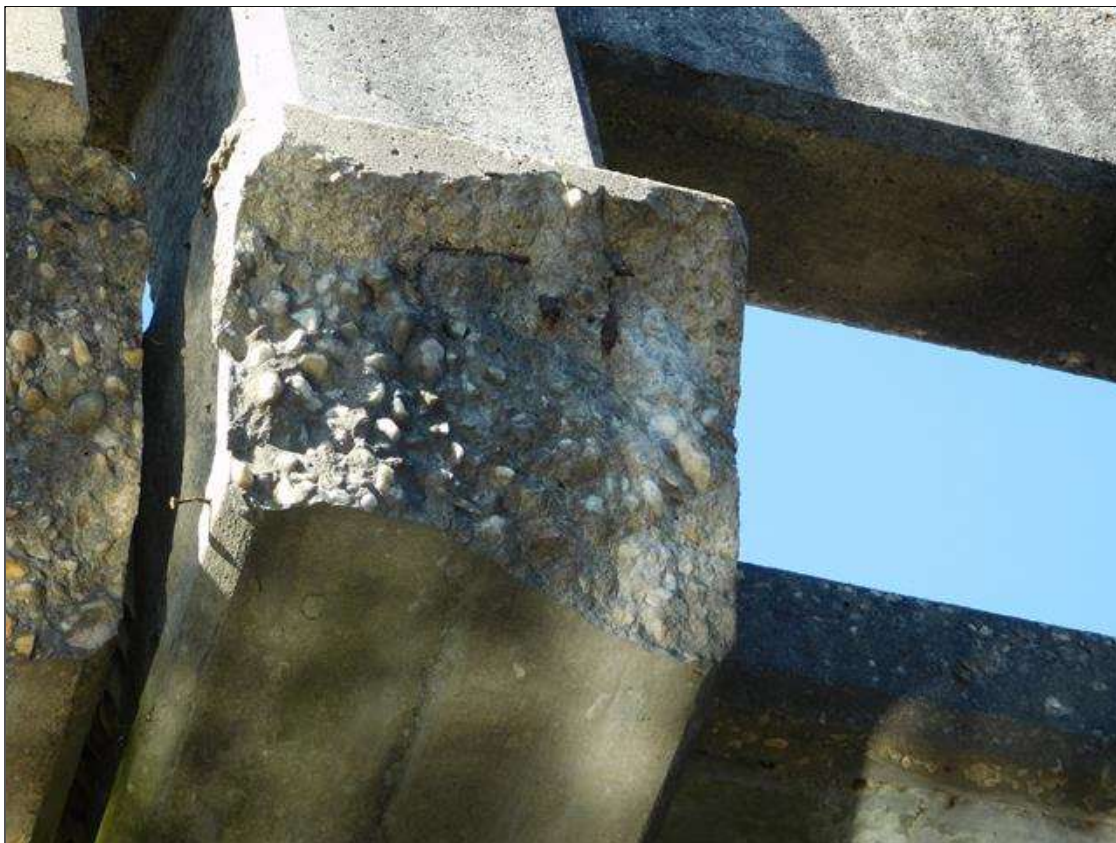
Span 4 Right Bridge Rail: 1 FOOT OF SPALLING 3" DEEP WITH EXPOSED REBAR IN THE GUARDRAIL POST BASE AT BENT 3. PAR ISSUED.

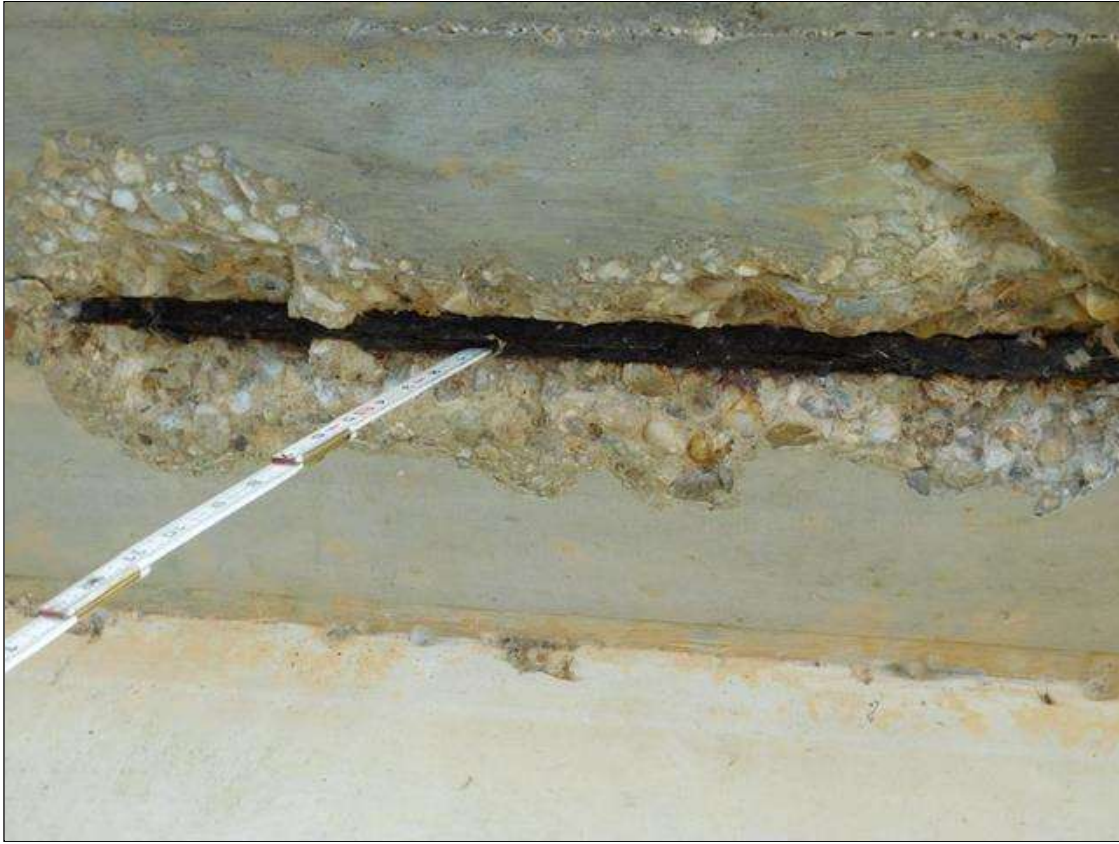
Bent 3 Cap 1: 26" LONG X 7" WIDE X 2" DEEP SPALL WITH SECTION LOSS TO EXPOSED BAR IN BOTTOM OF CAP AT BENT 3 SPAN 3 SIDE UNDER BAY 4 (ESTIMATED 1" DIAMETER BAR REMAINING). PAR ISSUED.

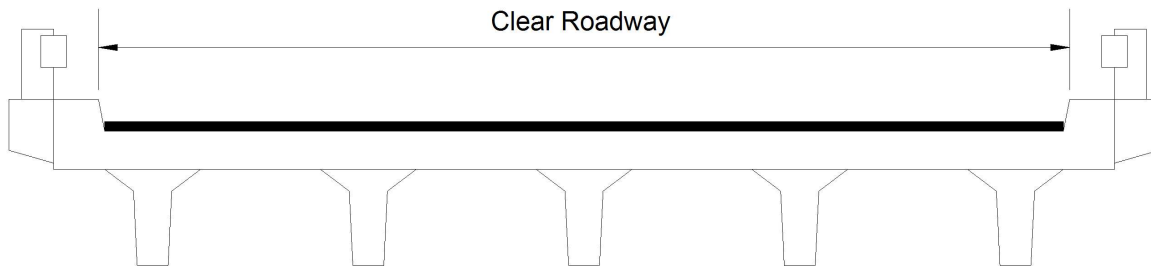
Measurements for Span #	1		
Deck Thickness	.625	Left Overhang	3.3333
Top of Rail to Bottom of Beam	*6.8333	Right Overhang	3.3333
