NC DEPARTMENT OF TRANSPORTATION
 DIVISION OF HIGHWAYS
 STRUCTURE MANAGEMENT UNIT

ATTENTION: **PAR ISSUED**

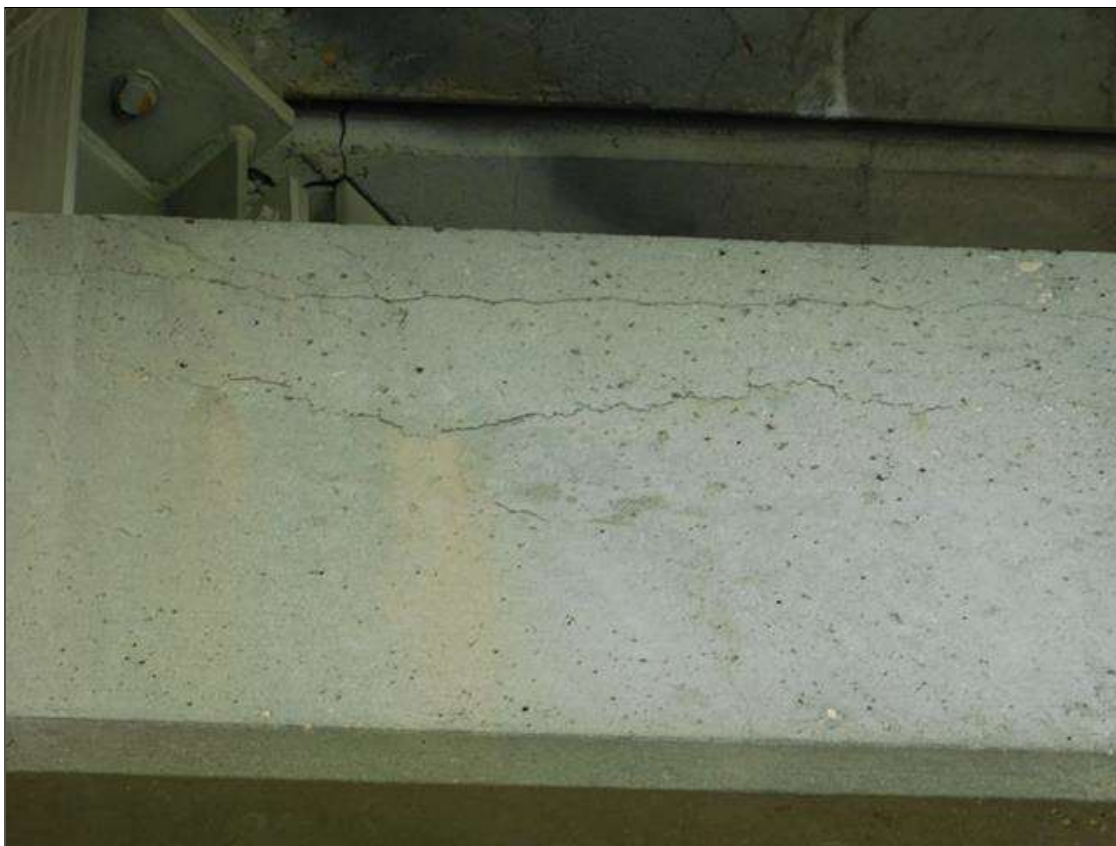
Bent 3 Cap 1: 3 FEET 1/8 INCH LONGITUDINAL IN FACE OF CAP SPAN 3 SIDE BEAM 3

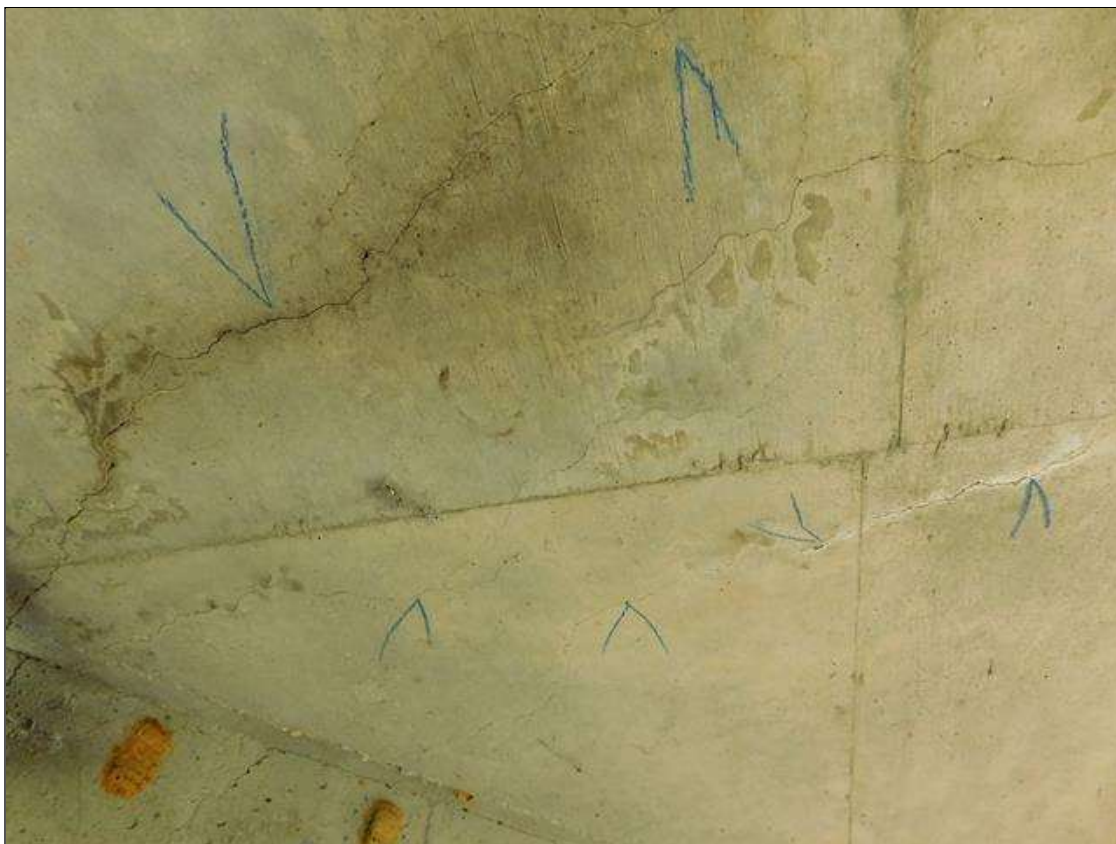
Span 4 Deck: 5 FEET OF 1/16 INCH TRANSVERSE AND MAP-CRACKING IN BOTTOM OF DECK BAY 3

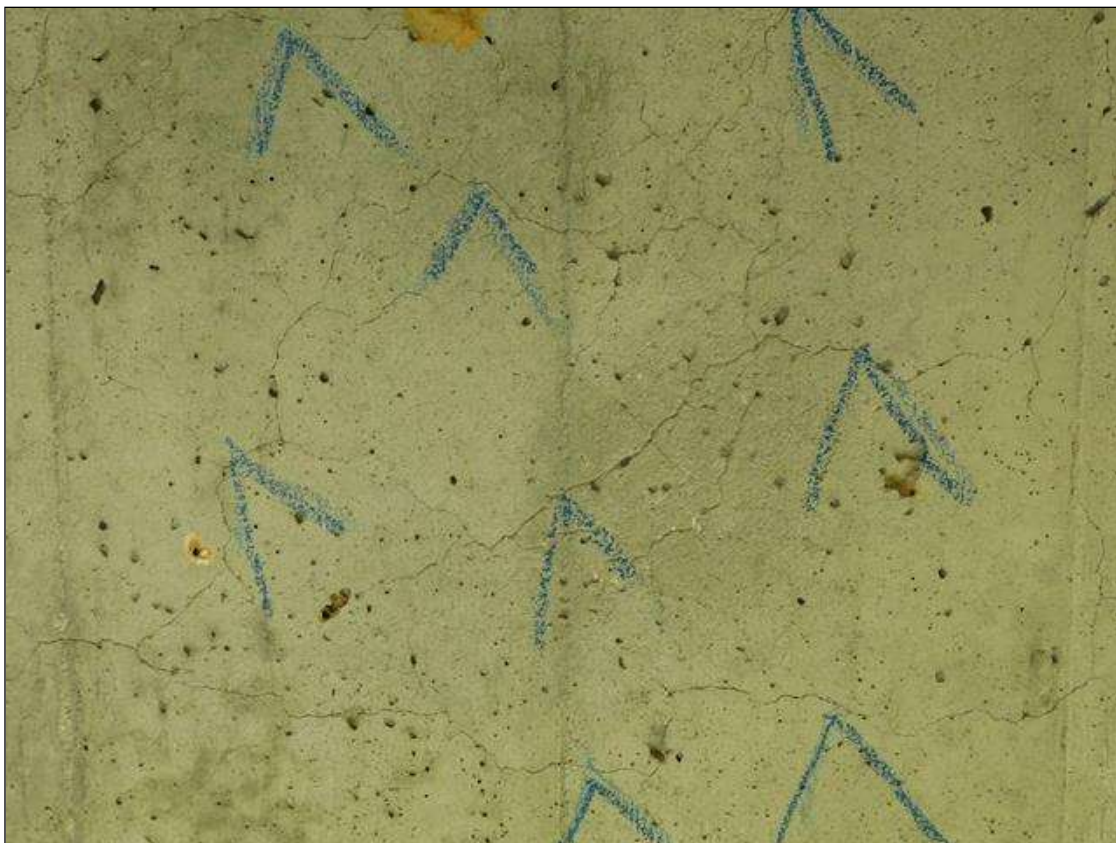
End Bent 2 Abutment: 28 FEET HAIRLINE MAP CRACKING FULL LENGTH

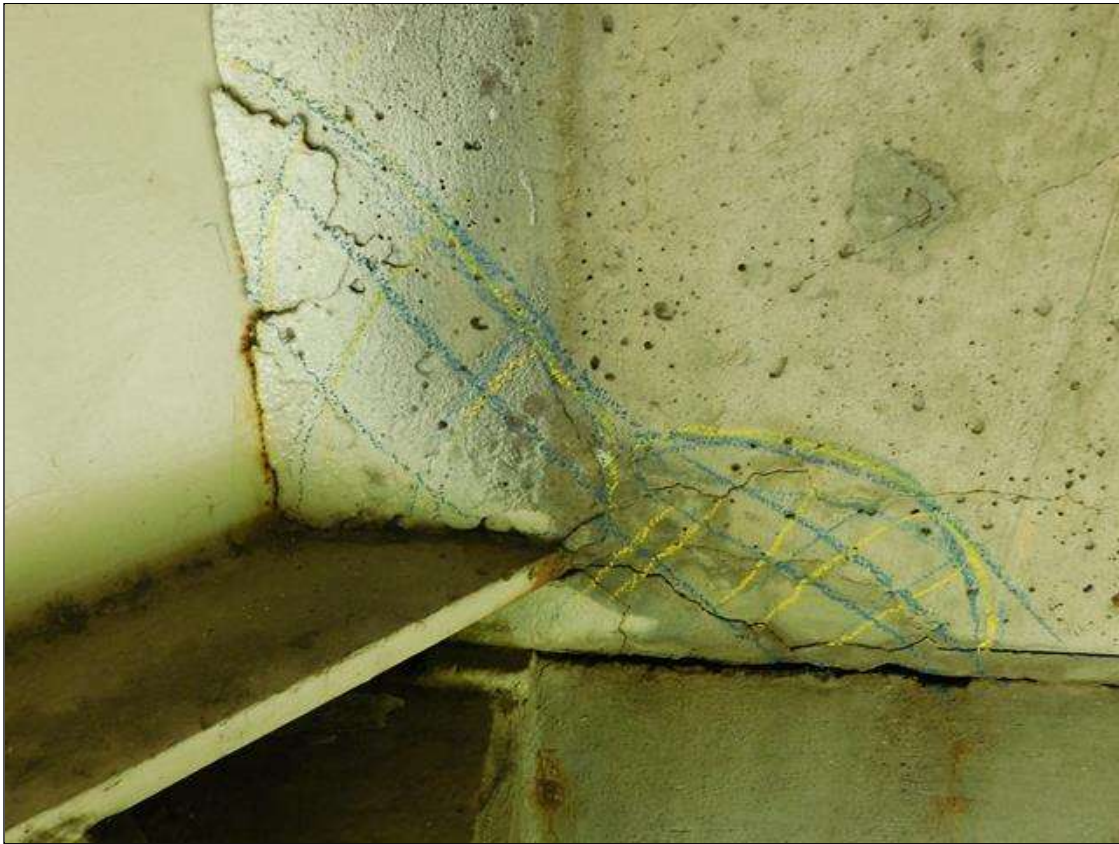
End Bent 2 Abutment: 4 FEET DELAMINATION IN ALL BAYS ADJACENT TO BEAMS.

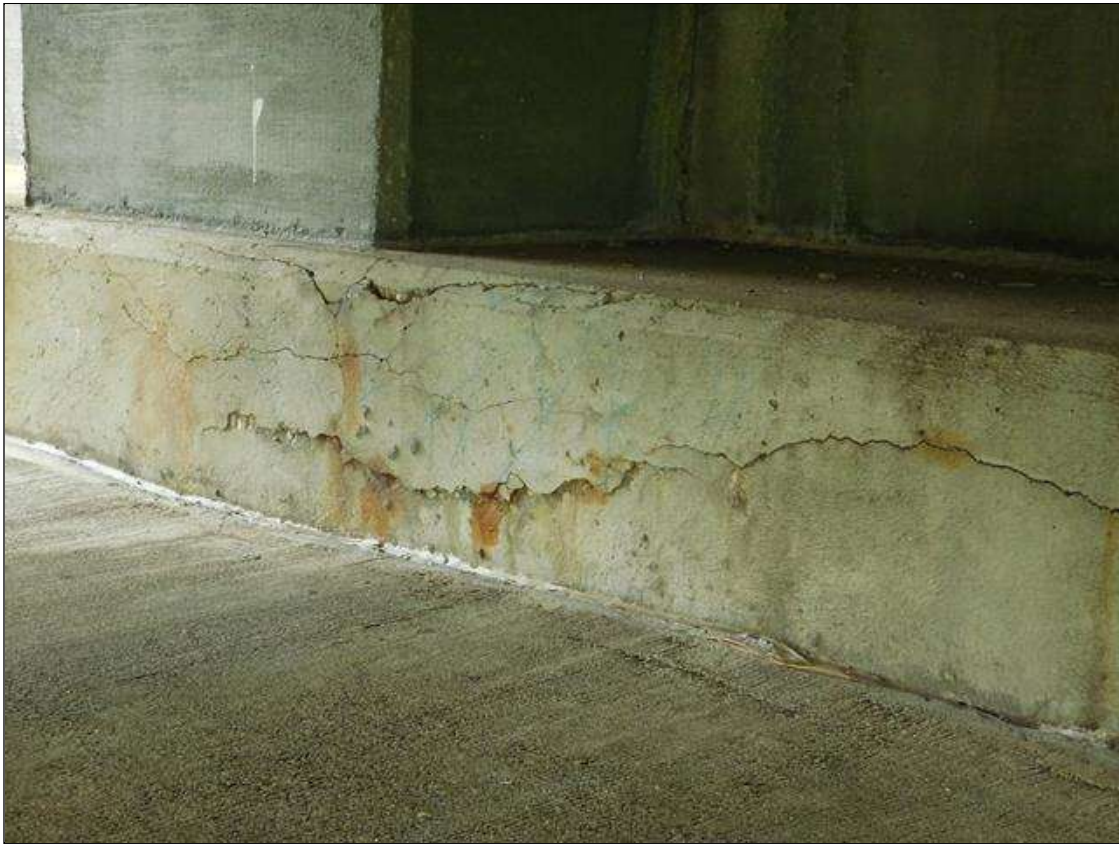
End Bent 2 Cap 1: 8 FEET LONGITUDINAL CRACKING FACE AND TOP WITH DELAMINATION AND RUST STAINING IN BAY 1.

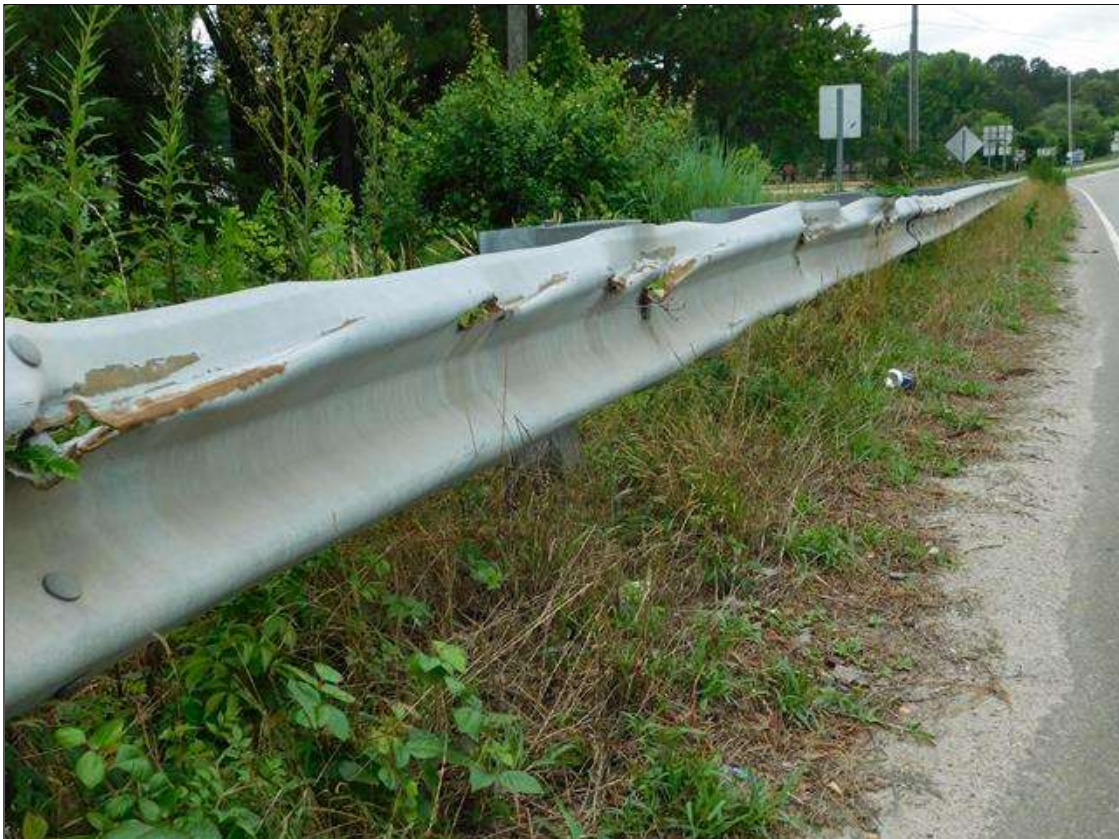
27 FEET OF IMPACT/SCRAPE DAMAGE ALONG THE LEFT SIDE APPROACH GUARDRAIL AT NORTH END WITH LOSS OF CONNECTION AT 4 POSTS. PAR ISSUED.

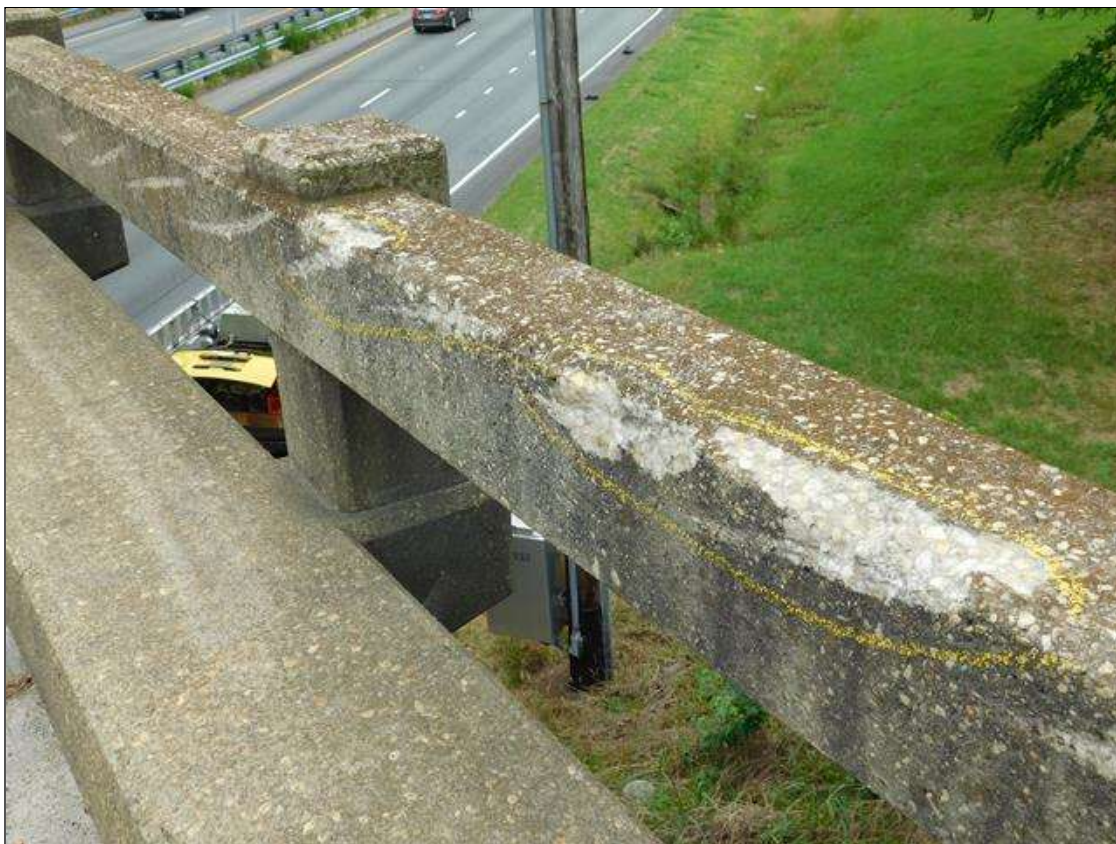
Span 4 Left Bridge Rail: 5 FEET OF IMPACT DAMAGE ALONG RAIL.

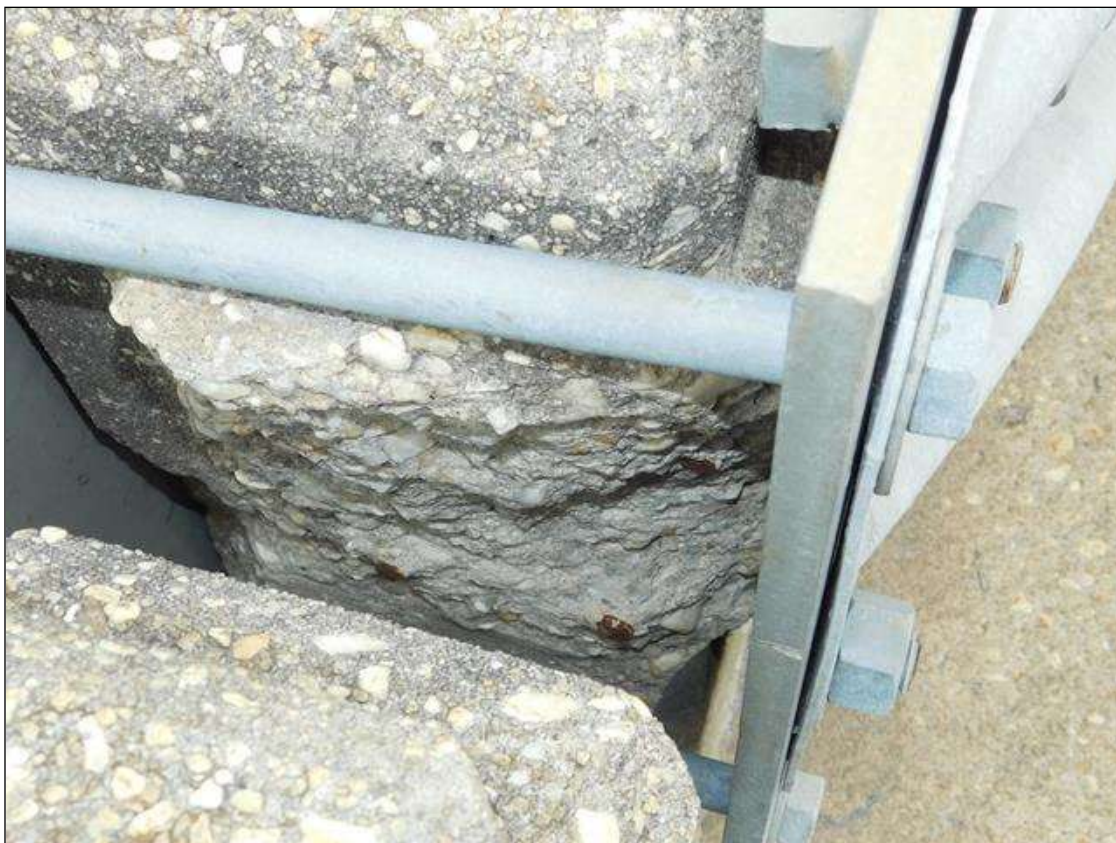
Span 4 Left Bridge Rail: 2 FEET OF SPALLING IN POSTS 5 & 6. WITH EXPOSED REBAR.

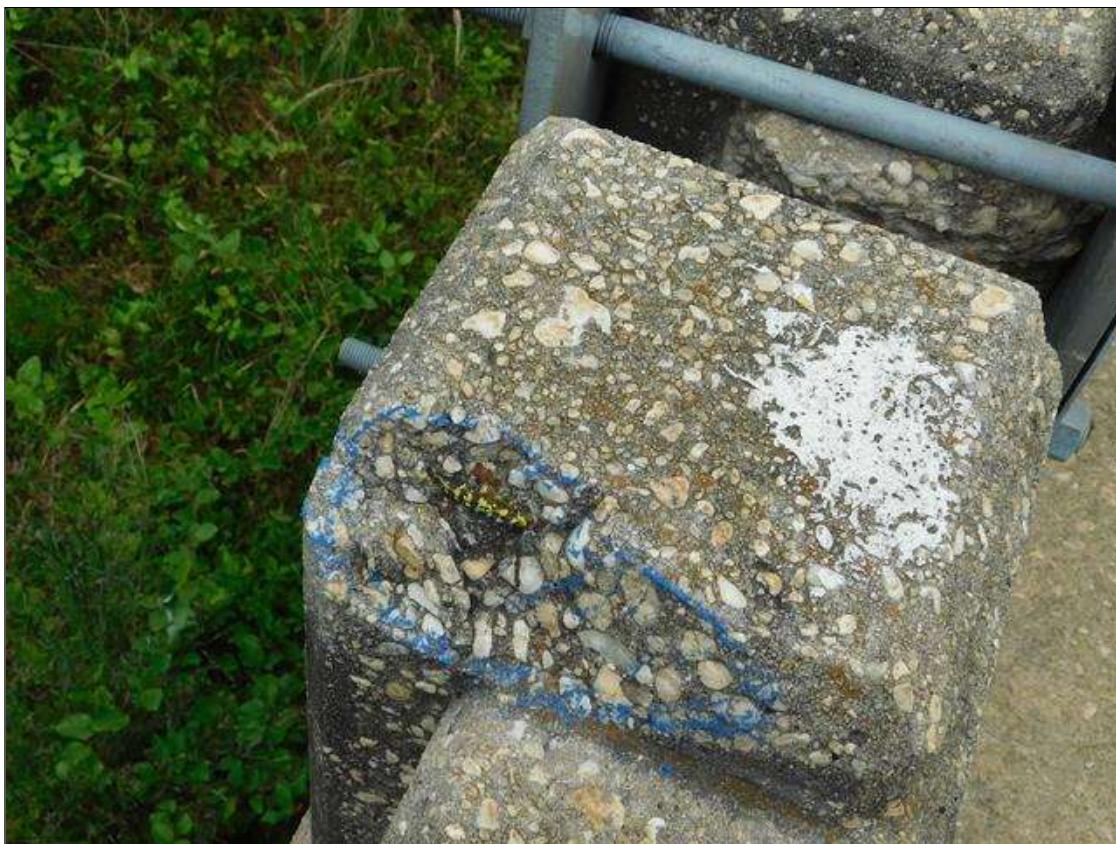
Span 4 Left Bridge Rail: 2 FEET OF SPALLING IN POSTS 5 & 6. WITH EXPOSED REBAR.

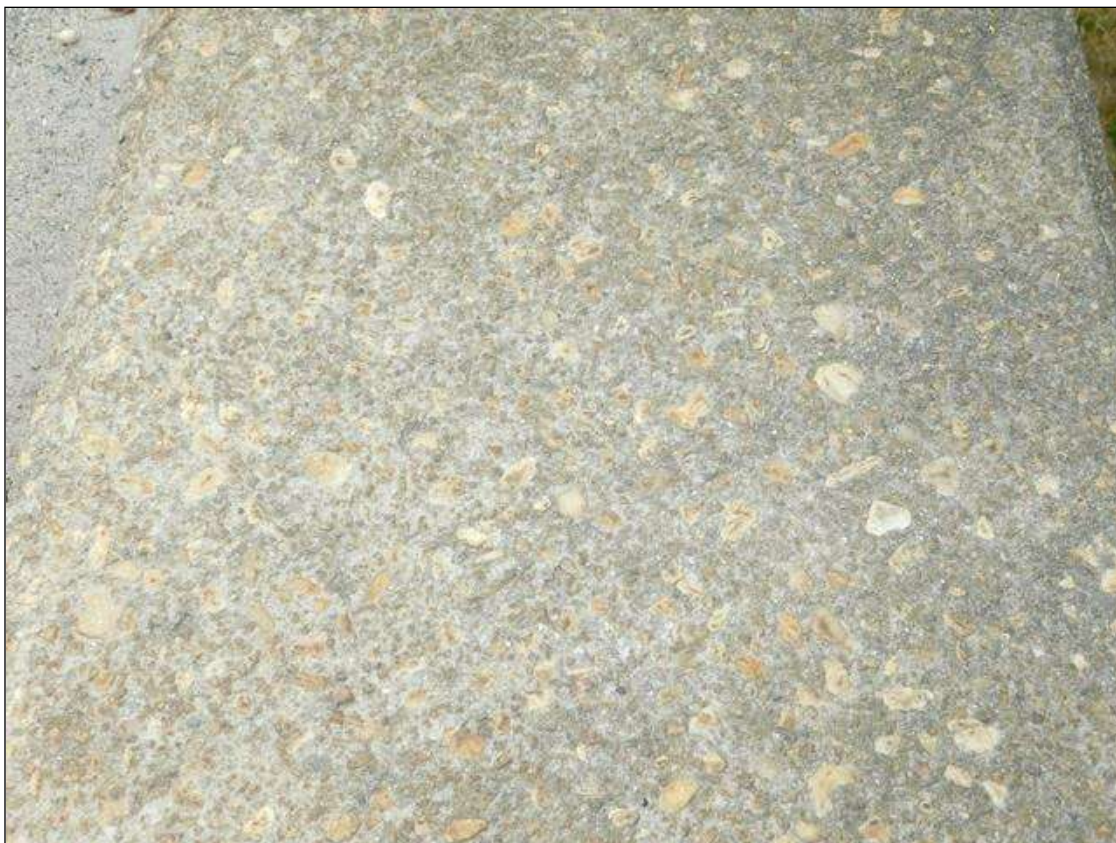
Span 4 Deck: 172 SQUARE FEET OF ABRASION ALONG DECK CURBS.

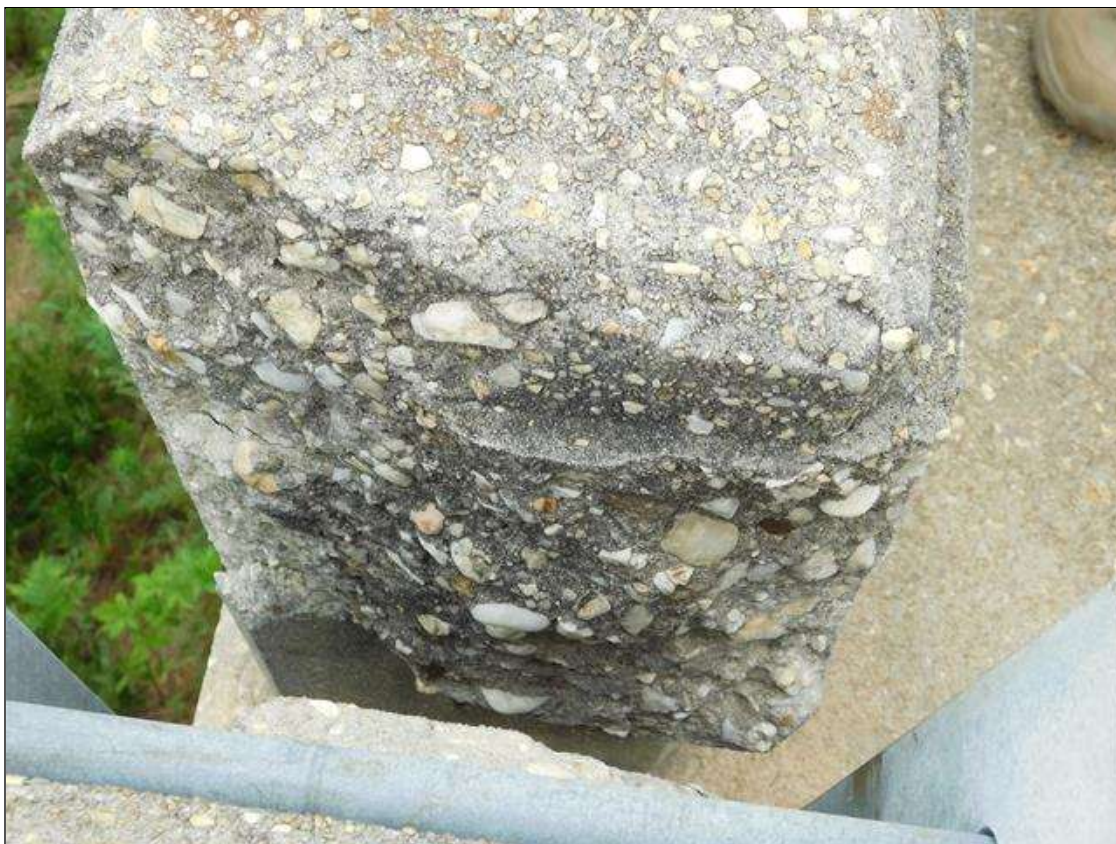
Span 4 Right Bridge Rail: 1 FOOT OF SPALLING WITH EXPOSED REBAR IN POST #6.

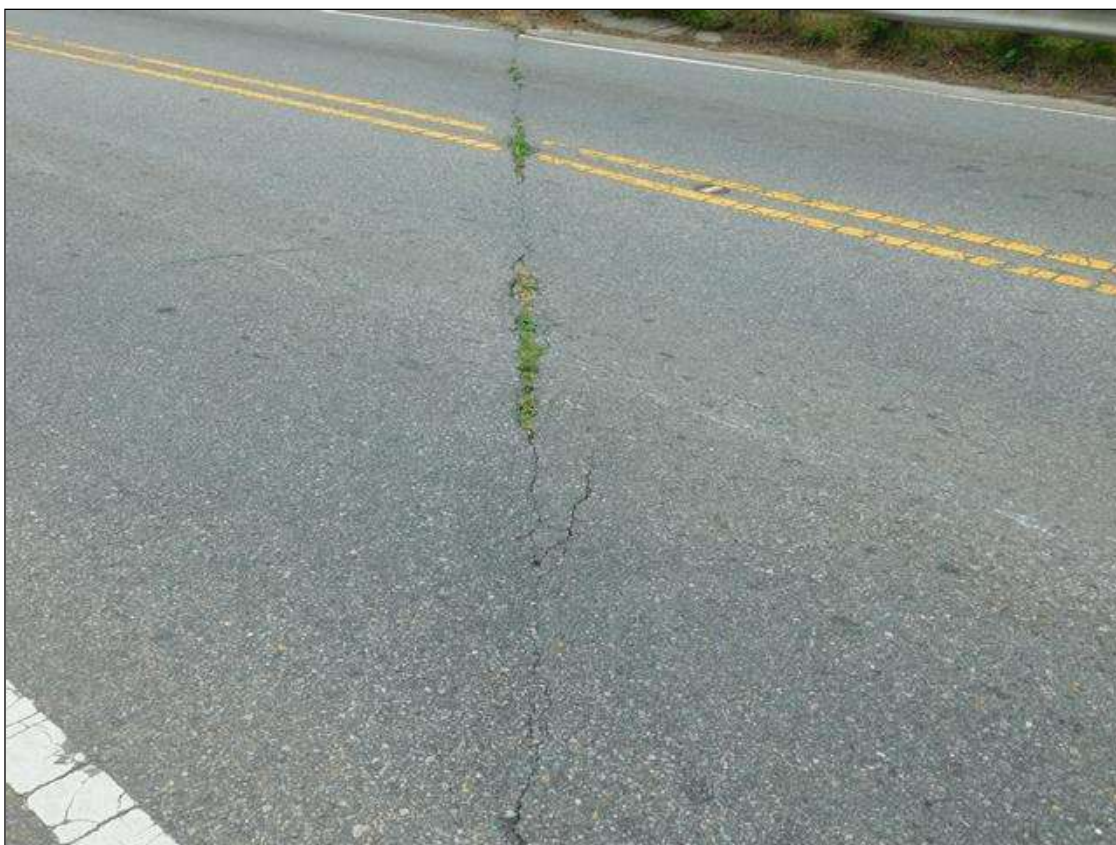
Span 4 Wearing Surface: 29 SQUARE FEET OF CRACKING OVER END BENT 2.

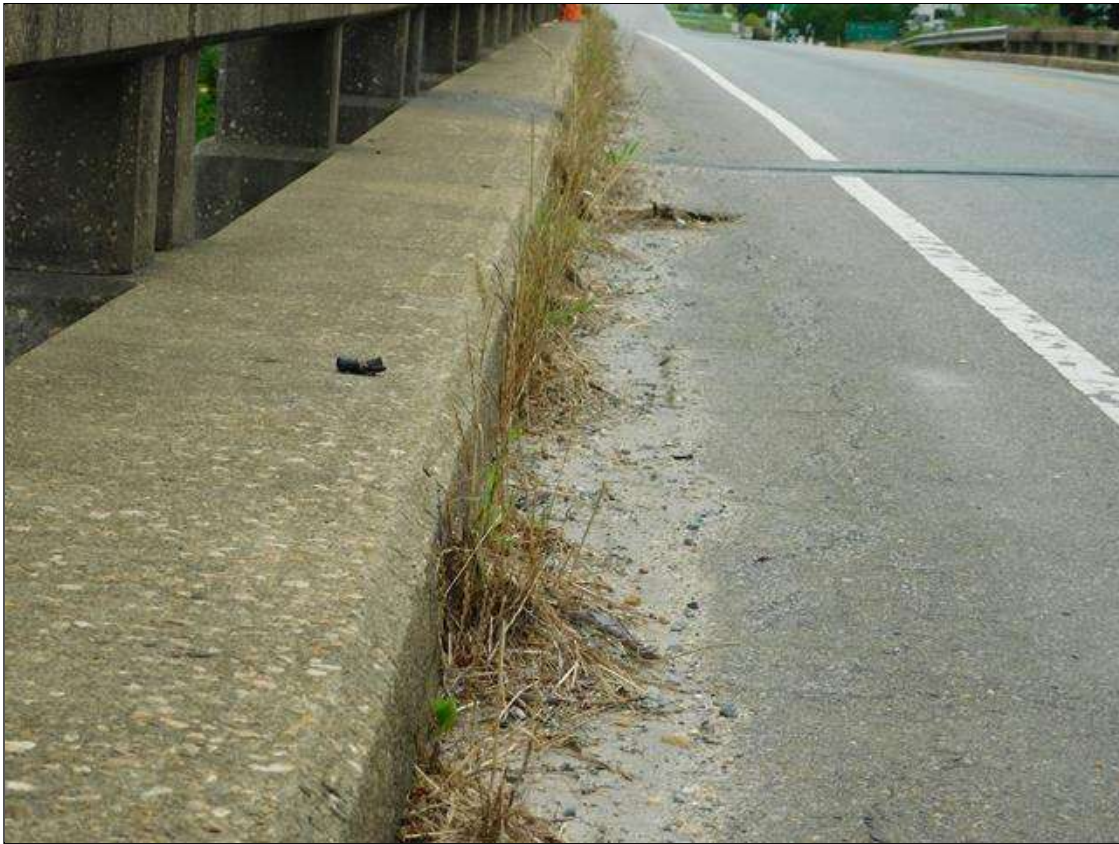
DIRT AND VEGETATION ALONG CURBLINES

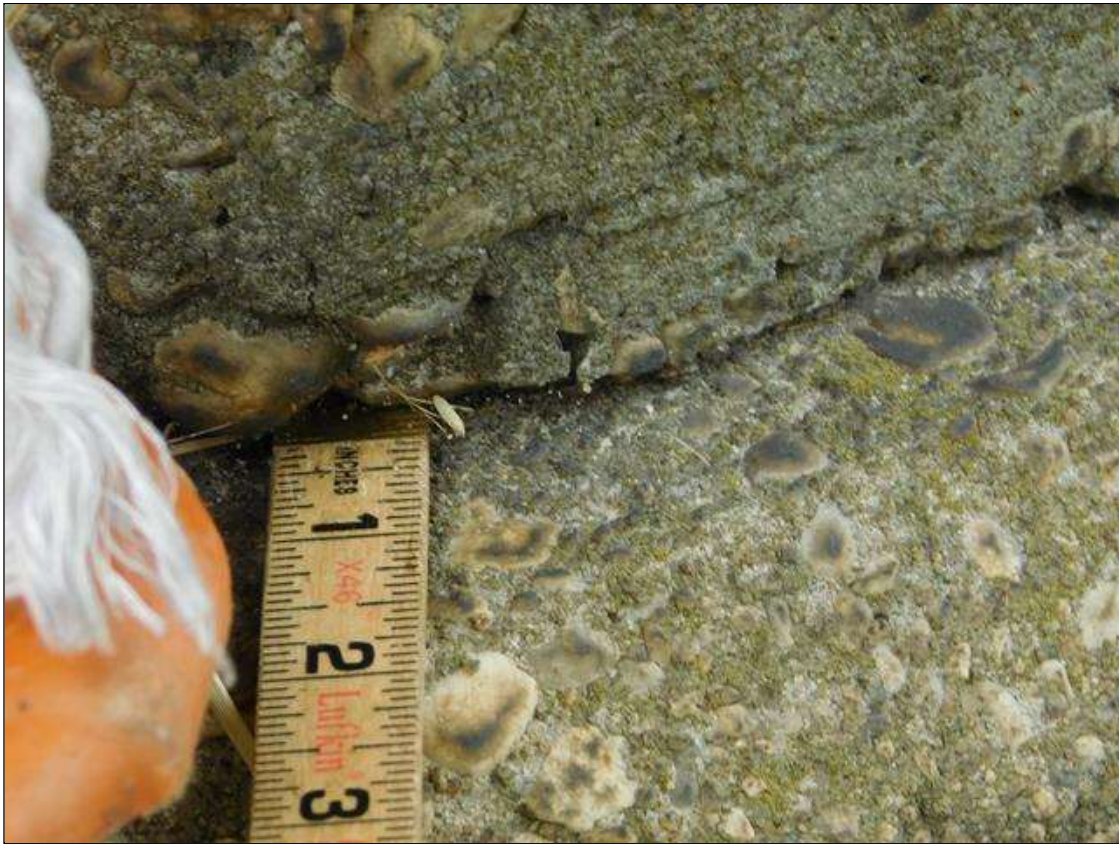
Span 2 Right Bridge Rail: IMPACT DAMAGE. THE 4TH GUARDRAIL POST FROM BENT 1 IS CRACKED, SPALLED AND LEANING OUT 1.5" AT TOP (REFERENCED FROM POST 3). HORIZONTAL RAILING FROM POST 4 TO POST 5 IS CRACKED AND PUSHED OUT. POSTS 5 & 6 HAVE WRAP-AROUND CRACKING AT BOTTOM OF POSTS BUT APPEAR TO BE PLUMB. TEMPORARY STEEL GUARDRAIL HAS BEEN ADDED FROM POST 3 TO POST 7. AFFECTED AREA IS OVER THE NORTHBOUND LANES OF I-95. PAR ISSUED.

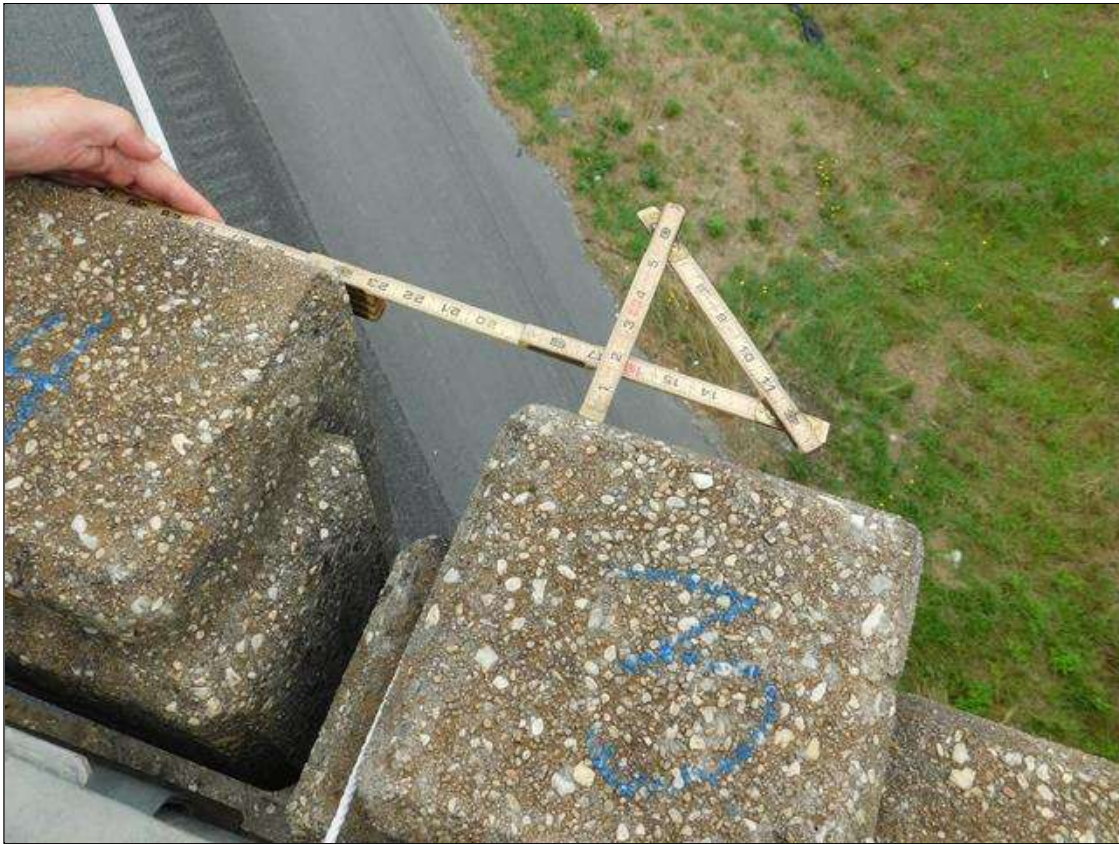
Span 2 Right Bridge Rail: IMPACT DAMAGE. THE 4TH GUARDRAIL POST FROM BENT 1 IS CRACKED, SPALLED AND LEANING OUT 1.5" AT TOP (REFERENCED FROM POST 3). HORIZONTAL RAILING FROM POST 4 TO POST 5 IS CRACKED AND PUSHED OUT. POSTS 5 & 6 HAVE WRAP-AROUND CRACKING AT BOTTOM OF POSTS BUT APPEAR TO BE PLUMB. TEMPORARY STEEL GUARDRAIL HAS BEEN ADDED FROM POST 3 TO POST 7. AFFECTED AREA IS OVER THE NORTHBOUND LANES OF I-95. PAR ISSUED.

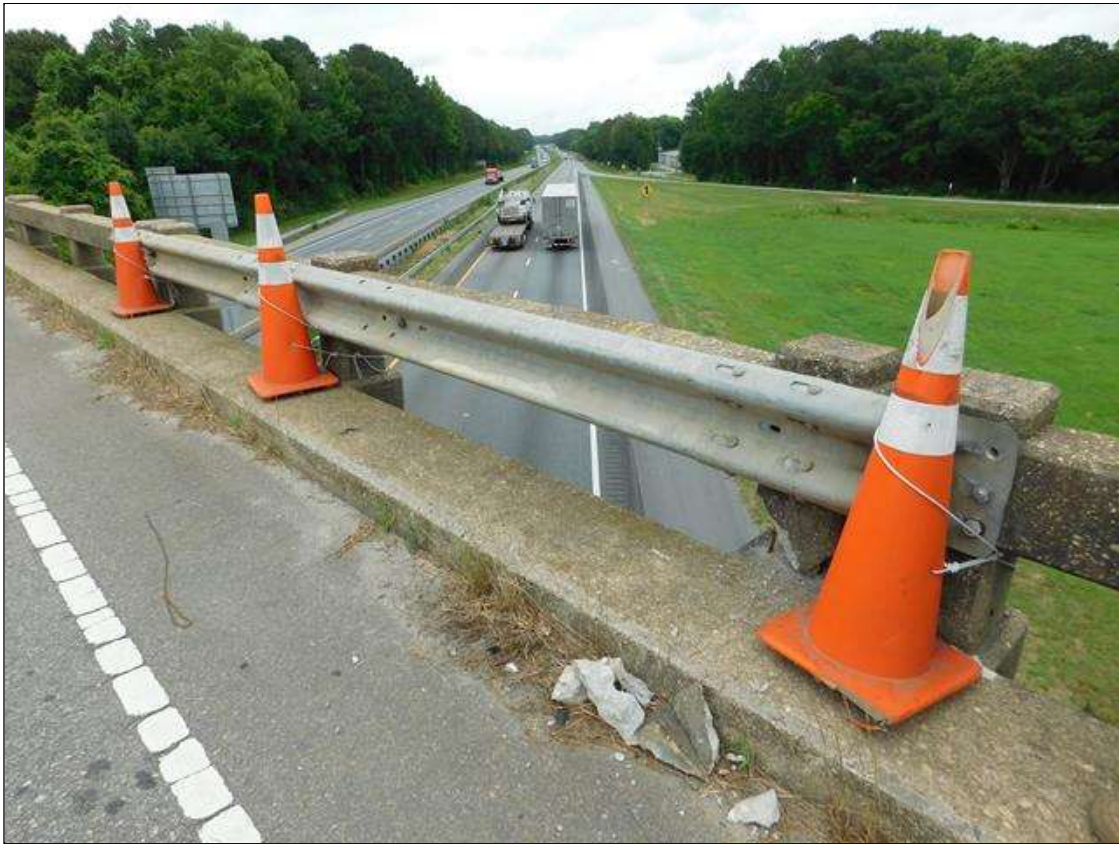
Span 2 Right Bridge Rail: IMPACT DAMAGE. THE 4TH GUARDRAIL POST FROM BENT 1 IS CRACKED, SPALLED AND LEANING OUT 1.5" AT TOP (REFERENCED FROM POST 3). HORIZONTAL RAILING FROM POST 4 TO POST 5 IS CRACKED AND PUSHED OUT. POSTS 5 & 6 HAVE WRAP-AROUND CRACKING AT BOTTOM OF POSTS BUT APPEAR TO BE PLUMB. TEMPORARY STEEL GUARDRAIL HAS BEEN ADDED FROM POST 3 TO POST 7. AFFECTED AREA IS OVER THE NORTHBOUND LANES OF I-95. PAR ISSUED.

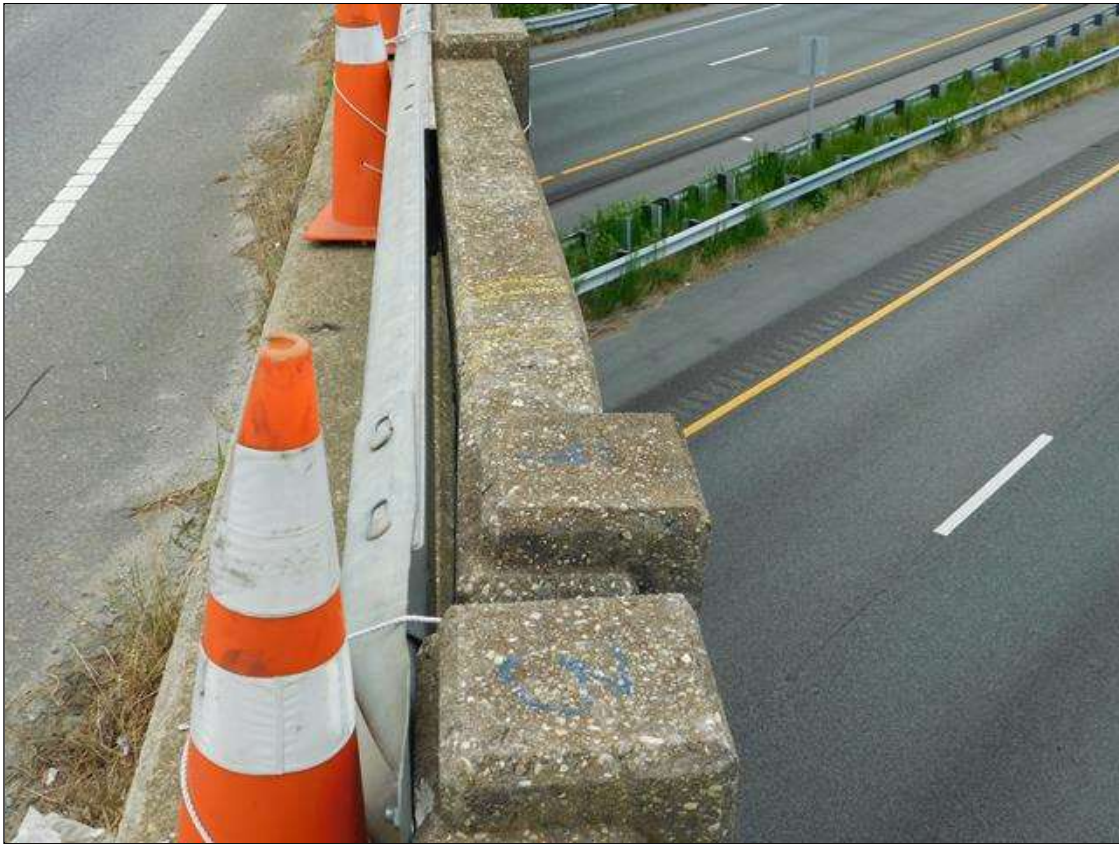
Span 2 Right Bridge Rail: IMPACT DAMAGE. THE 4TH GUARDRAIL POST FROM BENT 1 IS CRACKED, SPALLED AND LEANING OUT 1.5" AT TOP (REFERENCED FROM POST 3). HORIZONTAL RAILING FROM POST 4 TO POST 5 IS CRACKED AND PUSHED OUT. POSTS 5 & 6 HAVE WRAP-AROUND CRACKING AT BOTTOM OF POSTS BUT APPEAR TO BE PLUMB. TEMPORARY STEEL GUARDRAIL HAS BEEN ADDED FROM POST 3 TO POST 7. AFFECTED AREA IS OVER THE NORTHBOUND LANES OF I-95. PAR ISSUED.

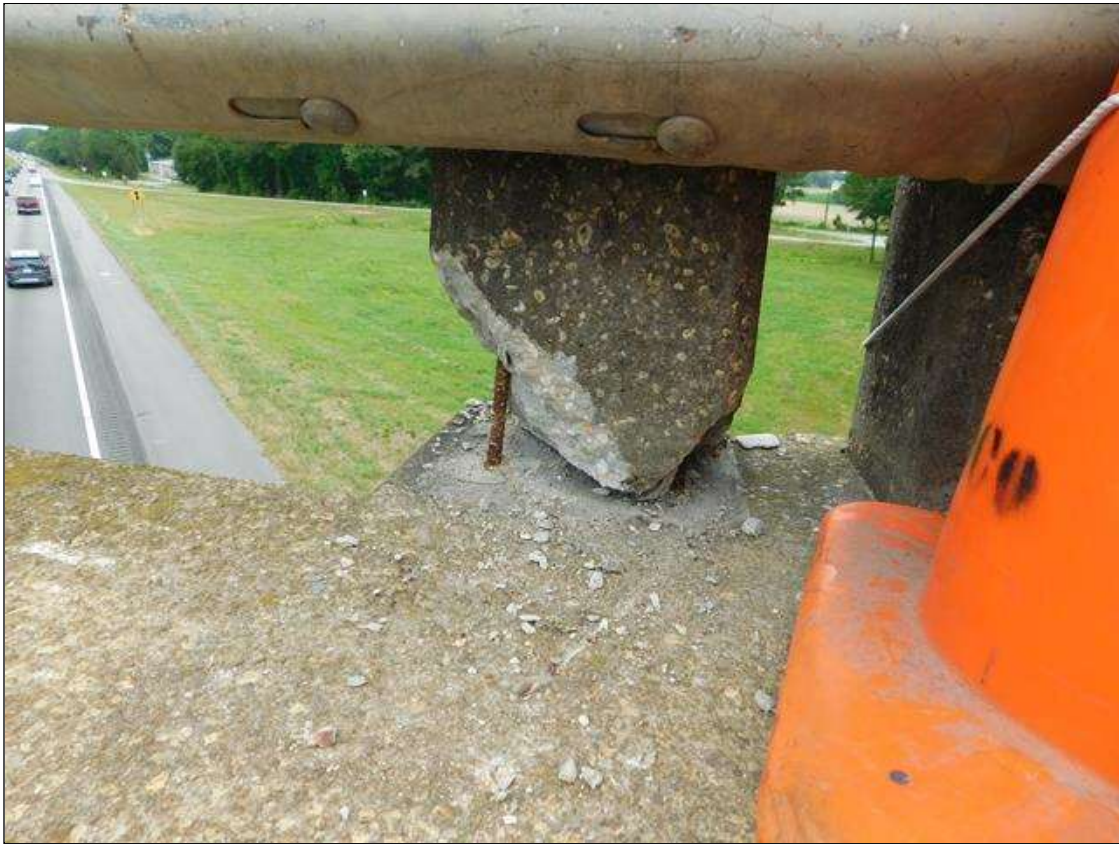
Span 2 Right Bridge Rail: IMPACT DAMAGE. THE 4TH GUARDRAIL POST FROM BENT 1 IS CRACKED, SPALLED AND LEANING OUT 1.5" AT TOP (REFERENCED FROM POST 3). HORIZONTAL RAILING FROM POST 4 TO POST 5 IS CRACKED AND PUSHED OUT. POSTS 5 & 6 HAVE WRAP-AROUND CRACKING AT BOTTOM OF POSTS BUT APPEAR TO BE PLUMB. TEMPORARY STEEL GUARDRAIL HAS BEEN ADDED FROM POST 3 TO POST 7. AFFECTED AREA IS OVER THE NORTHBOUND LANES OF I-95. PAR ISSUED.

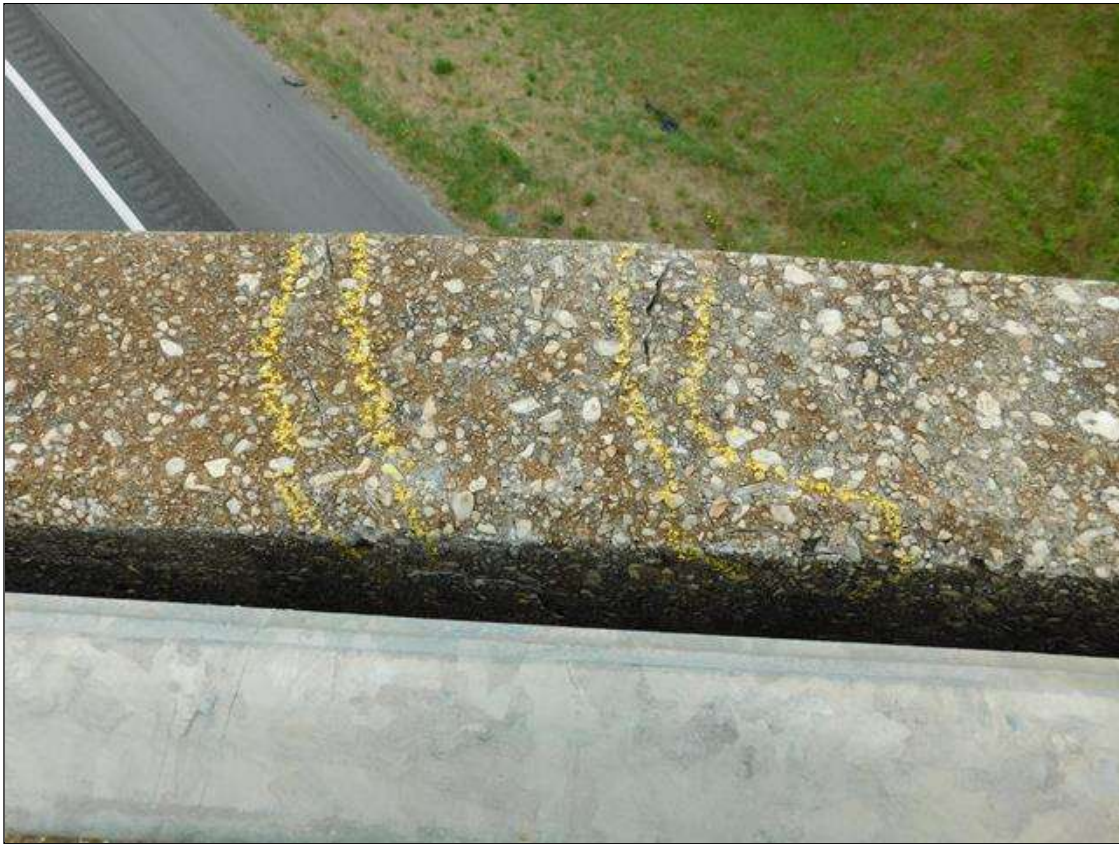
Span 2 Right Bridge Rail: IMPACT DAMAGE. THE 4TH GUARDRAIL POST FROM BENT 1 IS CRACKED, SPALLED AND LEANING OUT 1.5" AT TOP (REFERENCED FROM POST 3). HORIZONTAL RAILING FROM POST 4 TO POST 5 IS CRACKED AND PUSHED OUT. POSTS 5 & 6 HAVE WRAP-AROUND CRACKING AT BOTTOM OF POSTS BUT APPEAR TO BE PLUMB. TEMPORARY STEEL GUARDRAIL HAS BEEN ADDED FROM POST 3 TO POST 7. AFFECTED AREA IS OVER THE NORTHBOUND LANES OF I-95. PAR ISSUED.

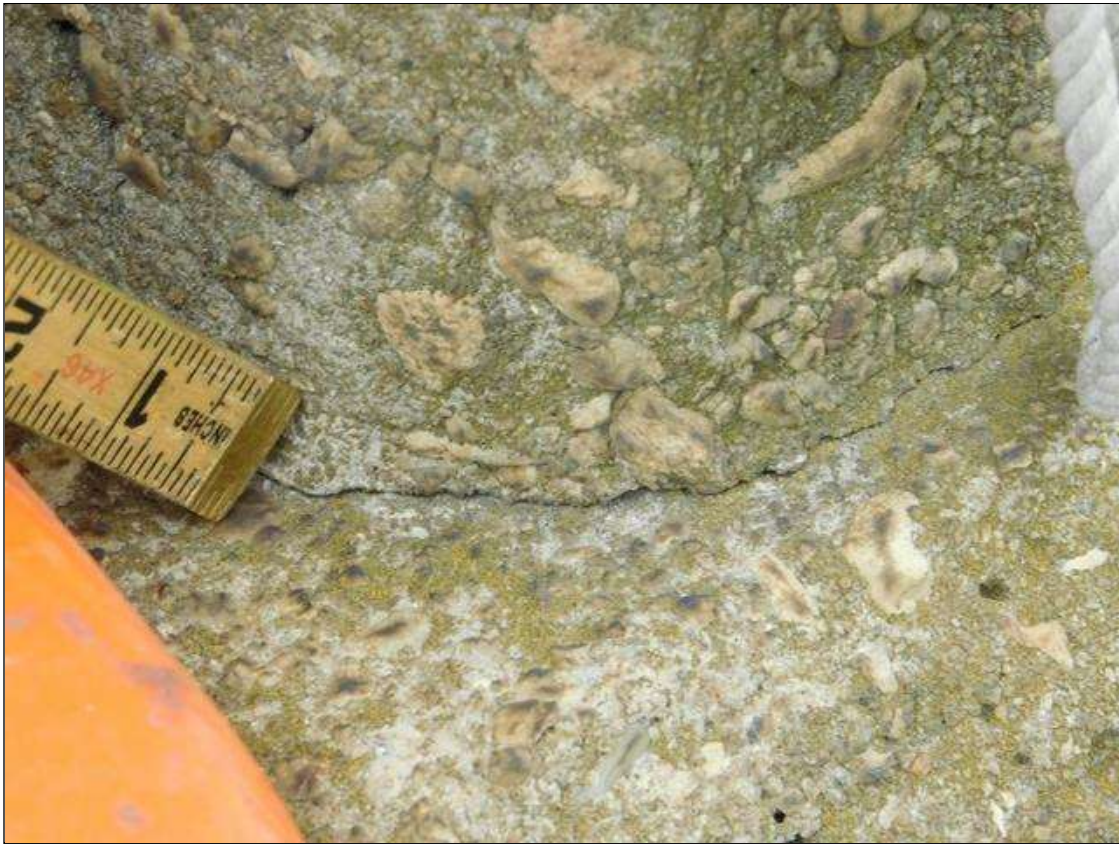
Span 2 Right Bridge Rail: IMPACT DAMAGE. THE 4TH GUARDRAIL POST FROM BENT 1 IS CRACKED, SPALLED AND LEANING OUT 1.5" AT TOP (REFERENCED FROM POST 3). HORIZONTAL RAILING FROM POST 4 TO POST 5 IS CRACKED AND PUSHED OUT. POSTS 5 & 6 HAVE WRAP-AROUND CRACKING AT BOTTOM OF POSTS BUT APPEAR TO BE PLUMB. TEMPORARY STEEL GUARDRAIL HAS BEEN ADDED FROM POST 3 TO POST 7. AFFECTED AREA IS OVER THE NORTHBOUND LANES OF I-95. PAR ISSUED.

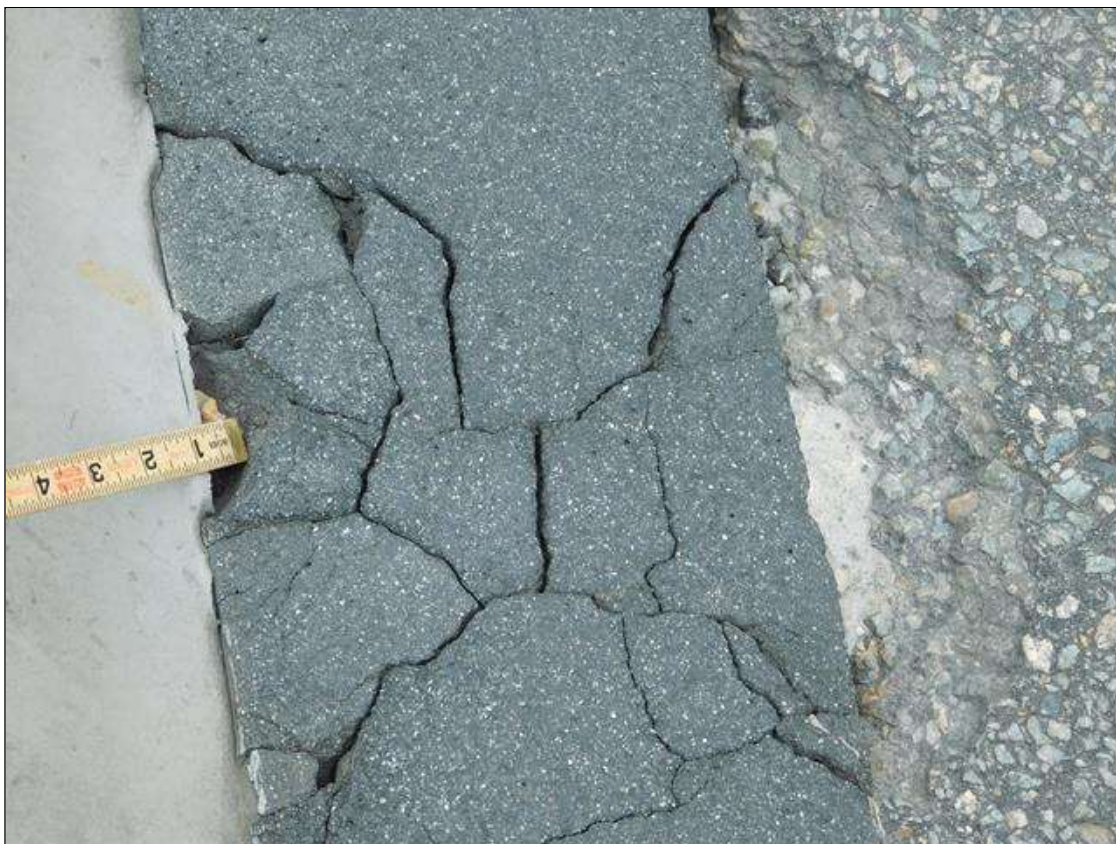
Span 2 Wearing Surface: CRACKING IN ELASTOMERIC CONCRETE OVER THE SOUTHBOUND LANE.

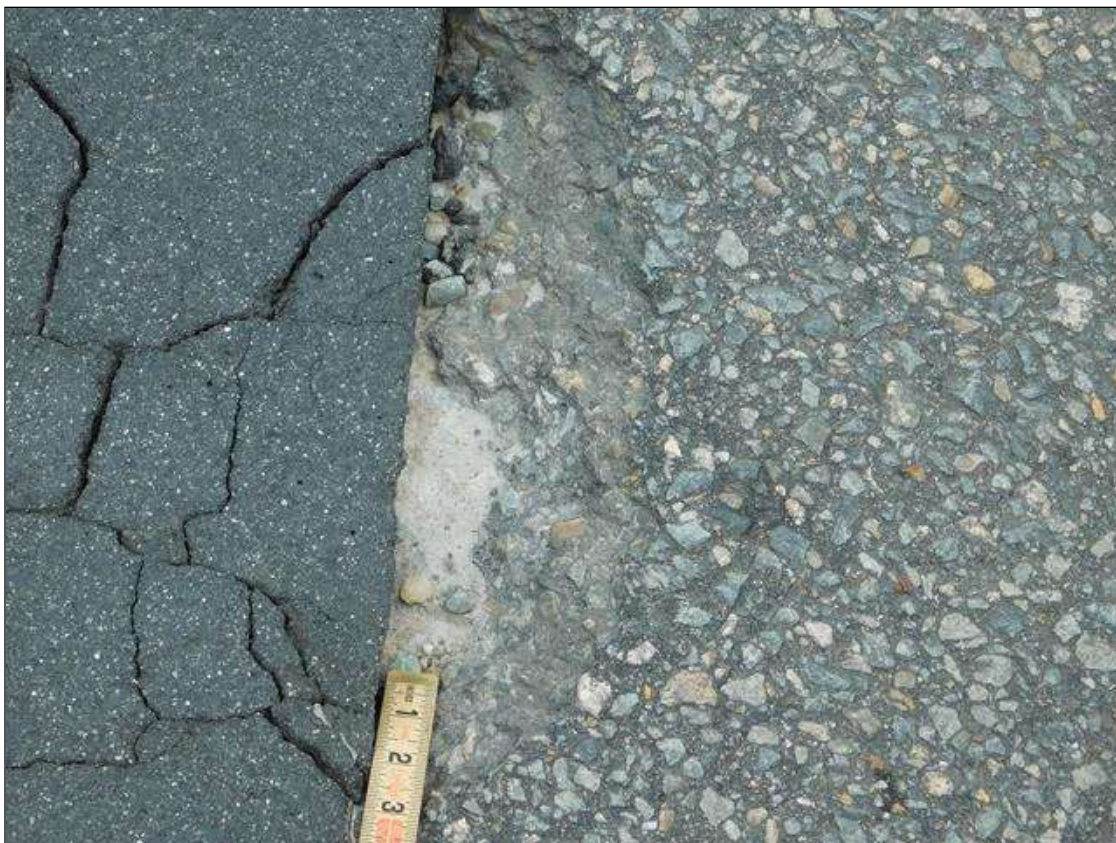
Span 1 Wearing Surface: 1 SQUARE FOOT FULL DEPTH POTHOLE IN THE SOUTHBOUND LANE AT BENT 1.

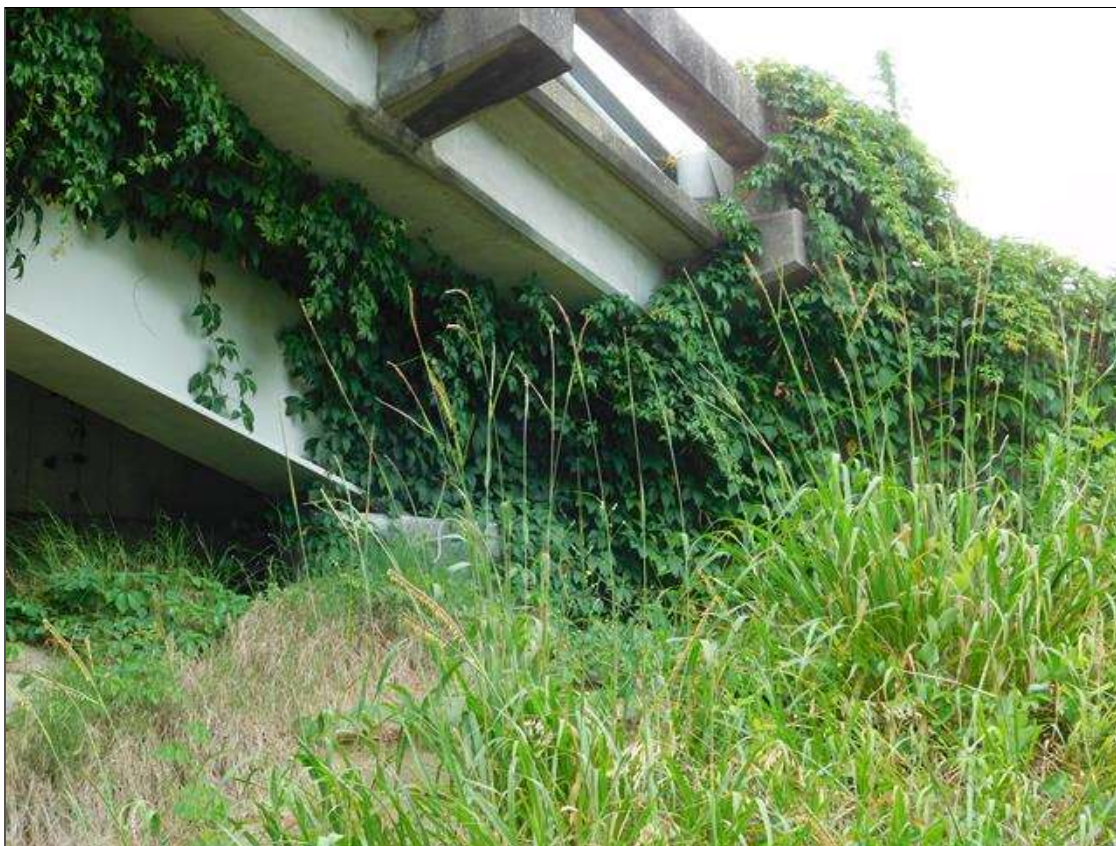
VEGETATION GROWTH AT ENDS OF BRIDGE
