NC DEPARTMENT OF TRANSPORTATION
 DIVISION OF HIGHWAYS
 STRUCTURE MANAGEMENT UNIT

ATTENTION: **PAR ISSUED**

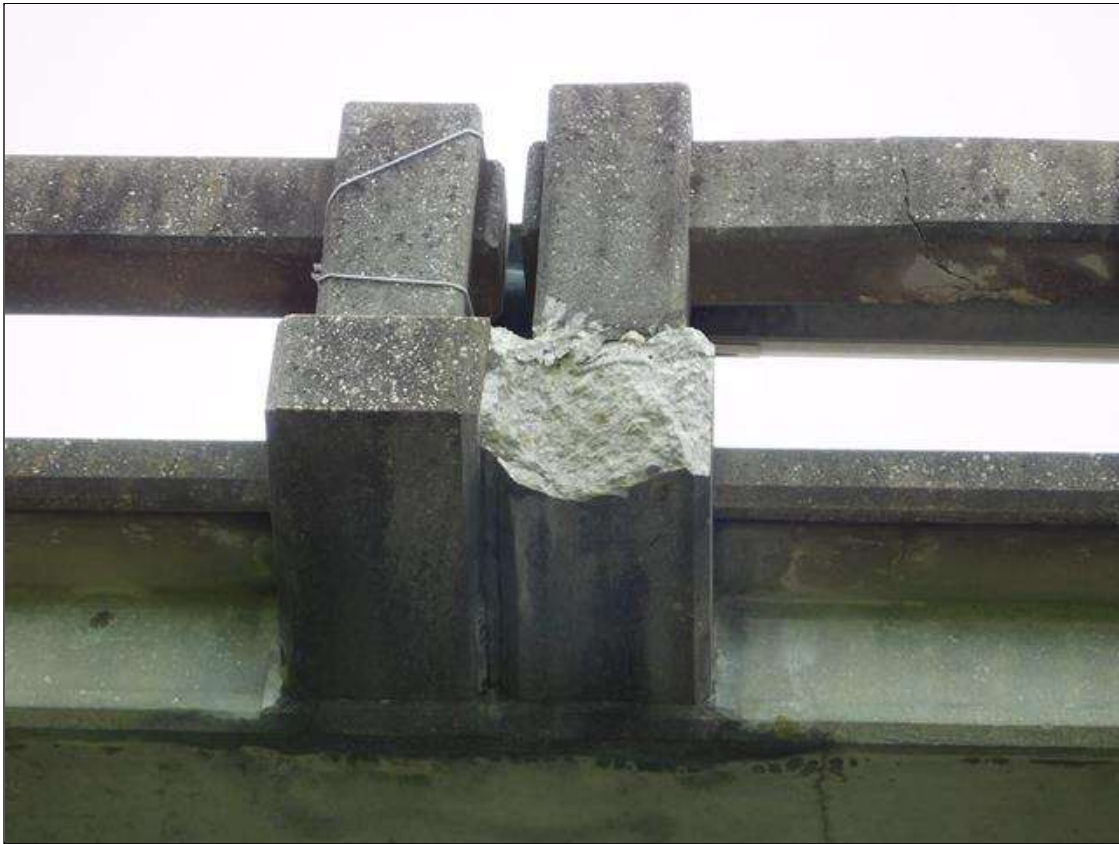
Span 2 Right Bridge Rail: IMPACT DAMAGE. THE 4TH GUARDRAIL POST FROM BENT 1 IS CRACKED, SPALLED AND LEANING OUT 1.5" AT TOP (REFERENCED FROM POST 3). HORIZONTAL RAILING FROM POST 4 TO POST 5 IS CRACKED AND PUSHED OUT. POSTS 5 & 6 HAVE WRAP-AROUND CRACKING AT BOTTOM OF POSTS BUT APPEAR TO BE PLUMB. TEMPORARY STEEL GUARDRAIL HAS BEEN ADDED FROM POST 3 TO POST 7. AFFECTED AREA IS OVER THE NORTHBOUND LANES OF I-95. PAR ISSUED.

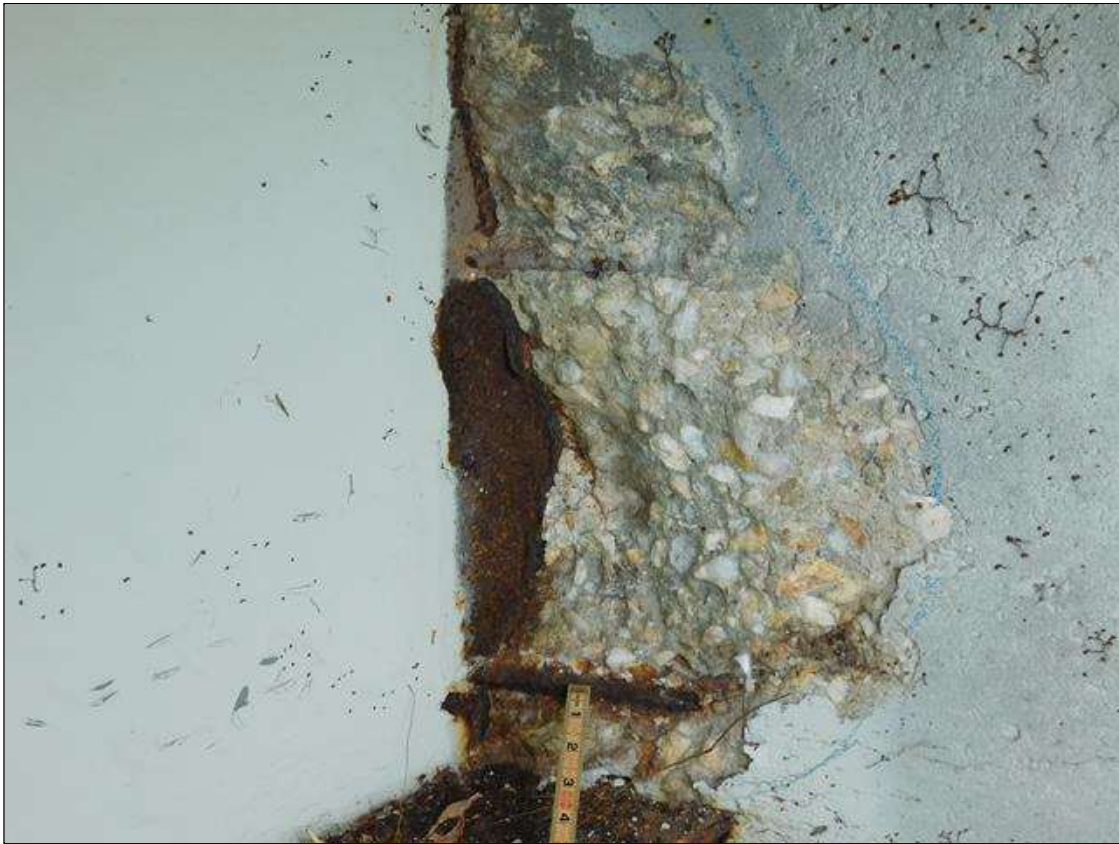
End Bent 1 Abutment: 20" HIGH X 12" WIDE X 3: DEEP SPALL WITH EXPOSED REBAR IN BACKWALL ADJACENT TO THE LEFT SIDE WEB OF BEAM 1.

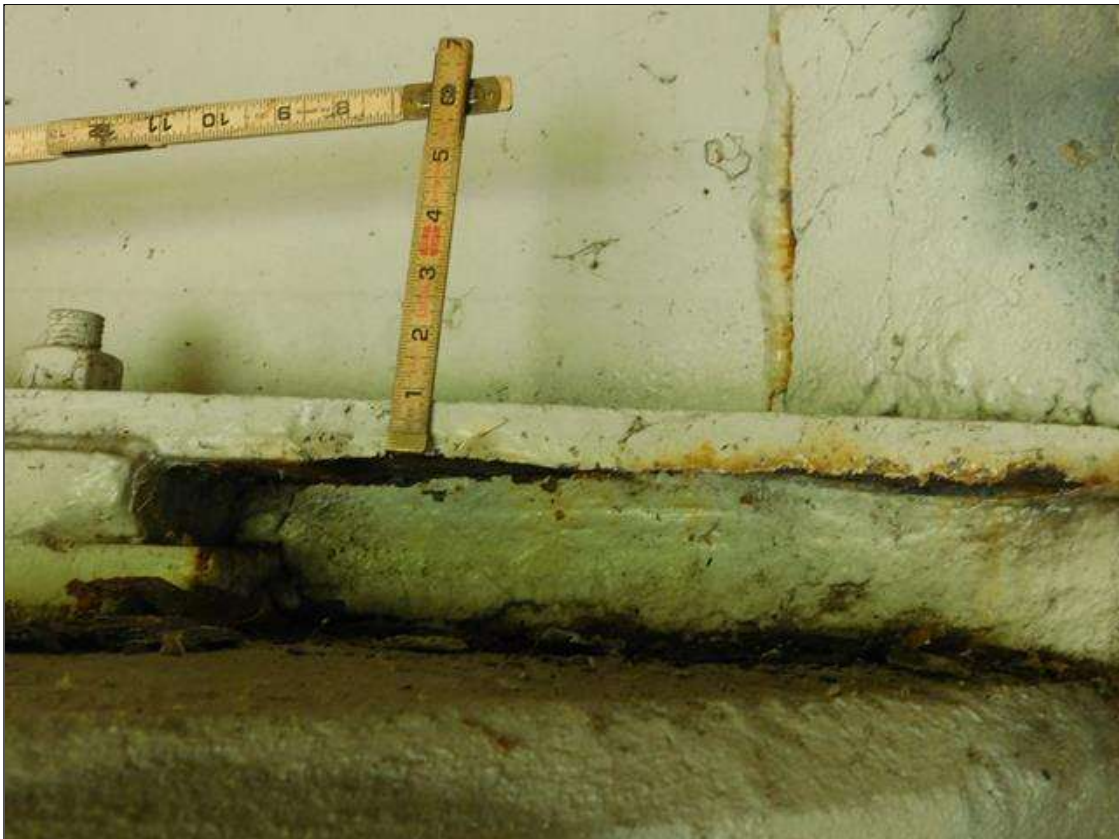
Span 1 Beam 4: 1/8" SECTION LOSS IN THE BOTTOM FLANGE AT END BENT 1 WITH 7/8 INCH REMAINING BETWEEN BACKWALL AND BEARING ASSEMBLY (NOT IN BEARING AREA)

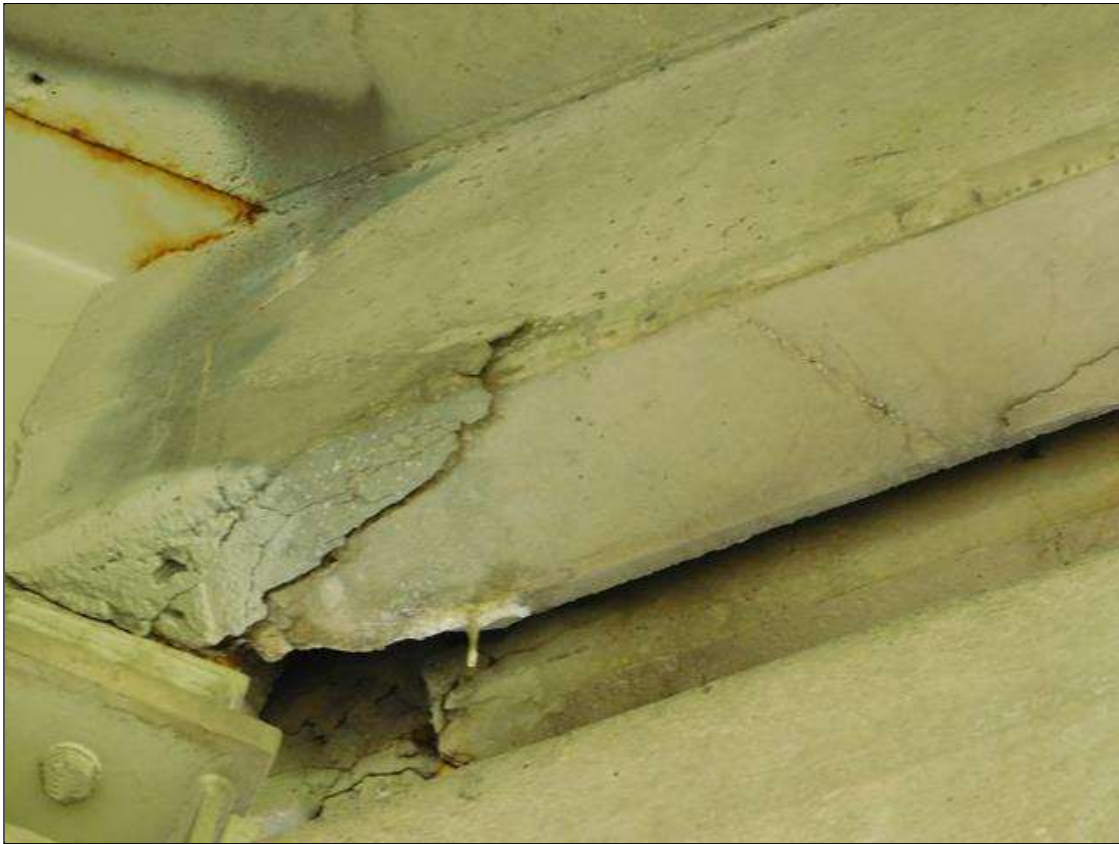
Span 1 Deck: BOTTOM OF DECK: 1/4 INCH WIDE CRACK LEFT OVERHANG DIAPHRAGM. CRACKING IN BAY 1, 2 AND 3 DIAPHRAGMS.

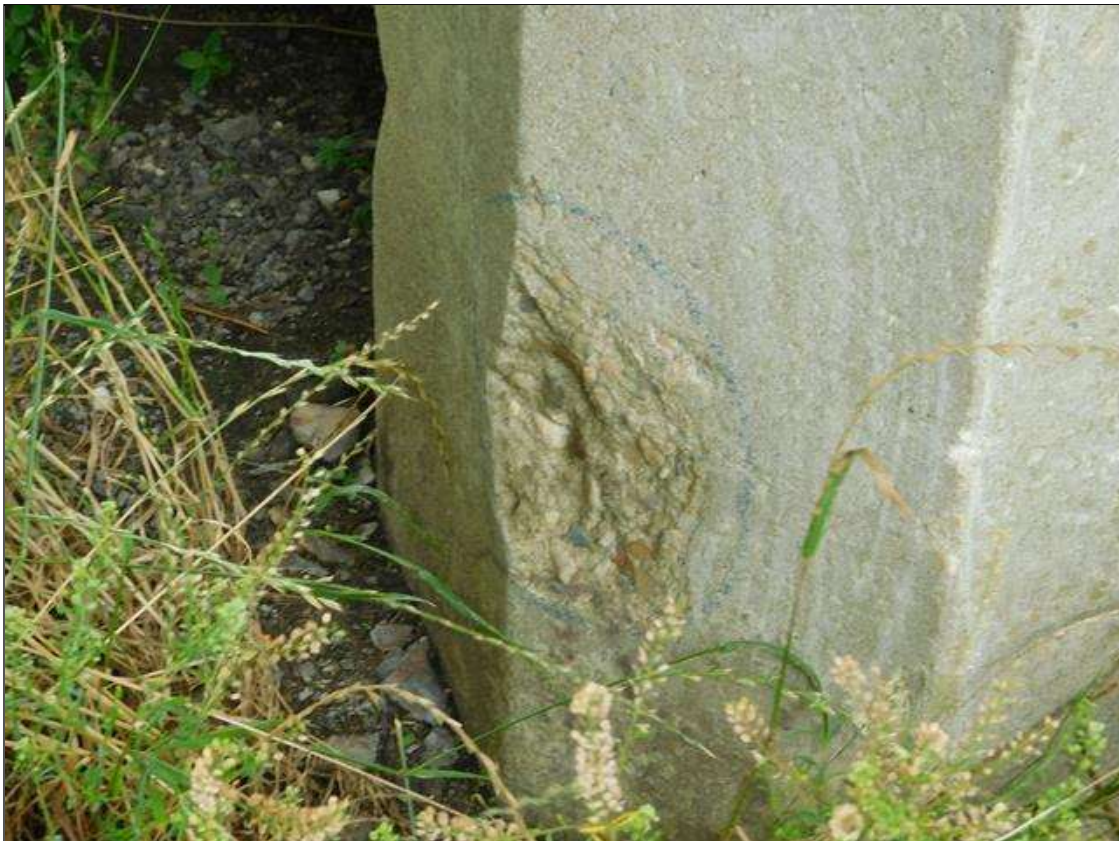
Bent 1 Pile 3: 5 INCH DIAMETER SPALL 1/2 INCH DEEP GROUNDLINE

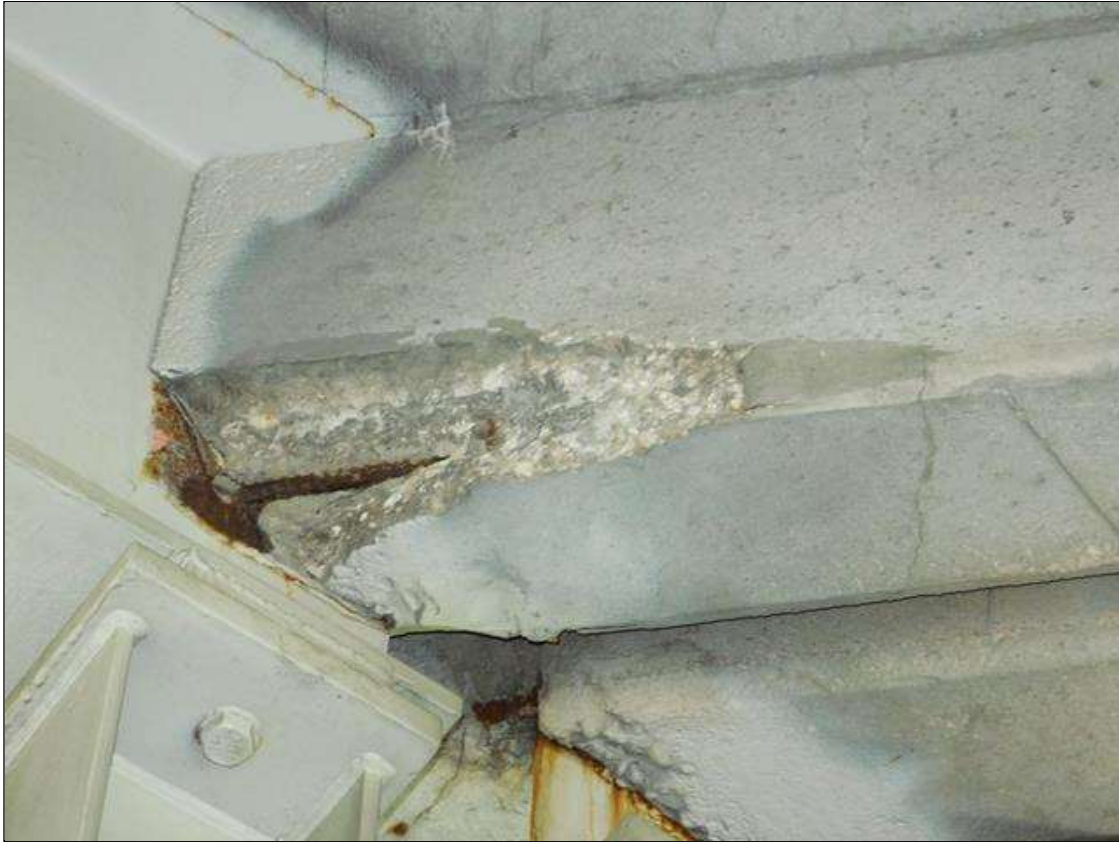
Span 2 Deck: 12 INCH X 8 INCH X 3 INCH DEEP SPALL WITH EXPOSED REBAR (WITHOUT SECTION LOSS) IN END DIAPHRAGM AT BENT 1 BAY 2.

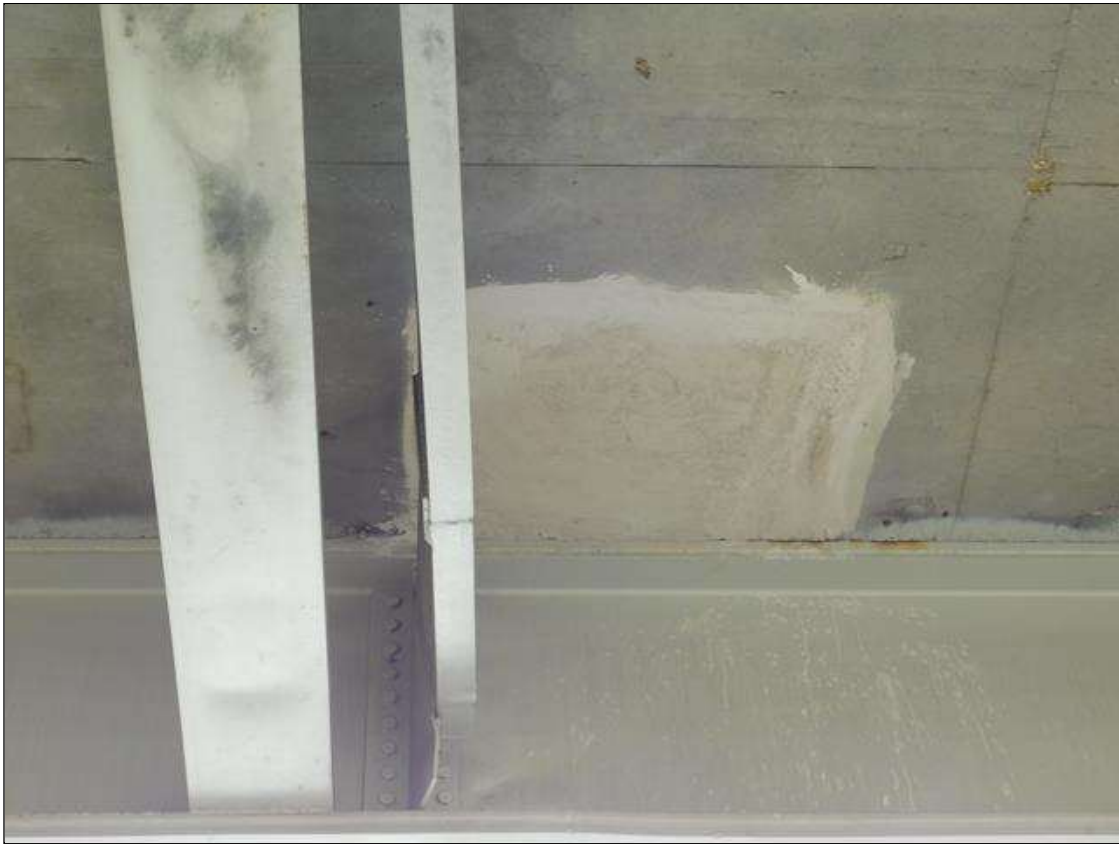
Span 2 Deck: 10 SQUARE FEET OF SOUND PATCHING IN BOTTOM OF DECK BAY 1 AT 1/3 POINT FROM BENT 1. THIS AREA WAS PREVIOUSLY DELAMINATING OVER LANES OF TRAFFIC AND WAS ISSUED A PRIORITY MAINTENANCE AND HAS BEEN REPAIRED SINCE LAST INSPECTION.

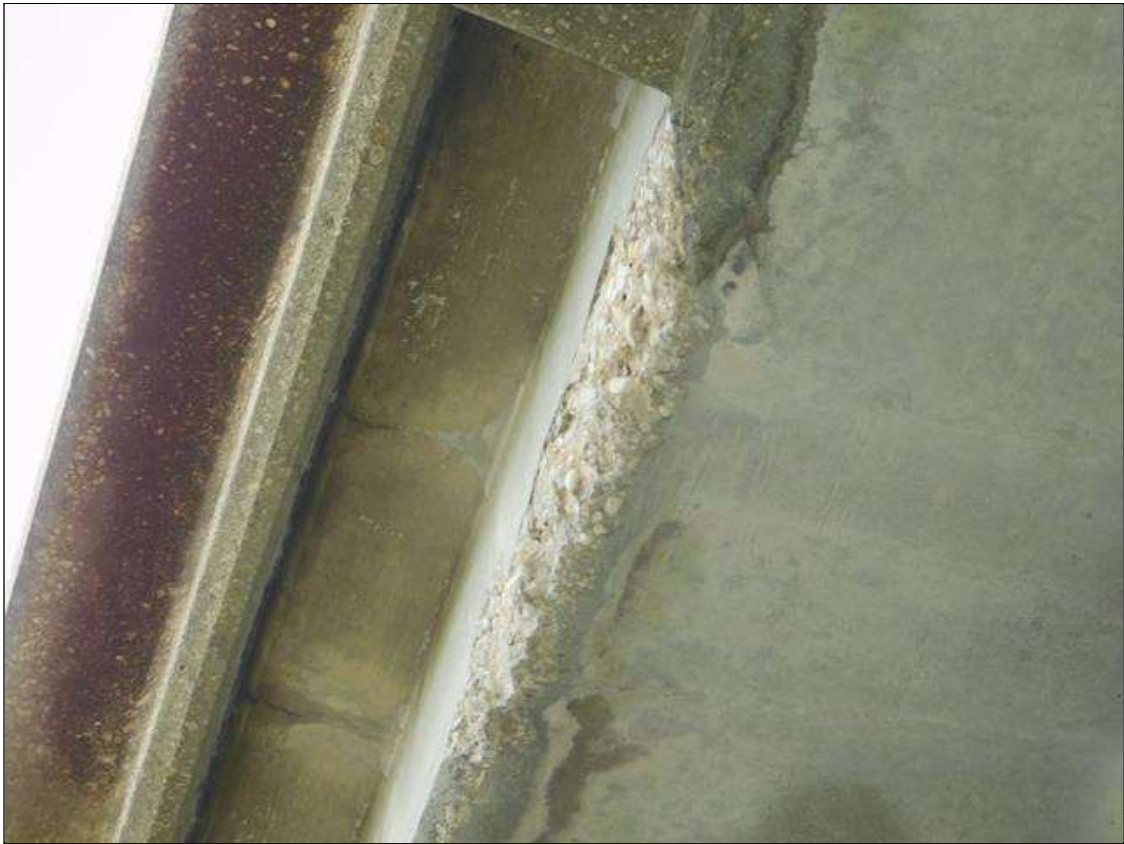
Span 2 Deck: SPALL LEFT OVERHANG 2 FEET X 6 INCH X 1 INCH DEEP

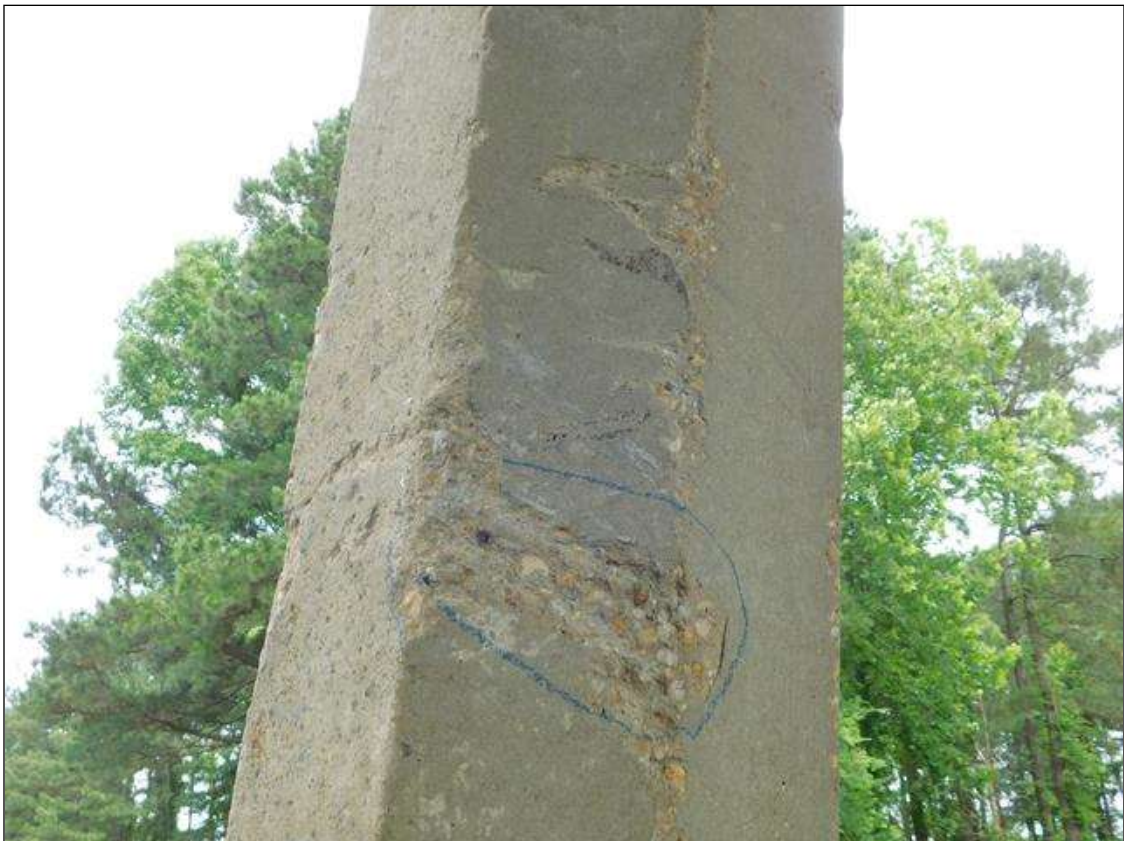
Bent 2 Pile 1: 1 FOOT SPALLING 1 INCH DEEP SPAN 2 SIDE

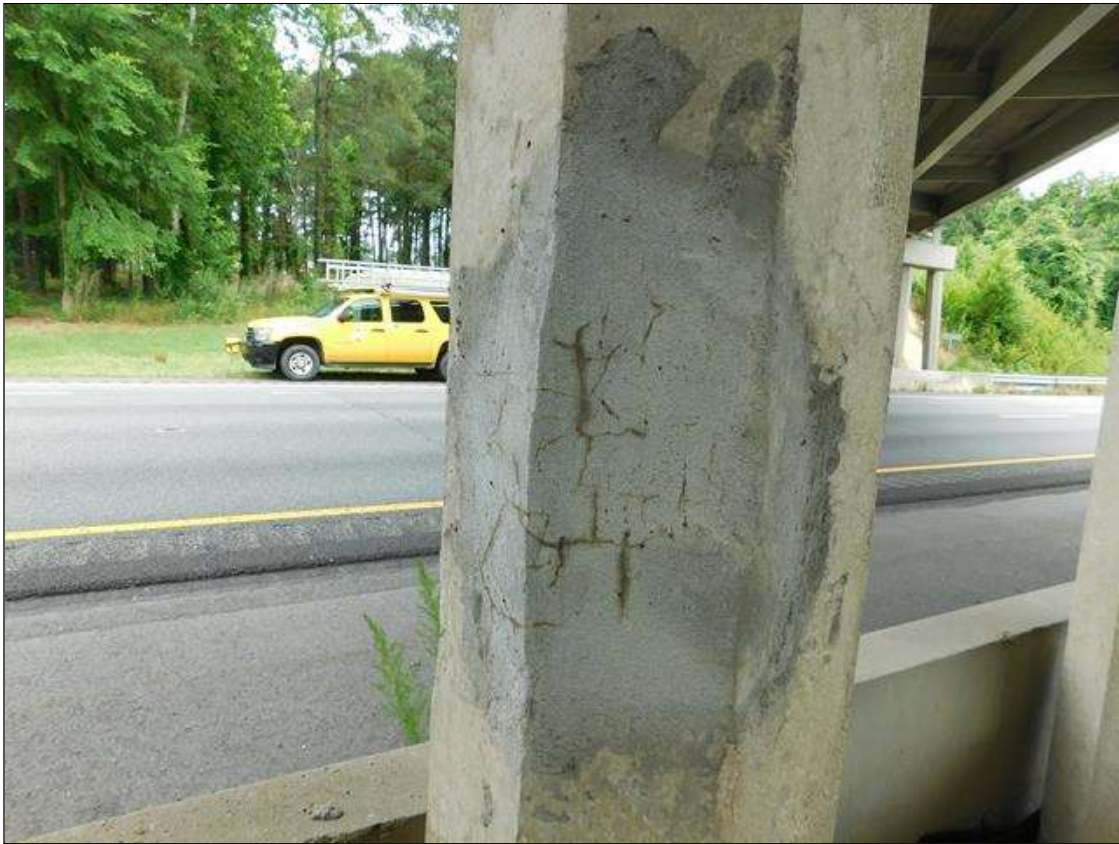
Bent 2 Pile 2: 2 FEET PATCHING

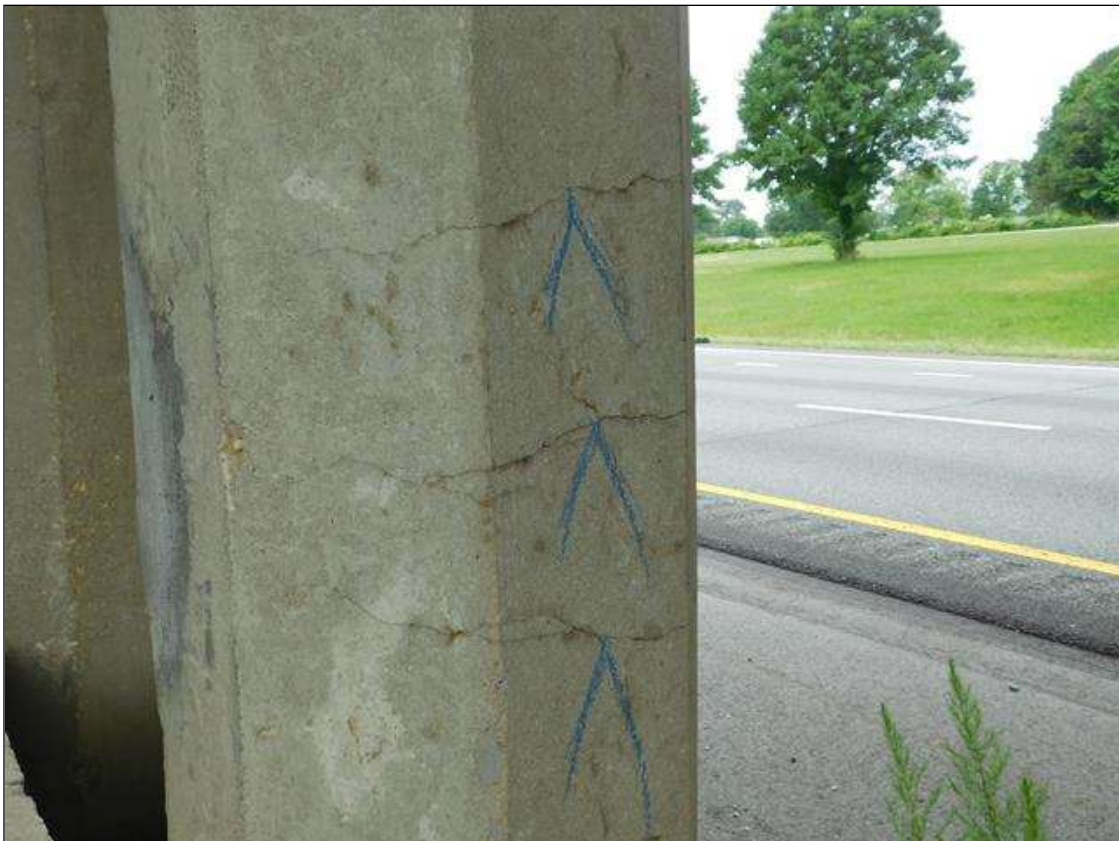
Bent 2 Pile 2: 3 TRANSVERSE 1/32 INCH CRACKS RIGHT SIDE 4 FEET FROM GROUNDLINE

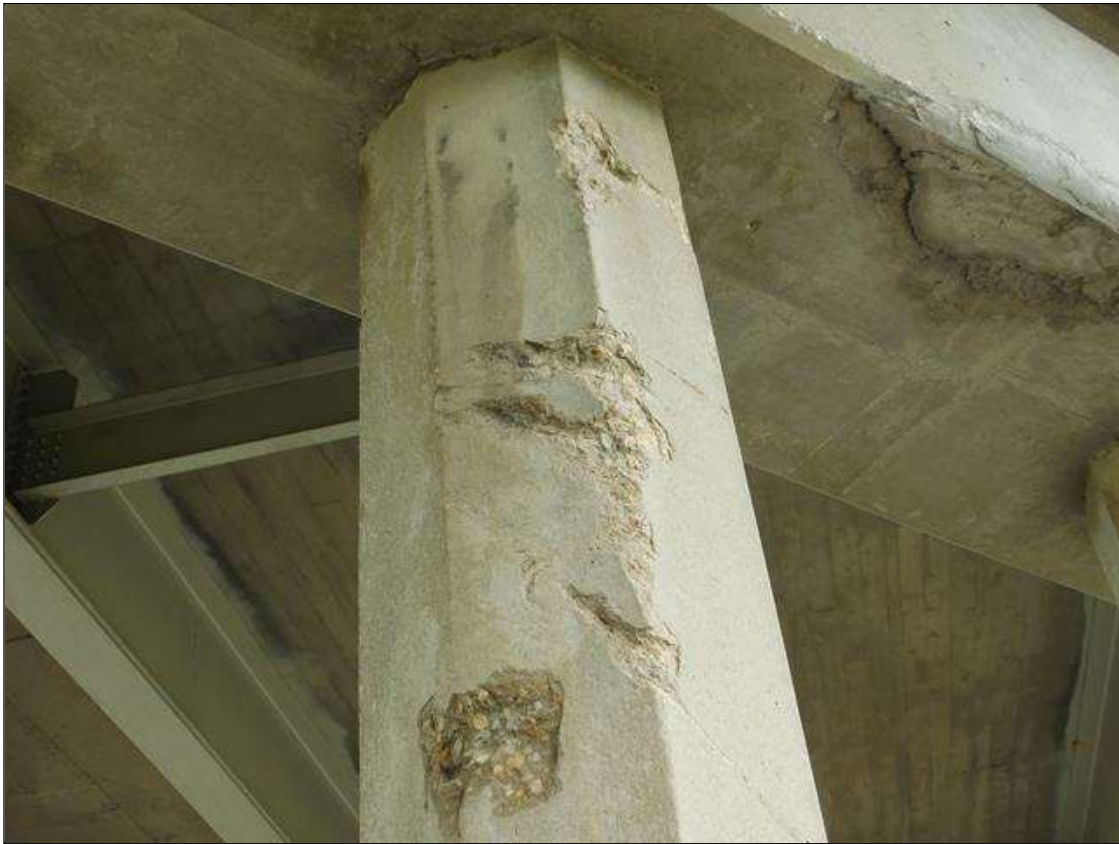
Bent 2 Pile 5: 5 SPALLS 1 IN DEEP TOTALLING 6 SQUARE FEET

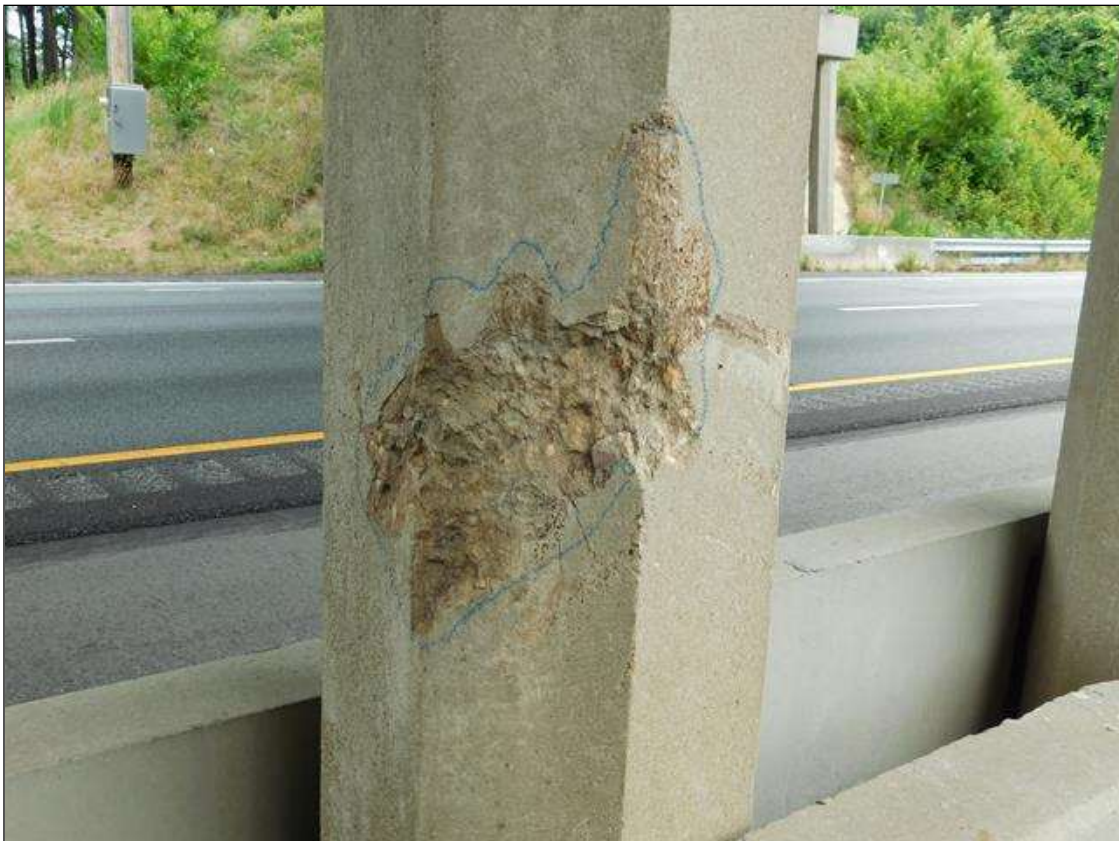
Bent 2 Pile 5: 5 SPALLS 1 IN DEEP TOTALLING 6 SQUARE FEET

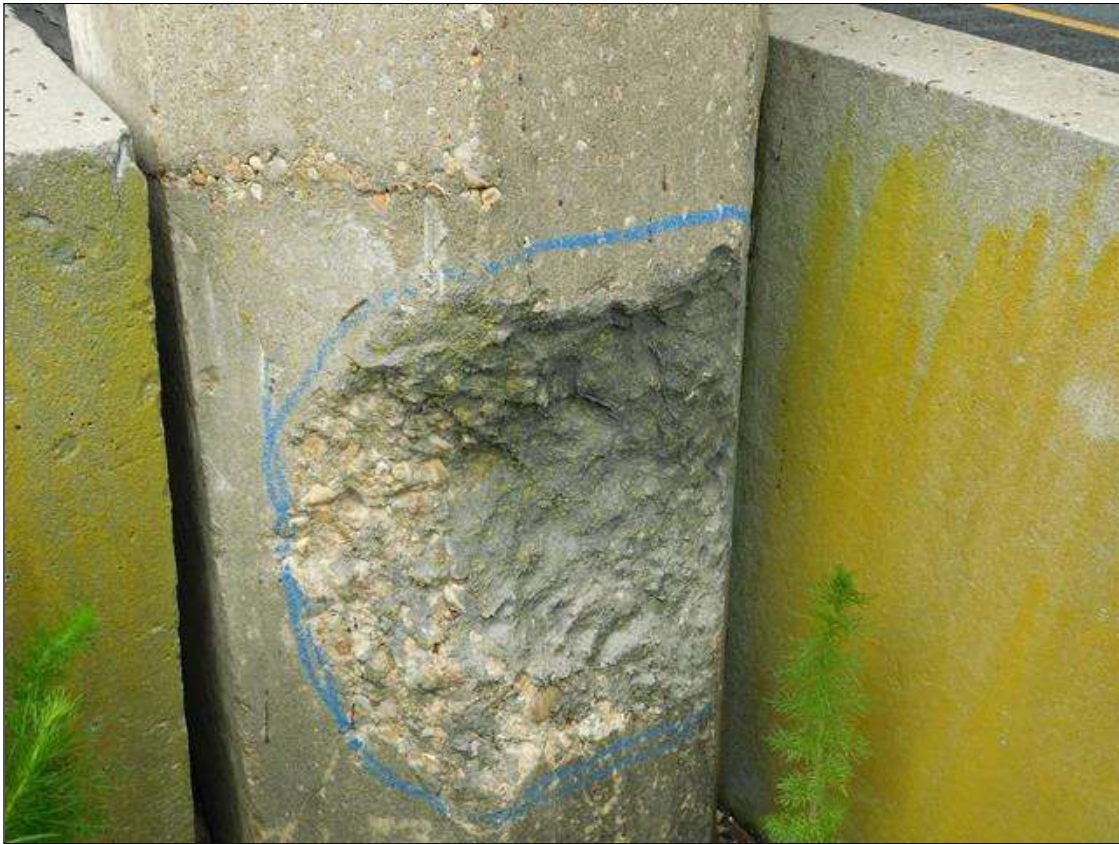
Bent 2 Pile 7: SPALL 1 FOOT FROM GROUNDLINE 4 INCH DEEP X 16 INCH DIAMETER RIGHT SIDE WITH 3 1/32 INCH HORIZONTAL CRACKS LEFT SIDE OPPOSITE SPALL

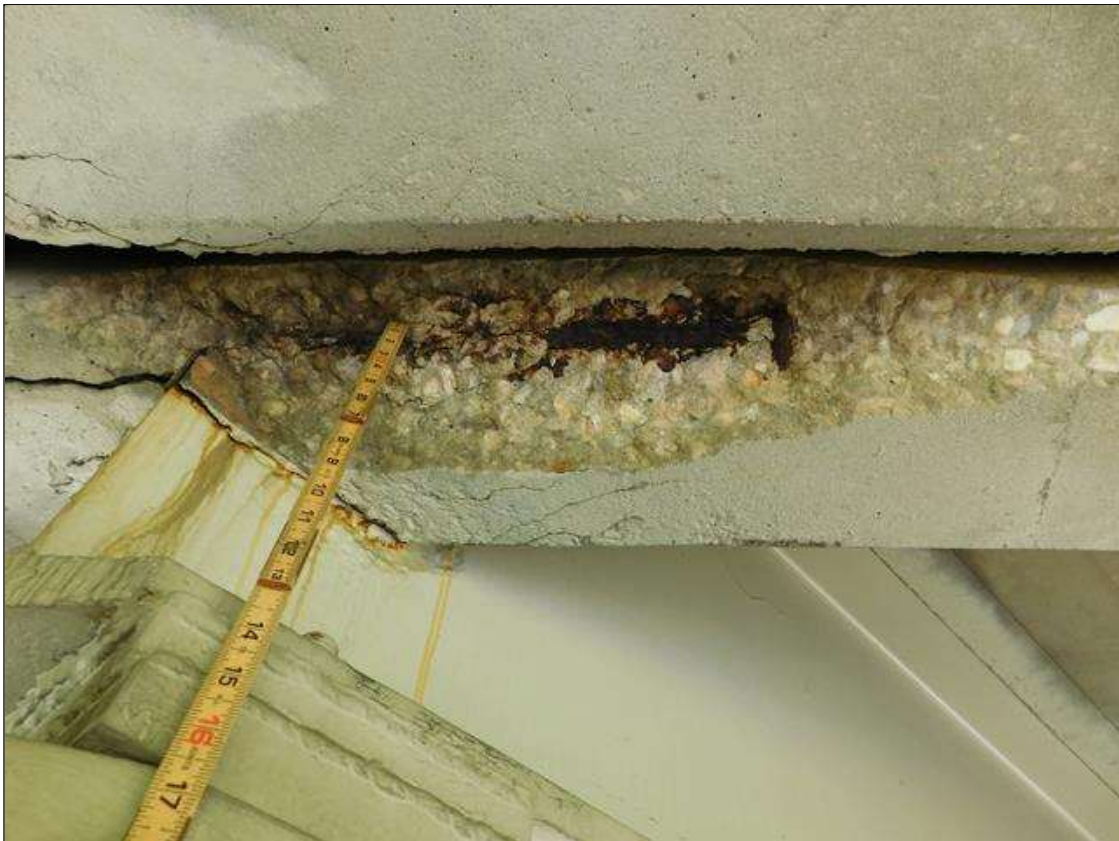
Span 3 Deck: 36" LONG SPALL 6" WIDE X 3" DEEP WITH SECTION LOSS TO EXPOSED REBAR (ESTIMATED 3/4" REMAINING) IN END DIAPHRAGM AT BENT 2 BAY 2. PAR ISSUED.

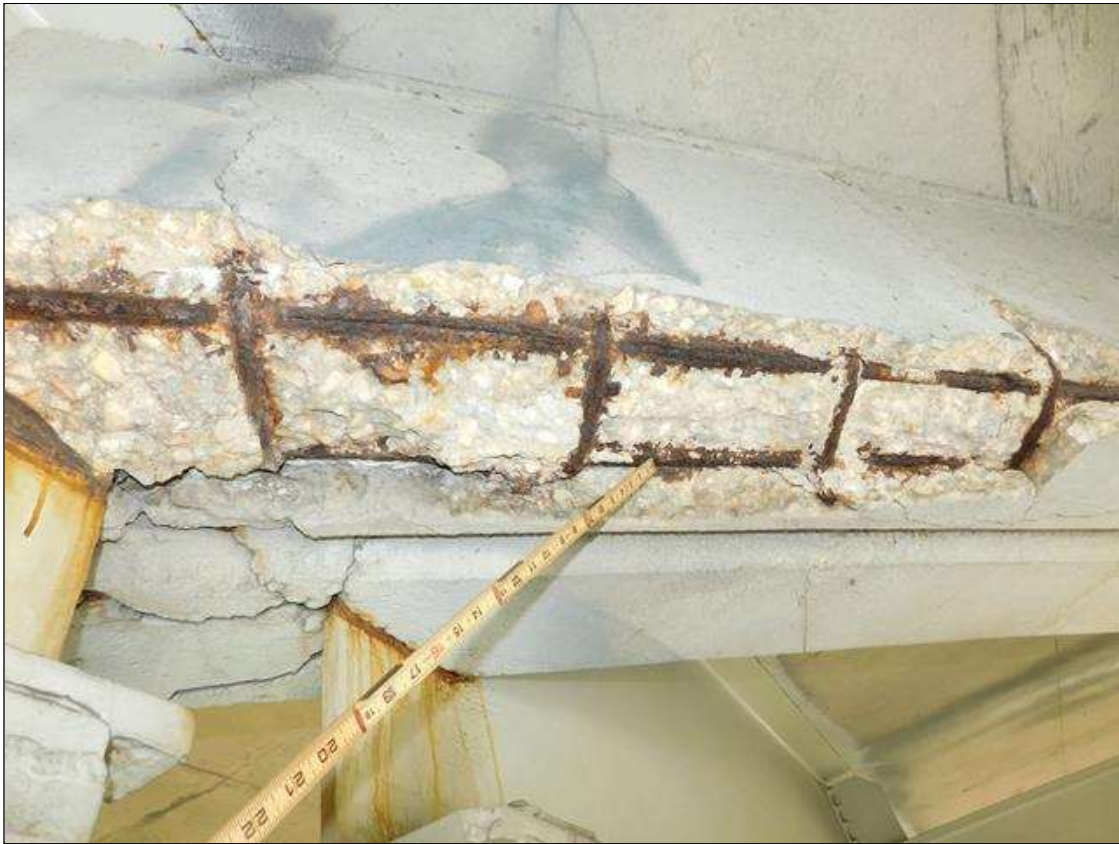
Span 3 Deck: 6' OF SPALLING AND DELAMINATION WITH SECTION LOSS TO EXPOSED REBAR (ESTIMATED 1 INCH REMAINING) 4 INCHES DEEP X 6 FEET LONG X 10 INCHES WIDE IN SPAN 3 END DIAPHRAGM OVER BENT 3, BAY 2. PAR ISSUED.

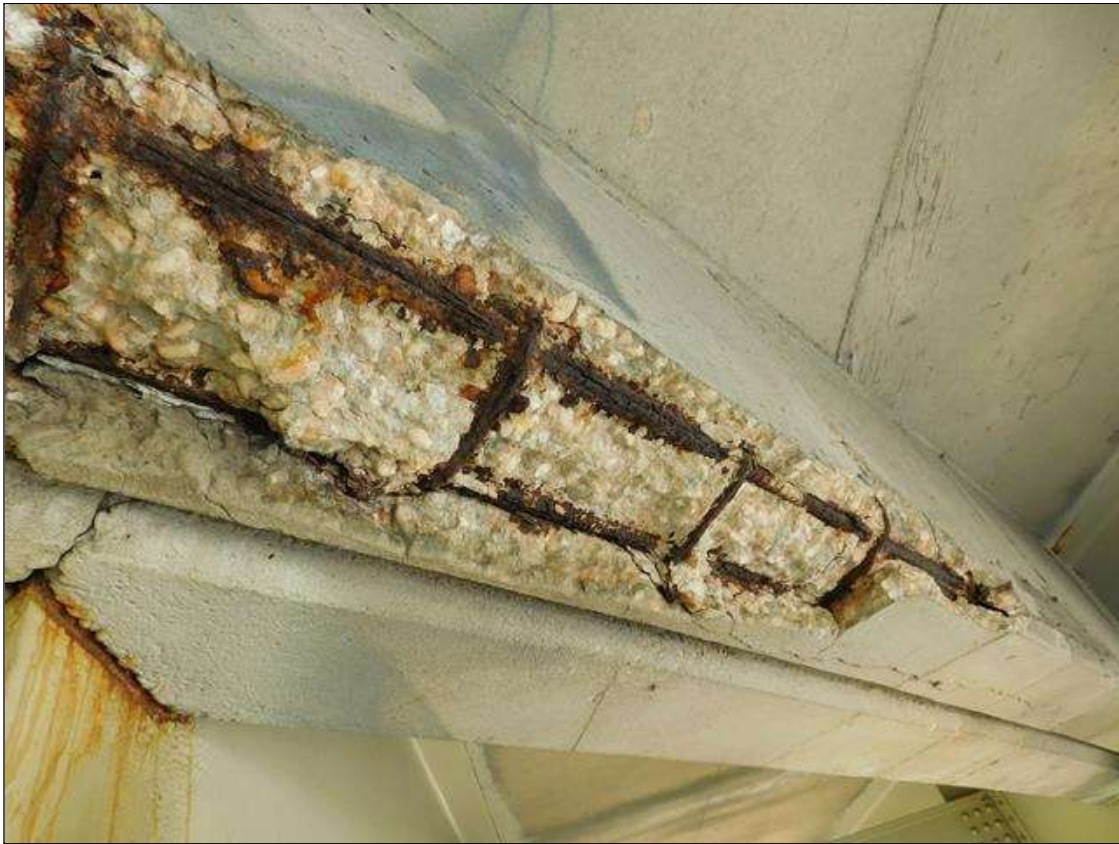
Span 3 Deck: 6' OF SPALLING AND DELAMINATION WITH SECTION LOSS TO EXPOSED REBAR (ESTIMATED 1 INCH REMAINING) 4 INCHES DEEP X 6 FEET LONG X 10 INCHES WIDE IN SPAN 3 END DIAPHRAGM OVER BENT 3, BAY 2. PAR ISSUED.

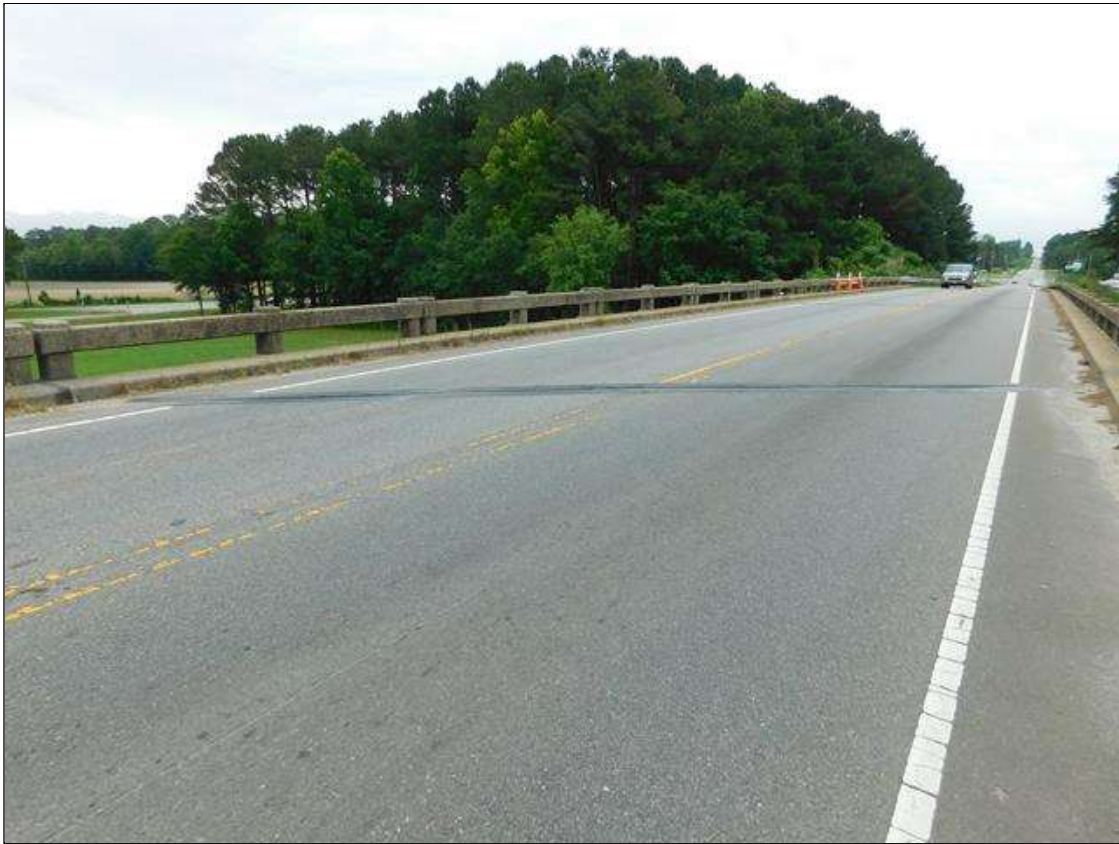
ASPHALT WEARING SURFACE OVERVIEW

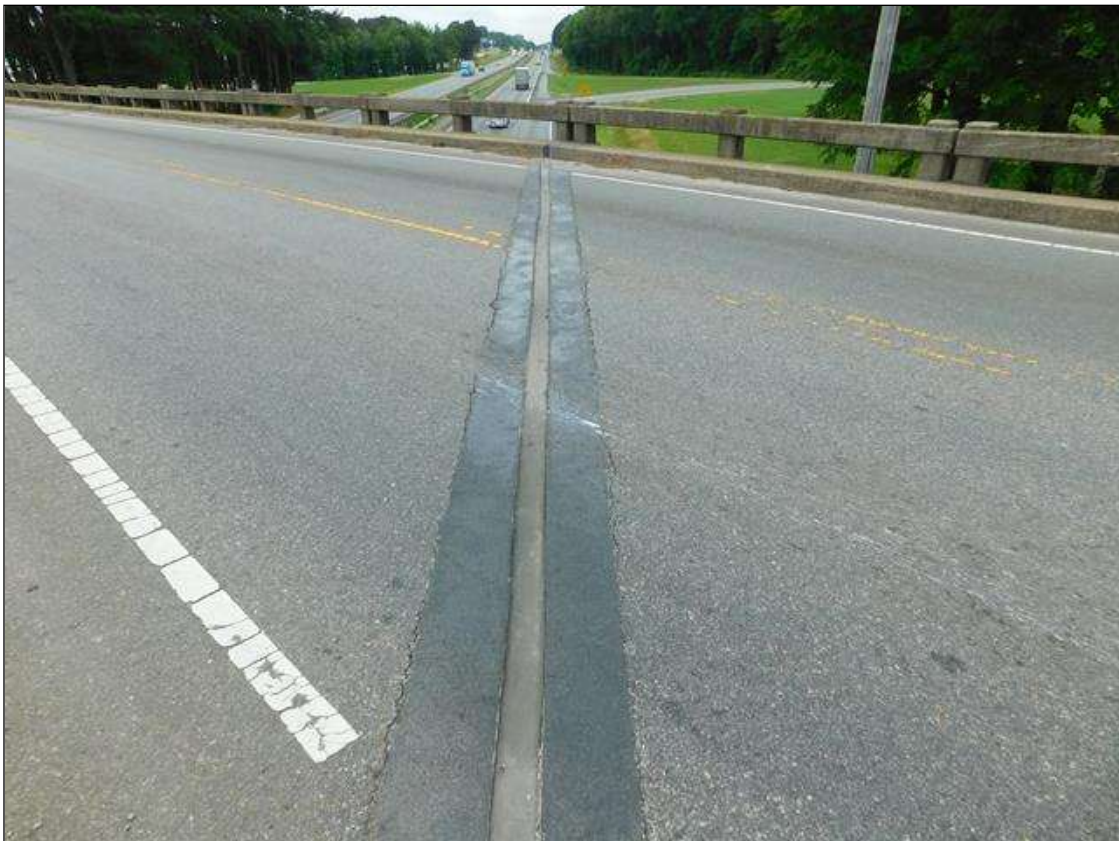
EXPANSION JOINT AT BENT 3 - OTHERS SIMILAR

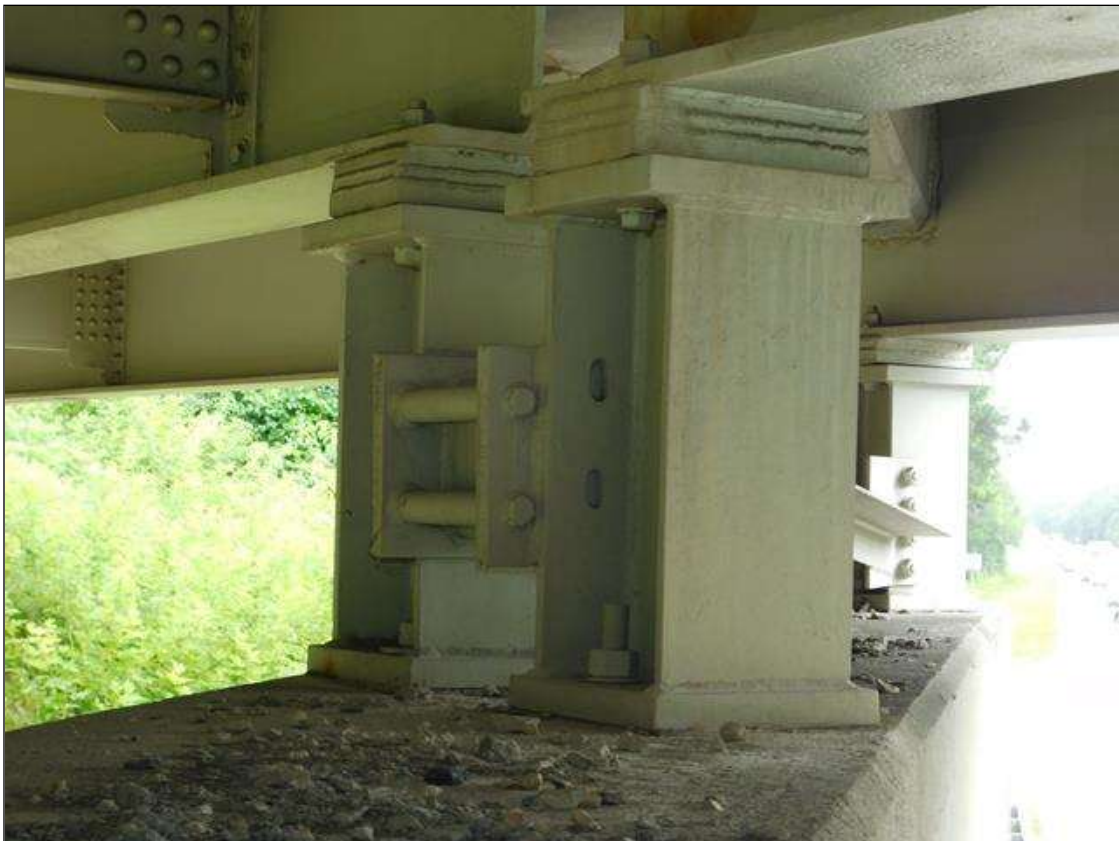
TYPICAL BEARING ASSEMBLY AT INTERIOR BENTS

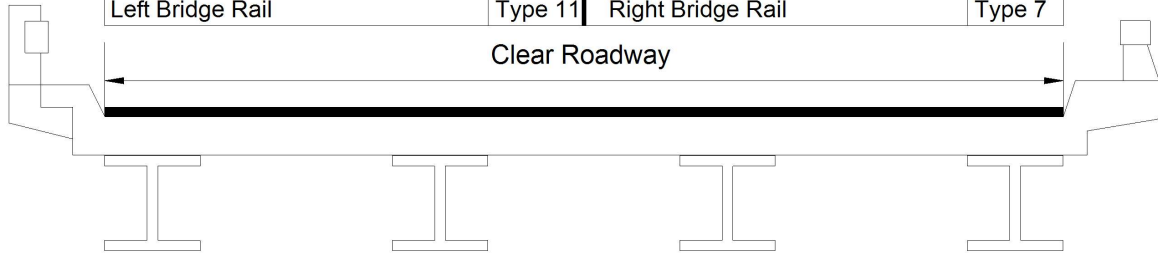
Measurements for Span #	1	ALL SPANS SIMILAR	
Deck Thickness	0.583	Left Overhang	4.708
Top of Rail to Bottom of Beam	6.083	Right Overhang	4.708

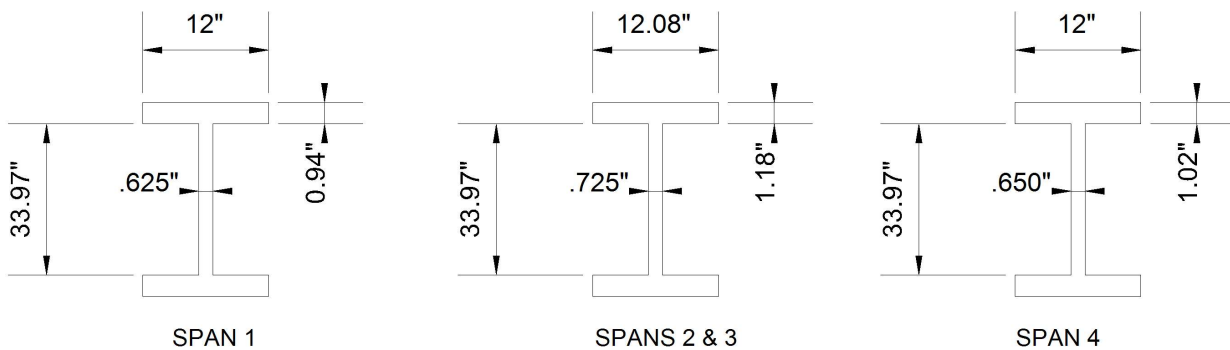
VERIFIED BY: WTW 6/8/2021

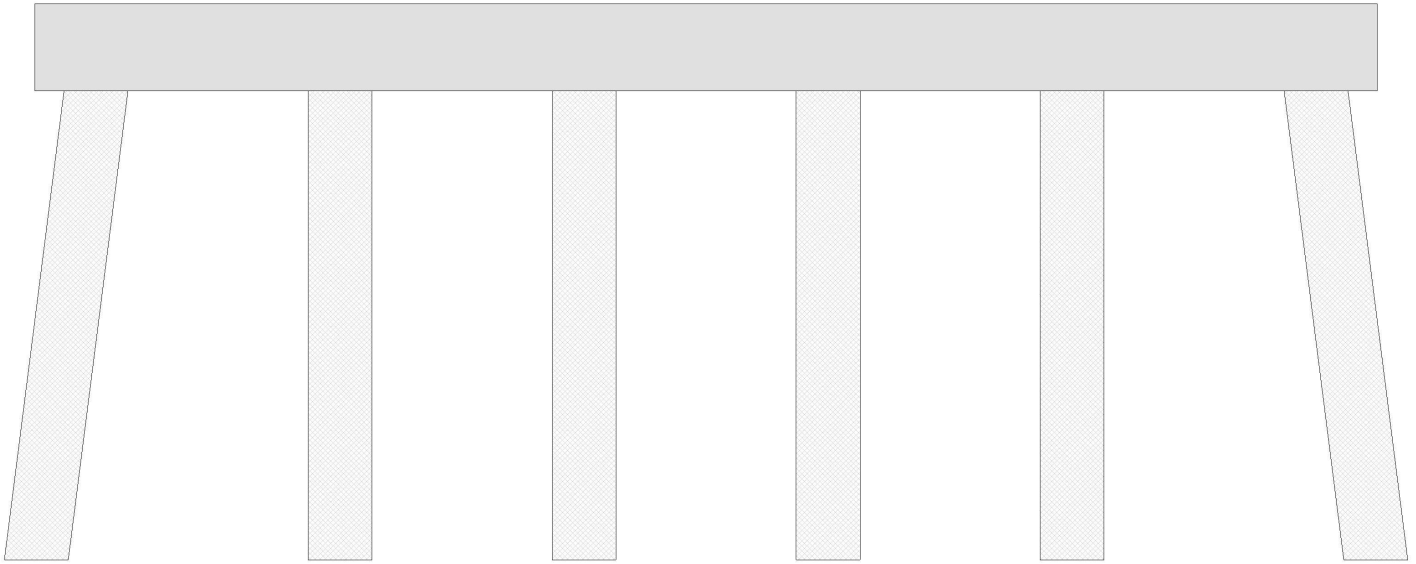
Cap Information			Material Cast-in-Place Concrete							
Length	Width	Height	Left Overhang	Right Overhang	Left Beam to End of Cap.	Right Beam to End of Cap.				
38.500 ft.	3.000 ft.	2.500 ft.	1.750 ft.	1.750 ft.	2.000 ft.	2.000 ft.				
Subcap Information			Material							
Length	Width	Height	Left Overhang	Right Overhang	Left Pile to Splice.					
Sill Information			Material							
Length	Width	Height	VERIFIED BY: WTW 6/8/2021							
Pile #	Material	Spacing	Width/Dia.	Height	Length	Orientation	Driven?	Replacement?	Removed?	Collar?
1	Concrete	7 ft.	1.833 ft.			Battered	No	No	No	No
2	Concrete	7 ft.	1.833 ft.			Vertical	No	No	No	No
3	Concrete	7 ft.	1.833 ft.			Vertical	No	No	No	No
4	Concrete	7 ft.	1.833 ft.			Vertical	No	No	No	No
5	Concrete	7 ft.	1.833 ft.			Vertical	No	No	No	No
6	Concrete		1.833 ft.			Battered	No	No	No	No
Bent/Abutment #: 1			Similar Bents:

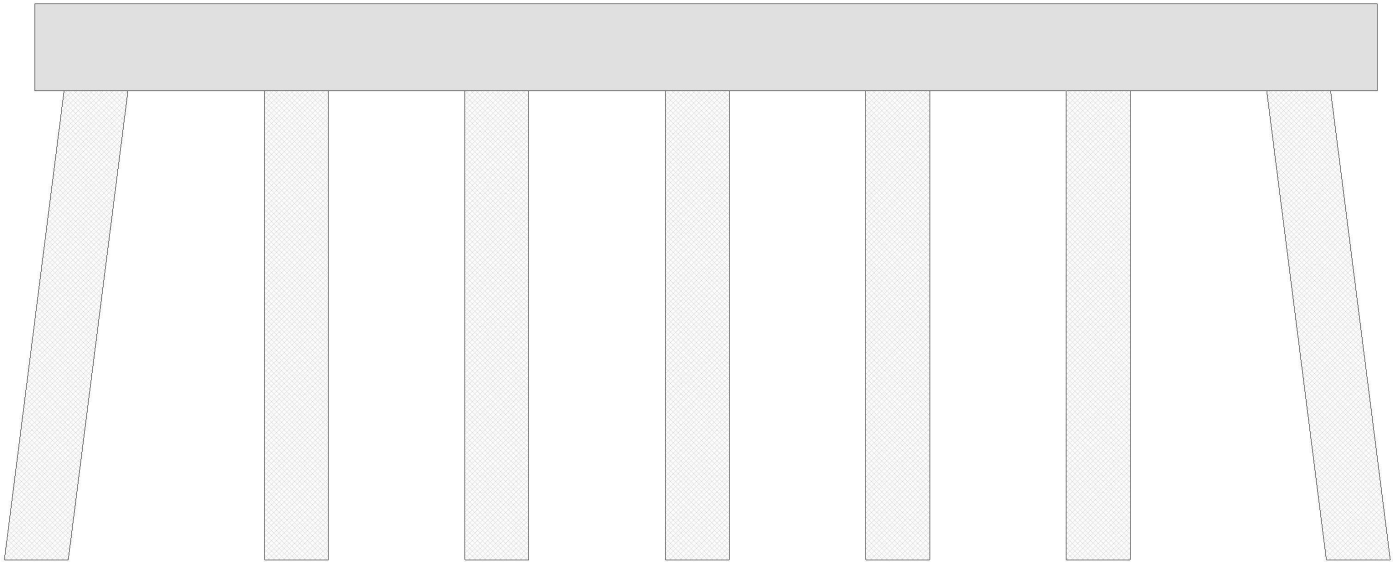
Cap Information			Material Cast-in-Place Concrete							
Length	Width	Height	Left Overhang	Right Overhang	Left Beam to End of Cap.	Right Beam to End of Cap.
