NC DEPARTMENT OF TRANSPORTATION
 DIVISION OF HIGHWAYS
 STRUCTURE MANAGEMENT UNIT

ATTENTION: Priority Maintenance; Approach Roadway, Typical Section Modified

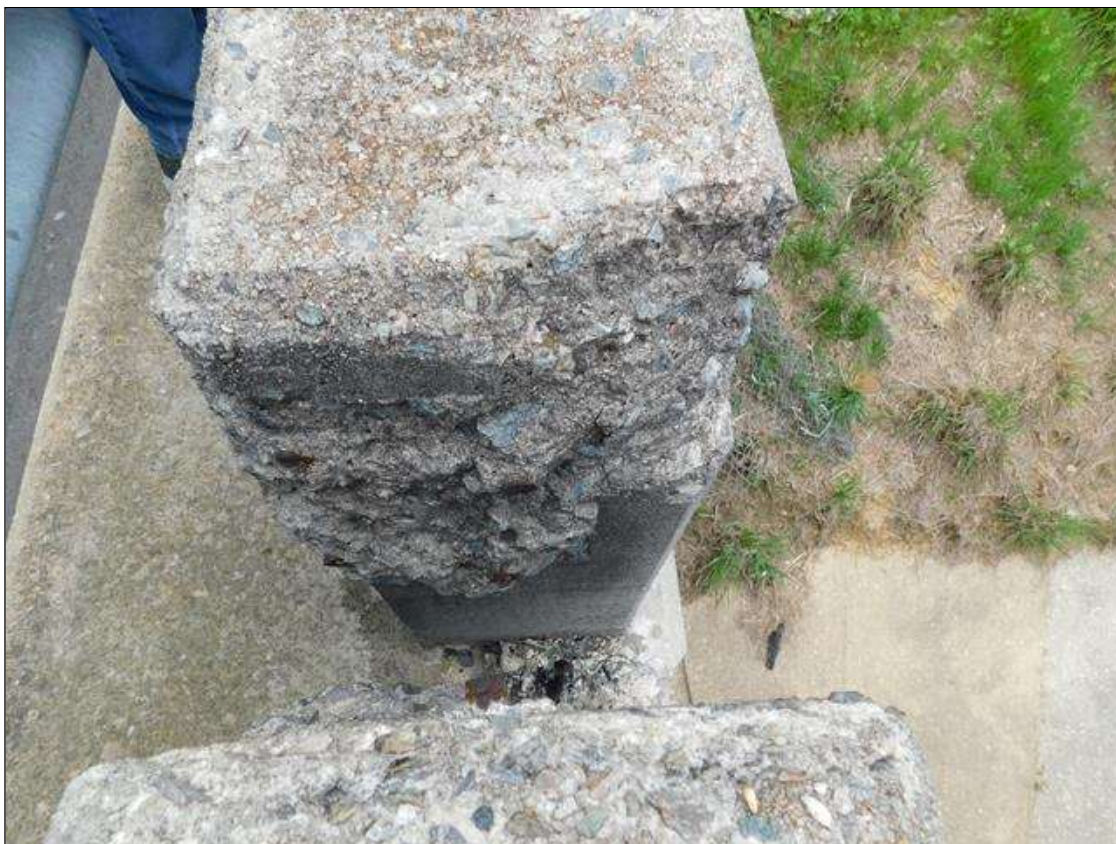
Span 4 Right Bridge Rail: 2" x 8" x 10" deep spall with exposed rebar on concrete Post 7 (Post 6 similar)

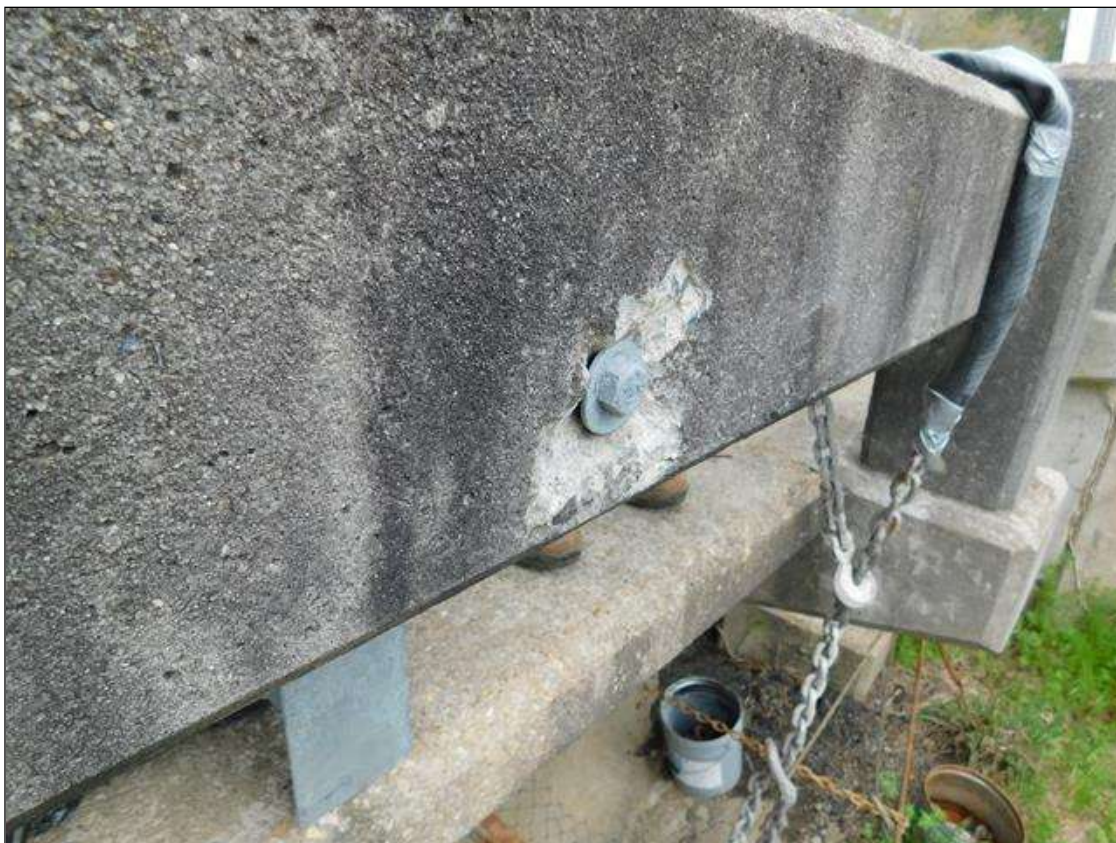
Span 4 Right Bridge Rail: 5" x 4" x 1/2" deep spall on outside face of concrete rail

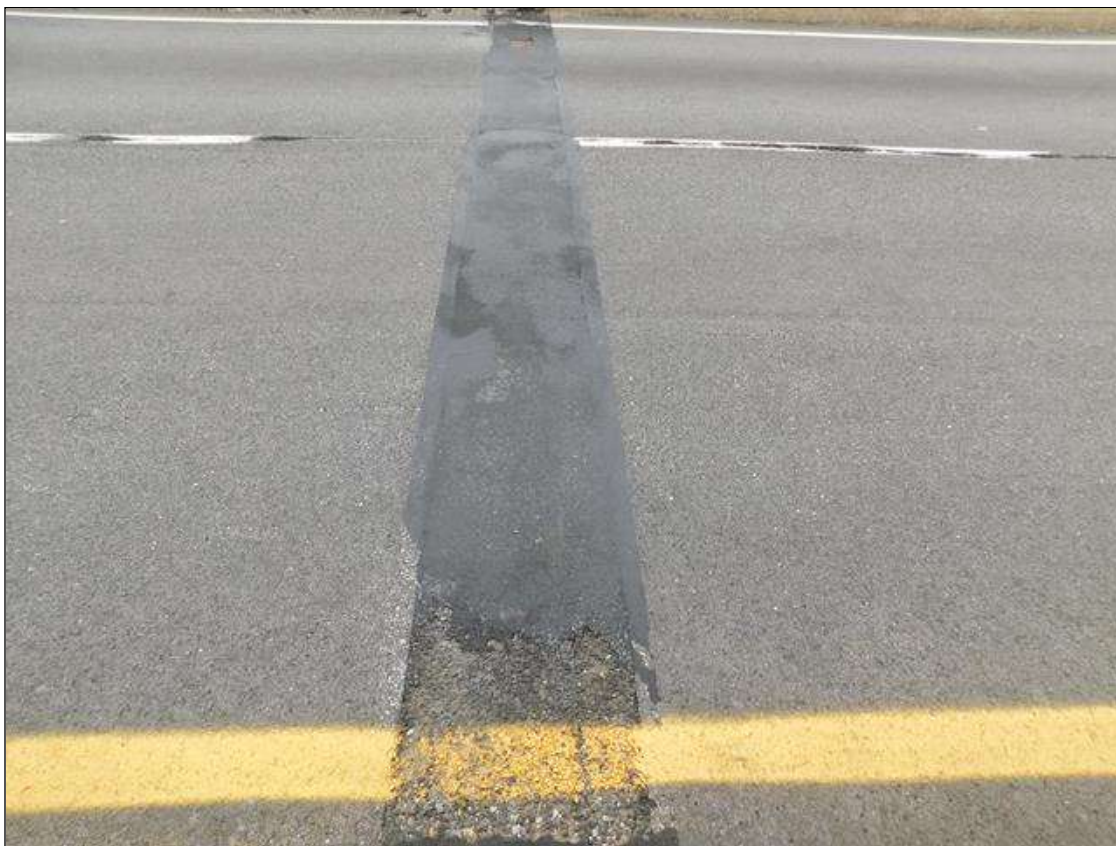
Expansion Joint : (2) up to 20" x 20" x 1/2" deep area of missing asphalt wearing surface along joint

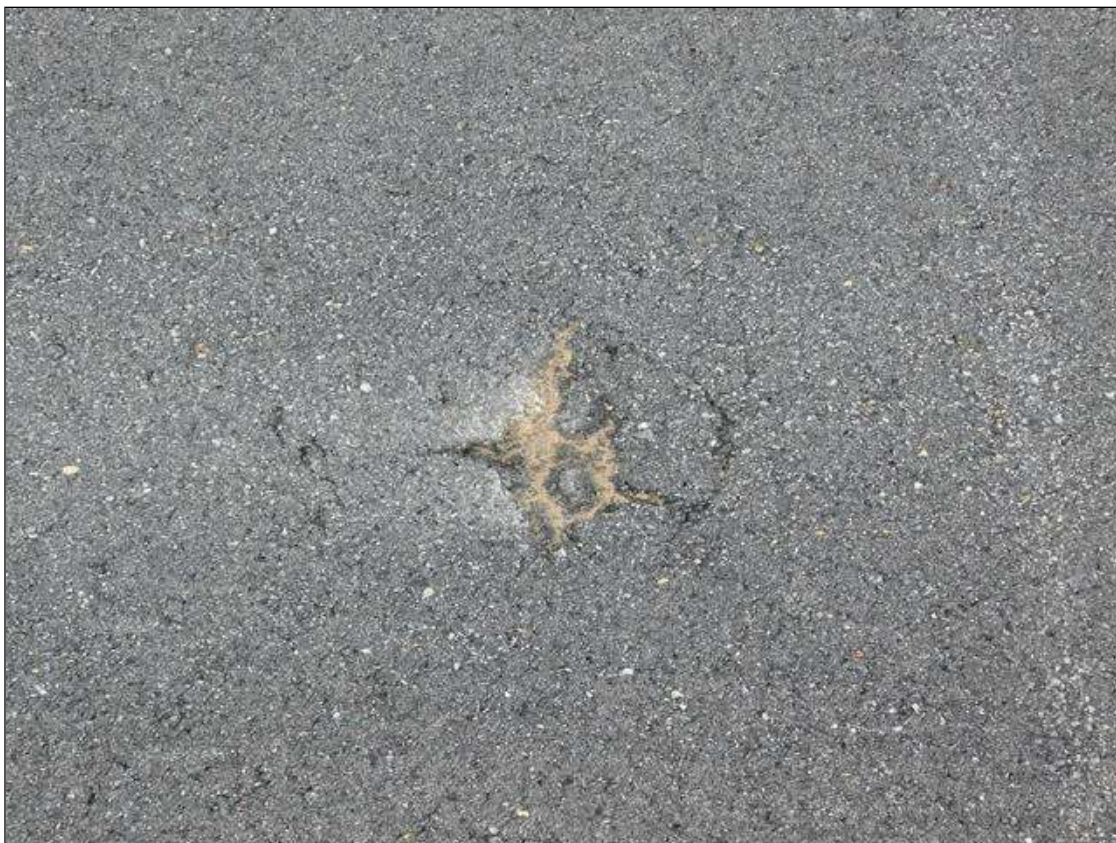
Span 3 Wearing Surface: 6" x 6" area of hairline longitudinal and transverse cracks in East lane, 9' from Bent 2

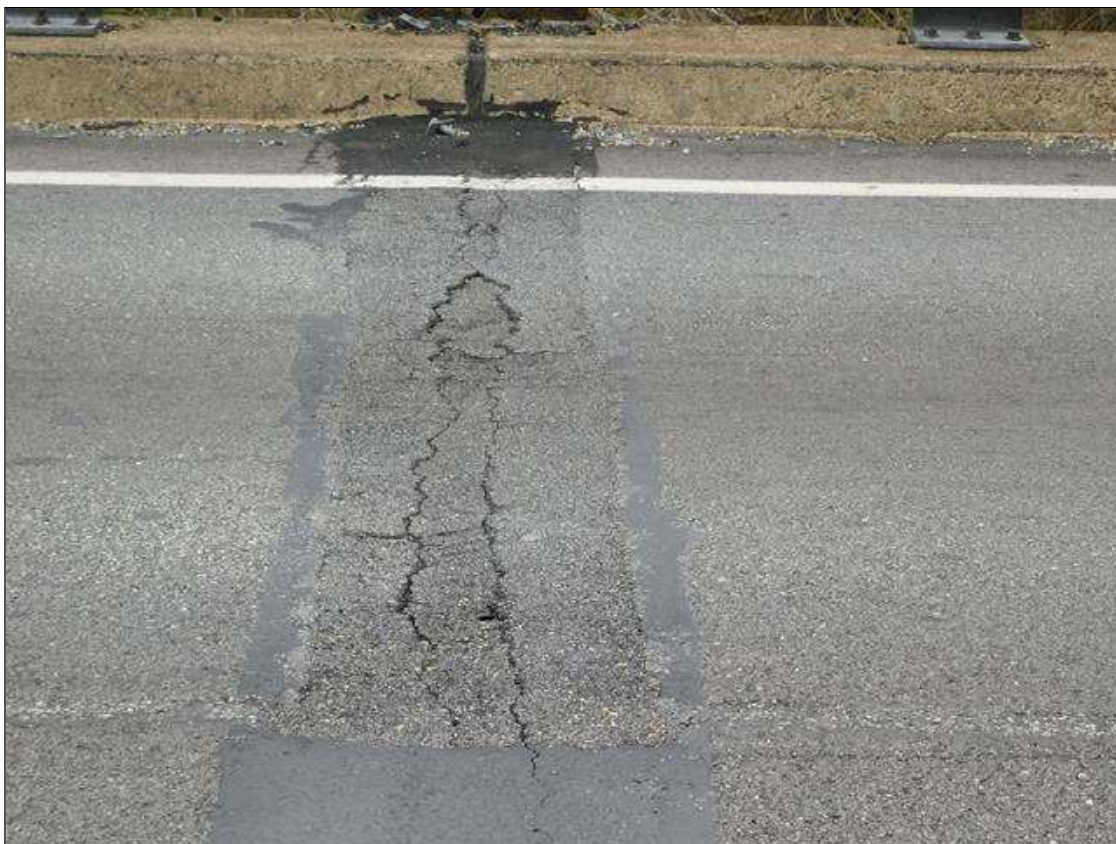
Expansion Joint: 14' x 1' area of up to 1/8" transverse cracks in East lane

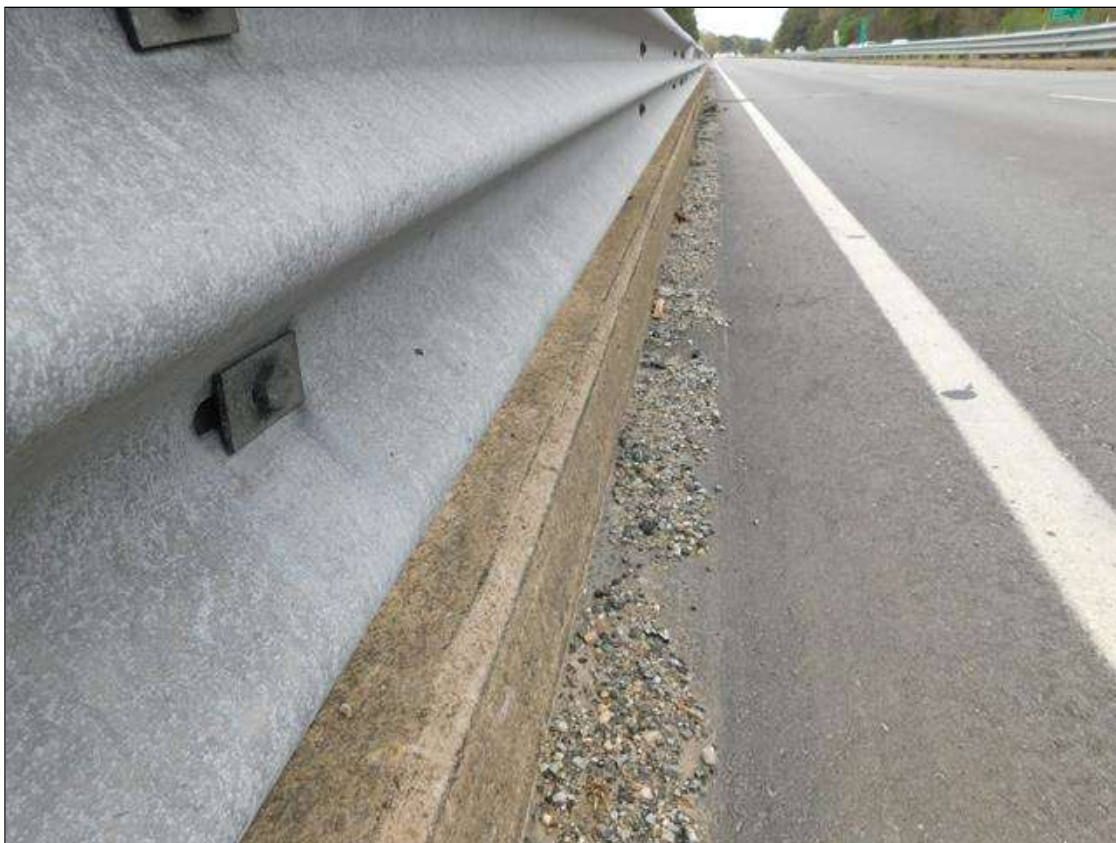
Full length x 1' dirt and debris in West gutter

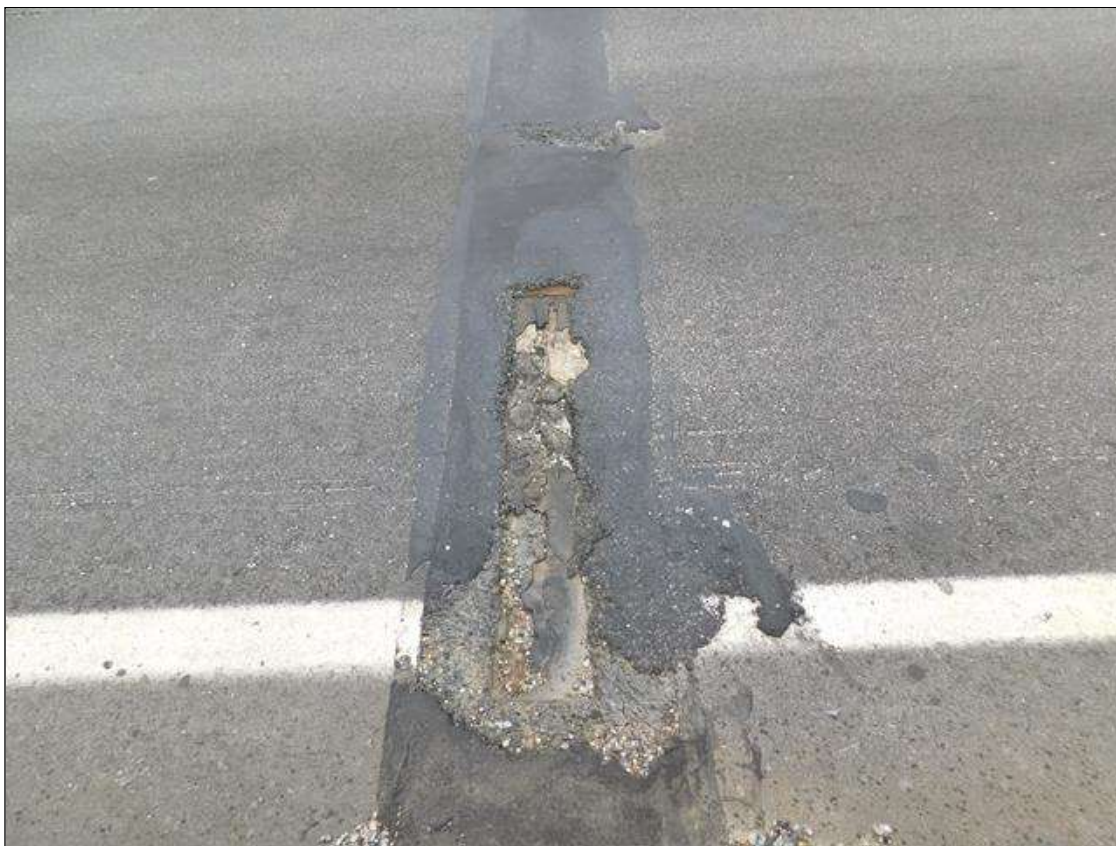
Expansion Joint : (2) up to 36" x 7" x 1" deep area of missing asphalt wearing surface along joint

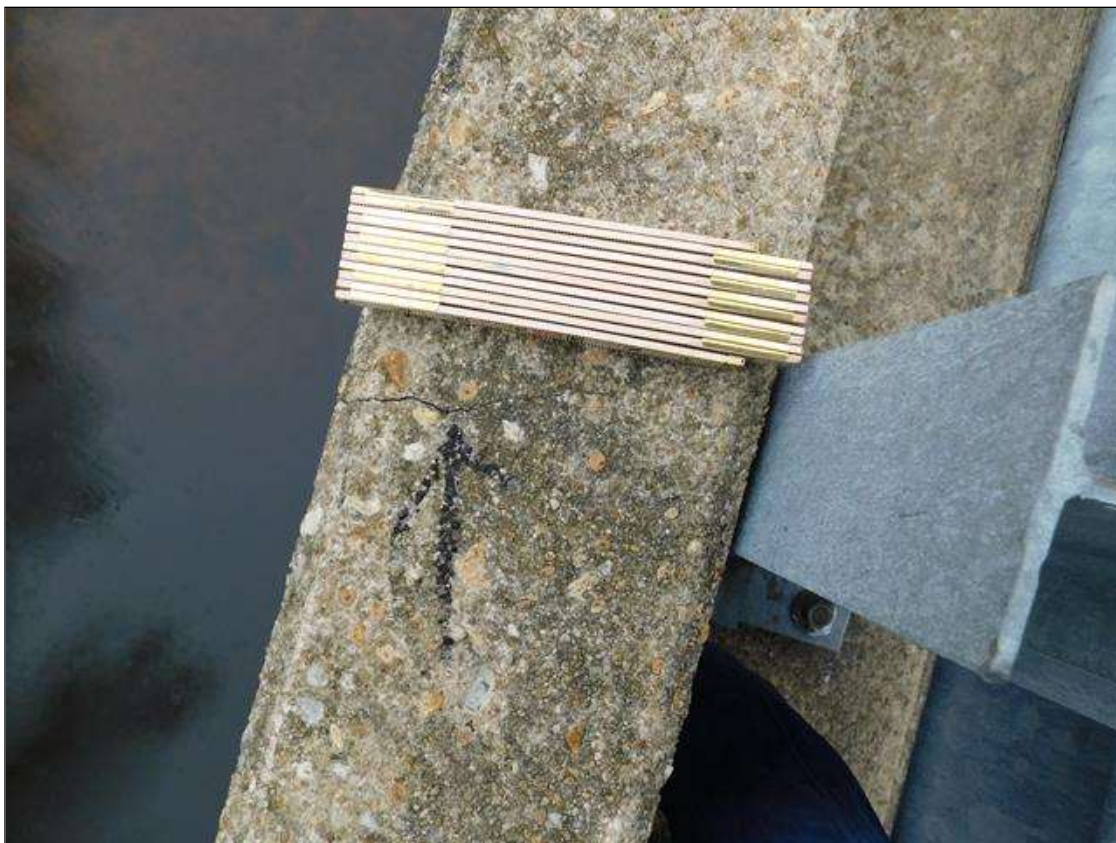
Span 2 Left Bridge Rail: (4) hairline vertical and transverse cracks on concrete rail and curb

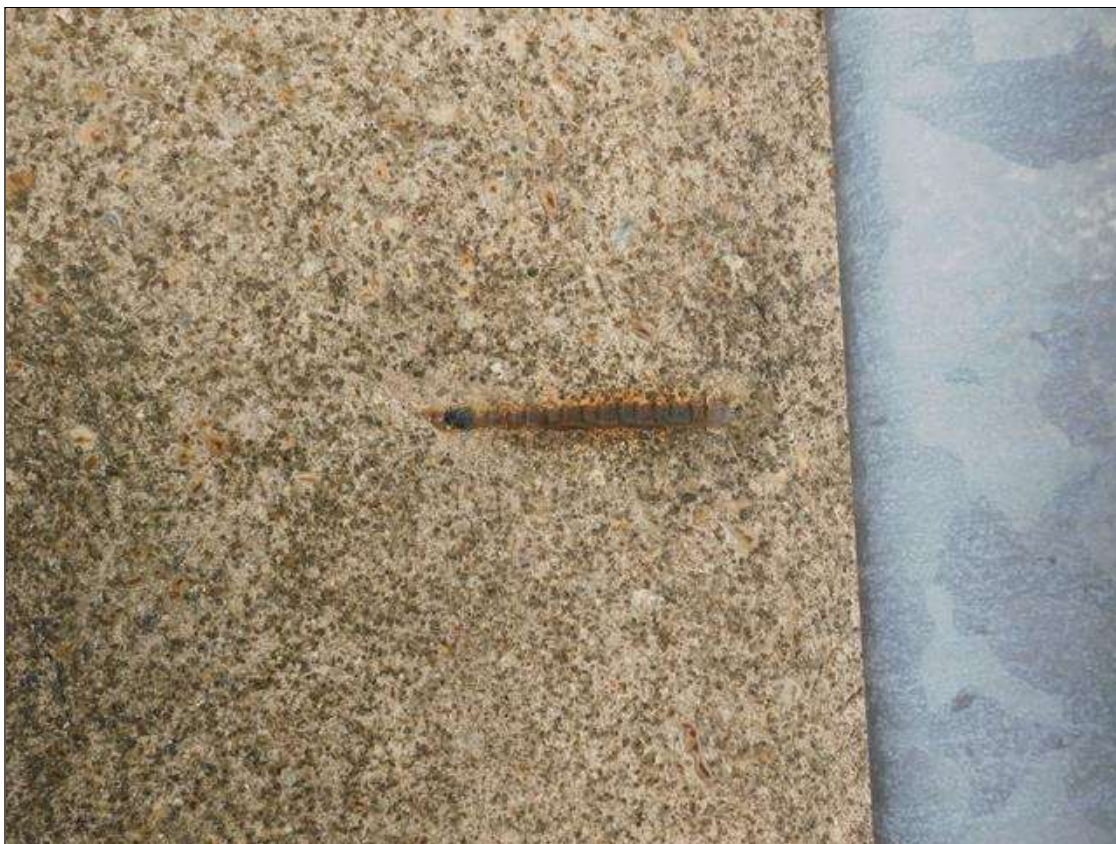
Span 4 Left Bridge Rail: 6" x 1" x 1/2" deep spall with exposed rebar on top of curb, 7' from Bent 3

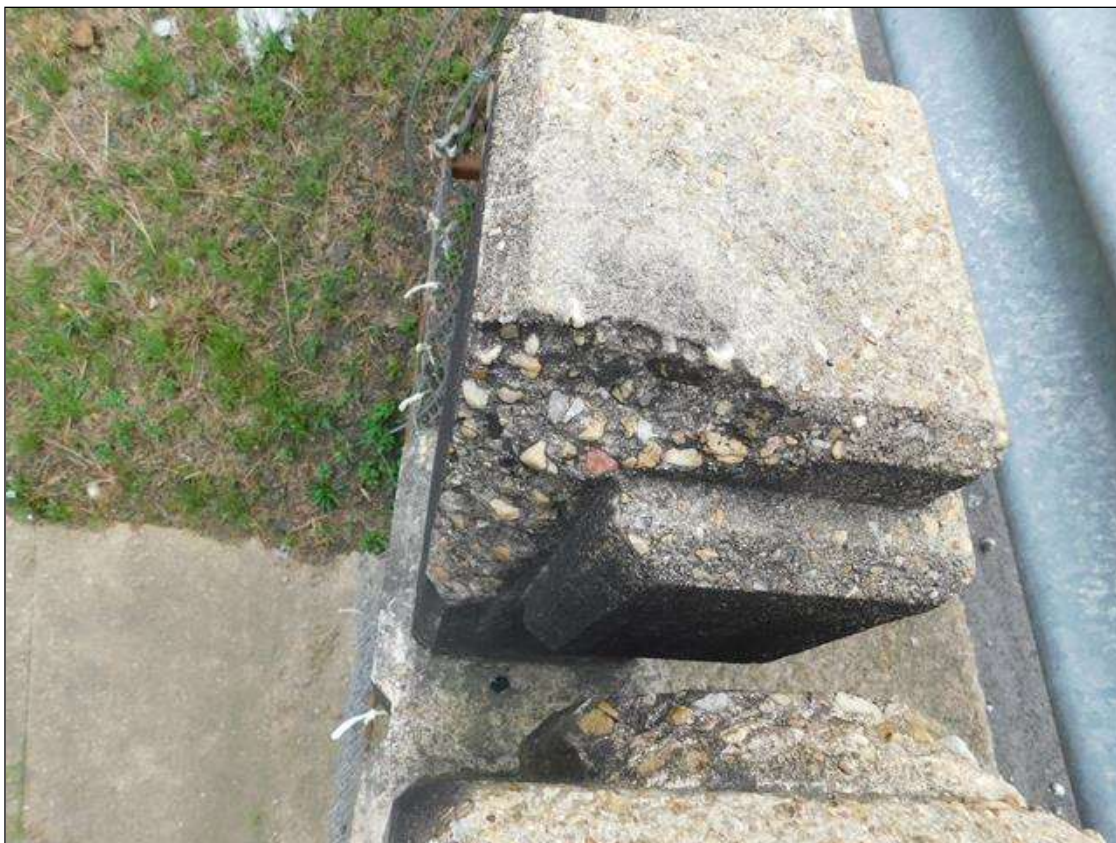
Span 4 Left Bridge Rail: 2" x 10" x 6" deep spall on concrete Post 7

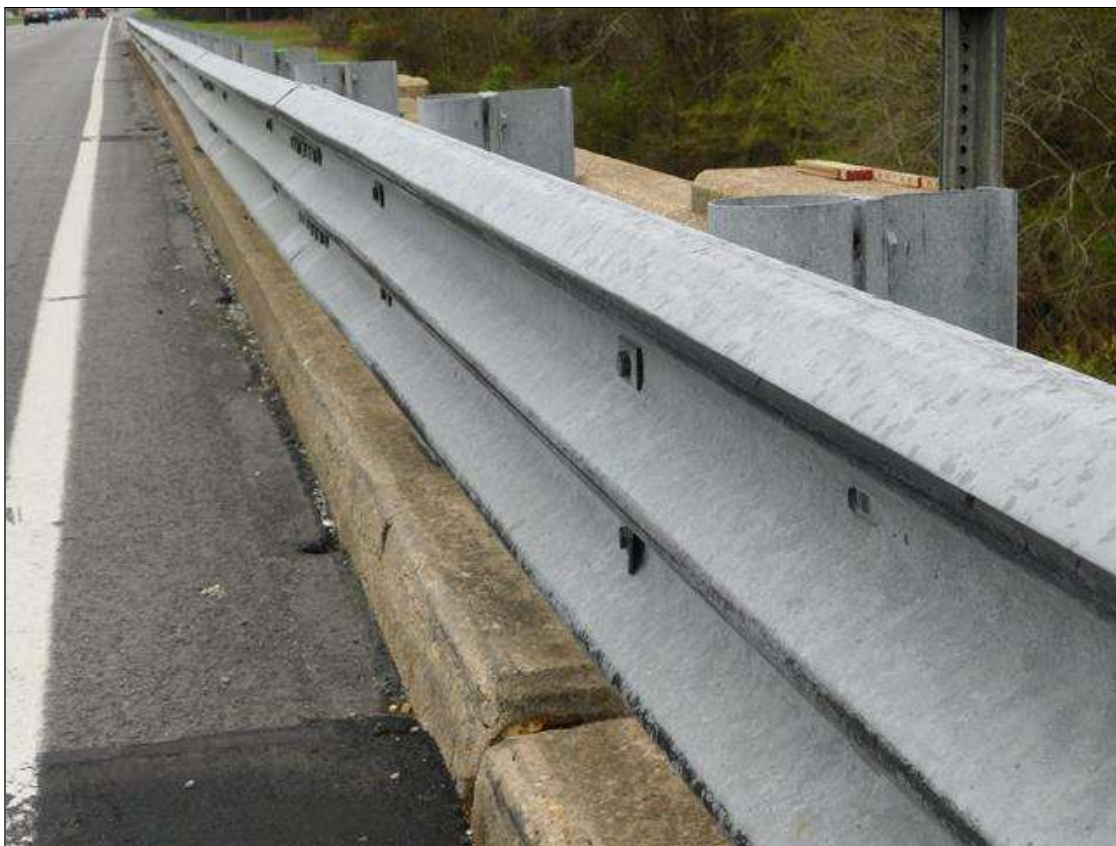
Span 4 Left Bridge Rail: 22' scrapes on metal rail at End Bent 2

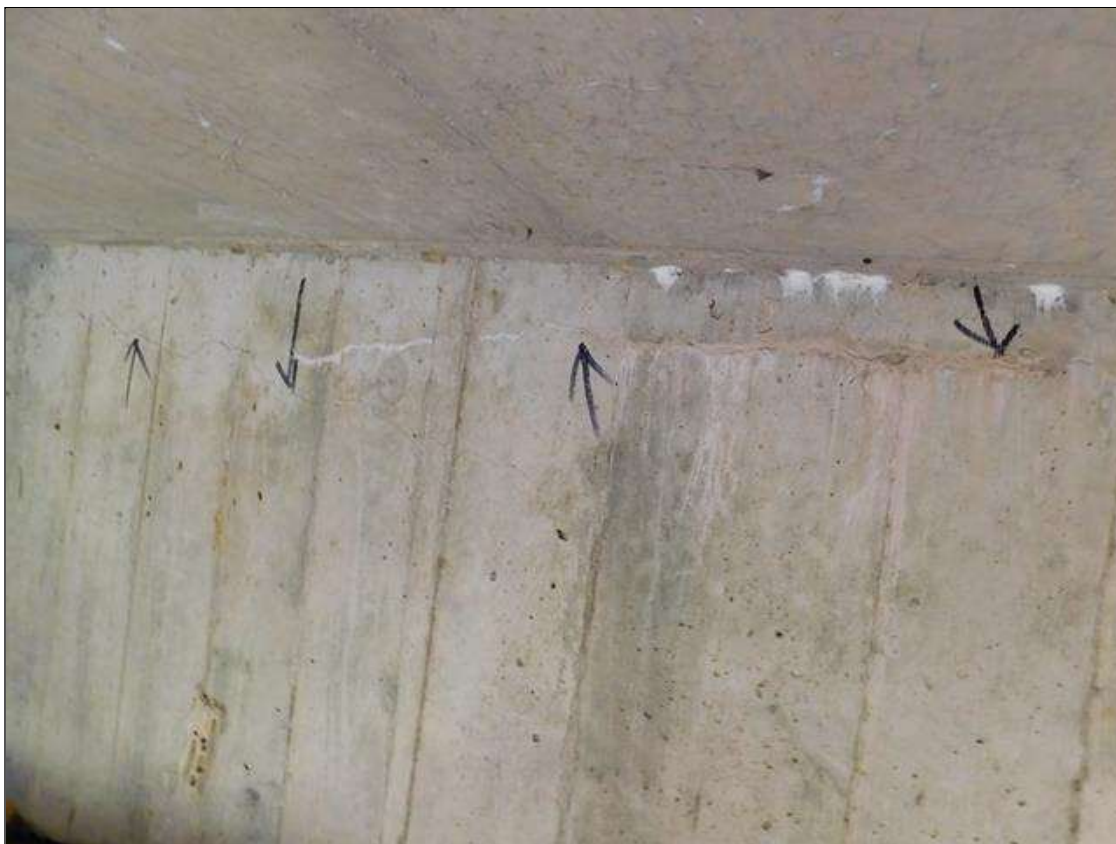
End Bent 2 Abutment/Backwall : 7' hairline horizontal crack with efflorescence in Bay 3

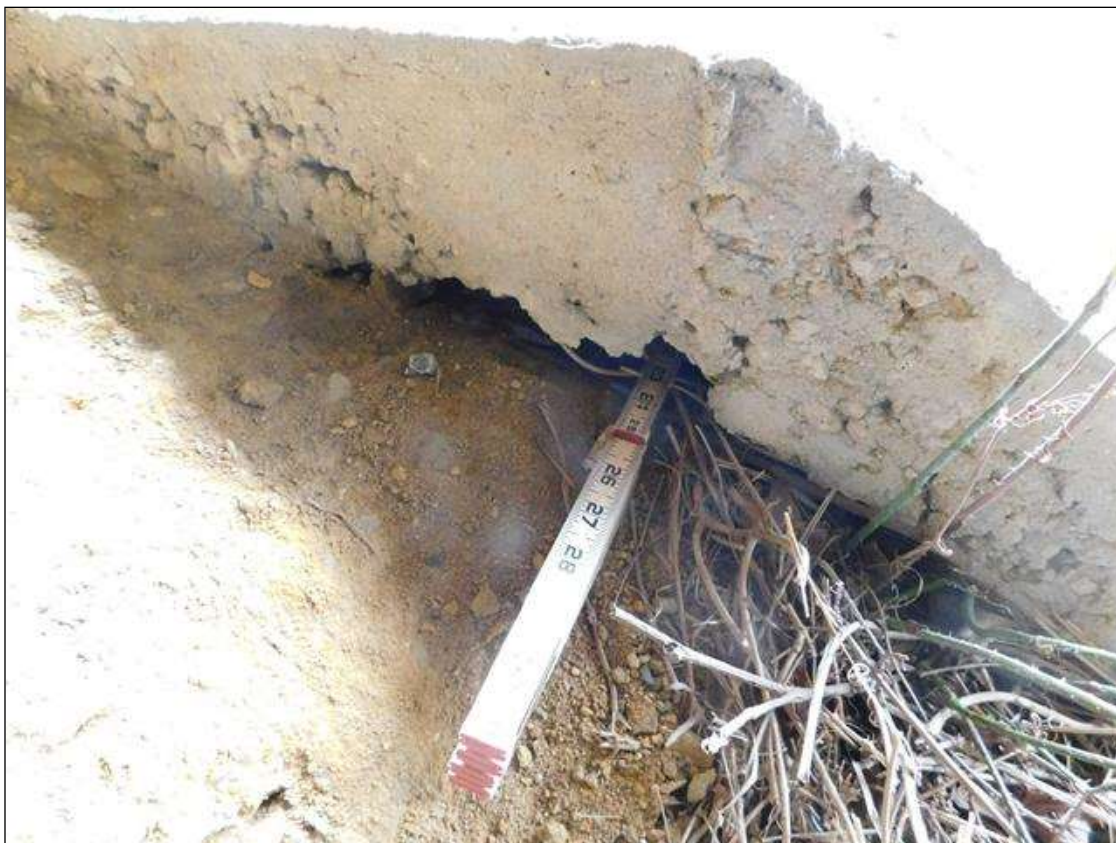
12" x 3" area of up to 24" undermining under End Bent 2 slope protection at East end (West end similar)

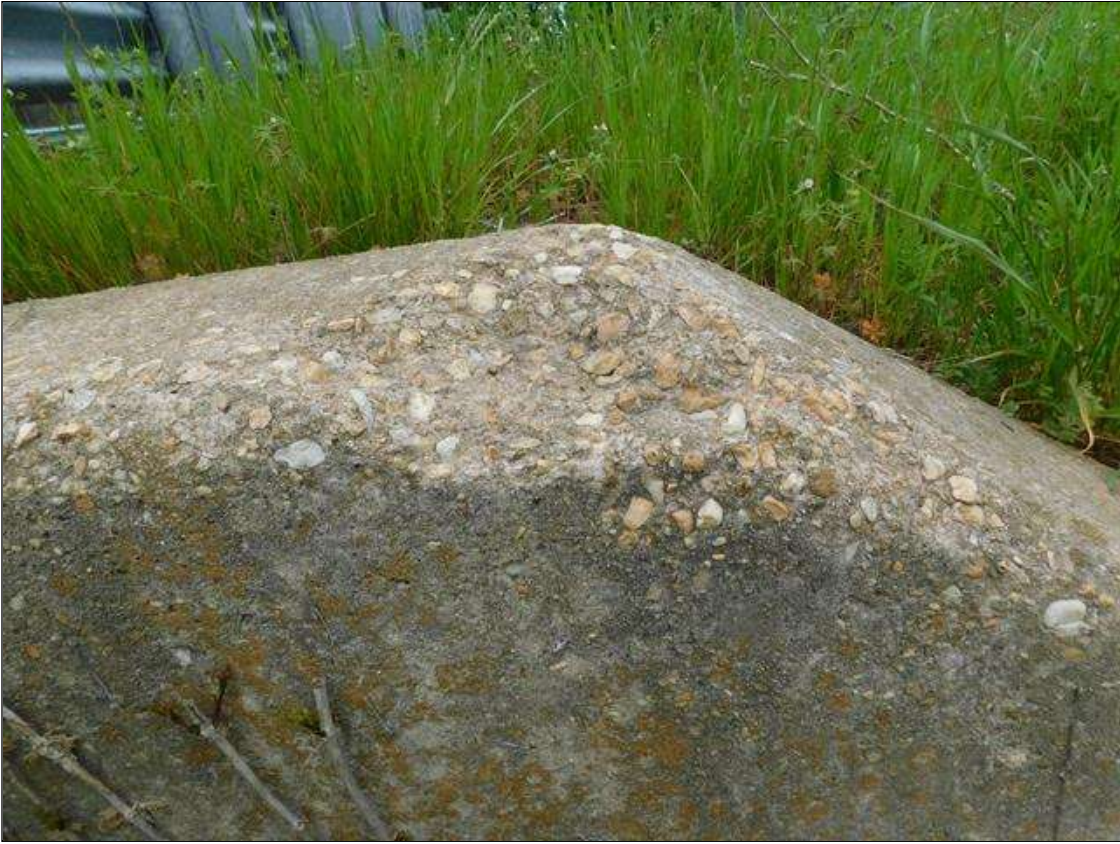
24" x 12" x 2" deep spall on Northwest wingwall

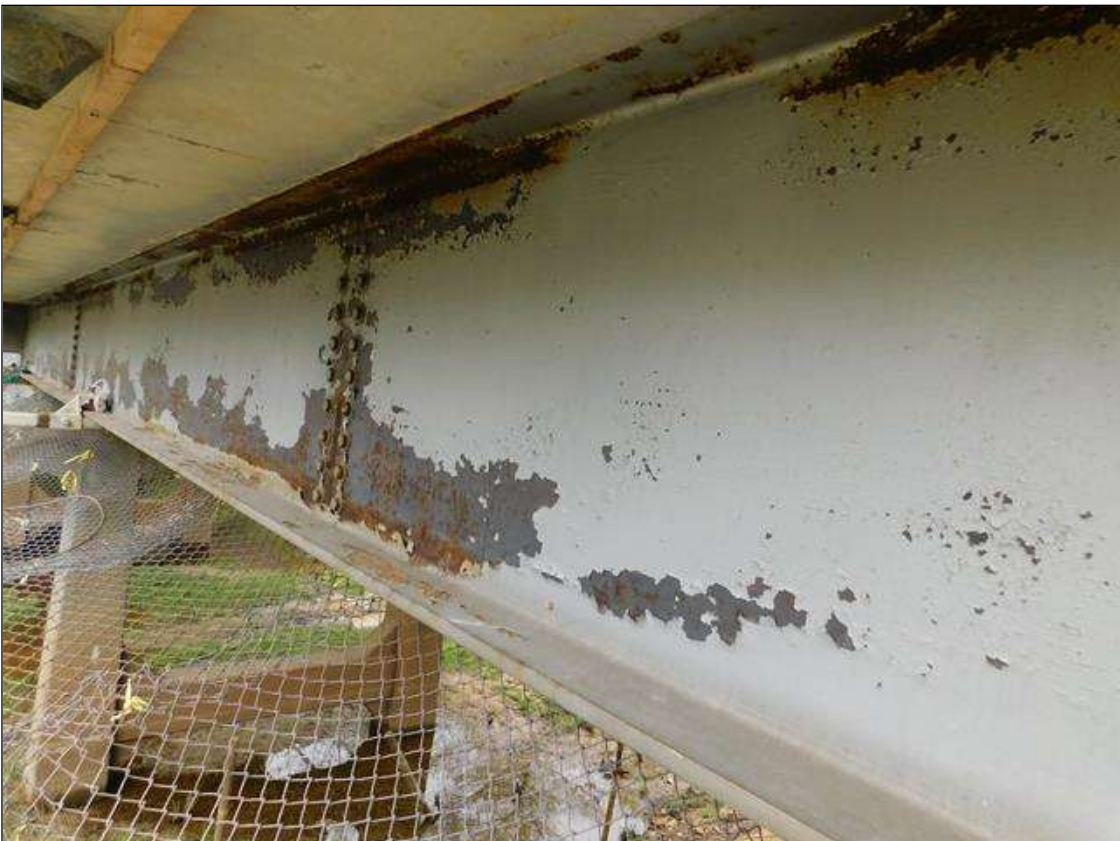
Span 4 Beam 4: Full length peeling paint with rust on both flanges and web

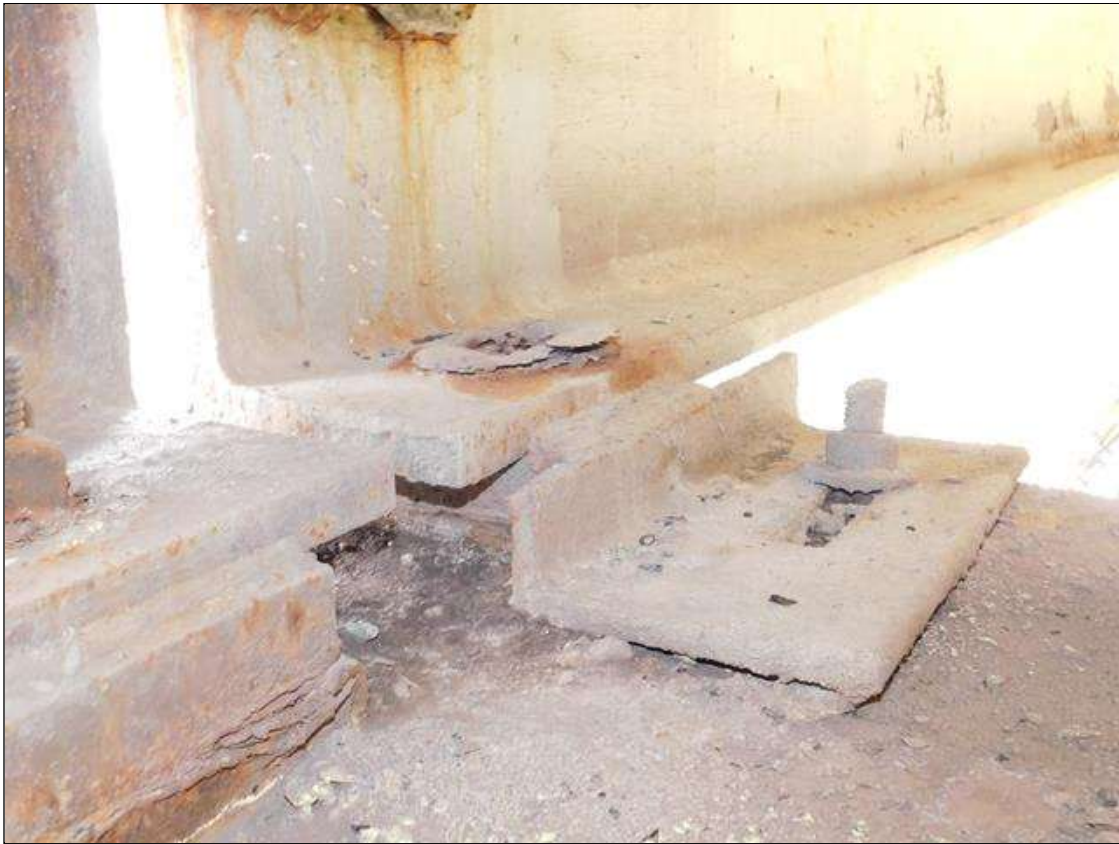
Span 3 Beam 4 Far Bearing: Temporary repair - Plate bolted on left side of bearing

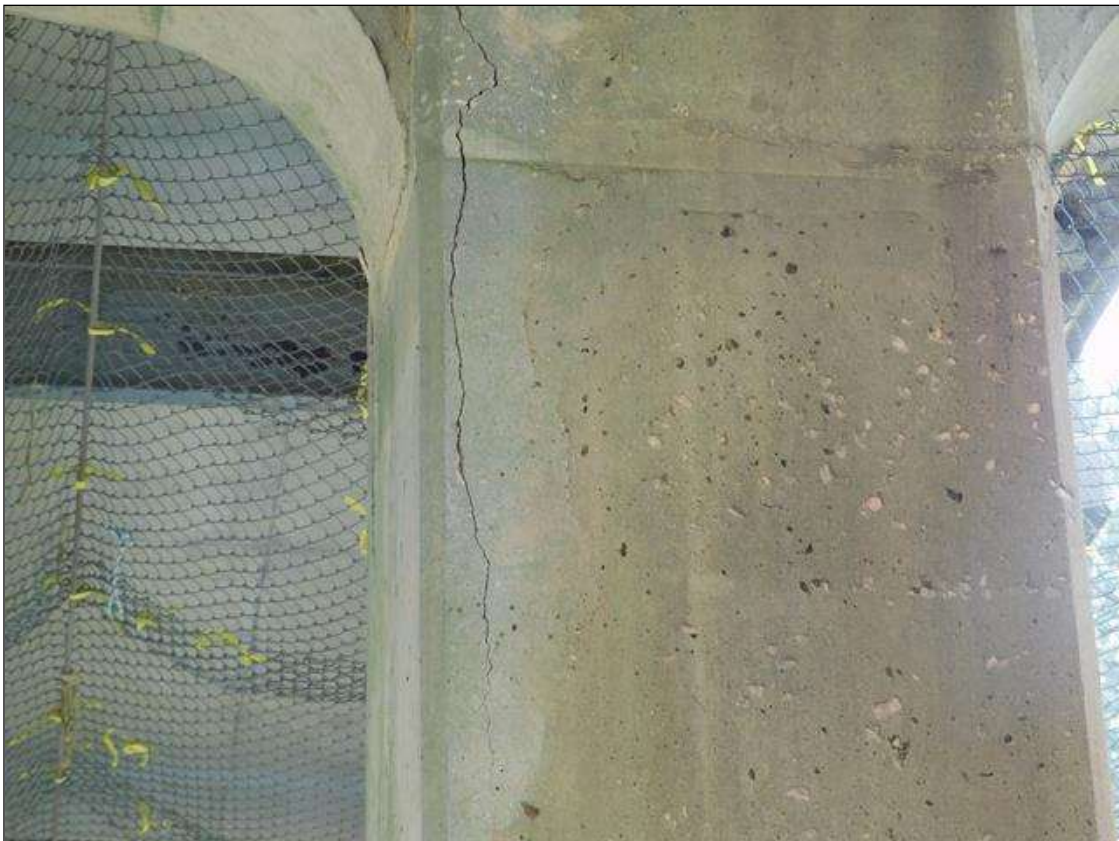
Bent 3 Pile 1: 3' up to 1/16" vertical crack on Span 4 face (East face similar)

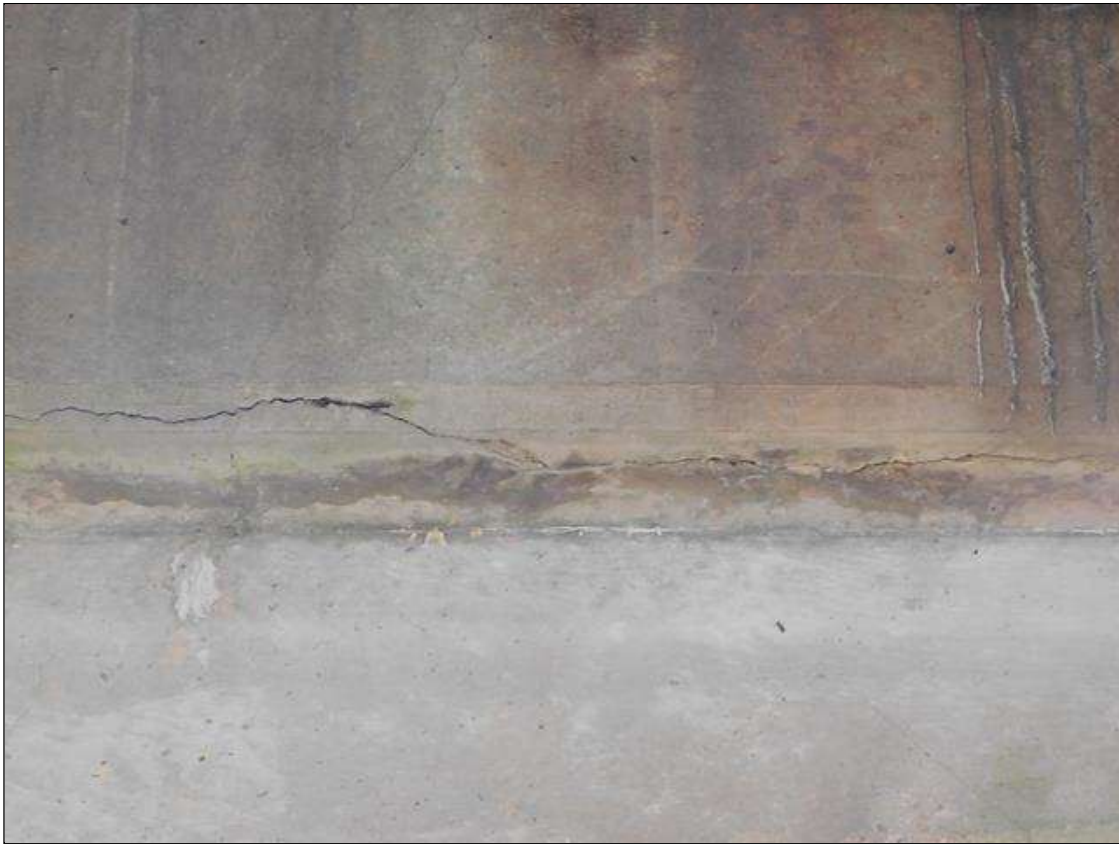
Bent 3 Cap 1: 30" up to 1/16" horizontal crack on Span 3 face

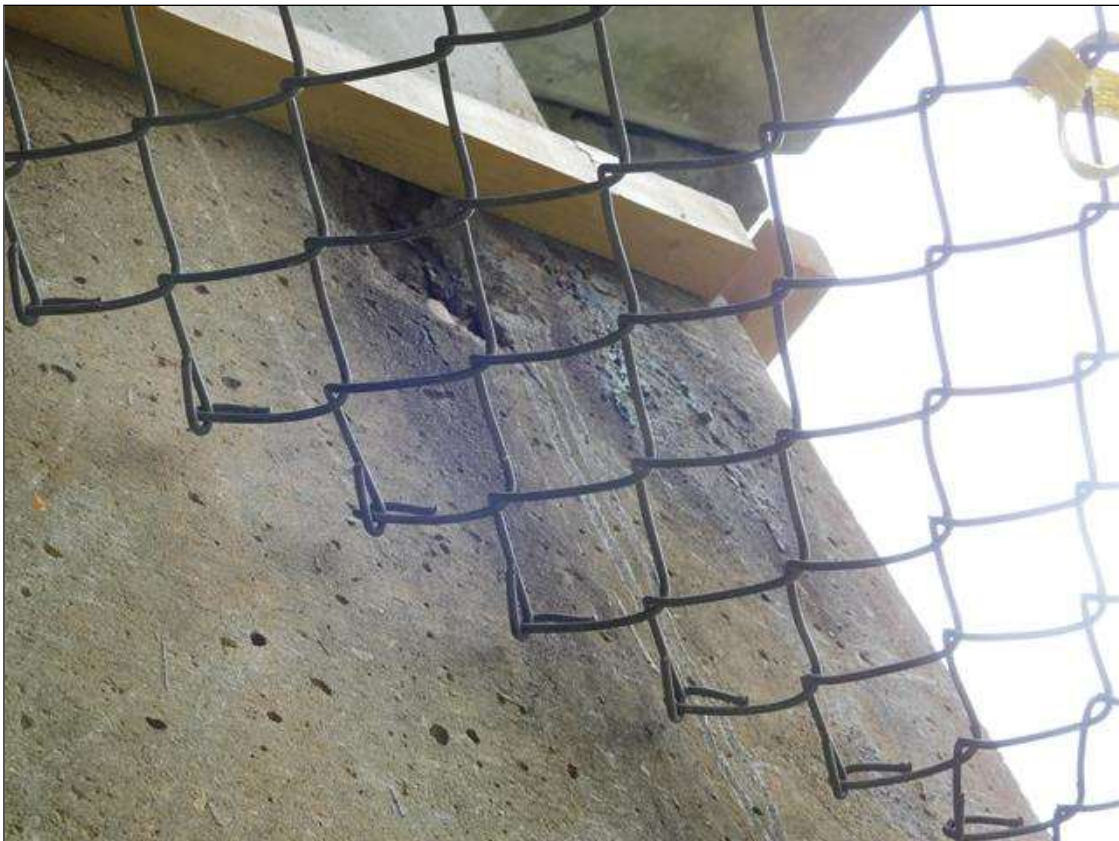
Bent 3 Cap 1: 4" x 6" x 1" deep spall with exposed rebar on Span 3 face at East end

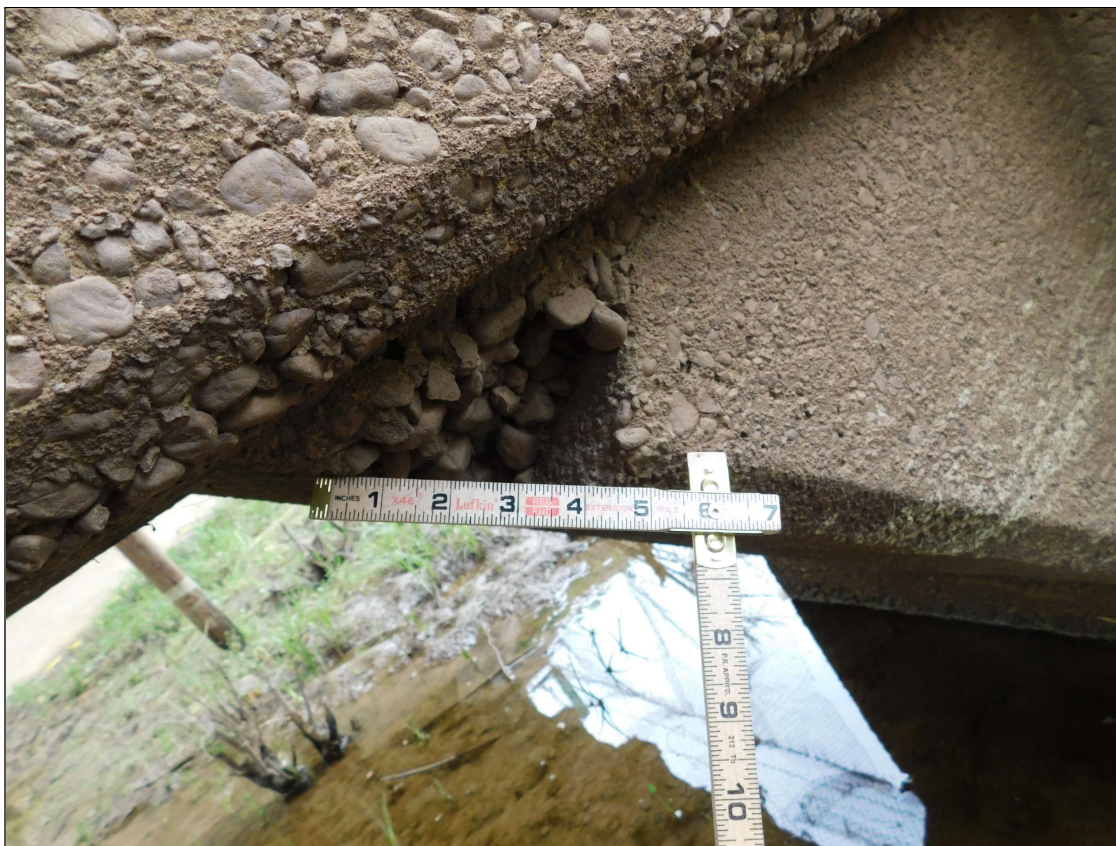
Bent 3 Pile 2: 4" x 4" x 3" deep spall on Span 3 face of corbel under strut

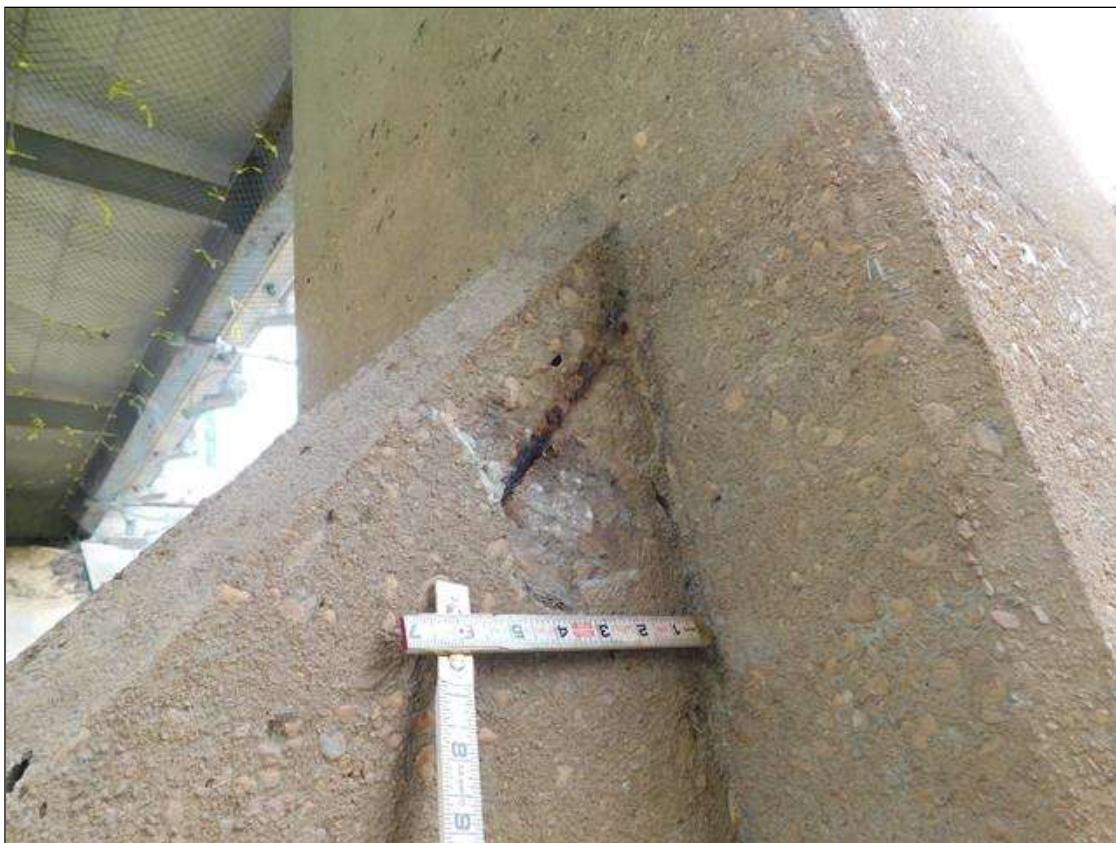
Bent 3 Pile 2: 6" x 8" x 1" deep spall with exposed rebar on Span 3 face of corbel above strut

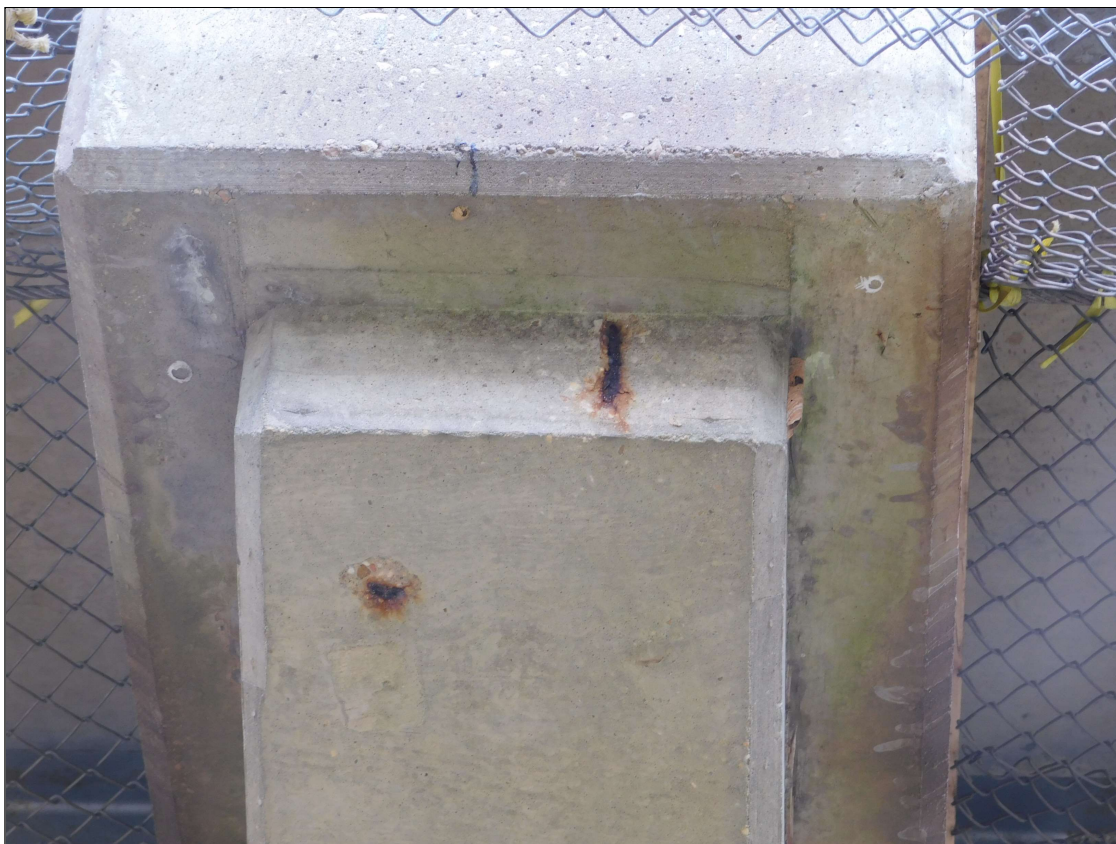
Bent 3 Cap 1: (2) up to 3" x 6" x 1" deep spall with exposed rebar on West face of corbel

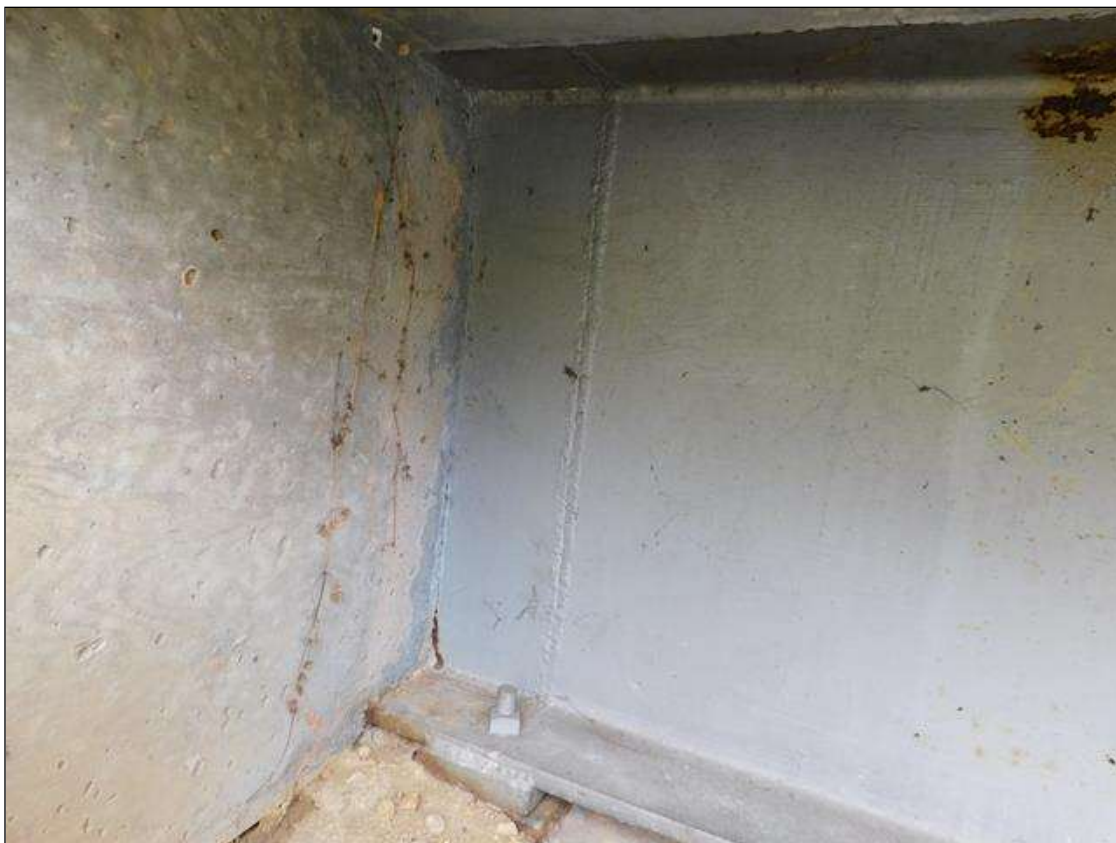
Span 1 Beam 1: Temporary Repair - 7" x 31" area of replaced beam at End Bent 1

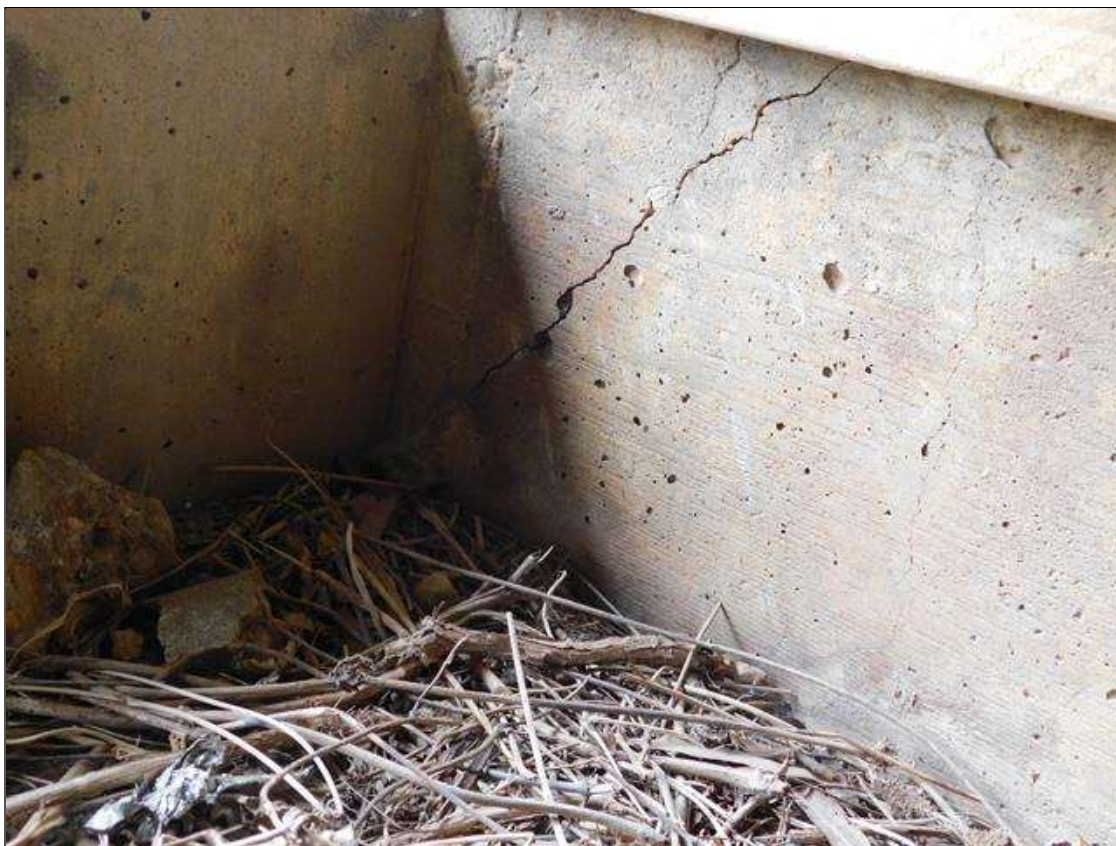
End Bent 1 Cap 1: 16" up to 1/16" diagonal crack under Beam 4
