NC DEPARTMENT OF TRANSPORTATION
 DIVISION OF HIGHWAYS
 STRUCTURE MANAGEMENT UNIT

ATTENTION: Priority Maintenance; Approach Roadway, Typical Section Modified

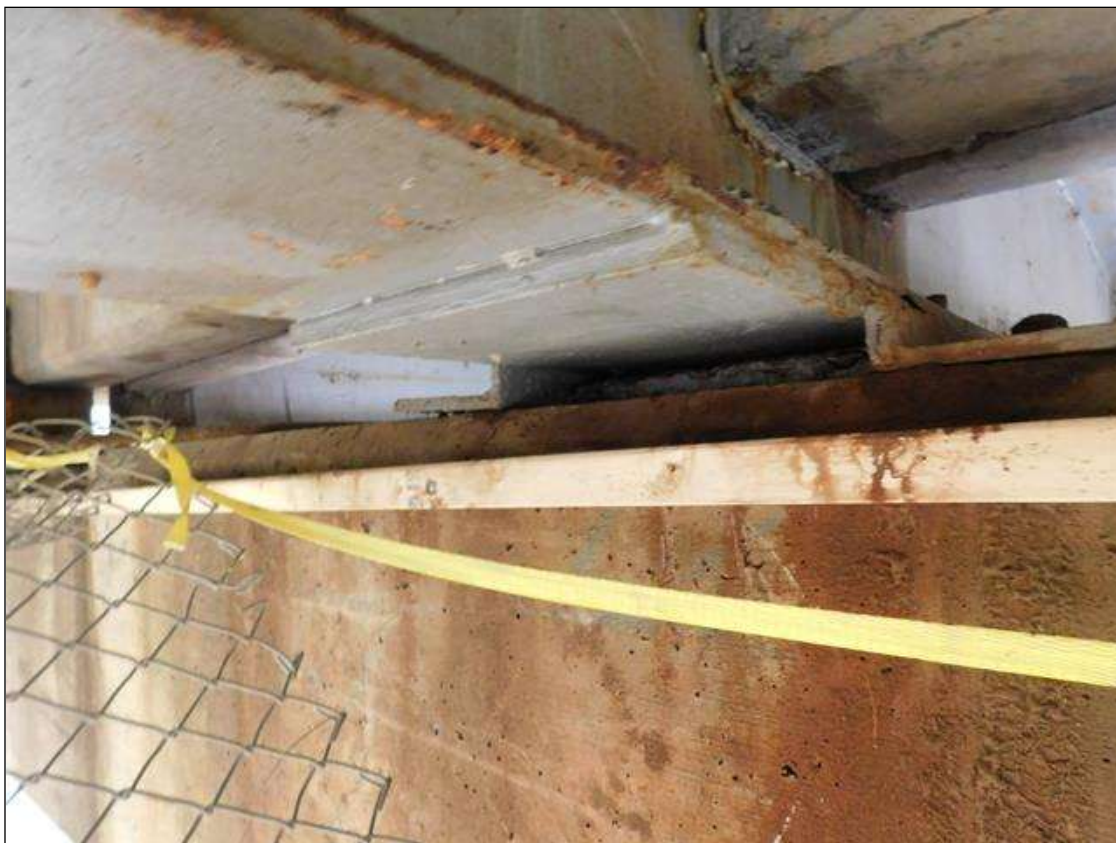
Span 1 Beam 2: Temporary Repair - 20" x 12" plate welded to bottom flange at Bent 1

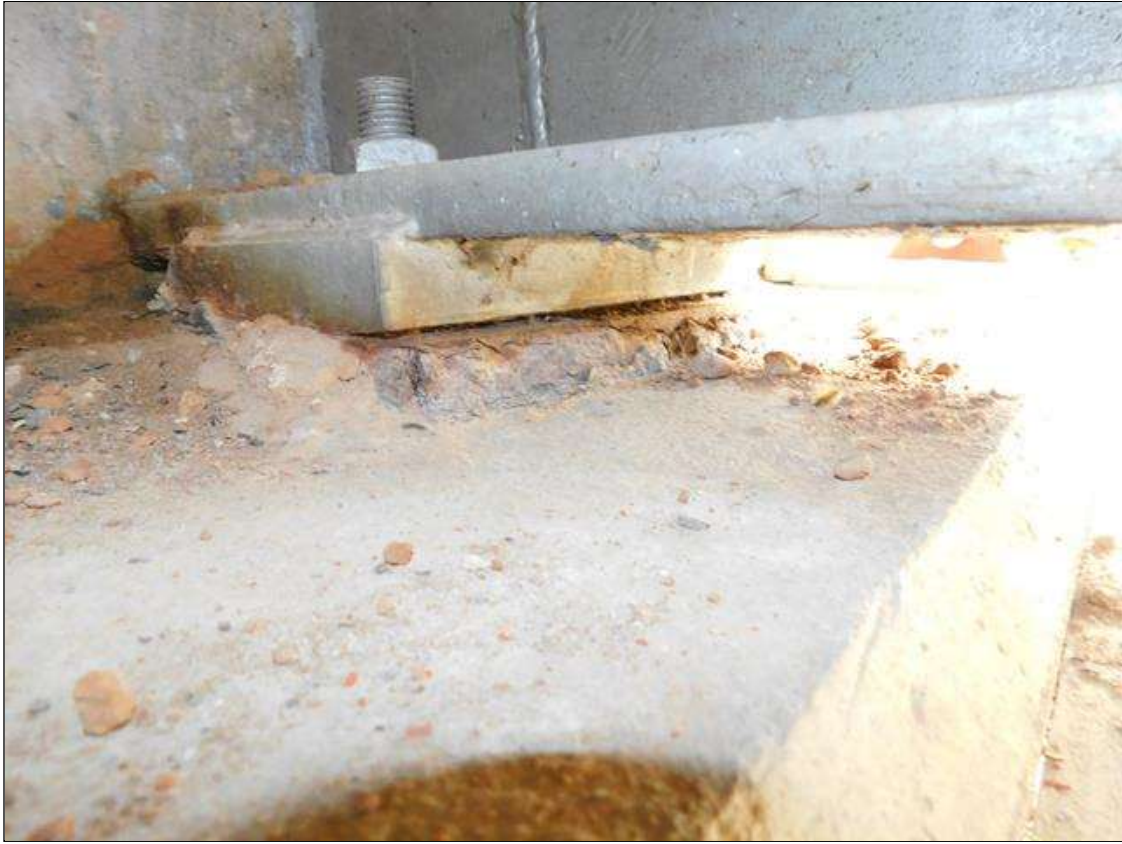
Span 1 Beam 1 Near Bearing: Peeling paint with rust

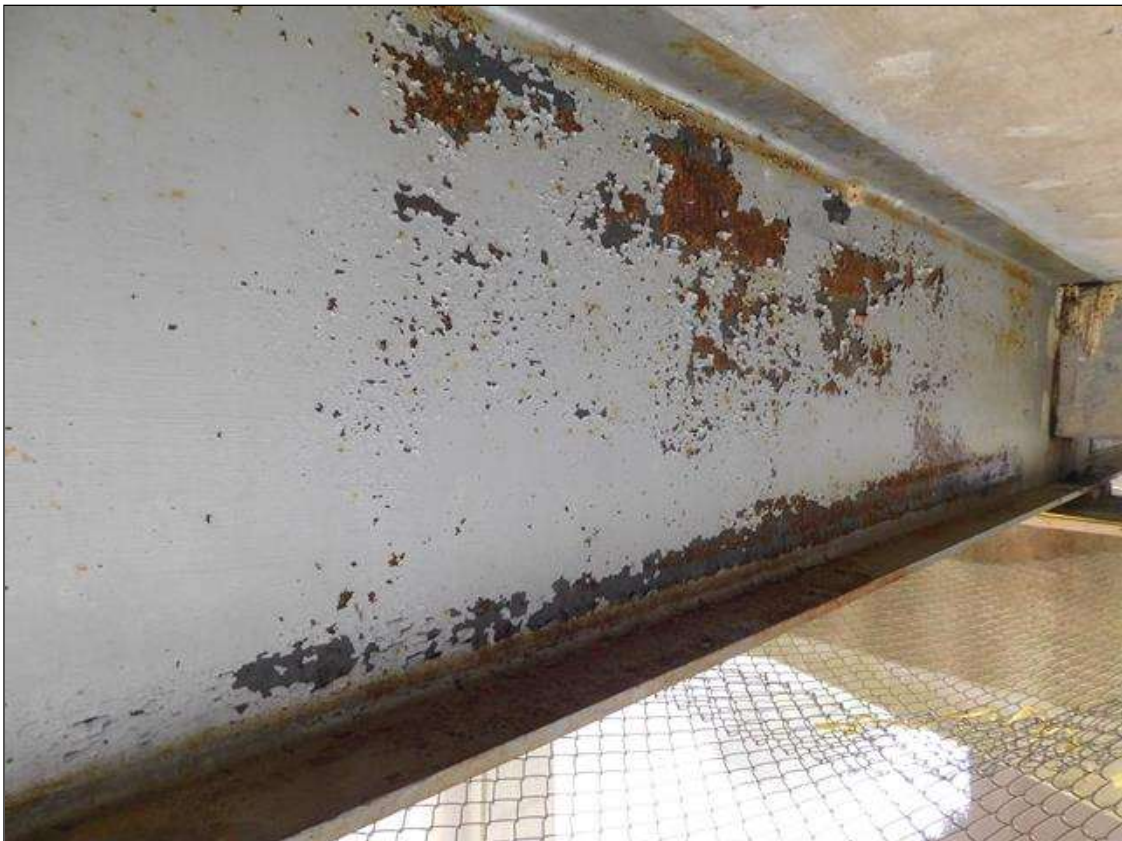
Span 1 Beam 2: 48' peeling paint with rust on web

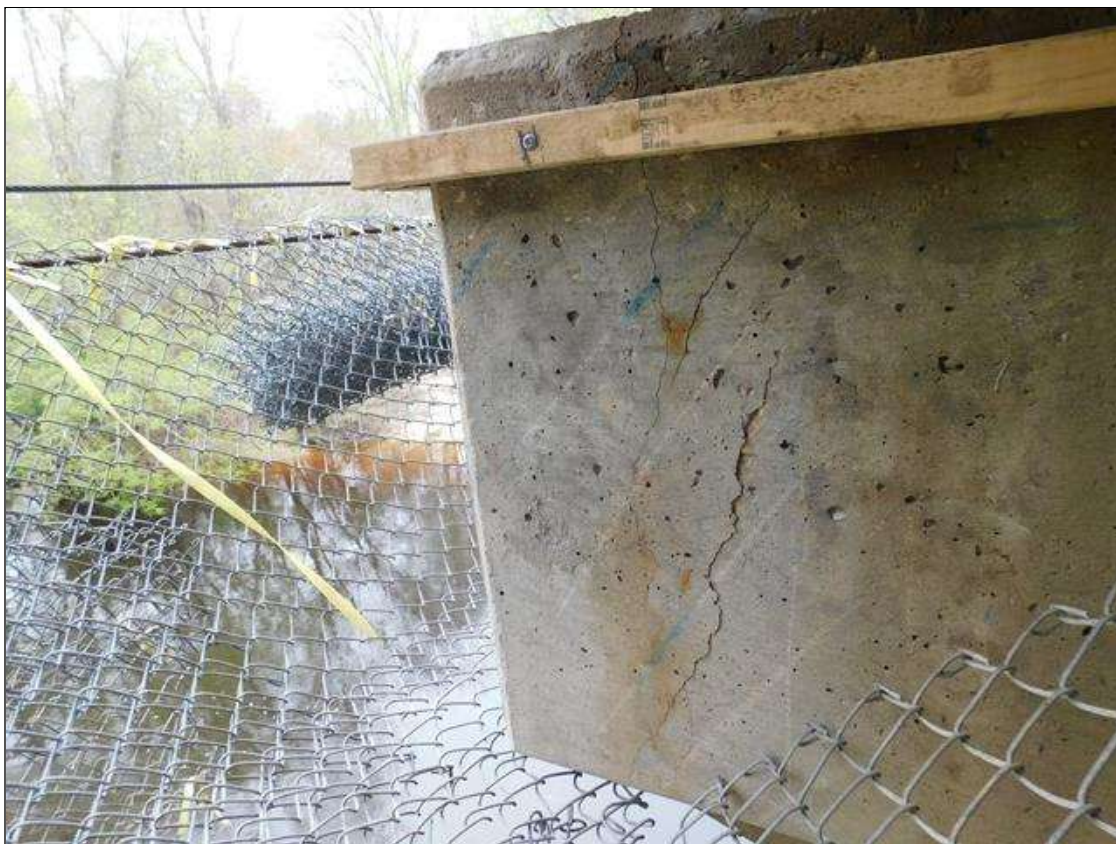
Bent 1 Cap 1: 12" x 24" area of delamination with hairline vertical, diagonal cracks on Span 1 face at West end

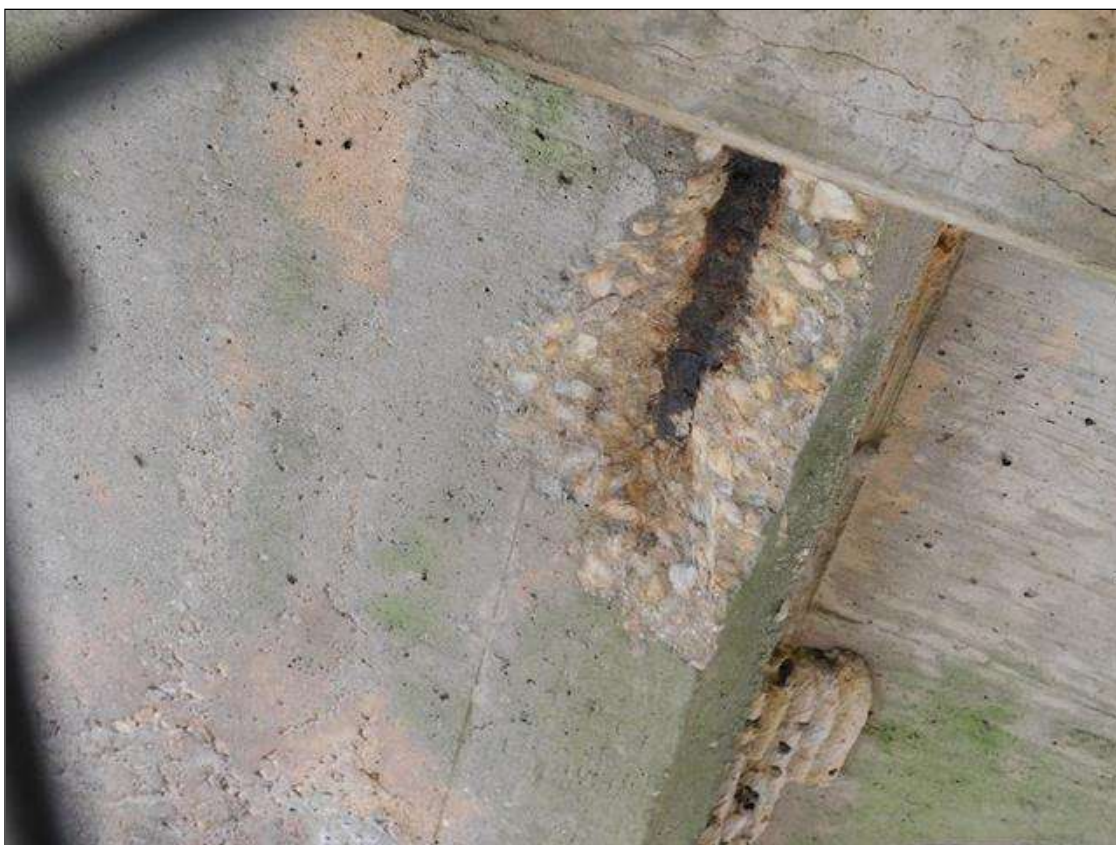
Bent 1 Pile 1: 12" x 5" x 1" deep spall with exposed rebar on Span 1 face (PM)

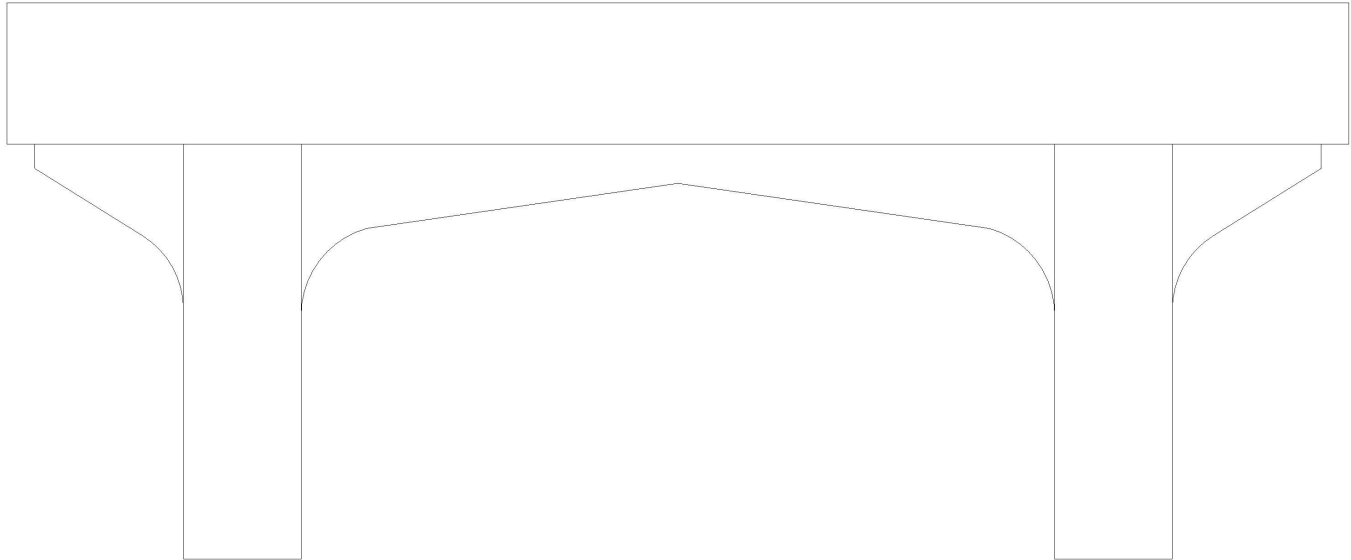
Cap Information			Material Cast-in-Place Concrete							
Length	Width	Height	Left Overhang	Right Overhang	Left Beam to End of Cap.	Right Beam to End of Cap.				
27.000 ft.	2.500 ft.	2.500 ft.	5.000 ft.	5.000 ft.	1.500 ft.	1.500 ft.				
Subcap Information			Material							
Length	Width	Height	Left Overhang	Right Overhang	Left Pile to Splice.					
Sill Information			Material							
Length	Width	Height								
Pile #	Material	Spacing	Width/Dia.	Height	Length	Orientation	Driven?	Replacement?	Removed?	Collar?
1	Concrete	17 ft.	2.333 ft.			Vertical	No	No	No	No
2	Concrete		2.333 ft.			Vertical	No	No	No	No
							SKETCH VERIFIED 4/9/18 BY COC			
Bent/Abutment #: 1			Similar Bents: BENTS 2 & 3
