NC DEPARTMENT OF TRANSPORTATION
 DIVISION OF HIGHWAYS
 STRUCTURE MANAGEMENT UNIT

ATTENTION: NEW REPAIRS, PAR, CHANGE IN STRUCTURAL DATA, HYDRA PLATFORM USED

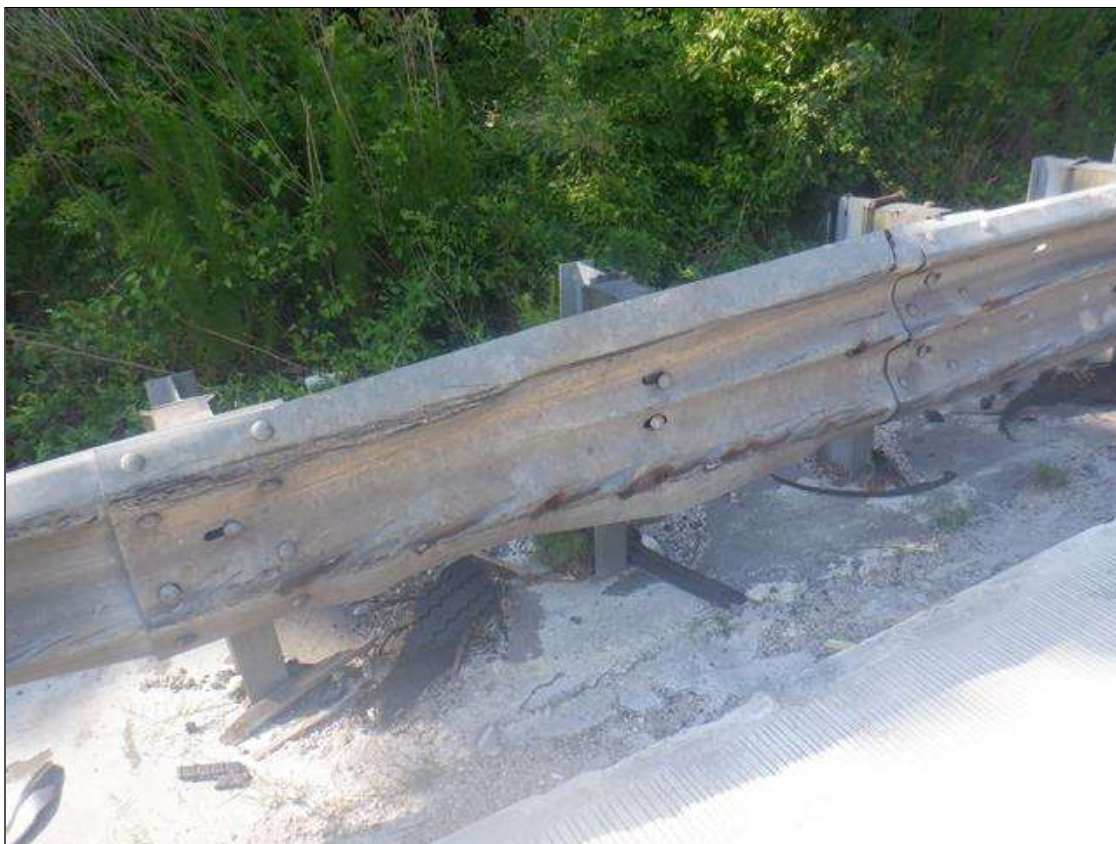
MODERATE IMPACT DAMAGE TO NORTHEAST APPROACH GUARDRAIL AT 15 FT FROM END BENT 2

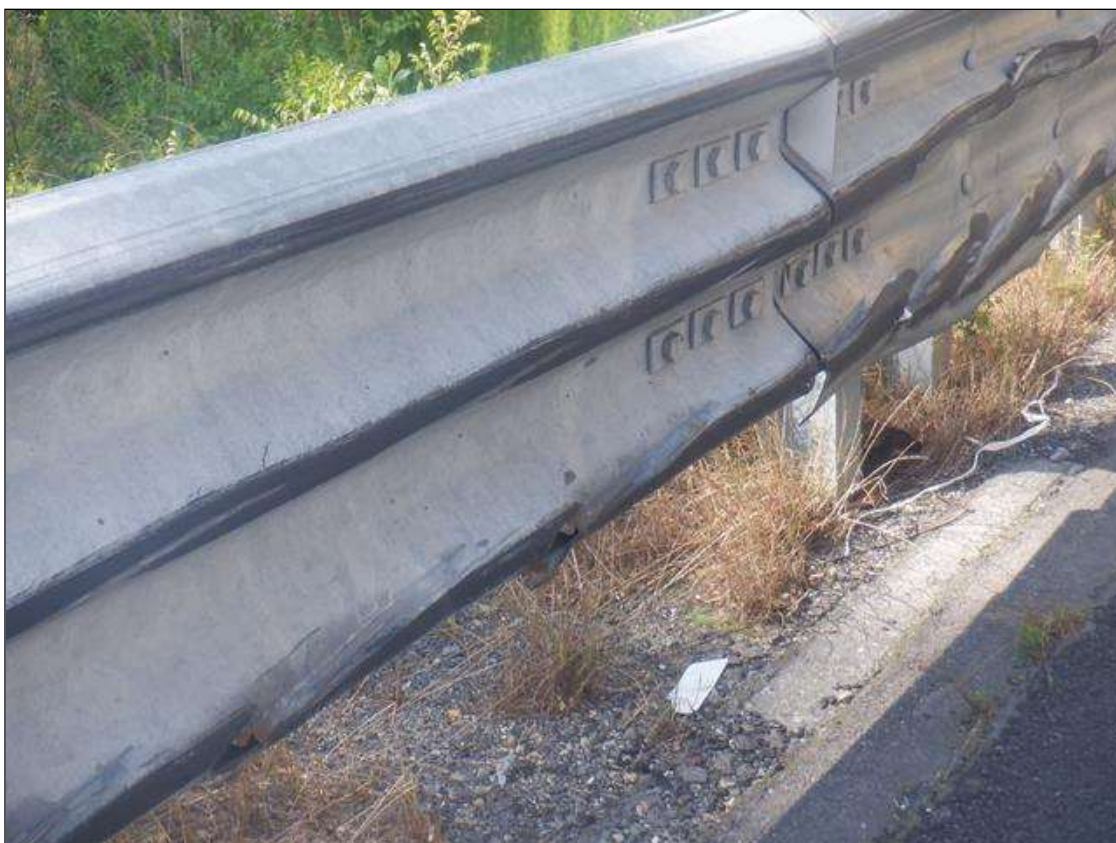
HEAVY IMPACT DAMAGE FOR 10 FT LONG IN SOUTHEAST APPROACH GUARDRAIL AT 15 FT FROM END BENT 1

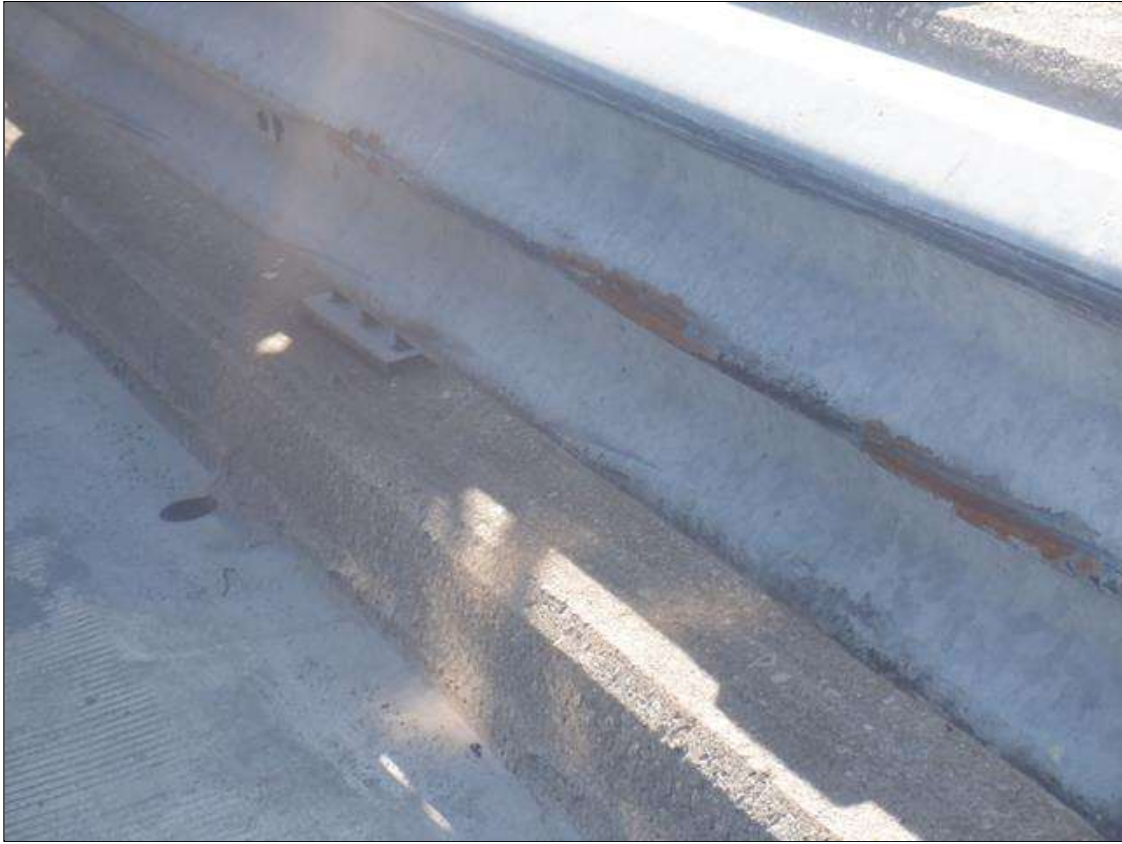
Span 1 Right Bridge Rail: IMPACT DAMAGE WITH SCRAPE MARKS FOR FULL SPAN LENTH IN BOTTOM OF SUPPLEMENTAL RAIL.

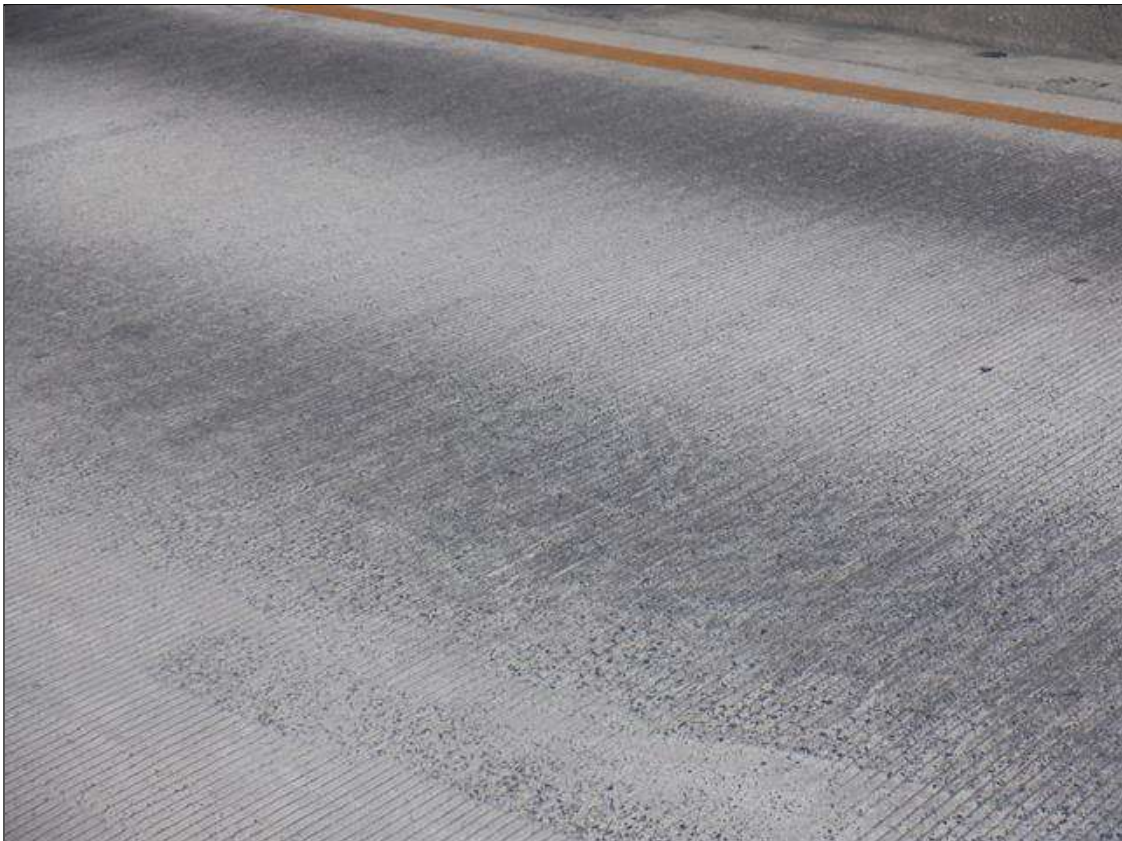
Span 1 Wearing Surface: MINOR ABRASION WITH EXPOSED AGGREGATE ALONG THE WHEEL PATHS FOR FULL LENGTH

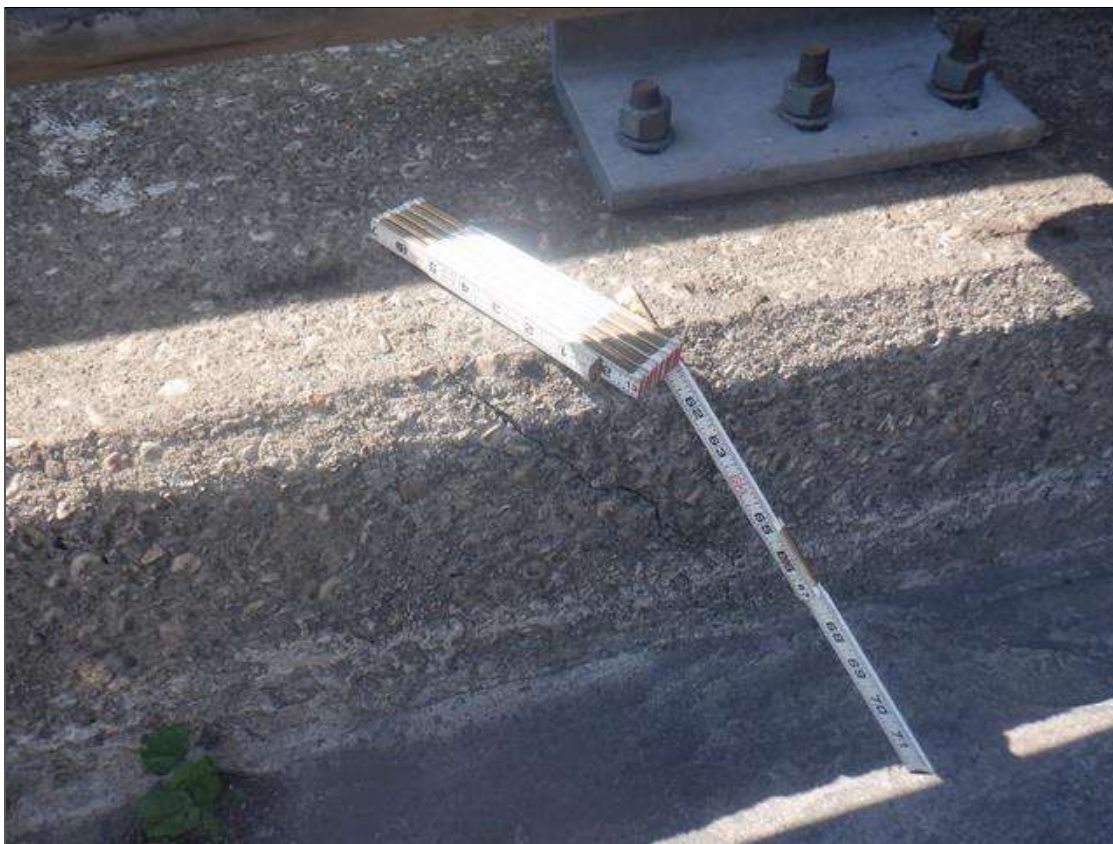
Span 2 Right Bridge Rail: UP TO 0.03 IN WIDE X 2 FT LONG DIAGONAL CRACKS IN BOTTOM OF CURB AT 1 FT FROM BENT 2.

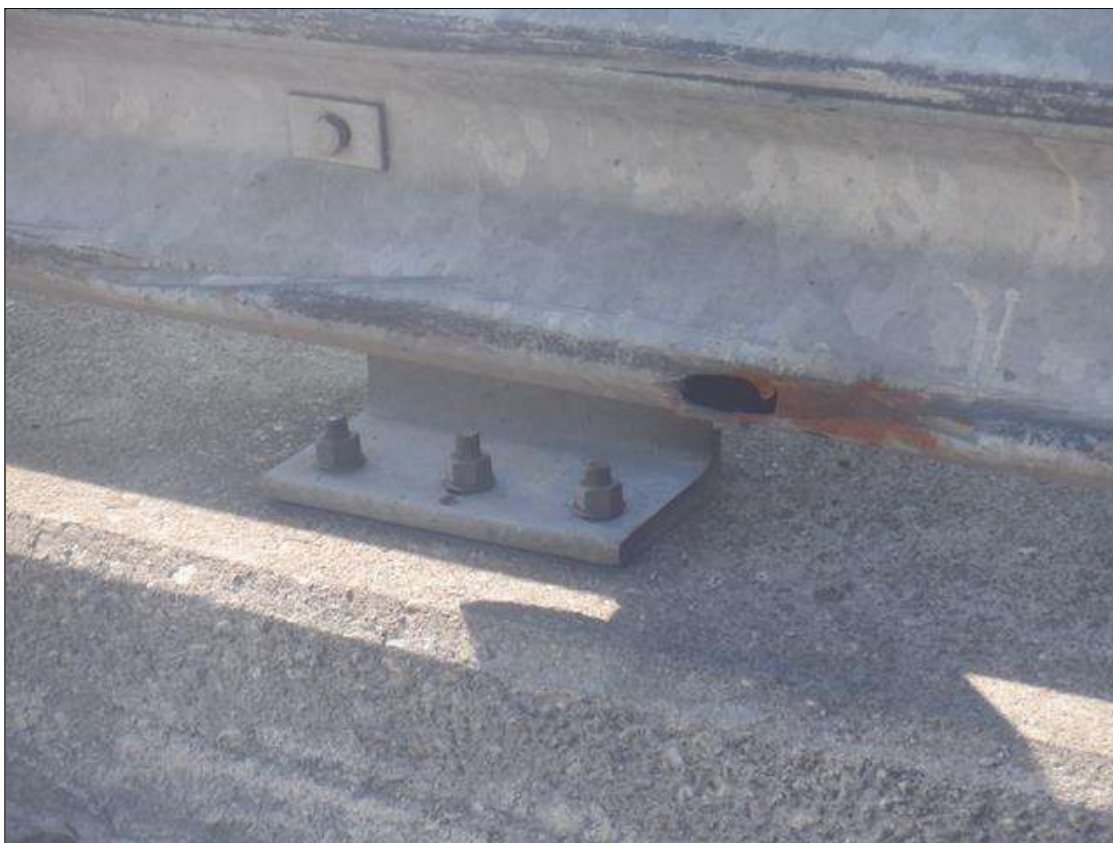
Span 2 Right Bridge Rail: IMPACT DAMAGE WITH SCRAPE MARKS FOR FULL SPAN LENTH IN BOTTOM OF SUPPLEMENTAL RAIL.

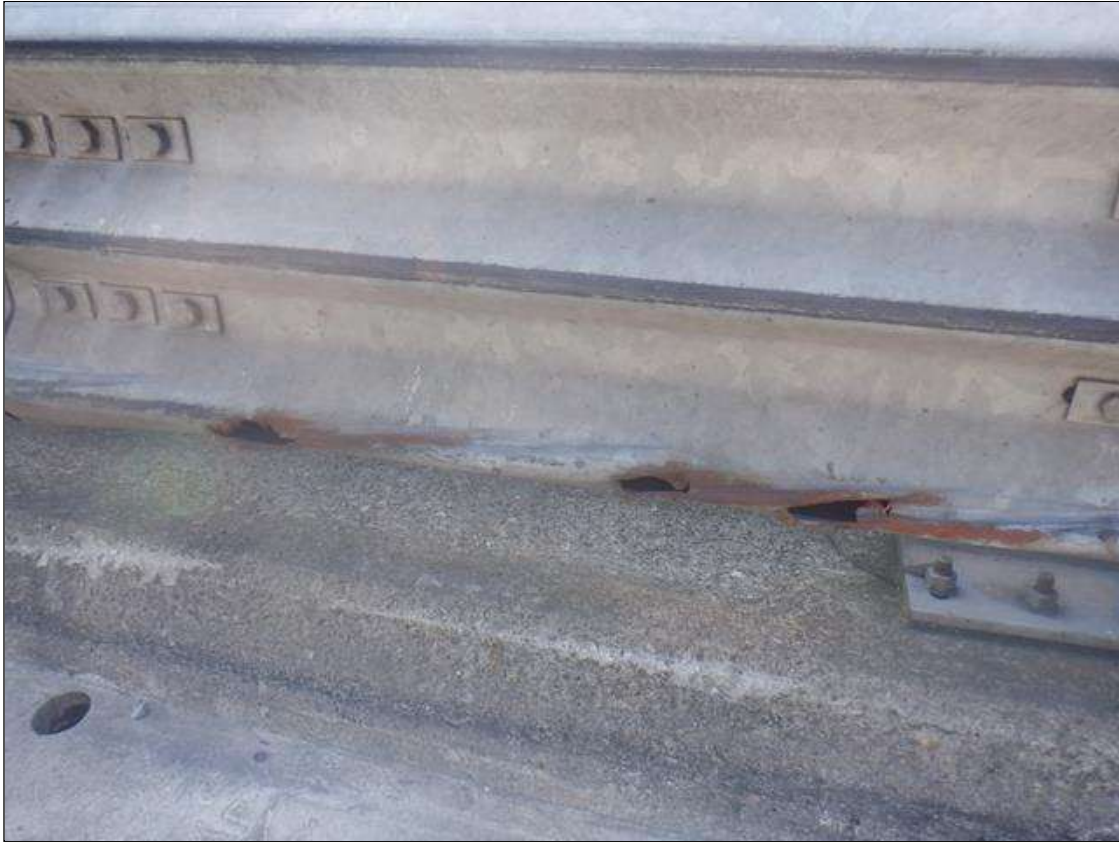
Span 8 Right Bridge Rail: HEAVY IMPACT DAMAGE WITH UP TO 3 IN LONG X 1 IN HIGH HOLES AND DENTS IN THE BOTTOM OF SUPPLMENTAL BRIDGE RAIL FOR FULL SPAN LENGTH. DAMAGE EXTENDS INTO SPANS 7 AND 6.

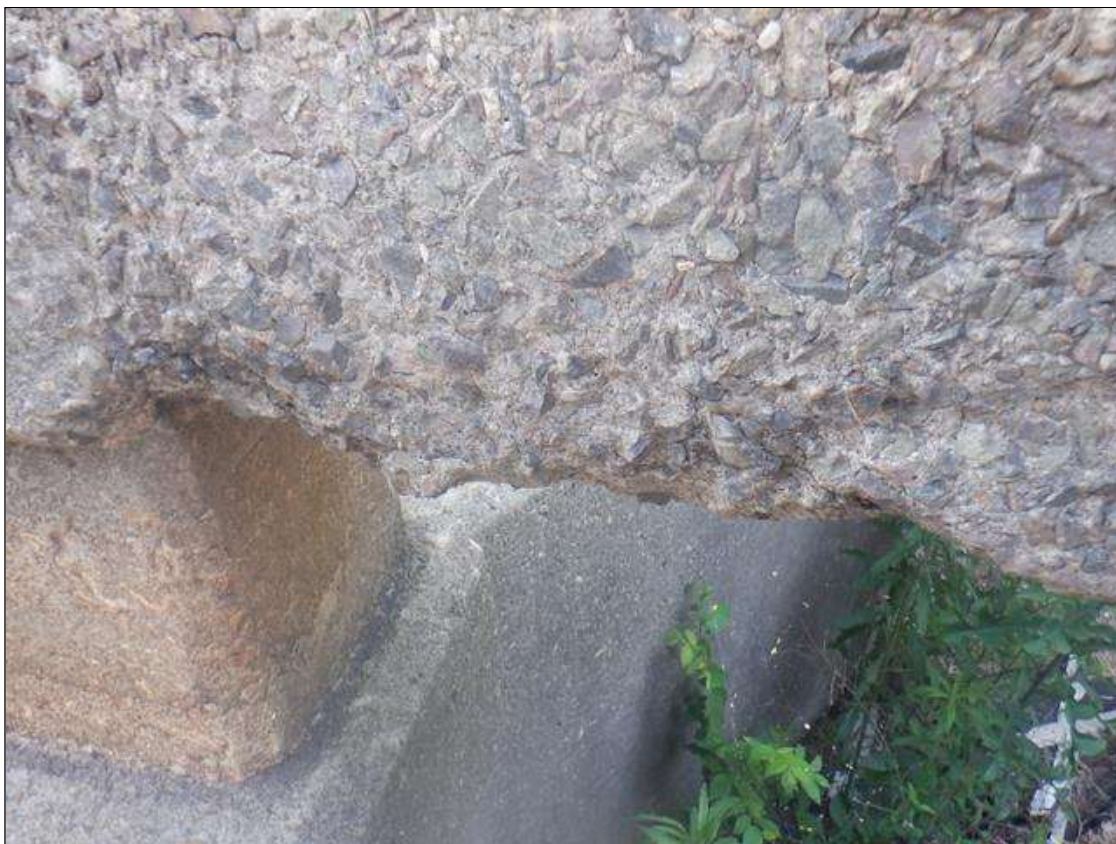
Span 8 Right Bridge Rail: 1 FT LONG X 4 IN WIDE X 1 IN DEEP SPALL IN BOTTOM FACE AT END BENT 2

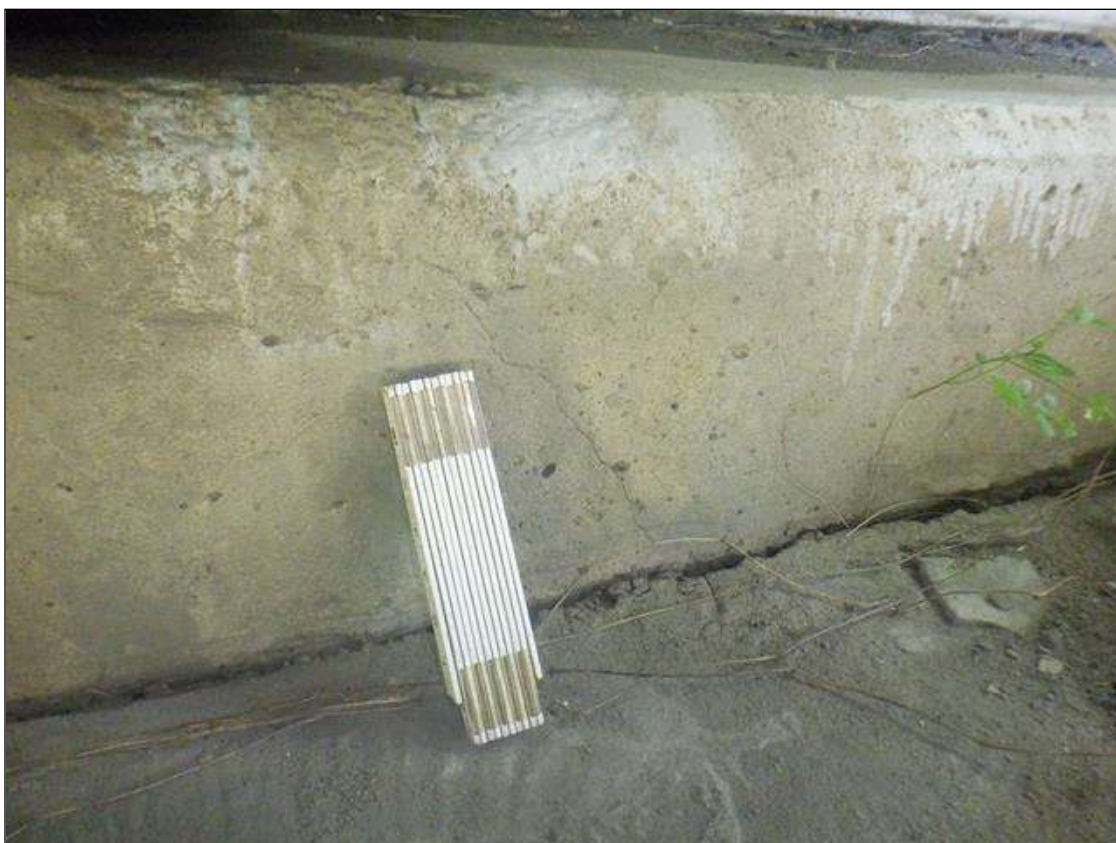
End Bent 2 Cap 1: 2 FT HIGH X 1/16 IN WIDE DIAGONAL CRACK UNDER BEAM 4.

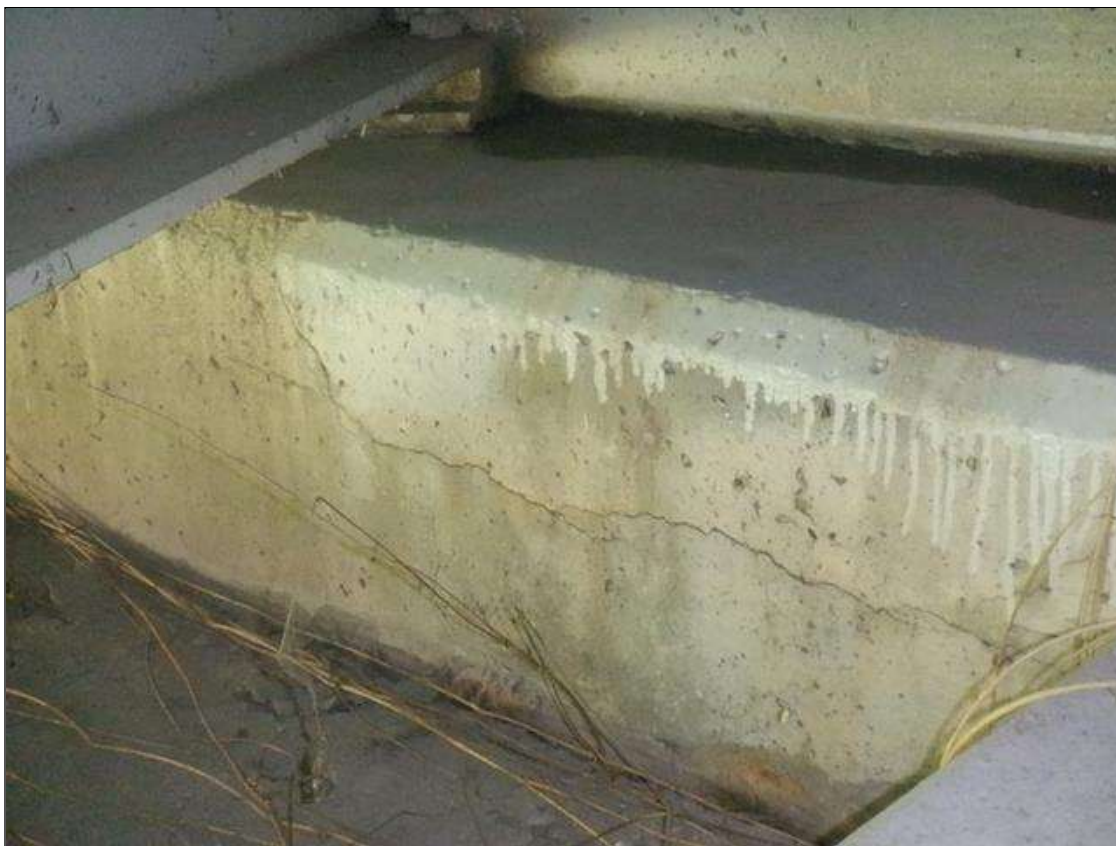
End Bent 2 Cap 1: 3 FT LONG X 1/16 IN WIDE HORIZONTAL CRACK, BELOW BEAM 2. TYPICAL AT BEAM 3.

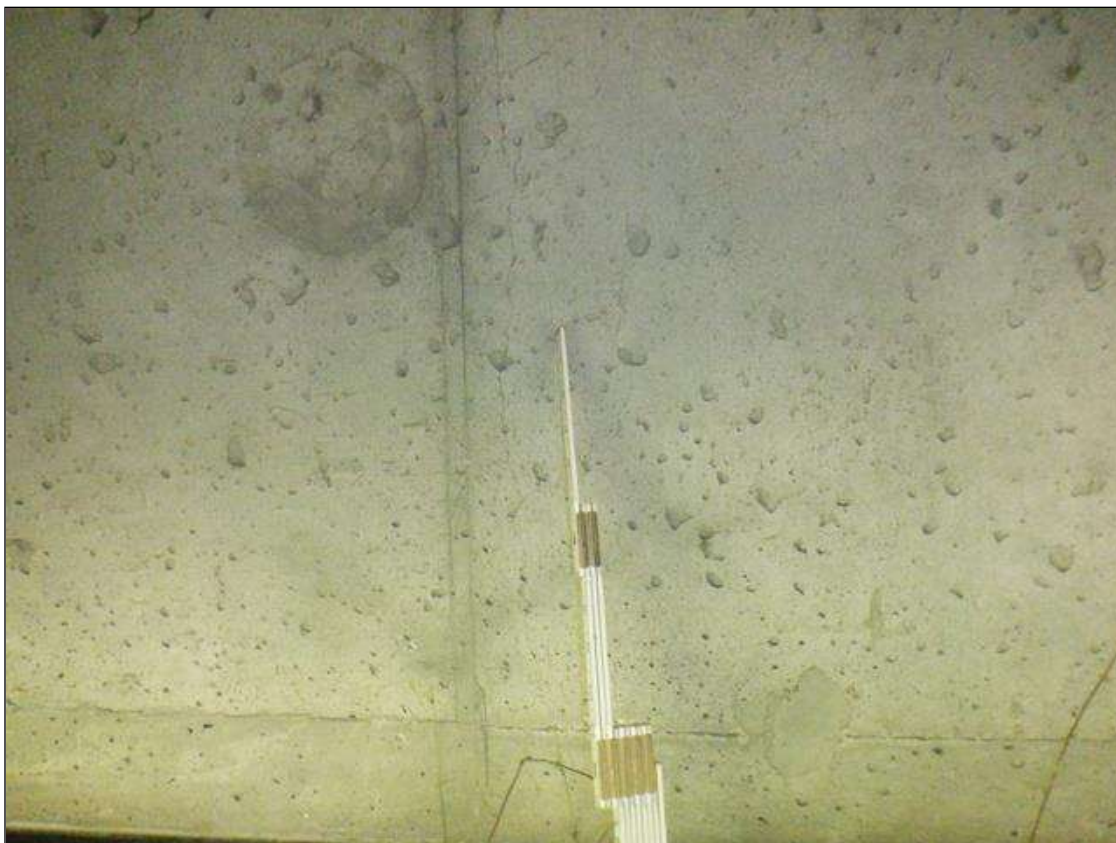
End Bent 2 Abutment: 4 FT HIGH X UP TO 0.05 IN WIDE VERTICAL CRACK IN BAY 2

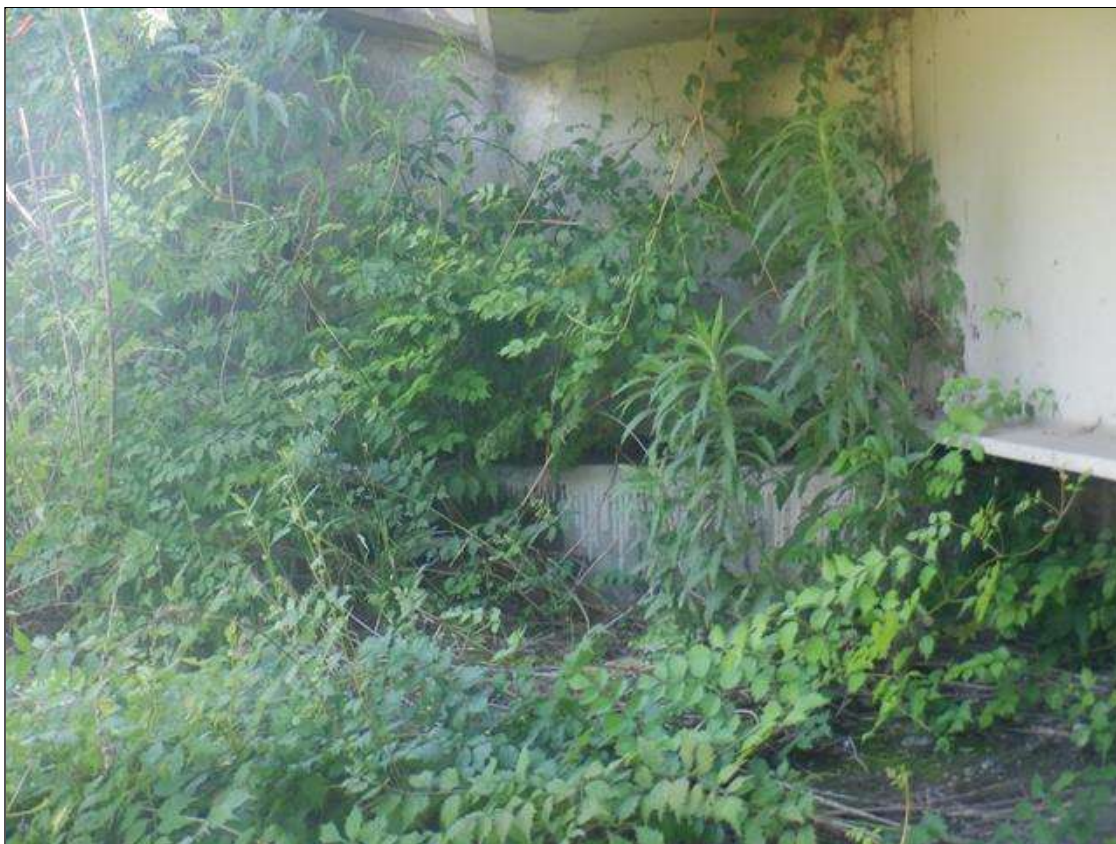
End Bent 2 Abutment: HEAVY VEGETATION GROWTH UNDER BOTH OVERHANGS

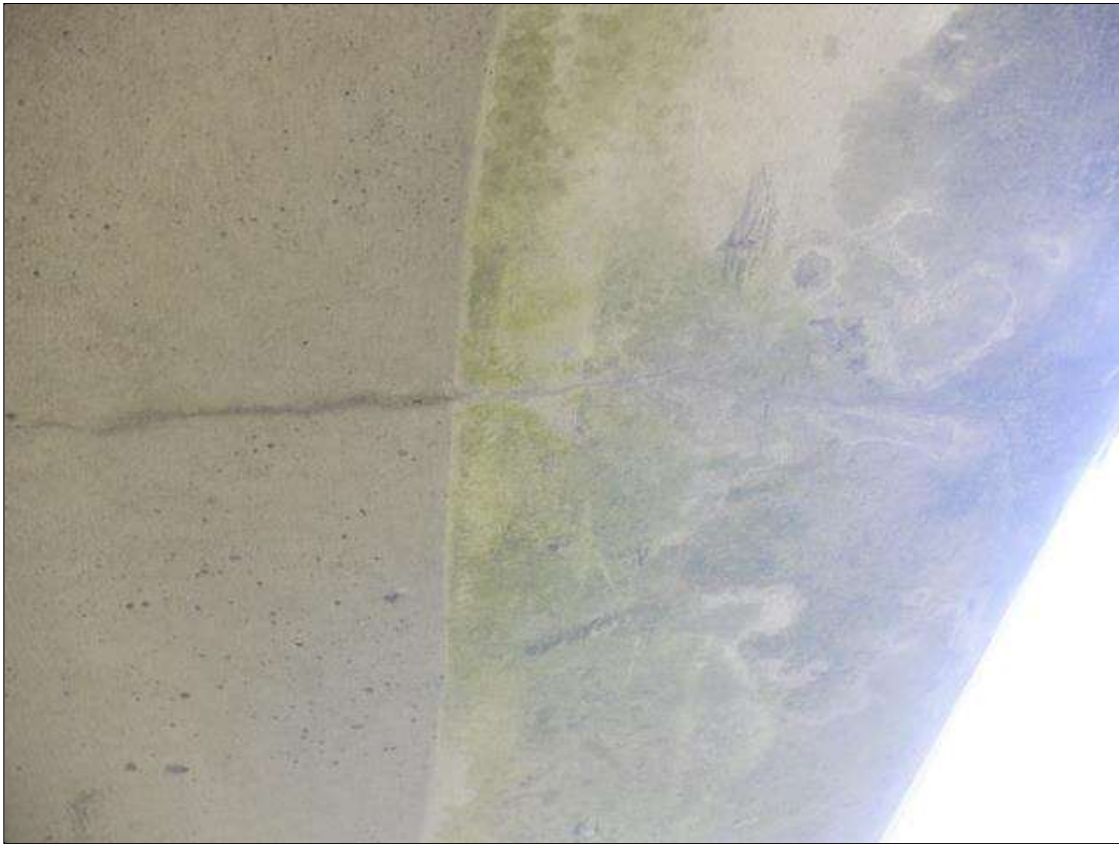
Span 8 Deck: UP TO .05 IN WIDE X 3 FT LONG HORIZONTAL CRACKS UNDER RIGHT OVERHANG SIMILAR UNDER LEFT OVERHANG

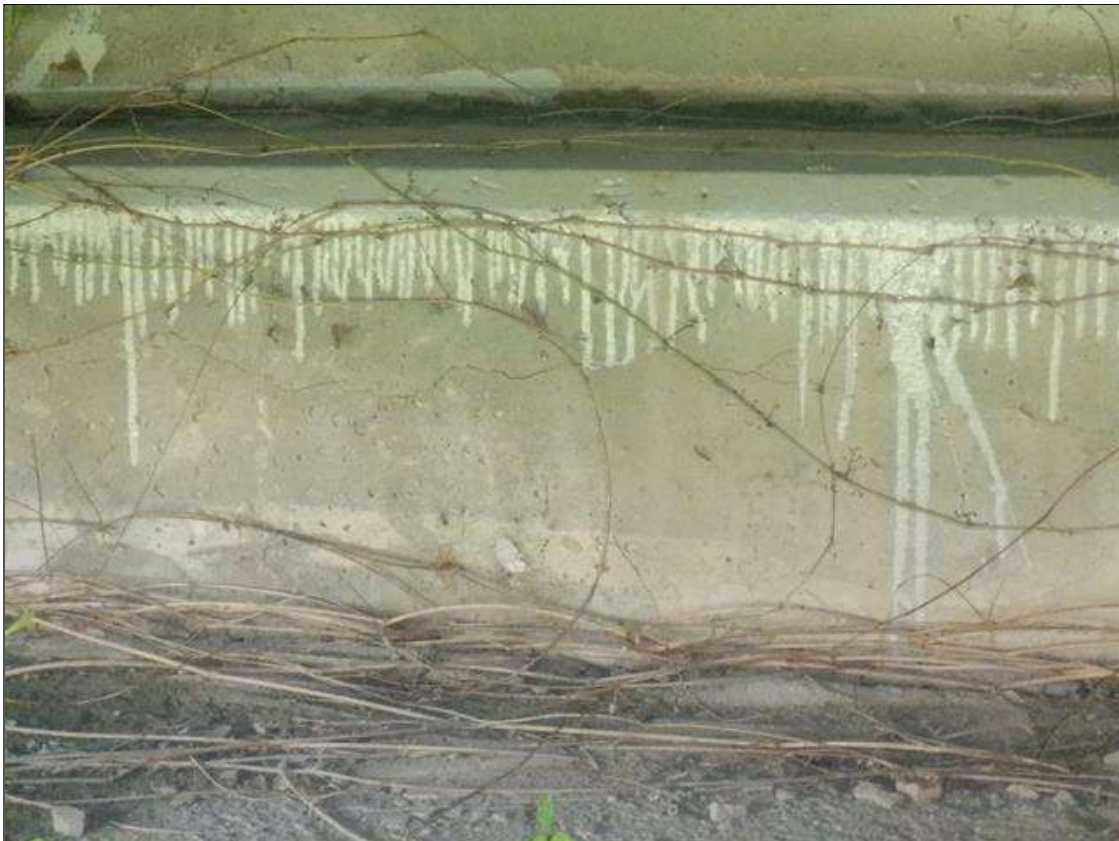
End Bent 2 Cap 1: 3 FT LONG X UP TO 1/16 IN WIDE HORIZONTAL CRACK, BELOW BAY 1.

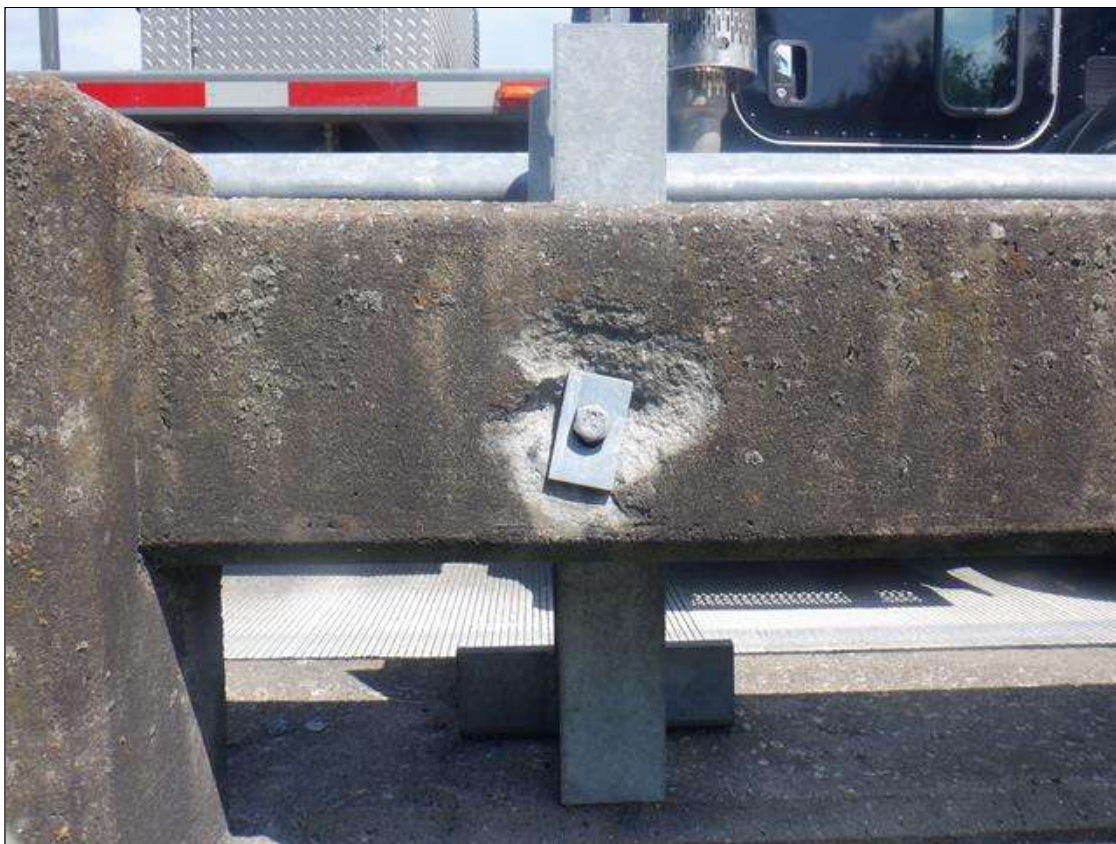
Span 1 Right Bridge Rail: UP TO 6 IN DIAMETER X 1.5 IN DEEP SPALL IN EXTERIOR FACE AT ANCHOR BOLT CONNECTION. TYPICAL AT SEVERAL CONNECTIONS.

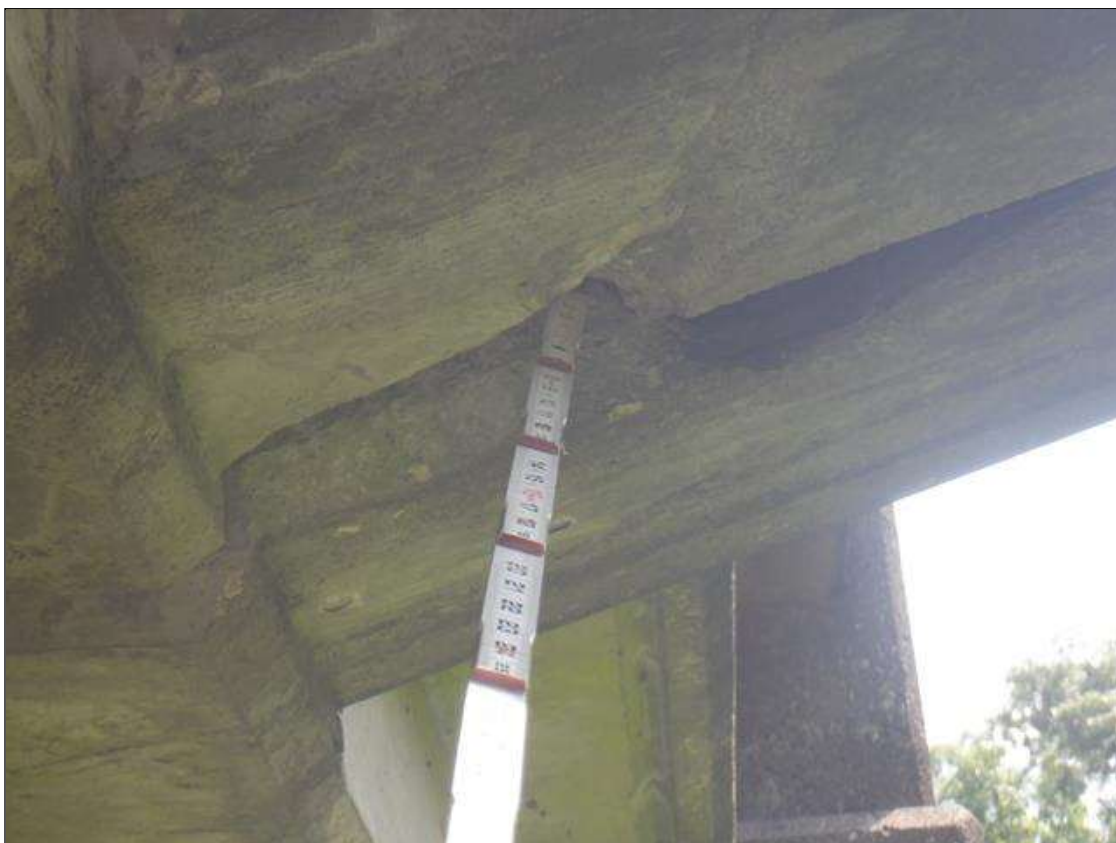
Span 1 Deck: 9 IN LONG X UP TO 4 IN WIDE X UP TO 2.5 IN DEEP SPALL IN RIGHT DECK OVERHANG ABOVE BENT 1.

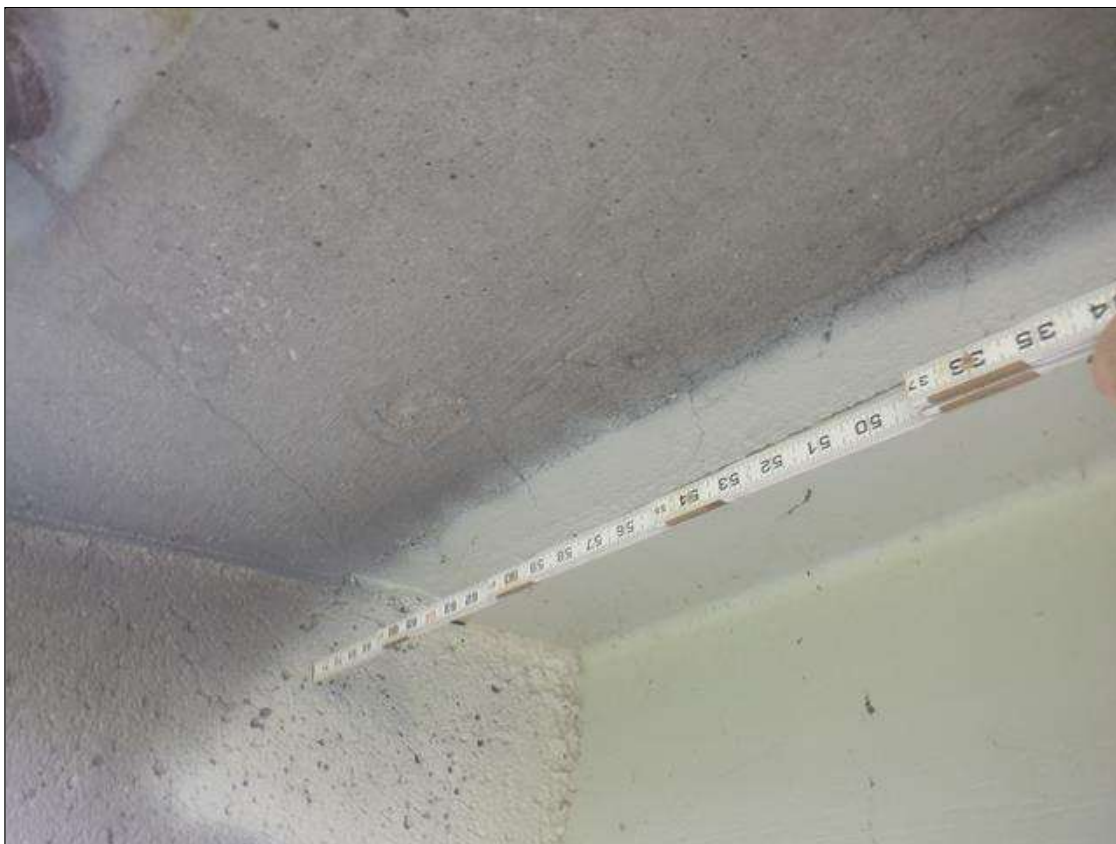
Span 1 Deck: SIX (6) UP TO 0.02 IN WIDE TRANSVERSE CRACKS UNDER LEFT OVERHANG, SCATTERED.

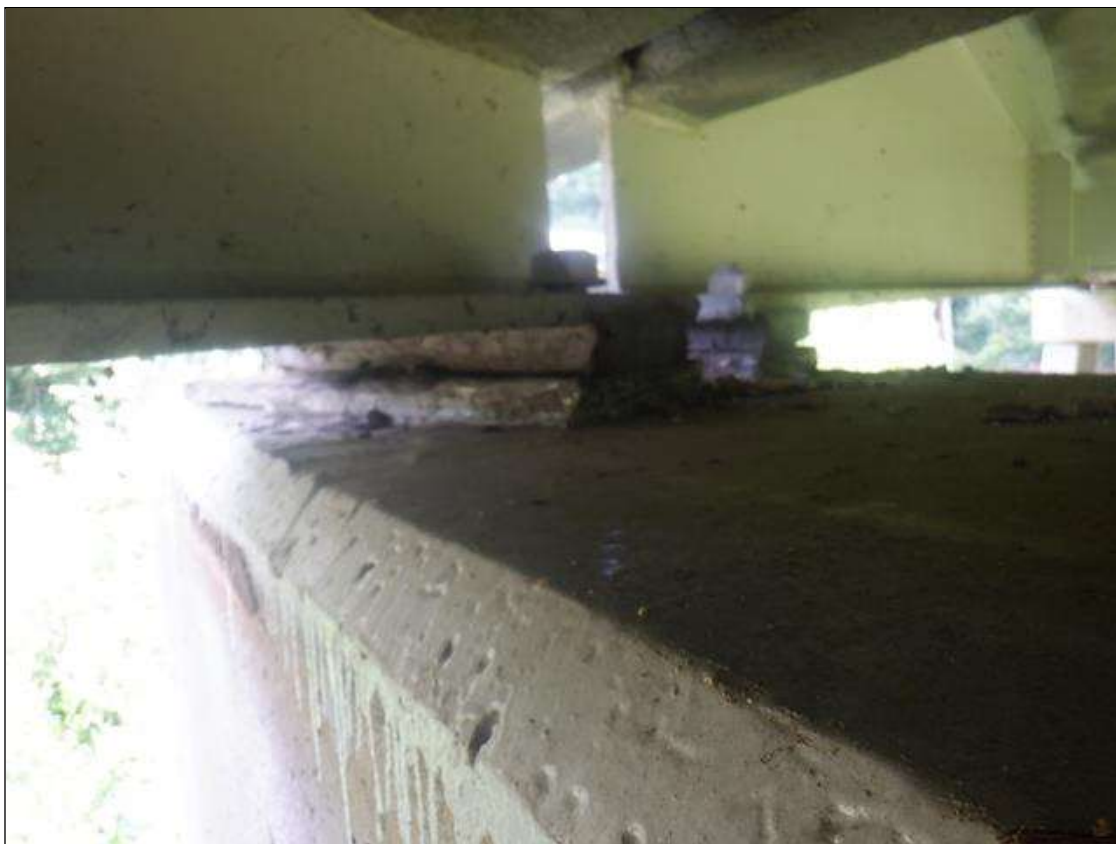
Span 1 Far Bearing: BEARINGS HAVE BEEN PAINTED SINCE PREVIOUS INSPECTION. SECTION LOSS EXISTS BENEATH THE PAINTED SURFACES IN BOTH MASONRY AND SOLE PLATES. UP TO 85% SECTION REMAINING.

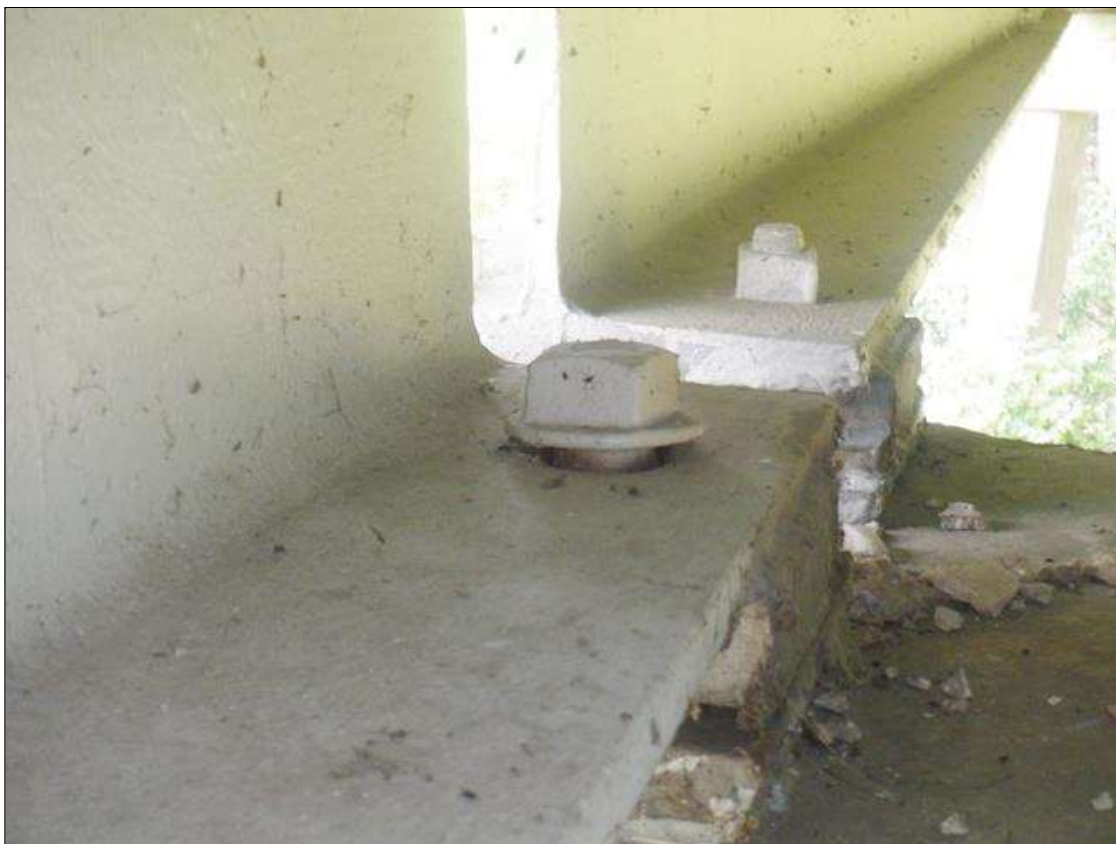
Span 1 Far Bearing: WELDED REPAIR, WITH NEW ANCHOR BOLT.

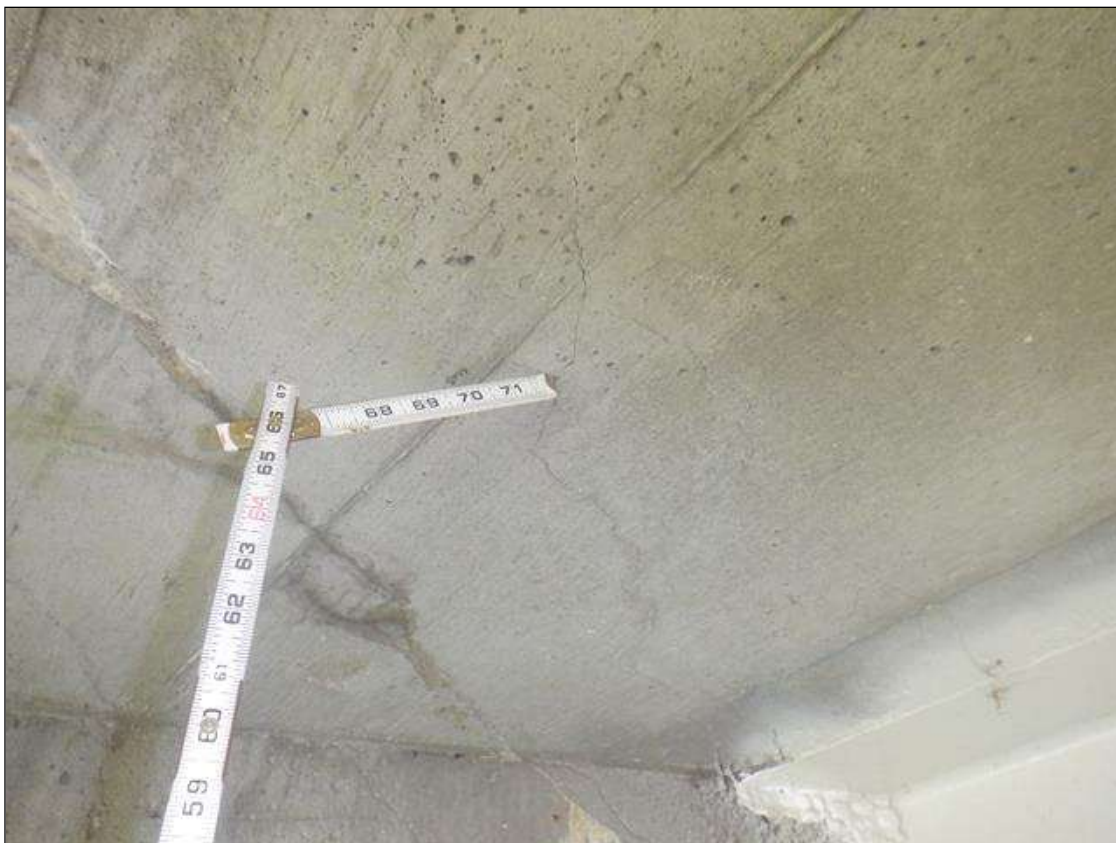
Span 1 Deck: UP TO 0.02 IN WIDE TRANSVERSE CRACKS IN DECK UNDERSIDE IN BAY 1 BETWEEN INTERMEDIATE DIAPHRAGMS TYPICAL IN BAYS 2 AND 3.

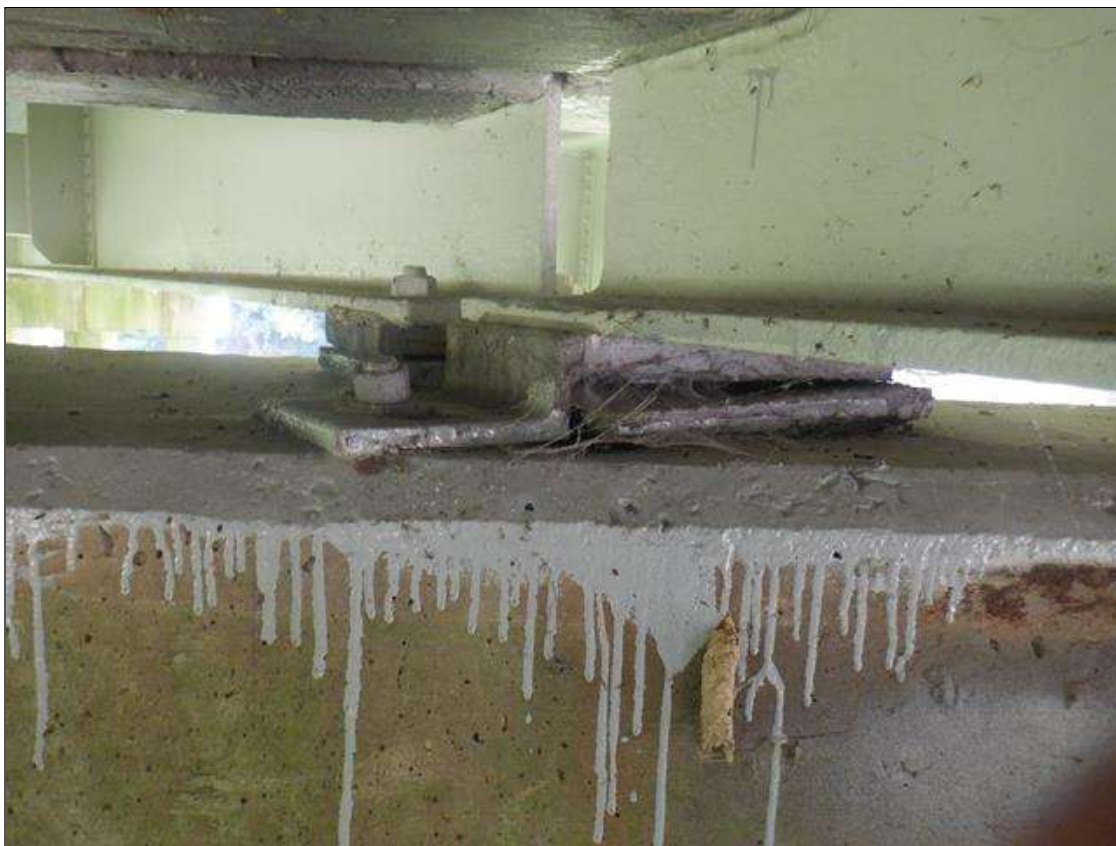
Span 1 Far Bearing: WELDED REPAIR WITH NEW ANCHOR BOLT.

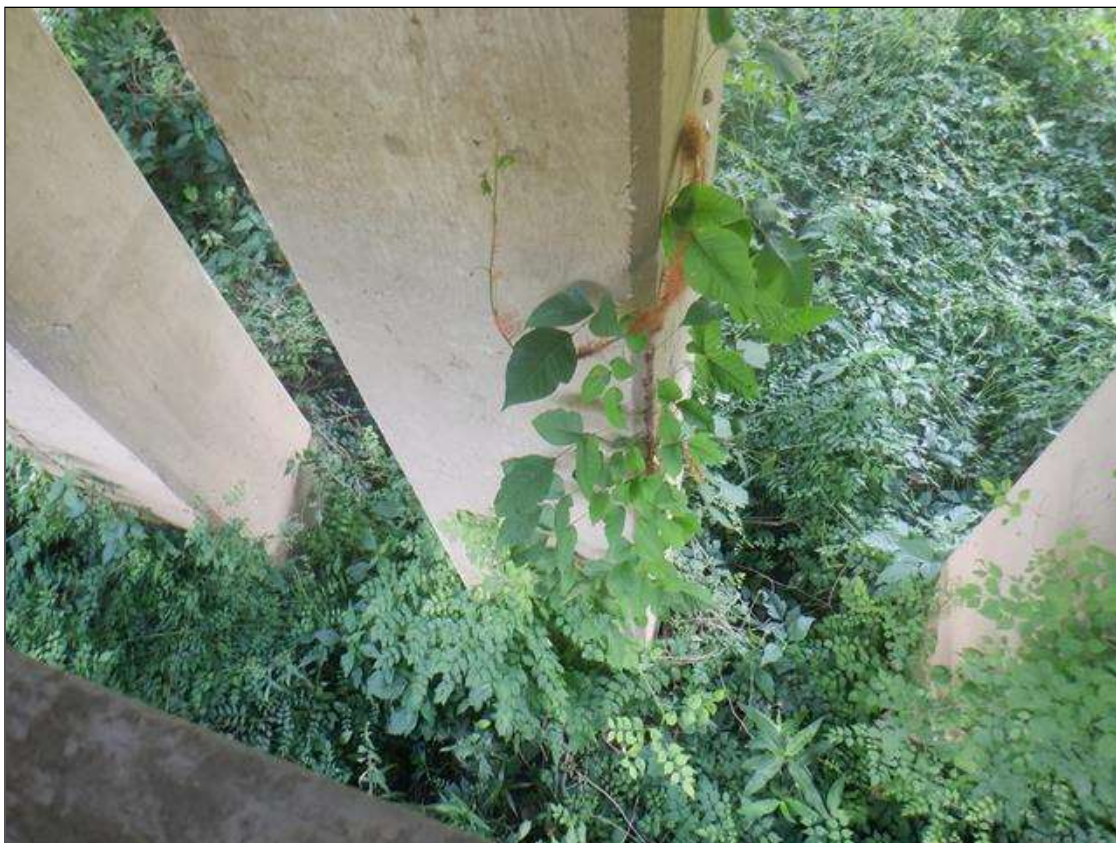
Bent 1 Pile 3: MINOR VEGETATION GROWTH IN SOUTH AND NORTH FACES.

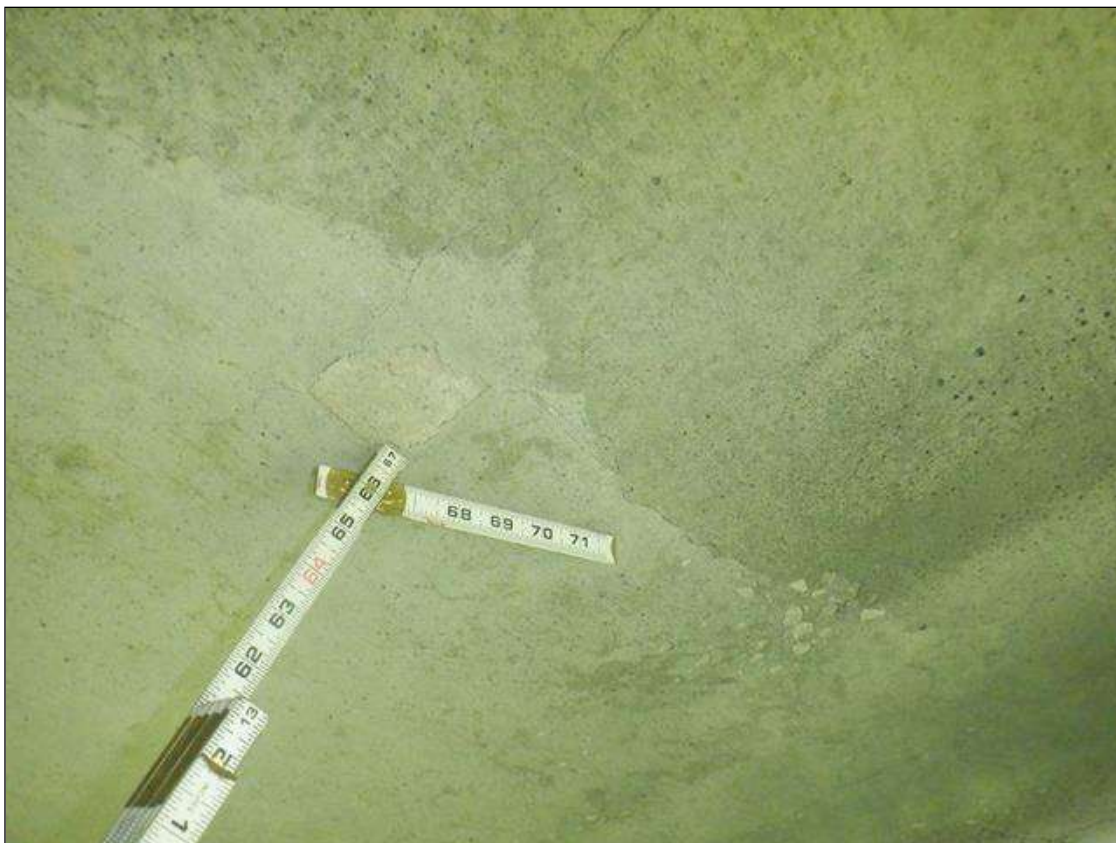
Span 2 Deck: UP TO 0.02 IN WIDE RANDOM CRACKING IN DECK UNDERSIDE, SCATTERED THROUGHOUT.

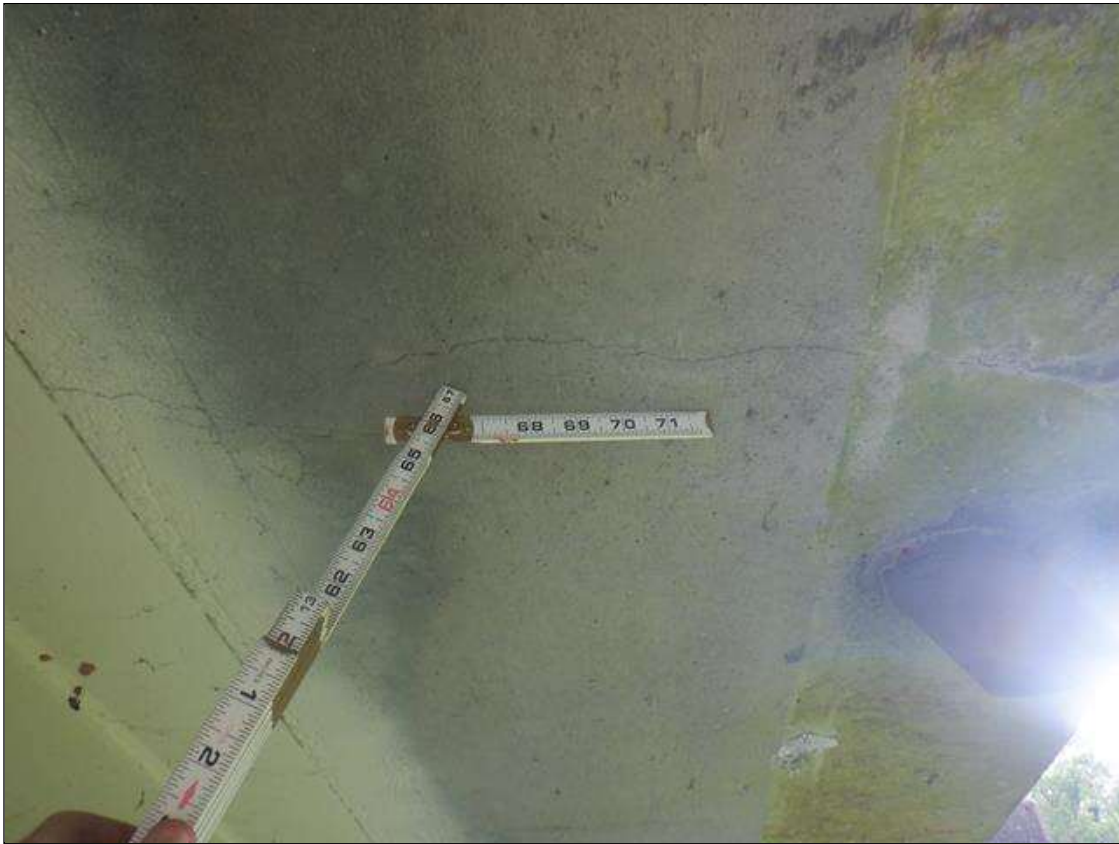
Span 2 Deck: NINE (9) UP TO 0.02 IN WIDE X UP TO 3 FT LONG TRANSVERSE CRACKS IN LEFT OVERHANG. TYPICAL AT RIGHT OVERHANG.
