NC DEPARTMENT OF TRANSPORTATION
 DIVISION OF HIGHWAYS
 STRUCTURE MANAGEMENT UNIT

ATTENTION: NEW REPAIRS, PAR, CHANGE IN STRUCTURAL DATA, HYDRA PLATFORM USED

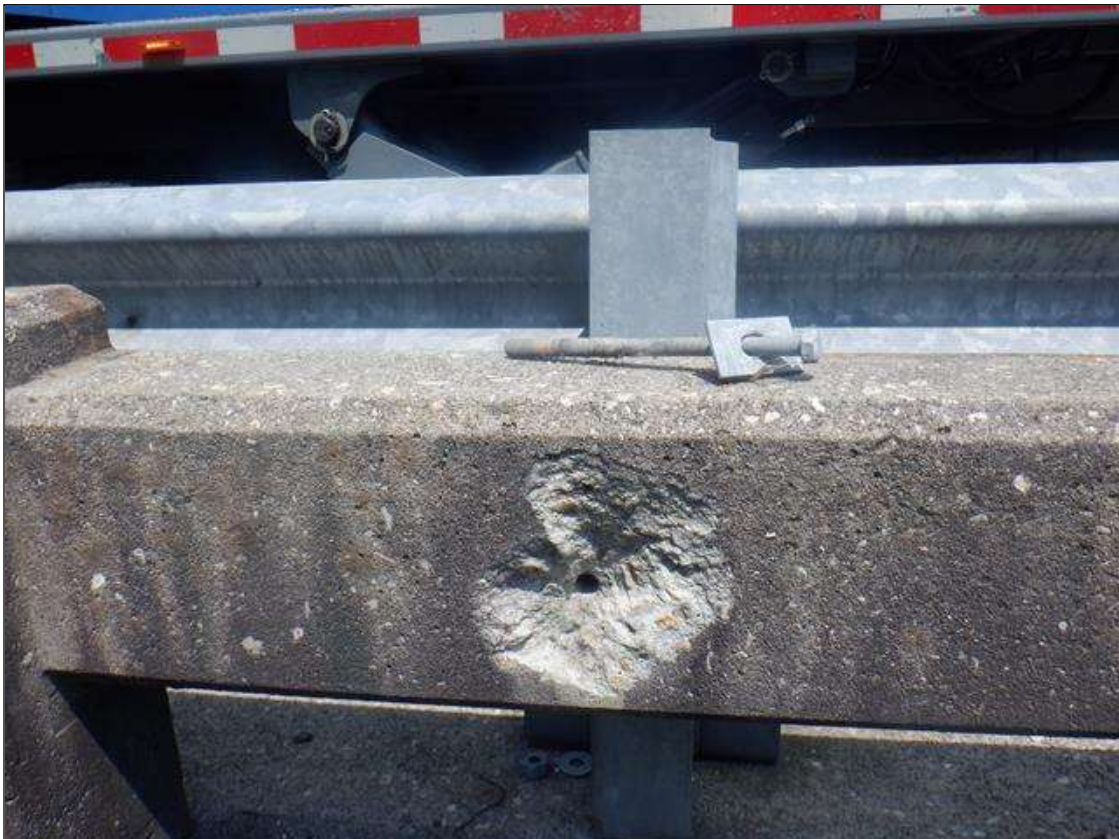
Span 2 Right Bridge Rail: BOLT HAS DETACHED FROM CONCRETE OUTER RAIL 10 FT FROM END BENT 1 LEAVING METAL INNER RAIL FREE. (PAR)

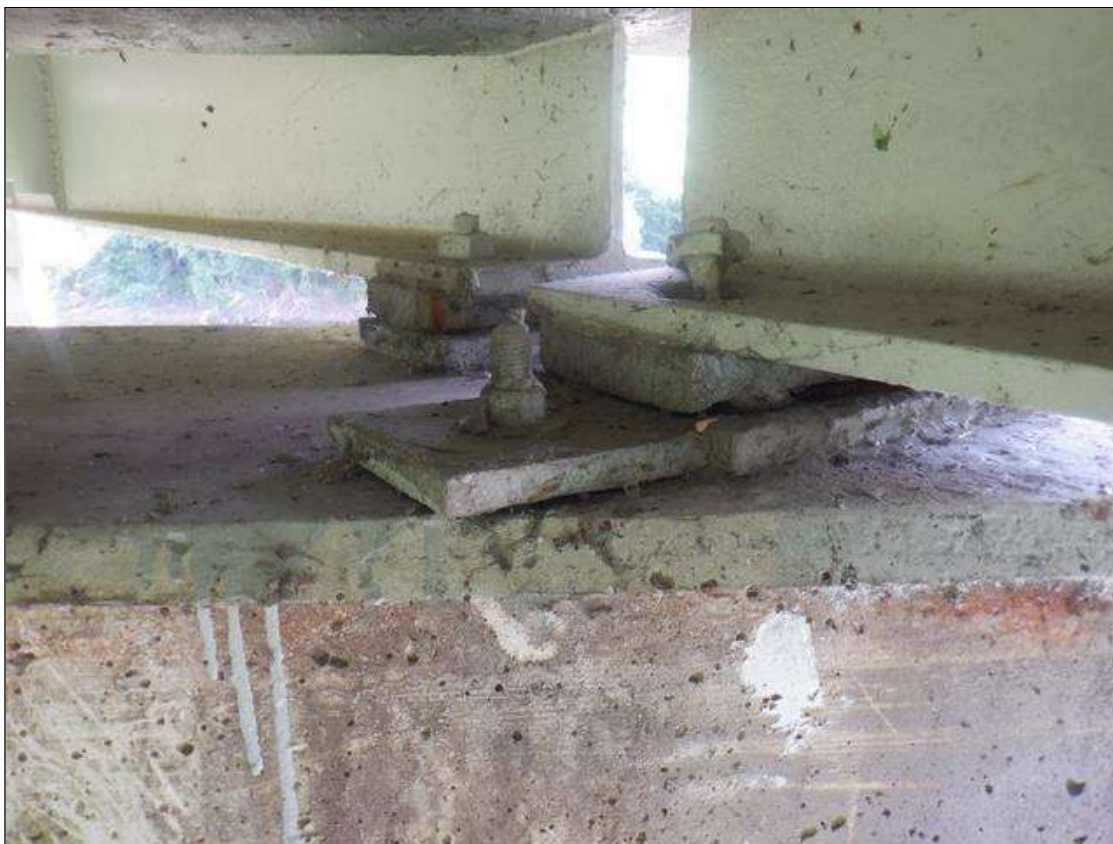
Span 2 Far Bearing: WELDED REPAIR WITH NEW ANCHOR BOLT. UP TO 50% SECTION LOSS IN OLD ANCHOR BOLT. PAR NOT ISSUED DUE TO NEW ANCHOR BOLT REPAIR.

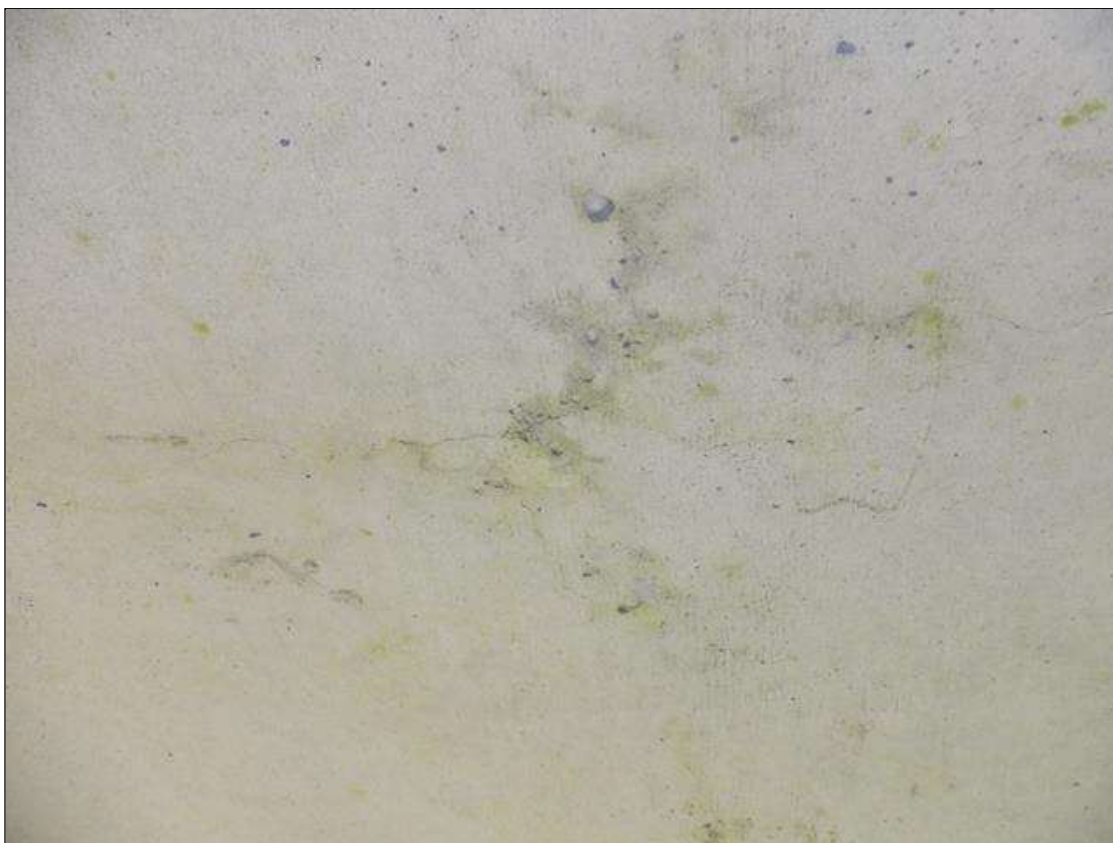
Span 3 Deck: UP TO 0.03 IN WIDE RANDOM CRACKING IN DECK UNDERSIDE, SCATTERED THROUGHOUT.

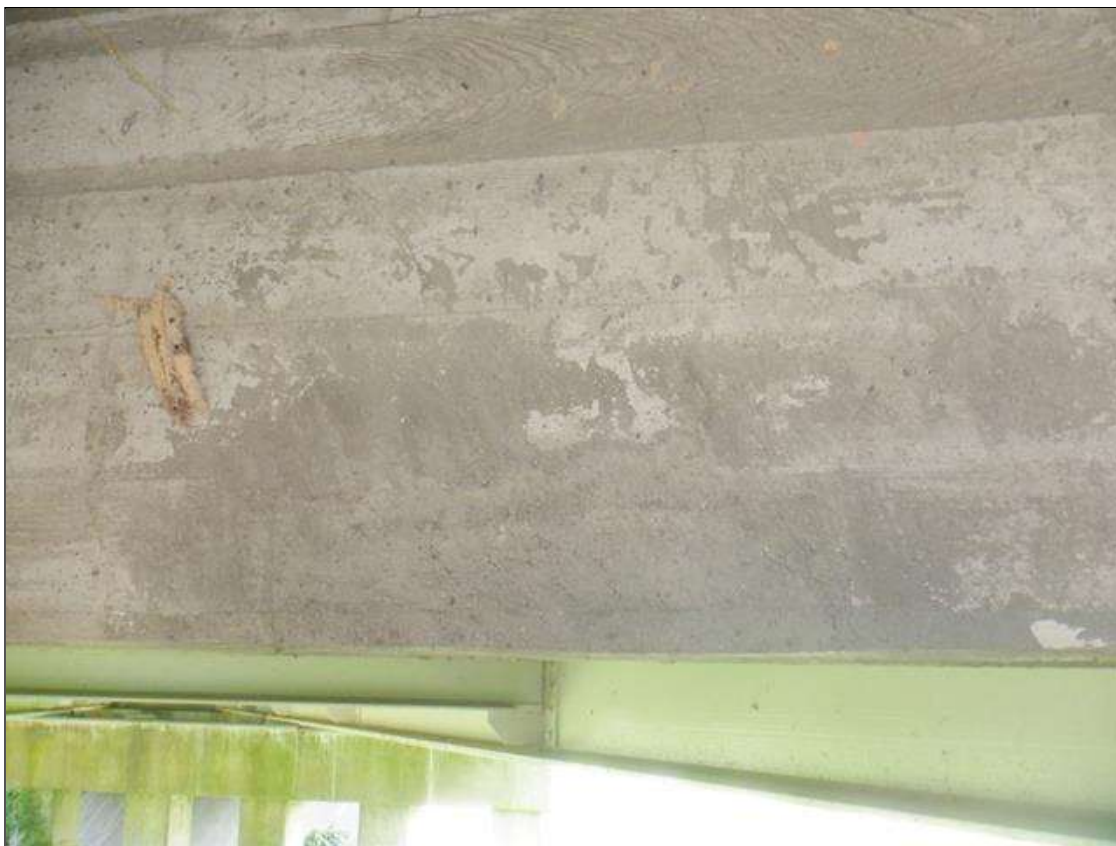
Span 3 Deck: 2 FT LONG X 1 FT HIGH SOUND CONCRETE PATCH IN BAY 2 BENT DIAPHRAGM AT BENT 2

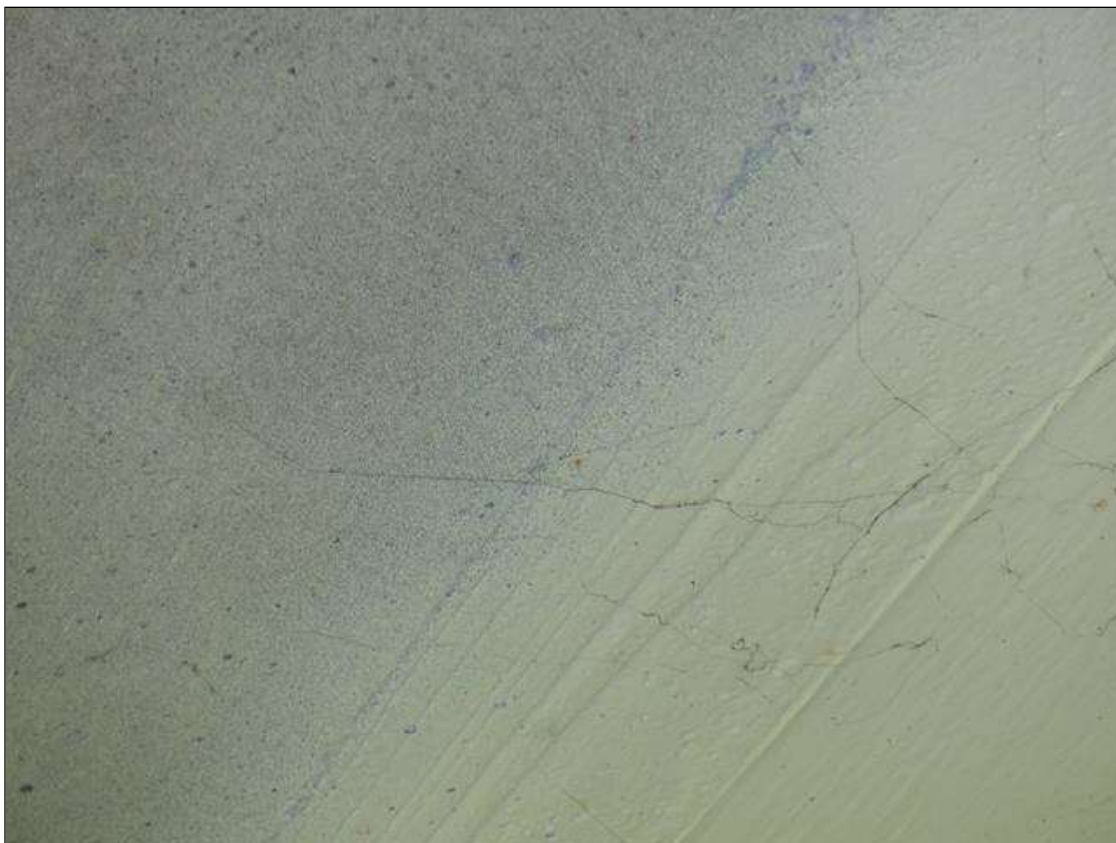
Span 3 Deck: SIX (6) UP TO 0.02 IN WIDE X UP TO 3 FT LONG TRANSVERSE CRACKS IN RIGHT OVERHANG. TYPICAL AT LEFT OVERHANG.

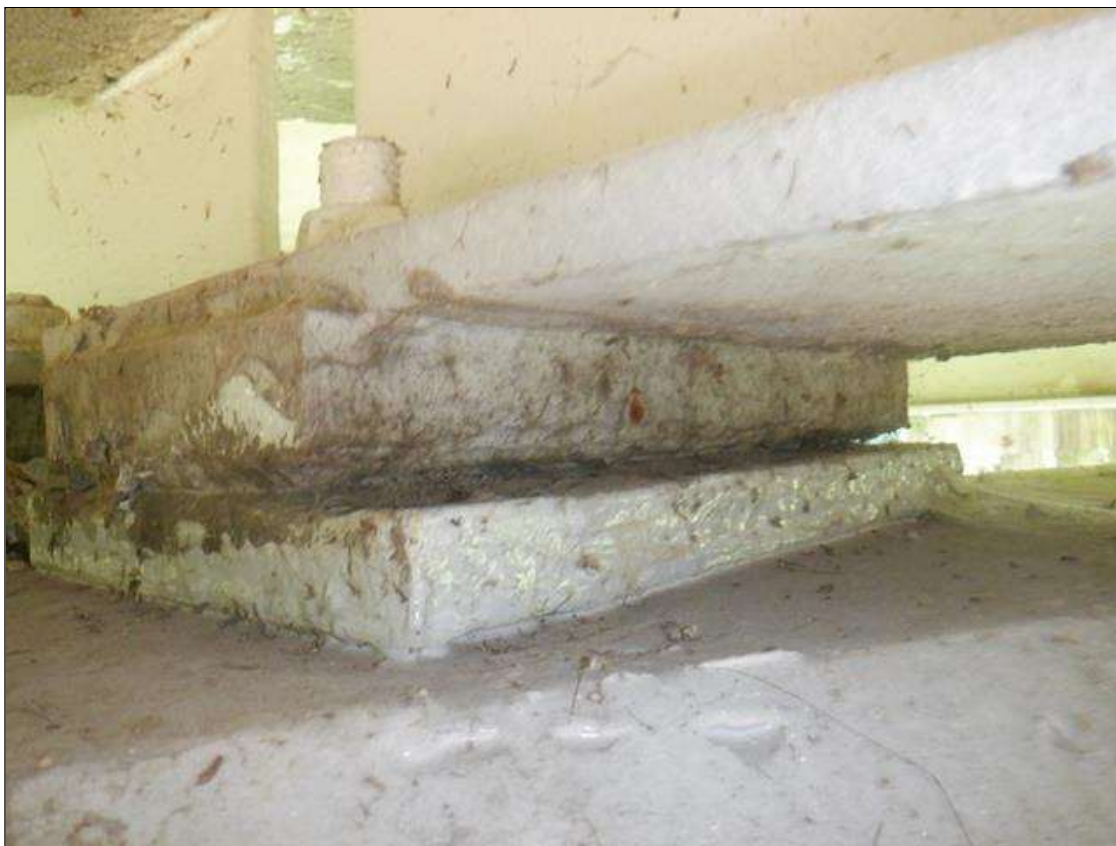
Span 3 Near Bearing: BEARINGS HAVE BEEN PAINTED SINCE PREVIOUS INSPECTION. SECTION LOSS EXSISTS BENEATH THE PAINTED SURFACES IN BOTH MASONRY AND SOLE PLATES. UP TO 95% SECTION REMAINING.

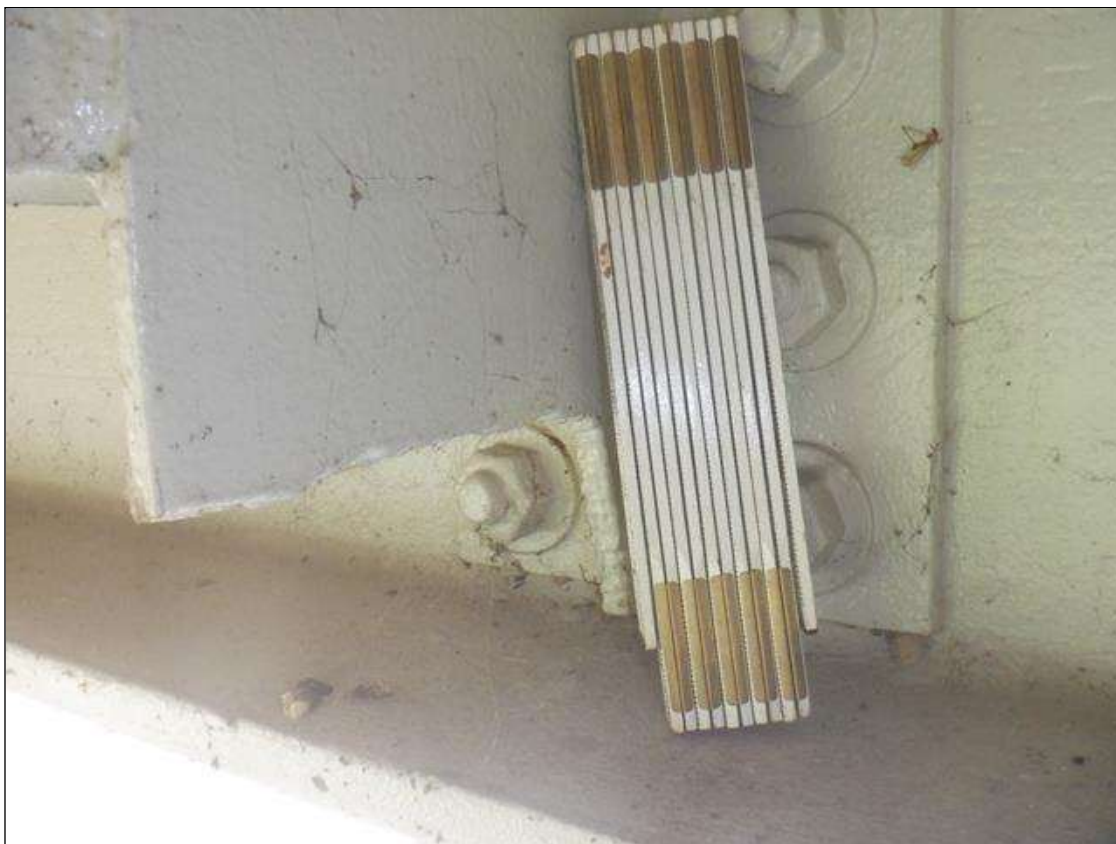
Span 3 Beam 4: 2 IN HIGH OF INTERMEDIATE STIFFENER IS CUT OUT AT BOTH LOCATIONS. PAR IS NOT ISSUED AS IT APPEARS TO BE FROM PREVIOUS BRIDGE REPAIR.

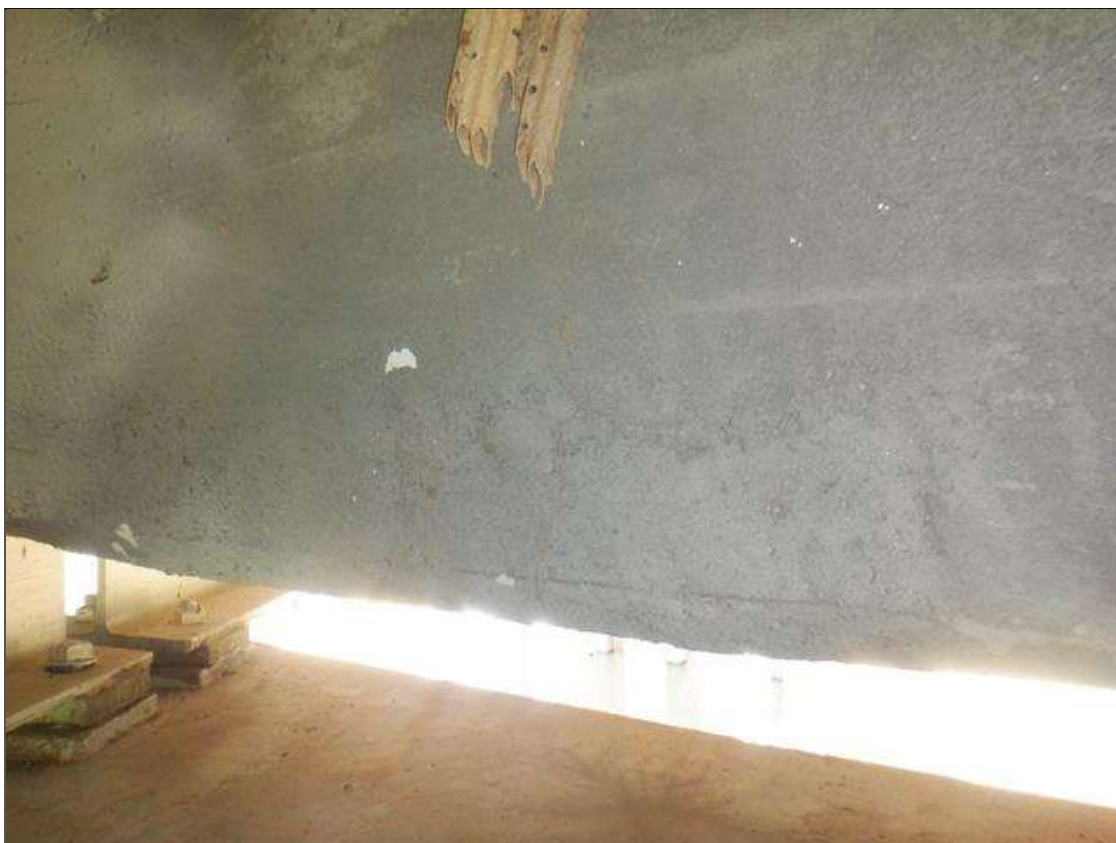
Span 3 Deck: NEW REPAIR 4 FT LONG X 1 FT HIGH SOUND CONCRETE PATCH IN BENT DIAPHRAGM AT BENT 2. NEW SINCE PREVIOUS INSPECTION.

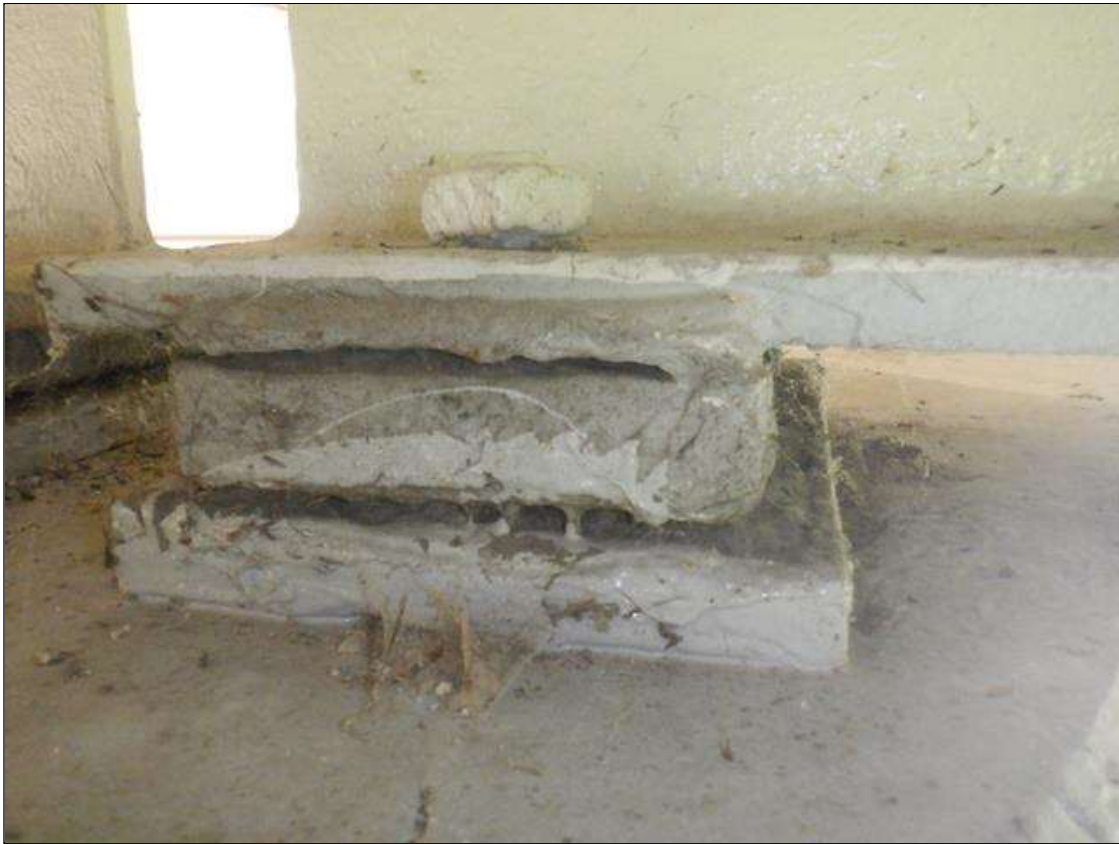
Span 3 Far Bearing: BEARINGS HAVE BEEN PAINTED SINCE PREVIOUS INSPECTION. SECTION LOSS EXISTS BENEATH THE PAINTED SURFACES IN BOTH MASONRY AND SOLE PLATES. UP TO 80% SECTION REMAINING.

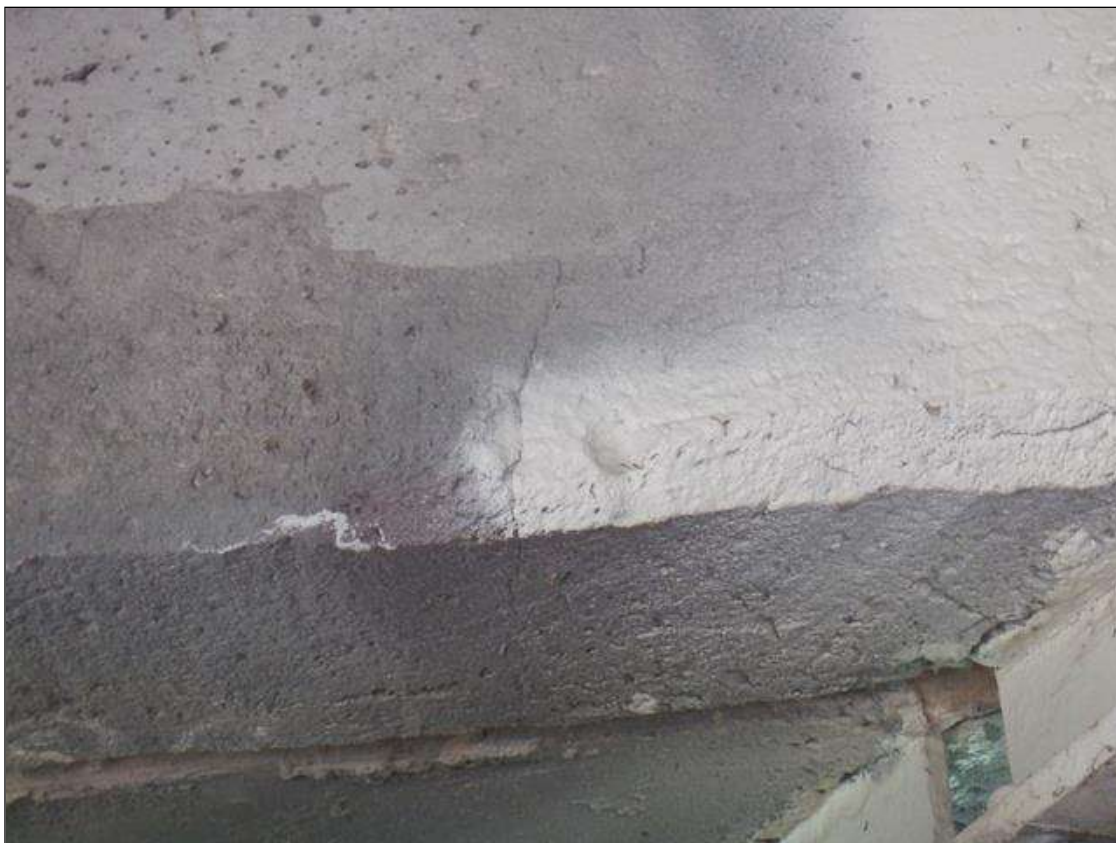
Span 4 Deck: 4 FT LONG X 1 FT HIGH AREA OF UNSOUND CONCRETE PATCH WITH UP TO 0.05 IN VERTICAL CRACKS IN BAY 3 BENT DIAPHRAGM AT BENT BENT 3

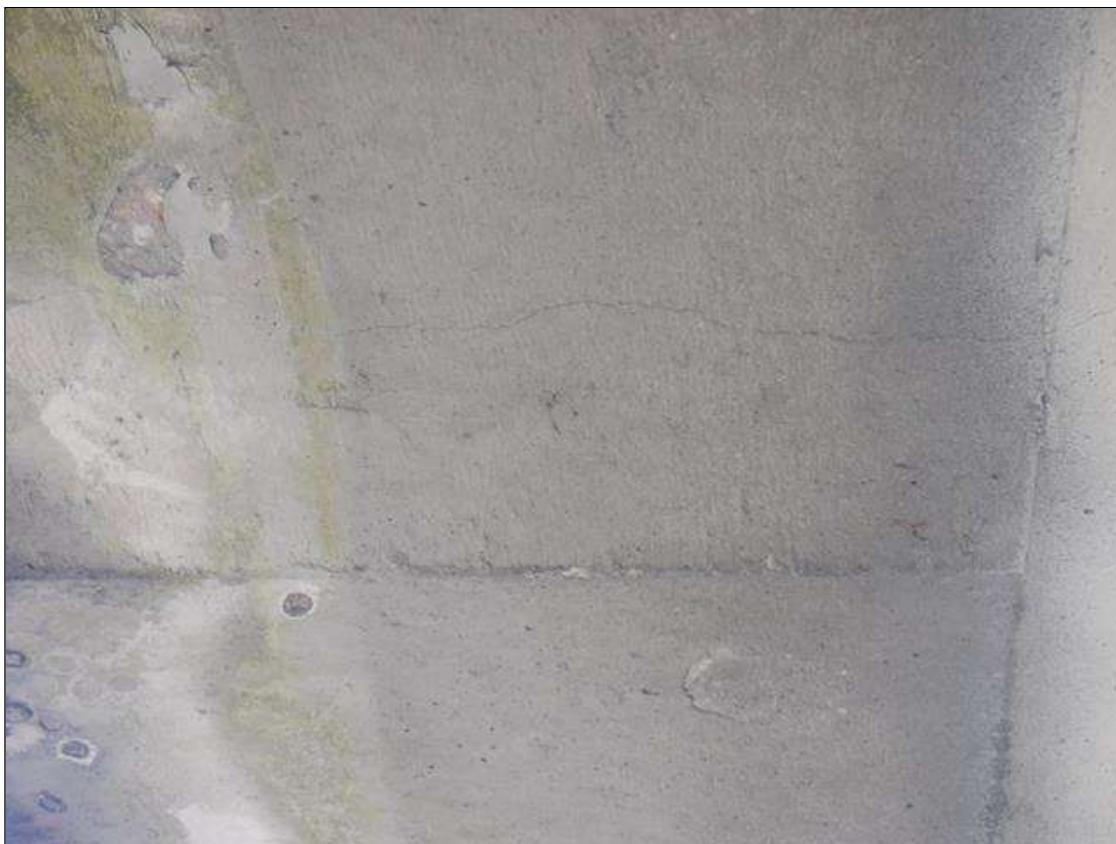
Span 4 Deck: EIGHT (8) UP TO 0.02 IN WIDE X UP TO 3 FT LONG TRANSVERSE CRACKS IN LEFT OVERHANG.

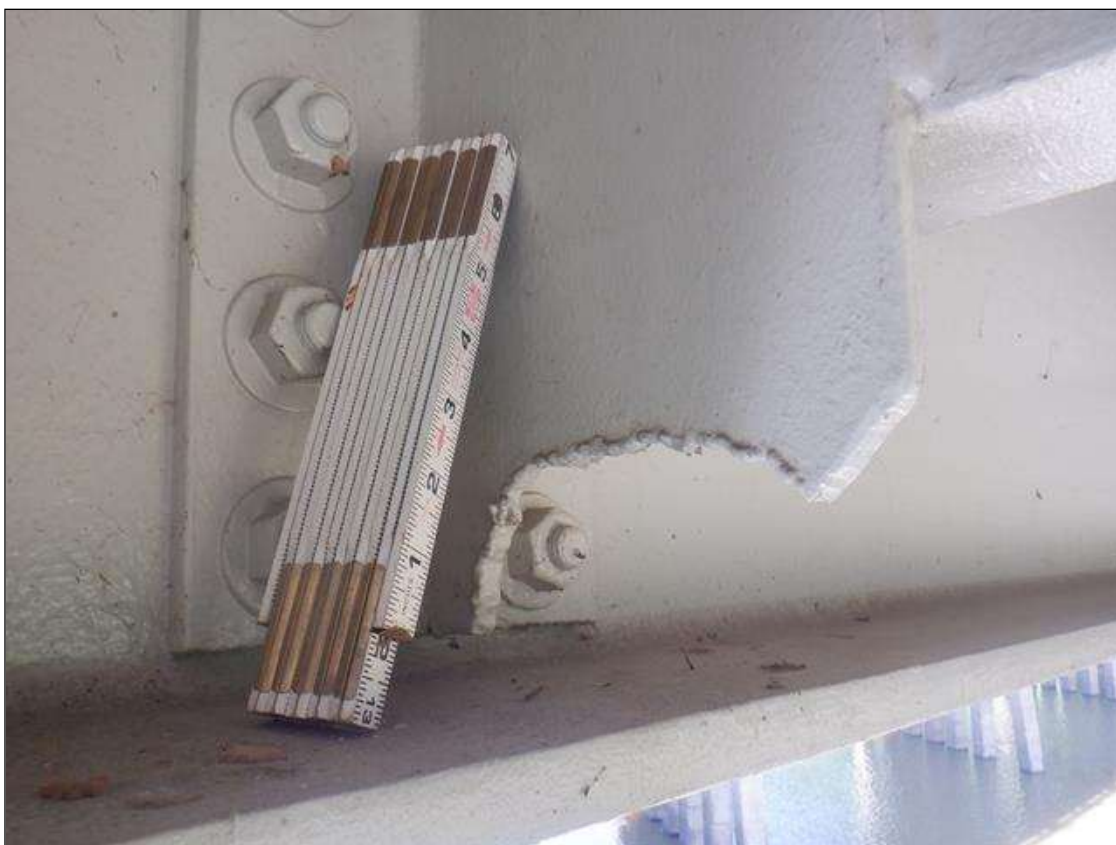
Span 4 Beam 1: 2 IN HIGH OF INTERMEDIATE STIFFENER IS CUT OUT AT BOTTOM AT BOTH LOCATIONS. PAR IS NOT ISSUED AS IT APPEARS TO BE FROM PREVIOUS BRIDGE REPAIR.

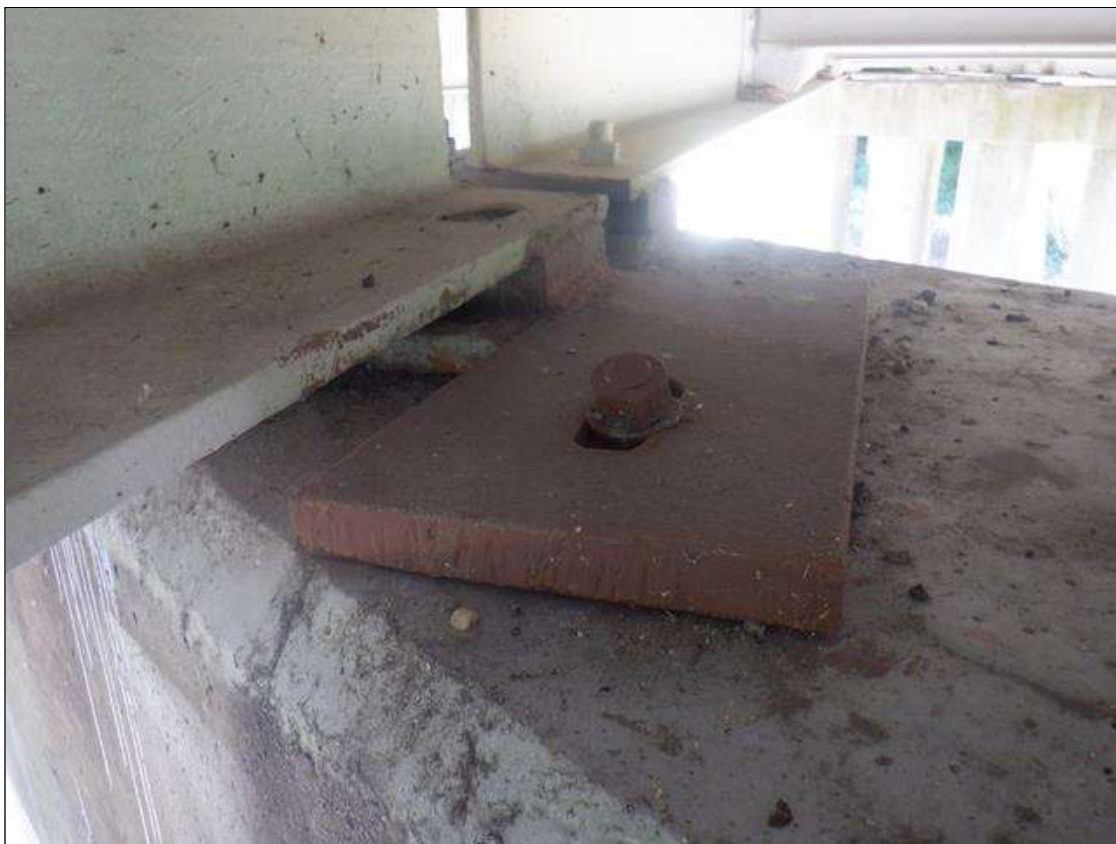
Span 4 Far Bearing: WELDED REPAIR WITH NEW ANCHOR BOLT.

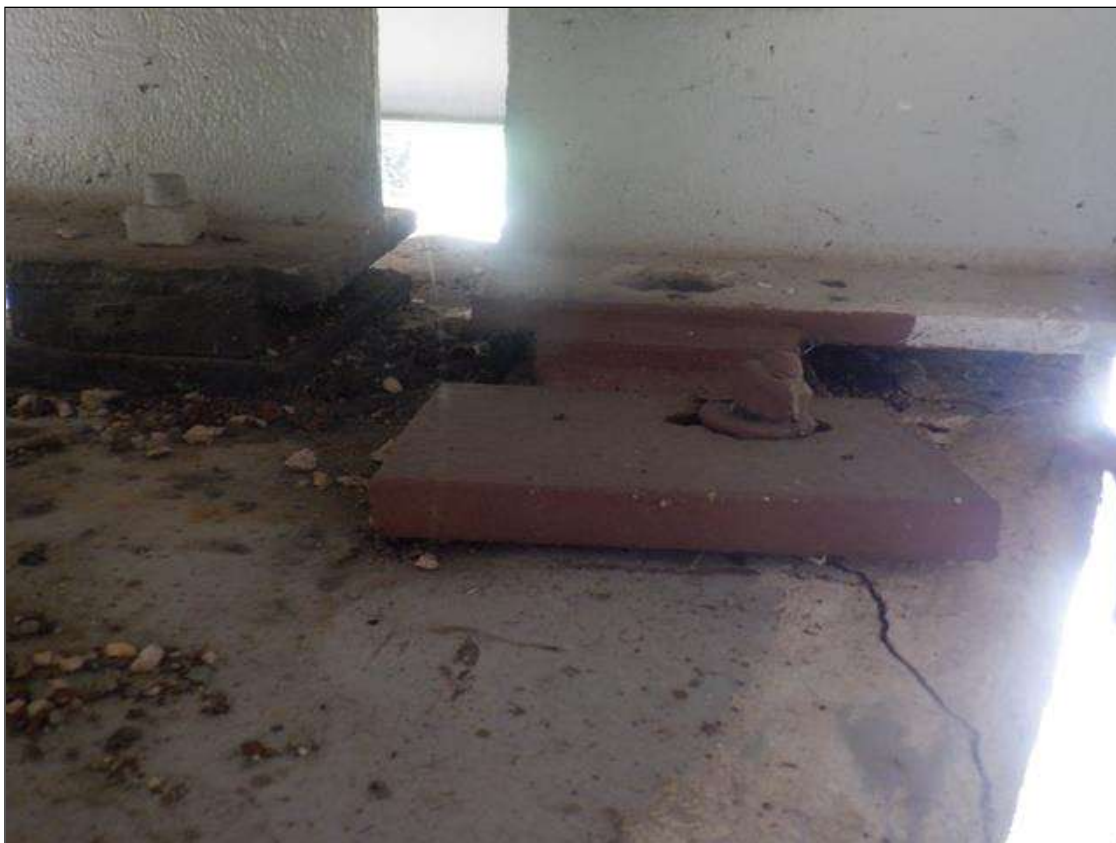
Span 4 Beam 3 - Far Bearing: BEARING HAS WELDED REPAIR WITH NEW ANCHOR BOLTS.

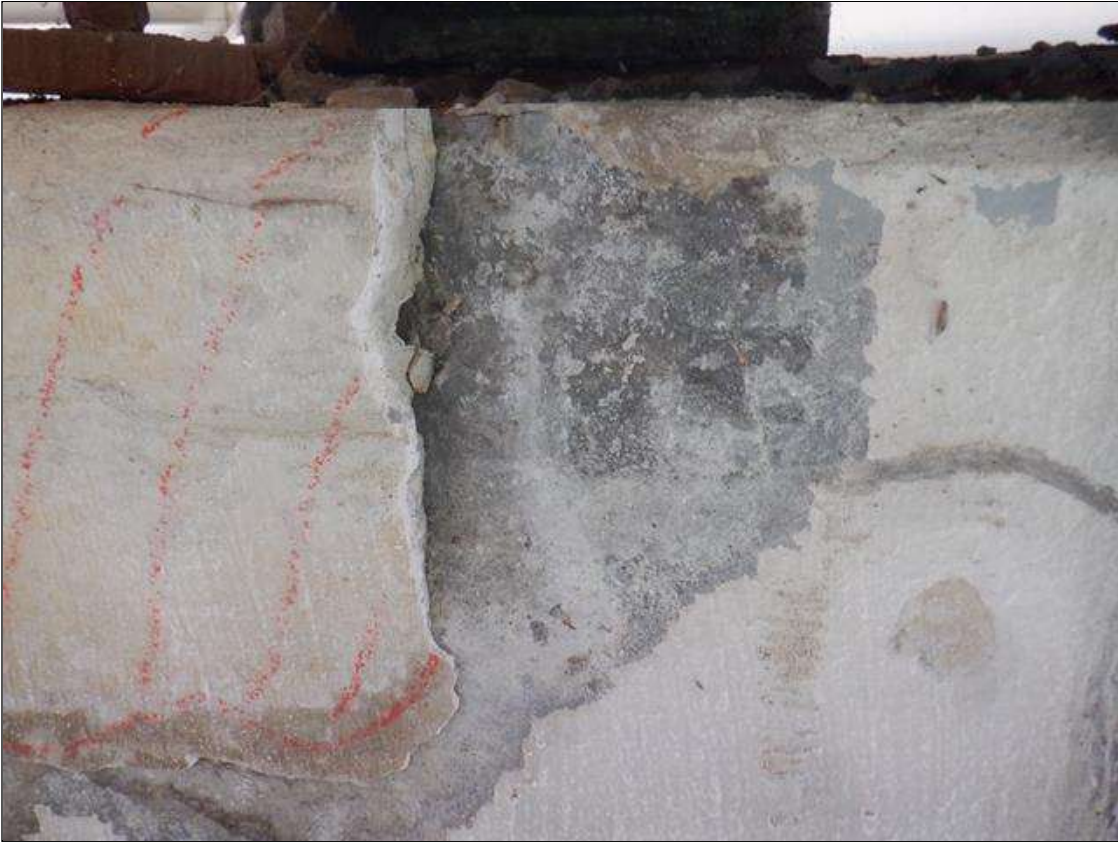
Span 4 Beam 3 - Far Bearing: NEW BEARING HAS A LOSS OF BEARING AREA DUE TO SPALL ON CAP. AREA REPAIRED IS UNSOUND AND HAS 6 IN HIGH X 5 IN WIDE X 2 IN DEEP SPALLS. (PAR)

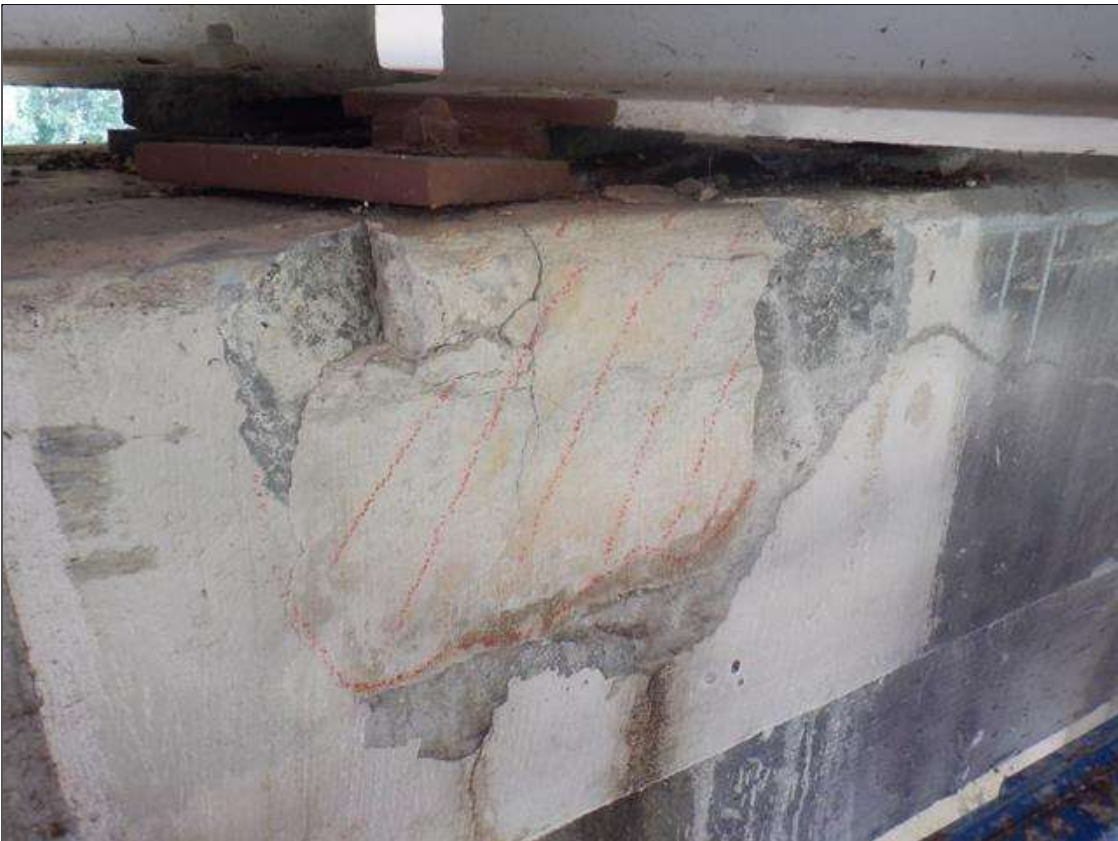
Span 4 Beam 3 - Far Bearing: NEW BEARING HAS A LOSS OF BEARING AREA DUE TO SPALL ON CAP. AREA REPAIRED IS UNSOUND AND HAS 6 IN HIGH X 5 IN WIDE X 2 IN DEEP SPALLS. (PAR)

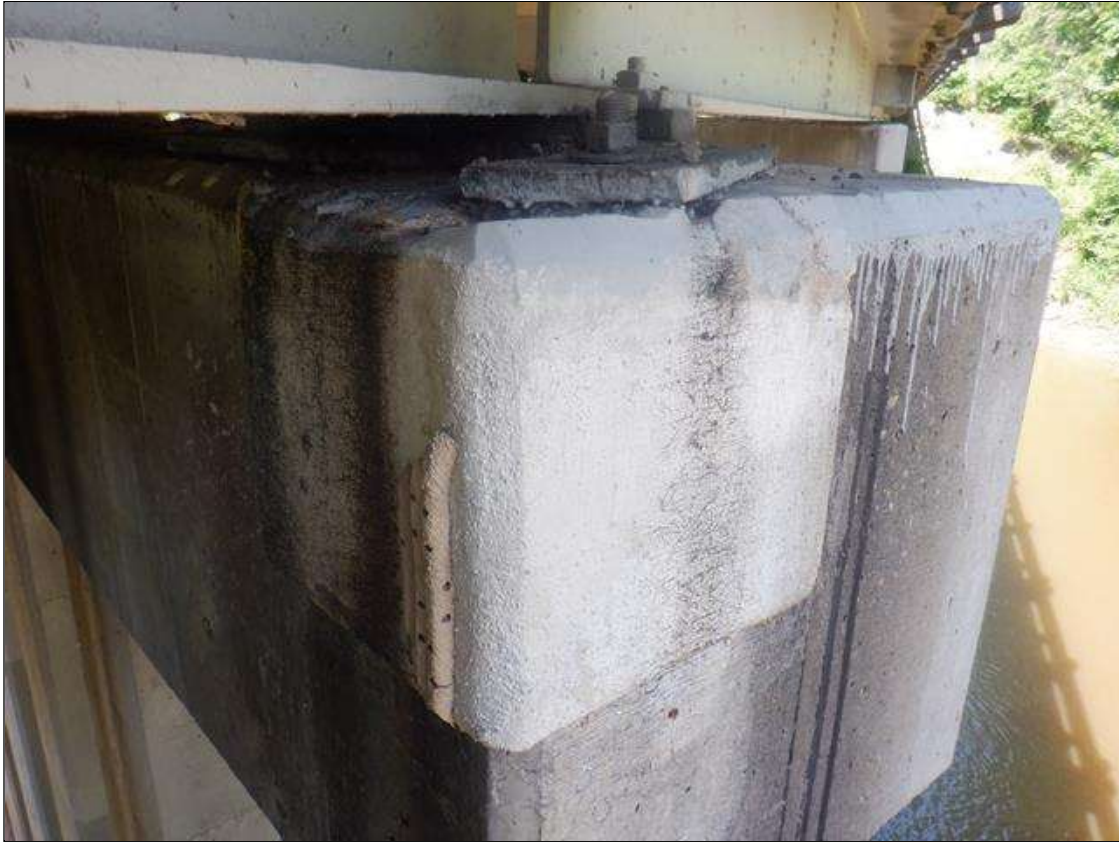
Bent 4 Cap 1: 15 IN HIGH X 21 IN WIDE SOUND CONCRETE PATCH AREA, TOP SOUTHEAST CORNER OF CAP, BELOW NEW BEARING ASSEMBLY OF BEAM 4. PATCH EXHIBITS A 8 IN LONG X 0.02 IN WIDE DIAGONAL CRACK STARTING AT TOP LEFT CORNER IN SOUTH FACE AND A UP TO 0.03 IN WIDE X 15 IN LONG VERTICAL CRACK IN EAST FACE.

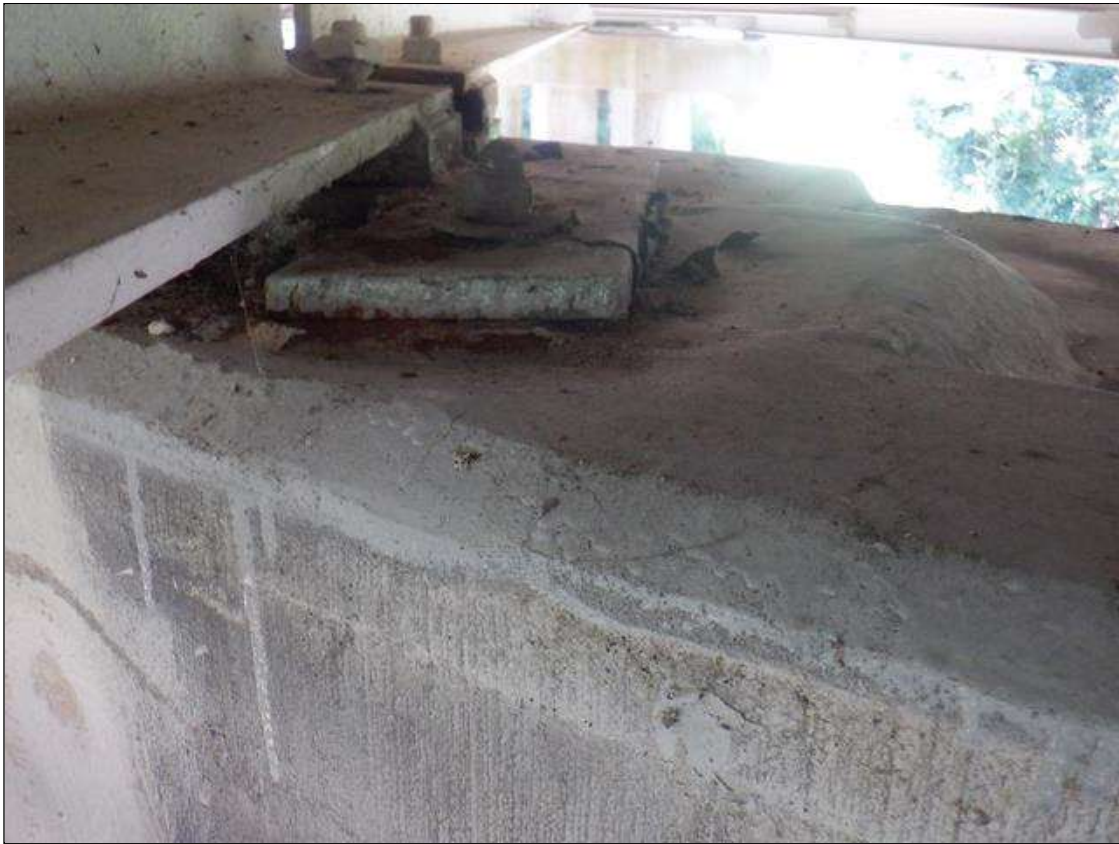
Bent 4 Cap 1: NEW REPAIR 18 IN WIDE X 1 FT HIGH UNSOUND CONCRETE PATCH IN SOUTH FACE BELOW BEAM 3. BEARING IS NOT SEATED LEVEL. REPAIRS MADE SINCE PREVIOUS INSPECTION ARE UNSOUND

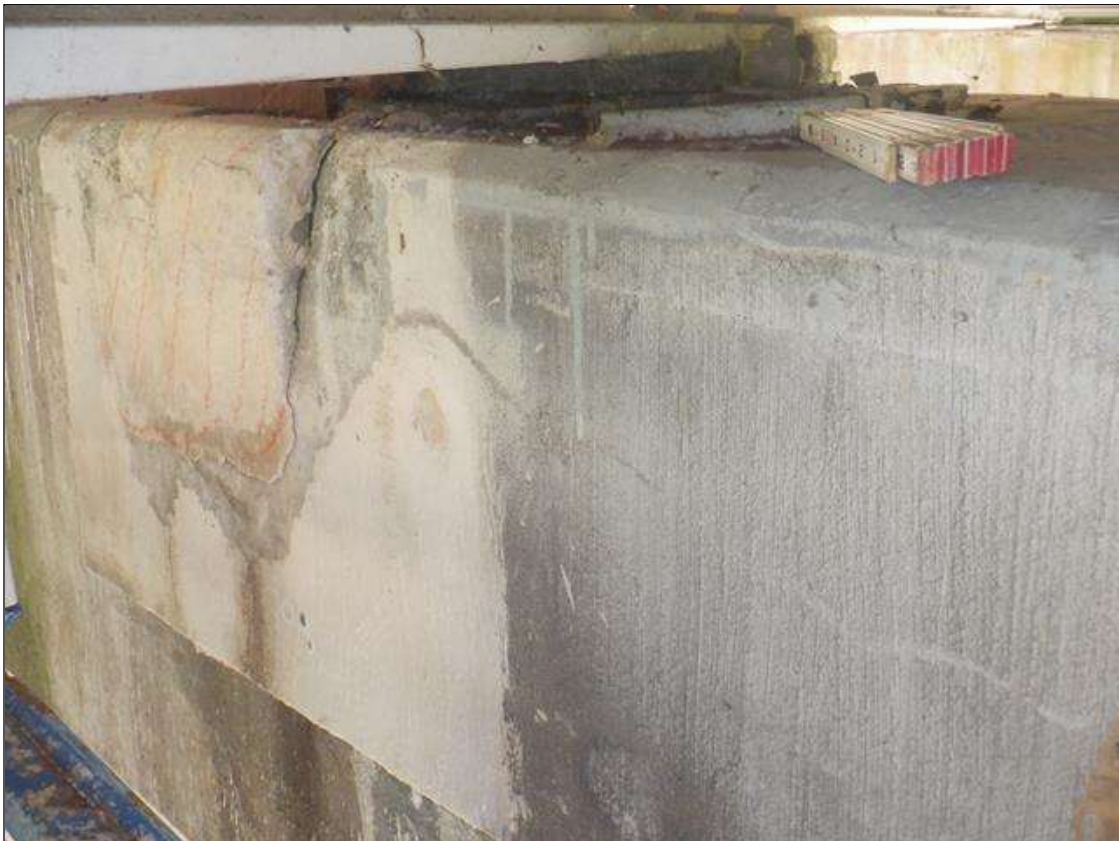
Bent 4 Cap 1: 3.5 FT LONG X 1.5 FT HIGH UNSOUND PATCHED AREA WITH SPALLS, TOP OF SOUTH FACE, BELOW BEAM 3.

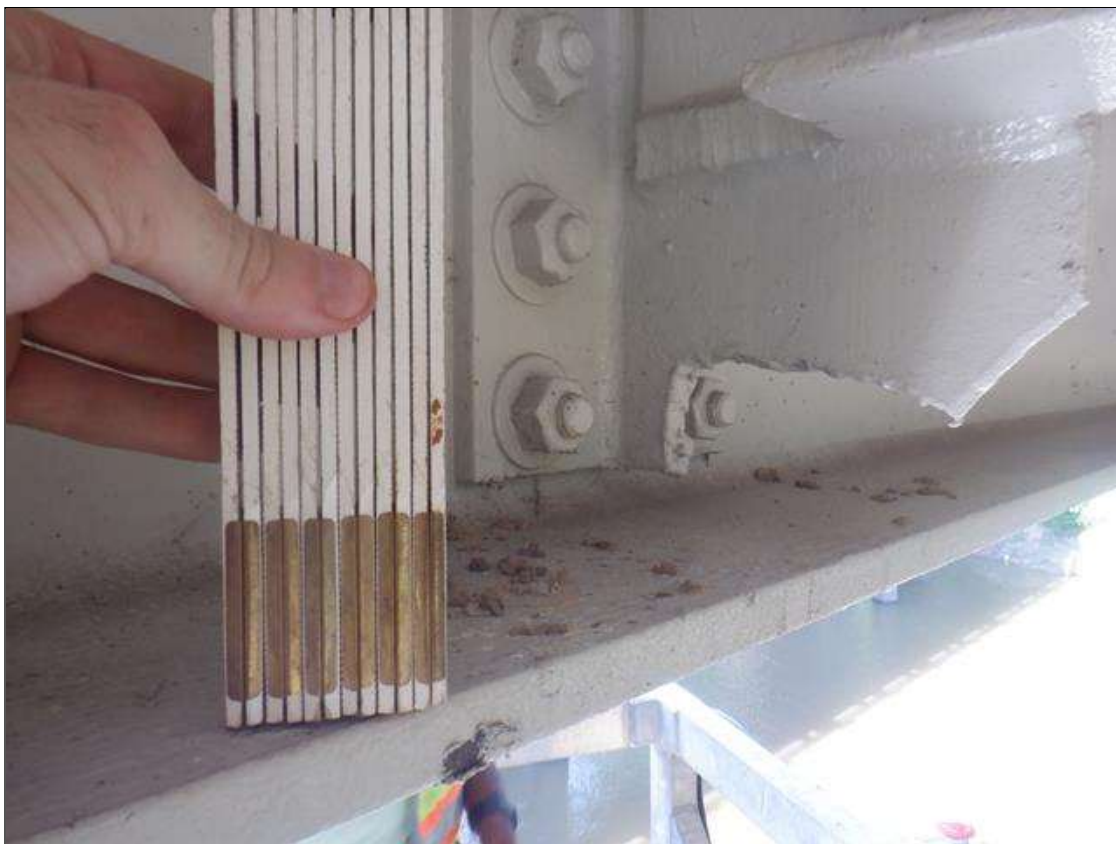
Span 4 Beam 1: 2 IN HIGH OF INTERMEDIATE STIFFENER IS CUT OUT AT BOTH LOCATIONS. PAR IS NOT ISSUED AS IT APPEARS TO BE FROM PREVIOUS BRIDGE REPAIR.

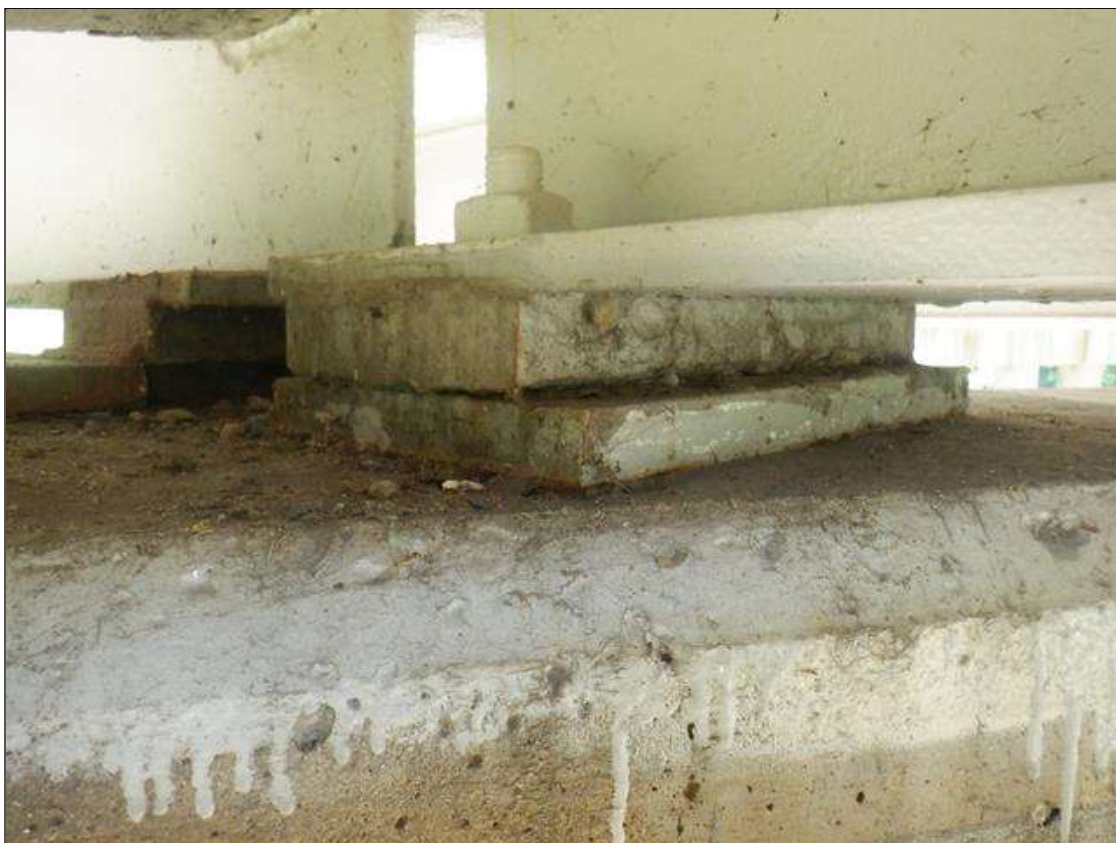
Span 4 Beam 3 - Near Bearing - Protective System: NEW REPAIR: PROTECTIVE SYSTEM IS REPAINTED SINCE PREVIOUS INSPECTION.

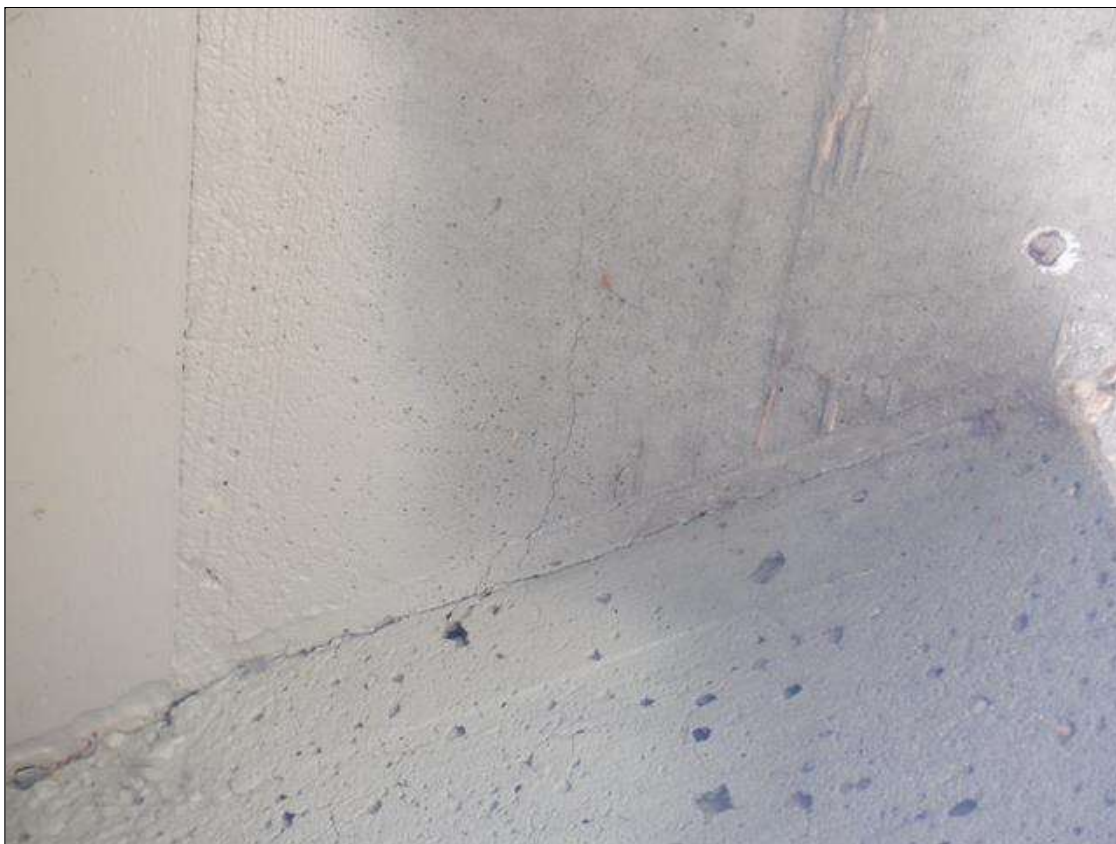
Span 4 Deck: EIGHT (8) UP TO 0.02 IN WIDE X UP TO 3 FT LONG TRANSVERSE CRACKS IN LEFT OVERHANG.

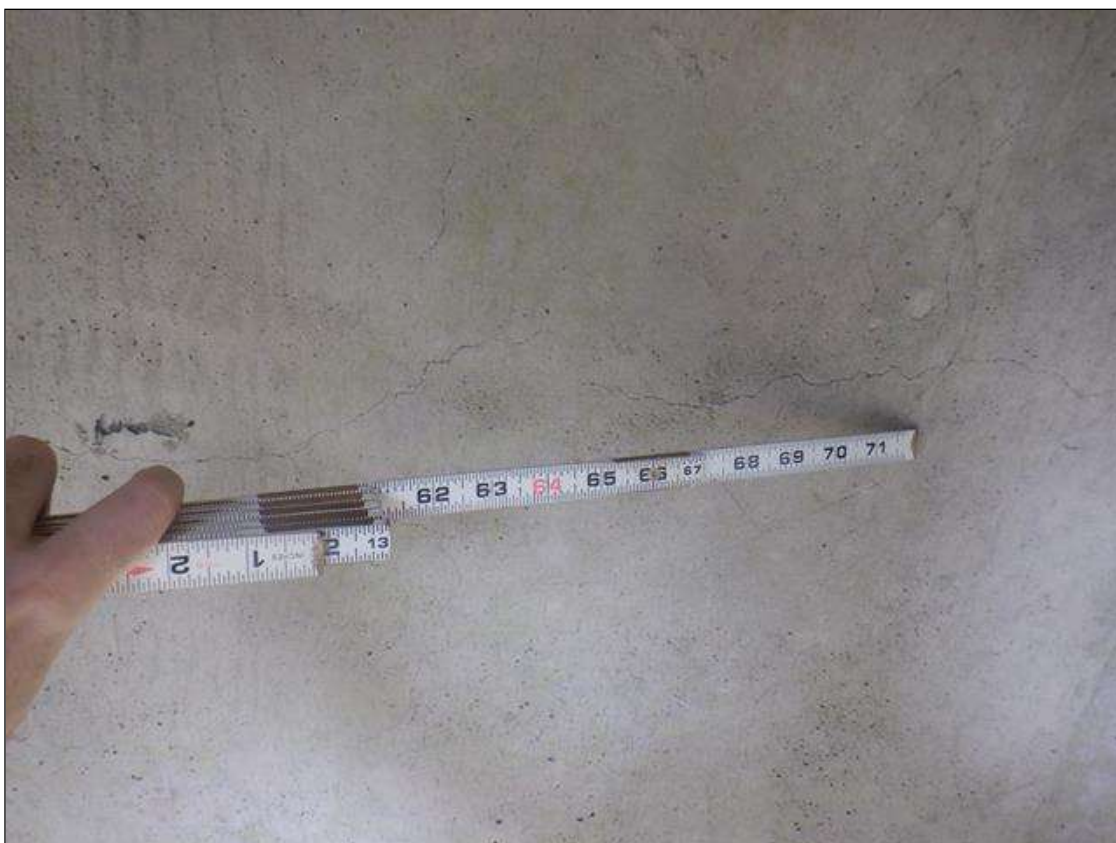
Span 4 Deck: UP TO 0.02 IN WIDE RANDOM CRACKING IN DECK UNDERSIDE, SCATTERED THROUGHOUT.
