NC DEPARTMENT OF TRANSPORTATION
 DIVISION OF HIGHWAYS
 STRUCTURE MANAGEMENT UNIT

ATTENTION: NEW REPAIRS, PAR, CHANGE IN STRUCTURAL DATA, HYDRA PLATFORM USED

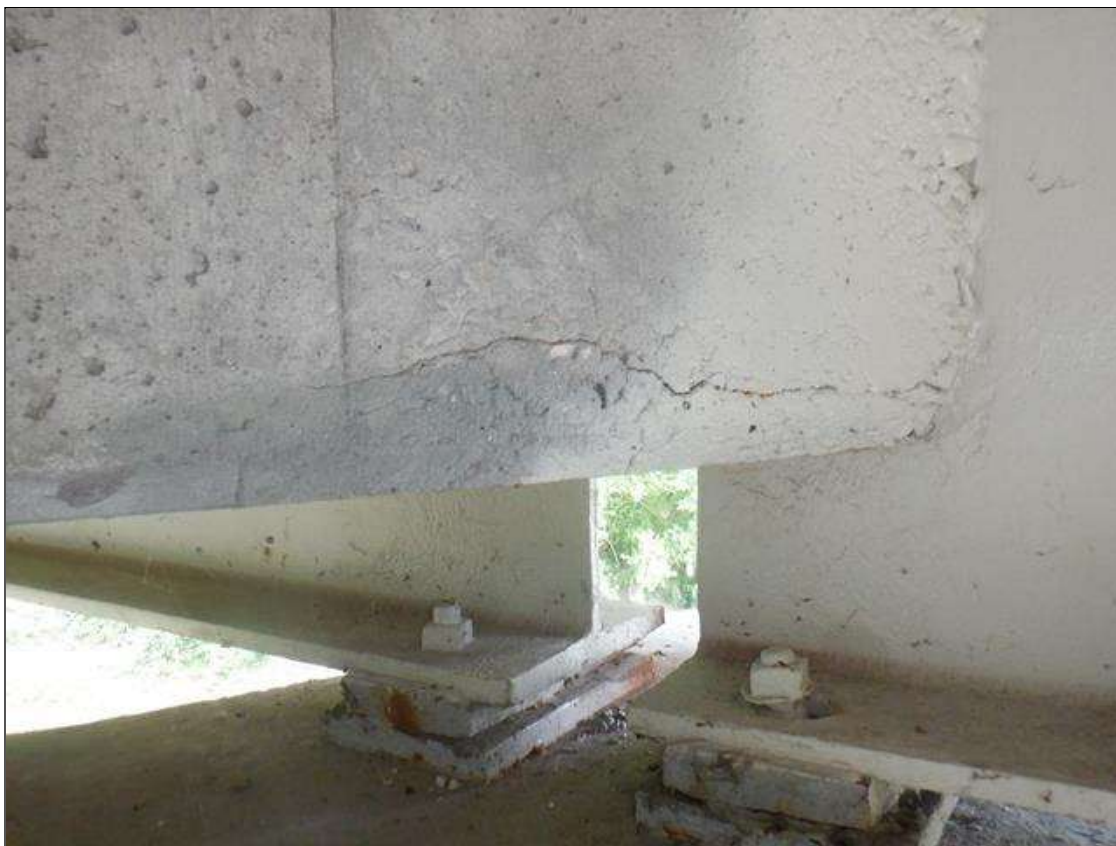
Span 5 Beam 4: 3 FT LONG X 1/16 IN WIDE HORIZONTAL CRACK IN BENT DIAPHRAGM AT BENT 5

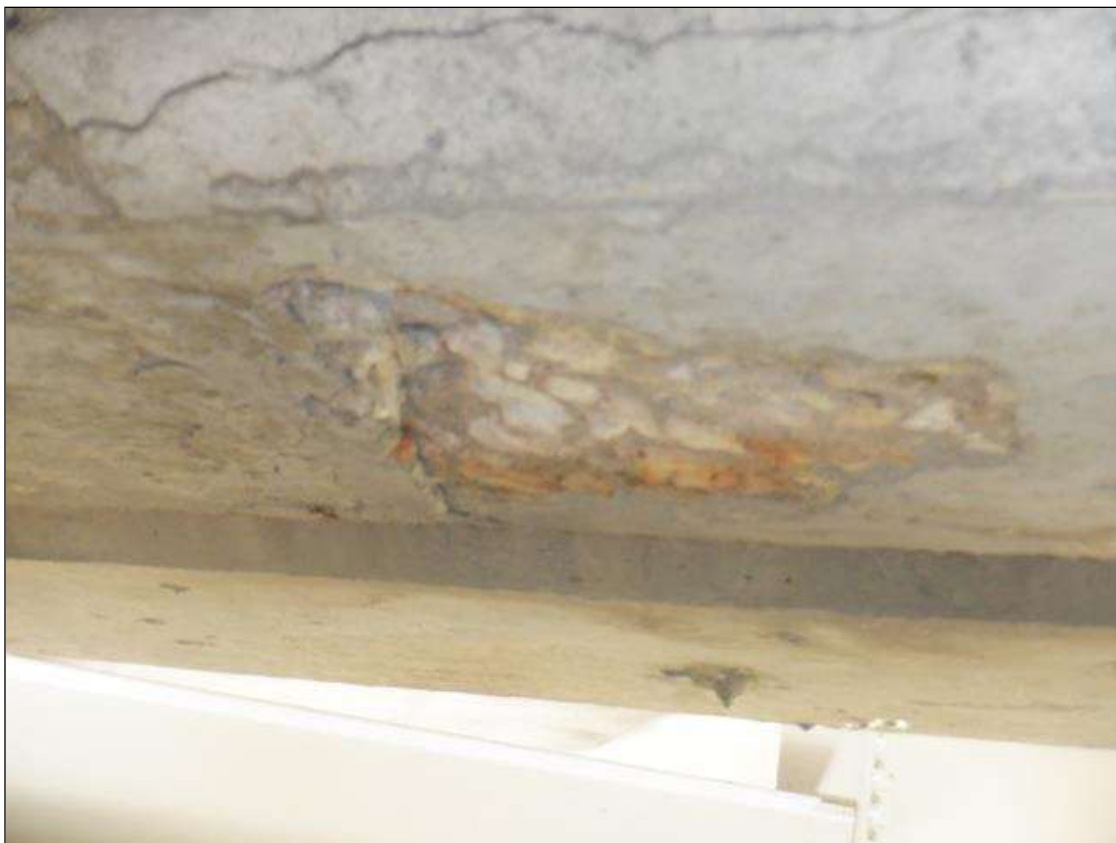
Span 5 Deck: 6 IN DIAMETER X 3/4 IN DEEP SPALL IN INTERMEDIATE DIAPHRAGM IN BAY 2 ABOVE BENT 5.

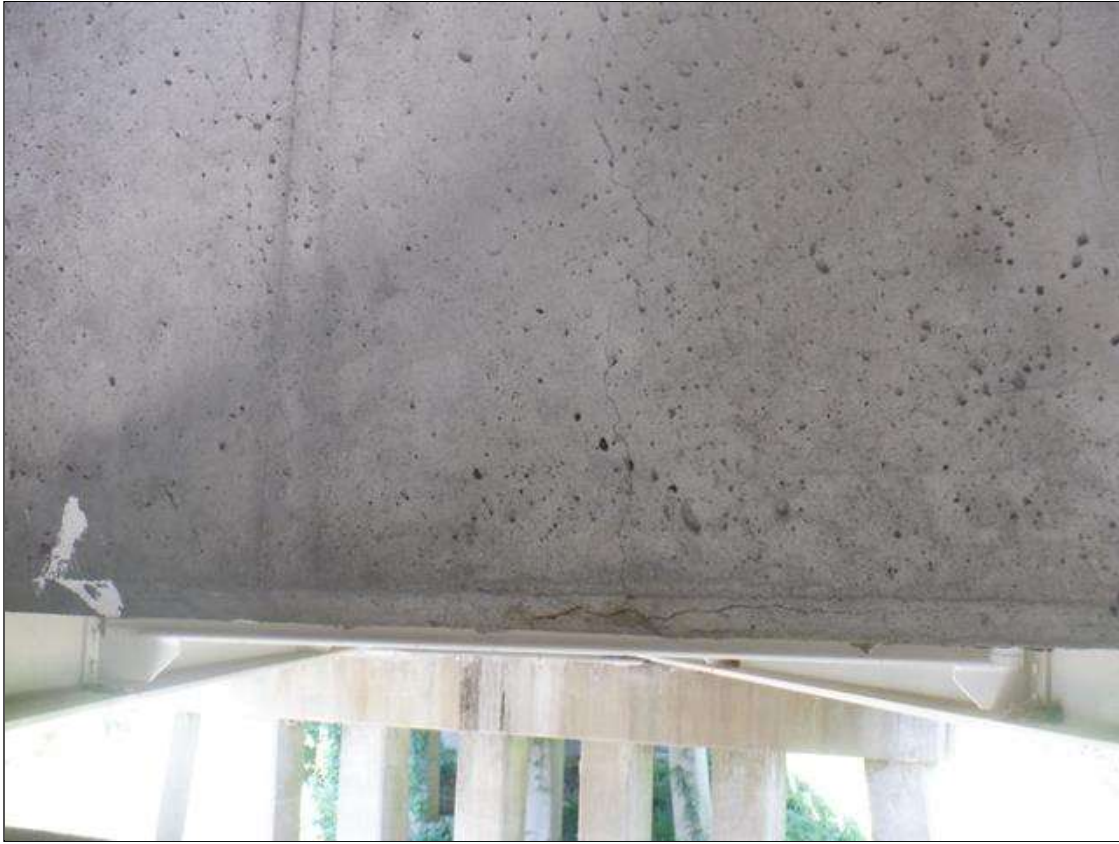
Span 5 Deck: UP TO 0.05 IN WIDE X 2 FT HIGH VERTICAL CRACKS IN BENT DIAPHRAGM IN SEVERAL BAYS AT BENT 5

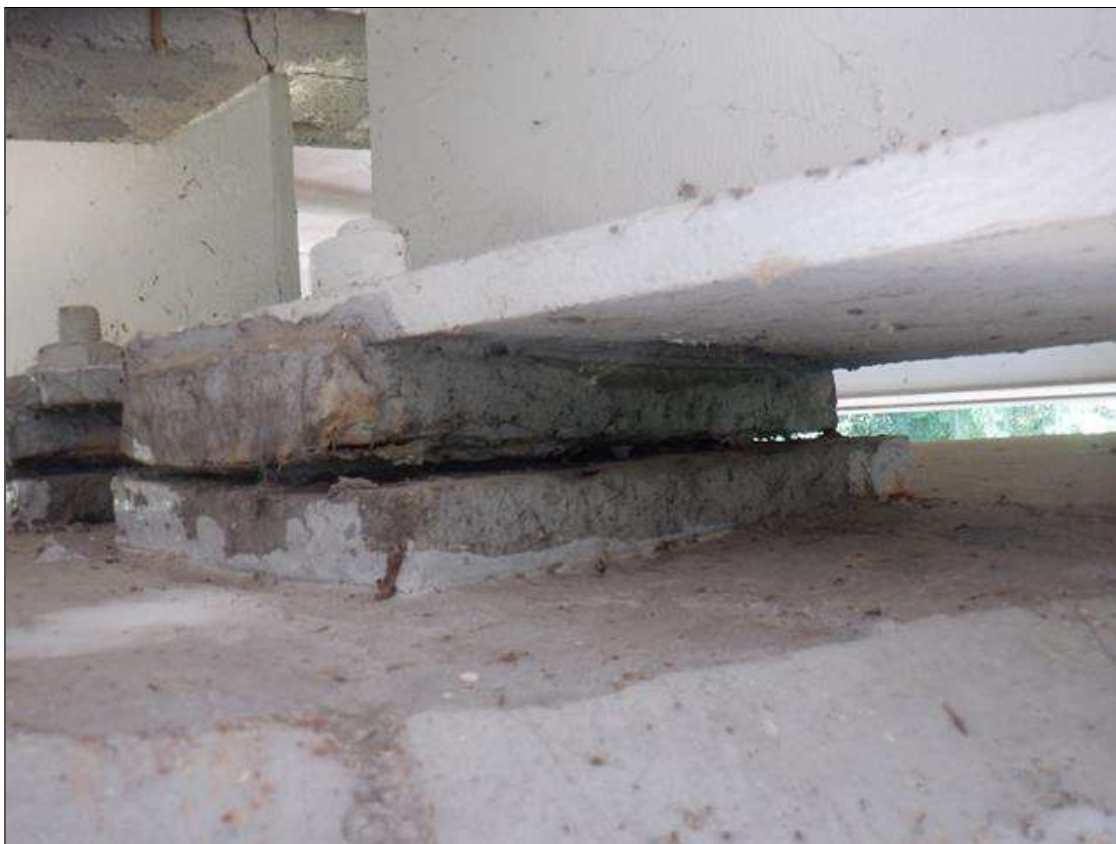
Span 5 Far Bearing: BEARINGS HAVE BEEN PAINTED SINCE PREVIOUS INSPECTION. SECTION LOSS EXISTS BENEATH THE PAINTED SURFACES IN BOTH MASONRY AND SOLE PLATES. UP TO 95% SECTION REMAINING.

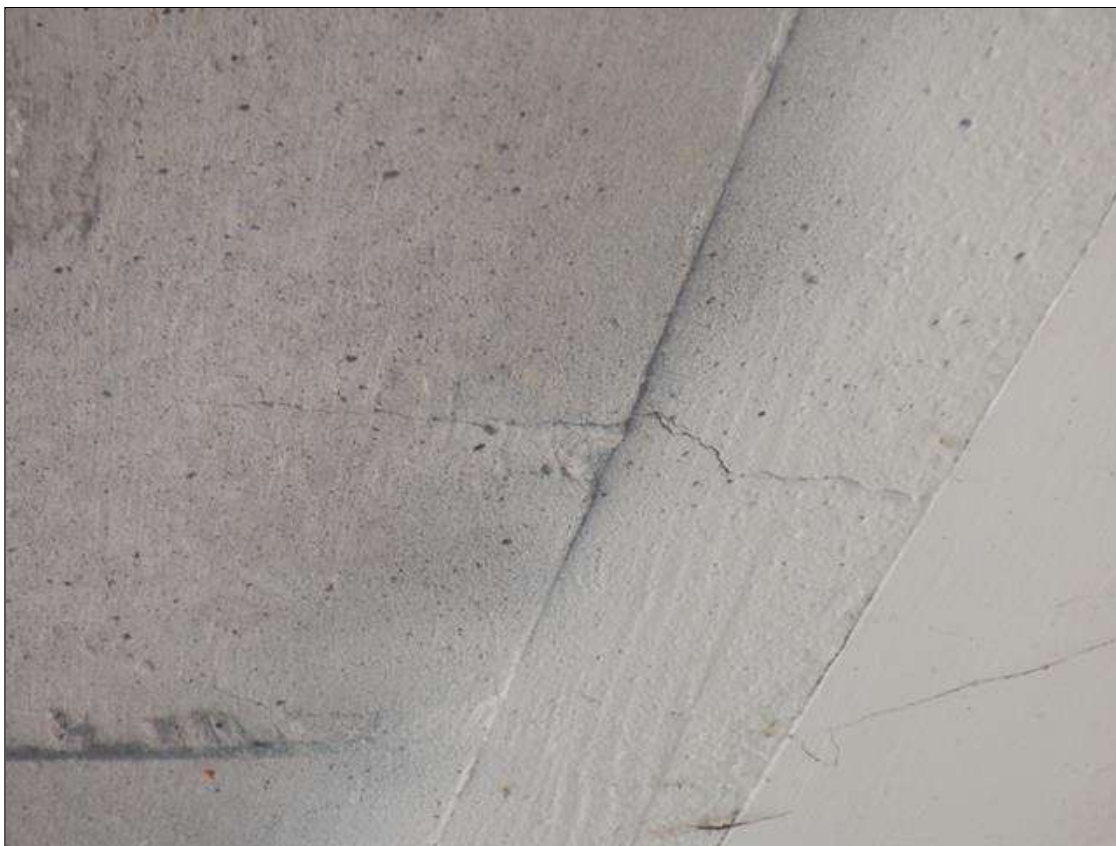
Span 6 Deck: FOUR (4) UP TO 0.02 IN WIDE X UP TO 3 FT LONG TRANSVERSE CRACKS IN RIGHT OVERHANG. SEVEN (7) SIMILAR CRACKS IN LEFT OVERHANG.

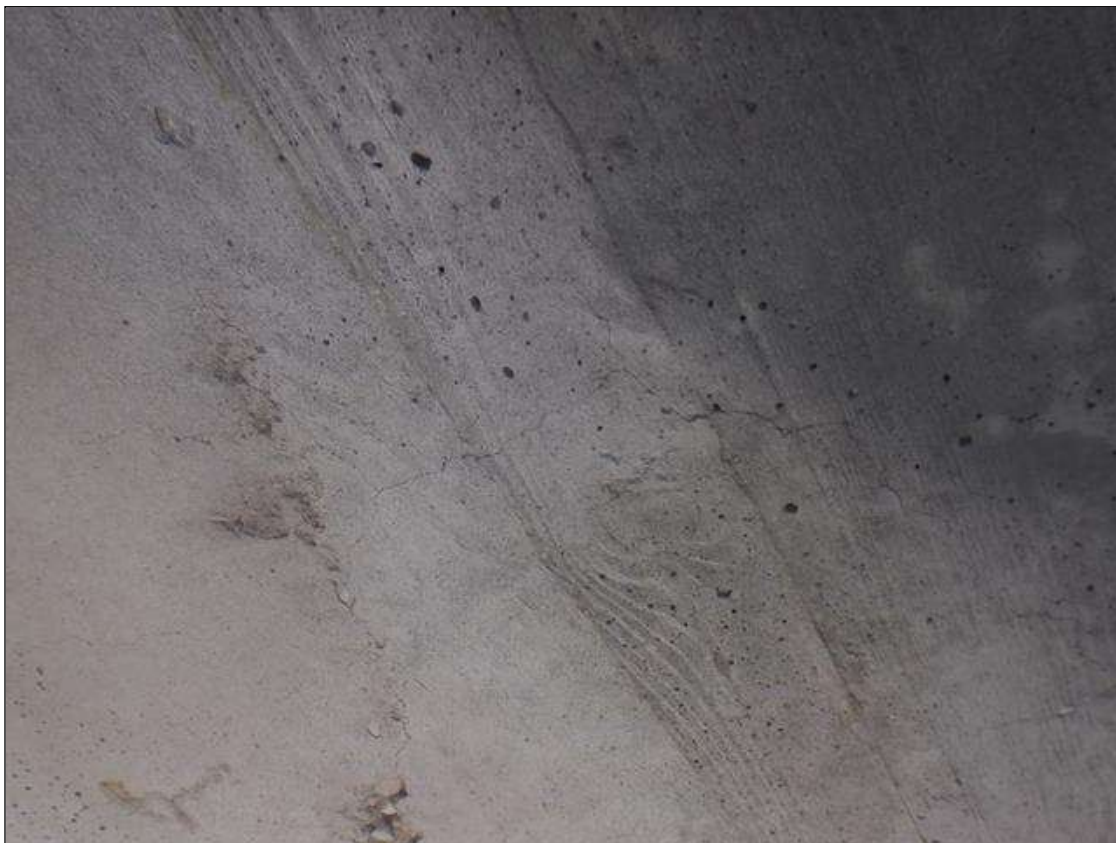
Span 6 Deck: UP TO 0.02 IN WIDE RANDOM CRACKING IN DECK UNDERSIDE, SCATTERED THROUGHOUT.

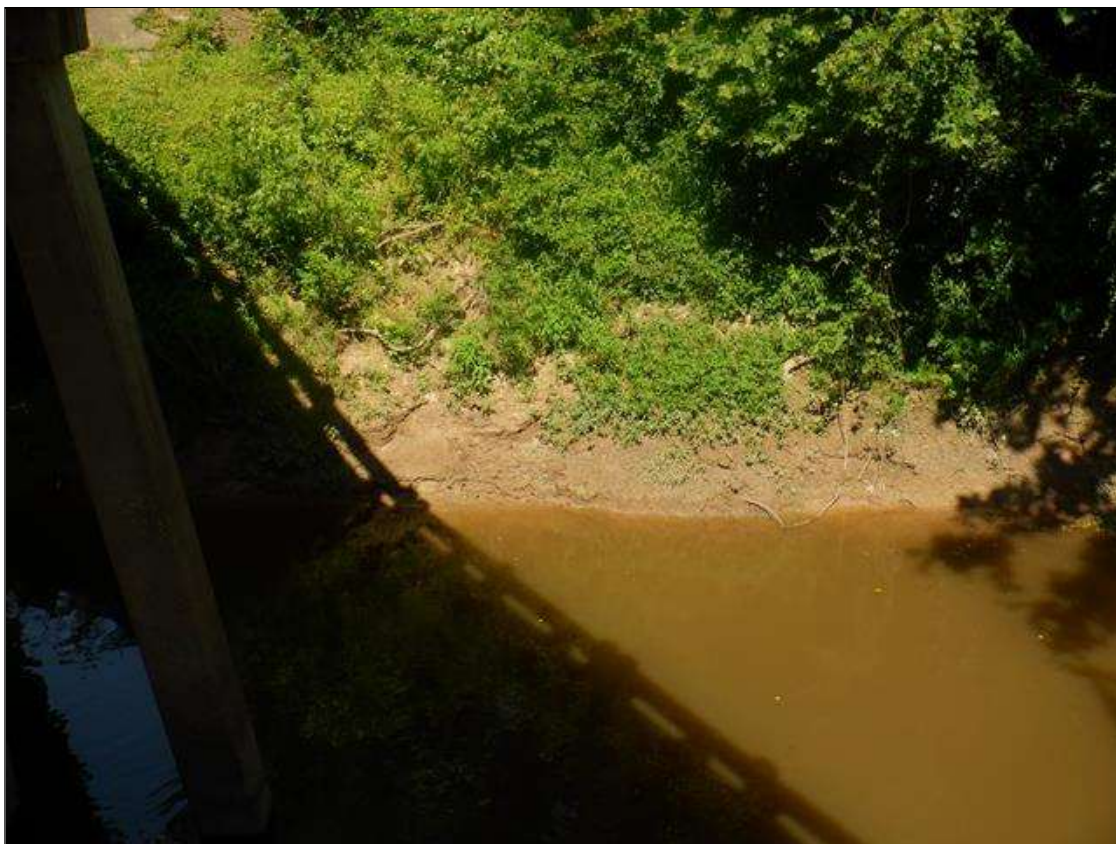
50 FT LONG X 4 FT HIGH X 4 FT DEEP AREA OF EROSION ALONG NORTH BANK

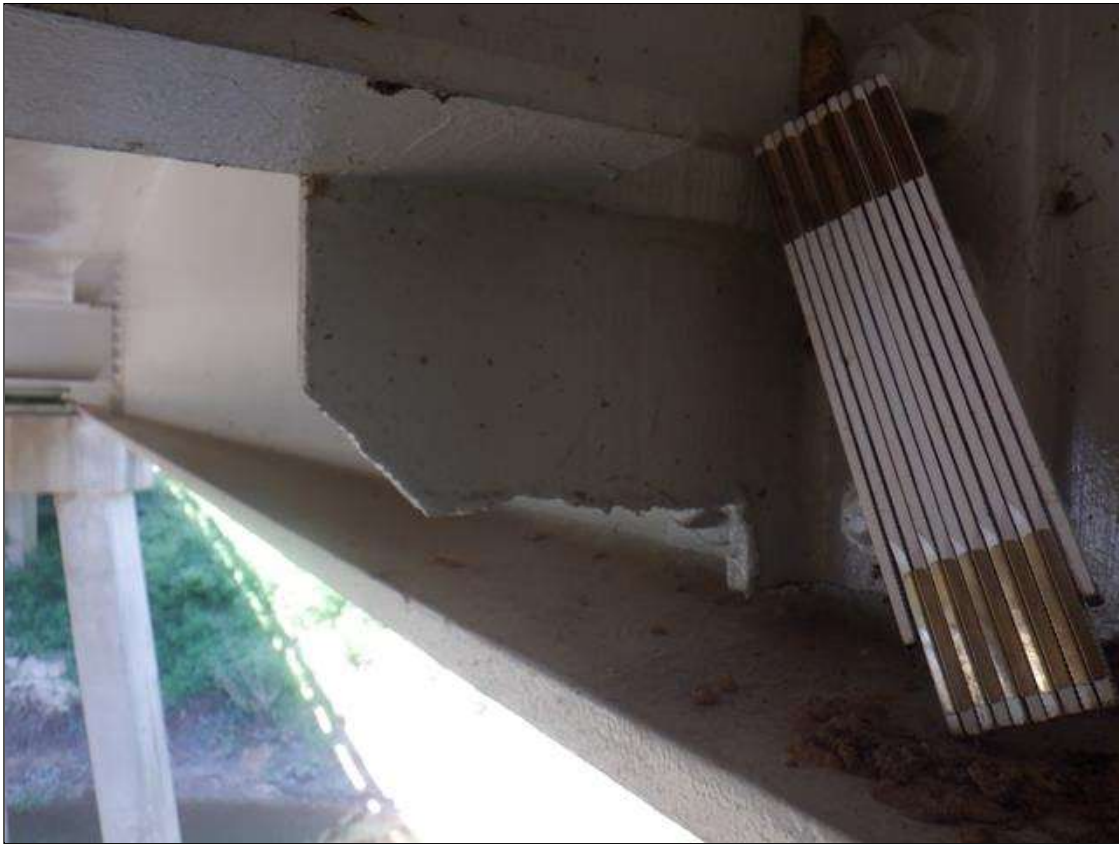
Span 6 Beam 4: 2 IN HIGH OF INTERMEDIATE STIFFENER IS CUT OUT AT BOTTOM AT BOTH LOCATIONS. PAR IS NOT ISSUED AS IT APPEARS TO BE FROM PREVIOUS BRIDGE REPAIR.

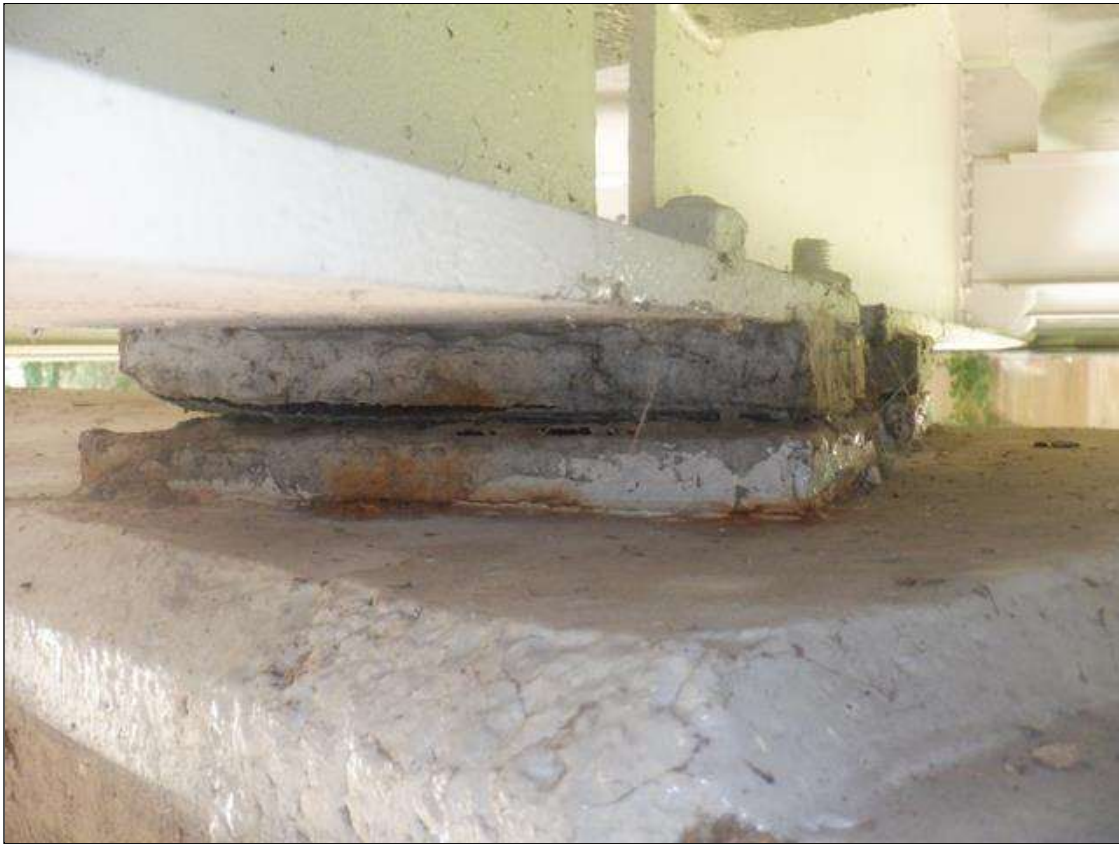
Span 6 Far Bearing: BEARINGS HAVE BEEN PAINTED SINCE PREVIOUS INSPECTION. SECTION LOSS EXISTS BENEATH THE PAINTED SURFACES IN BOTH MASONRY AND SOLE PLATES. UP TO 90% SECTION REMAINING.

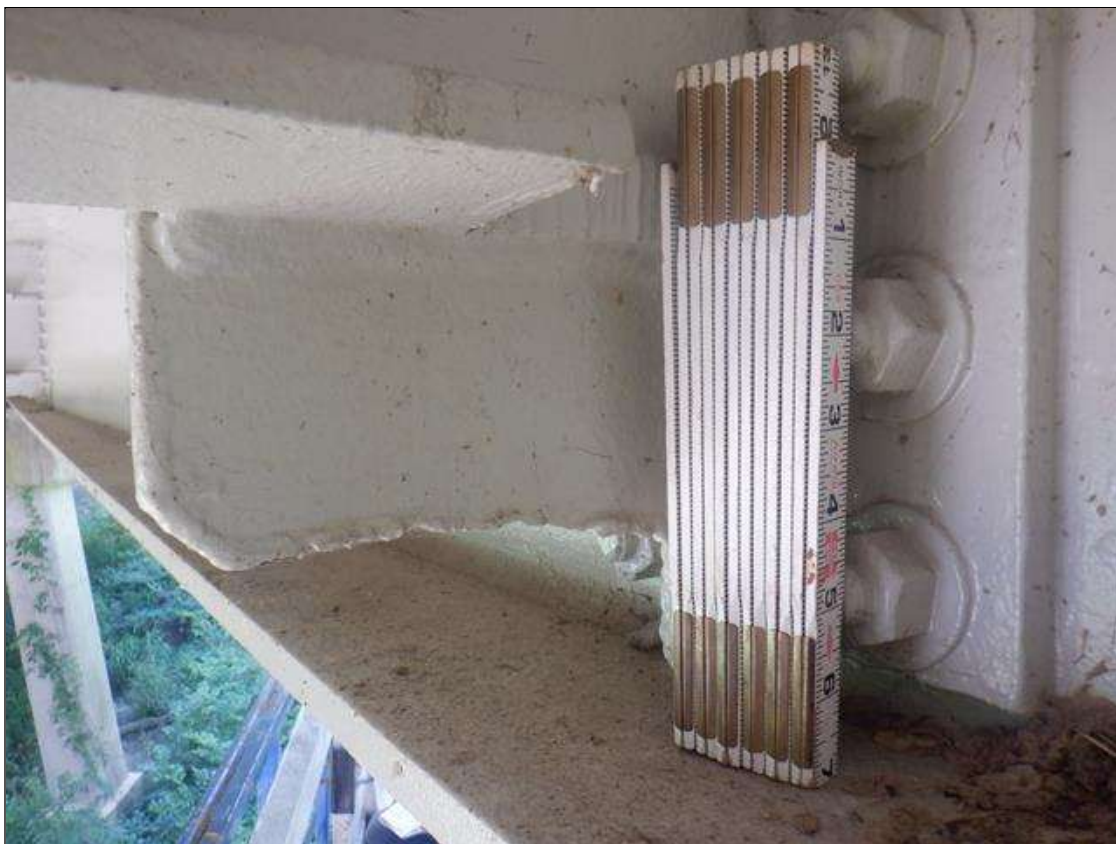
Span 7 Beam 4: 2 IN HIGH OF INTERMEDIATE STIFFENER IS CUT OUT AT BOTTOM AT BOTH LOCATIONS. PAR IS NOT ISSUED AS IT APPEARS TO BE FROM PREVIOUS BRIDGE REPAIR.

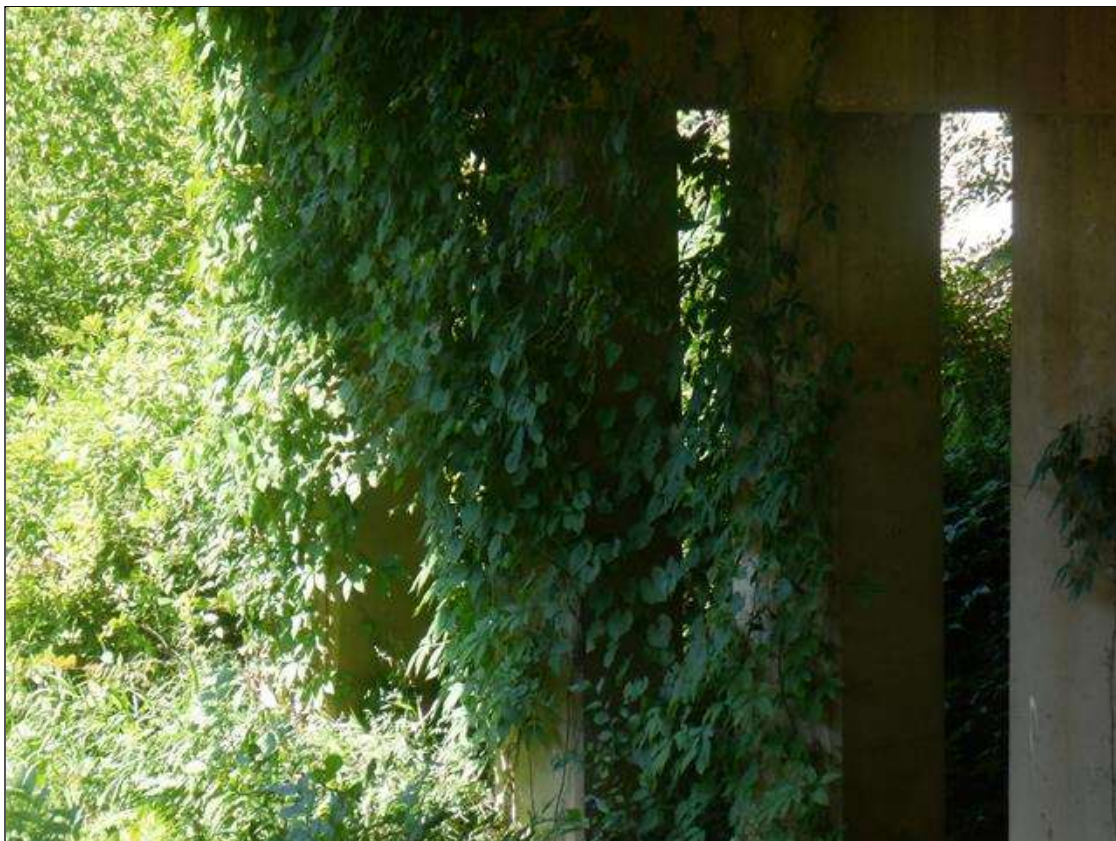
Bent 7 Pile 1: VEGETATION GROWTH ALONG NORTHWEST CORNER OF PILE FOR FULL HEIGHT.

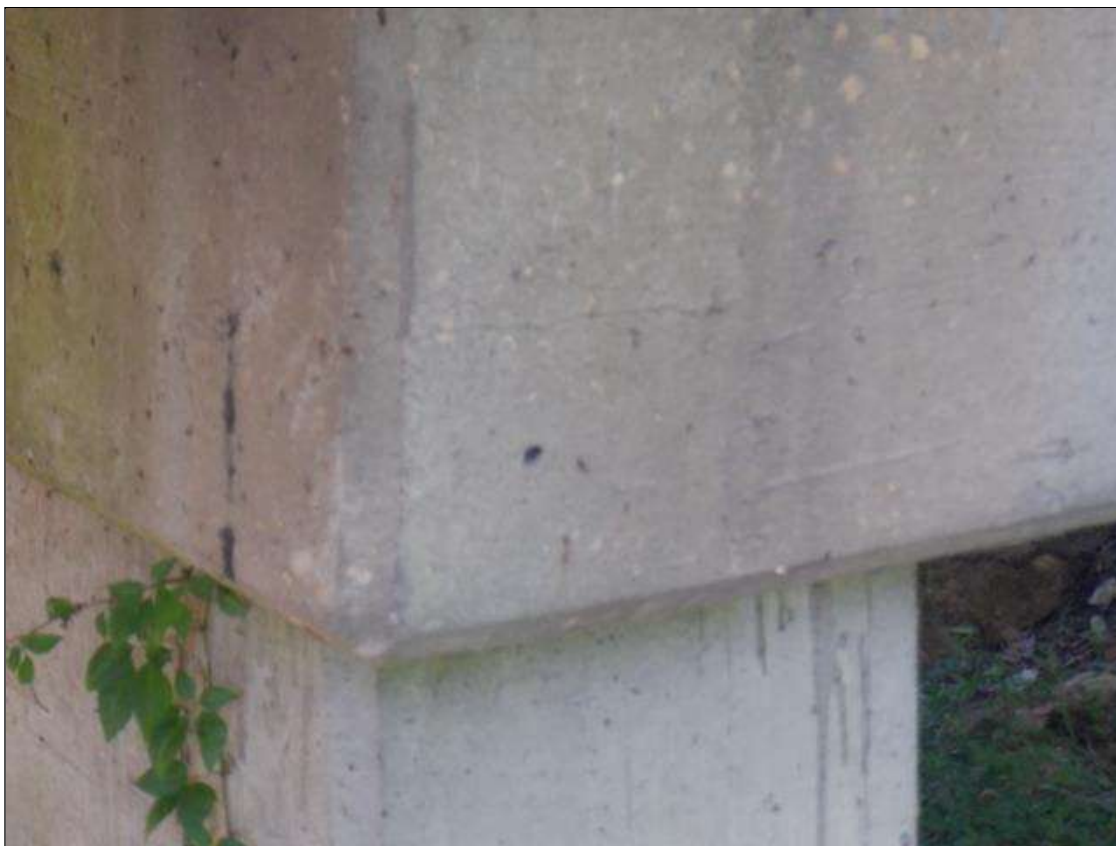
Bent 7 Cap 1: HAIRLINE HORIZONTAL CRACKS IN BOTH ENDS

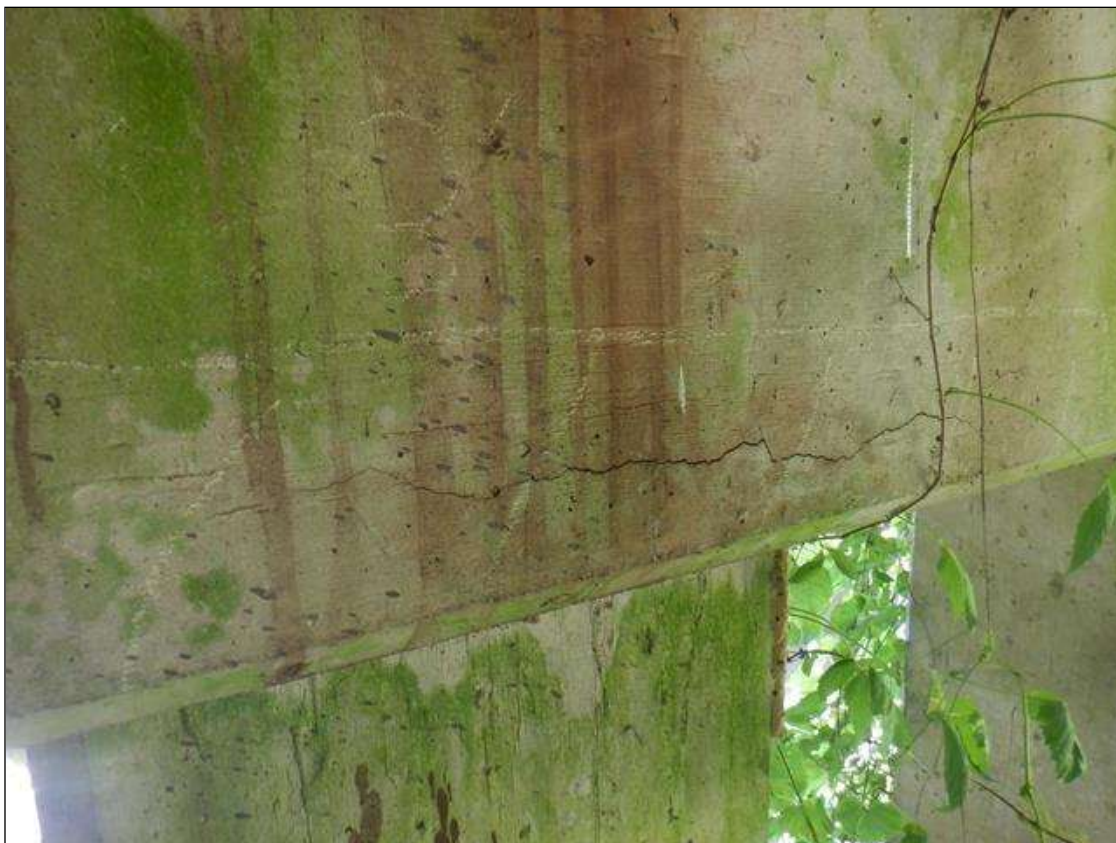
Bent 7 Cap 1: 3 FT WIDE X 6 IN HIGH DELAMINATION WITH A 3 FT LONG HORIZONTAL CRACK UP TO 1/32 IN WIDE BOTTOM OF NORTH FACE, OVER PILE 3.

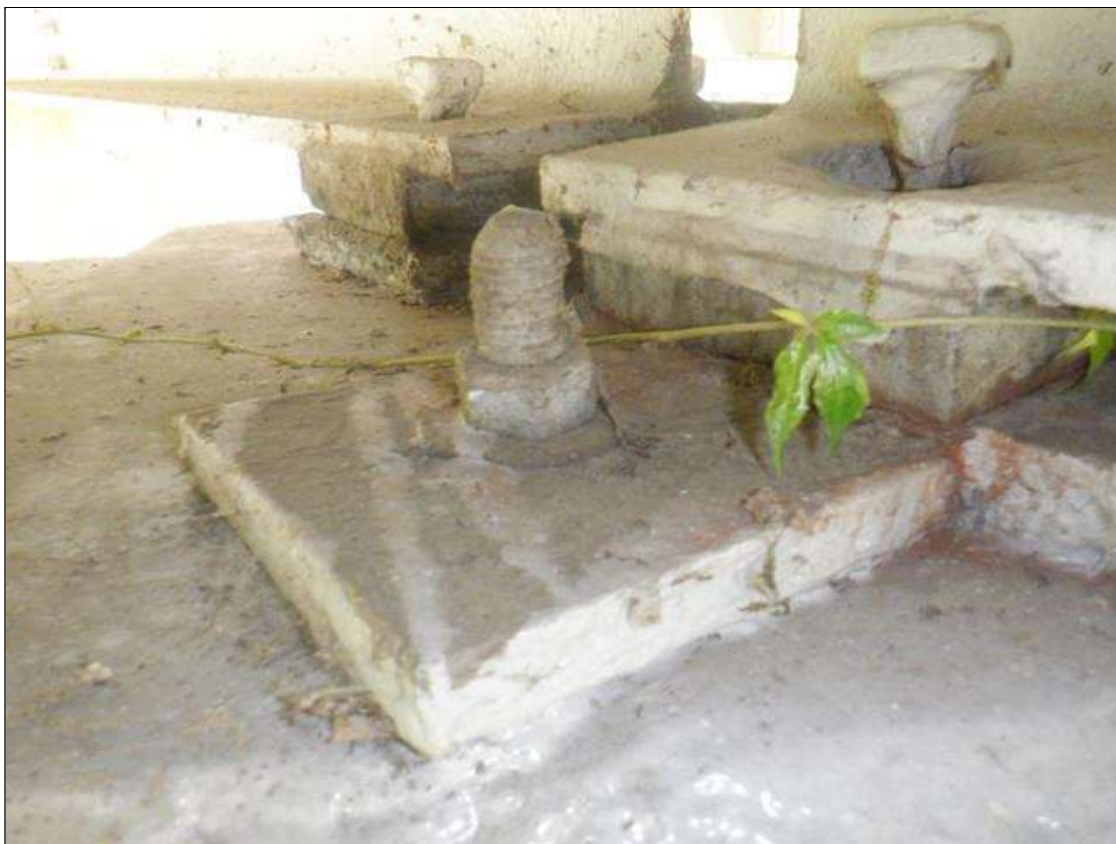
Span 8 Beam 3 - Near Bearing: BEARING ASSEMBLY HAS WELDED REPAIR WITH NEW ANCHOR BOLT.

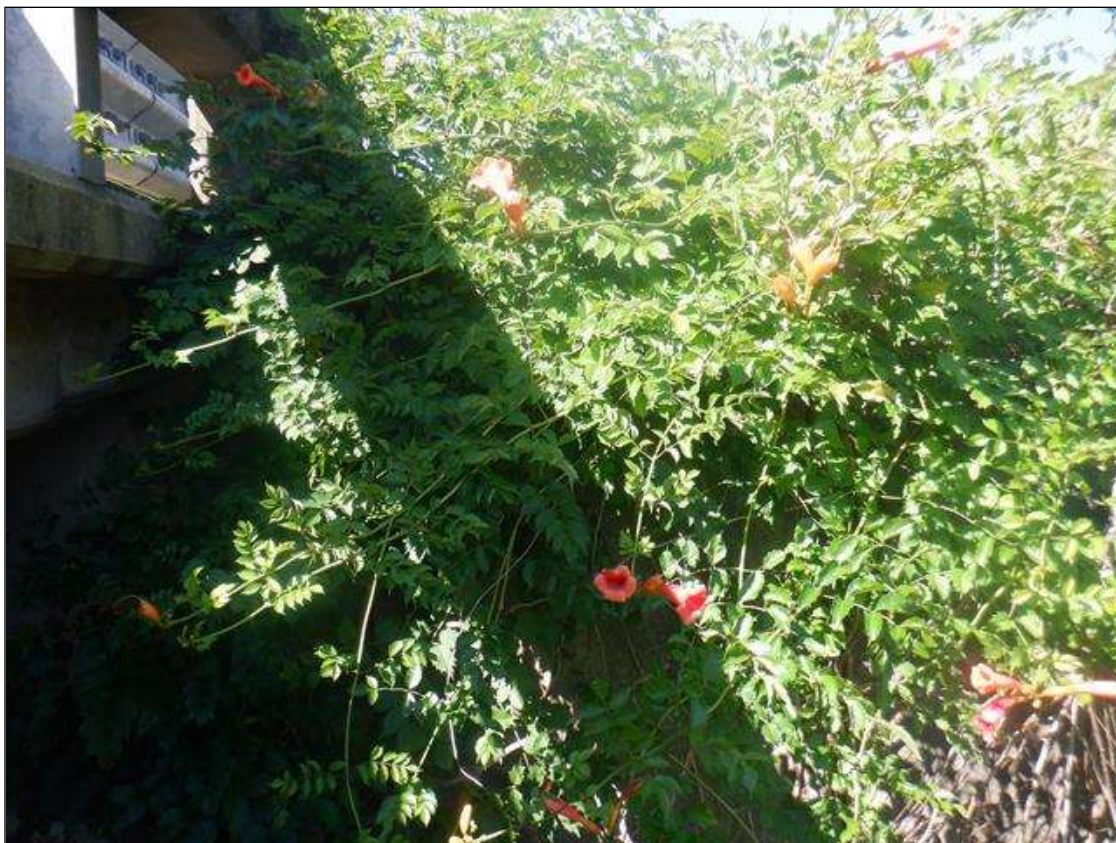
HEAVY VEGETATION GROWTH AT SOUTHWEST, SOUTHEAST, AND NORTHWEST WINGWALL

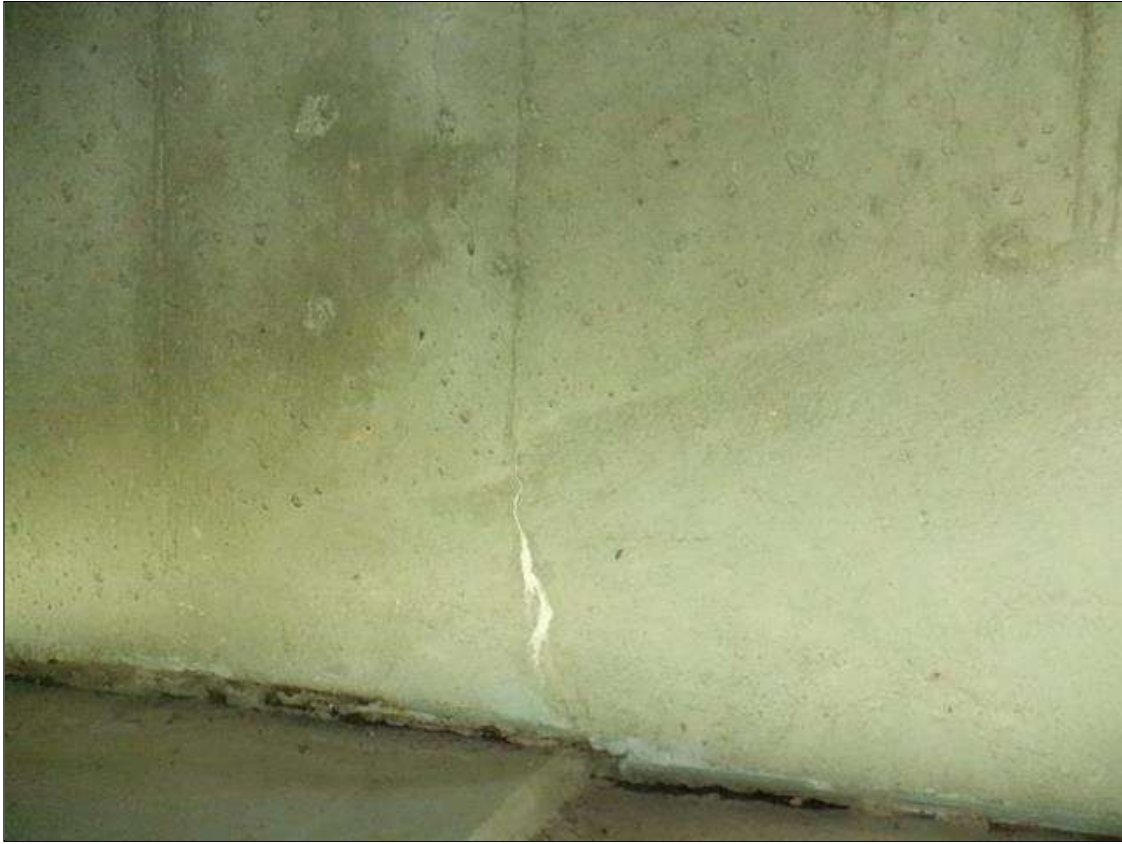
End Bent 1 Abutment: 3 FT HIGH X 0.05 IN WIDE VERTICAL CRACK WITH EFFLORESCENCE IN BAYS 1 AND 2

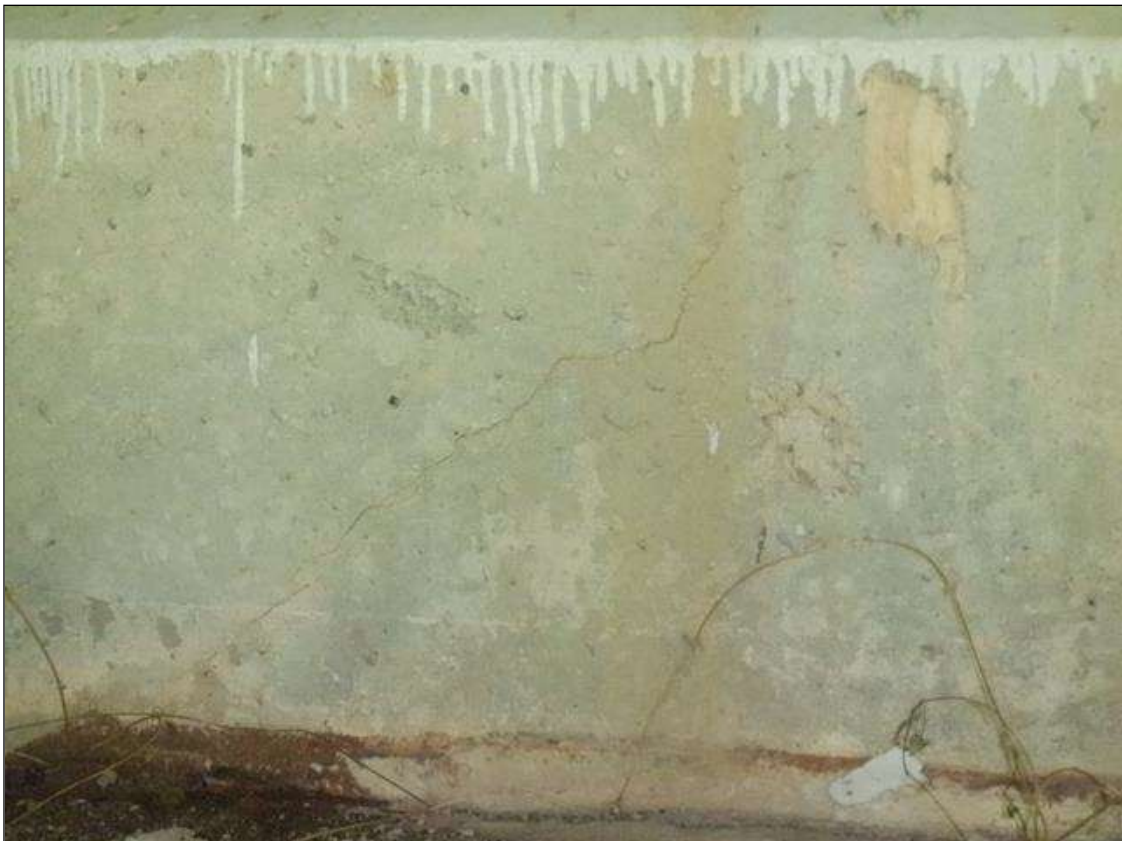
End Bent 1 Cap 1: TWO (2) 2 FT LONG X 0.03 IN WIDE DIAGONAL CRACKS IN FACE OF CAP BELOW BAY 2.

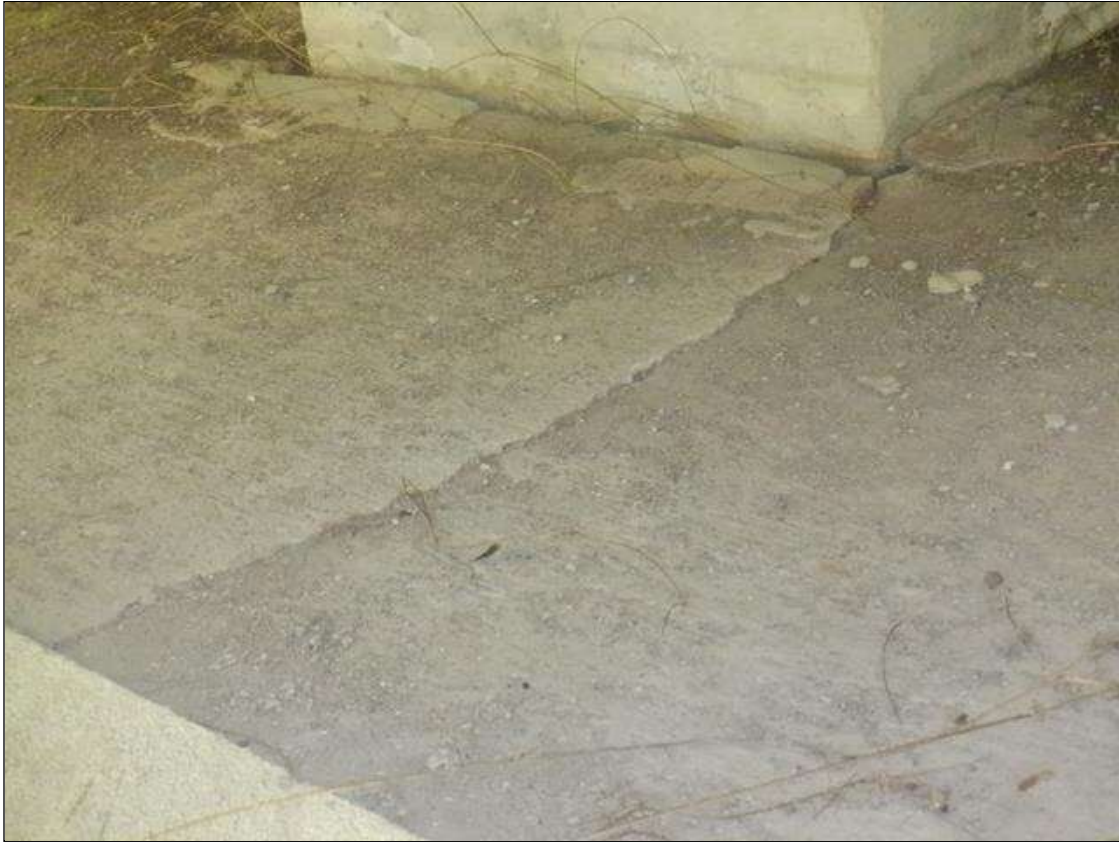
UP 3 FT LONG X 1/4 IN WIDE LONGITUDINAL CRACK IN TOP OF SLOPE PROTECTION AT BAY 2, IN BENT 1

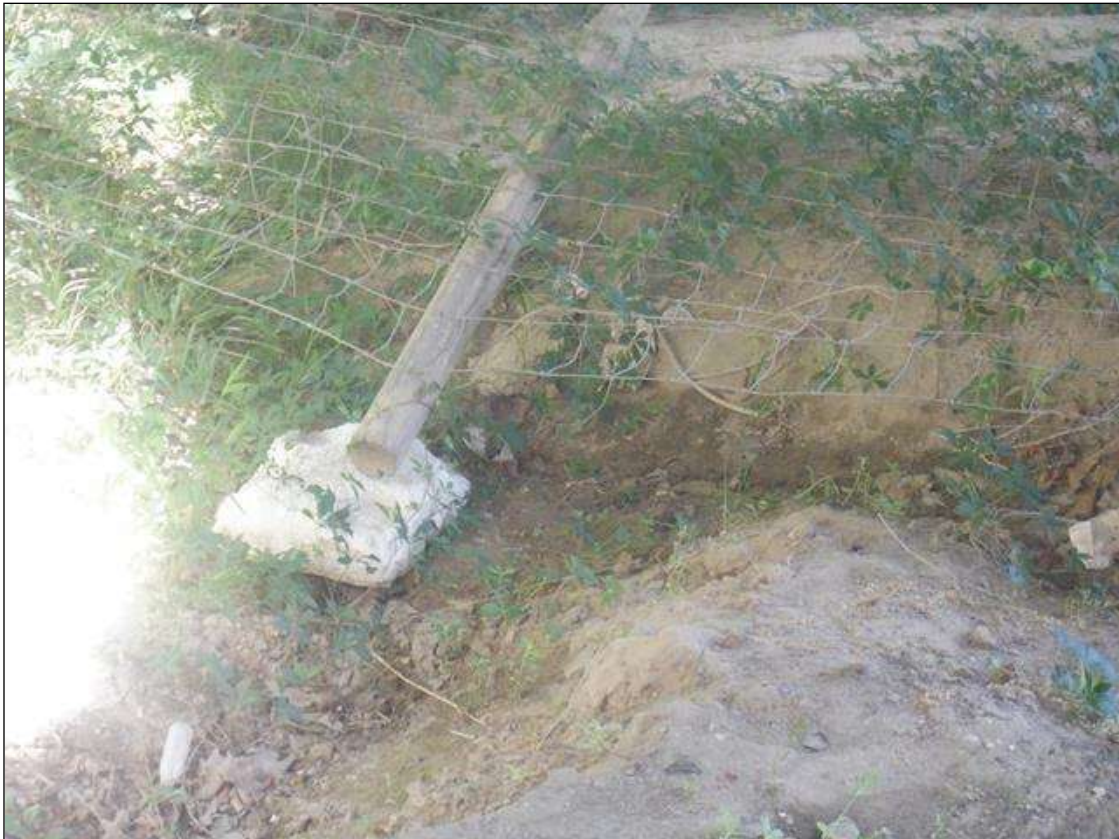
5 FT LONG X 20 FT WIDE AREA OF EROSION WITH FALLEN FENCE POST UNDER SPAN 8

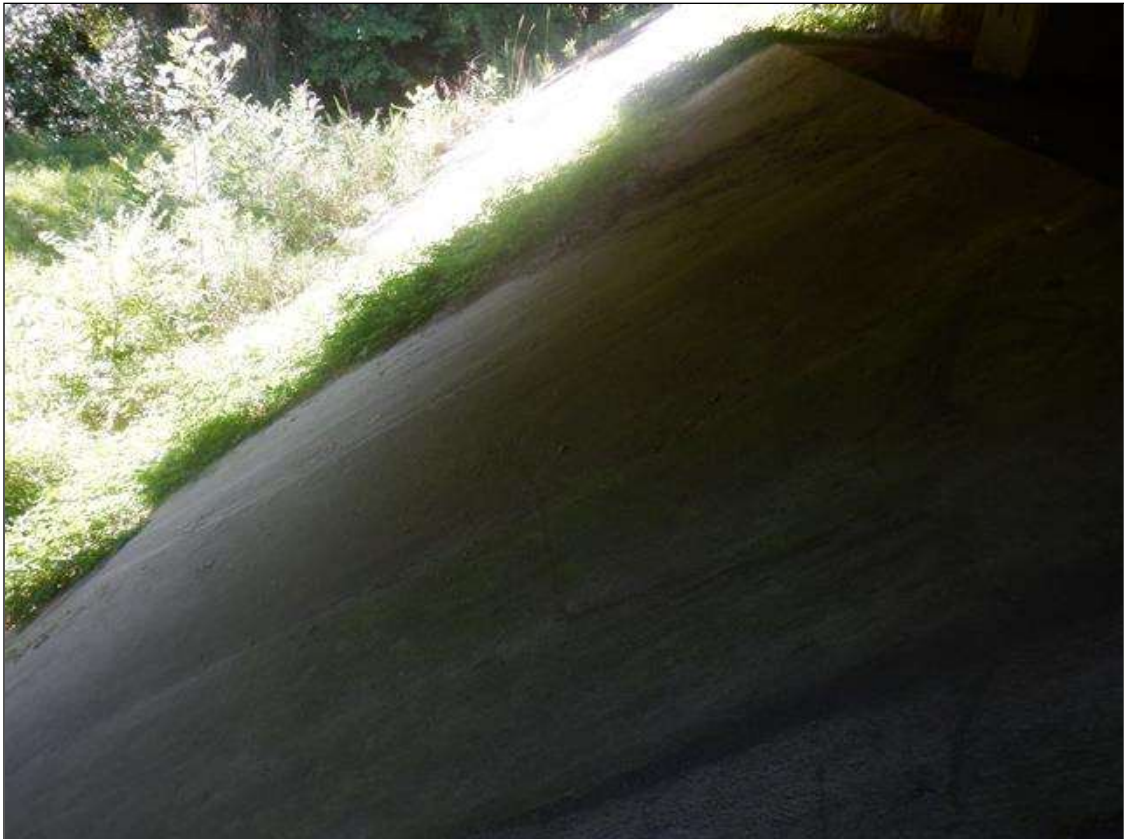
SLOPE PROTECTION AT END BENT 1

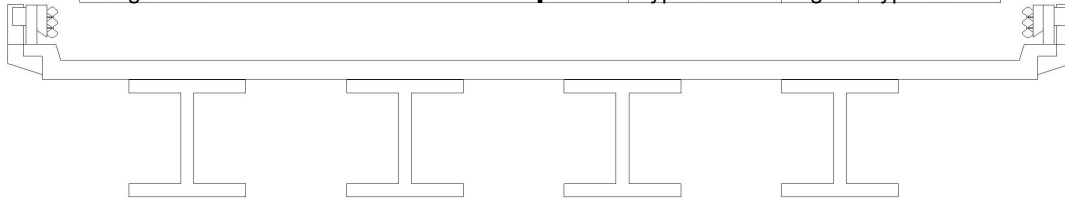
Measurements for Span #	1	TYPICAL IN OTHER SPANS	
Deck Thickness	0.895ft	Left Overhang	4.75'
Top of Rail to Bottom of Beam	6.541ft	Right Overhang	4.75'

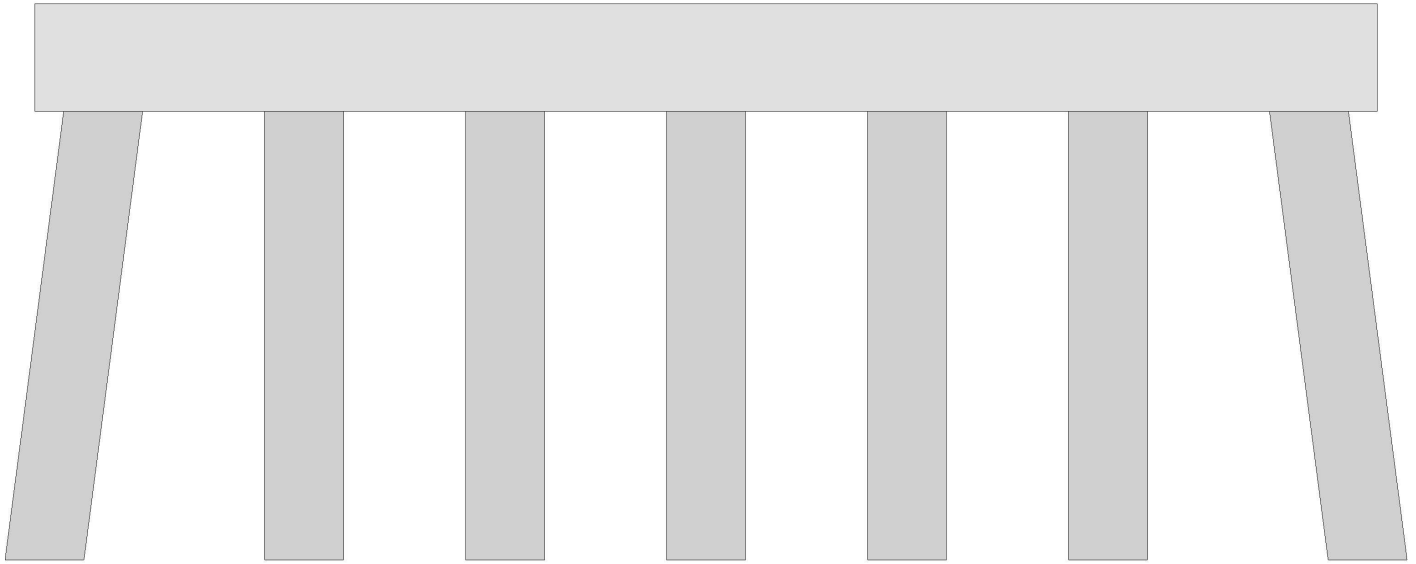
Cap Information			Material Cast-in-Place Concrete							
Length	Width	Height	Left Overhang	Right Overhang	Left Beam to End of Cap.	Right Beam to End of Cap.
