NC DEPARTMENT OF TRANSPORTATION
 DIVISION OF HIGHWAYS
 STRUCTURE MANAGEMENT UNIT

ATTENTION: **PAR SUBMITTED, CHANGE IN STRUCTURAL DATA, HYDRA PLATFORM USED, NEW REPAIRS**

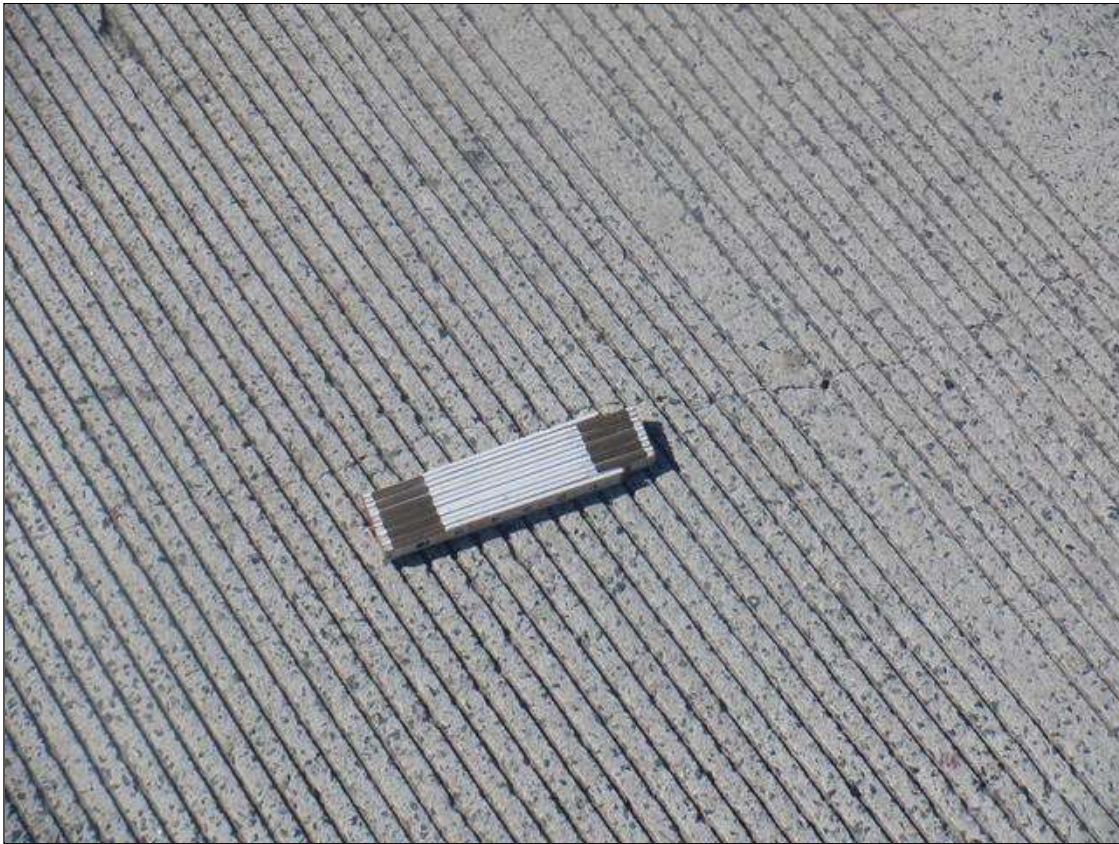
Span 1 Wearing Surface: UP TO 5 FT LONG X 1/16 IN WIDE LONGITUDINAL AND DIAGONAL CRACKS IN BOTH TRAVEL LANES, SCATTERED.

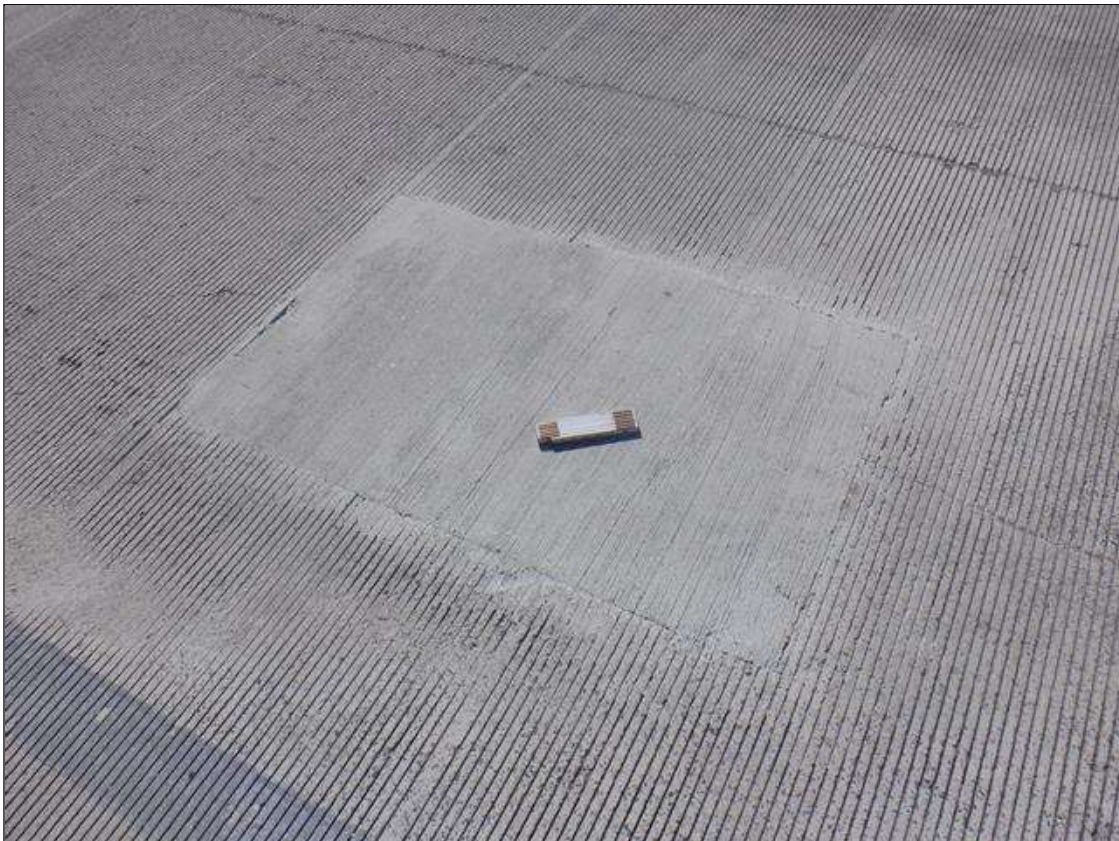
Span 1 Wearing Surface: 4 FT LONG X 3 FT WIDE UNSOUND CONCRETE PATCH WITH 1/16 IN WIDE X 3 FT LONG CRACKS EXTENDING FROM THIS PATCH IN RIGHT LANE AT END BENT 1

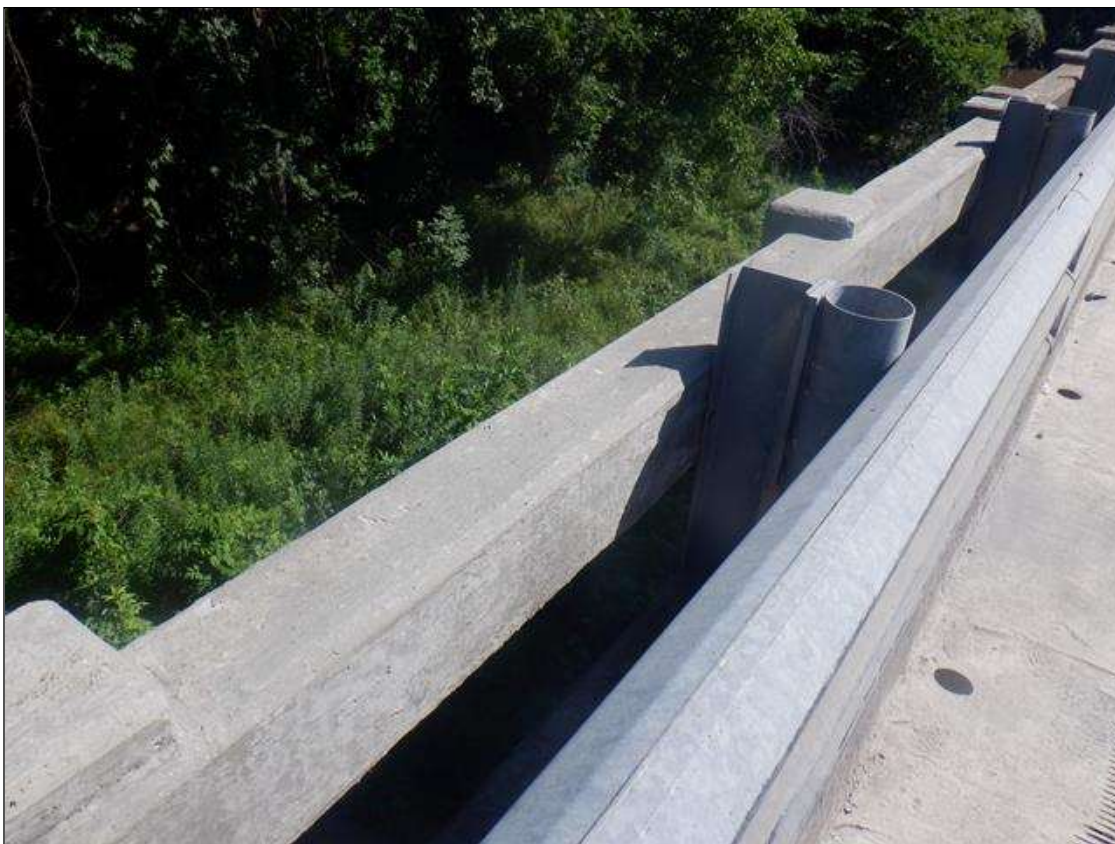
Span 1 Left Bridge Rail: 15 FT LONG AREA OF SOUND CONCRETE PATCHING TO CONCRETE RAIL, BEGINNING AT 15 FT FROM END BENT 1. PREVIOUS REPAIR.

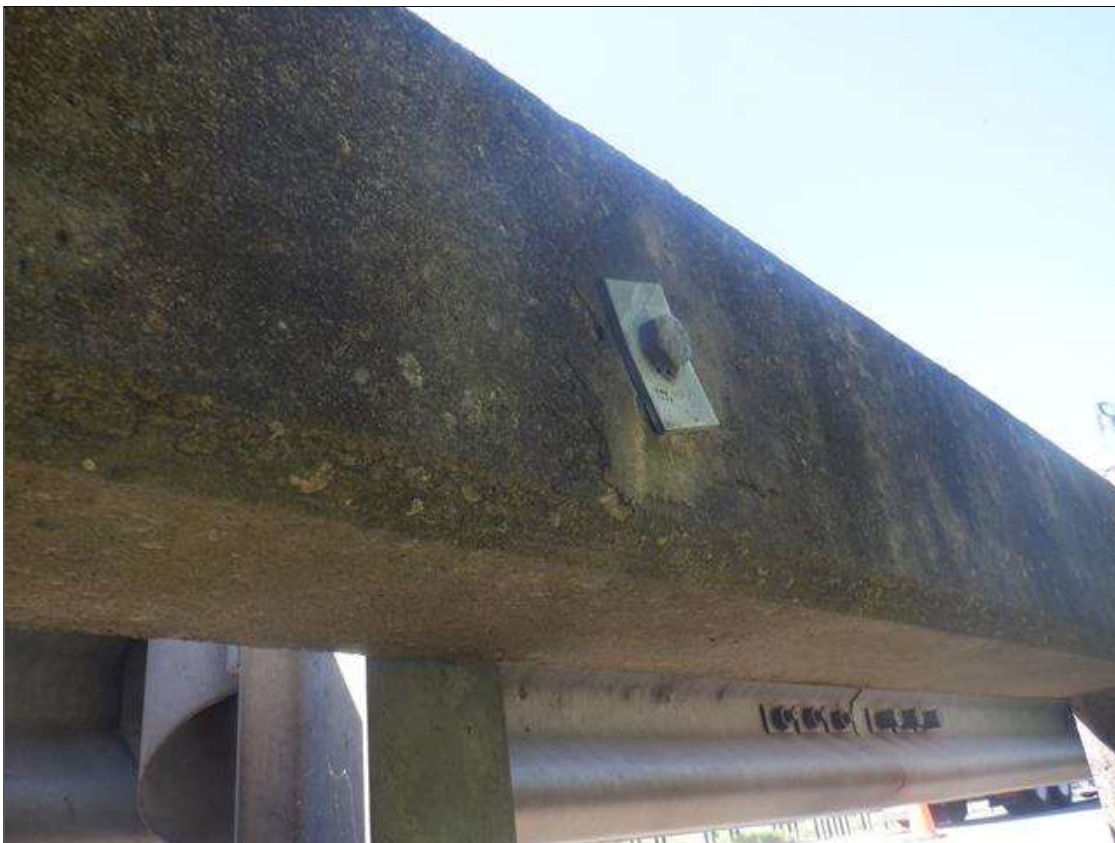
Span 1 Left Bridge Rail: NEW REPAIR: 6 IN DIAMETER SOUND CONCRETE PATCH AT ANCHOR BOLT CONNECTION TO SUPPLEMENTAL GUARDRAIL

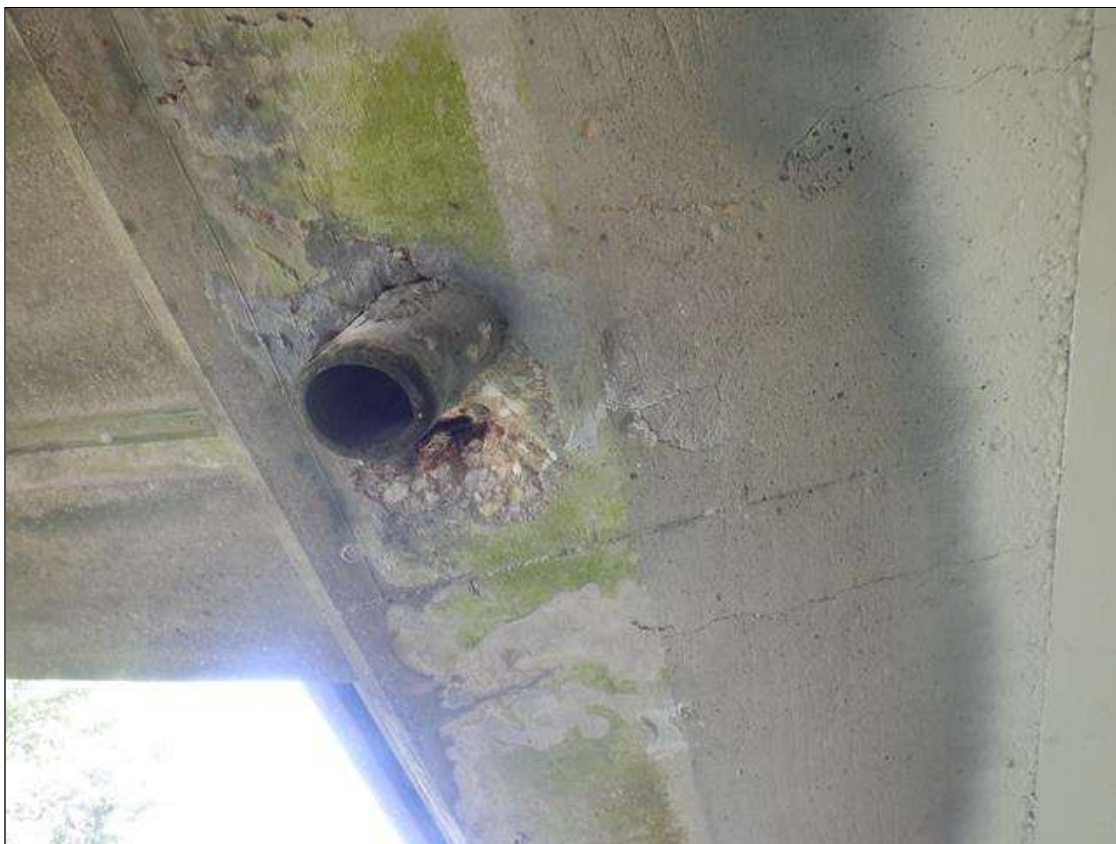
Span 1 Deck: 12 IN DIAMETER X 1.5 IN DEEP SPALL WITH EXPOSED REBAR AT DRAIN 4 IN LEFT OVERHANG.
NO MEASURABLE SECTION LOSS IN EXPOSED REBAR.

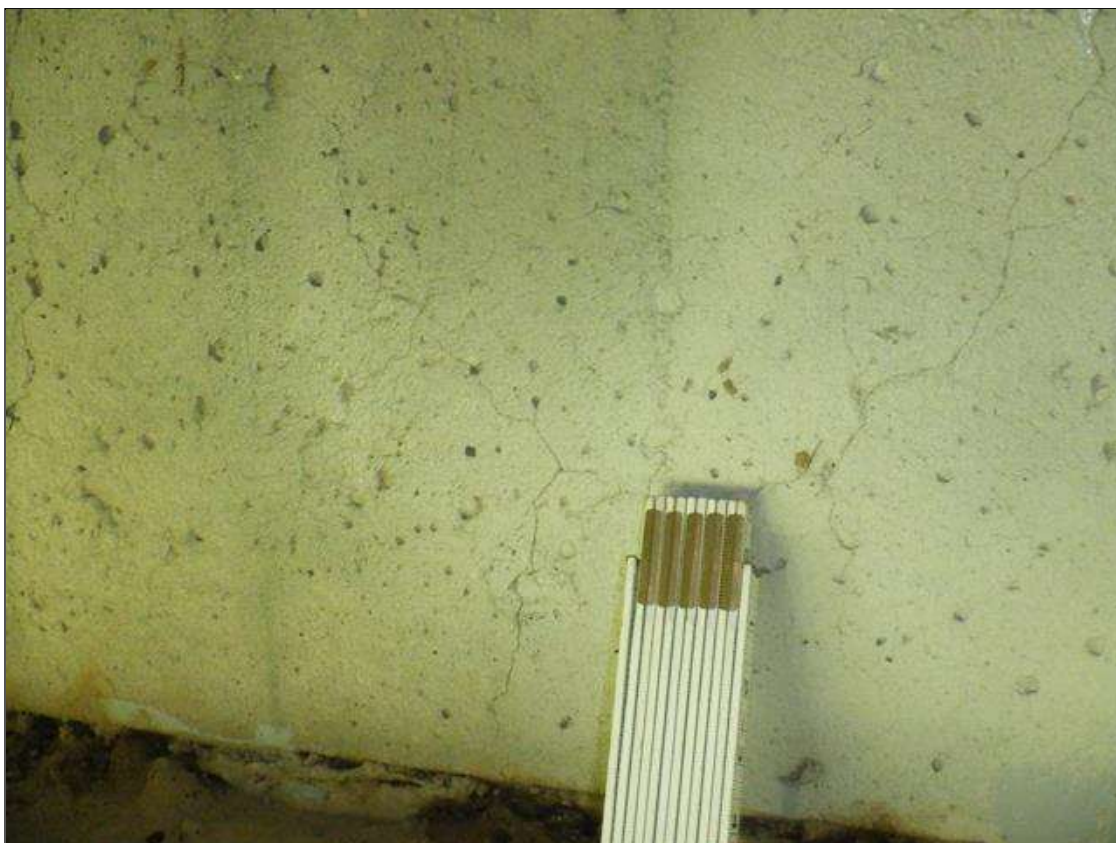
End Bent 1 Abutment: UP TO 0.03 IN WIDE RANDOM CRACKING IN BACKWALL FOR FULL LENGTH.

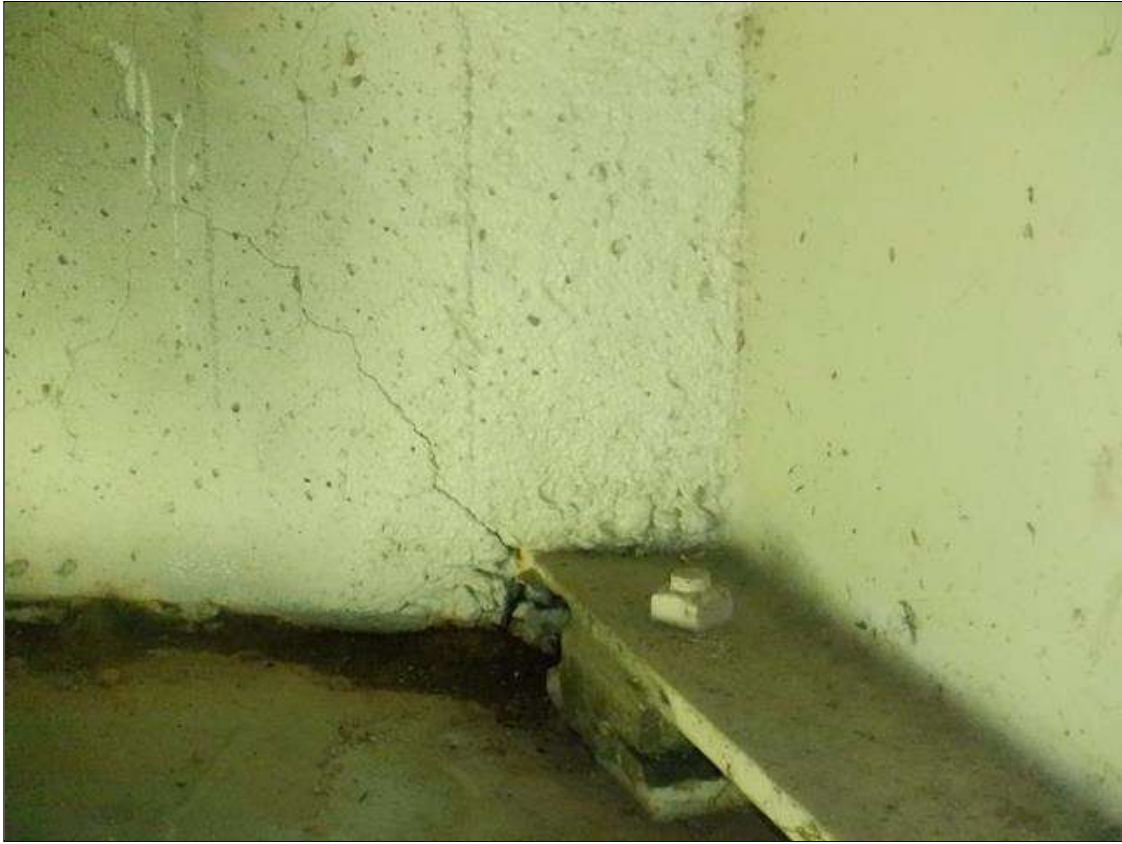
End Bent 1 Abutment: UP TO 1/16 IN WIDE X 2 FT LONG DIAGONAL CRACKS EXTENDING FROM BEARING AT ALL BEAMS

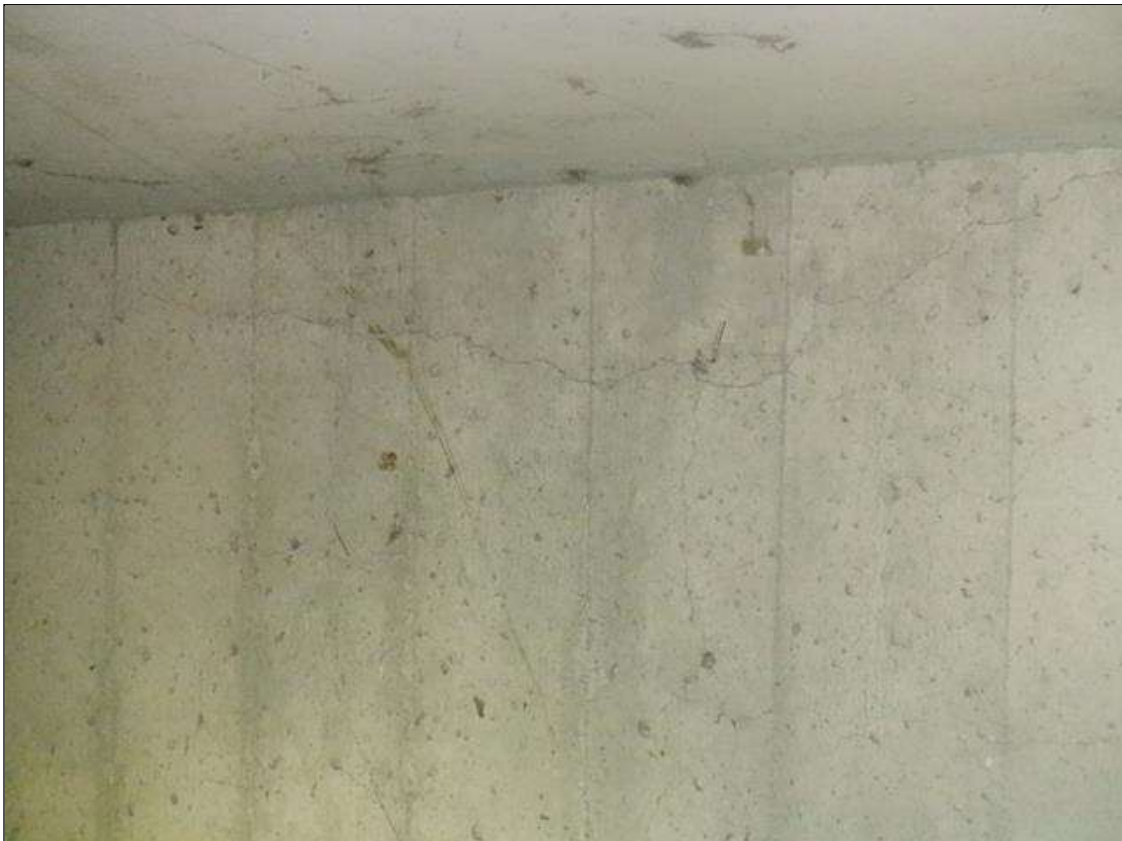
End Bent 1 Abutment: UP 1/16 IN WIDE HORIZONTAL CRACKS AT TOP IN BAYS 2 AND 3

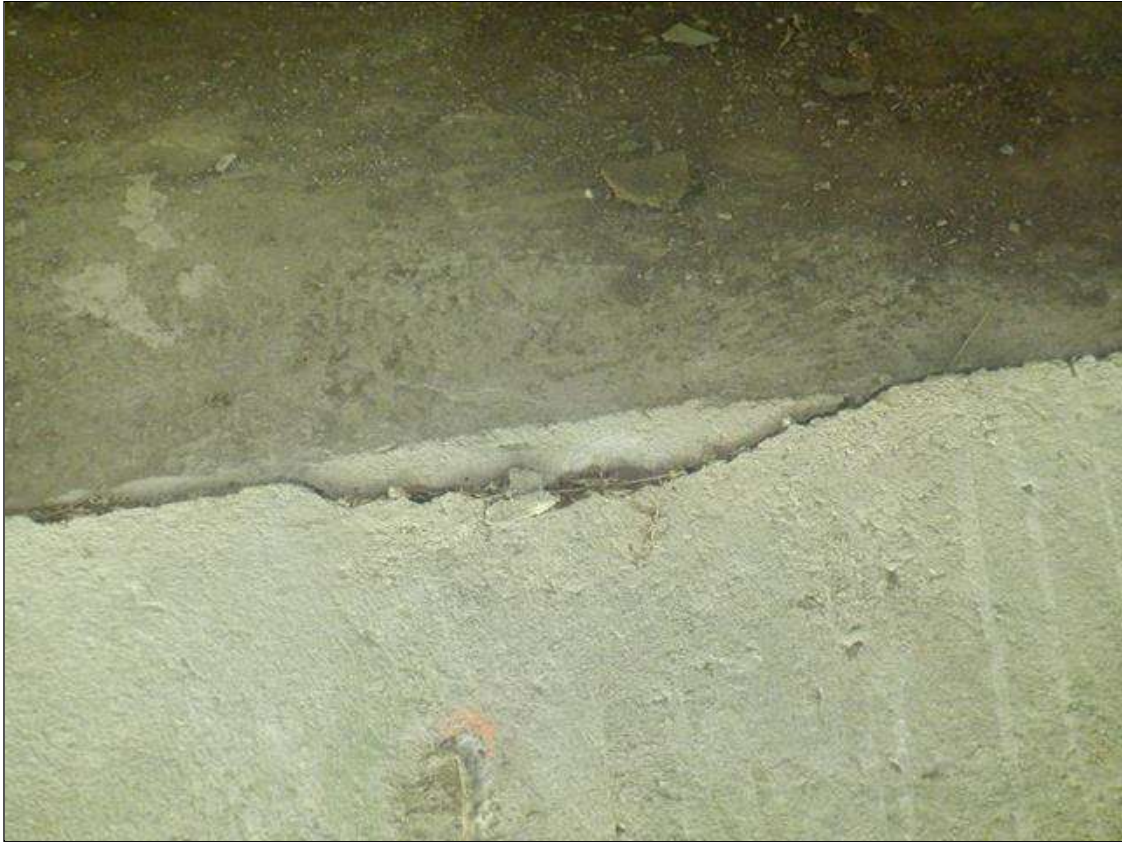
UP TO 12 IN LONG X 1/8 IN WIDE HORIZONTAL CRACK IN TOP OF BERM IN SLOPE PROTECTION AT END BENT 1

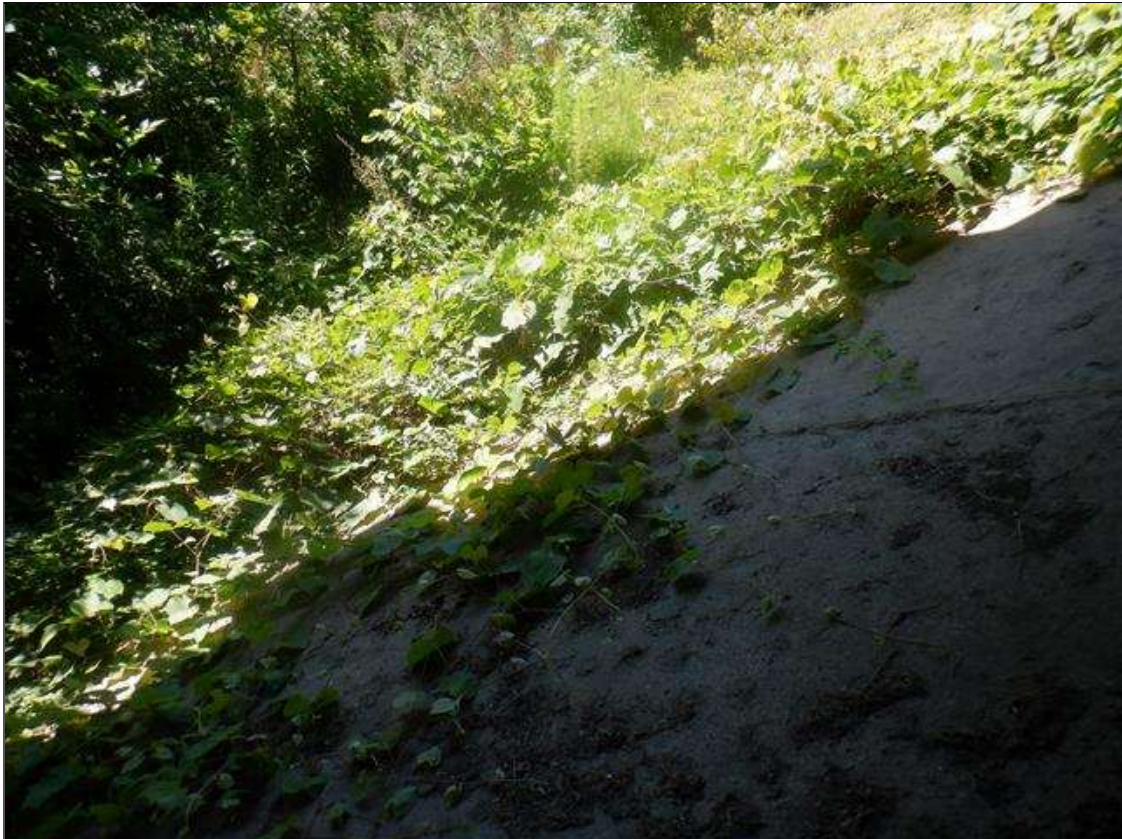
HEAVY VEGETATION GROWTH FOR FULL HEIGHT OF SLOPE PROTECTION AT END BENT 1 UNDER BAY 1

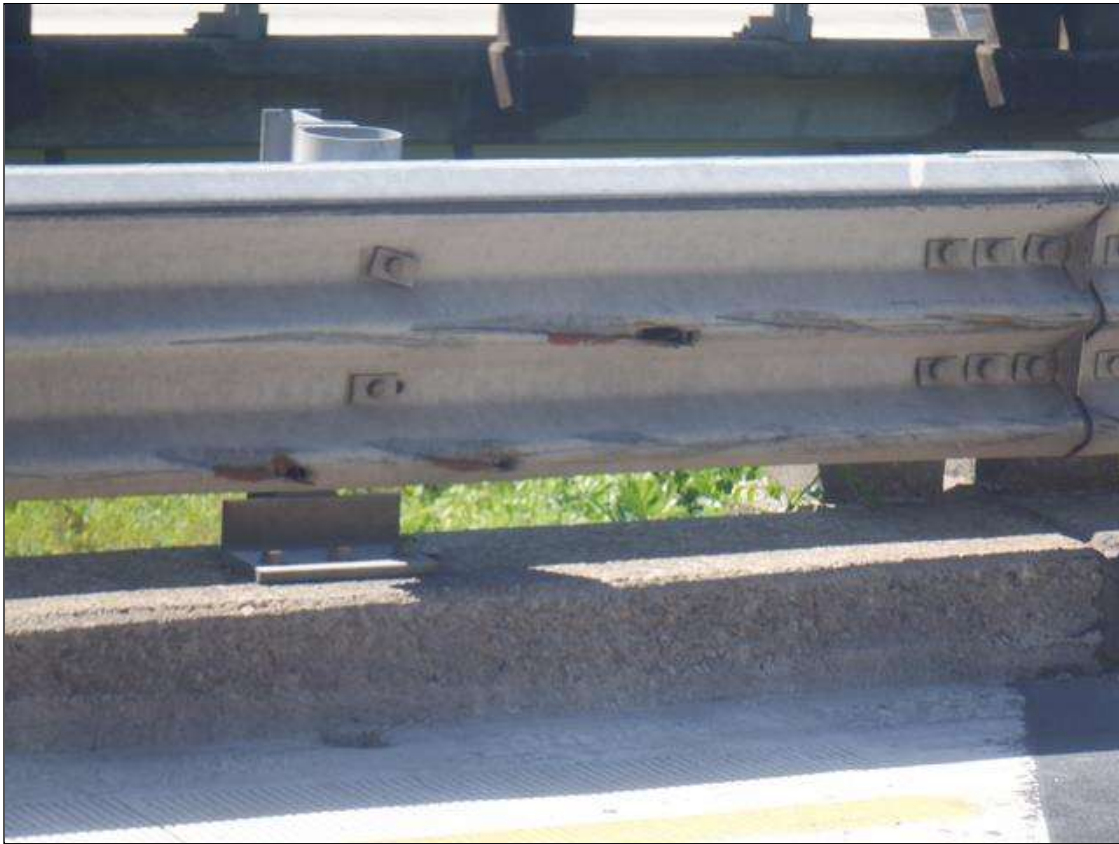
Span 2 Right Bridge Rail: HEAVY IMPACT DAMAGE WITH SCRAPE MARKS AND THROUGH HOLES IN SUPPLEMENTAL GUARDRAIL AT SCATTERED LOCATIONS

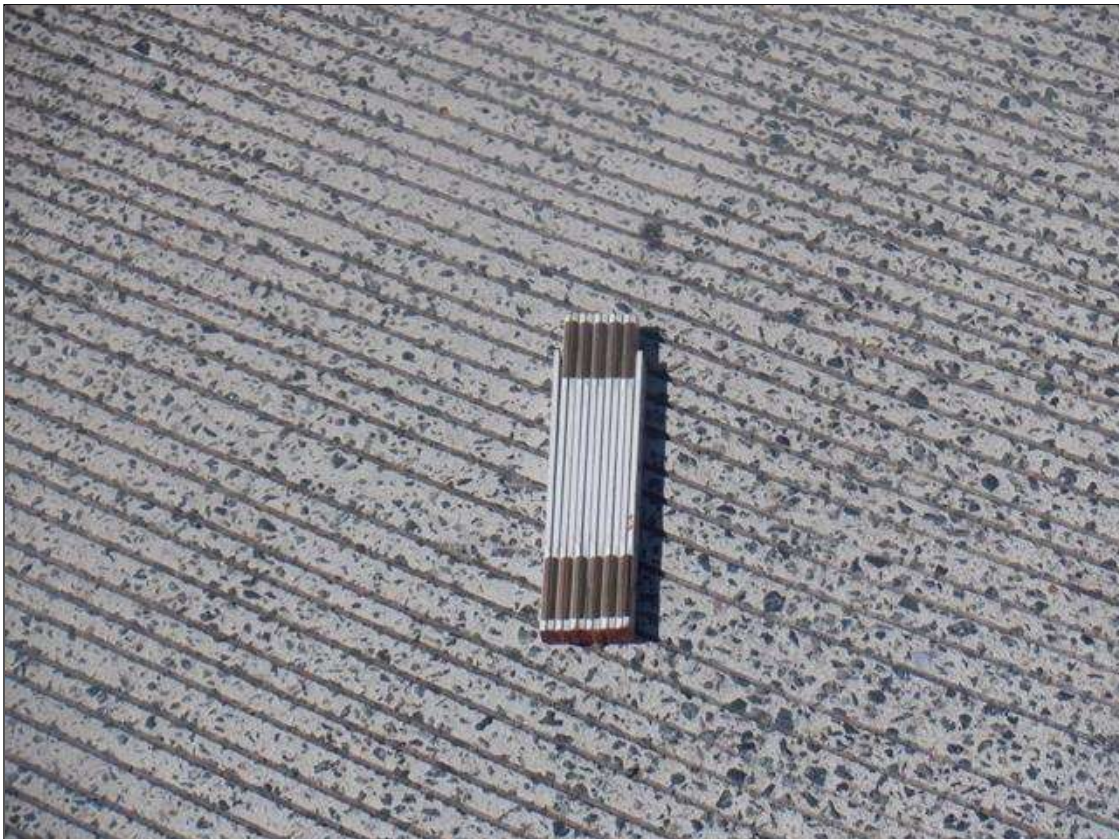
Span 4 Deck: MINOR ABRASION ON WALL MOUNT AND DECK WORN OUT WITH EXPOSED AGGREGATE IN WHEEL PATHS OF BOTH TRAVEL LANES

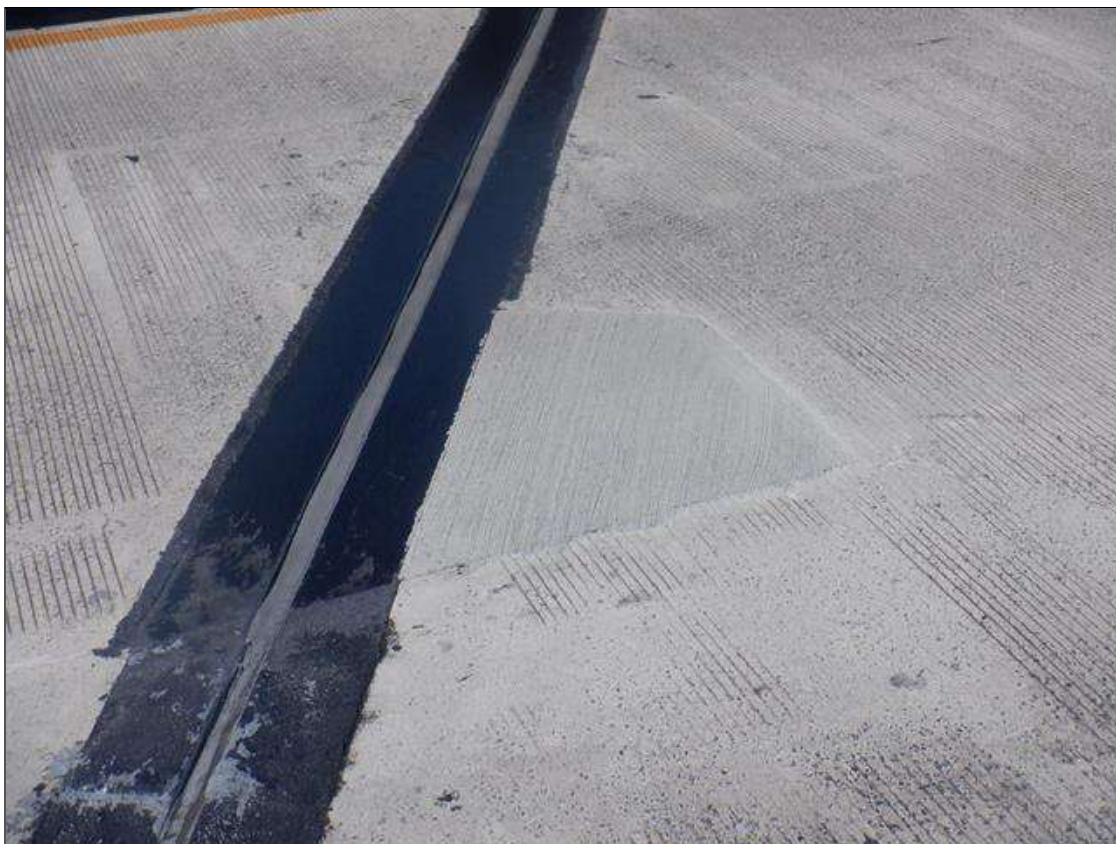
Span 4 Deck: 3 FT LONG X 2 FT WIDE SOUND CONCRETE PATCH IN LEFT TRAVEL LANE AT BENT 4

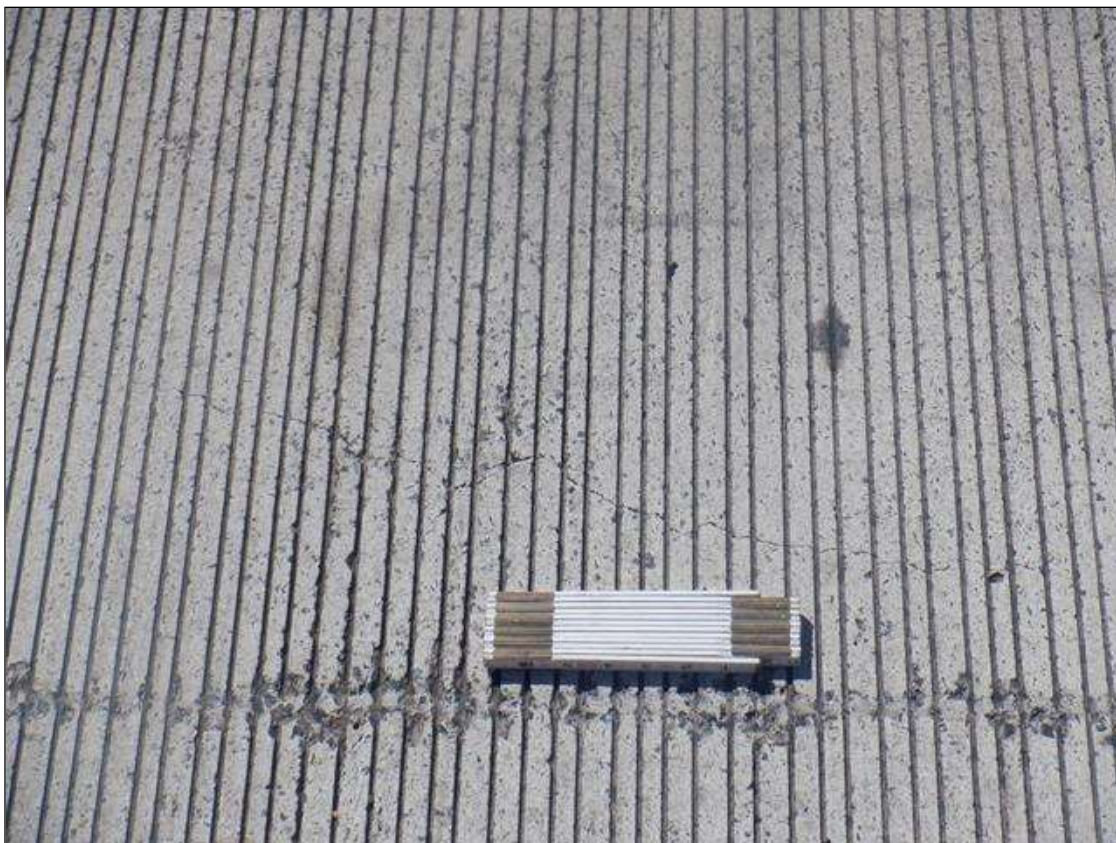
Span 5 Deck: UP TO 0.05 IN WIDE LONGITUDINAL AND TRANSVERSE CRACKS AT MID-SPAN IN BOTH TRAVEL LANES

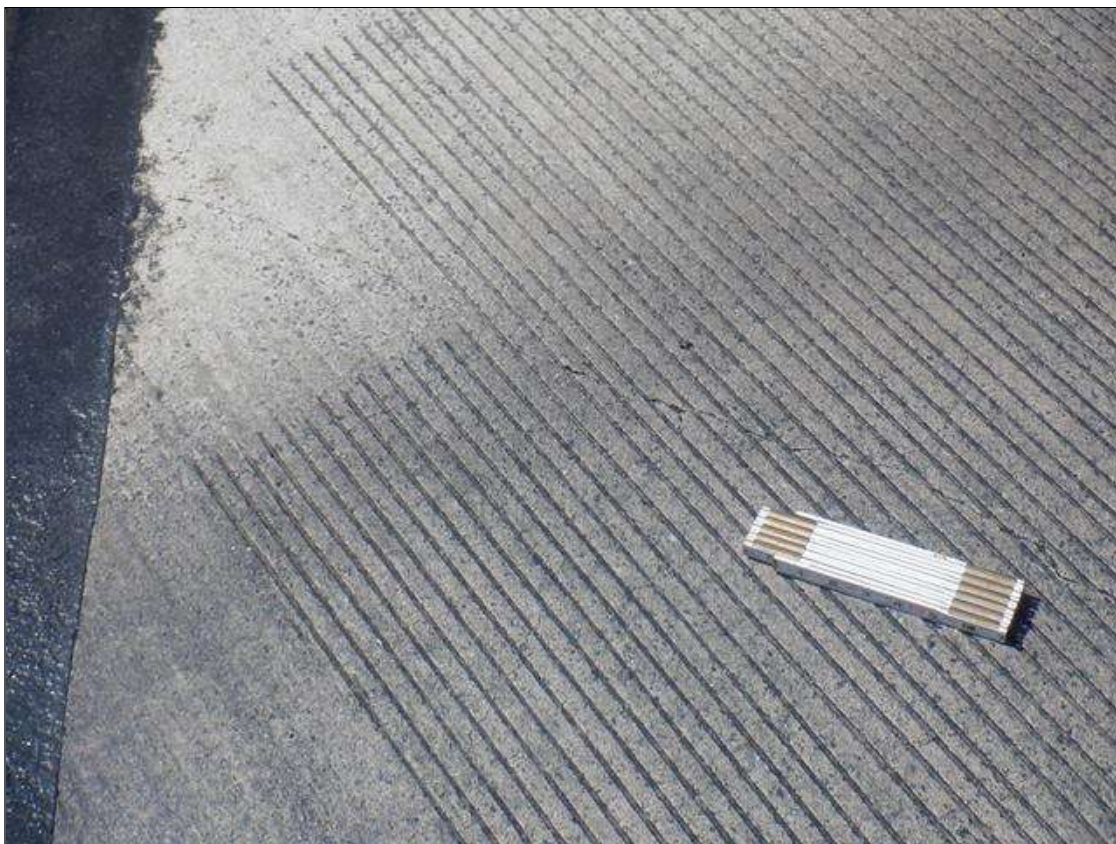
Span 8 Wearing Surface: UP TO 0.05 IN WIDE X 8 FT LONG DIAGONAL CRACKS EXTENDING FROM EXPANSION JOINT AT END BENT 2

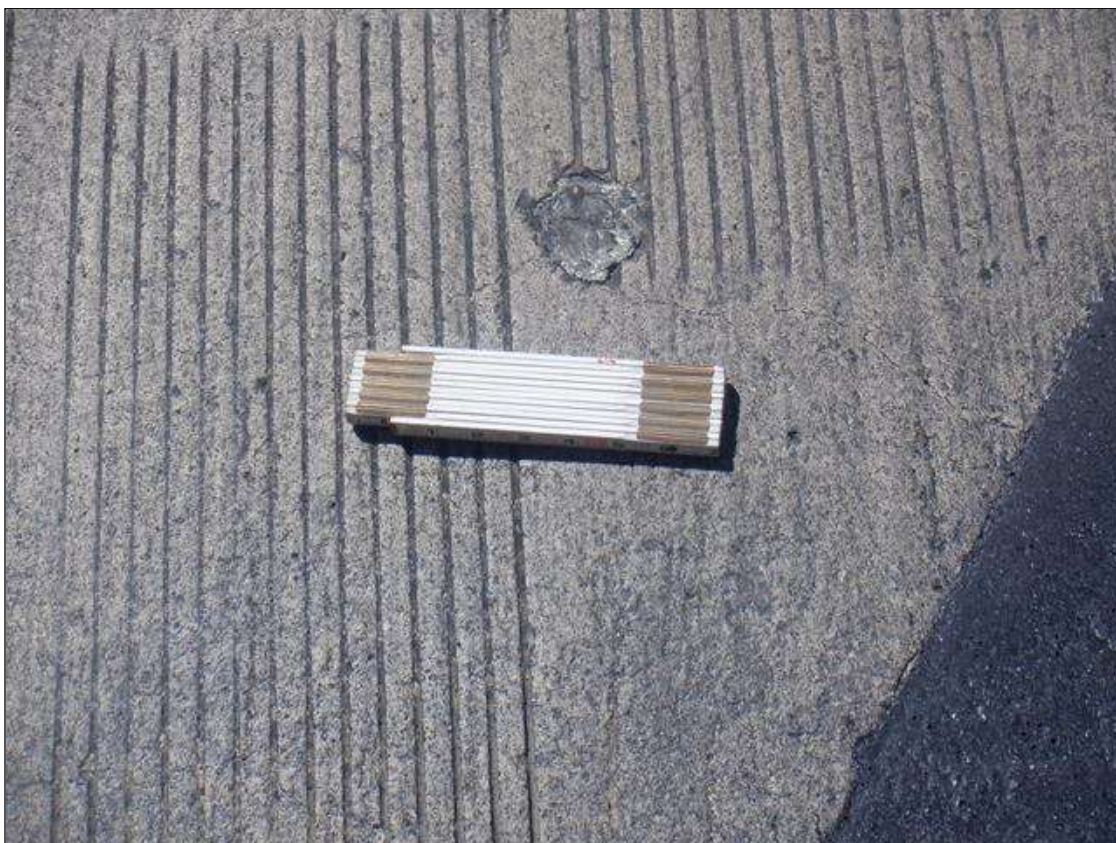
Approach 2 Approach 2: UP TO 0.05 IN WIDE DIAGONAL AND LONGITUDINAL CRACKS IN BOTH TRAVEL LANES

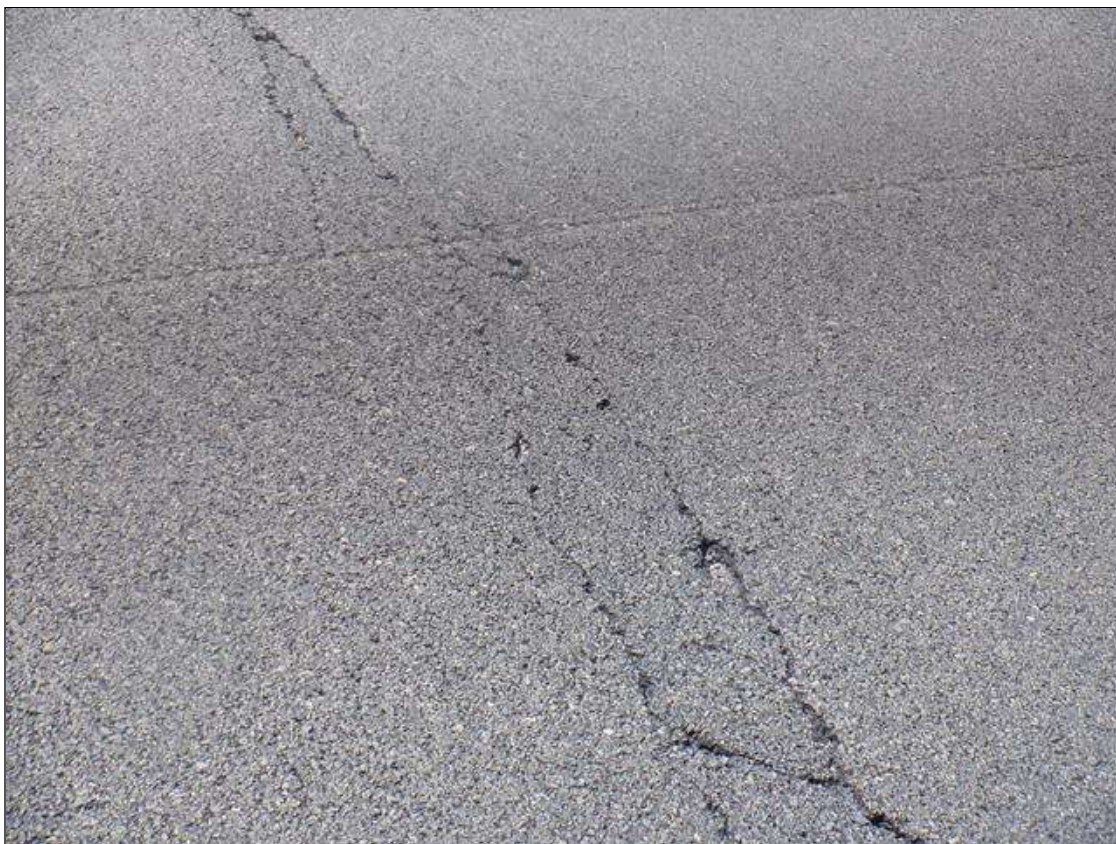
8 IN LONG X FULL TRAVEL LANE WIDTH OF UNSOUND ASPAHLT PAVEMENT IN NORTH APPROACH AT 15 FT FROM END OF APPROACH SLAB

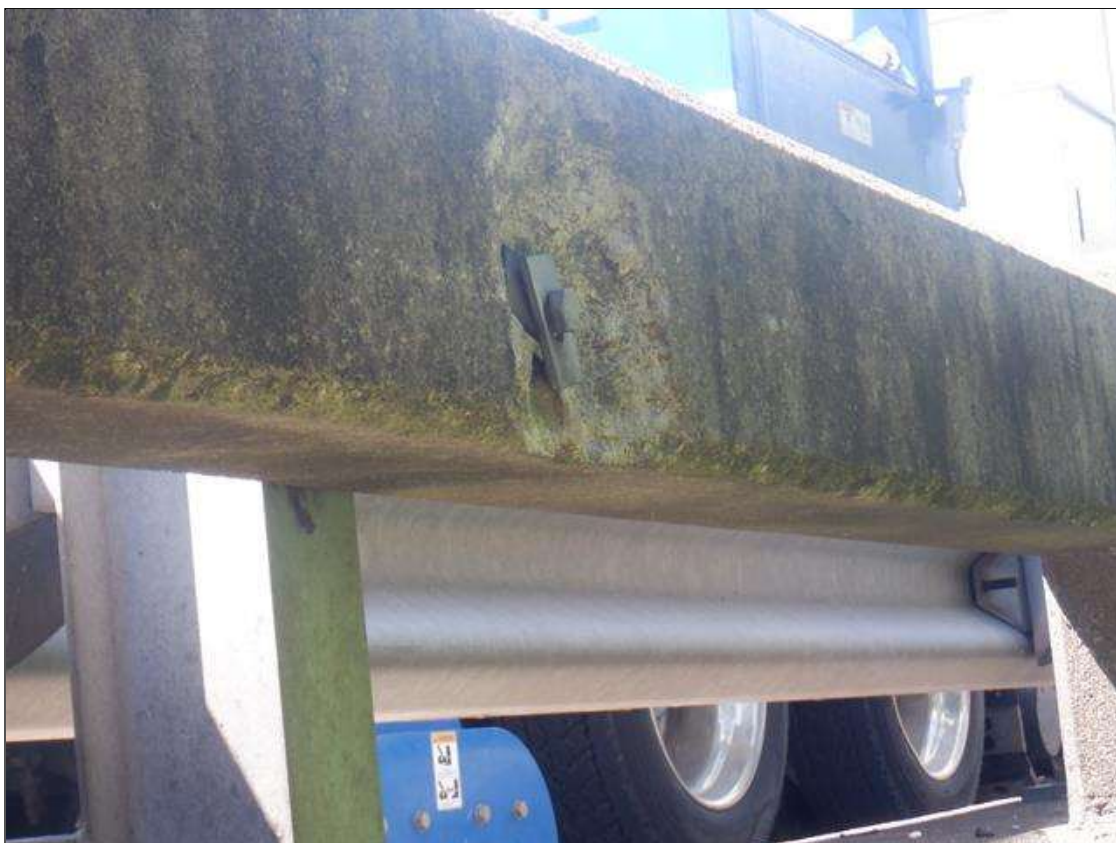
Span 8 Left Bridge Rail: 6 IN DIAMETER X 1.5 IN DEEP SPALL IN ANCHOR BOLT CONNECTION OF SUPPLEMENTAL GUARDRAIL TO BRIDGE RAIL AT SECOND POST FROM END BENT 2

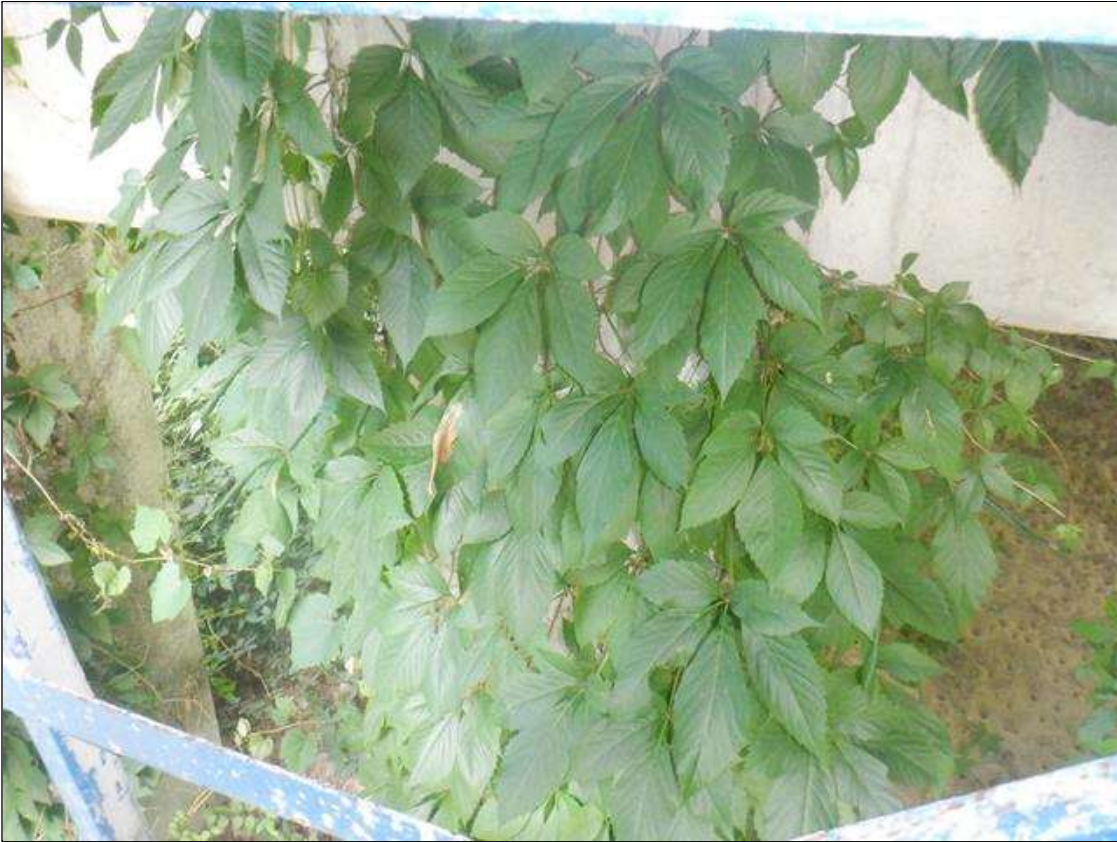
Bent 7 Pile 2: HEAVY VEGETATION GROWTH FOR FULL HEIGHT

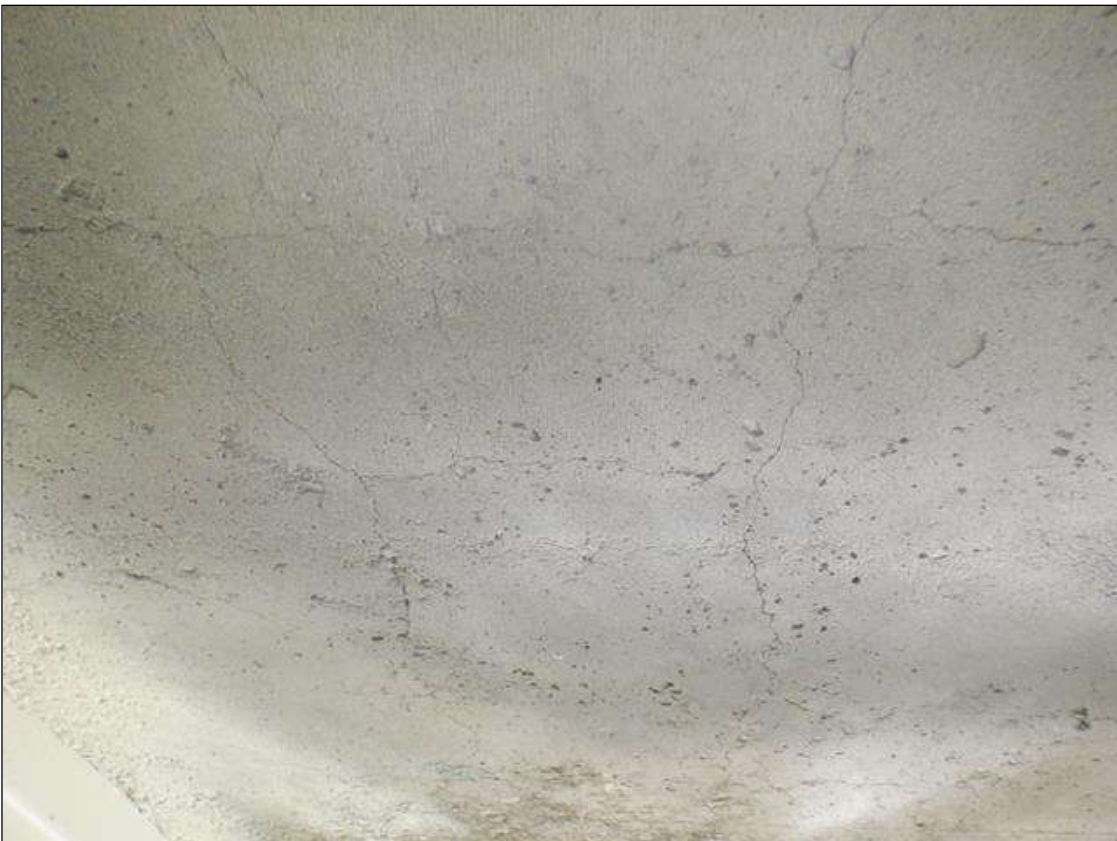
Span 7 Deck: UP TO 0.02 IN WIDE RANDOM CRACKING IN DECK UNDERSIDE IN ALL BAYS, SCATTERED THROUGHOUT.

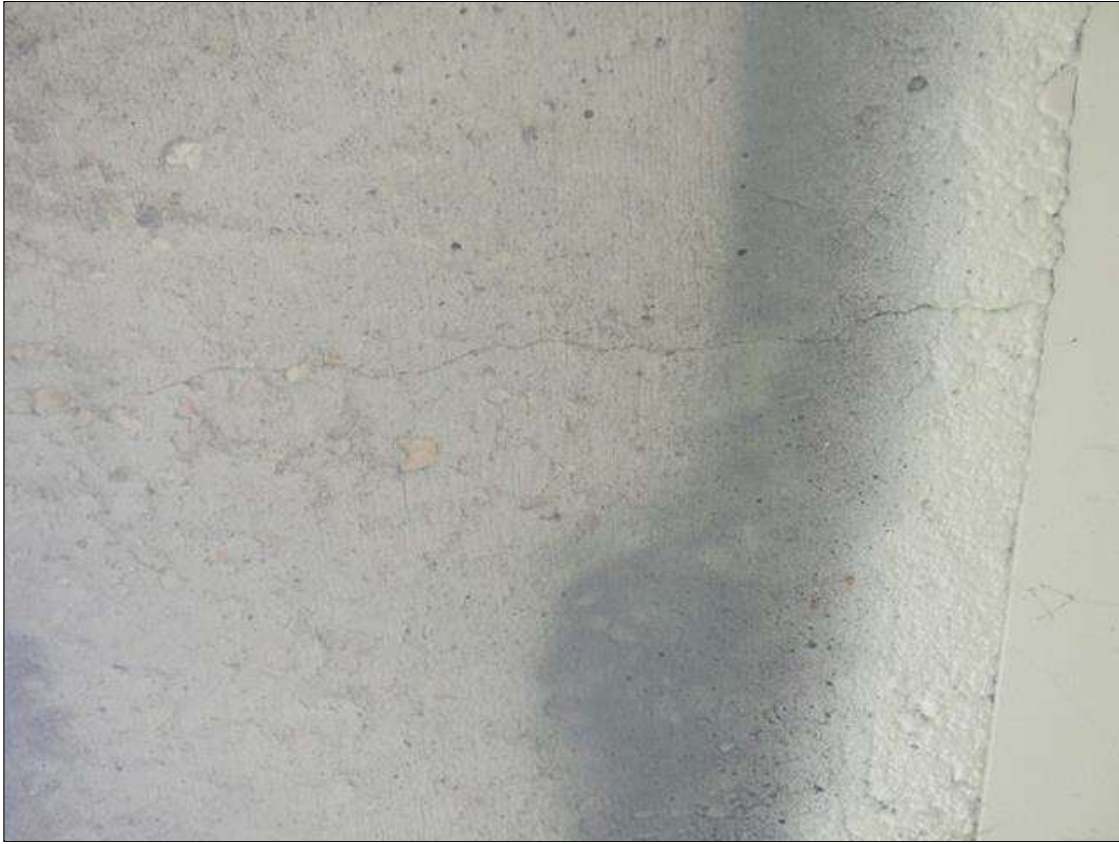
Span 7 Deck: EIGHT (8) UP TO 0.03 IN WIDE X UP TO 3 FT LONG TRANSVERSE CRACKS IN LEFT OVERHANG. RIGHT OVERHANG TYPICAL.

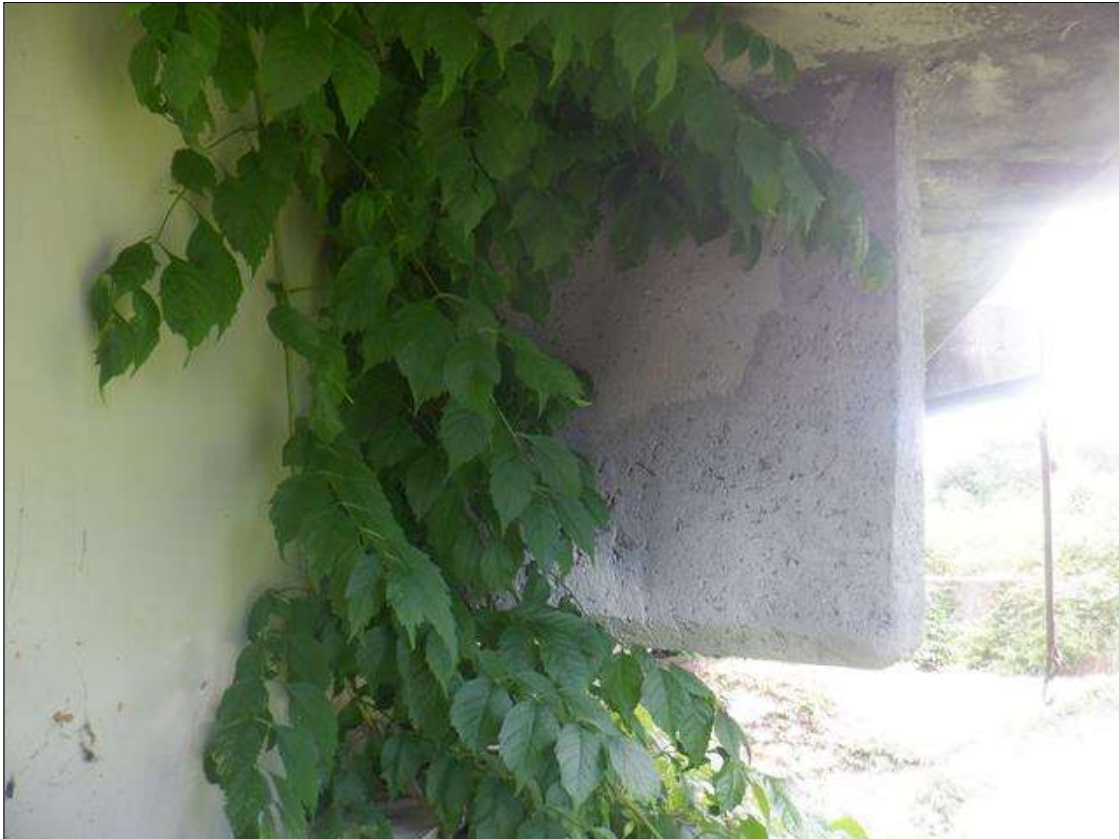
Span 7 Deck: 2 FT HIGH X 1 FT WIDE SOUND CONCRETE PATCH IN DIAPHRAGM OUTSIDE BEAM 4 AT BENT 7.

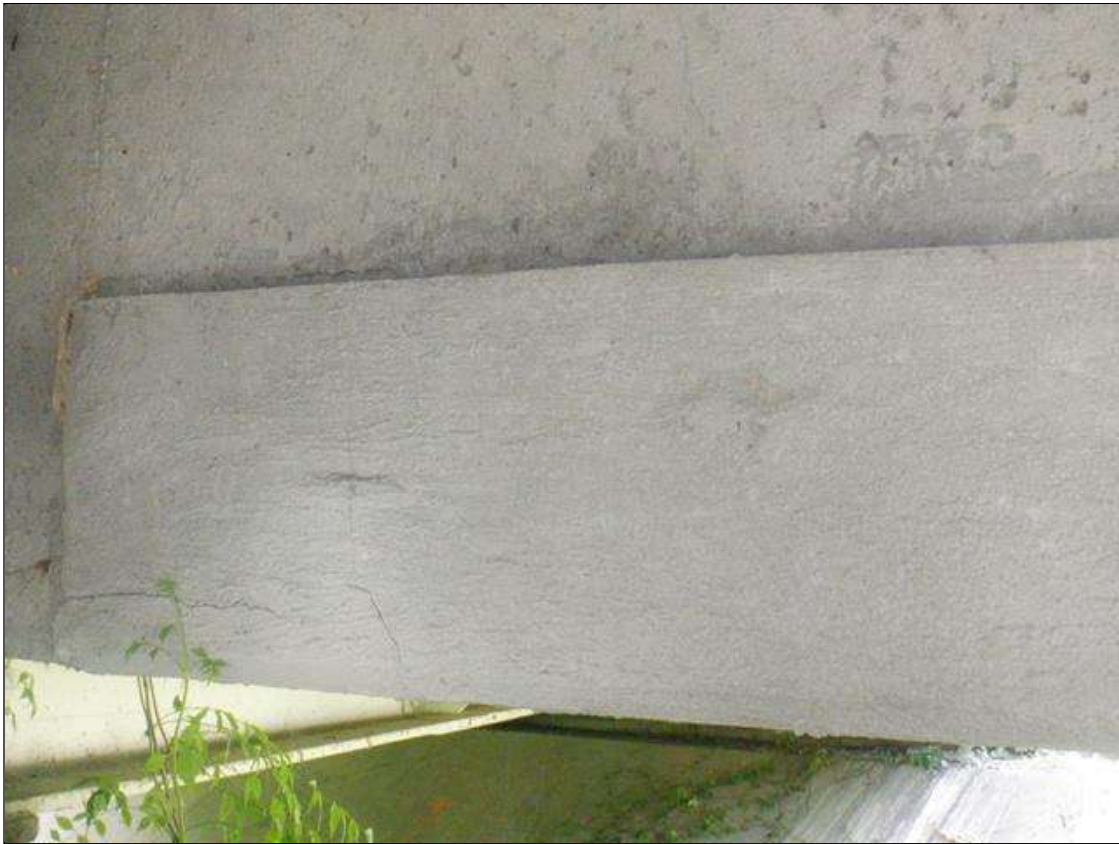
Span 7 Deck: 7 FT LONG X 1 FT HIGH UNSOUND CONCRETE PATCH WITH UP TO 0.05 IN WIDE CRACKS IN INTERMEDIATE DIAPHRAGM IN BAY 3 AT BENT 7.

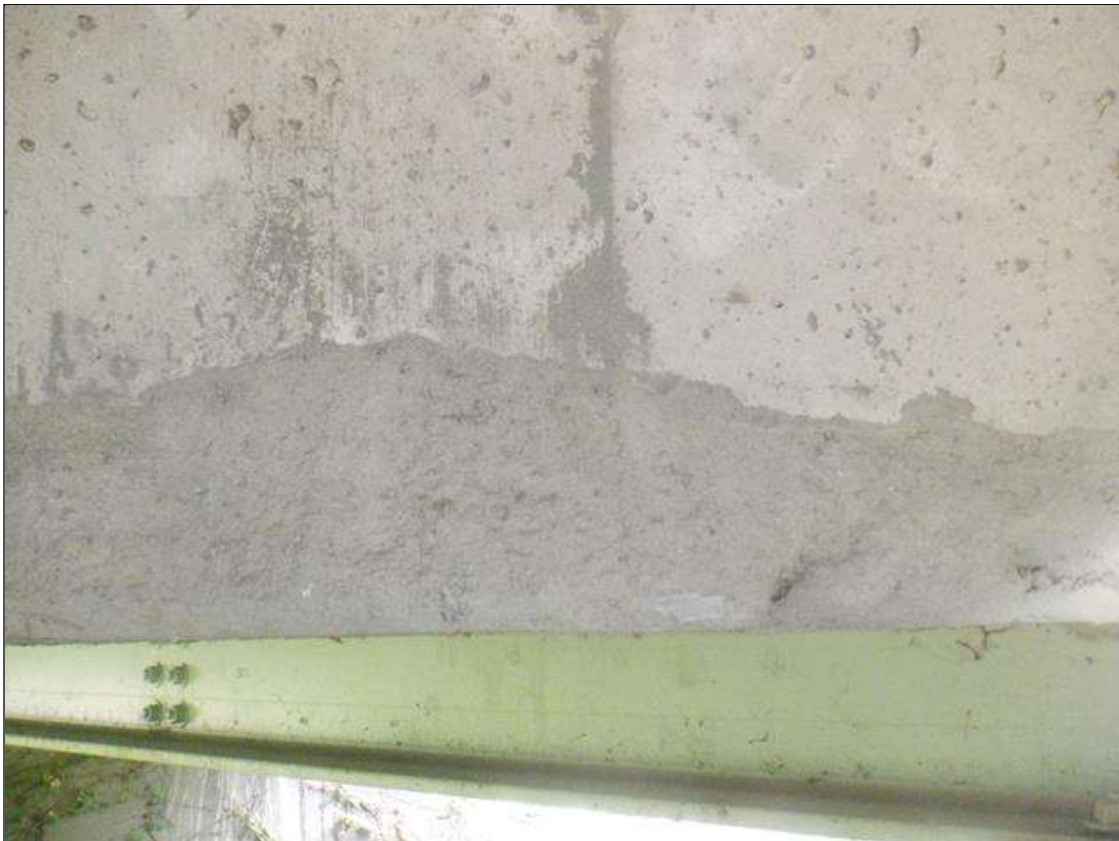
Span 7 Deck: 20 IN WIDE X 18 IN HIGH SOUND CONCRETE PATCHED AREA, BAY 1 END DIAPHRAGM, OVER BENT 7, NEXT TO BEAM 2.
