NC DEPARTMENT OF TRANSPORTATION
 DIVISION OF HIGHWAYS
 STRUCTURE MANAGEMENT UNIT

ATTENTION: **PAR SUBMITTED, CHANGE IN STRUCTURAL DATA, HYDRA PLATFORM USED, NEW REPAIRS**

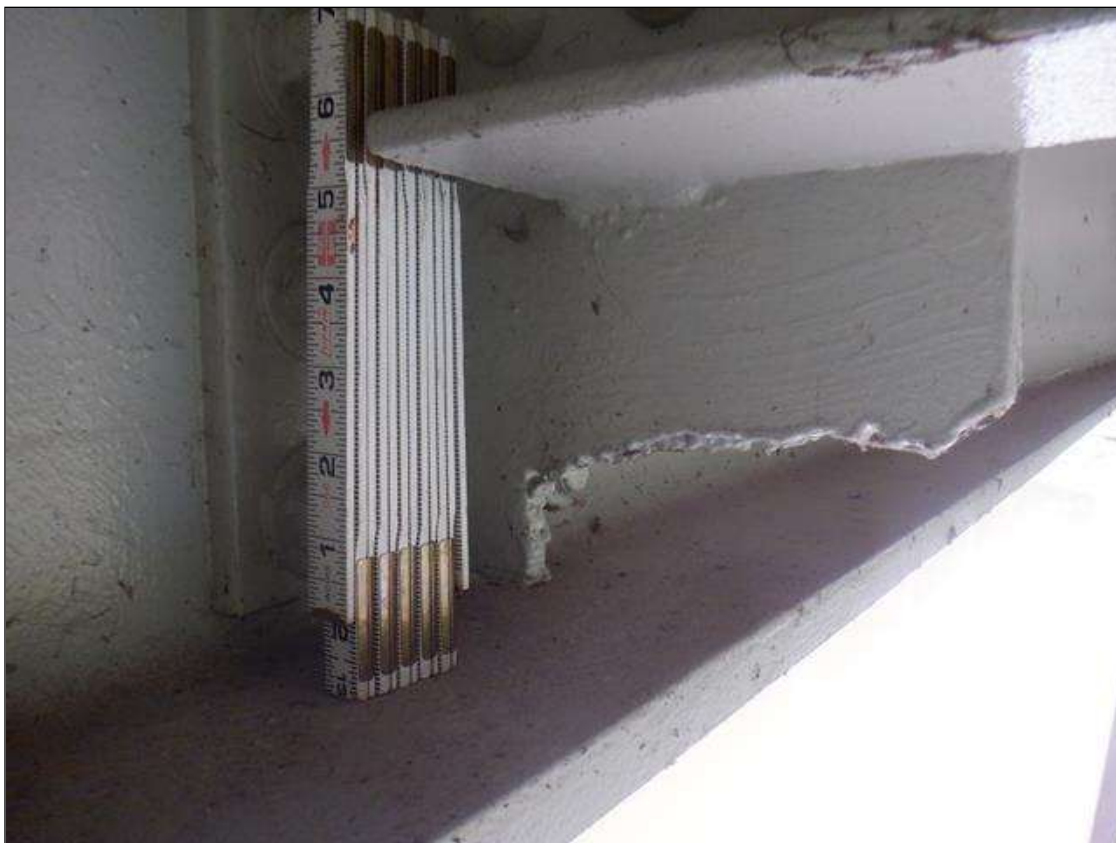
Span 7 Beam 4: UP TO 2 IN HIGH OF SECTION CUT OUT AT BOTTOM OF INTERMEDIATE STIFFENER. PAR IS NOT ISSUED AS IT APPEARS TO BE FROM A BRIDGE REPAIR

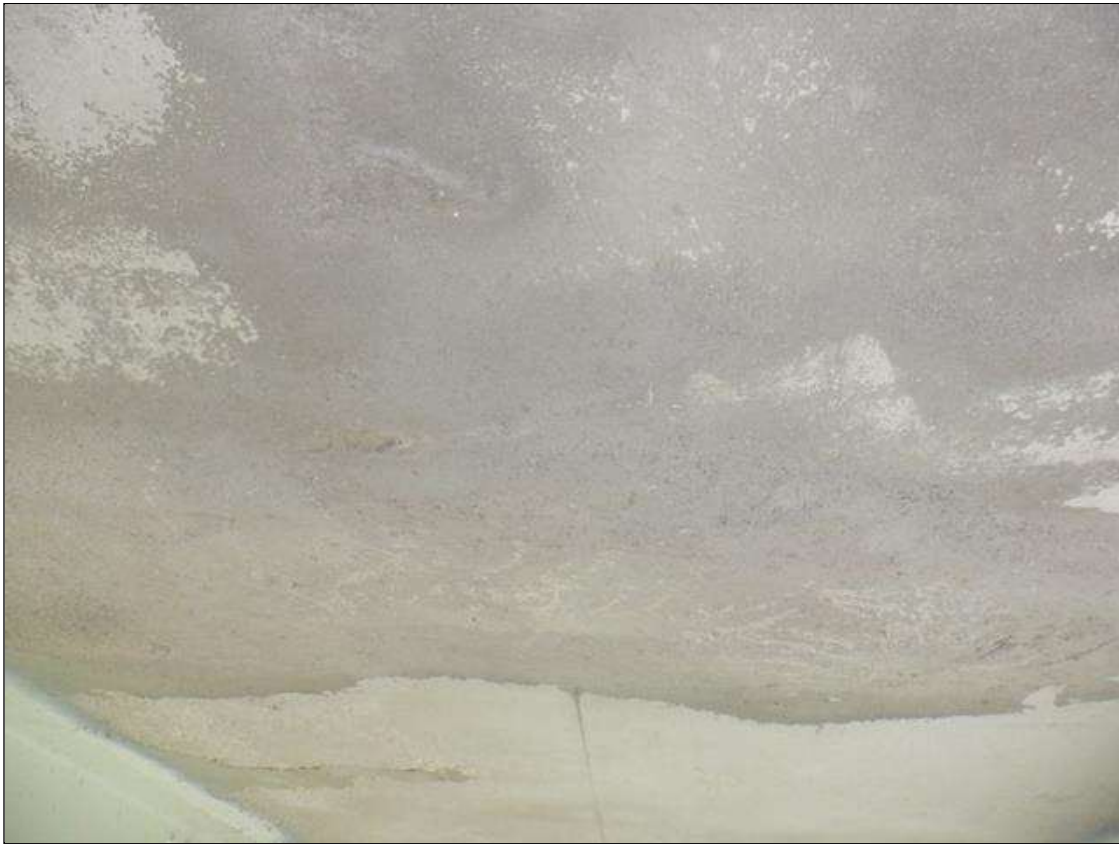
Span 7 Deck: 75 SQ FT OF PATCHED AREA, UNDERSIDE OF DECK, AT RANDOM THROUGHOUT ALL BAYS.

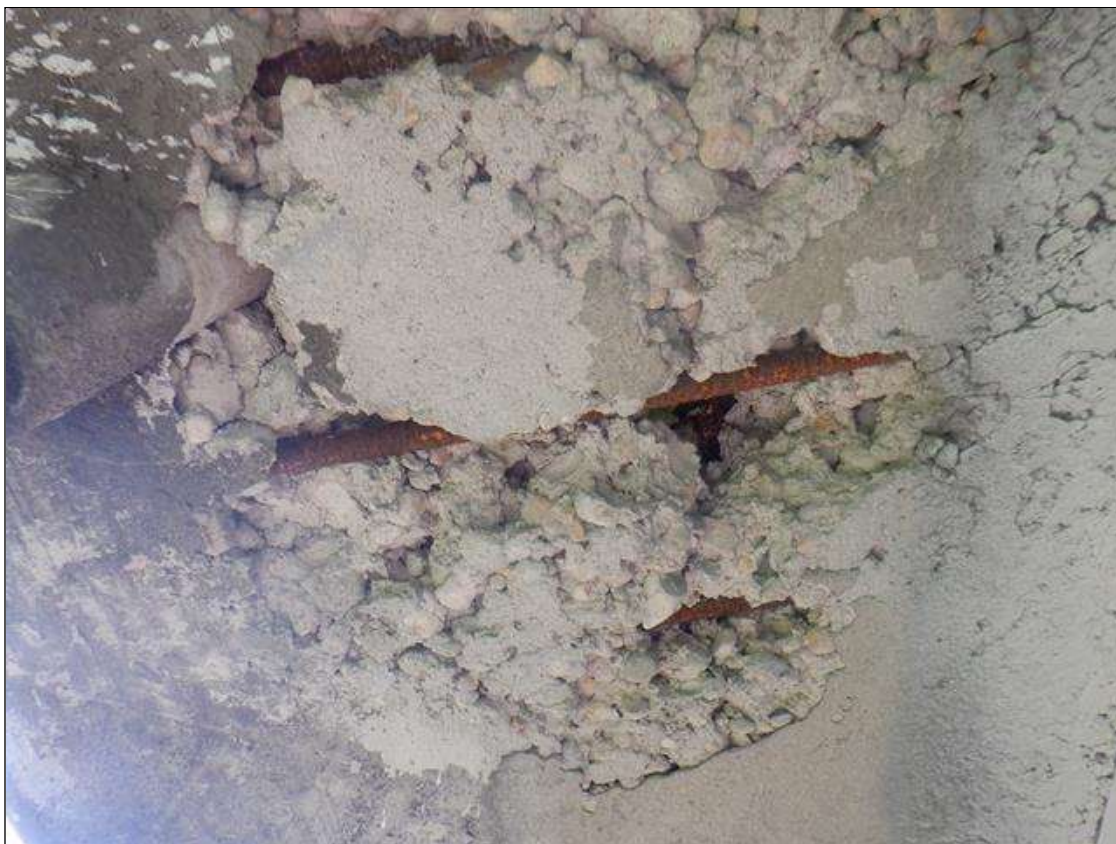
Span 7 Deck: 24 IN LONG X 2 FT WIDE X 2 IN DEEP DELAMINATION/SPALL WITH EXPOSED REINFORCING, UNDERSIDE OF EAST OVERHANG AT 2/3 POINT. 90% REMAINING IN EXPOSED REINFORCEMENT.

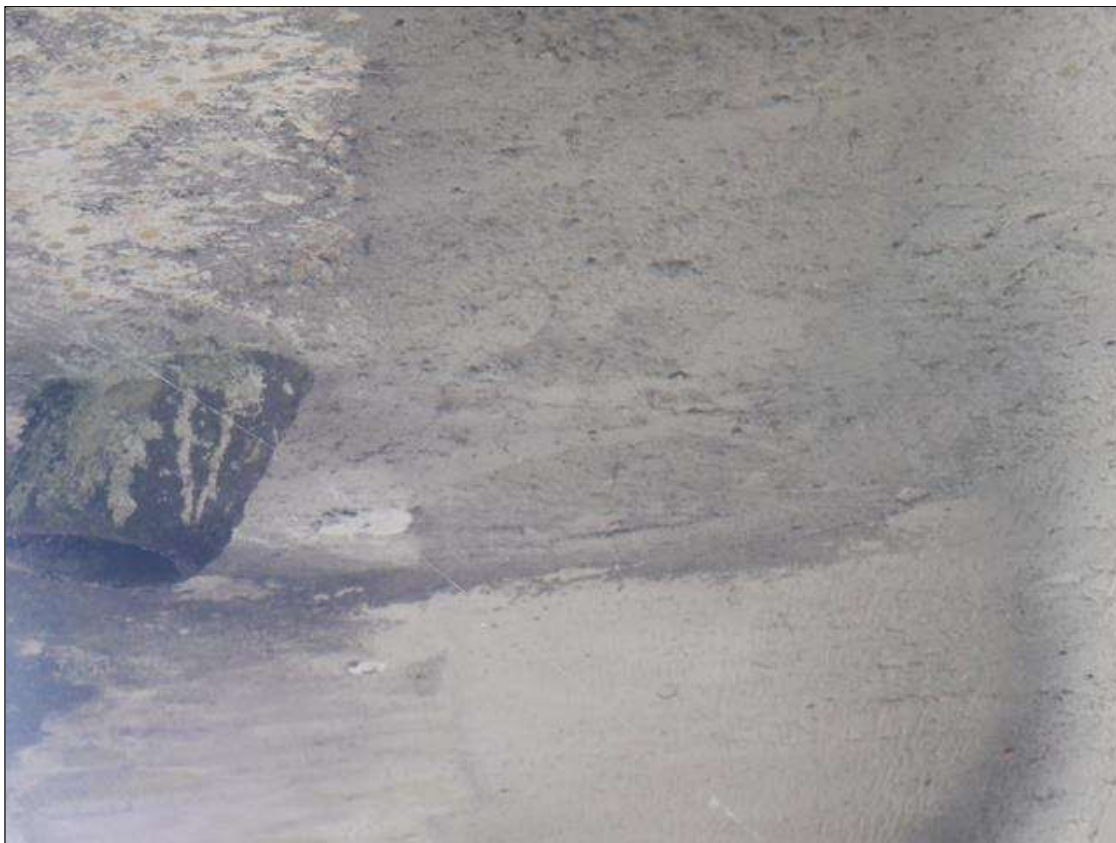
Span 7 Deck: 18 IN DIAMETER SOUND CONCRETE PATCH IN EAST OVERHANG AT THIRD DRAIN PIPE.

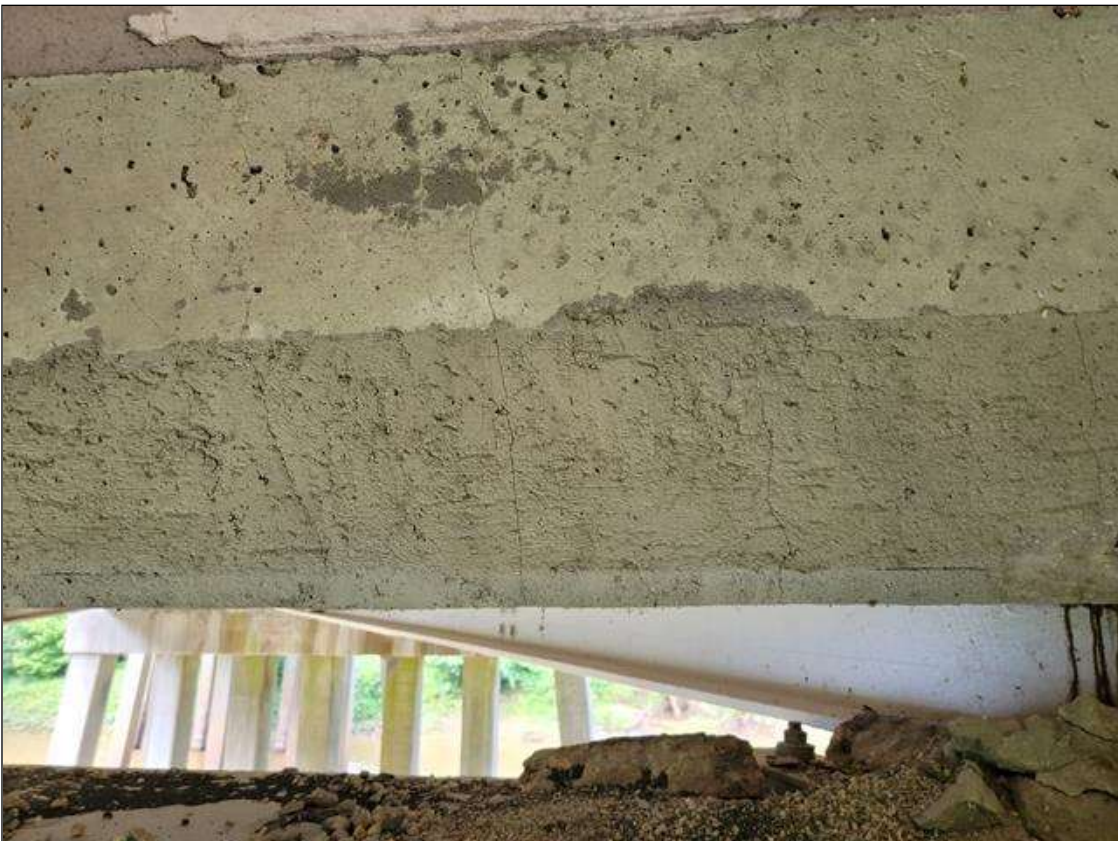
Span 7 Deck: 6 FT LONG X 12 IN HIGH SOUND CONCRETE PATCH BOTTOM OF BAY 3 END DIAPHRAGM, NEXT TO BEAM 3, AT BENT 6. PATCH EXHIBITS UP TO 0.03 IN WIDE VERTICAL CRACKS, SCATTERED.

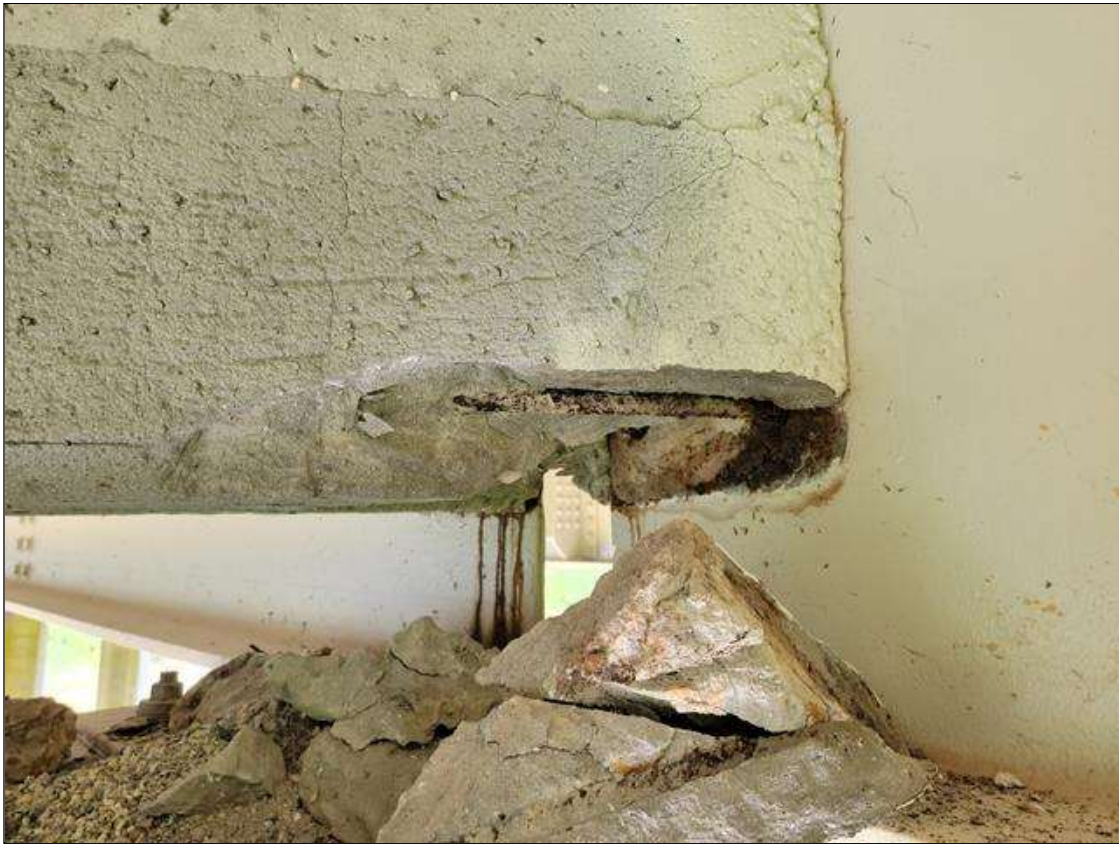
Span 7 Deck: 1 FT LONG X 6 IN HIGH X 12 IN WIDE SPALL WITH EXPOSED REBAR IN BAY 3 END DIAPHRAGM AT BENT 6. 90% SECTION REMAINING IN THE EXPOSED REBAR.

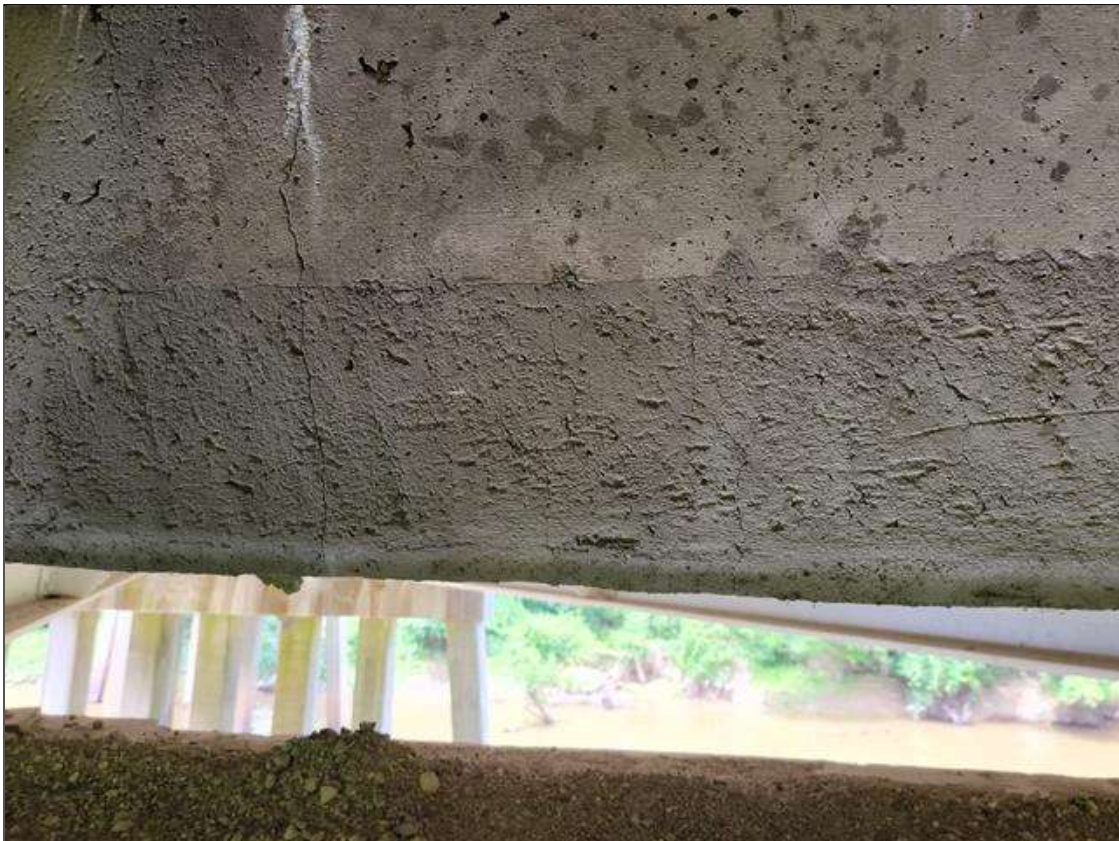
Span 7 Deck: 8 FT LONG X 6 IN HIGH UNSOUND CONCRETE PATCHED AREA WITH UP TO 0.05 IN WIDE VERTICAL AND HORIZONTAL CRACKS IN BAY 2 END DIAPHRAGM, AT BENT 6.

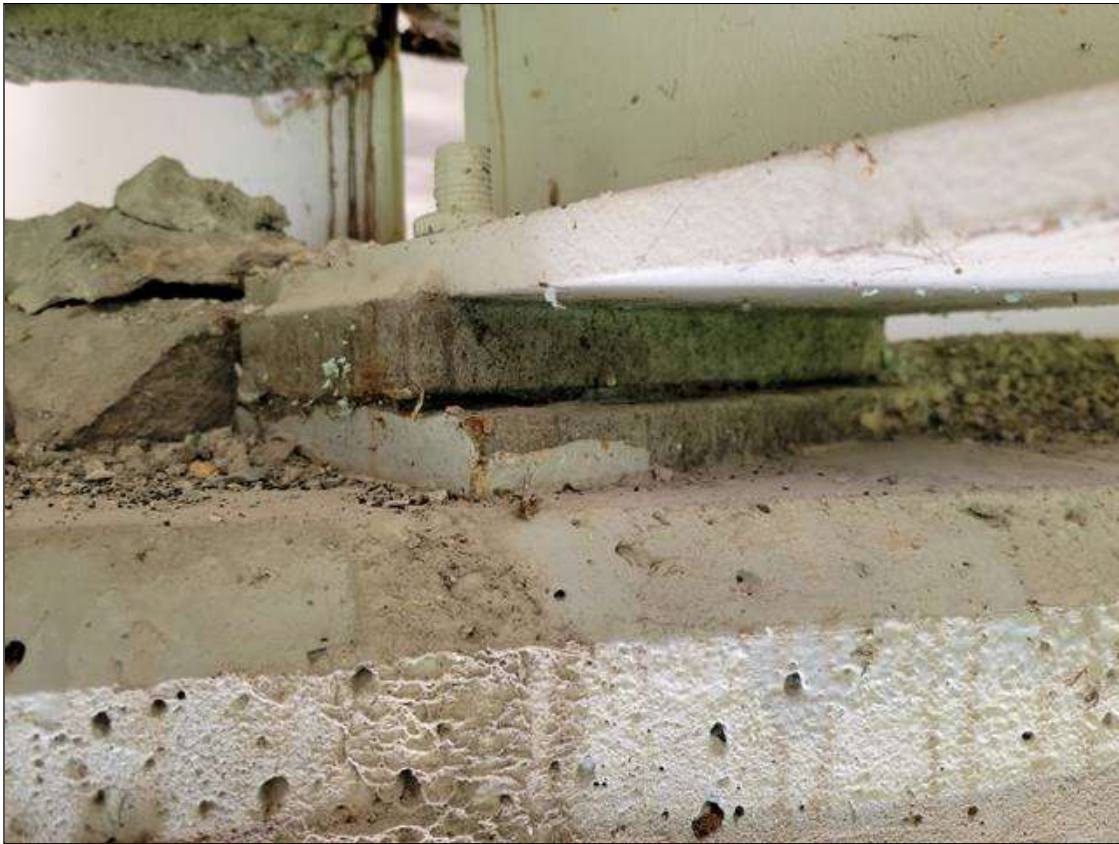
Span 7 Near Bearing: BEARINGS HAVE BEEN PAINTED SINCE PREVIOUS INSPECTION. SECTION LOSS REMAINS BENEATH THE PAINTED SURFACES. UP TO 90% SECTION REMAINING IN BOTH MASONRY AND SOLE PLATES.

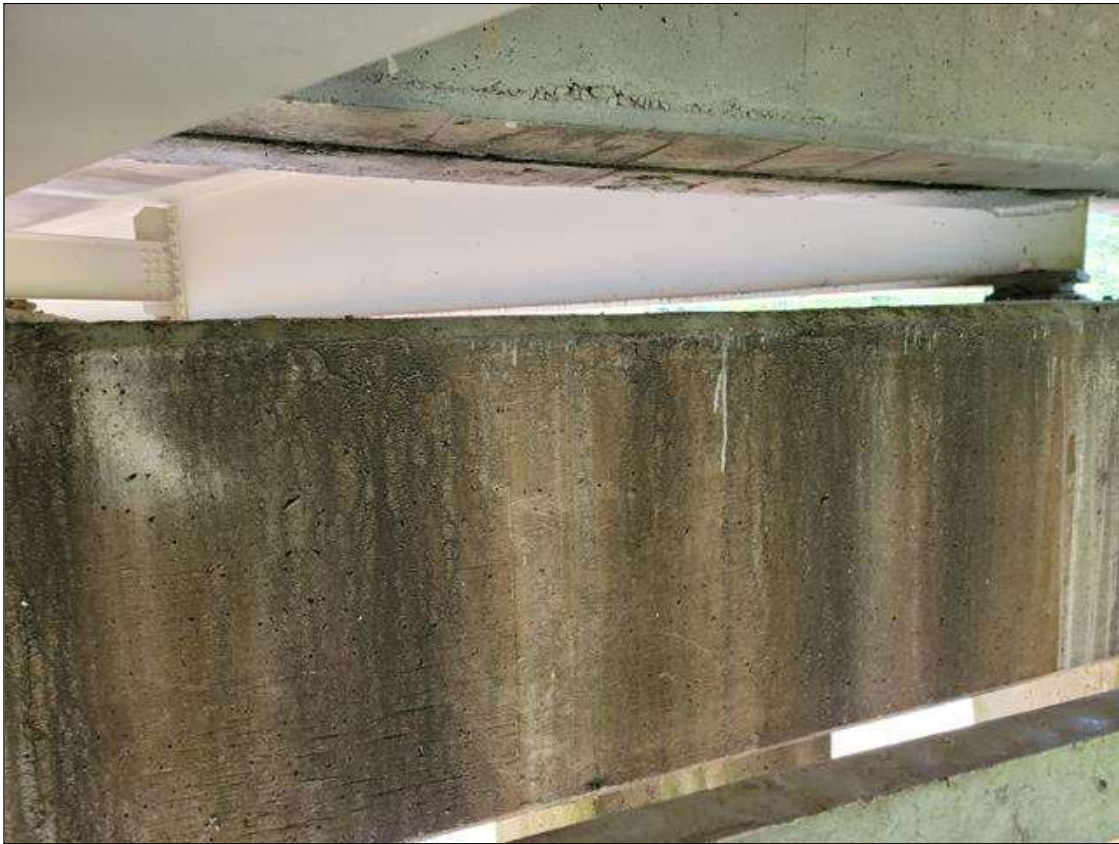
Bent 6 Cap 1: MODERATE LEAKAGE STAINS IN BOTH FACES OF CAP UNDER BEAMS 1 AND 2.

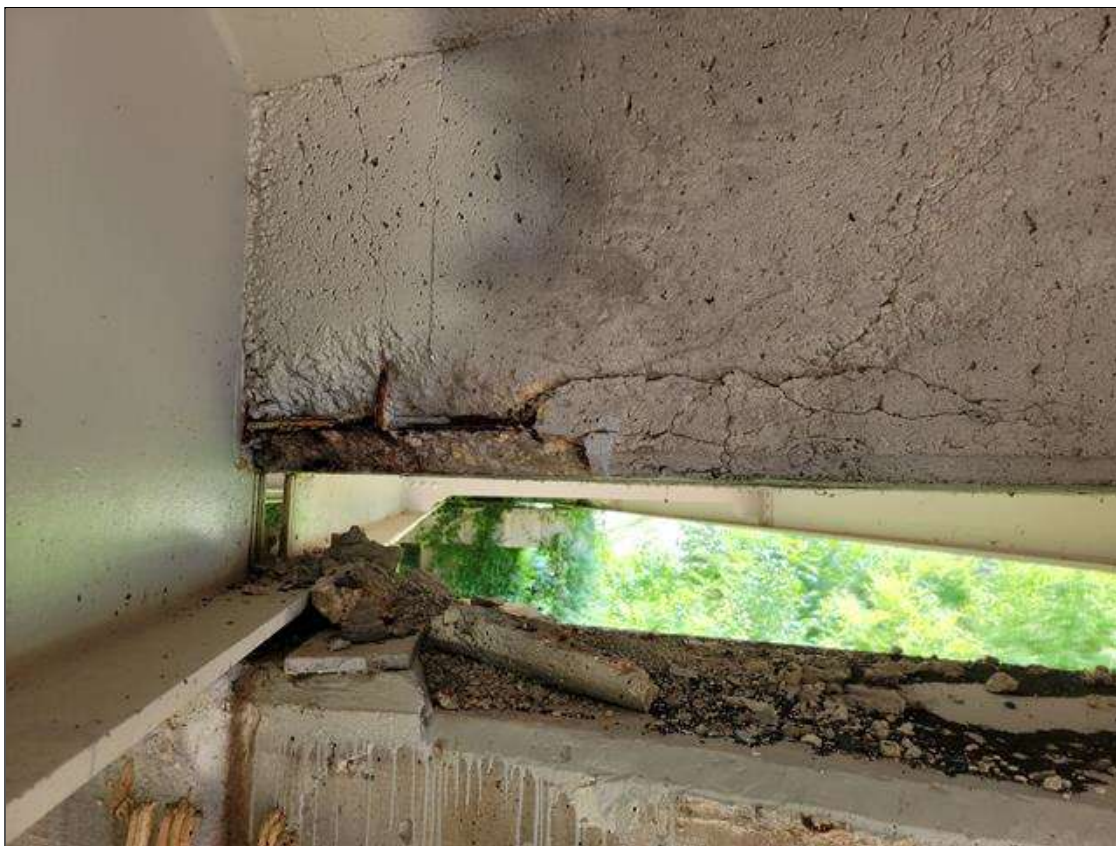
Span 6 Deck: 2.5 FT WIDE X 10 IN LONG X UP TO 6 IN HIGH AREA OF UNSOUND CONCRETE AND SPALL UP TO 2 IN DEEP WITH EXPOSED REINFORCEMENT IN BAY 3 END DIAPHRAGM AT BENT 6. 90% SECTION REMAINING IN EXPOSED REBAR.

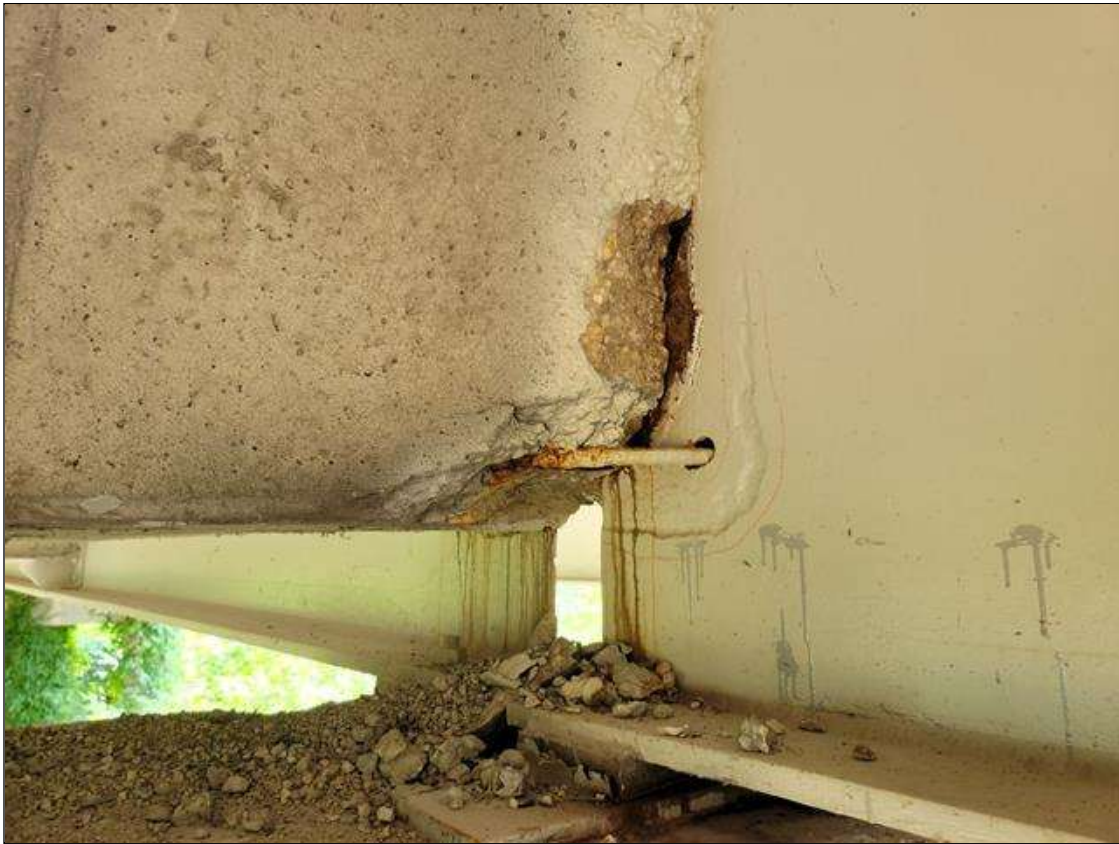
Span 6 Deck: 12 IN WIDE X 9 IN LONG X 14 IN HIGH IN SOUTH FACE SPALL UP TO 3.5 IN DEEP WITH EXPOSED REINFORCEMENT IN BAY 2 AT BENT 6. 90% SECTION REMAINING IN EXPOSED REINFORCEMENT.

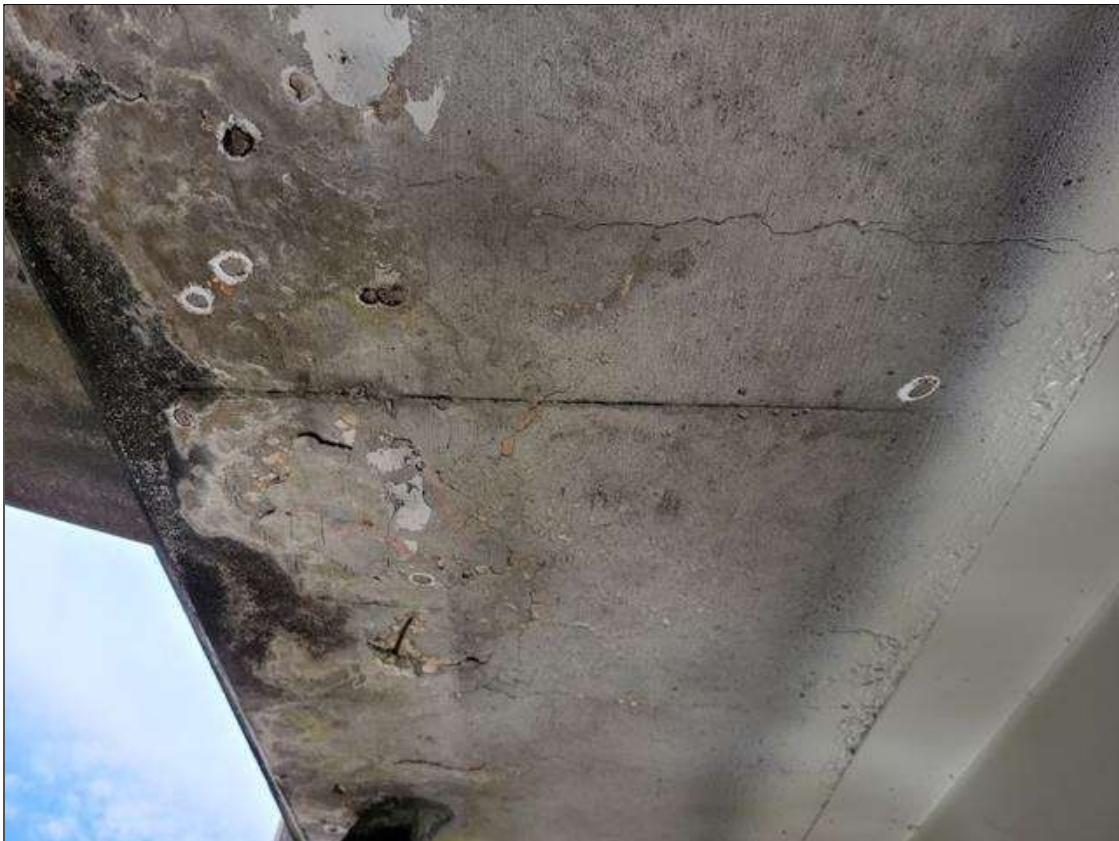
Span 6 Deck: THREE (3) AREAS OF DELAMINATED CONCRETE UP TO 6 IN DIAMETER IN EAST OVERHANG AT BENT 6.

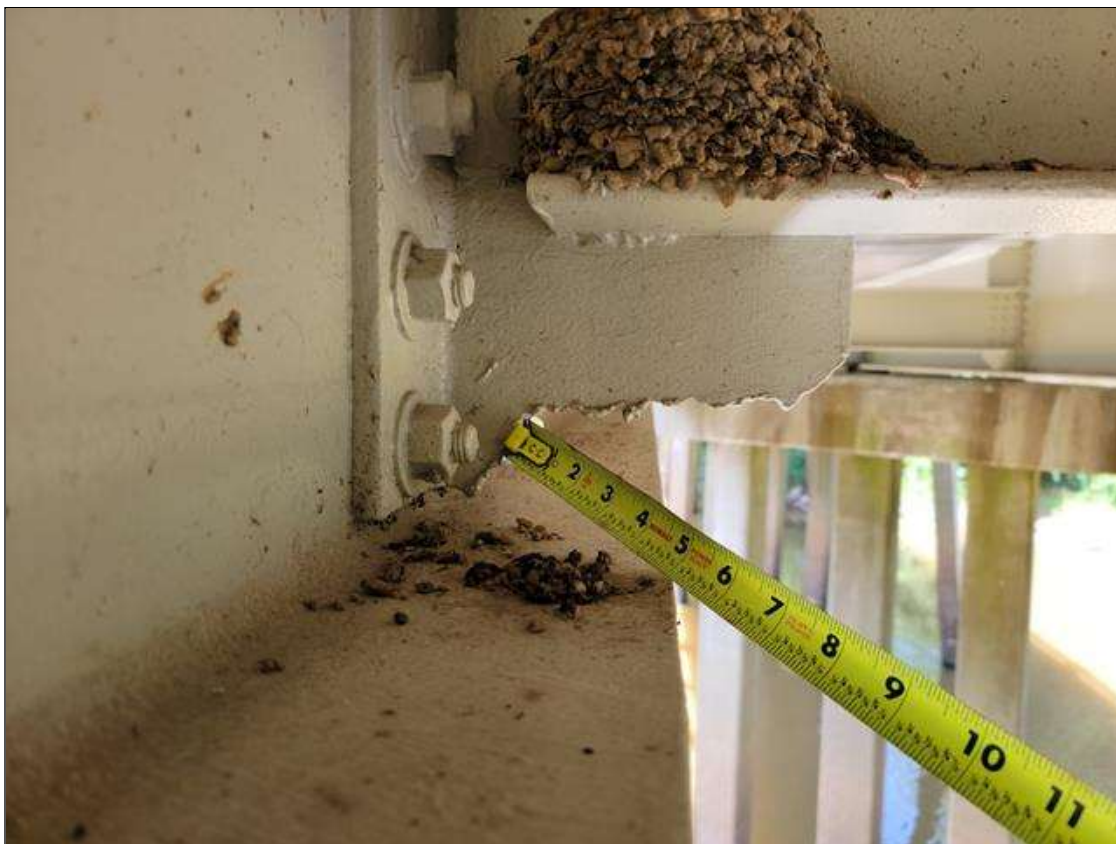
Span 6 Beam 4: UP TO 2 IN HIGH OF SECTION CUT OUT AT BOTTOM OF INTERMEDIATE STIFFENER. PAR IS NOT ISSUED AS IT APPEARS TO BE FROM A BRIDGE REPAIR

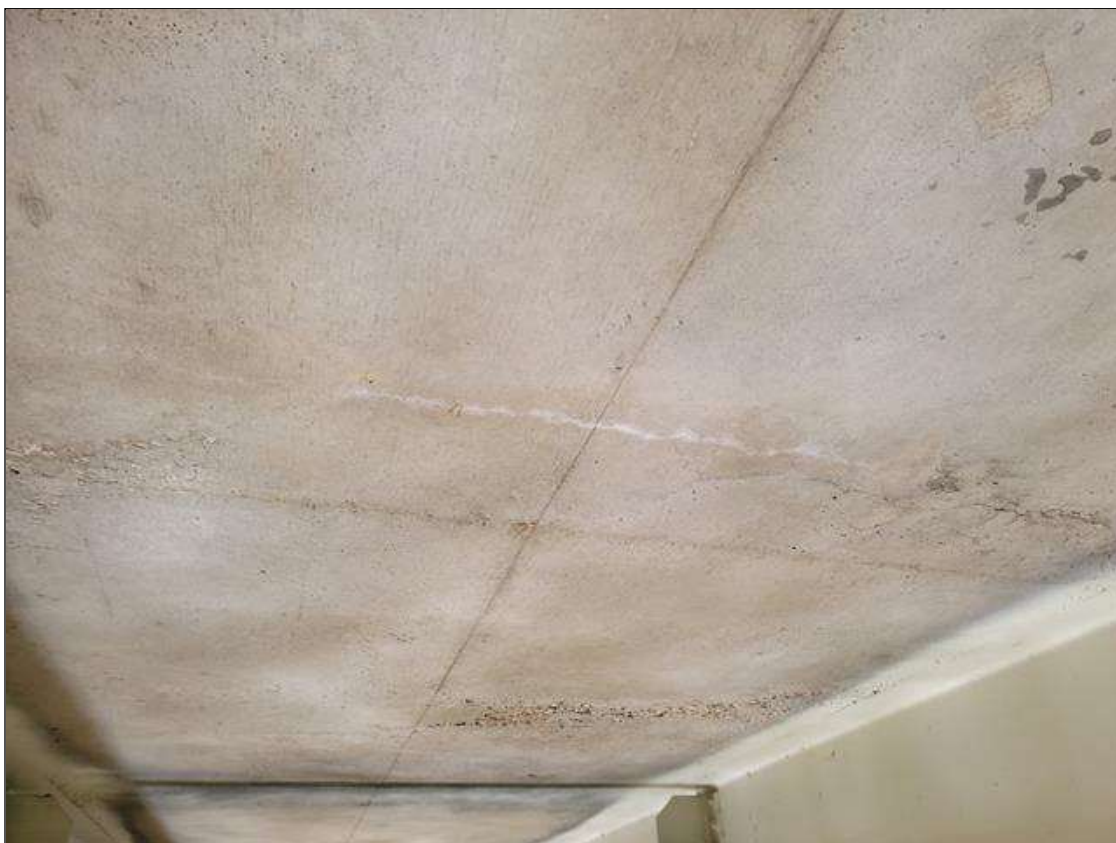
Span 6 Deck: UP TO 0.03 IN WIDE CRACKS IN DECK UNDERSIDE, SCATTERED IN ALL BAYS

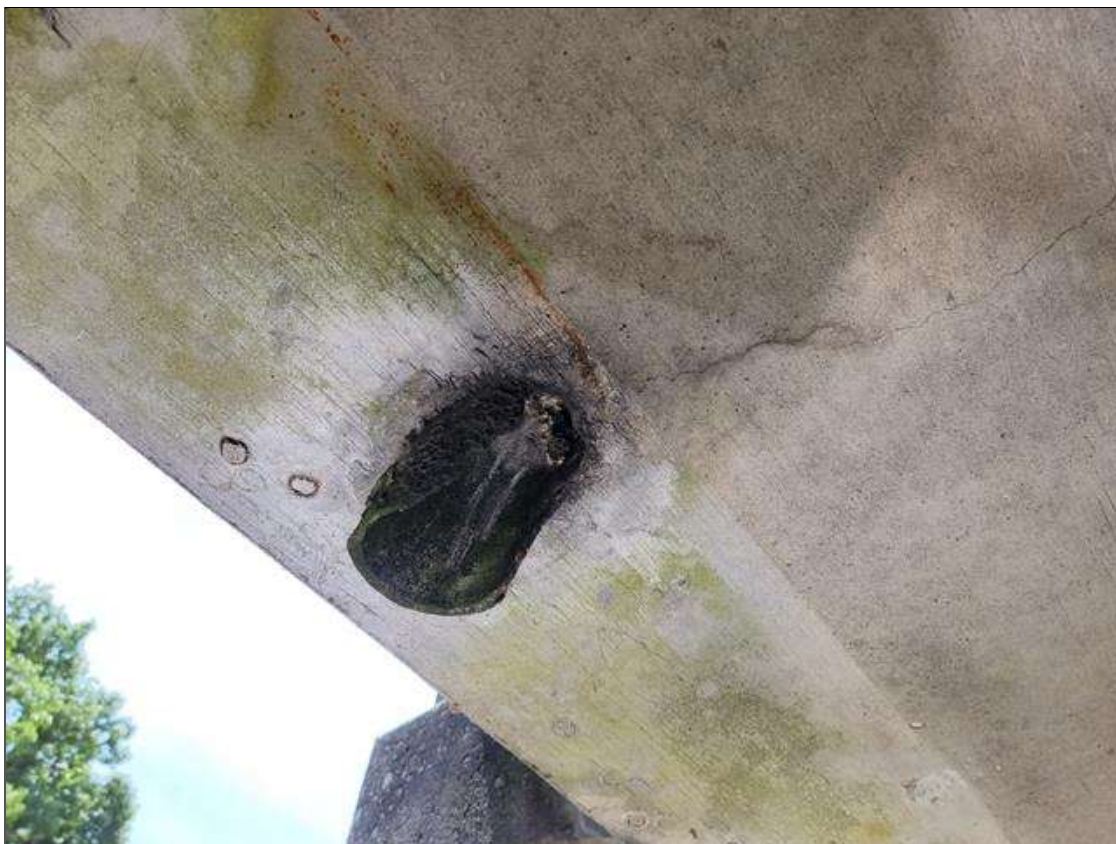
SEVERAL BROKEN DRAINAGE PIPES UNDER BOTH OVERHANGS

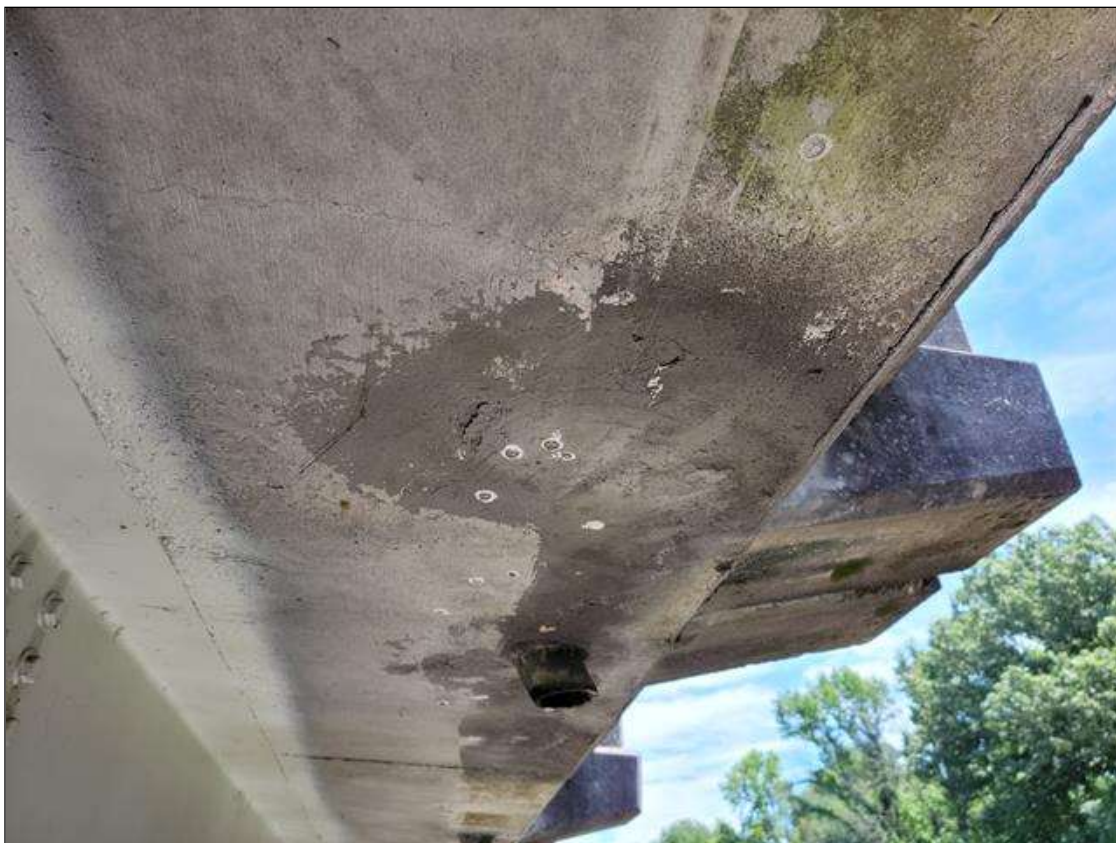
Span 6 Deck: 18 IN DIAMETER SOUND CONCRETE PATCH IN EAST OVERHANG BETWEEN 5TH AND 6TH DECK DRAINS.

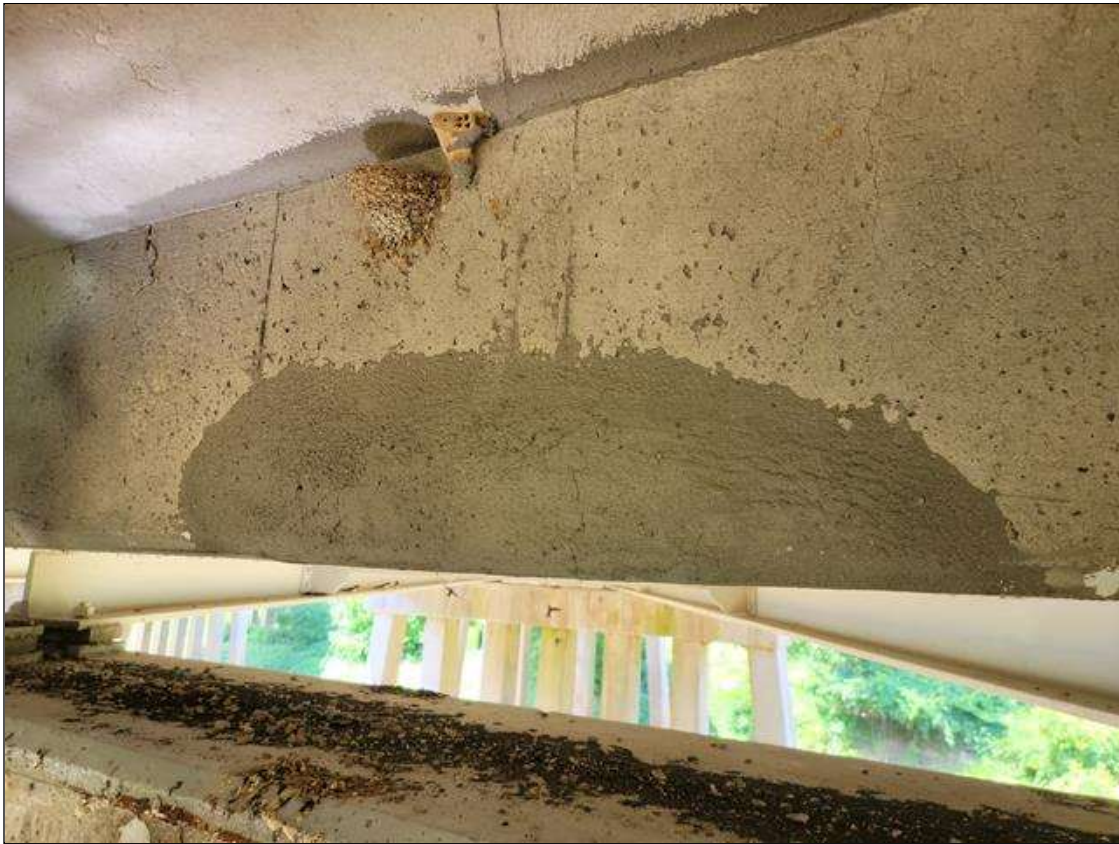
Span 6 Deck: 28 IN LONG X 1 FT HIGH SOUND CONCRETE PATCH IN BAY 2 END DIAPHRAGM, AT BENT 5. PATCH EXHIBITS HAIRLINE VERTICAL CRACKING, SCATTERED.

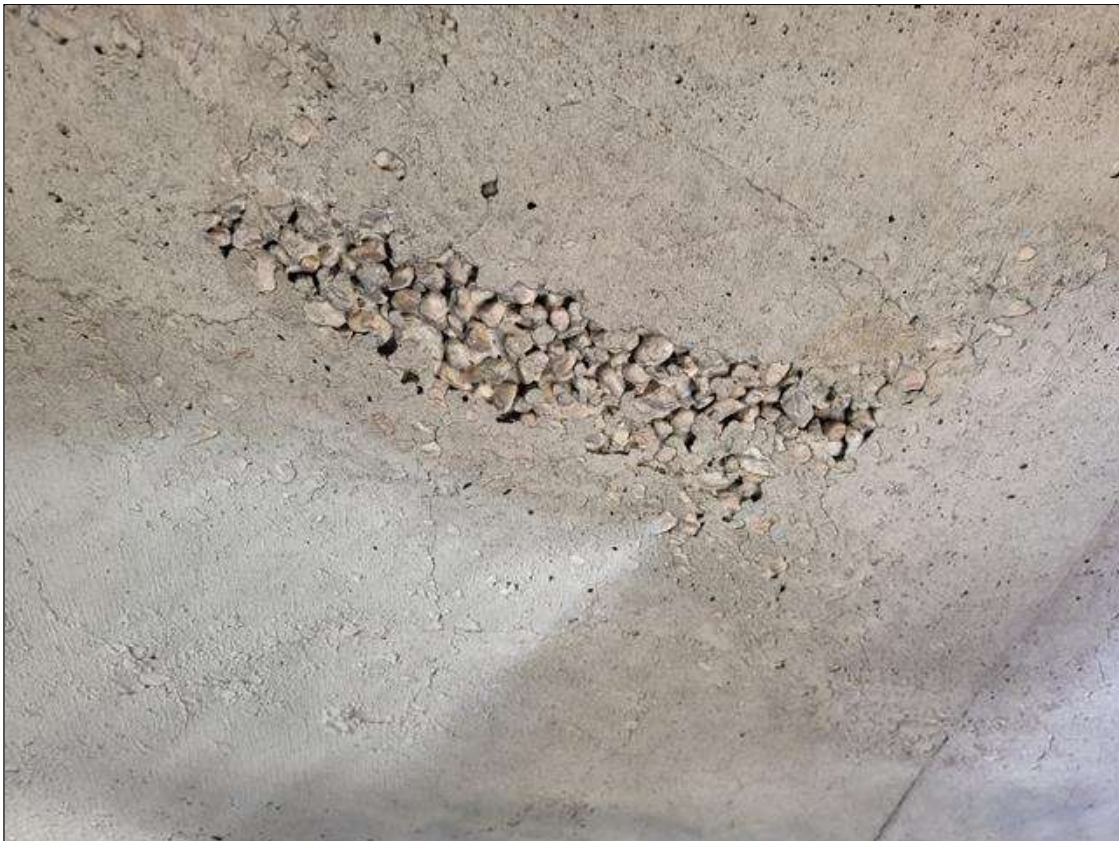
Span 6 Deck: SCATTERED AREAS OF HONEYCOMBING IN DECK UNDERSIDE IN ALL BAYS

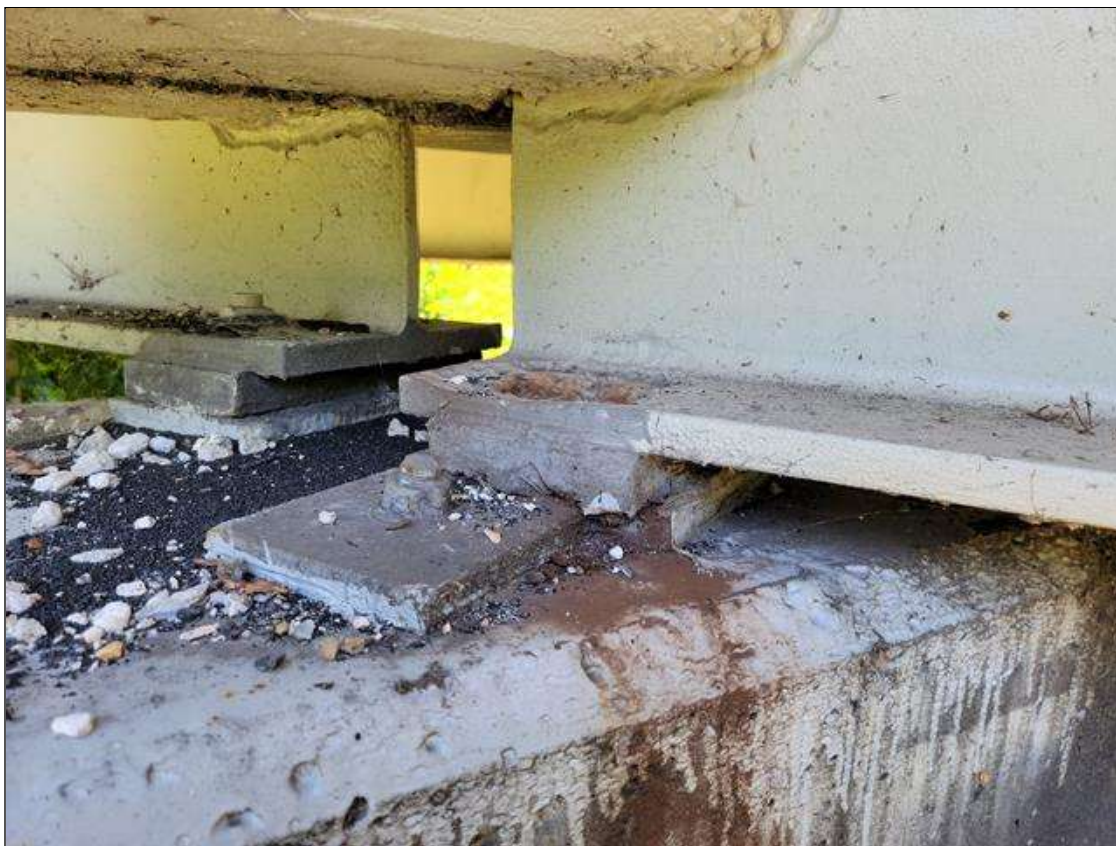
Span 6 Far Bearing: BEARING ASSEMBLY HAS WELDED REPAIR WITH NEW ANCHOR BOLT.

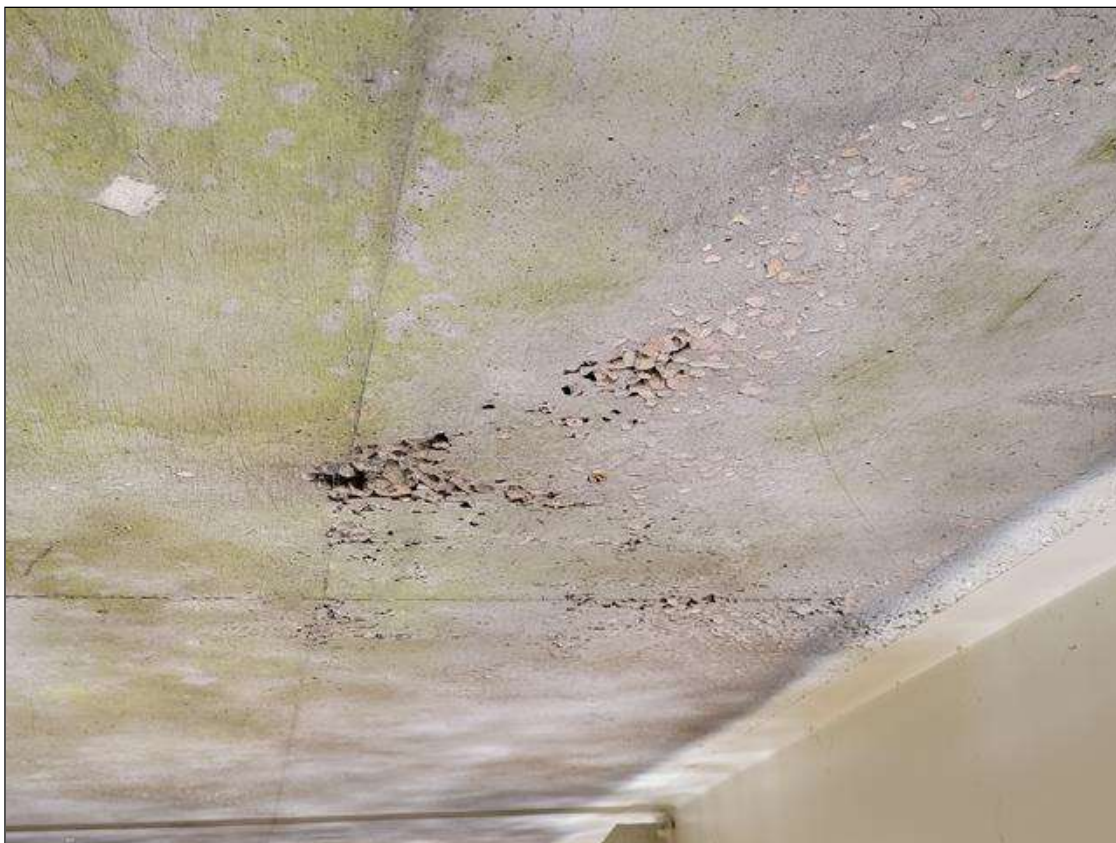
Span 5 Deck: 6 FT LONG X 3 FT WIDE X UP TO 3/4 IN DEEP AREA OF HONEYCOMBING IN BAY 3 NEAR BENT 5.

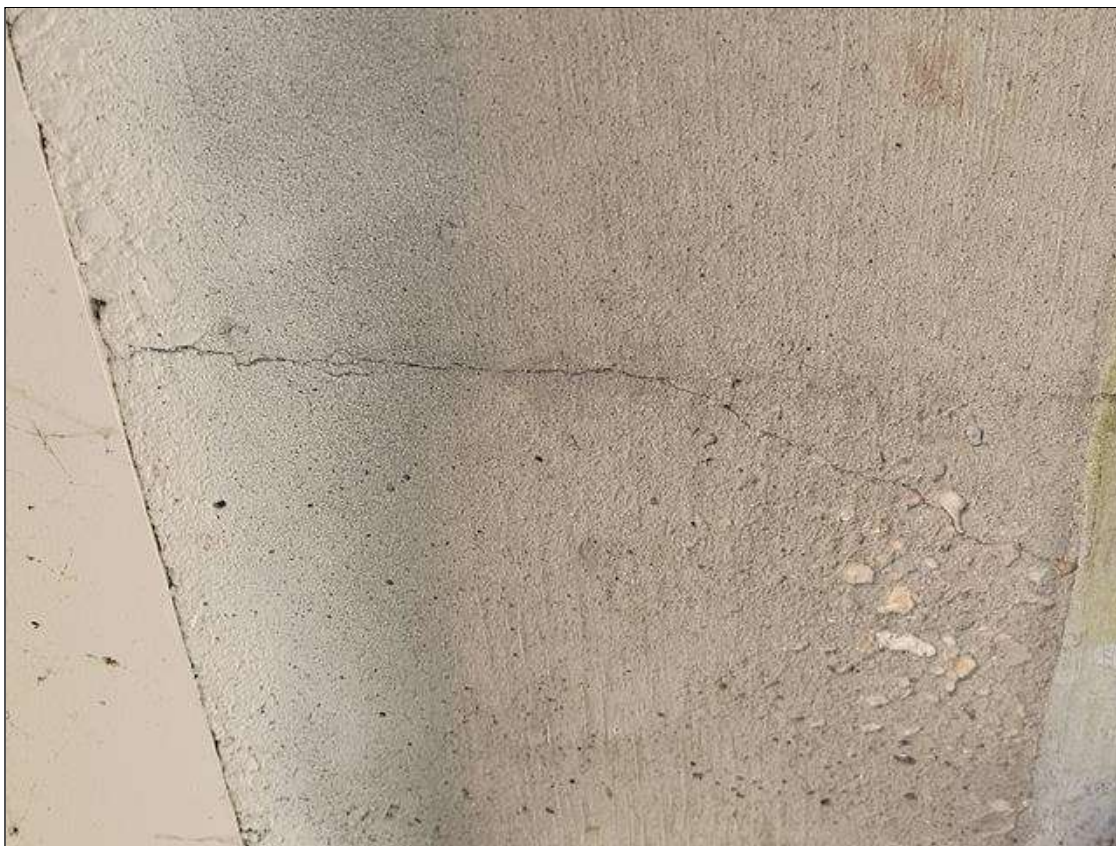
Span 5 Deck: SEVEN (7) UP TO 0.03 IN WIDE X UP TO 3 FT LONG TRANSVERSE CRACKS IN LEFT OVERHANG. TWELVE (12) SIMILAR CRACKS IN RIGHT OVERHANG.

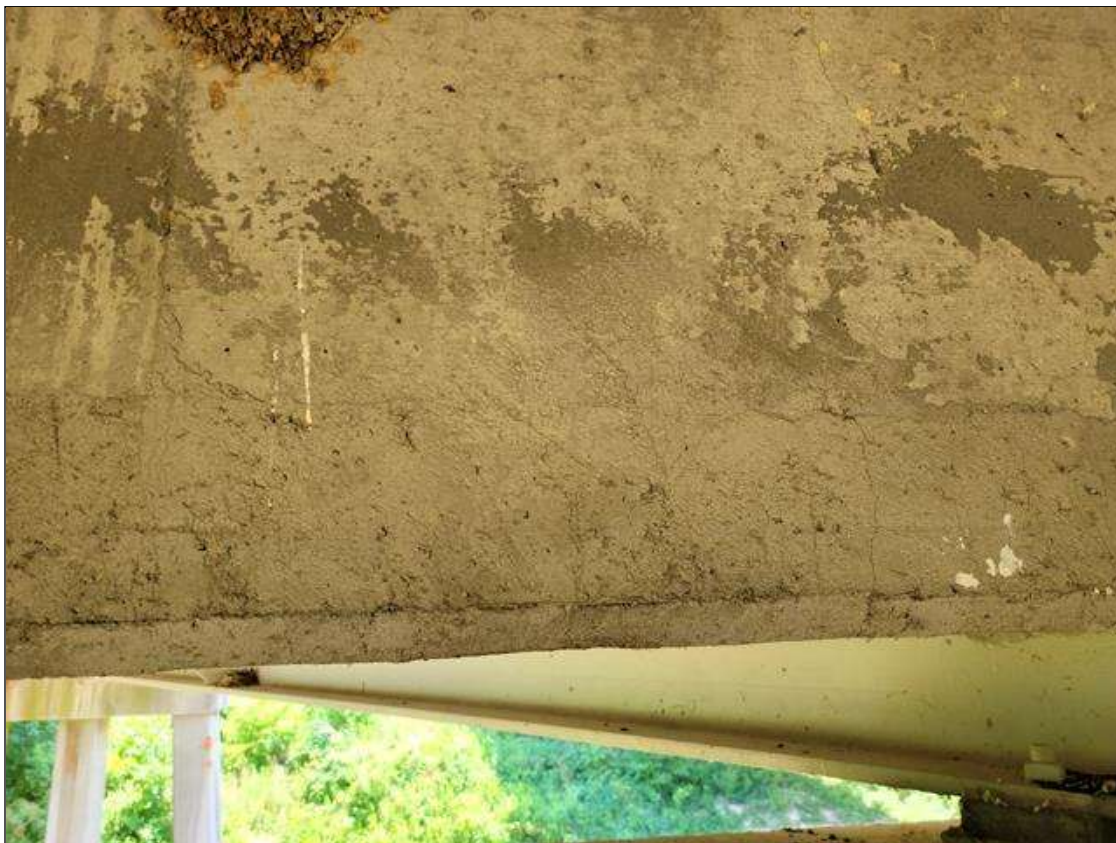
Span 5 Deck: 8 FT LONG X 6 IN HIGH UNSOUND CONCRETE PATCH WITH HAIRLINE CRACKS IN BAY 2 END DIAPHRAGM, AT BENT 5.

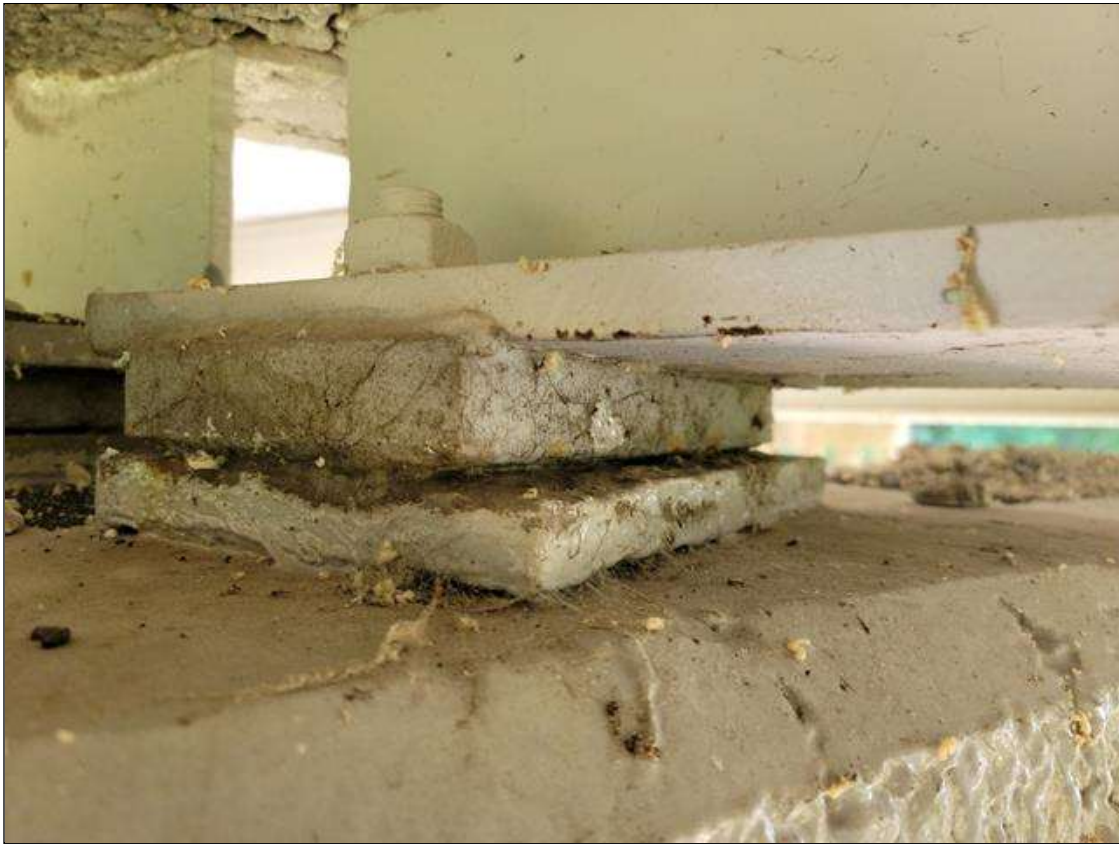
Span 5 Far Bearing: BEARINGS HAVE BEEN PAINTED SINCE PREVIOUS INSPECTION. SECTION LOSS REMAINS BENEATH THE PAINTED SURFACES. UP TO 90% SECTION REMAINING IN BOTH MASONRY AND SOLE PLATES.
