NC DEPARTMENT OF TRANSPORTATION
 DIVISION OF HIGHWAYS
 STRUCTURE MANAGEMENT UNIT

ATTENTION: **PAR SUBMITTED, CHANGE IN STRUCTURAL DATA, HYDRA PLATFORM USED, NEW REPAIRS**

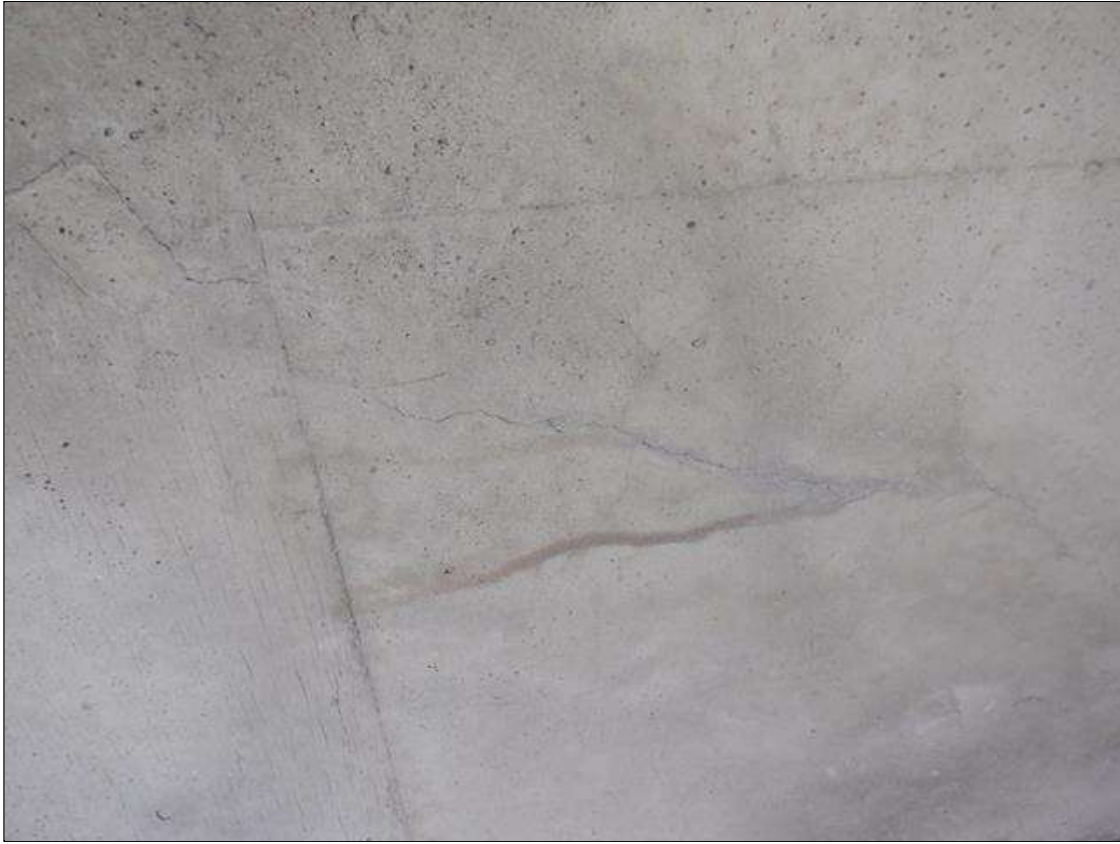
Span 3 Deck: 7 FT LONG X 0.05 IN WIDE DIAGONAL CRACK IN UNDERSIDE OF DECK, BAY 3 AT BENT 2.

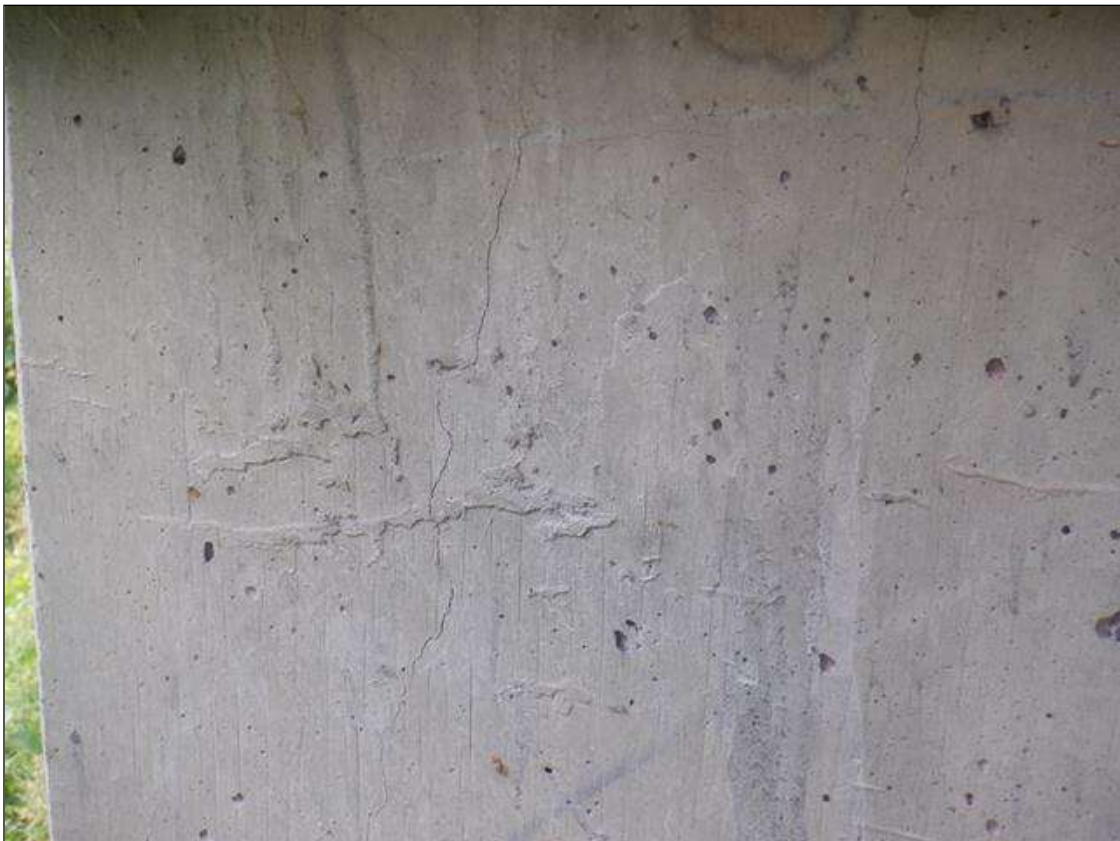
Bent 2 Pile 7: UP TO 0.05 IN WIDE X 22 IN HIGH VERTICAL CRACK IN TOP OF NORTH FACE.

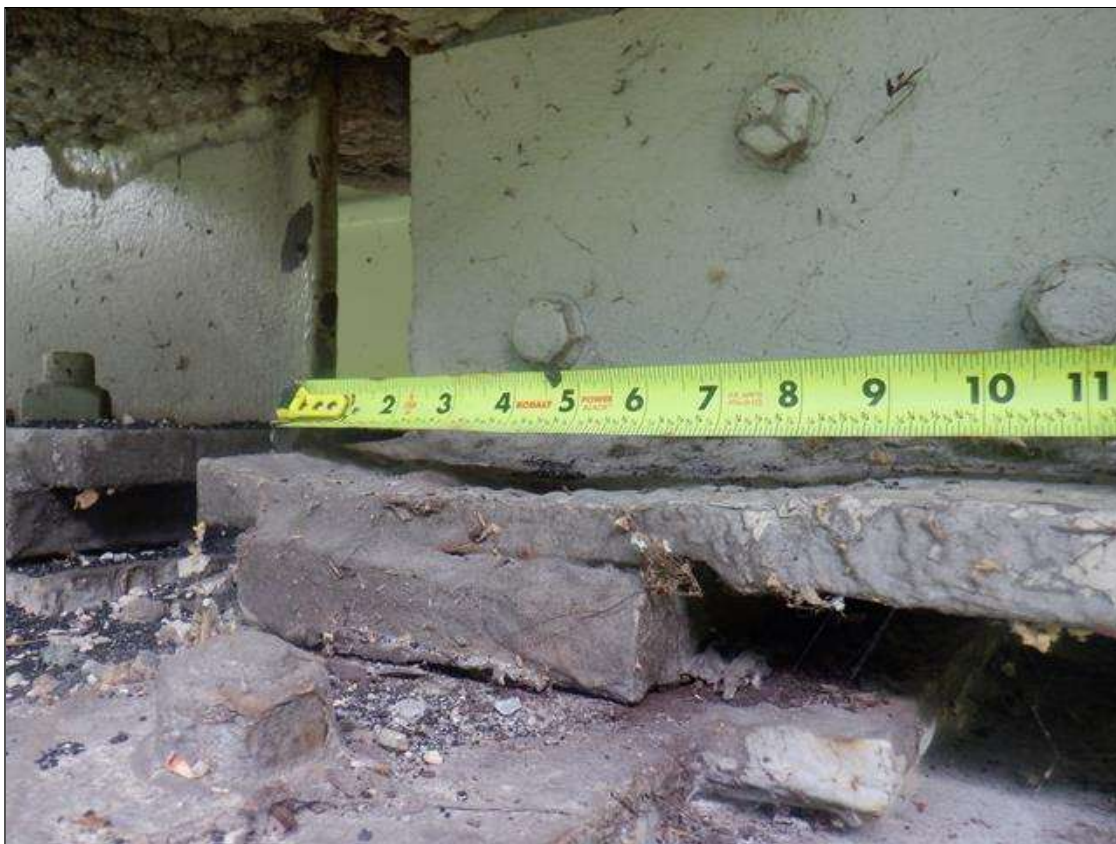
Span 2 Beam 1: 10 IN LONG X 5 IN WIDE AREA OF SECTION LOSS BENEATH THE PAINTED SURFACE ABOVE THE BEARING AT BENT 2. 0.60 IN SECTION REMAINING (PAR).

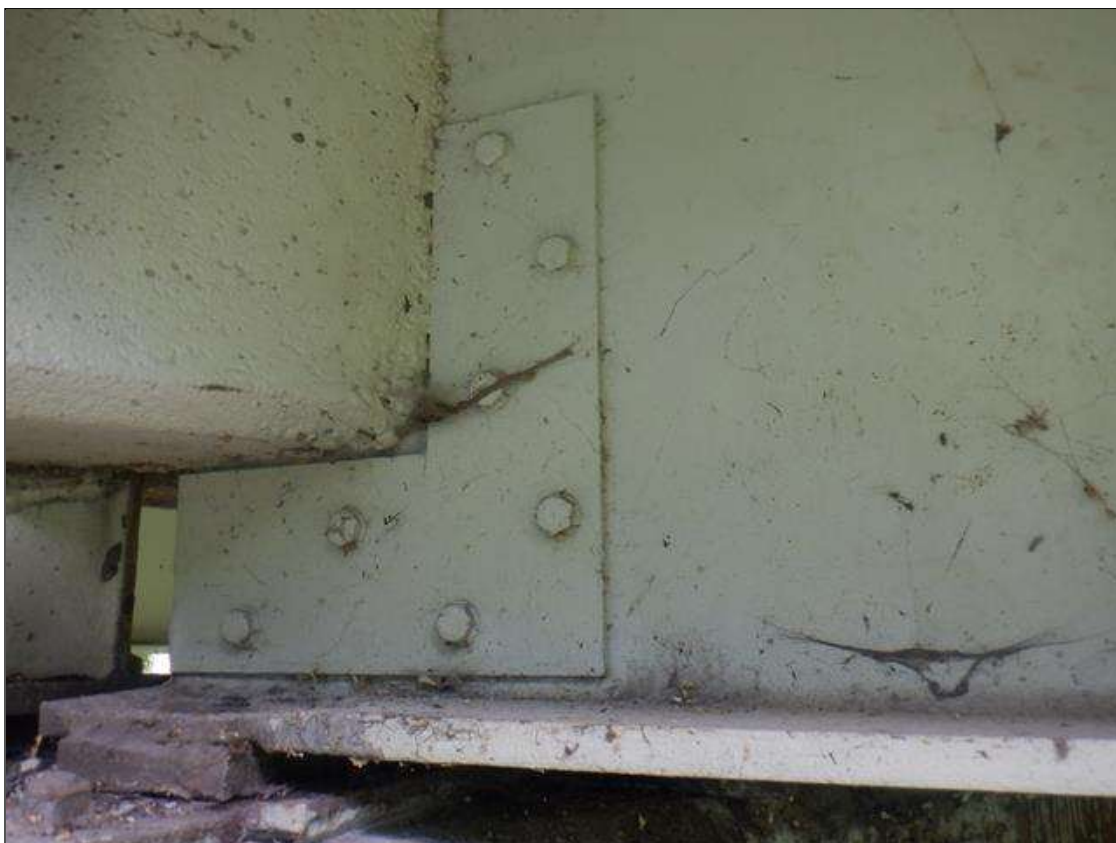
BOLTED PLATE REPAIR TO BOTH SIDES OF WEB FOR BEAM 1 IN SPAN 2 AT BENT 2

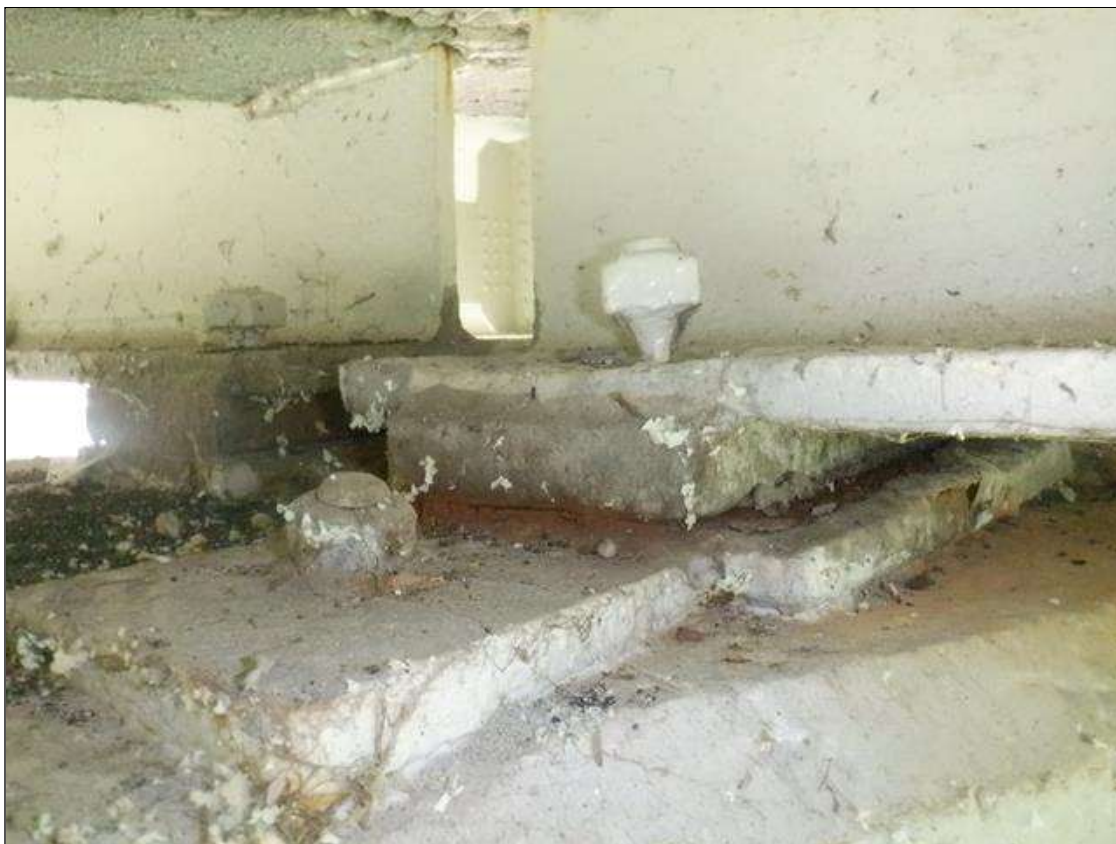
Span 2 Beam 2 - Far Bearing: WELDED BEARING REPAIR WITH ANCHOR ROD.

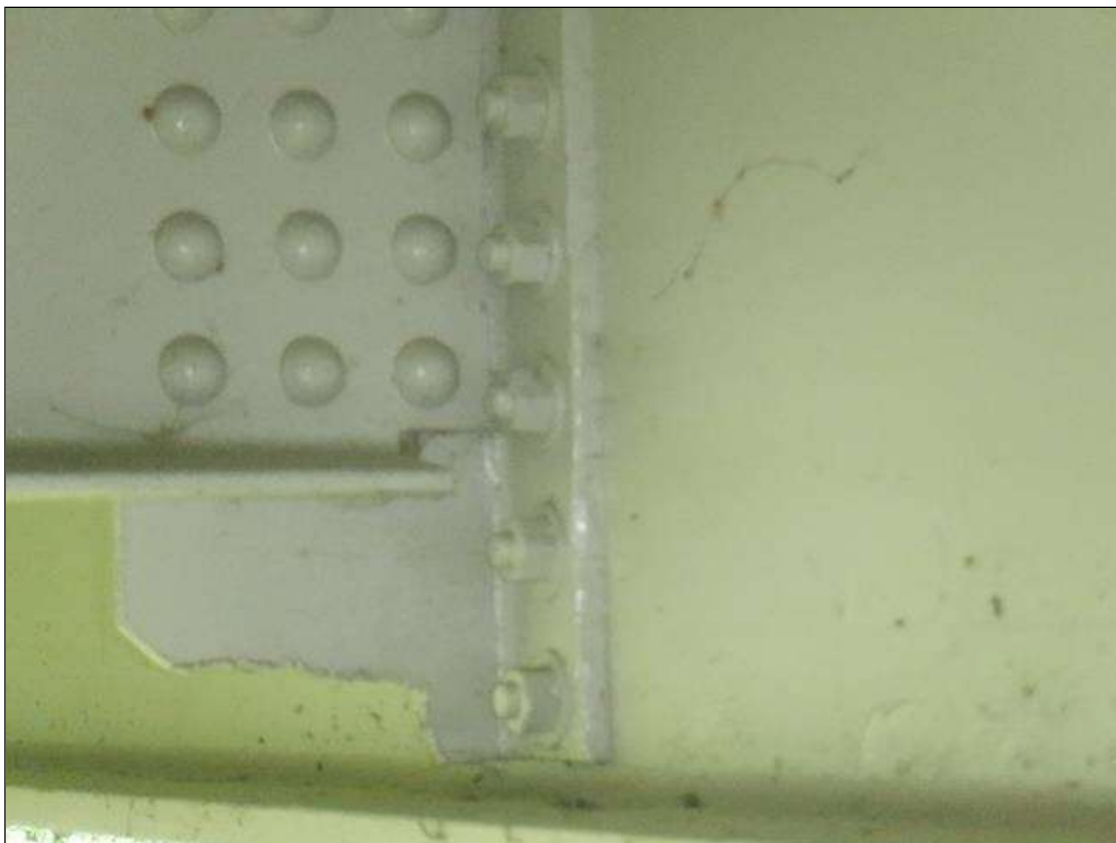
Span 2 Beam 1: UP TO 2 IN HIGH OF SECTION CUT OUT AT BOTTOM OF INTERMEDIATE STIFFENER. PAR IS NOT ISSUED AS IT APPEARS TO BE FROM A BRIDGE REPAIR

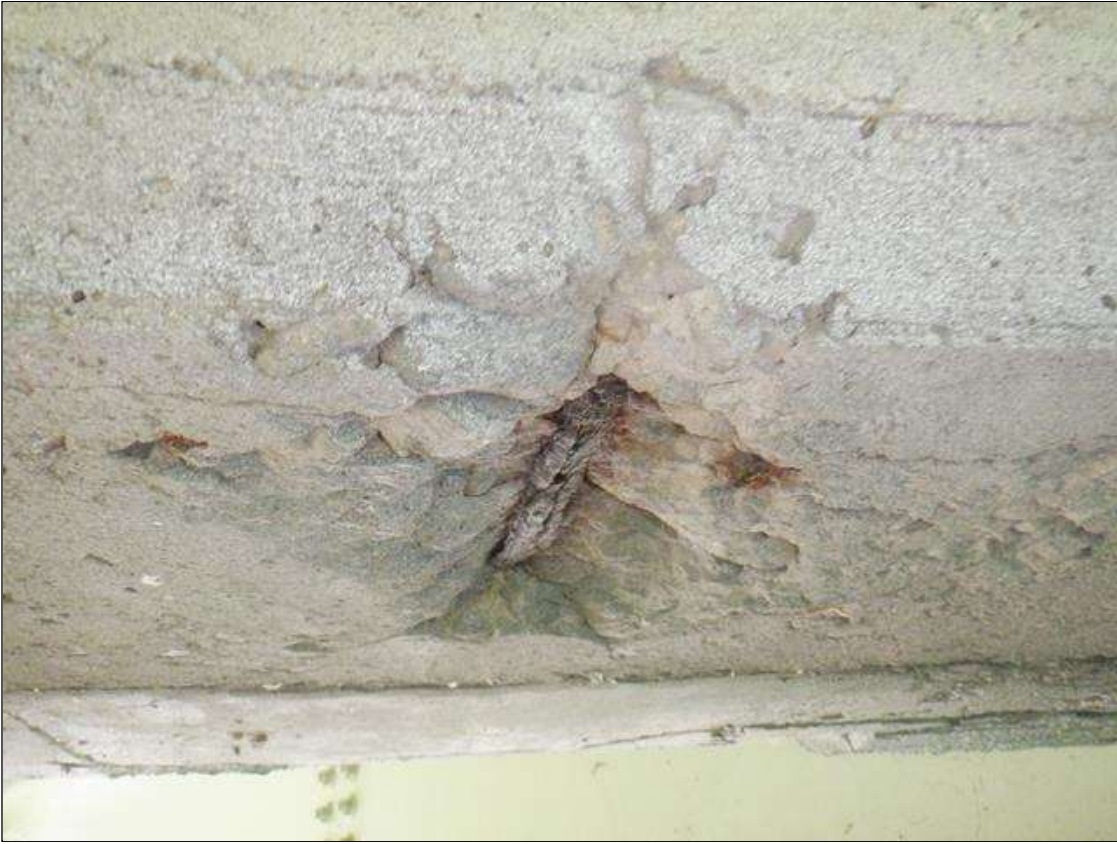
Span 2 Deck: (3) 6 IN DIAMETER X 1/2 IN DEEP SPALLS WITH EXPOSED REINFORCING, UNDERSIDE OF BAY 1 END DIAPHRAGM, AT BENT 2. 90% SECTION REMAINING IN EXPOSED REINFORCING.

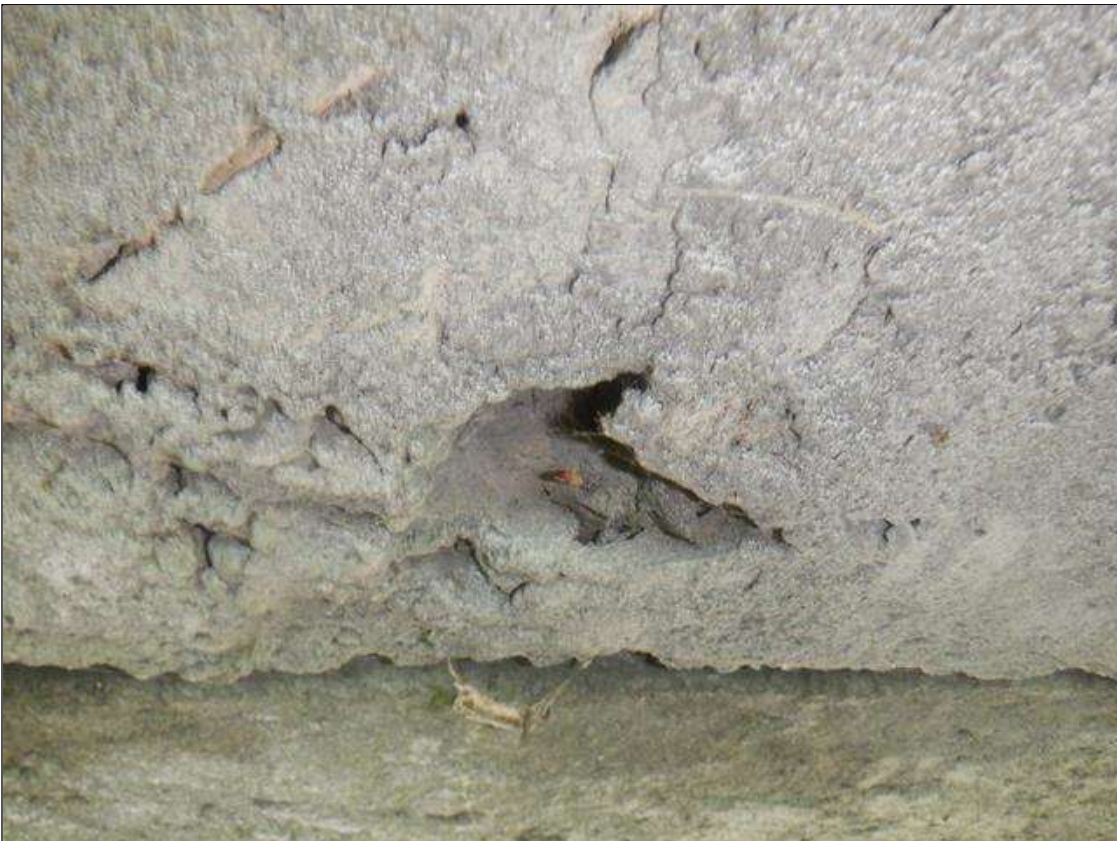
Span 2 Deck: 5 IN DIAMETER X 1 IN DEEP SPALL WITH EXPOSED REINFORCEMENT IN DIAPHRAGM IN BAY 3 AT BENT 1. 90% SECTION REMAINING IN EXPOSED REINFORCEMENT.

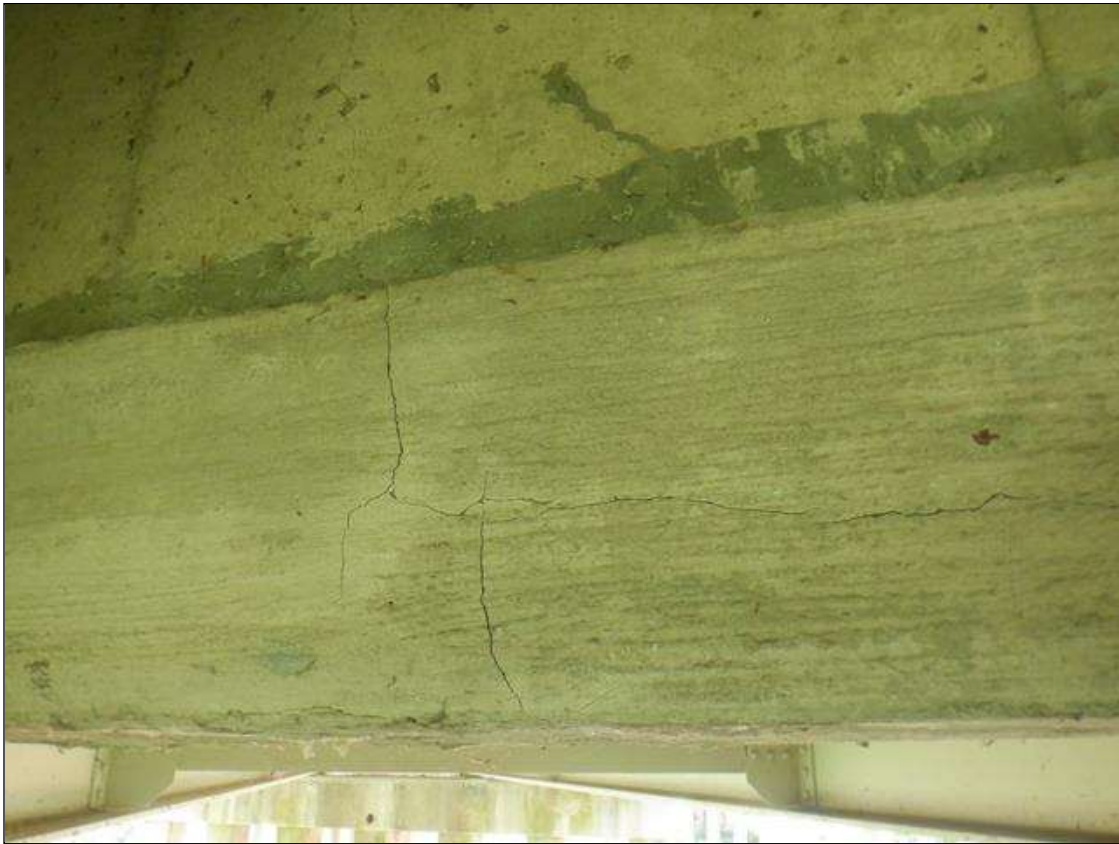
Span 2 Deck: 9 FT LONG X 1 FT HIGH CONCRETE PATCH, BAY 2 END DIAPHRAGM, AT BENT 2. PATCH EXHIBITS UP TO 1/8 IN WIDE X 5 FT LONG CRACK IN THE BOTTOM FACE WITH A 5 FT LONG X 5 IN WIDE UNSOUND CONCRETE AND UP TO 0.02 IN WIDE VERTICAL CRACKS IN FRONT FACE, SCATTERED.

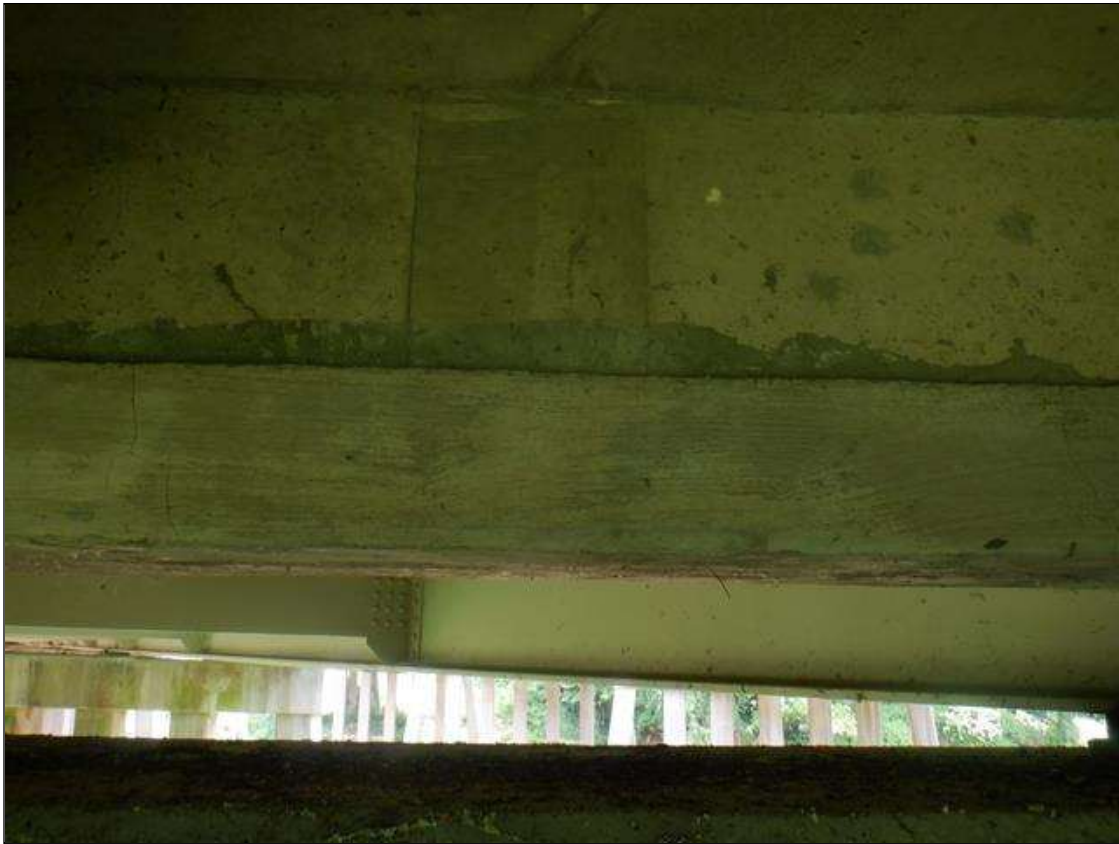
Span 2 Deck: 9 FT LONG X 1 FT HIGH CONCRETE PATCH, BAY 2 END DIAPHRAGM, AT BENT 2. PATCH EXHIBITS UP TO 1/8 IN WIDE X 5 FT LONG CRACK IN THE BOTTOM FACE WITH A 5 FT LONG X 5 IN WIDE UNSOUND CONCRETE AND UP TO 0.02 IN WIDE VERTICAL CRACKS IN FRONT FACE, SCATTERED.

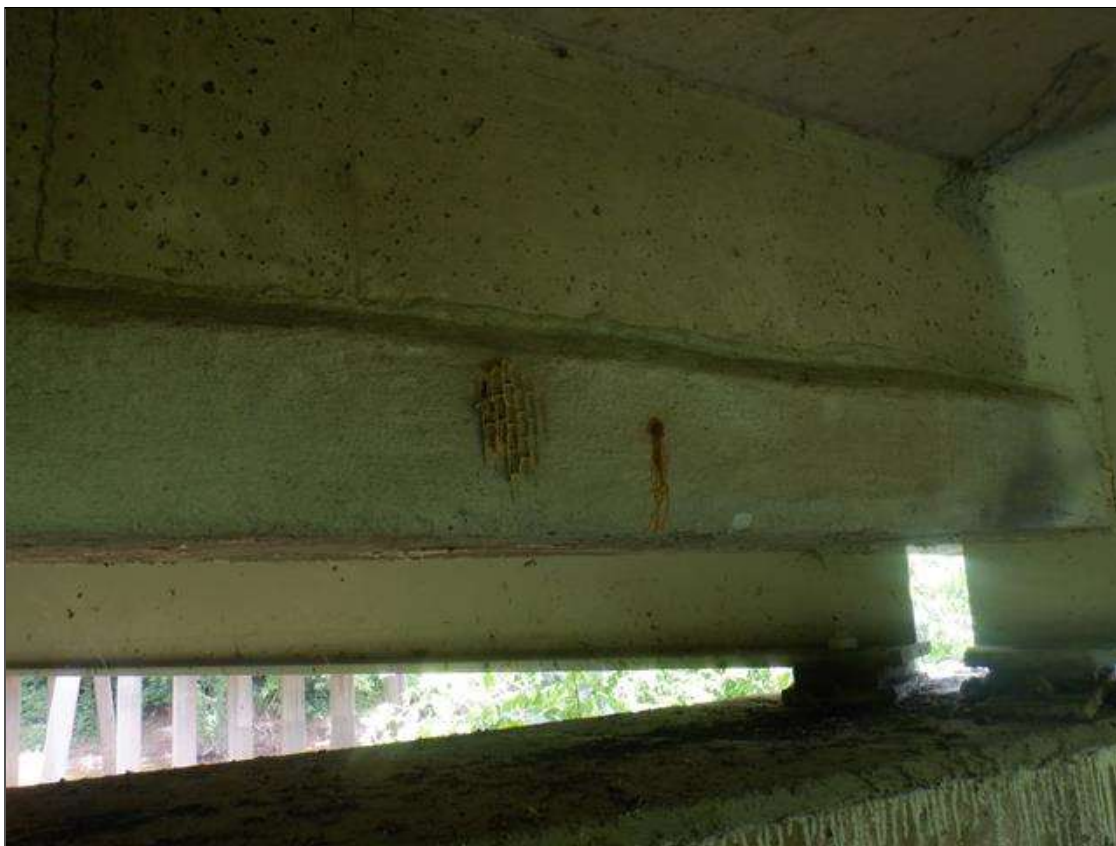
Span 2 Deck: 80 IN LONG X 1 FT HIGH SOUND CONCRETE PATCH IN BAY 3 END DIAPHRAGM, AT BENT 2.

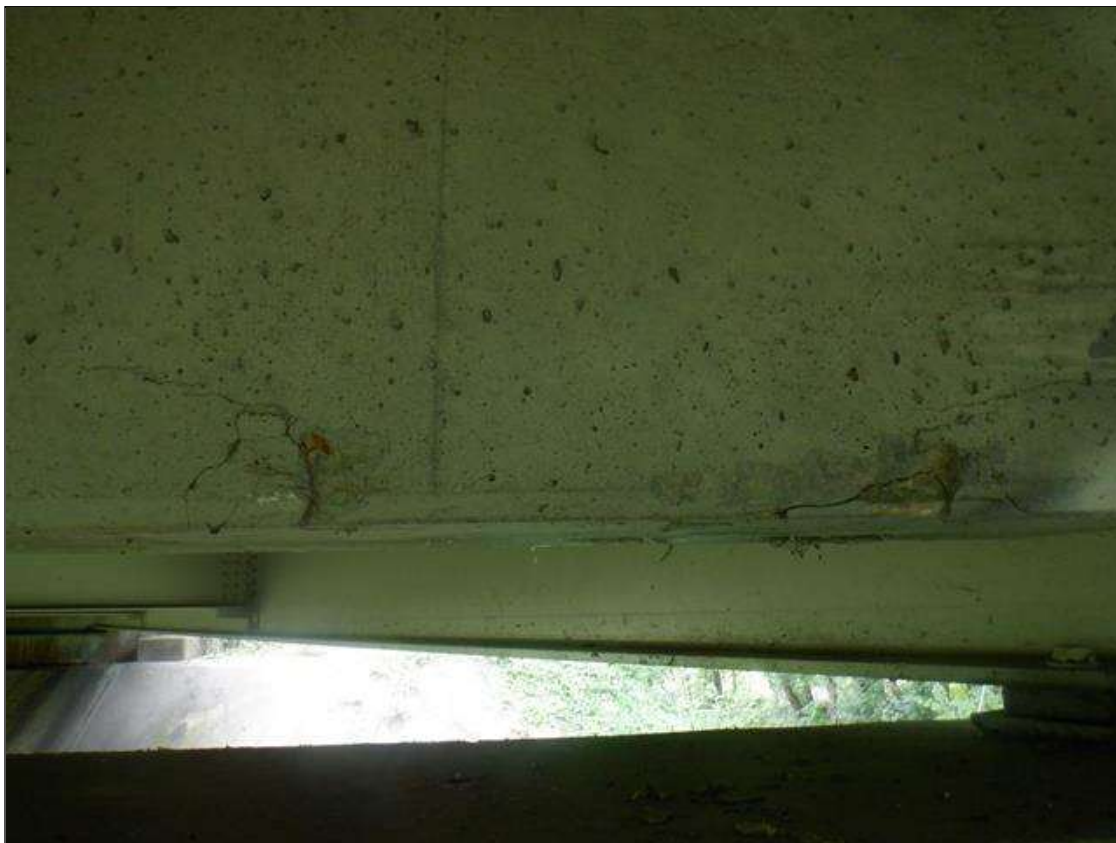
Span 2 Deck: TWO (2) AREAS OF UNSOUND CONCRETE UP TO 2.5 FT LONG X 1 FT HIGH WITH SPALLING UP TO 5 IN DIAMETER X UP TO 1 IN DEEP IN END DIAPHRAGM IN BAY 1 AT BENT 1.

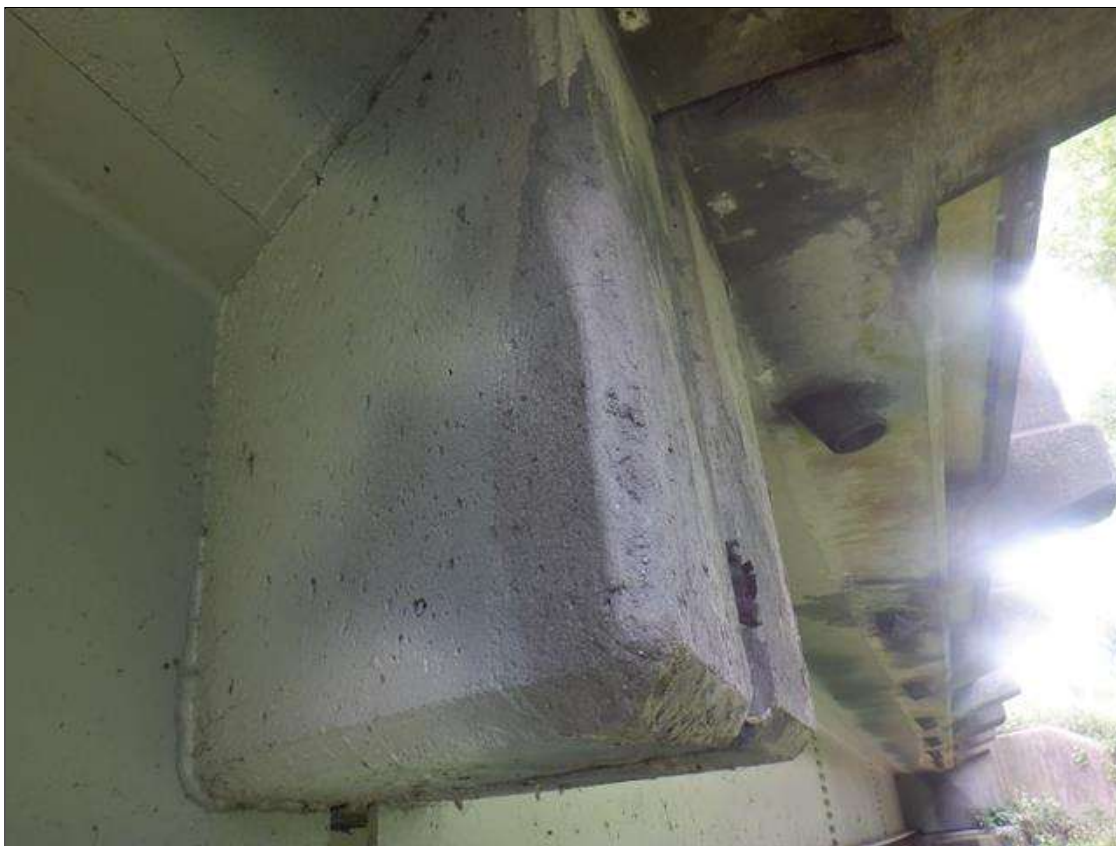
Span 2 Deck: 1 FT DIAMETER SOUND CONCRETE PATCH IN DIAPHRAGM OUTSIDE OF BEAM 1 AT BENT 1.

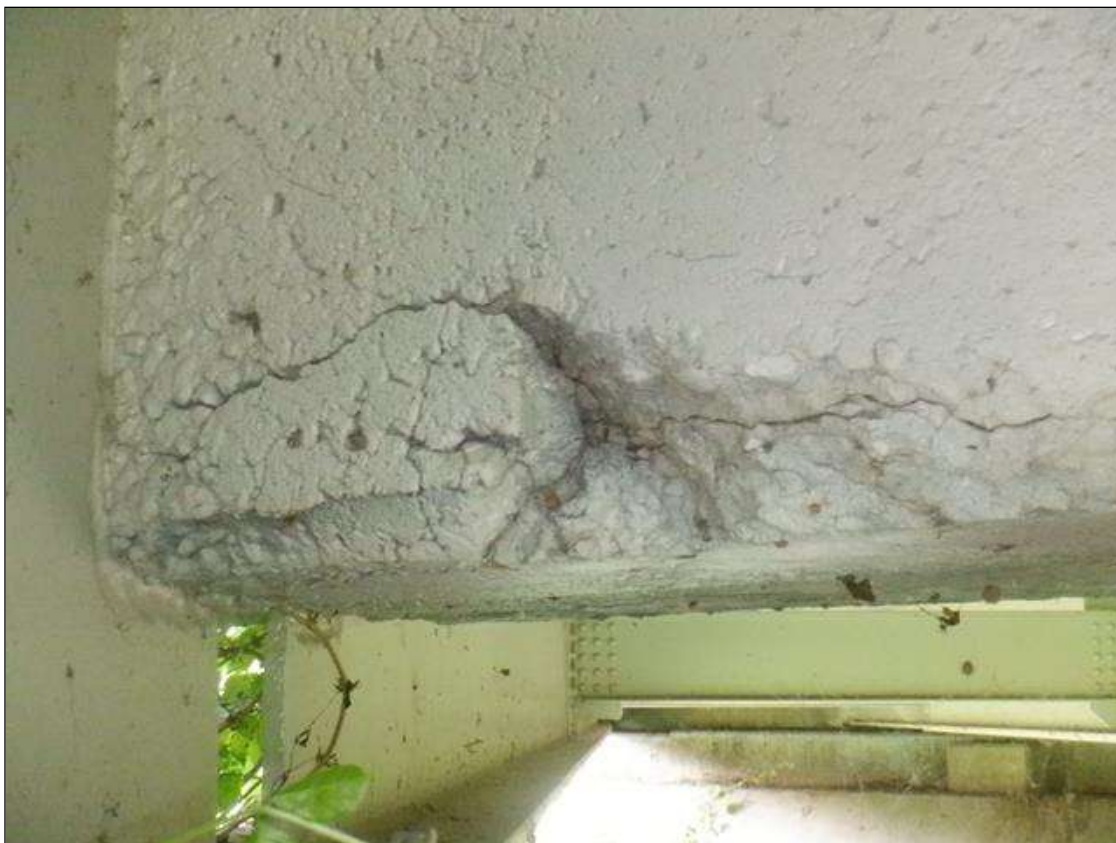
Span 2 Deck: UP TO 1.5 FT WIDE X 4 IN LONG X UP TO 2 IN DEEP SPALL IN DIAPHRAGM IN BAY 3 AT BENT 1.

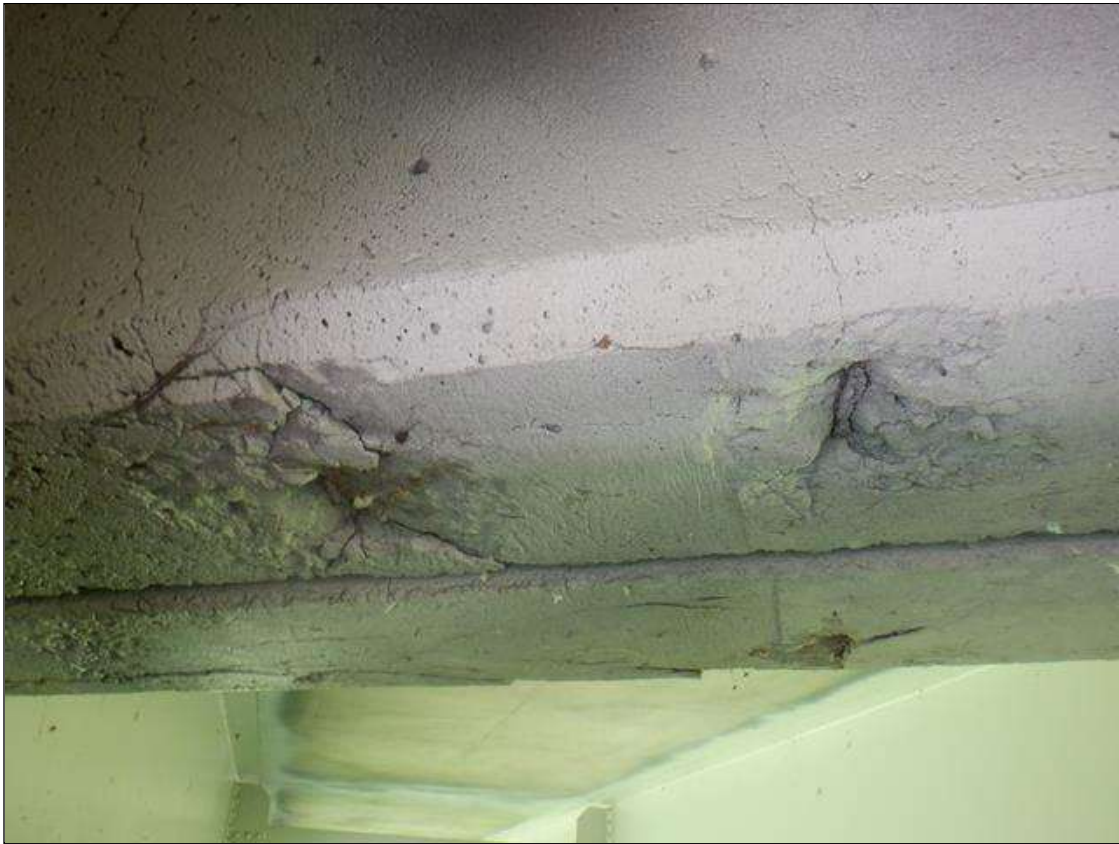
Span 1 Deck: (2) 6 IN DIAMETER X 3/4 IN DEEP SPALLS, UNDERSIDE OF BAY 1 END DIAPHRAGM, AT BENT 1.

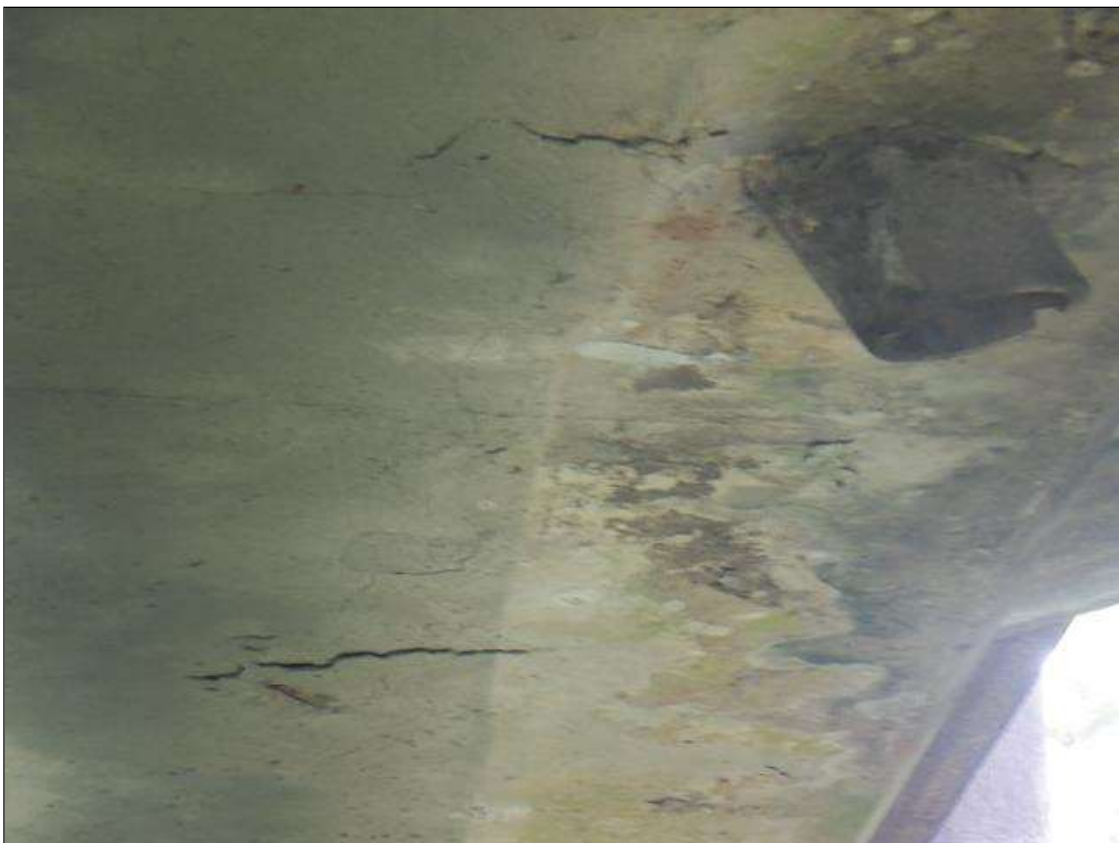
Span 1 Deck: (2) 12 IN DIAMETER DELAMINATIONS, UNDERSIDE OF WEST OVERHANG, AT DRAIN 7.

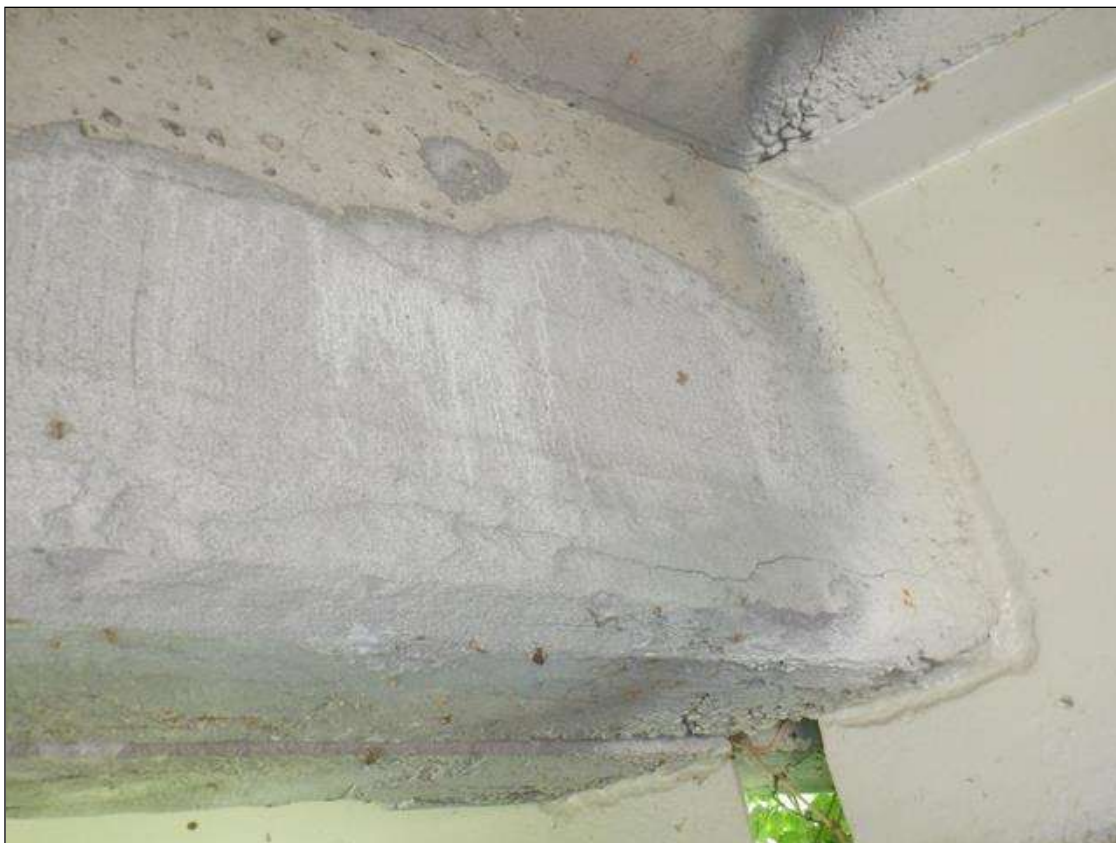
Span 1 Deck: 5 FT WIDE X 1 FT HIGH SOUND CONCRETE PATCH IN BAY 3 END DIAPHRAGM, AT BENT 1.
PATCH EXHIBITS A HAIRLINE X 1 FT LONG CRACK IN BOTTOM RIGHT CORNER.

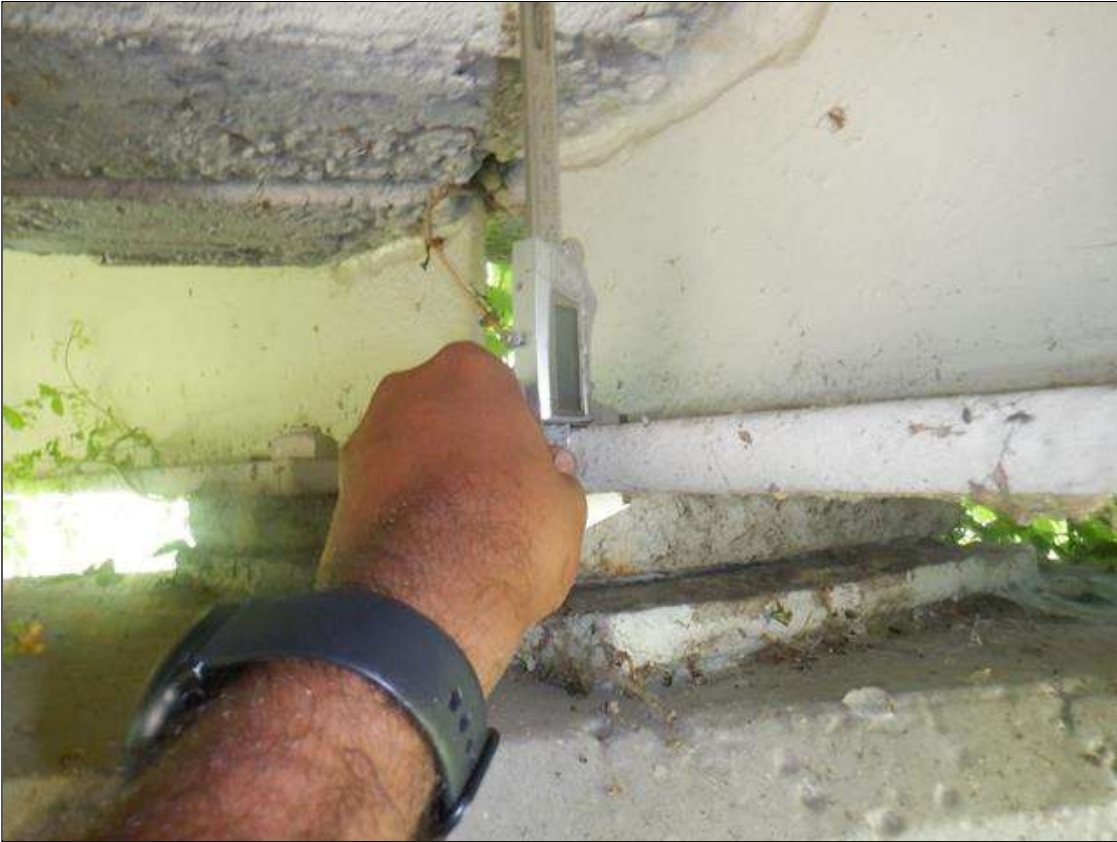
Span 1 Beam 4: 5 IN LONG X 5 IN WIDE AREA OF SECTION LOSS BENEATH THE PAINTED SURFACES IN BOTTOM FLANGE OF LEFT FLANGE ABOVE BEARING AT BENT 1. UP TO 0.77 IN SECTION REMAINING.

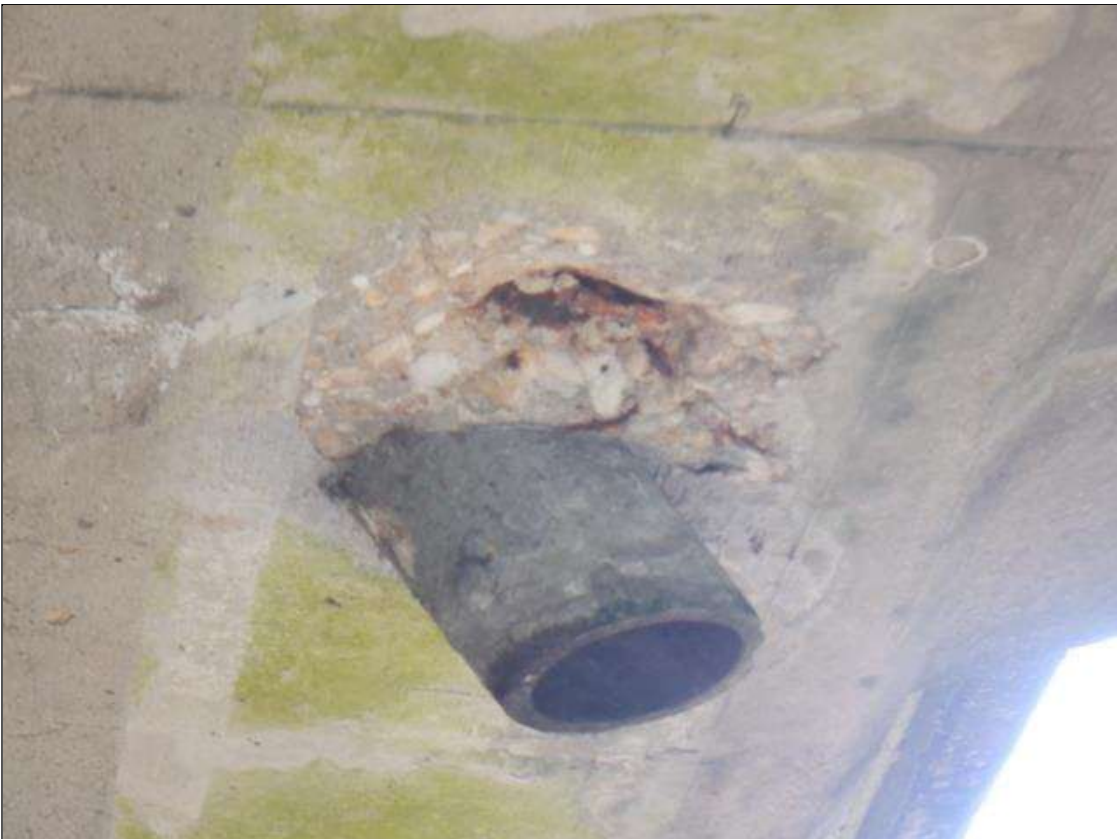
Span 1 Deck: UP TO 6 IN DIAMETER X UP TO 1 IN DEEP SPALL WITH EXPOSED REINFORCEMENT AT THIRD DRAIN PIPE IN LEFT OVERHANG. UP TO 90% SECTION REMAINING IN EXPOSED REINFORCEMENT.

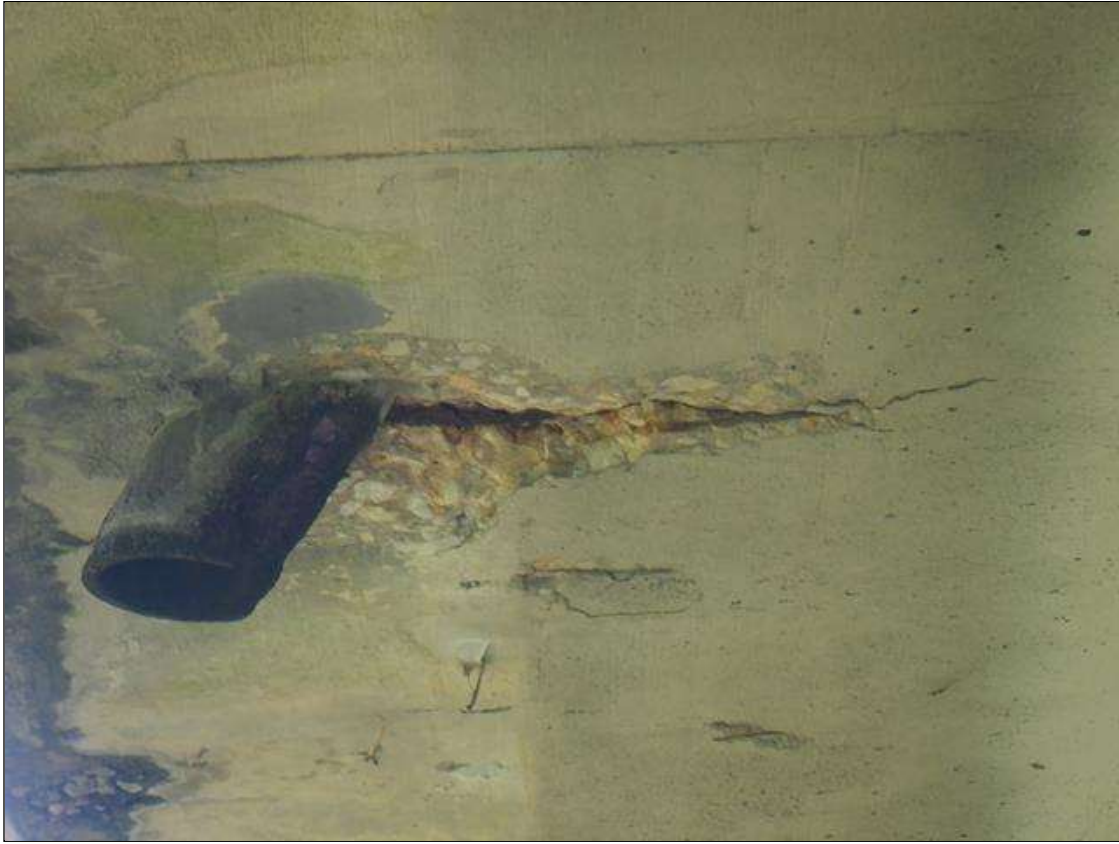
Span 1 Deck: UP TO 1 FT WIDE X 9 IN LONG X UP TO 1 IN DEEP SPALL WITH EXPOSED REINFORCEMENT IN RIGHT OVERHANG, LOCATED AT THIRD DRAIN PIPE. 80% SECTION REMAINING IN EXPOSED REINFORCEMENT.

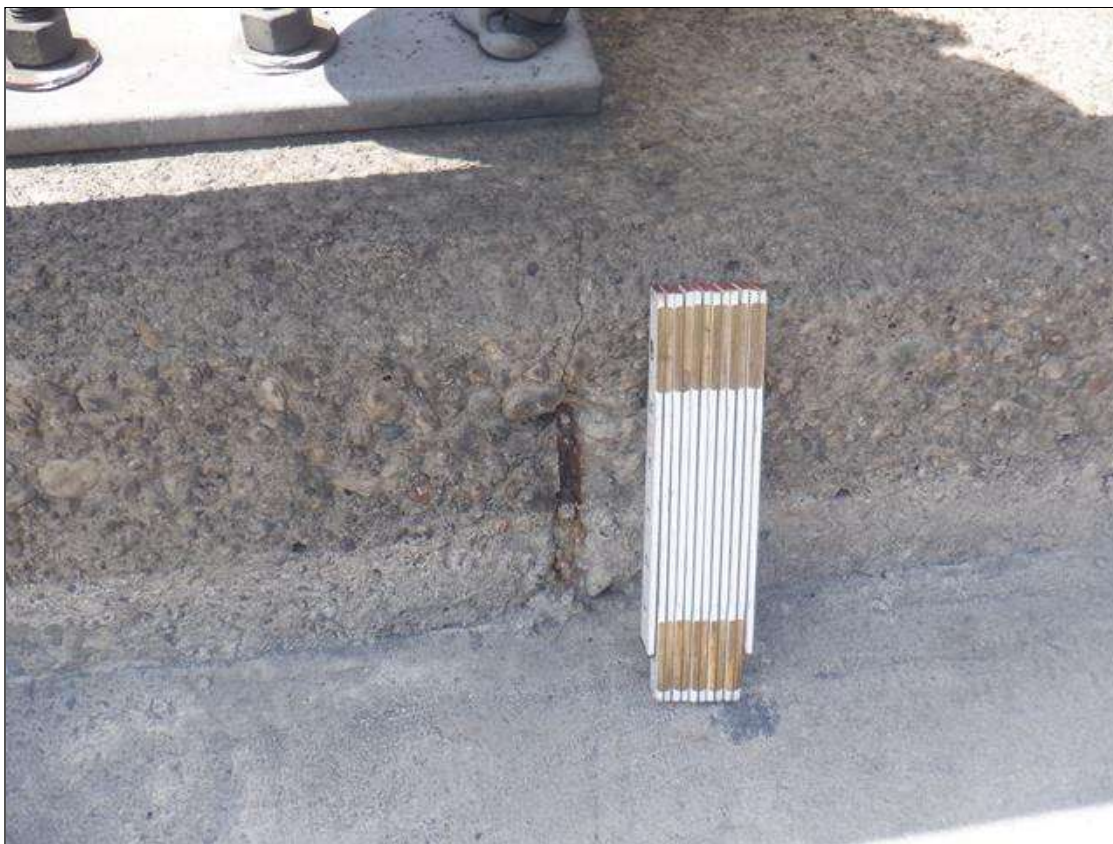
Span 3 Left Bridge Rail: TWO (2) SPALLS UP TO 8 IN IN DIAMETER X 1 IN DEEP WITH EXPOSED REINFORCEMENT IN BOTTOM OF CURB AT 6 FT AND 10 FT FROM BENT 3 JOINT. NO MEASUREABLE SECTION LOSS IN EXPOSED REINFORCEMENT.

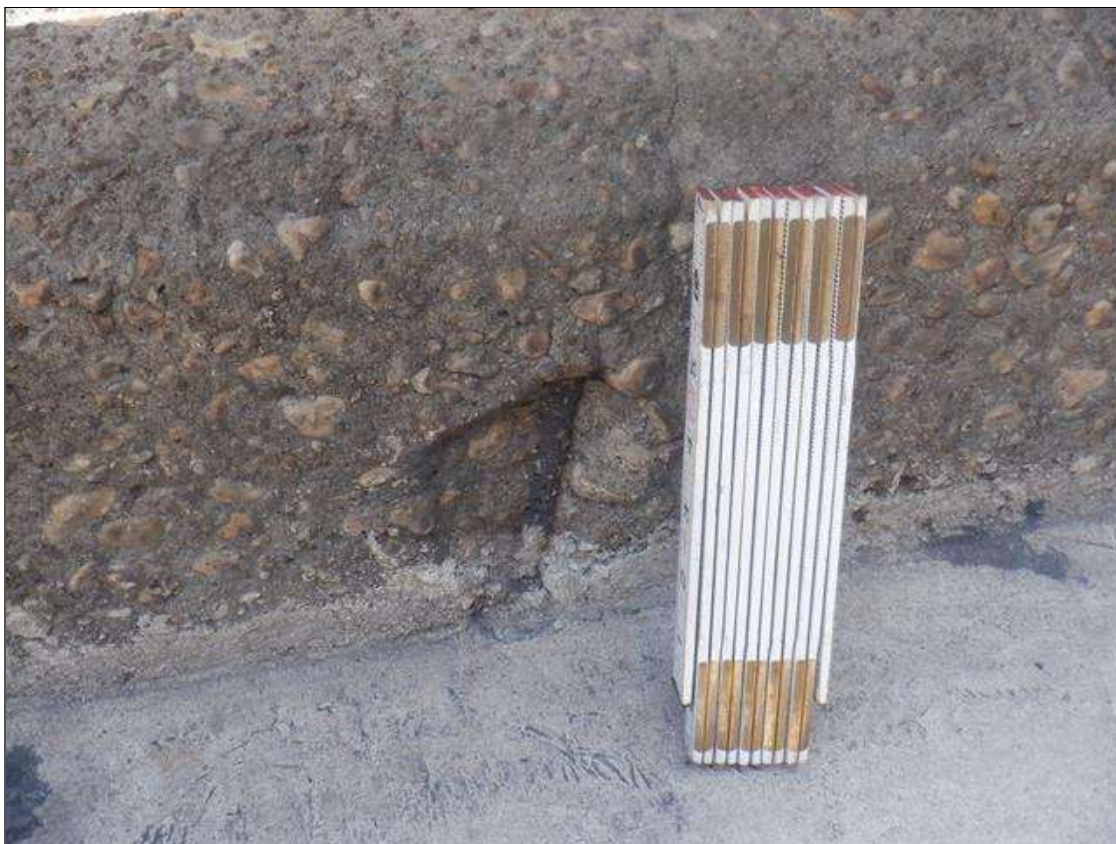
Span 5 Left Bridge Rail: 6 IN DIAMETER X 1 IN DEEP SPALL WITH EXPOSED PAINTED REBAR IN BOTTOM OF CURB AT 3 FT FROM BENT 6 JOINT. 90% SECTION LOSS IN EXPOSED REINFORCEMENT

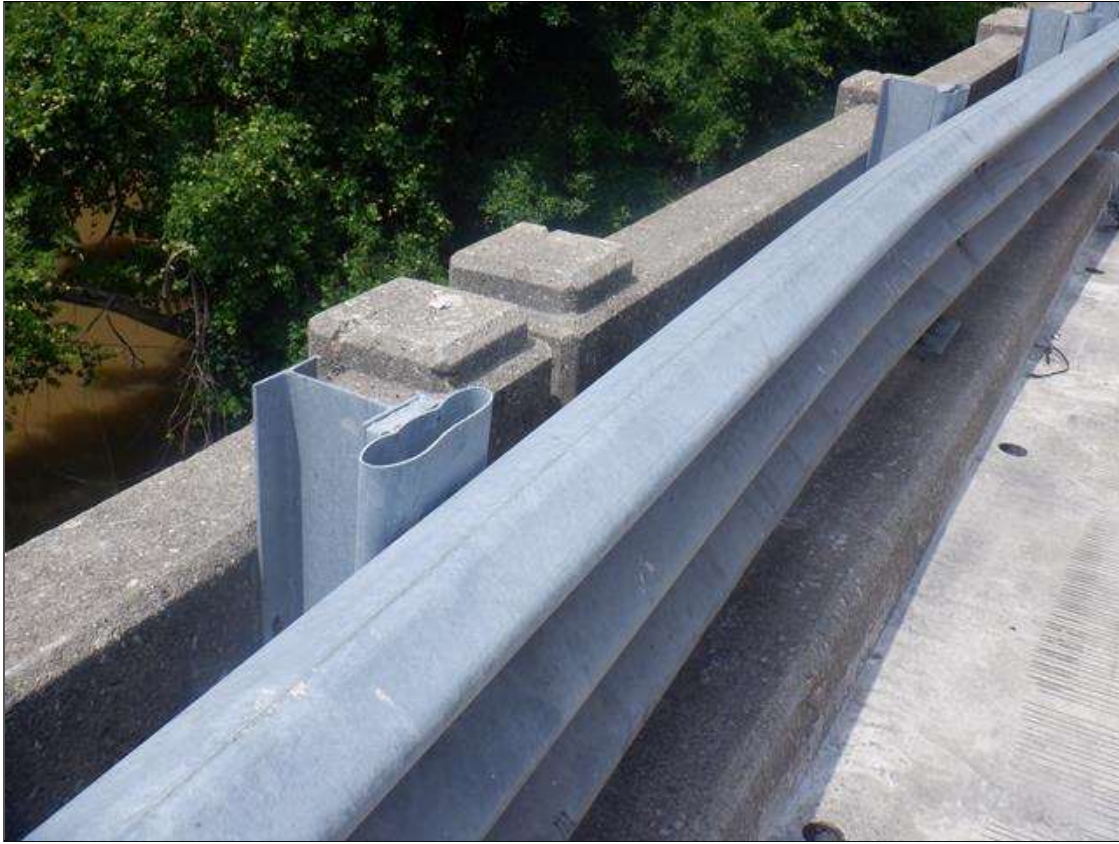
Span 6 Left Bridge Rail: MODERATE TO HEAVY IMPACT DAMAGE WITH UP TO 5 IN DEFLECTION TOWARDS WEST TO THE SUPPLEMENTAL BRIDGE RAIL FOR 20 FT LONG STARTING AT BENT 6. TWO (2) SPACER BLOCKS CONNECTING THE GUARDRAIL TO POSTS ARE PARTIALLY CRUSHED.
