NC DEPARTMENT OF TRANSPORTATION
 DIVISION OF HIGHWAYS
 STRUCTURE MANAGEMENT UNIT

ATTENTION: **PAR SUBMITTED, CHANGE IN STRUCTURAL DATA, HYDRA PLATFORM USED, NEW REPAIRS**

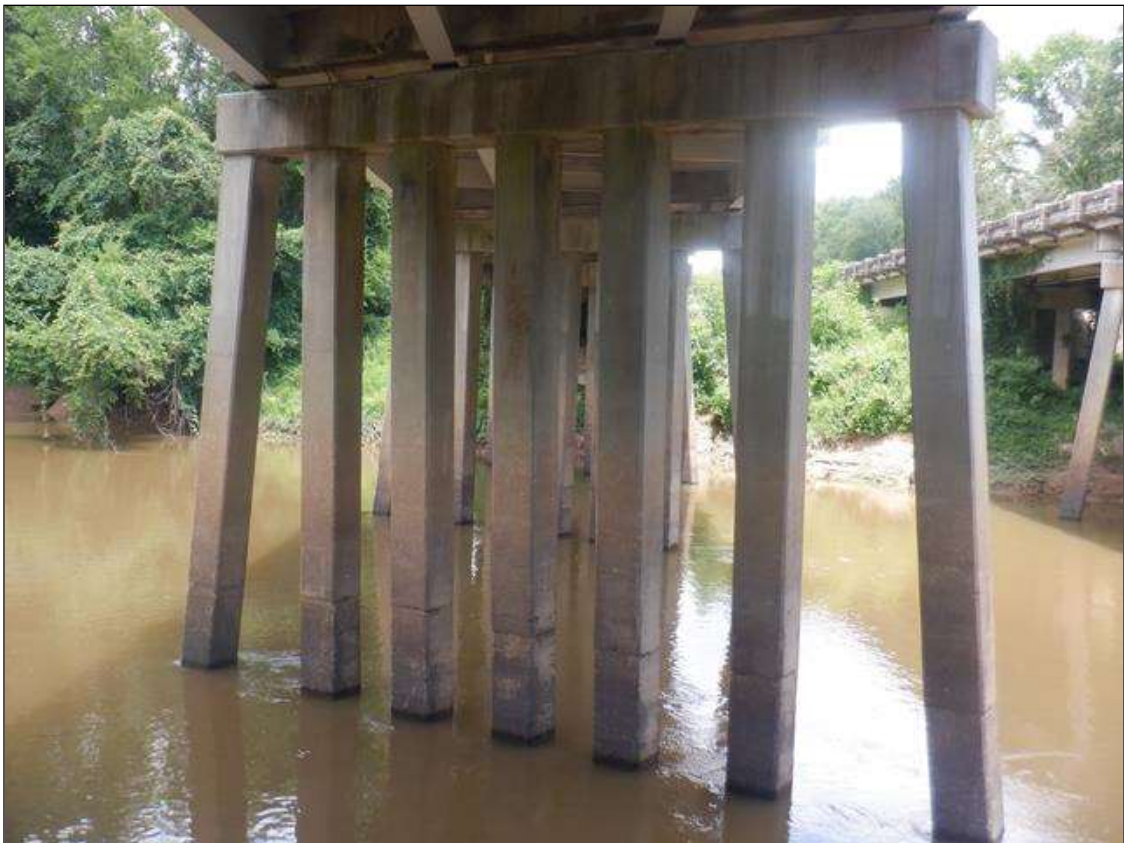
TYPICAL SUPERSTRUCTURE UNDERSIDE SPAN 4

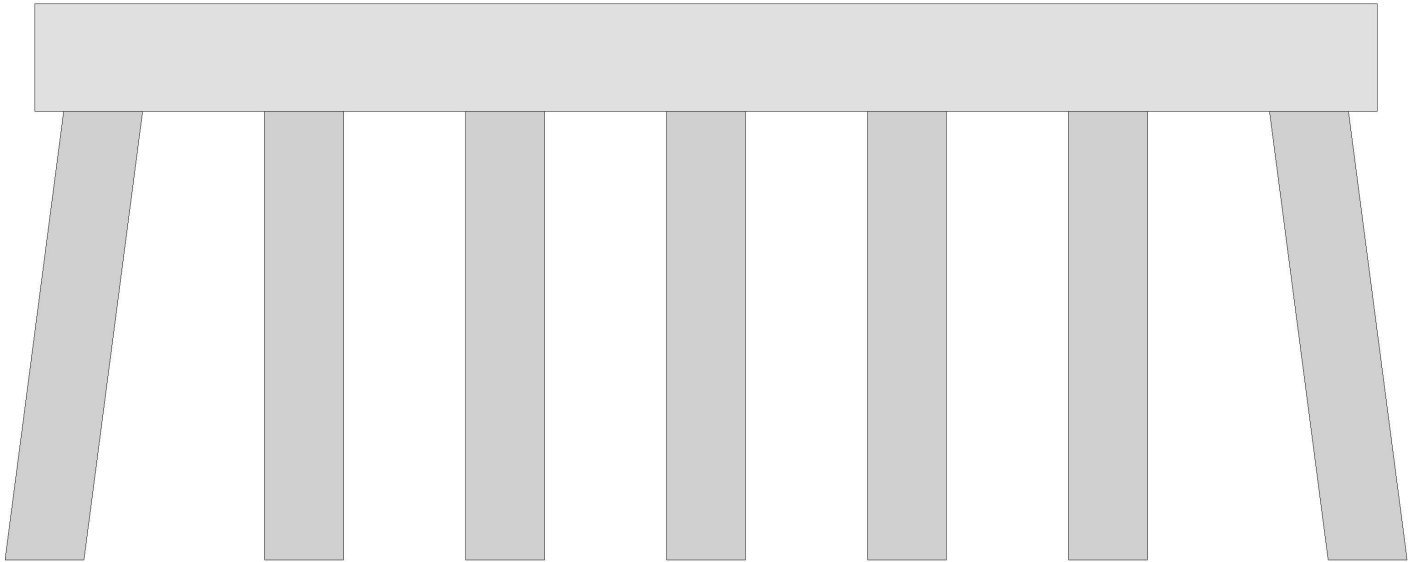
Cap Information			Material Cast-in-Place Concrete							
Length	Width	Height	Left Overhang	Right Overhang	Left Beam to End of Cap.	Right Beam to End of Cap.
