NC DEPARTMENT OF TRANSPORTATION  
 DIVISION OF HIGHWAYS  
 STRUCTURE MANAGEMENT UNIT

ATTENTION: **Painting Project in Progress Unable to Access Beams, Bearings and Caps; Approach Roadway, Typical Section Sketch Modified**

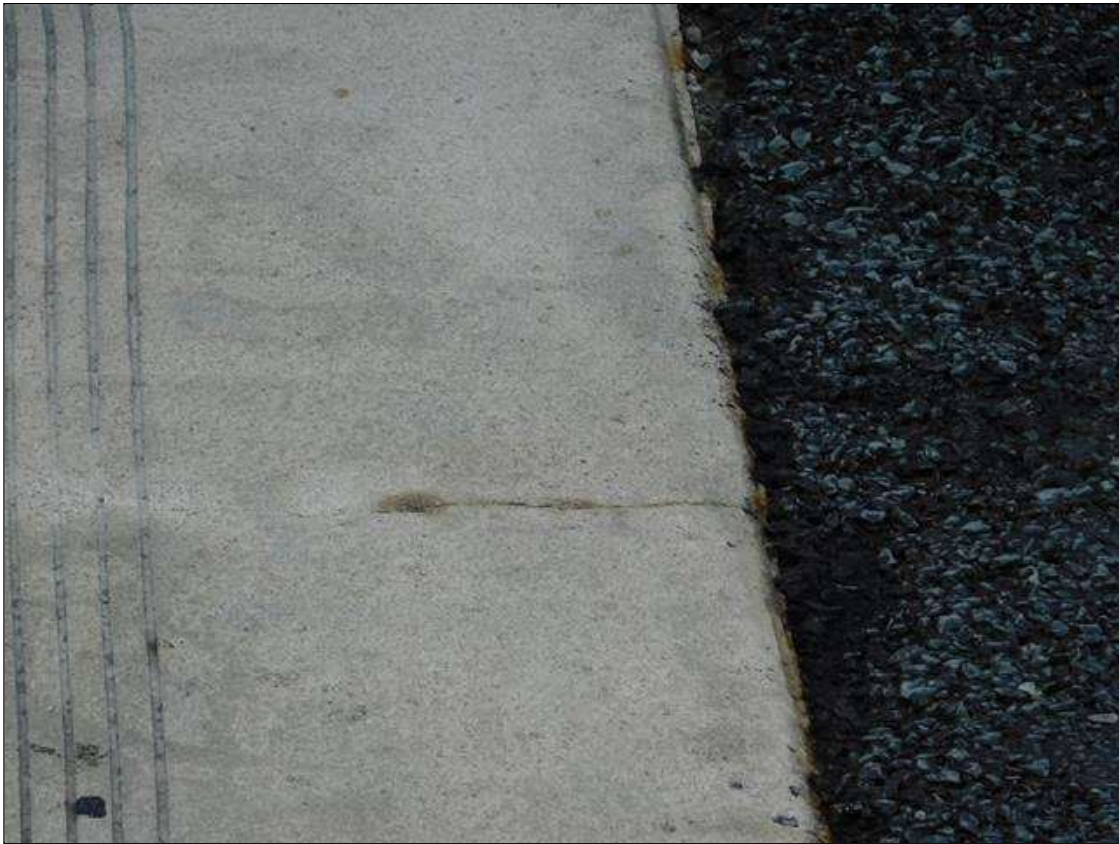
Approach 2: 1 square foot hairline longitudinal crack in East lane

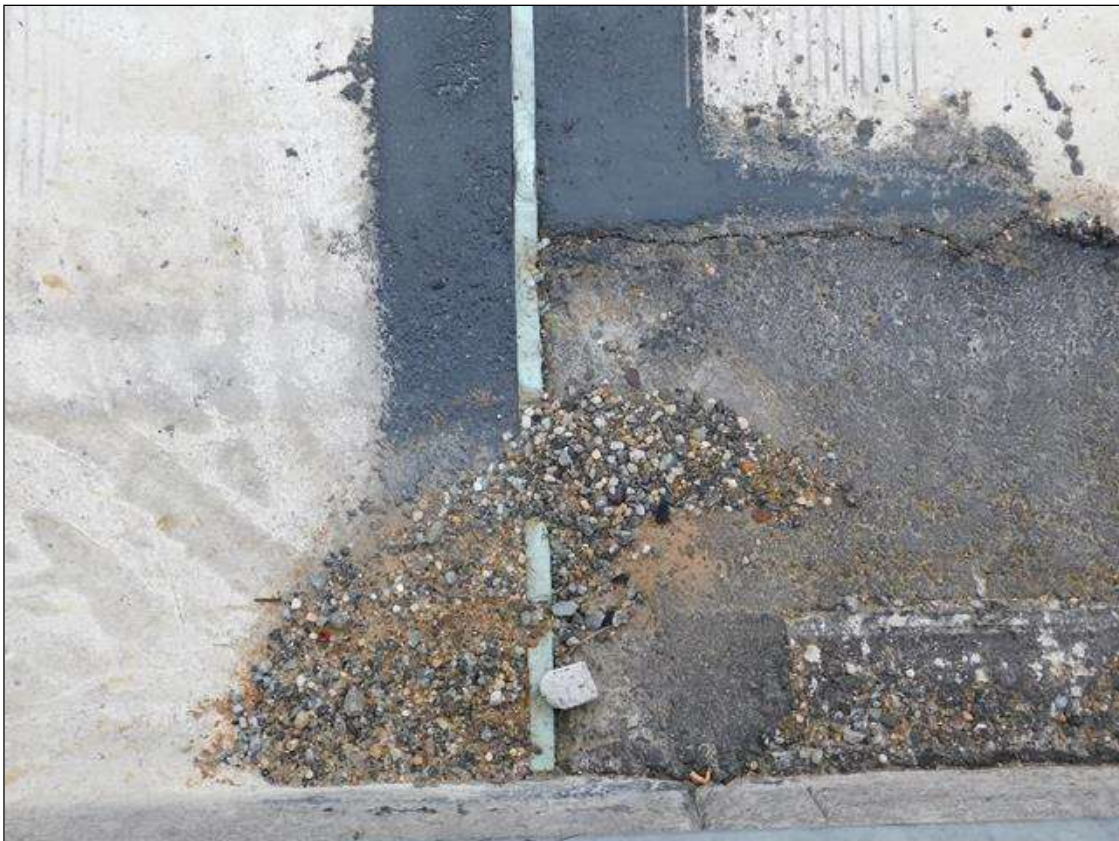
Expansion Joint: 2' dirt and debris in East gutter

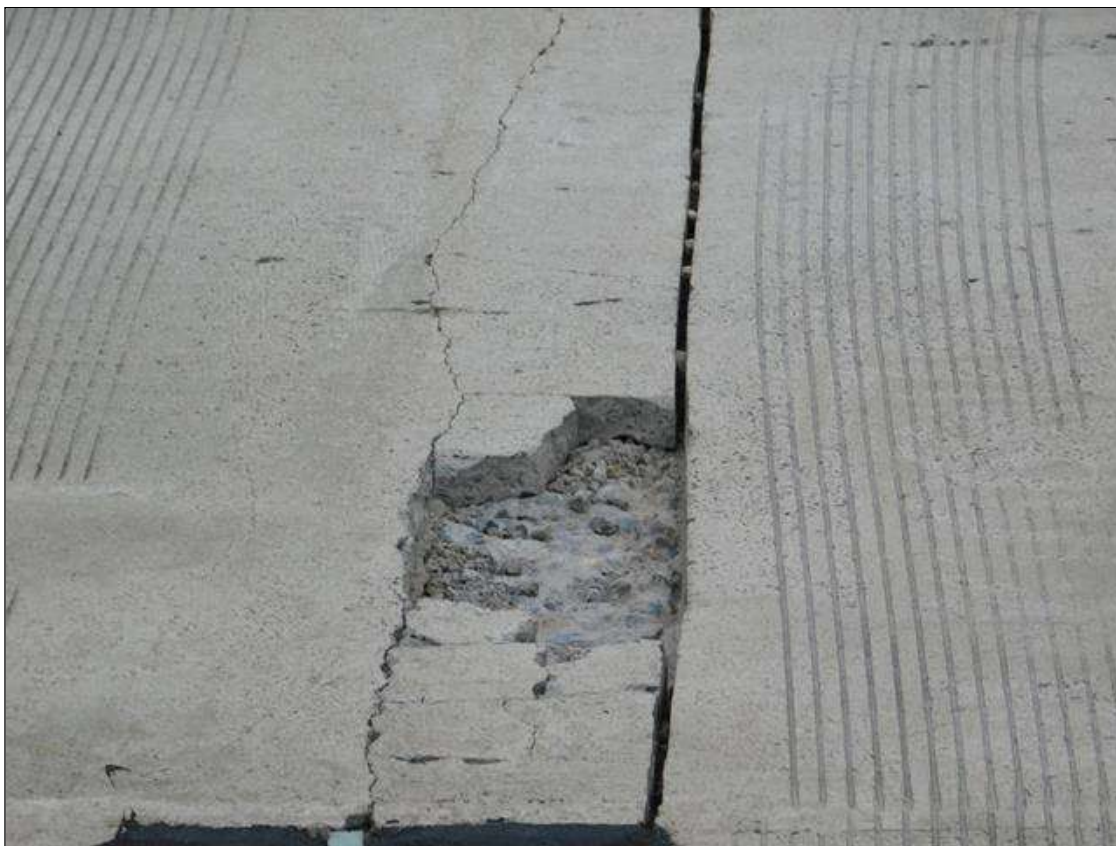
Expansion Joint: 30" x 6" x 2" spall along joint in West lane

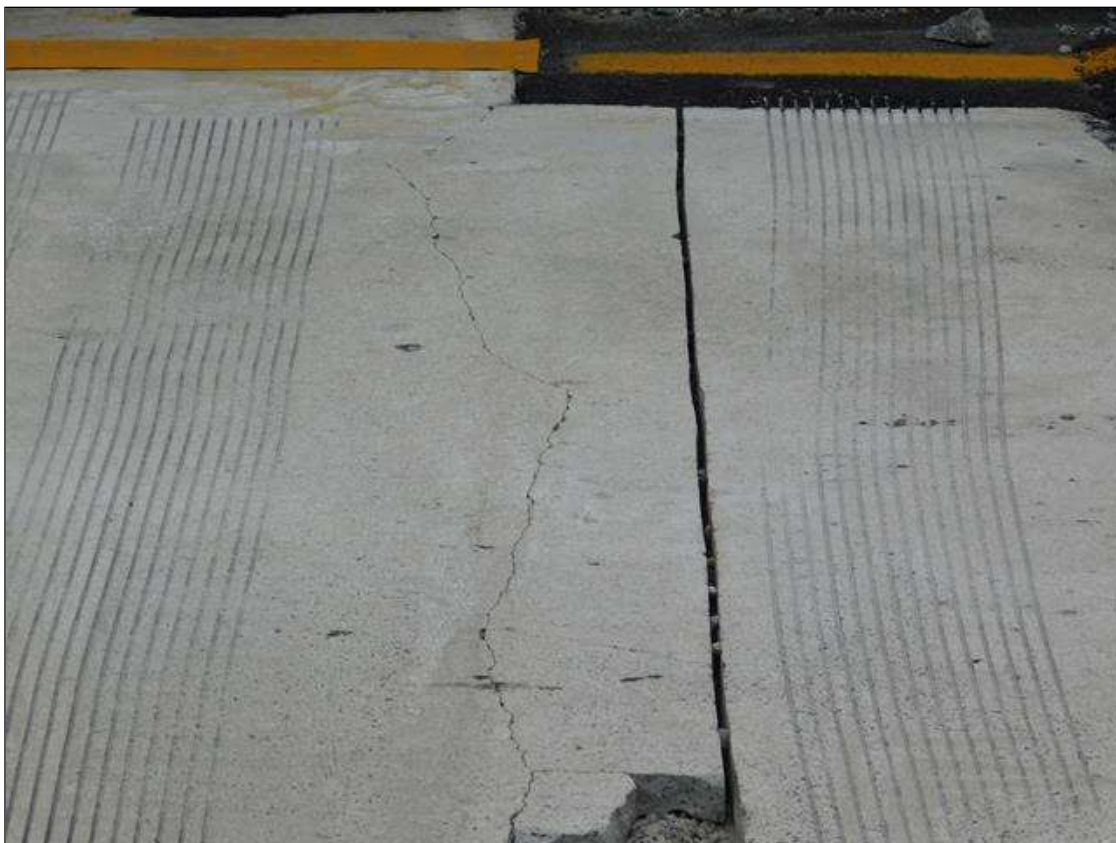
Span 4 Deck: 12 square feet hairline transverse crack in West lane near End Bent 2

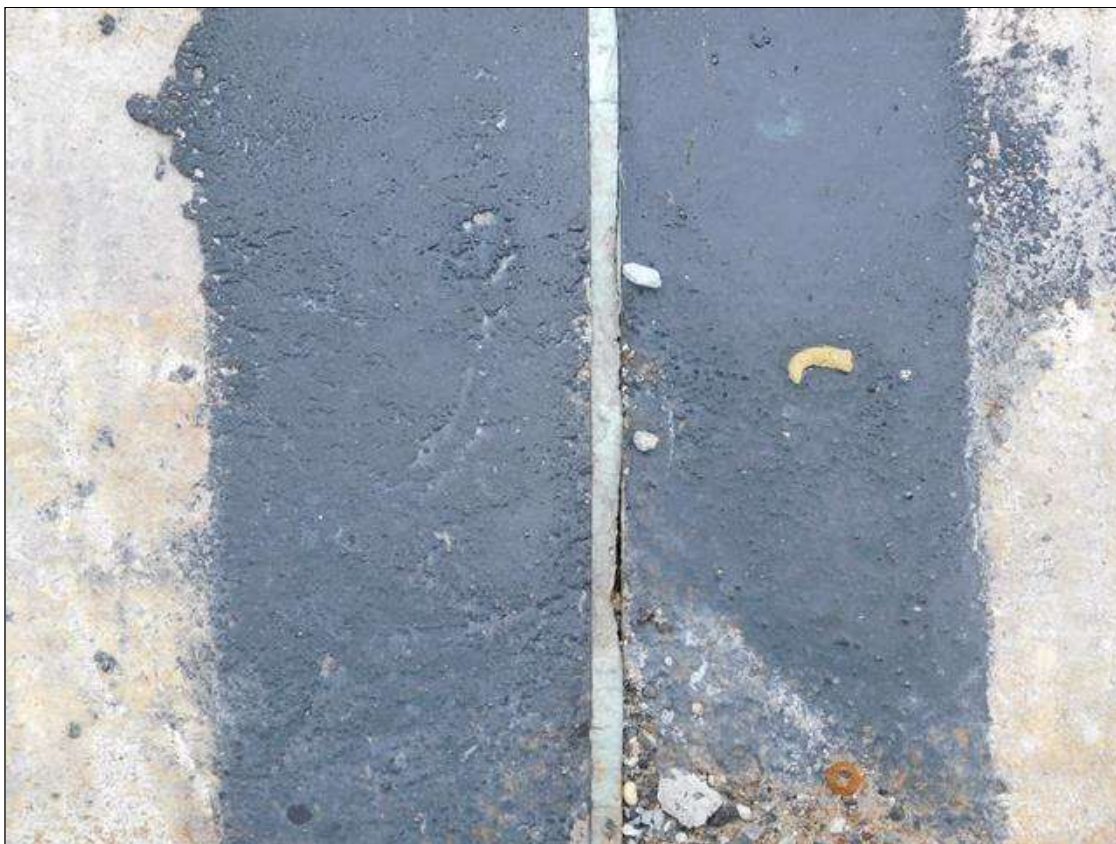
Expansion Joint: 7" x 1/2" deep detached joint material in East lane

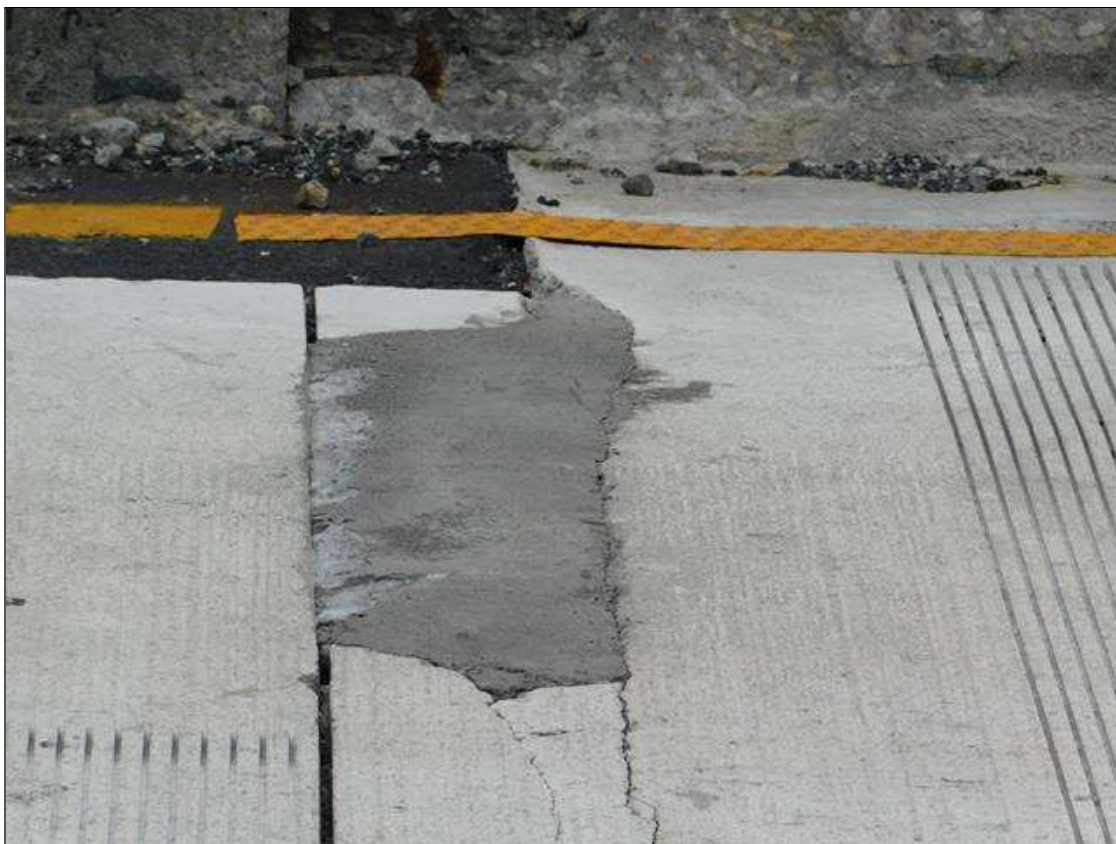
Span 1 Deck: 4" x 4' area of patch with hairline transverse crack in West lane at End Bent 1

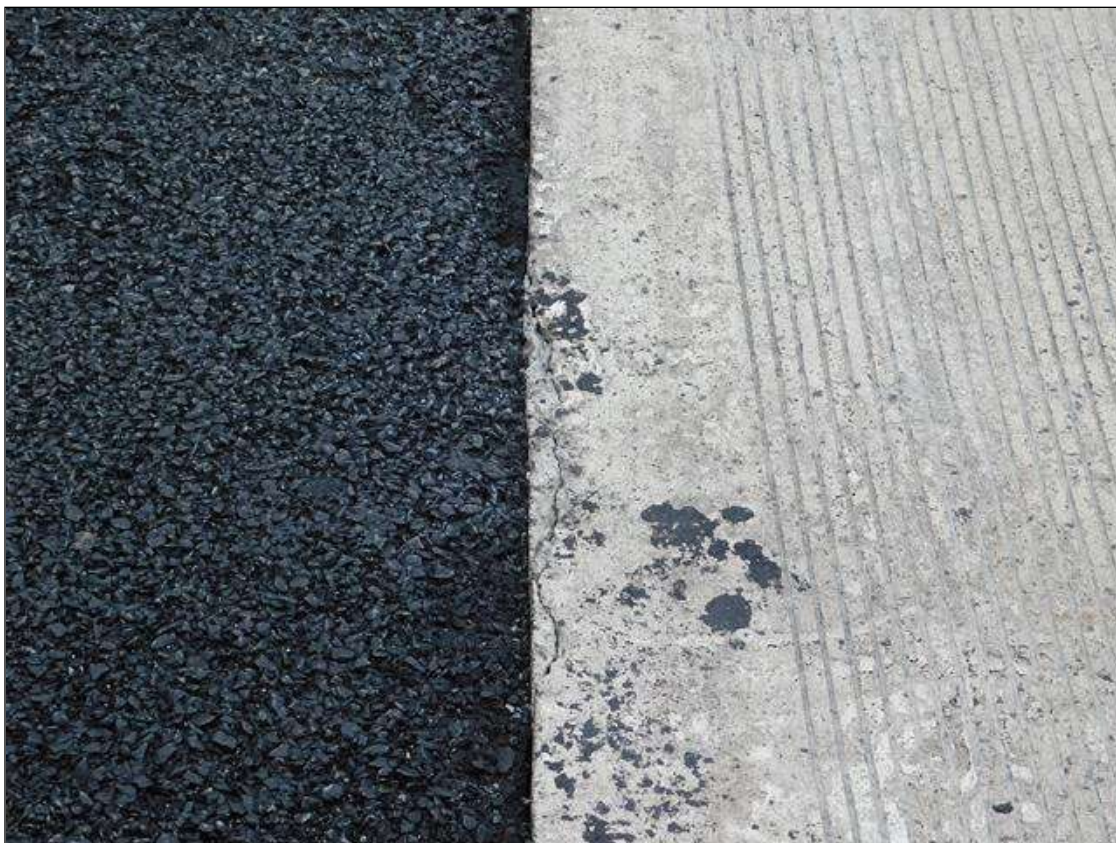
Approach 1: 3 square feet up to 1/16" transverse crack in East lane at South end

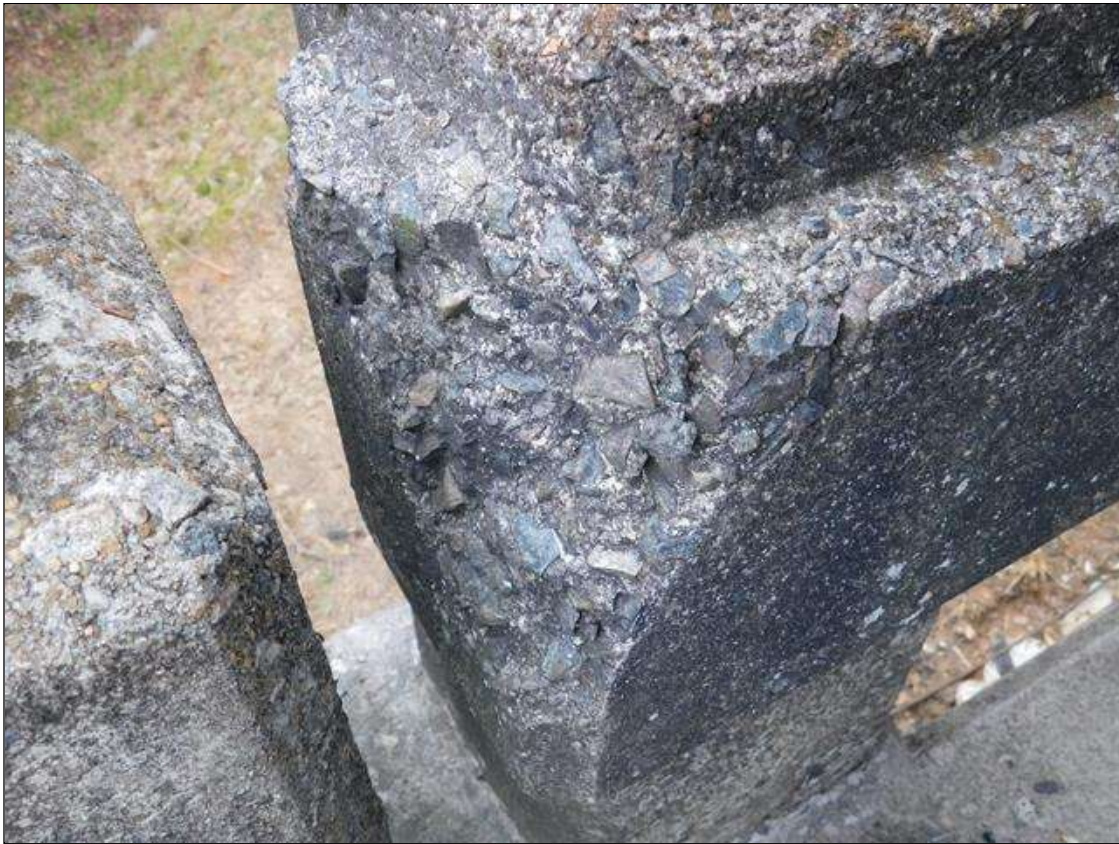
Span 1 Right Bridge Rail: 4" x 7" x 6" deep spall on concrete rail at Post 2

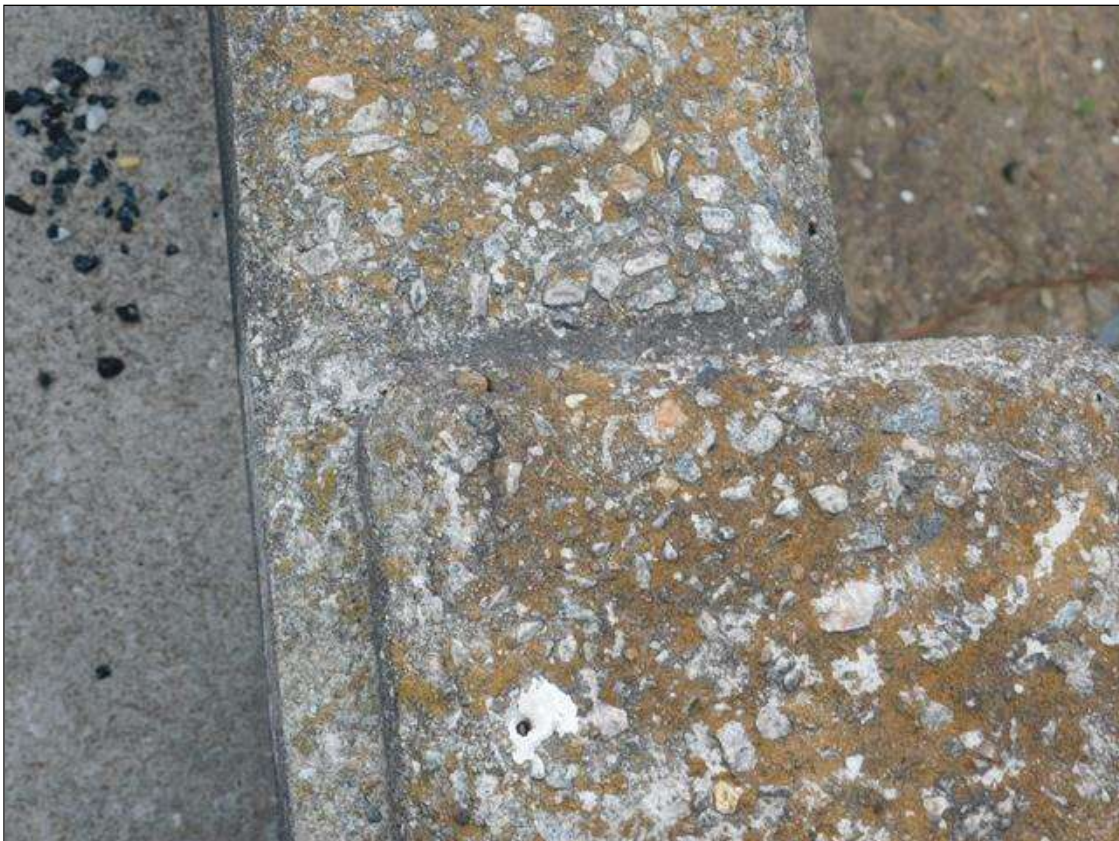
Span 1 Right Bridge Rail: 3" hairline longitudinal crack on Post 3

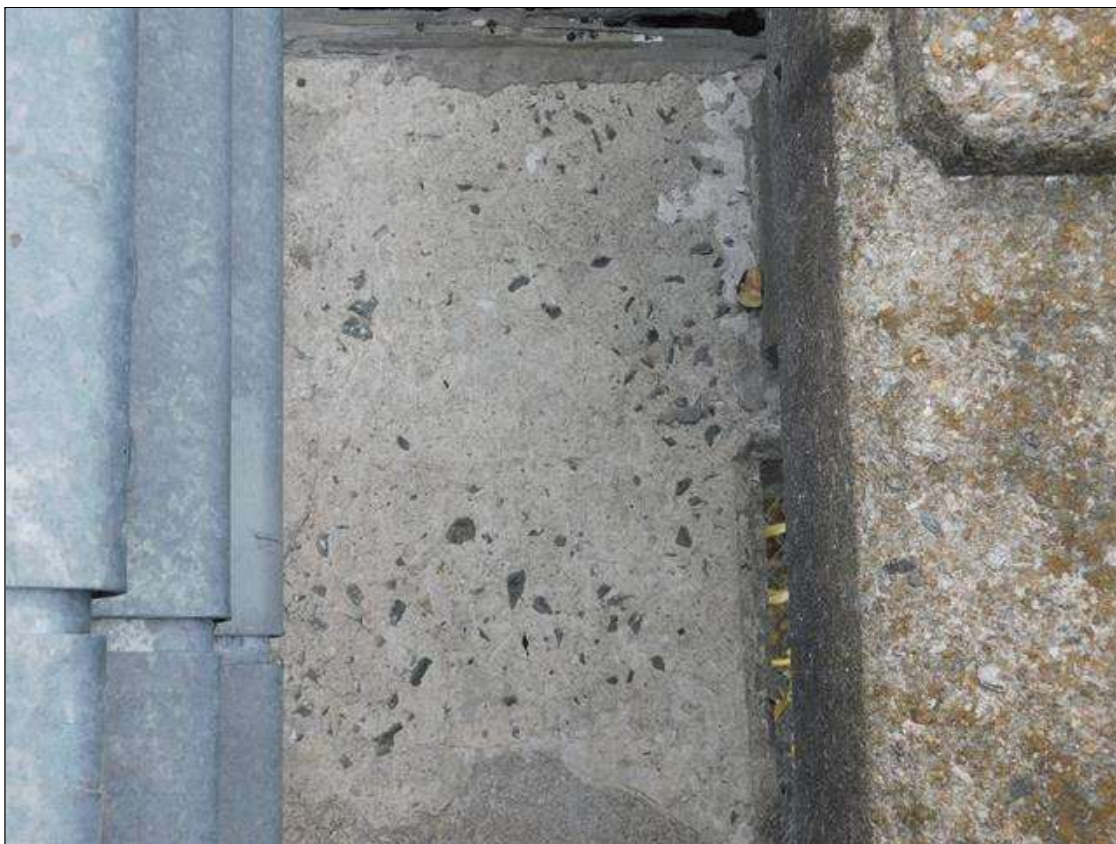
Span 1 Right Bridge Rail: 2' x 2' area of patch with hairline longitudinal and transverse cracks on curb at Bent 1

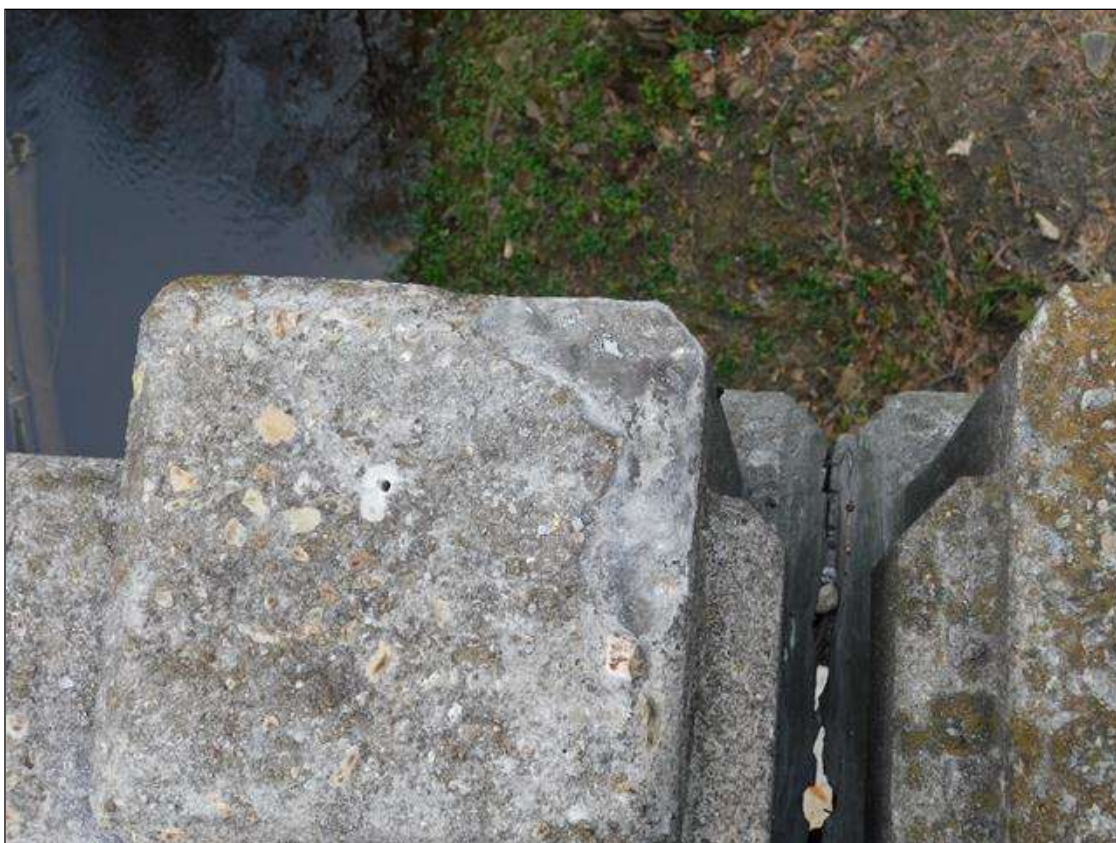
Span 2 Right Bridge Rail: 5" x 6" x 1" deep spall on Post 1

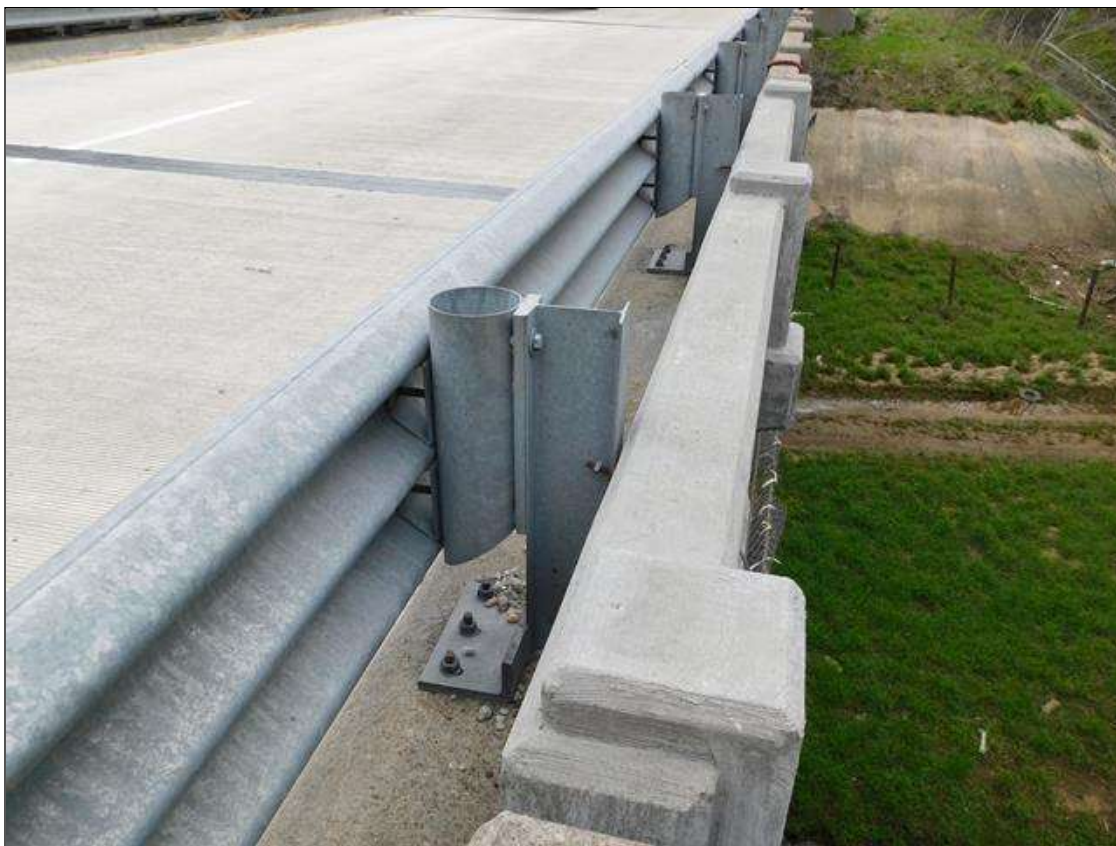
Span 2 Right Bridge Rail: 16' repaired section of concrete rail at Bent 2

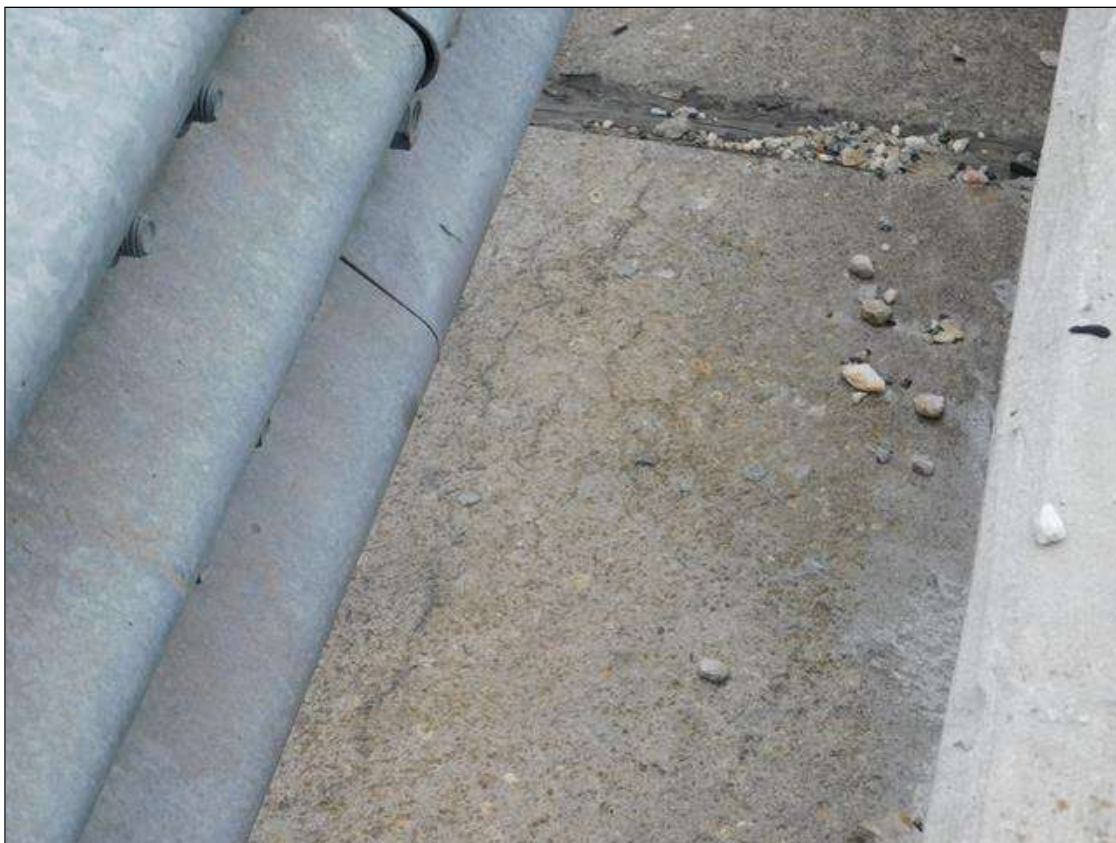
Span 2 Right Bridge Rail: 30" hairline longitudinal cracks on curb at Bent 2

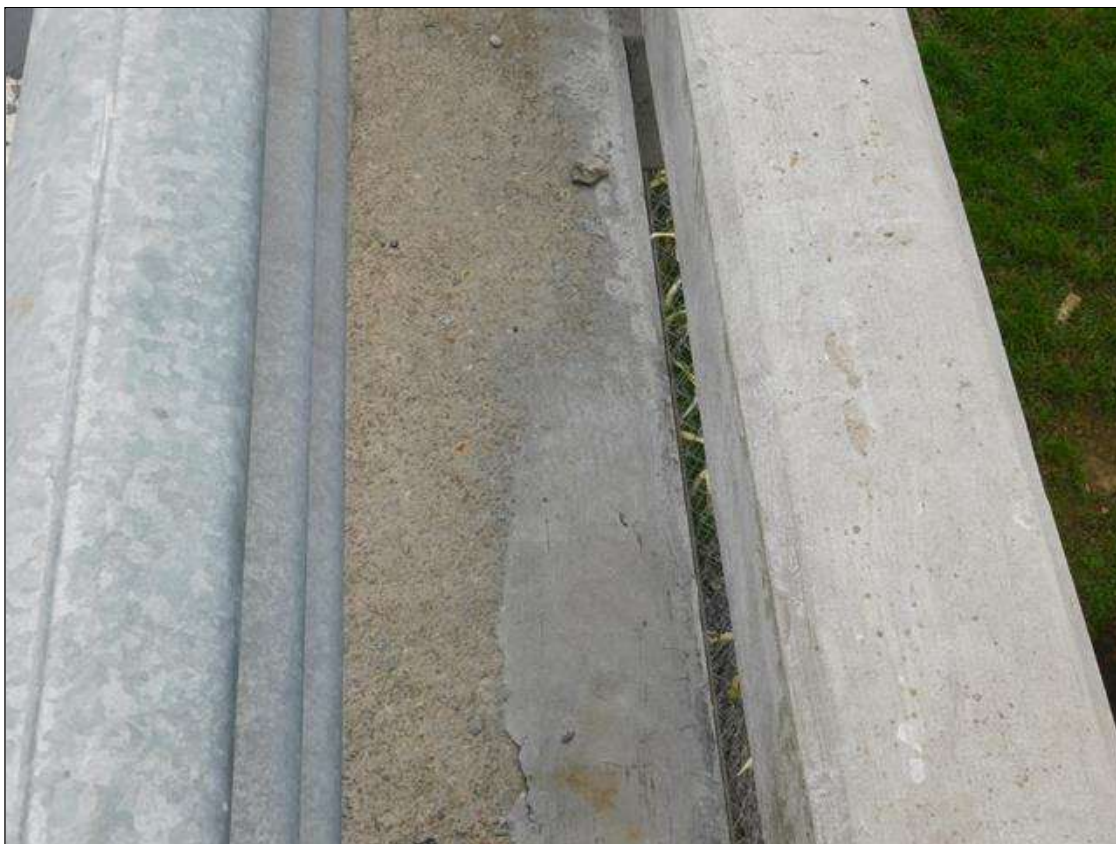
Span 2 Right Bridge Rail: 36" x 9" area of patch with hairline map cracking on curb near Bent 2

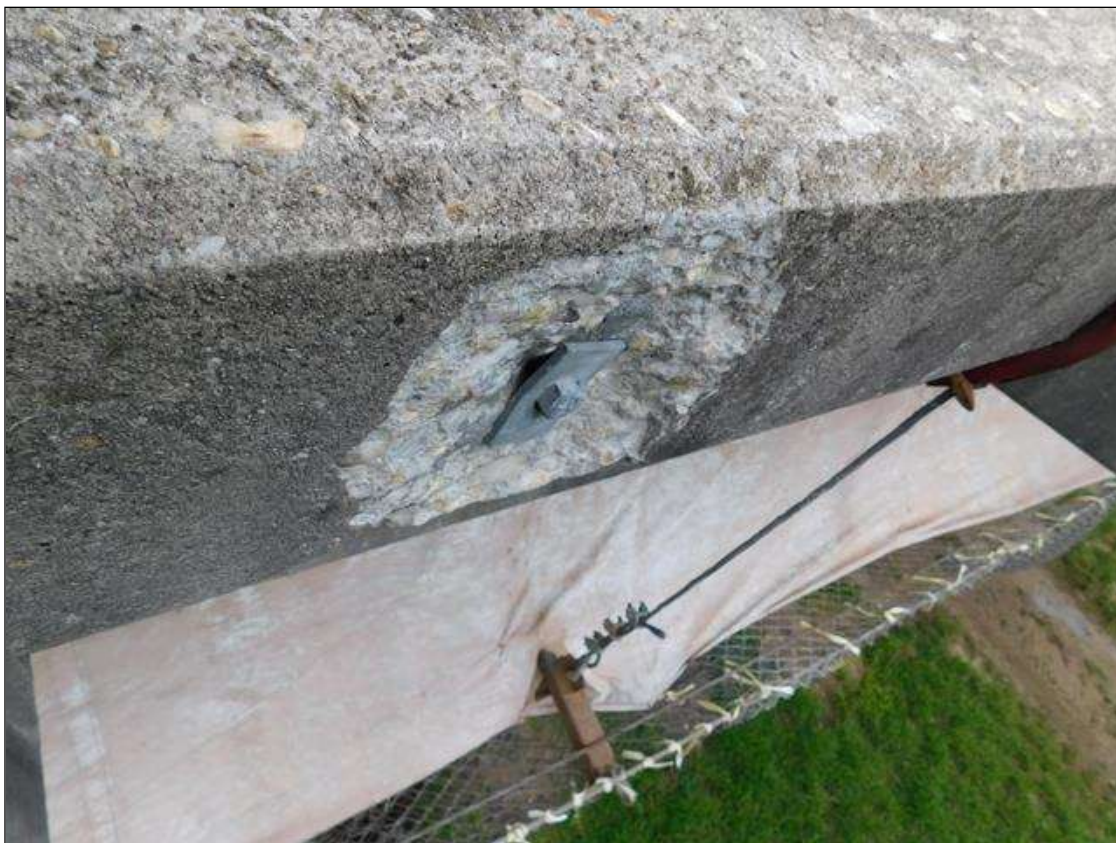
Span 3 Right Bridge Rail: (3) up to 9" x 9" x 1" deep spalls on outside face of concrete rail

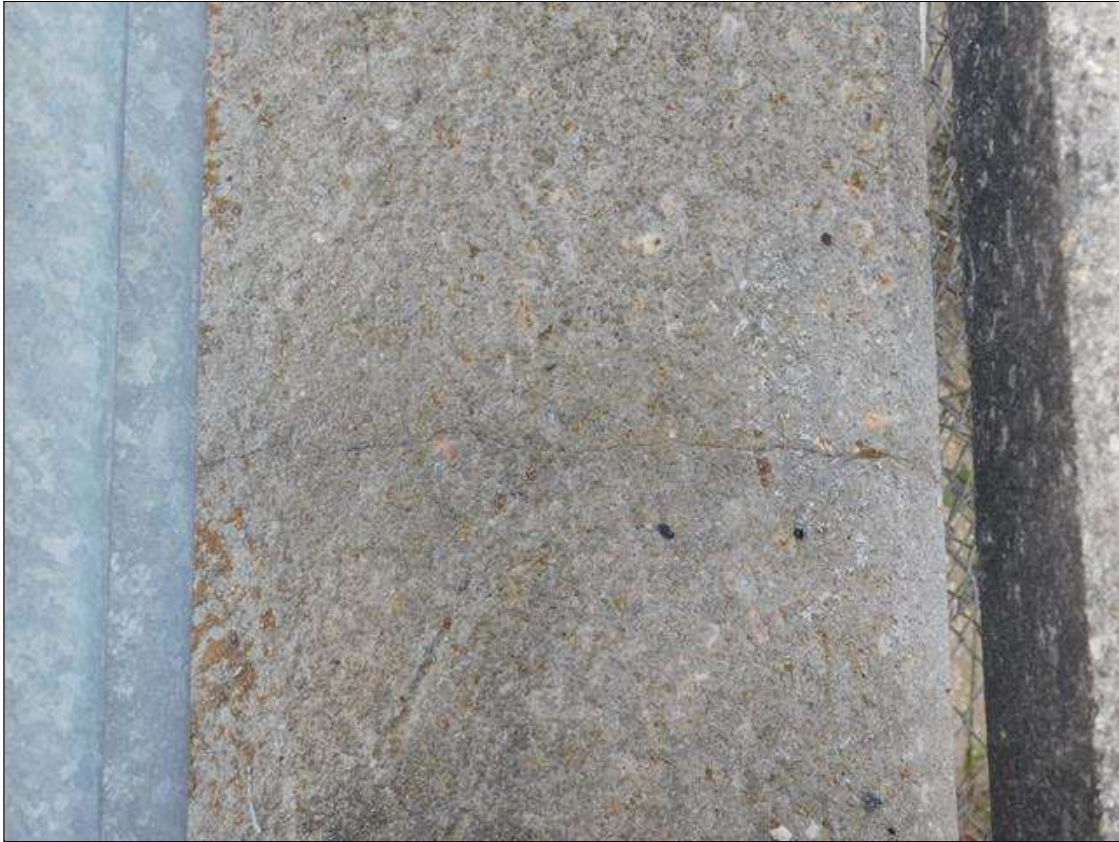
Span 4 Right Bridge Rail: (5) hairline vertical and transverse cracks on concrete curb and rail

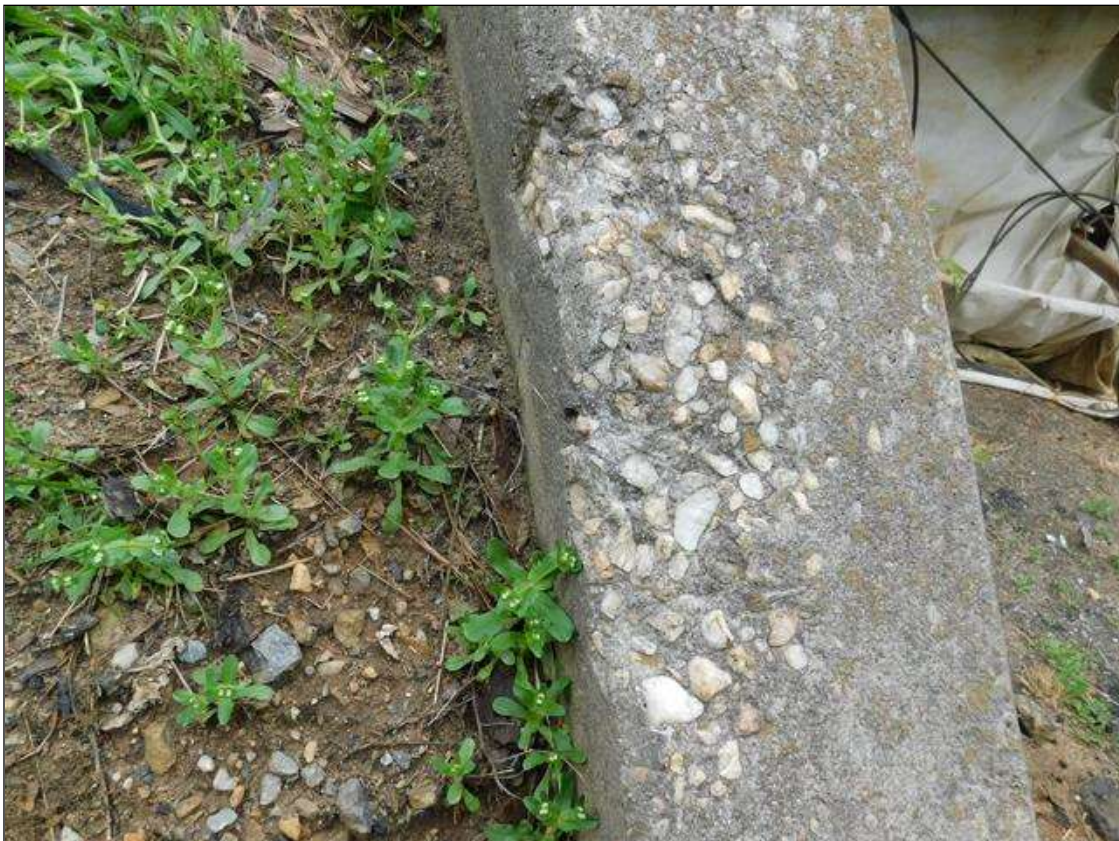
17" x 6" x 1 1/2" deep spall on Southeast wingwall

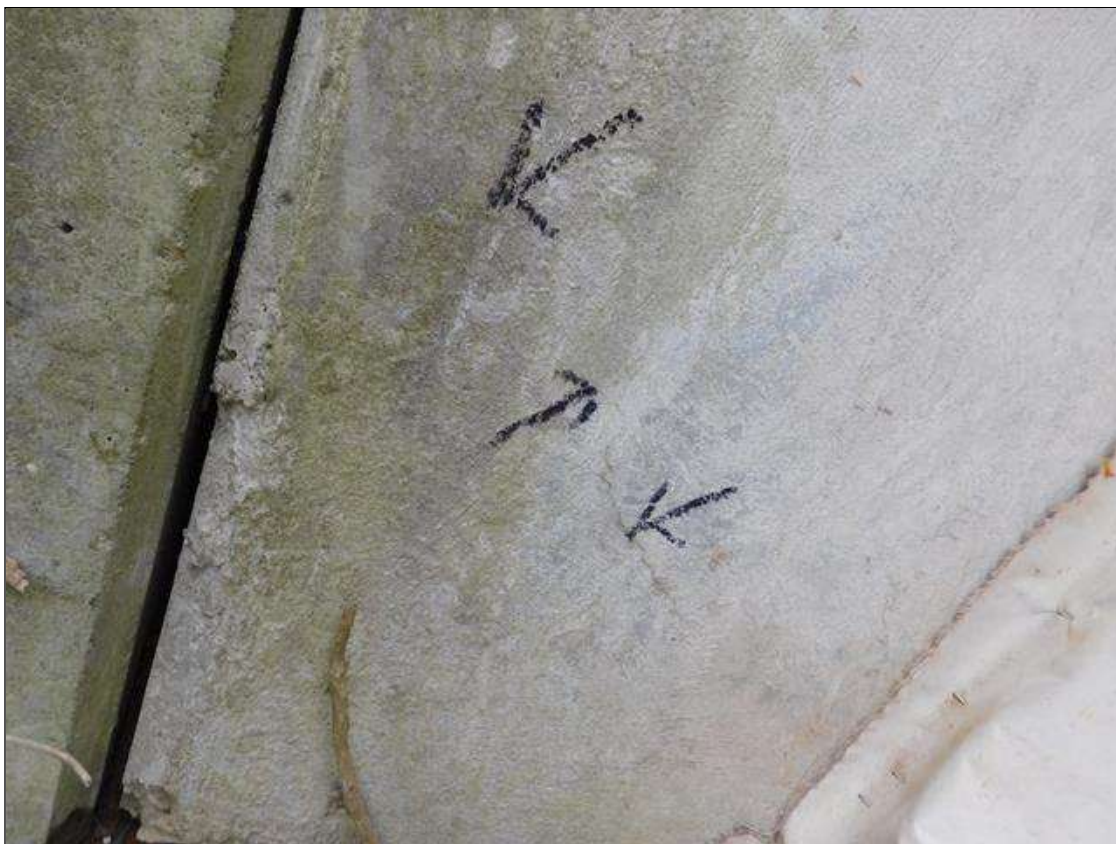
End Bent 1 Abutment/Backwall: 17" hairline diagonal crack at East end

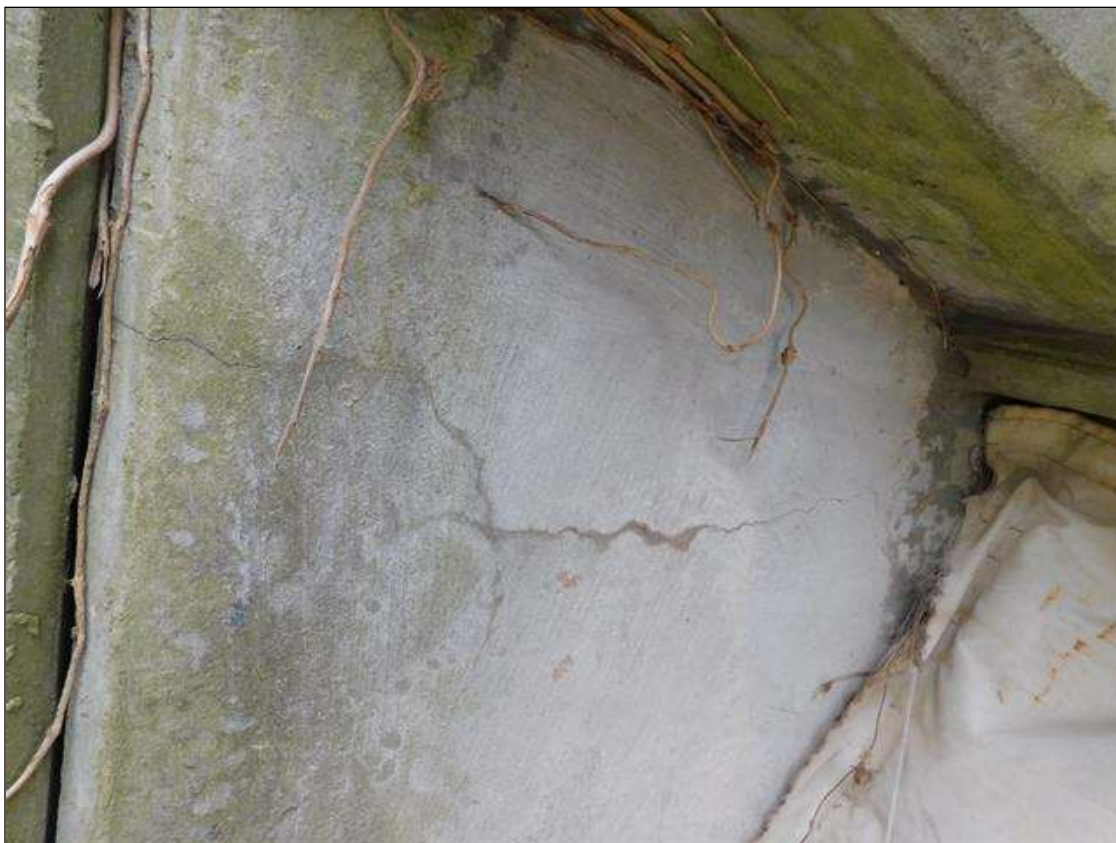
End Bent 1 Abutment/Backwall: 27" x 11" area of hairline vertical and horizontal cracks at East end

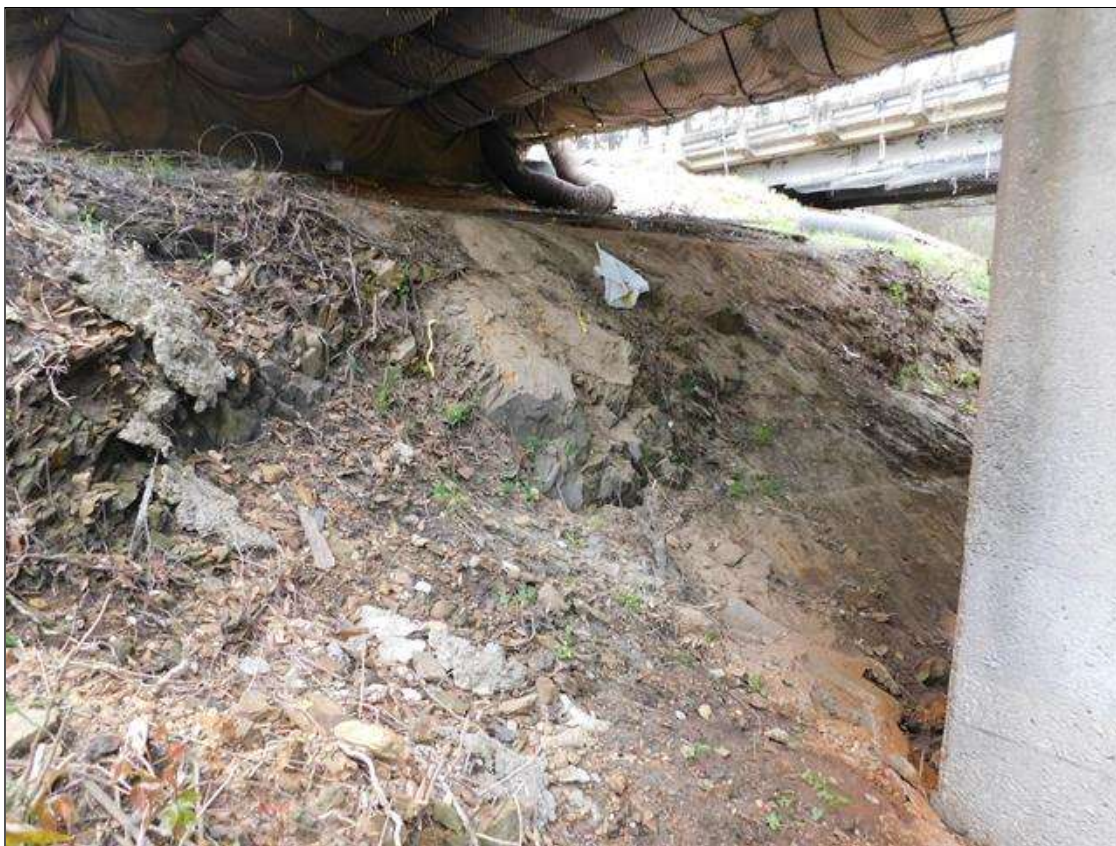
32' x 10' x 4' deep erosion on South streambank

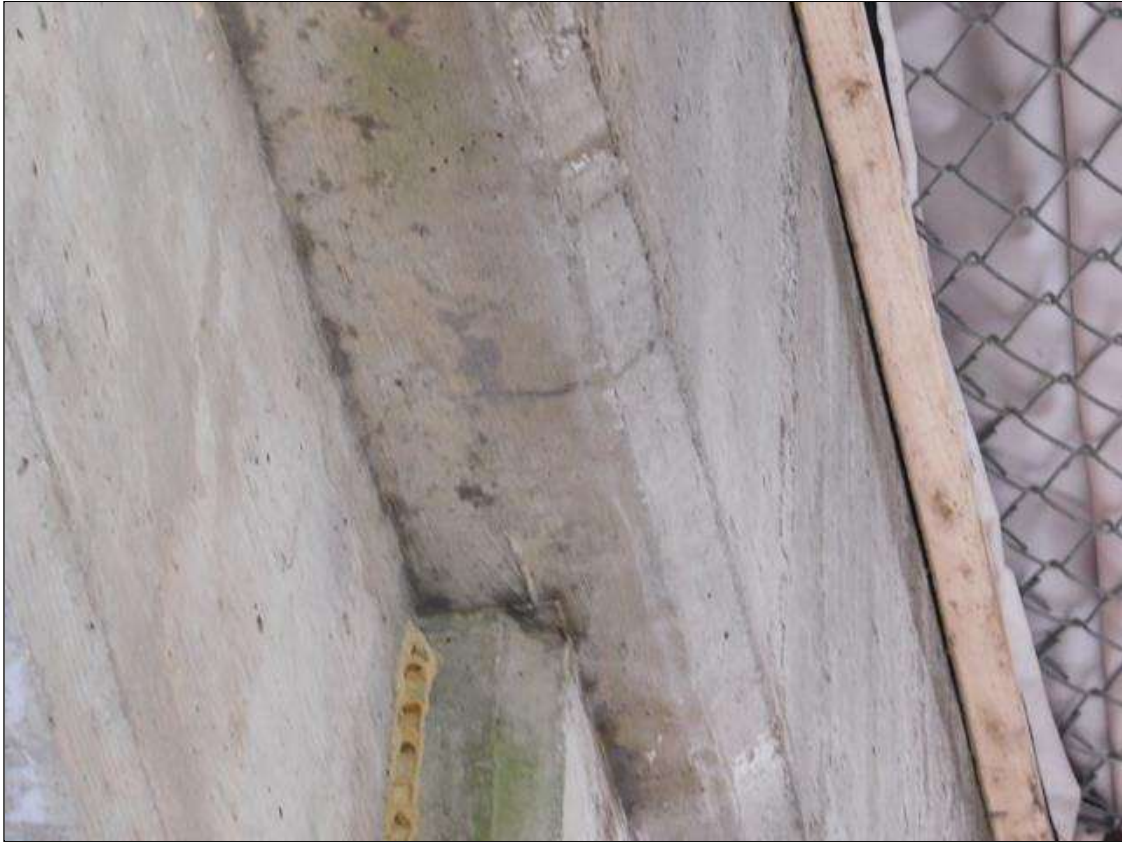
Bent 2 Cap 1: (13) up to 5" hairline longitudinal cracks on bottom of cap between Columns 1 and 2

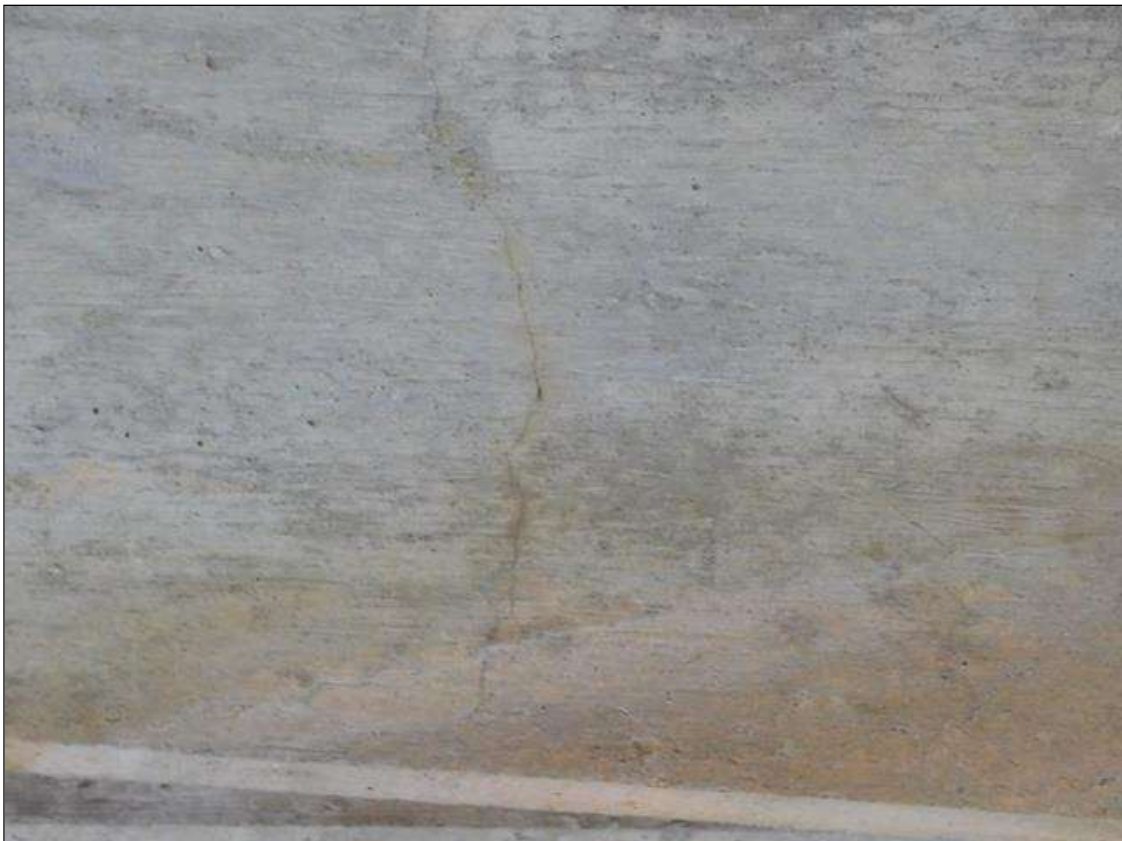
Bent 2 Cap 1: (3) up to 20" hairline longitudinal cracks on bottom of corbel between Columns 1 and 2

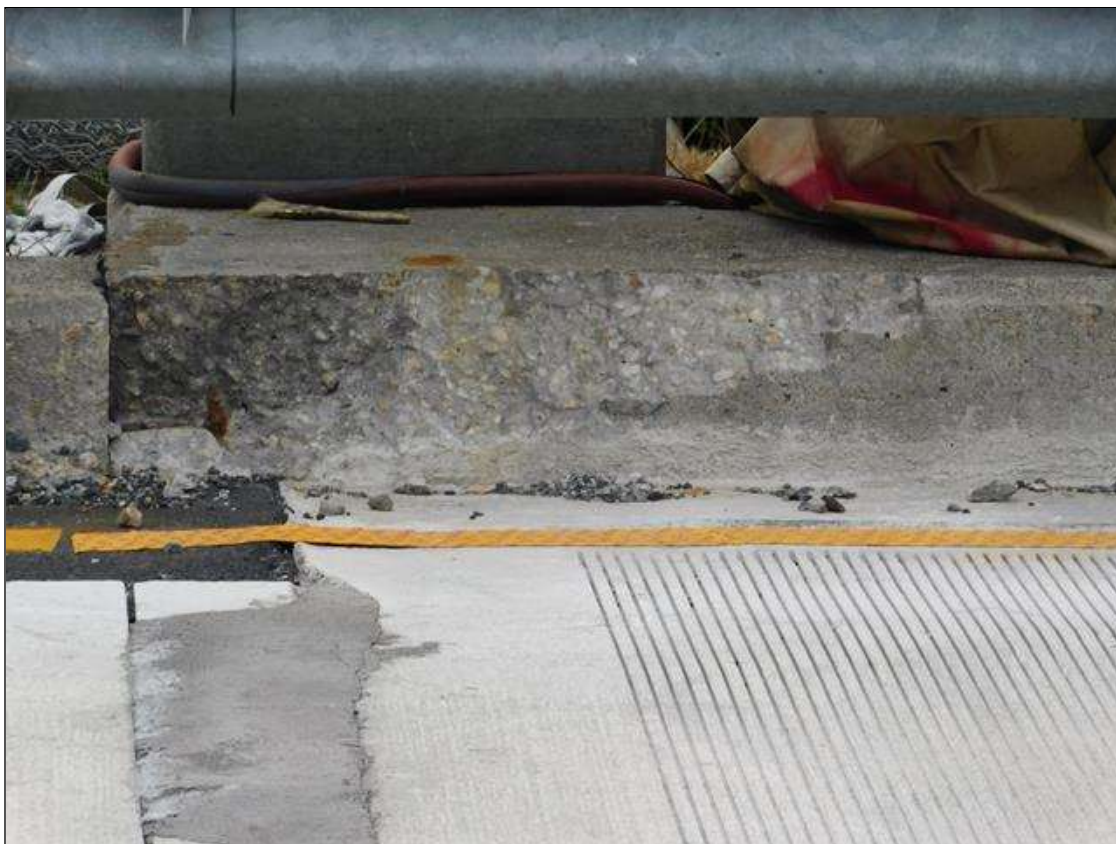
Span 1 Left Bridge Rail: 35" x 9" x 2" deep spall with exposed rebar on curb at End Bent 1

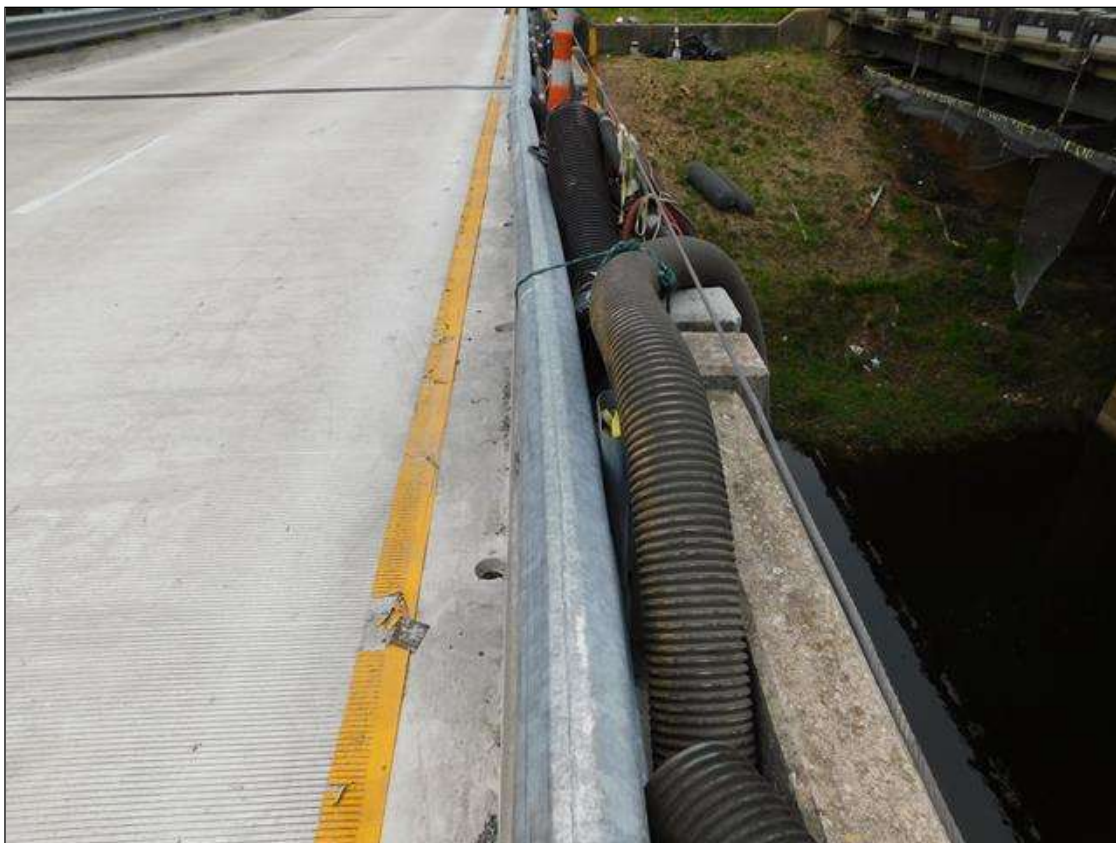
Span 2 Left Bridge Rail: 20' impact damage with 2" deflection to the West on metal rail
