NC DEPARTMENT OF TRANSPORTATION  
 DIVISION OF HIGHWAYS  
 STRUCTURE MANAGEMENT UNIT

ATTENTION: **Painting Project in Progress Unable to Access Beams, Bearings and Caps; Approach Roadway, Typical Section Sketch Modified**

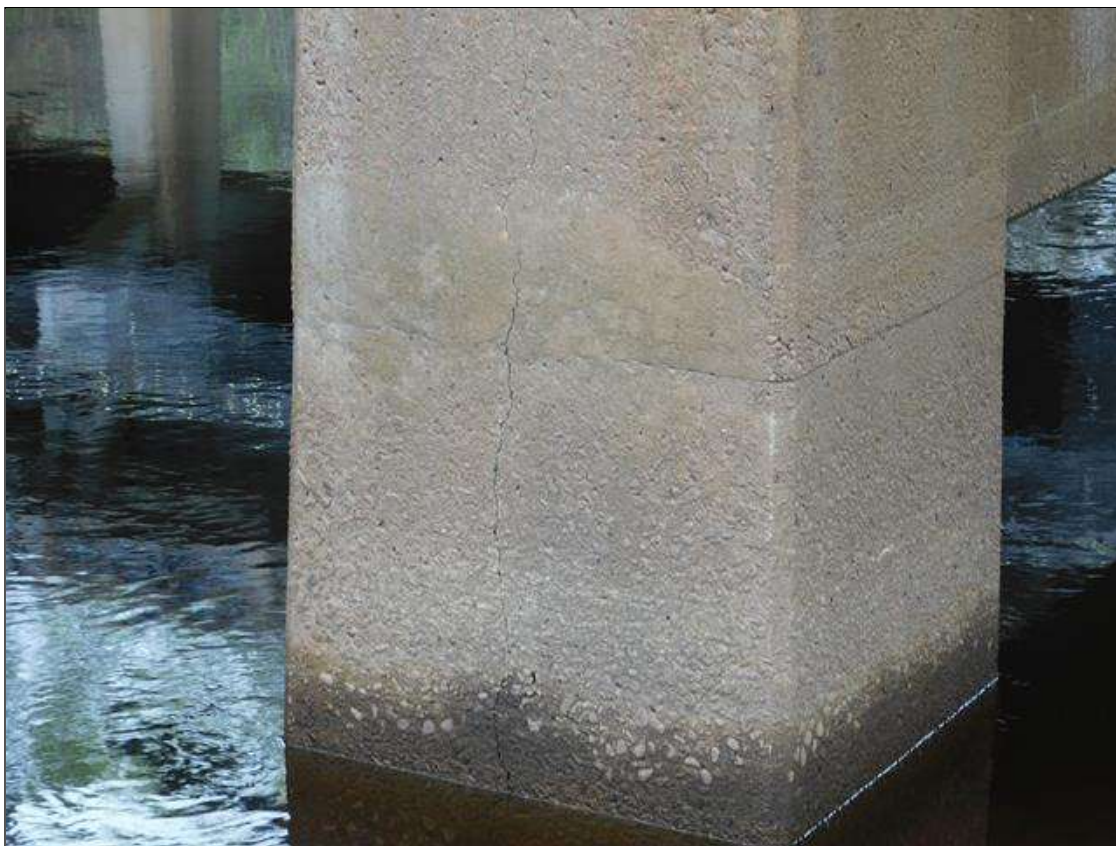
Bent 2 Pile 2: 46" up to 1/16" vertical crack on East face (Span 3 face similar)

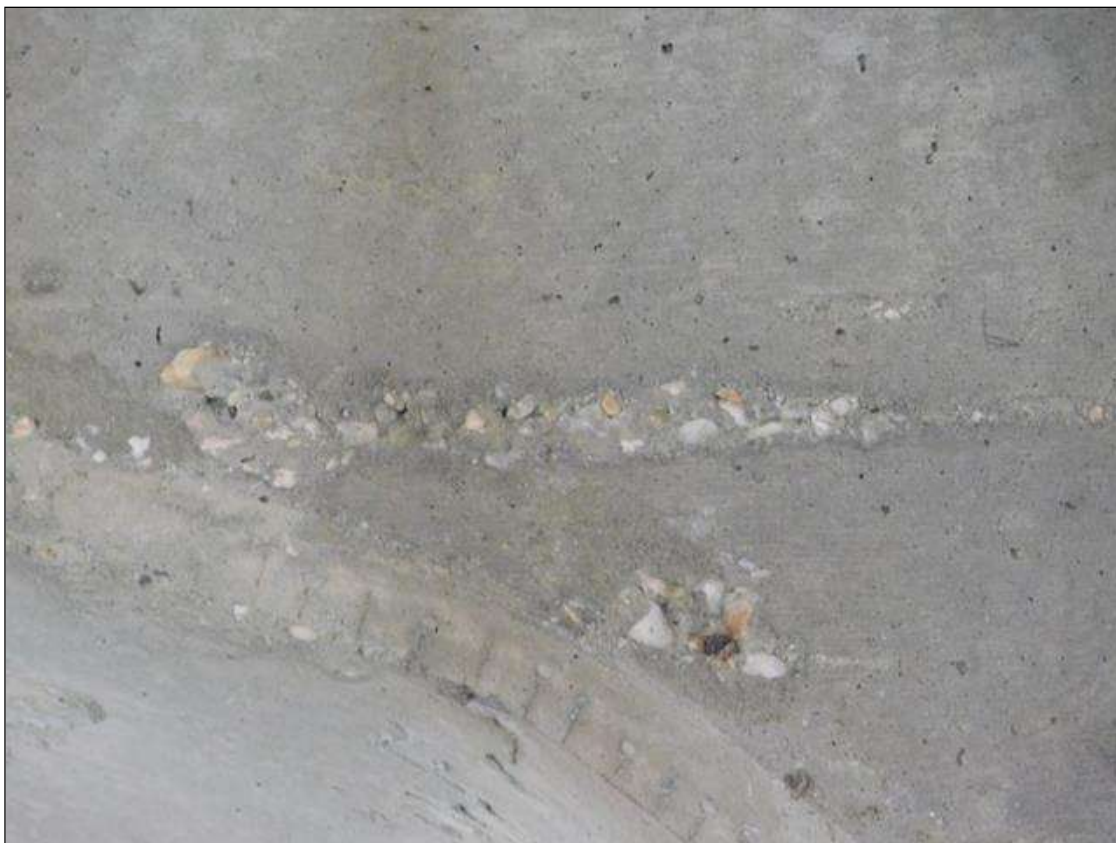
Bent 2 Pile 2: 2" x 10" x 1/2" deep spall on East corbel on Span 3 face

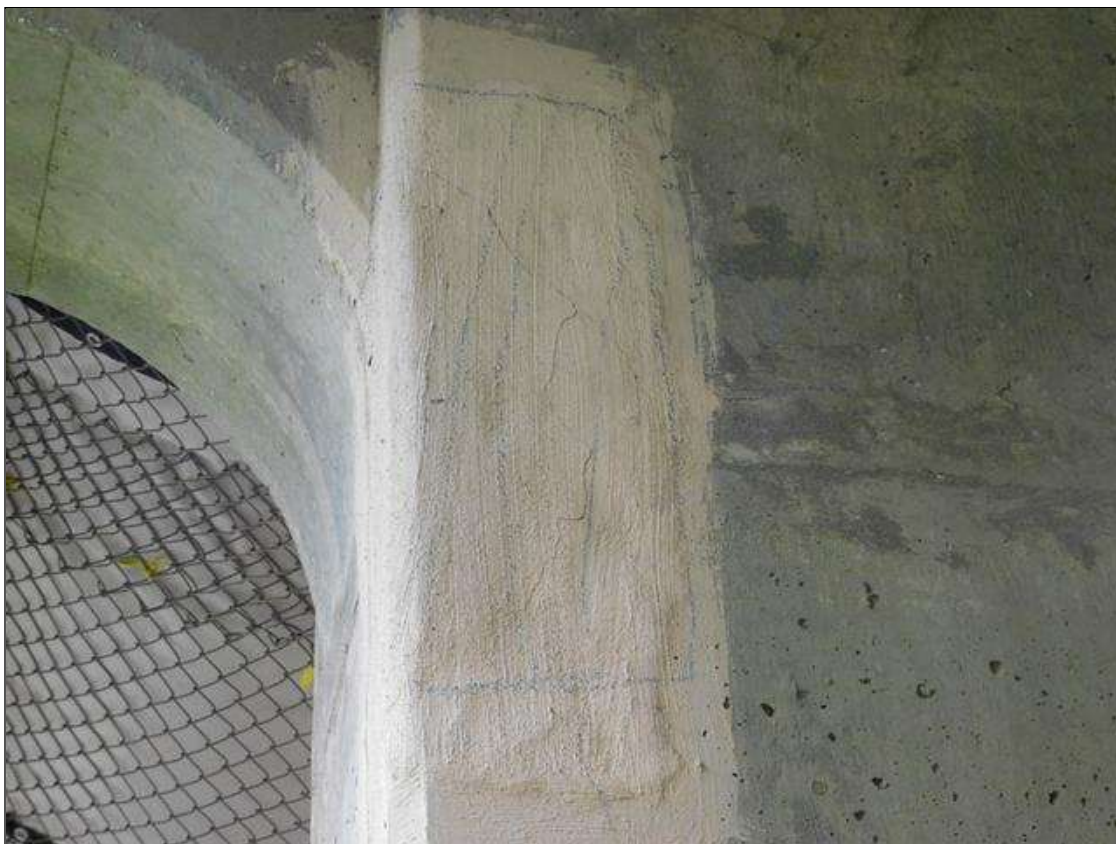
Bent 3 Pile 1: 28" x 11" area of patch with hairline vertical and diagonal crack on Span 3 face

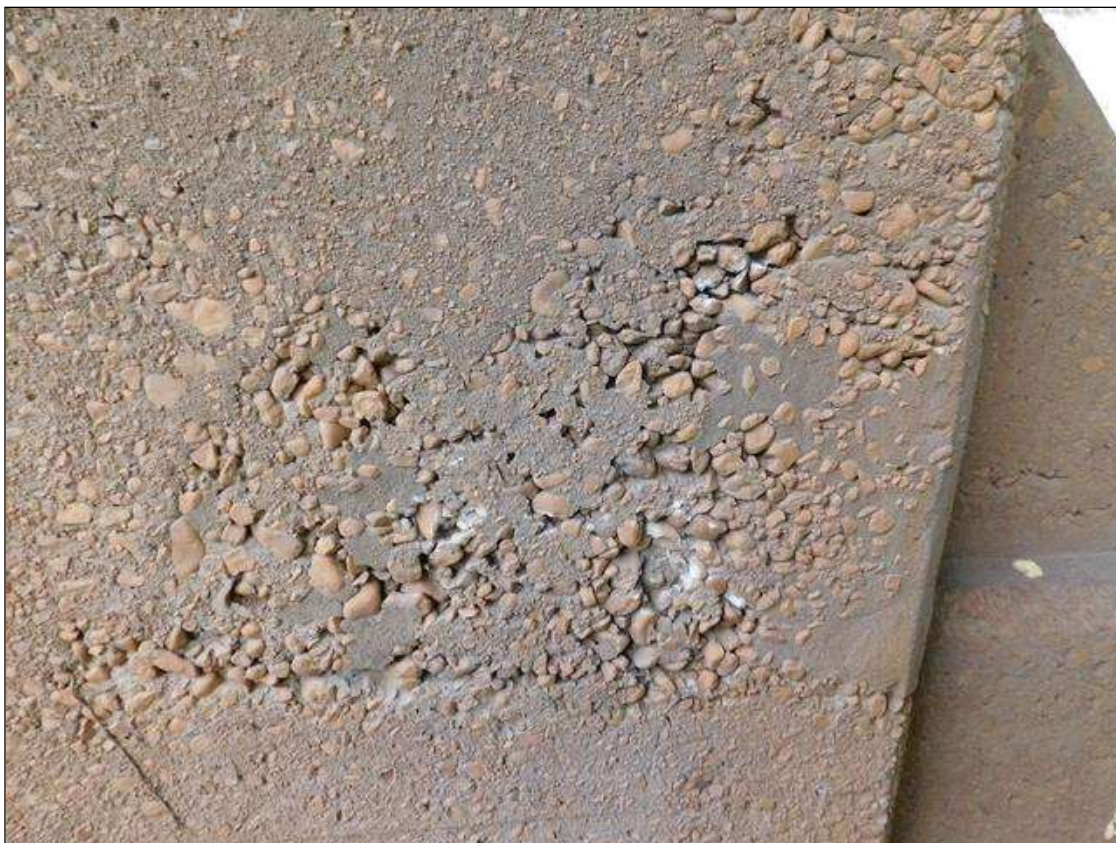
Bent 3 Pile 1: 15" x 19" area of honeycombing with loose aggregate on Span 3 face (Span 4 face similar)

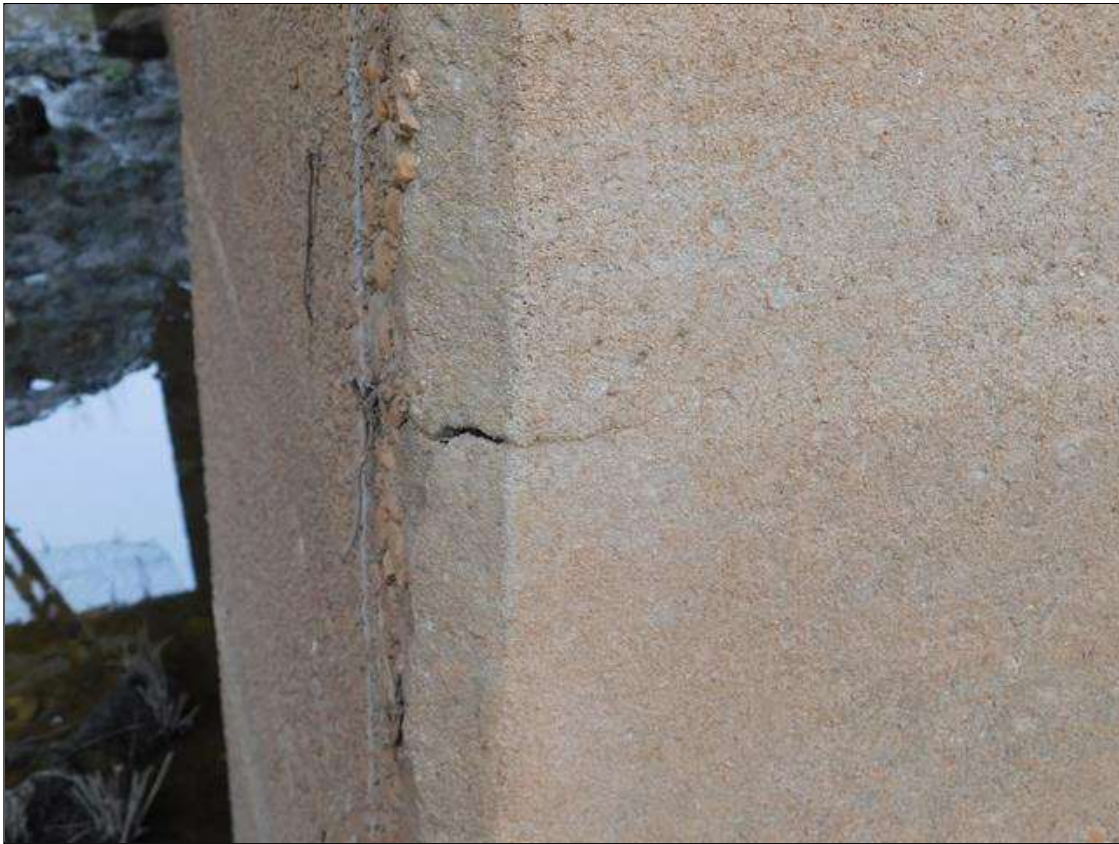
Bent 3 Pile 1: 6" up to 1/16" horizontal crack on West face

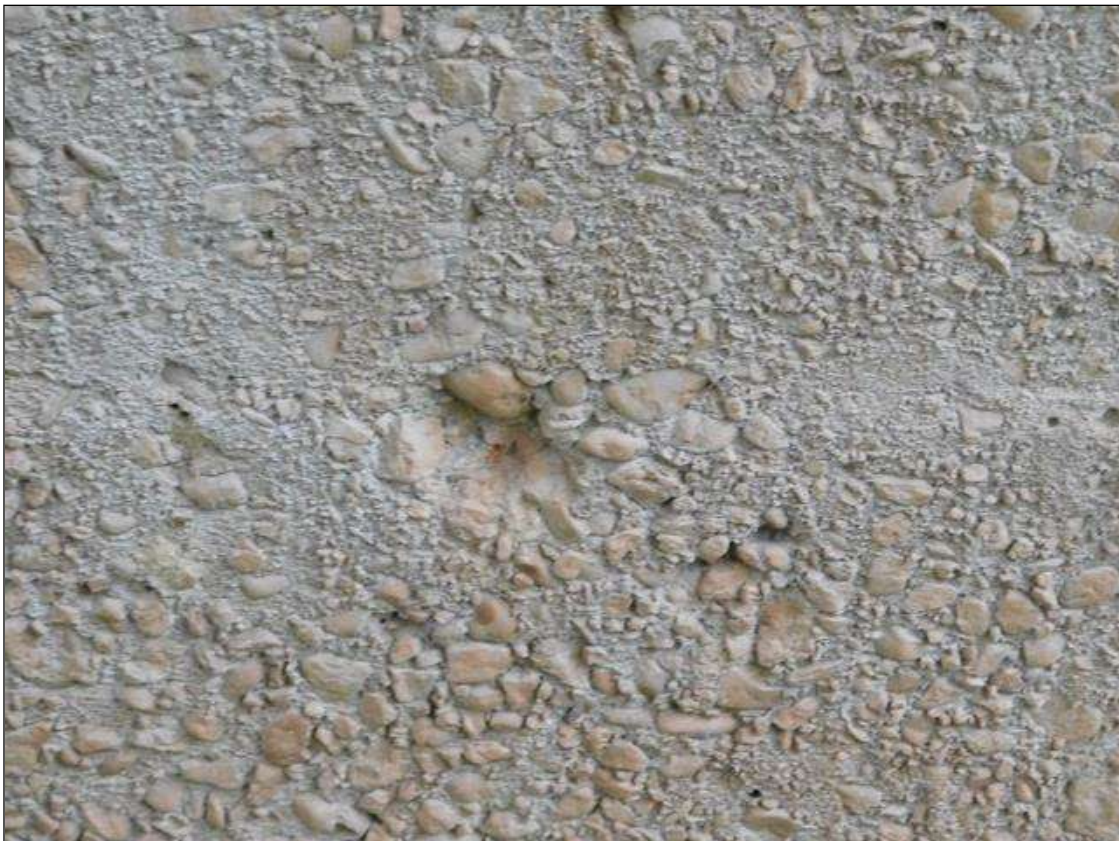
Bent 3 Pile 2: (3) up to 2" x 2" x 1/2" deep spalls on Span 3 face

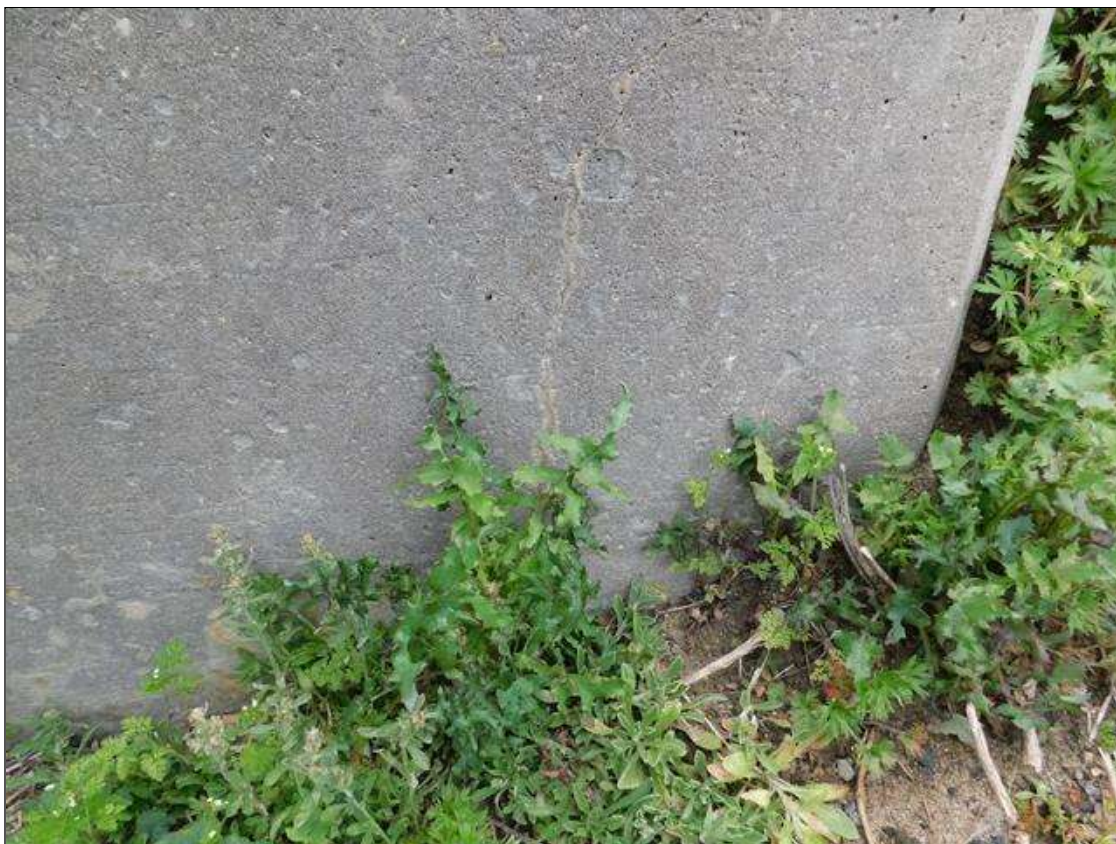
(2) up to 28" hairline vertical cracks with efflorescence on Northwest wingwall

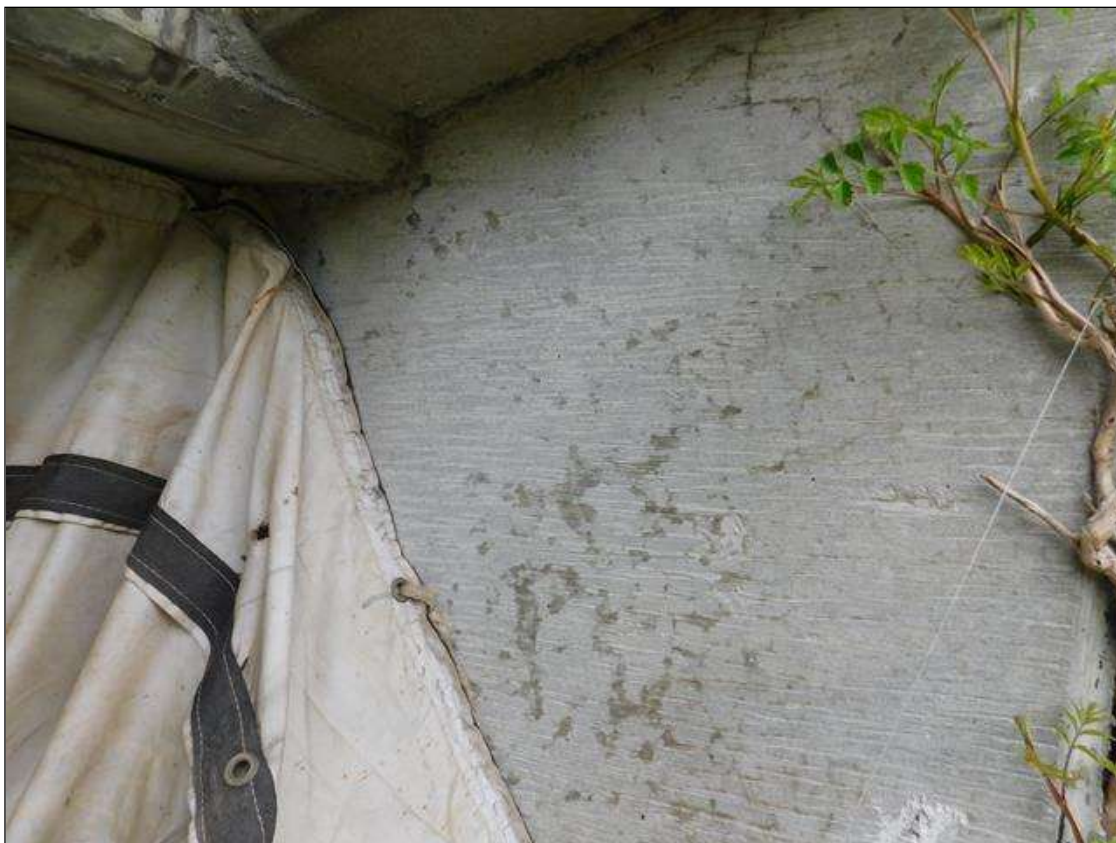
End Bent 2 Abutment/Backwall: 2' x 3' area of hairline map cracking at East end (West end similar)

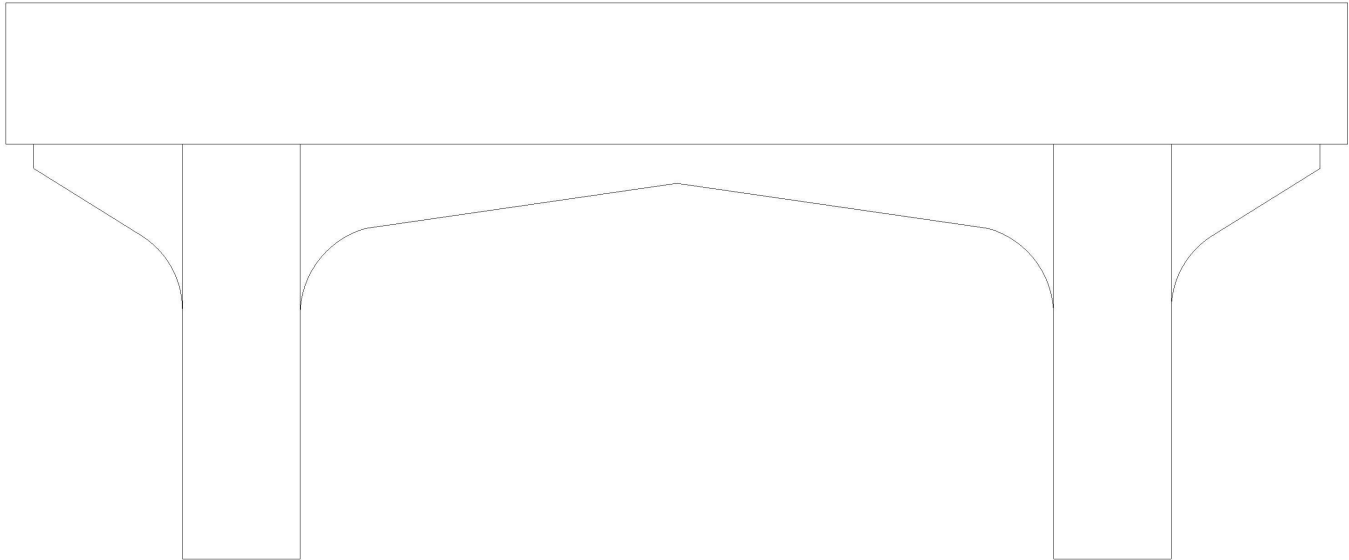
<b>Cap Information</b>			<b>Material</b> Cast-in-Place Concrete							
Length	Width	Height	Left Overhang	Right Overhang	Left Beam to End of Cap.	Right Beam to End of Cap.				
27.000 ft.	2.500 ft.	2.500 ft.	5.000 ft.	5.000 ft.	1.500 ft.	1.500 ft.				
<b>Subcap Information</b>			<b>Material</b>							
Length	Width	Height	Left Overhang	Right Overhang	Left Pile to Splice.					
<b>Sill Information</b>			<b>Material</b>							
Length	Width	Height								
Pile #	Material	Spacing	Width/Dia.	Height	Length	Orientation	Driven?	Replacement?	Removed?	Collar?
1	Concrete	17.000 ft.	2.333 ft.			Vertical	No	No	No	No
2	Concrete		2.333 ft.			Vertical	No	No	No	No
SKETCH VERIFIED 4/9/18 BY JMS										
<b>Bent/Abutment #:</b> 1			<b>Similar Bents:</b> BENTS 2 & 3
