NC DEPARTMENT OF TRANSPORTATION  
 DIVISION OF HIGHWAYS  
 STRUCTURE MANAGEMENT UNIT

ATTENTION: **PAR SUBMITTED, CHANGE TO STRUCTURE DATA**

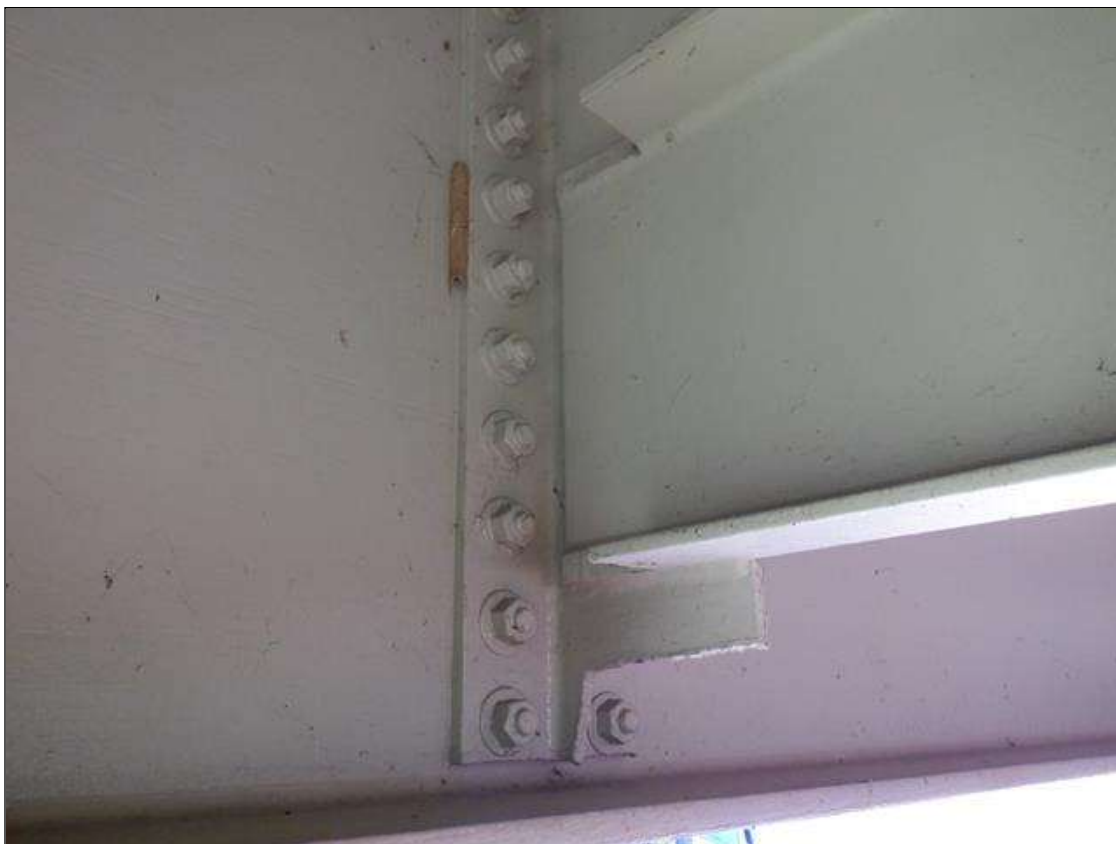
Span 1 Beam 4 : 2 INCHES HIGH OF INTERMEDIATE STIFFENER IS CUT OUT AT BOTTOM AT BOTH LOCATIONS. PAR IS NOT ISSUED AS IT APPEARS TO BE FROM PREVIOUS BRIDGE REPAIR.

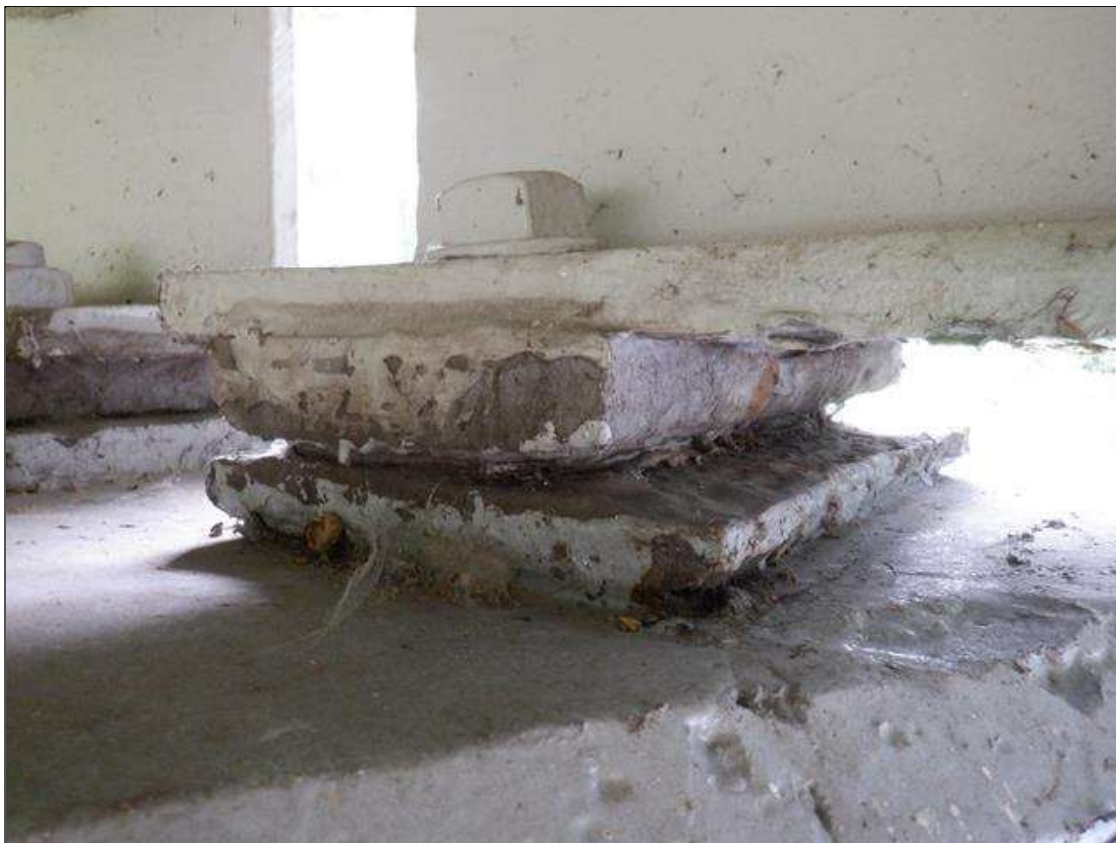
Span 1 Beam 4 - Far Bearing: SECTION LOSS EXISTS BENEATH THE PAINTED SURFACES IN BOTH MASONRY AND SOLE PLATES. UP TO 80 PERCENT SECTION REMAINING.

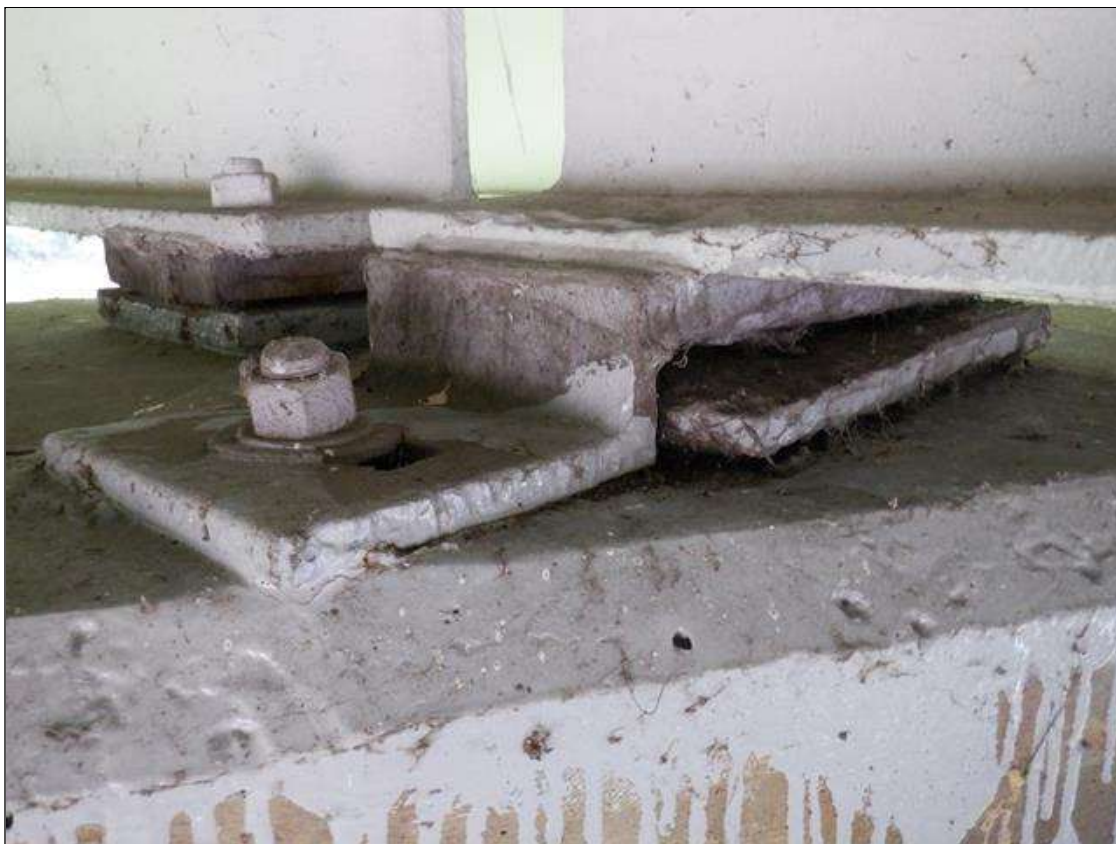
Span 1 Beam 3 - Far Bearing: WELDED REPAIR WITH ADDED ANCHOR BOLT.

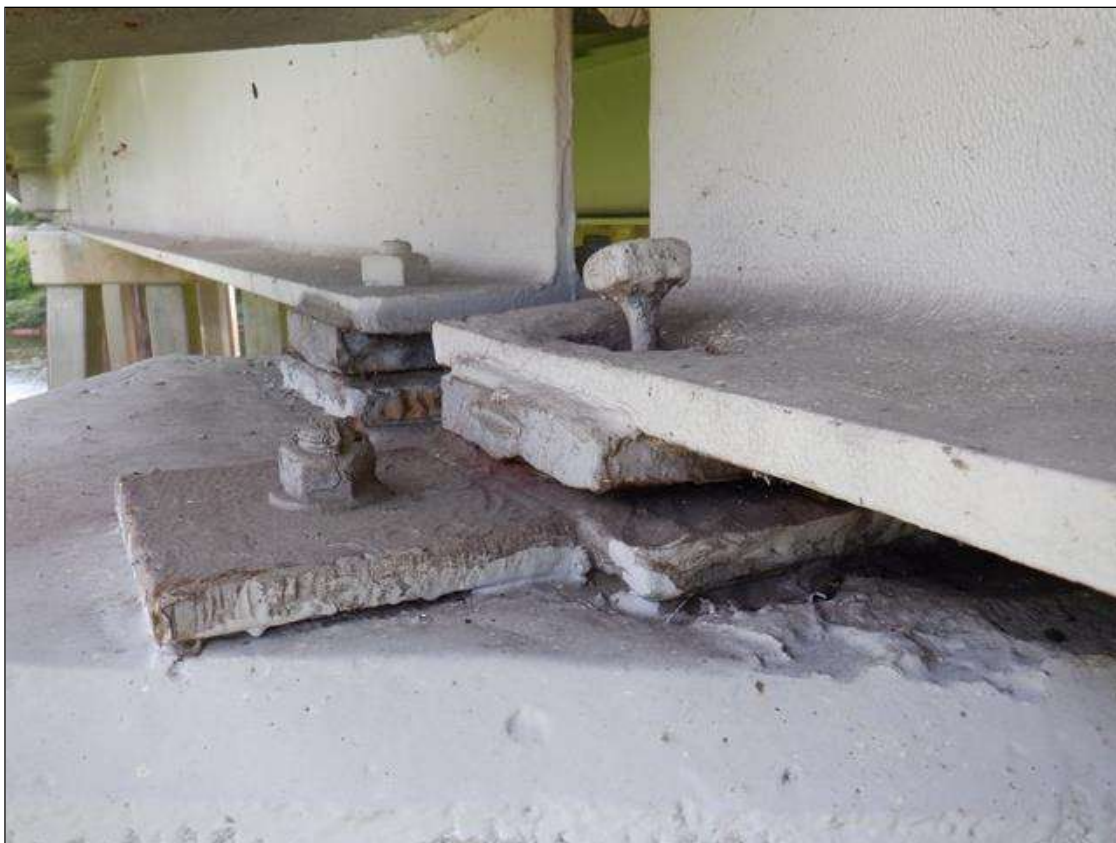
Span 1 Beam 1 - Far Bearing: WELDED REPAIR, WITH ADDED ANCHOR BOLT.

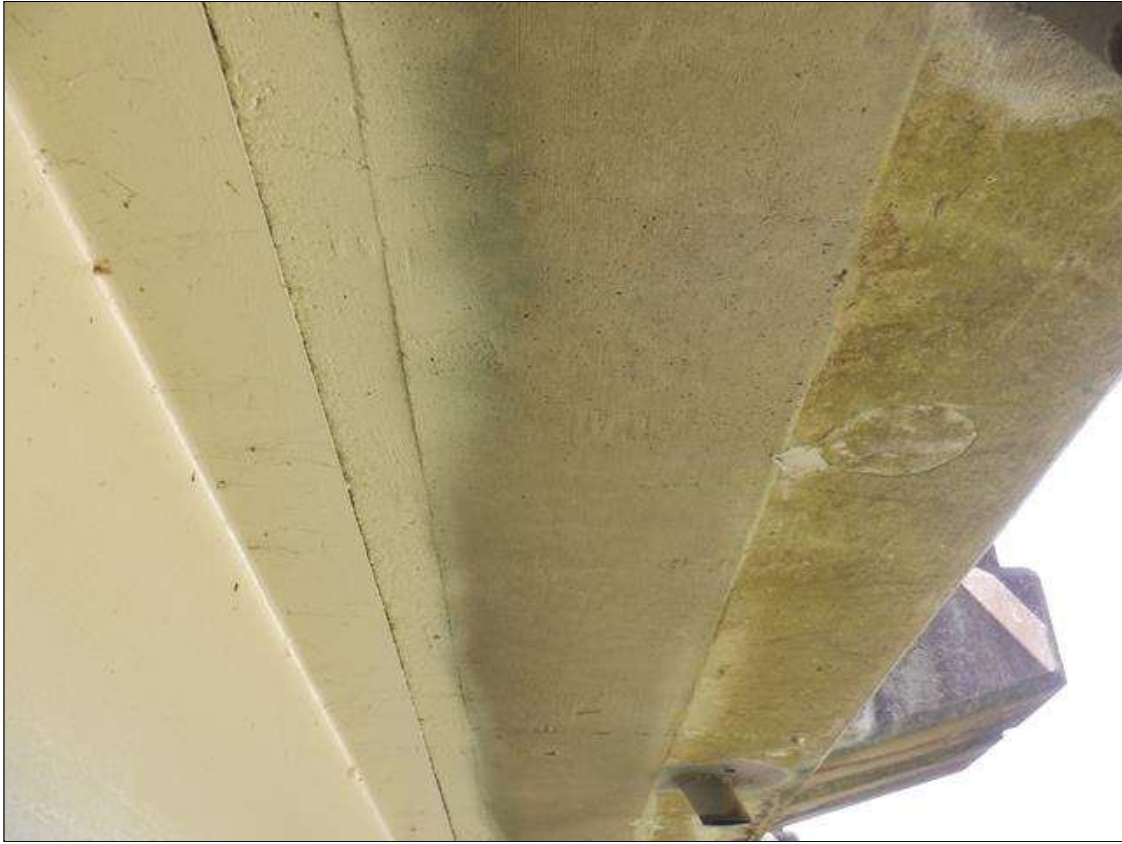
Span 1 Deck: SIX (6) UP TO 0.02 INCH WIDE TRANSVERSE CRACKS UNDER LEFT OVERHANG, SCATTERED.

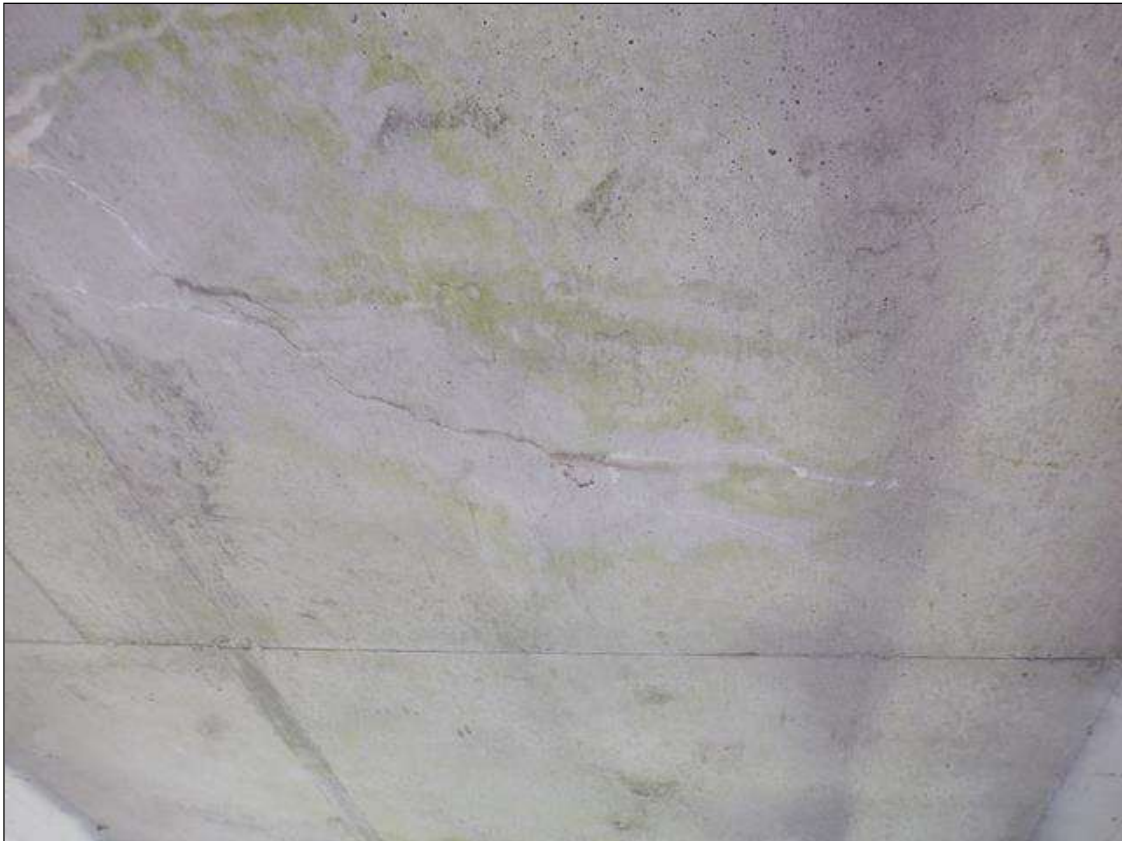
Span 1 Deck: UP TO 0.02 INCH WIDE TRANSVERSE CRACKS IN DECK UNDERSIDE IN BAY 1 BETWEEN INTERMEDIATE DIAPHRAGMS TYPICAL IN BAYS 2 AND 3.

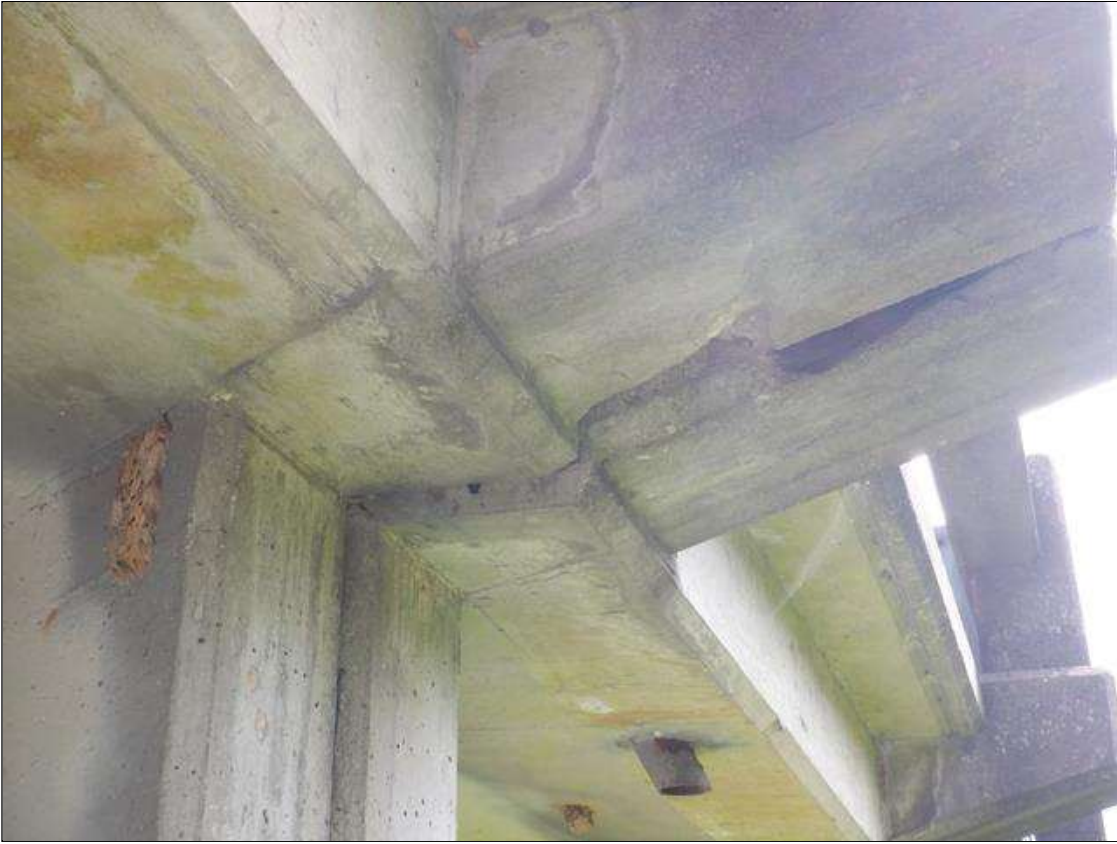
Span 1 Deck: 9 INCHES LONG X UP TO 4 INCHES WIDE X UP TO 2.5 INCHES DEEP SPALL IN RIGHT DECK OVERHANG ABOVE BENT 1.

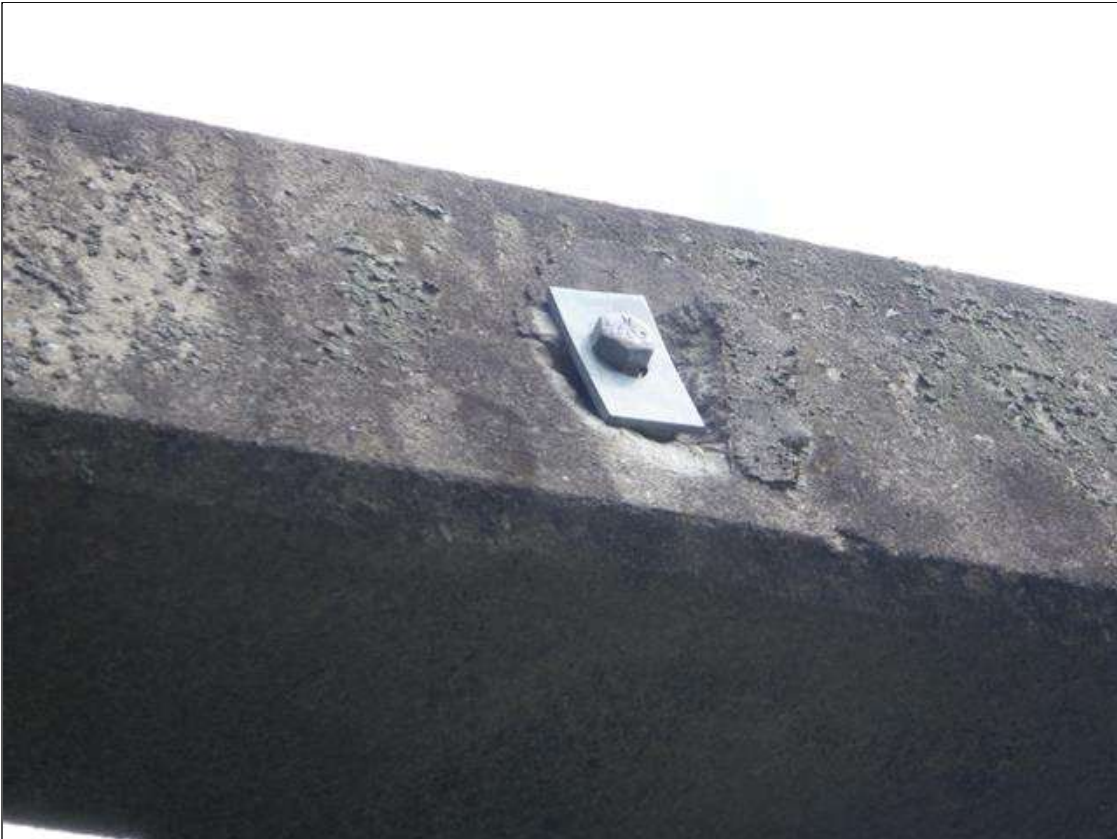
Span 1 Right Bridge Rail: UP TO 6 INCHES DIAMETER X 1.5 INCHES DEEP SPALL IN EXTERIOR FACE AT ANCHOR BOLT CONNECTION. TYPICAL AT SEVERAL CONNECTIONS.

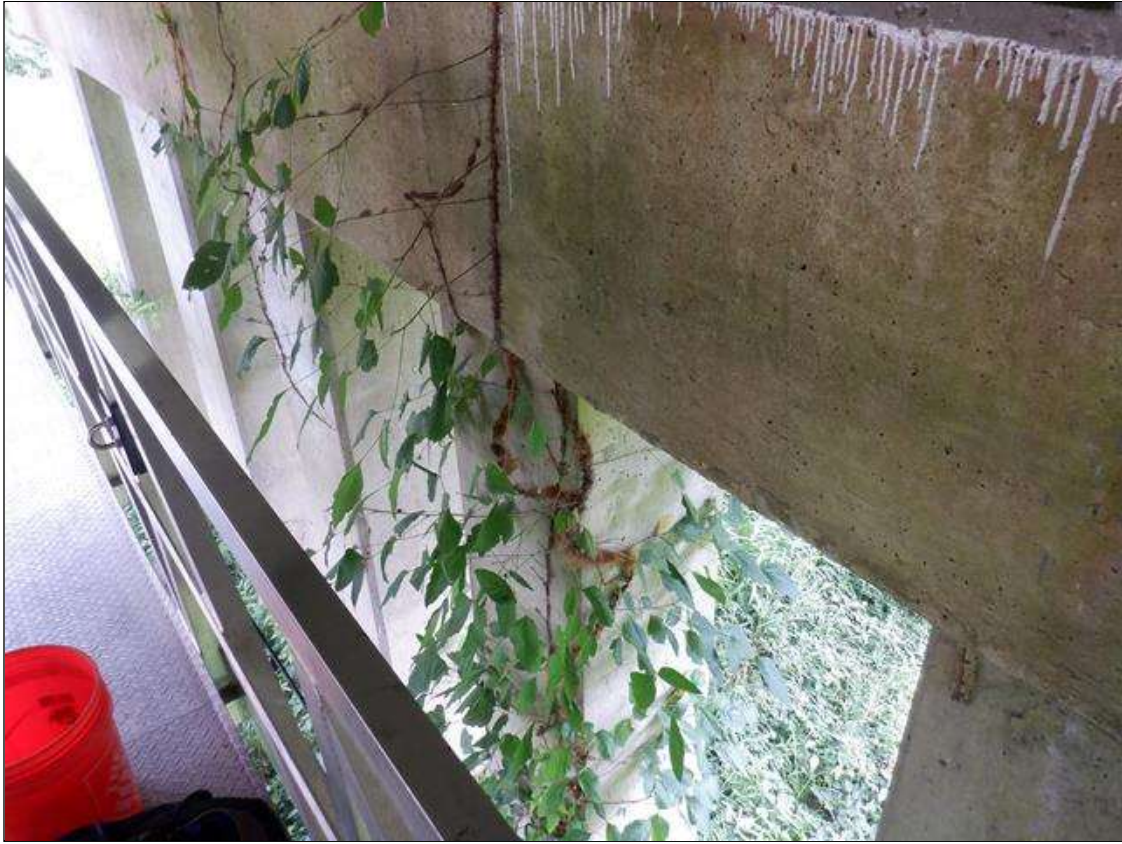
BENT 1 HAS VEGETATION GROWTH ON PILES AND CAP

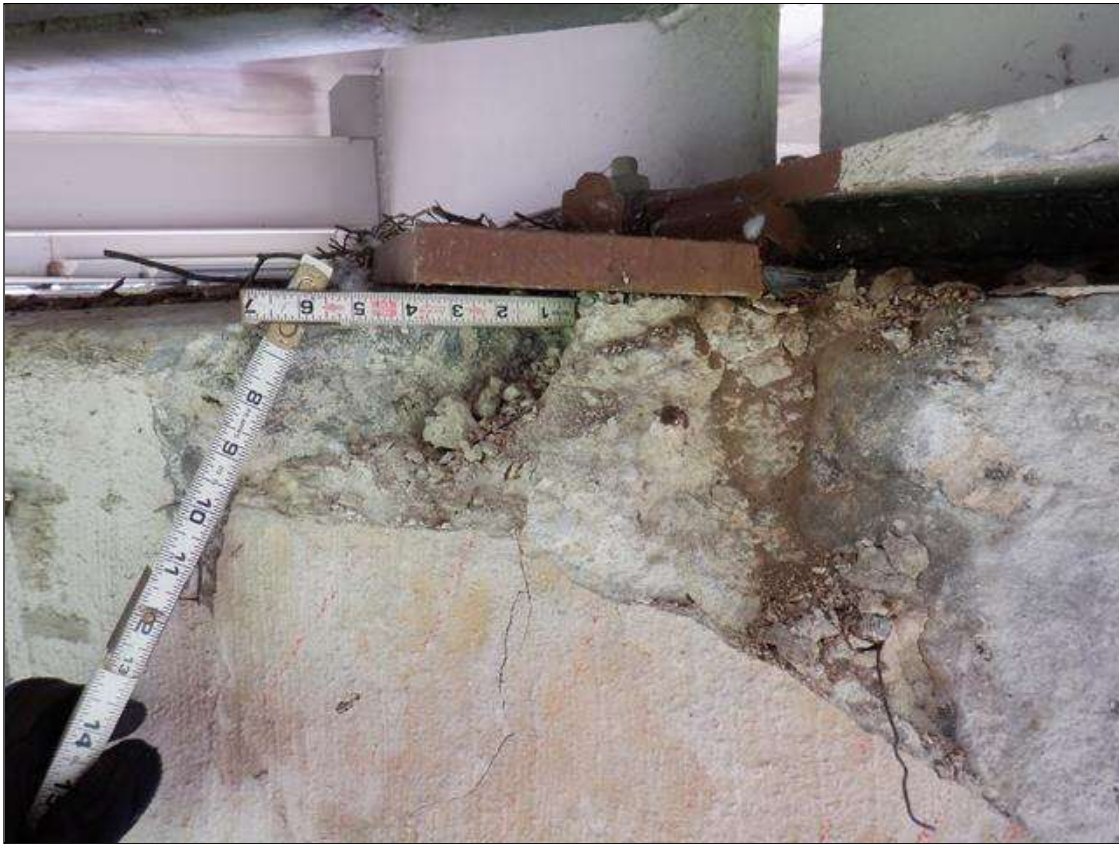
Span 4 Beam 3 - Far Bearing: PAR. ADDED BEARING HAS A LOSS OF BEARING AREA DUE TO SPALL ON CAP. AREA REPAIRED IS UNSOUND AND HAS 9 INCHES HIGH X 20 INCHES WIDE X 6 INCHES DEEP SPALLS.

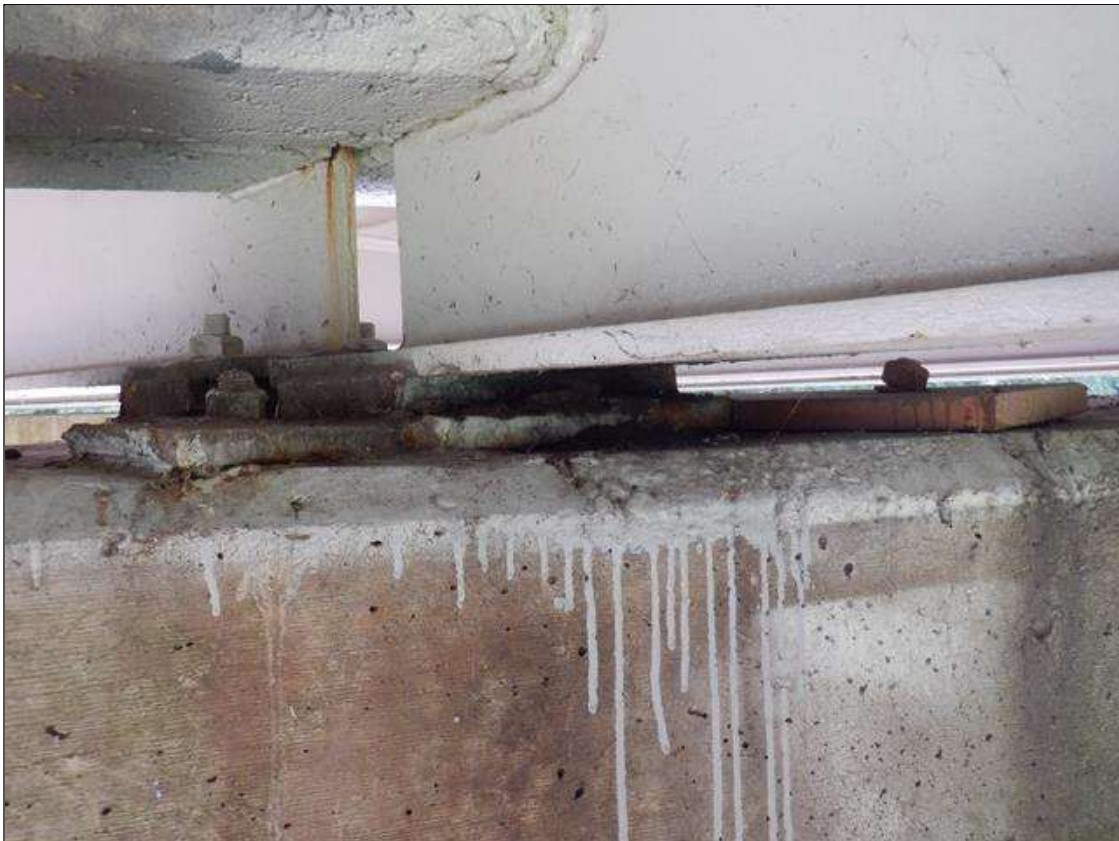
Span 4 Beam 2 - Far Bearing: WELDED REPAIR WITH ADDED ANCHOR BOLT.

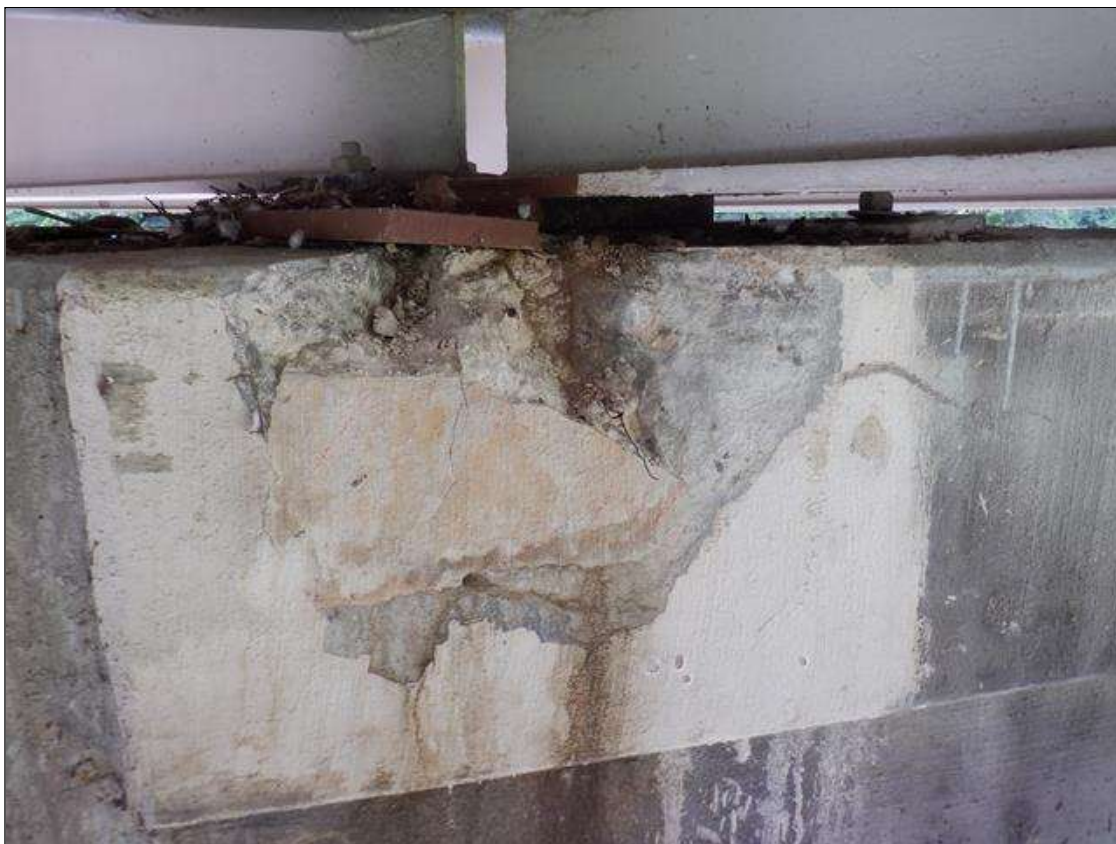
Bent 4 Cap 1: SOUTH FACE BELOW BEAM 3 UNSOUND PATCHED AREA WITH SPALLING 4 FEET X 18 INCHES, SPALLS 18 INCHES X 8 INCHES X 6 INCHES.

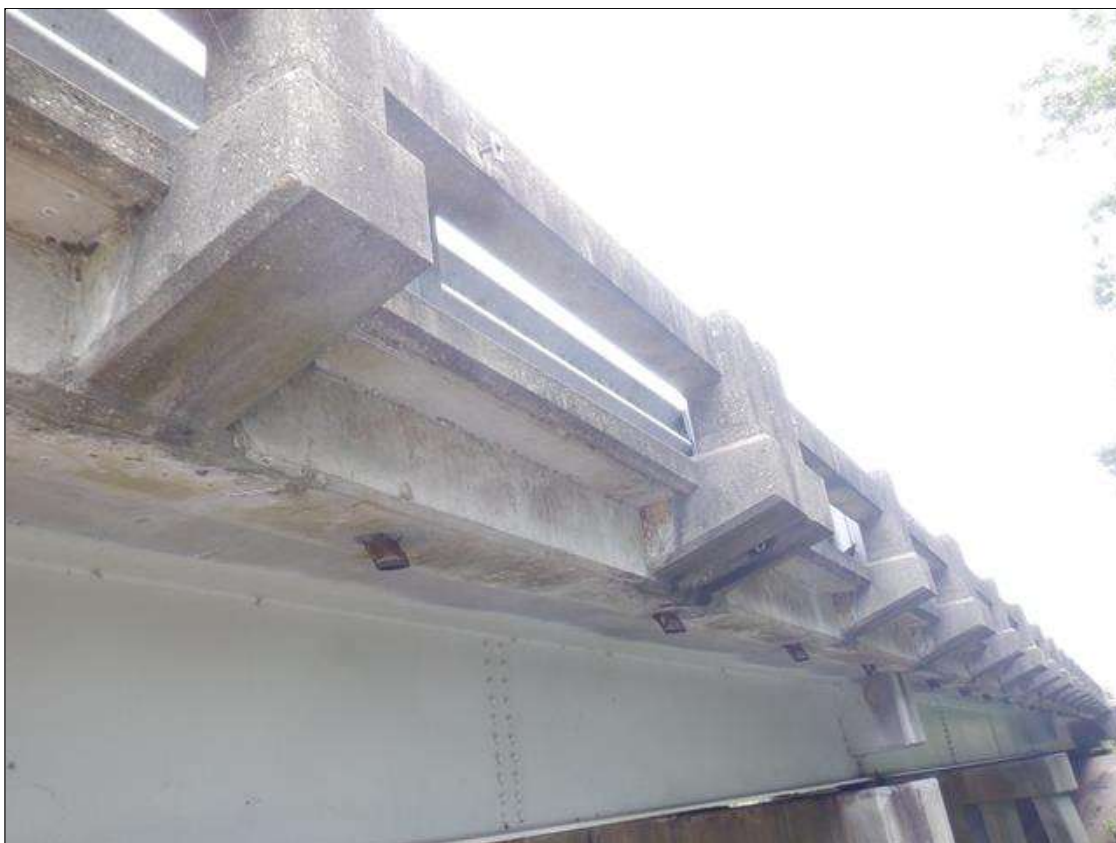
Span 6 Right Retrofit Bridge Rail: PAR. ADJACENT TO POSTS 5 AND 8, 2 BOLTS DISCONNECTED AND PROTRUDING ON THE OUTSIDE OF RAIL.

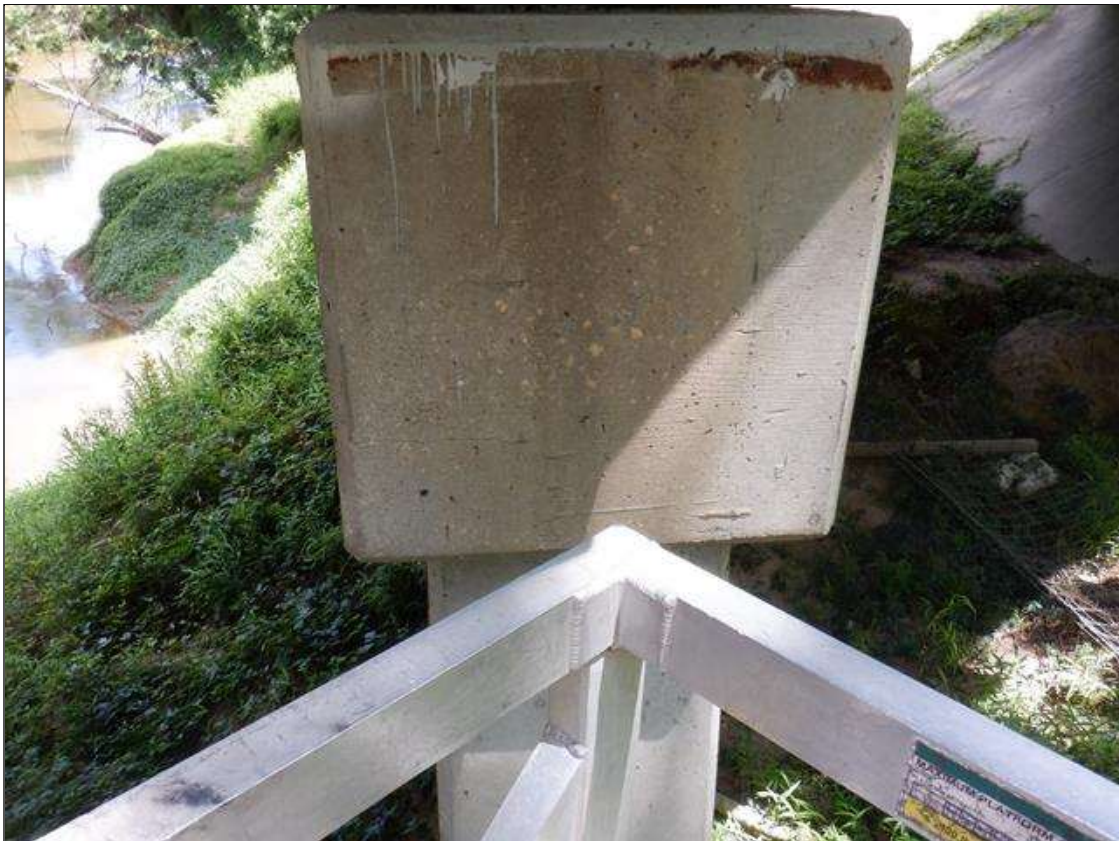
Bent 7 Cap 1: HAIRLINE HORIZONTAL CRACKS IN BOTH ENDS

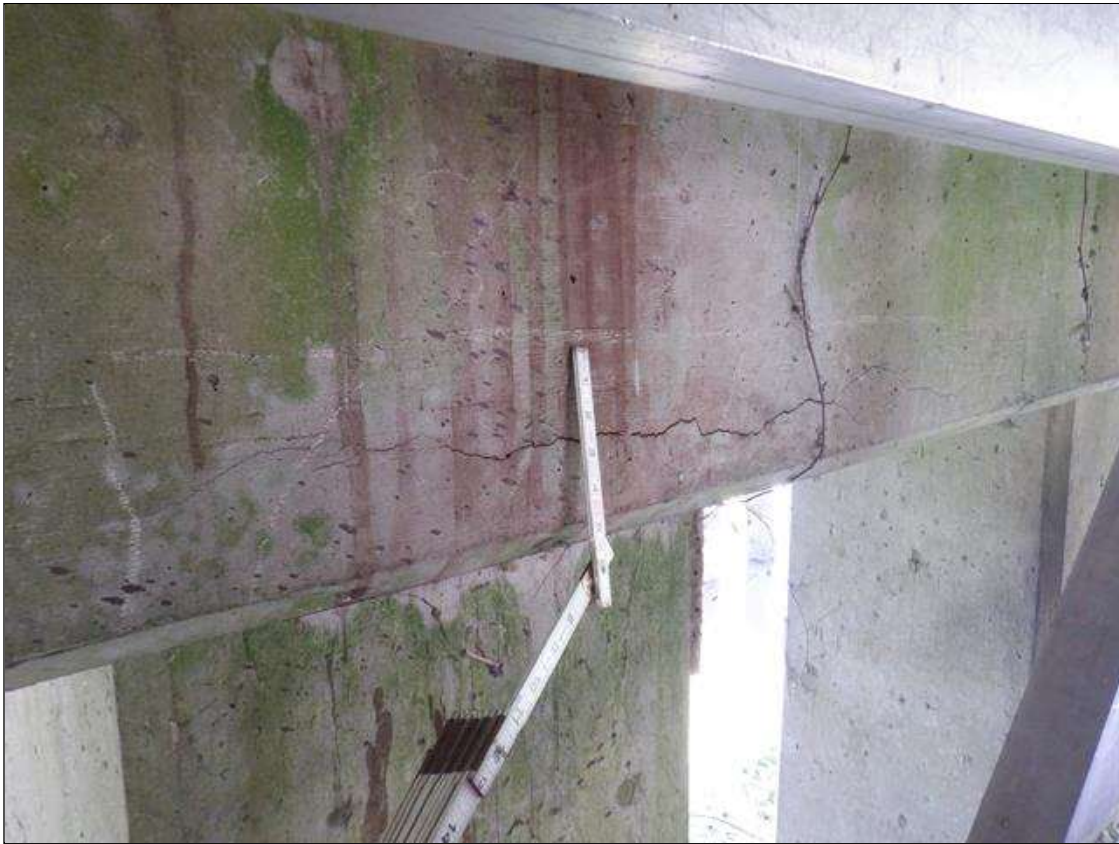
Bent 7 Cap 1: 3 FEET WIDE X 6 INCHES HIGH DELAMINATION WITH A 3 FEET LONG HORIZONTAL CRACK UP TO 1/16 INCH WIDE BOTTOM OF NORTH FACE, OVER PILE 3.

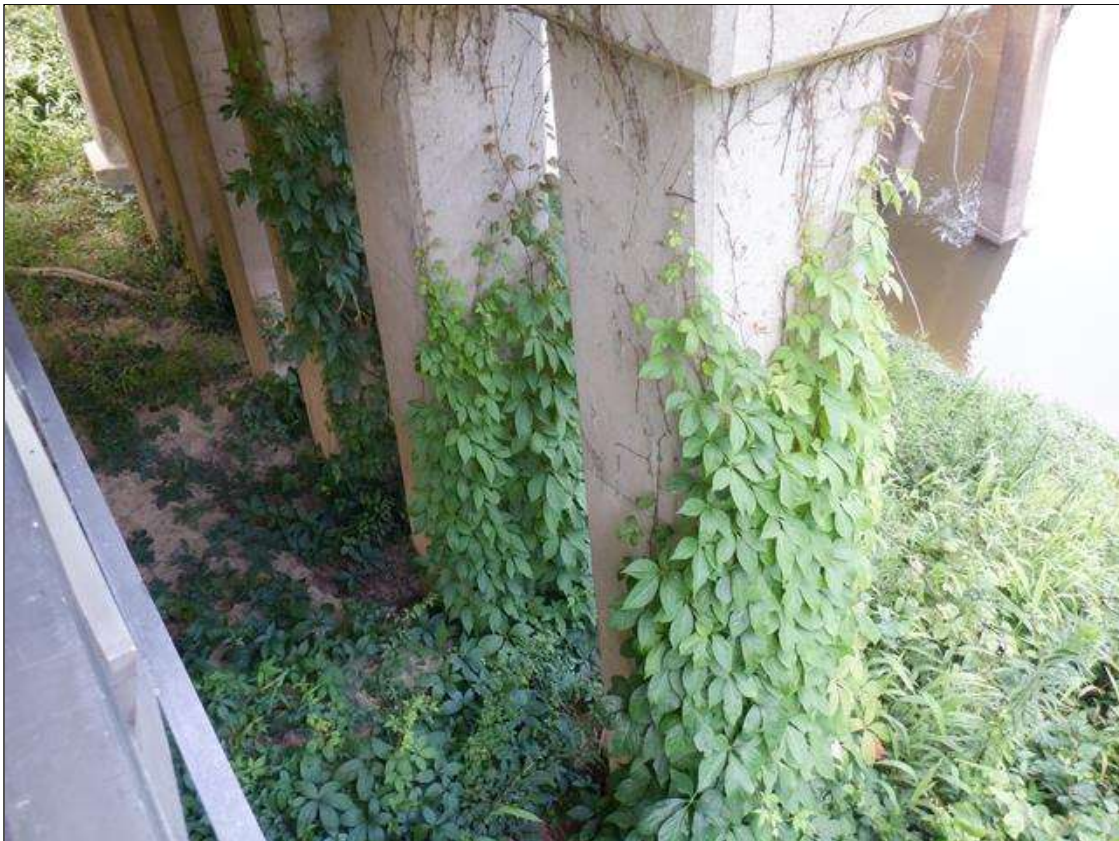
BENT 7 PILES 1 THROUGH 6 HAVE VEGETATION GROWTH UP TO FULL HEIGHT

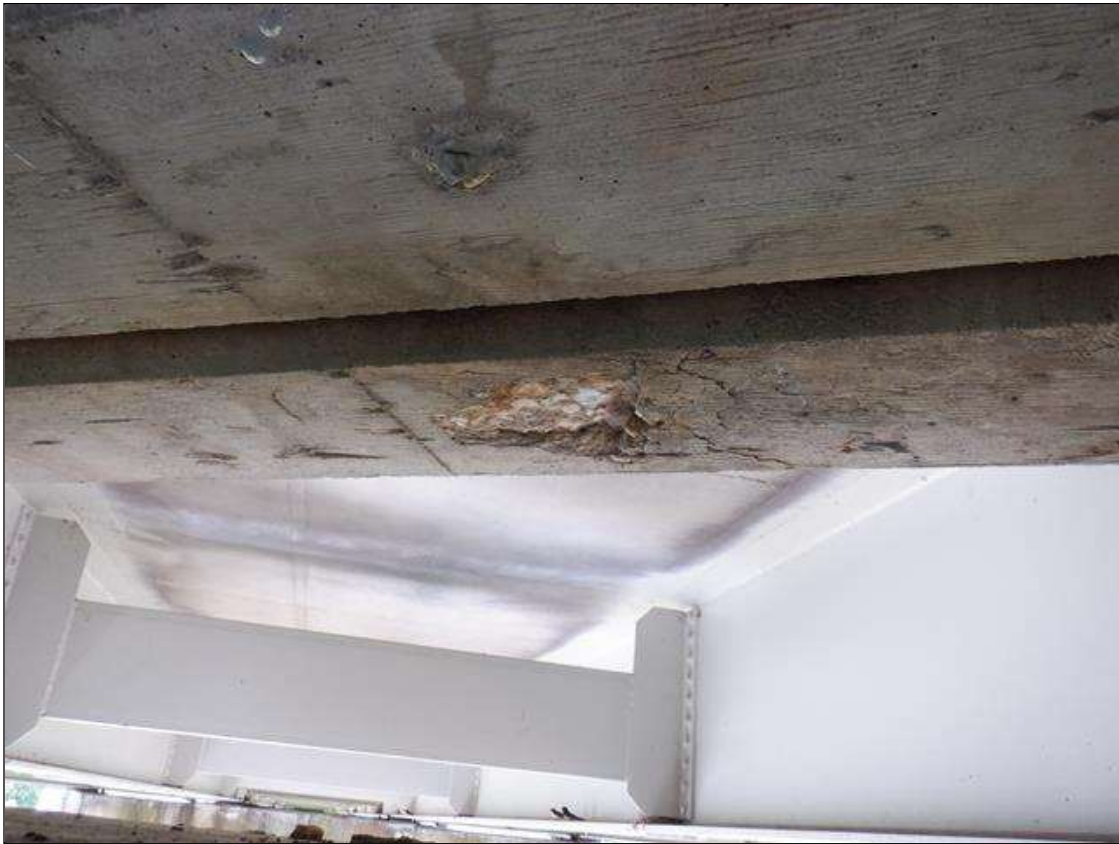
Span 5 Deck: 6 INCHES DIAMETER X 3/4 INCH DEEP SPALL IN INTERMEDIATE DIAPHRAGM IN BAY 2 ABOVE BENT 5.

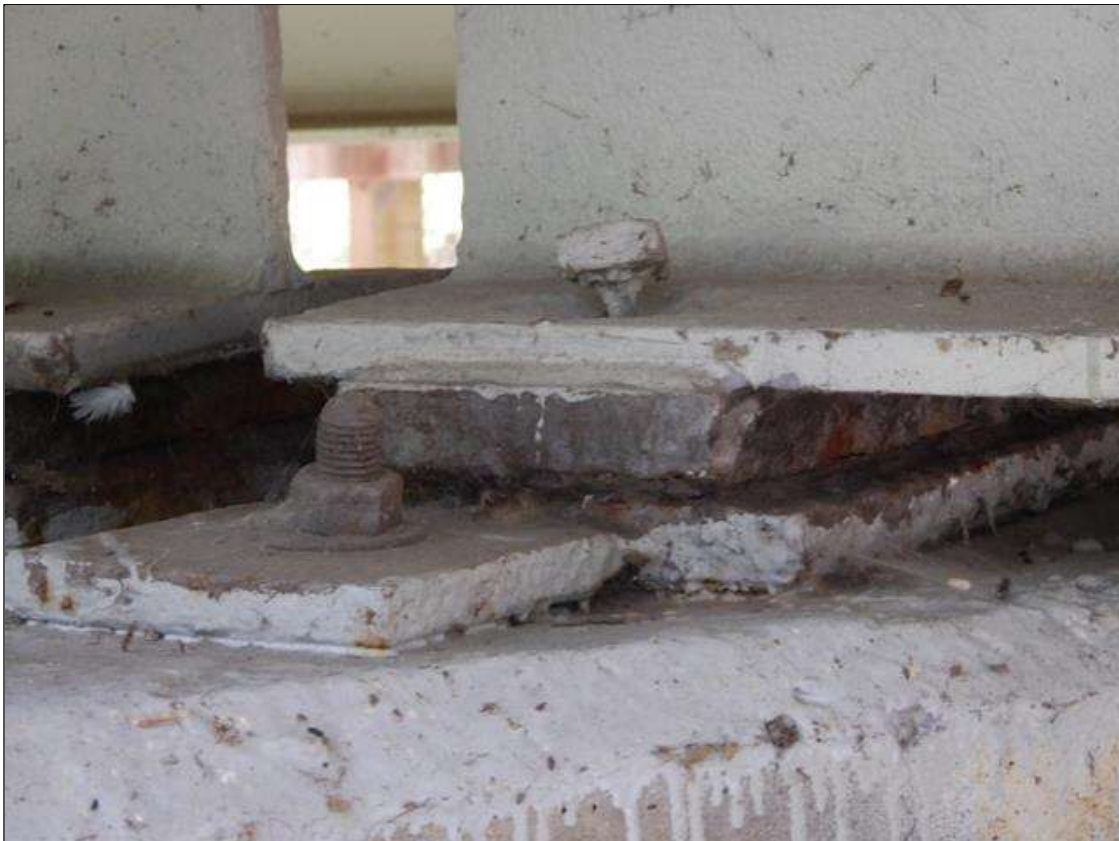
Span 8 Beam 4 - Near Bearing: SECTION LOSS EXISTS BENEATH THE PAINTED SURFACES IN BOTH MASONRY AND SOLE PLATES. UP TO 95 PERCENT SECTION REMAINING.

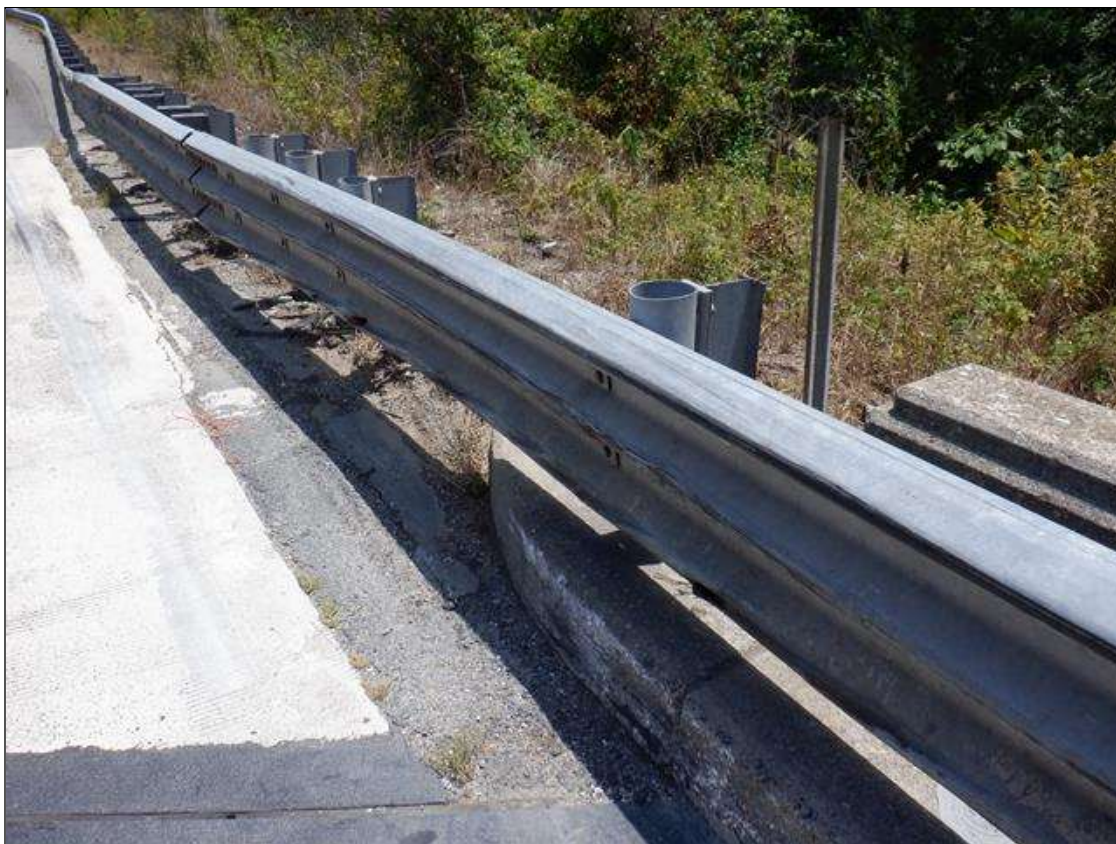
PAR. AT NORTHEAST CORNER IMPACT DAMAGE TO GUARDRAIL 50 FEET X UP TO 6 INCHES DEFLECTION.

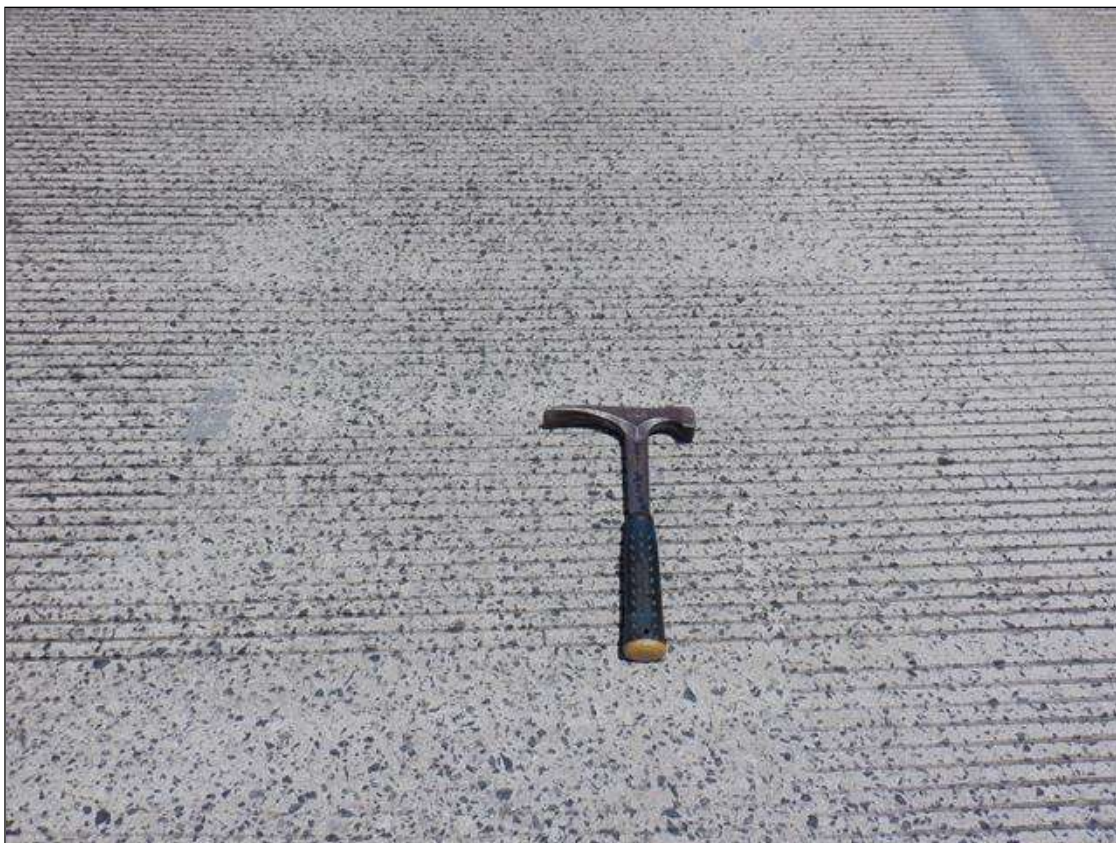
Span 8 Deck: MINOR ABRASION WITH EXPOSED AGGREGATE ALONG THE WHEEL PATHS FOR FULL LENGTH

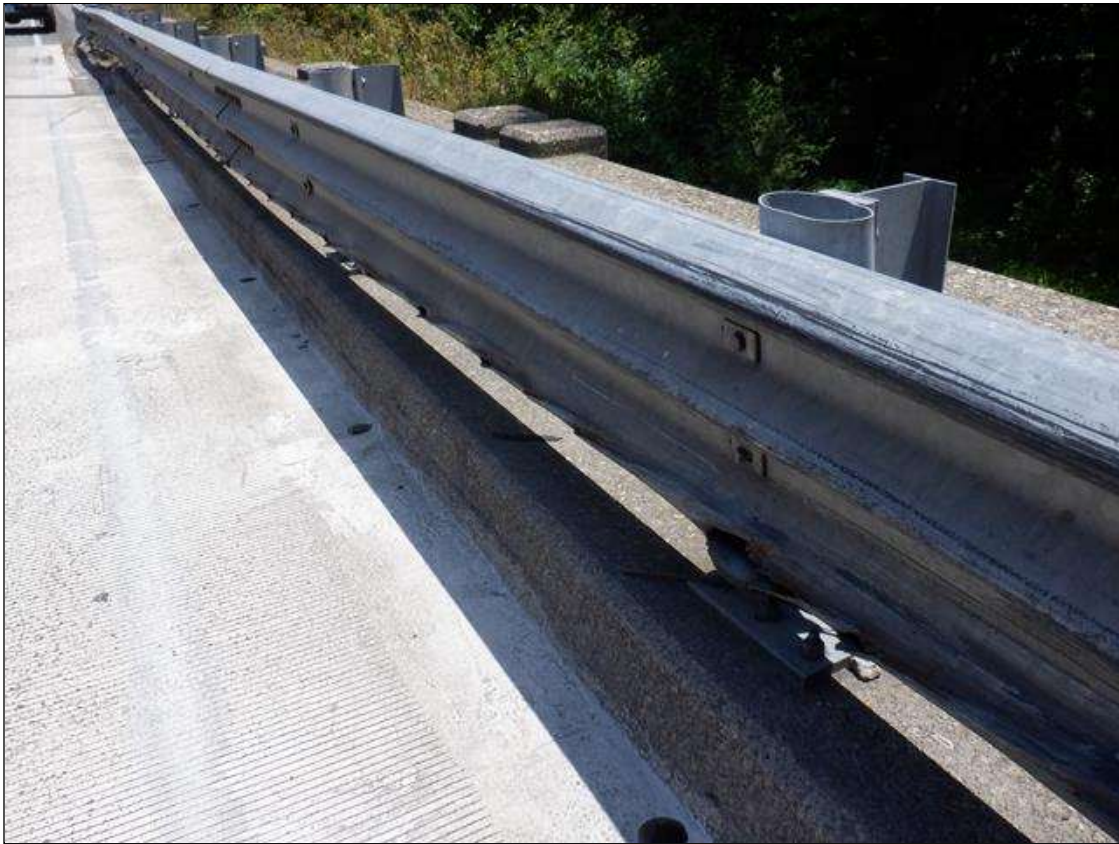
Span 8 Right Retrofit Bridge Rail: PAR, HEAVY IMPACT DAMAGE WITH UP TO 3 INCHES LONG X 1 INCH HIGH HOLES AND DENTS IN THE BOTTOM OF THE RAIL AND DEFLECTION UP TO 5 INCHES FOR FULL LENGTH

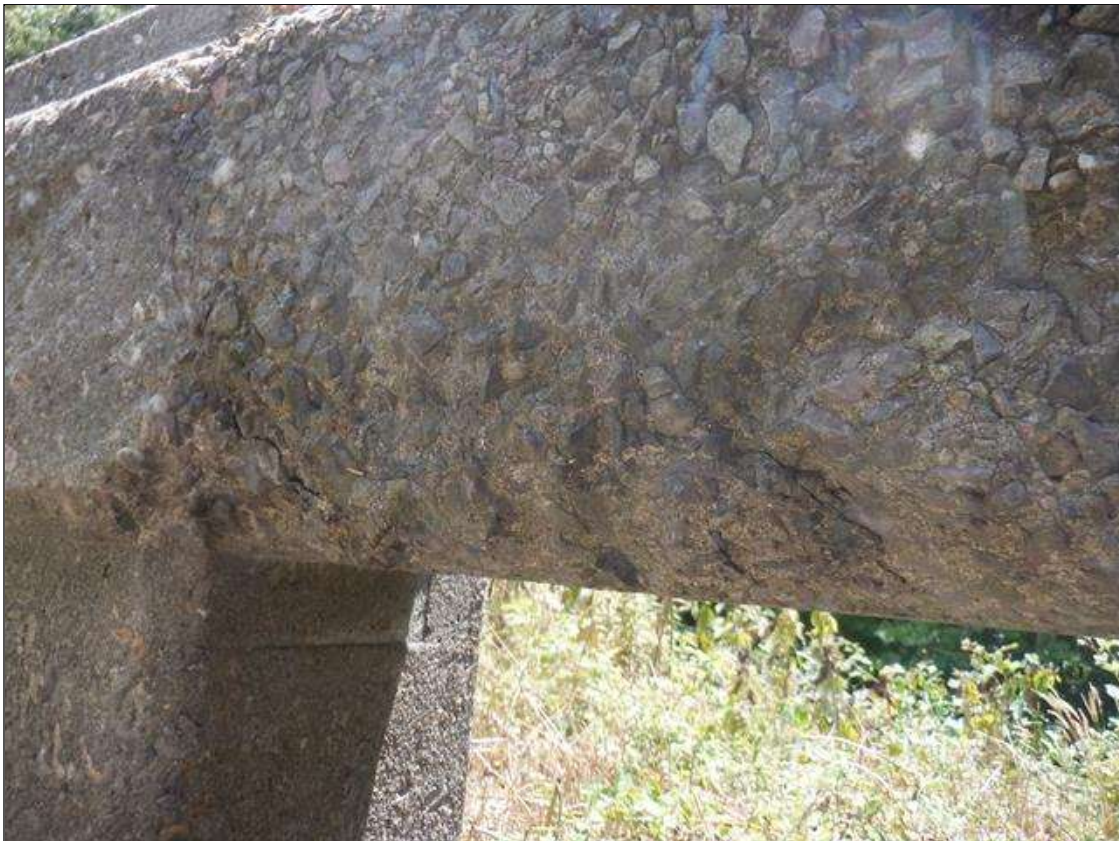
Span 8 Right Bridge Rail: 1 FOOT LONG X 4 INCHES WIDE X 1 INCH DEEP SPALL IN BOTTOM FACE AT END BENT 2

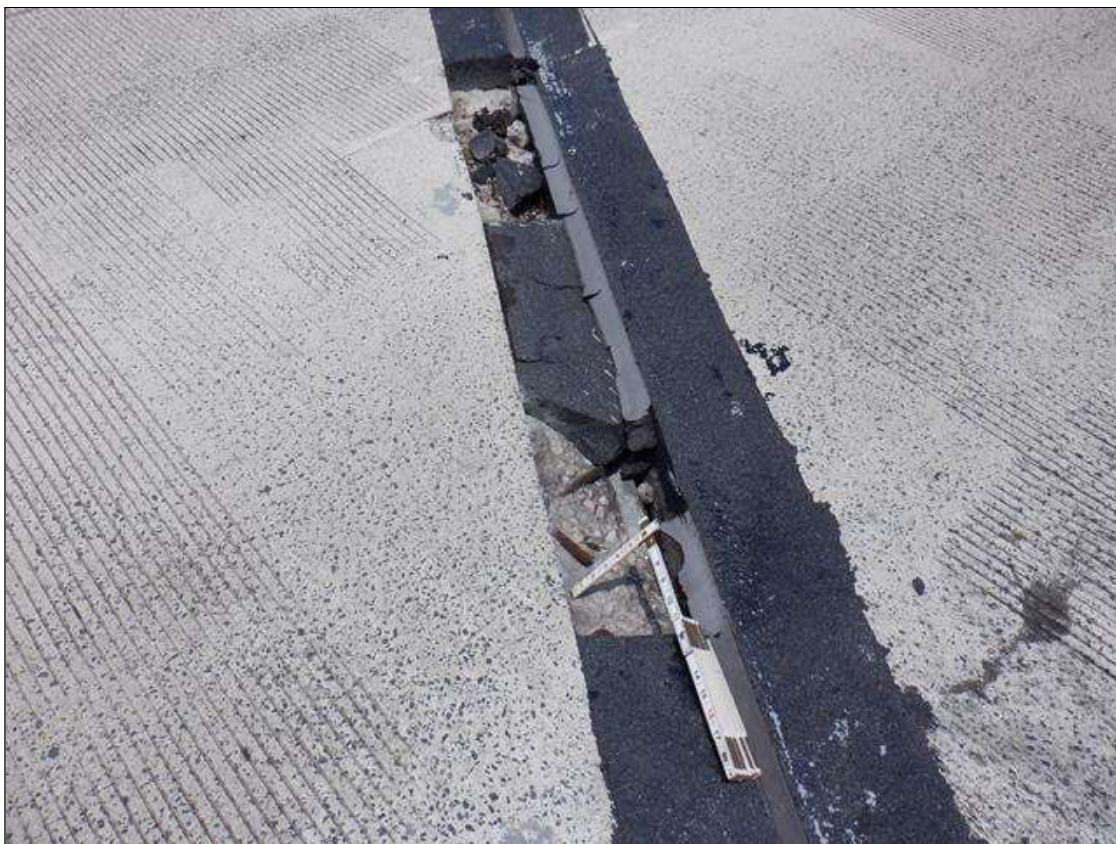
Span 7 Expansion Joint, Bent 6: PAR. IN RIGHT LANE 2 AREAS OF MISSING HEADER AND JOINT MATERIAL UP TO 2 FEET X 8 INCHES X FULL DEPTH.
