NC DEPARTMENT OF TRANSPORTATION  
 DIVISION OF HIGHWAYS  
 STRUCTURE MANAGEMENT UNIT

ATTENTION: **PAR SUBMITTED, CHANGE TO STRUCTURE DATA**

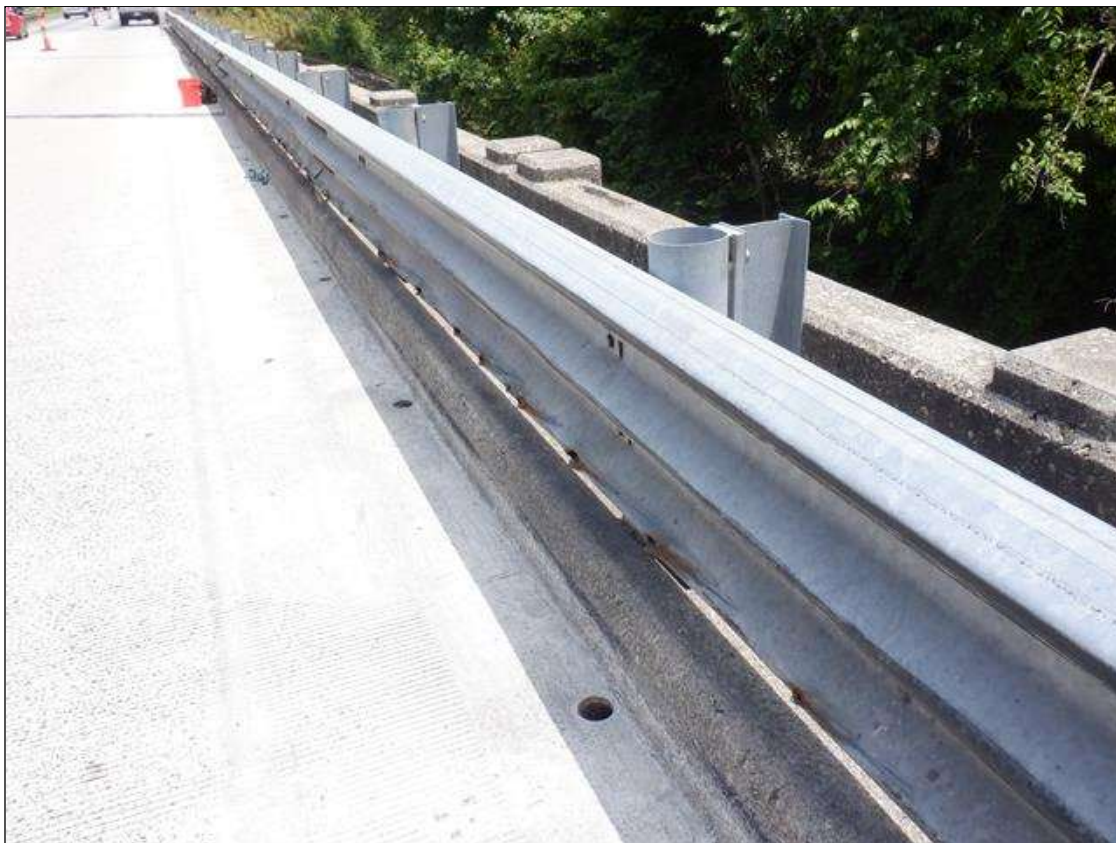
Span 6 Right Retrofit Bridge Rail: HEAVY IMPACT DAMAGE WITH UP TO 3 INCHES LONG X 1 INCH HIGH HOLES AND DENTS IN THE BOTTOM OF THE RAIL FOR FULL LENGTH

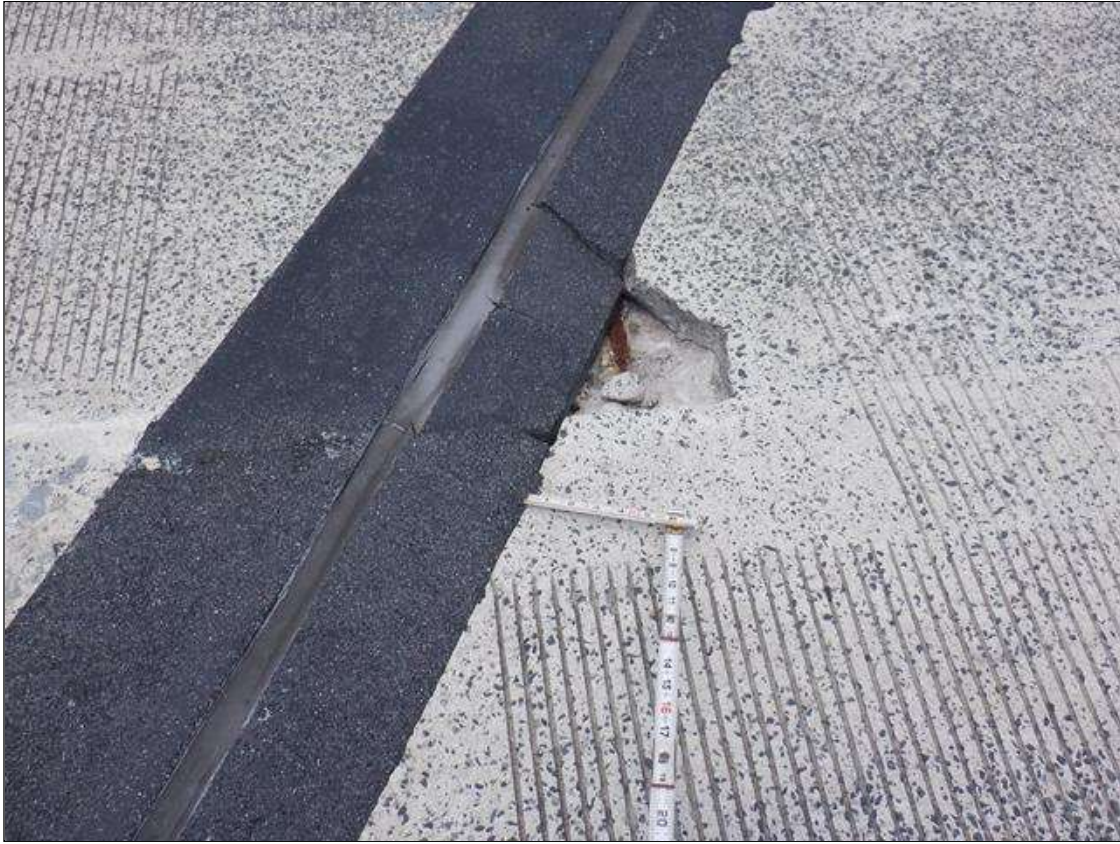
Span 6 Deck: PAR. AT CENTERLINE ADJACENT TO BENT 5, FULL DEPTH SPALL 8 INCHES DIAMETER WITH EXPOSED REBAR. NO SECTION LOSS.

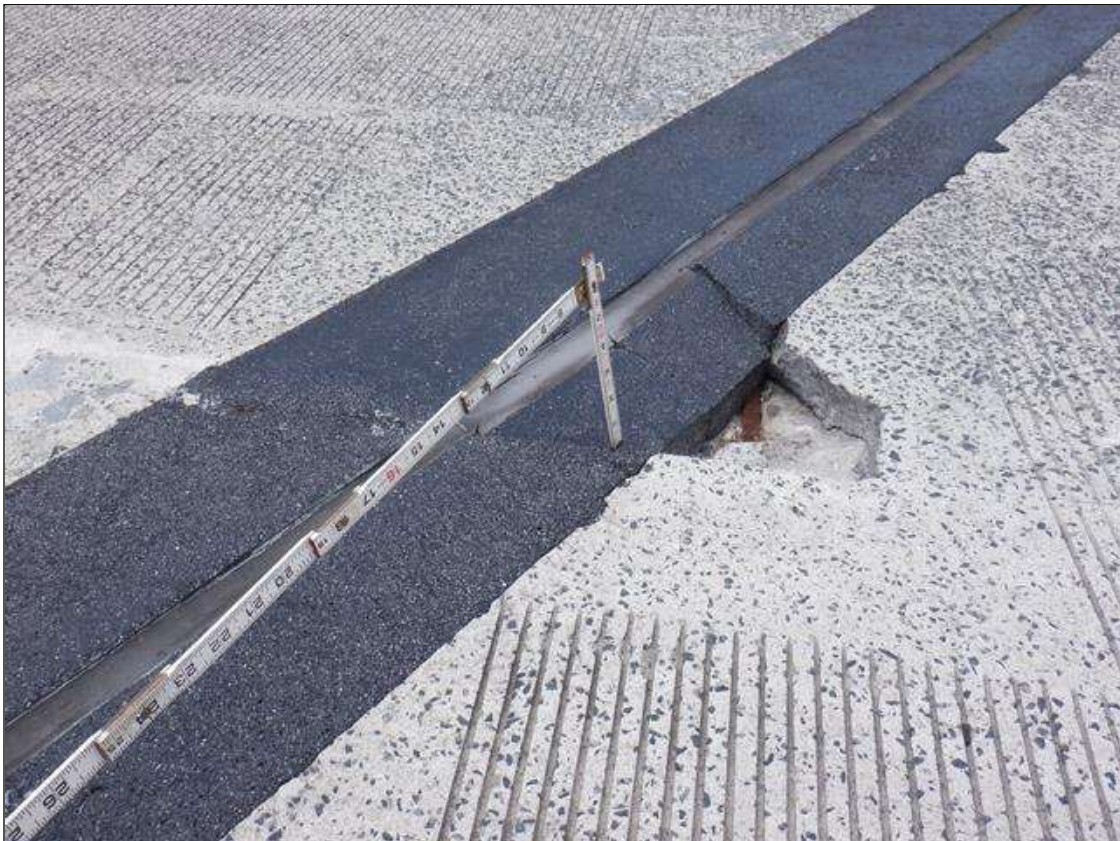
Span 6 Expansion Joint, Bent 5: ADJACENT TO DECK SPALL IN SPAN 6, 8 INCHES AREA OF HEADER DEPRESSED BY 1 INCH.

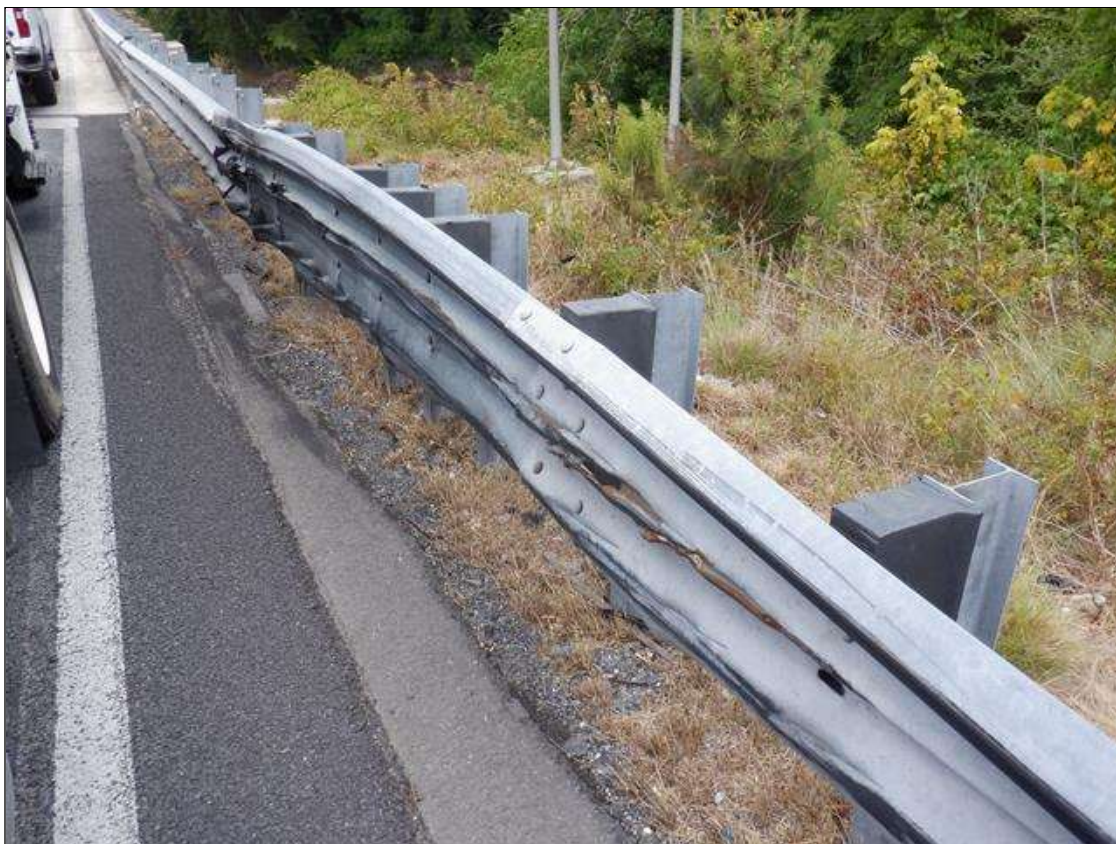
PAR. SOUTHEAST GUARDRAIL AT APPROACH HAS IMPACT DAMAGE 75 FEET LONG X UP TO 5 INCHES DEFLECTION.

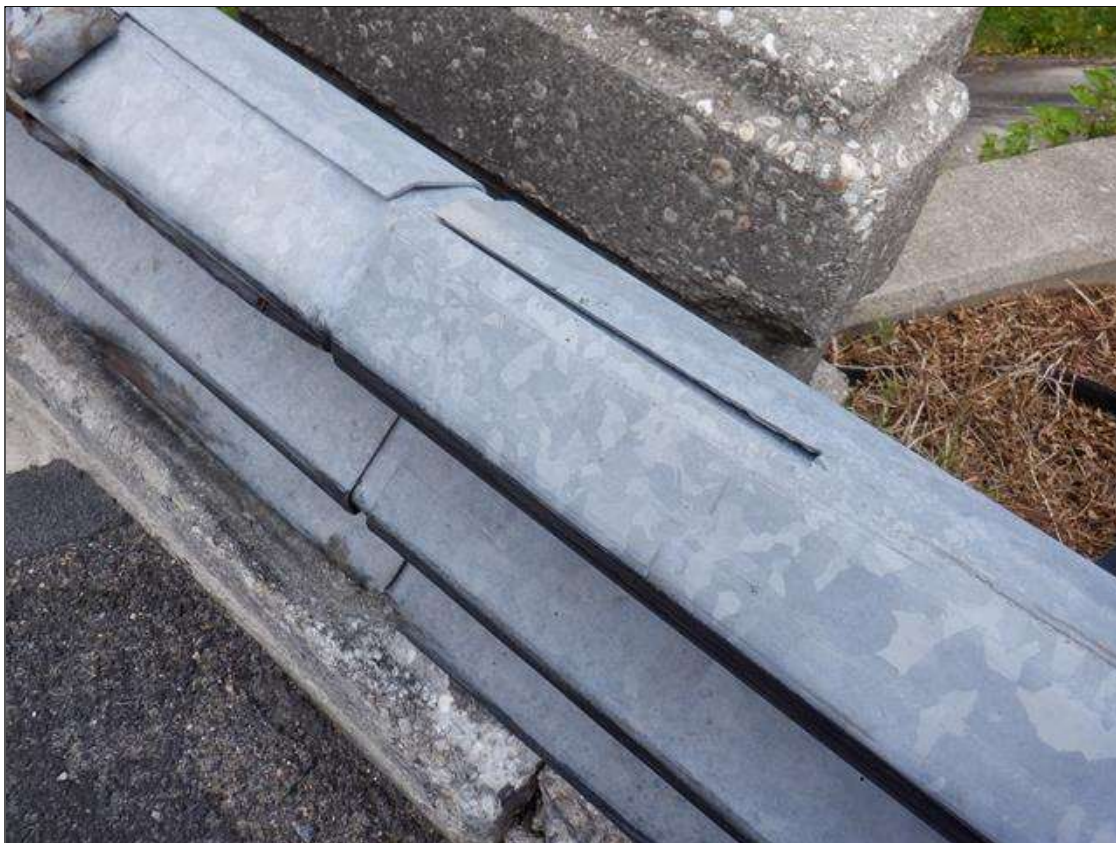
Span 1 Right Bridge Rail: AT END BENT 1, 2 SPALLS IN RAIL AND TOP OF CURB, 1 FOOT LONG X UP TO 4 INCHES X 4 INCHES

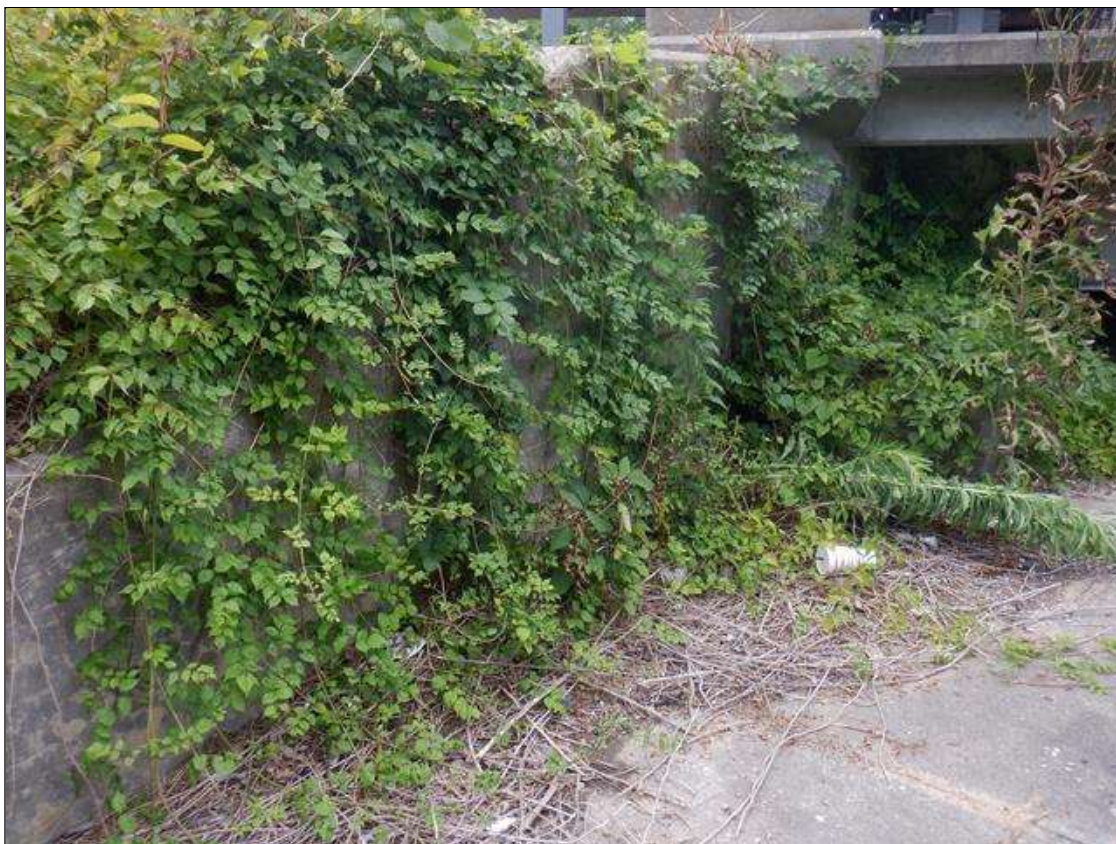
SOUTHEAST, SOUTHWEST, AND NORTHWEST WINGWALL HAVE VEGETATION GROWTH ALONG FULL LENGTH.

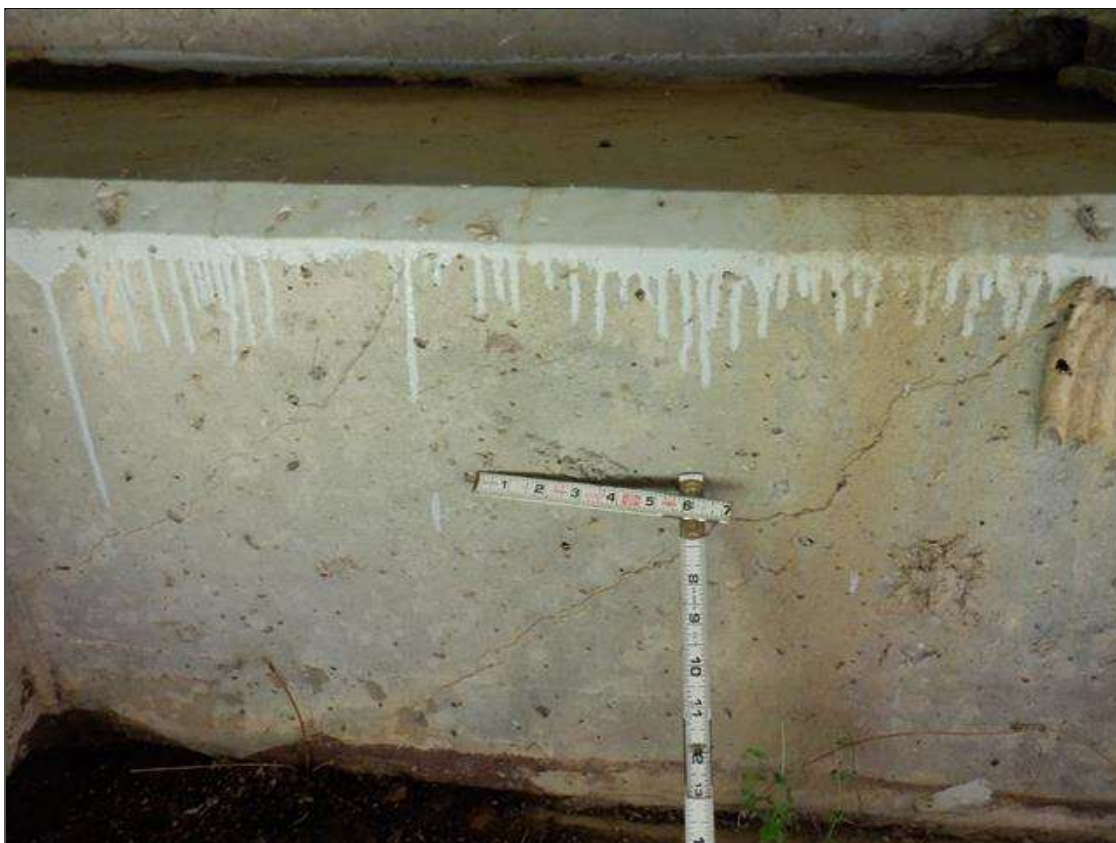
End Bent 1 Cap 1: TWO (2) 2 FEET LONG X 0.03 INCH WIDE DIAGONAL CRACKS IN FACE OF CAP BELOW BAY 2.

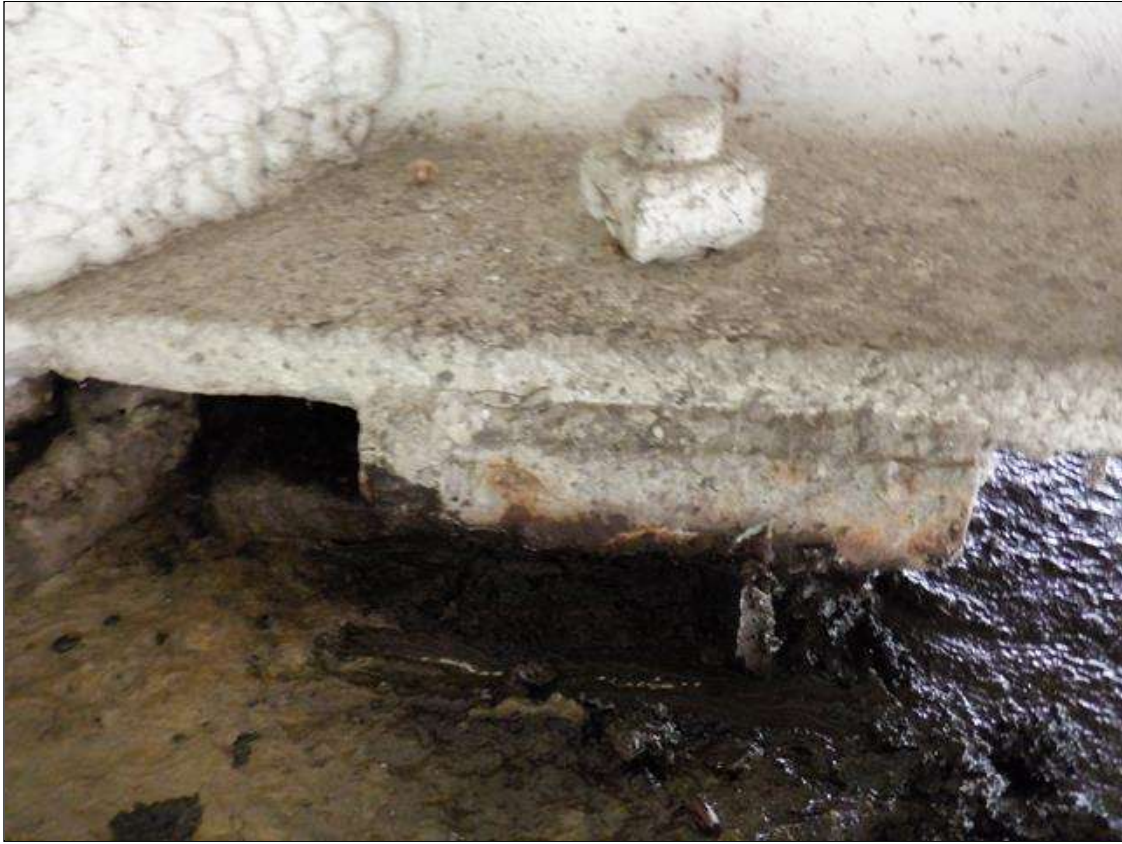
Span 8 Beam 4 - Far Bearing: UP TO 1/2 INCH MOVEMENT TOWARDS THE SOUTH LEFT HALF OF THE MASONRY PLATE.

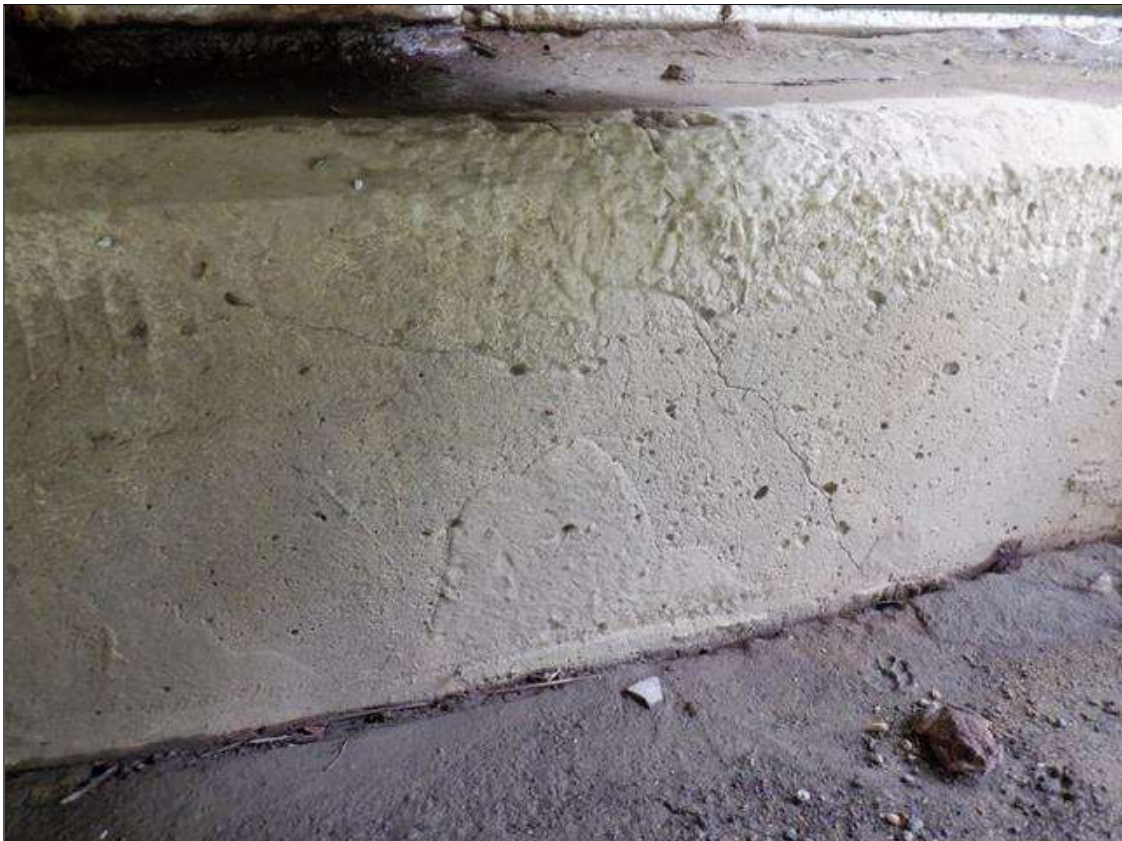
End Bent 2 Cap 1: 2 FEET HIGH X 1/16 INCH WIDE DIAGONAL CRACK UNDER BEAM 4.

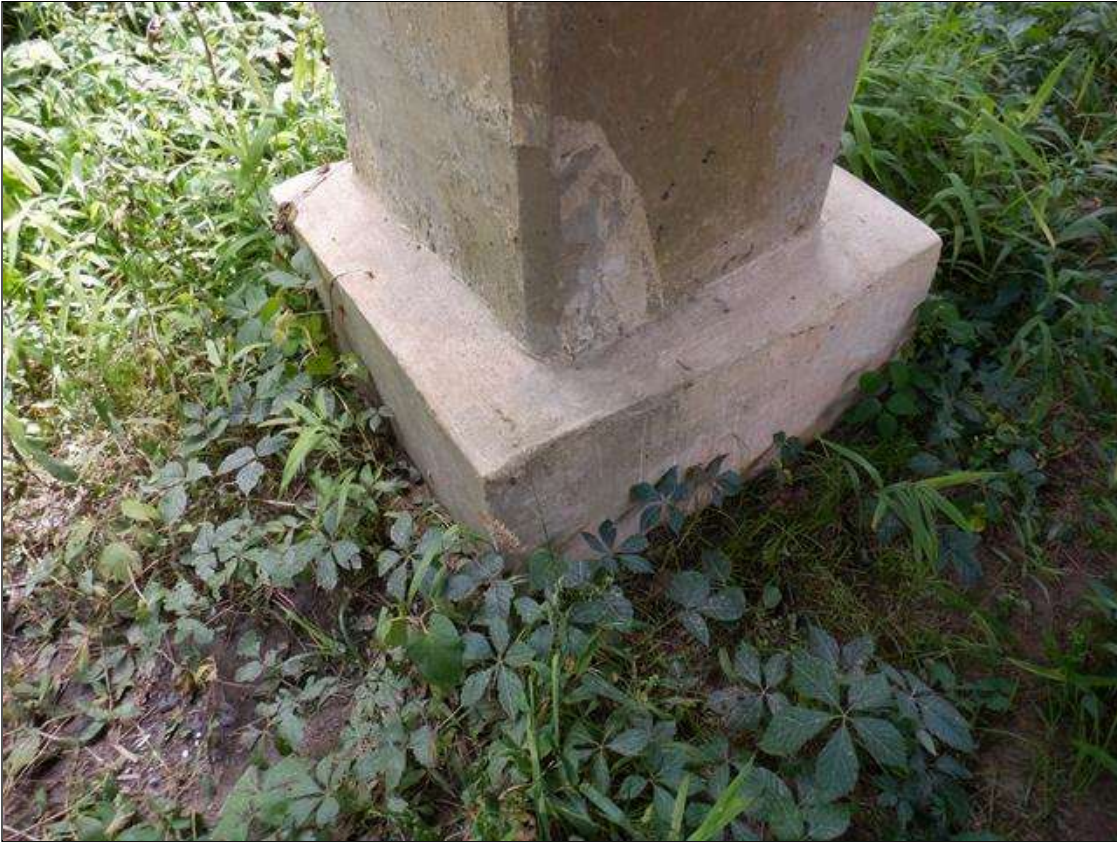
Bent 7 Pile 7: 15 INCHES WIDE X 10 INCHES HIGH AREA OF THE SOUTH FLANGE EXHIBITS HEAVY SURFACE CORROSION WITH SECTION LOSS ON WEB AND FLANGES OF EXPOSED STEEL PILE AT GROUNDLINE. UP TO 0.50 INCH SECTION REMAINING. NORTH FLANGE AND THE WEB EXHIBIT HEAVY SURFACE CORROSION WITH NO MEASUREABLE SECTION LOSS. CONCRETE REPAIR AT BASE OF PILE COVERS STEEL PILE.

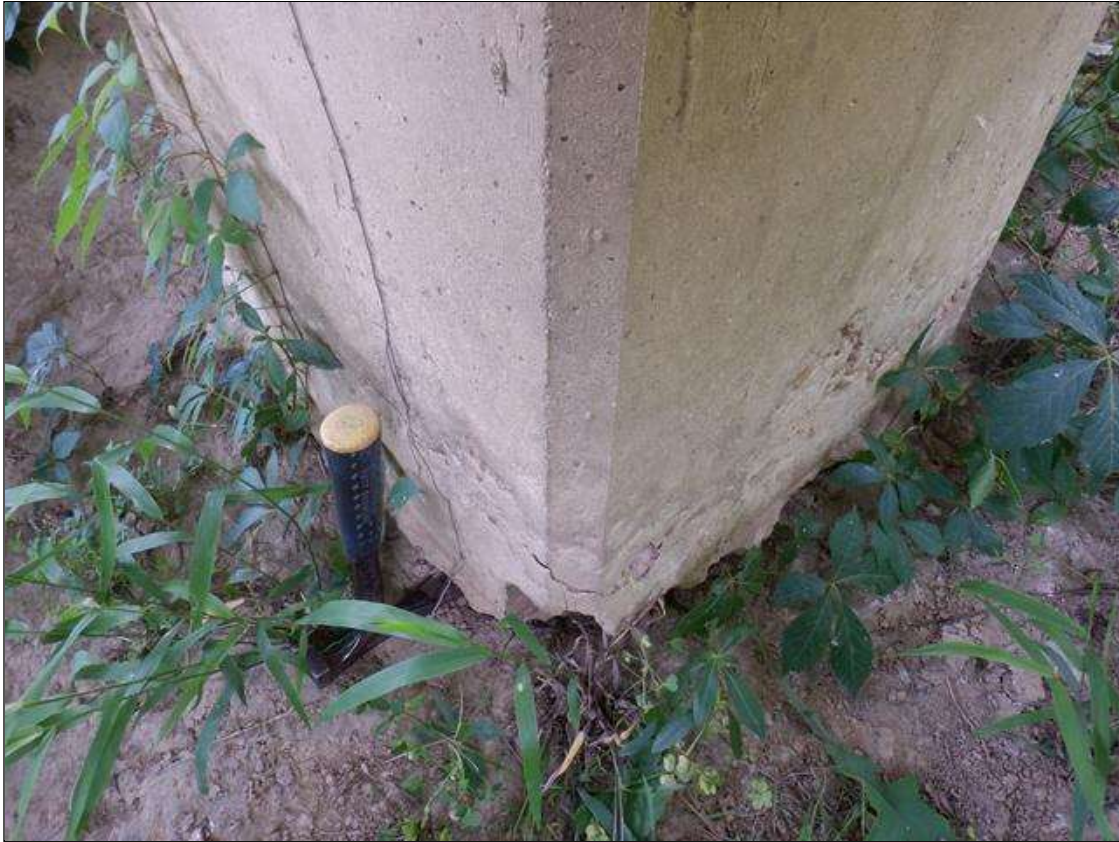
**Bent 7 Pile 6: UP TO 3 INCHES HIGH OF THE STEEL PILE EXPOSED AT THE BOTTOM EXHIBITS HEAVY SURFACE CORROSION WITH NO MEASUREABLE SECTION LOSS IN THE FLANGES AND WEB. CONCRETE REPAIR AT BASE OF PILE COVERS STEEL PILE.**

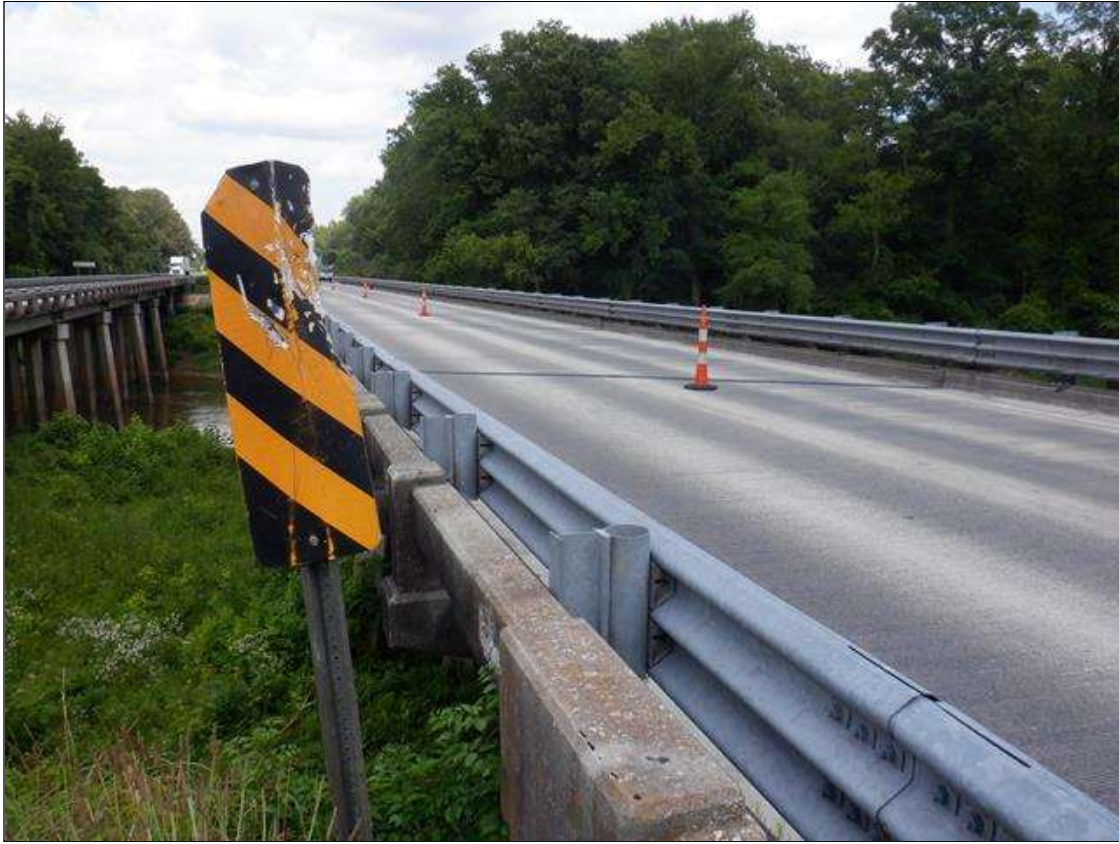
Span 1 Delineator SOUTHWEST: PAR. IMPACT DAMAGE TO SIGN WITH SCRAPING AND DISTORTIONS

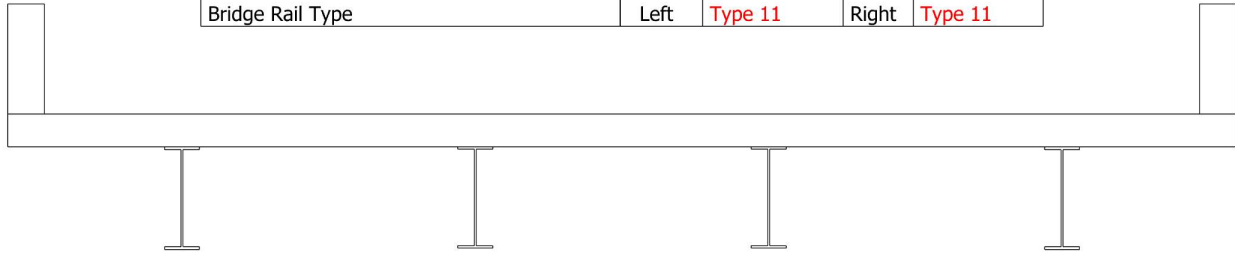
Measurements for Span #	1	ALL SPANS SIMILAR	
Deck Thickness	10.74in	Left Overhang	4.75ft
Top of Rail to Bottom of Beam (Avg)	6.697ft	Right Overhang	4.75ft
