NC DEPARTMENT OF TRANSPORTATION  
 DIVISION OF HIGHWAYS  
 STRUCTURE MANAGEMENT UNIT

ATTENTION: **PAR SUBMITTED, CHANGE TO STRUCTURE DATA**

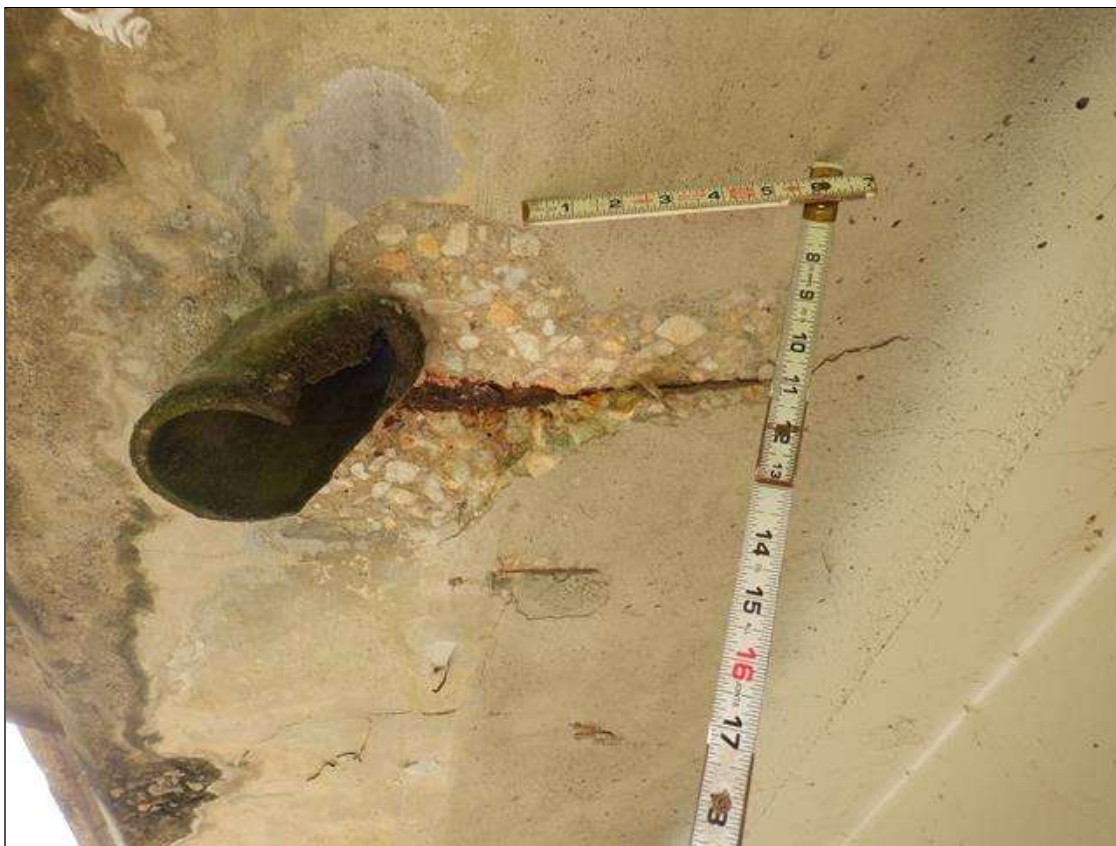
Span 1 Deck: PAR. UP TO 1 FOOT WIDE X 9 INCHES LONG X UP TO 1 INCH DEEP SPALL WITH EXPOSED REINFORCEMENT IN RIGHT OVERHANG, LOCATED AT THIRD DRAIN PIPE. 15 PERCENT SECTION LOSS IN EXPOSED REINFORCEMENT.

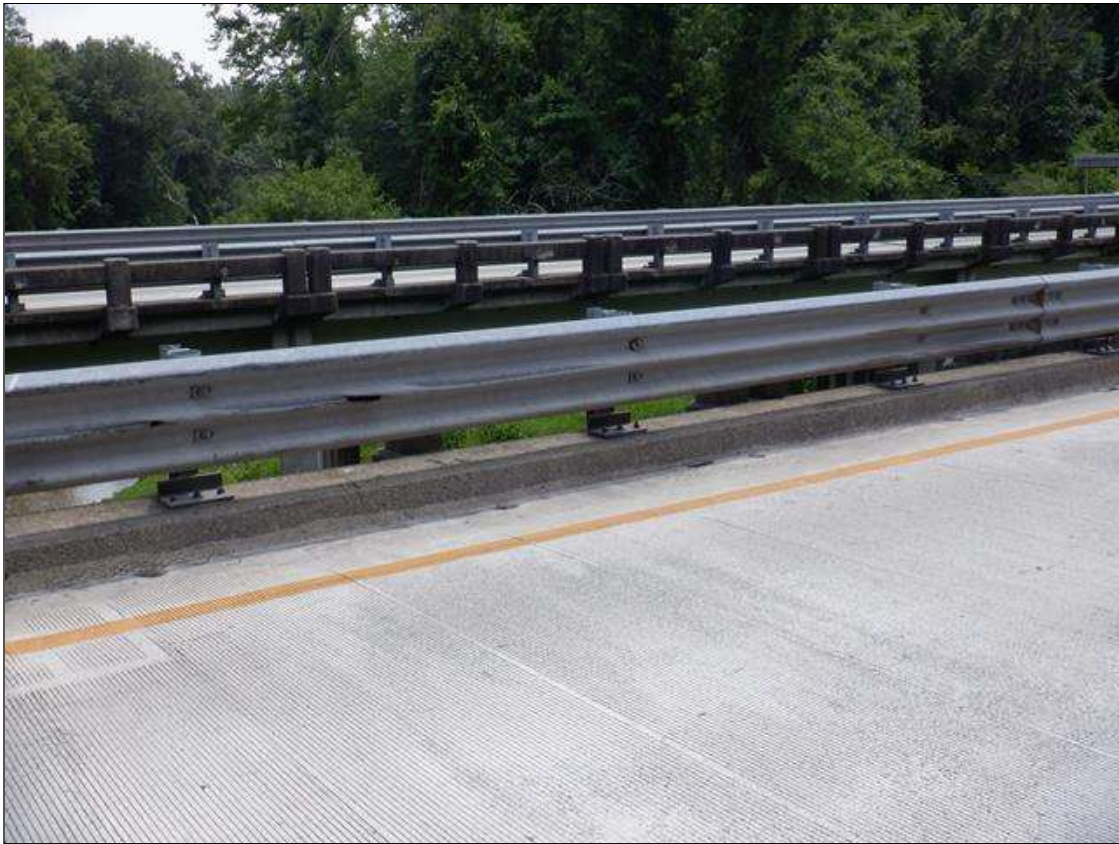
Span 2 Right Retrofit Bridge Rail: HEAVY IMPACT DAMAGE WITH SCRAPE MARKS AND THROUGH HOLES IN RETROFIT RAIL AT SCATTERED LOCATIONS

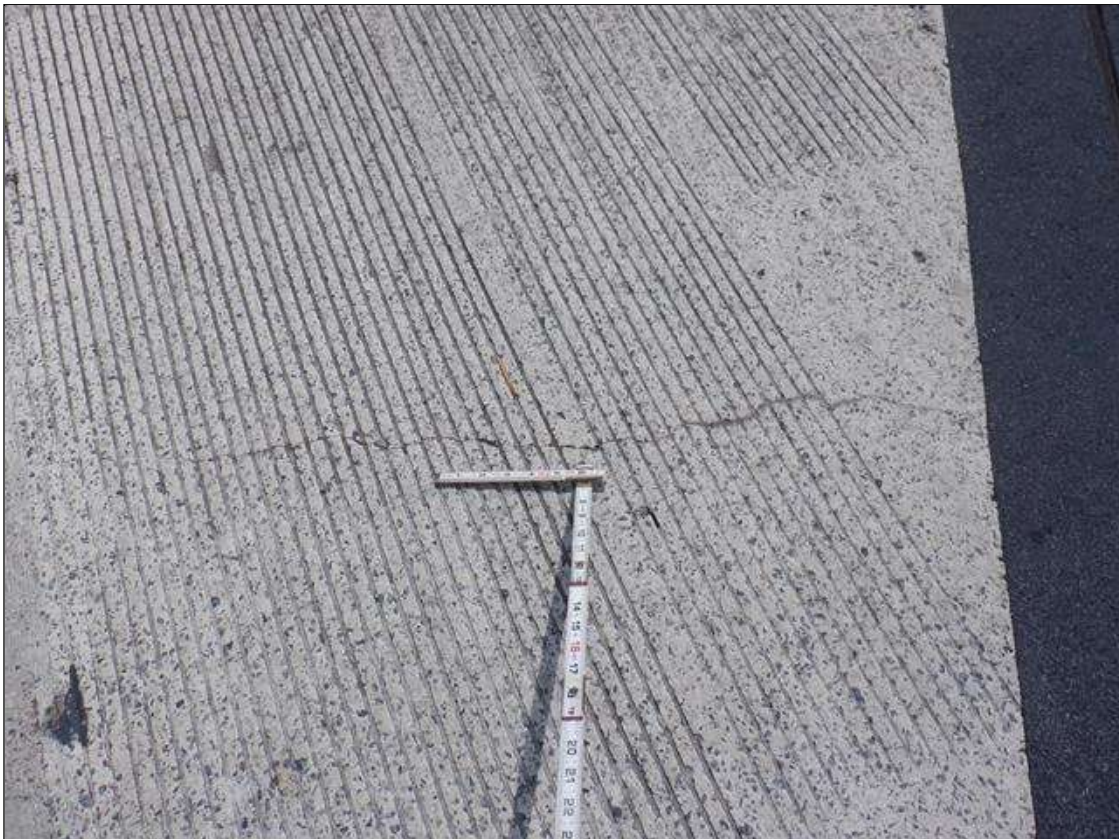
Span 1 Deck: UP TO 5 FEET LONG X 1/16 INCH WIDE LONGITUDINAL AND DIAGONAL CRACKS IN BOTH TRAVEL LANES, SCATTERED.

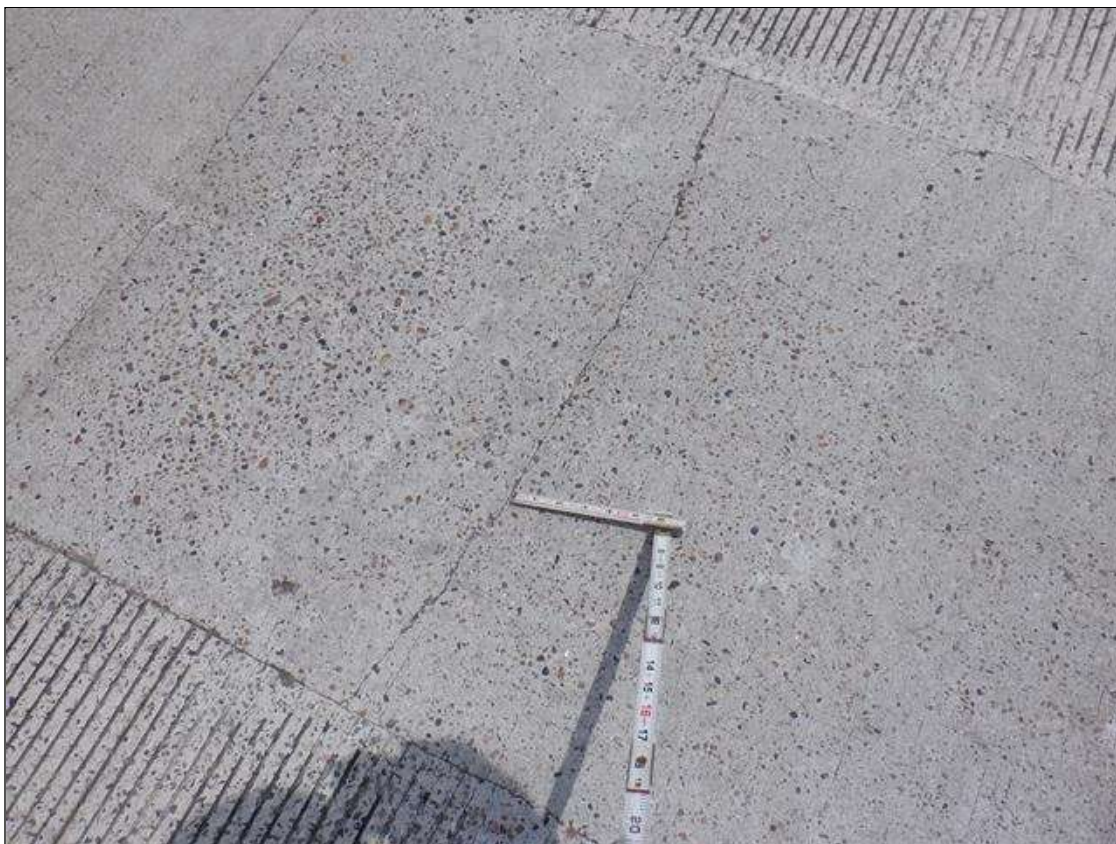
Span 1 Deck: 4 FEET LONG X 3 FEET WIDE UNSOUND CONCRETE PATCH WITH 1/16 INCH WIDE X 3 FEET LONG CRACKS EXTENDING FROM THIS PATCH IN RIGHT LANE AT END BENT 1

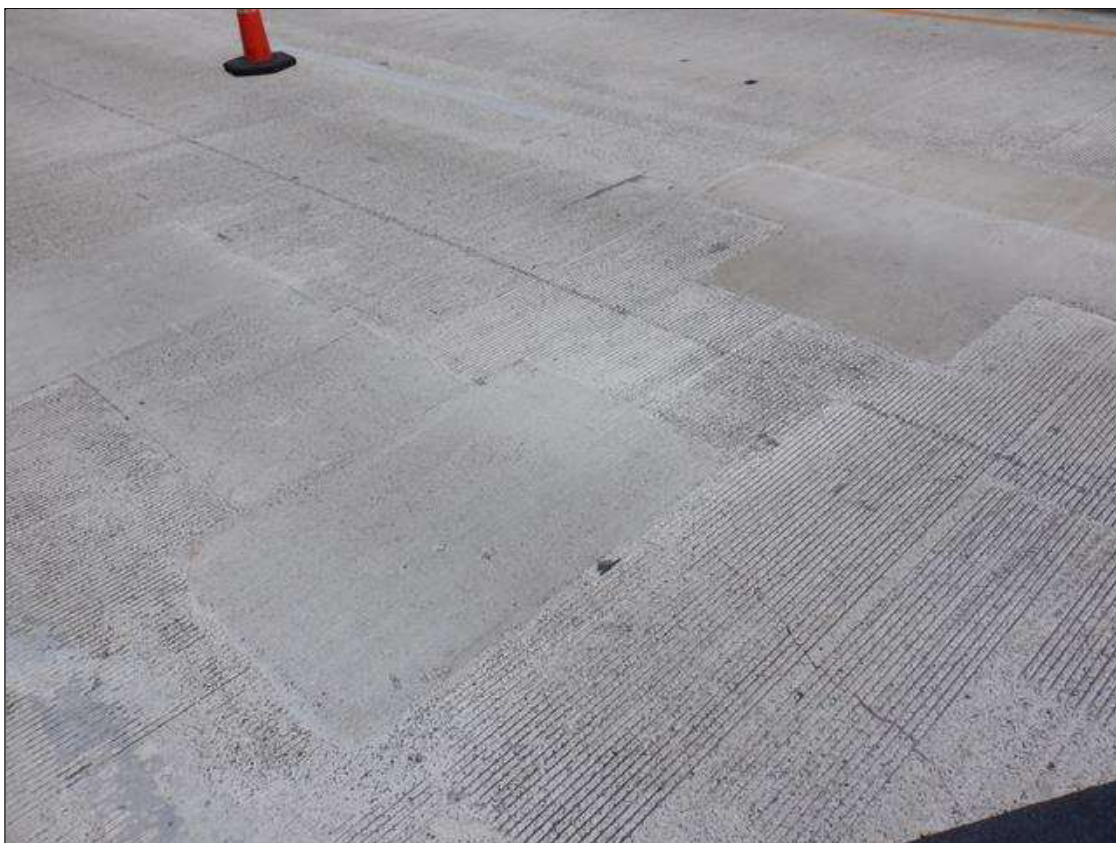
Span 1 Deck: NEAR END BENT 1 IN BOTH LANES PATCHES UP TO 6 FEET X 6 FEET

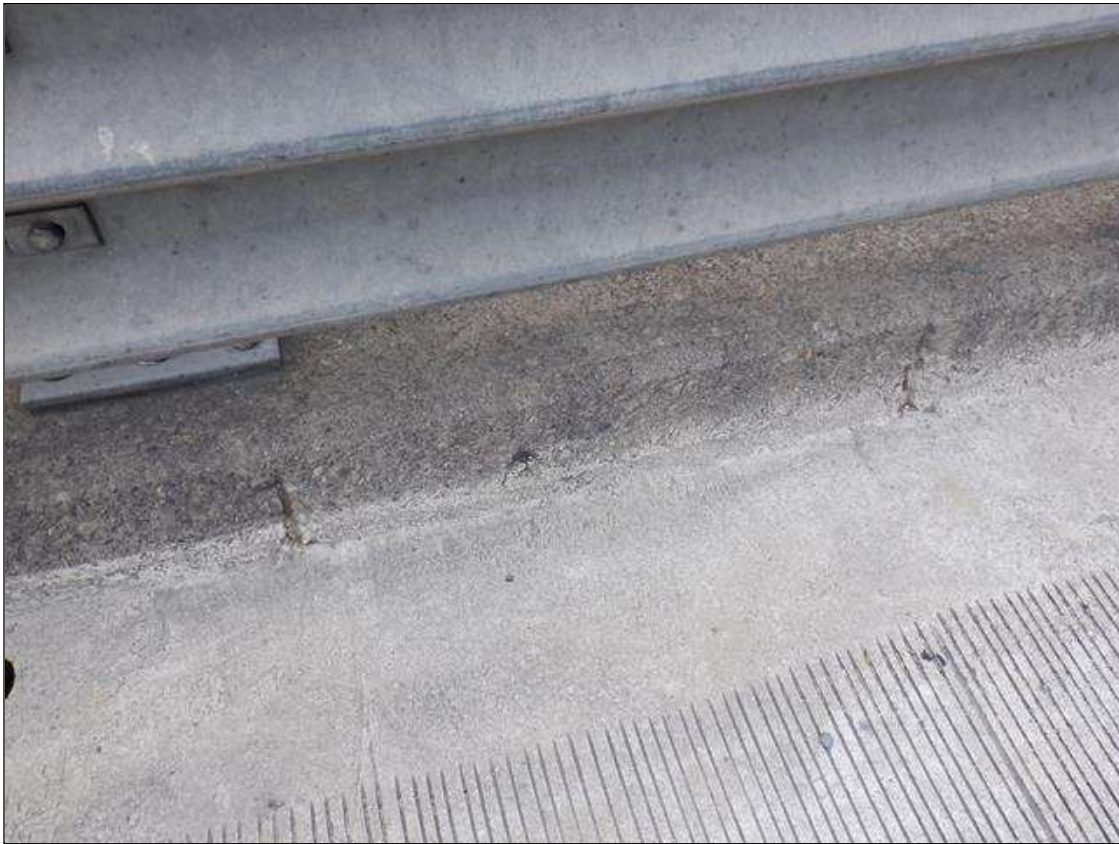
Span 3 Left Bridge Rail: 6 FEET AND 10 FEET FROM BENT 3 JOINT, BOTTOM OF CURB, TWO (2) SPALLS UP TO 8 INCHES DIAMETER X 1 INCH DEEP WITH EXPOSED REINFORCEMENT. NO MEASUREABLE SECTION LOSS IN EXPOSED REINFORCEMENT.

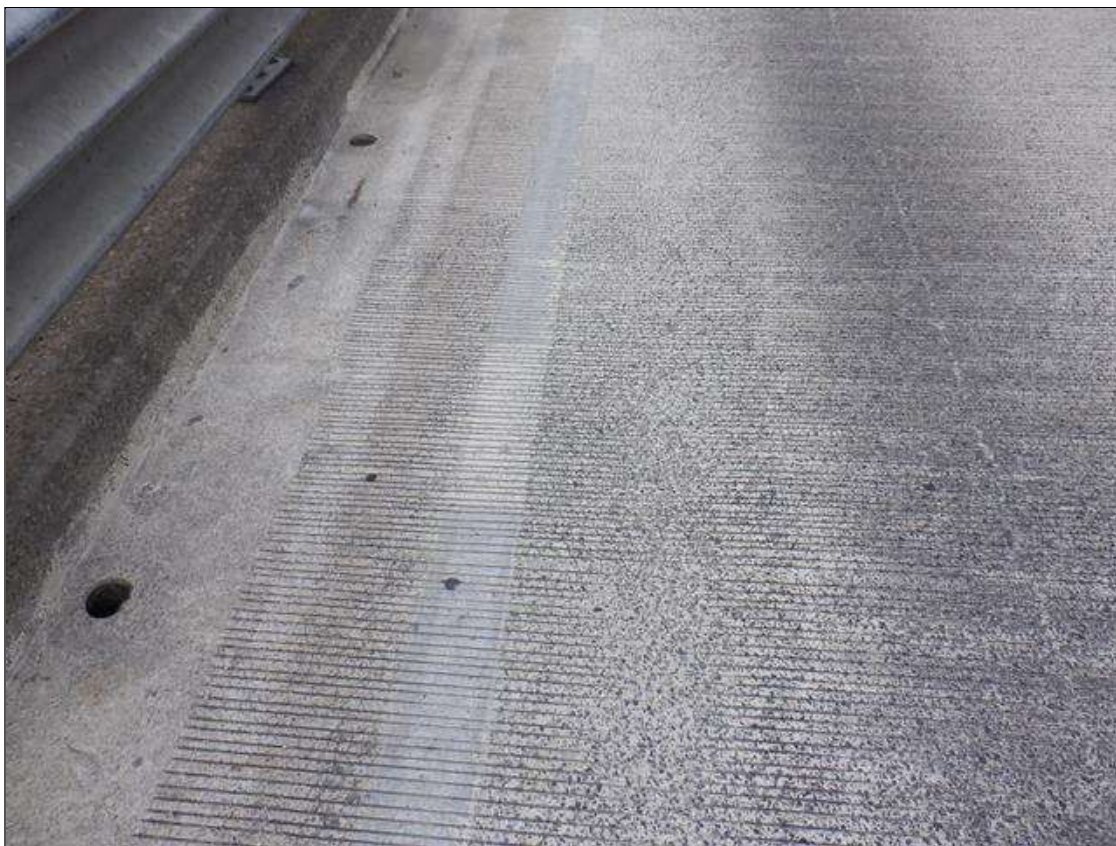
Span 4 Deck: MINOR ABRASION ON WALL MOUNT AND DECK WORN OUT WITH EXPOSED AGGREGATE IN WHEEL PATHS OF BOTH TRAVEL LANES

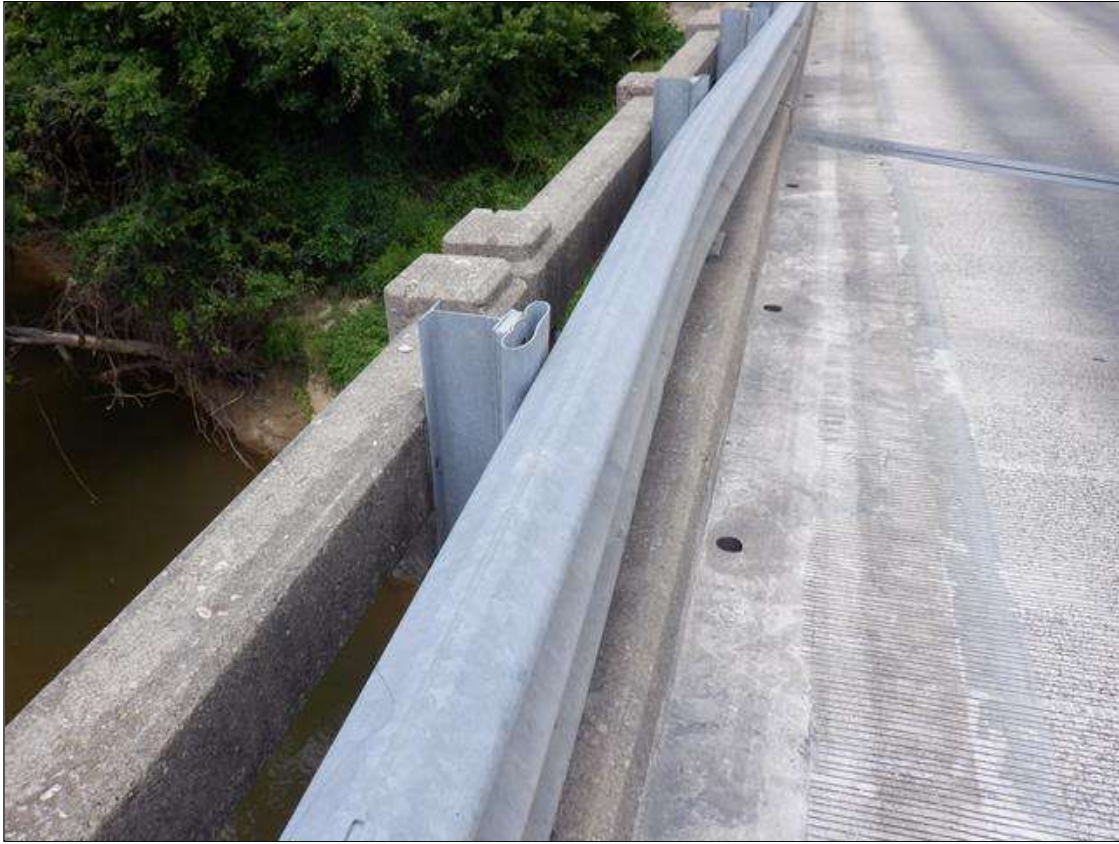
Span 6 Left Retrofit Bridge Rail: PAR, MODERATE TO HEAVY IMPACT DAMAGE WITH UP TO 5 INCHES DEFLECTION TOWARDS WEST TO THE SUPPLEMENTAL BRIDGE RAIL FOR 20 FEET LONG STARTING AT BENT 6. TWO (2) SPACER BLOCKS CONNECTING THE GUARDRAIL TO POSTS ARE PARTIALLY CRUSHED.

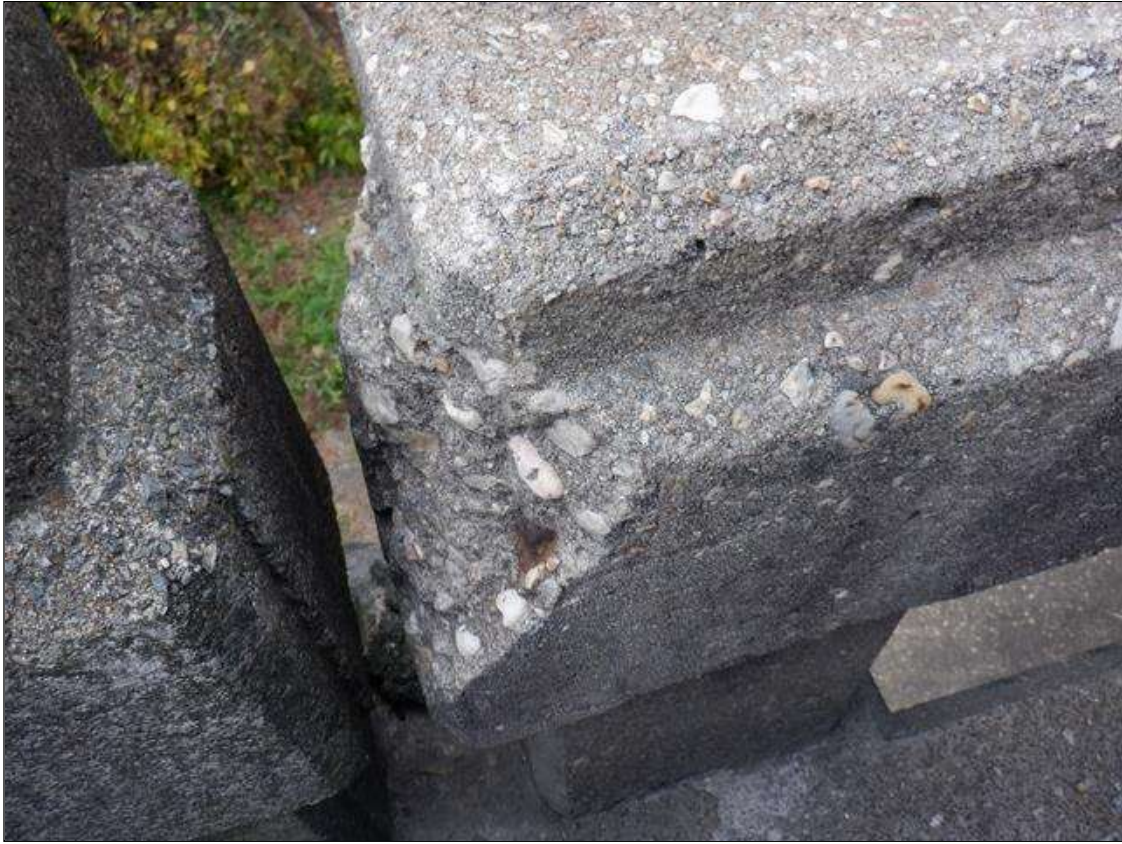
Span 8 Left Bridge Rail: TOP OF RAIL AT FIRST RAIL JOINT FROM END BENT 2, 8 INCHES WIDE X 8 INCHES HIGH X UP TO 3 INCHES DEEP SPALL WITH EXPOSED REINFORCEMENT, 10 PERCENT SECTION LOSS

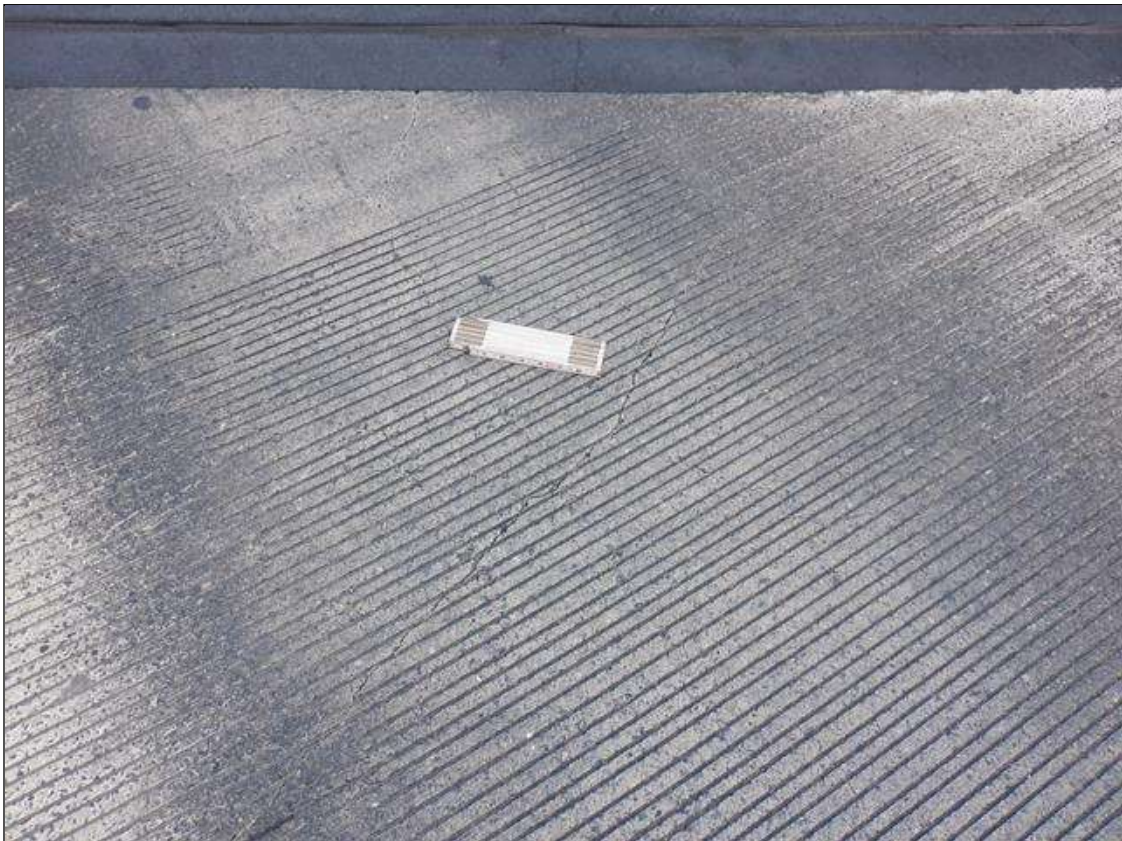
Span 8 Deck: UP TO 0.05 INCH WIDE X 8 FEET LONG DIAGONAL CRACKS EXTENDING FROM EXPANSION JOINT AT END BENT 2

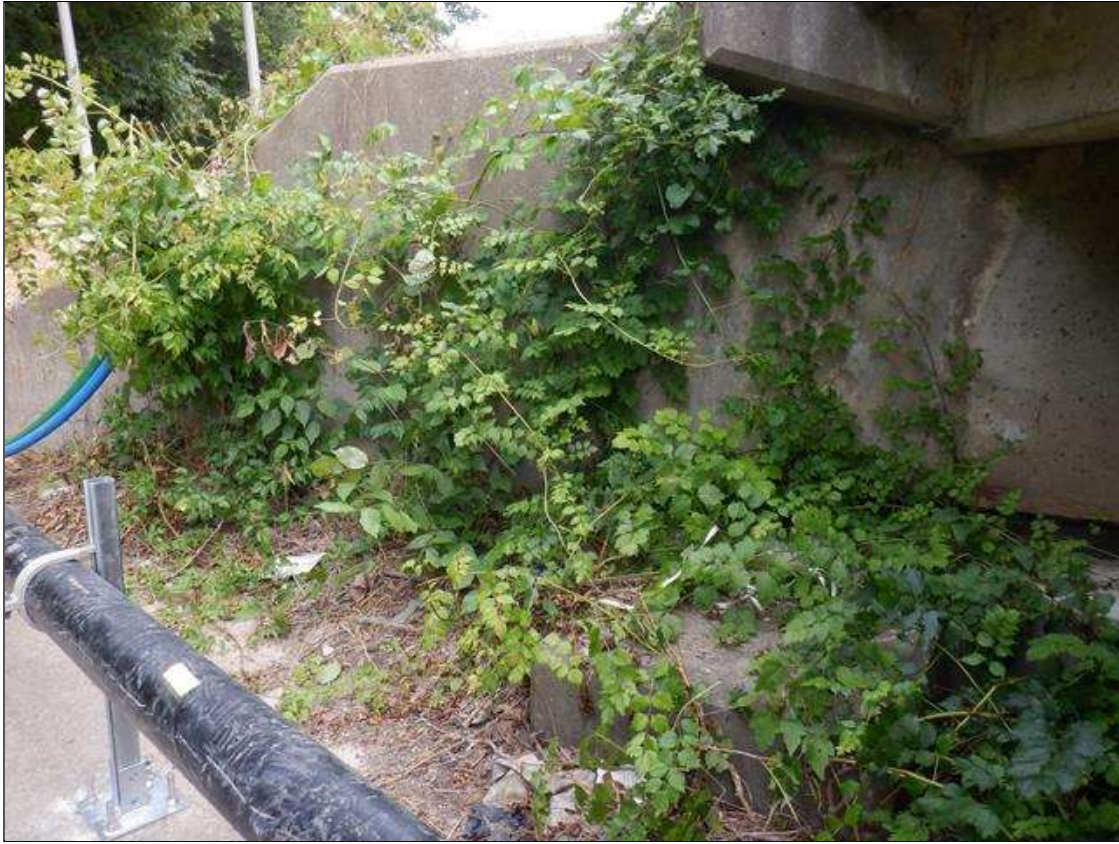
NORTHWEST WING HAS VEGETATION GROWTH. SIMILAR AT NORTHEAST.

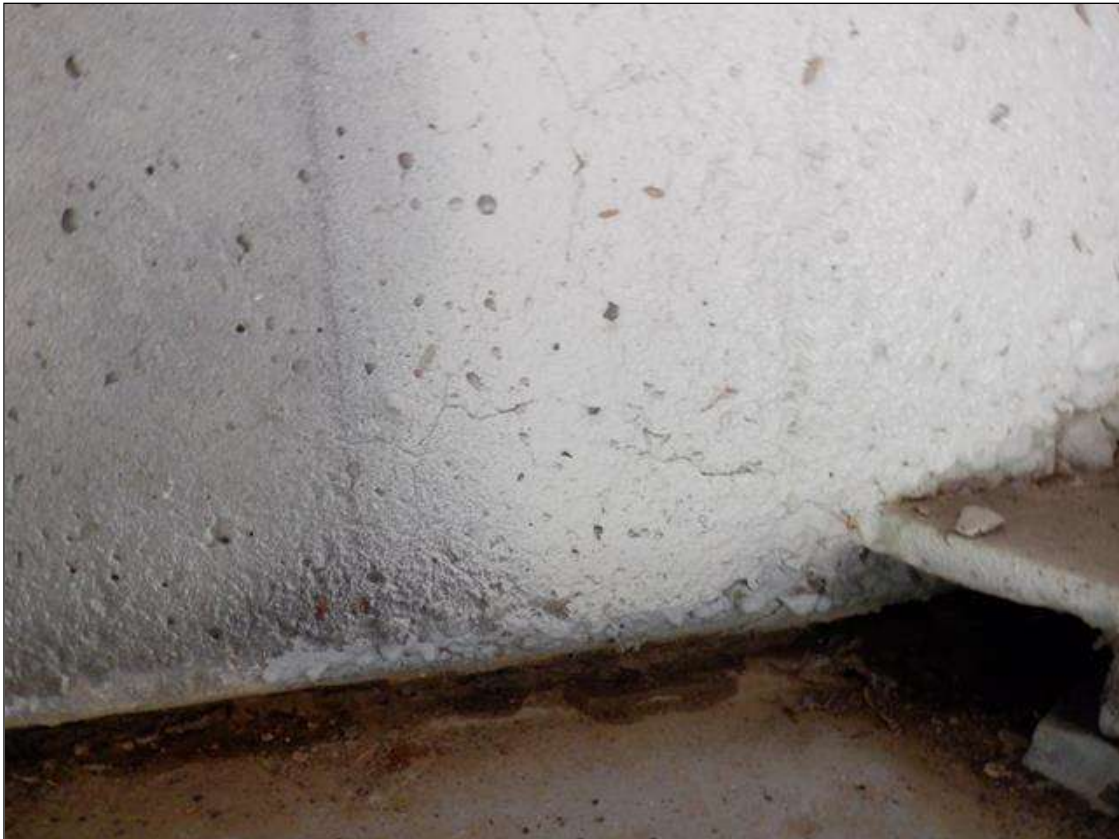
End Bent 2 Abutment: UP TO 1/16 INCH WIDE X 2 FEET LONG DIAGONAL CRACKS EXTENDING FROM BEARING AT ALL BEAMS

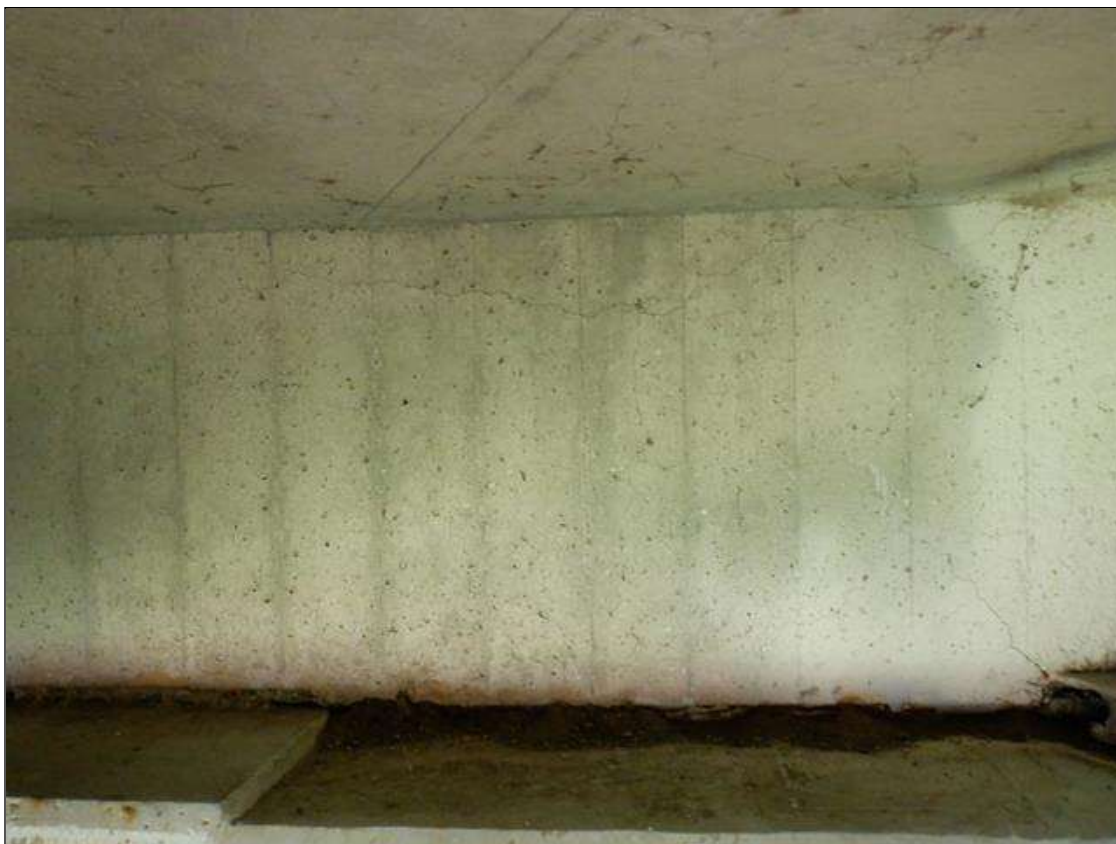
End Bent 1 Abutment: UP TO 0.03 INCH WIDE RANDOM CRACKING IN BACKWALL FOR FULL LENGTH.

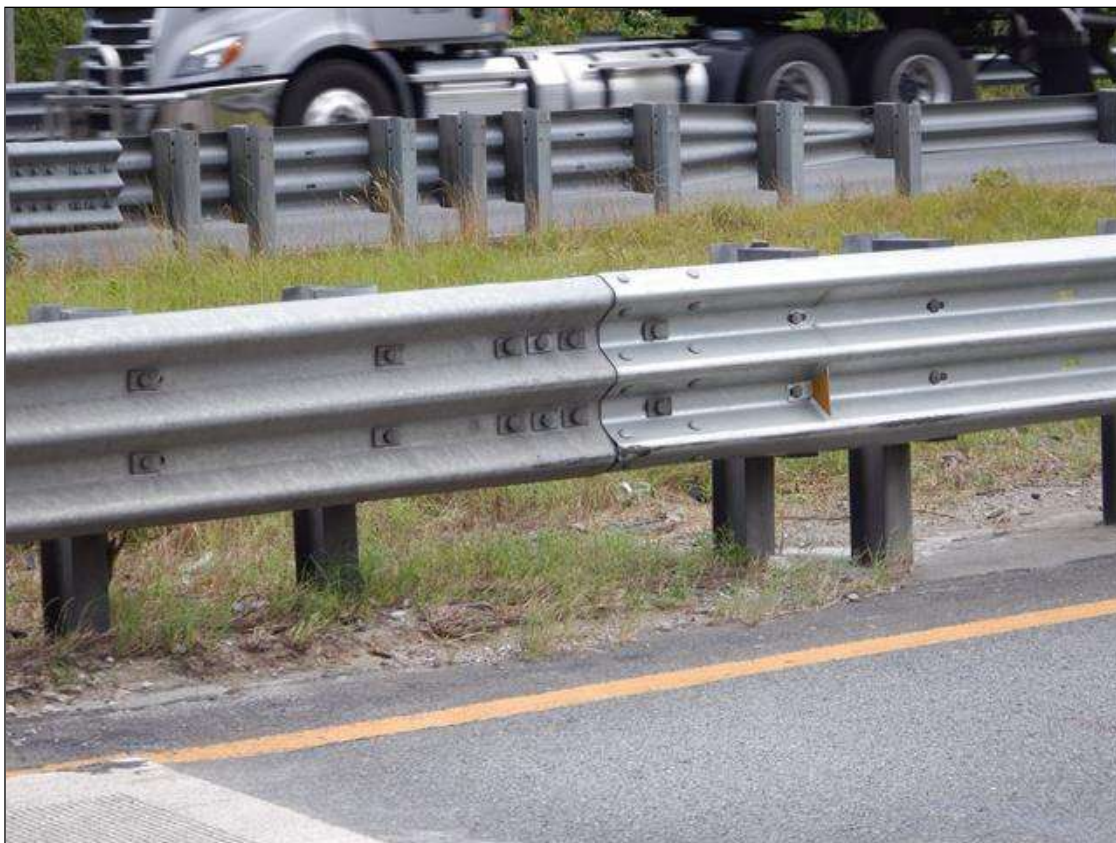
PAR. SOUTHEAST GUARDRAIL AT APPROACH LAPPED OPPOSITE TRAFFIC.

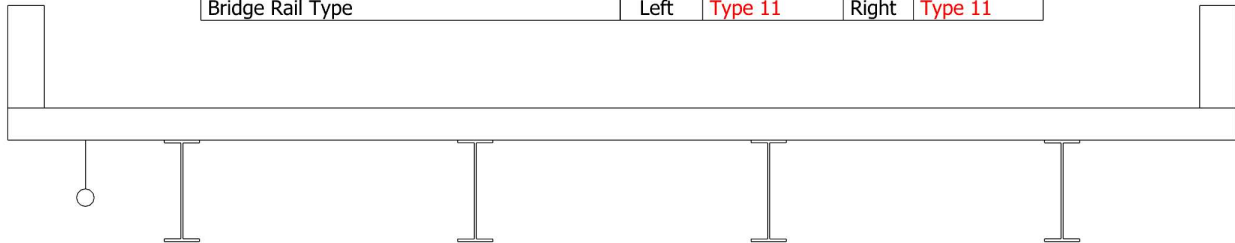
Measurements for Span #	1	ALL SPANS SIMILAR	
Deck Thickness	10.5in	Left Overhang	4.75ft
Top of Rail to Bottom of Beam (Avg)	6.438ft	Right Overhang	4.75ft
